MONTANA DEPARTMENT OF ENVIRONMENTAL QUALITY

McLaren Tailings  
Project Update  
September 3, 2014

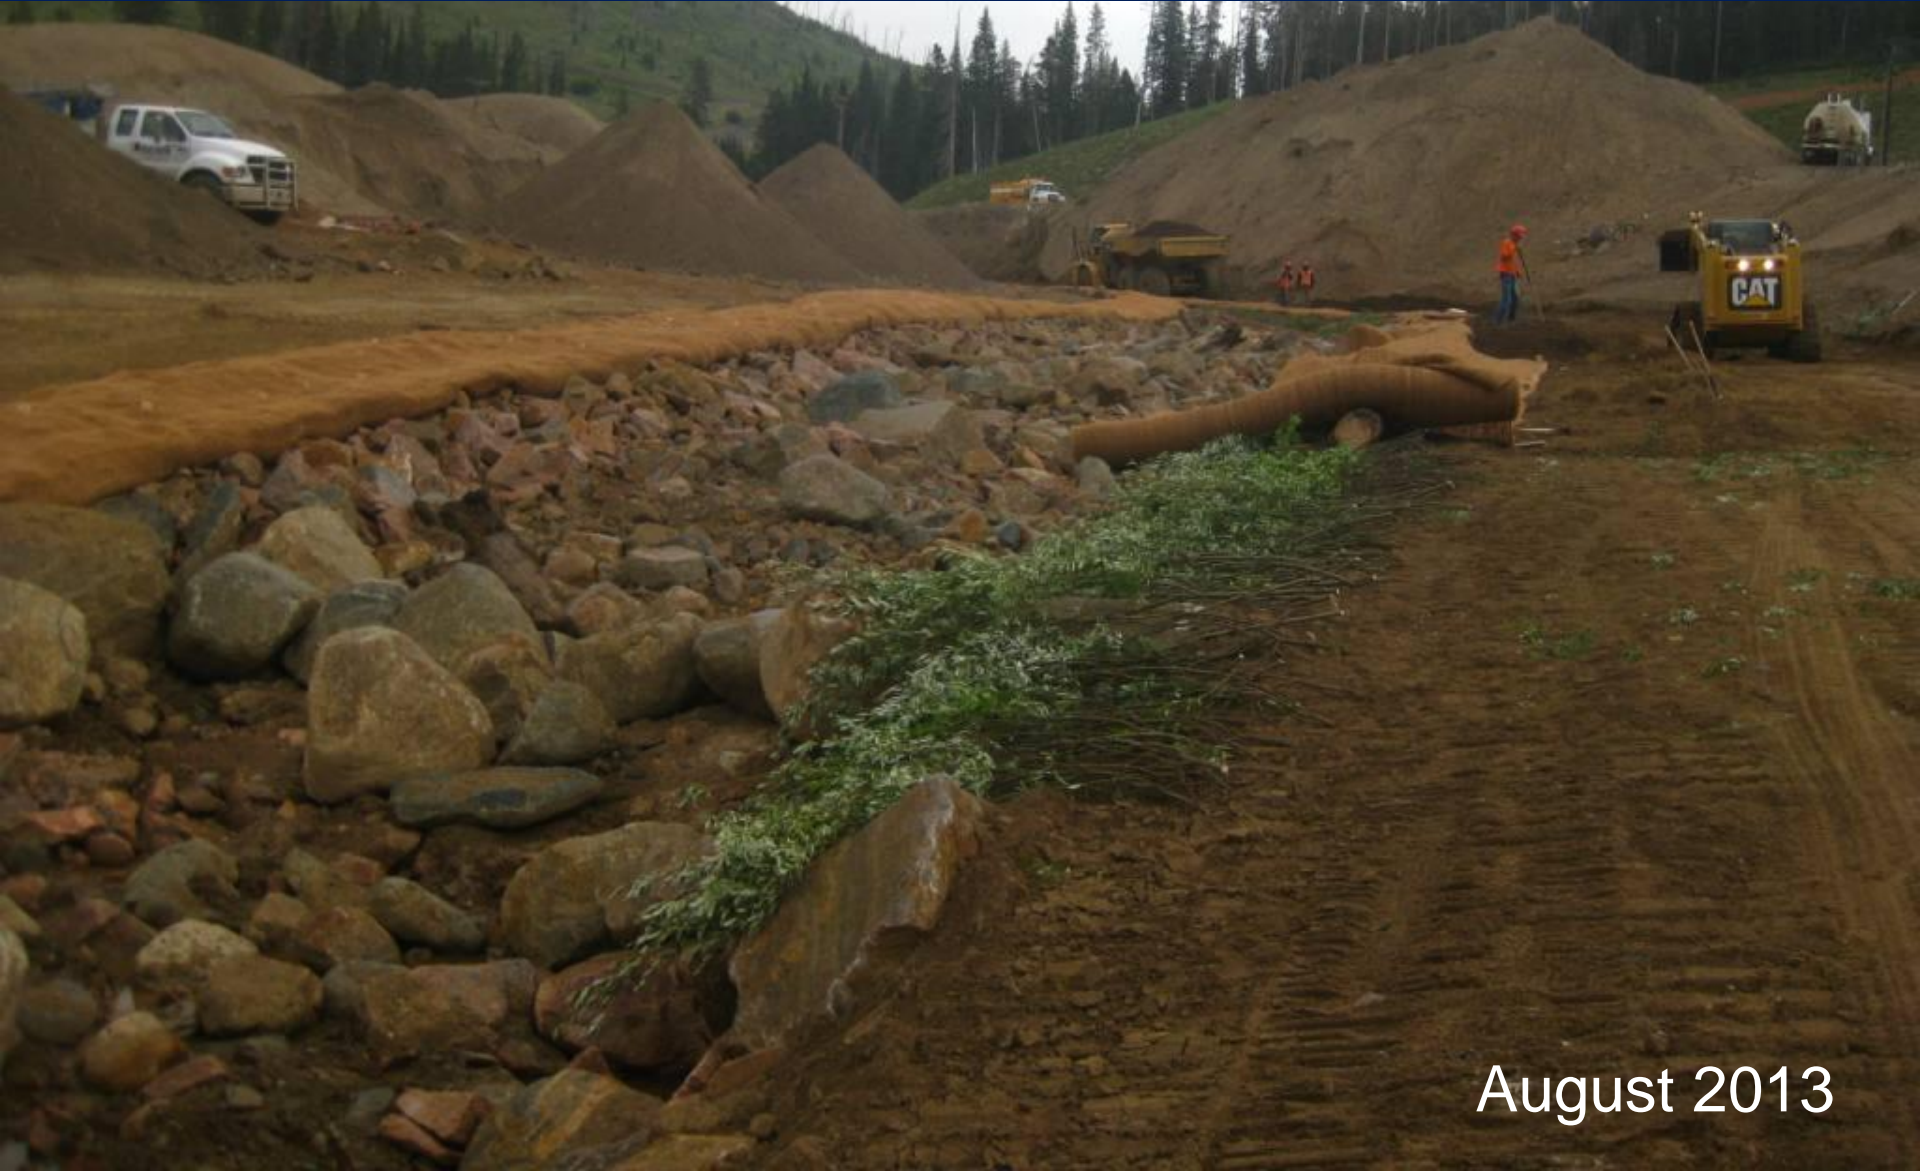
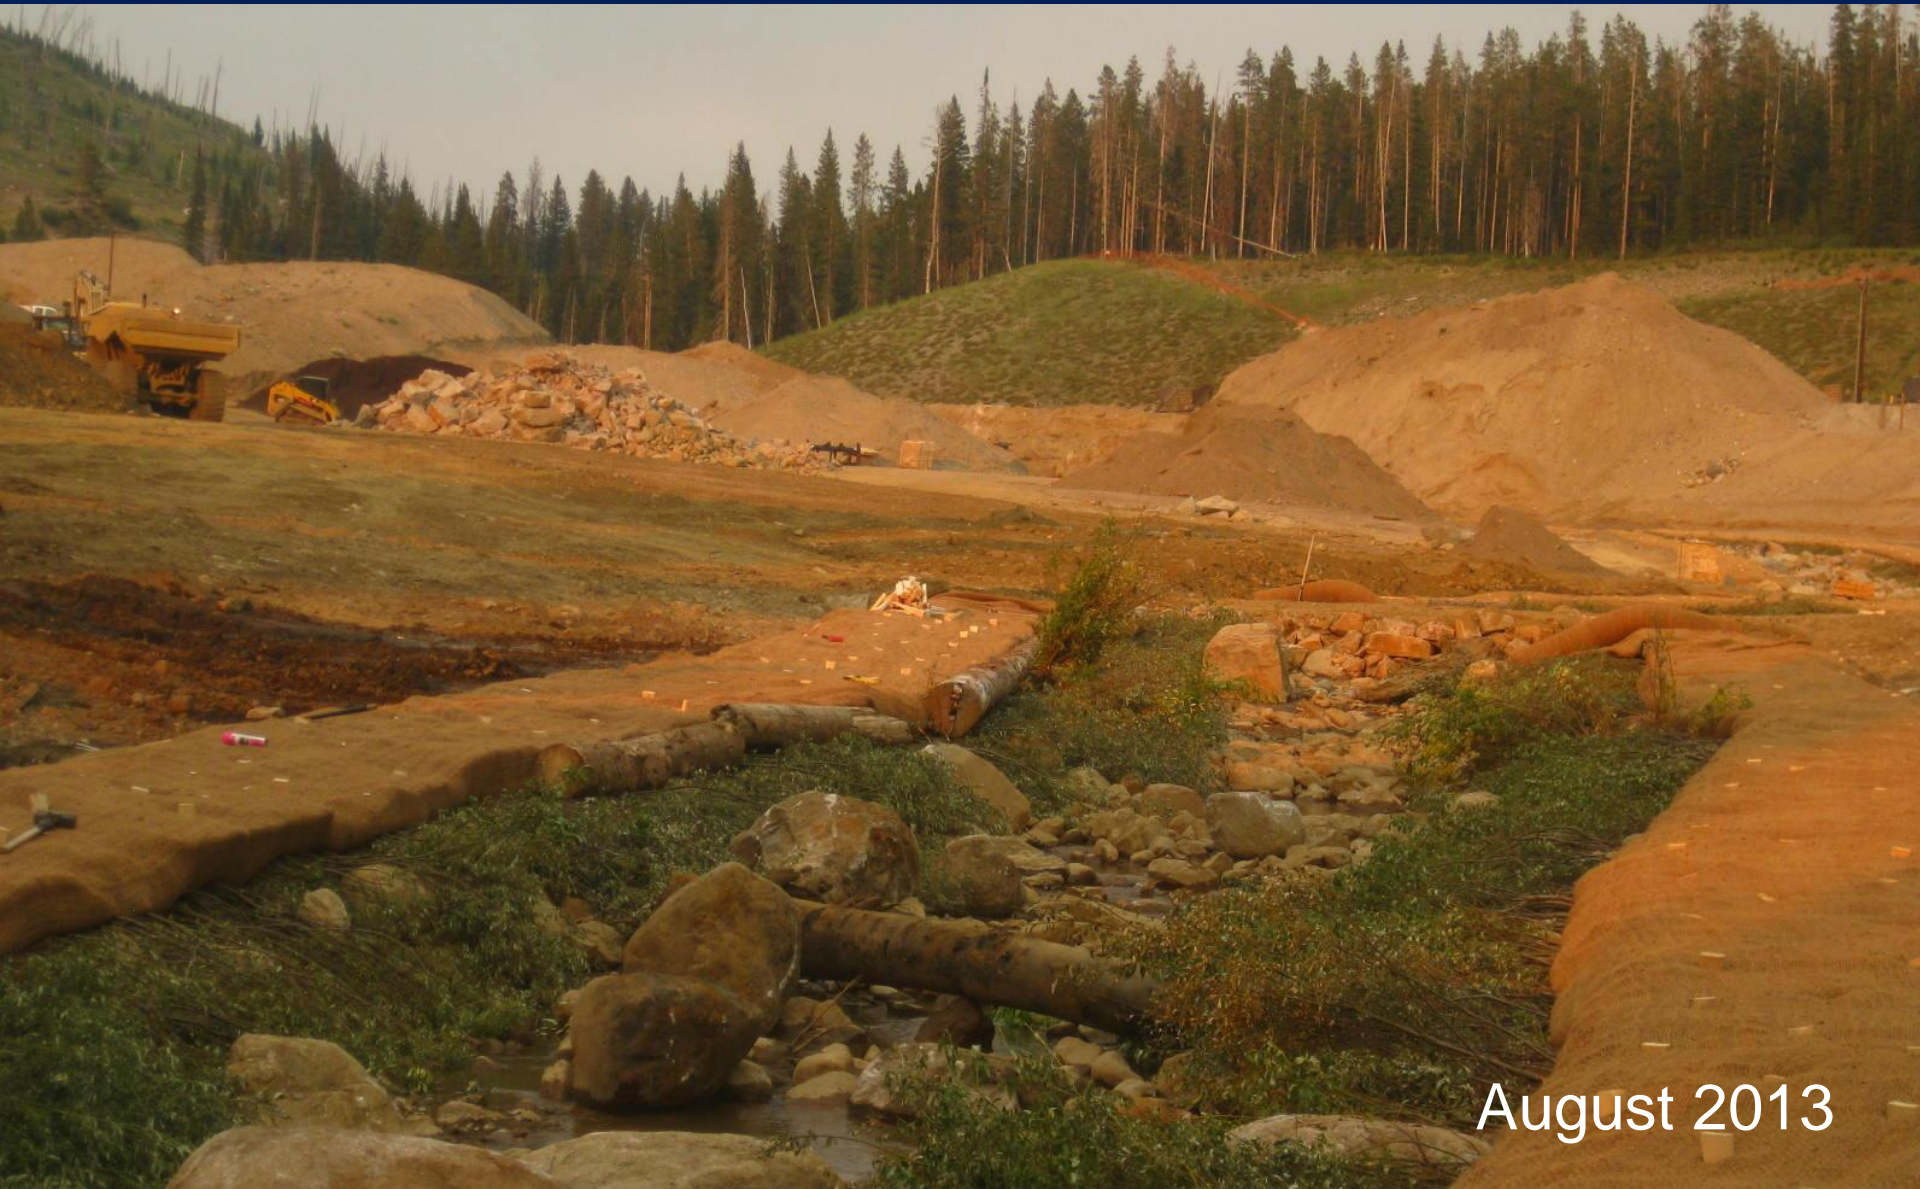
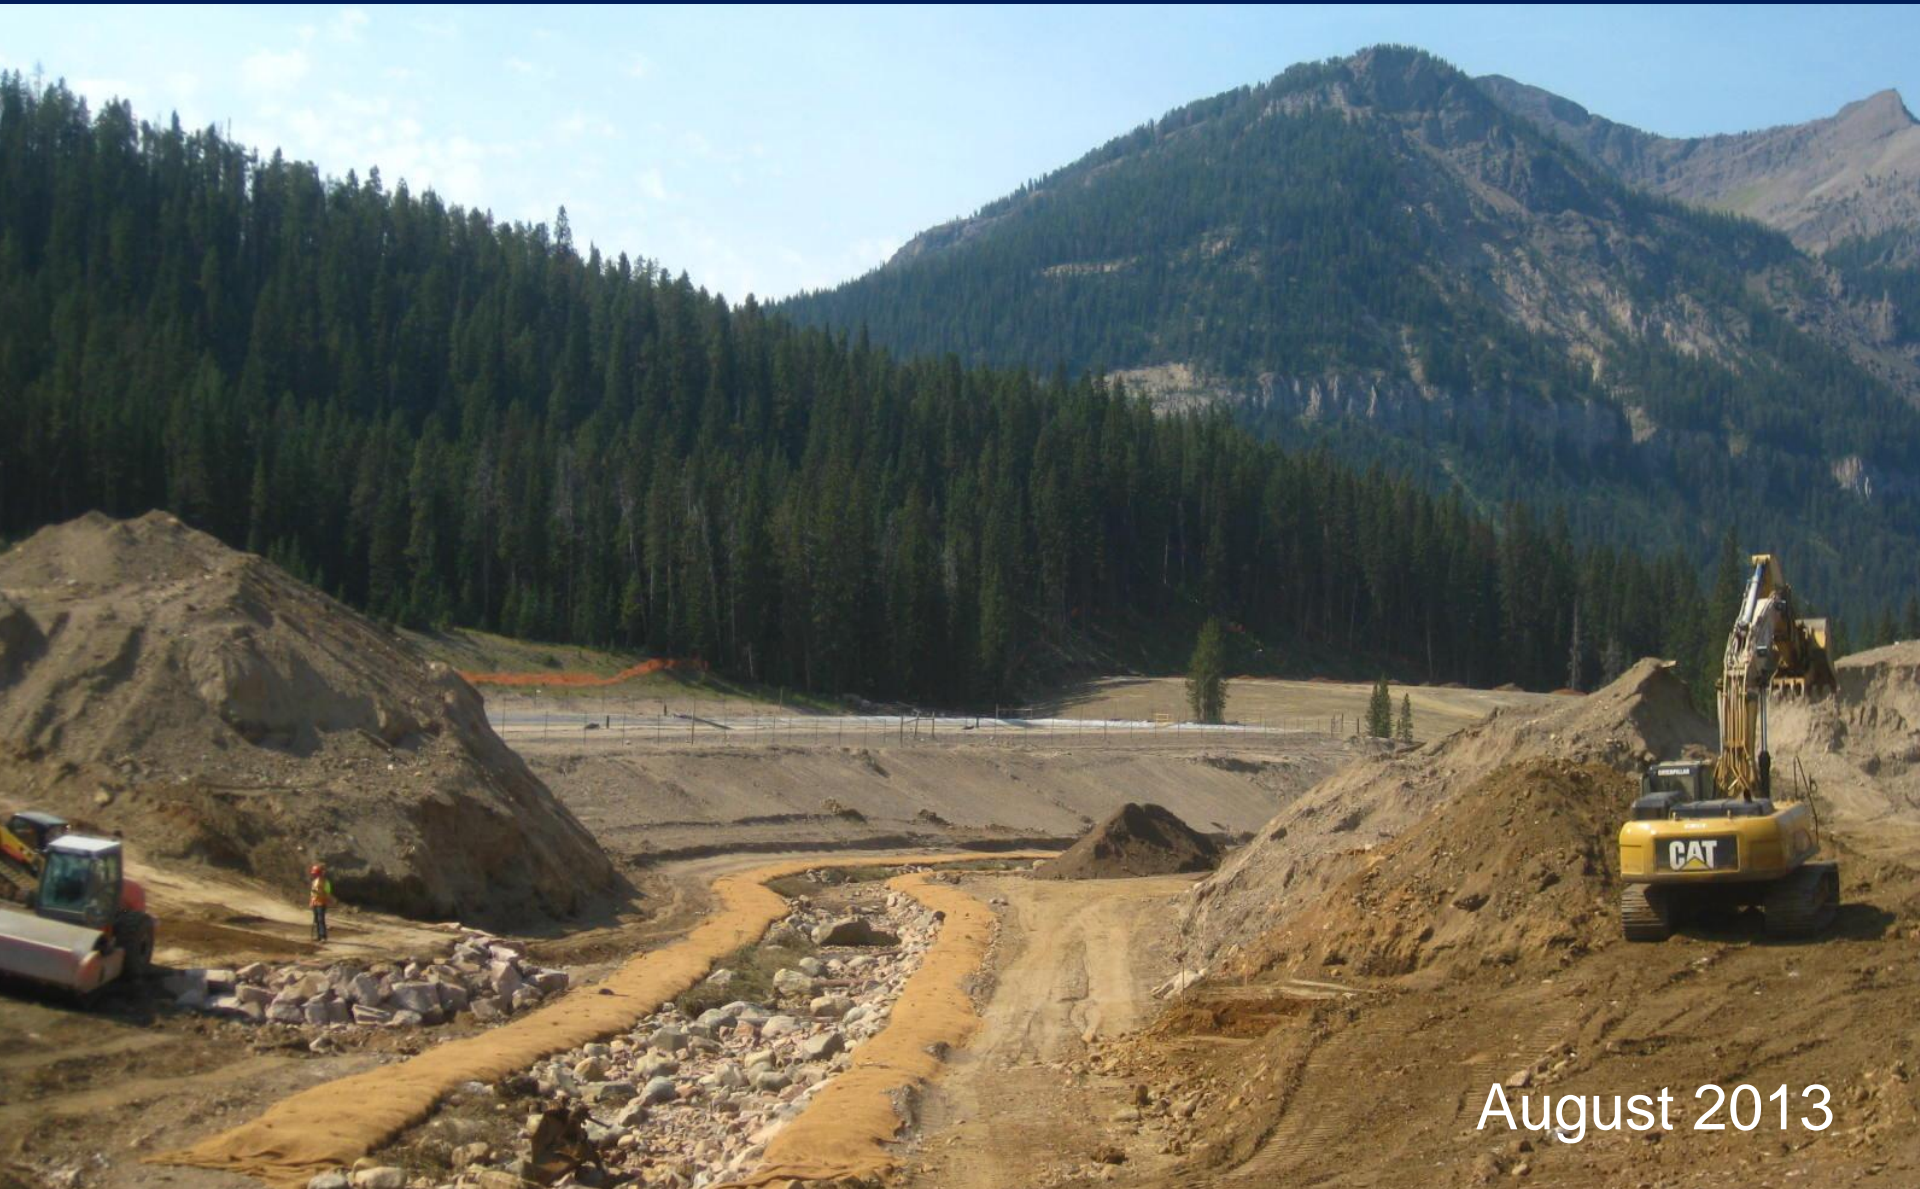
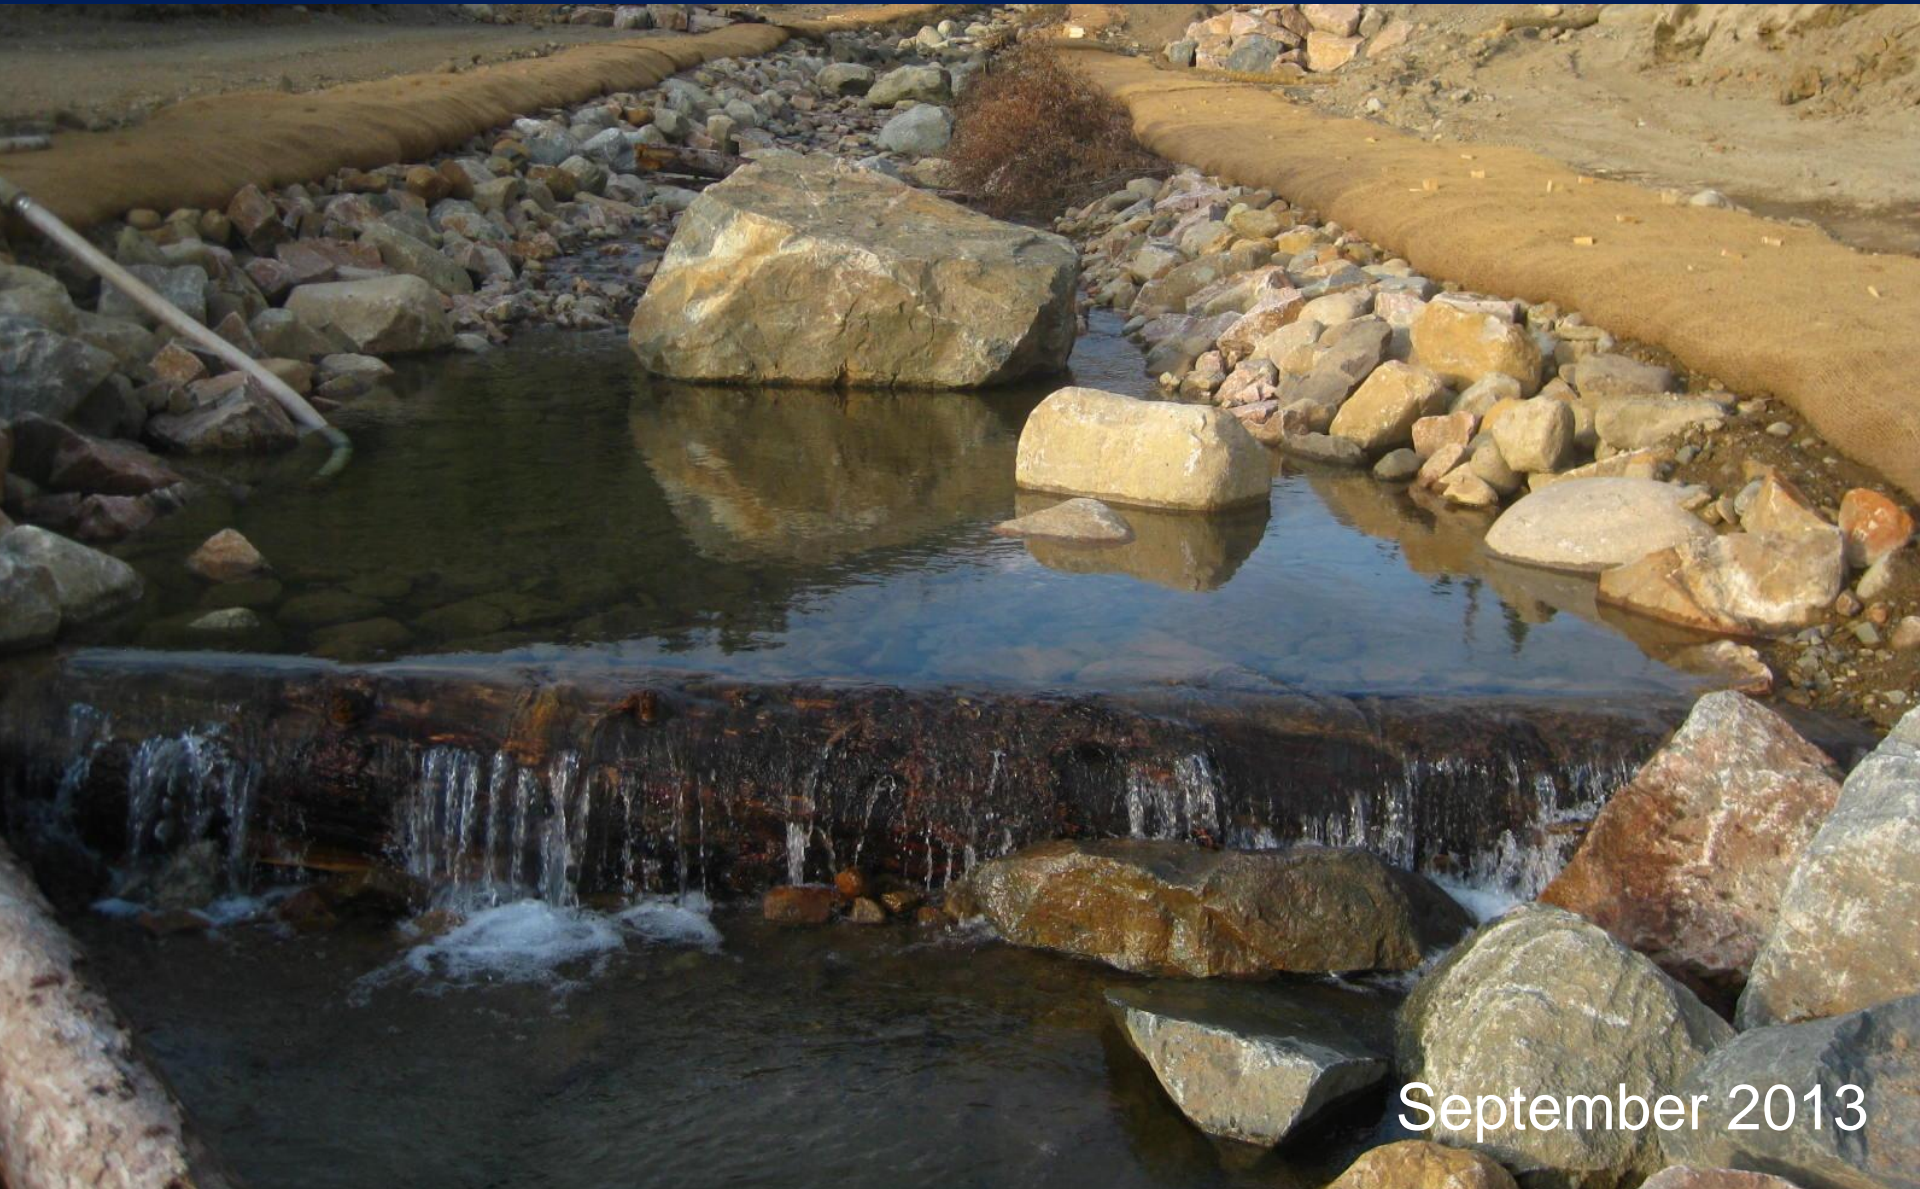
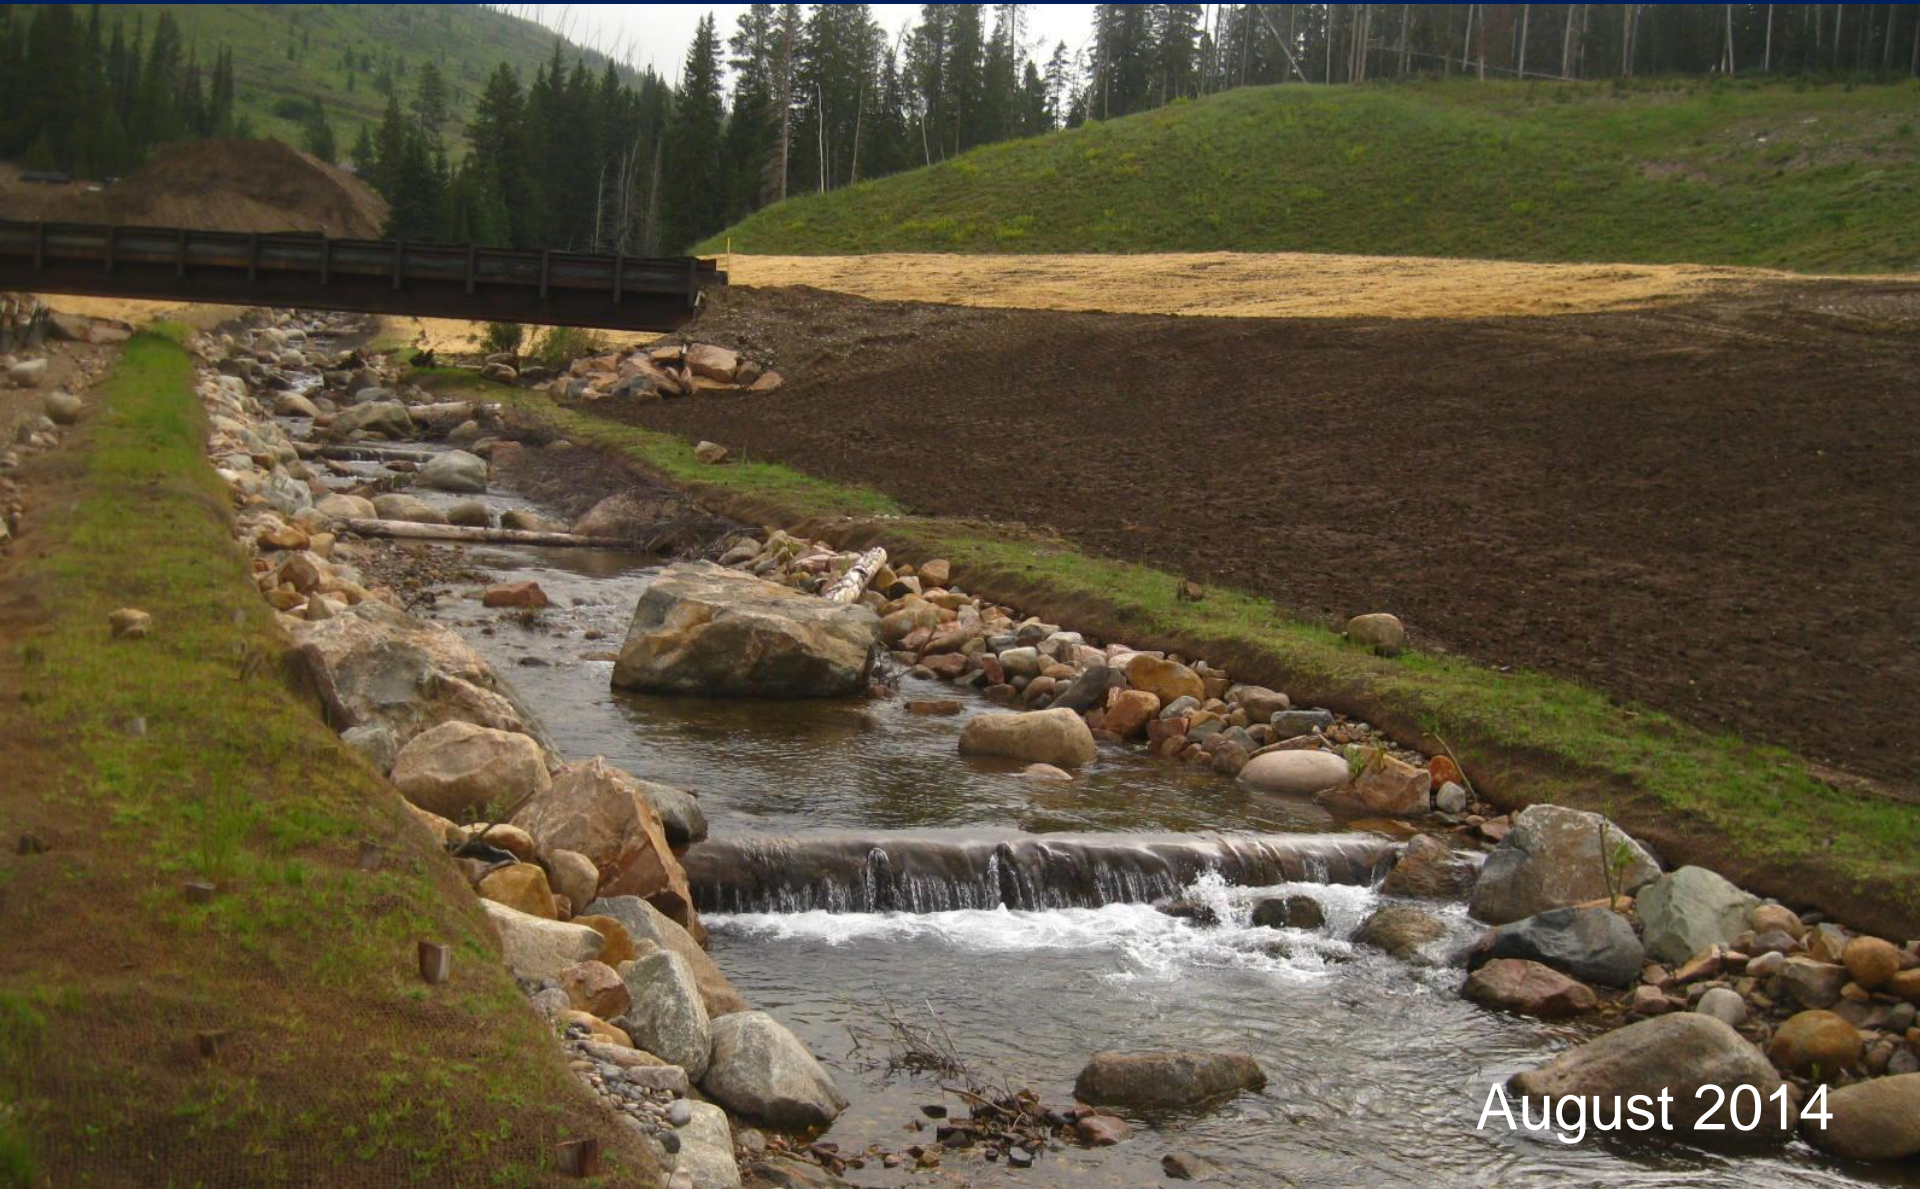
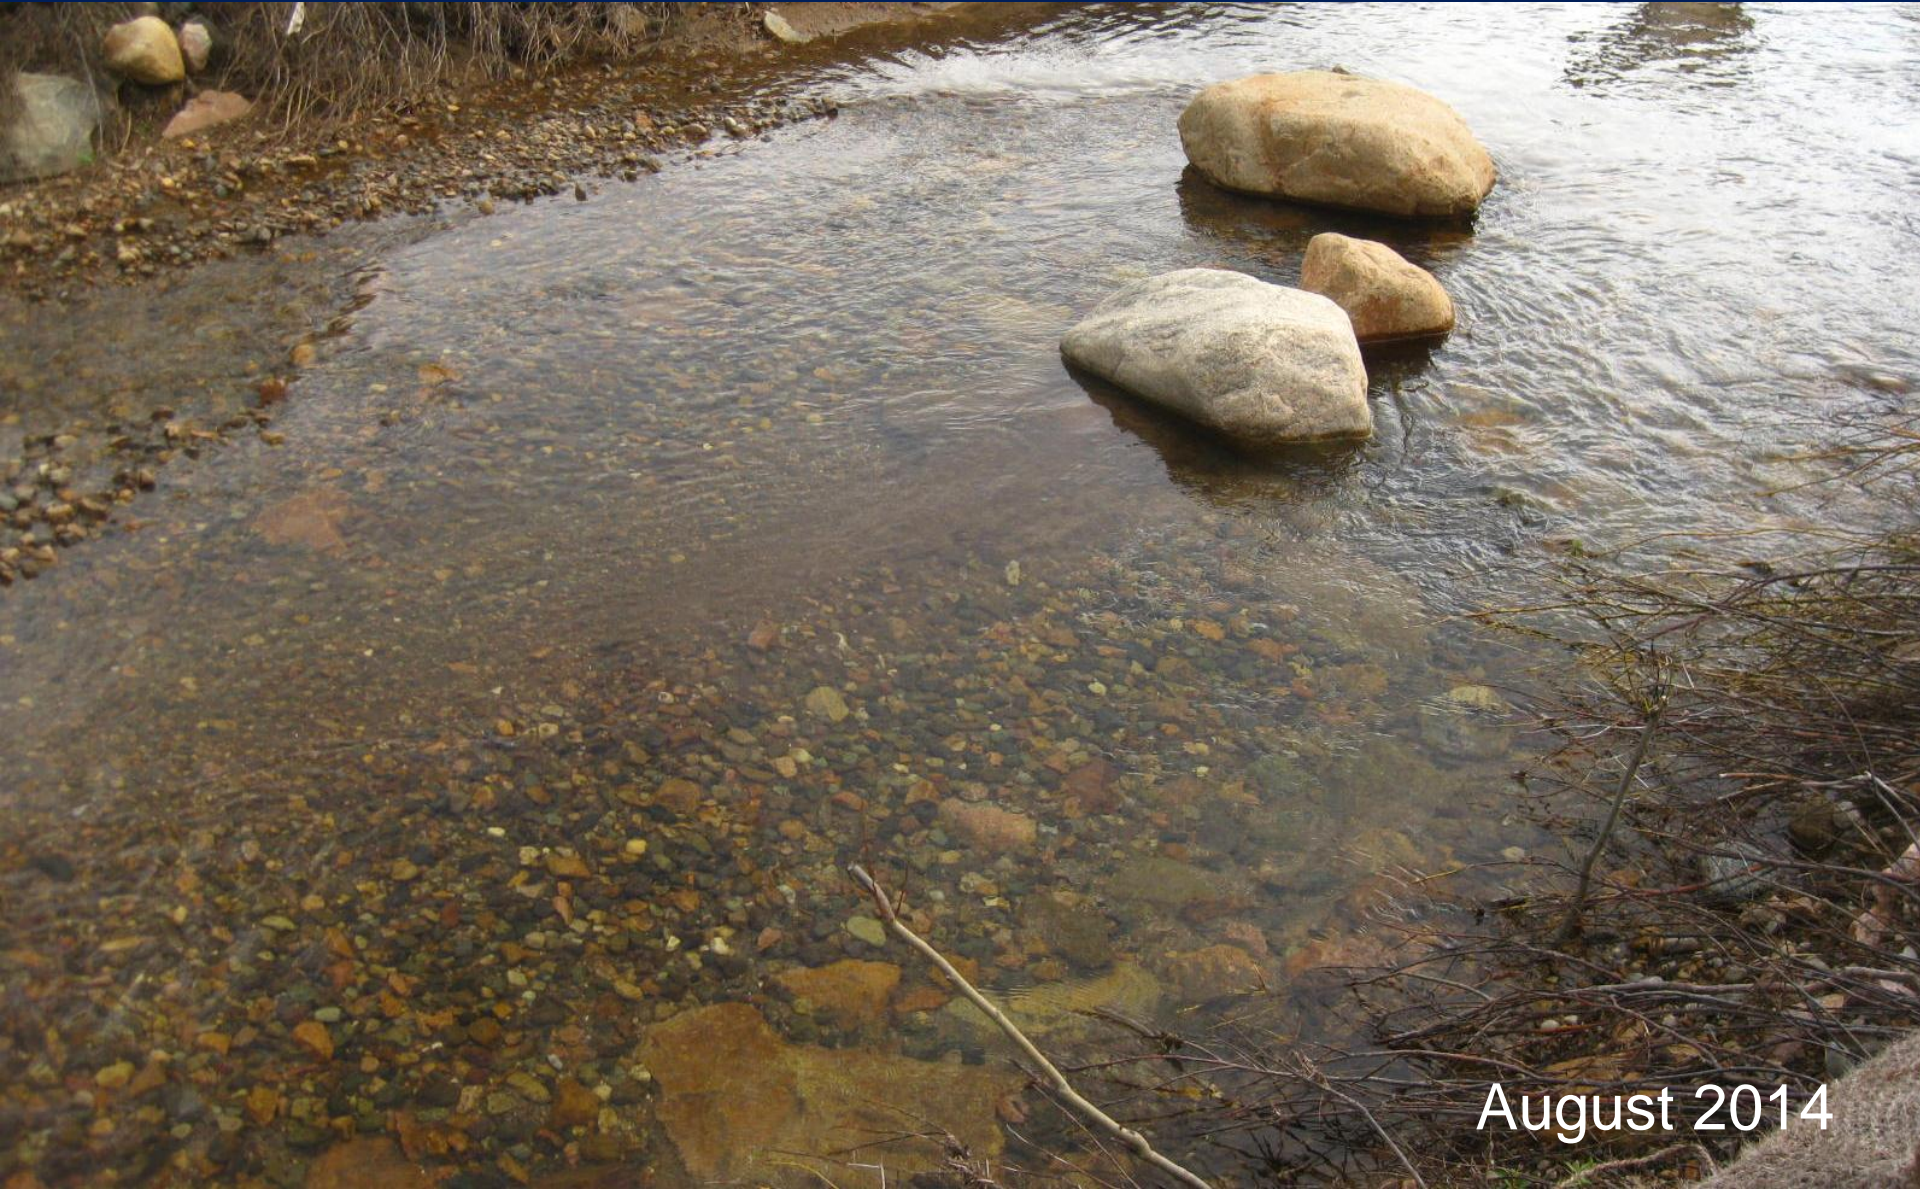
# Soda Butte Creek Reconstruction

- Initiated in July 2013
- Approximately 1,500 linear feet of Soda Butte Creek
- Approximately 525 linear feet of Miller Creek
- Willow brush, root wads and boulder clusters
- Coconut fabric to stabilize banks
- Riparian seeding
- Planting of willow stakes

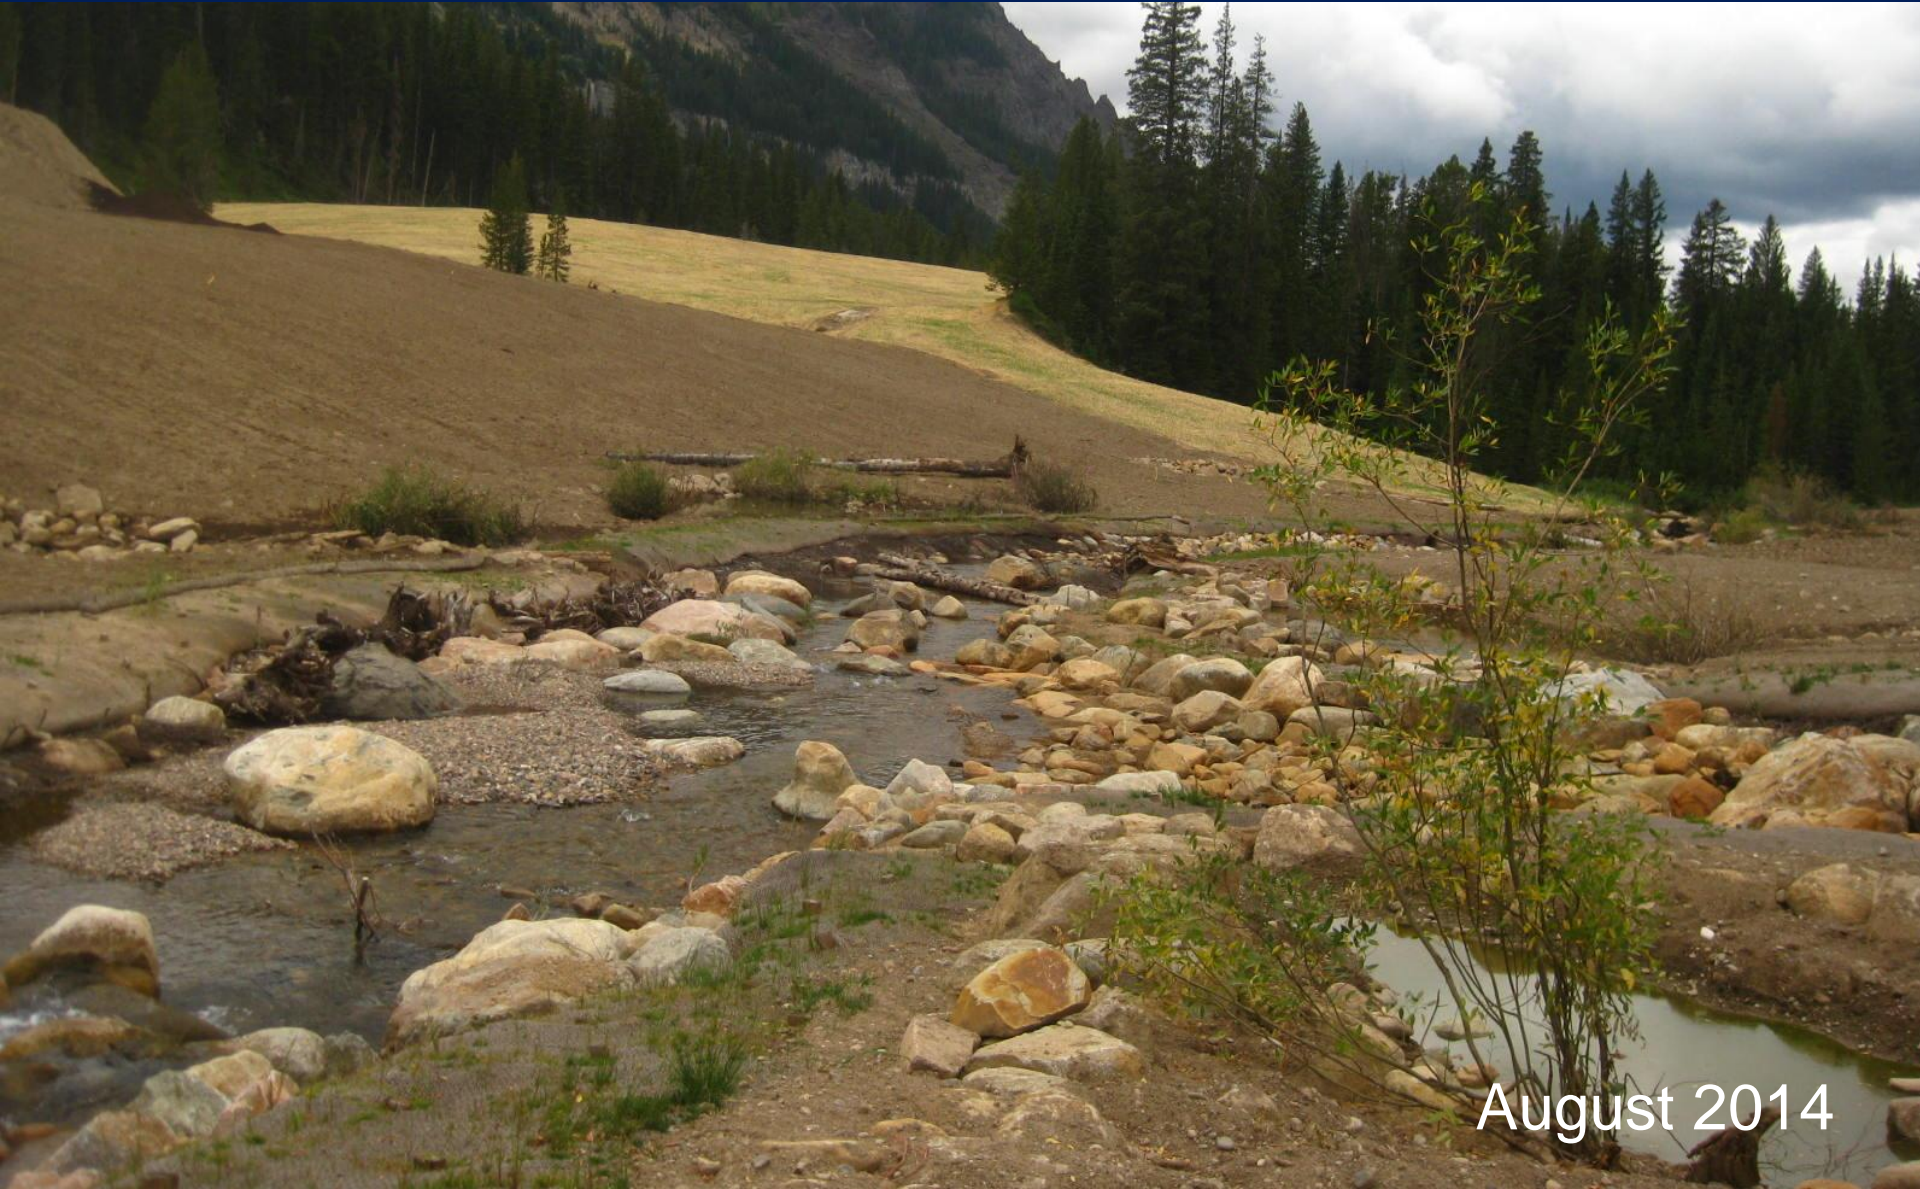
August 2014

# Soda Butte Creek Reconstruction
