**FINAL
CONSTRUCTION REPORT
FOR THE
SPRING MEADOW LAKE RECLAMATION PROJECT
HELENA, MONTANA
MT DEQ MWCB CONTRACT NO. 410001**

March 2010

**CONSTRUCTION REPORT
FOR THE
SPRING MEADOW LAKE STATE PARK - SOIL/SEDIMENT REMOVAL
LEWIS & CLARK COUNTY, MONTANA
MT DEQ CONTRACT NO. 409005**

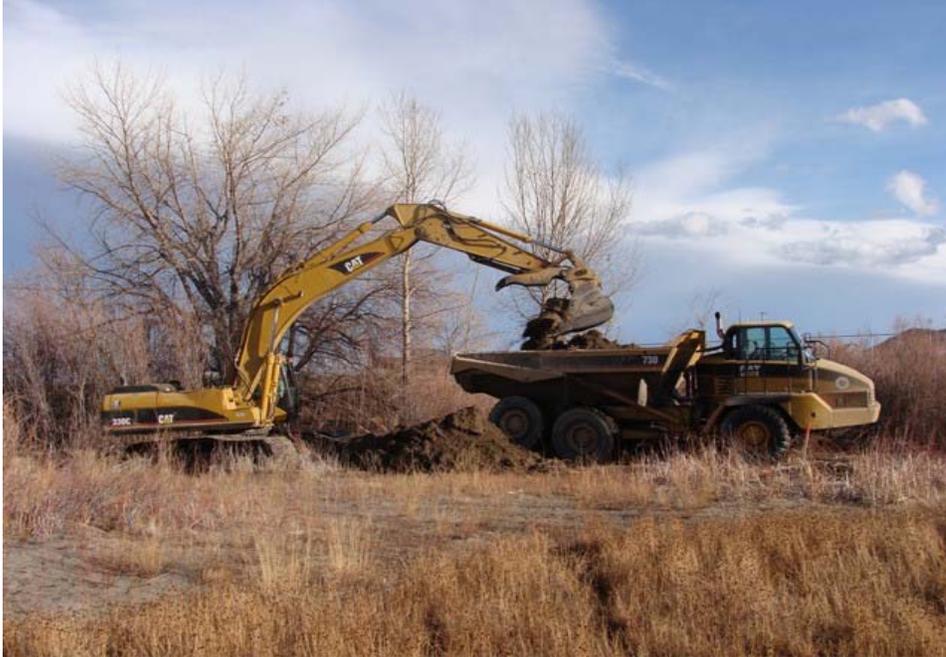
Photo Number: 4 Date: 2/20/2009 Time 17:28

Description: Excavating waste from area around trees on east portion of removal area.

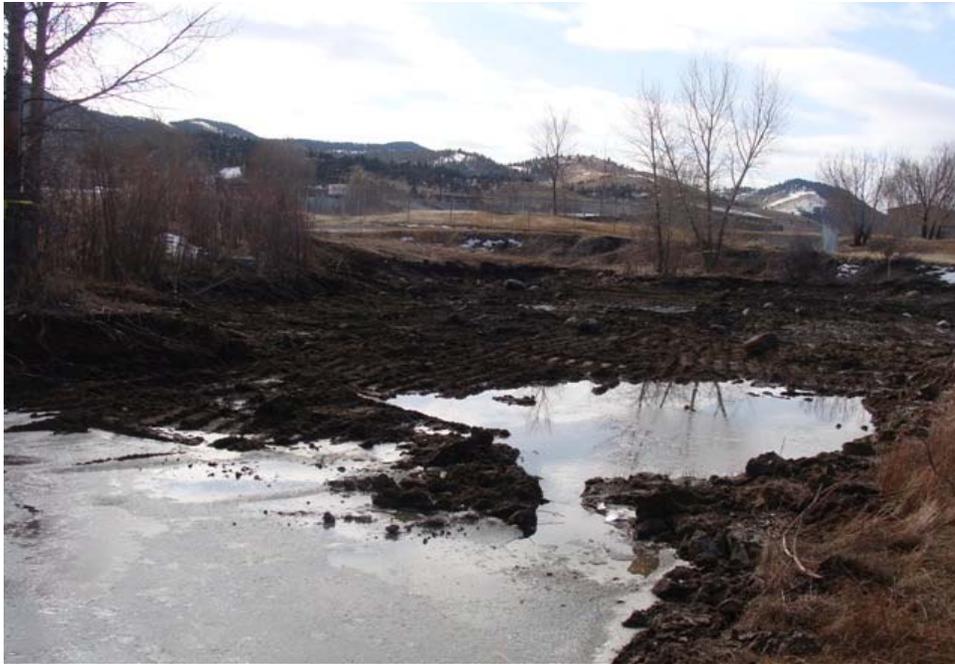
Photo Number: 1 Date: 2/20/2009 Time 13:08

Description: Removal area looking toward MWC after excavation.

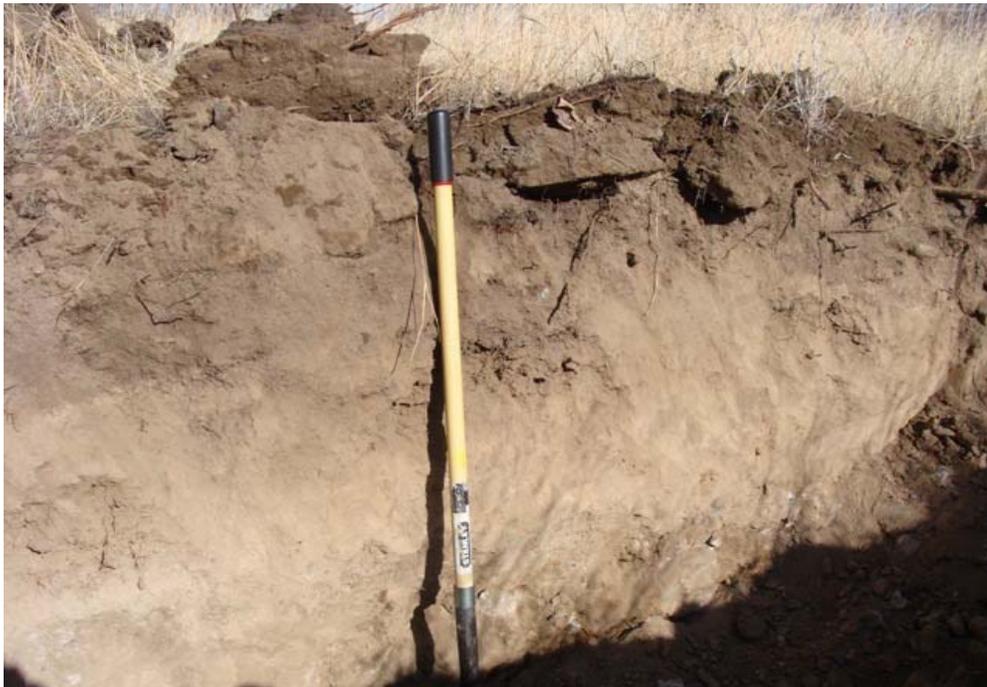
Photo Number: 2 Date: 2/20/2009 Time 17:28

Description: Test pit 404 located northeast of removal area near sample site TP-156. Depth to cobble level at bottom of pit about 42 inches.

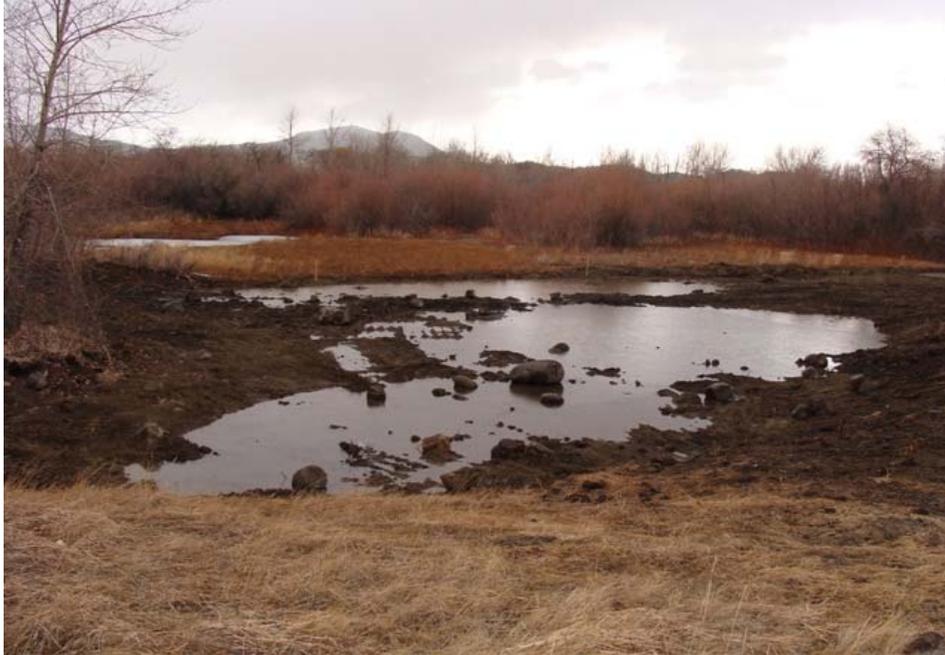
Photo Number: 1 Date: 2/24/2009 Time 10:09
Description: Removal area looking north with large portion flooded by groundwater post excavation.

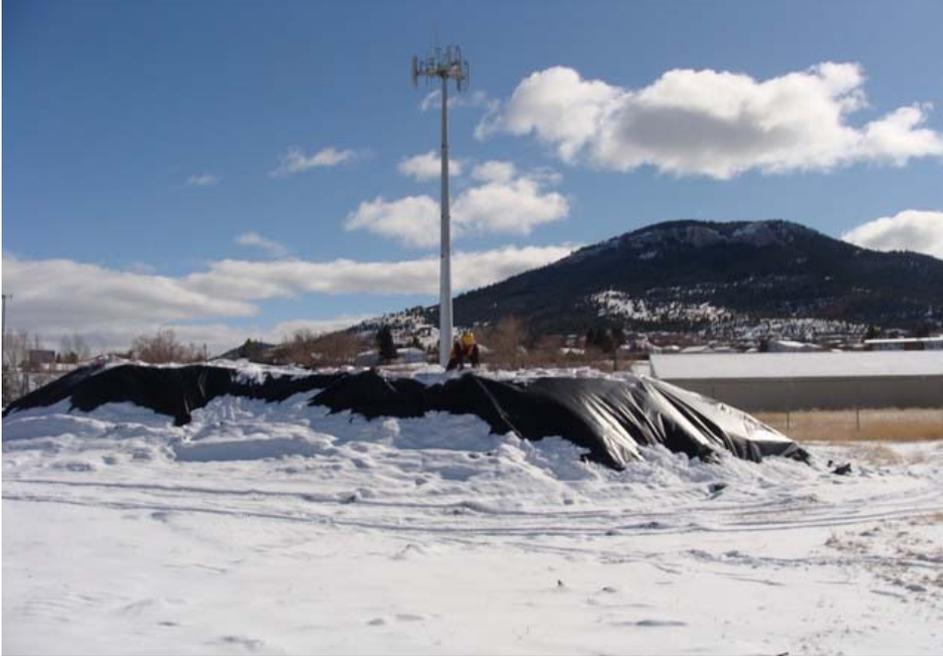
Photo Number: 1 Date: 2/27/2009 Time 13:41
Description: Placing additional sandbags along outer edge of top of stockpile per Work Directive #2.

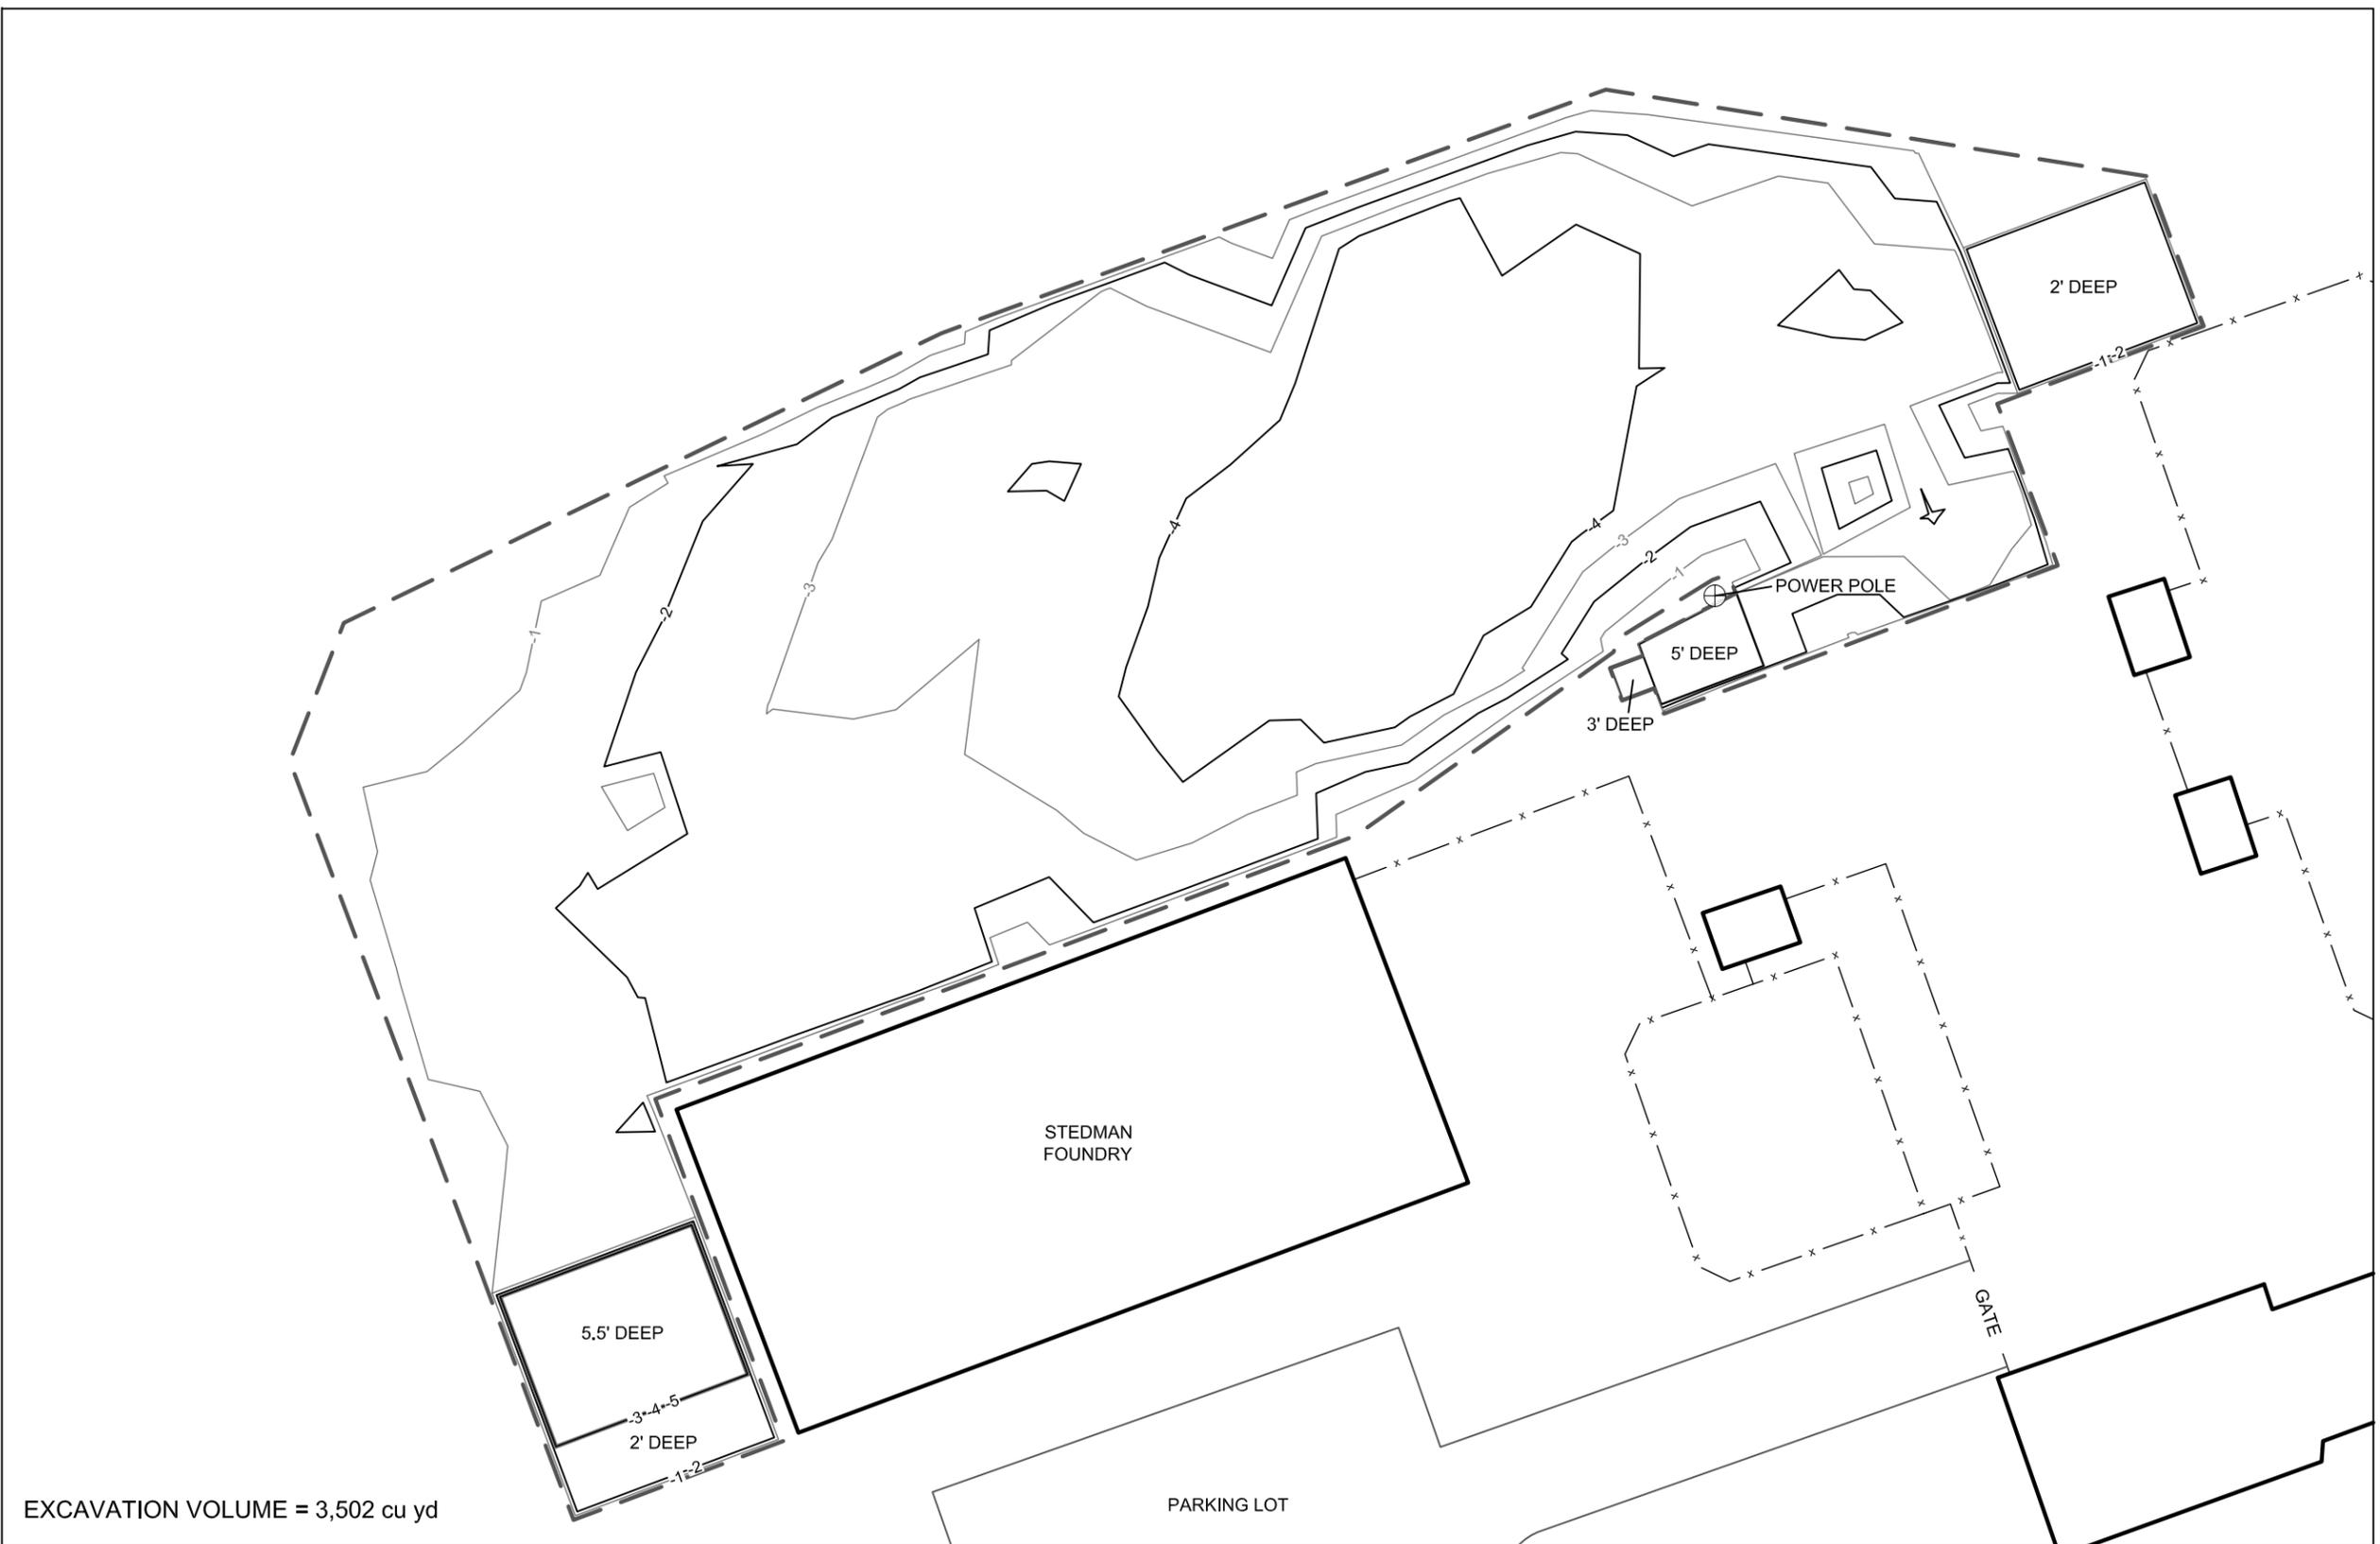
DRAWING NAME	SHEET 4-PARK REGRADE
PROJECT NUMBER	103DS1613036-03
DRAWN BY: D.W.H.	SHEET 4 OF 8
CHK'D BY: C.E.M.	
APPR. BY: G.L.S.	
DATE: 5 / 2009	
REV. NO. 1	DATE: 2 / 2010

EXCAVATION VOLUME = 3,502 cu yd

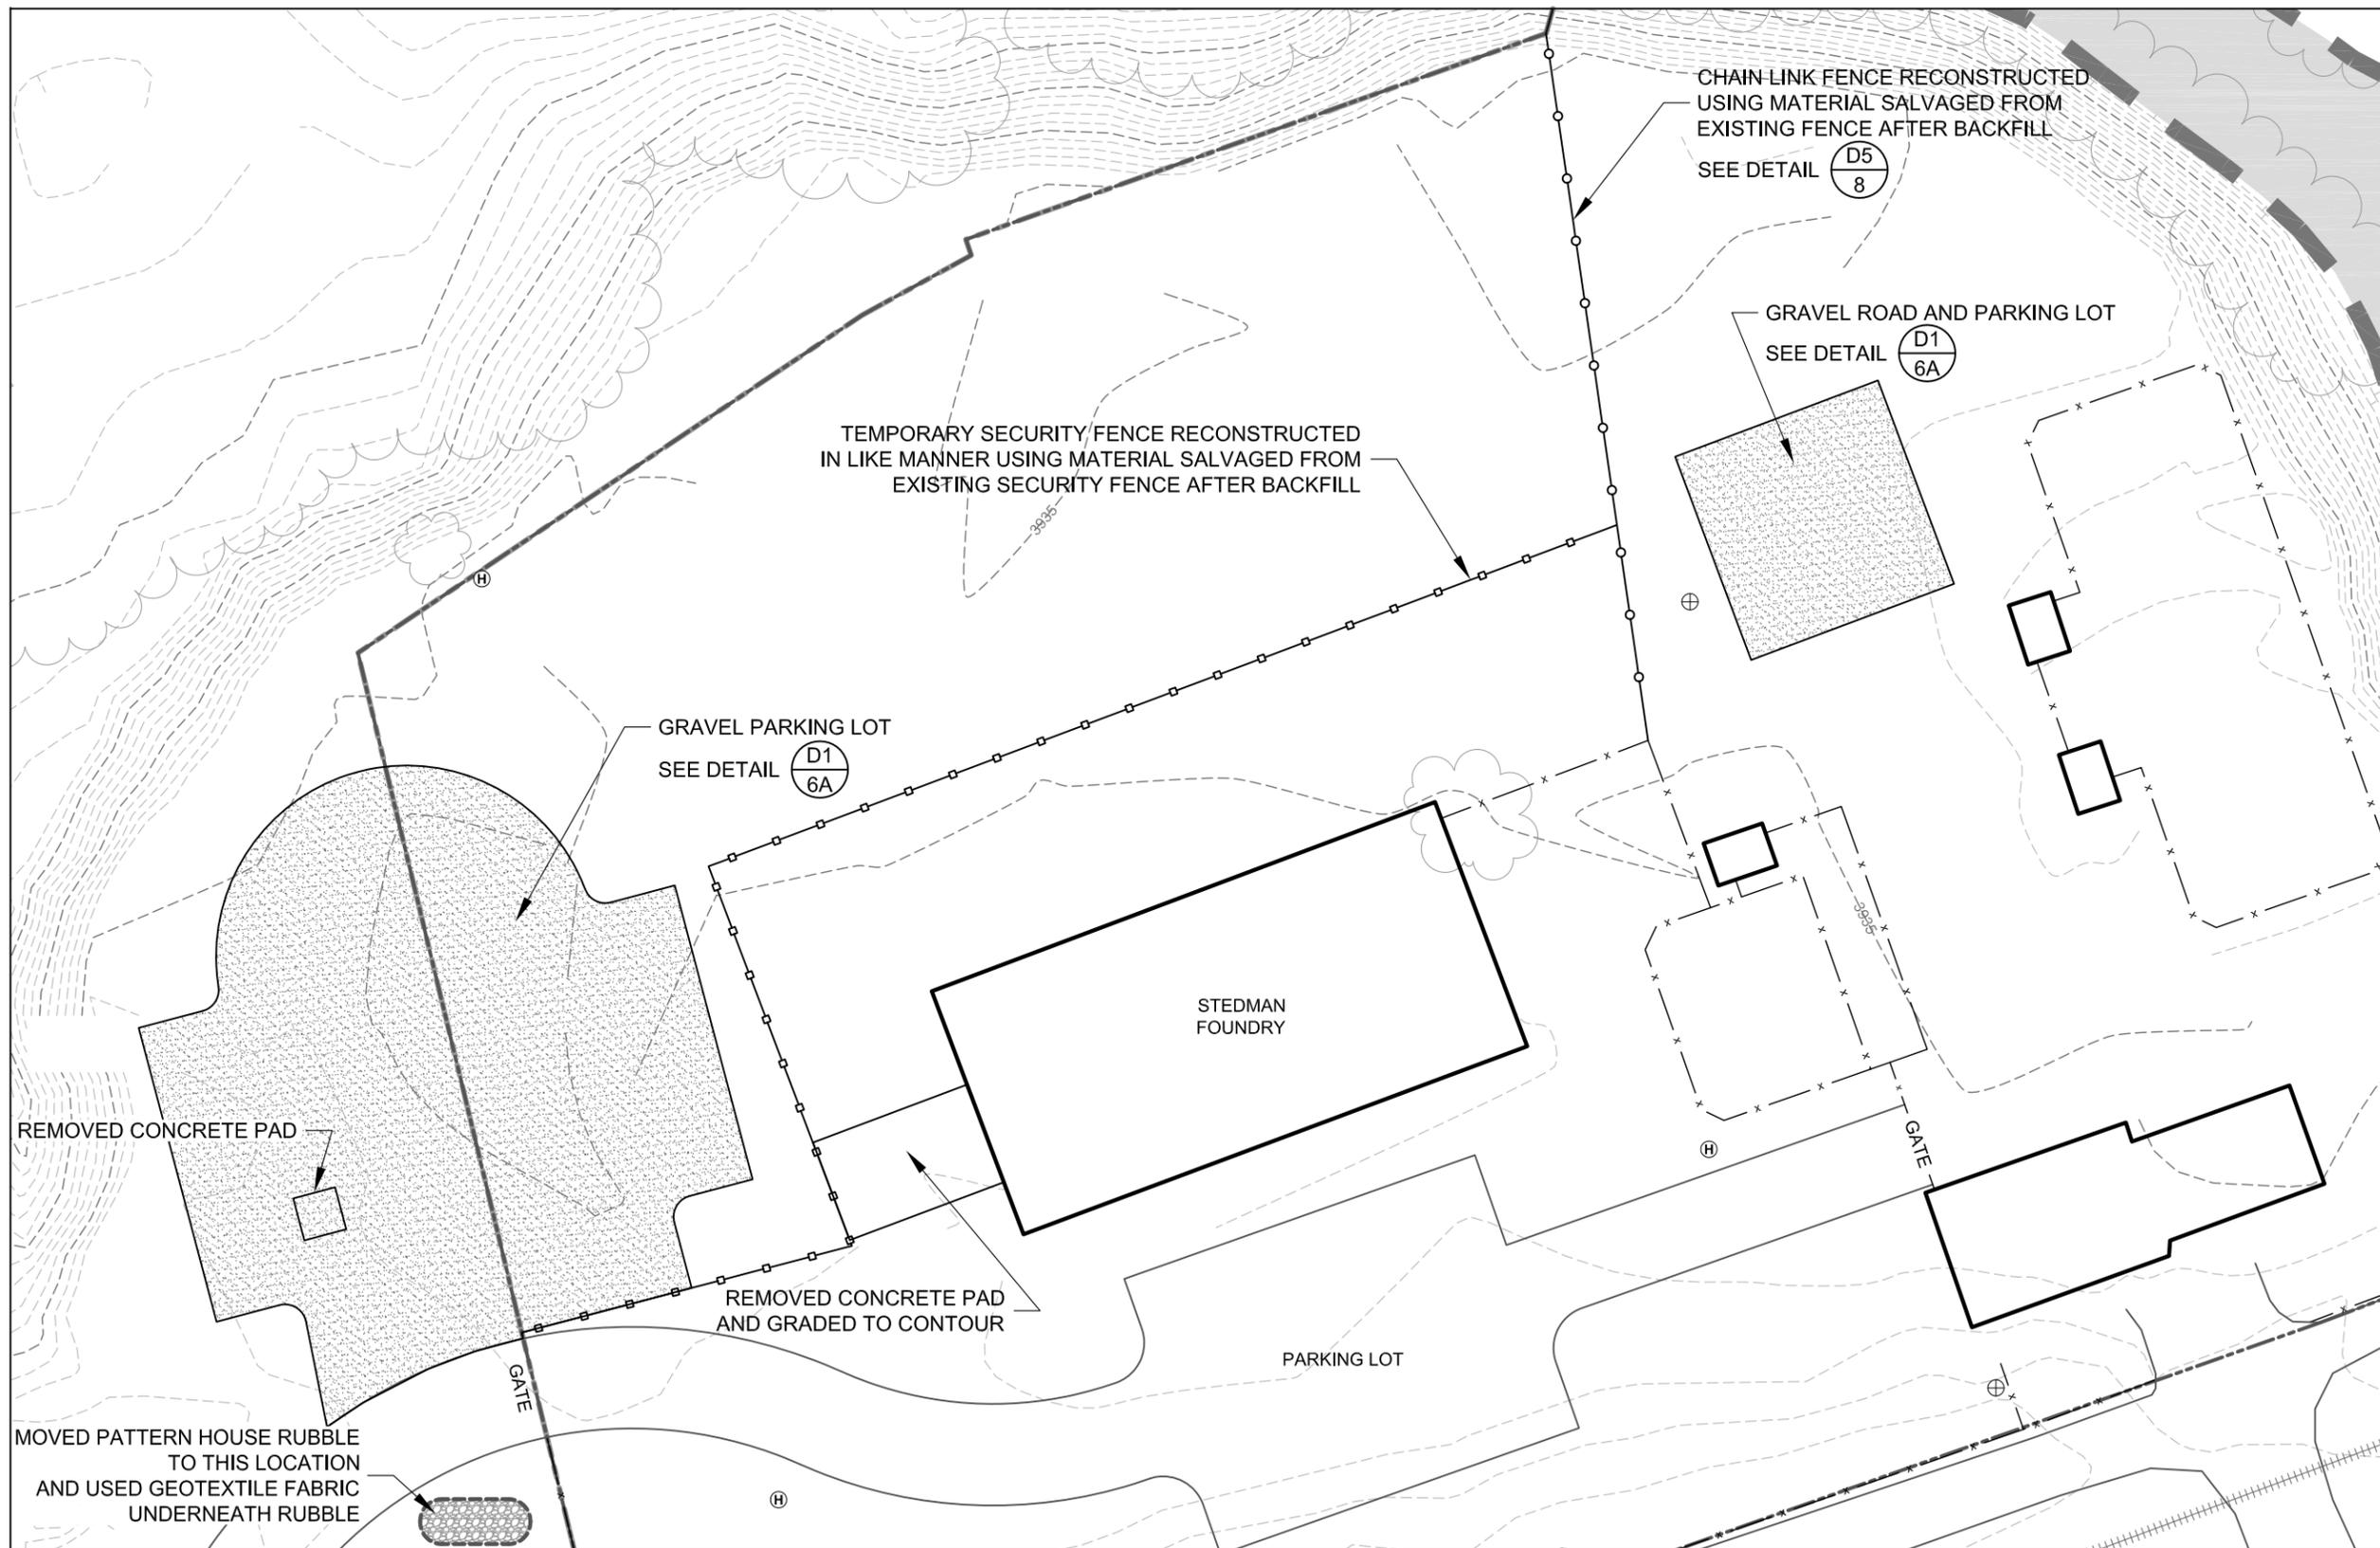
DRAWING NAME	SHEET 5-MWC-EXCAVATION
PROJECT NUMBER	103DS1613036-03
DRAWN BY: D.W.H.	SHEET 5 OF 8
CHK'D BY: C.E.M.	
APPR. BY: G.L.S.	
DATE: 5 / 2009	
REV. NO. 1	
DATE: 2 / 2010

GRAVEL ROAD AND PARKING LOT CONSTRUCTION DETAIL (D1/6A)
NOT TO SCALE

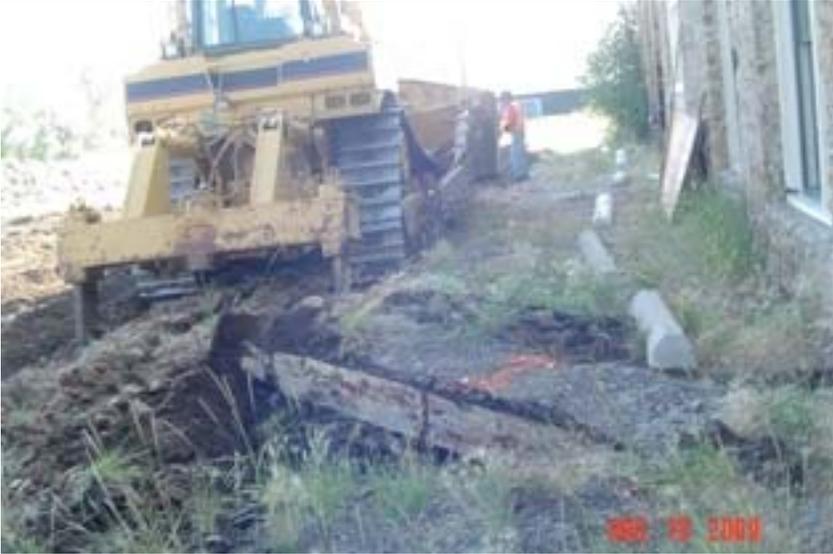
A yellow CAT D8R ripper is shown in the process of pulling out a concrete pad. The machine is positioned on a dirt and grass area adjacent to a building's foundation. The concrete pad is partially broken and being lifted. A red date stamp 'AUG 10 2009' is visible in the bottom right corner of the photo.	<p>Photograph 7</p> <p>Concrete pad pulled out near MWC foundation while ripping with CAT D8R.</p> <p>August 10, 2009</p>

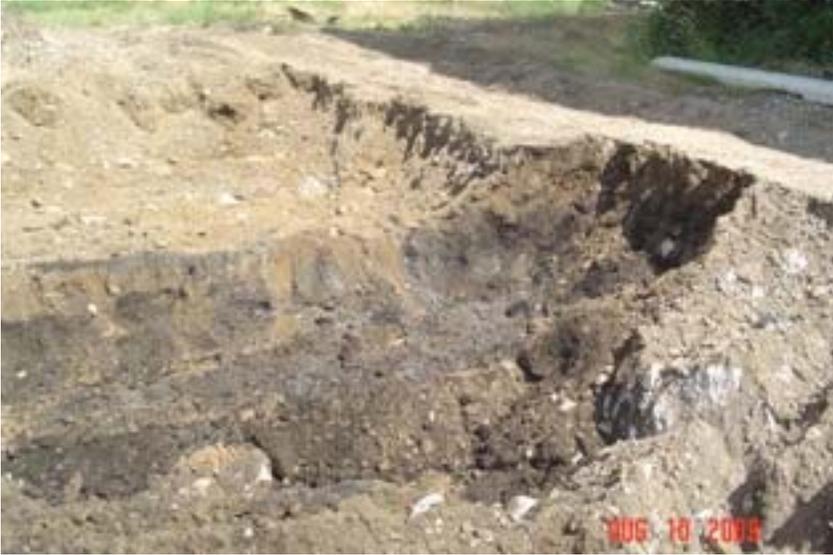
A large, deep excavation pit is shown, revealing dark, contaminated soil. The soil appears to be a mix of brown and black, indicating potential contamination. The pit is surrounded by a concrete curb and some vegetation. A red date stamp 'AUG 10 2009' is visible in the bottom right corner of the photo.	<p>Photograph 8</p> <p>Contaminated soils excavated at MWC.</p> <p>August 10, 2009</p>

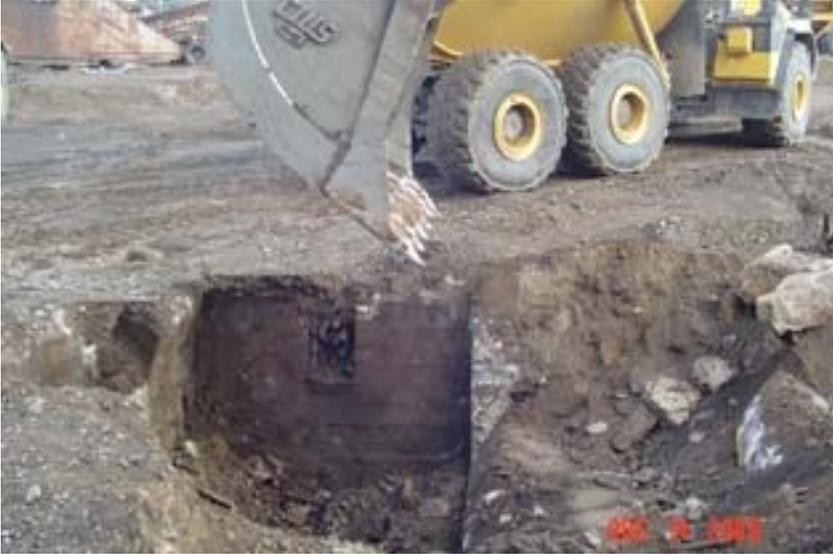
<p>Photograph 15</p> <p>Attempted excavation of buried concrete foundations and waste at the MWC.</p> <p>August 14, 2009</p>

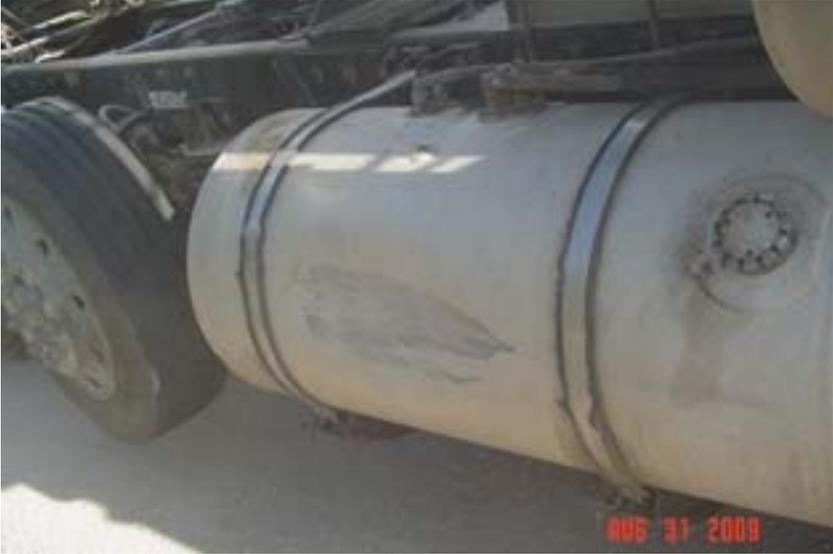
<p>Photograph 33</p> <p>Dent in fuel tank of haul truck caused by traffic incident.</p> <p>August 31, 2009</p>

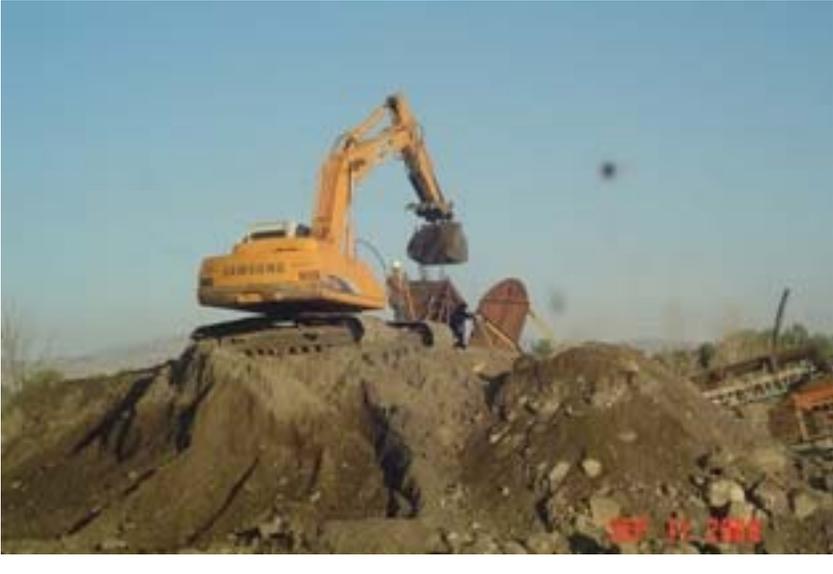
<p>Photograph 50</p> <p>Excavator feeding soil into the screening plant hopper.</p> <p>September 11, 2009</p>

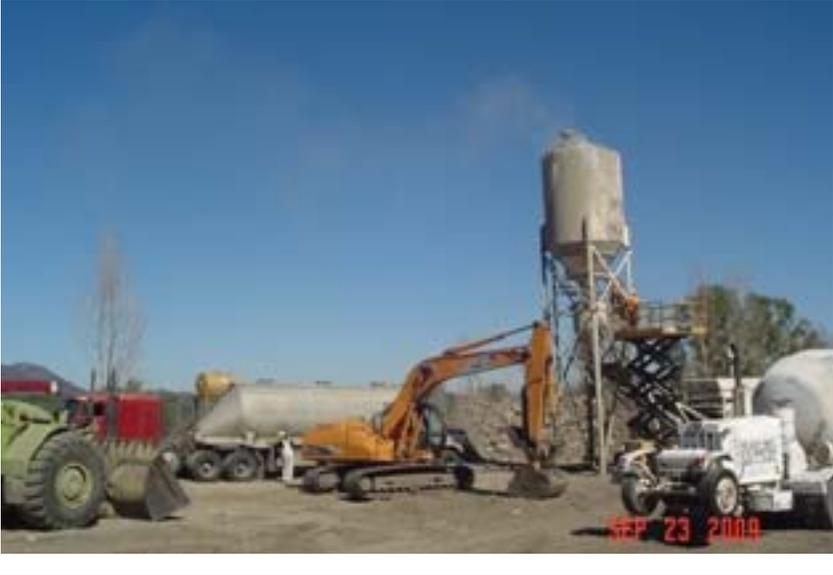
A photograph showing a concrete batch plant. A tall, cylindrical silo stands on a metal frame. An orange excavator is positioned in front of the silo, and a white concrete mixer truck is parked to the right. A green tractor is visible on the left. The date "SEP 23 2009" is printed in red at the bottom right of the image.	<p>Photograph 65</p> <p>Truck filling batch plant with cement.</p> <p>September 23, 2009</p>

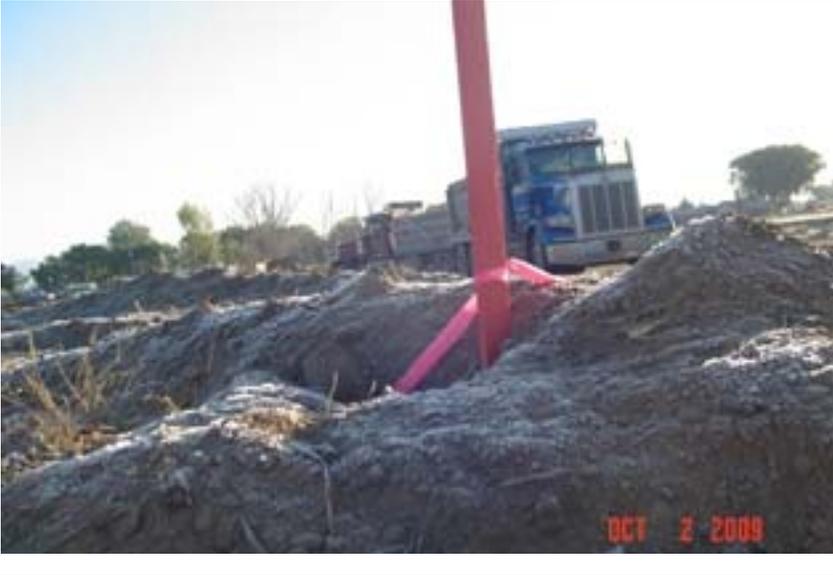
<p>Photograph 77</p> <p>Pedestal stake showing soil backfill at 24 inches; ribbon height.</p> <p>October 2, 2009</p>

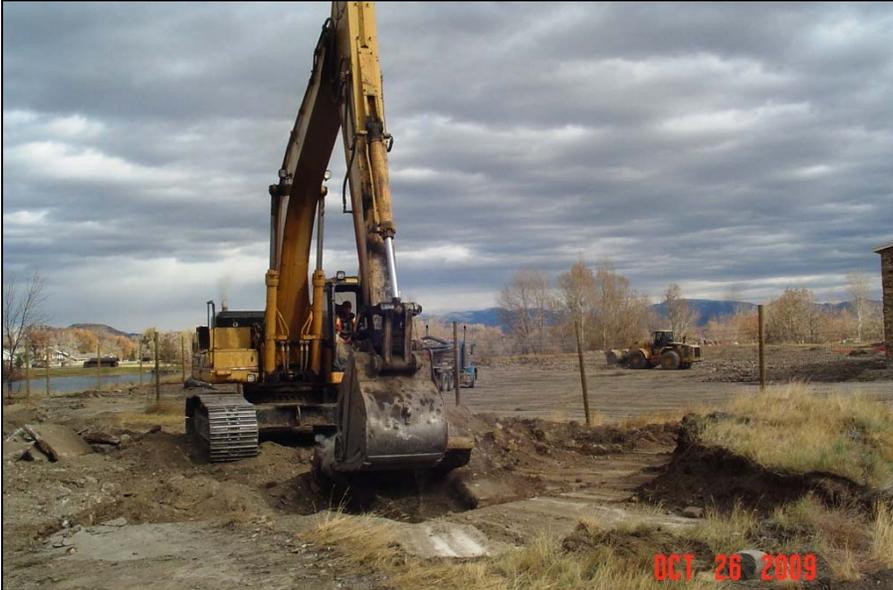
<p>Photograph 108</p> <p>Excavator uncovering and removing portion of concrete pad located west of Wildlife Center fence.</p> <p>October 26, 2009</p>

Work Directive No. 6 was issued on October 27, 2009. It directed the contractor to demolish and remove concrete foundations west of the Stedman building and concrete slabs from beneath the site of the future parking lot.

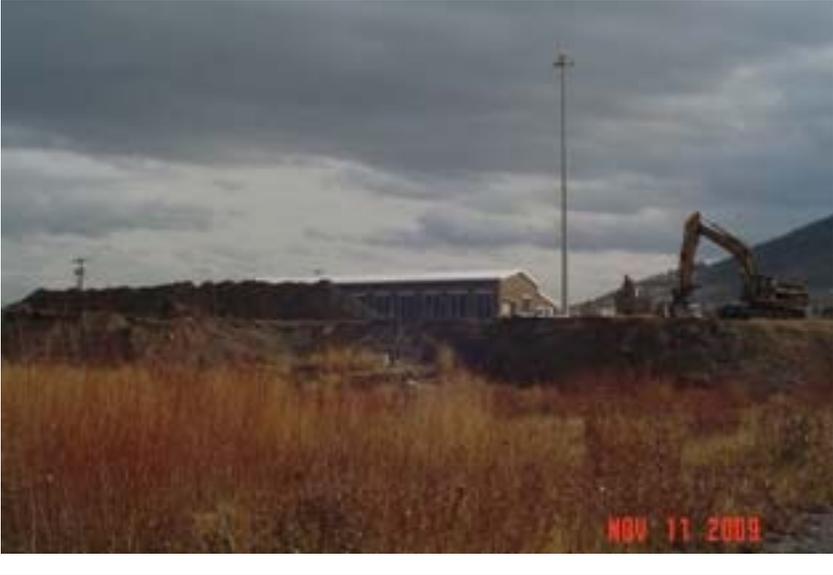
A photograph showing a construction site on a hillside. In the foreground, there is a field of tall, dry, brown grass. In the middle ground, a large excavator is visible on a dirt embankment. In the background, there are some buildings and a tall utility pole under a cloudy sky. A red date stamp 'NOV 11 2009' is visible in the bottom right corner of the photo.	<p>Photograph 124</p> <p>North slope of the wildlife center.</p> <p>November 11, 2009</p>

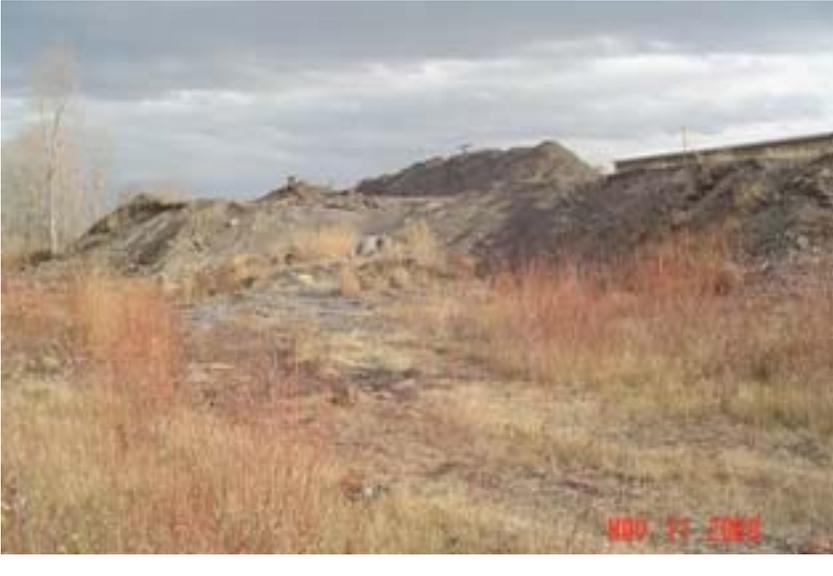
A photograph showing a large pile of dark, rocky debris on a hillside. The foreground is covered with dry, brown grass. The sky is overcast. A red date stamp 'NOV 11 2009' is visible in the bottom right corner of the photo.	<p>Photograph 125</p> <p>Debris pile on the north slope of the wildlife center.</p> <p>November 11, 2009</p>
