# Clark Fork River Operational Unit of the Milltown Reservoir/Clark For River Superfund Site

Project Update  
November 7, 2017

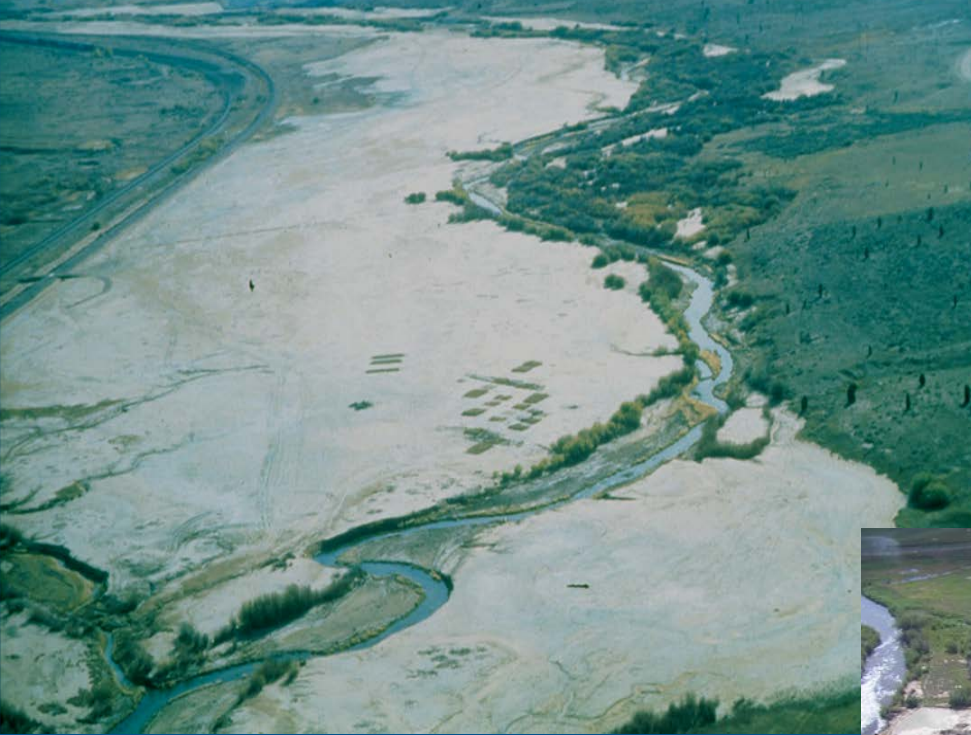
# Mine waste along Silver Bow Creek

In the Anaconda area, large quantities of wastes from the Anaconda Company's operations also reached the Clark Fork River through Warm Springs Creek and other tributaries. In early 1908, the largest flood event on record for the Clark Fork River drainage occurred. This resulted in flooding down the entire Clark Fork River drainage. During this event, extensive quantities of waste, contaminated soils, and contaminated sediments were deposited within the Clark Fork River floodplain.

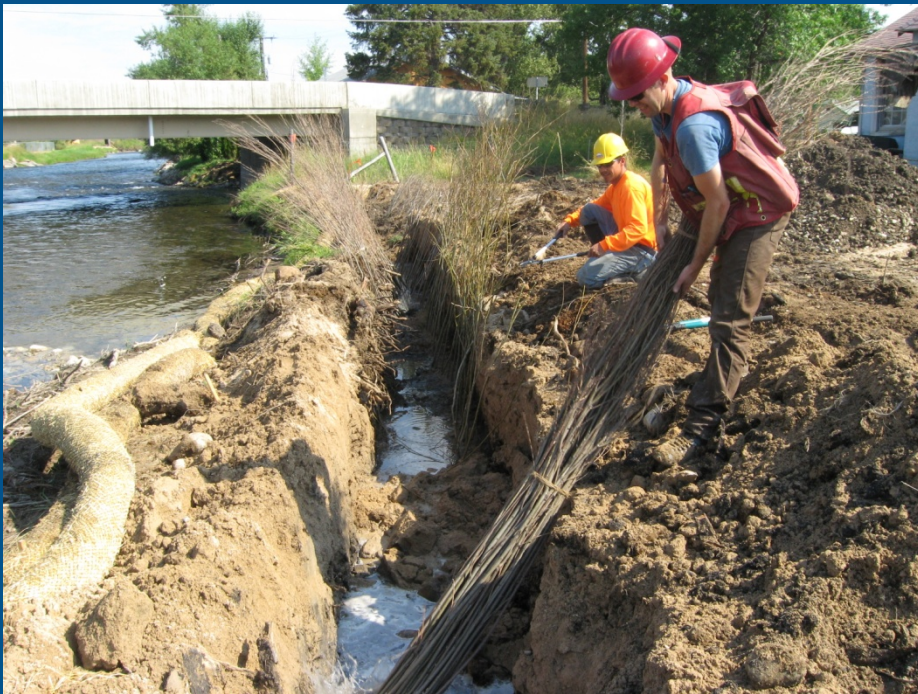
## During Cleanup

The Trestle Area Cleanup was carried out in the fall and winter 2011-2012, with planting in spring 2012. The trestle cleanup involved removal of residential soils with elevated levels of arsenic, and reconstruction and revegetation of 1,000 feet of streambank. In the fall and winter of 2012, DEQ performed the remedial action for pasture areas that were historically irrigated with Clark Fork River water.

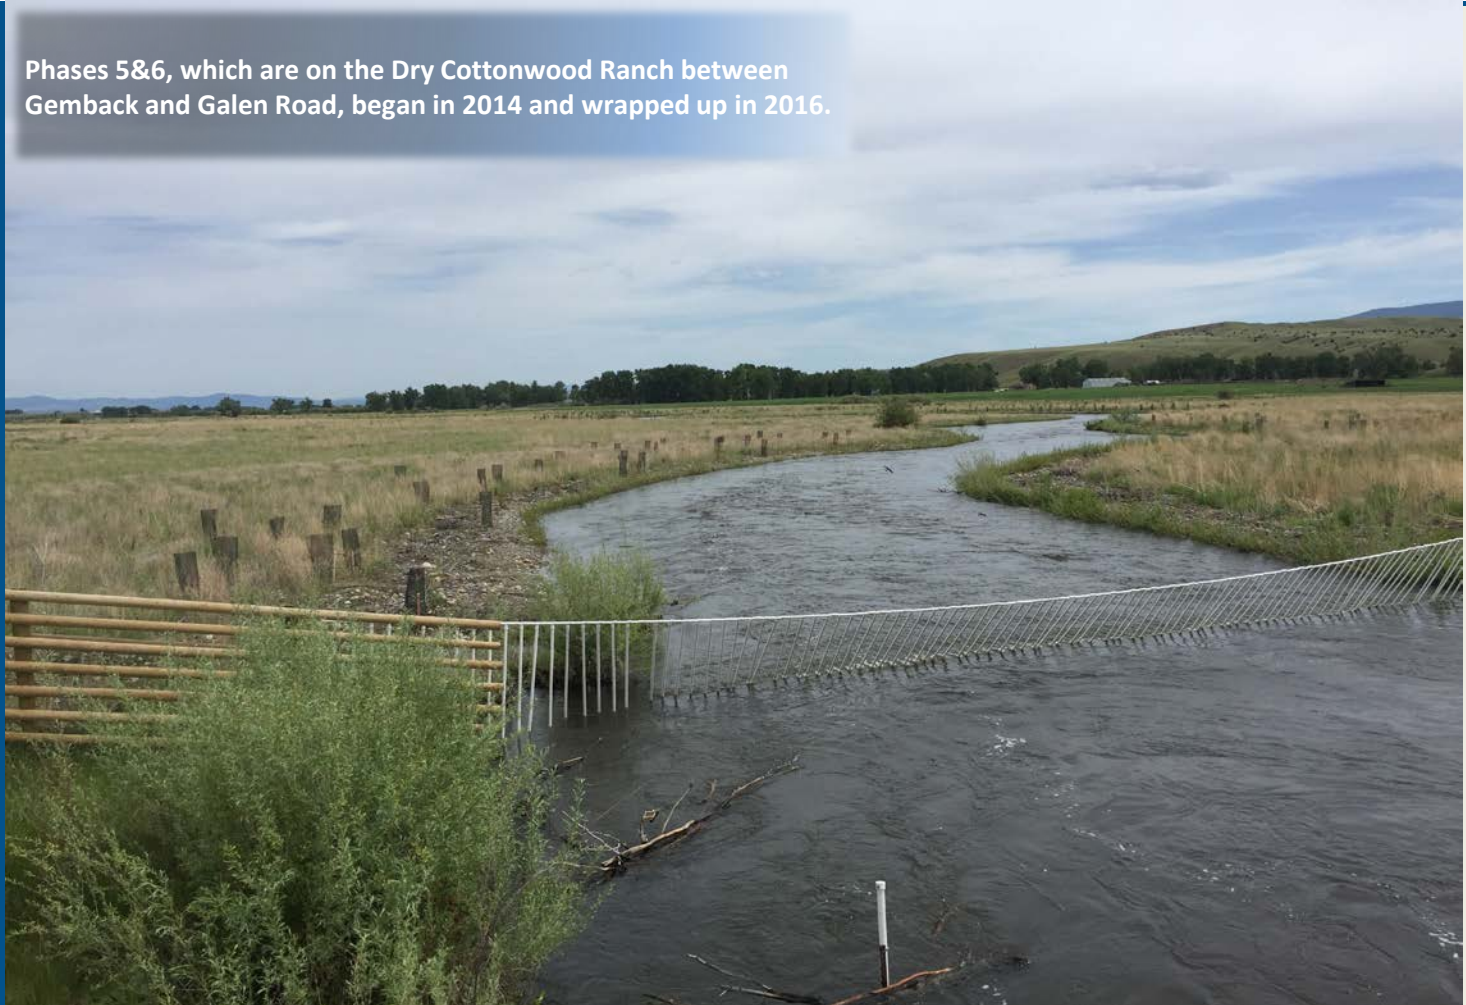
# Phase 5&6 Gemback – Galen Road

Phases 5&6, which are on the Dry Cottonwood Ranch between Gemback and Galen Road, began in 2014 and wrapped up in 2016.

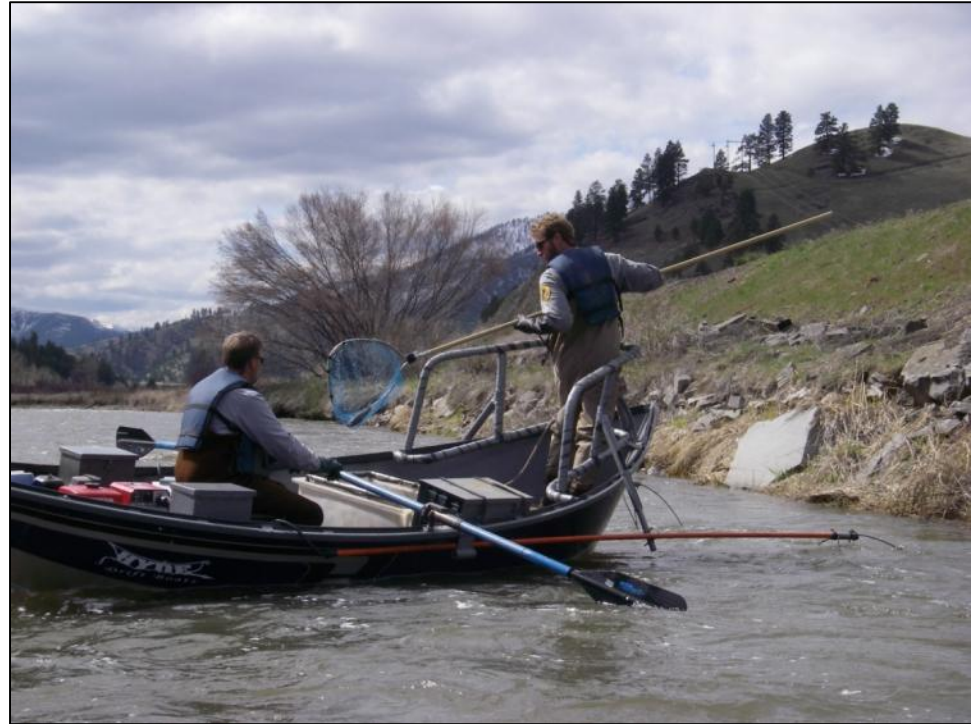
- 6 sections sampled annually. FWP samples trout at six sections on the mainstem Clark Fork River each year. Some of the sections have been sampled every year since 2008.
- Trout population estimates

Trout numbers are much lower in the downstream sections (Bearmouth and Morse Ranch) compared to upstream sections (pH Shack, Sager Lane, Williams-Tavenner).

Trout numbers also go down from year-to-year. These annual fluctuations are at least in part related to river flow and drought. For example, most sections had the highest estimates in 2013 and 2014 which is related to high survival of young trout hatched in 2010 and 2011, which were good flow years.

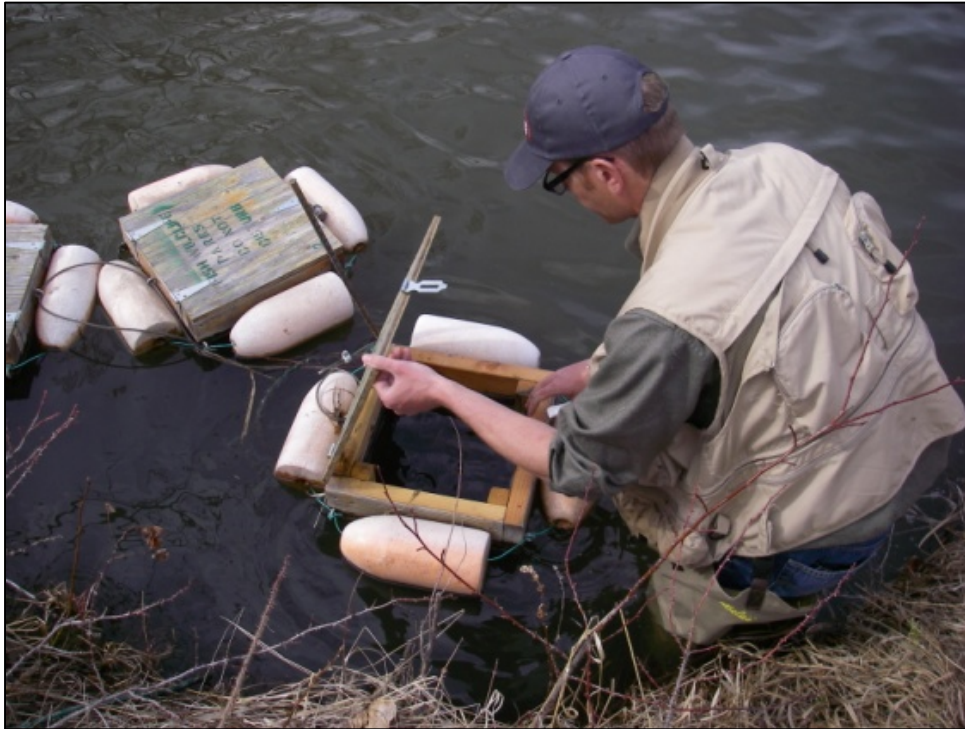
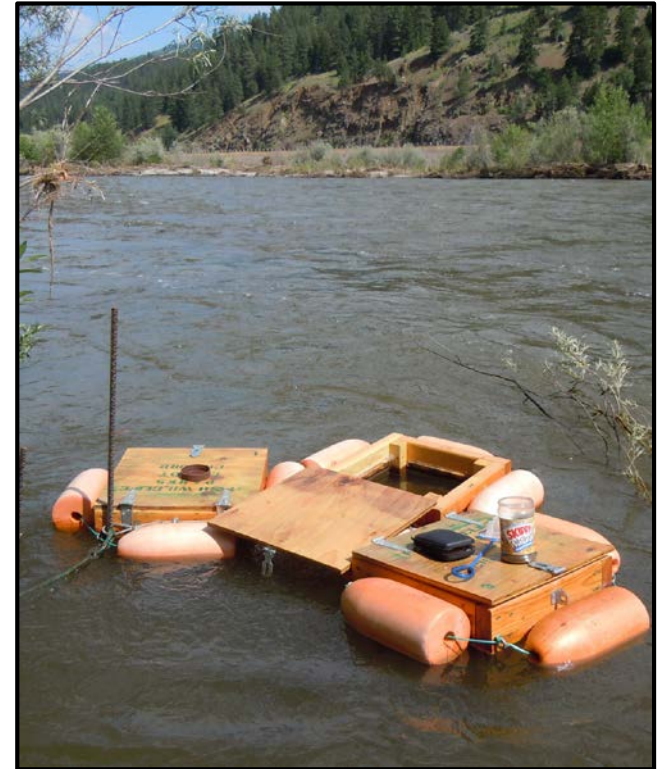
FWP has also been monitoring the amount of heavy metals (Copper, Zinc, Cadmium, Arsenic, and Lead) in fish tissues. One way we have been doing this is with caged fish studies where hatchery brown trout are held in these boxes over the spring and summer.

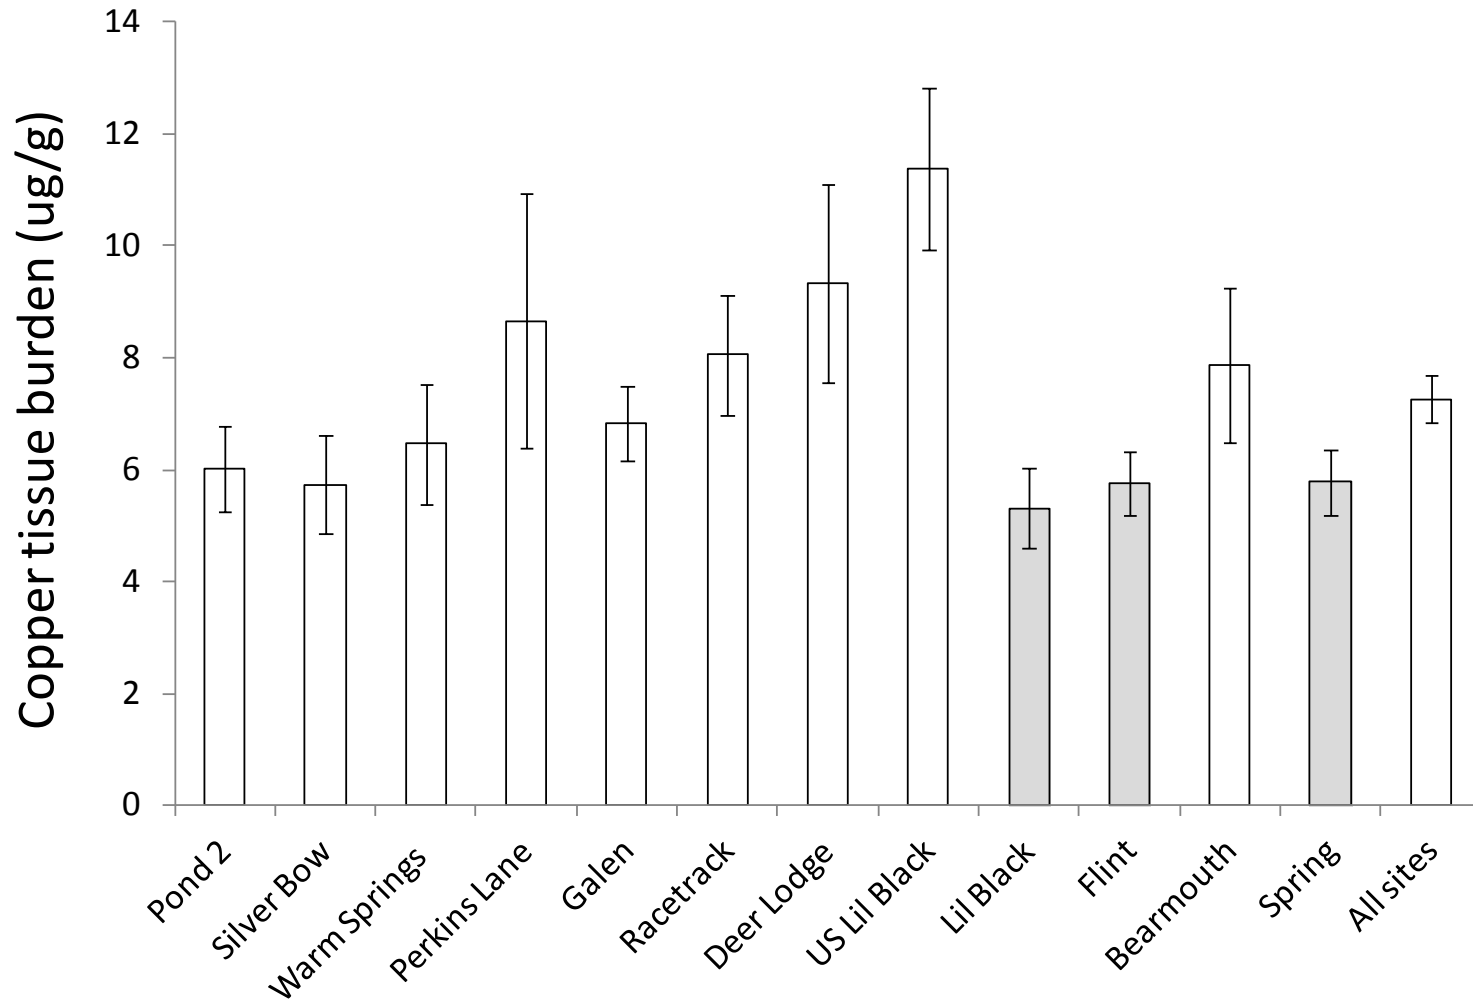
# Caged fish whole body copper

Copper concentrations in caged brown trout increase from the Warm Spring area (the Pond 2 Site) to the Deer Lodge area. Copper levels are lower downstream of the Little Blackfoot and in tributaries (grey bars).

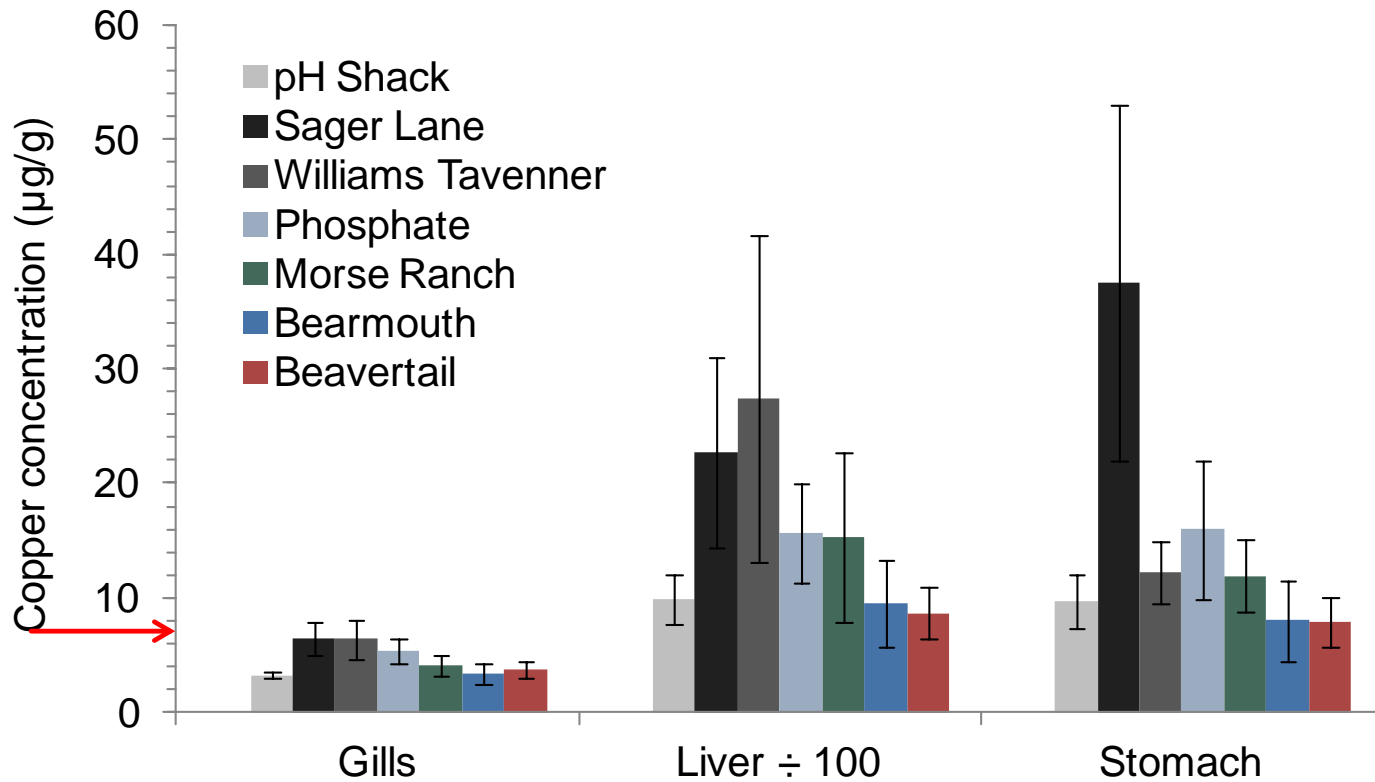
# Wild brown trout tissues: copper

FWP also examined metals in wild brown trout from the Clark Fork River. These fish also showed more copper just upstream of the Little Blackfoot compared to other parts of the Clark Fork River.

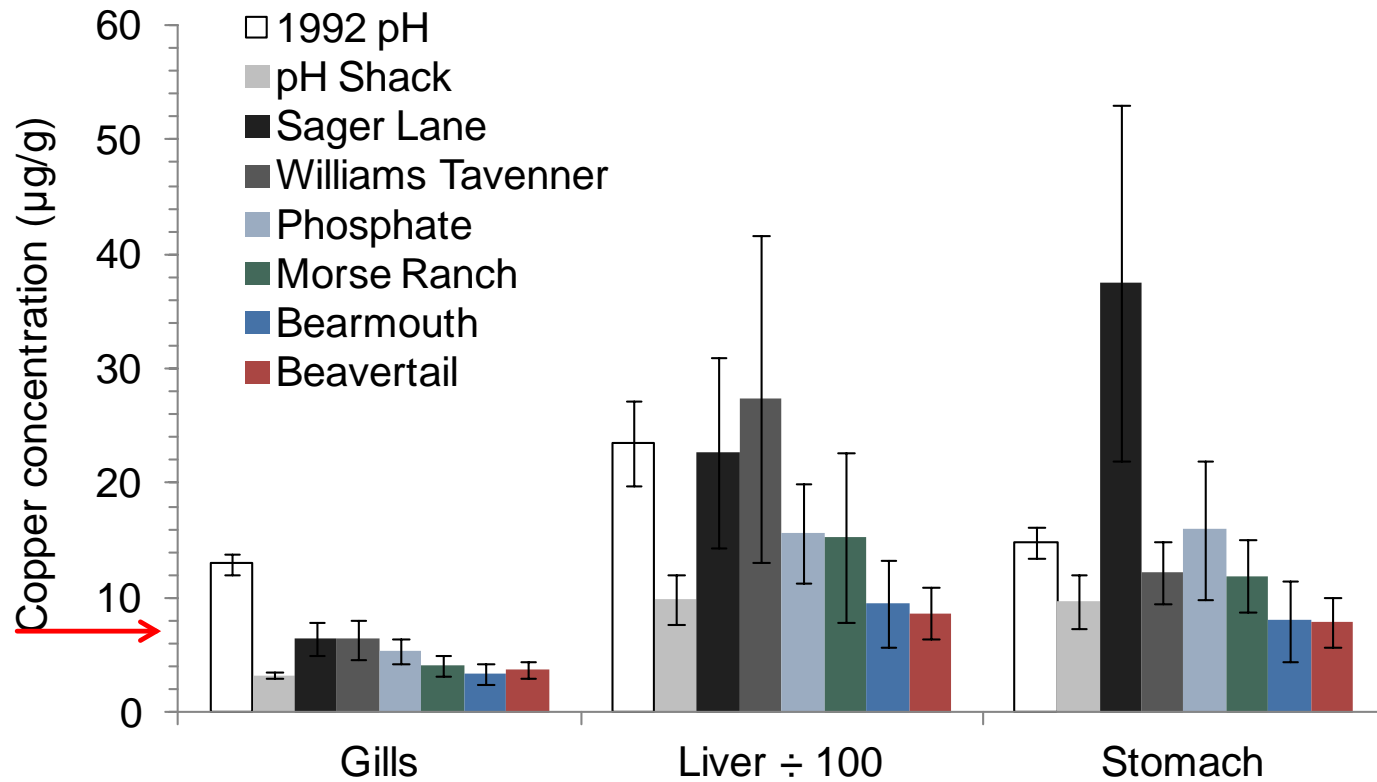
# Wild brown trout tissues: copper

Copper levels in brown trout appear to have declined since the early 1990s in the Clark Fork River near Warm Springs (pH Shack section).

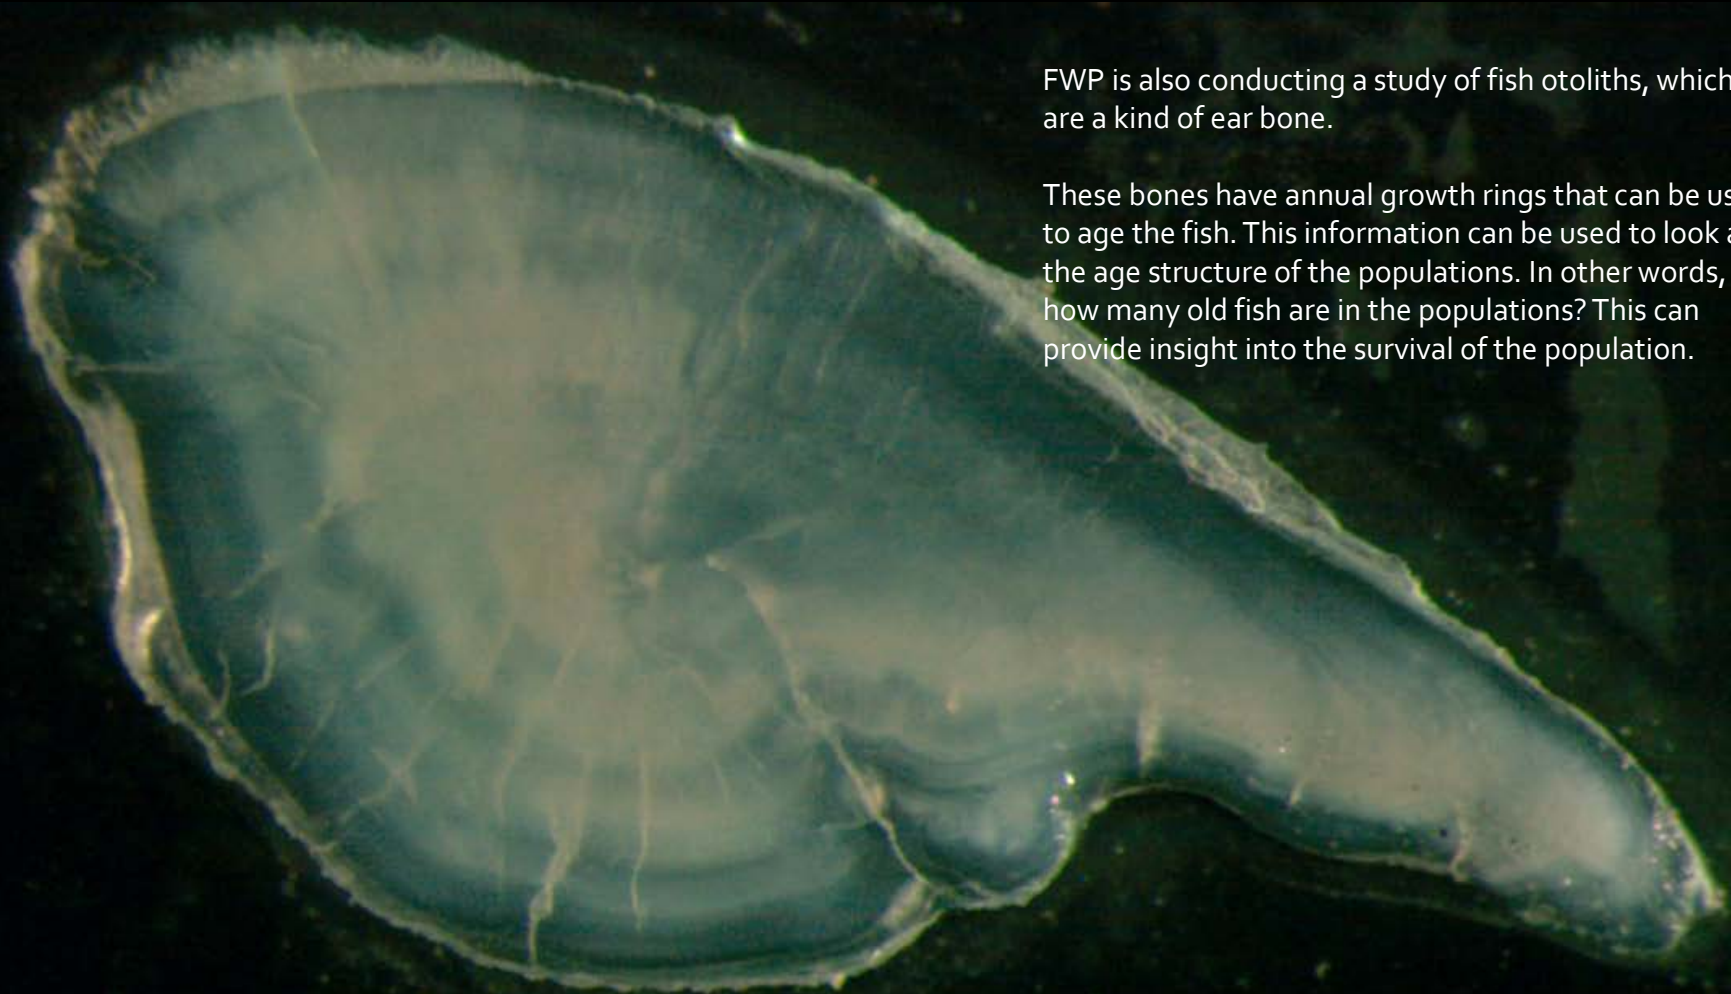
# Otolith study

FWP is also conducting a study of fish otoliths, which are a kind of ear bone.

These bones have annual growth rings that can be used to age the fish. This information can be used to look at the age structure of the populations. In other words, how many old fish are in the populations? This can provide insight into the survival of the population.

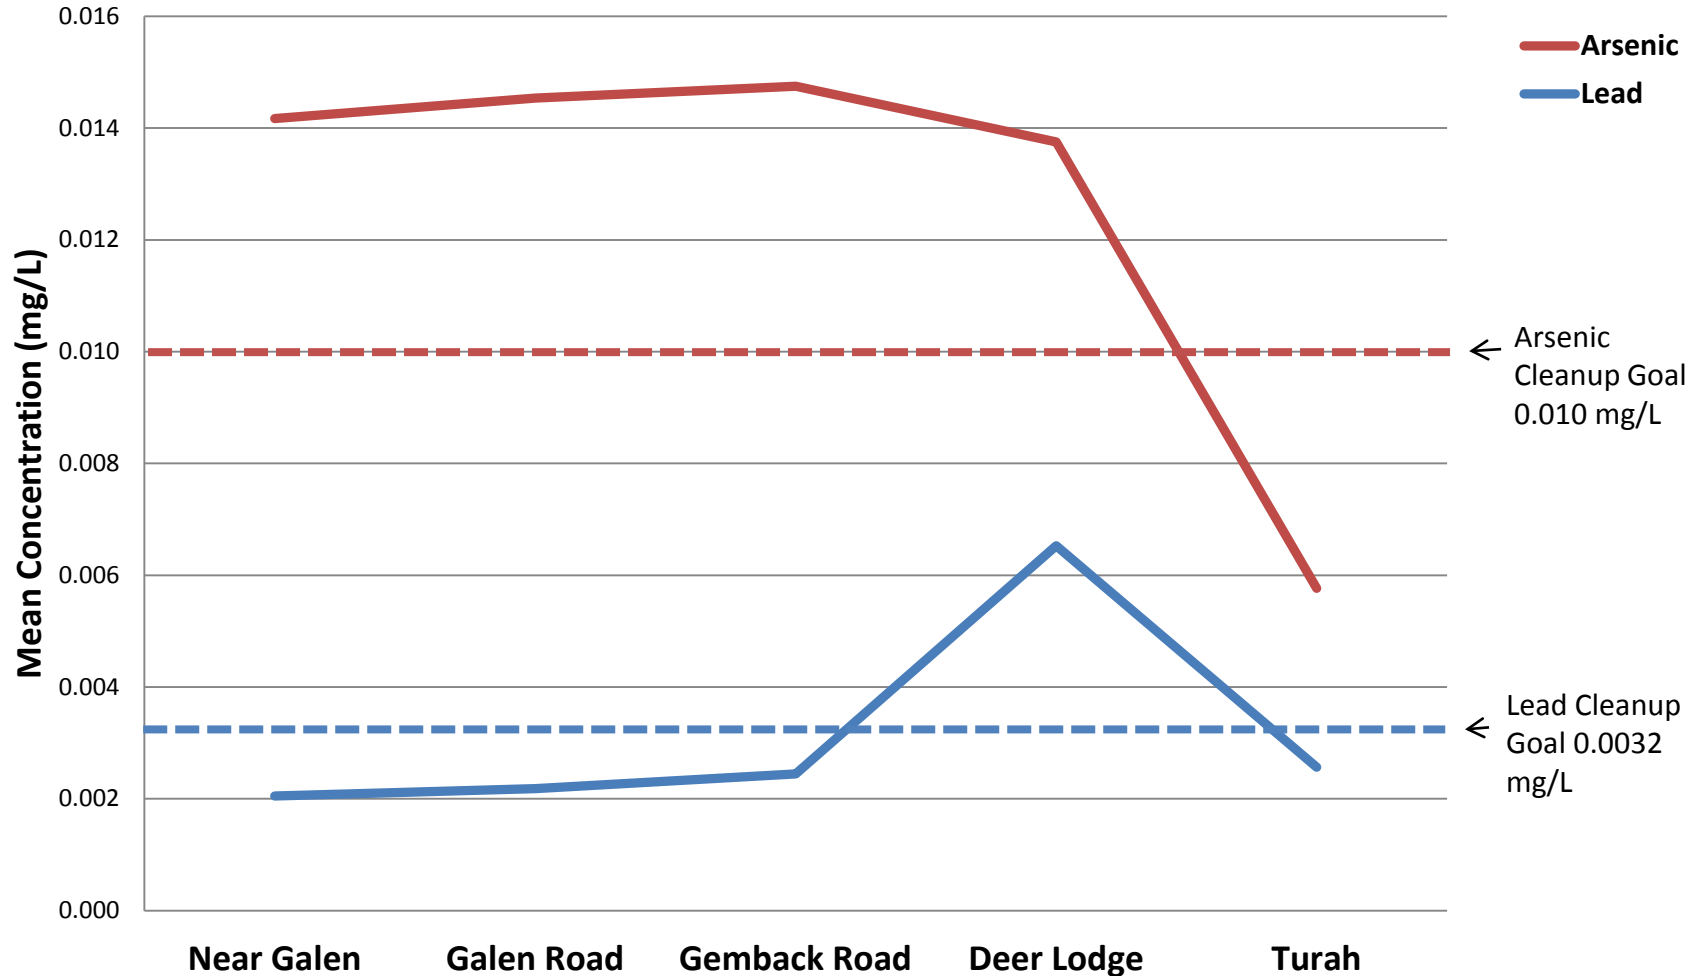
**Arsenic and Lead Concentrations  
Clark Fork River Monitoring Sites  
2010-2017**

More than seven years years of (SW??) data has shown no definitive trend from year-to-year. However we have noticed decreases in AS (arsenic?) and PB?? as we move downstream. Similar trends are noted with sediment for all of the contaminants. Levels are high at the headwaters and tail off as we move downstream.

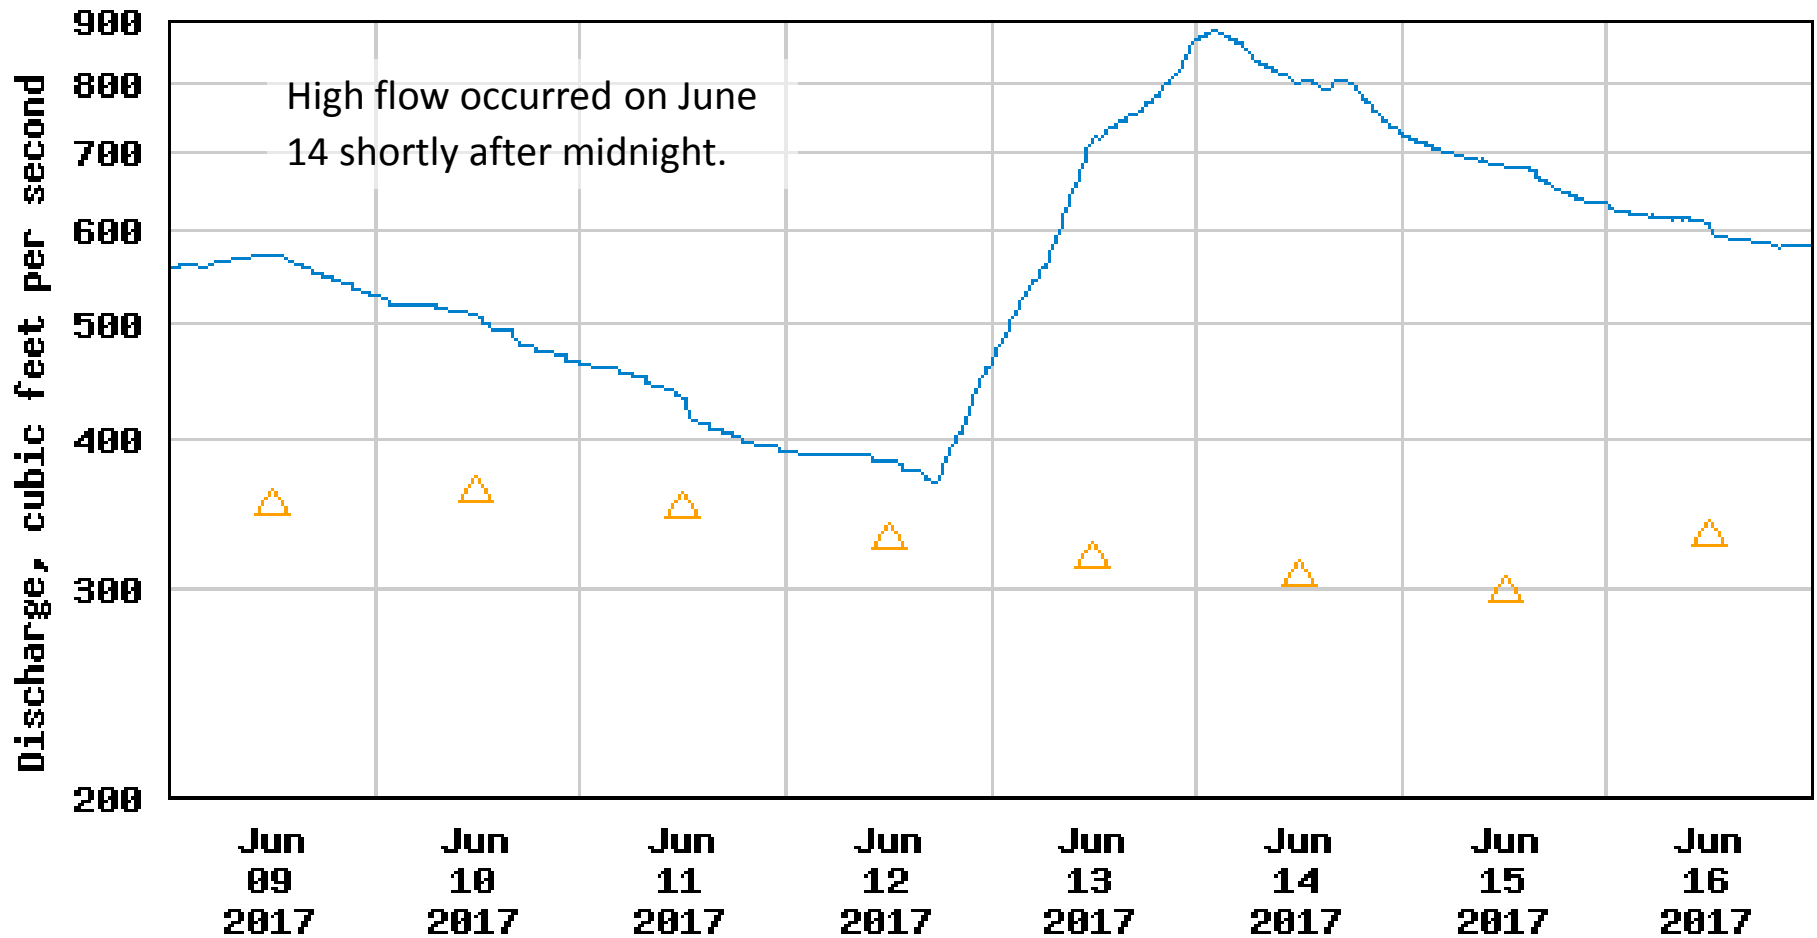
USGS 12323800 Clark Fork near Galen MT

△ Median daily statistic (28 years) — Discharge

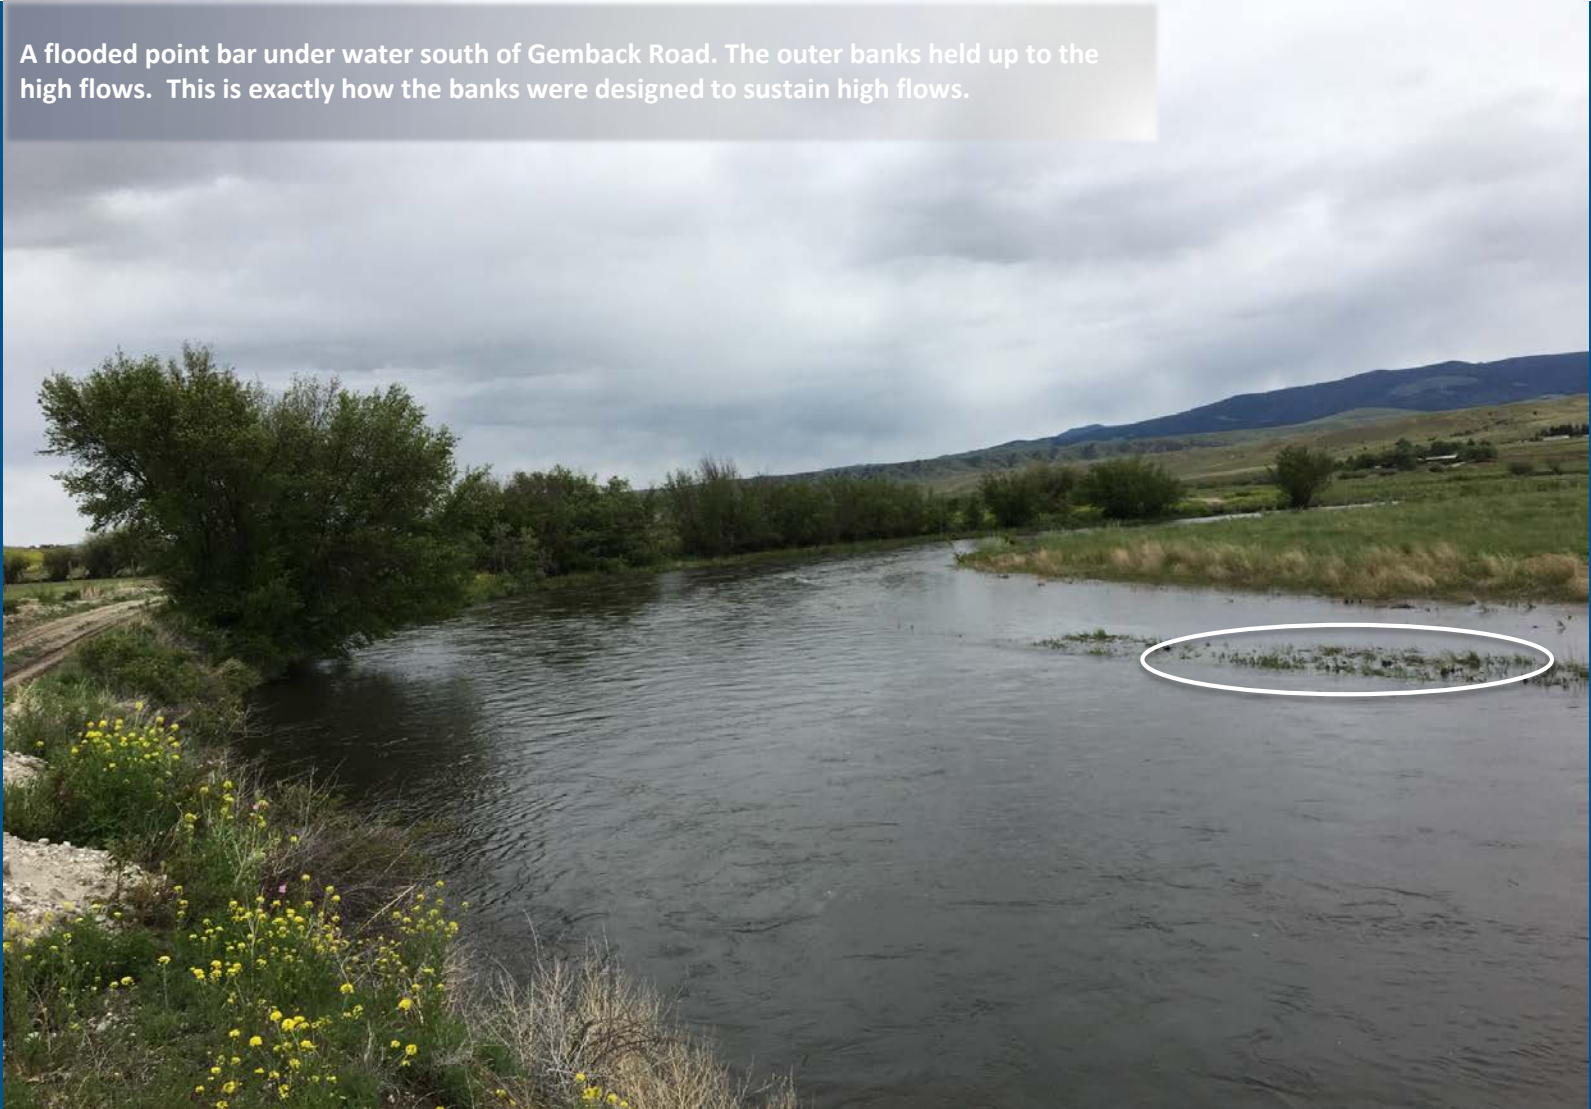
A flooded point bar under water south of Gemback Road. The outer banks held up to the high flows. This is exactly how the banks were designed to sustain high flows.

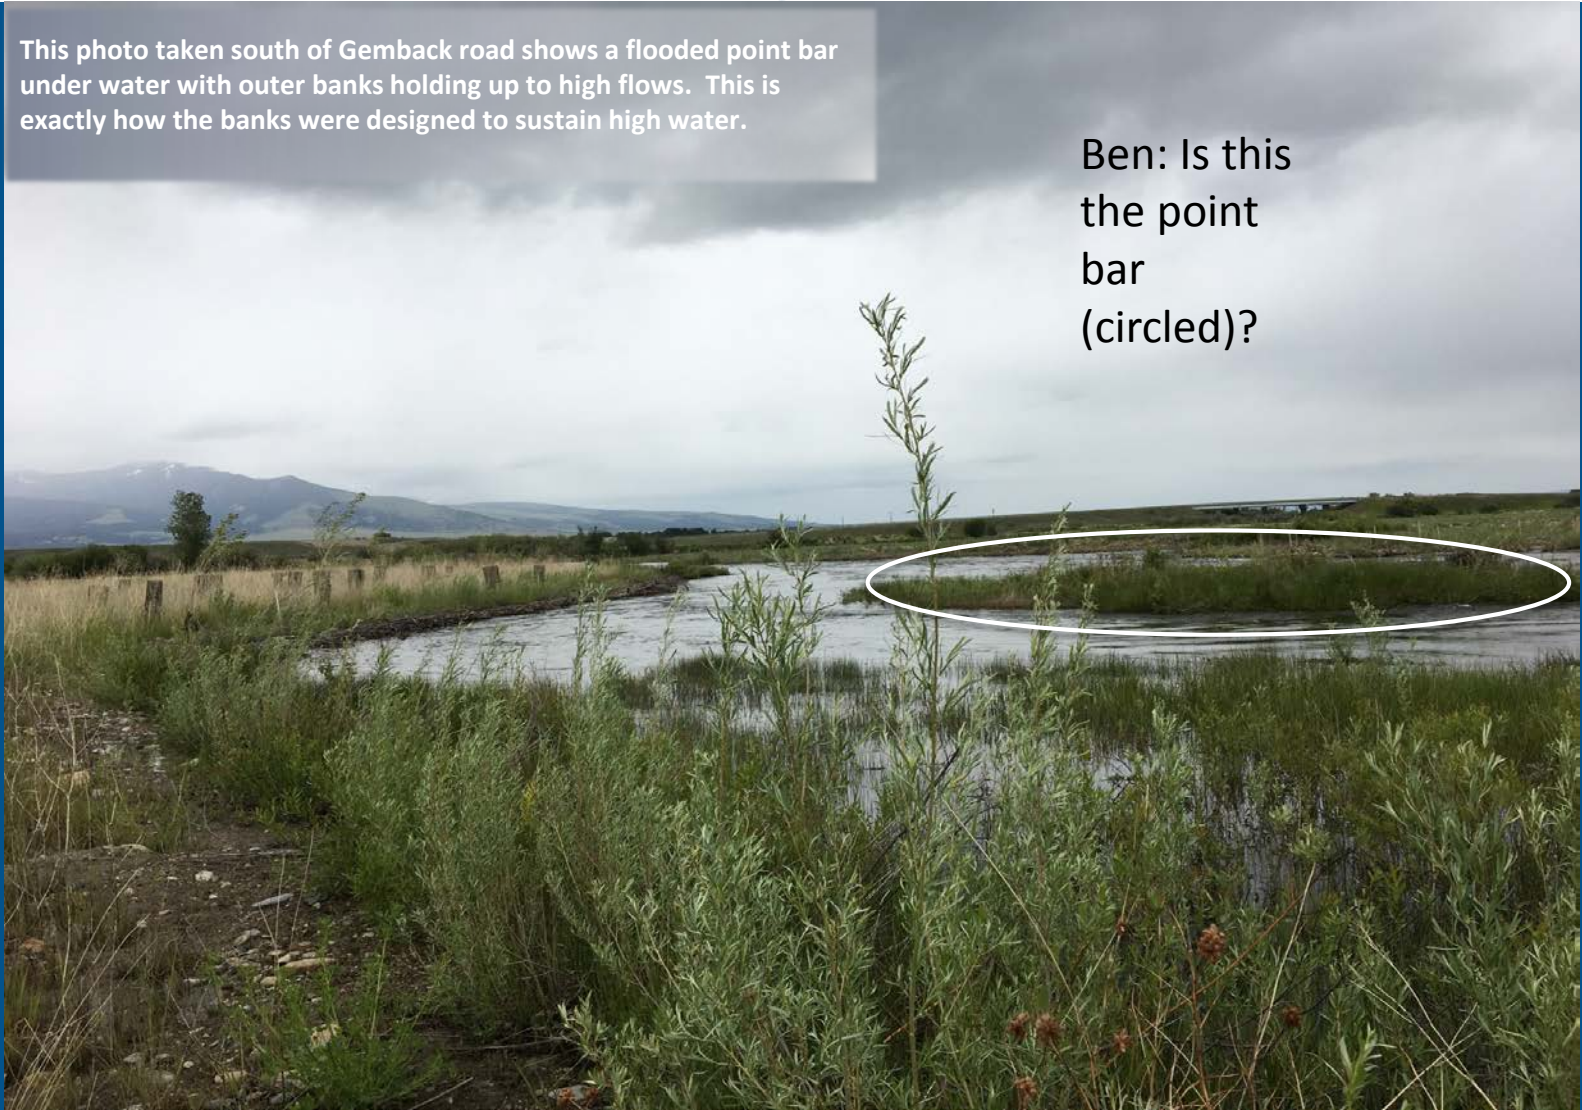
This photo taken south of Gemback road shows a flooded point bar under water with outer banks holding up to high flows. This is exactly how the banks were designed to sustain high water.

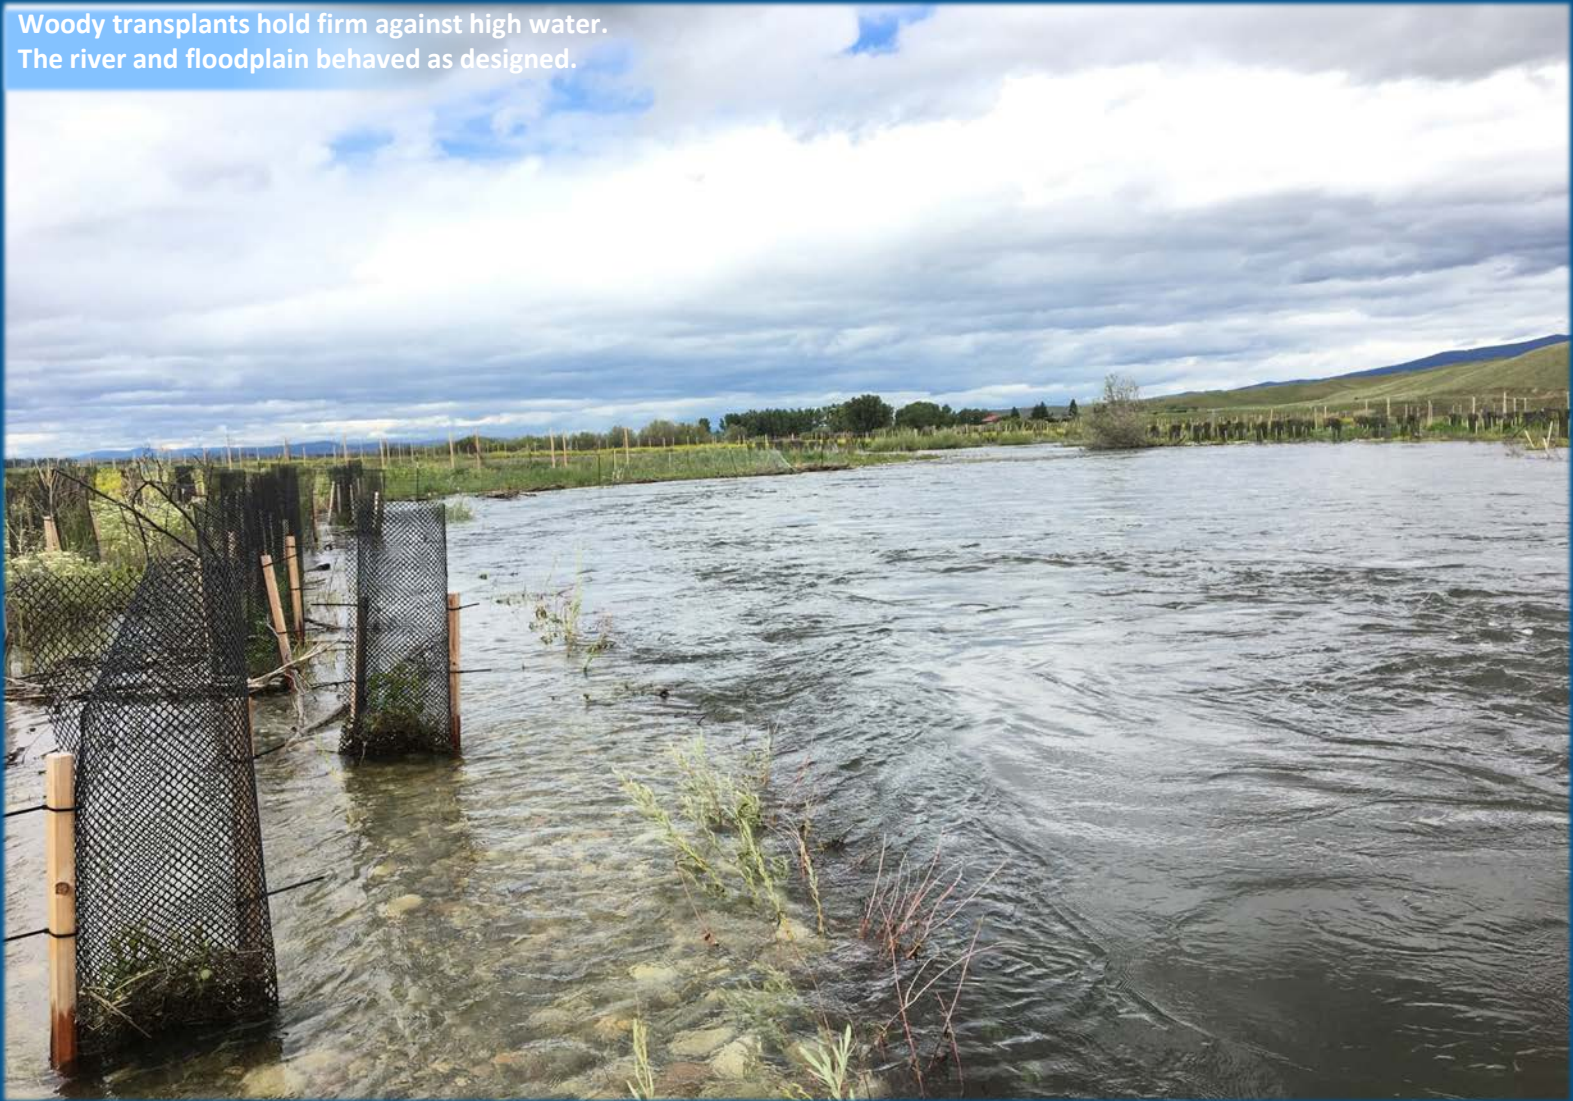
Woody transplants hold firm against high water.  
The river and floodplain behaved as designed.

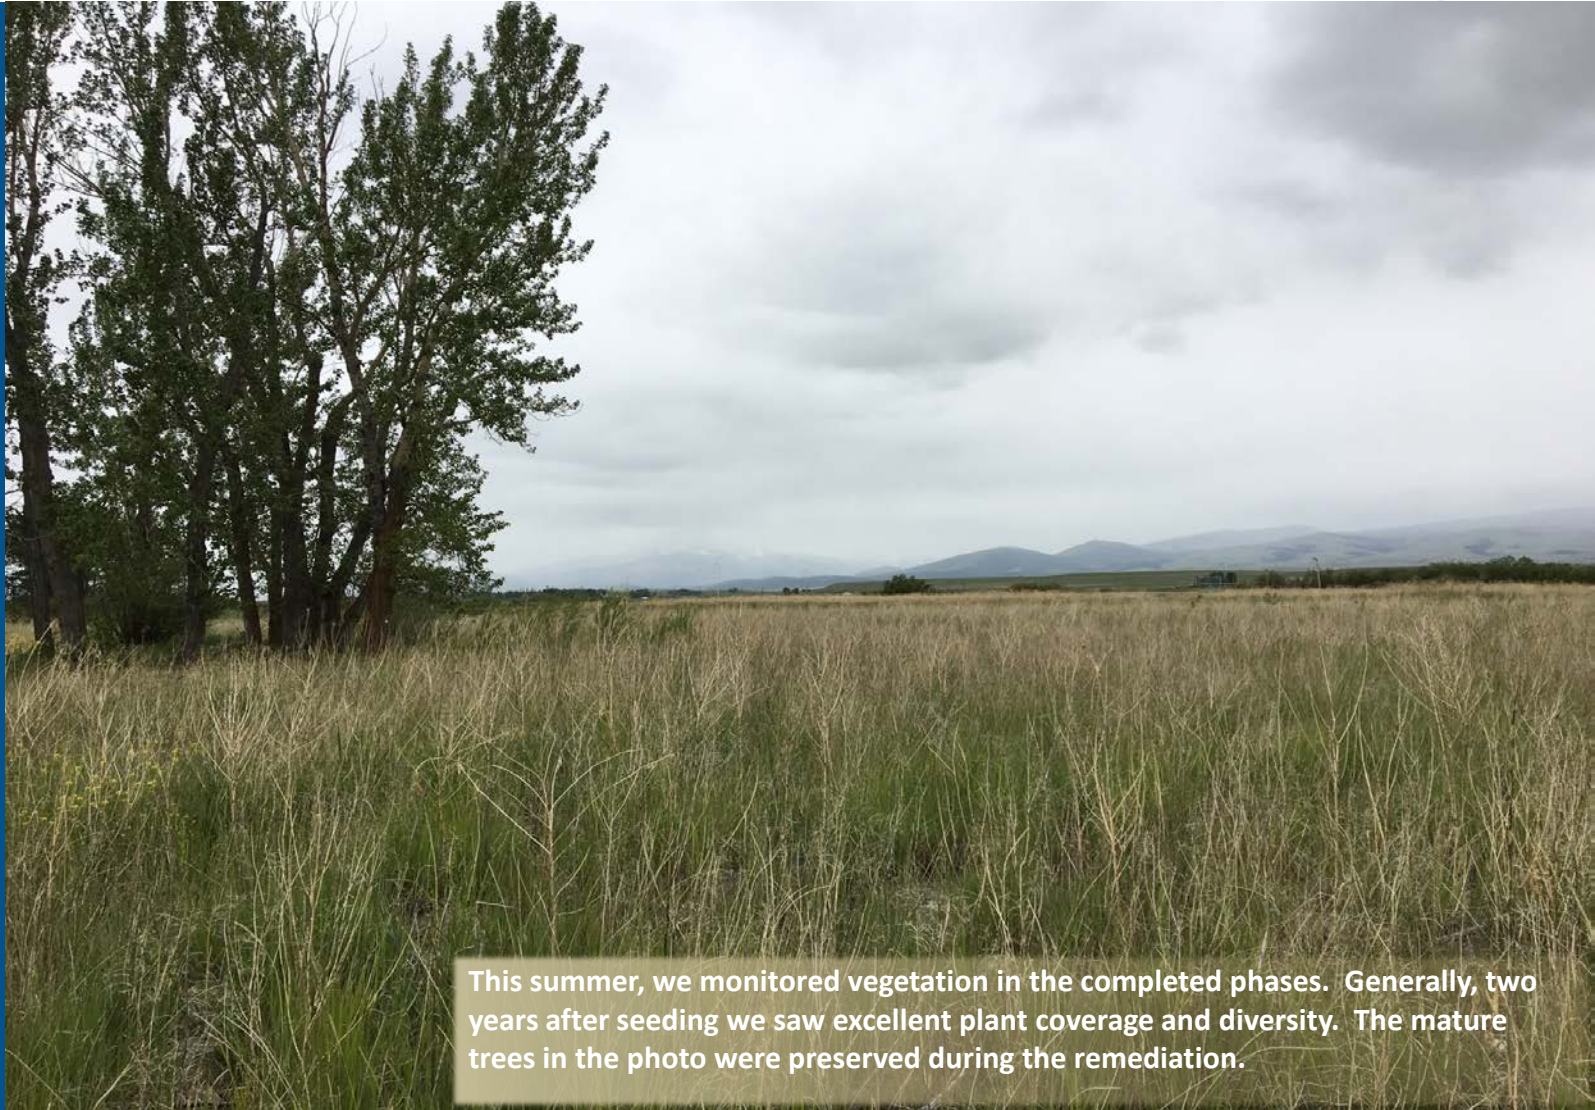
This summer, we monitored vegetation in the completed phases. Generally, two years after seeding we saw excellent plant coverage and diversity. The mature trees in the photo were preserved during the remediation.

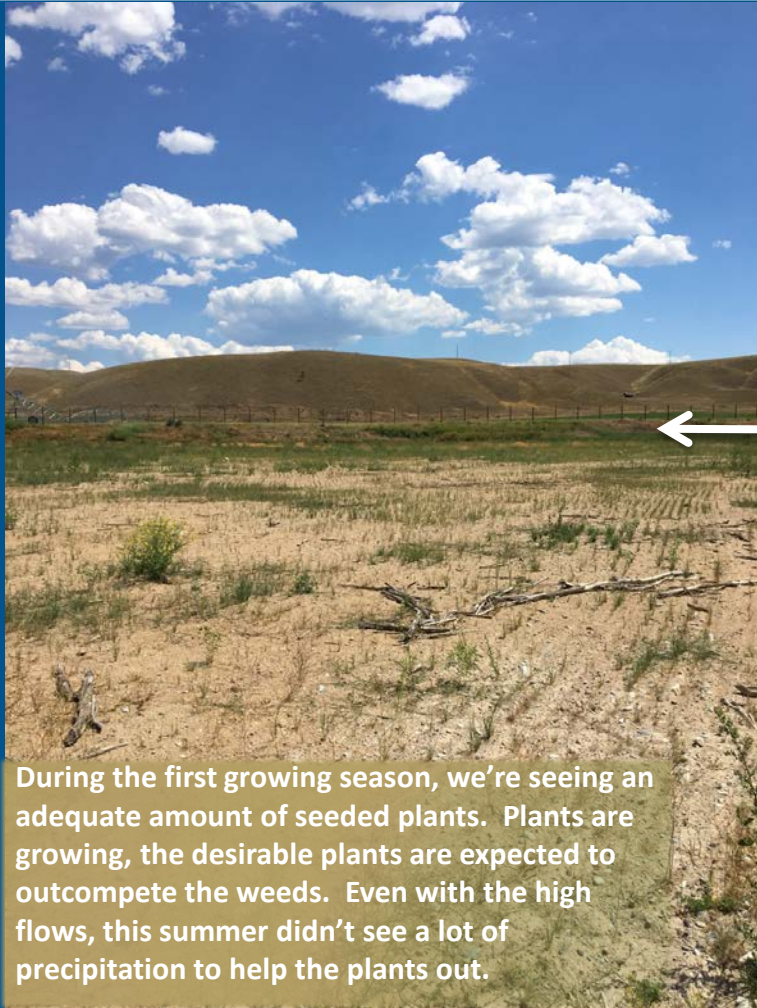
ONE  
SUCCESSFUL  
GROWING  
SEASON

During the first growing season, we're seeing an adequate amount of seeded plants. Plants are growing, the desirable plants are expected to outcompete the weeds. Even with the high flows, this summer didn't see a lot of precipitation to help the plants out.
