# Clark Fork River Operational Unit of the Milltown Reservoir/Clark For River Superfund Site

Project Update  
November 7, 2017

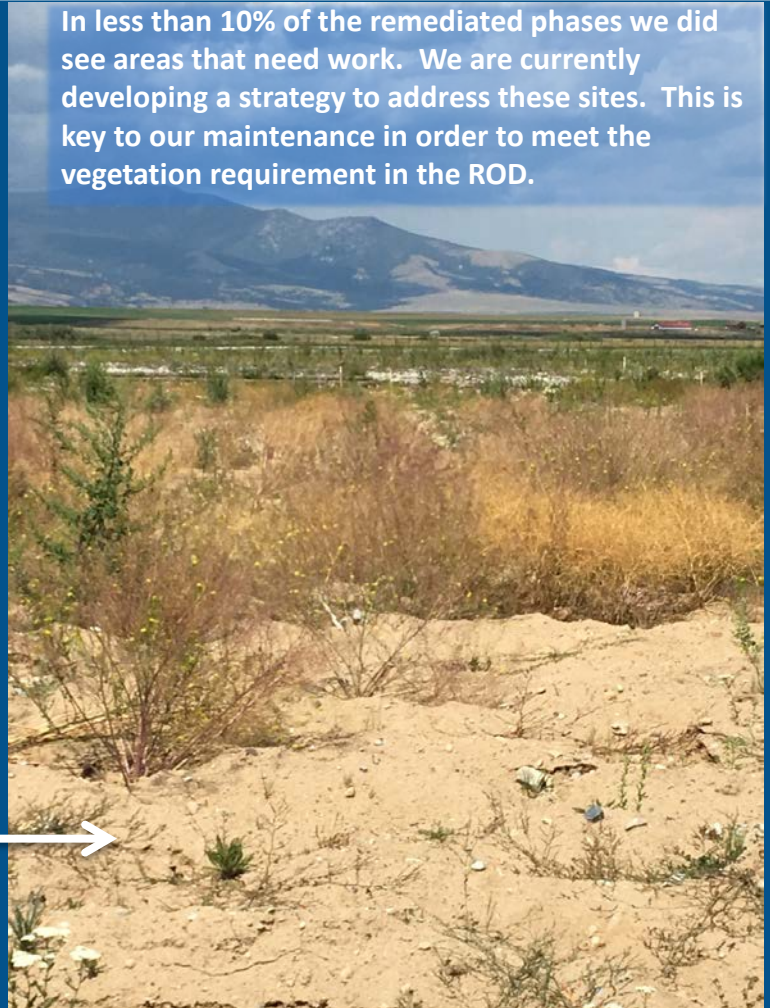
NEEDS  
MAINTANCE

In less than 10% of the remediated phases we did see areas that need work. We are currently developing a strategy to address these sites. This is key to our maintenance in order to meet the vegetation requirement in the ROD.
