**Clark Fork River  
Operable Unit of the  
Milltown Reservoir Clark  
Fork River  
Superfund Site**

**Phase I Construction Update– The Clark Fork Has Begun Its Return Home.**

**A Photo Journey Through the Clark Fork River  
Phase I Remediation Project**

**March 4, 2013– December 20, 2013**

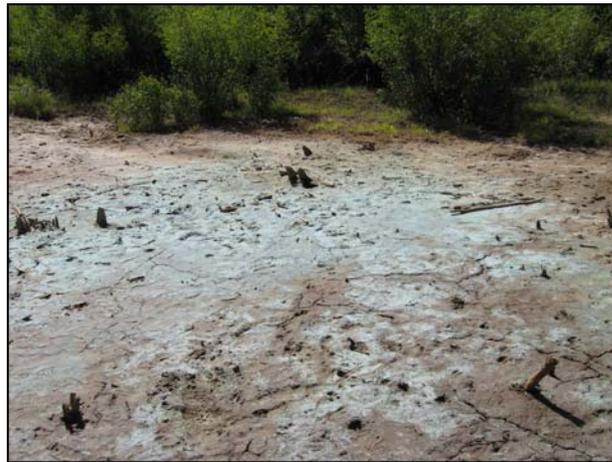
Left: Mine waste tailings in the floodplain of the Clark Fork River prior to removal.

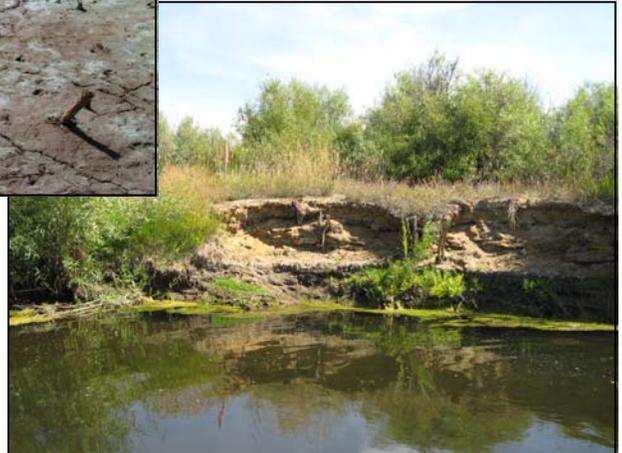
Right: Severely eroded banks containing tailings were along the Phase I project area. These were removed and re-built using bio-engineered techniques.

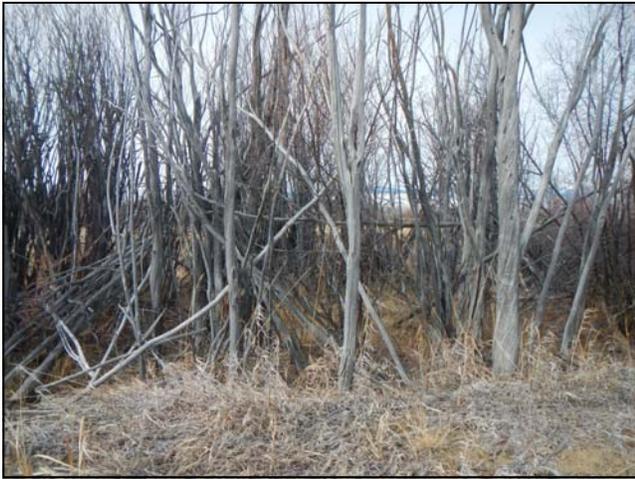
Dead and decaying woody vegetation existed along the river banks, creating undesirable habitat and instability along the streambanks.

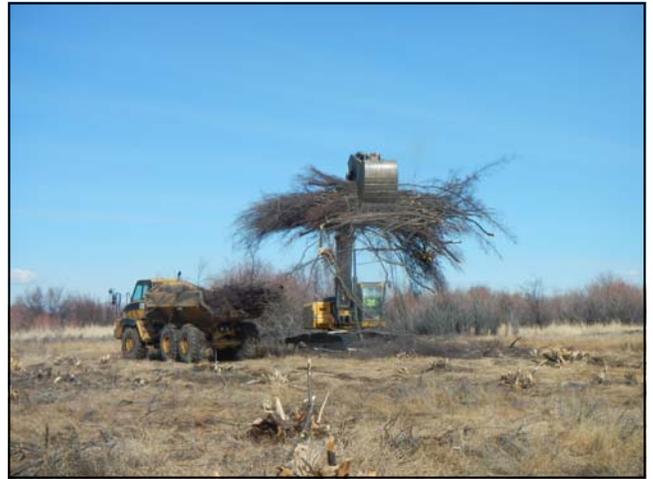
Woody material (decaying willows) was removed and stockpiled for eventual placement in the floodplain to create roughness and natural seed bed niches.

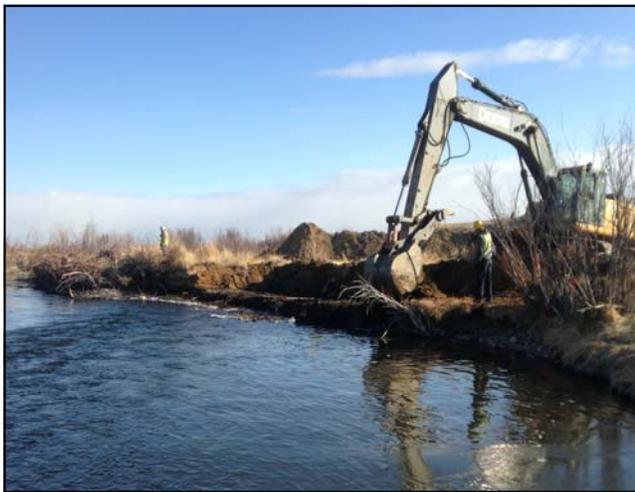
Above: Tailings are being excavated from the streambanks in order to install double vegetated soil lifts for stability.

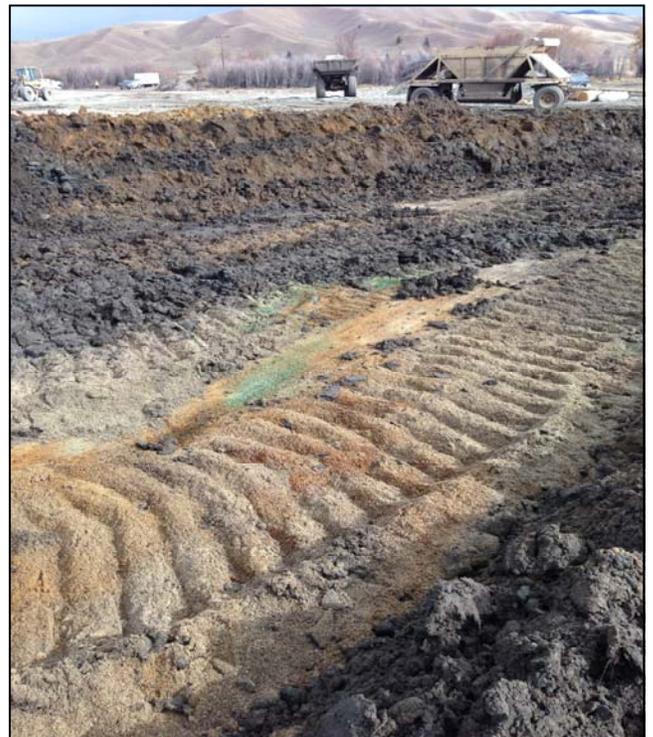
Above: Area where tailings have been excavated behind the existing stream bank.

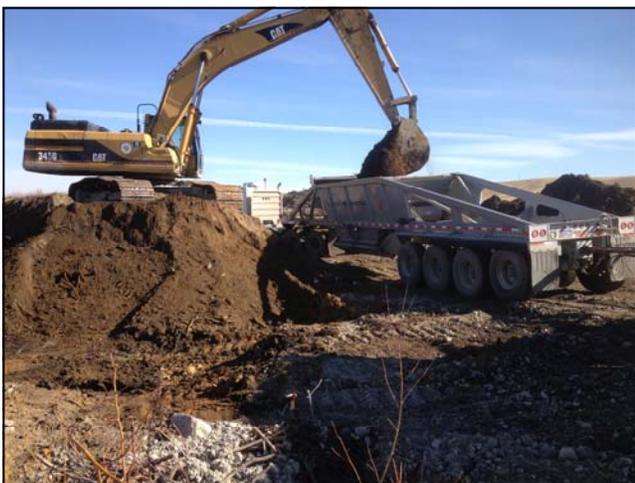
Left: Tailings were loaded into haul trucks and taken to the BP Waste Management Area. 330,000 cubic yards of tailings were removed and replaced with 189,000 of clean alluvium and vegetative fill in the floodplain.

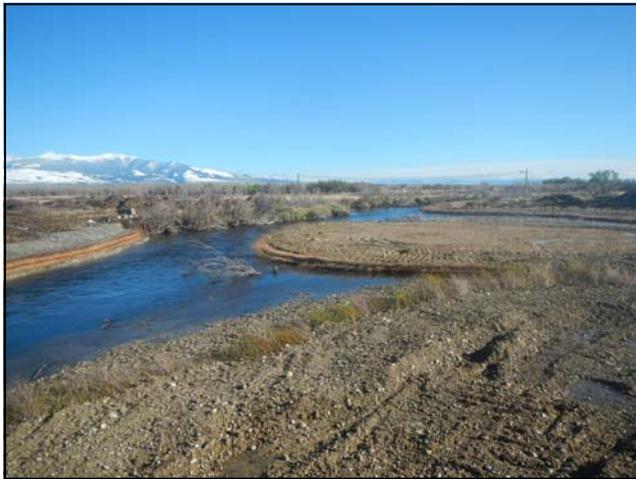
Completed streambanks along the river and point bars will gather native seeds during high flow and help create plant diversity.

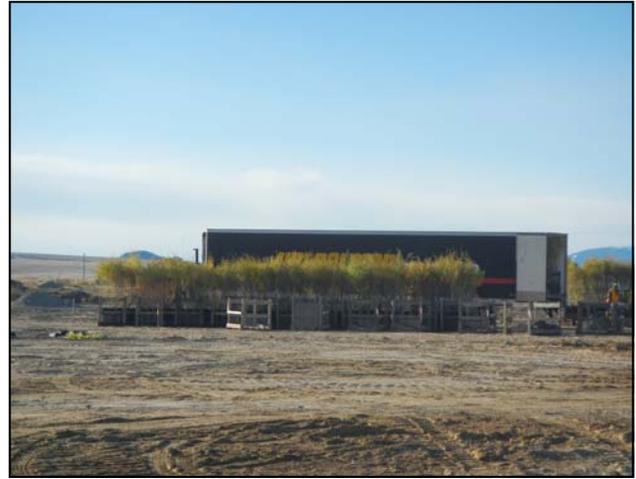
Over 11,000 containerized plants were planted this fall, with over 100,000 more to be planted during the spring and fall of 2014.

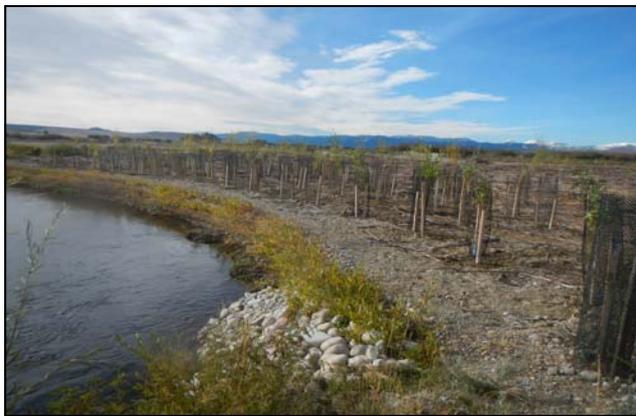
Streambanks along the newly rebuilt river channel.

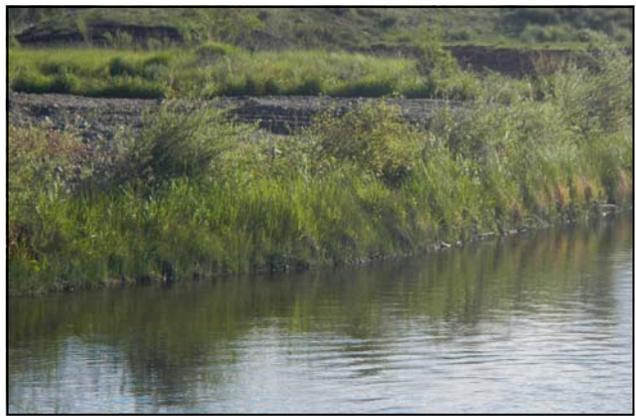
New willow growth started to appear in early June where willows had been trimmed and preserved, or contamination removed.

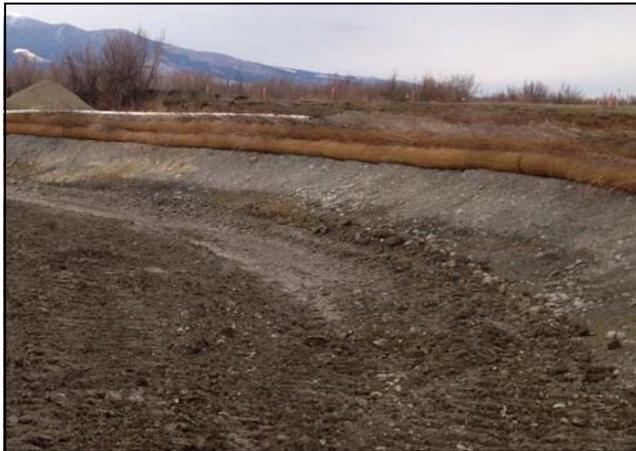
The river channel bed being built after removals.

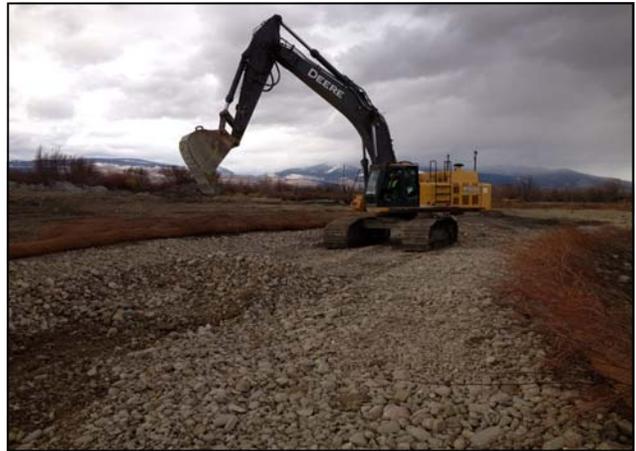
Double vegetated soil lifts were constructed to form the new channel banks.

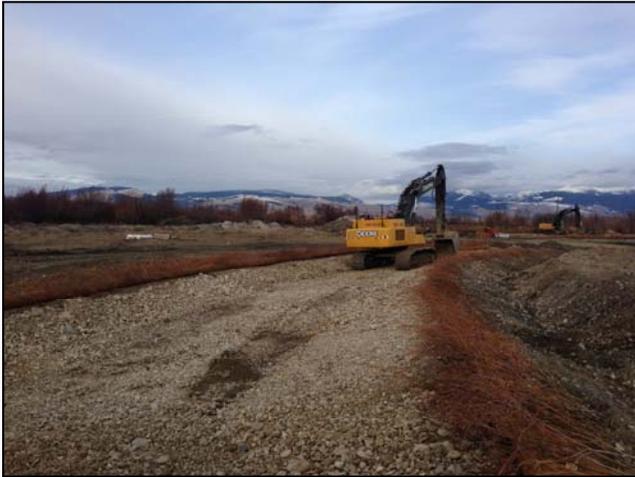
The excavator operator works to shape the streambed materials in the rebuilt Clark Fork River channel where deep tailings were removed.

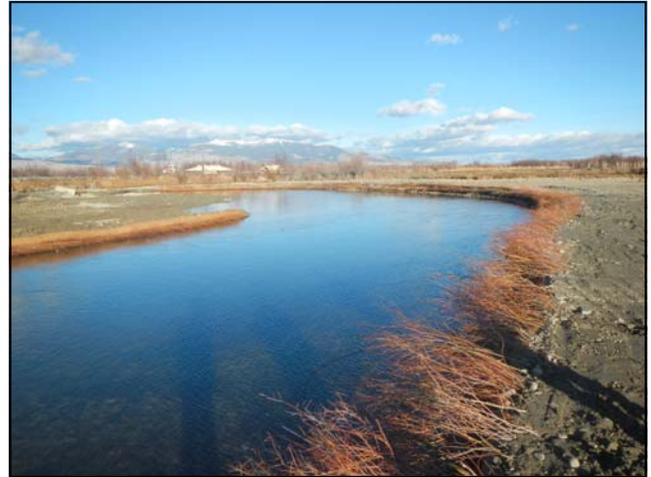
The river was diverted in order to remove deep tailings. Here, the river has been put back in the original channel and returns home to clean streambanks.

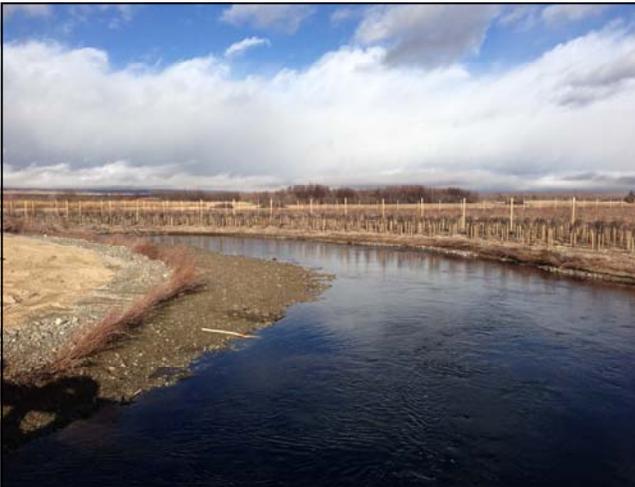
The view looking downstream from the Morel Road Bridge. The streambanks were excavated, re-built using bio engineered techniques, and revegetated with a variety of native trees, shrubs and a native seed mix.

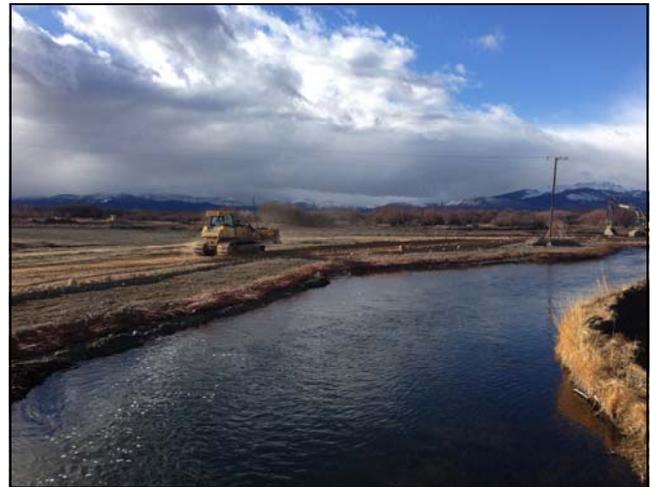
The view looking upstream from the Morel Road Bridge. The bulldozer works to push vegetative fill around the floodplain. This material will provide a good growth medium for vegetation.
