**Clark Fork River
Operable Unit of the
Milltown Reservoir
Clark Fork River
Superfund Site**

June 2009

Soil Sampling at Deer Lodge Trestle, October 2008

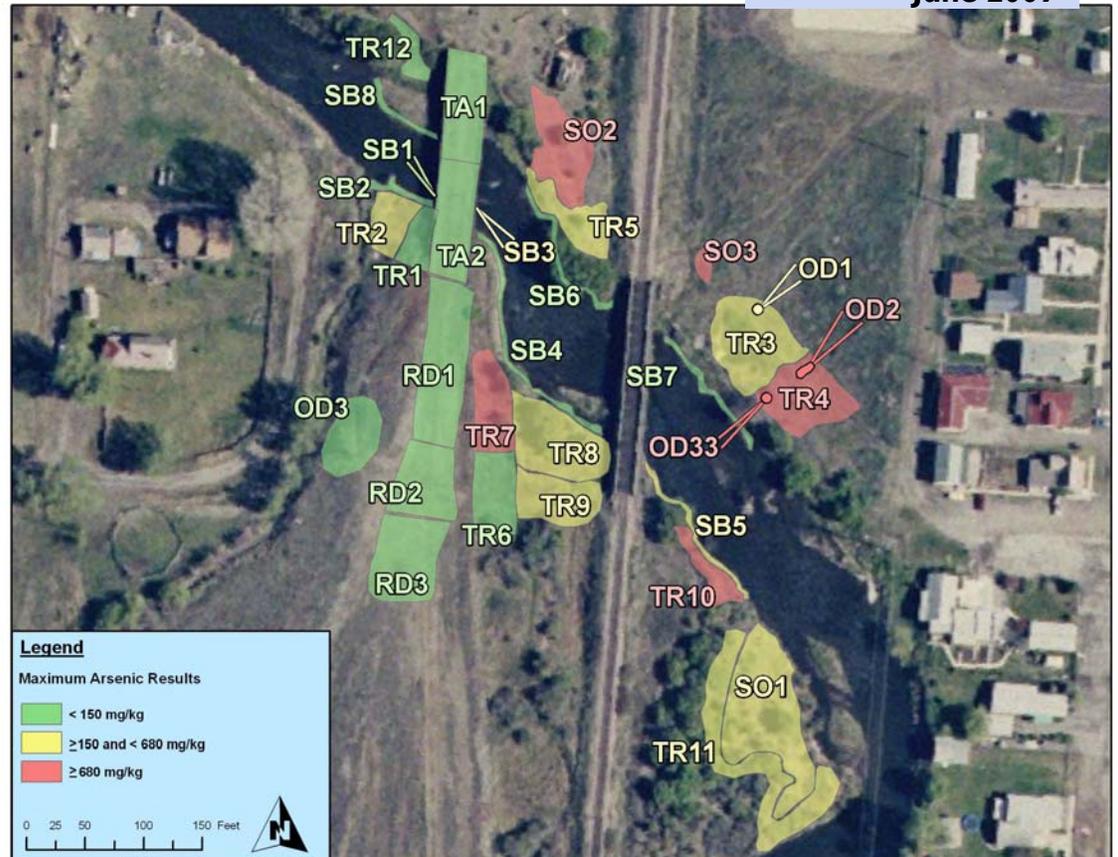
Sample Location	Arsenic Results (mg/kg)				
	A Depth (0-2 in.)	B Depth (2-6 in.)	C Depth (6-12 in.)	D Depth (12-18 in.)	E Depth (18-24 in.)
OD1	679	327	175	77	
OD2	299	502	1020	661	
OD3 ^a	42	22	ND	5	ND
OD33 ^a	248	284	308	1000	1180
OD4	20	47	43	19	
OD5	148	453	167	10	
RD1	20	ND	ND	15	
RD2	21	9	ND	28	
RD3	26	13	7	21	
SB1 ^b	53	51	20	14	
SB2	108	111	111	102	
SB3 ^b	30	149	247	82	
SB4	53	72	85	78	
SB5	237	280	396	187	
SB6	55	41	63	55	
SB7	108	101	111	132	
SB8	54	42	48	43

Sample Location	Arsenic Results (mg/kg)				
	A Depth (0-2 in.)	B Depth (2-6 in.)	C Depth (6-12 in.)	D Depth (12-18 in.)	E Depth (18-24 in.)
SO1	620	373	322	469	
SO2	Mine Waste Throughout, No Samples Collected				
SO3 ^a				941	12
TA1 ^c	18	17			
TA2 ^c	19	29			
TR1	34	46	125	68	
TR2	120	300	311	190	
TR3	246	193	460	358	
TR4	215	259	467	736	
TR5	239	259	350	643	
TR6	42	70	47	29	
TR7	272	849	1210	140	
TR8	356	324	198	218	
TR9	202	265	53	145	
TR10	280	344	398	1100	
TR11	141	187	185	281	
TR12	140	77	81	83

^a Different sampling levels than those shown in the table are:
OD3 - E (36 in.)
OD33 - A (0-3 in.), B (3-9 in.), C (9-10 in.), D (10-20 in.), E (20-24 in.)
SO3 - no samples taken from 0 - 18in.; D (18-26 in.), E (26-32 in.)

^b SB1 & SB3 - sample locations under trestle

^c TA1 & TA2 - Soil on top of trestle only 6 inches deep
ND - Not Detected
mg/kg - milligrams per kilogram

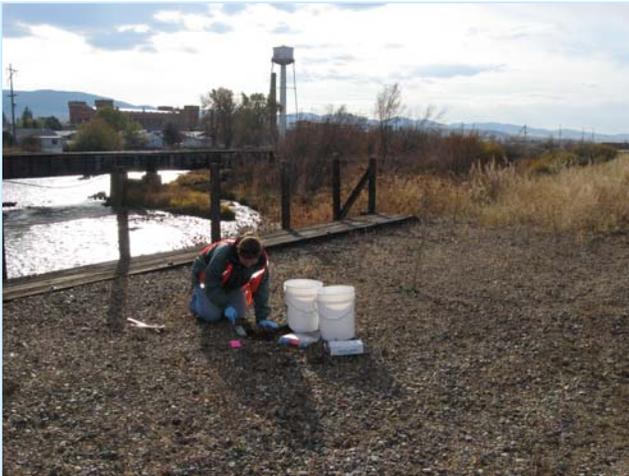
During the week of October 20, 2008, the Montana Department of Environmental Quality (DEQ) conducted soil sampling and survey work in the Trestle Area of Deer Lodge, Montana. Objectives of the Trestle Area sampling consisted of: i) identifying areas of arsenic contamination above human health action levels on and around the trestle, ii) identifying slickens areas and estimating removal volumes for those areas identified for removal by a 2007 EPA study (Riparian Evaluation System, or RipES study), iii) characterizing and evaluating the stream banks within the Trestle Area for remedial action, iv) evaluating the structural stability of the trestle relative to adjacent removals, and v) collecting necessary data to determine and support a remedial design if a human health response action is required. The data will be interpreted to assess risk to human health within the context of expected land use and used to develop any proposed response action.

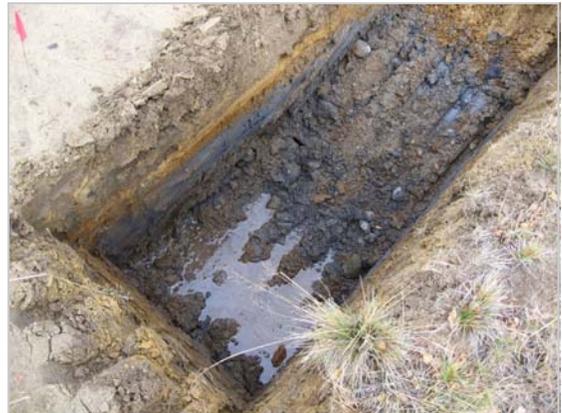
Soil Sampling Pit Showing Visible Contamination at Depth

Two slickens areas were identified by the 2007 EPA study on the north bank of the Trestle Area.

Based on square footage information obtained from the study data and depth information obtained from the October 2008 sampling, the total removal volume for both areas is estimated to be approximately 600 cubic yards.

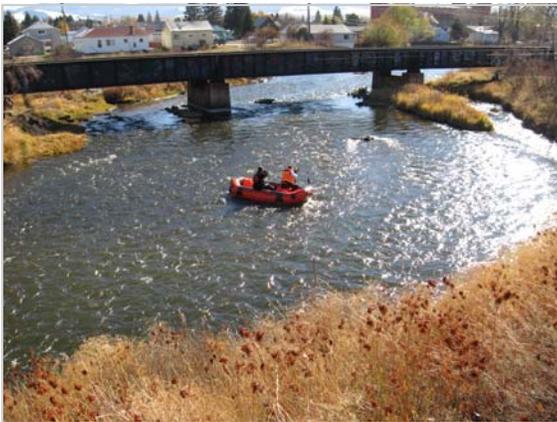
Structural integrity of the two trestles was visually assessed and found to be adequate for current uses. Any remedial activities that occur at this site should be designed such that scour at the bridge pilings is not increased. Geomorphic (river) conditions in the project area were surveyed and recorded. Five areas of stream bank erosion were found, four of which are active, and one of which is severe. Topographic (surface features) survey information was collected throughout the Trestle Area, and cross-sections of the river were surveyed.

Cross-Section River Surveying, October 2008
