# BNSF RAILWAY FORMER TIE TREATING PLANT SOMERS, MONTANA

USEPA Region 8 Montana Office  
Montana DEQ

Thursday, September 20, 2012  
Somers Fire Hall

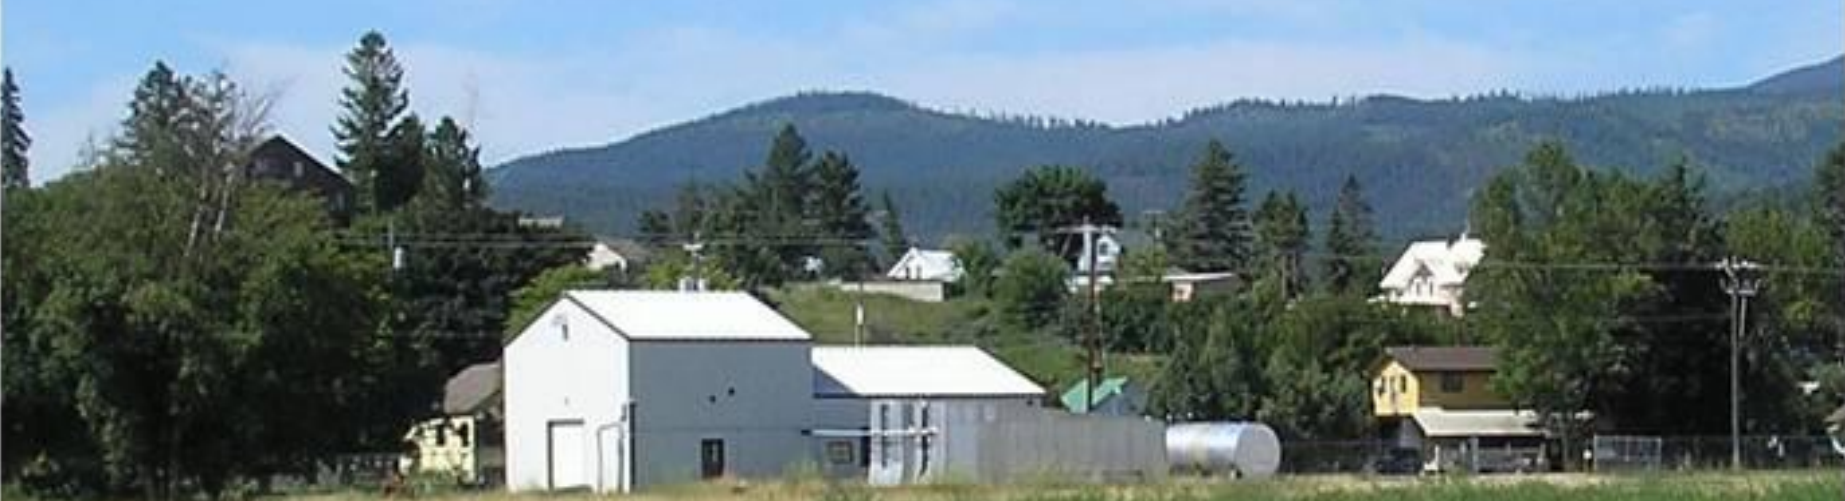
- ❑ In situ biological treatment and hot water flushing within water table aquifer
  - ❑ 1992 , 1998 changes to the ROD
  - ❑ Installed injection and recovery wells
  - ❑ Groundwater Treatment System (GWTS) operates from 1994-2007

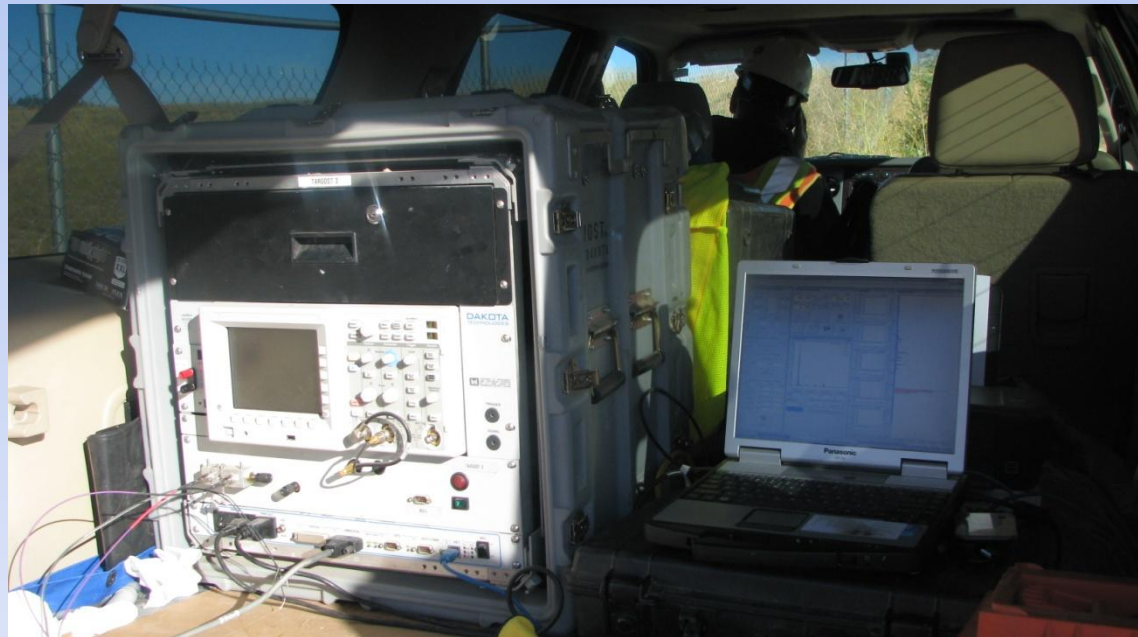
- TarGOST
  - Tar + Green Optical Screening Technology
  - ▣ Used to detect presence/absence of creosote
  - ▣ Creosote “fluoresces”
  - ▣ Intensity of reaction varies

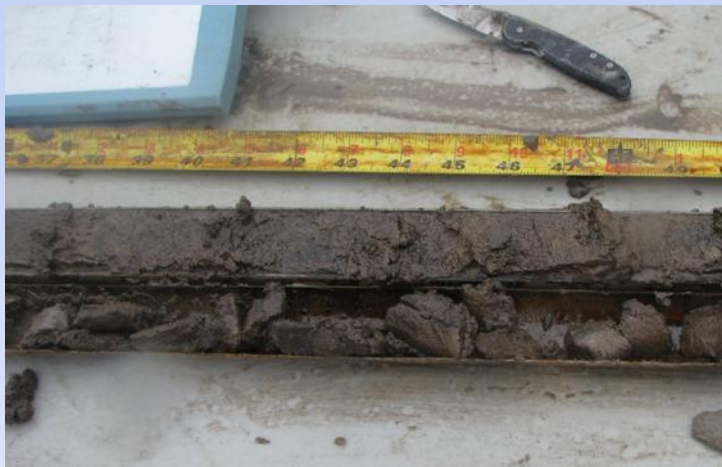
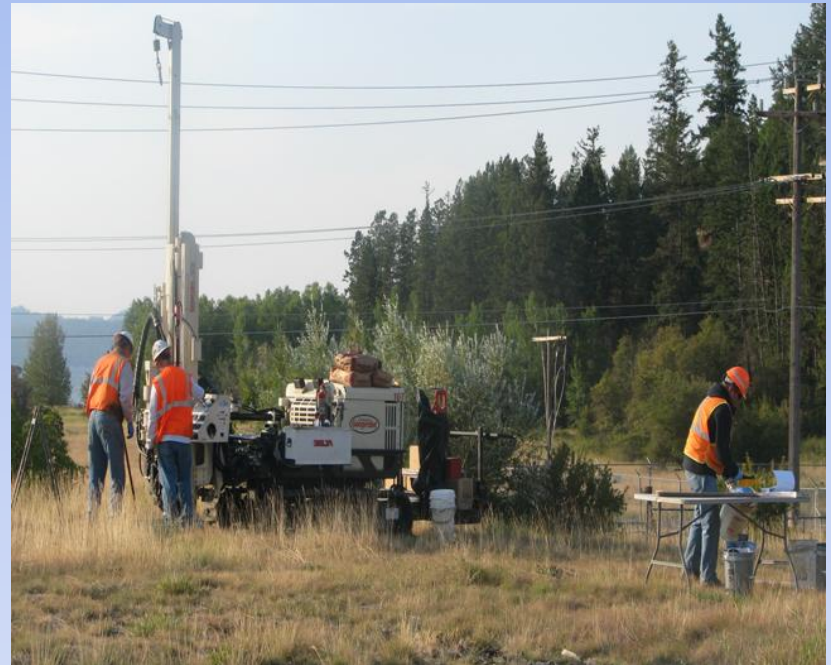
- Conducted September 2011-February 2012
- Collect soil profile, sample
- Groundwater level, sample
- Collected 145 soil and  
196 groundwater samples
