# RELEASE CLOSURE PACKET

## Petroleum Tank Cleanup Section – Closure Report for Petroleum Release

Submitted by: Shannon Cala  
Date: September 21, 2018

Facility and Petroleum Release Information			
<b>Facility Name:</b>	Winifred Farmers Oil Co.	<b>Facility ID:</b>	14-01292
<b>Address:</b>	108 Main Street	<b>Release #:</b>	3008
<b>City:</b>	Winifred	<b>Date Confirmed:</b>	09/17/96
<b>Responsible Party:</b>	CHS, Inc.	<b>County:</b>	Fergus

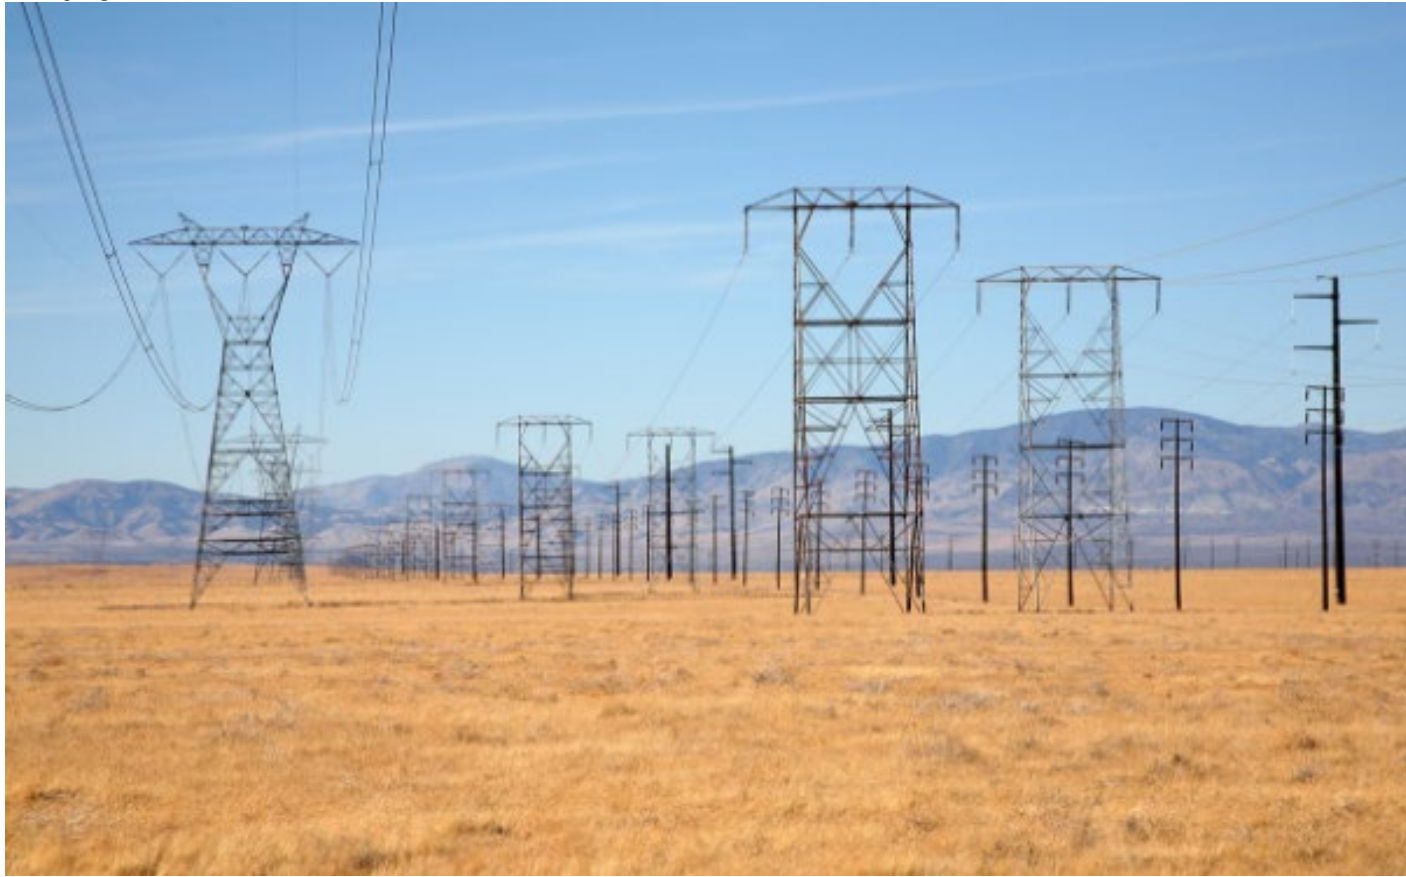
~95 cubic yards of impacted soils were excavated and successfully landfarmed.

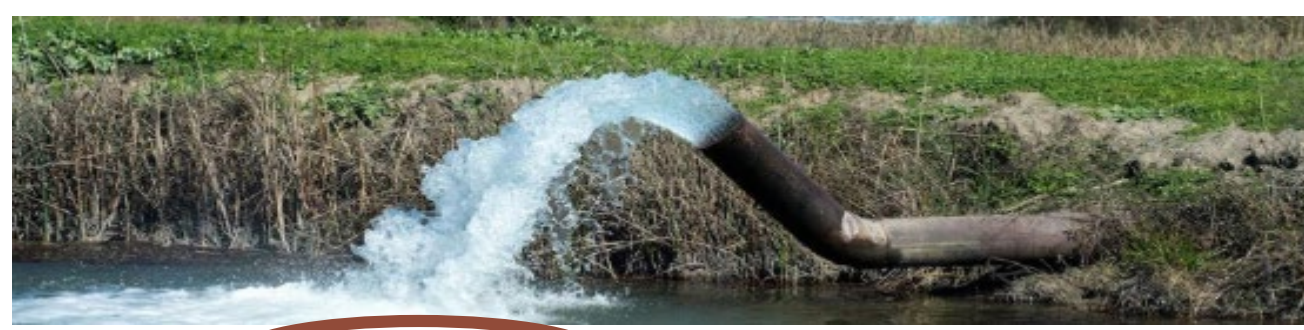
Groundwater (GW) Impacts - Investigation and Pathway Elimination	
Was GW encountered at the facility (Y/N)?	Y
Depth to GW (feet below ground surface)	>7.0
General GW flow direction	SE
Tier 1 RBSLs extent defined (Y/N)?	Yes
GW Pathway eliminated (Y/N)?	Yes
<b>GW Exposure Pathway eliminated by:</b> (check all that apply)	
Lab data: Analytes < RBSL and WQ Standards	Yes
Lab data: Analytes <WQ standards; and TPH / EPH fractions >RBSLs; and exposure pathway to receptor(s) incomplete. If Yes, explain why exceedance is not a threat:	
The subsurface water located on the facility appears to be a non-contiguous water bearing unit that is fed by surface water. The water appears to accumulate in the more porous tank basin backfill or soils used to fill the roadway. Monitoring wells installed in native soils were dry to 18' <u>bgs</u> .

Compliance Monitoring -- Groundwater
<b>Summary of Monitoring Wells, Number, Locations, Time Interval (Years) of Monitoring:</b>
Well MW1 was installed in 1997 and was used as the injection point for surfactant. The well has been monitored and shown a declining trend in diesel range constituents. Wells MW2 through MW6 were installed in August 2018, three wells had measurable groundwater which was sampled and two were dry.
<b>Summary of Trend(s) in Groundwater Attenuation and Quality:</b>
Diesel contamination in groundwater does not exceed RBSLs in any of the sampled wells.
