2020 319 Application Form

Project Name Lower Bitterroot Tributary Restoration

Sponsor Name Clark Fork Coalition

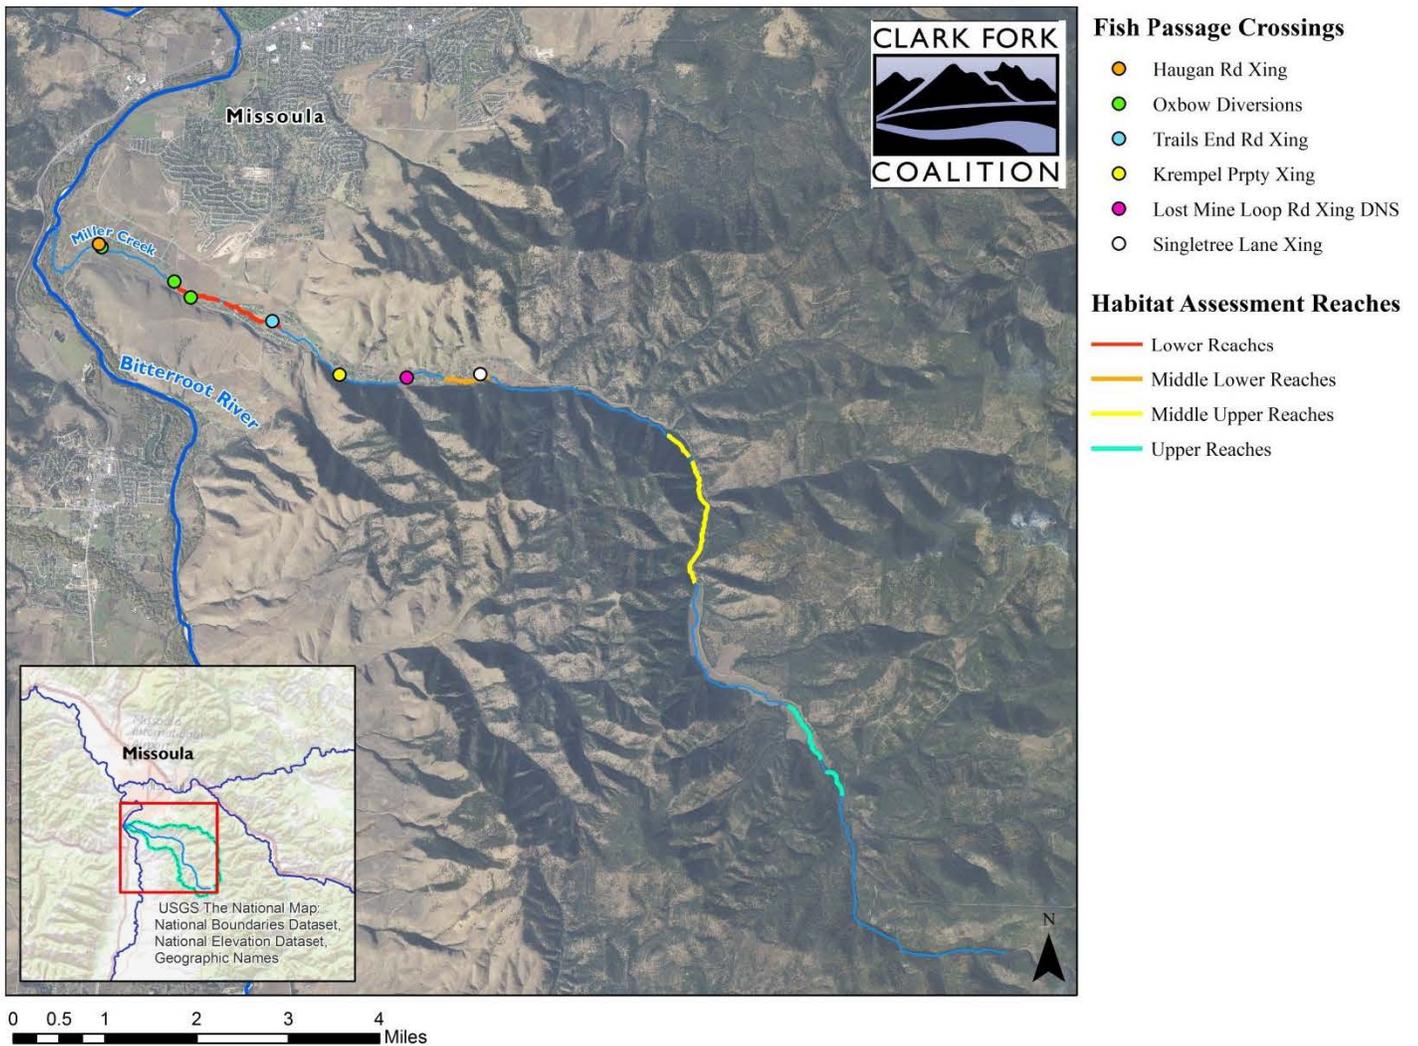
Figure 1. Map depicting the habitat assessment reaches and crossings surveyed for fish passage in Miller Creek.

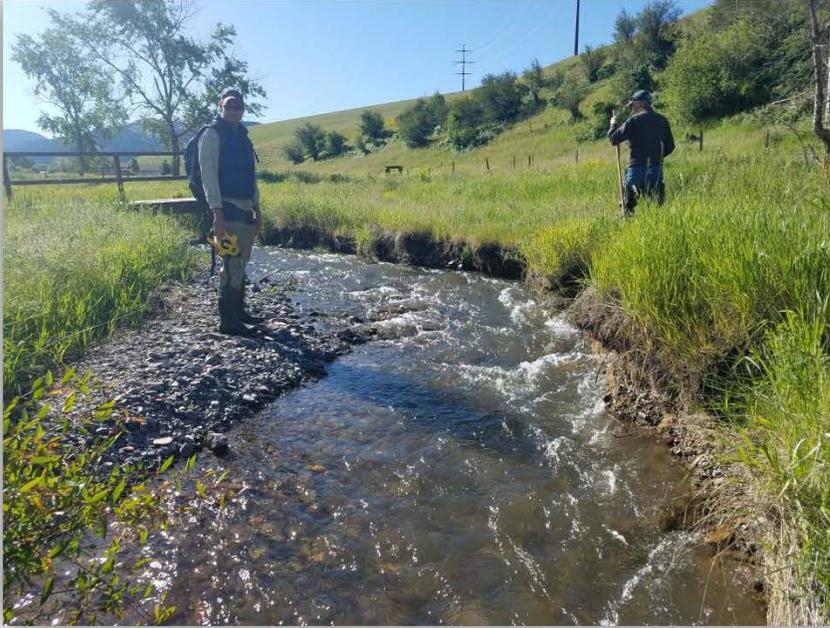
Reach NWE_1

Figure 2. Conditions in the upstream end of reach NWE_1.

This reach of Miller Creek flows through property that is owned by Northwestern Energy and contains one streamflow diversion at the upstream end of the reach, where the water right is owned and operated by Oxbow Cattle Company. Reach length is 0.26 miles. The stream appears to have been straightened throughout most of the reach, as the sinuosity is very low, the slope of the stream is very steep for the location within the watershed, and there are very few pools within the reach. This reach is dominated by fast water (riffles). This section is clearly a sediment transport reach, as the dominant substrate is cobble and there are very few depositional zones. There is a definitive lack of riparian hardwood vegetation in this reach and the dominant riparian vegetation is grasses. The stream is incised one to two feet throughout the reach.

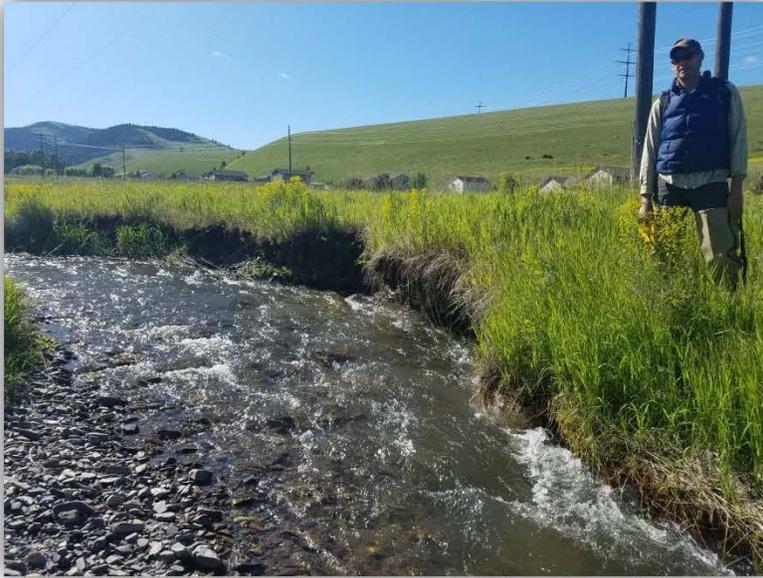
Reach NWE_2

Figure 3. Conditions in reach NWE_2.

This reach of Miller Creek flows through property that is owned by Northwestern Energy. Reach length is 0.33 miles. The stream appears to have been straightened throughout most of the reach, as the sinuosity is very low, the slope of the stream is very steep for the location within the watershed, and there are very few pools within the reach. This reach is dominated by fast water (riffles). This section is clearly a sediment transport reach, as the dominant substrate is cobble and there are very few depositional zones. There is a definitive lack of riparian hardwood vegetation in this reach and the dominant riparian vegetation is grasses. The stream is incised one to two feet throughout the reach.

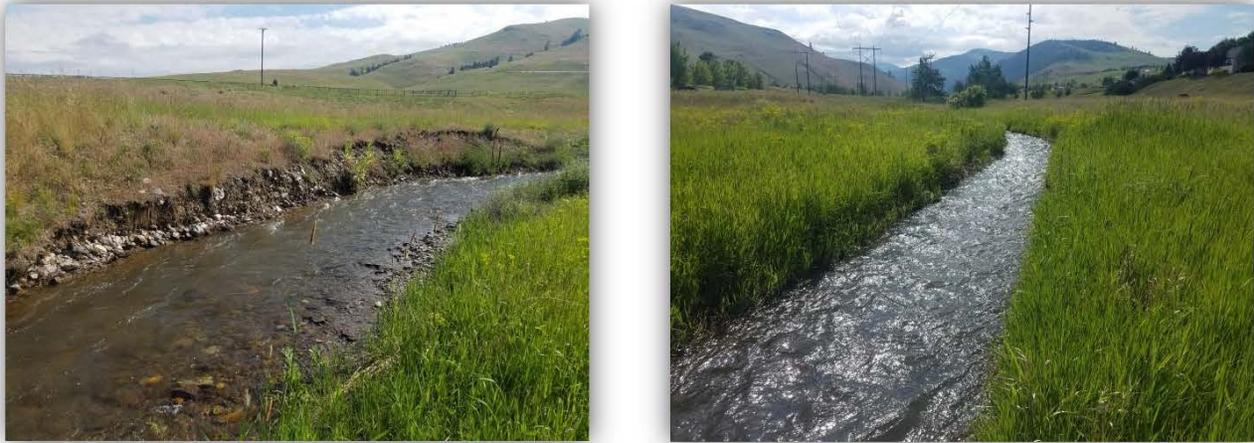
Reach Stillwater_1

Figure 4. Conditions in Stillwater_1 reach.

This reach of Miller Creek flows through property that is owned by Stillwater Addition Homeowners. Reach length is 0.5 miles. The stream appears to have been straightened throughout most of the reach, as the sinuosity is very low, the slope of the stream is steep for the location within the watershed, and there are no pools within the reach. This reach is one long continuous riffle. This section is clearly a sediment transport reach, as the dominant substrate is cobble and there are very few depositional zones. There is a definitive lack of riparian hardwood vegetation in this reach and the dominant riparian vegetation is grasses. The stream is slightly incised throughout the reach. Lateral bank erosion was visible along the outside bends where banks were 4-5' tall and eroded.

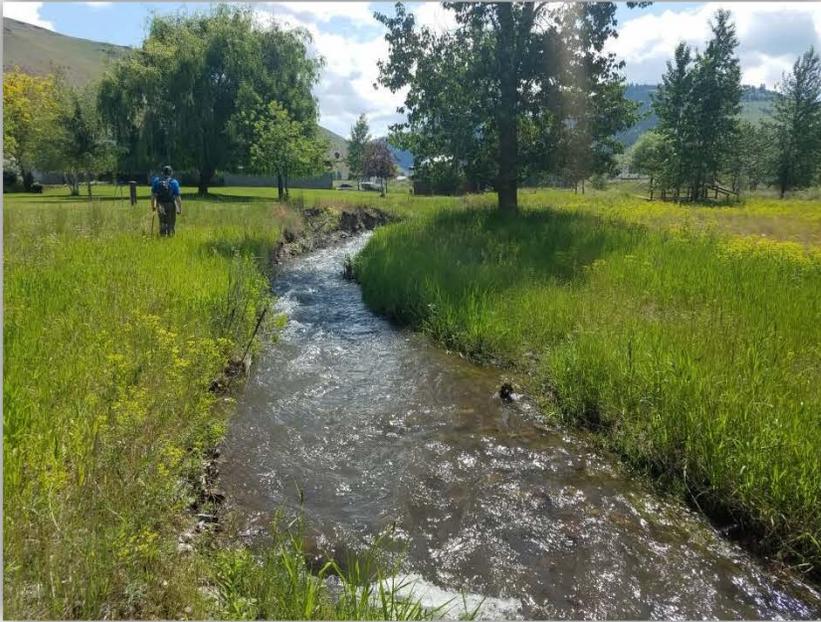
Reach Capon_1

Figure 5. Conditions in Capon_1 reach.

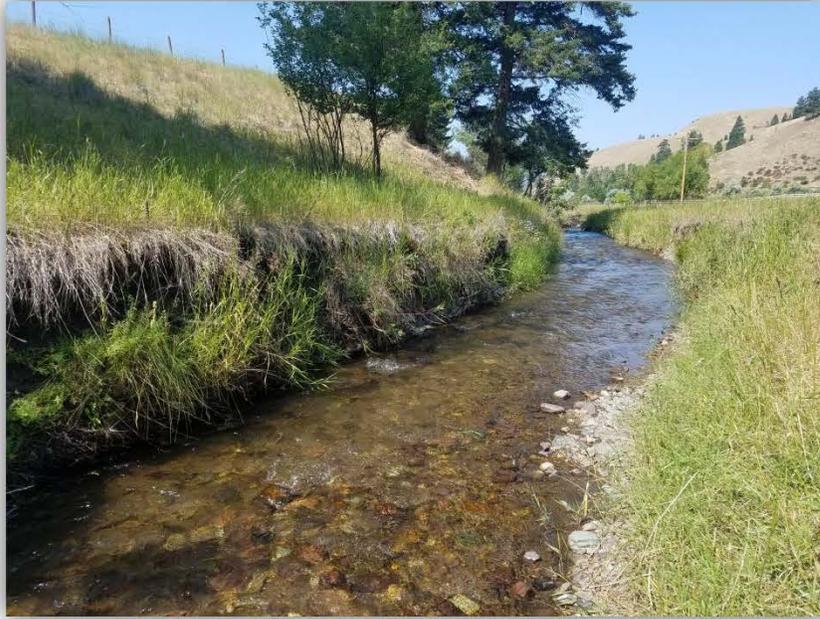
Reach Singletree_1

Figure 6. Conditions in Singletree_1 reach.

This reach of Miller Creek flows through property that is owned by two private entities. Reach length is 0.19 miles. There are few pools (4) within the reach, and there is a definitive lack of riparian hardwood vegetation in this reach and the dominant riparian vegetation type is grasses. The stream is incised an average of 5 feet throughout the reach, and lateral bank erosion was evident throughout the reach as the channel is actively widening. There was an increased amount of fine sediment observed in this reach.

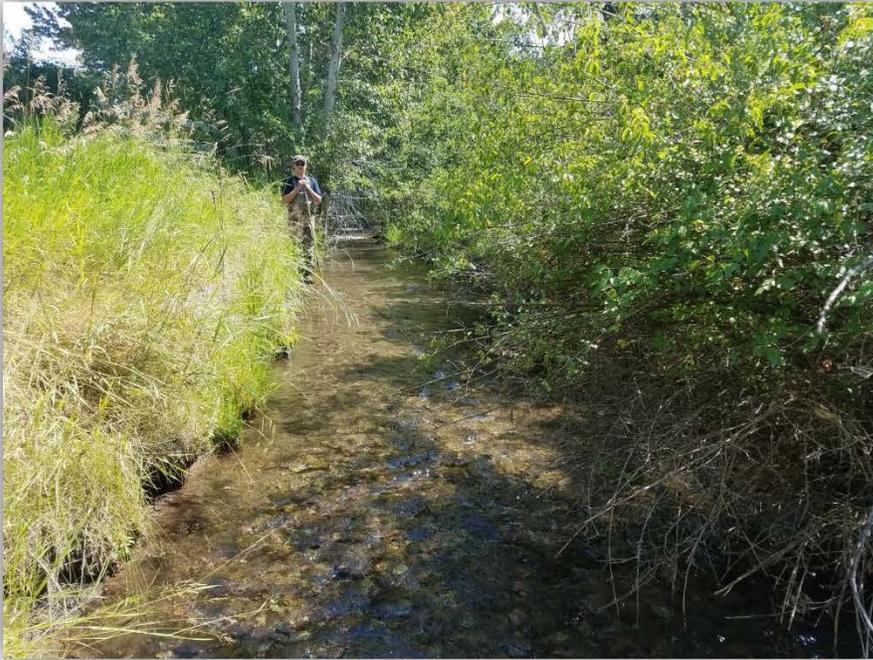
Reach Singletree_2

Figure 7. Conditions in Singletree_2 reach.

This reach of Miller Creek flows through property that is owned by a private entity and Missoula County. Reach length is 0.19 miles. There are six pools within the reach, and there was an increased amount of fine sediment observed in this reach. Channel incision observed in this reach begins with a 4 foot average on the downstream end, and generally decreases as you move upstream, giving an average of 3 feet throughout the reach. Lateral bank erosion was evident throughout the reach as the channel is actively widening. Riparian vegetation increased in this reach, with cottonwood, chokecherry, aspen, and willow as the dominant hardwood riparian vegetation present.

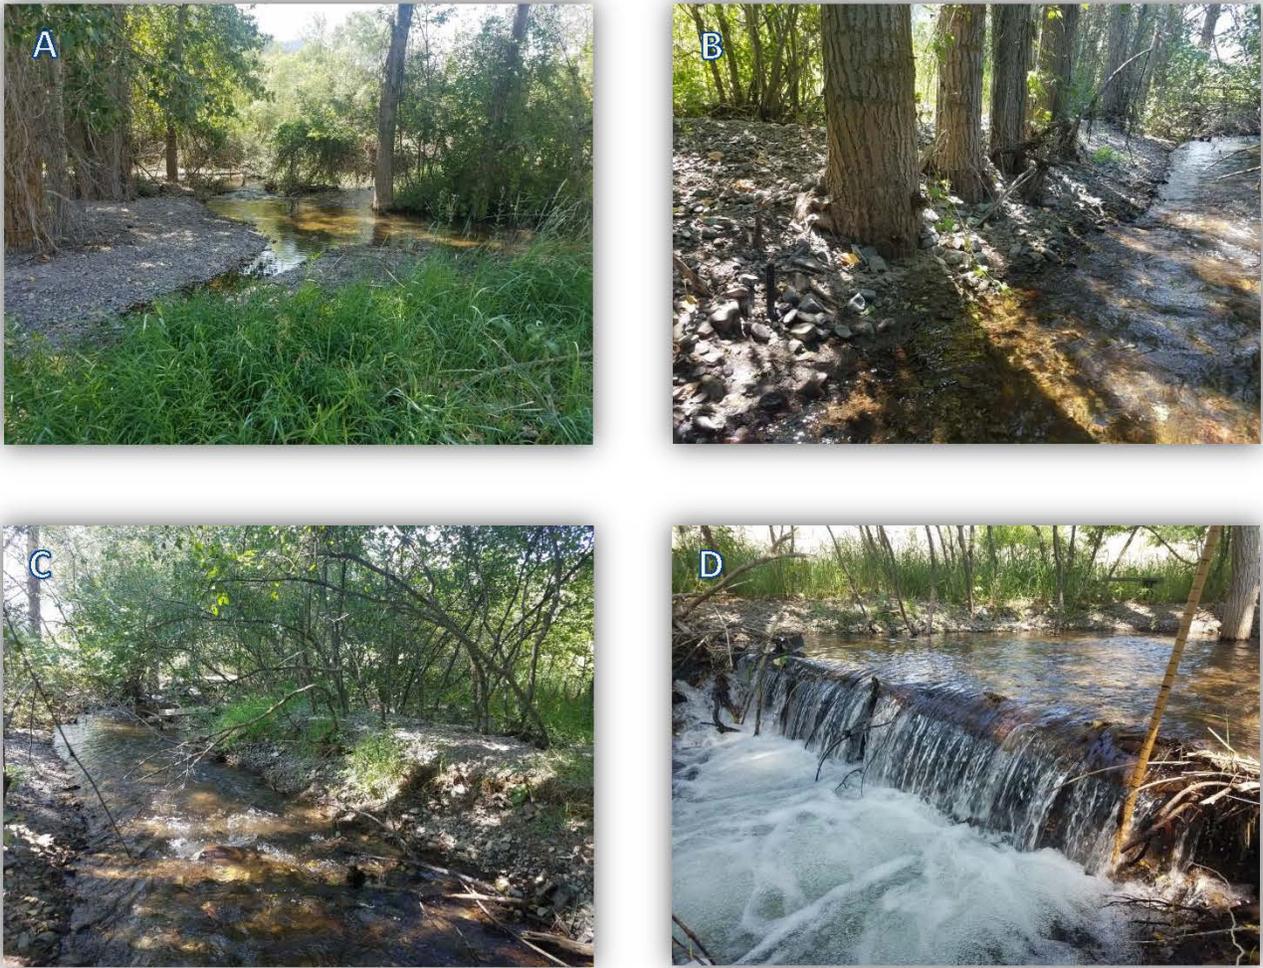
Reach Singletree_3

Figure 8. Photo A: Sediment deposition and channel avulsion occurring downstream of the Singletree Lane crossing. Photos B&C: Large sediment plug that has deposited approximately 4 ft of sediment for 400 ft upstream of the crossing. Photo D: Channel spanning log causing a potential fish passage barrier with a 1.8 ft fish jump height.

Restoration recommendations for this reach are to:

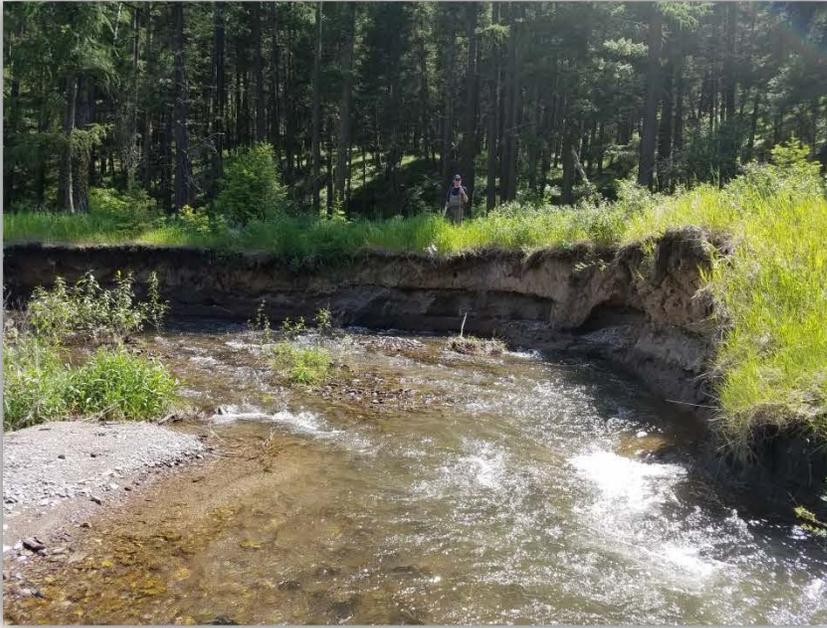
Reach Wustner_1

Figure 9. Conditions in the Wustner_1 reach. Note person standing on bank for scale of incision.

This reach of Miller Creek flows through property that is owned by a private entity. Reach length is 0.35 miles. The stream has been relocated to the south side of the valley and straightened throughout most of the reach. This section of stream is very incised and is actively widening. Banks were actively sloughing throughout the reach. The stream is incised 8-10 ft on average throughout the reach – the worst seen in the watershed. The floodplain is disconnected throughout the reach, and dead riparian vegetation was visible because of this. An inset floodplain is forming inside the incised channel (see photo). Pools were minimal in this reach, and there was minimal shade and cover for fish.

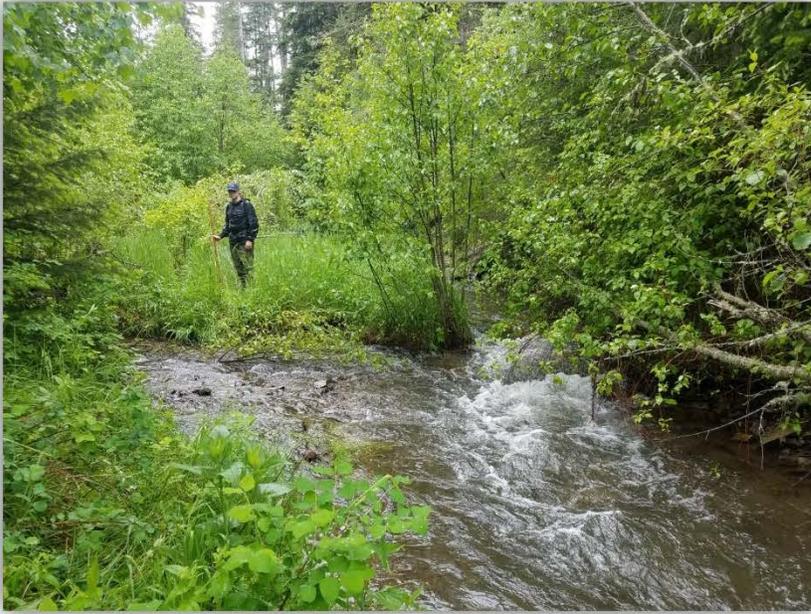
Reach DNRC_1

Figure 10. Conditions in the DNRC_1 reach.

This reach of Miller Creek flows through property that is owned by the MT Department of Natural Resources and Conservation. Reach length is 0.13 miles. This reach can be characterized as an incising channel with a thick riparian zone. Although not shown well in the photo for the reach, incision is approximately 6-7 ft on average throughout the reach, with very few bars and low sinuosity in most places. It appears that the channel has been moved to the west side of the valley. The reach consists of mostly fast water, with a slope of 2%, however some wood formed pools were present. Shade is not a limiting factor in this reach, but if incision continues, the floodplain could become more disconnected and the riparian zone could die off.

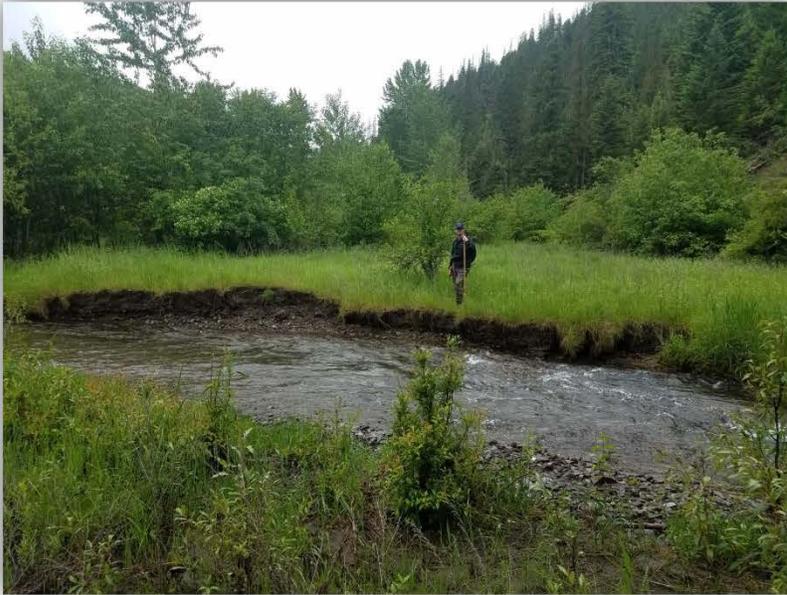
Reach DNRC_2

Figure 11. Conditions in the DNRC_2 reach.

This reach of Miller Creek flows through property that is owned by the MT Department of Natural Resources and Conservation. Reach length is 0.22 miles. This reach can be characterized as an actively incising and widening channel with a thick riparian zone. Incision is approximately 2-3 ft on average throughout the reach and there was an extensive amount of lateral bank erosion occurring. The channel moves away from the valley edge, overall is wider, has an inset floodplain, and a decreased slope. However, there were few pools observed in this reach. Shade is not a limiting factor, but if incision continues, the floodplain could become disconnected.

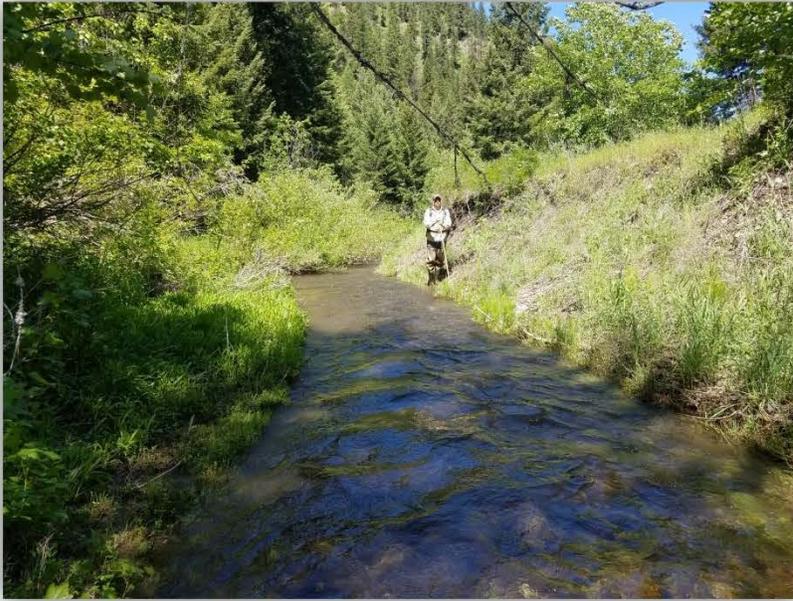
Reach DNRC_3

Figure 12. Conditions in the DNRC_3 reach.

This reach of Miller Creek flows through property that is owned by the MT Department of Natural Resources and Conservation. Reach length is 0.25 miles. This reach can be characterized as an incised and widened channel with a thick riparian zone growing on the inset floodplain. The stream here appears to be recovering from a historic incision and widening event. Incision is approximately 5-6 ft on average throughout the reach and there was a minimal amount of active lateral bank erosion occurring. There was an even mix of deep, shallow, large, and small pools observed in this reach. Gravels were partially embedded, and shade was not a limiting factor.

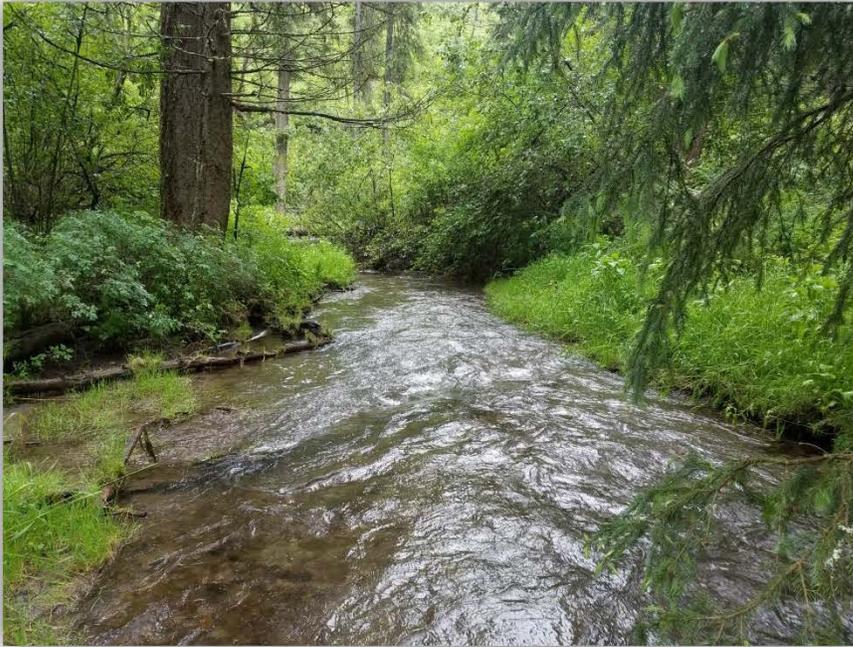
Reach MPG_1

Figure 13. Conditions in the MPG_1 reach.

This reach of Miller Creek flows through property that is owned by the MPG Ranch. Reach length is 0.54 miles. This reach can be characterized as a slightly incised and widened channel with a thick riparian zone growing in the floodplain. Incision is approximately 1-2 ft on average throughout, and an inset floodplain is in the formation process here. The riparian zone was very diverse and thick, with all age classes present. There was an even mix of deep, shallow, large, and small pools observed in this reach. Gravels were partially embedded, and shade was not a limiting factor.

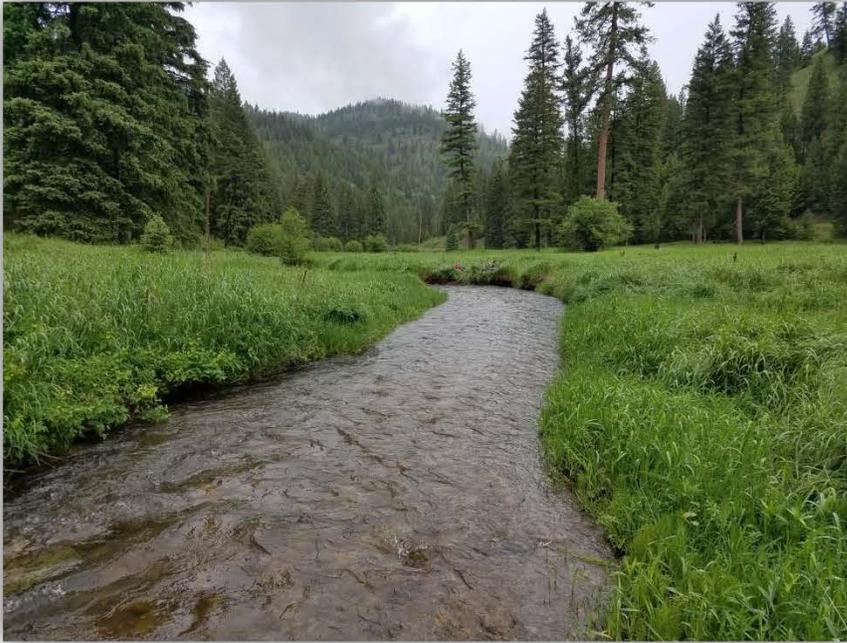
Reach MPG_2

Figure 14. Conditions in the MPG_2 reach.

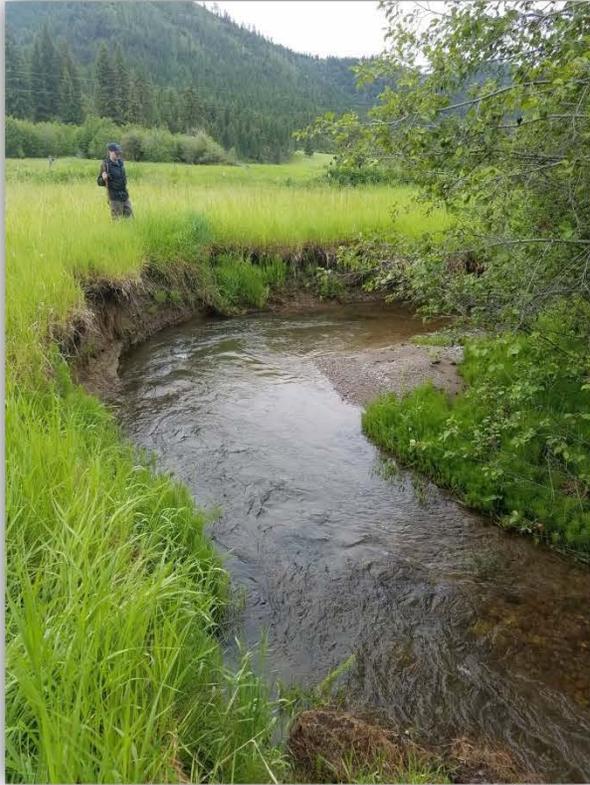
Reach Spooner_1

Figure 15. Conditions in the Spooner_1 reach.

This reach of Miller Creek flows through property that is owned by a private entity. Reach length is 0.73 miles. This reach can be characterized as an actively incising and widening channel with a riparian zone beginning to establish in an inset floodplain. Incision is approximately 4-5 ft on average throughout the reach and there was an extensive amount of active lateral bank erosion occurring. There is a definitive lack of riparian hardwood vegetation in this reach and the dominant riparian vegetation is grasses.

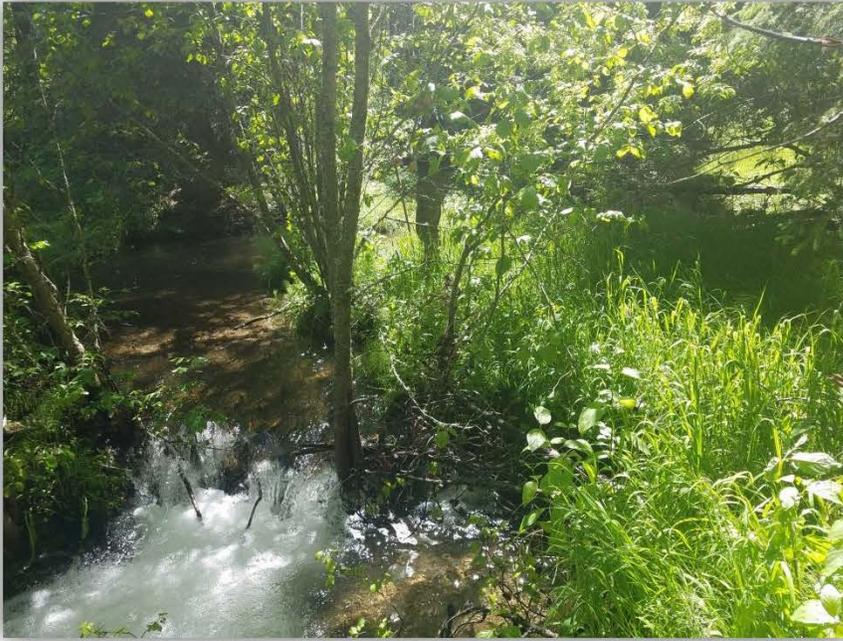
Reach USFS_1

Figure 16. Conditions in the USFS_1 reach.

This reach of Miller Creek flows through property that is owned by the U.S. Forest Service. Reach length is 0.19 miles. This reach can be characterized as an actively incising narrow channel with minimal lateral bank erosion. Incision is approximately 2 ft on average throughout the reach. The riparian zone consists mainly of alder with a conifer overstory. Shade is not a limiting factor in this reach. Gravels were embedded in fine sediment and there was a lack of bars present. The instream habitat in this reach was homogenized with few pools present, likely due to incision.

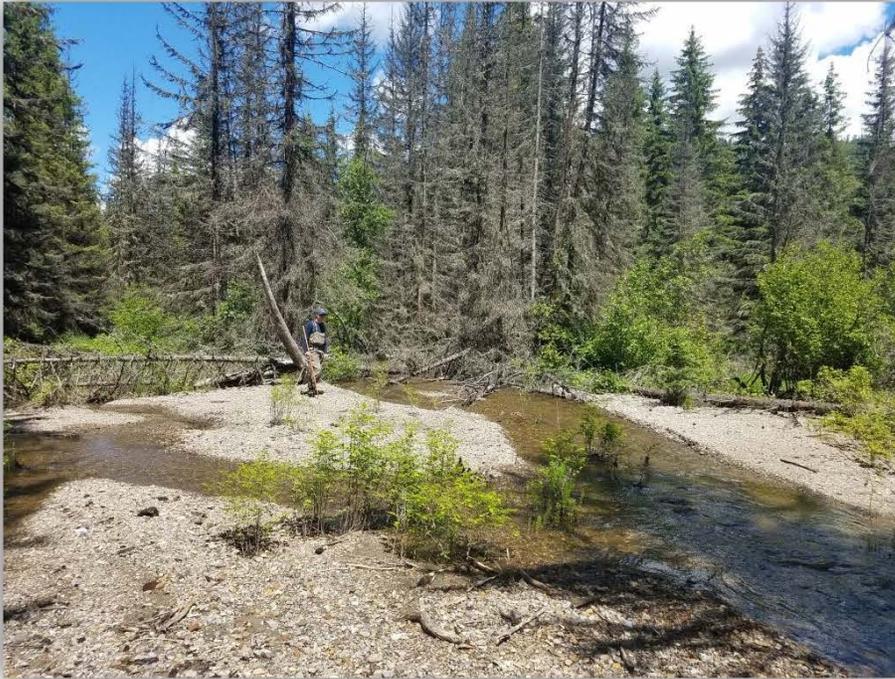
Reach USFS_2

Figure 17. Conditions at the upstream end of the USFS_2 reach.

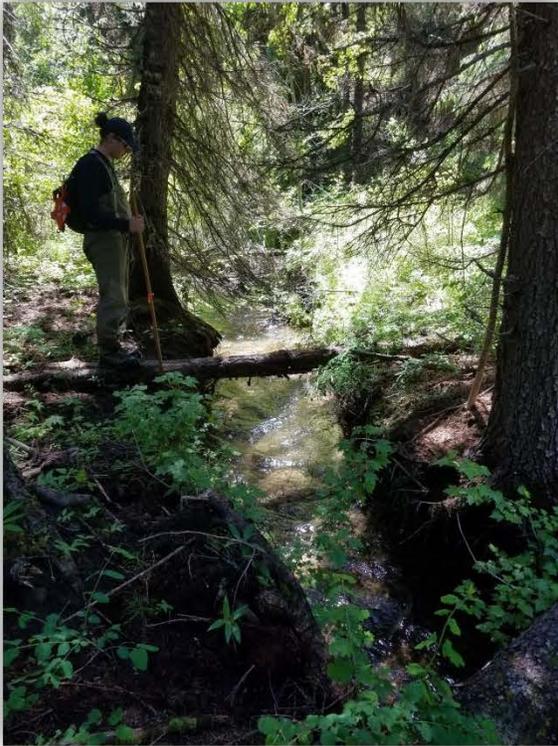
Reach USFS_3

Figure 18. Conditions in the USFS_3 reach.

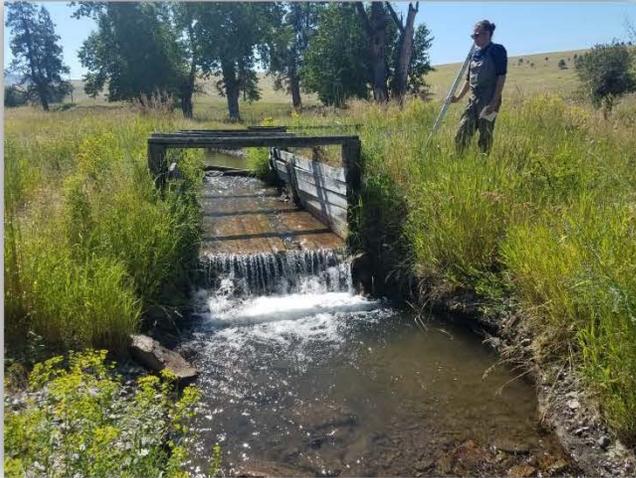
The fish jump height at the lower Oxbow Cattle Company stream diversion was measured at 2.2 ft and the water surface slope from downstream of the diversion to upstream of the diversion was measured at 4.5%.

Figure 19. The lower Oxbow Cattle Company stream diversion.

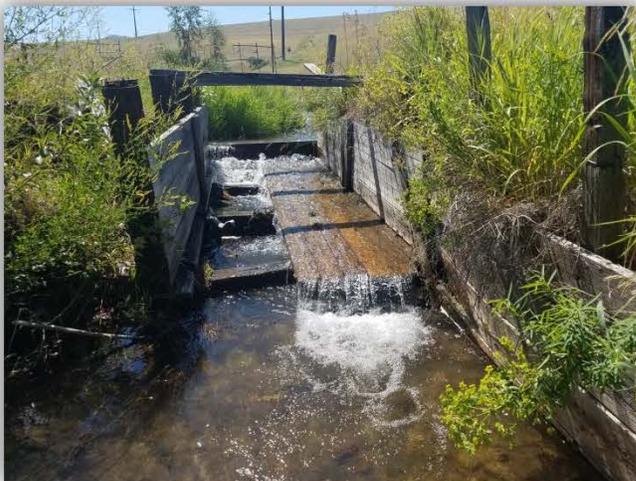
The fish jump height at the middle Oxbow Cattle Company stream diversion was a combined 2.7 ft and the water surface slope from downstream of the diversion to upstream of the diversion was measured at 4.0%.

Figure 20. The middle Oxbow Cattle Company stream diversion.

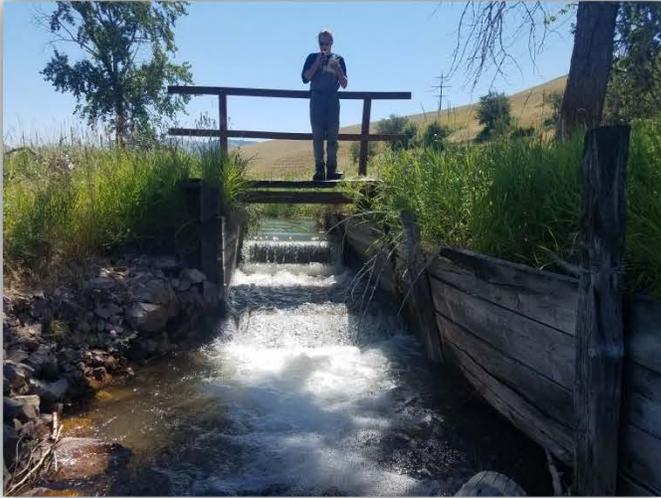
The fish jump height at the upper Oxbow Cattle Company stream diversion was measured to have a combined fish jump height of 3.4 ft and the water surface slope from downstream of the diversion to upstream of the diversion was measured at 7.0%.

Figure 21. The upper Oxbow Cattle Company stream diversion.

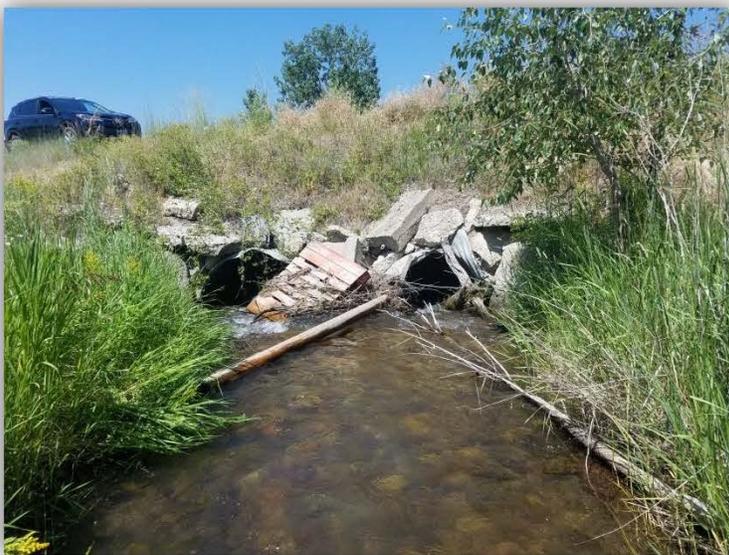
The Trails End Road crossing is a double barrel style crossing consisting of two corrugated metal pipes that are 3.9 (right bank) and 4.8 ft (left bank) in diameter. The outlet of the left bank culvert had a fish jump height of 2.1 ft and the gradient of the culvert was measured to be 2.5%. The outlet of the right bank culvert had a fish jump height of 2.3 ft and the gradient of the culvert was measured to be 3.7%. Based off of USFS fish passage evaluation criteria (USFS, 2008), both culverts were rated as total barriers to all life stages of salmonids due to the fish jump height at the outlets, and the slope, length, and diameter of the culverts.

Figure 23. The outlet (top photo) and inlet (bottom photo) of the Trails End Road crossing.

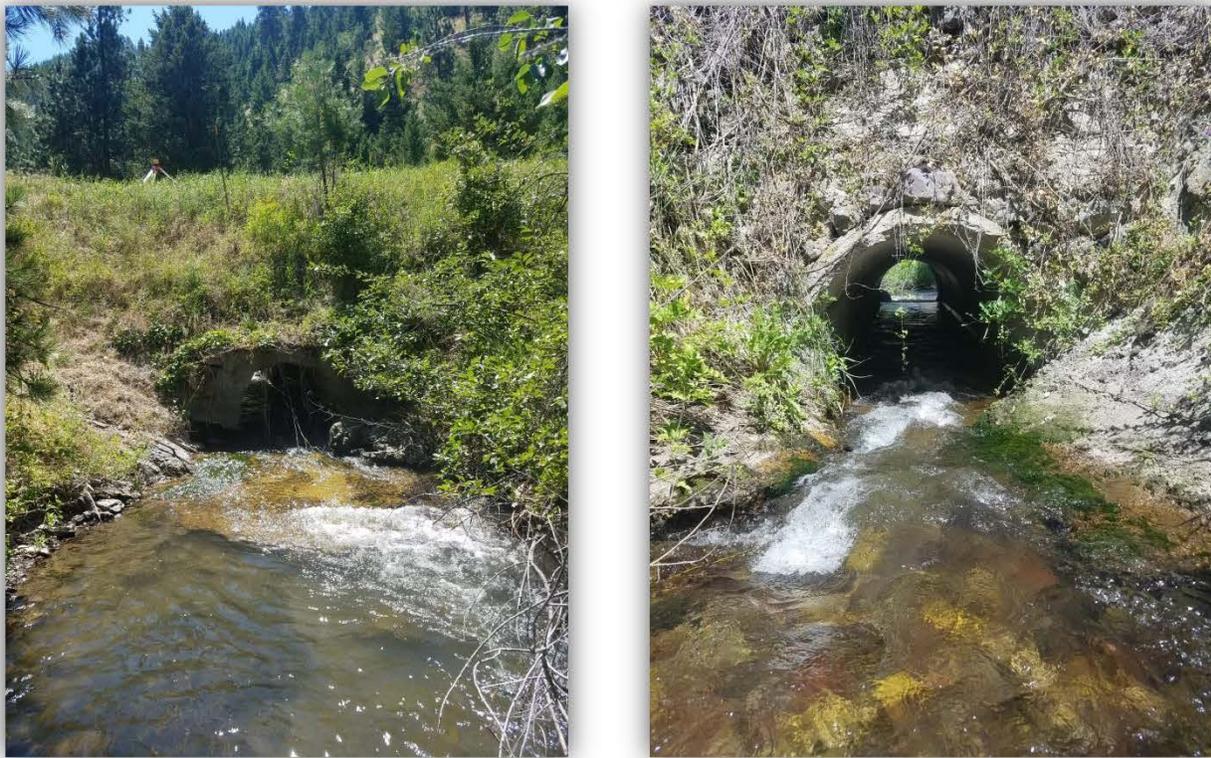
The Krempel Private Drive culvert is a 4.3 ft diameter concrete culvert with a concrete apron at the outlet. While there was no change in elevation at the outlet of the culvert, there was a 0.9 ft change in elevation (i.e. fish jump height) at the outlet of the apron. The gradient of the culvert was measured to be 1.2%. This crossing did not appear to be a fish passage barrier at the outlet of the apron at these flows (date of survey was July 23, 2018), but at base flows the apron could be an impediment to fish passage. There was visual evidence of water ponding up at the inlet, causing scour of the road fill, indicating that this culvert is undersized. Based off of USFS fish passage evaluation criteria (USFS, 2008), this crossing was rated as “Red” (total barrier) to juvenile salmonids based off of the fish jump height at the apron outlet, and the slope, length, and diameter of the culvert.

Figure 24. The outlet (left) and inlet (right) of the Krempel Private Drive crossing.

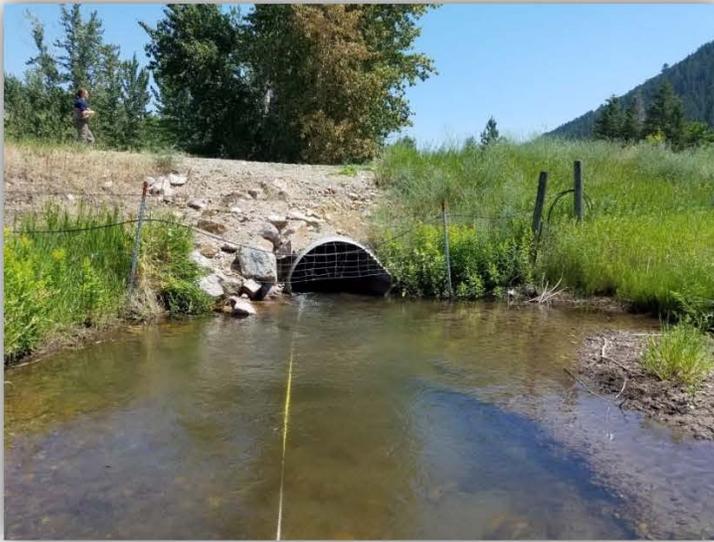
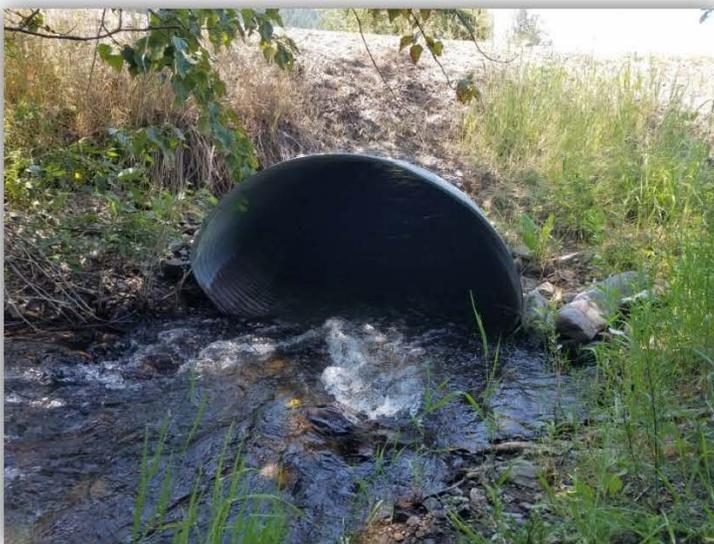
The Lost Mine Loop Road has two crossings with Miller Creek. The lower crossing is a 5.5 ft diameter squashed corrugated metal pipe (the upper crossing is a bridge and was not surveyed). While there was no drop in water at the outlet of the culvert at these flows, there was a 0.3 ft change in elevation from the outlet of the culvert to the channel bed. The slope of the culvert was measured to be 4.4%. Based off of USFS fish passage evaluation criteria (USFS, 2008), this crossing was rated as “Gray” because the culvert width to bankfull width ratio was less than 0.7 and the residual inlet depth is less than 0.34 ft. Further analysis will have to determine the exact barrier type, but this crossing is likely a velocity barrier to juvenile salmonids at high flows.

Figure 25. The outlet (top photo) and inlet (bottom photo) of the lower culvert on Lost Mine Loop Road.

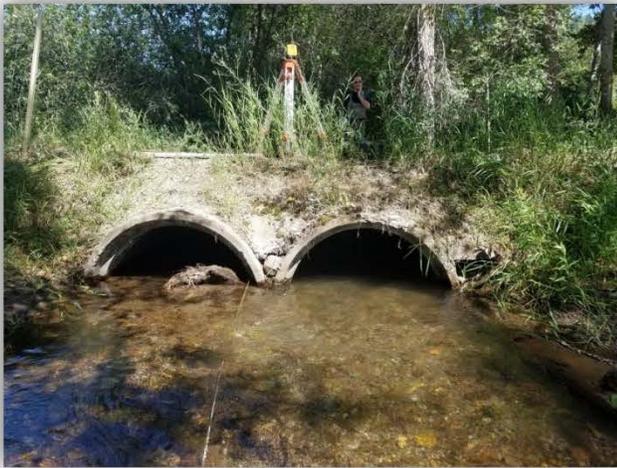
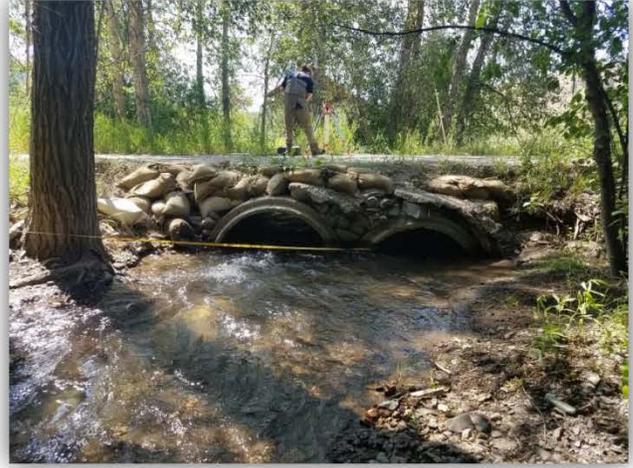
The Singletree Lane crossing consists of two aged double barrel concrete culverts that are 3.5 ft in diameter each. Both culverts are partially plugged with sediment (Figure x) and are clearly undersized as there is an extremely large amount of sediment (~1185 cy) deposited upstream of the crossing, and much more has been deposited downstream. Based off of the size of the sediment plug, this issue appears to have been ongoing for decades. Due to the large amount of sediment deposited downstream of the crossing, the channel has avulsed there, and a portion of the water was flowing into Singletree Lane at the time of survey (July 18, 2018). Although there were sandbags placed in the stream to prevent this from happening, some flow was still escaping into the road and traveling 500 feet along the road before flowing back into Miller Creek. Additionally, upstream of the crossing, during high flows, the stream has formed a side channel that flows over the road, and into the avulsion downstream along the road. Sandbags were also placed around the inlet to prevent erosion of the road fill (Figure x). Based off of USFS fish passage evaluation criteria (USFS, 2008), this crossing was rated as “Gray” because the culvert width to bankfull width ratio was less than 0.7 and there was no resting habitat immediately upstream of the crossing. Further analysis will have to determine the exact barrier type, but this crossing is likely a velocity barrier to juvenile salmonids at high flows.

Figure 26. The outlet (left photo) and inlet (right photo) of the Singletree Lane crossing.

1. Replace the Singletree Lane culverts with a bridge.
2. Reconstruct the channel upstream and downstream of the culvert to control the grade and prevent the sediment plug from eroding and delivering downstream. This includes the removal of the fish passage barrier shown in photo D (Figure x).
3. Move Singletree Lane out of the floodplain.
4. Revegetate open areas in the riparian zone that have been covered in years of depositional gravel.

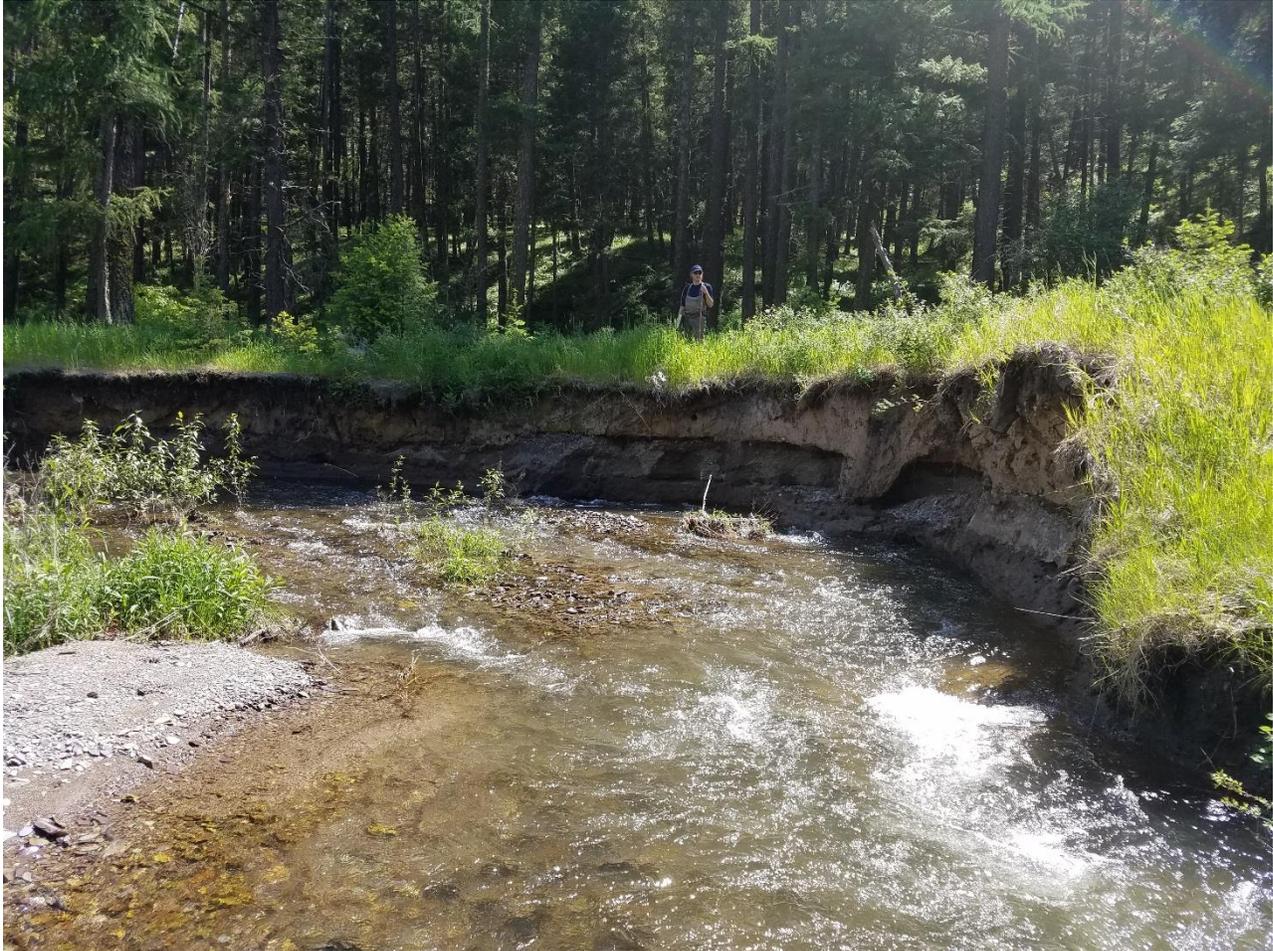
Figure 1: Picture taken Summer, 2018. This reach of Miller Creek is characterized by 8-10 foot incised banks.

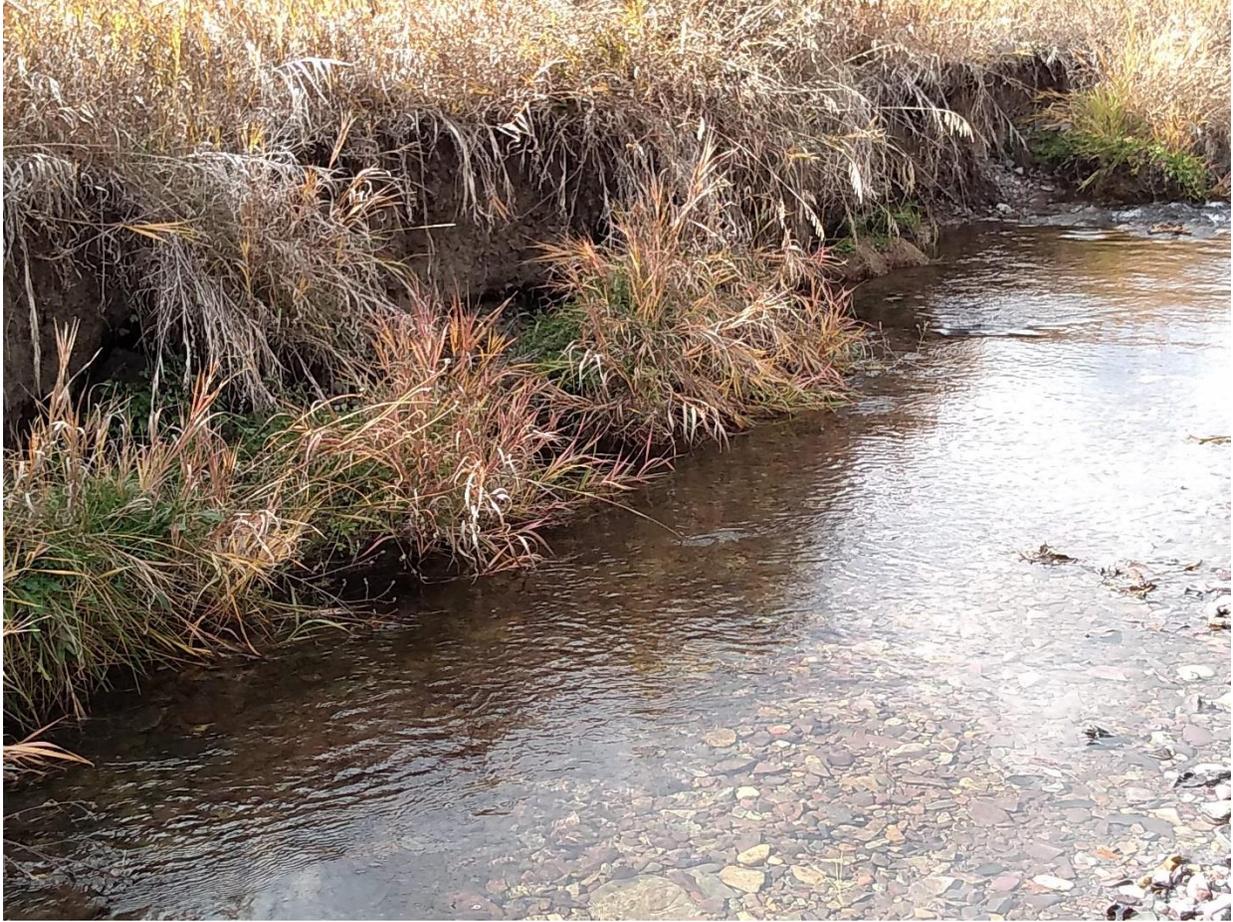
Figure 2: Picture taken October, 2019. Sloughing banks on the lower stretch of the Wustner Property reach of Miller Creek.

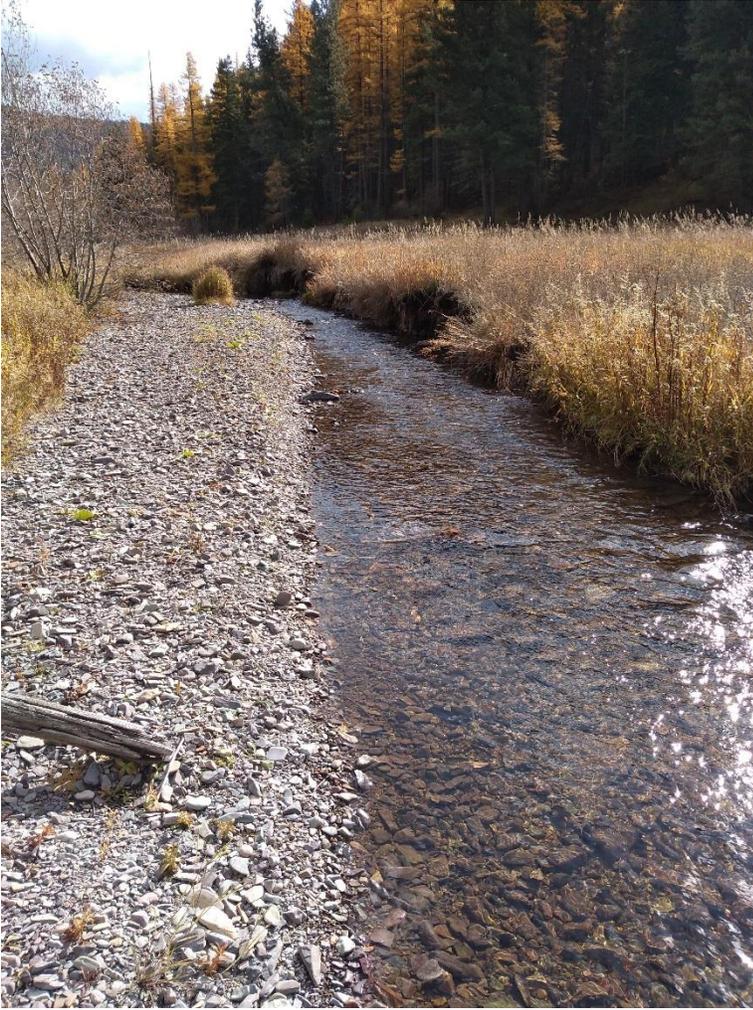
Figure 3: Photo taken October, 2019. Miller Creek has been straightened in this stretch. The system is incised and has a simplified habitat, with little riparian vegetation.
