2020 319 Application Form

Project Name Lower Bitterroot Tributary Restoration

Sponsor Name Clark Fork Coalition

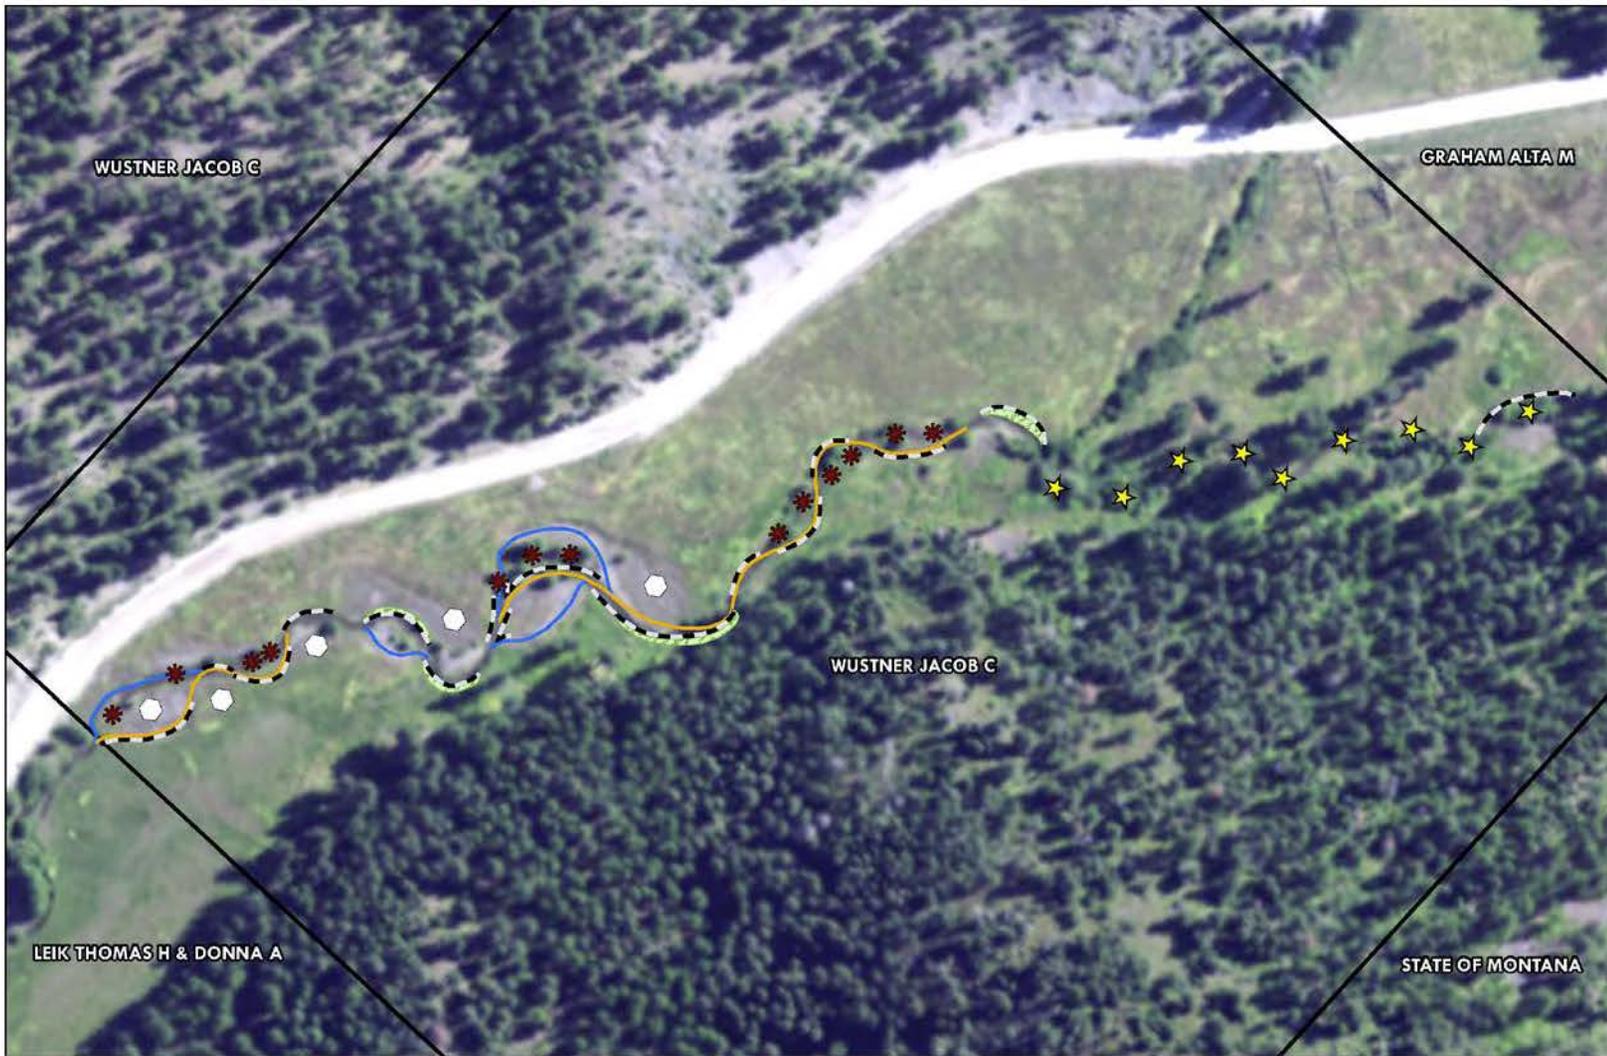
WUSTNER PROPERTY - OPTION 1

- - - Woody brush matrix
- Channel shaping/realignment
- Distributary side channel
- Woody debris channel plug
- Woody debris habitat structure
- Riparian shrub clump planting with fence
- Floodplain grading
- Parcel ownership

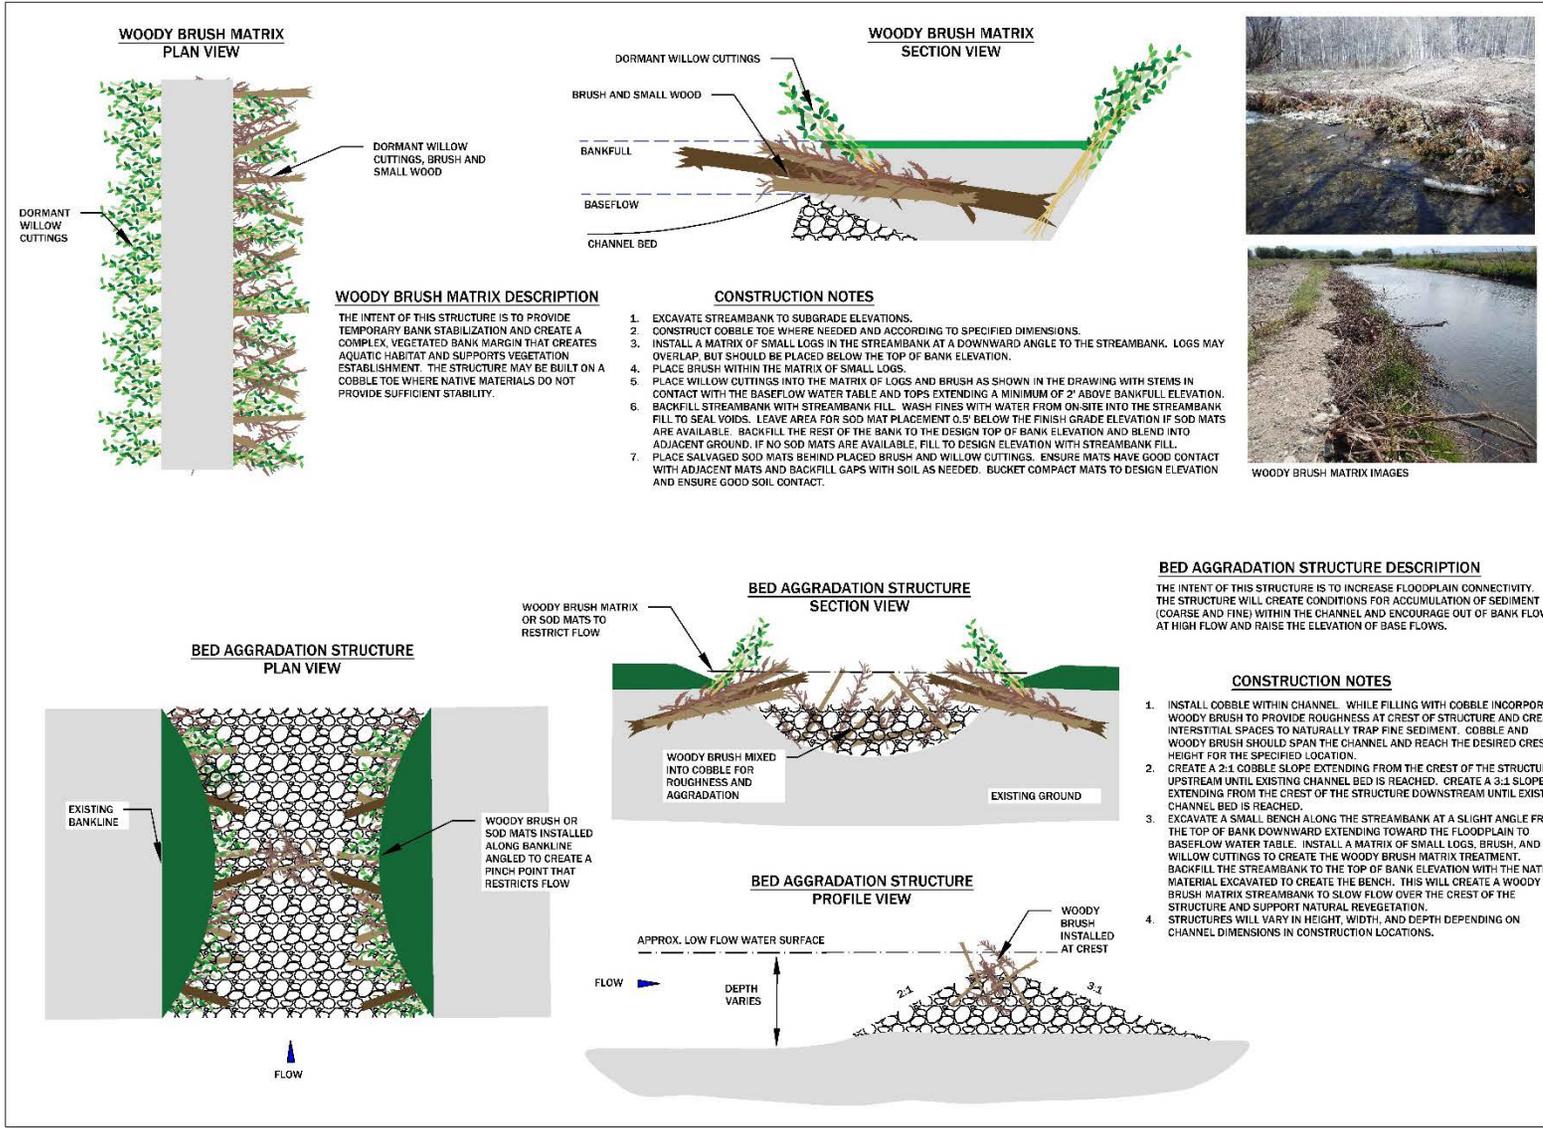
SHEET
1.0

WOODY BRUSH MATRIX AND BED AGGRADATION STRUCTURE DETAILS

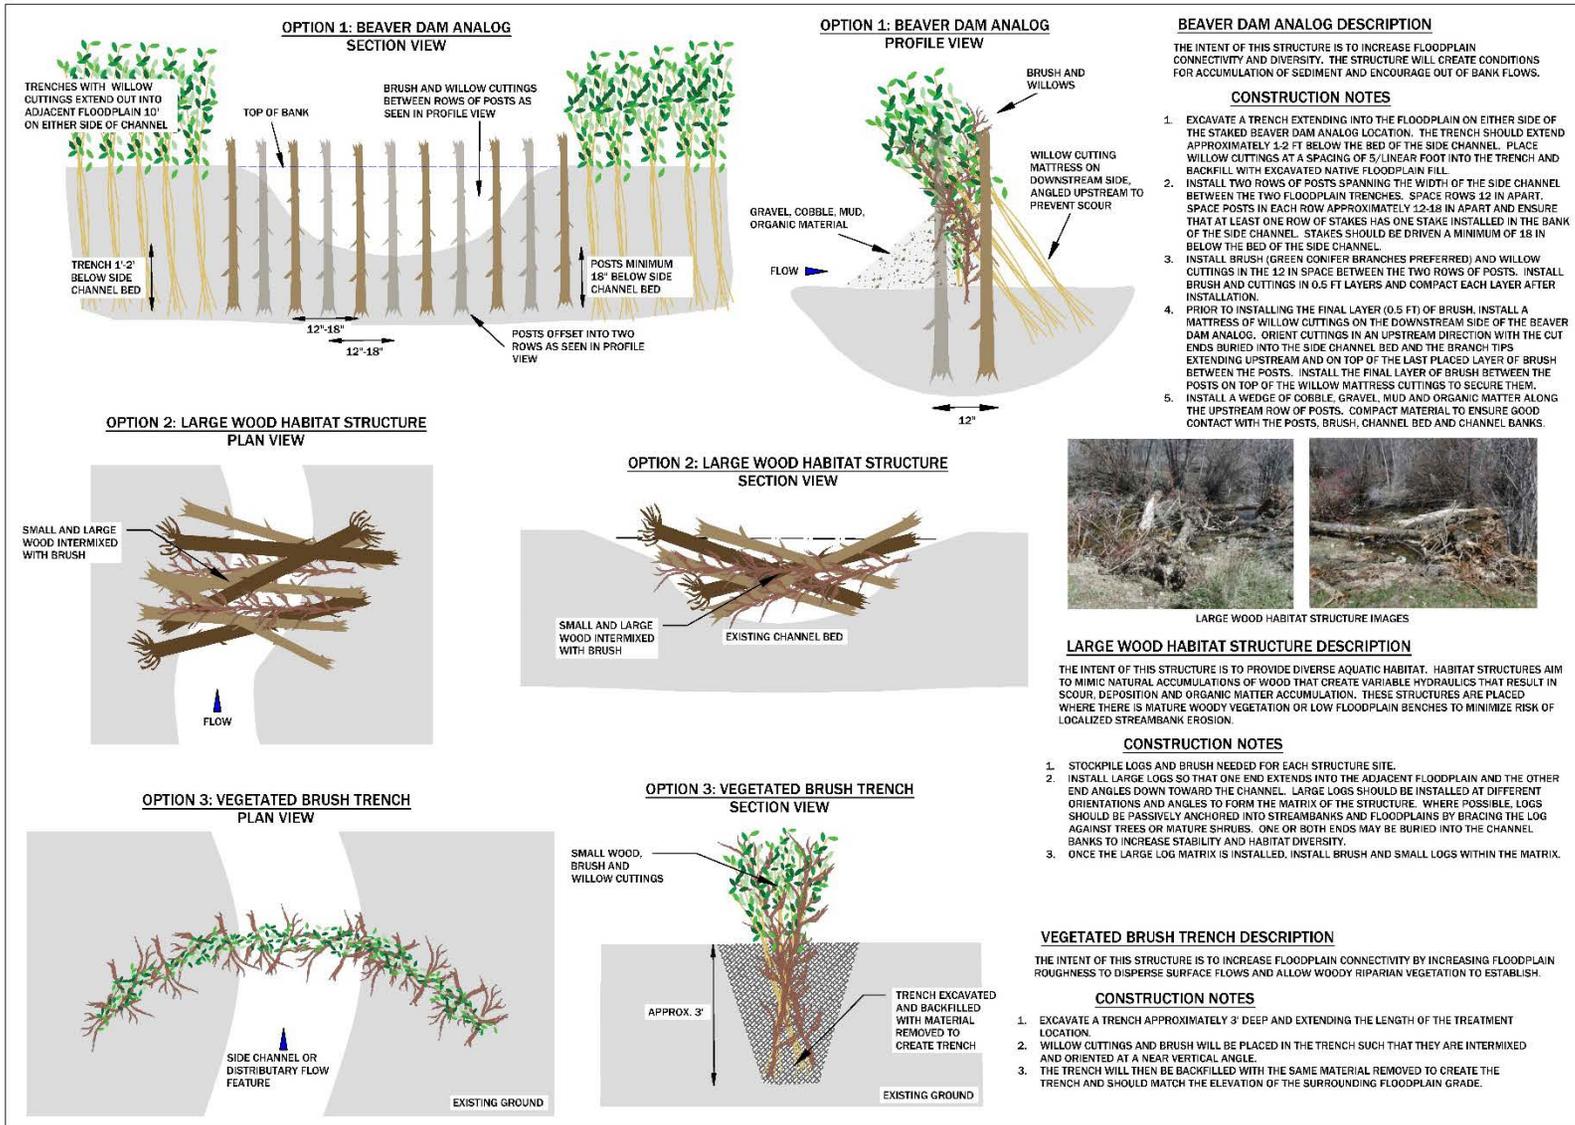
WOODY DEBRIS HABITAT STRUCTURE OPTIONS
 MILLER CREEK

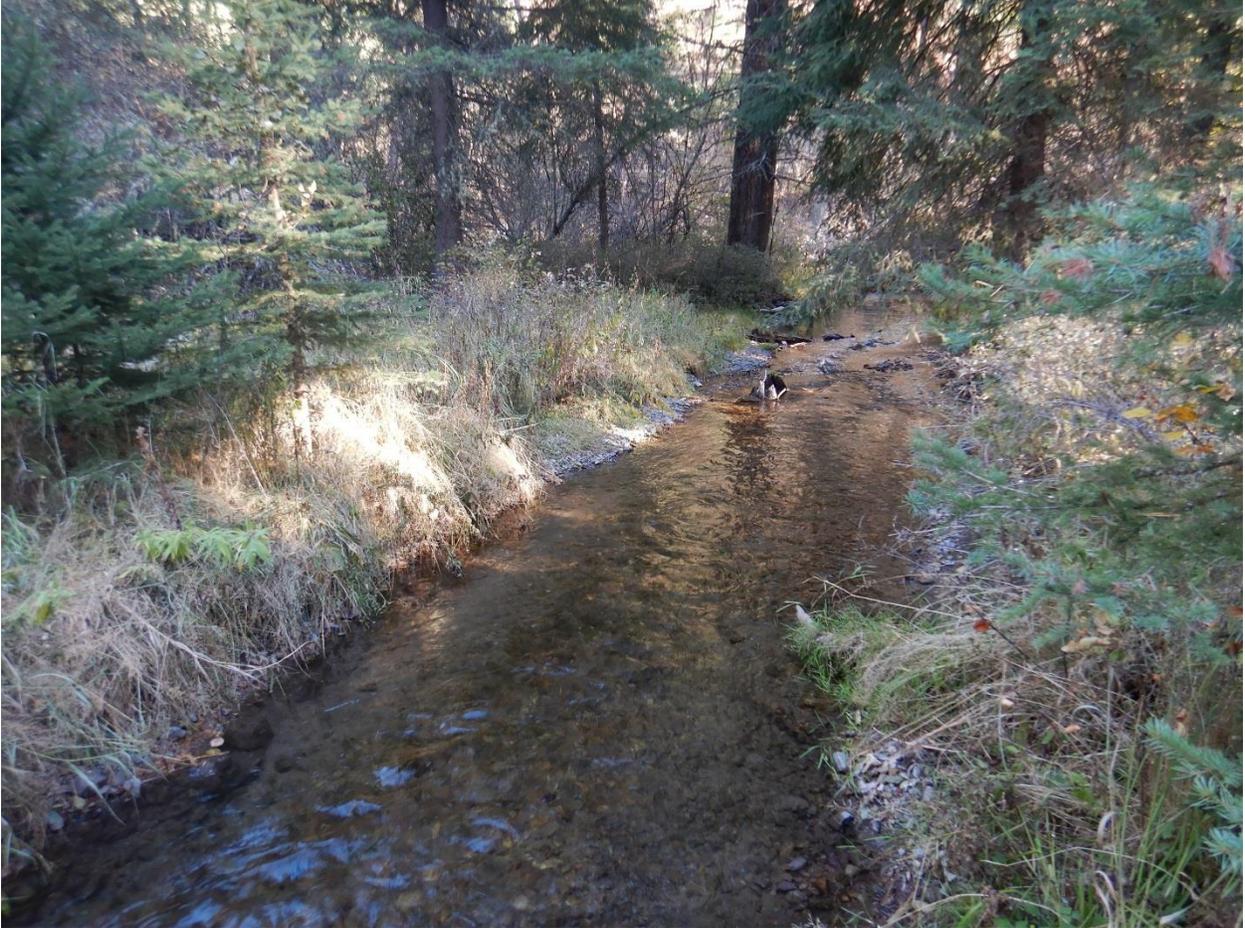
Figure 1: Picture taken October, 2019. This reach of Miller Creek is channelized, entrenched and lacking riparian vegetation.

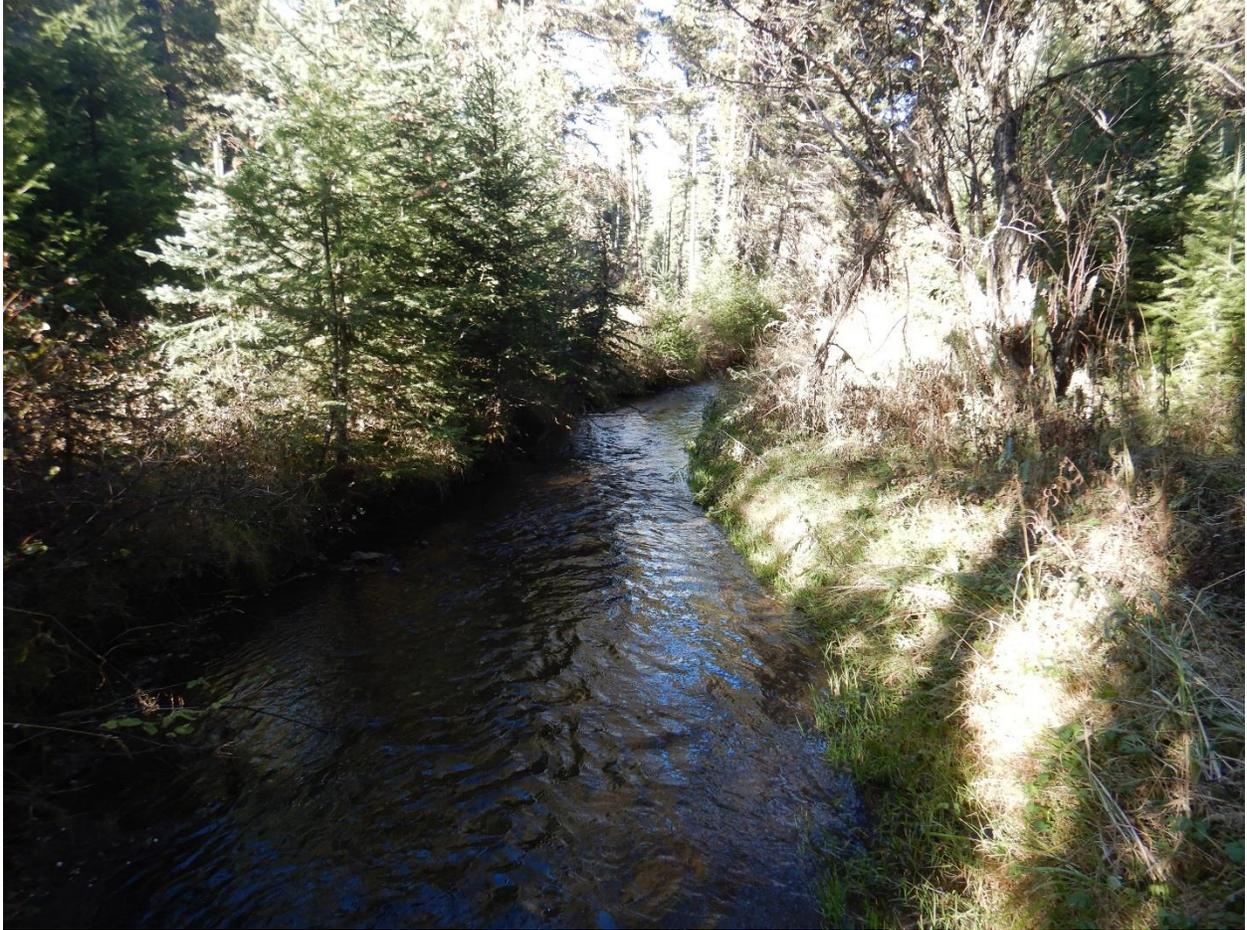
Figure 2: Photo taken October, 2019. This reach of Miller Creek is channelized, entrenched, and lacking riparian vegetation.

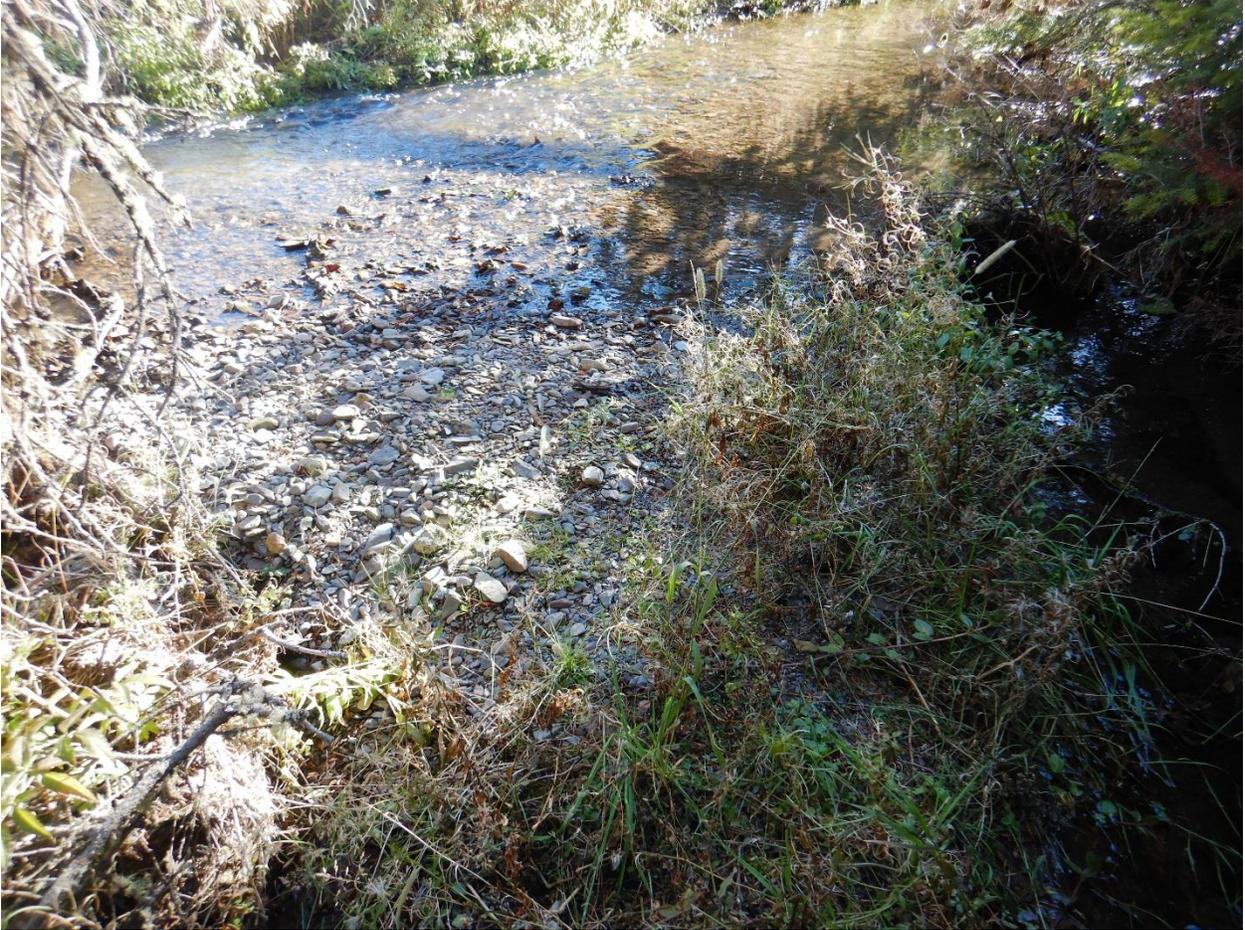
Figure 3: Photo taken October, 2019. This reach of Miller Creek is channelized, entrenched, and lacking riparian vegetation.

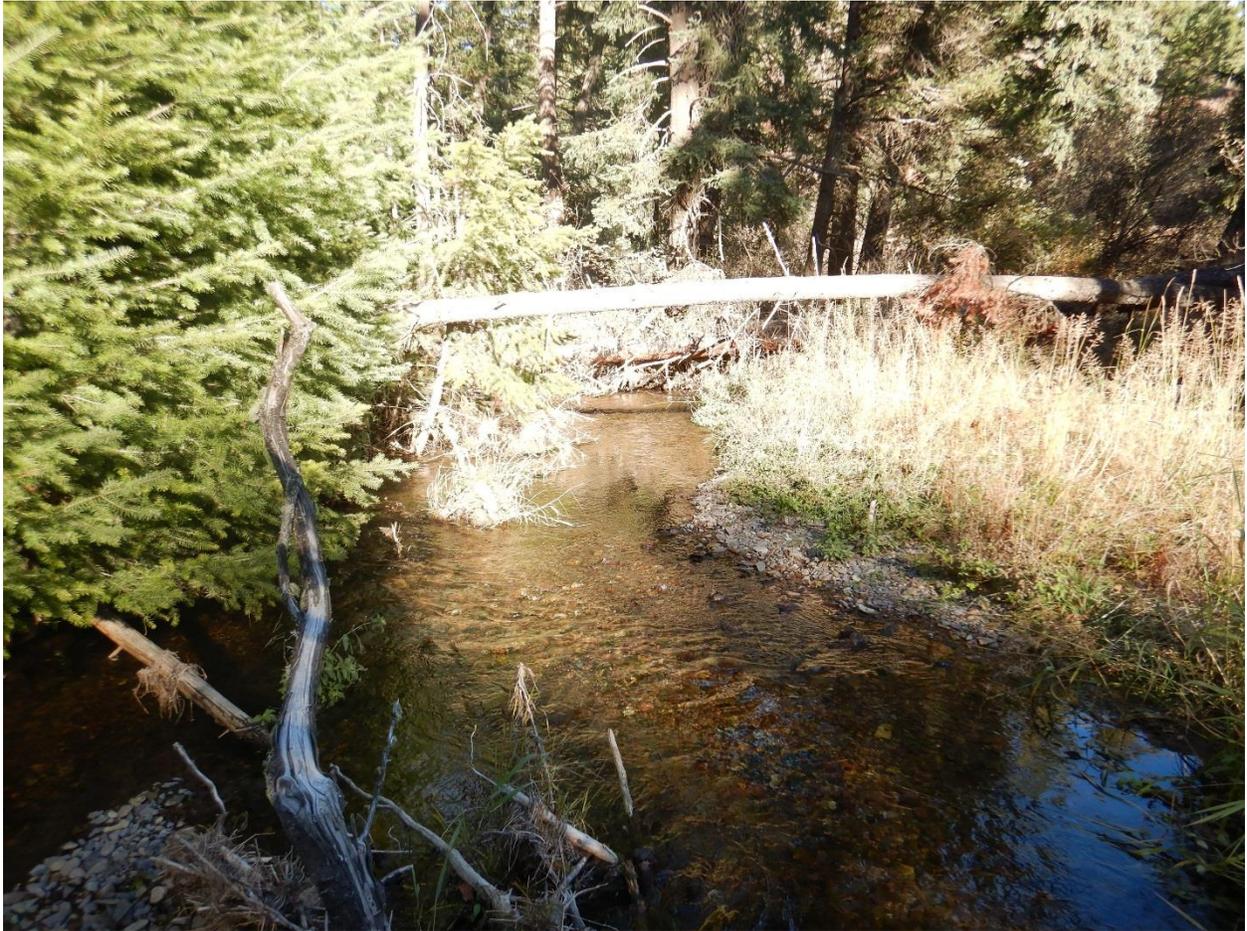
Figure 4: Photo taken October, 2019. This reach of Miller Creek is channelized, entrenched, and lacking riparian vegetation.

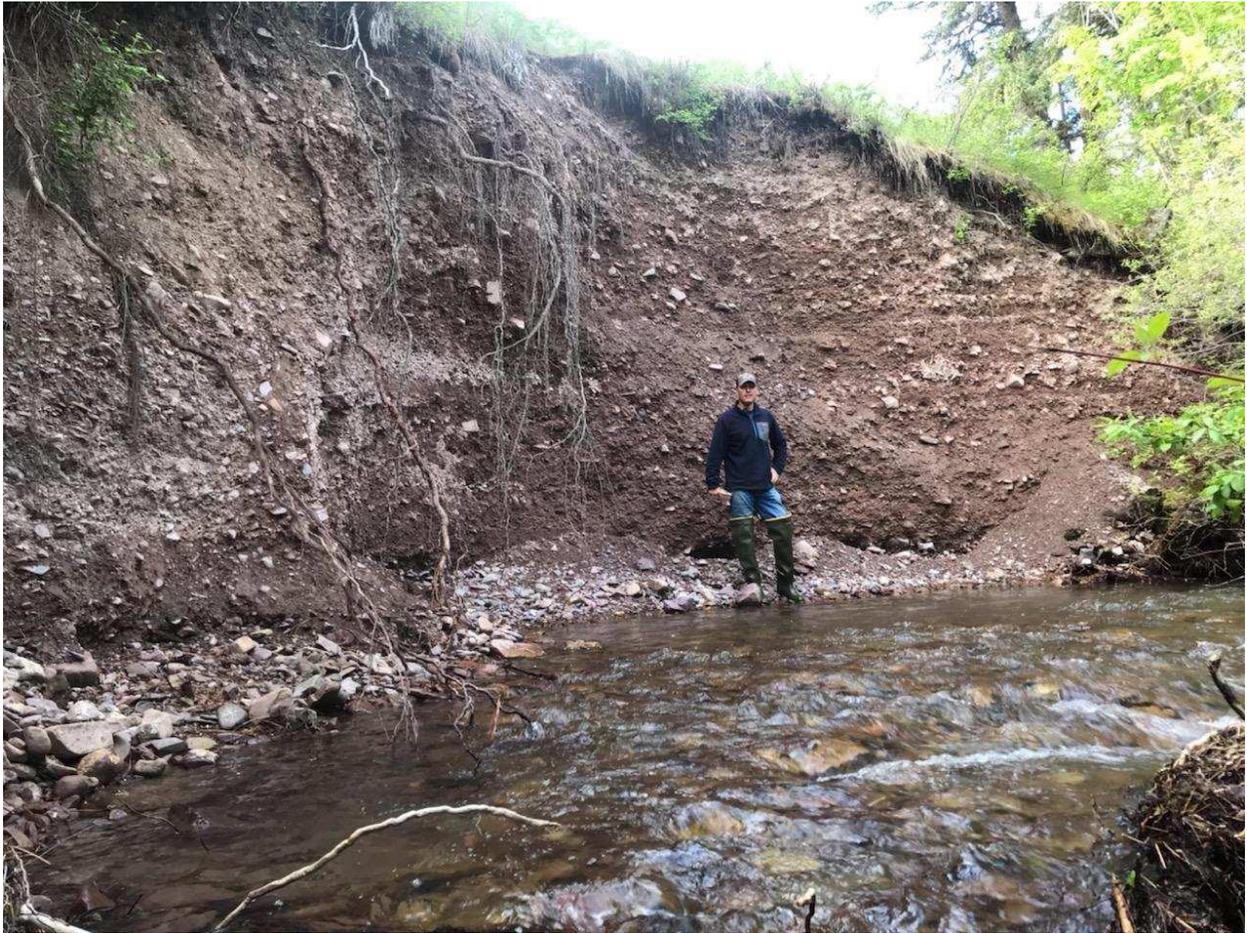
Large cut bank at the top of the reach

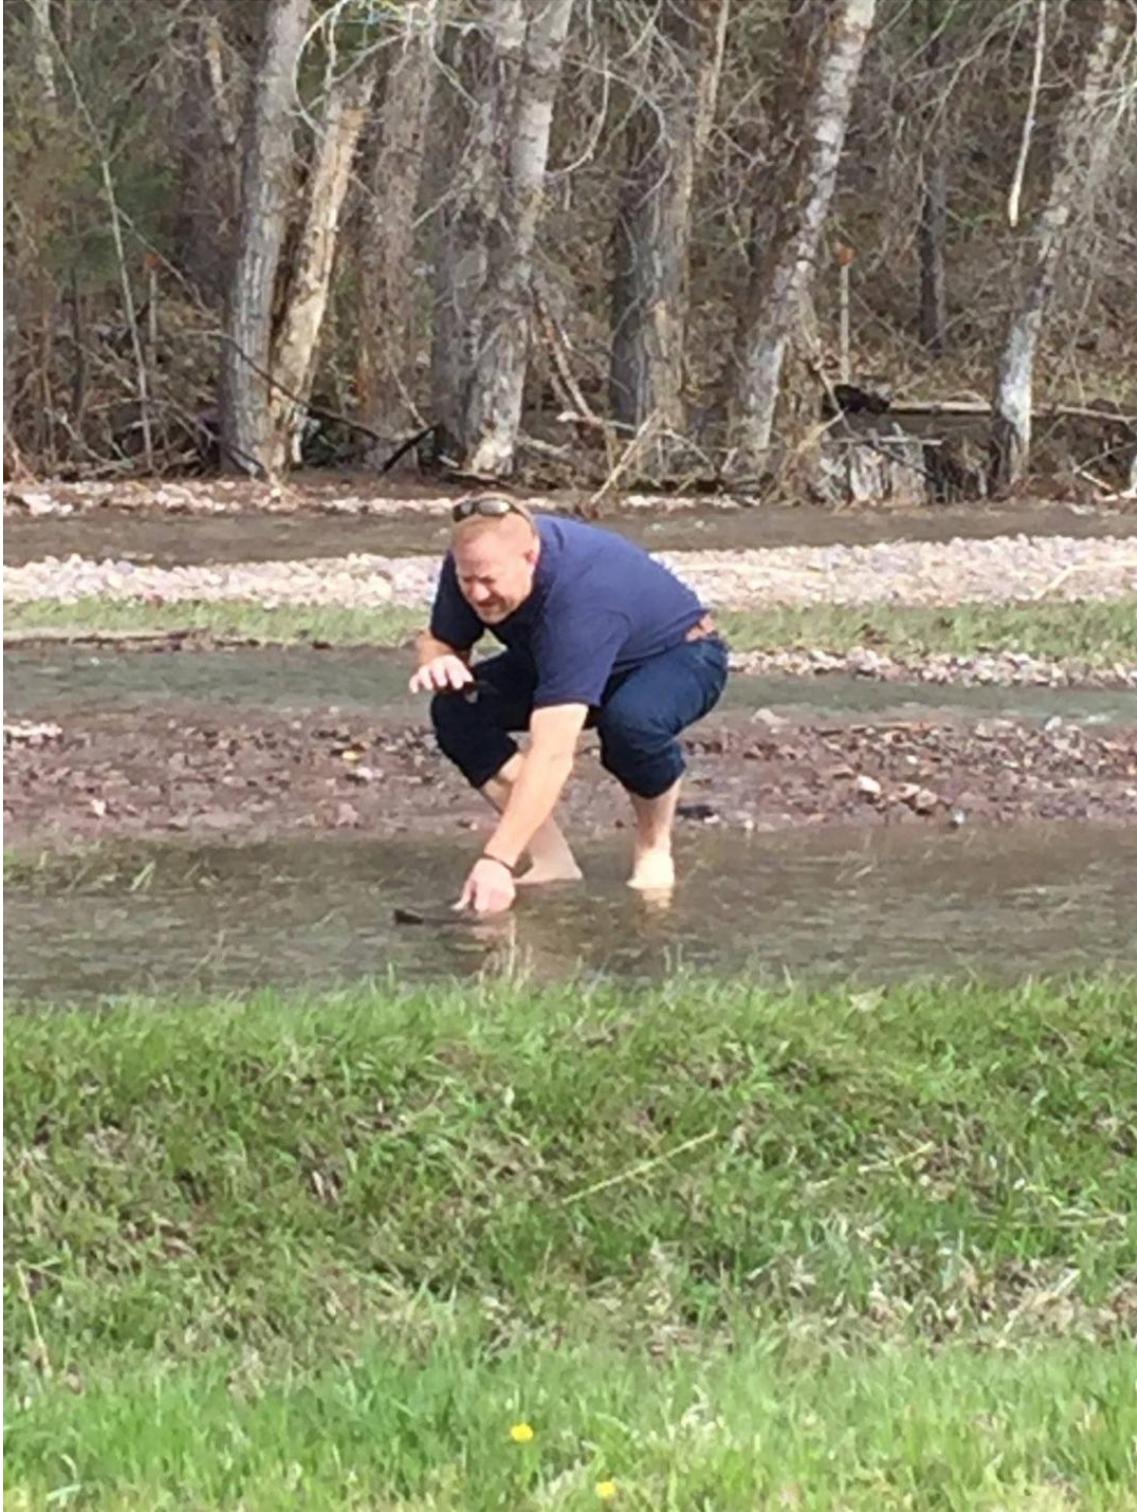
O'Brien Creek left its banks this spring and flooded large areas due to massive sediment aggradation

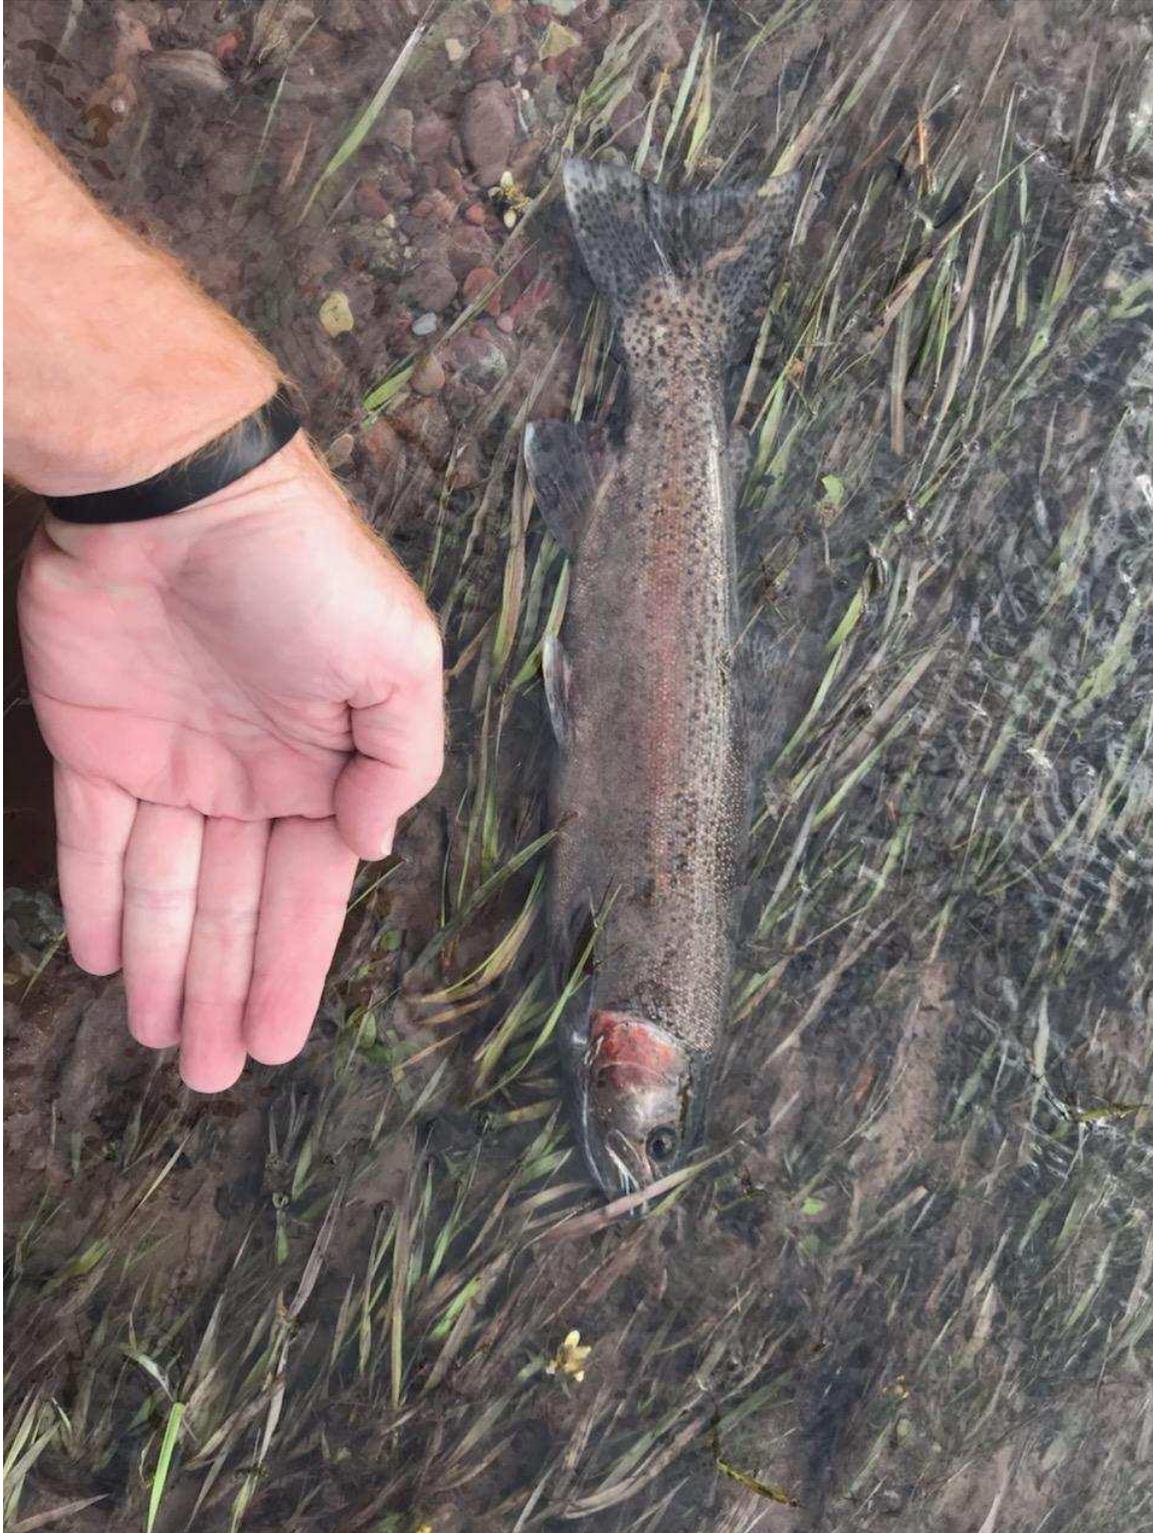
Spawning out migrating Westslope Cutthroat trout stranded due to massive sediment choking creek

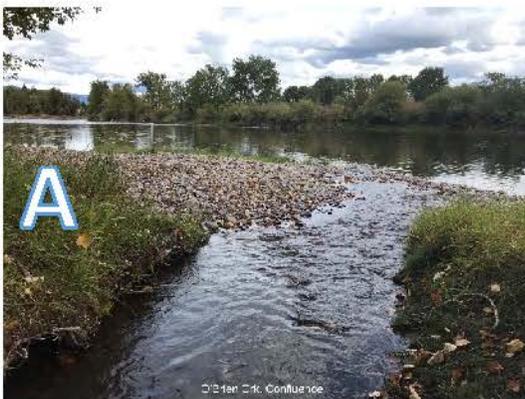
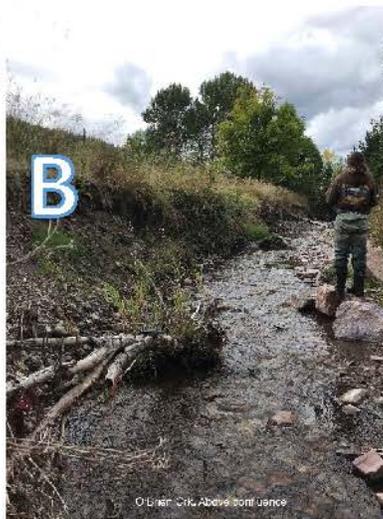
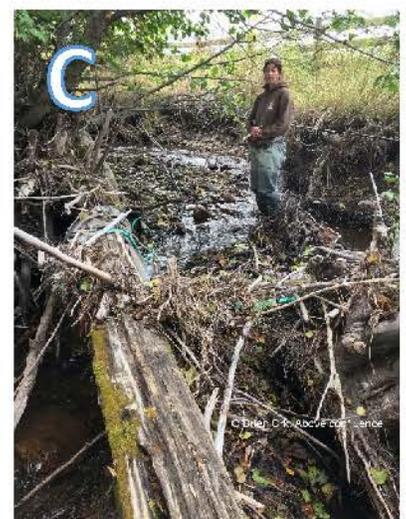
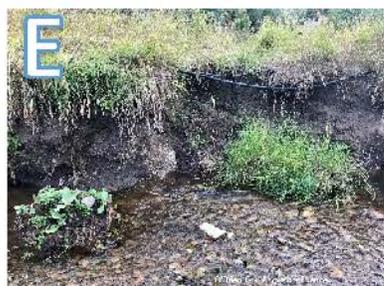
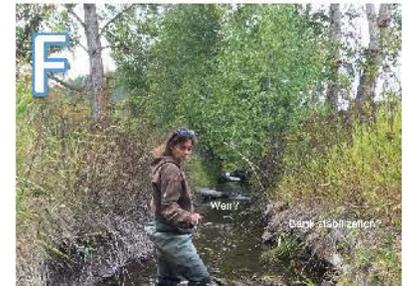
At the confluence with the Bitterroot River there is a relatively large gravel bar (A). Moving upstream, large erosive banks (B) are contributing slump blocks to the creek. PVC pipes, associated with landowner irrigation, are present in active erosion areas (C). Large woody debris (LWD) is present in some segments where streamside vegetation has sloughed (D). Several large angular boulders and wood structures from previous rehabilitation efforts have failed. Overall, there is very little habitat, a large amount (and variety of) trash, and the channel is very entrenched with tall, eroding banks (E). Some large wood used for bank stabilization and weir construction remains in place beginning approximately 250' above the mouth (F). These structures are at risk of failure should erosion continue upstream.

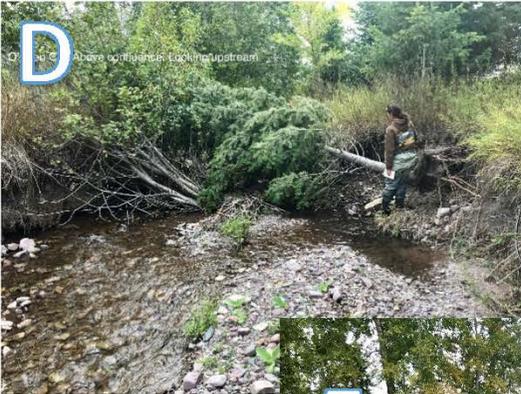
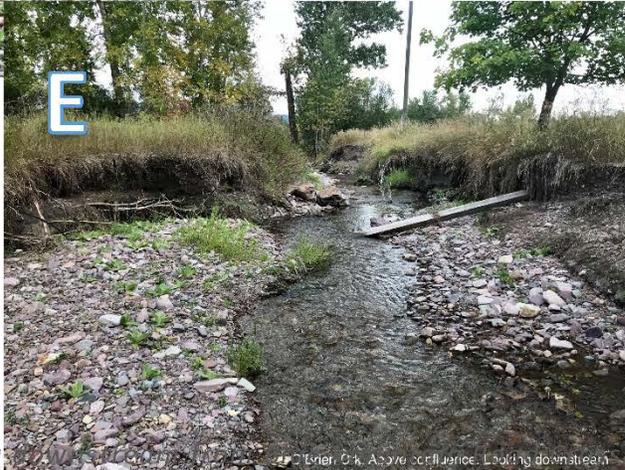
Reach 1 (moving from the culvert towards the confluence, looking downstream)

There is a 20' wide concrete box culvert at the crossing with Blue Mountain Road (G). Stream substrates exist throughout the culvert, which should accommodate fish passage at most flows. At the inlet the average stream bed elevation to the culvert is 4.5'. Average spring runoff water depth (measured by the stain line on the inside of the culvert) to the culvert is 2.9'. At the outlet, the mean streambed elevation to culvert is 4.2' and freeboard above the water stain line is 2.2'. As such, there may be minimal freeboard to accommodate bedload and debris during very large flood flows.

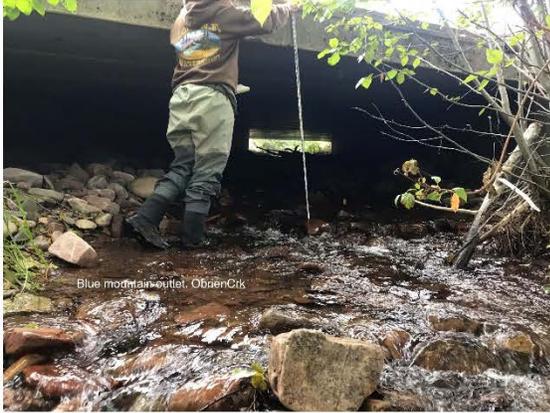
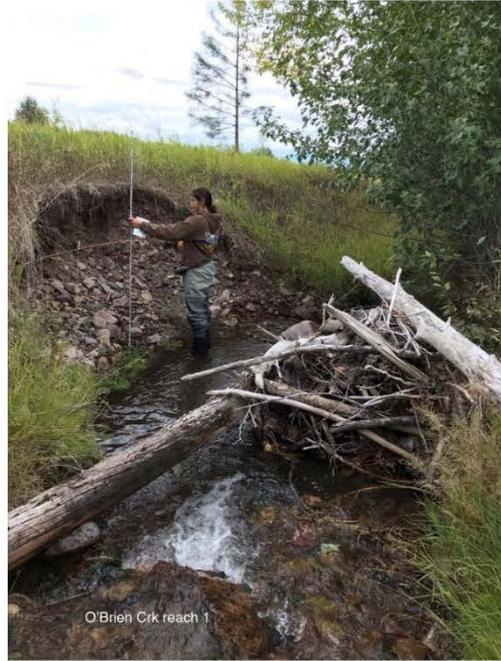
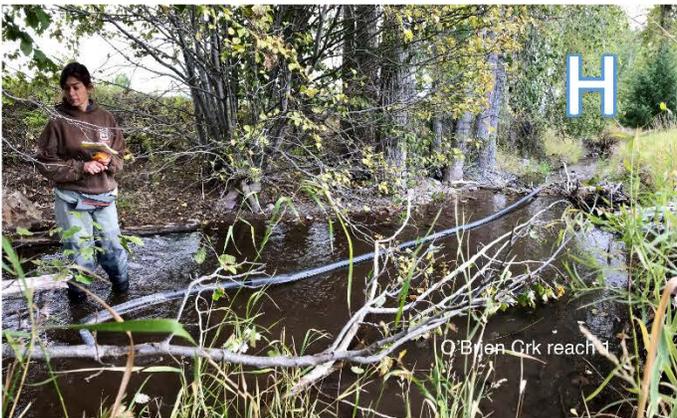
There was one major bank failure (I). Though there was not as much trash or irrigation infrastructure present, one long piece of PVC pipe was lodged in the creek bed (H).

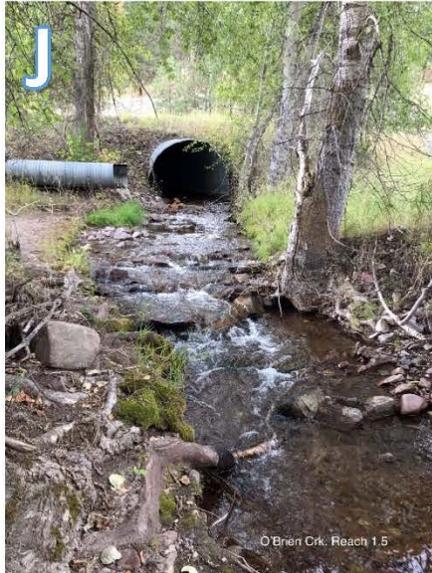
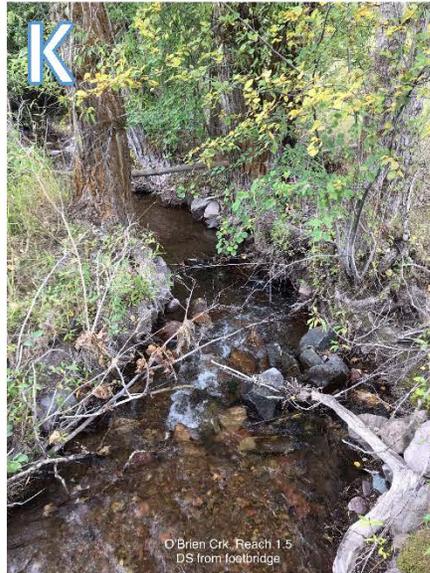
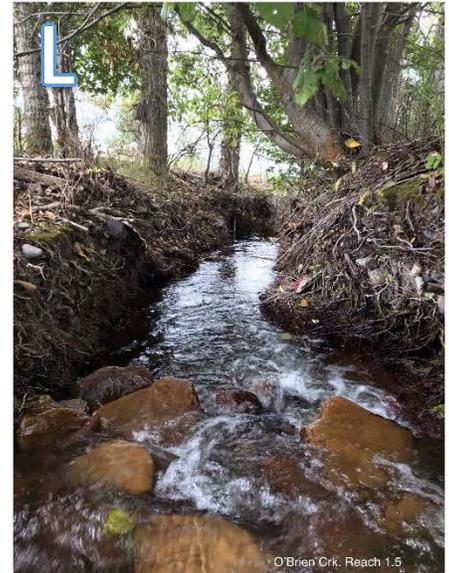
Reach 2

This reach spans from the O'Brien Meadow subdivision road crossing to the Blue Mountain Road crossing. The reach was slightly to moderately entrenched (ratios ranged from 1.8 to 3.3) and actively incising. As one moves downstream it becomes increasingly entrenched. There were zero pieces of LWD between the crossings and the stream flow is very funneled. Three pools were noted but not measured.

Fish were spotted, and a possible old redd from this past fish spawning was identified.

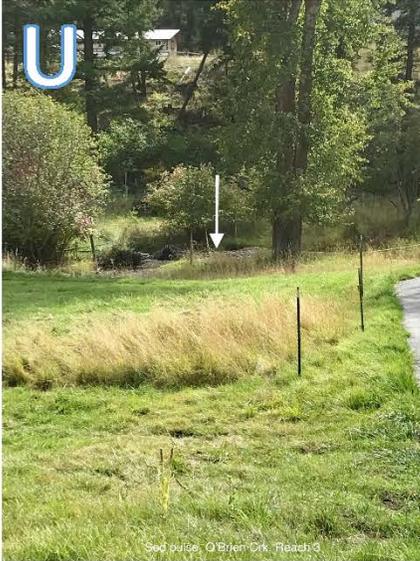
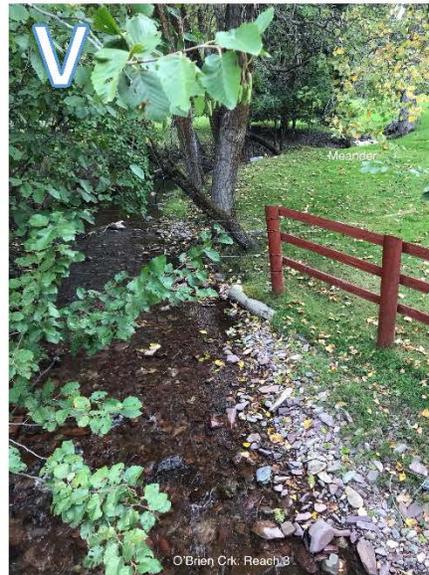
Before the road turns to gravel, there were a few sediment pulses visible in the stream. These were seen

across fields, though, so no measurements or up close inspection could be made (U).

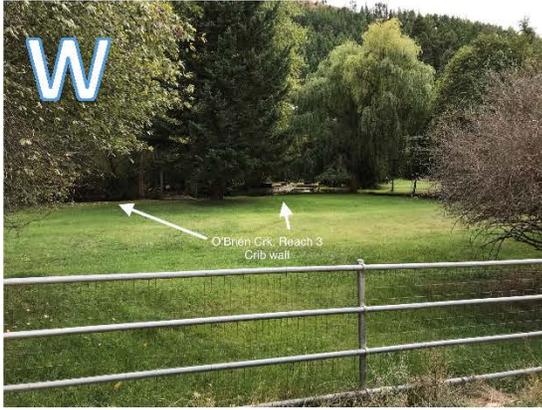
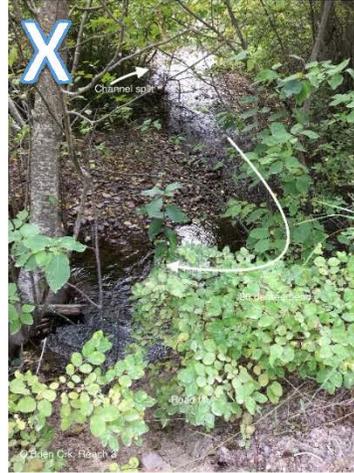
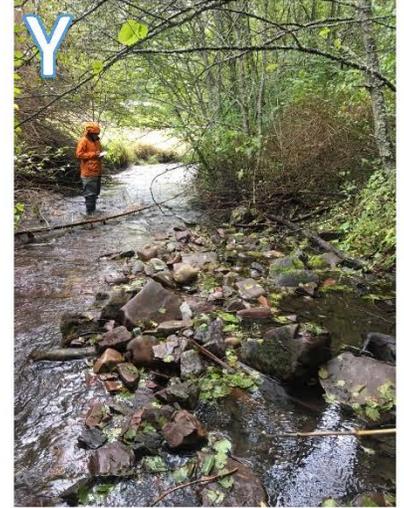
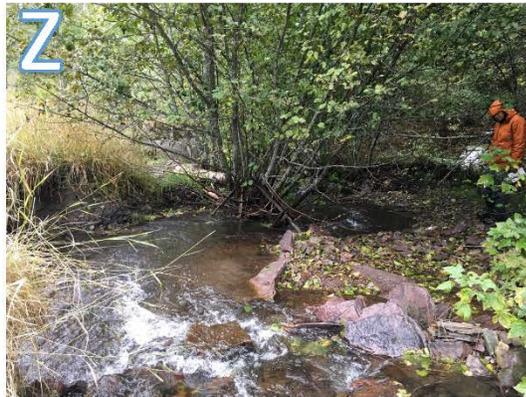
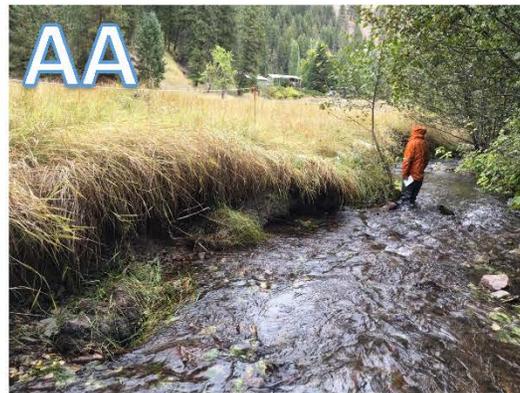
There is a section of the creek that flows along the backside of a pasture. There is little to no riparian vegetation here and the left bank has erosive, slumping banks (AA). The stream suddenly becomes over

widened, reaching a bankfull of 21.2'. When the riparian vegetation returns at the bottom of the field, the stream also returns to typical bankfulls.

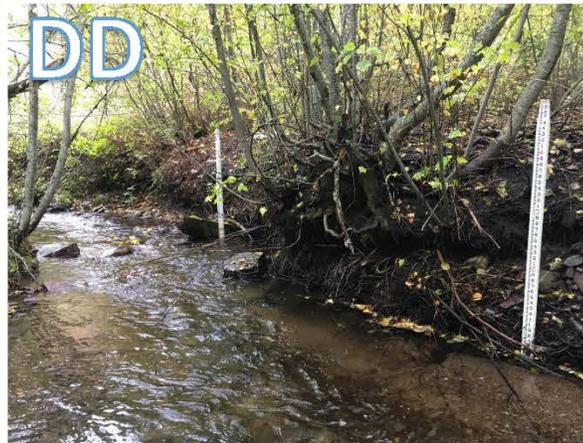
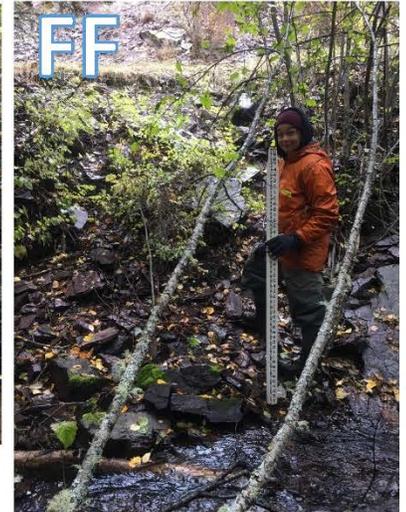
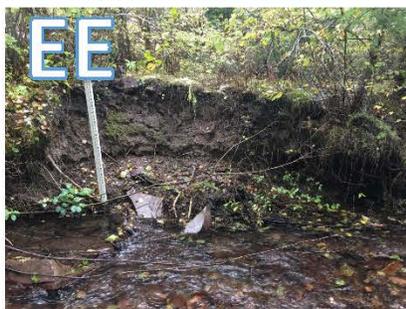
Reach 6 is a 195 meter PIBO reach that starts just upstream of the boundary between private and Forest Service. Evidence of beaver was noted, but there were no dams within the reach. Approximately 25 m of the left bank of the creek was along the Forest Service road or near the toe of the fill. The creek area near the trailhead is heavily used by recreationists with a user created trail and bridge over the creek. Very few, if any, high quality pools were found. Most of the pools noted in the PIBO data are low quality scour pools created by lateral constriction or are located at a bend. Along many reaches erosive banks were up to 4 feet high (DD), with at least two local failures (EE) and two slides of road fill directly into the creek (FF). There appears to be an old road bed near one or both banks in old/potential floodplain (CC). This could possibly be a legacy railroad. The slope of the entire reach was 1.7%.

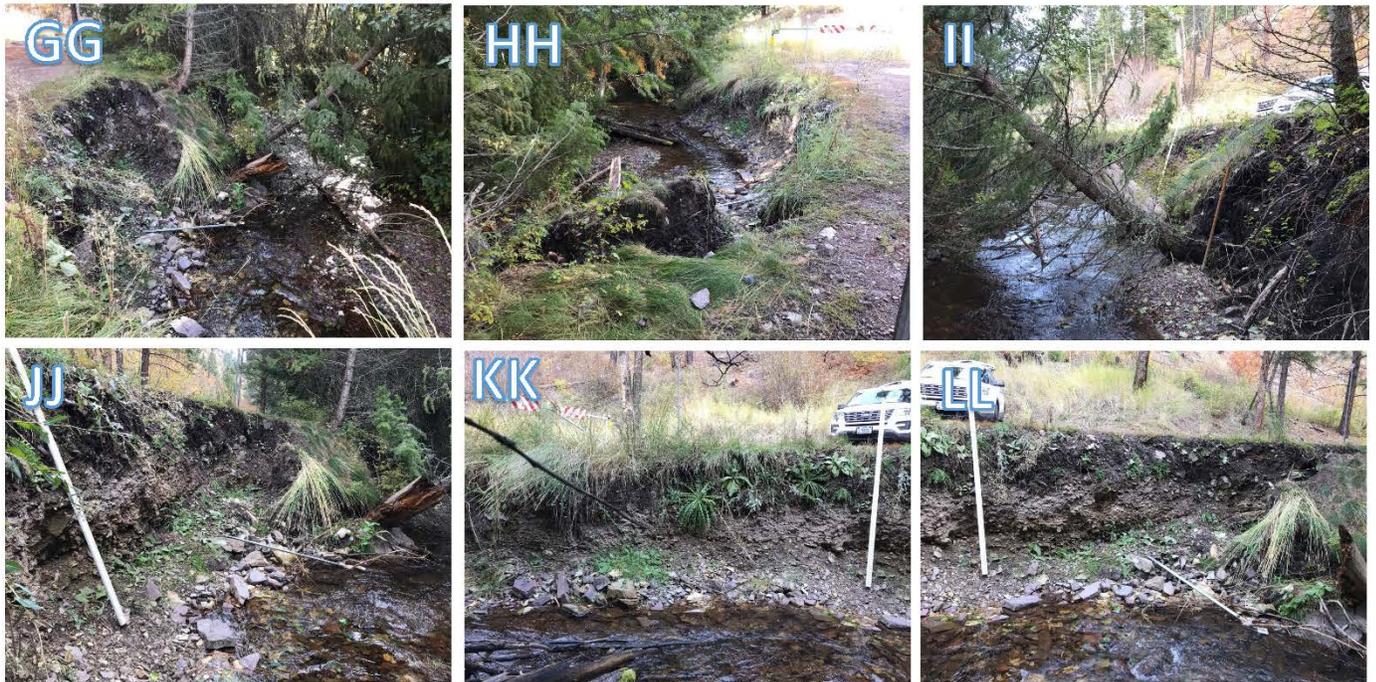
Directly before the locked Forest Service gate on FS road 123, a large road failure is actively slumping into O'Brien Creek. As of early October 2019, the dimensions were measured to be 54 x 6 x 6.2 ft (approximately 2,678 ft³). A newly fallen tree and road sign was present in the stream. Parking is limited to one car, with the road bed remaining at 12 ft mostly due to a user-created turnaround off to the right (and directly opposite of the failure). See photos GG-LL.

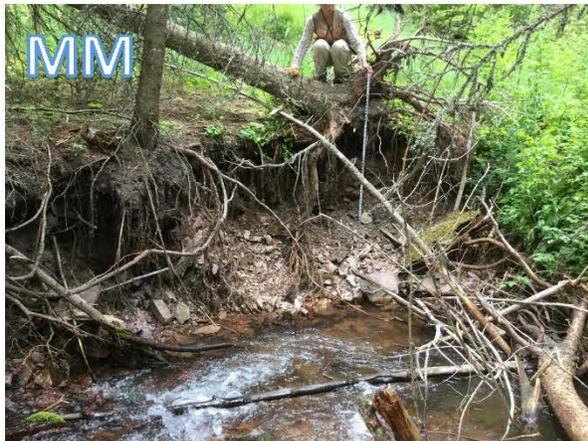
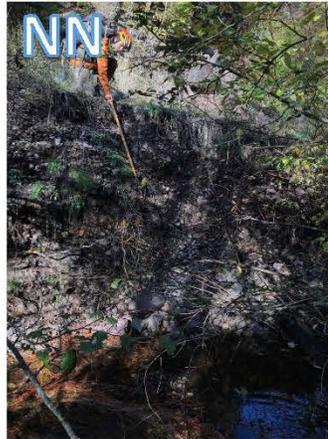
Heading up-valley past the gate, road 123 crosses decommissioned road number 19244. This road crosses O'Brien Creek with a bridge. The bankfull width here is 10.2 feet. Engineers should check the bridge for structural integrity, as it does not appear sound and there is over widening at the inlet with 19 ft between the bridge abutments and a definite hourglass shape to stream.

Upstream of here, before a second confluence with a mapped intermittent stream, there is 35 feet of fill unraveling directly into the creek. Similar instances occur periodically throughout the reach (MM, NN). We mapped 10 obvious sections of road/fill slumping. Nine of those sections were measured, and lengths of failures ranged from 10 to 100 feet, with a total of 345 feet. The average length of a failure was 38 feet. One instance of ponding on the road was found.

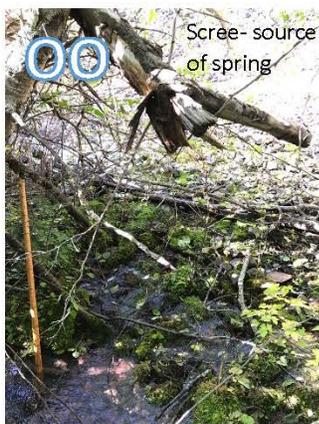
Scree- source of spring

mapped end of road 123 and its top of reach marker just downstream of O'Brien Creek's confluence with a major scree-slope spring (OO, PP). There was no evidence of beaver found. The stream goes dry above this reach where the valley narrows and a steep scree slope develops on the south facing valley wall. Because of this, we were unable to sample outside of the influence of the road. There was a good amount of habitat forming, small diameter wood in the stream. One large fish was found in a pool. Erosive, high banks are typical of the reach (QQ, RR). Some meander bends are very sharp (possibly unnaturally so), resulting in deep pools (SS, TT). Ten meters of the stream in this reach seems to have captured the old road, as evidenced by a sharp change in grade, change in bed load, and dead trees in the bed (UU, VV). The slope of the entire reach was 2.7%.
