2020 319 Application Form

Project Name Lower Bitterroot Tributary Restoration

Sponsor Name Clark Fork Coalition

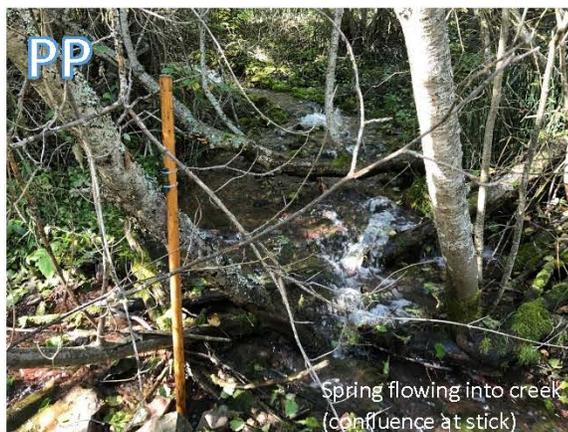
Spring flowing into creek (confluence at stick)

mapped end of road 123 and its top of reach marker just downstream of O'Brien Creek's confluence with a major scree-slope spring (OO, PP). There was no evidence of beaver found. The stream goes dry above this reach where the valley narrows and a steep scree slope develops on the south facing valley wall. Because of this, we were unable to sample outside of the influence of the road. There was a good amount of habitat forming, small diameter wood in the stream. One large fish was found in a pool. Erosive, high banks are typical of the reach (QQ, RR). Some meander bends are very sharp (possibly unnaturally so), resulting in deep pools (SS, TT). Ten meters of the stream in this reach seems to have captured the old road, as evidenced by a sharp change in grade, change in bed load, and dead trees in the bed (UU, VV). The slope of the entire reach was 2.7%.

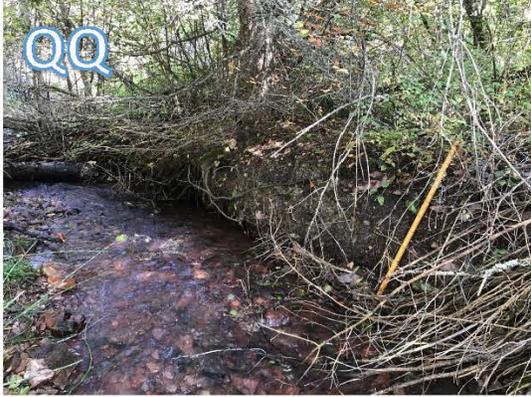
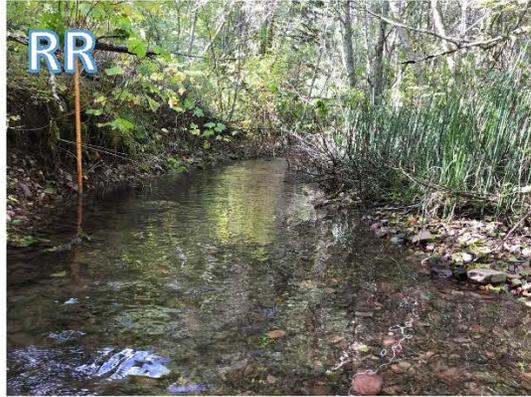
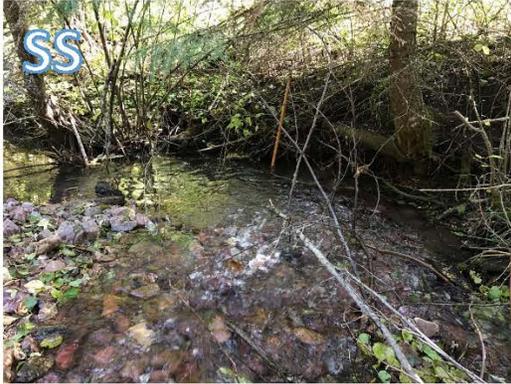
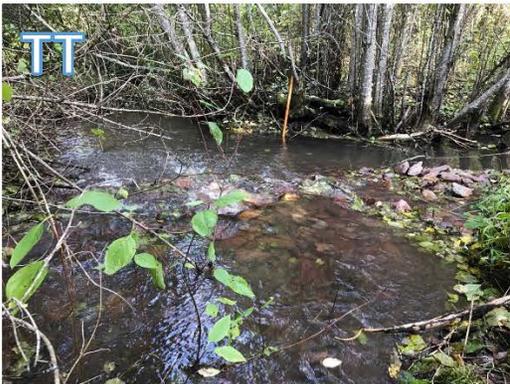
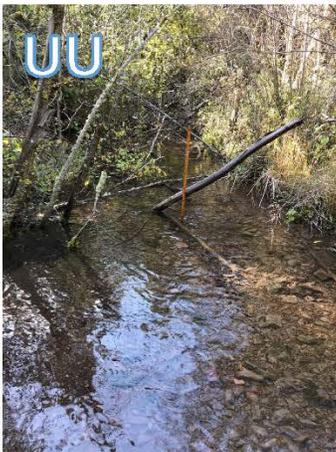
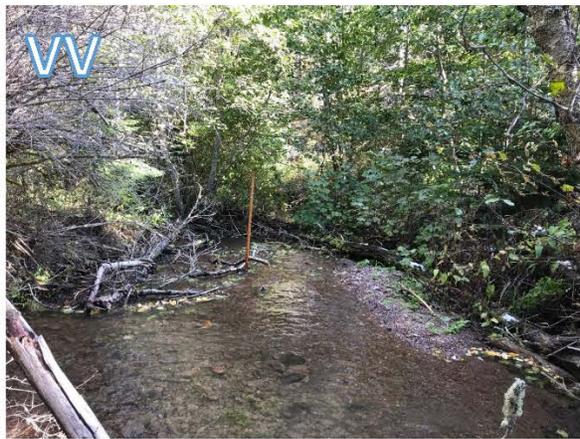
Pre-project conditions on the West Fork of Lolo Creek and Lee Creek

Summer 2019

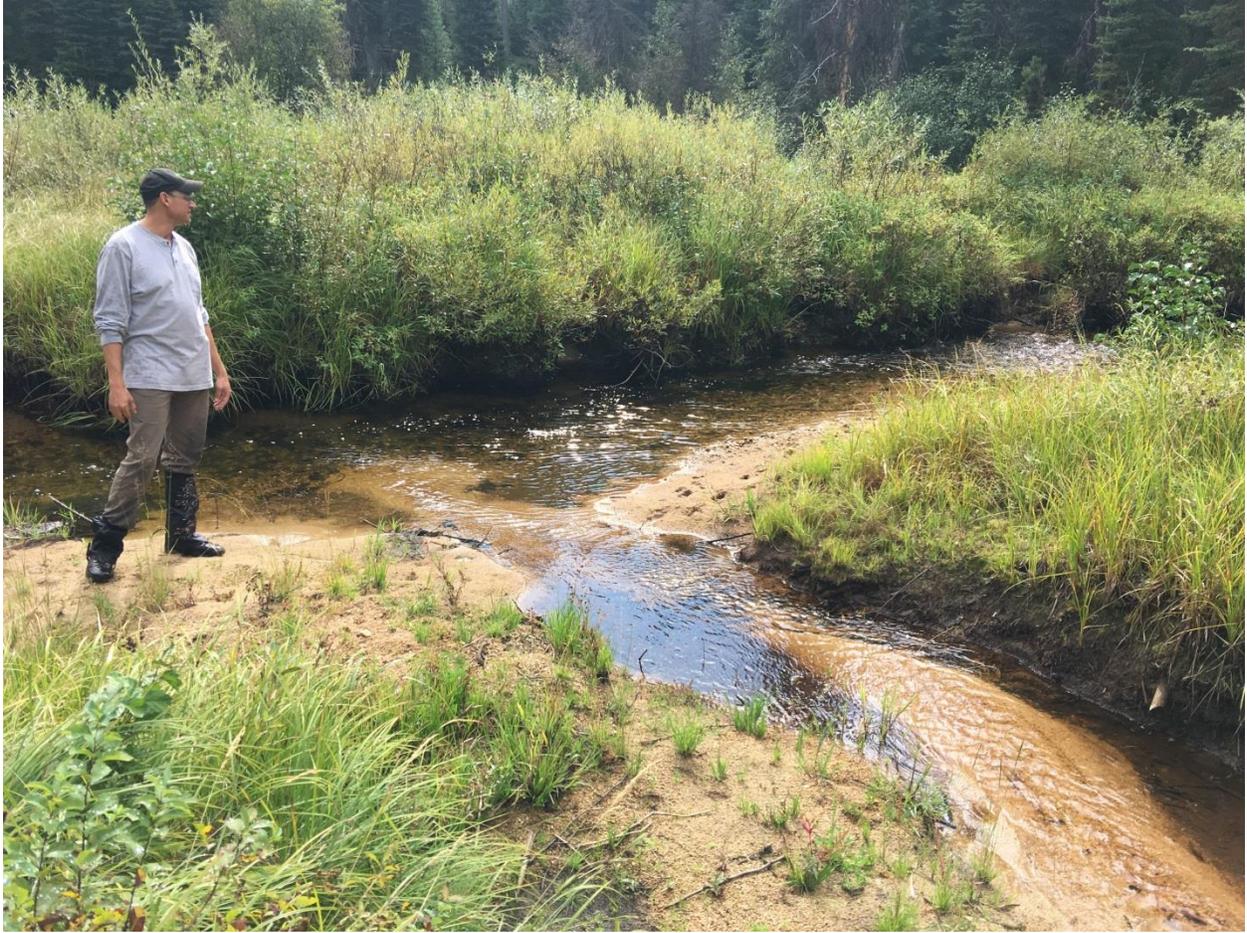
Tributary confluence with West Fork

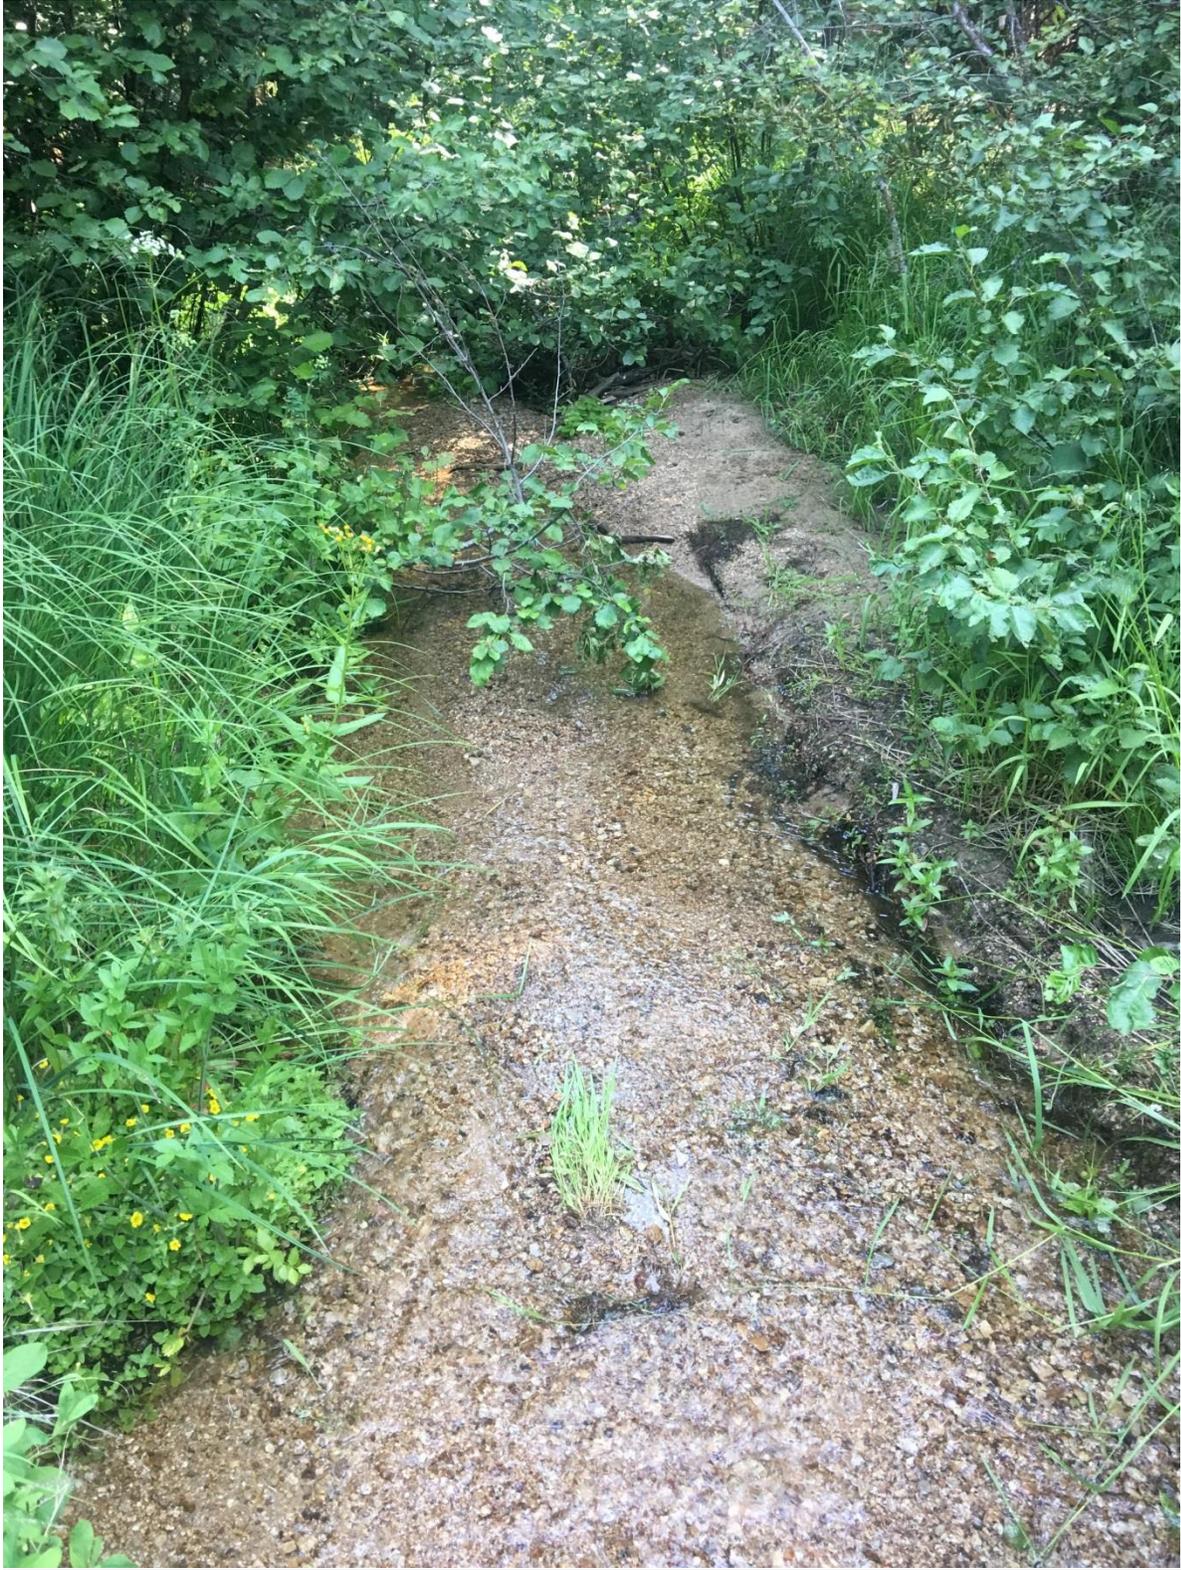
Sediment below project culvert

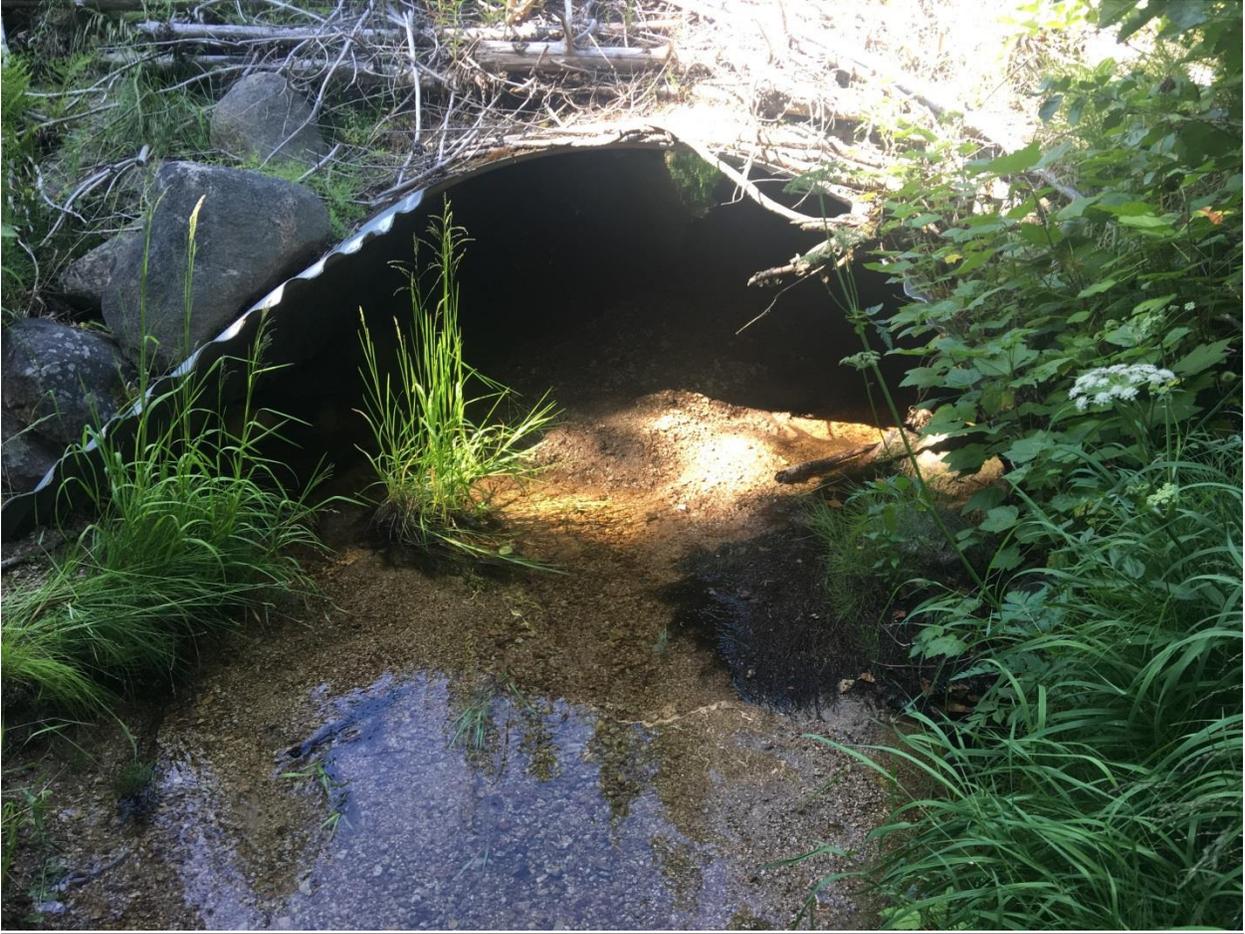
Partially blocked culvert to be removed

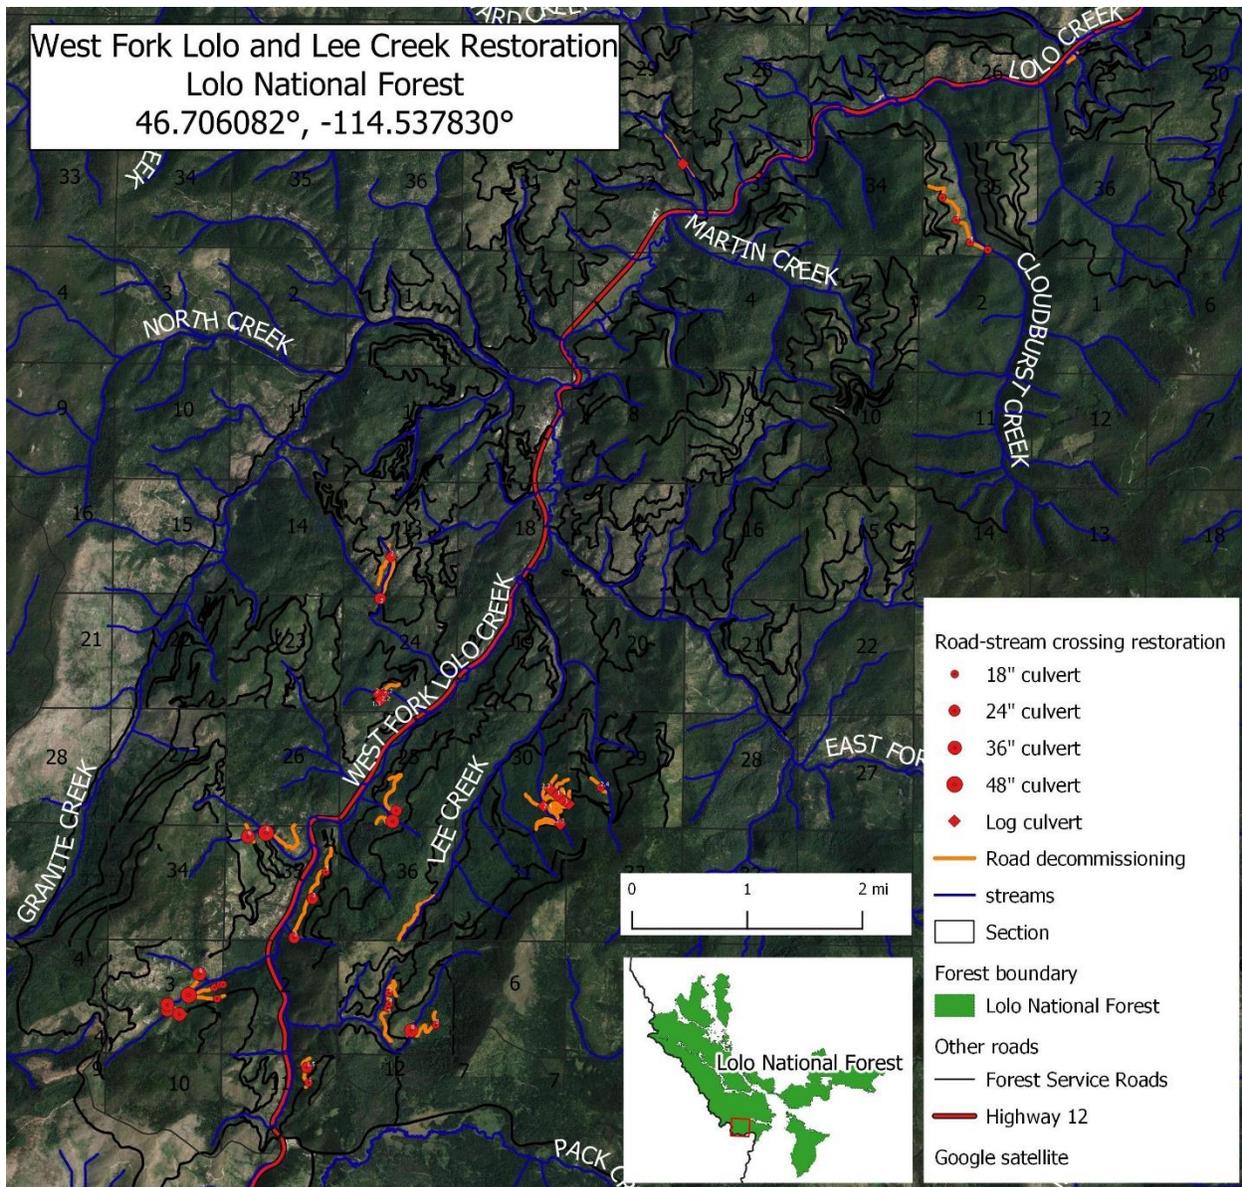
Figure 1: Overview map of the West Fork Lolo and Lee watershed restoration. Proposed roads for decommissioning are in orange while other Forest Service roads are in black. Metal culverts and log culverts proposed for restoration are in red. US Hwy 12 bisects the project and is displayed in red. The center of the project area is it roughly 46.706082°, -114.537830° at the confluence of Lee and West Fork Creeks. Maps at the 1:12,500 scale are included in Appendix B.

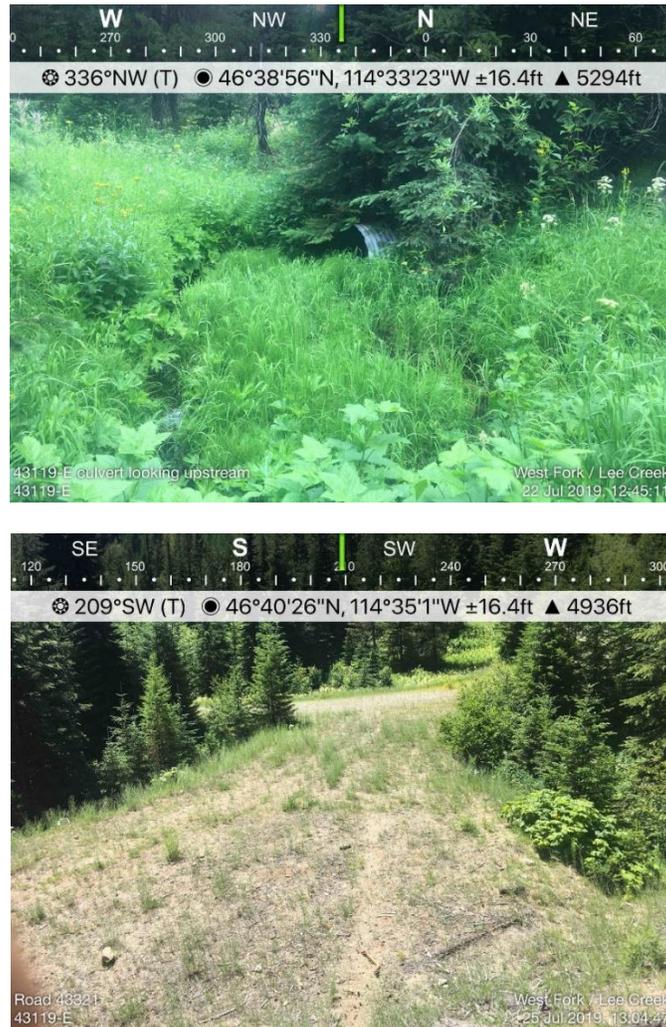
Figure 2: Examples of a road-stream crossing baseline photopoint.

Photo-points were taken at 14 larger, perennial stream crossing adapted from Hall (2001). The smart phone application “Solocator - GPS Field Camera” was used for photo-points. This application takes photos with GPS coordinates, compass direction, altitude, and timestamp overlay. Photos were systematically taken from the downstream side of the road-stream crossing from a vantage point that clearly shows the entire restoration area (Figure 2). Photos will be re-taken after restoration efforts.
