RE: Trout Unlimited 319 Funding Request for Flint Creek Riparian Restoration

Project Name Flint Creek Riparian Restoration

Flint Creek Assessment and Conceptual Design Report

Near Hall, Montana

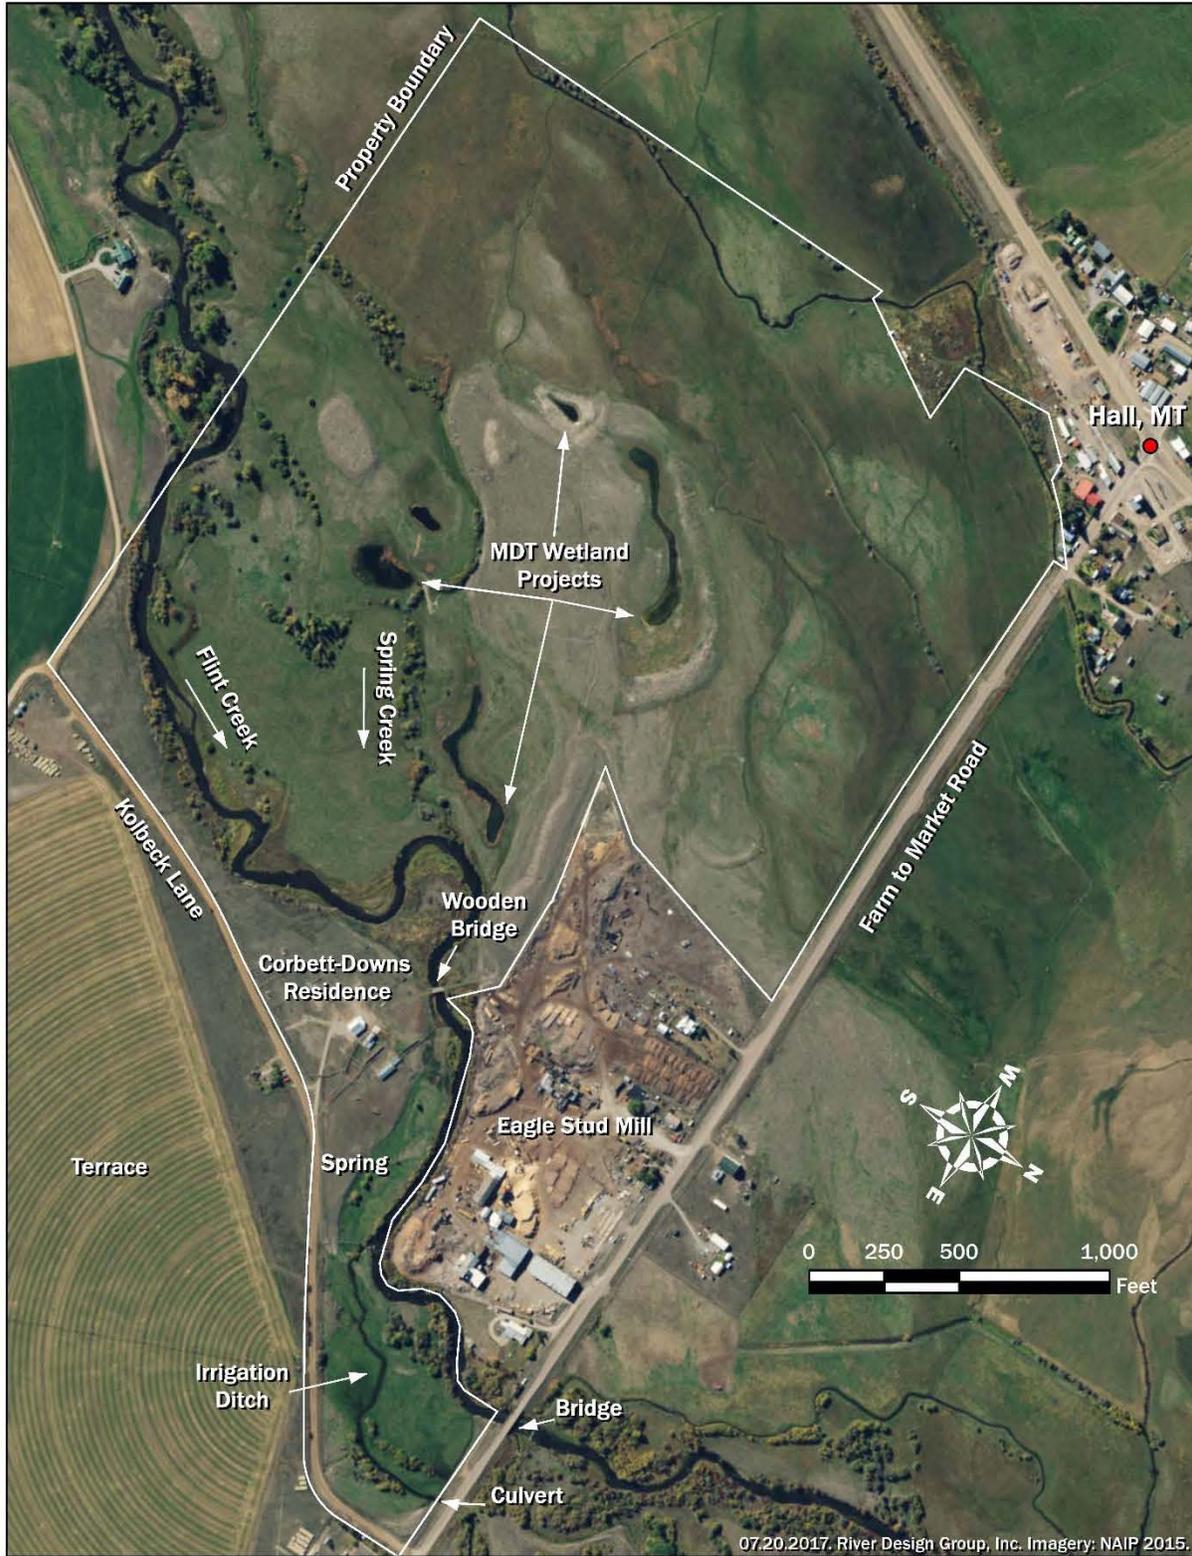
Figure 2-3. Project site map for the Corbett-Downs property near Hall, MT.

The Corbett-Downs property is a 139-acre parcel located approximately one-half mile southeast of Hall, MT (Figure 2-3). Cattle ranching has been the predominant land use on the parcel, and riparian conditions reflect the impacts of grazing. At the downstream end of the property, an irrigation ditch diverts flow from Flint Creek to the downstream landowner (water right of 8.13 cfs maximum). At least two springs flow through the property and flows are presumed to be enhanced by irrigation ditch return flows. A wetland mitigation project constructed by Montana Department of Transportation (MDT) is located in the southwest portion of the property. The Eagle Stud Mill is located west of the property along Flint Creek. Other adjacent land uses are residential and agricultural. The following sections summarize hydrology, geomorphology and vegetation assessments that were completed in support of evaluating existing site conditions and restoration potential.

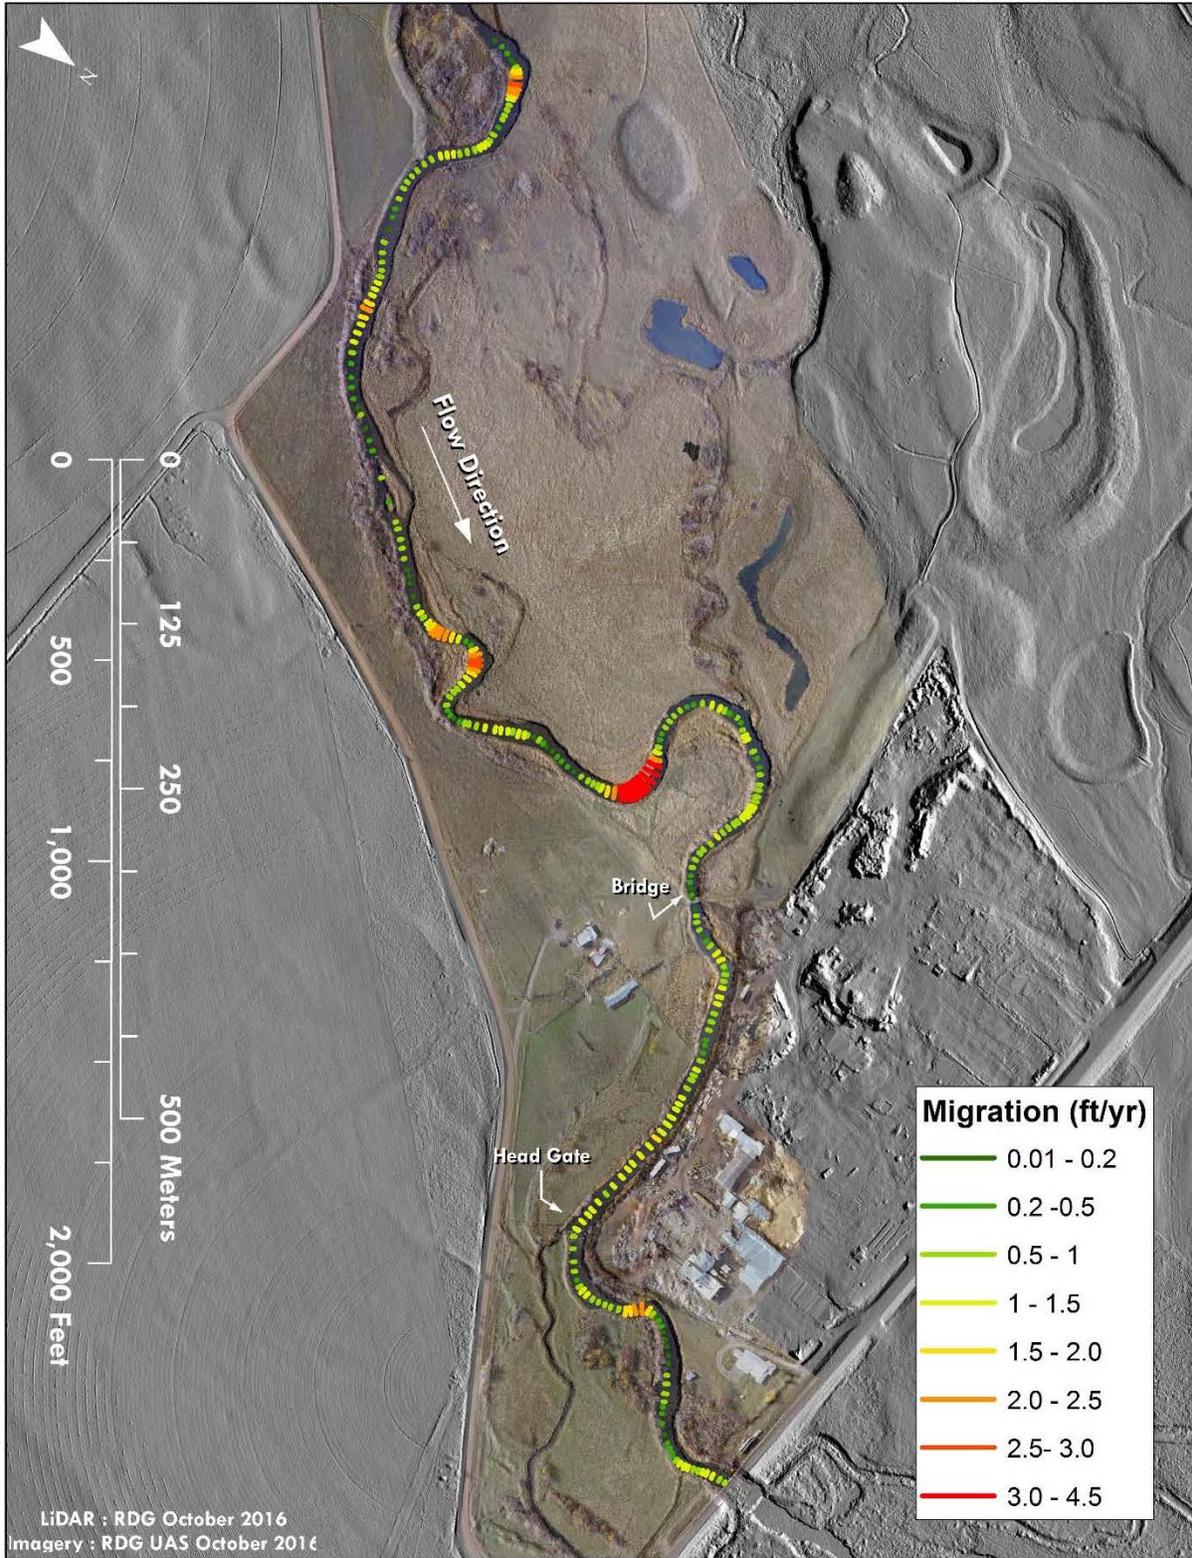
Figure 2-4. Map of channel migration rates calculated from aerial photos 2004 to 2015.

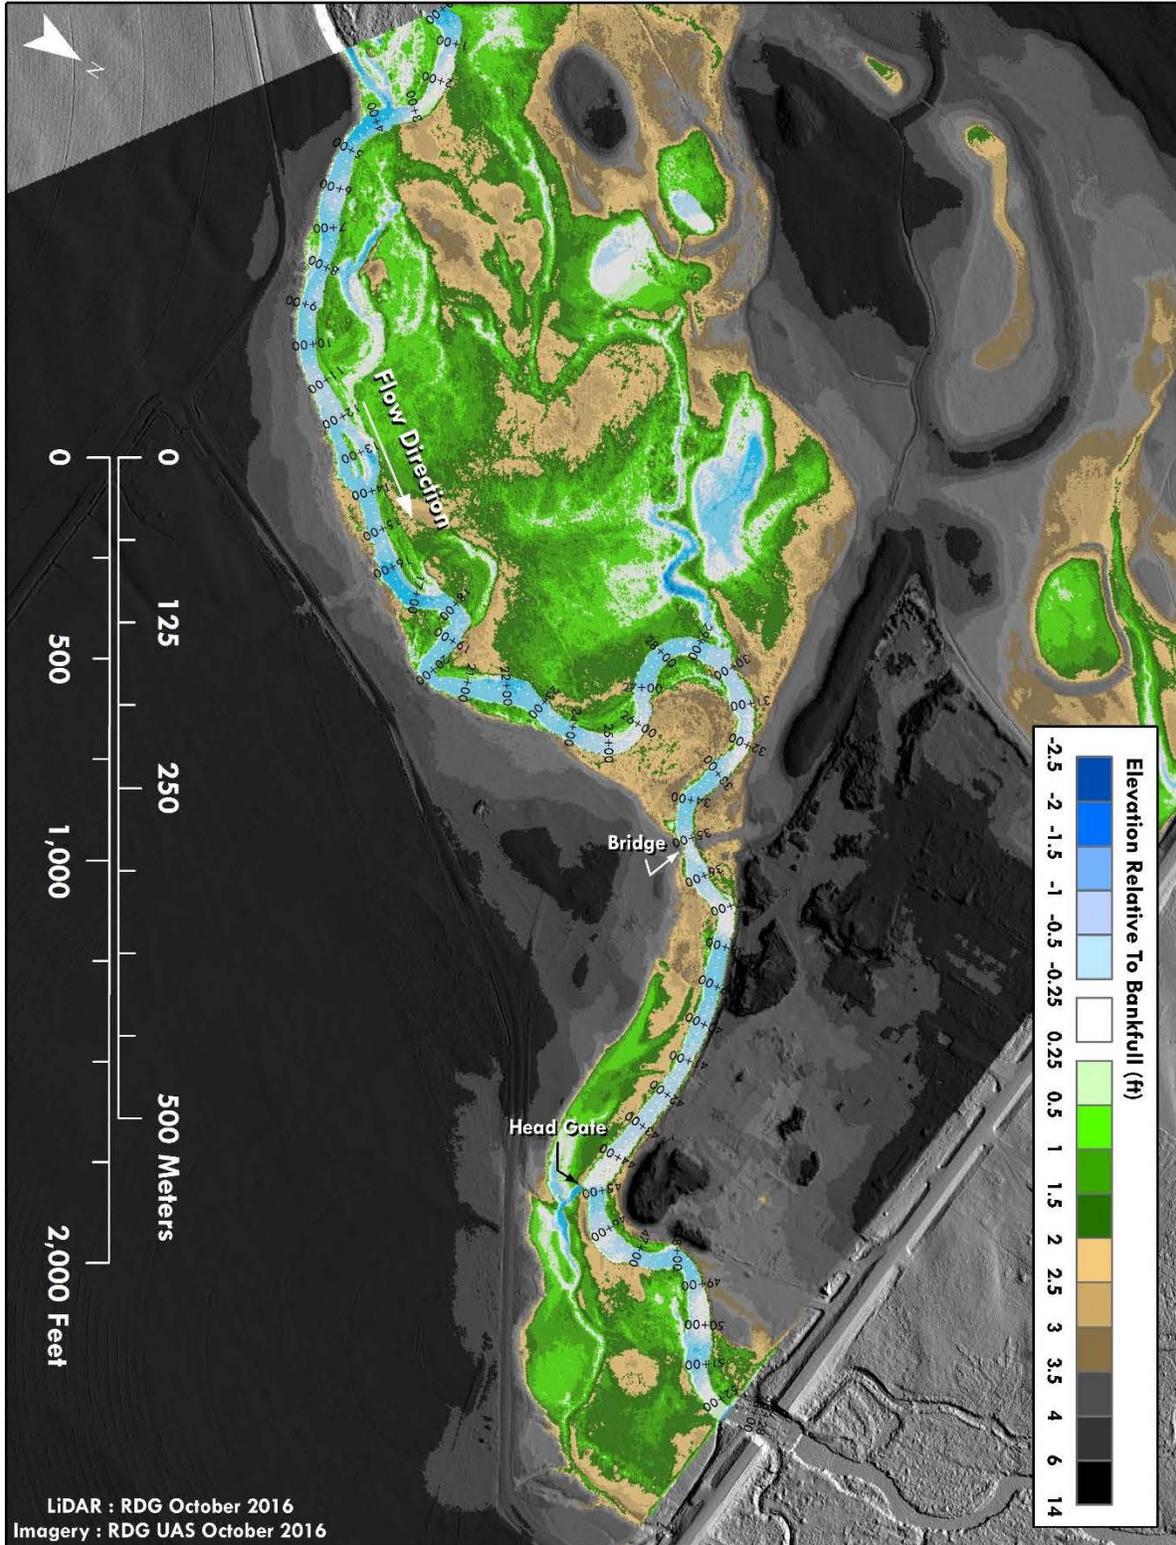
Figure 2-5. Map of floodplain connectivity of the Flint Creek Assessment reach derived from the LiDAR collected in October, 2016.

Floodplain and stream connectivity is vital to the maintenance of stable channels and productive riparian ecosystems. River channels convey one- to two-year flow events (i.e. bankfull), and larger over-bank flows are often dissipated over floodplain surfaces adjacent to channels. When forced to convey large flows within the bankfull channel margin, channels can exhibit incision, bank erosion, and widening. Floodplains disperse stream energy over a much larger area than what is available within the bankfull channel margin. Benefits of connected floodplains include flood water storage and attenuation, slowing of stream velocities, and reduction of bank erosion. In addition, over-bank flows deliver nutrients and fine sediment to floodplain areas, which helps sustain riparian vegetation communities and provide natural seed recruitment opportunities. Floodplain connection was analyzed using LiDAR data and surveyed bankfull elevations from field work (Figure 2-5). Results from this analysis show a connected floodplain in the upper half of the reach until reaching the mill where connectivity is significantly decreased by floodplain encroachment.

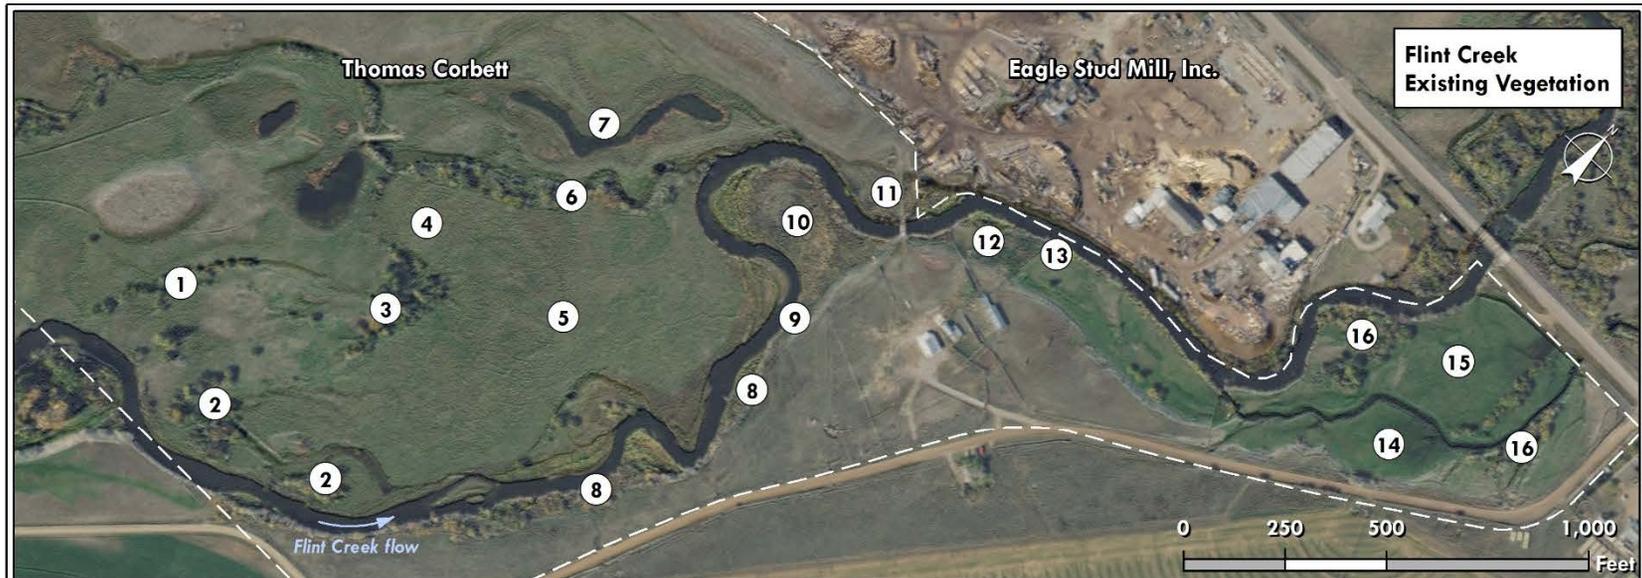
1. Decadent willow stand; some younger shoots regenerating.
2. Decadent willow stands, some young dogwood in understory. Small side channel cuts through area at high flow.

6. Large crack willow stand, very large spring birch.
7. Cattails along pond fringe, as well as in upstream and downstream swale areas. Beaver seen in pond.

Field work to assess existing vegetation conditions at the project site was completed on June 19, 2017. Dominant vegetation type and condition was noted for habitat units, as were any grazing impacts. Figure 2-2 provides a summary of existing vegetation in the project area, with a focus on dominant species and distinctive features.

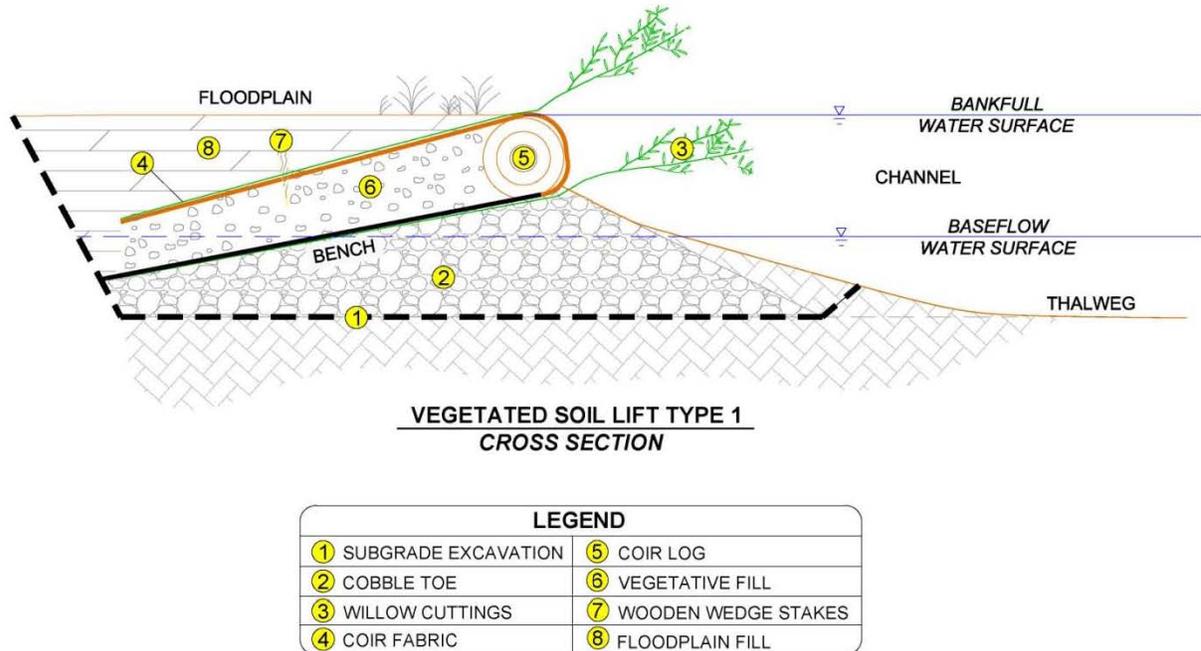
Figure 3-1. Conceptual cross section of a vegetated soil lift bioengineering treatment.

that support the establishment of woody vegetation. Figure 3-1 shows a conceptual cross section view of a typical bioengineering streambank treatment called a vegetated soil lift. Figure 3-2 shows example photos of bioengineering streambank structures.

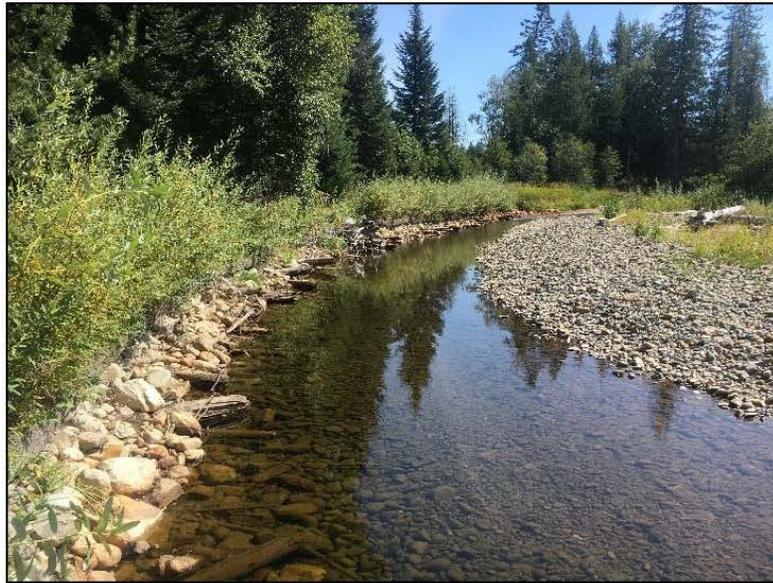
Figure 3-2. Example of vegetated soil lift 5 years after construction.

Supplemental Information: Bioengineering provides conditions along the channel banks that are suitable for growing woody riparian vegetation. Bioengineering is built on a gravel or cobble toe. Short term structure performance is dependent on toe stability as well as smooth transitions to stable upstream and downstream tie-in points. Placement of healthy woody vegetative cuttings that are placed to a depth to ensure contact with the water table throughout the growing season is critical, and long term structure performance is dependent on development of dense rootmass.

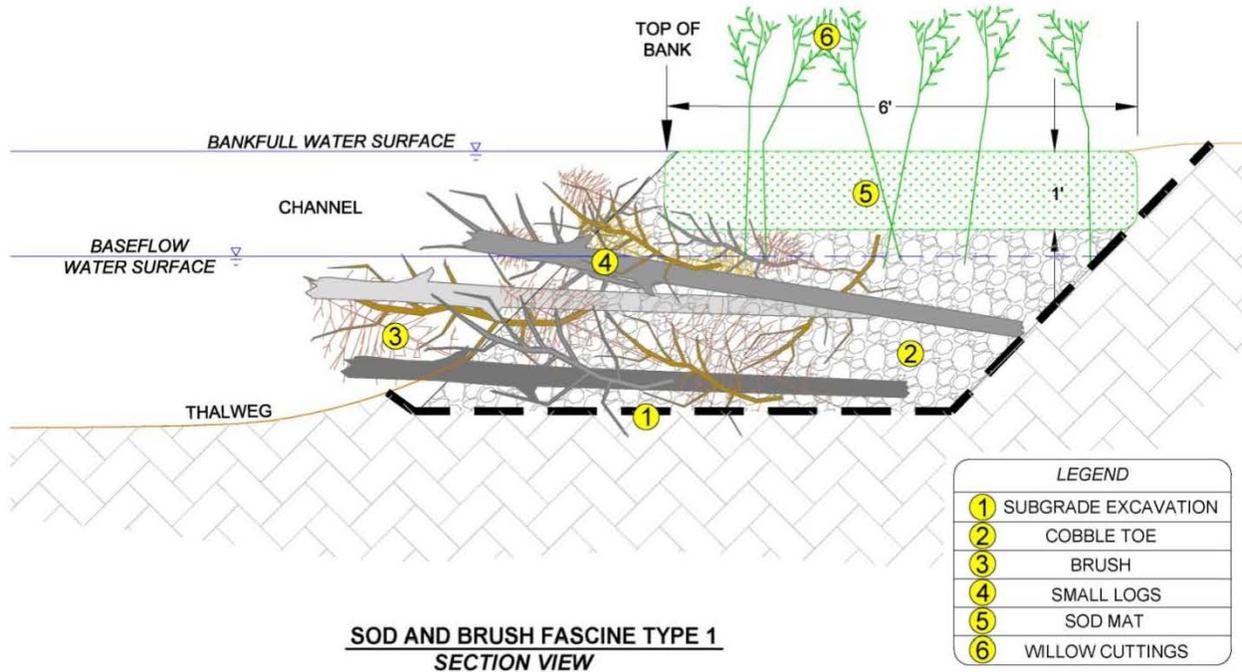
Figure 3-3. Conceptual cross section of a sod and brush fascine.

Brush banks and fascines are a category of streambank structures consisting of brush bundles and live plant material. Depending on the application and availability of materials, structures may also include woody debris and/or wetland sod mats. Figure 3-3 shows a conceptual cross section view of a typical streambank treatment called a sod and brush fascine.

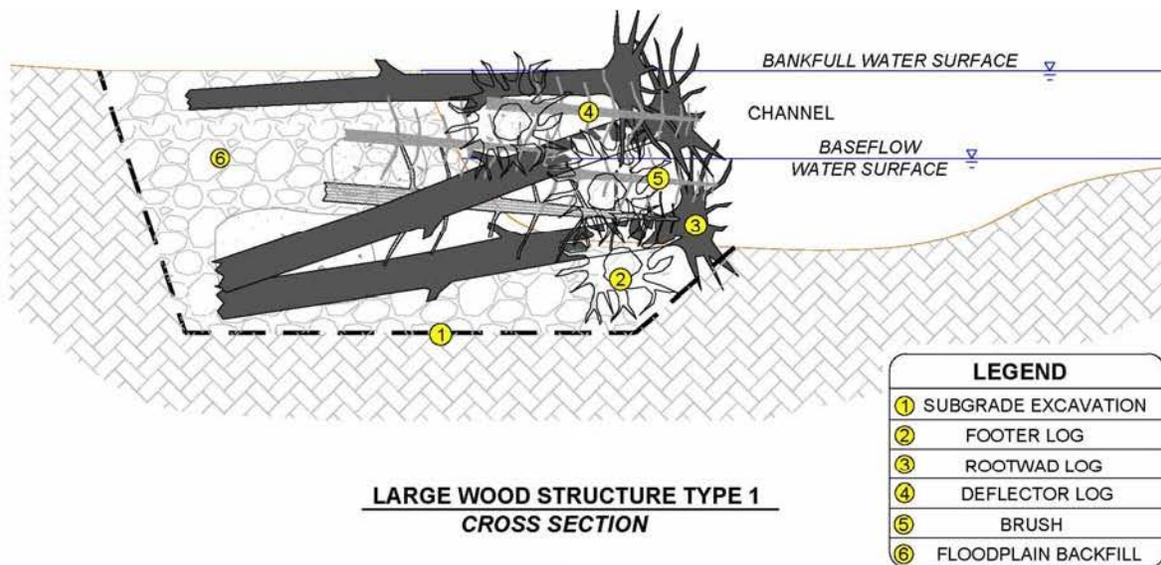
Figure 3-4. Conceptual cross section of a large wood structure.

Large wood structures are a category of streambank structures consisting of logs and brush buried into the streambank and projecting out into the channel. Large wood structures are intended to emulate natural accumulations of large wood along the bank margins. Figure 3-4 shows a conceptual cross section view of a large wood jam structure.

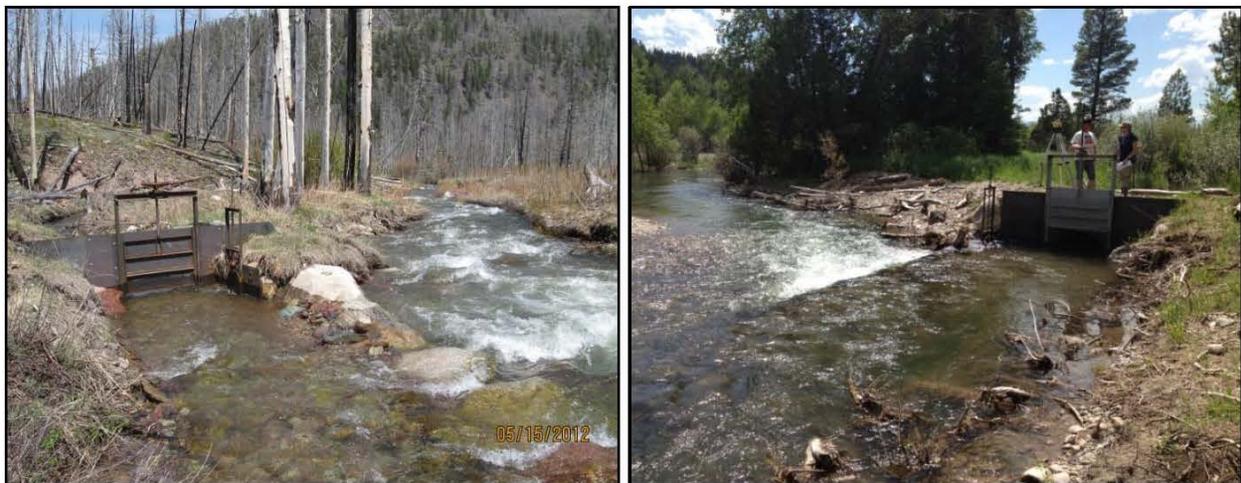
Figure 3-5. Typical rock diversion structure (left), and typical log diversion structure (right).

Several types of diversion structures could be constructed to divert the required flows to the ditches. Typical structures, including include rock and log structures, are shown in Figure 3-5. One potential pitfall of constructing such structures is the potential for beaver dams to be built on them. This could result in the need to remove the beaver dams as part of routine maintenance.

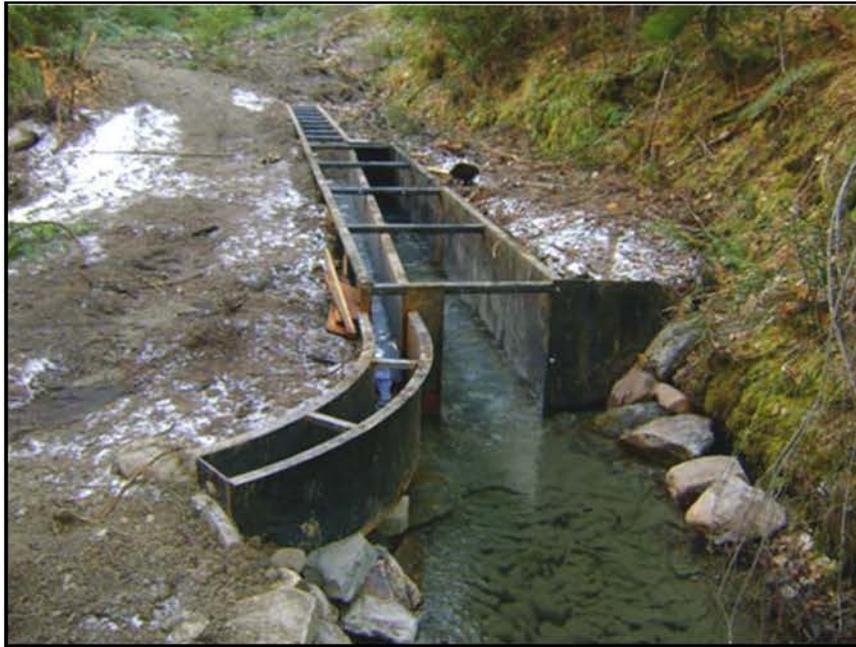
Figure 3-6. Example modular FCA screen on Sixmile Creek near Frenchtown, MT, courtesy of FCA. Water flows down the flume to the screen.

The first alternative considered consists of a horizontal plate screen manufactured by Farmers Conservation Alliance (FCA) of Hood River, Oregon. FCA screens have no moving parts and require relatively little maintenance. The FCA screen is installed in an existing ditch (off-channel), and consists of a screen box constructed from plate steel and a fish screen constructed from perforated stainless steel plate. FCA screens meet or exceed all NMFS (2011) criteria. An example installation is shown in Figure 3-6.

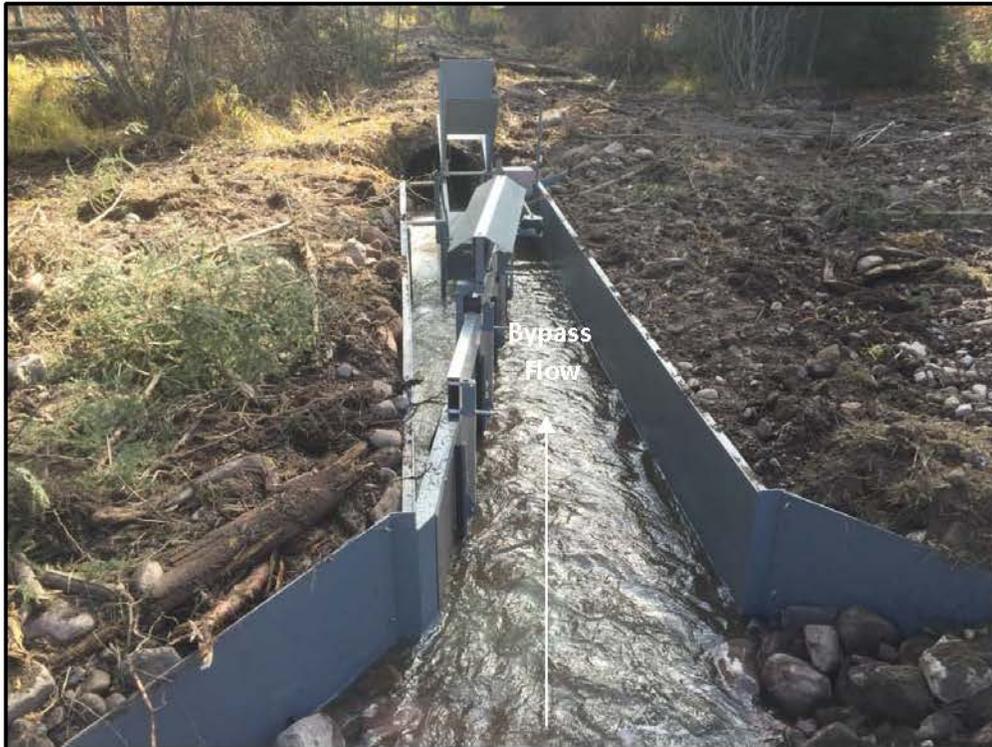
Figure 3-8. Example of a vertical flat plate screen set at an angle to flow in the ditch. A portion of flow passes through the flat plate screen and down the irrigation ditch, and a portion of flow passes down the bypass pipe (upper right) and is returned to the channel. Brushes driven by the paddle wheel move back and forth across the screen to remove debris.

Alternative 2 consists of a vertical flat panel screen placed within the irrigation ditch. Vertical flat panel screens have a good track record of operating in the Blackfoot River Basin and are manufactured locally in Seeley Lake, Montana and other custom fabricators. The screen consists of a metal or concrete screen box placed within the existing ditch, vertical flat panel screen(s) angled to the path of flow, and a paddle wheel mechanical system to move the brushes. An example installation is shown in Figure 3-8.

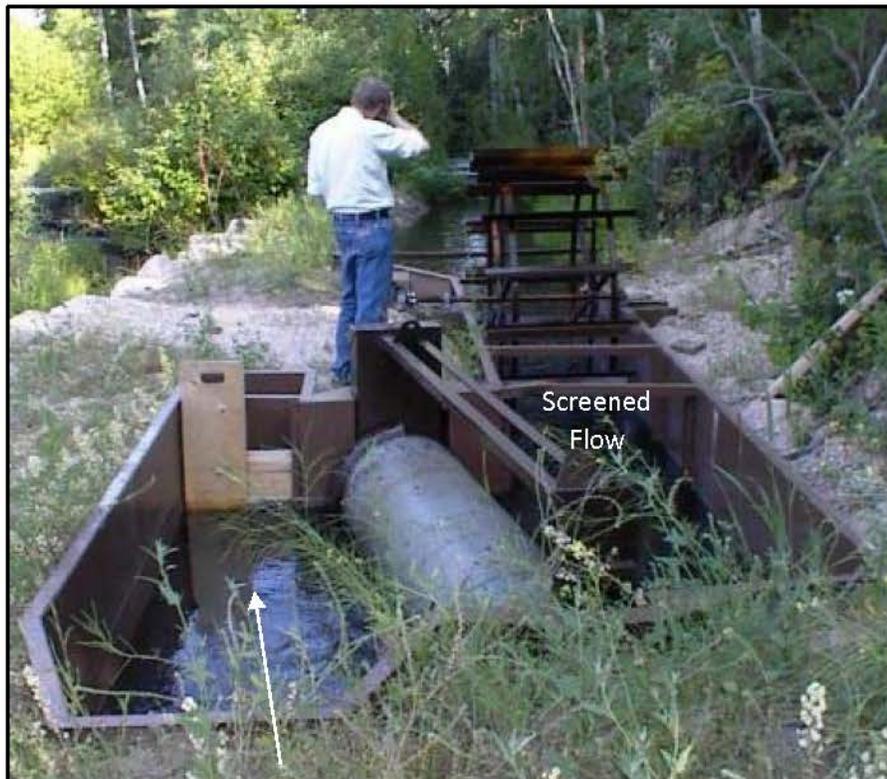
Figure 3-9. Example of a drum screen set at an angle to flow in the ditch with a paddle wheel and gear system to turn it.

Alternative 3 consists of a rotary drum screen placed within the irrigation ditch. Rotary drum screens have a good track record of operating in the nearby Blackfoot River Basin and are manufactured by Hydroscreen LLC, and other custom fabricators. The screen consists of a concrete screen box placed within the existing ditch, rotary drum screen angled to the path of flow, and an internal paddle wheel mechanical system to turn the drum. An example installation is shown in Figure 3-9.

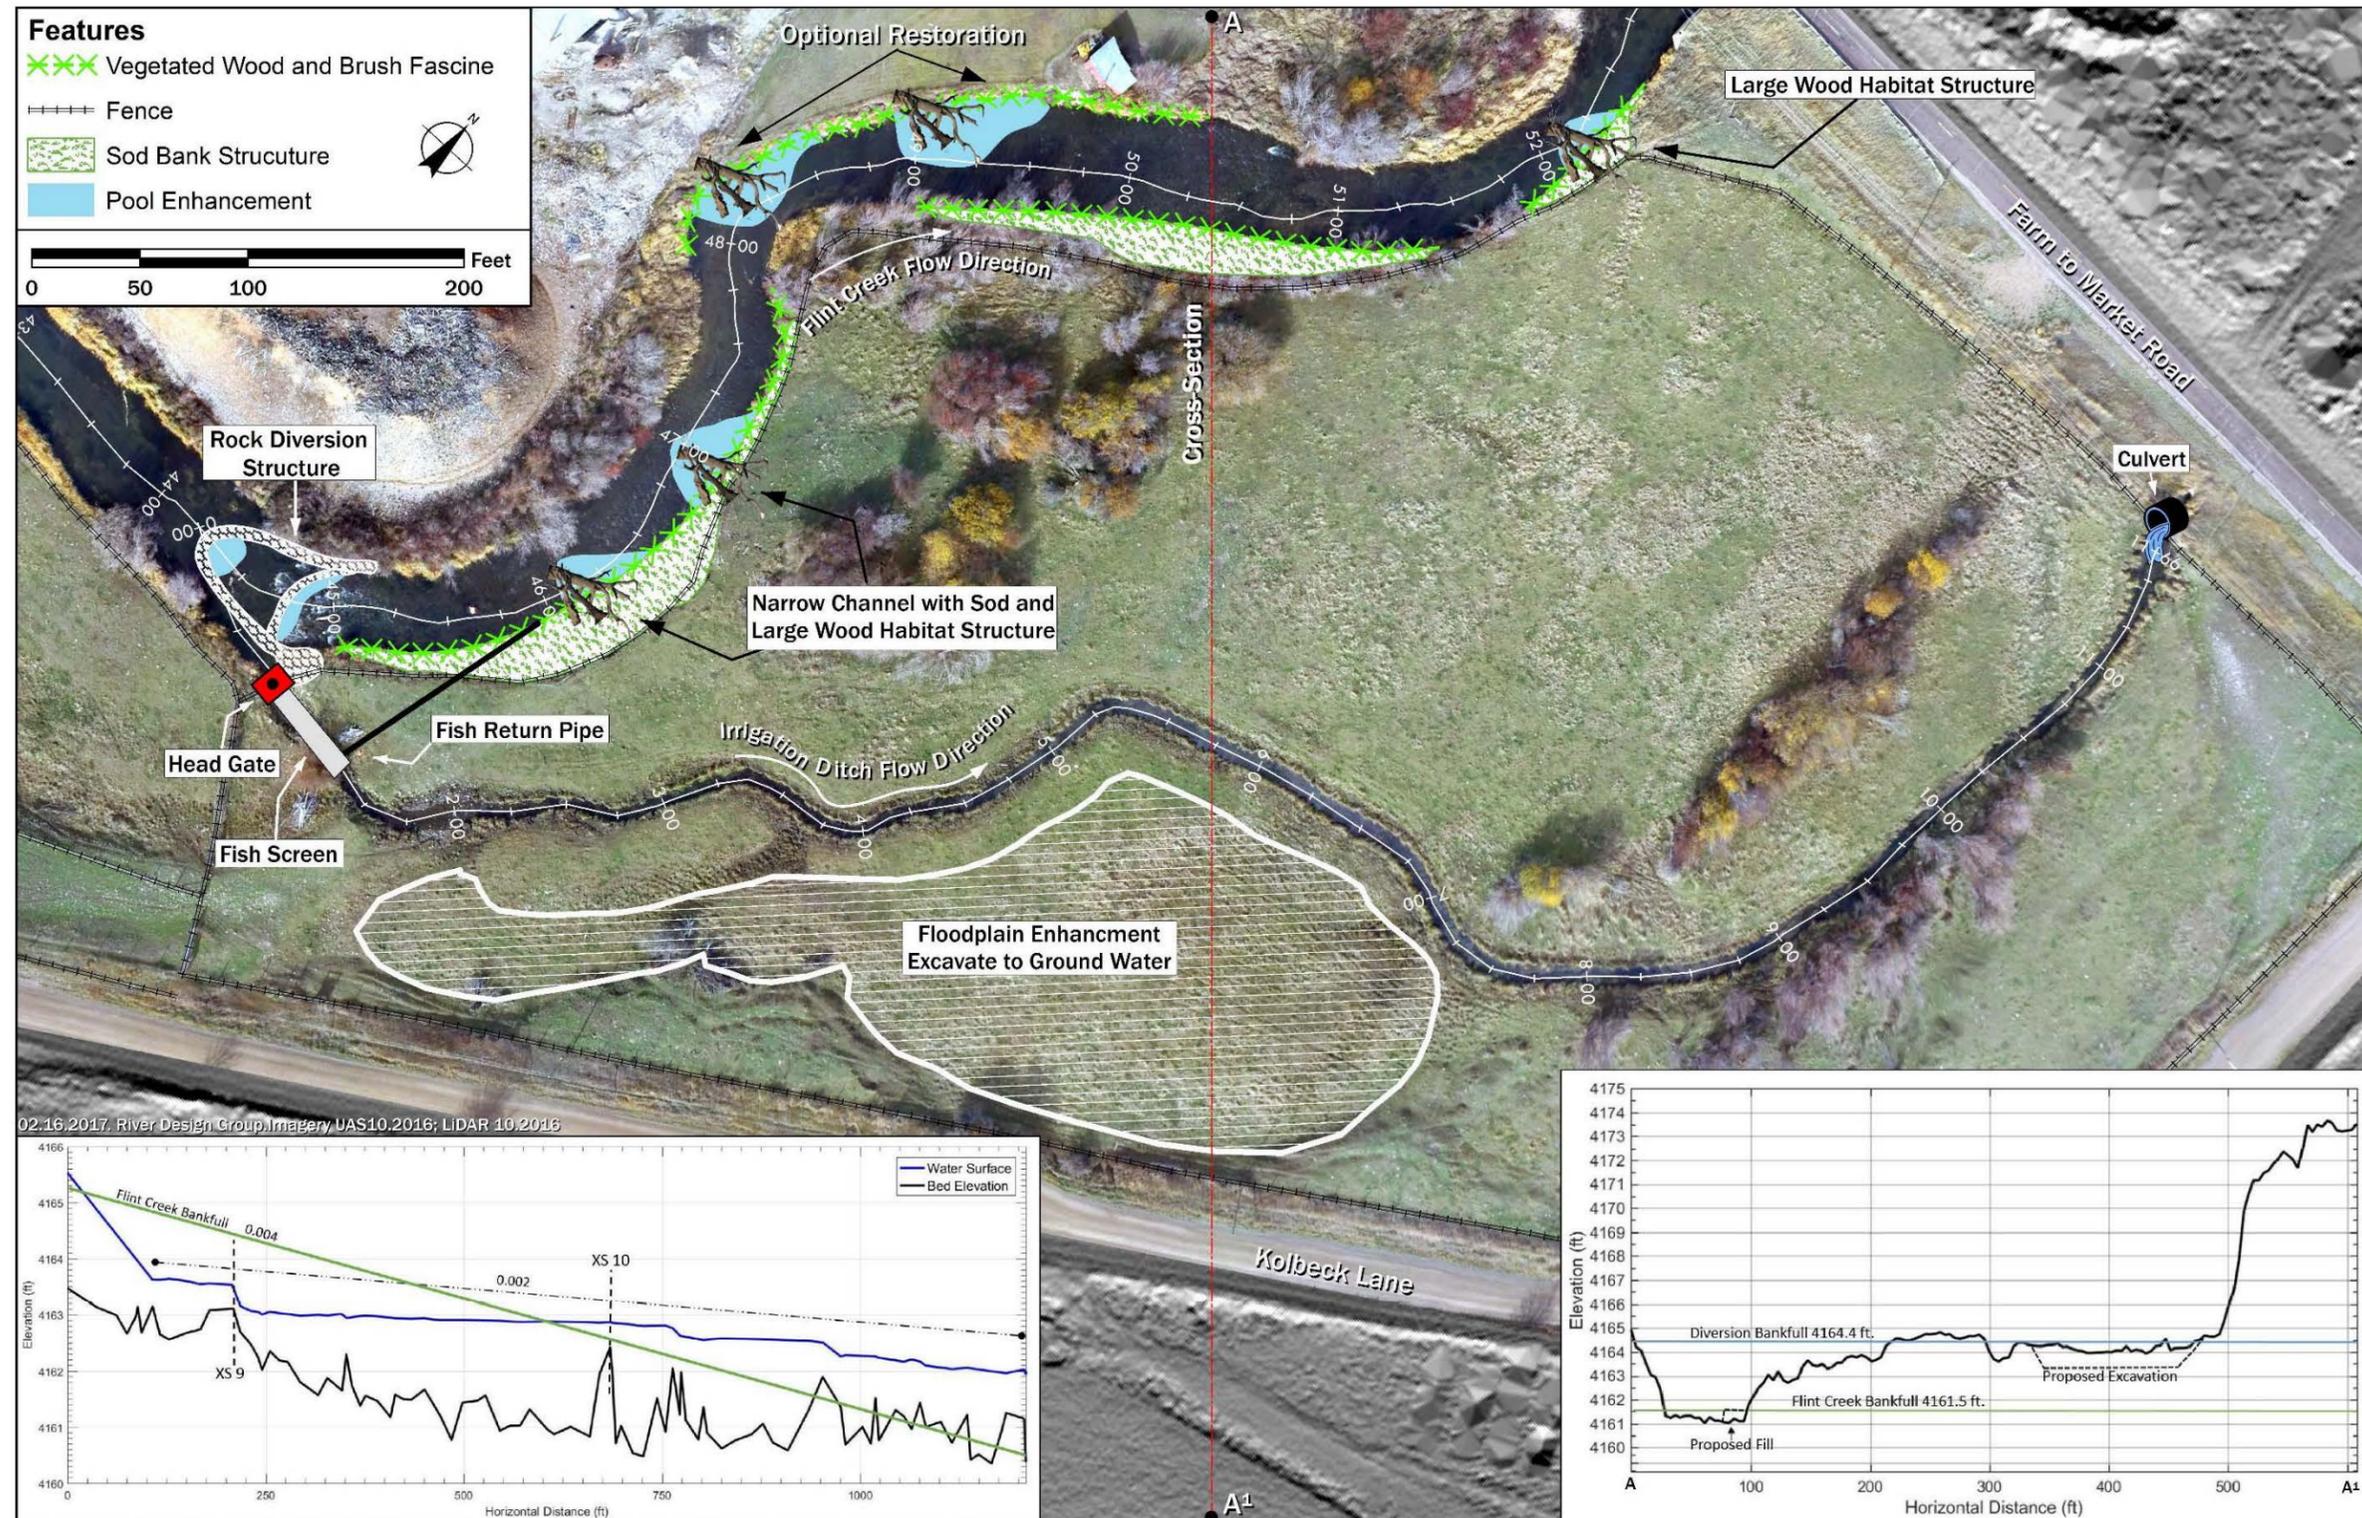
Figure 4-1. Conceptual irrigation diversion plan and conceptual design for the fish screen and lower project site on Flint Creek.

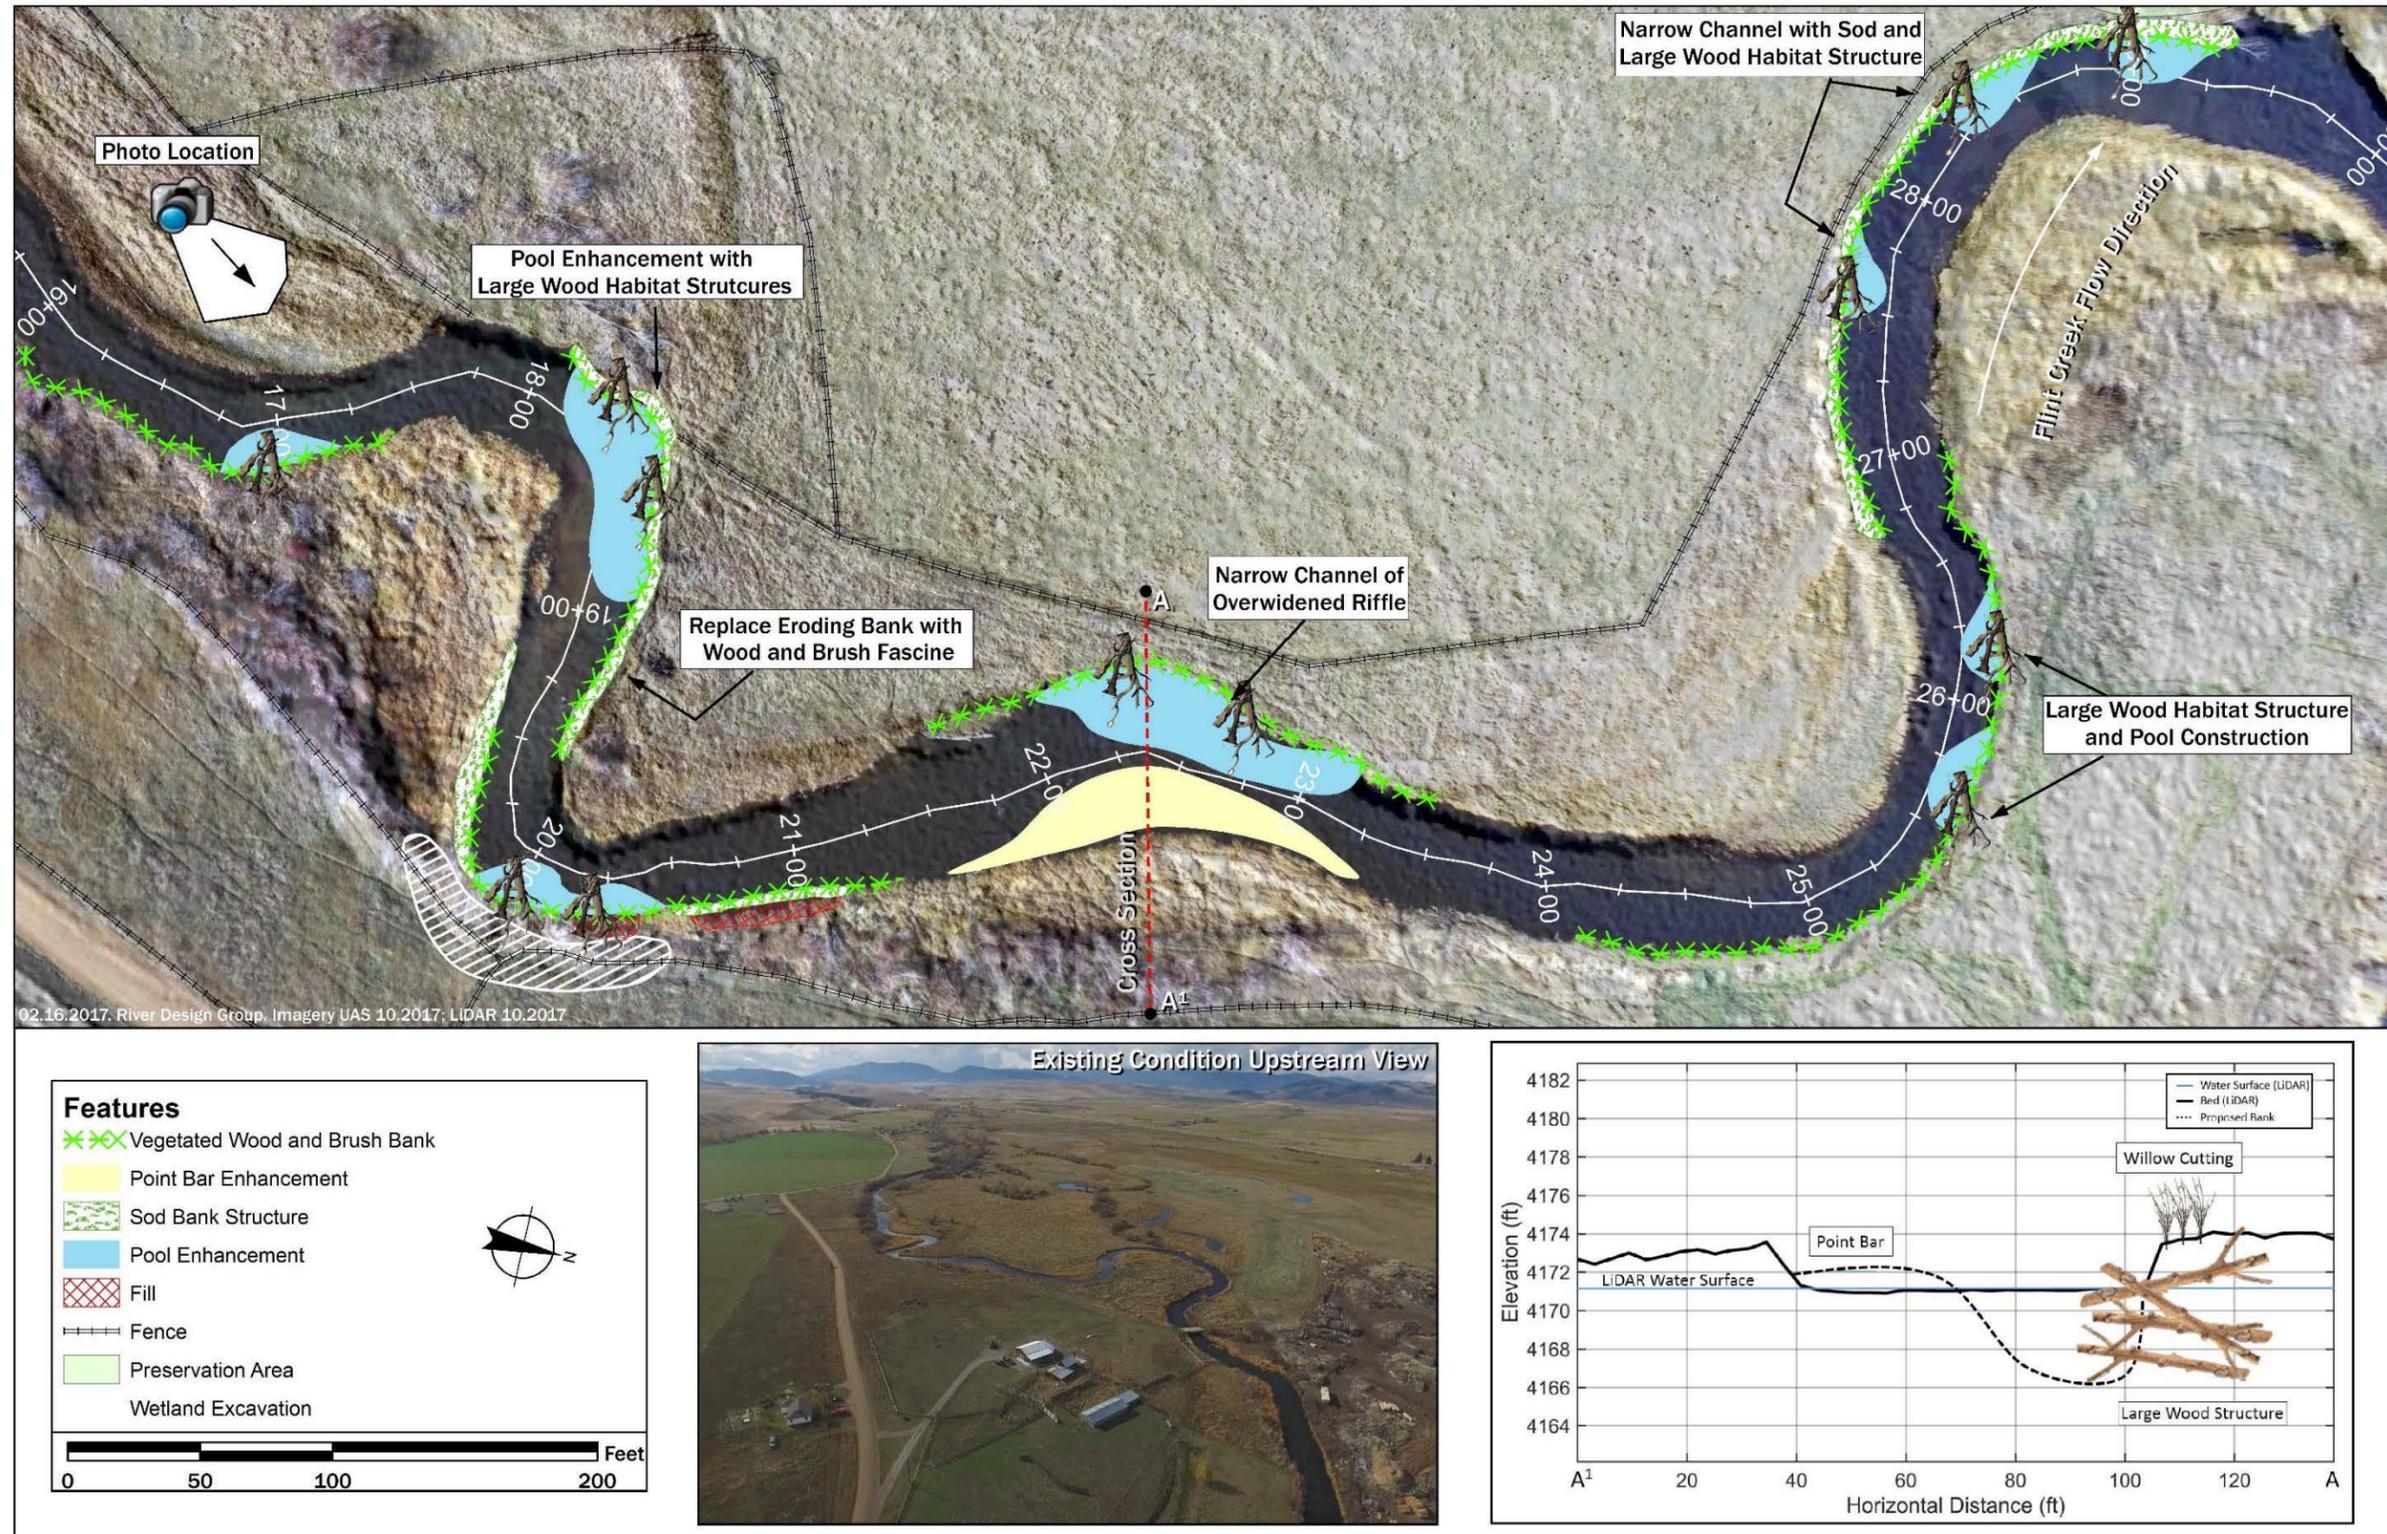
Figure 4-2. Conceptual streambank restoration plan and conceptual design for the downstream portion of the upper site for the Flint Creek.
