RE: Trout Unlimited 319 Funding Request for Flint Creek Riparian Restoration

Project Name Flint Creek Riparian Restoration

Flint Creek Assessment and Conceptual Design Report

Near Hall, Montana

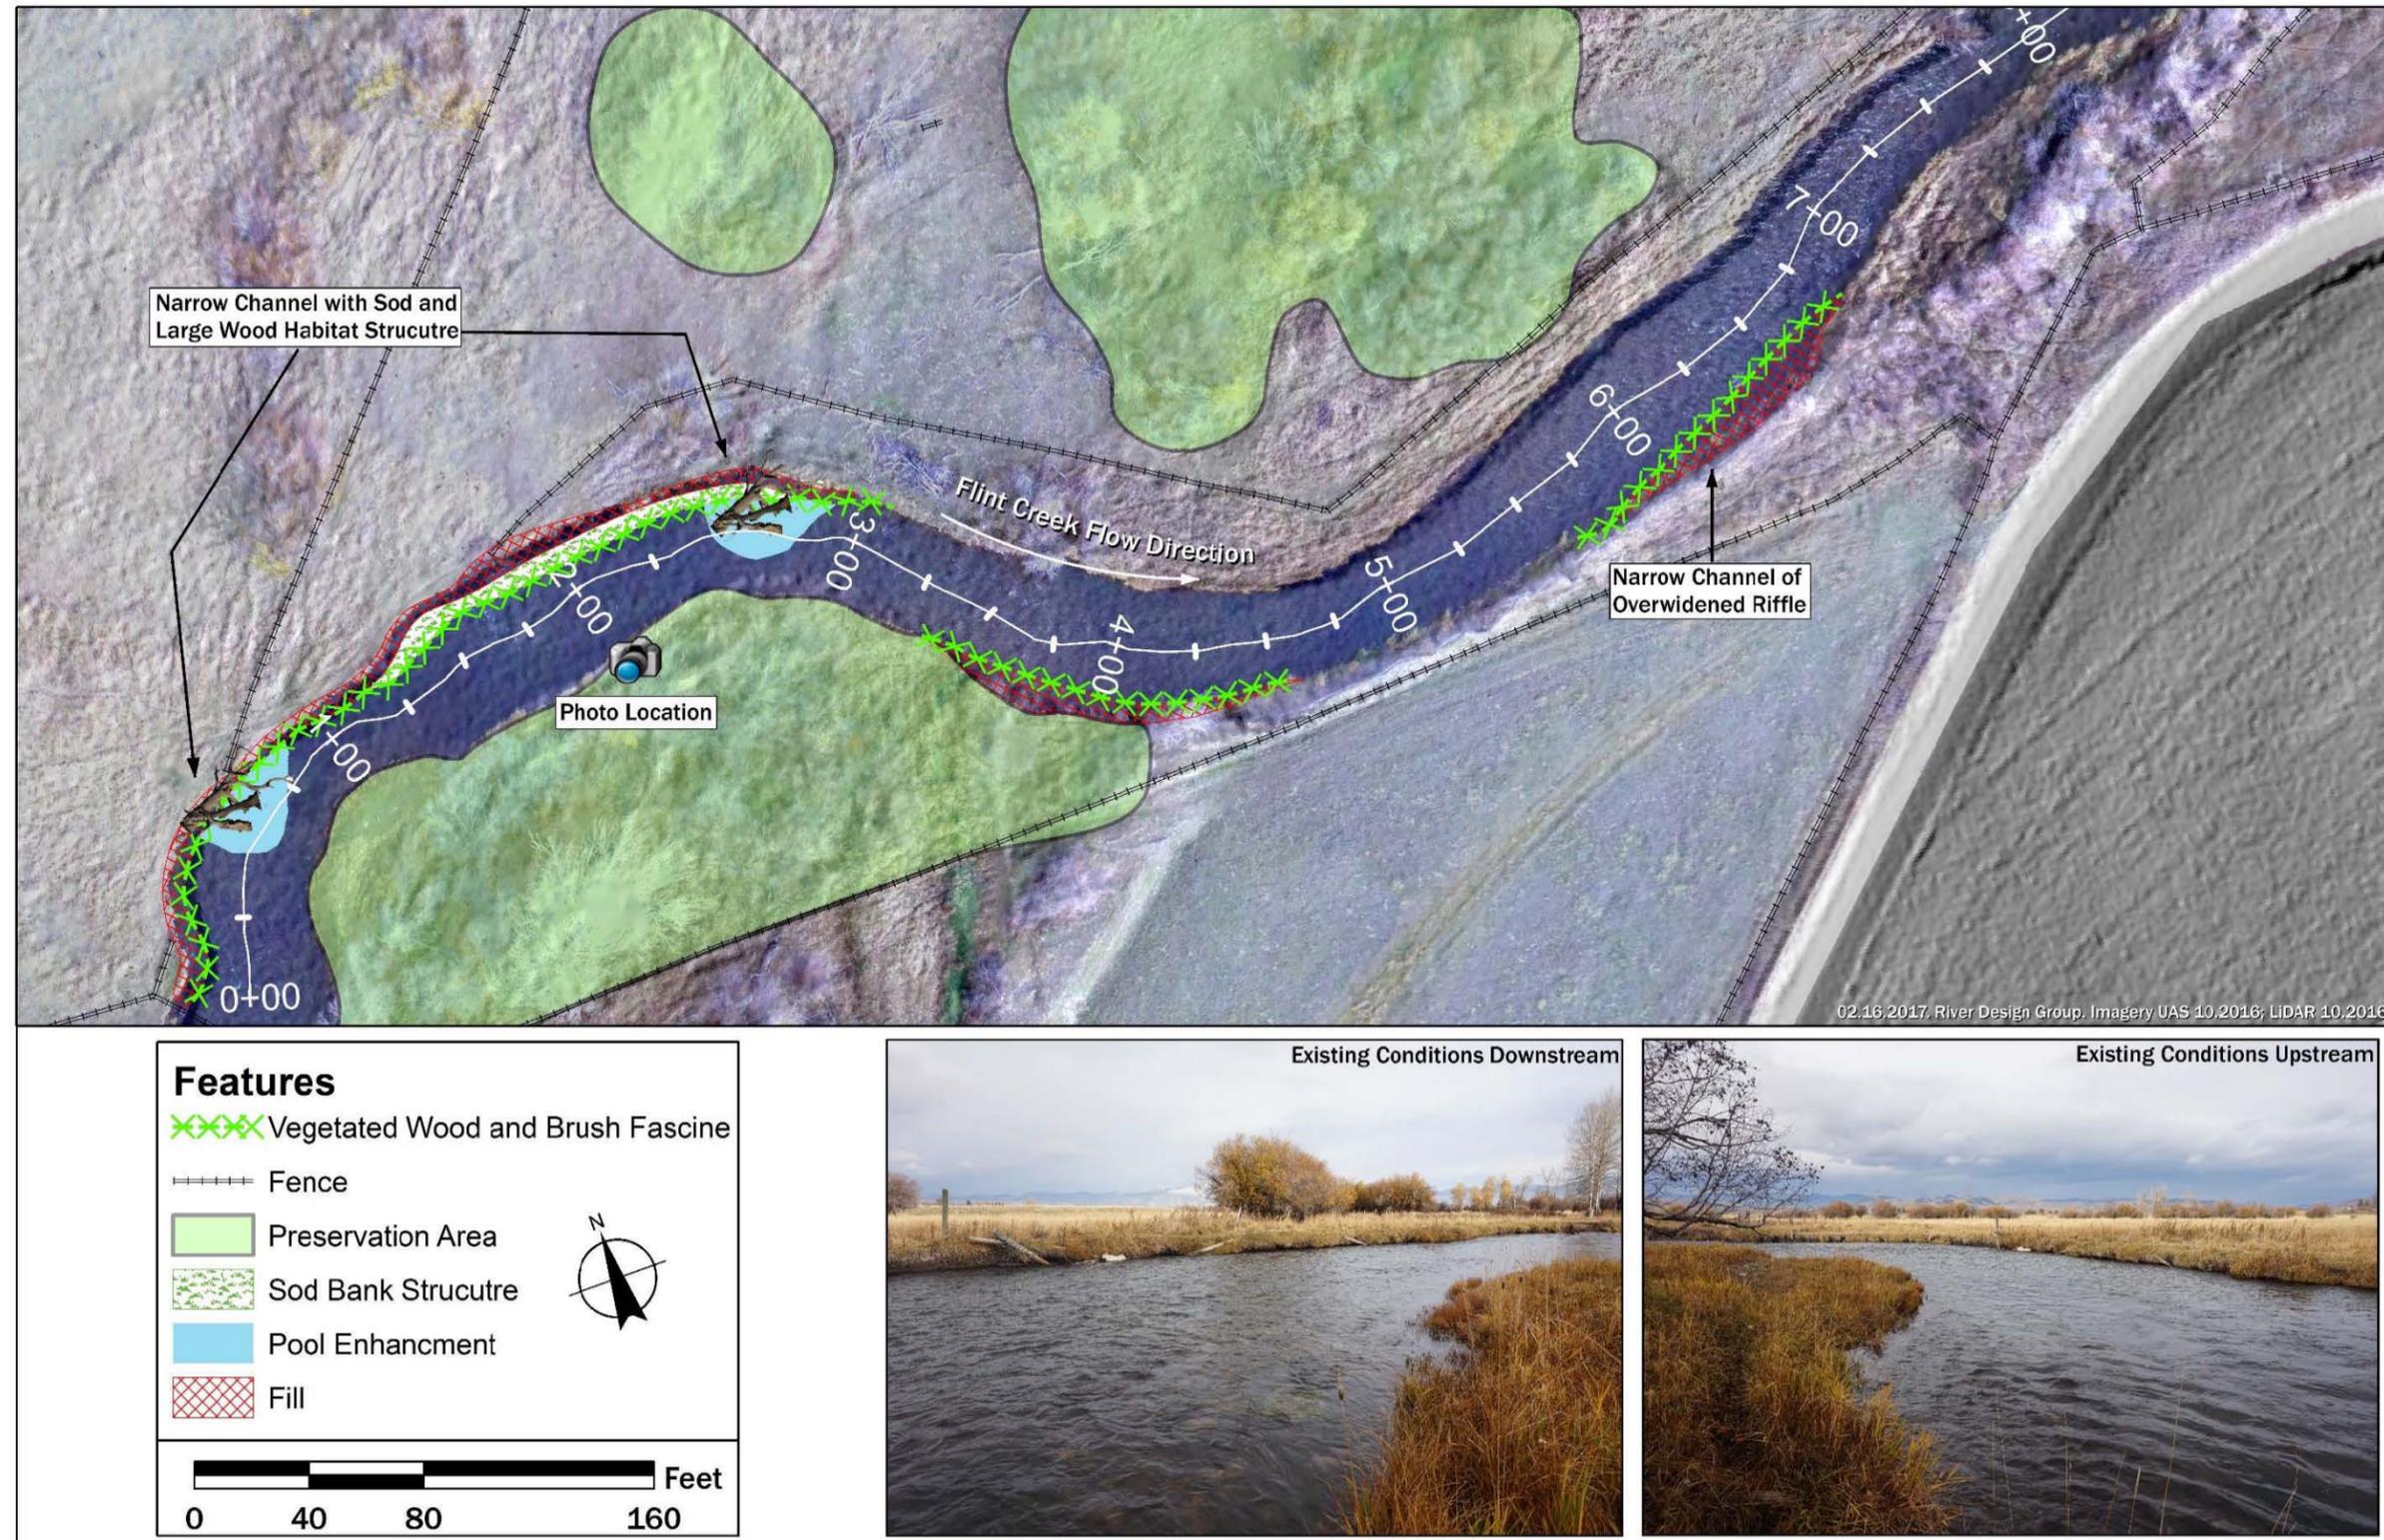
Figure 4-3. Conceptual streambank restoration plan and conceptual design for the upstream portion of the upper site for the Flint Creek.

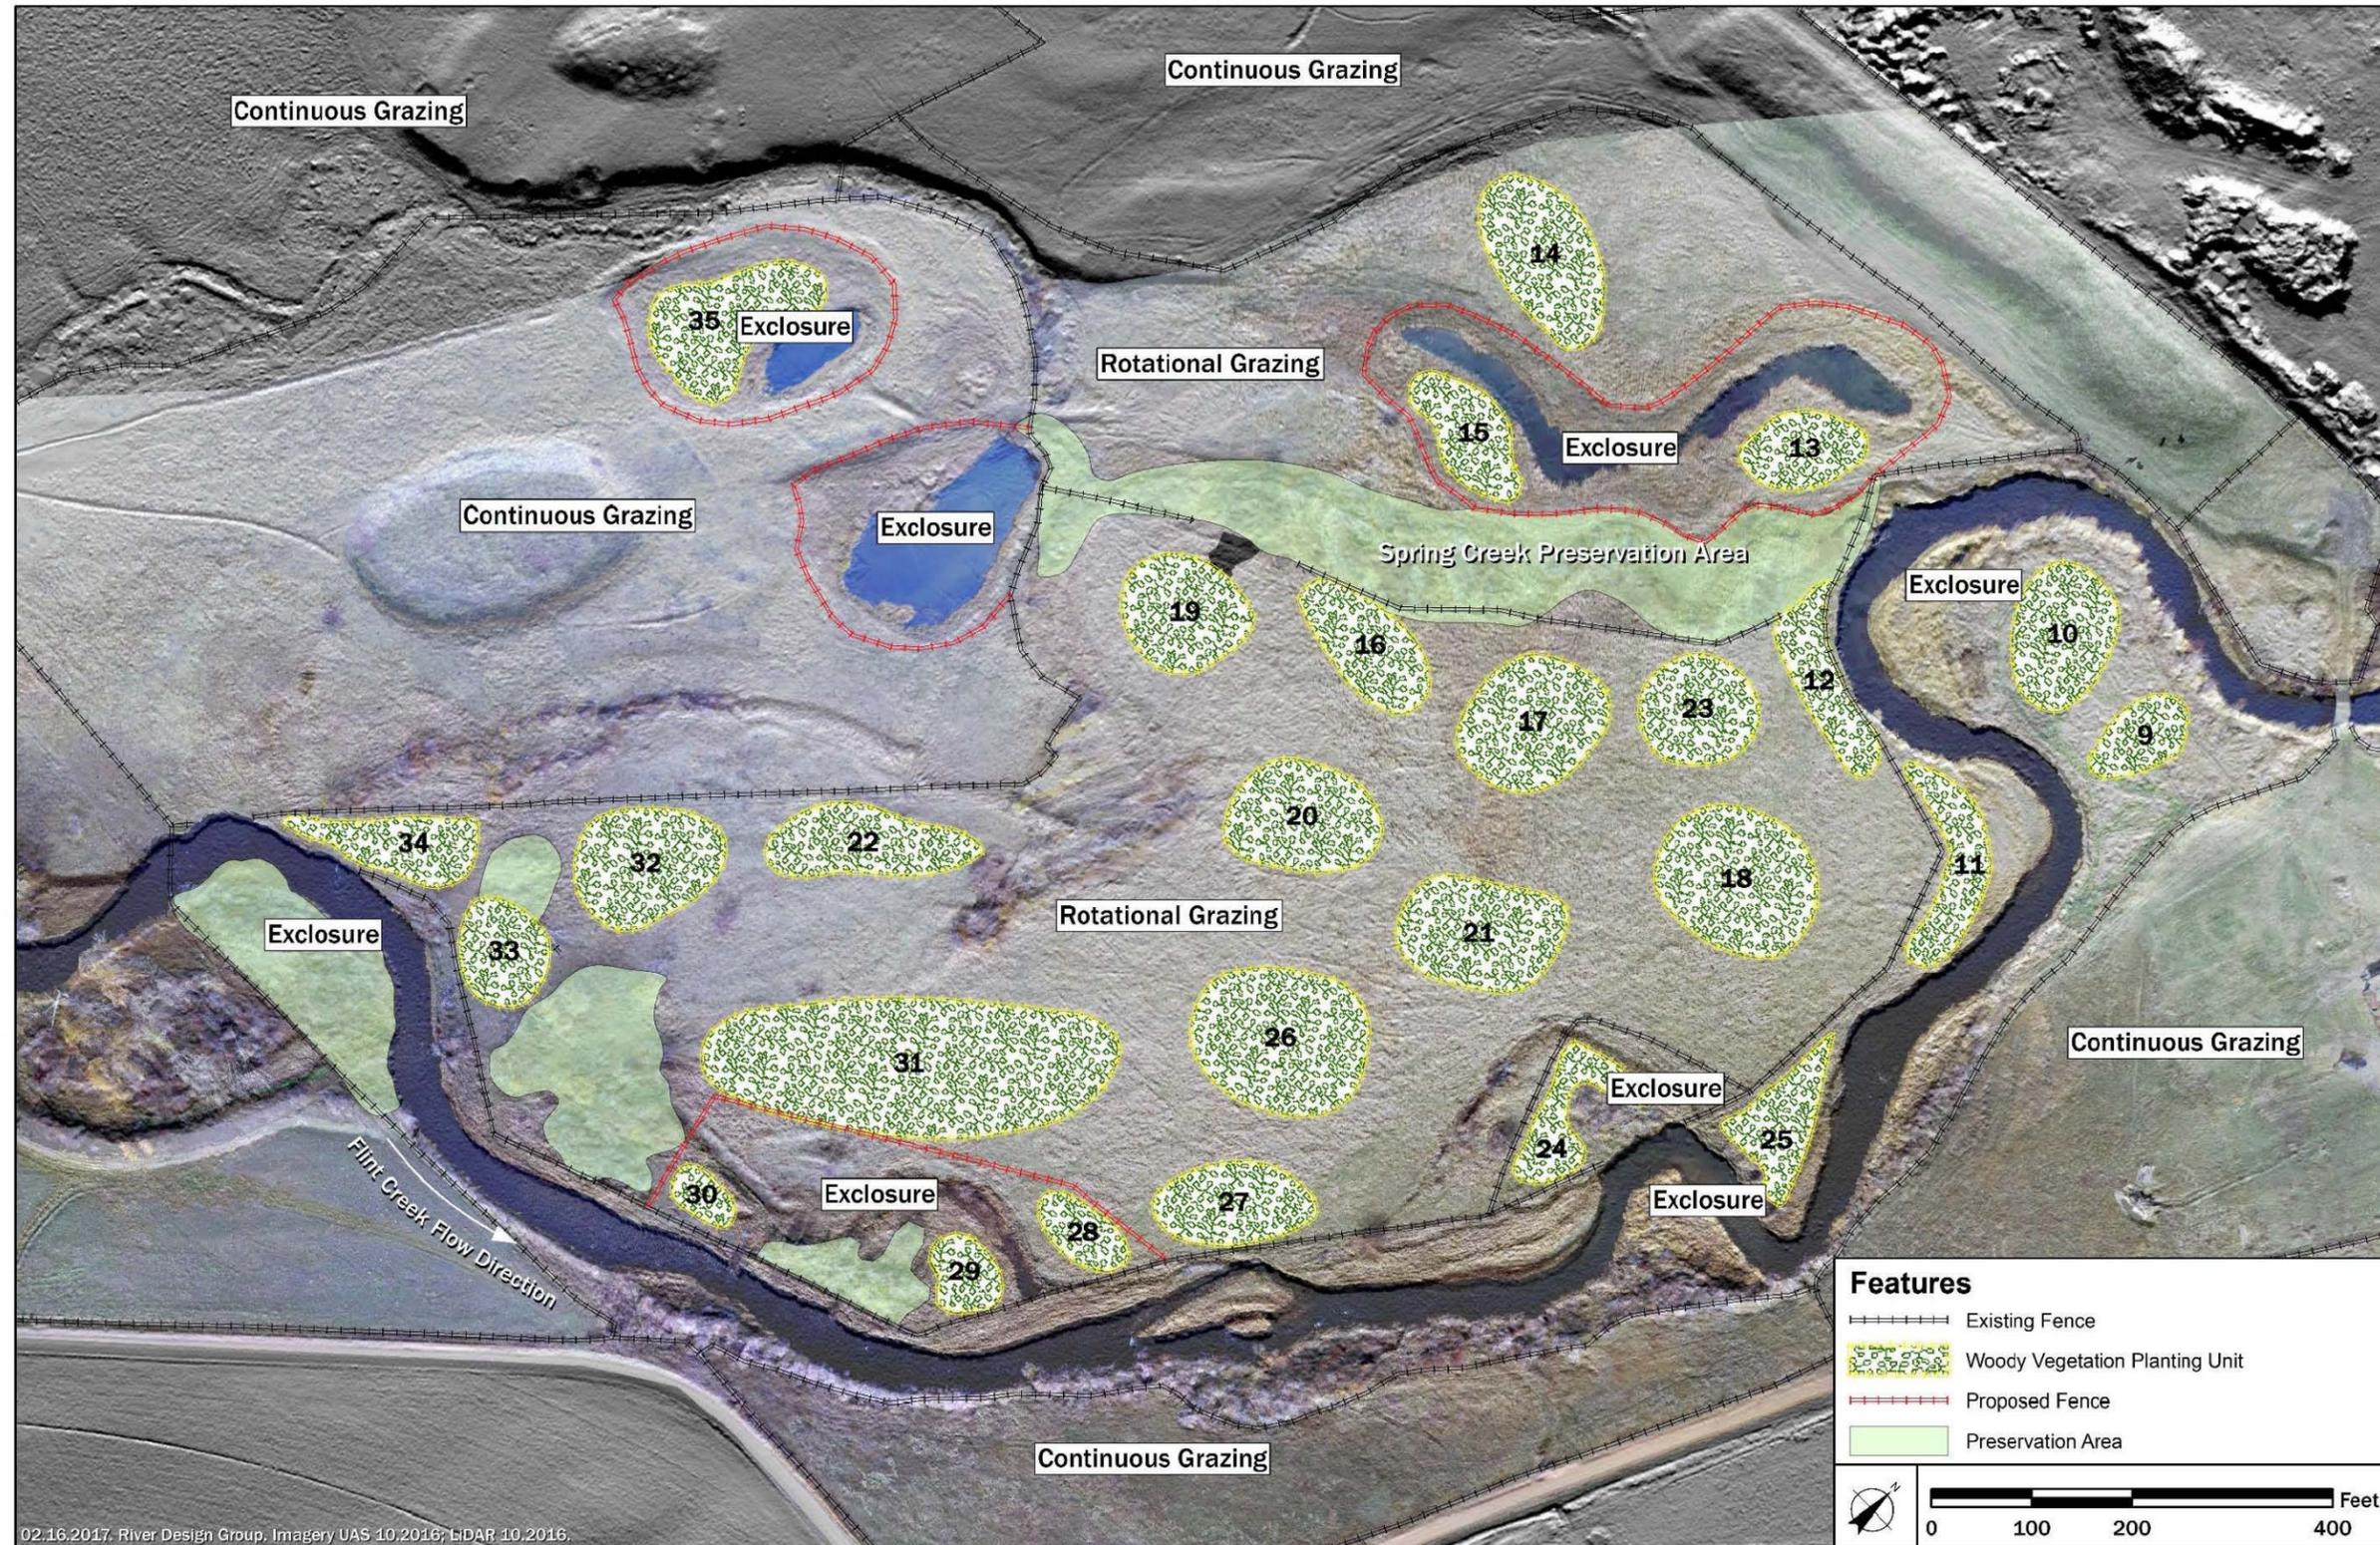
Figure 4-4. Conceptual revegetation and grazing plan for the upstream portion of the project site on Flint Creek.

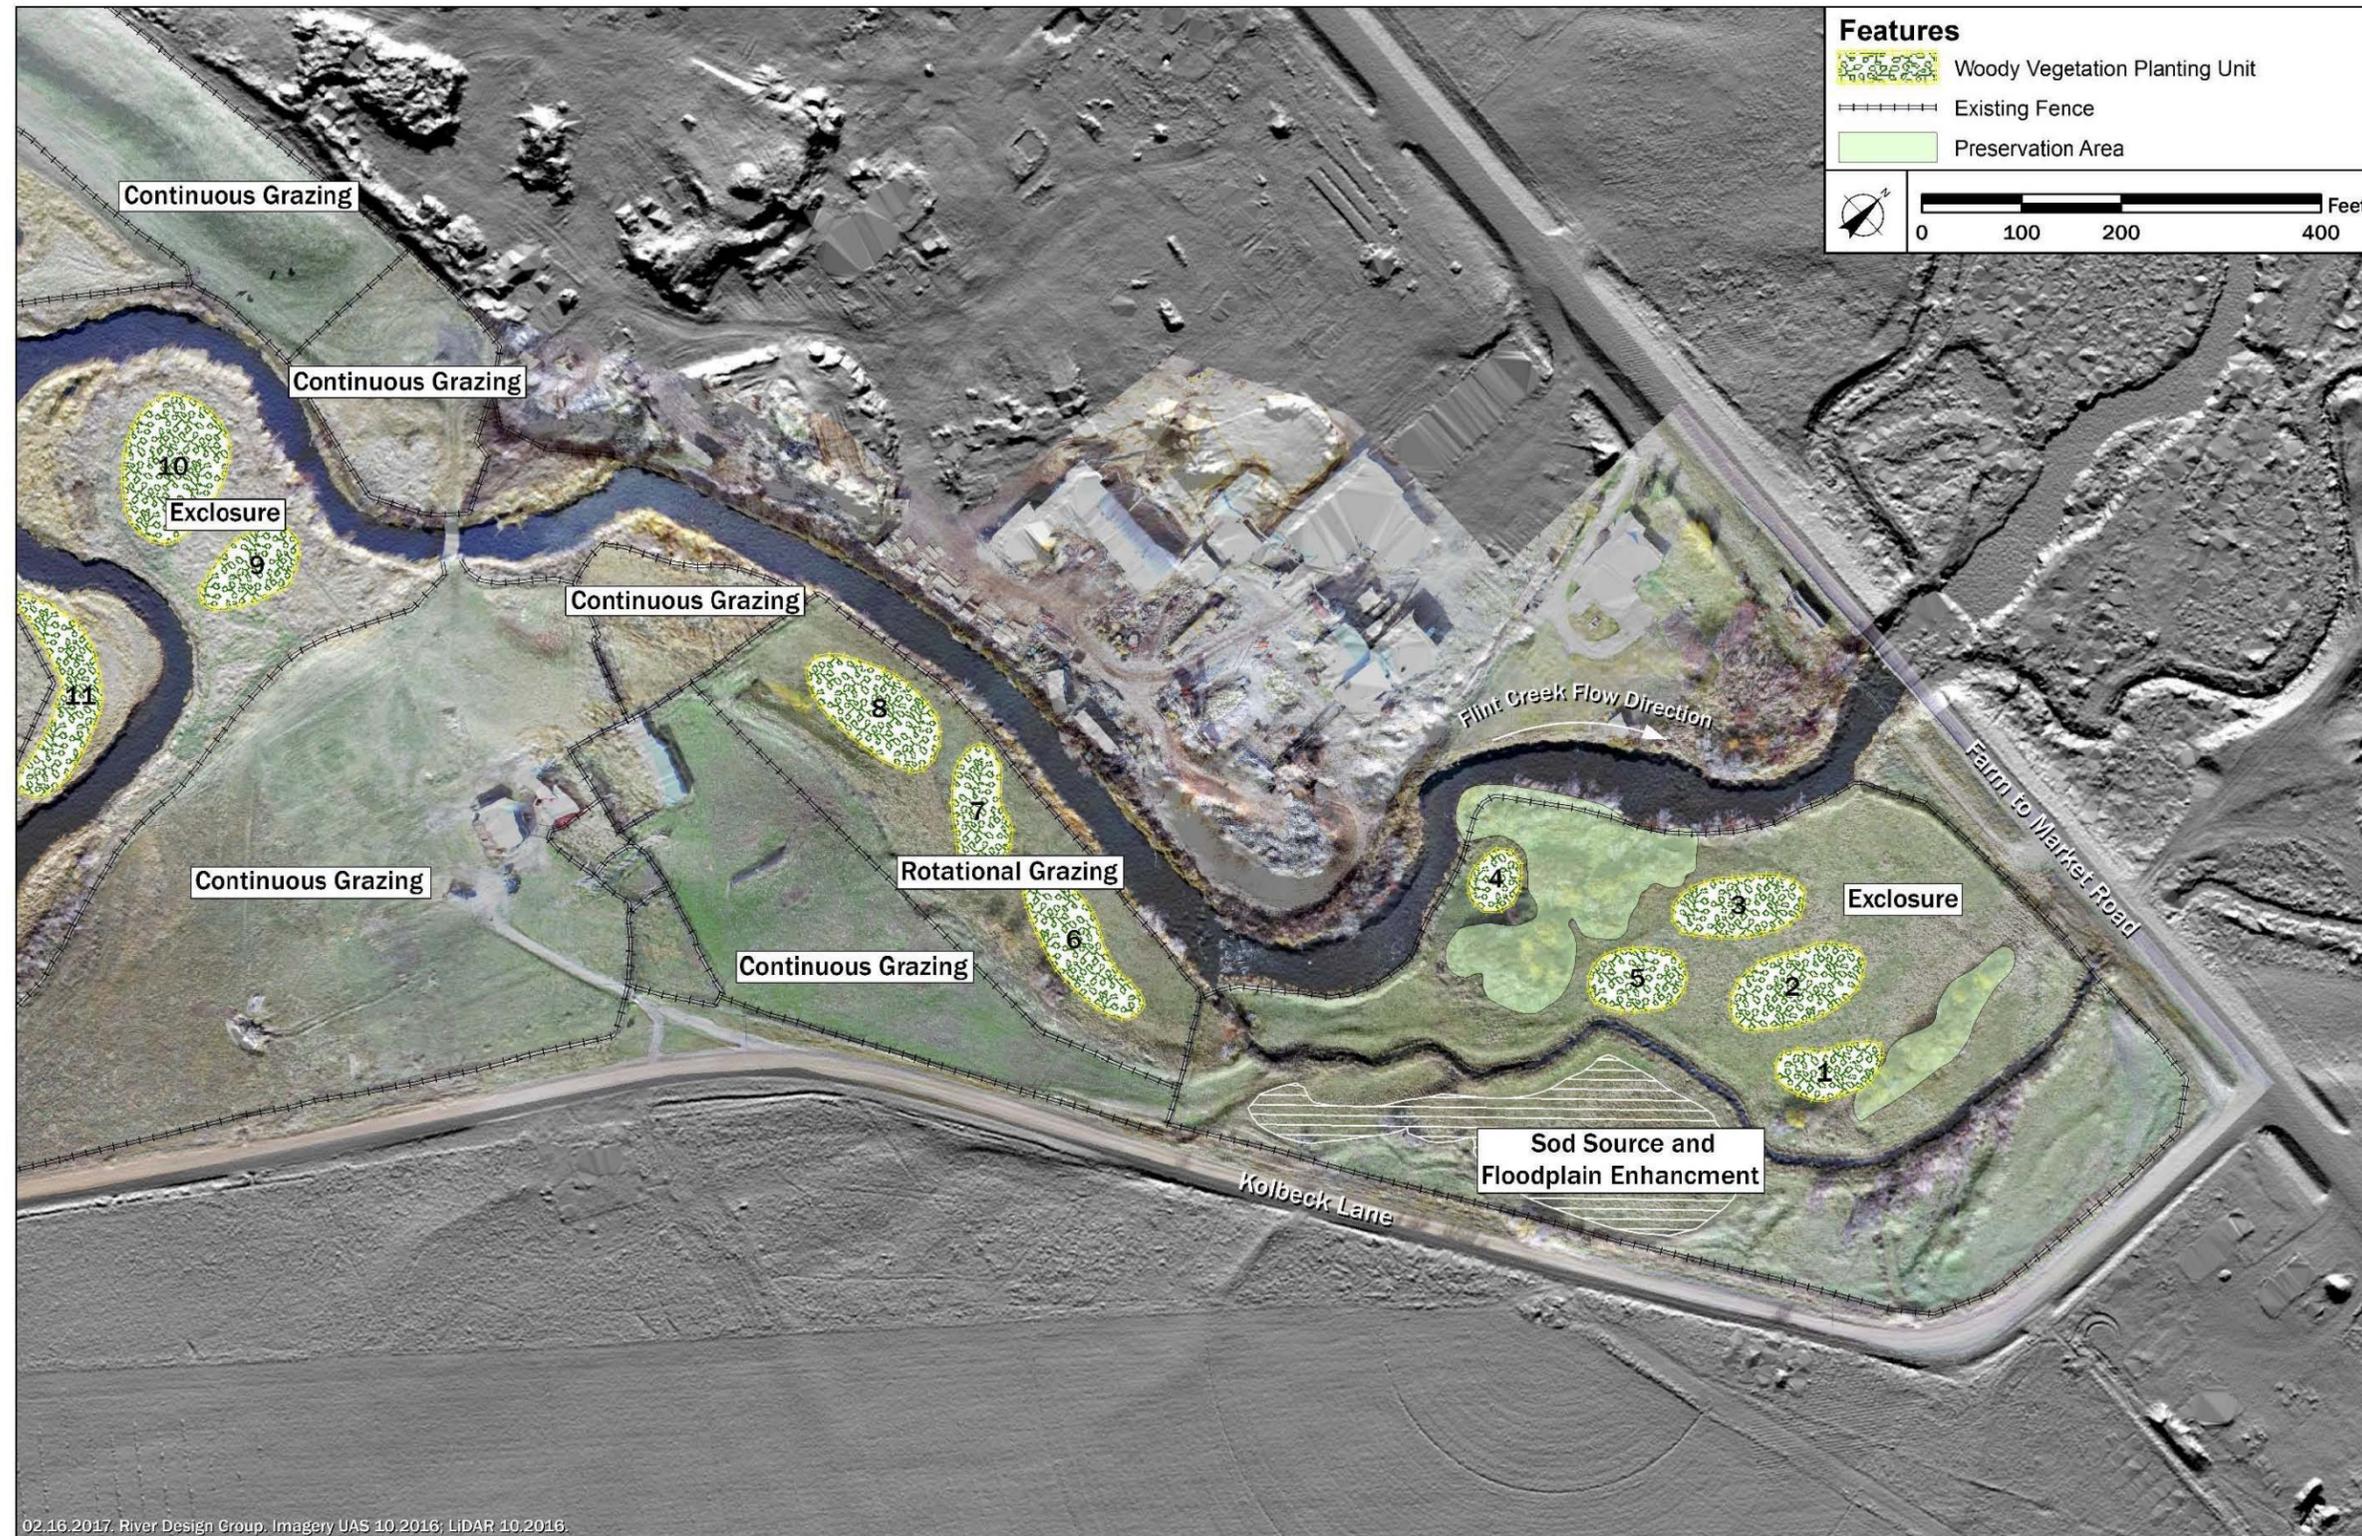
Figure 4-5. Conceptual revegetation and grazing plan for the downstream portion of the project site on Flint Creek.

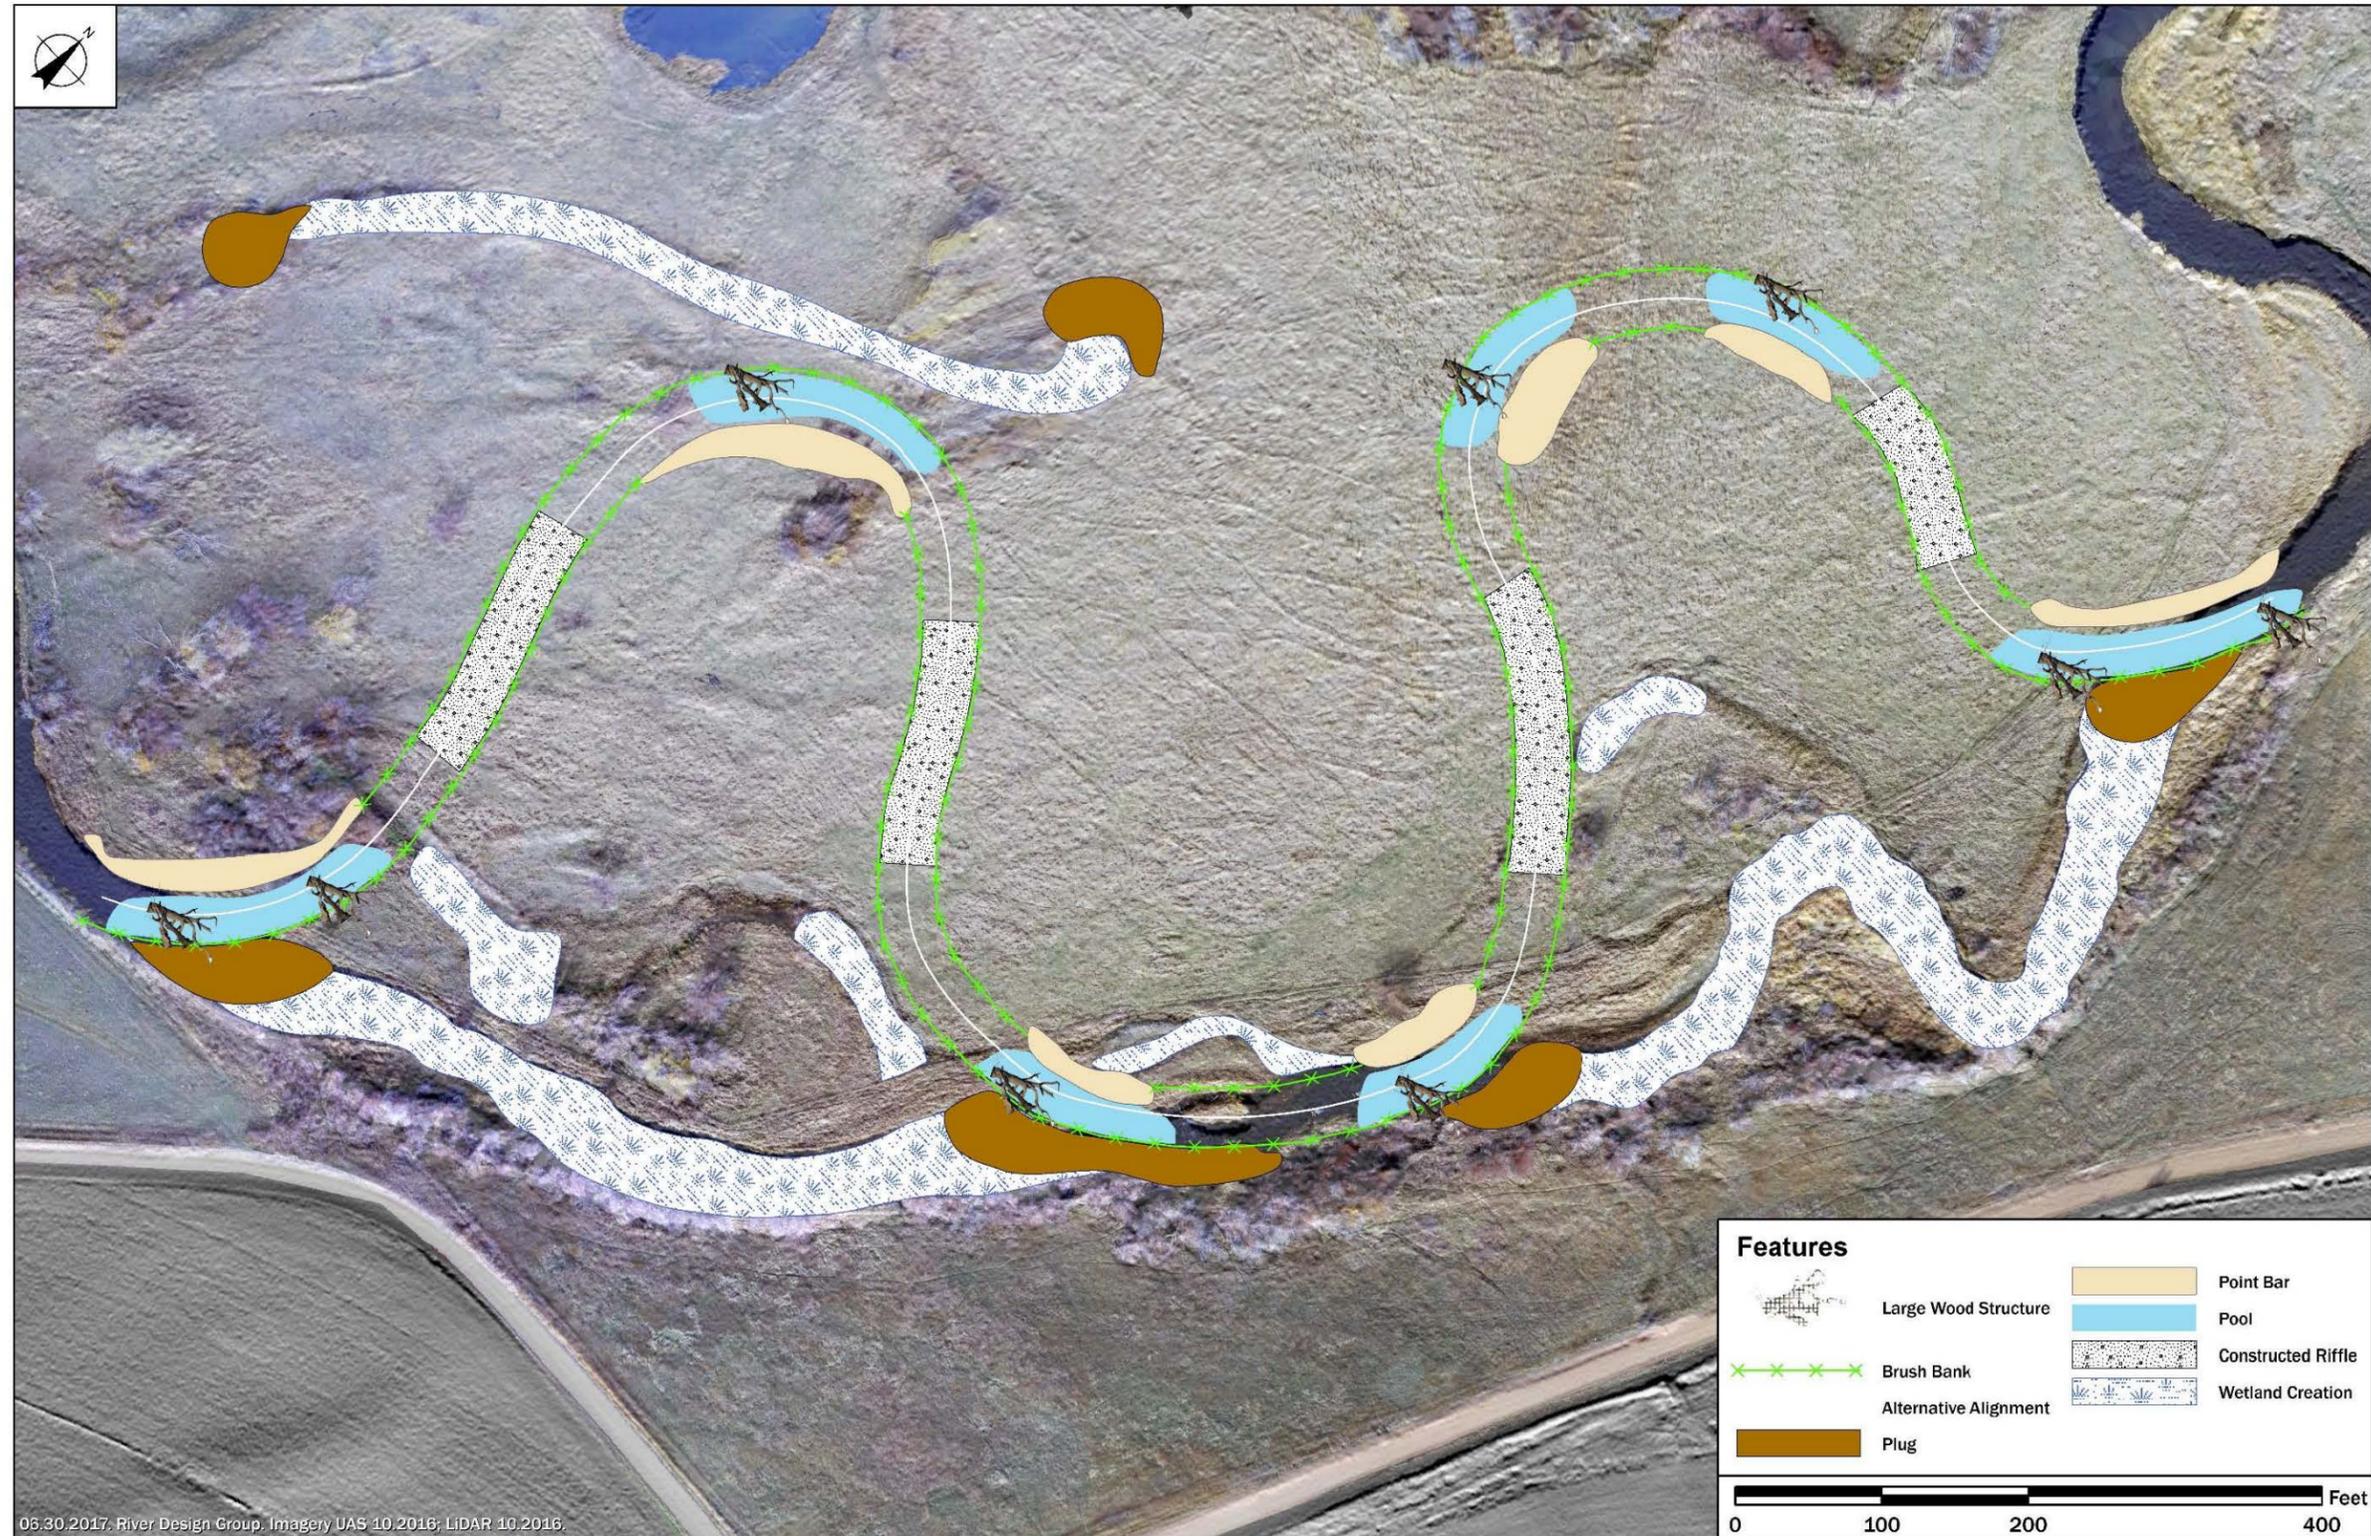
Figure 4-6. Alternative concept for a channel reconstruction plan for the upstream portion of the project site on Flint Creek.

The channel reconstruction plan includes 2,650 feet of new channel, 10 large wood structures and 2,650 feet of vegetated wood and brush structures. Materials needed for construction include approximately 700 trees, 1,200 cubic yards of streambed fill for riffle construction, and 26,000 vegetative cuttings for the streambank structures. Excavation of the new channel is estimated to be approximately 14,000 cubic yards.

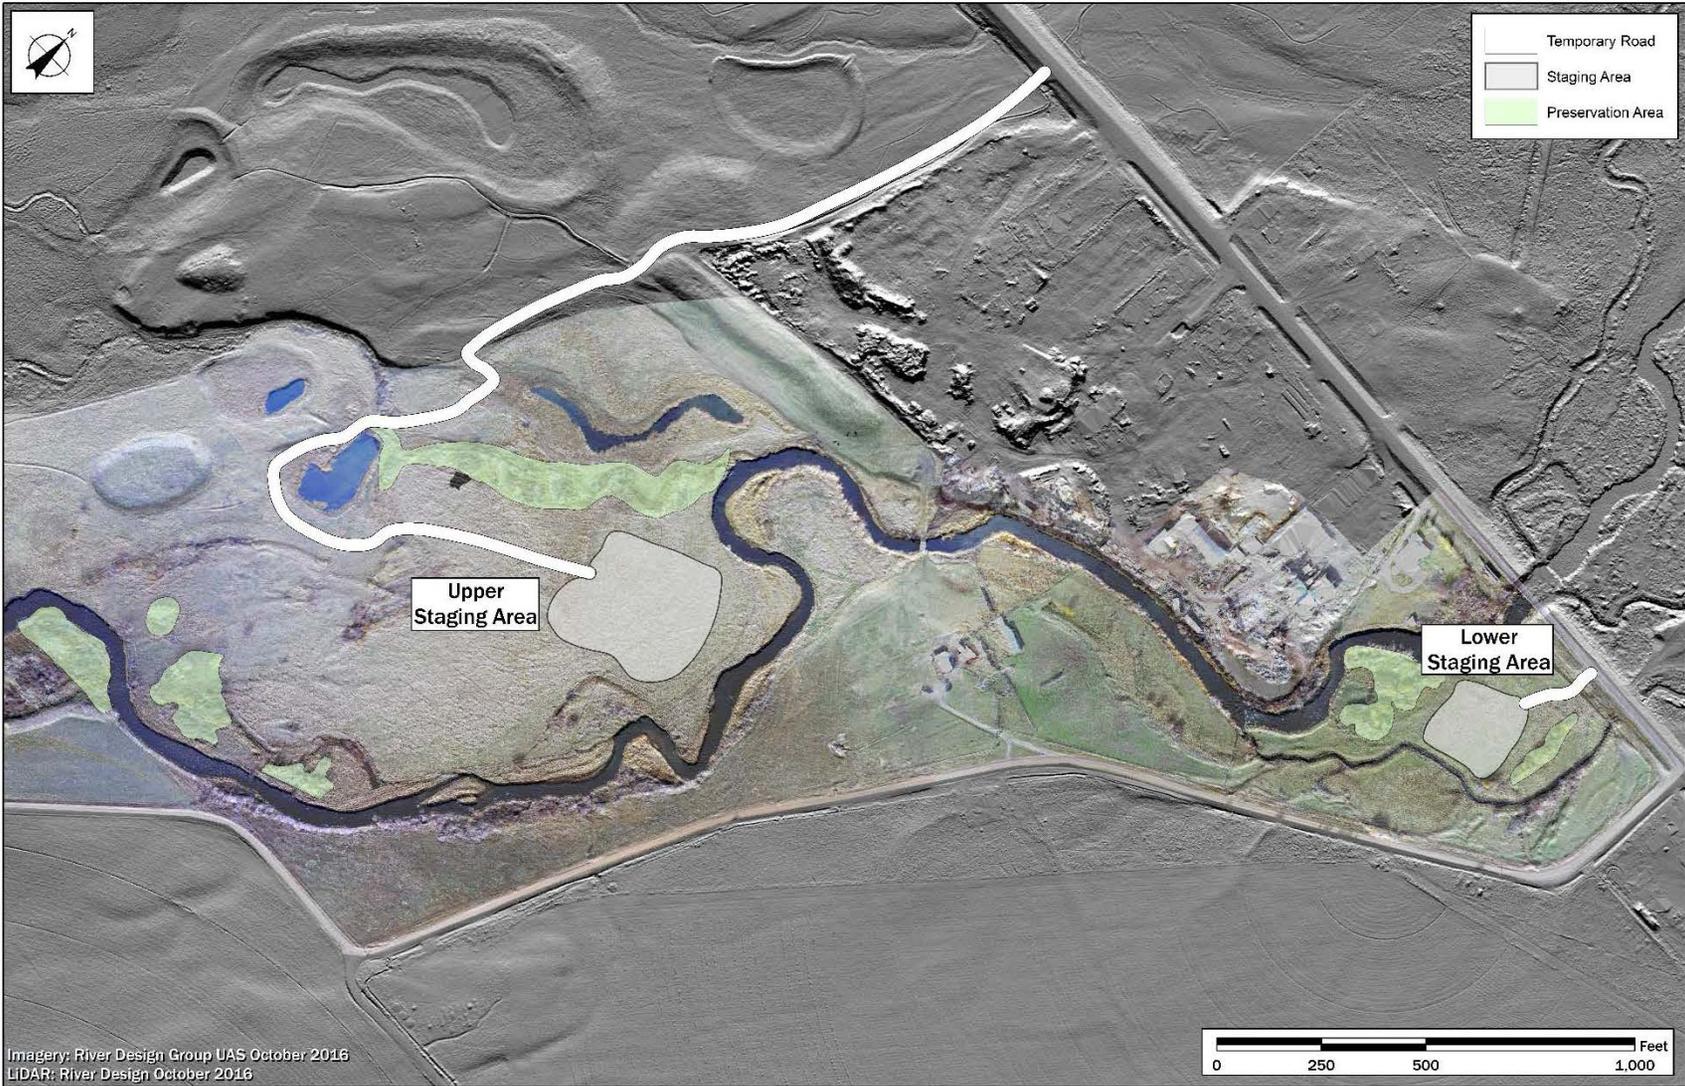
Figure 5-1. Staging areas and access roads for proposed construction efforts.

Two staging areas have been identified in the project reach to allow for the storage of equipment and materials for the construction phase of the project (Figure 5-1). Both access routes to the staging areas are on the Corbett-Downs property and will require removal of a small portion of fencing and a temporary gate installed. The lower staging area would be utilized for the installation of the fish screen, floodplain enhancement, and bank structure construction from station 44+00 to 53+00. The Upper staging area will be utilized for the bank treatments and revegetation efforts from station 00+00 to 32+00. After project completion, these sites will be reclaimed and any damage to fencing will be repaired or replaced in coordination with the landowner.

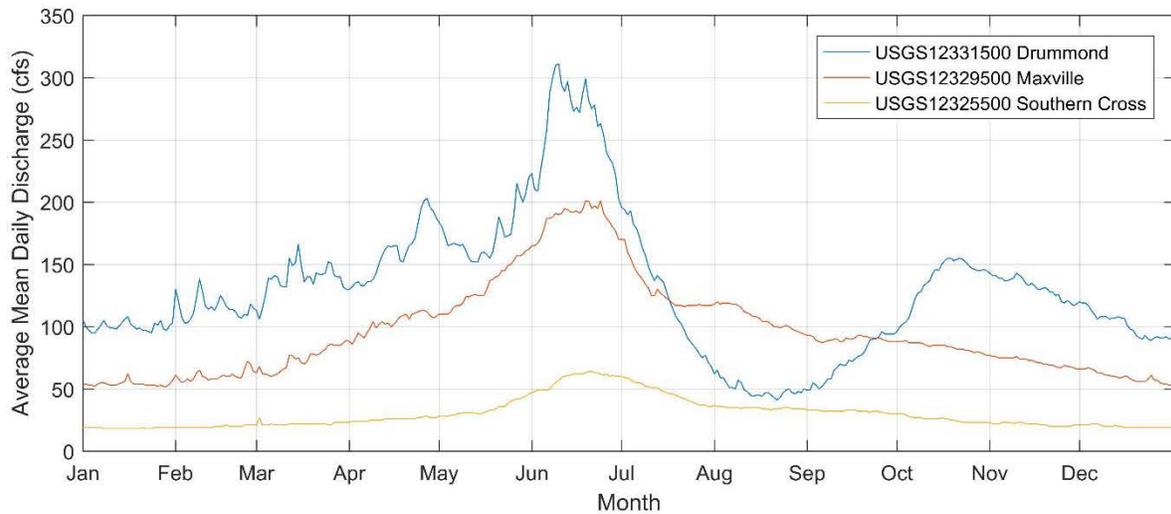
Figure A-3. Average mean daily discharge for three Flint Creek USGS gages that are still active. These values were obtained by averaging the daily mean flow values over the period of record (Drummond: 1991-2002, 2003-2004; Maxville: 1942-2016; Southern Cross: 1940-2016).

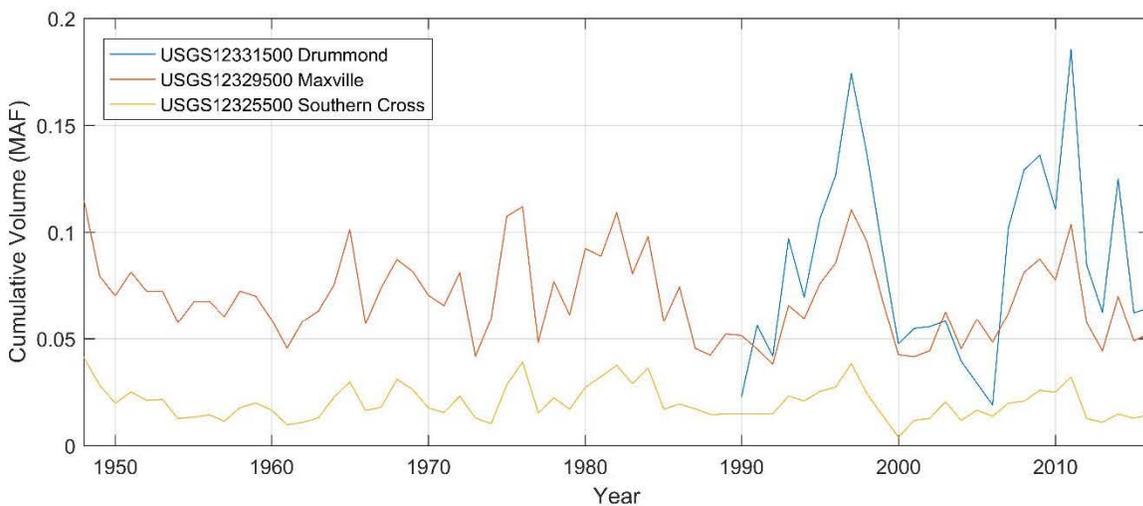
Figure A-4. Cumulative volume in million acre feet for the water years of record for the 3 active USGS gages.

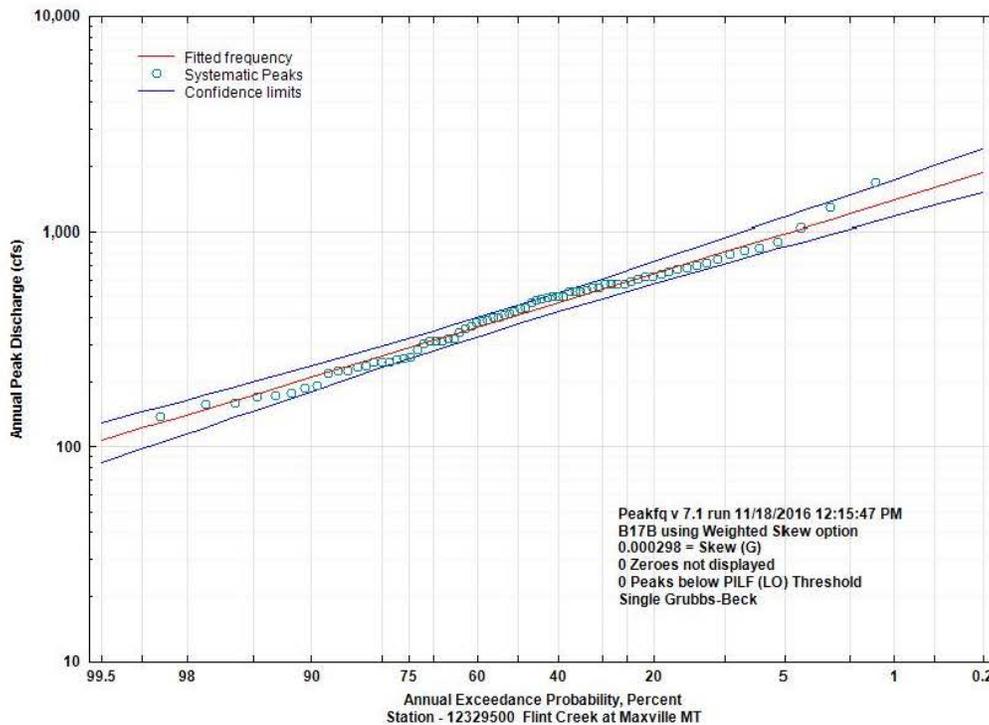
Figure A-5. Flood frequency analysis for Maxville gage conducted with USGS PeakFQ.

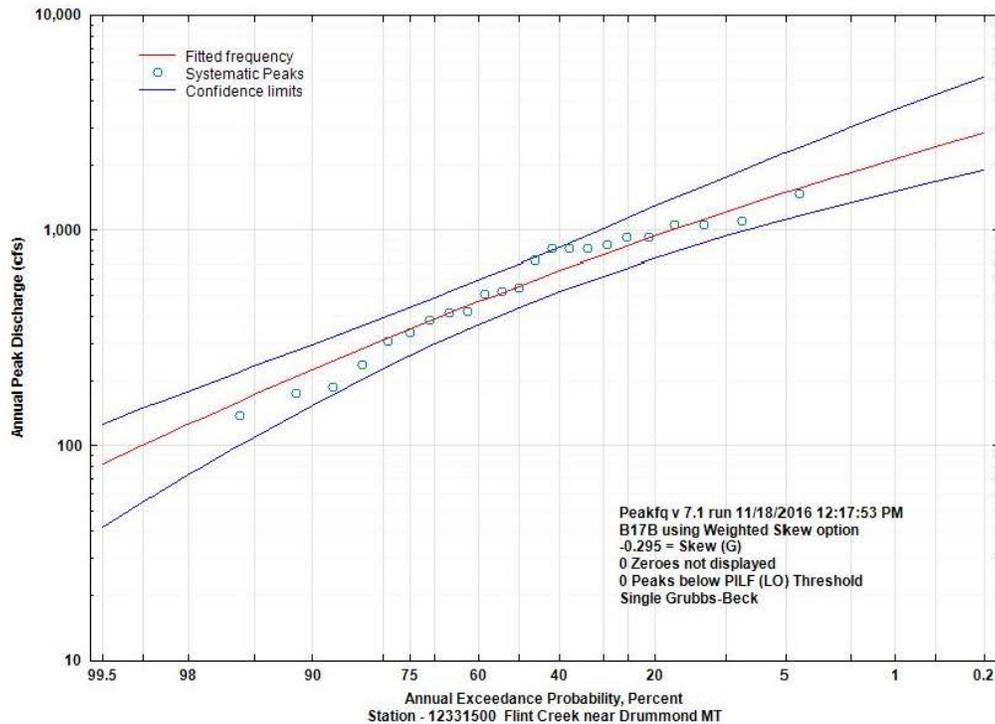
Figure A-6. Flood frequency analysis for Drummond gage conducted with USGS PeakFQ.

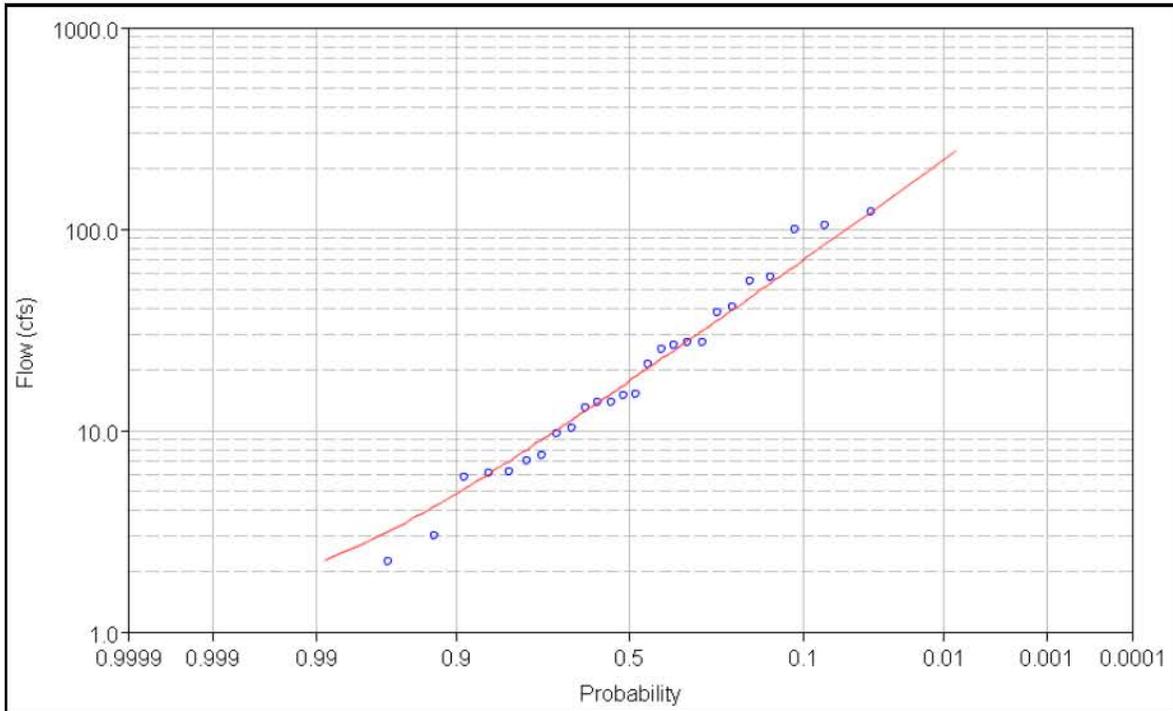
Figure A-7. 7-Day average low flow probability of exceedance analysis.

Low flow conditions present a hazard to aquatic species through increased water temperature, decreased dissolved oxygen, and can present a physical barrier for fish passage. To characterize the extent and frequency of low flow events on Flint Creek 7-day annual low flow statistics were calculated from the Drummond USGS Gage with 26 years of record. 7-day annual low flow statistics are based on an annual series of the smallest values of mean discharge computed over any 7 consecutive days during the annual period. A log Pearson type III probability distribution is fit to the annual series of 7 day minimums (Risley 2008). The results from this analysis are shown in Figure A-6 and Table A-5. Figure A-6 shows the probability of exceedance for the annual 7-day low flow event. Table A-5 shows the probability of non-exceedance which was then converted into recurrence interval in year. The 7-day low flow 10-year event calculated from the Drummond gage is 4.8 cfs. This is strikingly low compared to the regional curve estimation of the 7-day low flow 10-year event of 23.4 cfs (McCarthy 2016). This is likely caused by the extensive irrigation that occurs in the Flint Creek watershed.

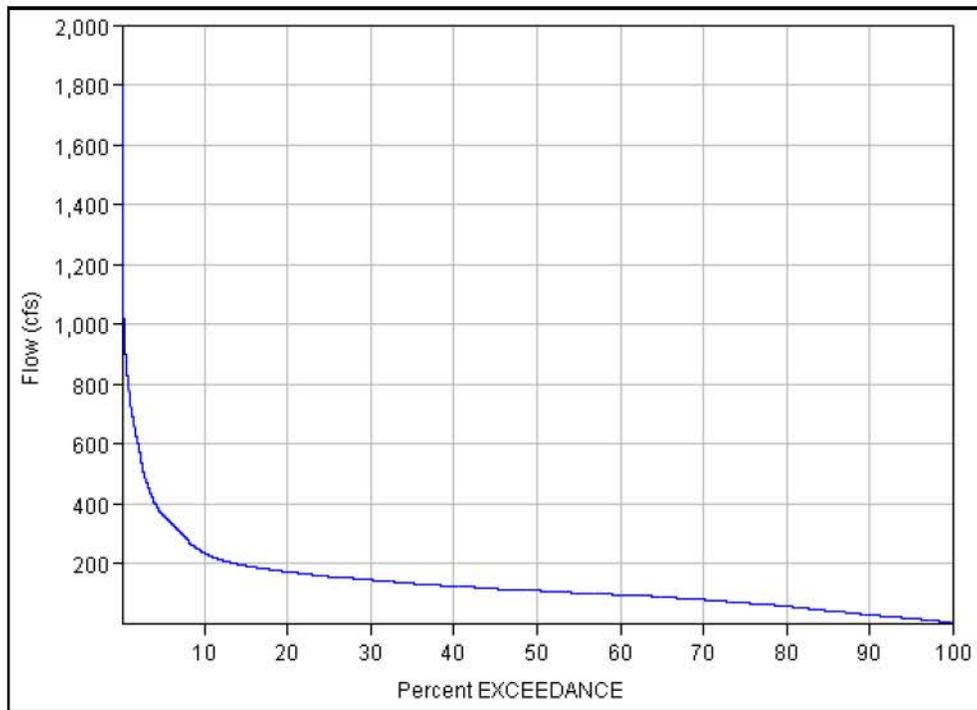
Figure A-8. Flow duration curve for the USGS Drummond gage downstream of the Corbett property.

A flow duration curve depicts statistically the percent of time in which the discharge of a river is above a given value. Figure A-8 and Table A-6 depict the results from the creation of a flow duration curve for the Drummond USGS gage, downstream of the Corbett property. This data will be used to help guide the design of the fish screen in the preliminary and final design stages of the project. This will ensure the diversion can be used during dry conditions which often fall during the irrigation season.
