RE: Trout Unlimited 319 Funding Request for Flint Creek Riparian Restoration

Project Name Flint Creek Riparian Restoration

Flint Creek Assessment and Conceptual Design Report

Near Hall, Montana

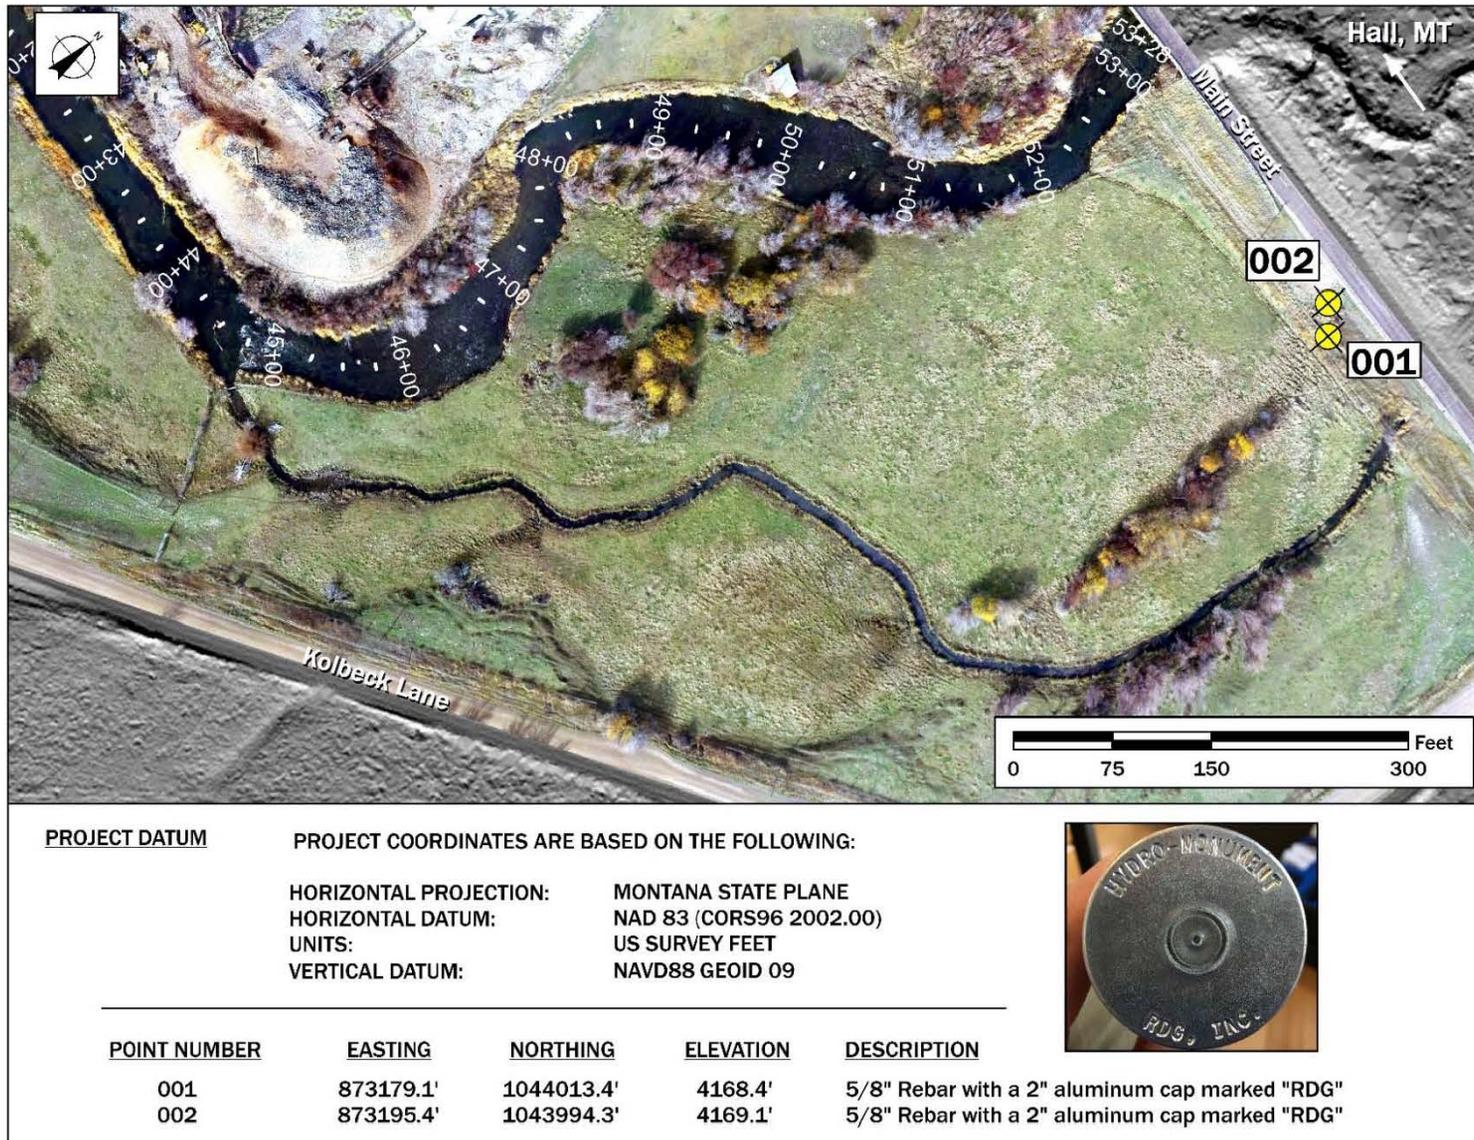
Figure B-2. Survey control plan for the Flint Creek Assessment project area.

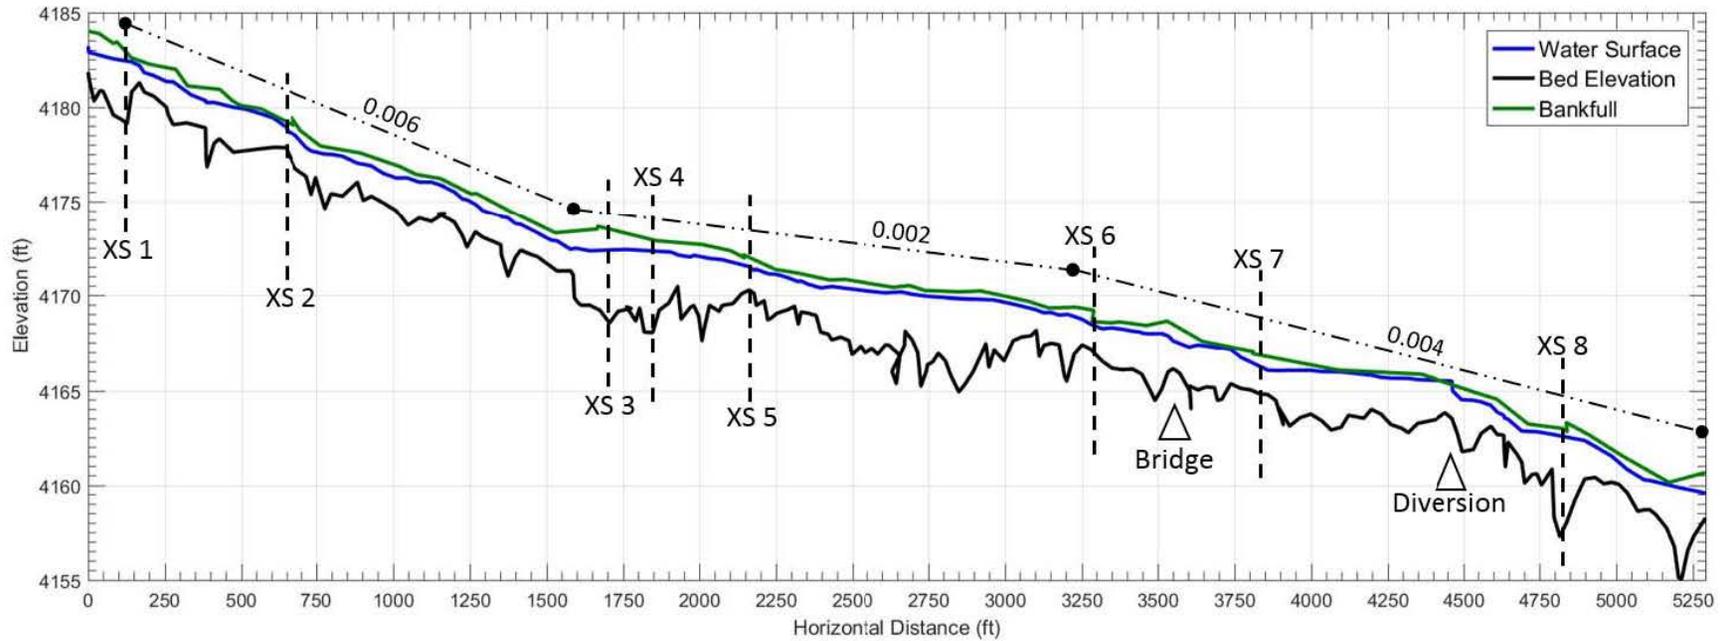
Flint Creek Assessment Reach

Figure B-3. Flint Creek Assessment project reach longitudinal profile. North American Datum 1983.

The project reach on Flint Creek exhibits geomorphic conditions that are indicative of degradation from a number of sources. The channel planform has a sinuosity of 1.5, which is lower than expected for the morphologic setting. The upper and lower portions of the reach appear to have been straightened at some point in history resulting in the decreased sinuosity and increased slope in these segments (Appendix B, Figure B-3).

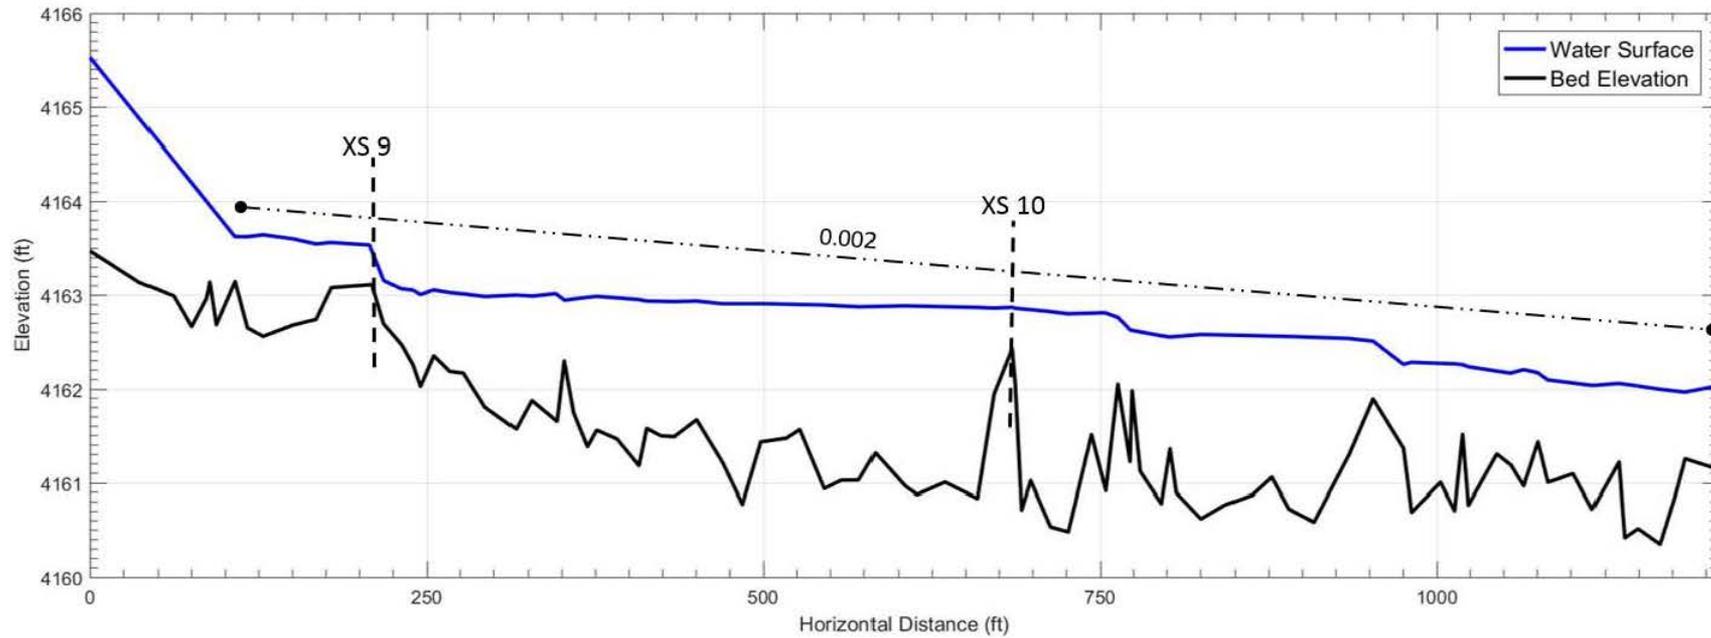
Longitudinal Profile Flint Creek Diversion

Figure B-4. Flint Creek Assessment diversion longitudinal profile. North American Datum 1983.

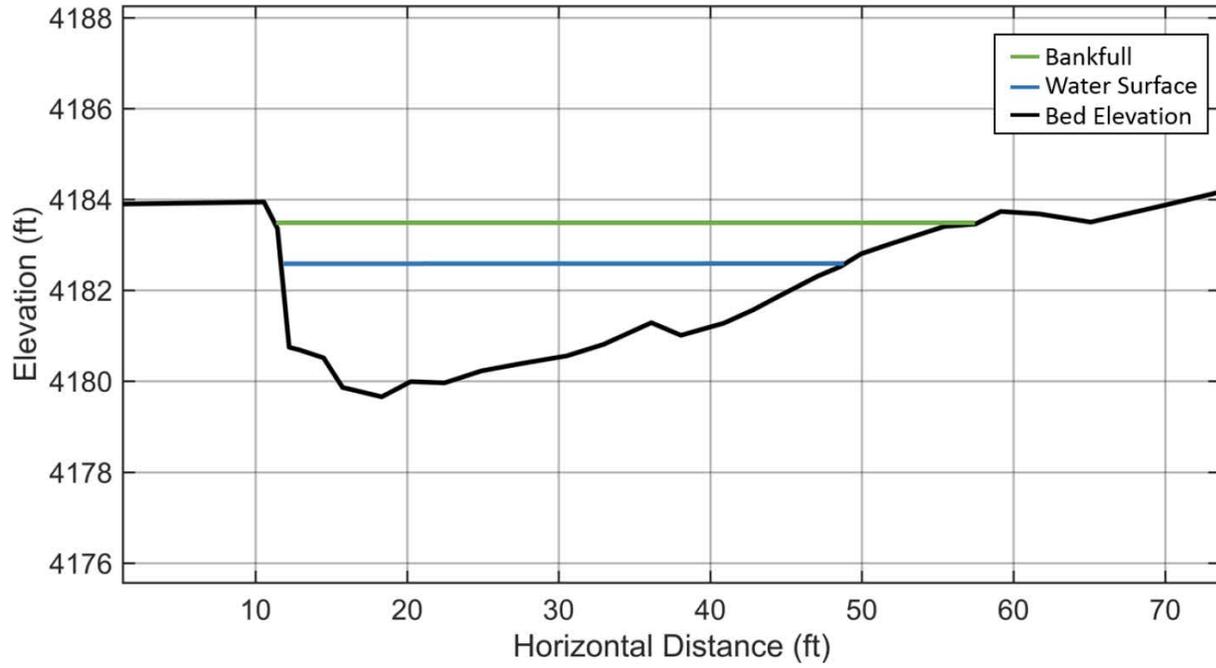
Figure B-5. Cross section 1 in the Flint Creek project reach (Longitudinal Profile Station 01+00).

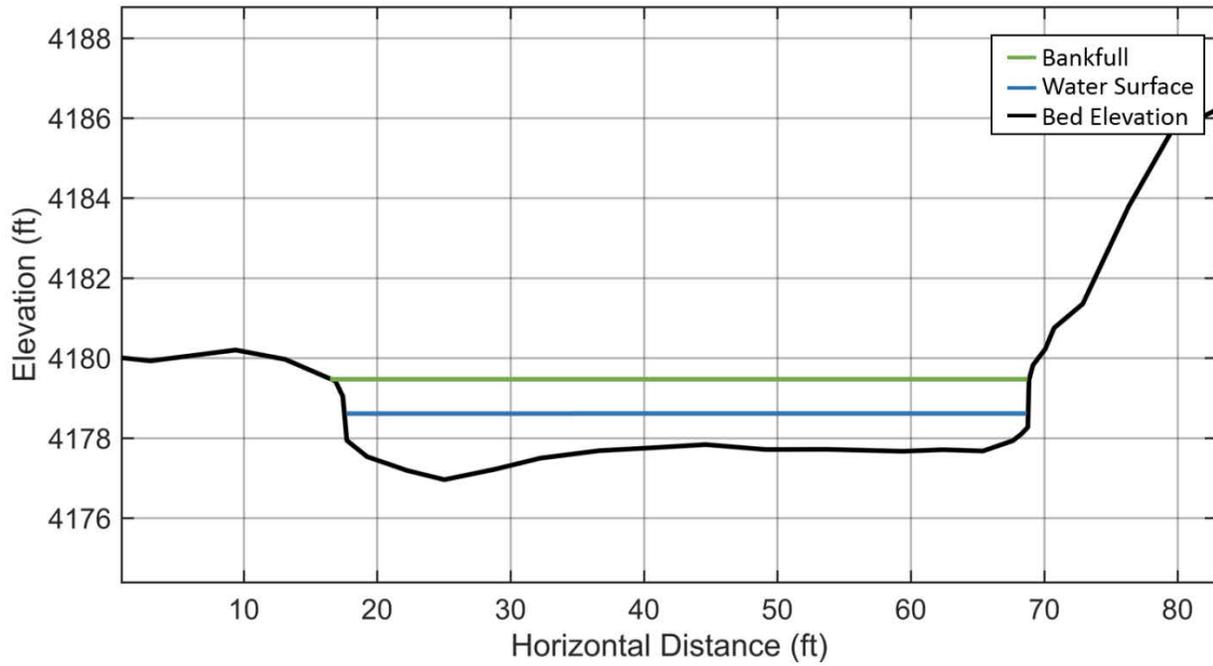
Figure B-7. Cross section 2 in the Flint Creek project reach (Longitudinal Profile Station 06+75).

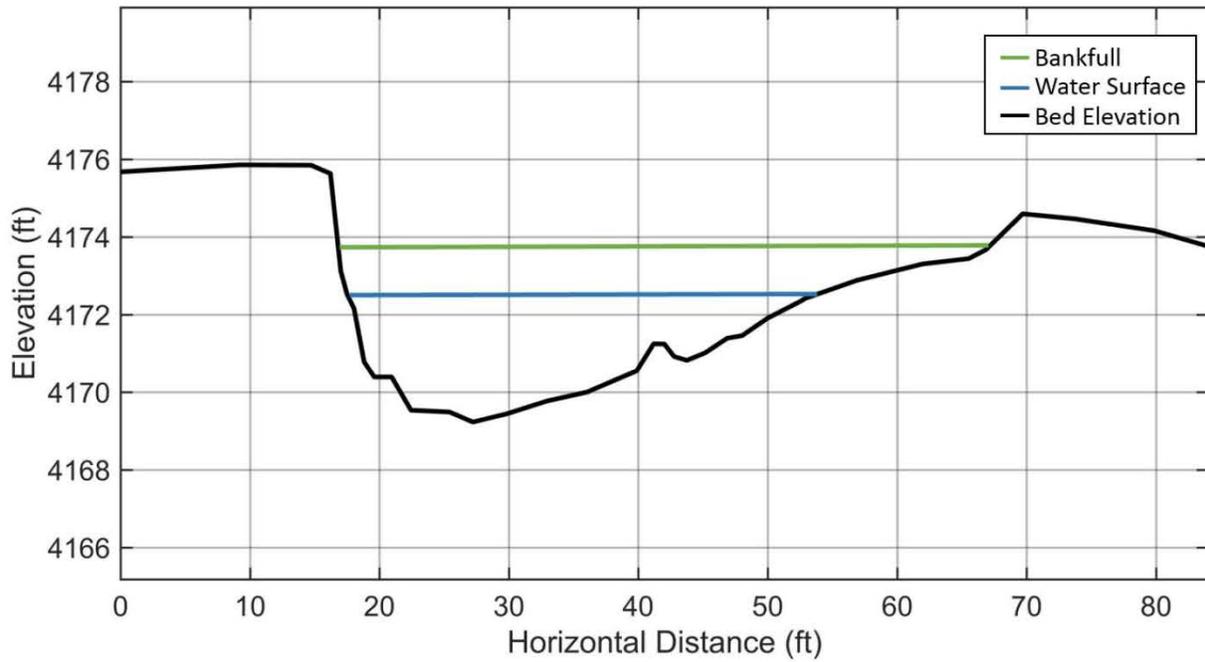
Figure B-9. Cross section 3 in the Flint Creek project reach (Longitudinal Profile Station 16+75).

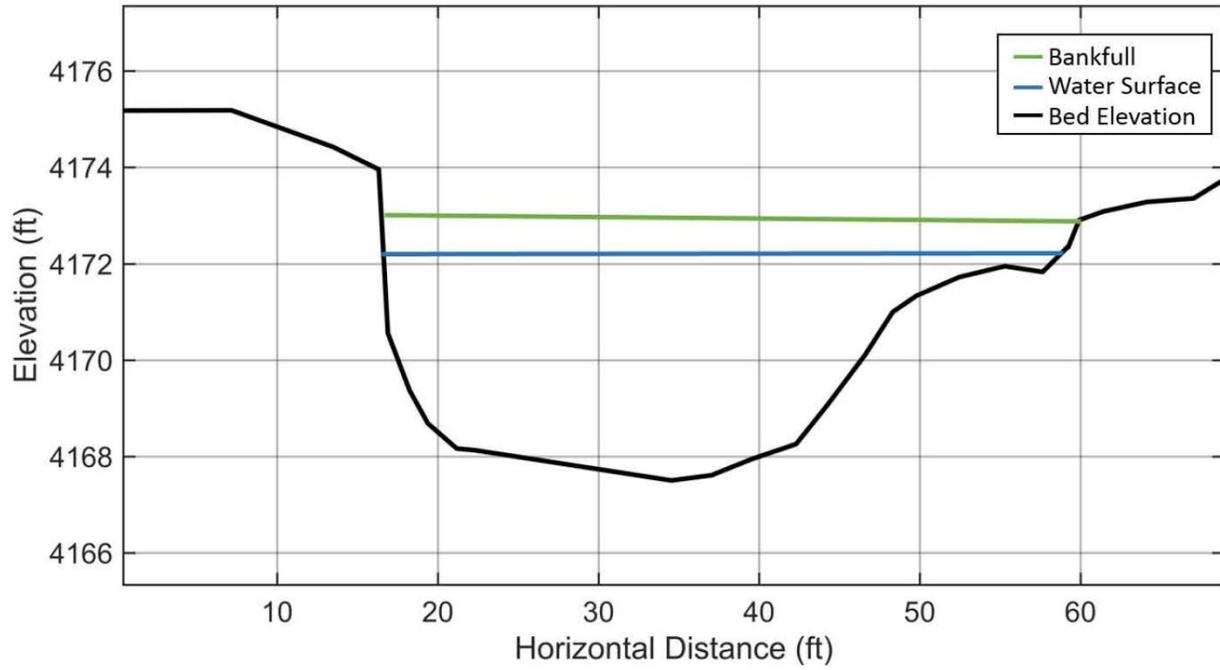
Figure B-11. Cross section 4 in the Flint Creek project reach (Longitudinal Profile Station 18+50).

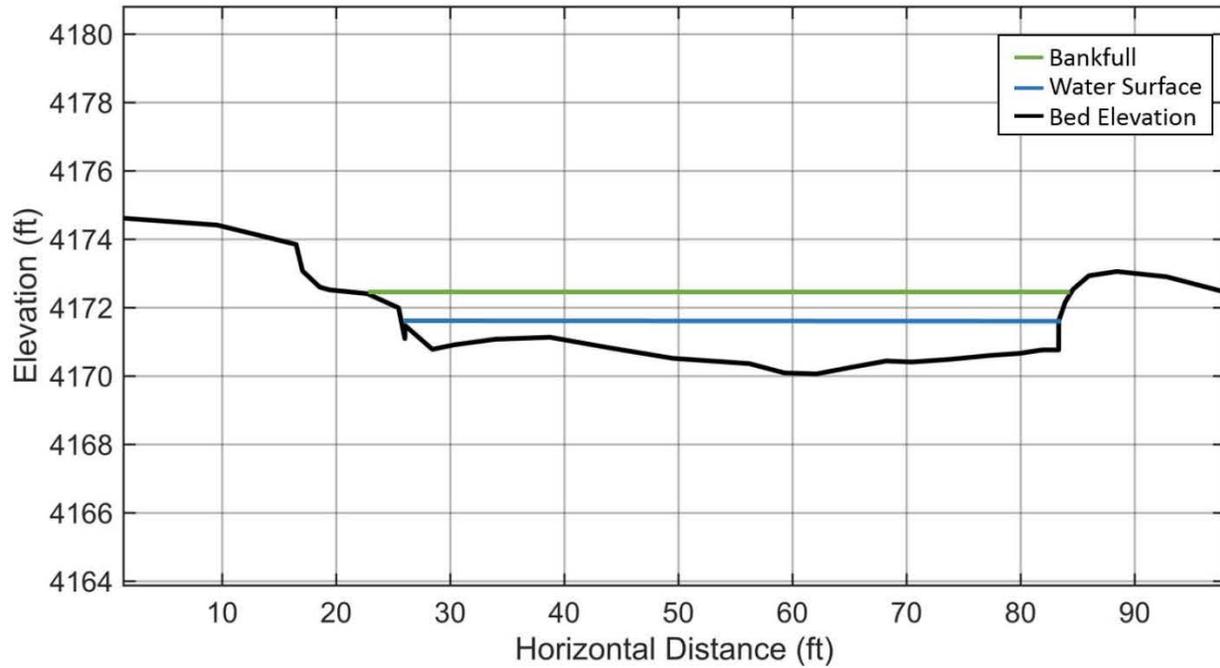
Figure B-13. Cross section 5 in the Flint Creek project reach (Longitudinal Profile Station 21+50).

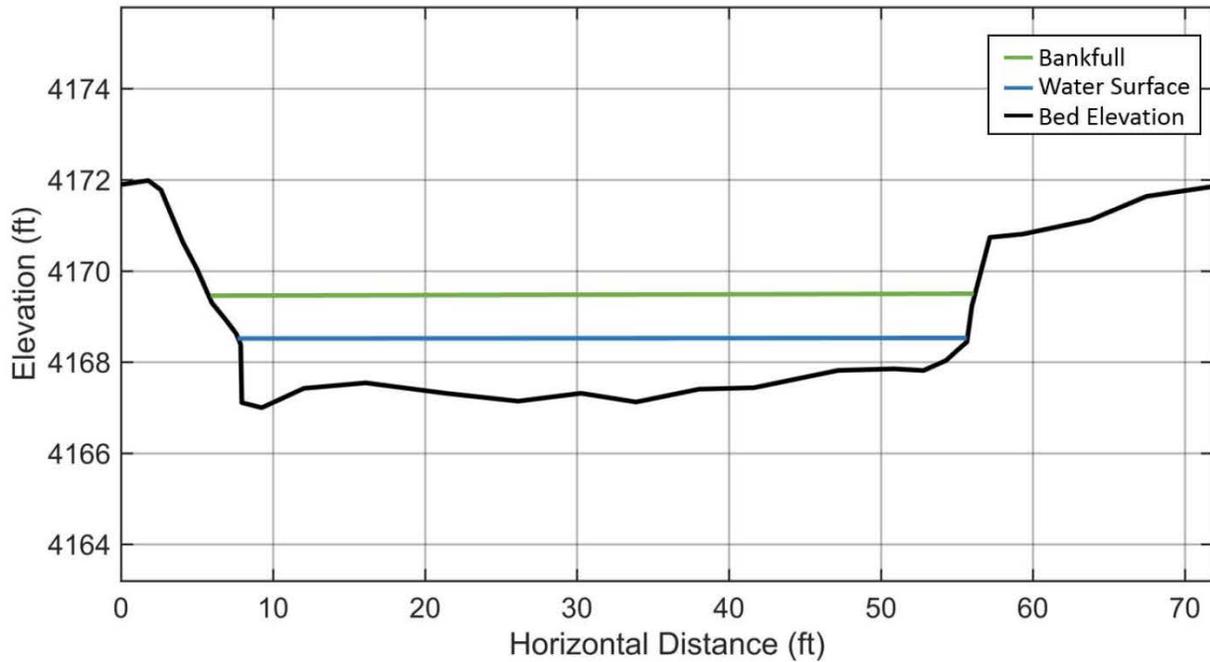
Figure B-15. Cross section 6 in the Flint Creek project reach (Longitudinal Profile Station 33+00).

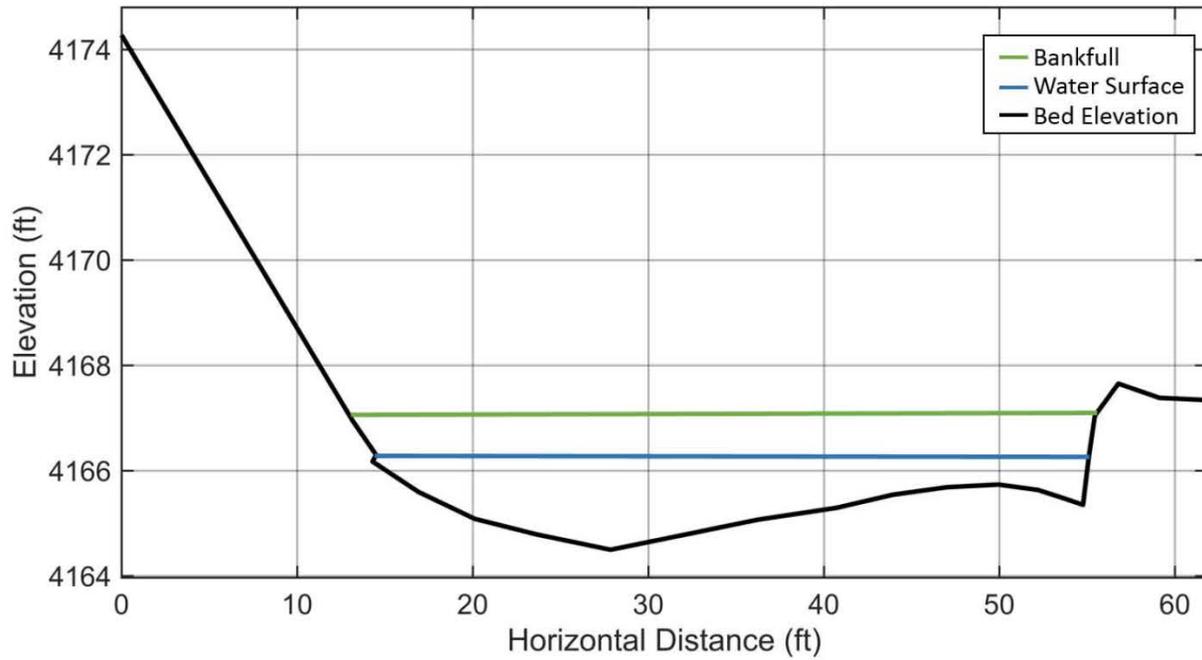
Figure B-17. Cross section 7 in the Flint Creek project reach (Longitudinal Profile Station 38+25).

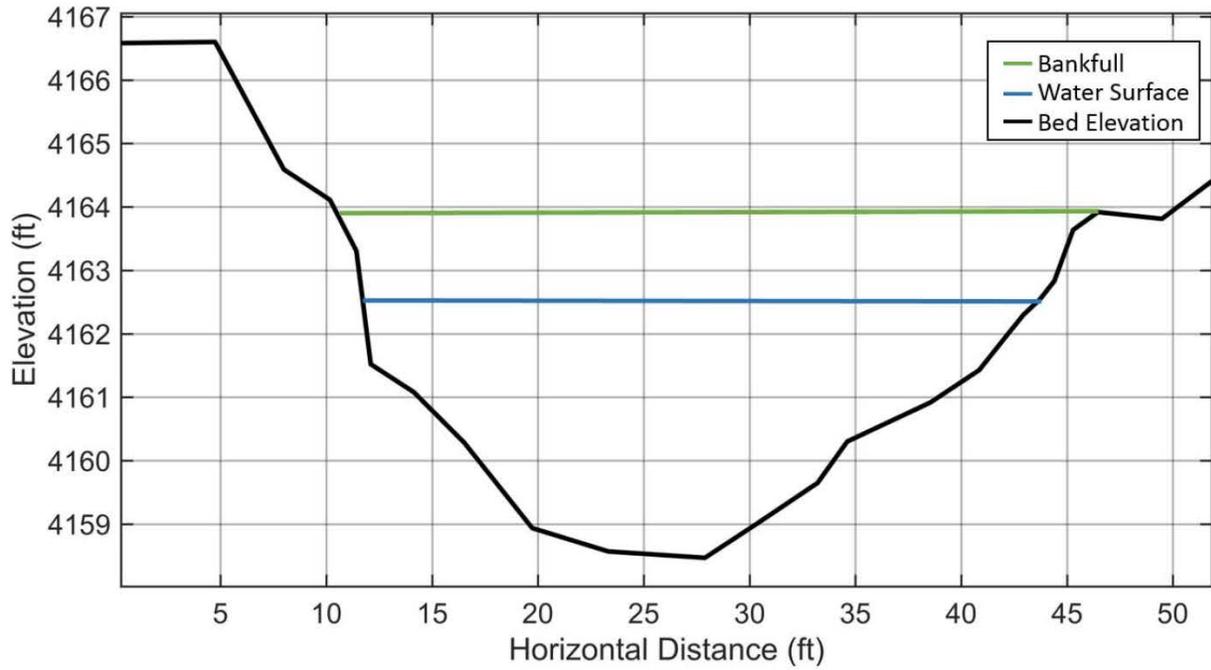
Figure B-19. Cross section 8 in the Flint Creek project reach (Longitudinal Profile Station 48+50).

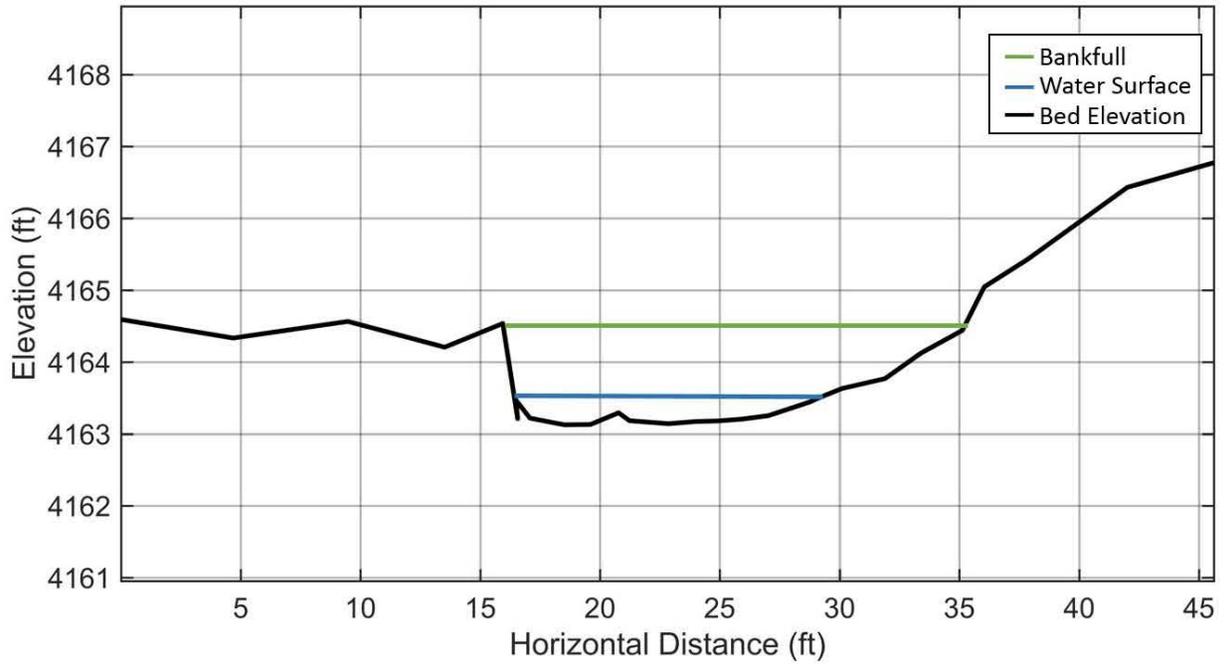
Figure B-21. Cross section 9 in the Flint Creek diversion.

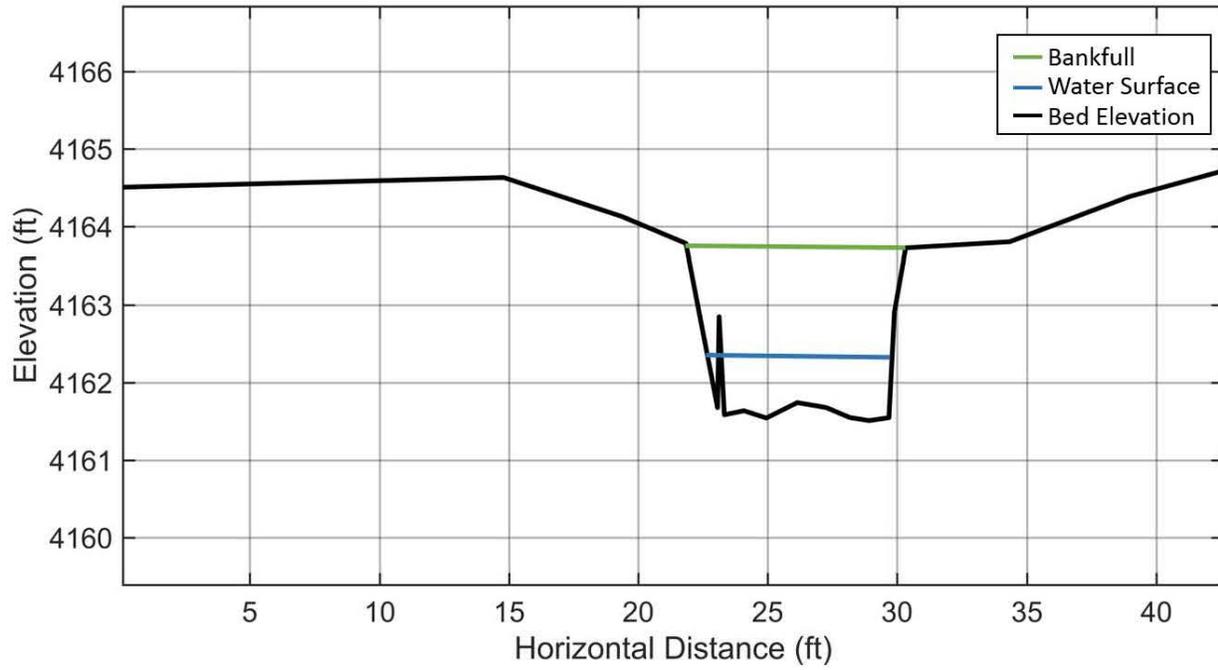
Figure B-22. Cross section 10 in the Flint Creek diversion.

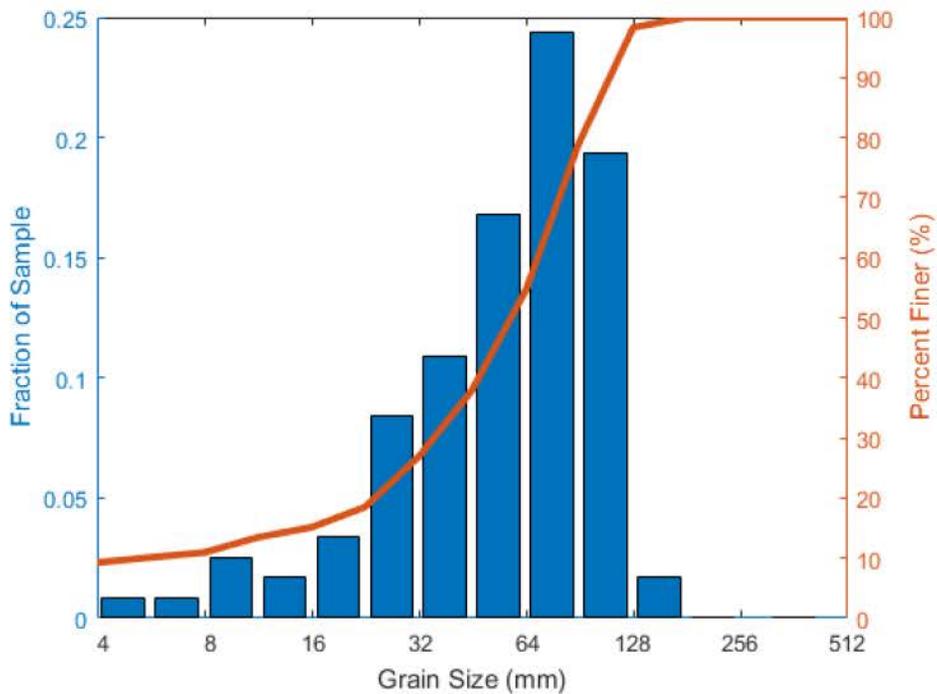
Figure B-23. Pebble count results from cross section 2 (XS 2). Histogram shows the fraction of sample for grain size classes, while the line indicates the cumulative grain size distribution.

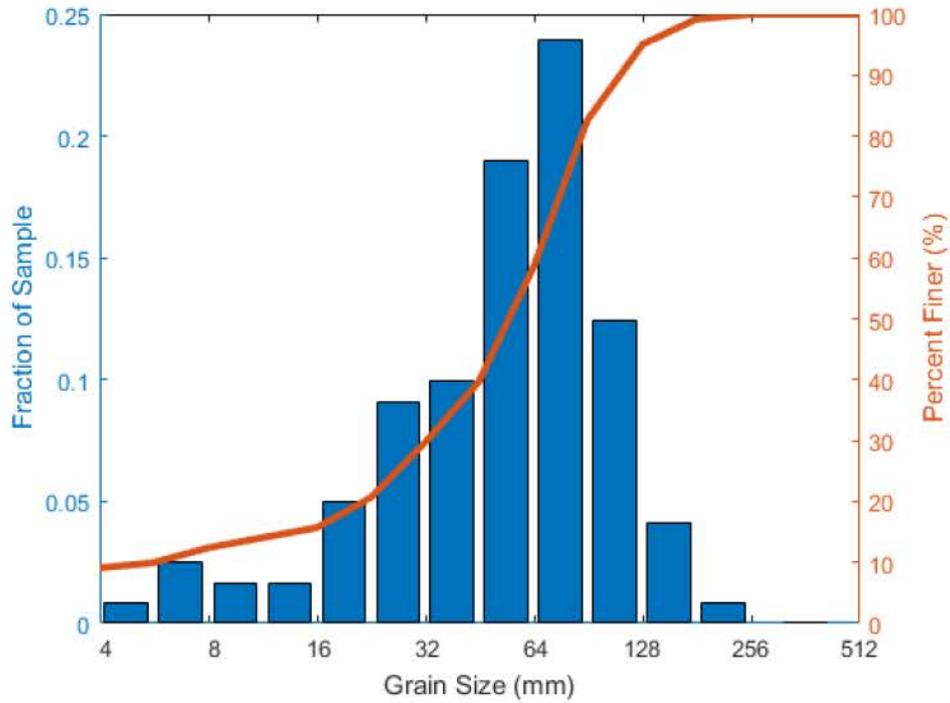
Figure B-24. Pebble count results from cross section 5 (XS 5). Histogram shows the fraction of sample for grain size classes, while the line indicates the cumulative grain size distribution.

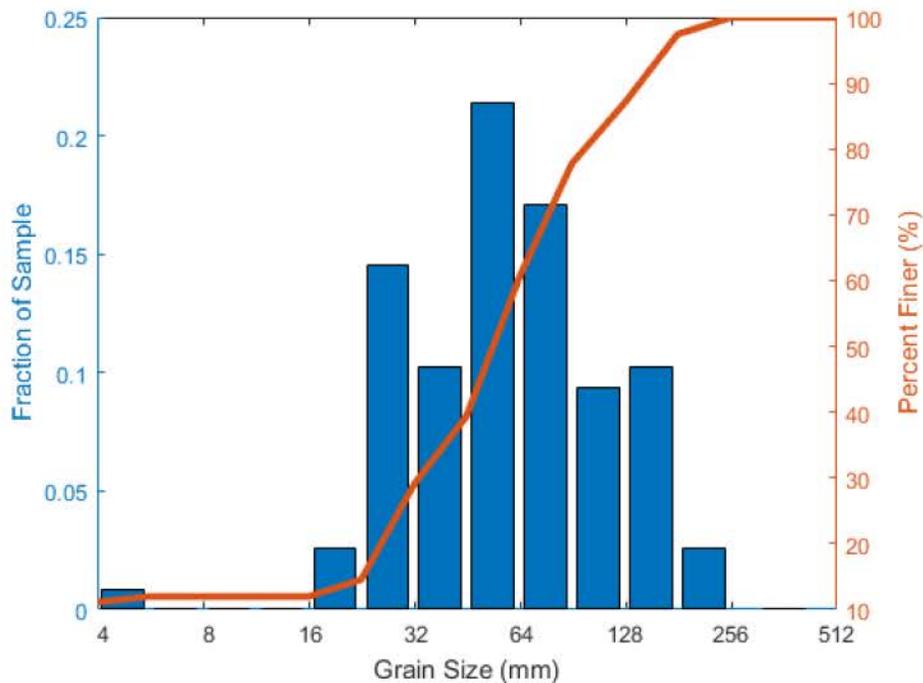
Figure B-25. Pebble count results from cross section 6 (XS 6). Histogram shows the fraction of sample for grain size classes, while the line indicates the cumulative grain size distribution.

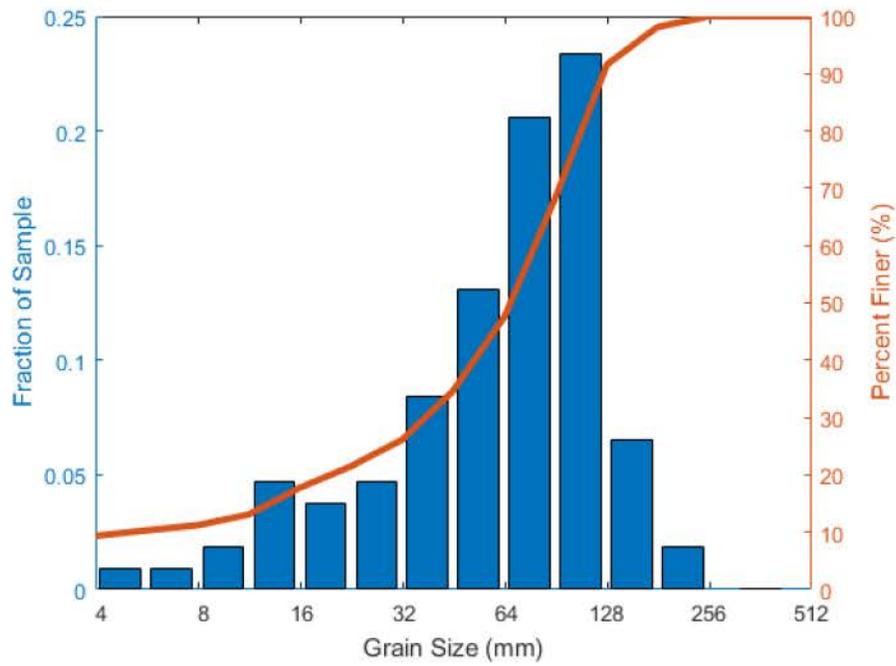
Figure B-26. Pebble count results from cross section 7 (XS 7). Histogram shows the fraction of sample for grain size classes, while the line indicates the cumulative grain size distribution.

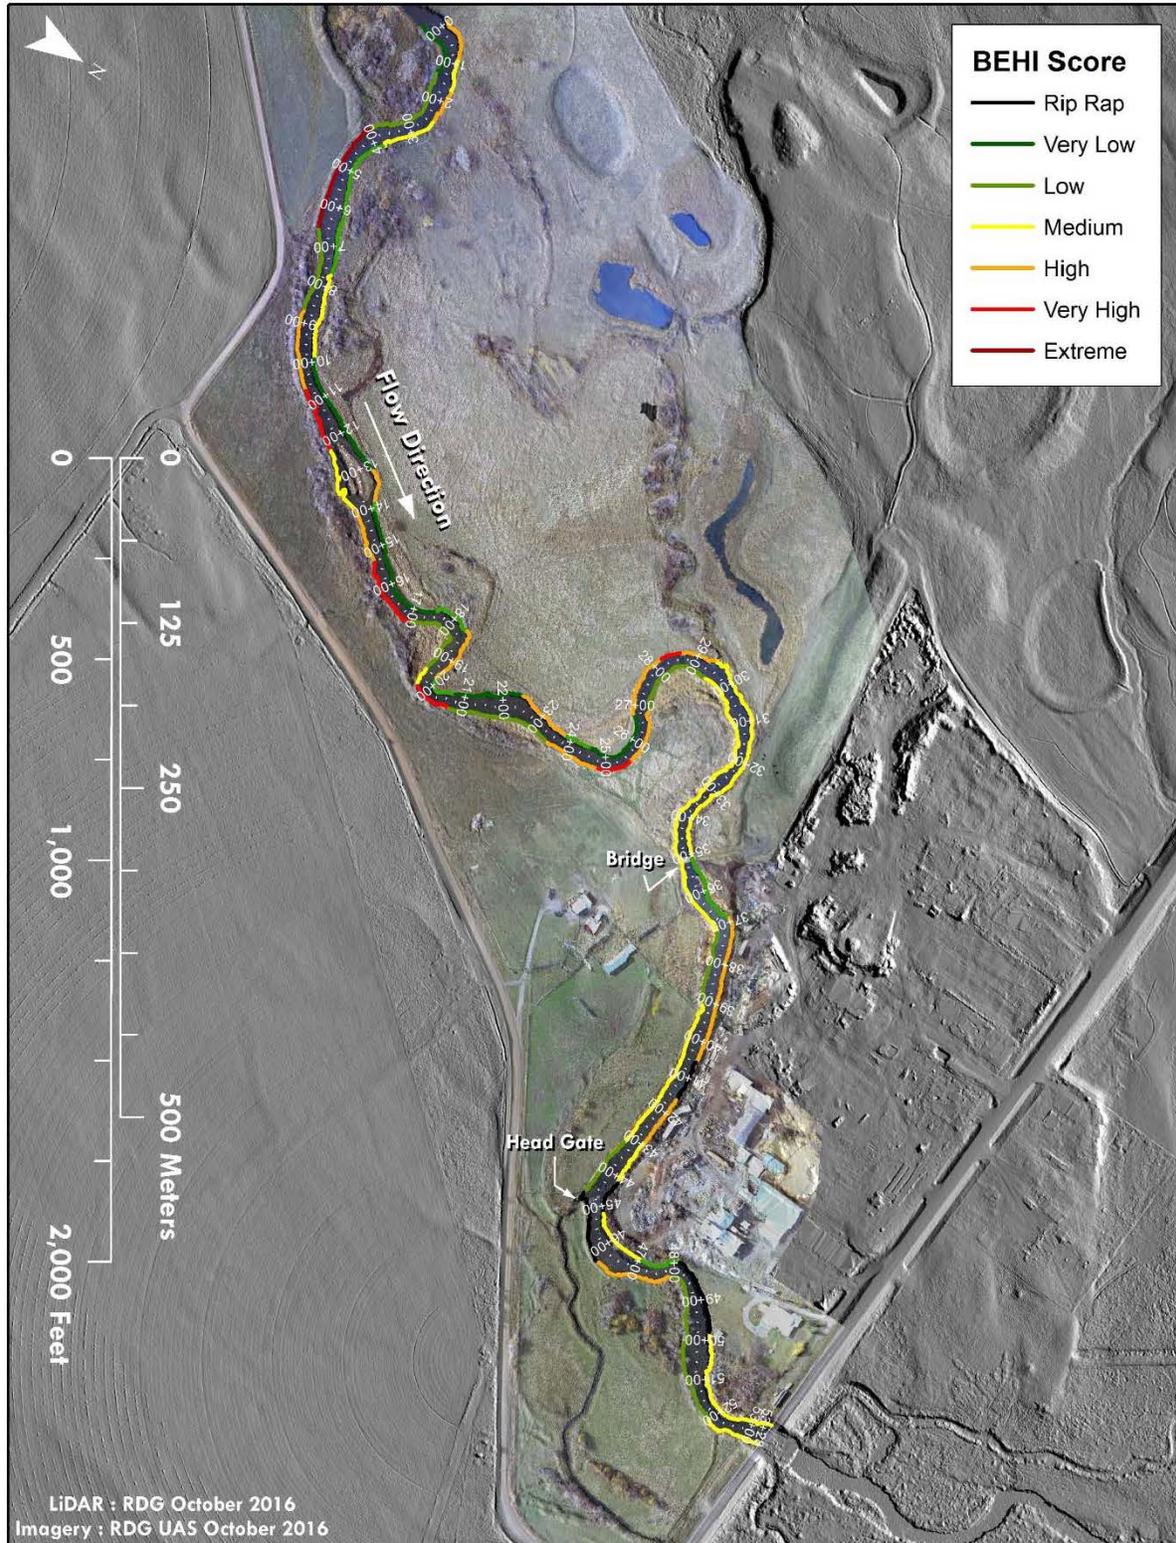
Figure B-27. Map of the results from the BEHI field analysis of the Flint Creek Assessment reach.

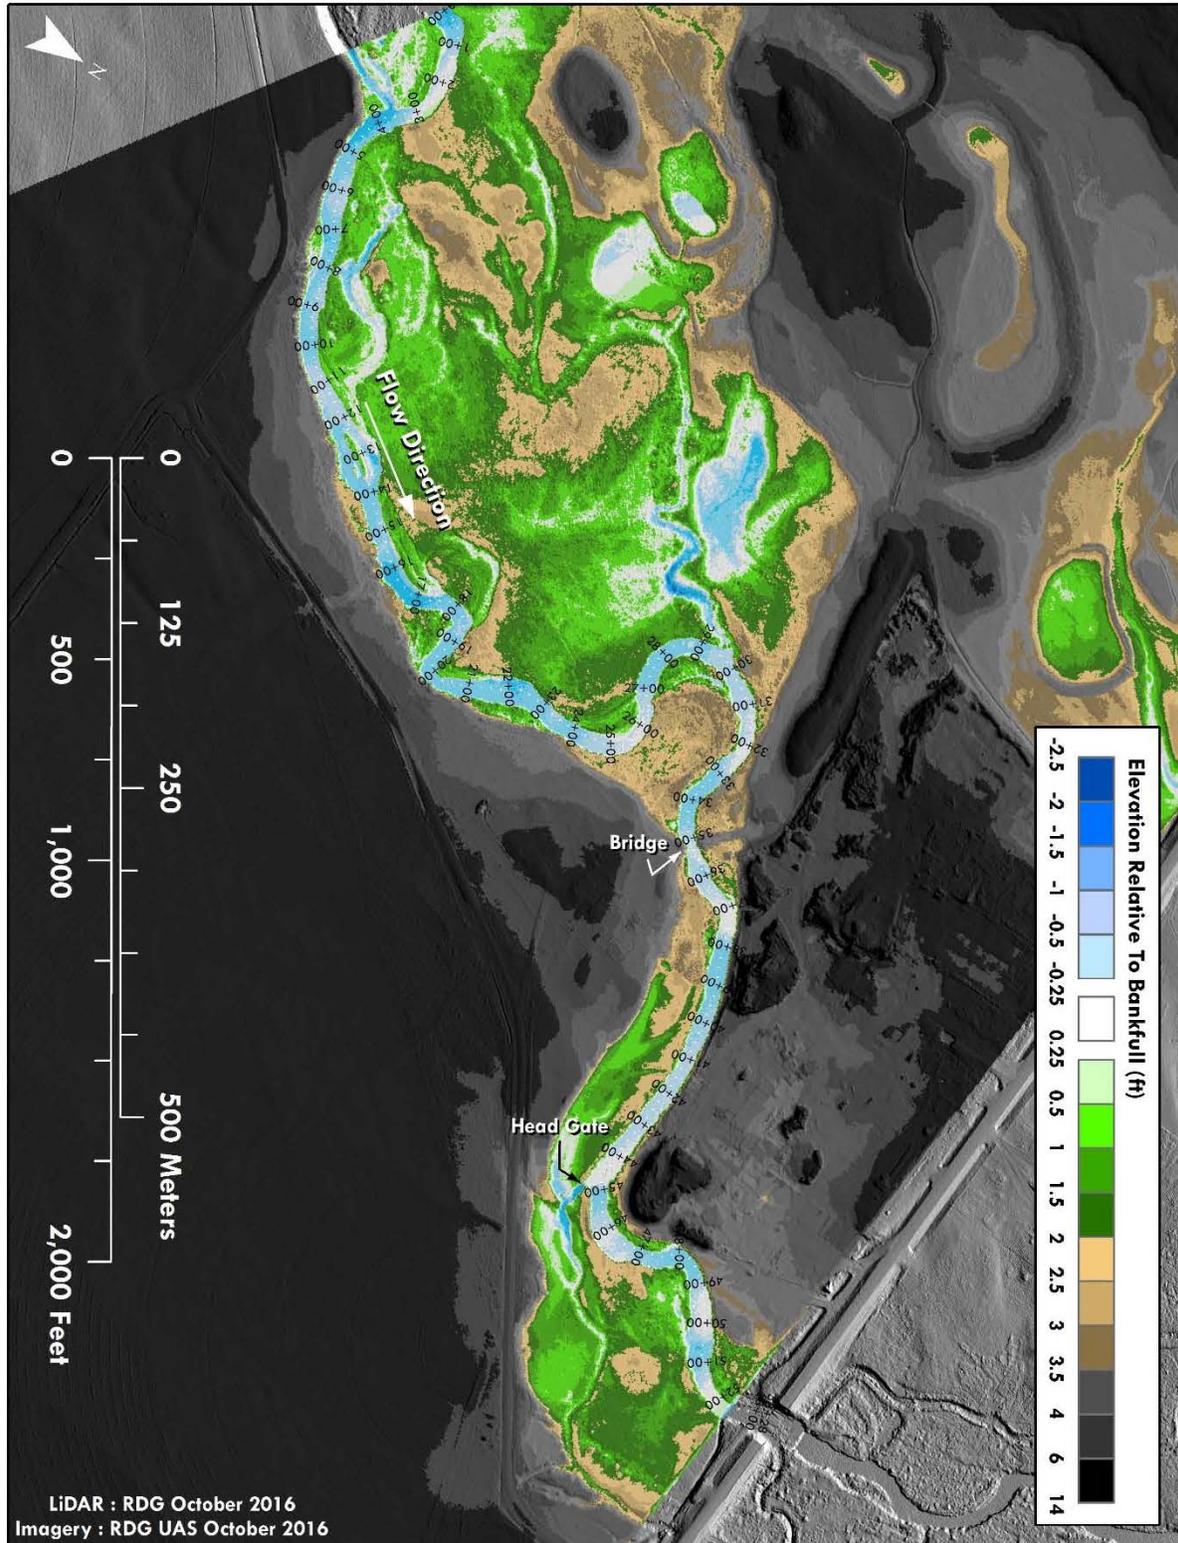
Figure B-28. Map of floodplain connectivity of the Flint Creek Assessment reach derived from the LiDAR collected in October, 2016.

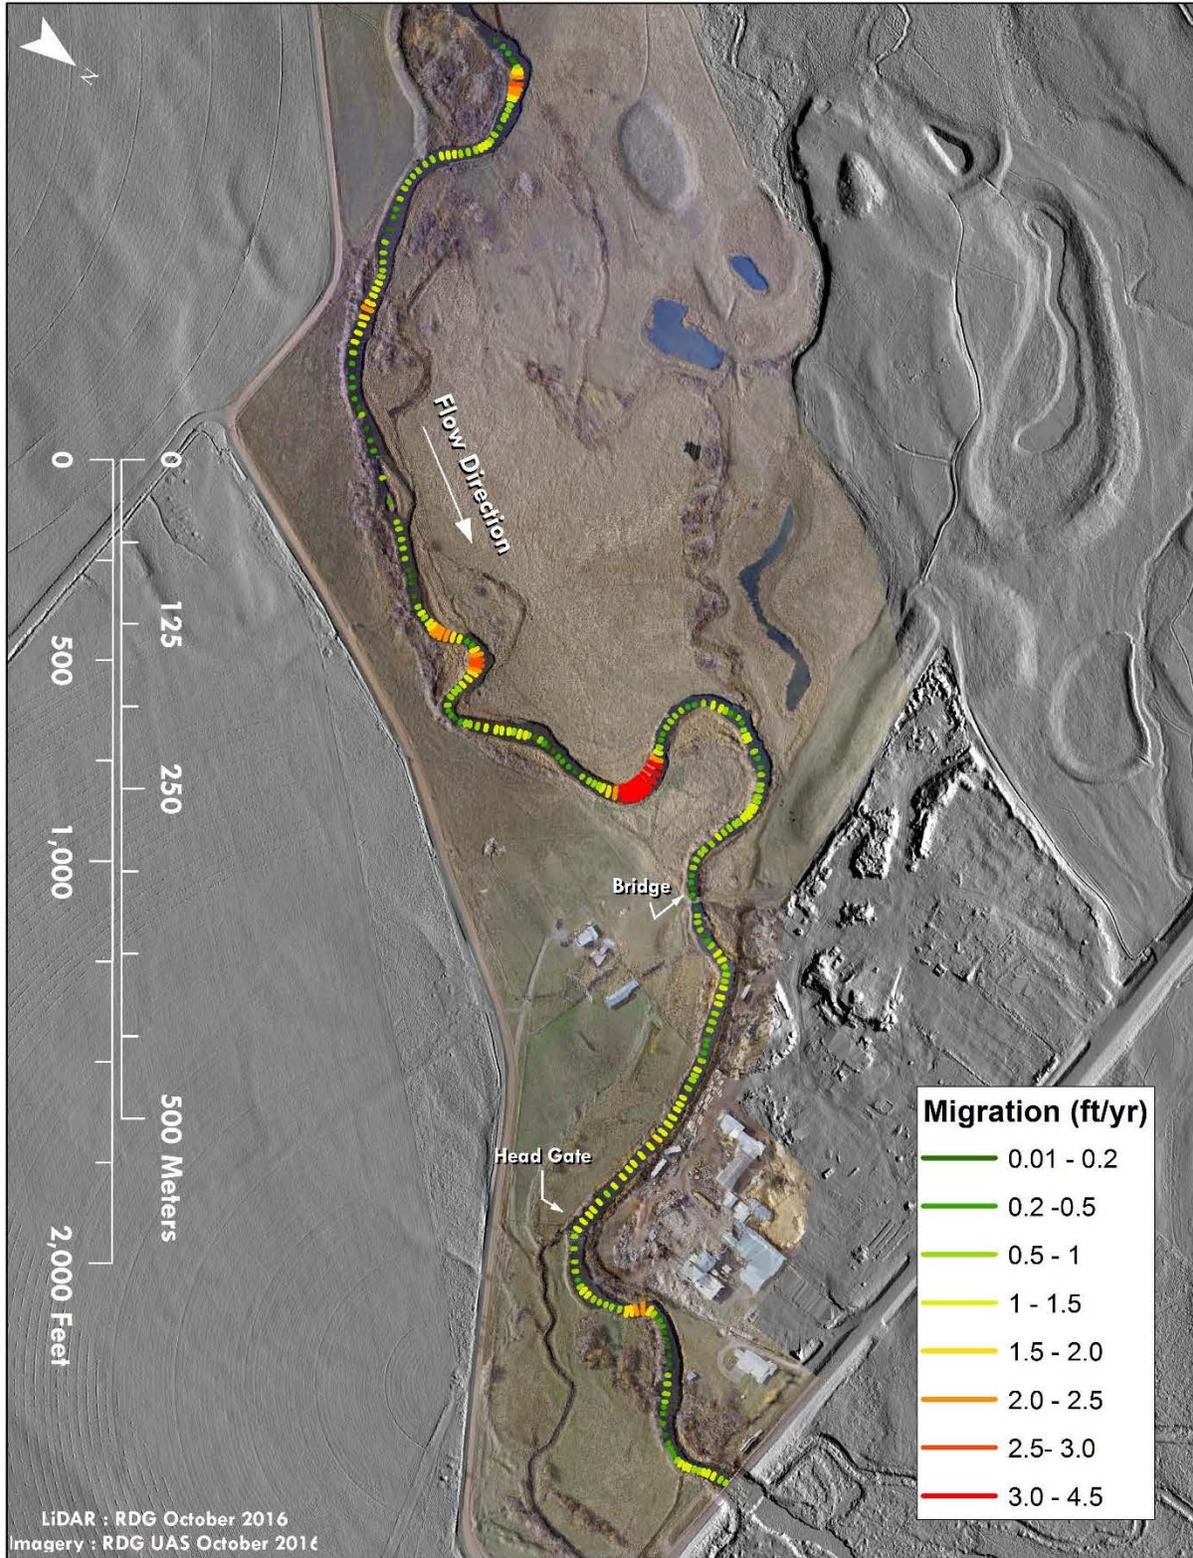
Figure B-299. Map of channel migration rates calculated from aerial photos over a 10-year span.
