RE: Trout Unlimited 319 Funding Request for Flint Creek Riparian Restoration

Project Name Flint Creek Riparian Restoration

Flint Creek Assessment and Conceptual Design Report

Near Hall, Montana

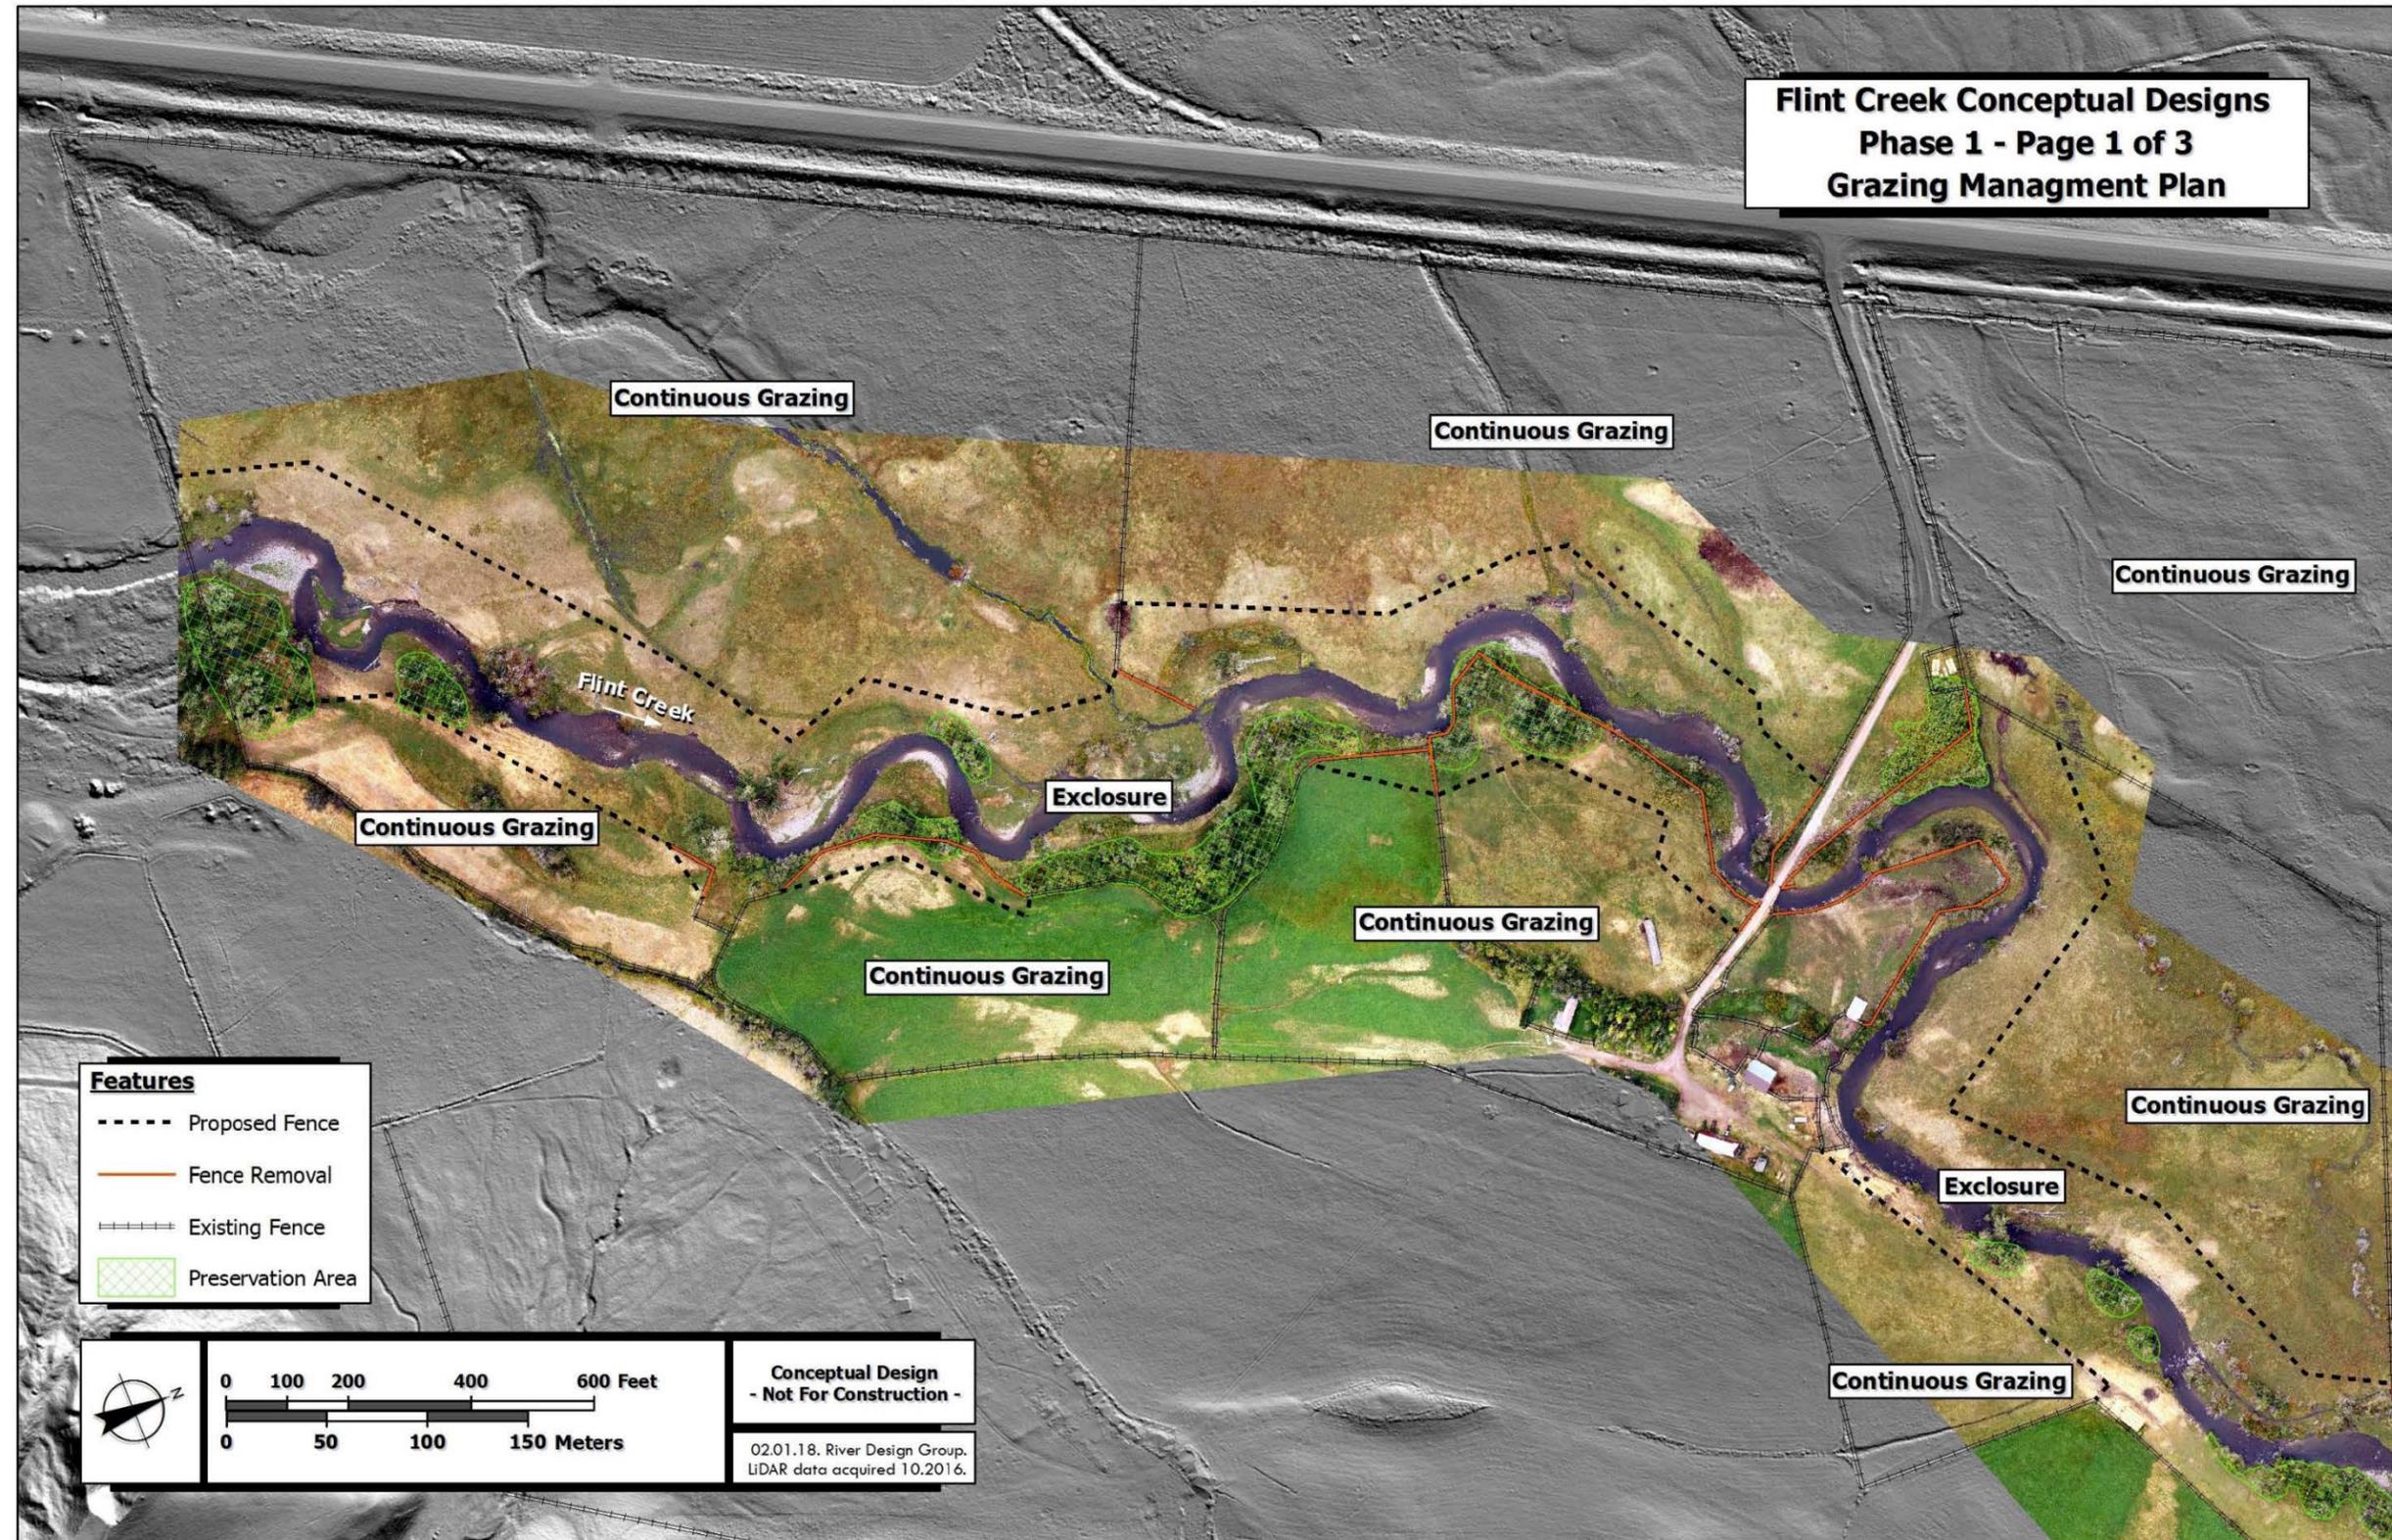
Figure 2. Conceptual grazing management plan for the lower Flint Creek project area.

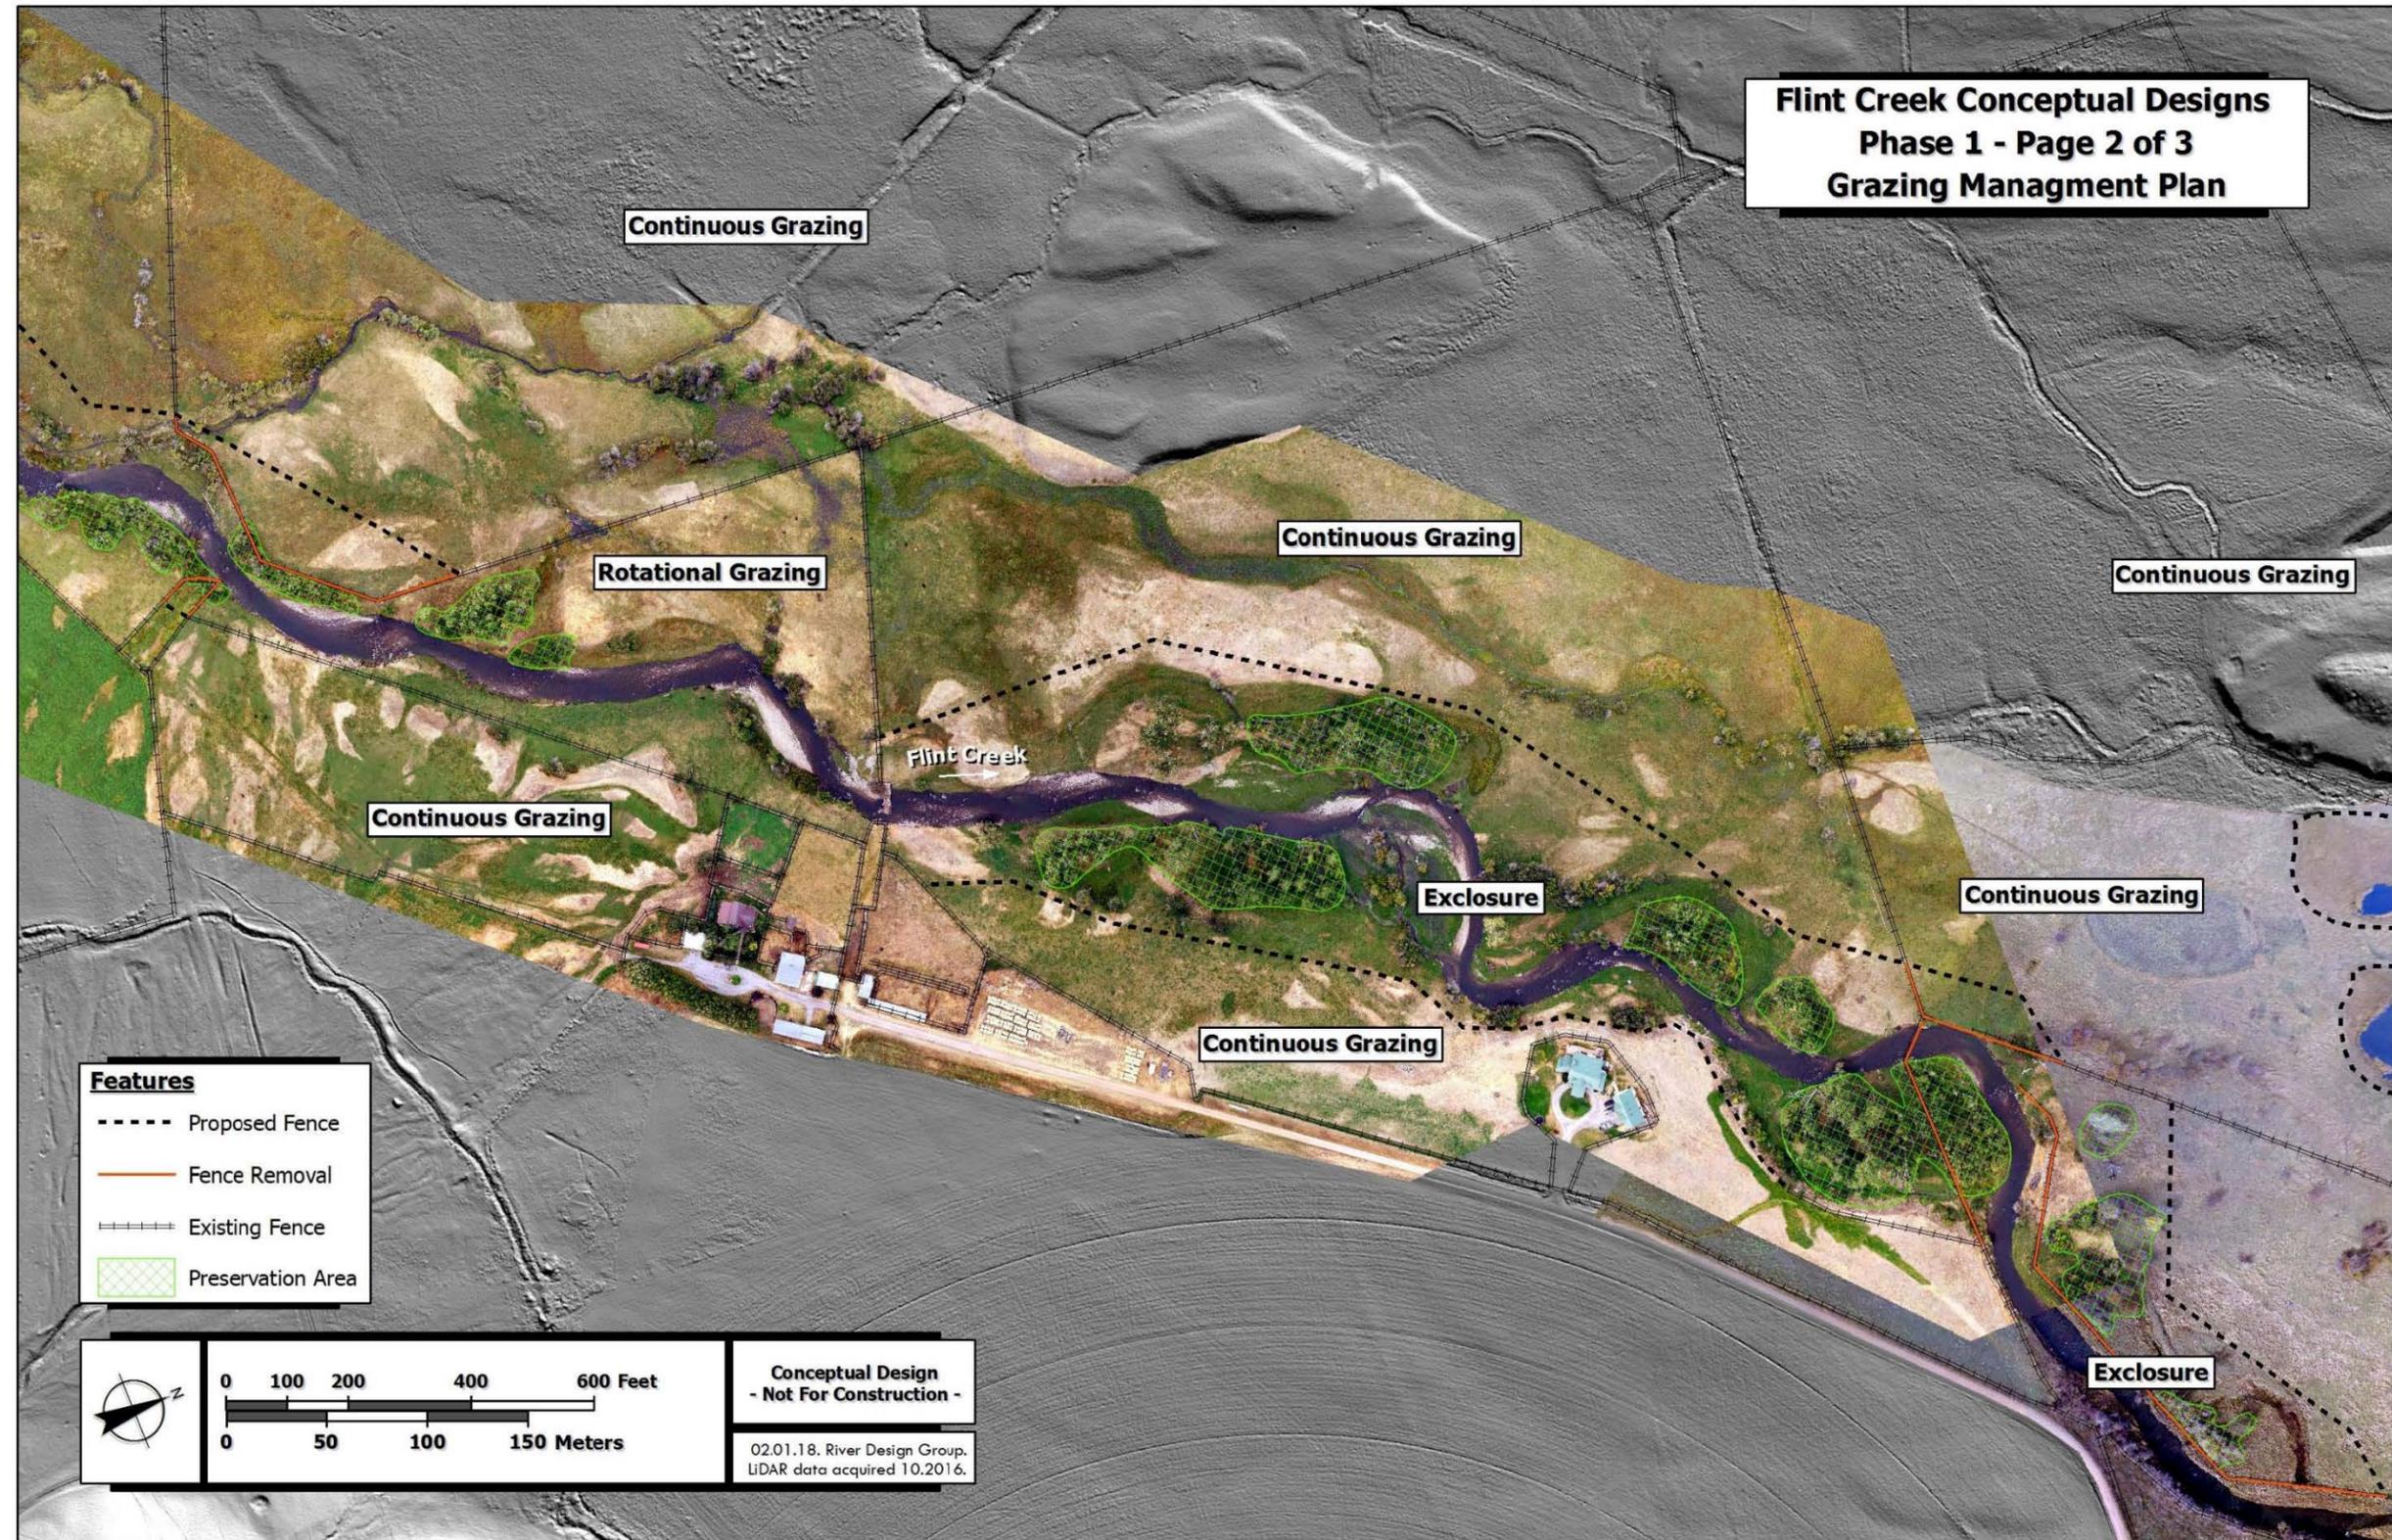
Figure 3. Conceptual grazing management plan for the lower Flint Creek project area.

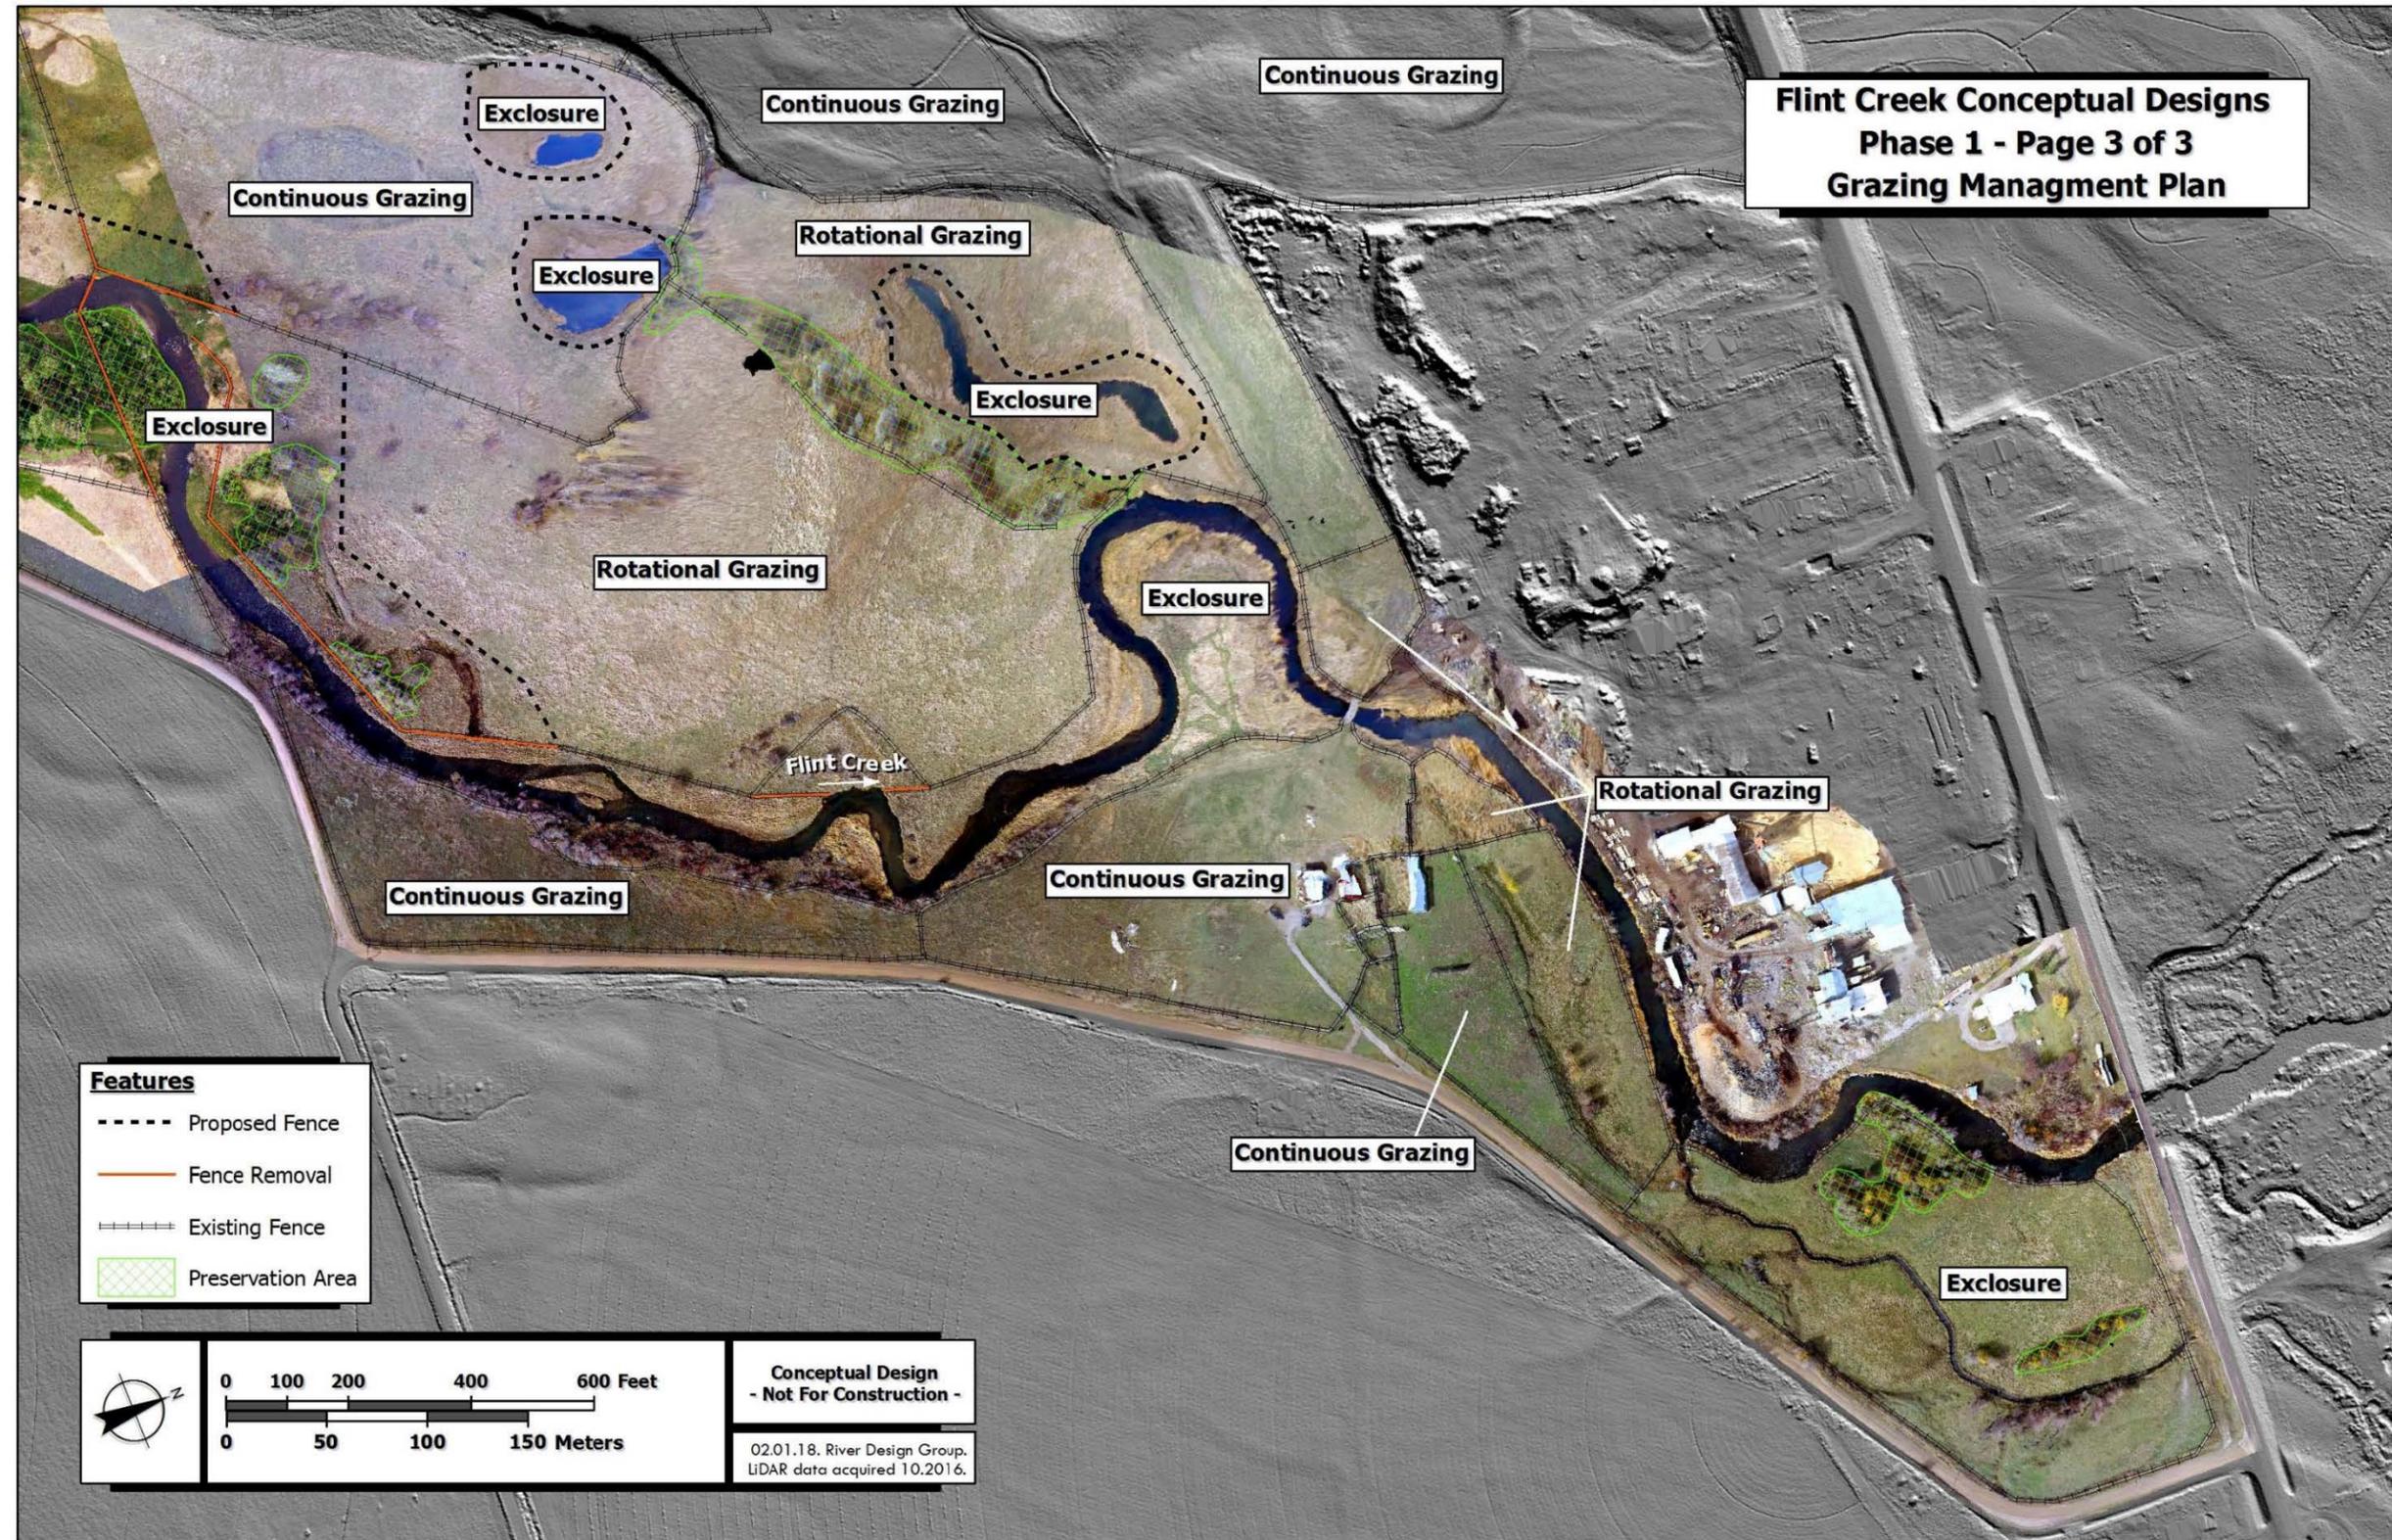
Figure 4. Conceptual grazing management plan for the lower Flint Creek project area.

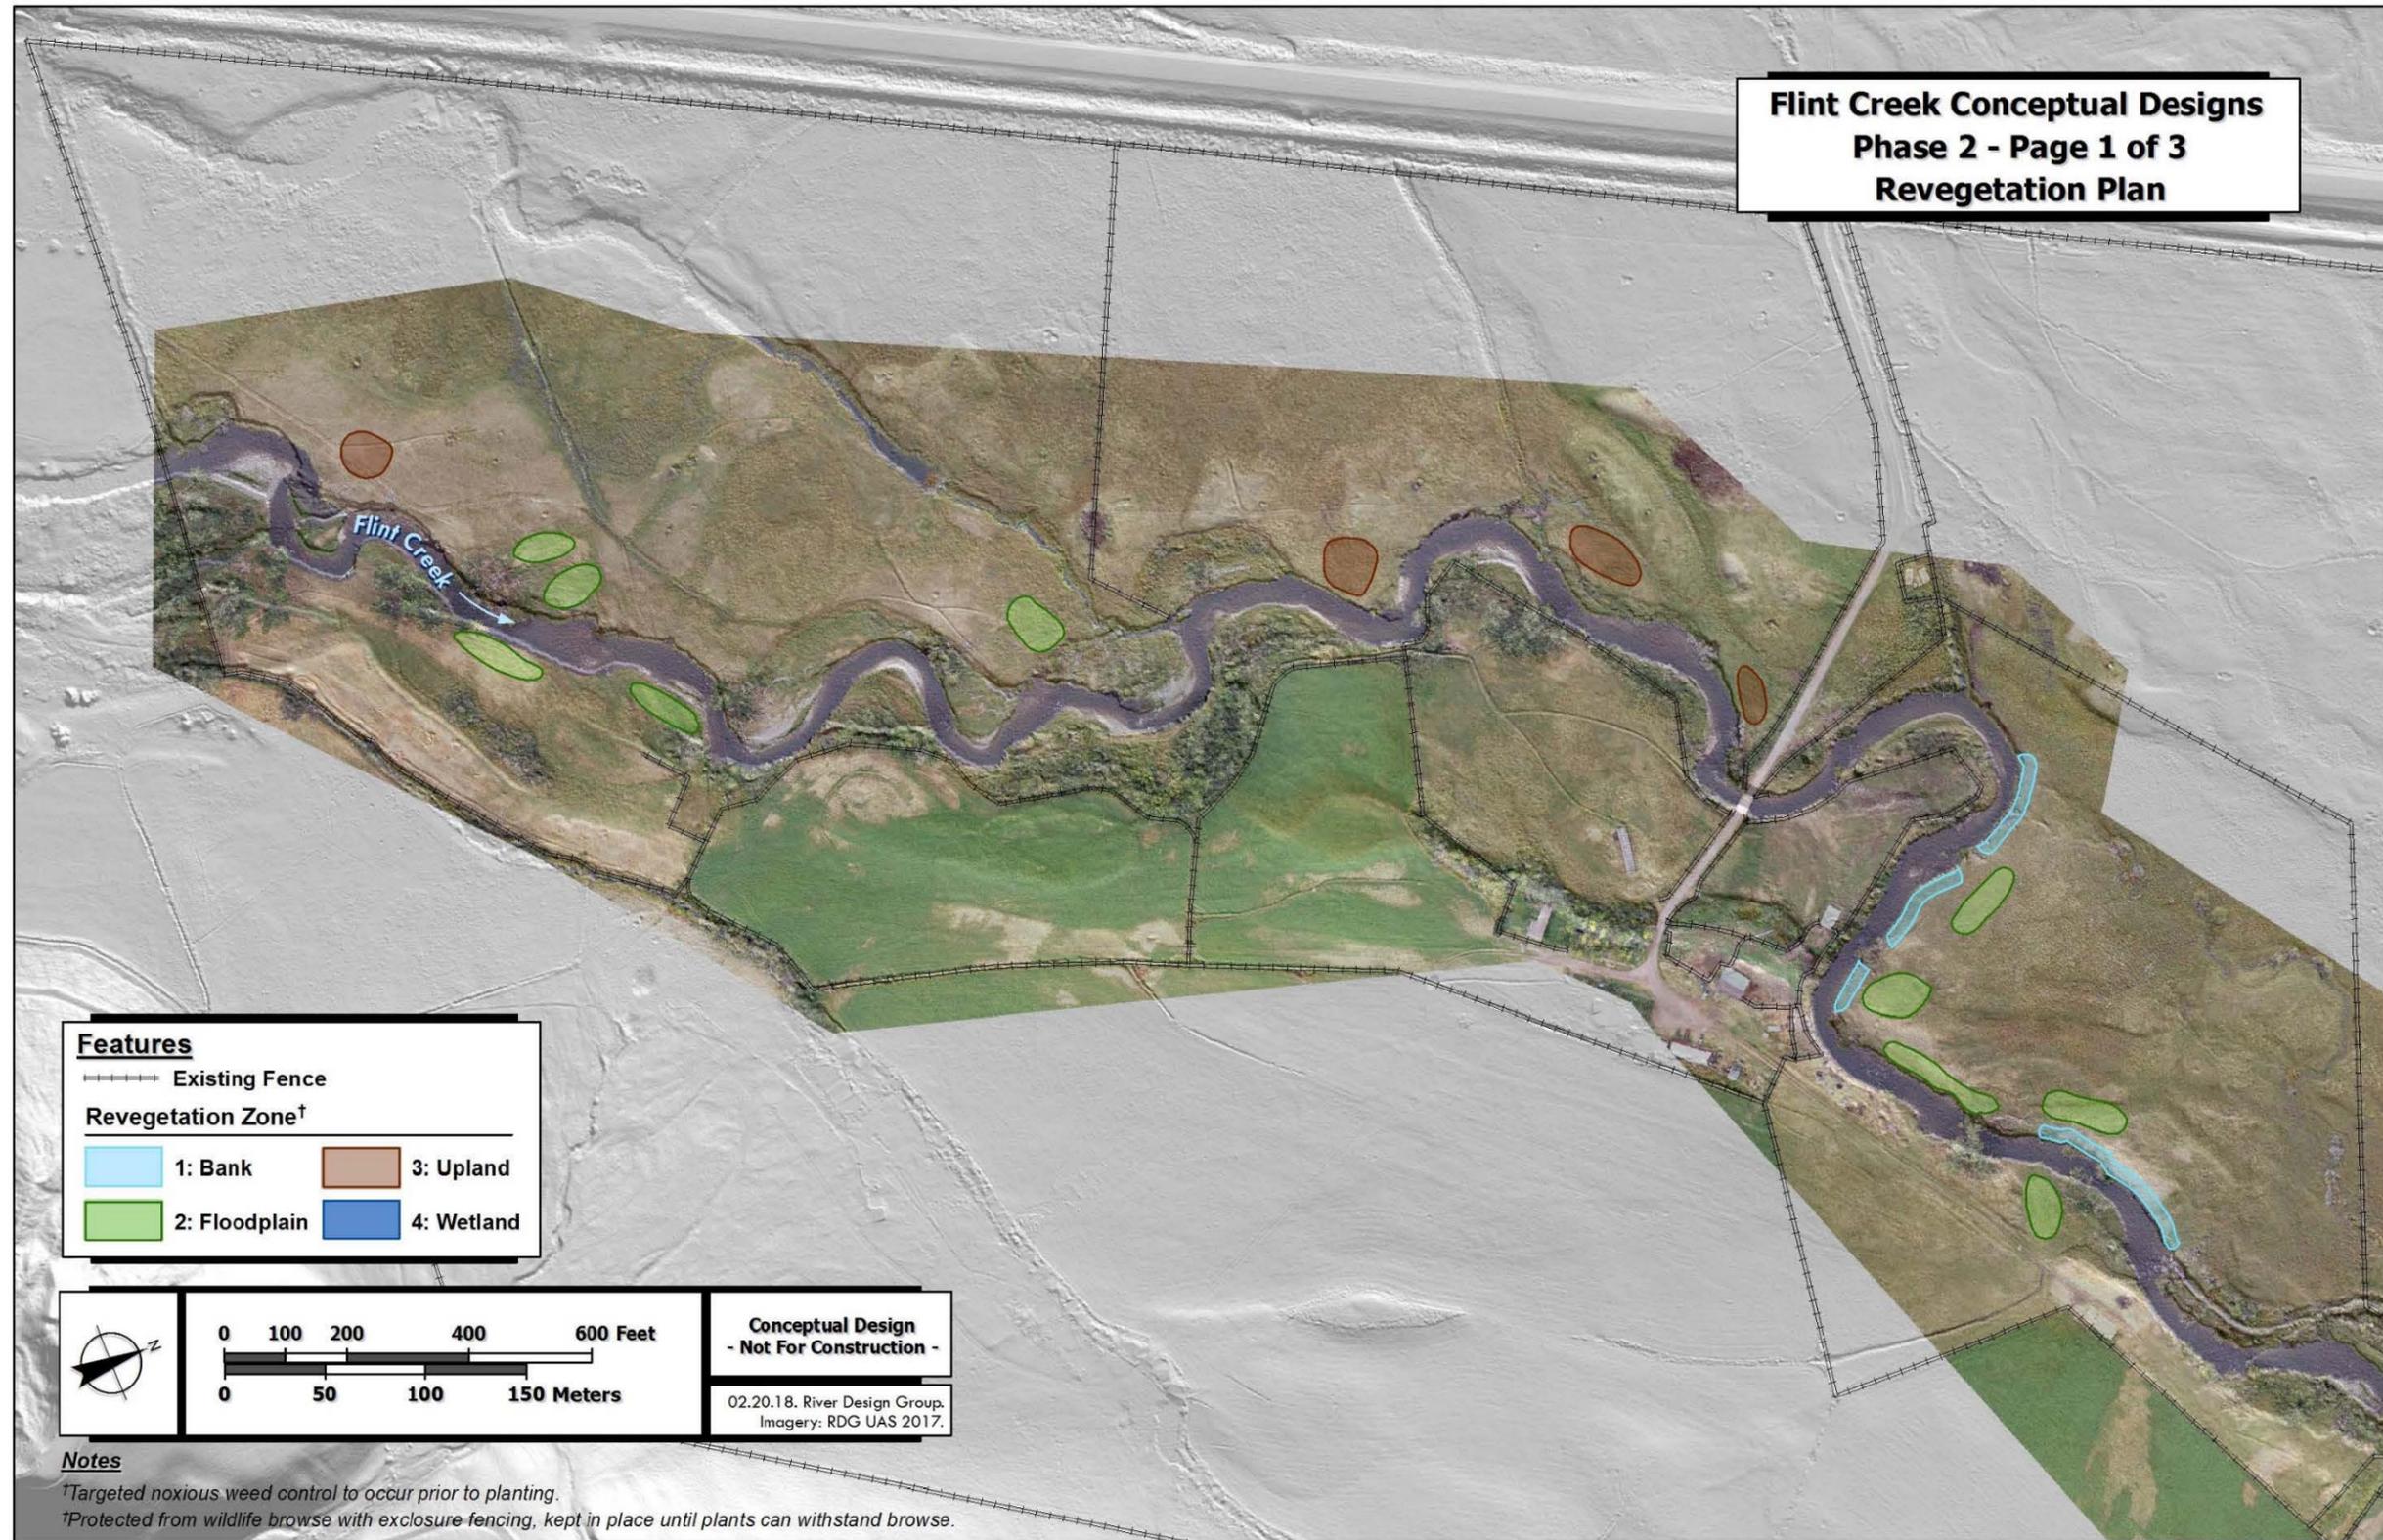
Figure 5. Conceptual revegetation plan for the lower Flint Creek project area.

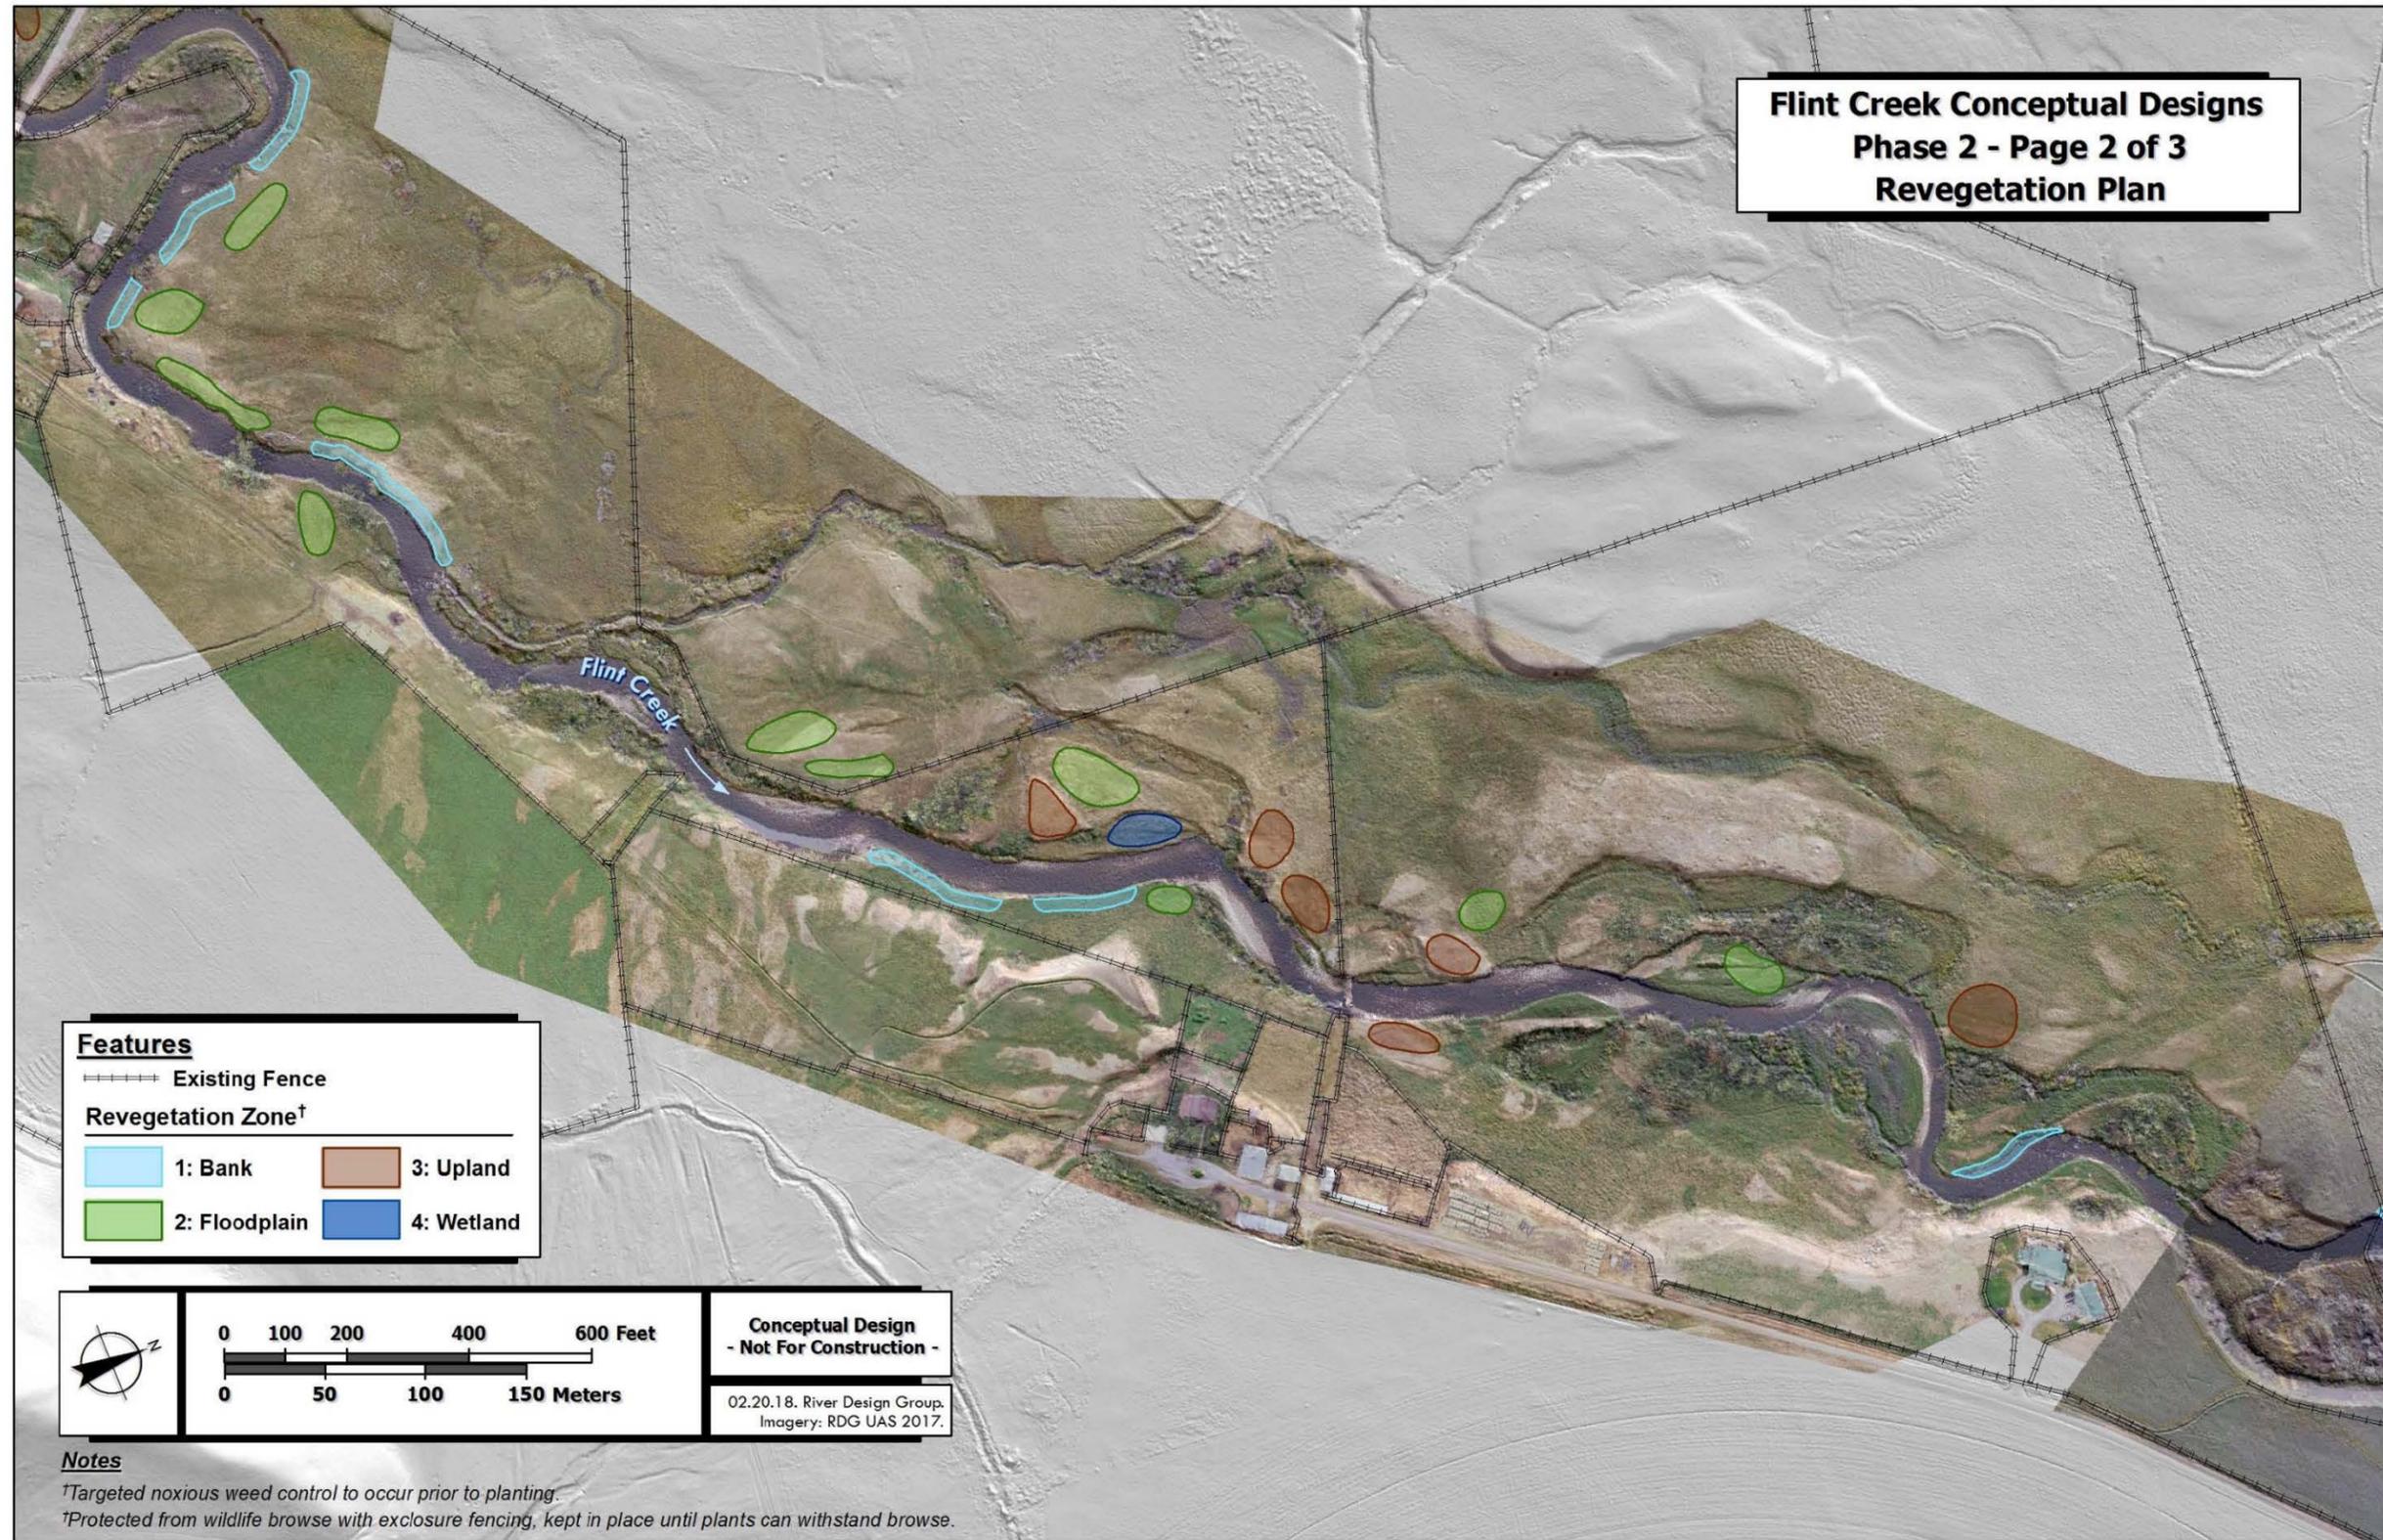
Figure 6. Conceptual revegetation plan for the lower Flint Creek project area.

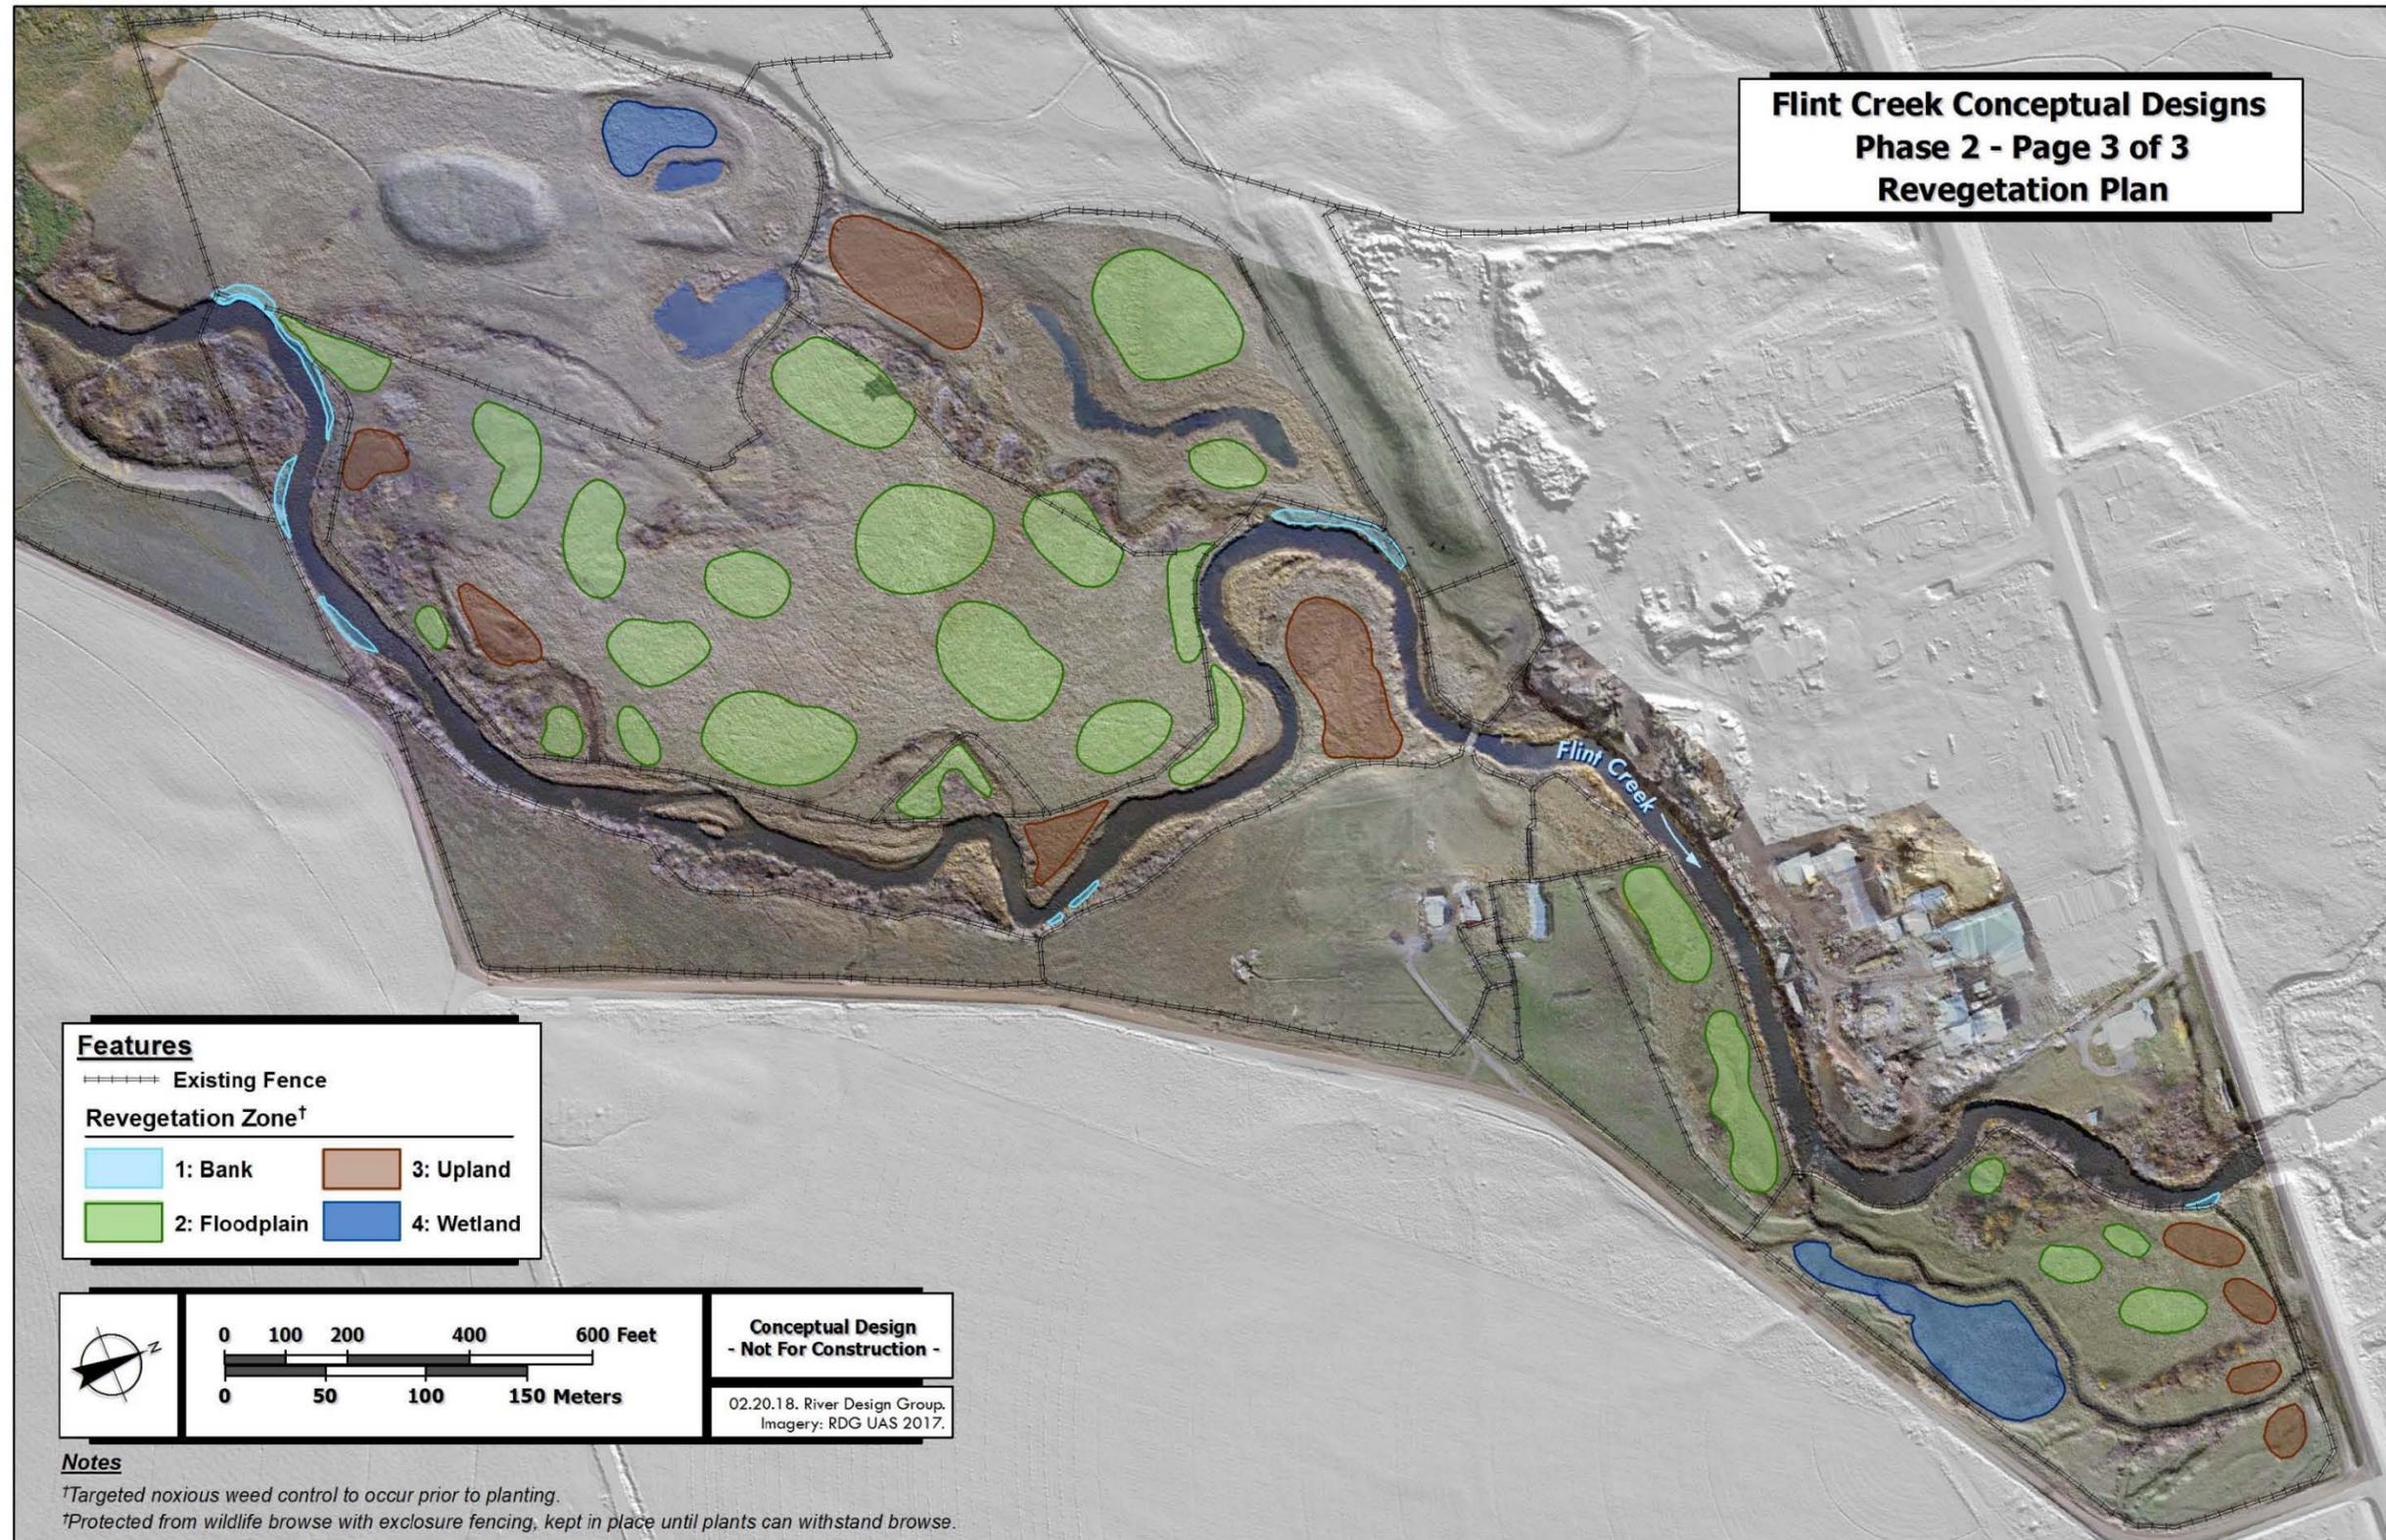
Figure 7. Conceptual revegetation plan for the lower Flint Creek project area.
