RE: Trout Unlimited 319 Funding Request for Flint Creek Riparian Restoration

Project Name Flint Creek Riparian Restoration

Flint Creek Assessment and Conceptual Design Report

Near Hall, Montana

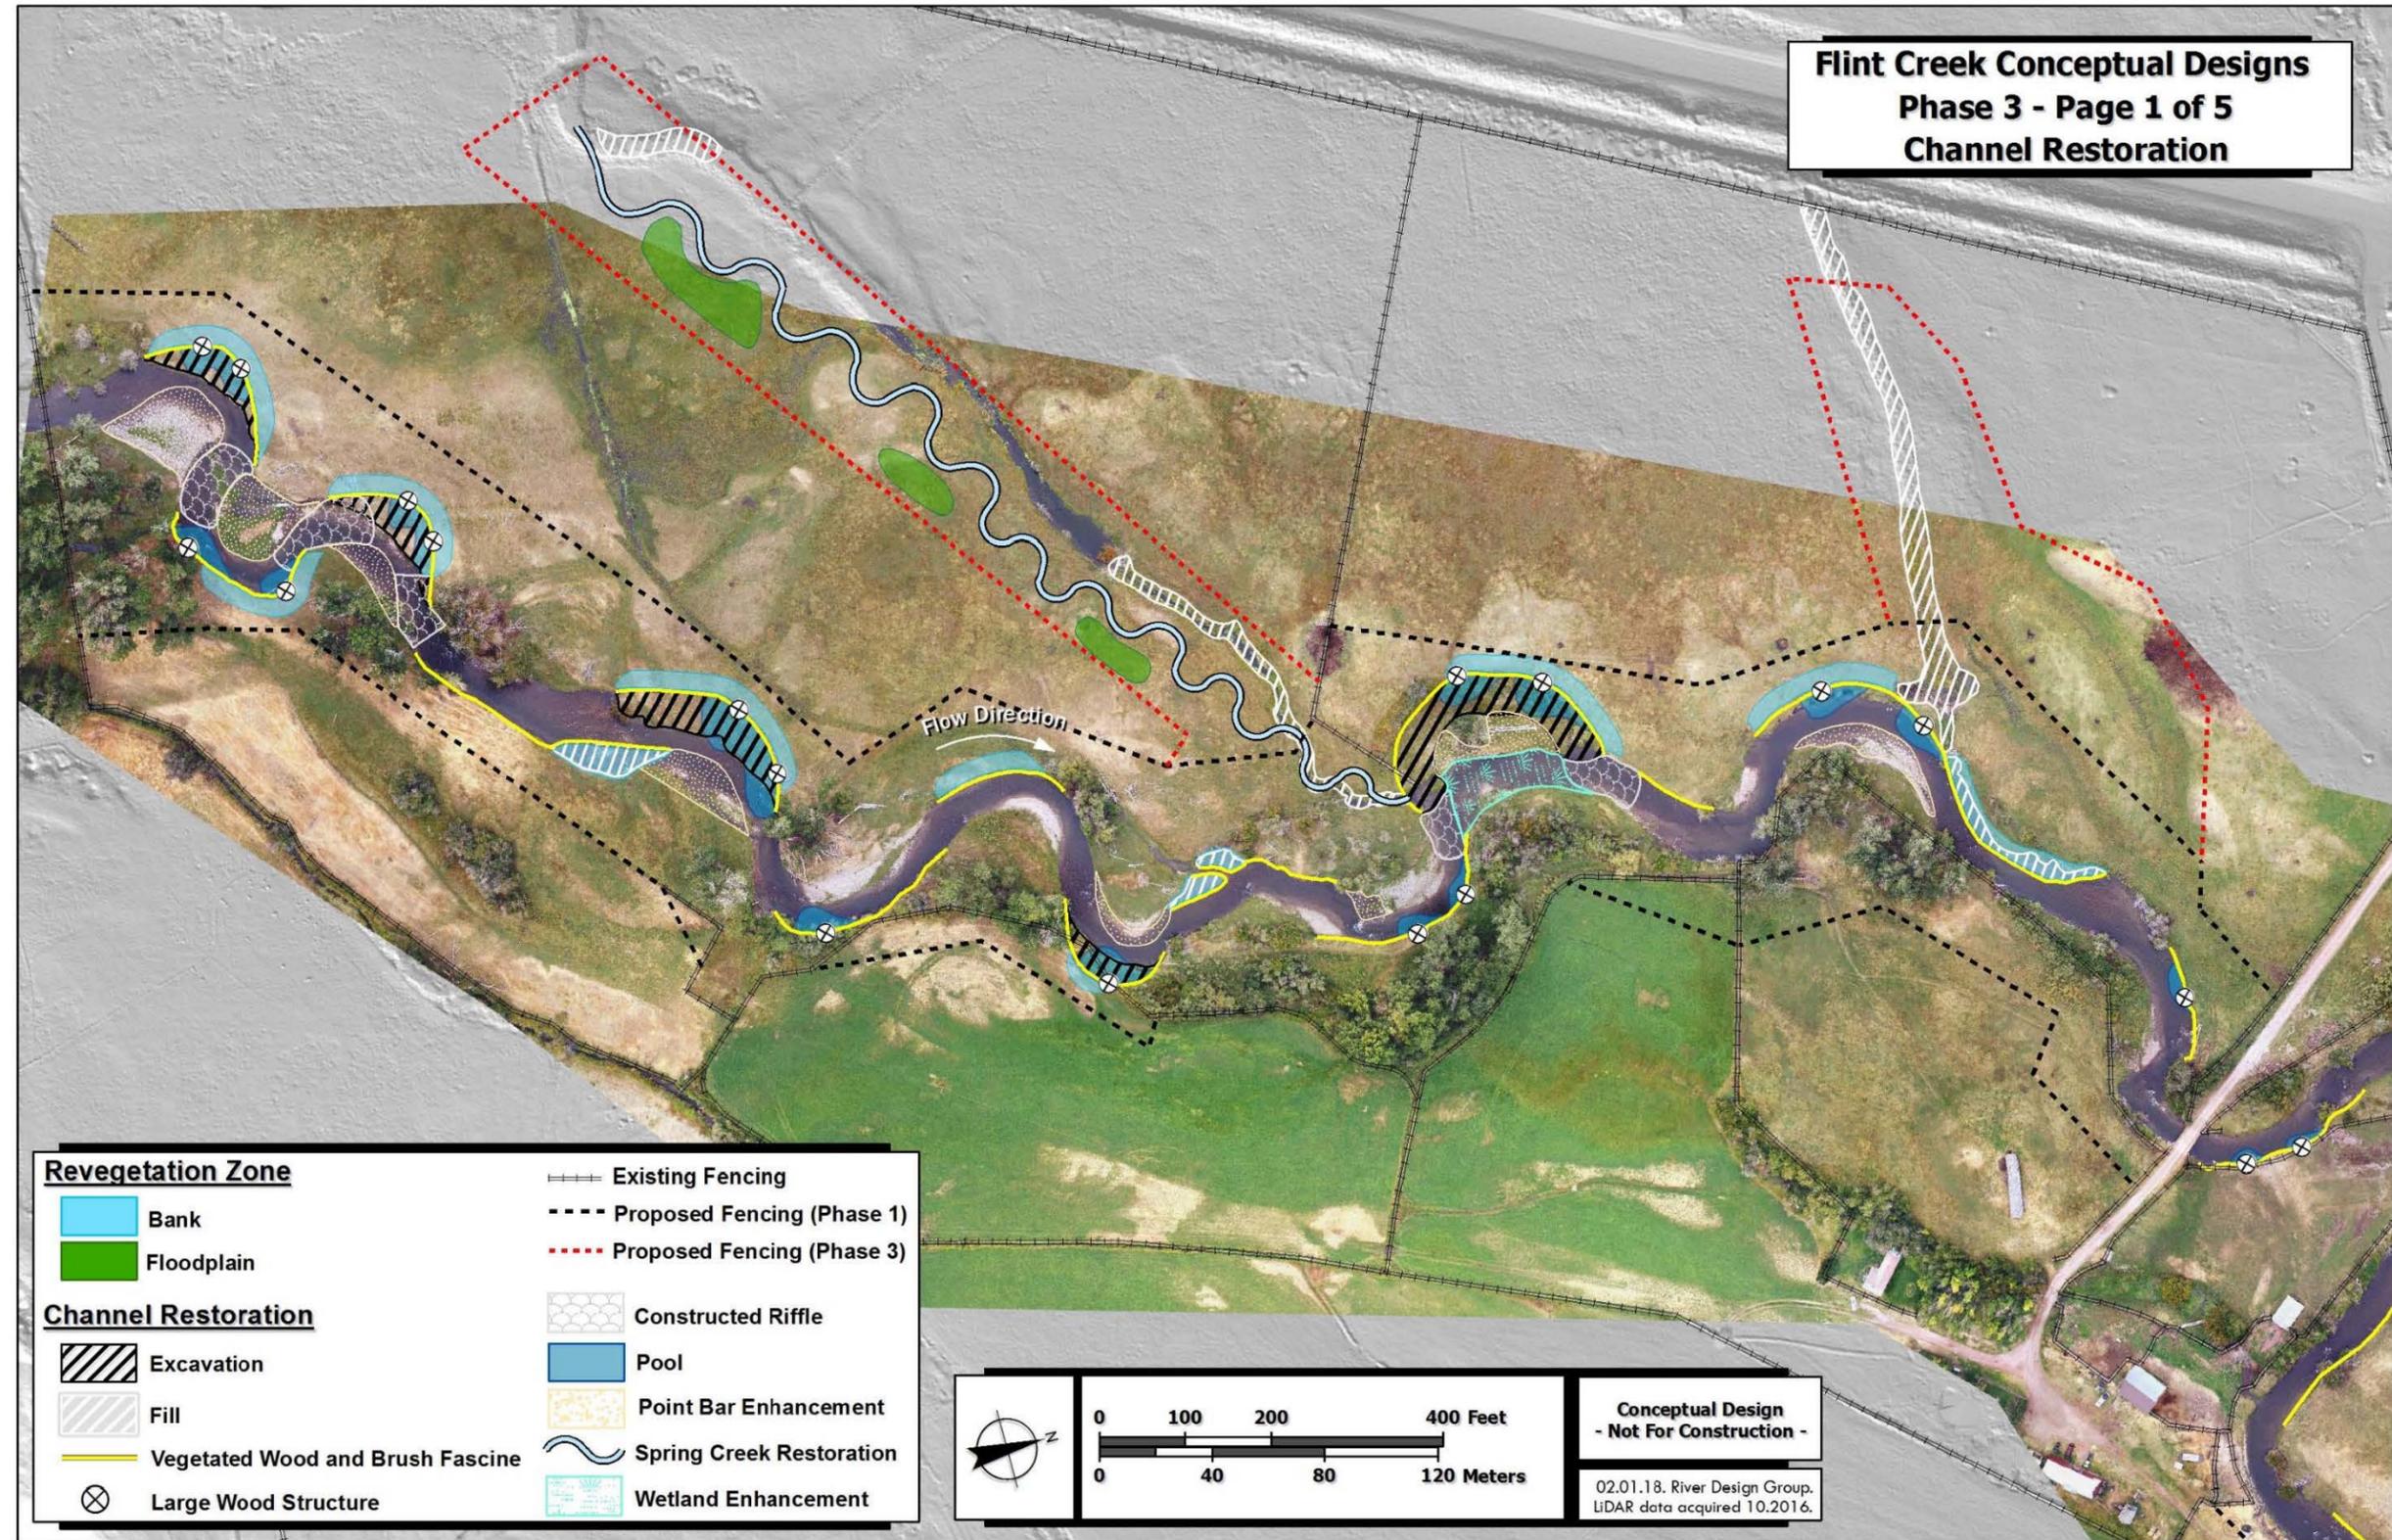
Figure 8. Conceptual channel restoration plan for the lower Flint Creek project area.

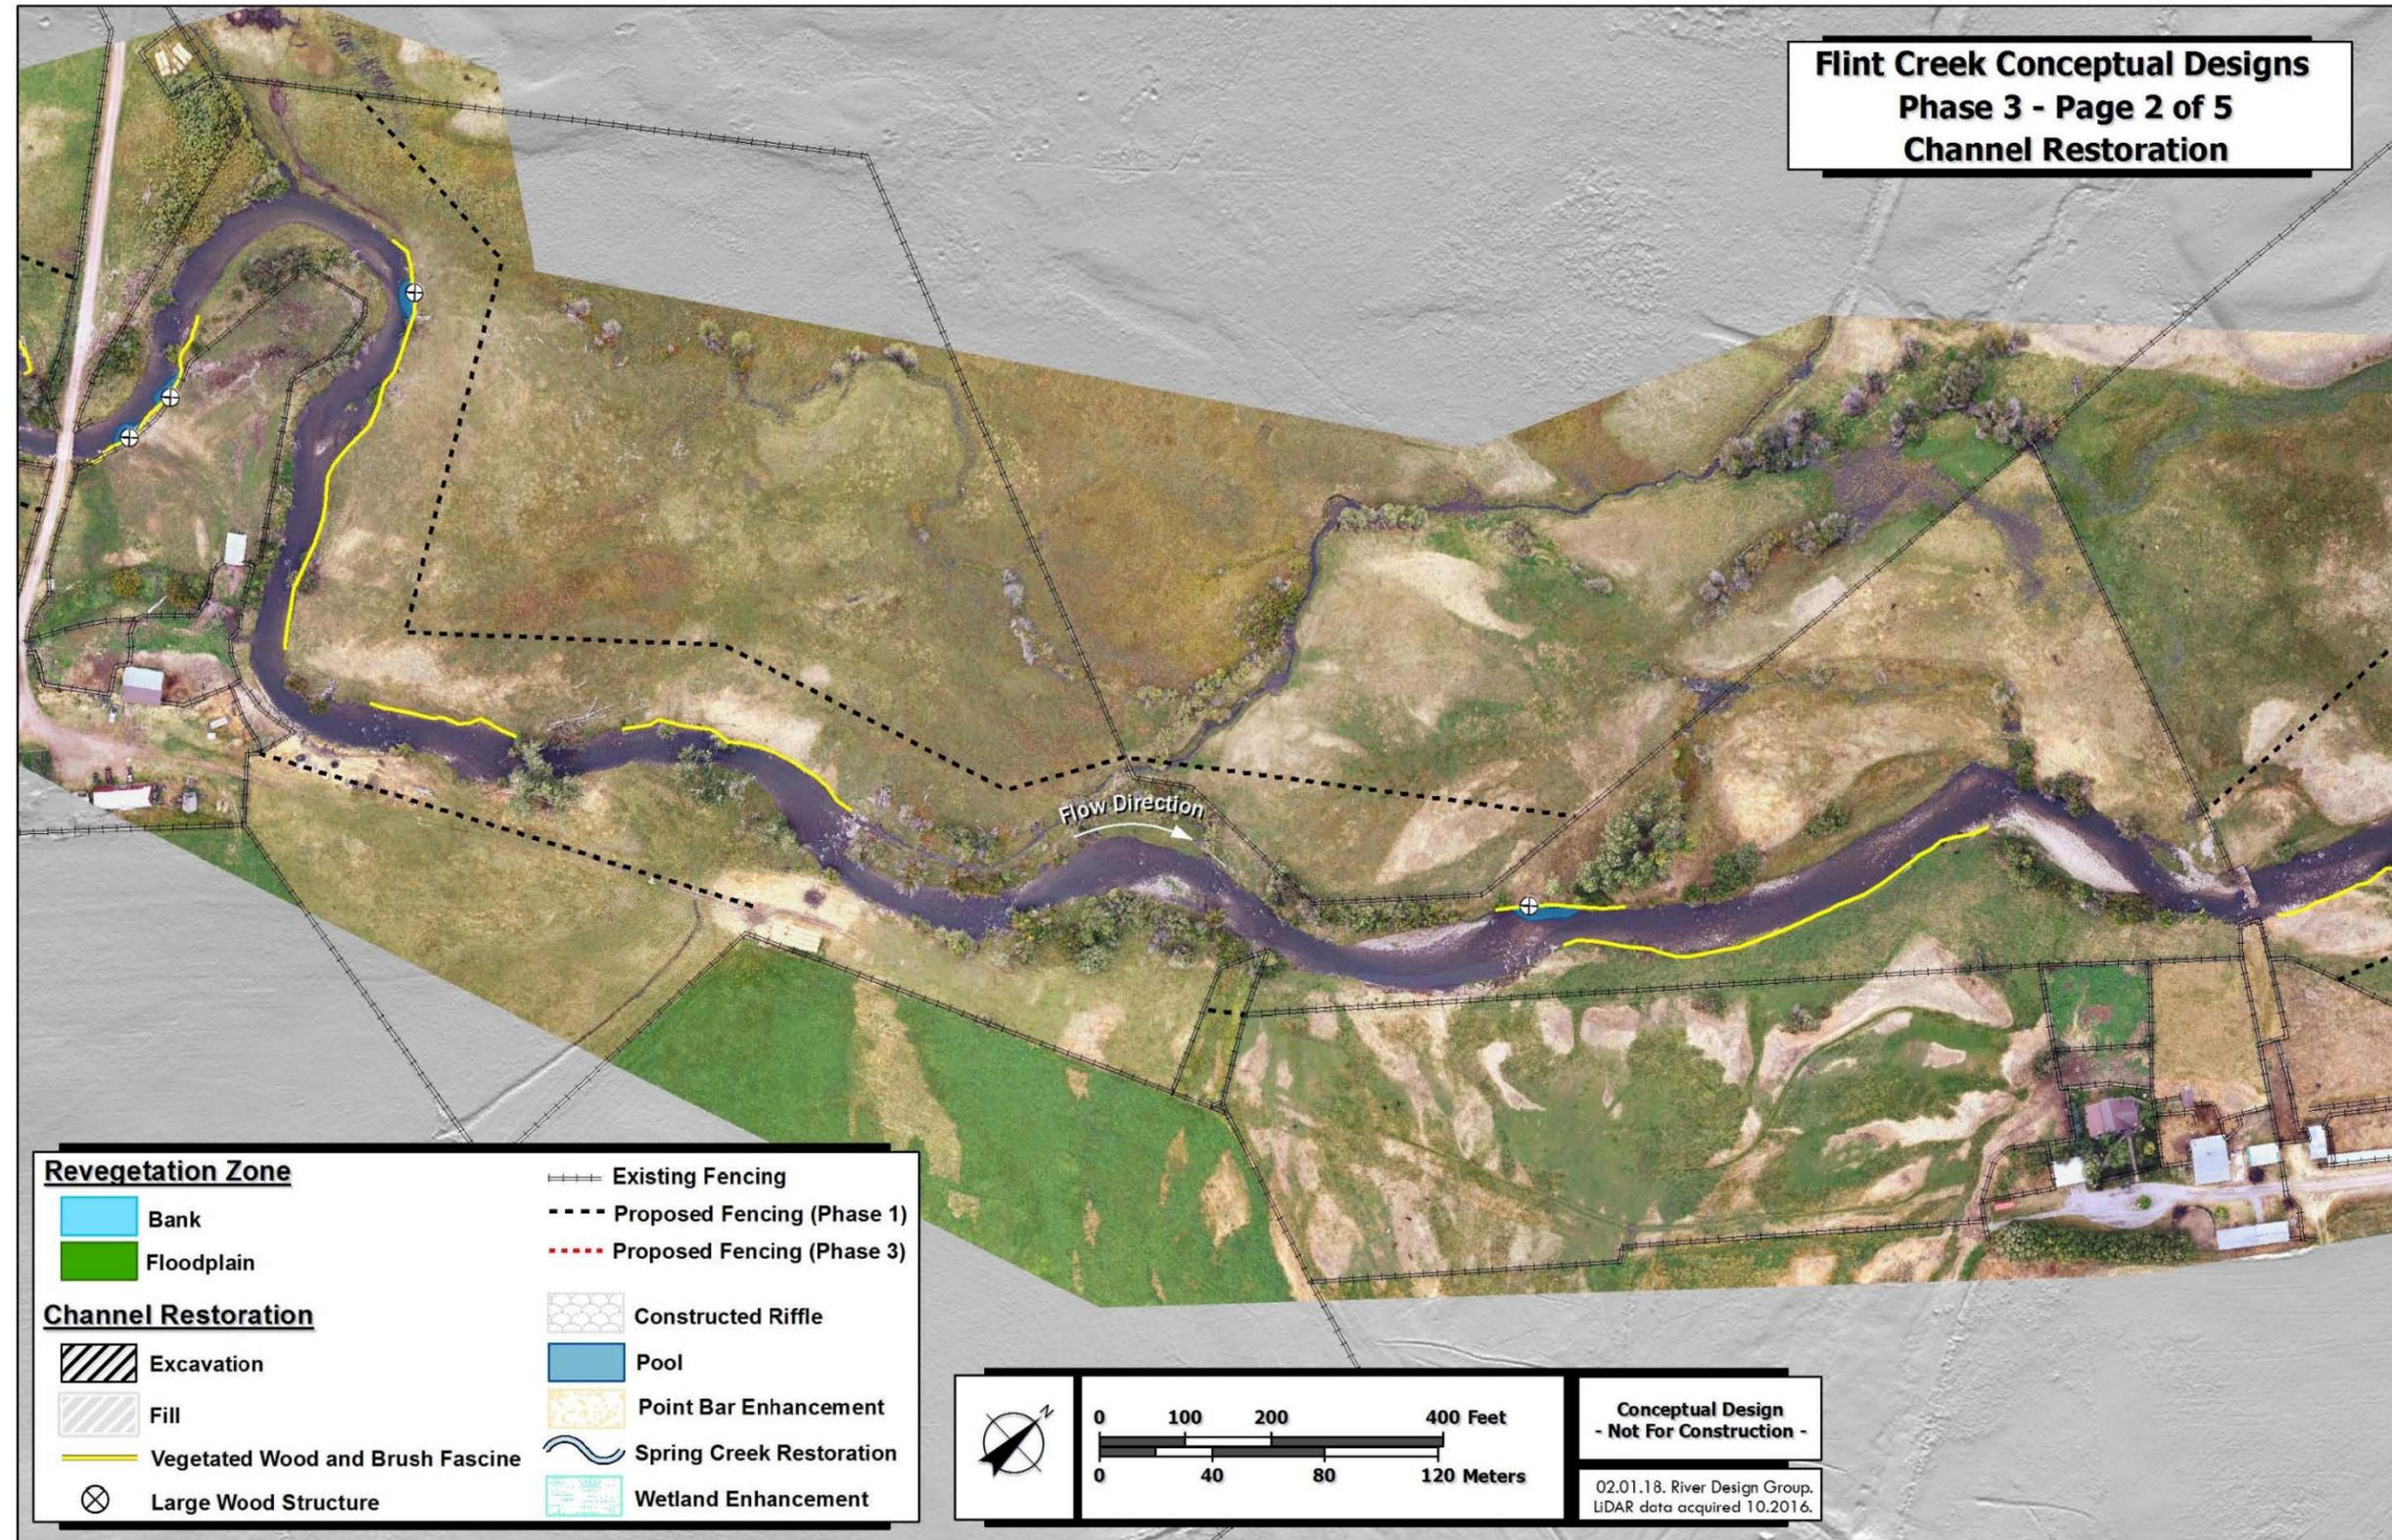
Figure 9. Conceptual channel restoration plan for the lower Flint Creek project area.

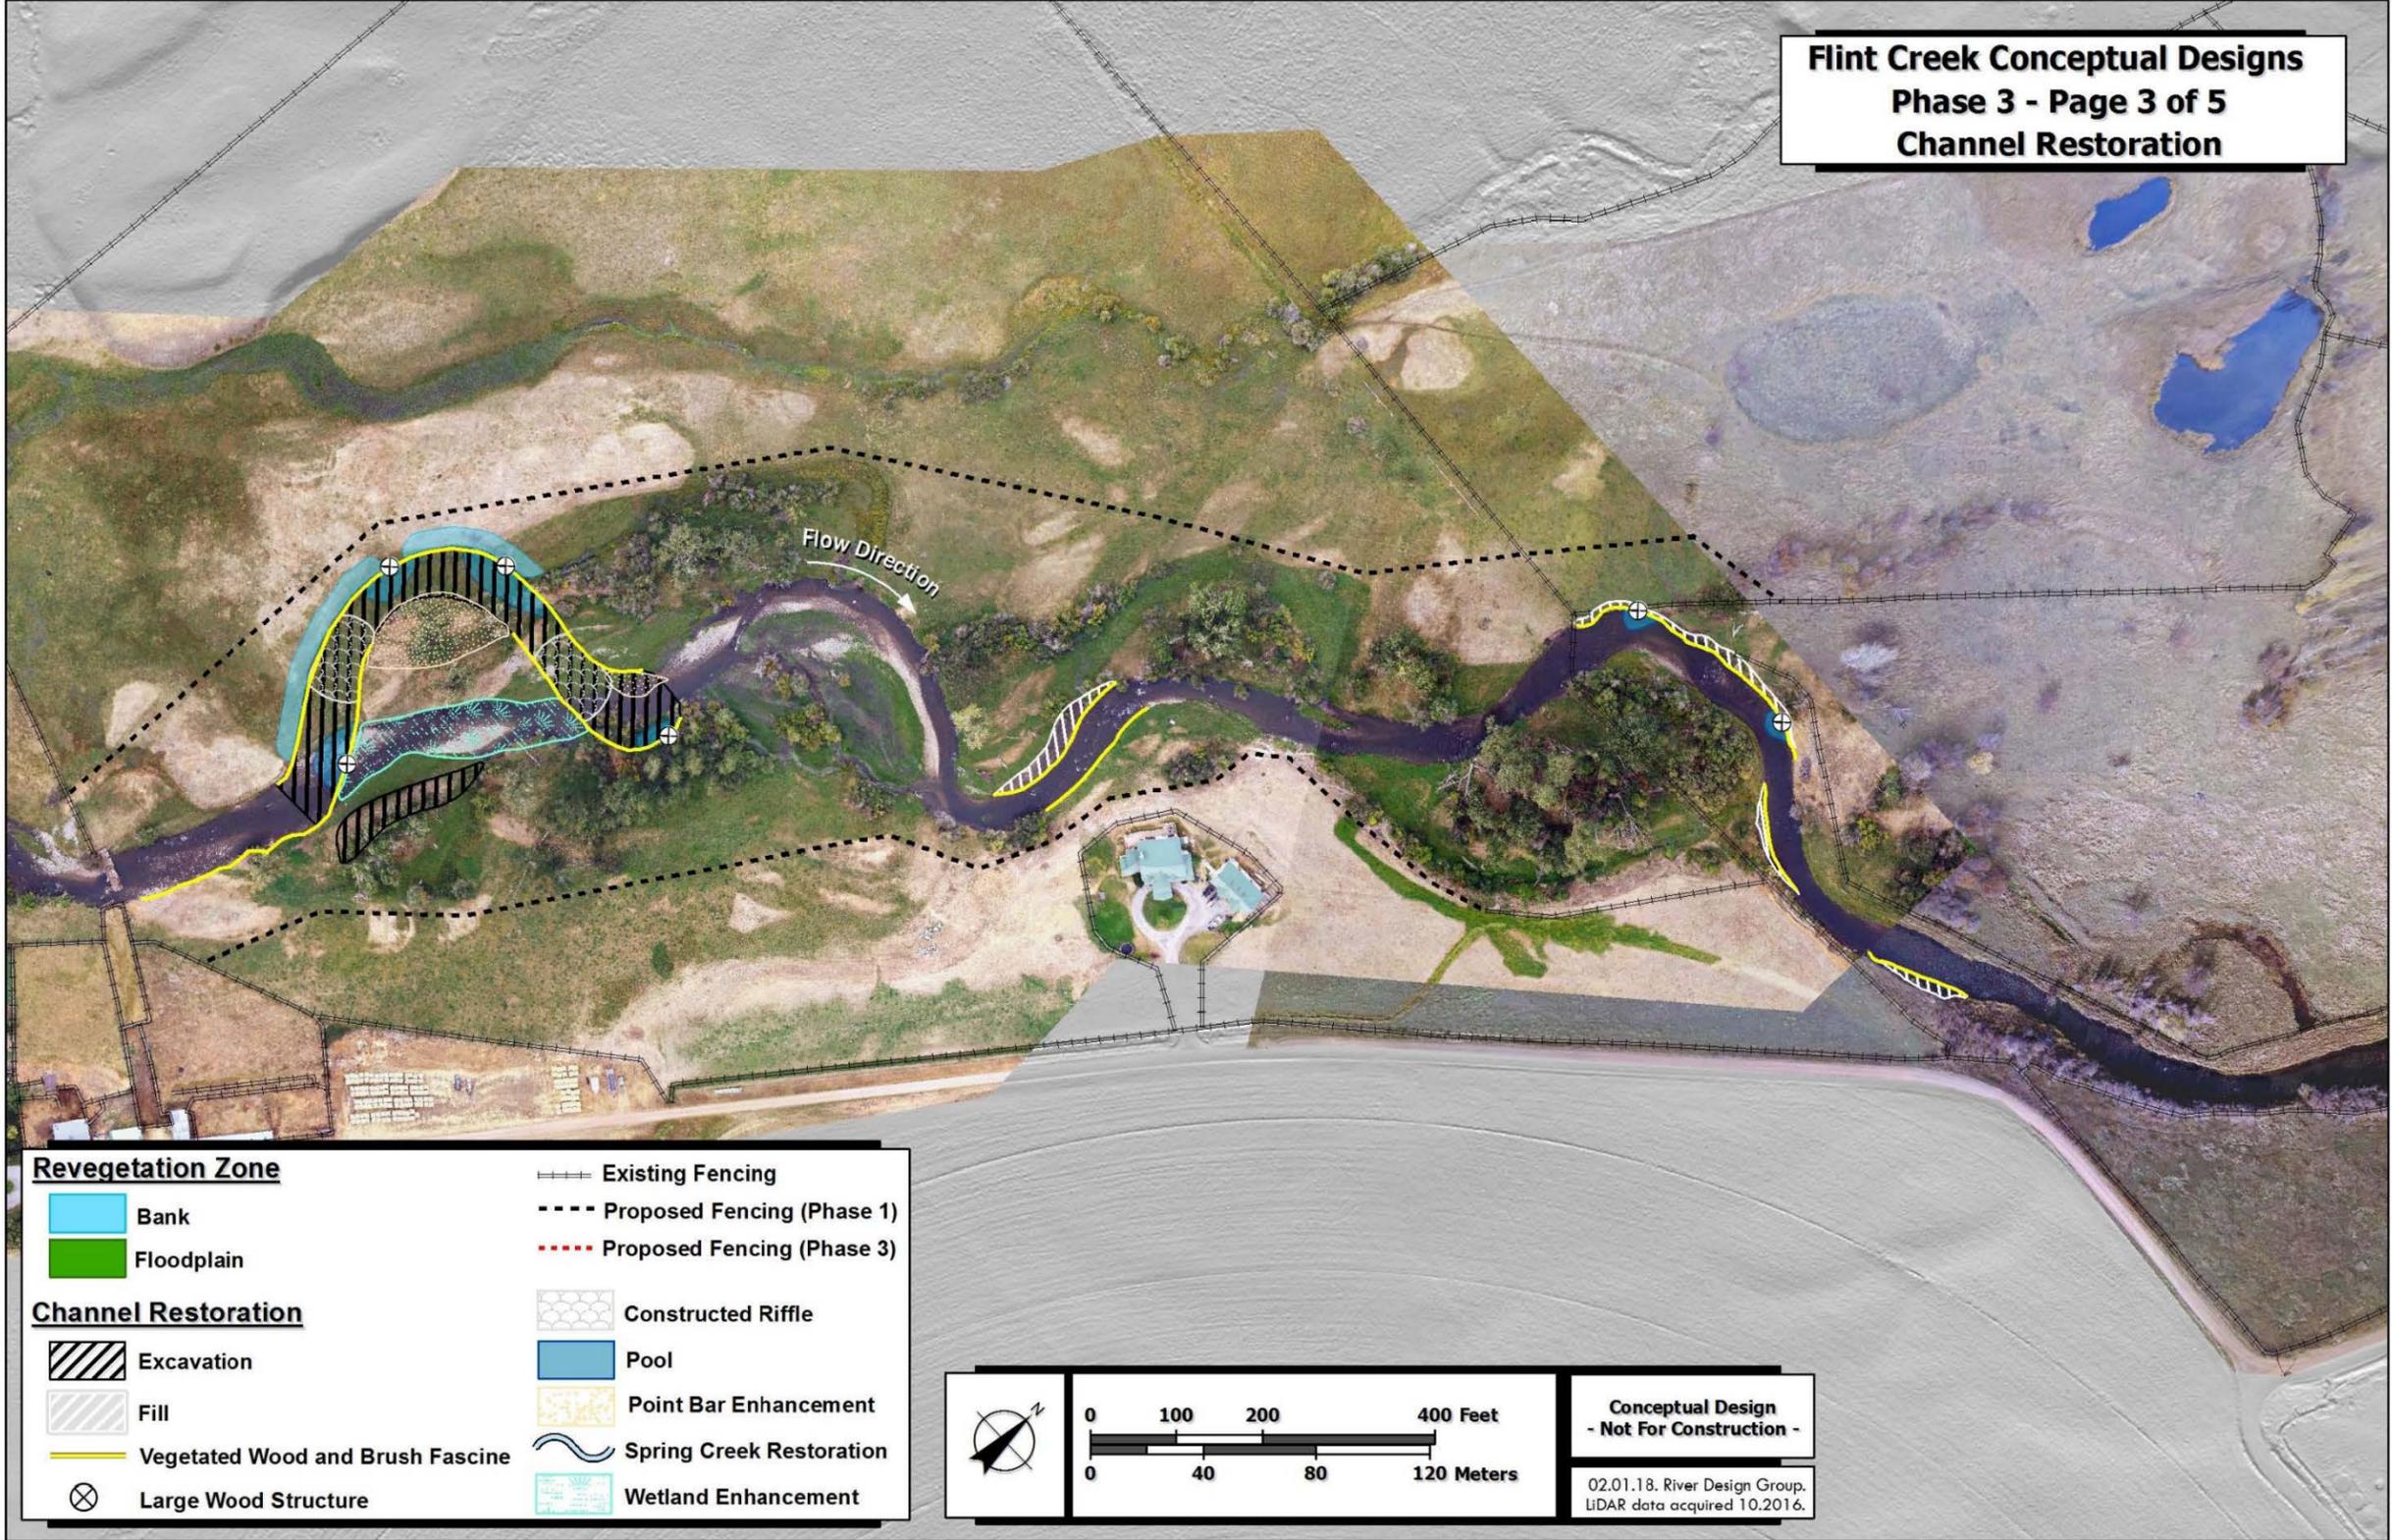
Figure 10. Conceptual channel restoration plan for the lower Flint Creek project area.

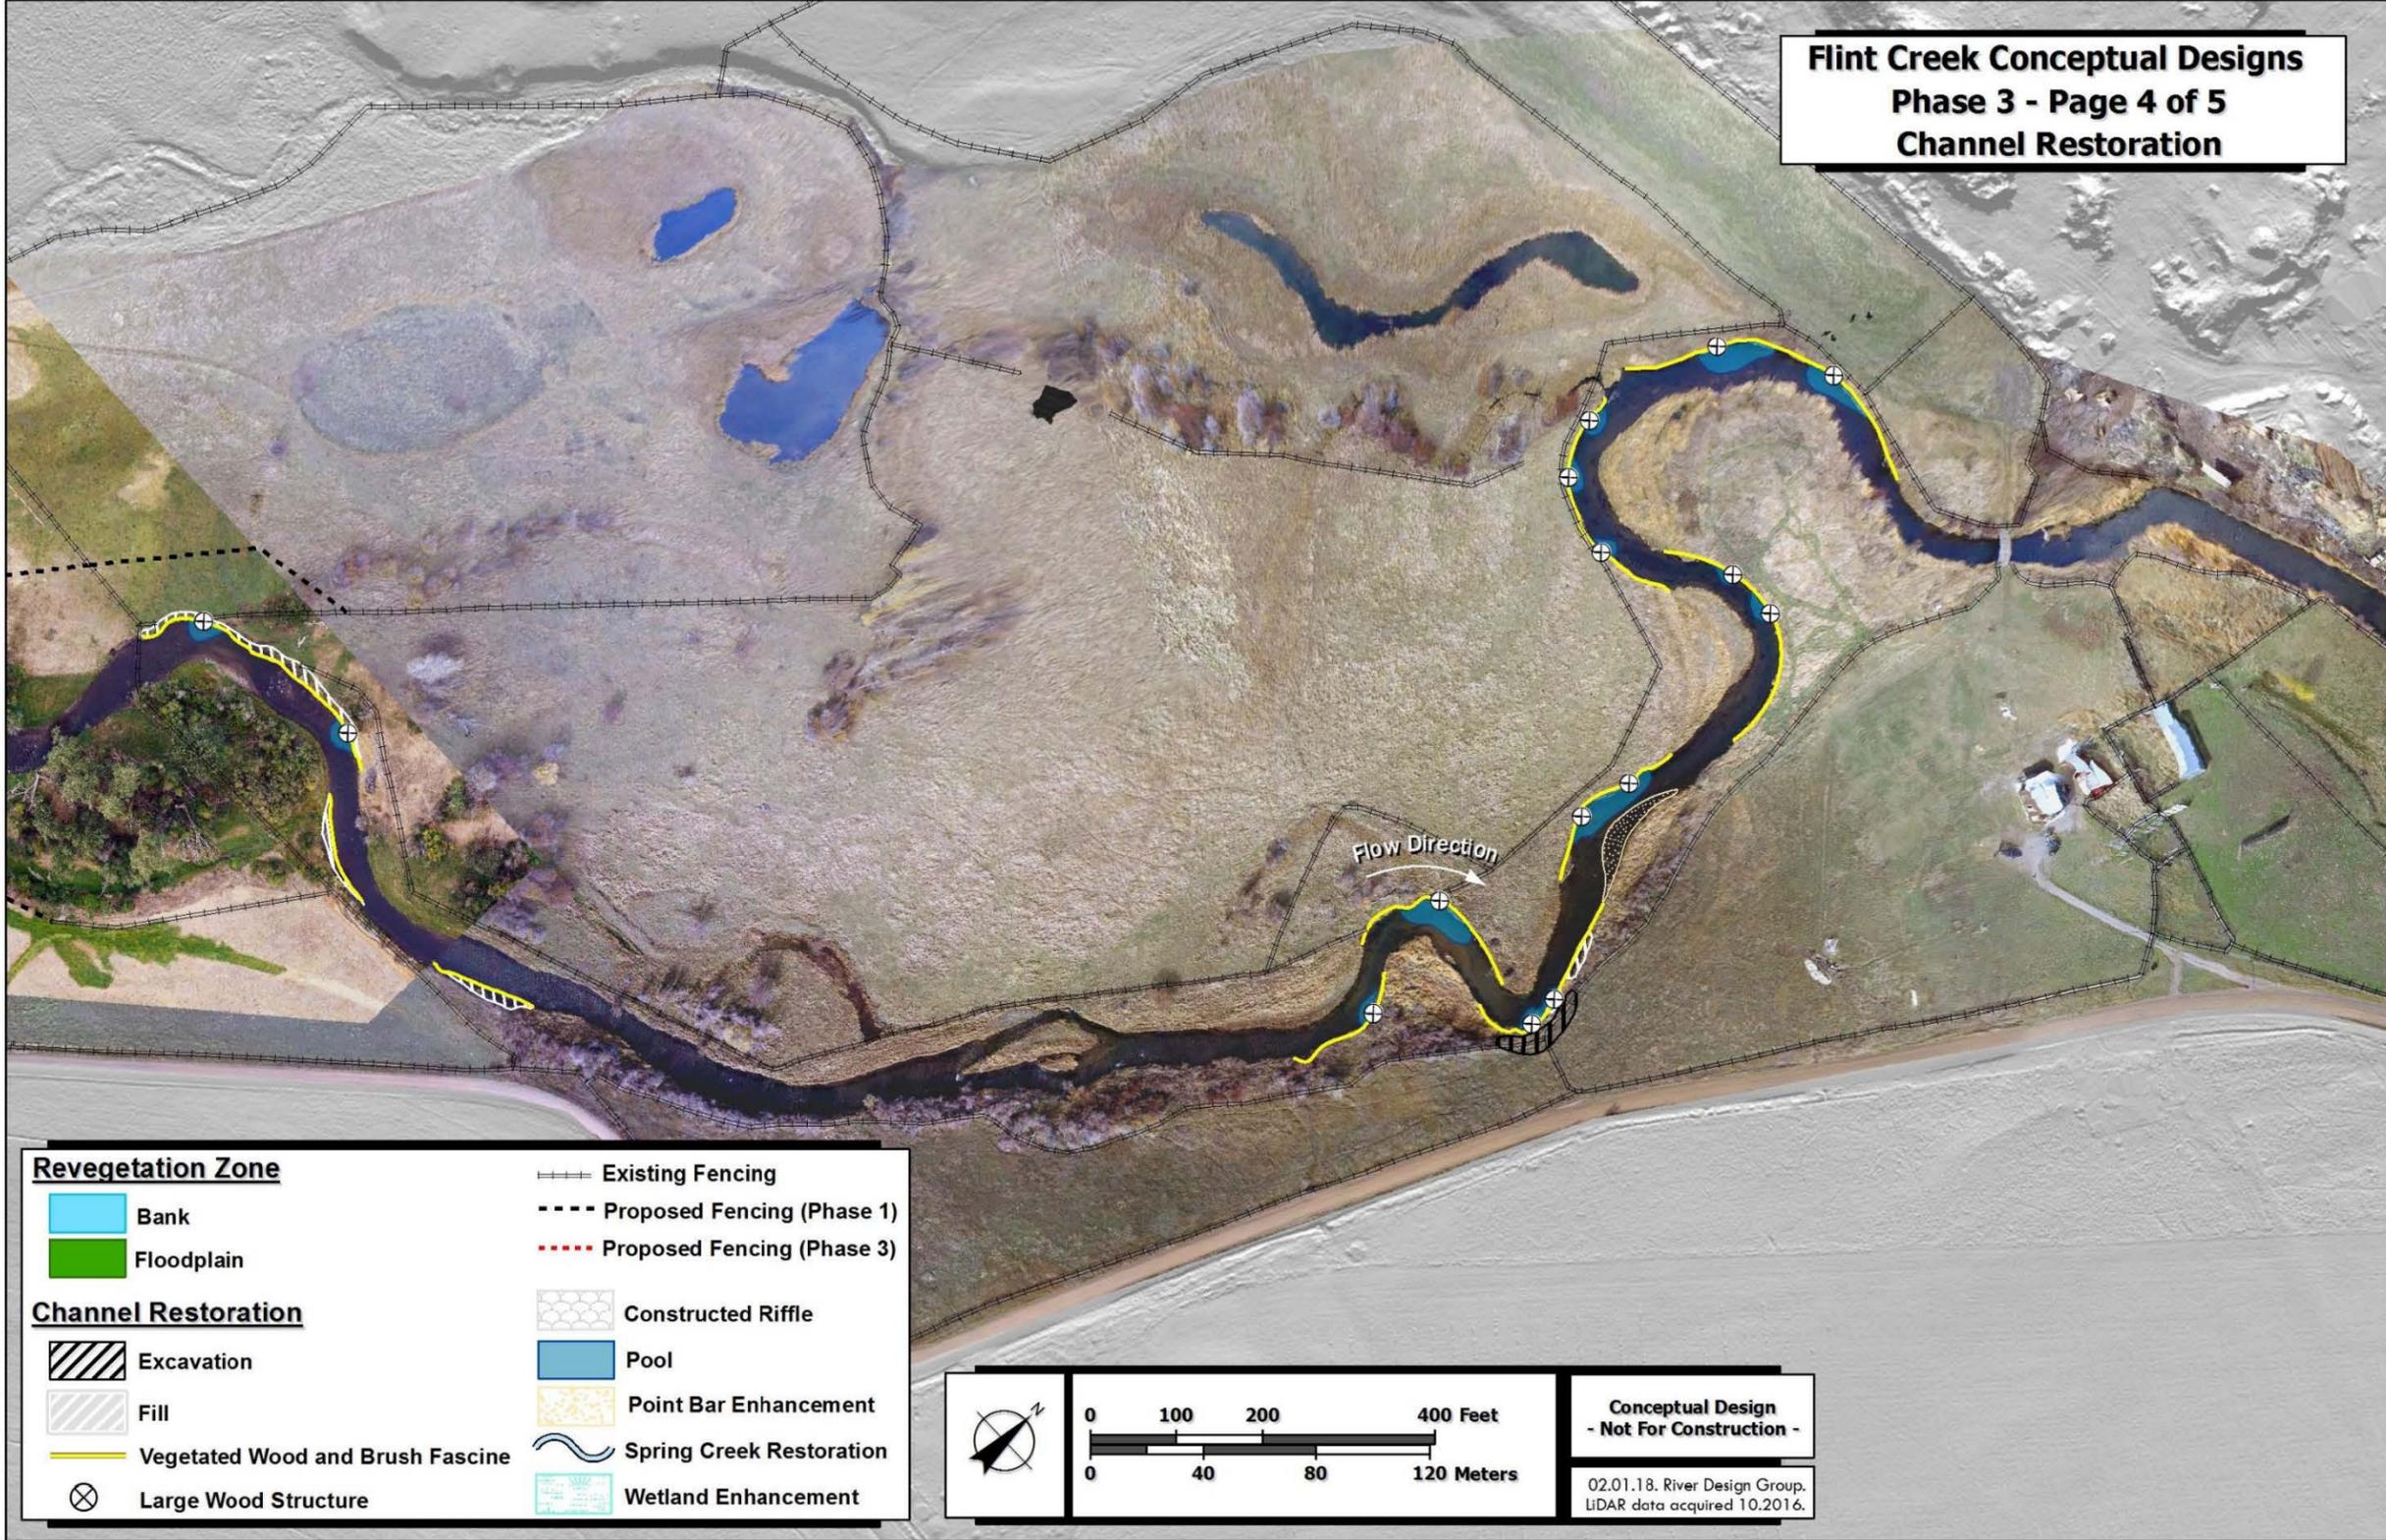
Figure 11. Conceptual channel restoration plan for the lower Flint Creek project area.

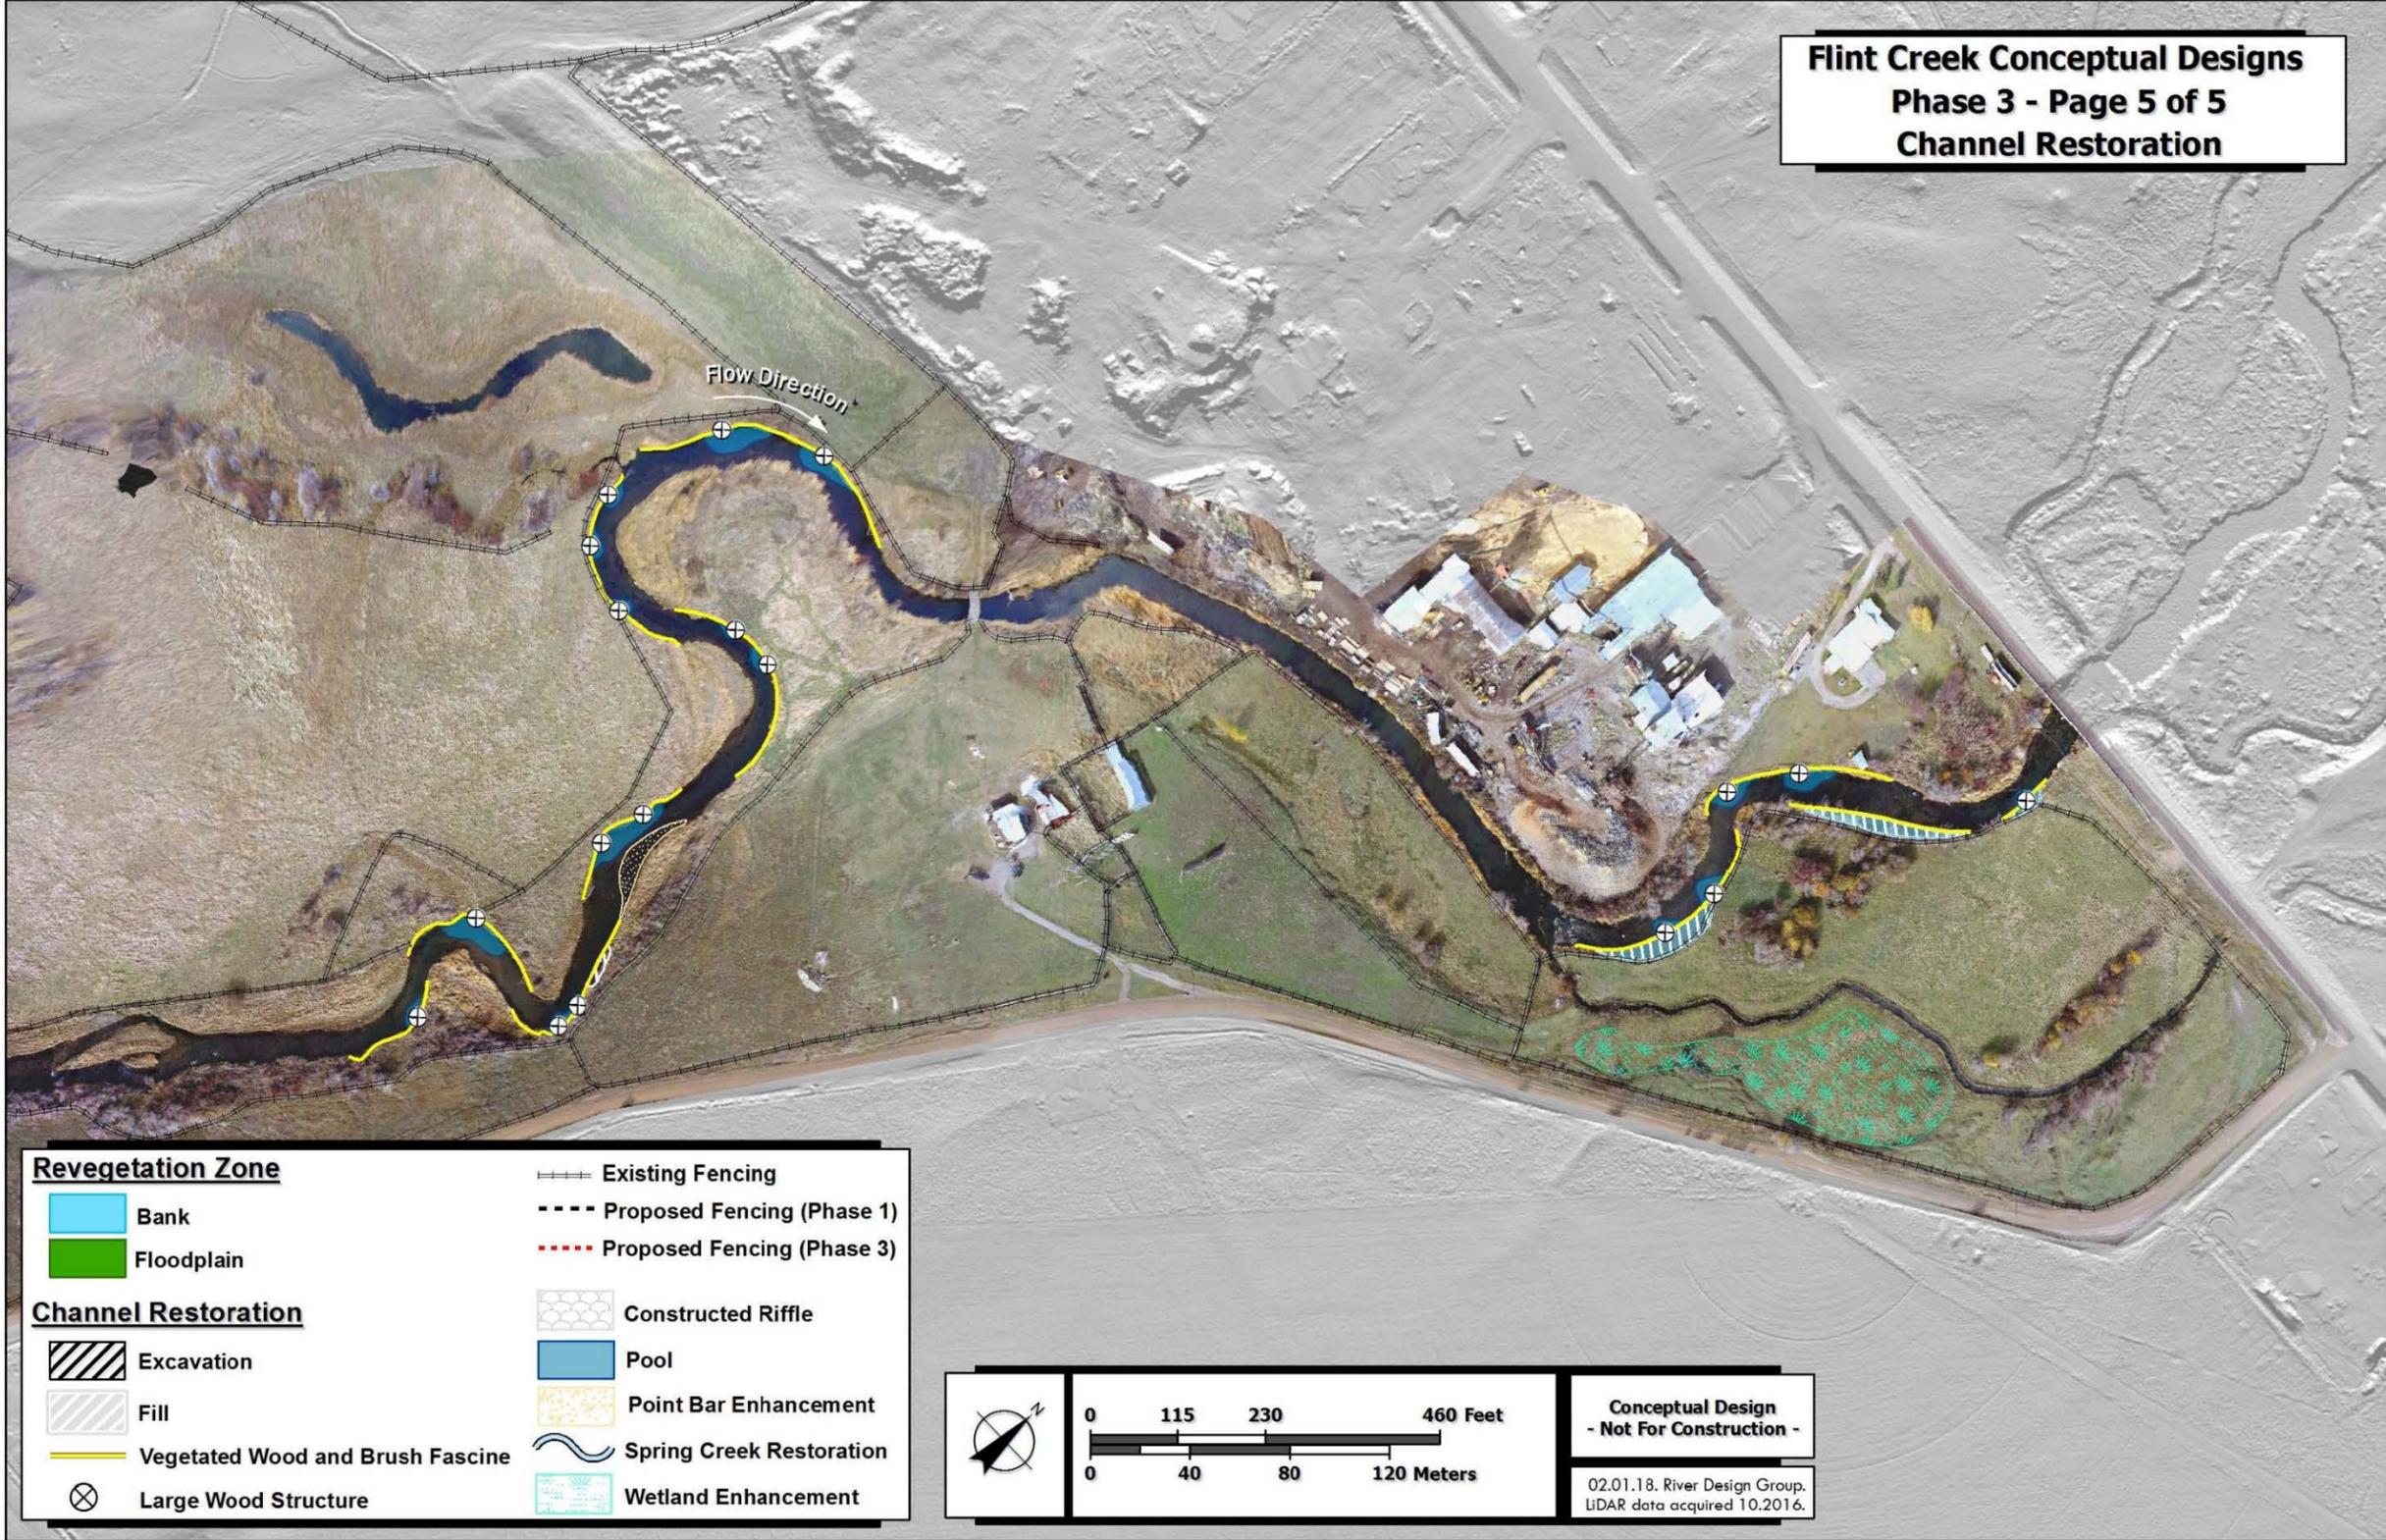
Figure 12. Conceptual channel restoration plan for the lower Flint Creek project area.

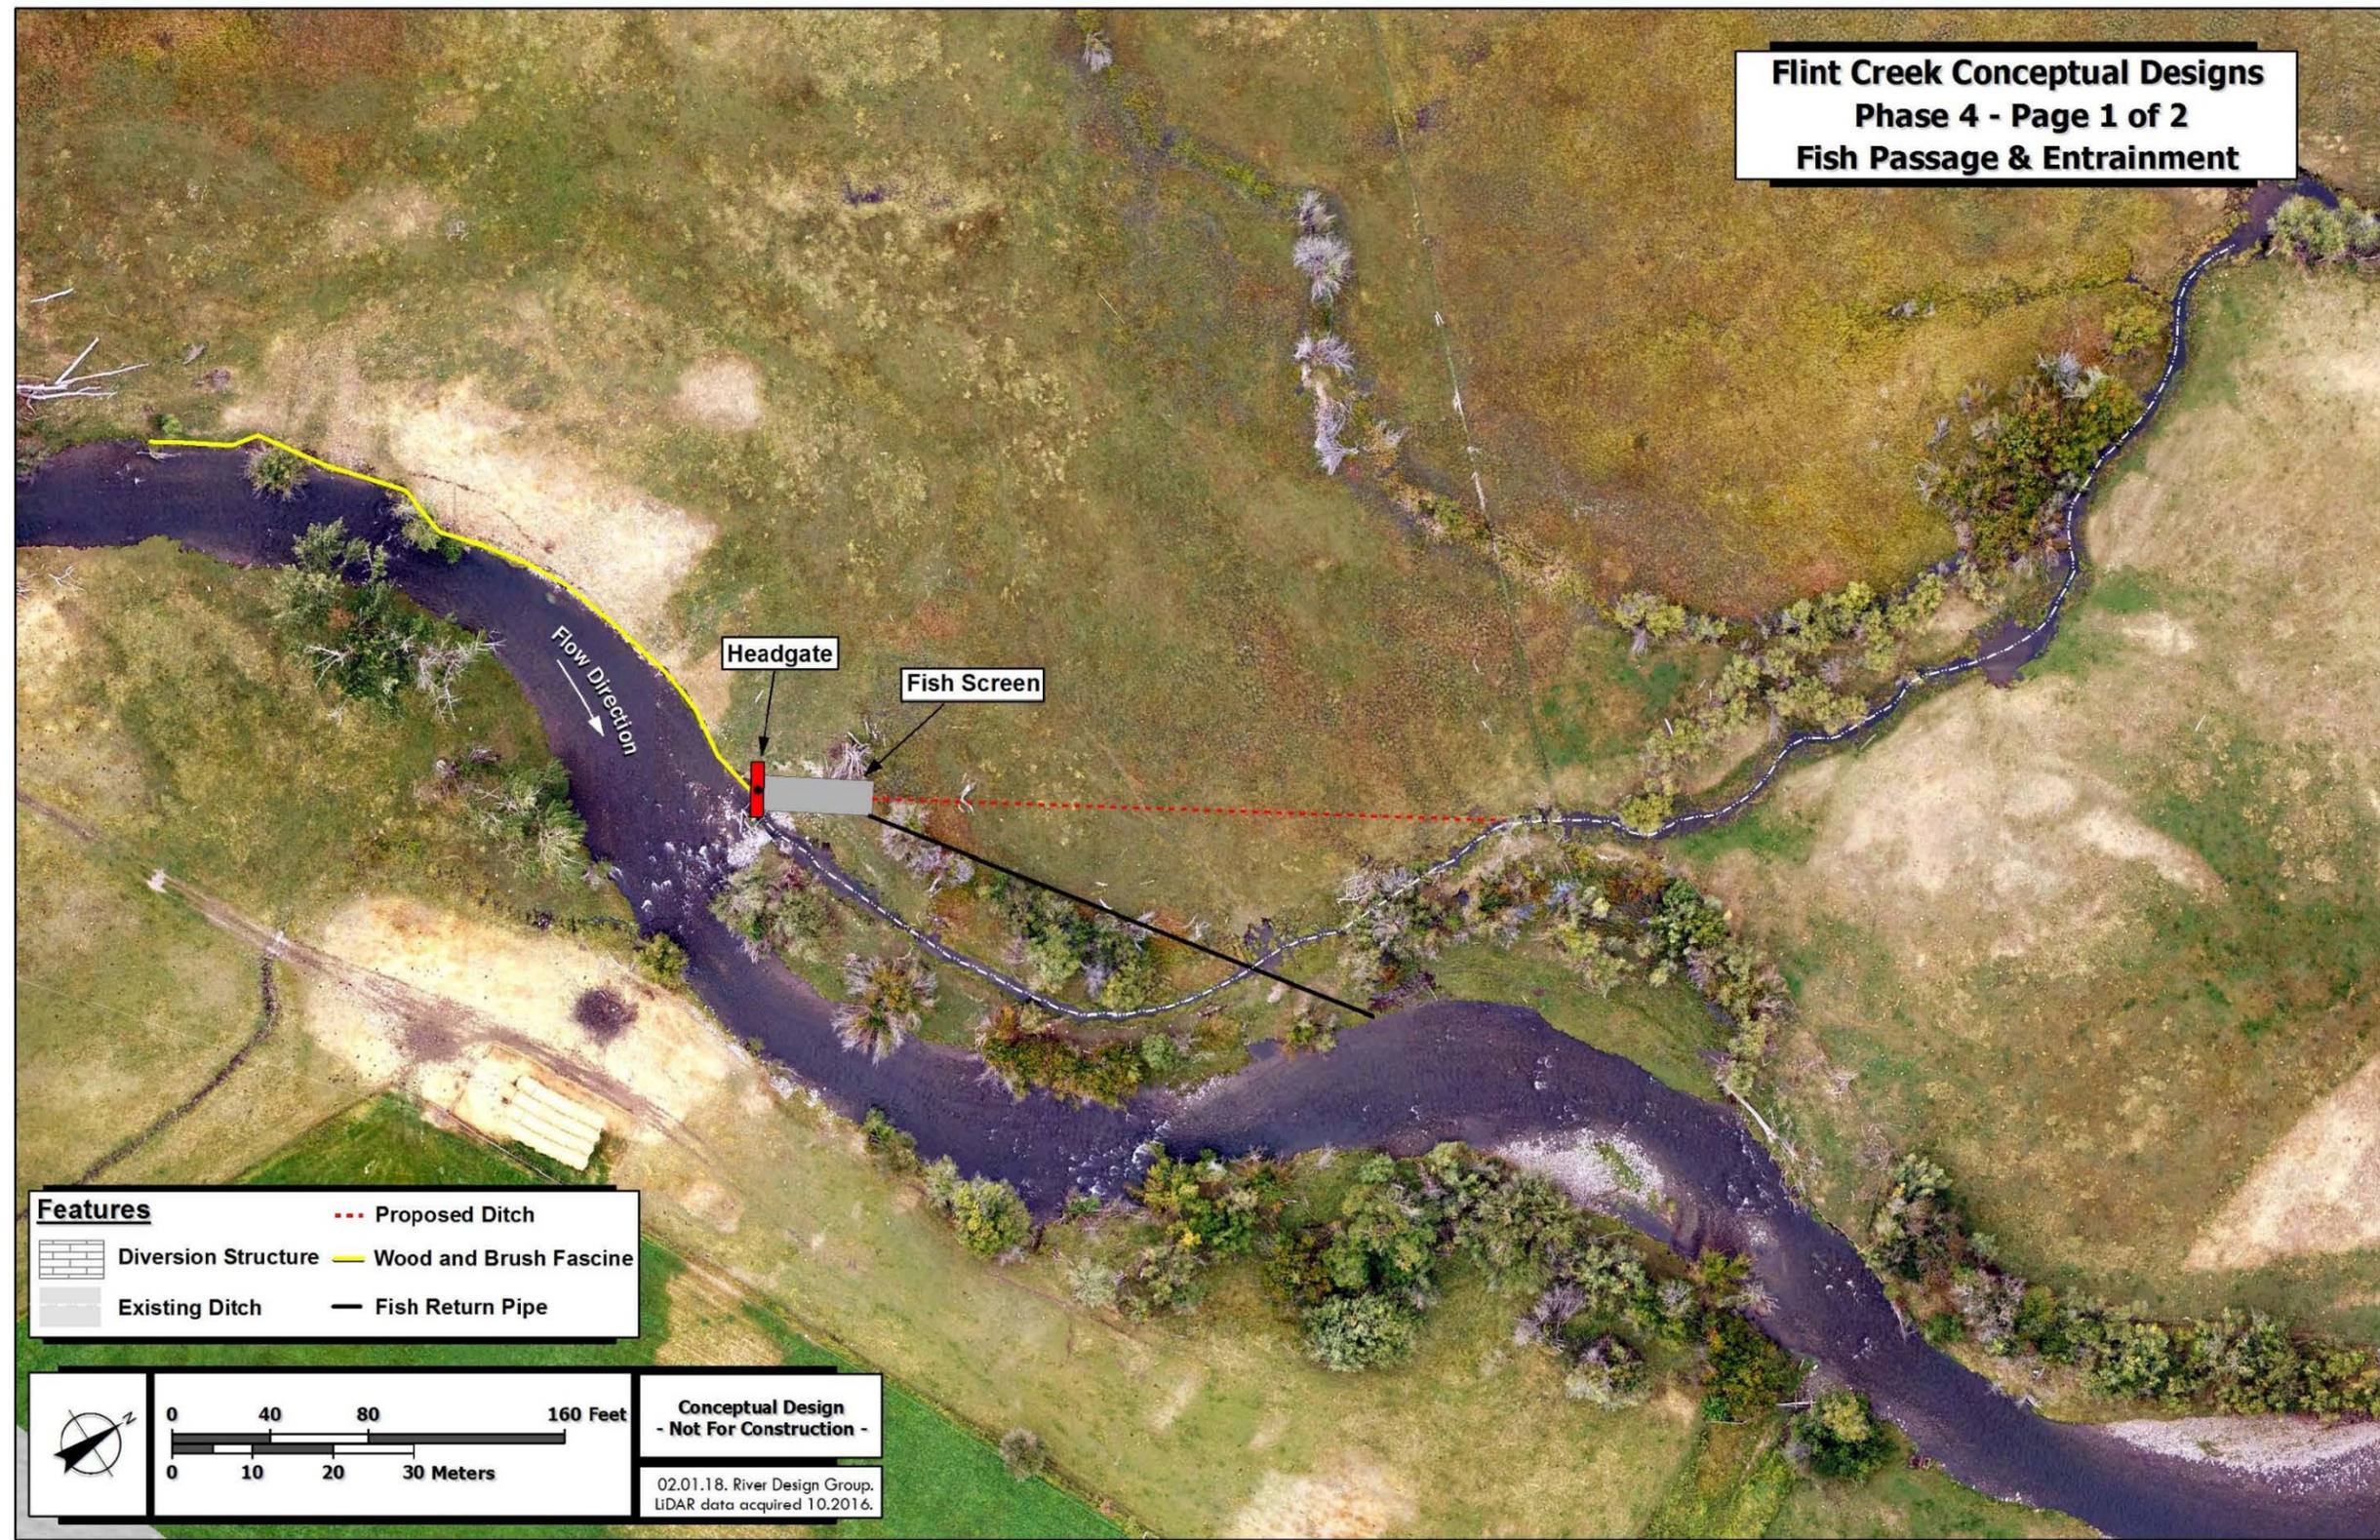
Figure 13. Conceptual fish screen plan for the Johnson property in the lower Flint Creek project area.
