RE: Trout Unlimited 319 Funding Request for Flint Creek Riparian Restoration

Project Name Flint Creek Riparian Restoration

Flint Creek Assessment and Conceptual Design Report

Near Hall, Montana

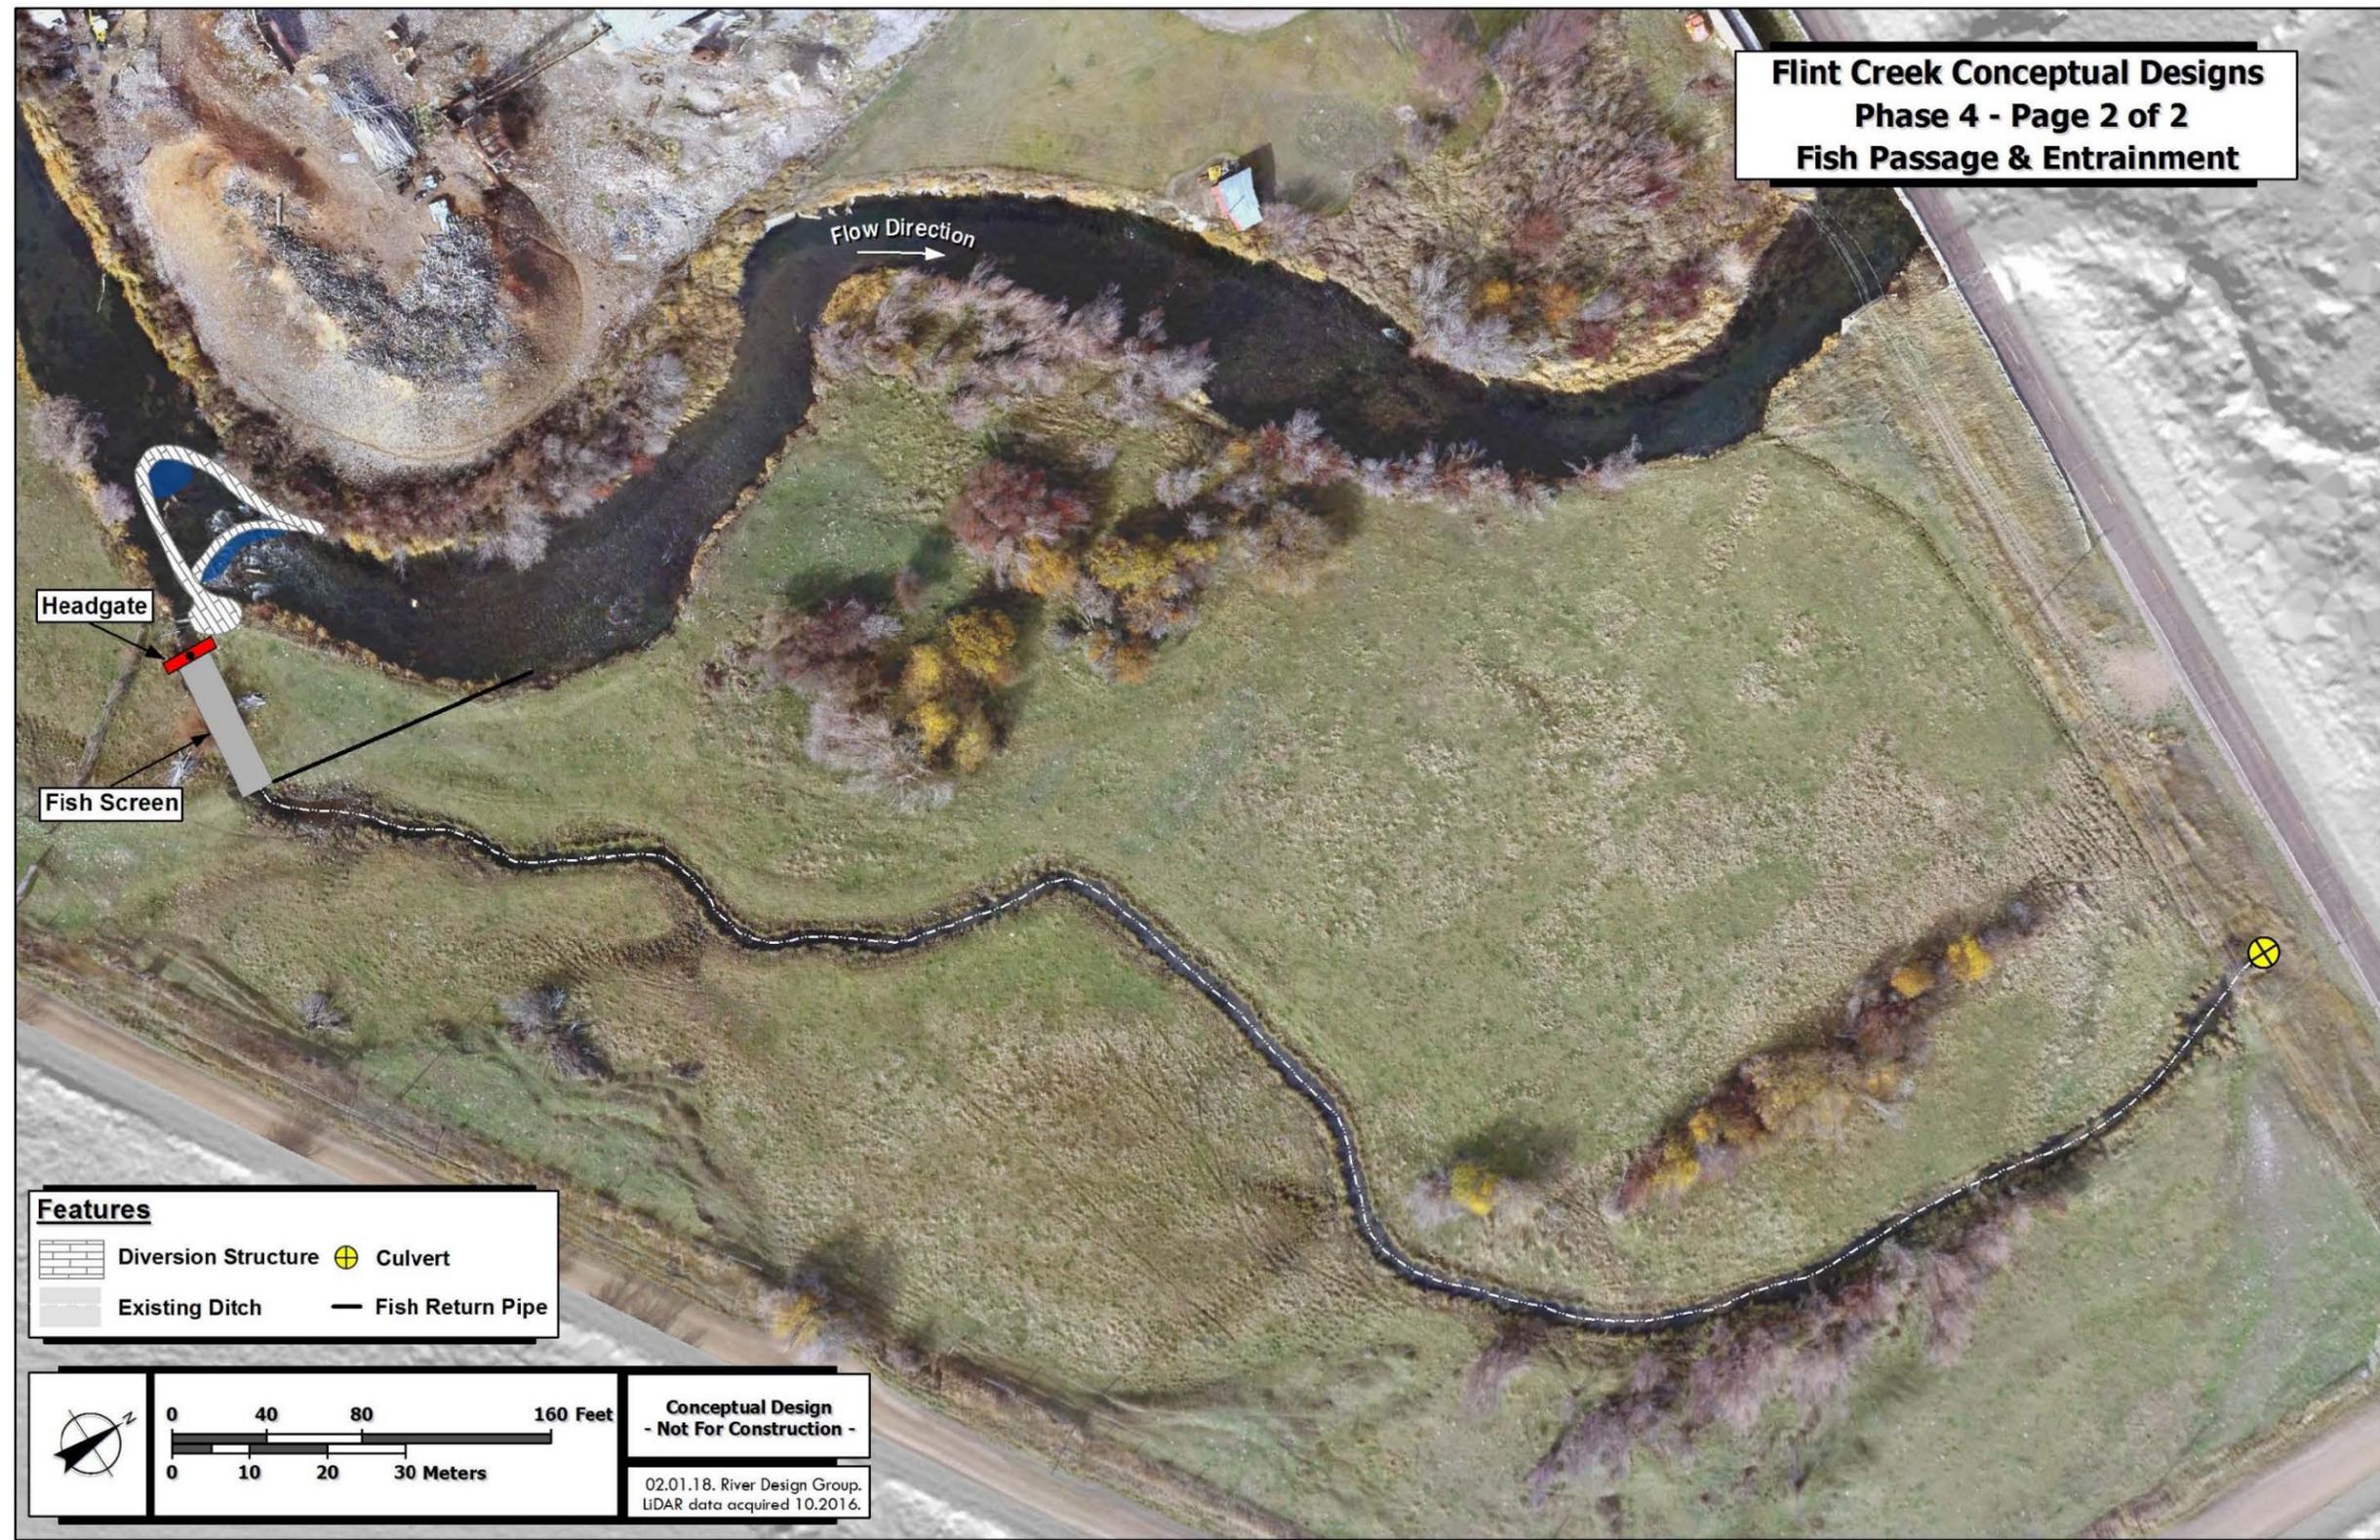
Figure 14. Conceptual fish screen plan for the Corbett-Downs property in the lower Flint Creek project area.
