# Bitterroot Watershed Restoration Plan

Bitter Root Water Forum

1/6/2020

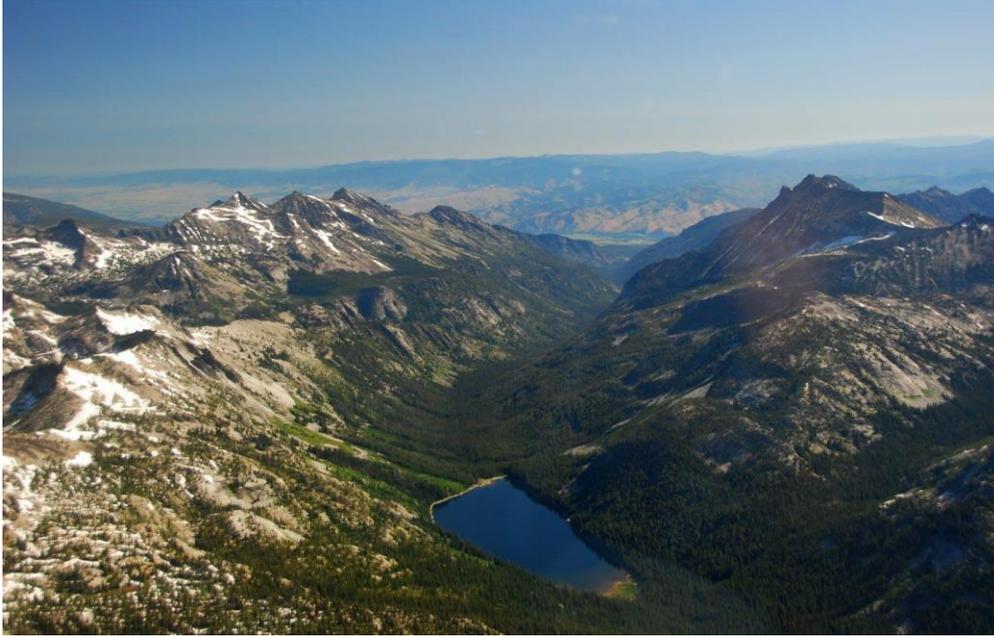
*Figure 7: View of high glaciated mountains with alpine ridges and lower elevation lake basin from above Tin Cup Lake/Reservoir. Tin Cup Lake is a natural lake that has become much larger in size because it has been dammed for water storage.<sup>14</sup>*

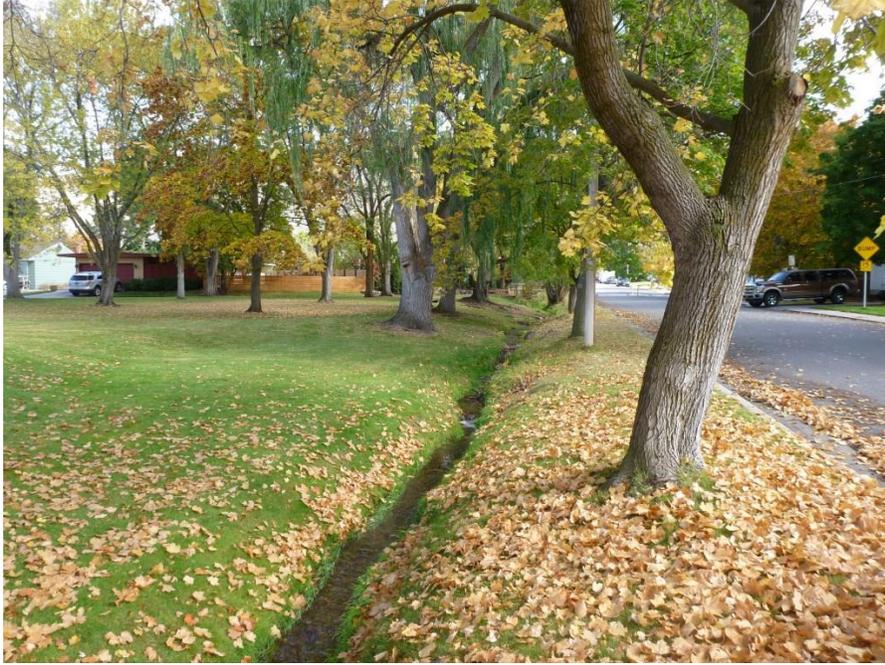
Figure 11: Pattee Creek channelized through residential development

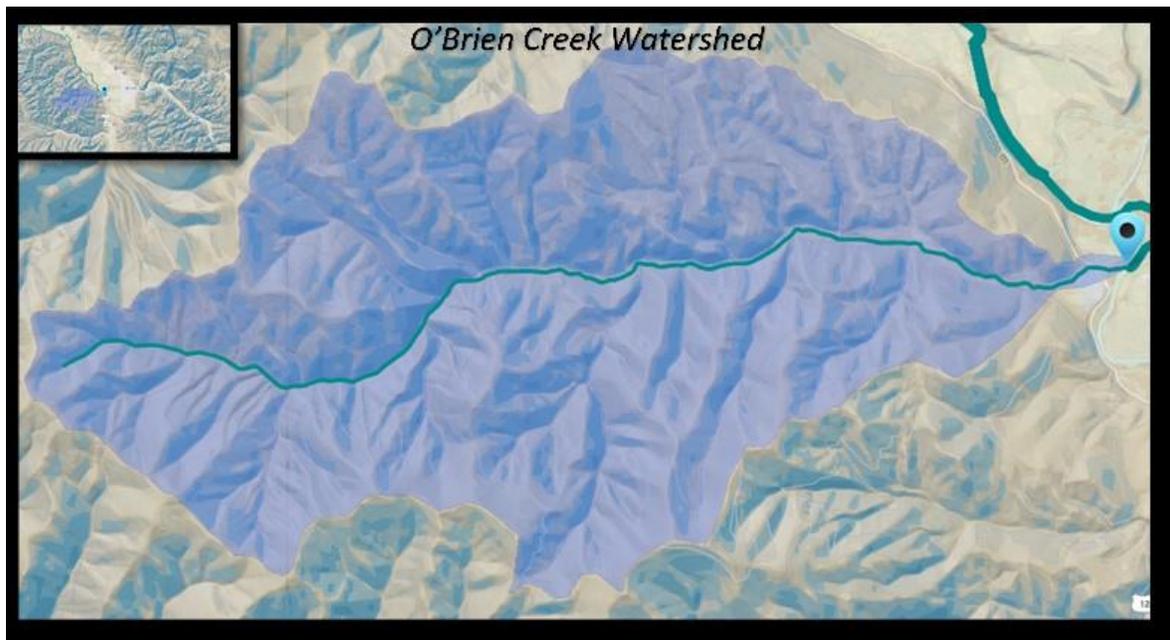
*Figure 13: O'Brien Creek watershed flowing east to confluence with the Lower Bitterroot River*

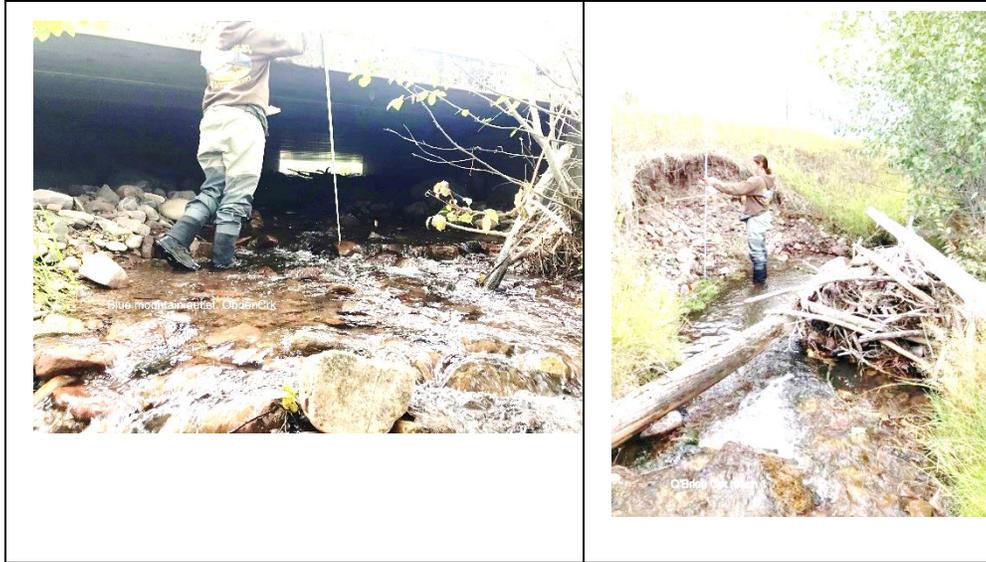
Figure A.9. Road crossing of O'Brien Creek at Blue Mountain Road and bank failure immediately upstream.

Reach 2 consists of the segment between Blue Mountain Road and the road crossing accessing O’Brien Meadow Subdivision. The crossing at the lower end of the reach at Blue Mountain Road is a 20’ wide concrete structure (Figure A.9). Stream substrates exist continuously throughout the structure, indicating that fish passage is likely possible at most flows. Additional morphologic assessment is necessary to determine an appropriate bankfull width; however, a reasonable estimate is 12-14 ft. As such, the road crossing span is likely meeting typical stream-simulation design criteria to accommodate at least the bankfull width. Flooding freeboard to accommodate large debris and bedload during large floods may be compromised. (Figure A.10).

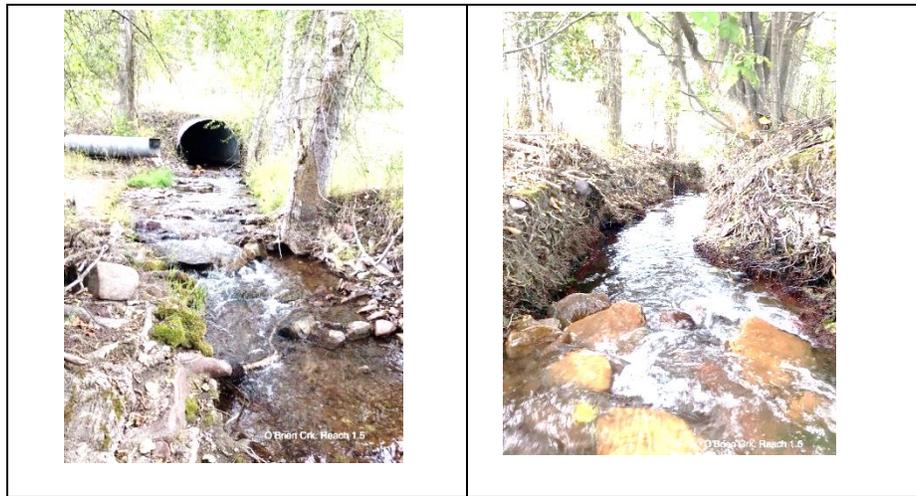
Figure A.10. Road crossing to O'Brien Creek Meadow Subdivision and critically undersized and actively downcutting segment downstream of the subdivision crossing and upstream of Blue Mtn. Rd.

Reach 2 is actively incising upstream of the Blue Mountain Road with significantly undersized channel capacity. Because of the low stream widths, stream depths are deeper and holding some fish.

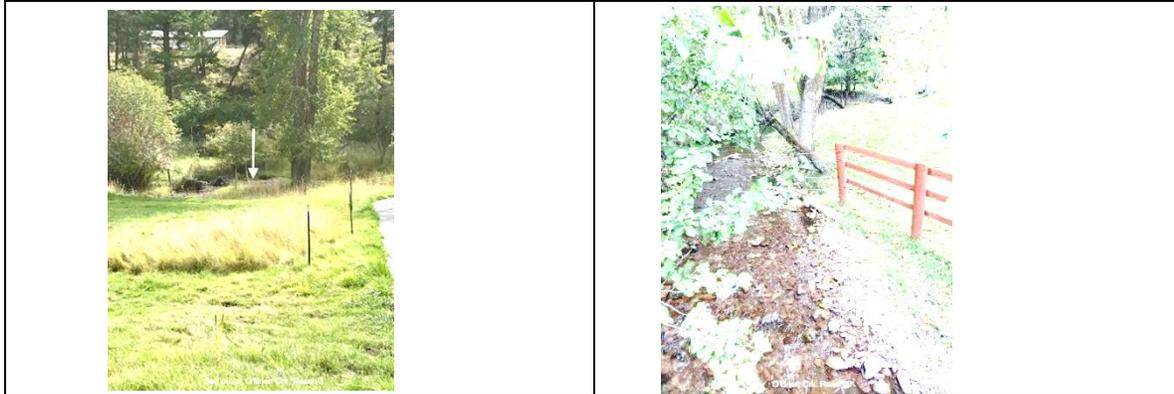
Figure A.14: Reach 4 - Pasture and maintained lawn section.

Reach 4 Summary: Riparian vegetation, instream wood, and pool habitat appear lacking. Land loss and sediment delivery does not appear substantive, but assessment is needed to verify.

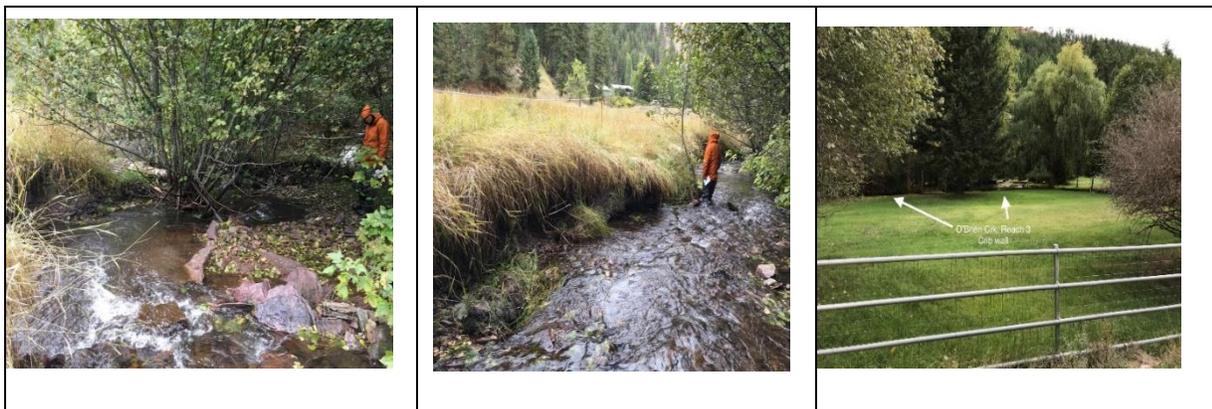
Figure A.15. Reach 5 – Private Land to Forest Service, public land boundary.

Reach 5 Summary: Lack of riparian vegetation in some segments with bank erosion and land loss present. One segment is substantively over-wide and shallow.

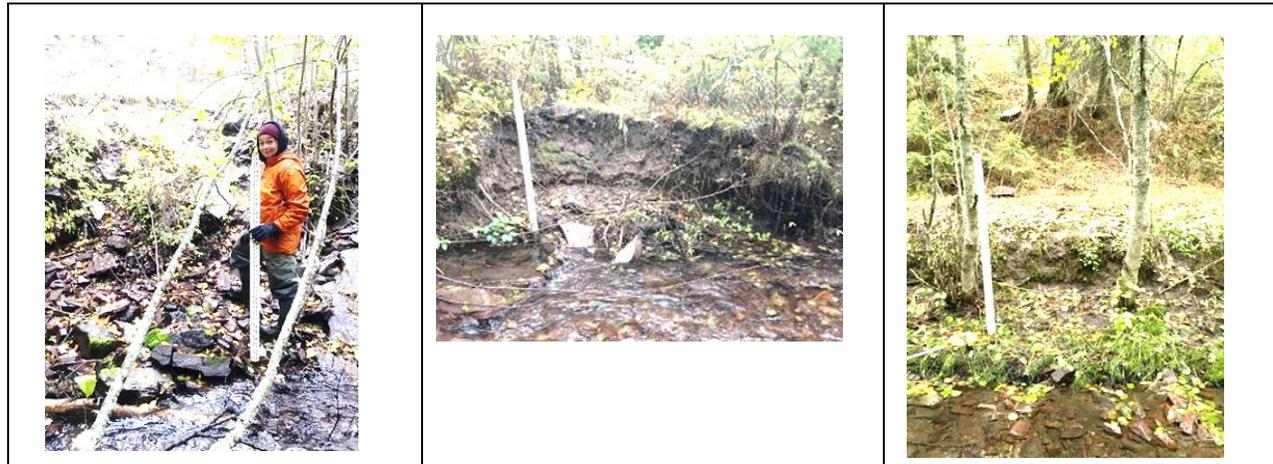
Figure A.16. Reach 6 – High bank erosion with some segments with low banks and floodplain connectivity.

Reach 6 is an approximately 640 foot beginning just upstream of the boundary between private and USFS. Evidence of beaver was noted, but there were no dams. Approximately 75 feet of the left bank is adjacent to the road. The creek area near the trailhead is heavily used by recreationists with a user created trail and bridge over the creek. Pool habitat is limited. Erosive banks are prevalent with heights up to 4 t. At least

two road fill failures are causing substantive sediment delivery. This segment appears near an old road bed or historic railroad prism. Average stream gradient is 1.7%.

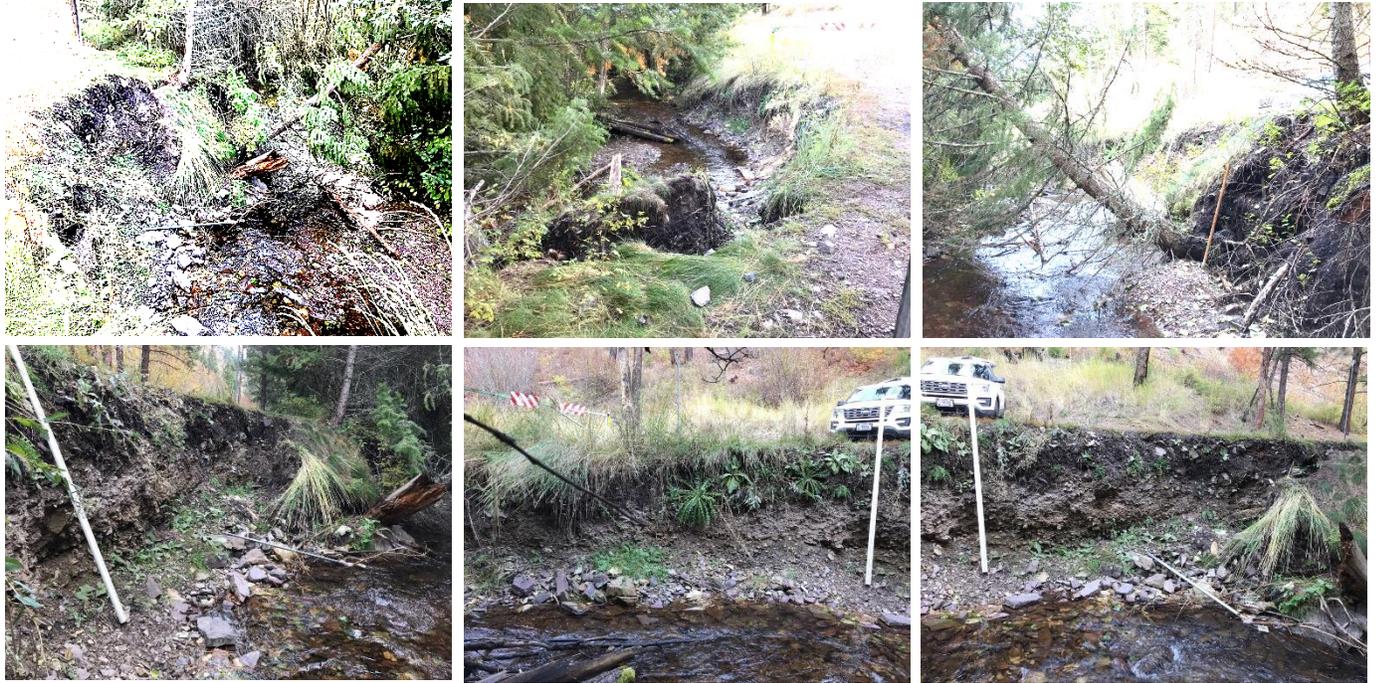
*Figure A.18: Reach 8 – significant bank erosion section along streamside Forest Road. No. 123.*

Road No. 123, a large road failure is actively slumping into O'Brien Creek. As of early October 2019, the dimensions of the sediment contribution from the slump were measured to be 54 x 6 x 6.2 ft (approximately 2,678 ft<sup>3</sup>). A newly fallen tree and road sign was in the stream. Parking is limited to one car, with 12 ft. road width and user-created turnaround off.

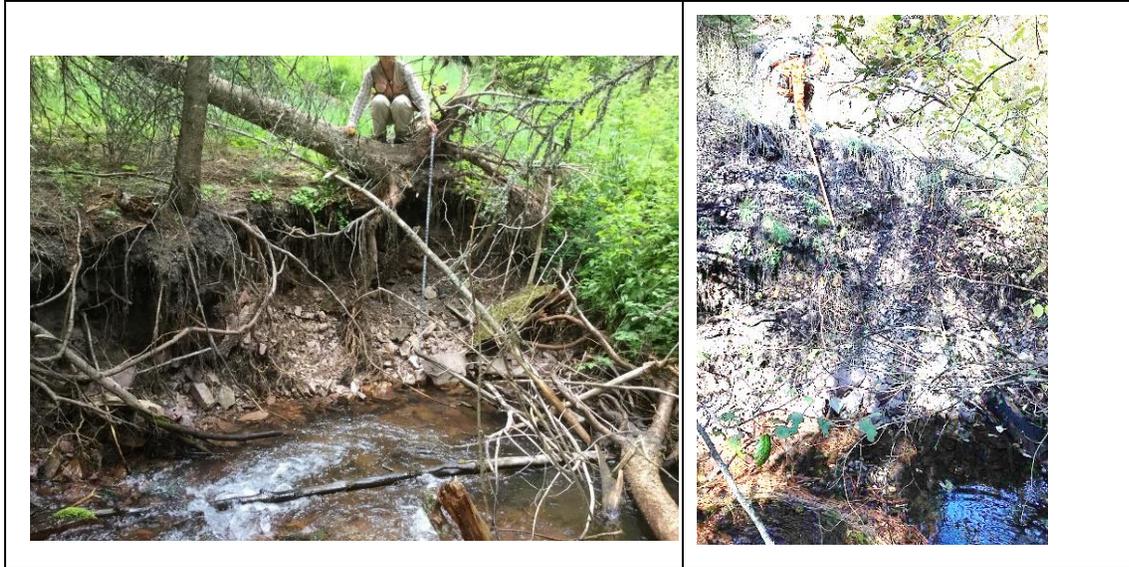
*Figure A.19: Road 123 (non-motorized trail) – Reach 8 – High erosive banks caused from likely historic channel manipulation and recovering stream adjustments.*

Above the upper Forest Service gate, Road No. 123, an old bridge crosses O'Brien Creek to decommissioned Road No. 19244. The bankfull width here is 10.2 feet. The bridge appears unsound with over widening at the inlet. Negative road and stream interactions continue upstream for several hundred feet with many road fill failures, bank erosion, and high sediment deliveries.

Reach 8 Summary: Significant departure from stable bankfull conditions, high bank erosion and land loss, channel incision, active head-cutting, loss of floodplain connectivity, lack of dense riparian vegetation, lack of pool habitat.

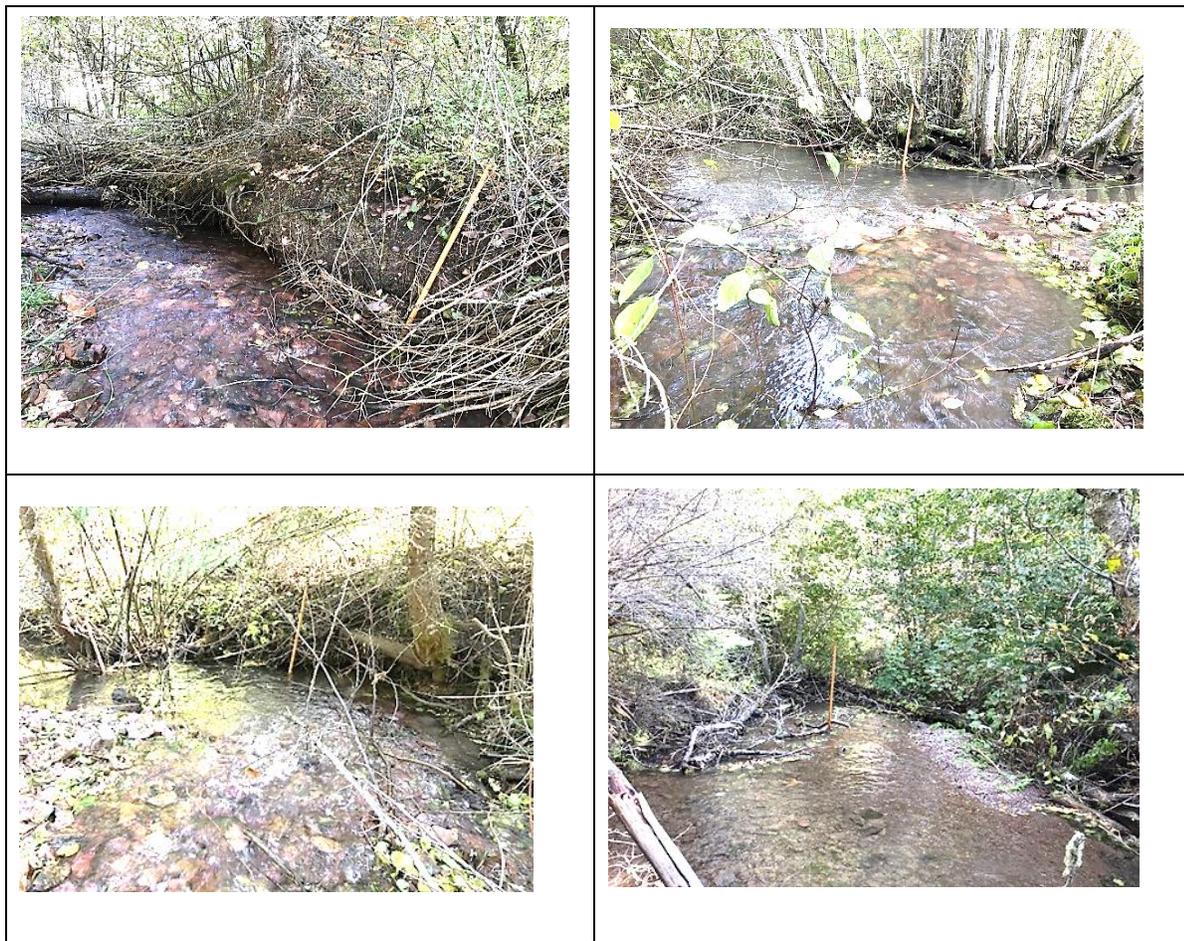
Figure A.21: Reach 9 – Bank erosion and aggradation present. Pool habitat and stream dimensions are more representative of stable channel conditions.

Reach 9 Summary: Erosive, high banks are typical of the reach. Some meander bends exist, resulting in deep pools and larger fish observed. 1-2 miles above this reach there is a historic canal-like structure that is thought to be the upper extent of historic channel manipulation. More reconnaissance is necessary.

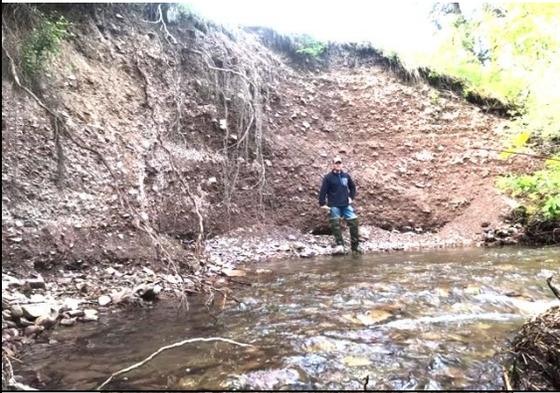
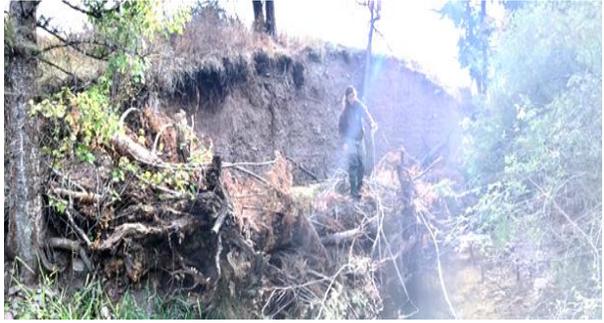
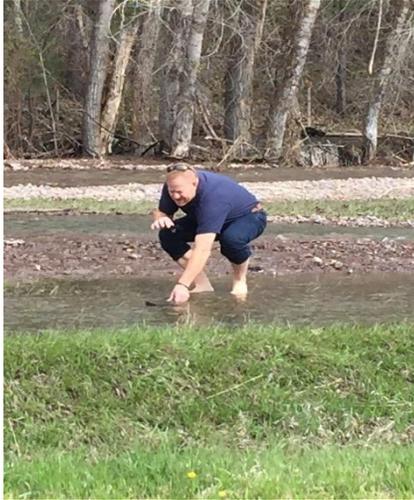
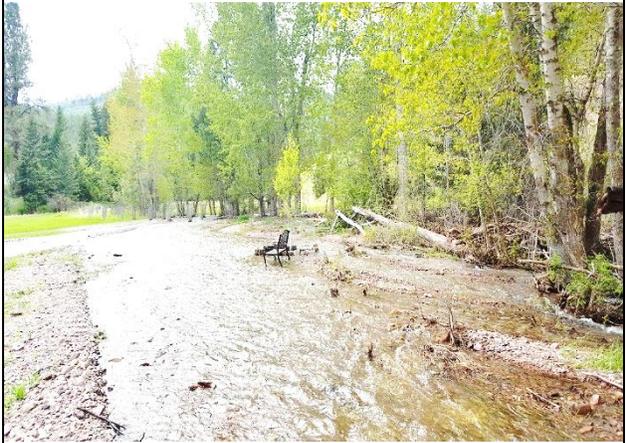
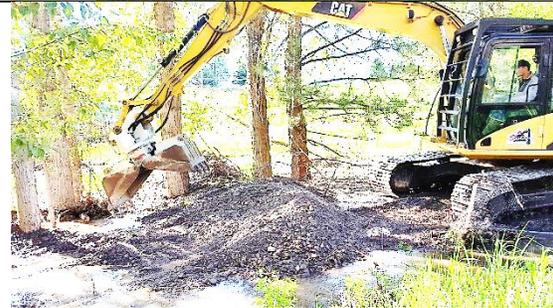
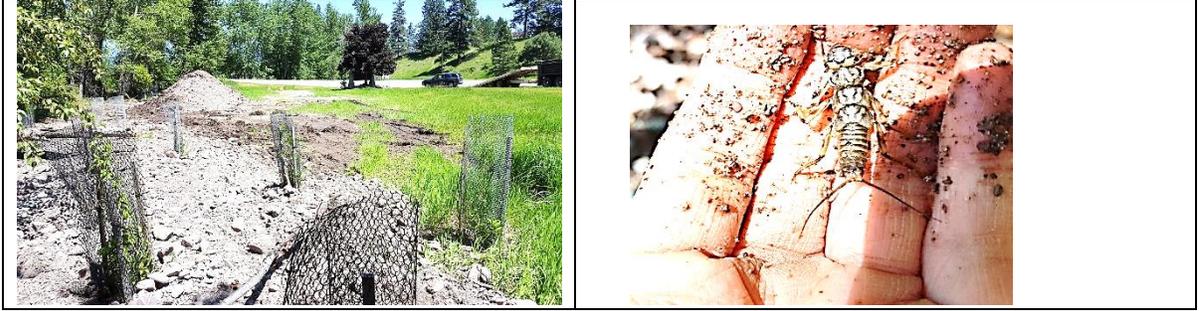
*Figure A.23. Reach 3 - 2019 Emergency Channel Remediation conducted by O'Brien Creek HOA with tree donation from Hillsdale Estates. Mass failure and temporary remediation with large tree toe protection; salvage of large rainbow trout and macroinvertebrates.*

2019 Post-flood remediation at O'Brien Creek Road crossing included removal of substrate deposition, returning stream to existing channel, re-grading channel, and placing large trees at the base of the mass failure side to temporarily reduce undercutting and risk of more failure until appropriate channel design and rehabilitation can occur. There was fish salvage of a large rainbow trout trapped in the meadow grass during the avulsion. The O'Brien Creek HOA hired a specialized articulating excavator with clam-shell to carefully extract stream bed deposition with minimal channel disturbance per 310 permit requirements.
