Beaverhead Sediment Total Maximum Daily Loads and Framework Water Quality Protection Plan

July 2012

Water Quality Planning Bureau
Watershed Management Section

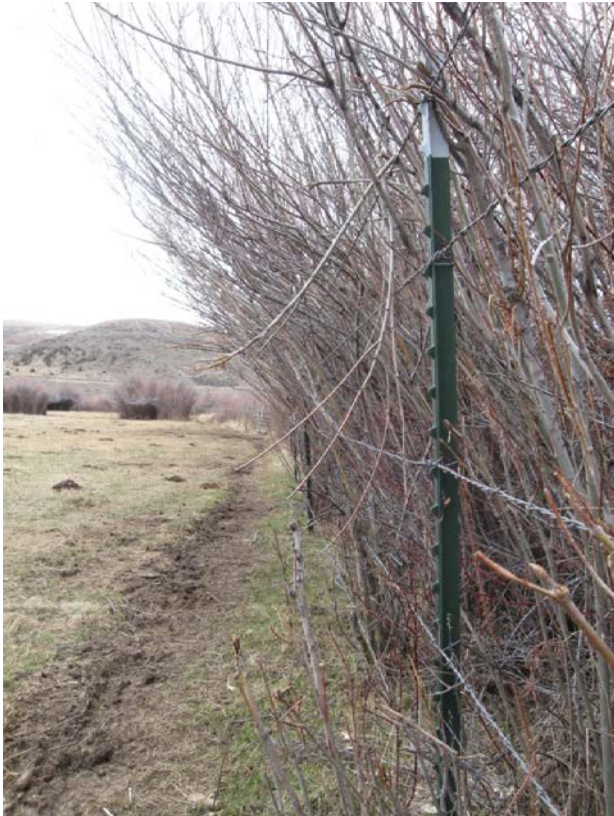
In 2011, DEQ performed two cross sections at two monitoring sites on the upper segment of the Beaverhead River. The upstream site (BEAV 04-02) was located on the Clark Canyon Ranch just downstream of the HWY 15 overpass. Stream channel conditions at the reach included landform confinement and subsequent braiding when the channel opened, with several oxbows and back sloughs observed. There was some embedded cobble and few fines. Stream channel measurements at the reach resembled Rosgen type C4. Bank erosion at the reach was minimal, because of heavily vegetated riparian areas. A good portion of the riparian area was fenced-in and included water gaps, with evidence of heavy livestock grazing just outside of the riparian area adjacent to the fencing (**Figure 5-2**). The

fencing has allowed the riparian area to develop quality vegetation dominated by sandbar willow, sedge along the water's edge, wetland grasses, rose, and currant.

Figure 5-2. Heavy willow browse outside of fenced riparian area

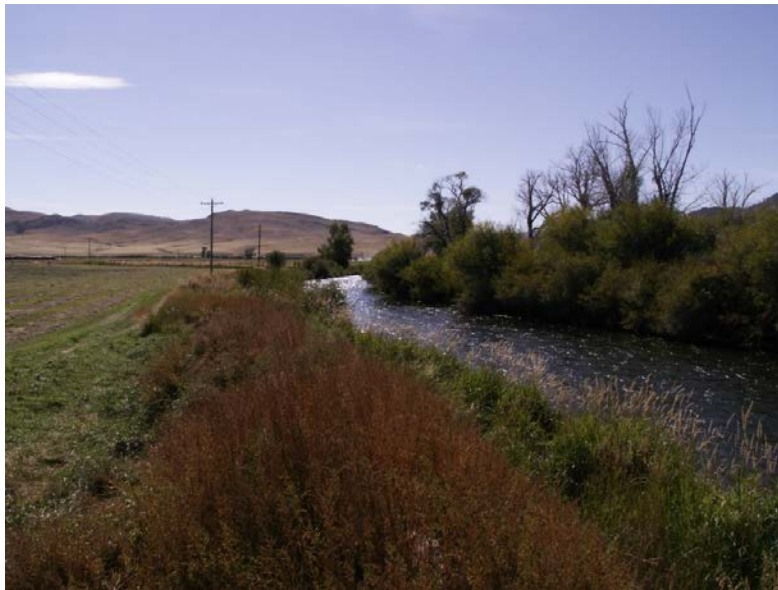
East Bench Canal Diversion off of Old Stage Rd. Stream channel conditions at the reach included a berm on river right from past channel manipulation and recent deposition of fill at the water's edge, with additional channel and flow manipulation for field irrigation. Stream channel measurements at the reach resembled Rosgen type C4. Within the sample reach, a layer of fines covered the gravel and cobble substrate and the reach had minimal pool habitat. Bank erosion at the site was minimal, where sandbar willow held the banks together. However, the lower quarter of the reach had some localized erosion where there was no fencing to keep grazing out of riparian area. The vegetation on river right, located next to cropland, was composed of mostly reed canary grass. Whereas the vegetation on river left, which had the riparian area fenced off from grazing and included a water gap, had high willow cover, sedge on the water's edge, grass ground cover, and decadent cottonwoods (**Figure 5-5**).

Figure 5-5. Difference in riparian cover on river right and left (BEAV 09-04)

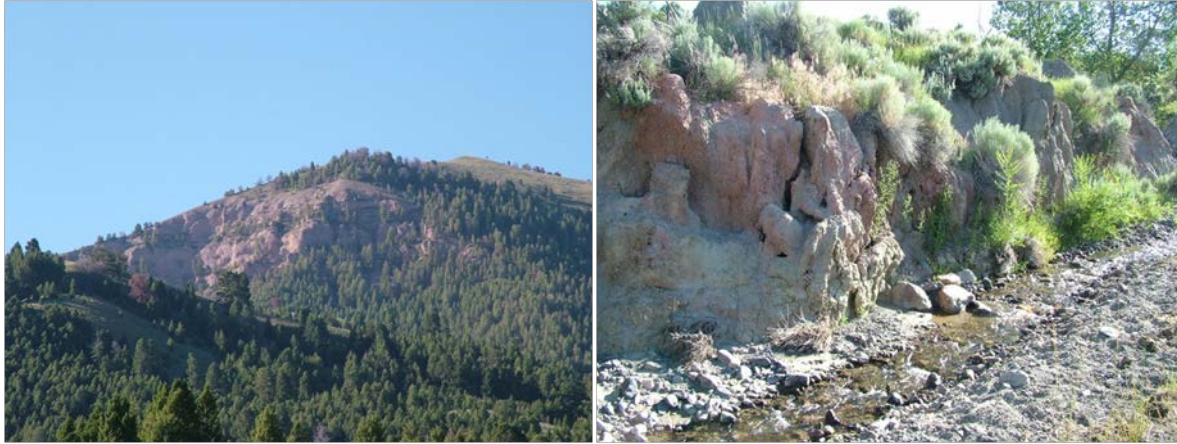
surface protection. The bank composition was made up of fines with some cobble interspersed. The actively eroding banks were lower and had evidence of hoof shear. Banks had minimal vegetated cover, mostly grasses and invasive weeds. Clark Canyon Creek had significant natural upland sediment sources (**Figure 5-8**).

Figure 5-8. Natural upland sediment sources in Clark Canyon Creek

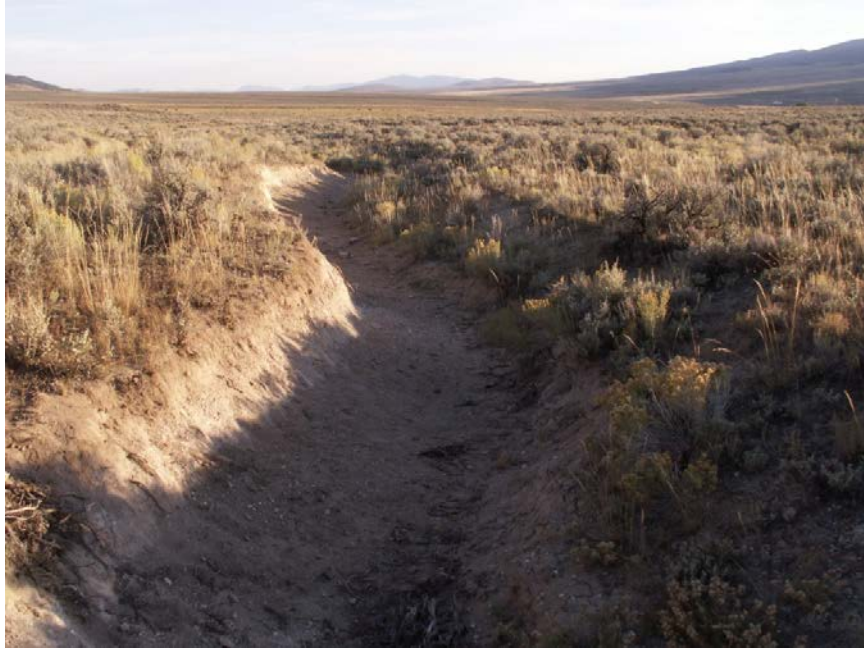
The downstream reach (STEL 10-01) that was visually assessed was located just off of Scudder Rd. The stream channel was dry at the reach in both the fall of 2010 and the spring of 2011. The lower end of the reach had a dry defined channel with long eroding banks (**Figure 5-19**). Moving up the reach, the stream channel remained dry and was difficult to define. The substrate was a mix of fines and gravel, with a few cobble noted in mid-reach. Stream appears to sink at slope change where the alluvial fan begins. The reach had long banks at the bottom of the reach that were approximately three feet high and composed of fines. Vegetation at the downstream end of the reach to the lower end of the wetted channel was composed of sagebrush with a few grasses. Human impacts include historic and current grazing throughout the reach.

Figure 5-19. Steel Creek – Dry channel
