**Development of a TMDL to Reduce NonPoint Source Sediment
Pollution in Deep Creek, Montana**

Report to Montana Department of Environmental Quality

Carol L. Endicott and Thomas E. McMahon Biology
Department/Fish and Wildlife Program Montana State
University-Bozeman

March 1996

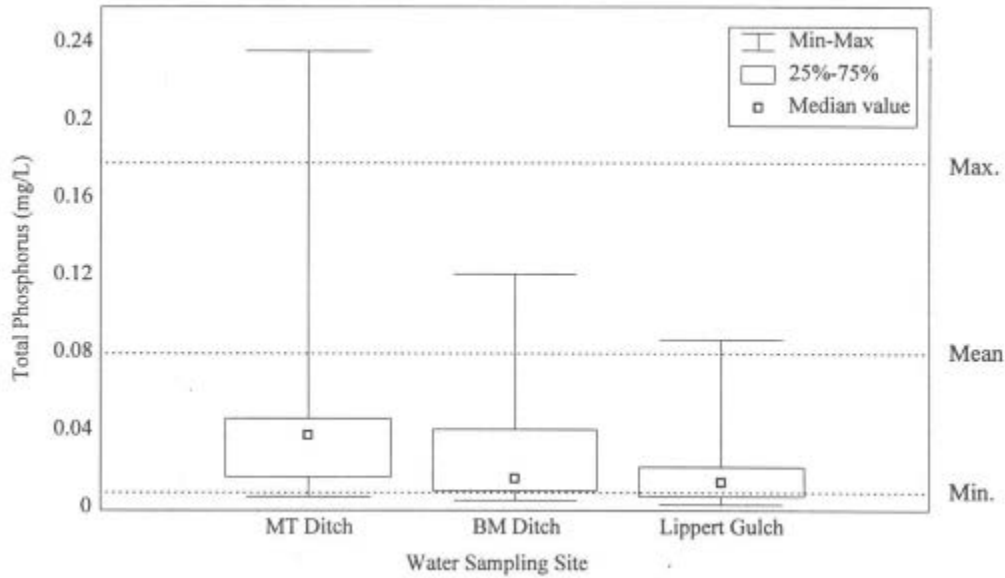
Figure 3. Total phosphorus concentration per water sampling site. Horizontal lines represent minimum, mean and maximum concentrations measured at Montana Valley and Foothill Prairies reference streams (Bahls et al. 1992).

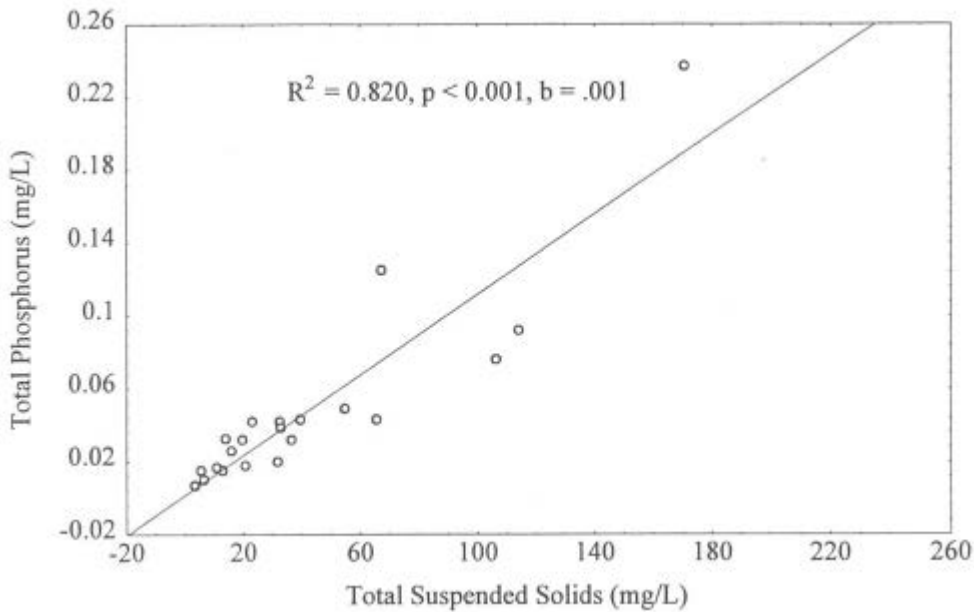
Figure 4. Relationship between total phosphorus concentration and TSS concentration at Montana Ditch.

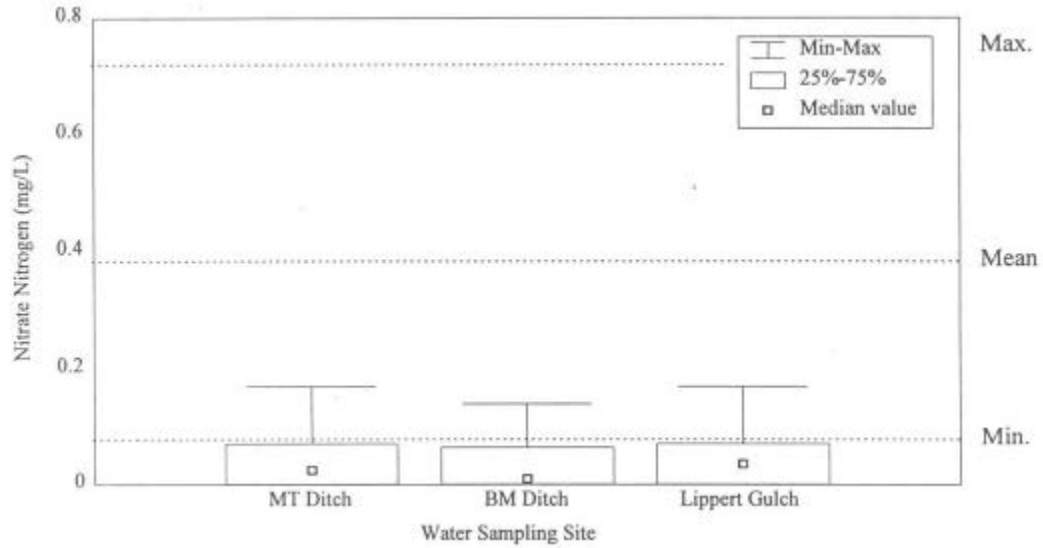
Figure 5. Nitrate-nitrogen per water sampling site. Horizontal lines represent minimum, mean, and maximum concentrations measured on Montana Valley and Foothill Prairies reference streams (Bahls et al. 1992).

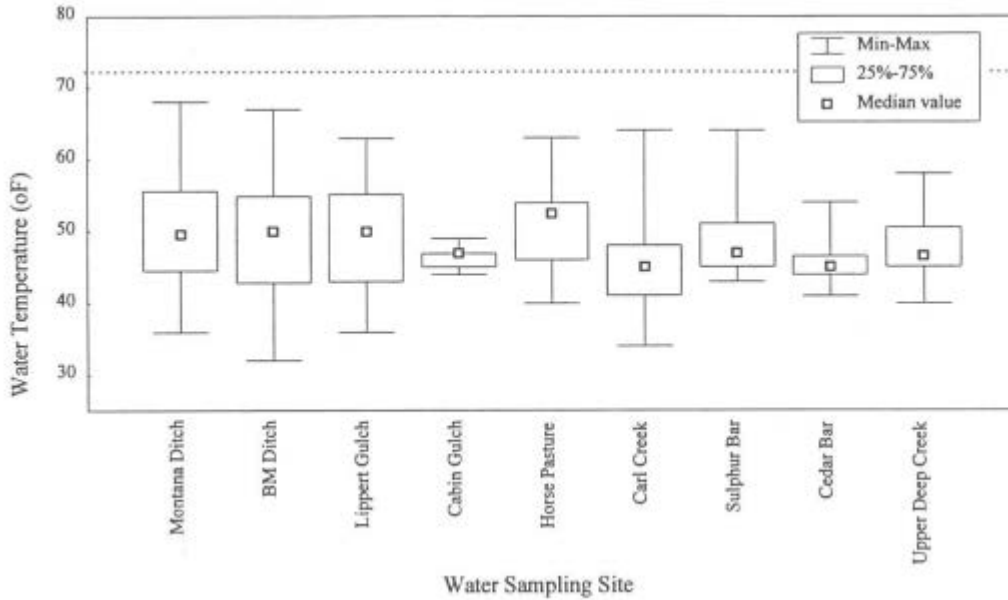
Figure 6. Water temperature during spring run-off (April through June). Horizontal line indicates thermal threshold for trout (Bell 1986).

Temperature data was collected at water sampling sites during spring run-off. Water temperatures did not exceed thermal threshold for trout (73 °F) during this sampling period (Figure 6); however, these data were likely to have missed conditions that were unfavorable to trout as the summer and irrigation season progressed. Temperature has been monitored at a permanent thermograph located near the Montana Ditch siphon. Data from 1993 and 1994, extremely wet and dry years, respectively, indicate that water temperatures can often exceed 73 °F during hot, dry summers (Figure 7). Water from Broadwater-Missouri Ditch may also be a significant source of thermal input to Deep Creek. However, spot temperatures during summer months indicate that water in the canal is somewhat cooler during hot, dry periods than water in Deep Creek (R. Spoon MDFWP, Townsend, personal communication).

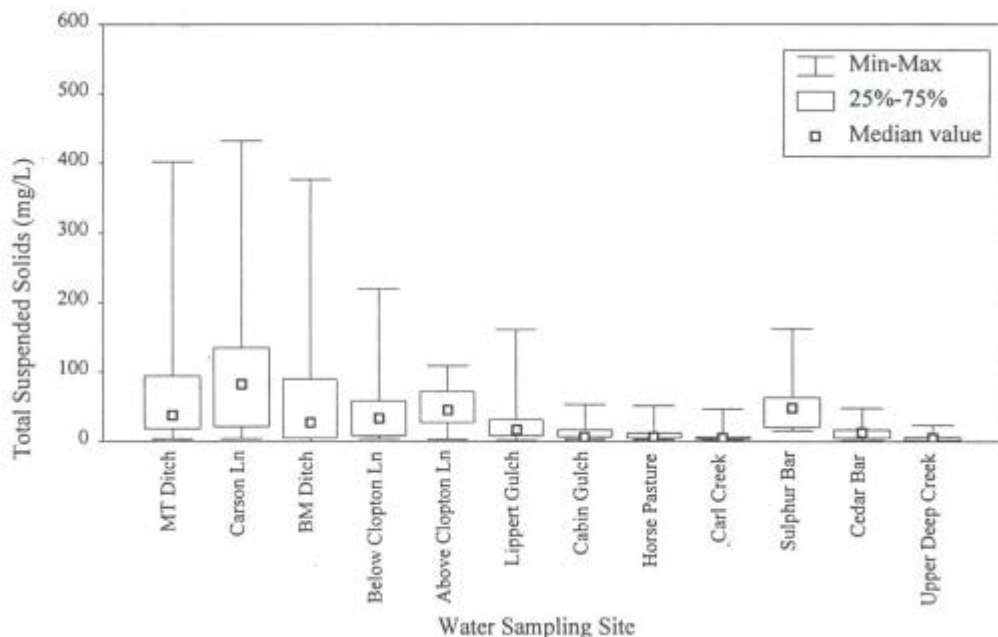
Figure 8. Total suspended solids concentration at each water sampling site.

Comparison of TSS levels encountered in Deep Creek (Figure 8) among water sampling sites illustrates the relative level of degradation in the watershed. Upper Deep Creek water sampling site has lowest TSS levels. Other upper tributaries (Carl Creek and Cedar Bar) had comparably low maximum concentrations (< 50 mg/L maximum). The tributary contributing the highest TSS was Sulphur Bar. This indicates that most headwater tributaries are not contributing much to the total TSS in the mainstem. TSS concentration increased markedly between the Horse Pasture sampling site (median = 6 mg/L; max. = 51 mg/L) and the lower four mainstem water sampling sites (median = 38 mg/L; max. = 402 mg/L at Montana Ditch). This indicates that the much of the TSS increase is associated with the lower reaches.

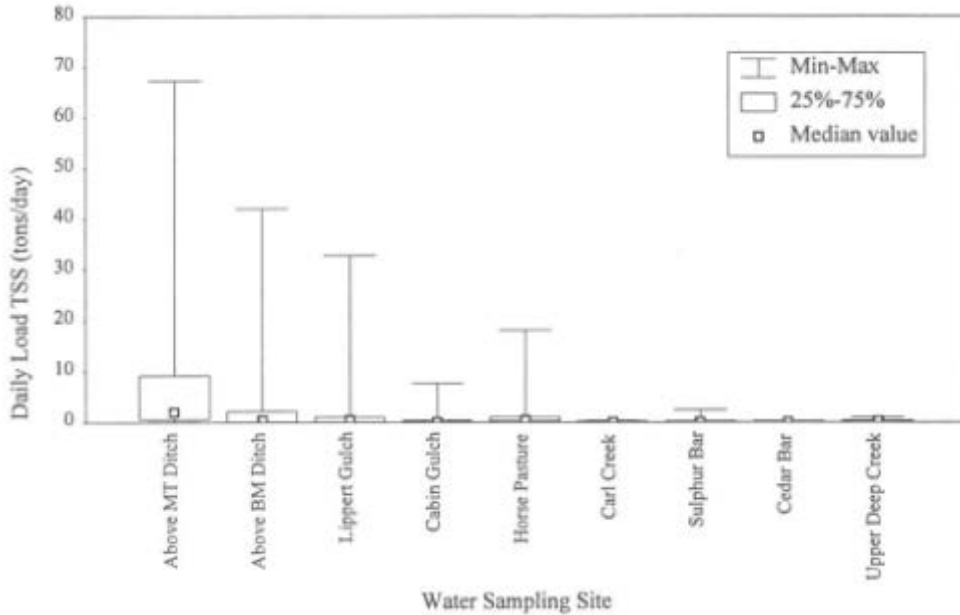
Figure 9. Daily load of total suspended solids per water sampling site.

Sources of fine sediment from bank erosion throughout the watershed can be inferred by comparing TSS load among water sampling sites (Figure 9). Daily load was calculated for water sampling sites by multiplying TSS concentration by daily discharge.

TSS load in Upper Deep Creek and upper tributaries indicates a small amount of sediment (i.e. maximum 2 tons/day at Sulphur Bar) compared to the lower portions of the watershed (between 40 and 70 tons/day at Montana Ditch and Broadwater-Missouri Ditch). Total sediment load is mostly from sources below Horse Pasture sampling. During peak flows, Deep Creek can transport 67 tons of sediment per day to the Missouri River.

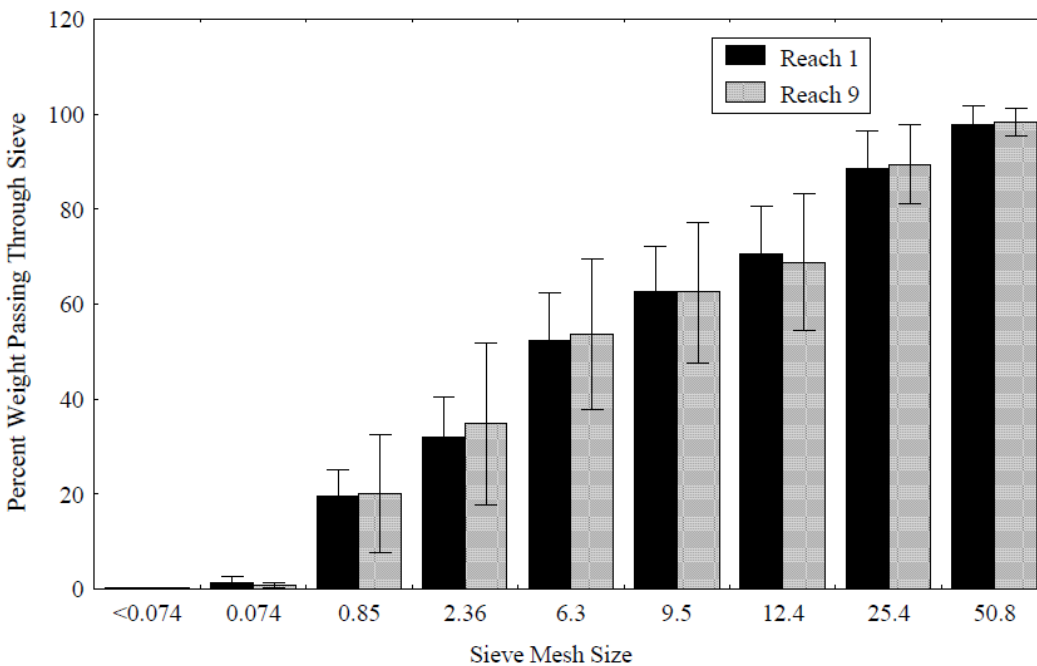
Figure 16. Mean percent weight of substrate particles passing through sieves of varying mesh size of core samples collected on Reaches 3 and 9 on Deep Creek. Error bars illustrate 95% confidence intervals.

Comparison of core samples among Reaches 3 and 11 does not indicate any striking differences in substrate composition (Figure 16). However, data is limited to 2 riffles and is not sufficient for broad inference to conditions throughout Deep Creek. Proportions of fine sediments in Deep Creek were slightly higher than proportions of fine sediments in redds in the Taylor Fork (Figure 17). Inference regarding these samples is limited by numerous factors including sample size and collection protocol, however, it does indicate that sedimentation on Deep Creek is possibly similar to sedimentation on the Taylor Fork.

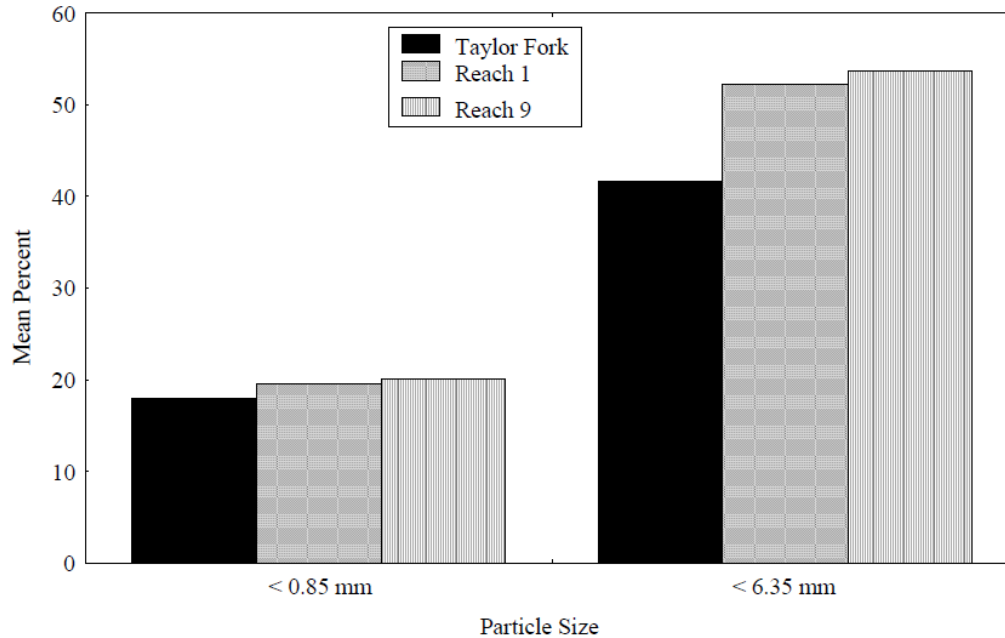
Figure 17. Comparison of proportion of fine sediment particles from Reaches 1 and 9 on Deep Creek and within redds in the Taylor Fork drainage (Magee et al., in press).

Although there were no striking differences in substrate conditions in Reaches 3 and 11, overall, riffles contained a very high proportion of fine sediments. In both reaches, particles < 6.35 mm comprised about 50% and < 0.85 mm comprised about 20% of total sediments by weight (Figure 17). These values are equal to or greater than those observed in Taylor Fork spawning redds. Emergence success of redds

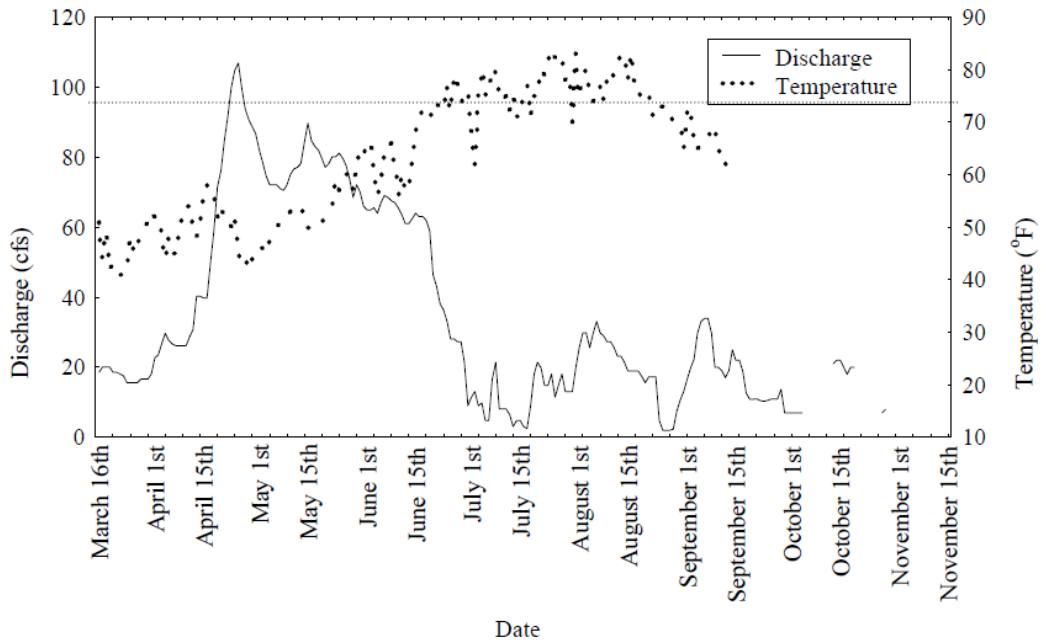
Figure 19. Discharge and water temperature measured at Montana Ditch gauging station and thermograph during 1994. Horizontal line represents thermal threshold for trout (Bell 1986).

The combination of high air temperatures and low flows results in increased water temperatures. During the hot summer of 1994, water temperatures increased concurrently with decreased flows and maximum temperatures were above the tolerable levels for trout for 50 days (Figure 19). During 1993, flows remained elevated throughout the summer and water temperatures remained within tolerable levels for trout (Figure 20). It should be noted, however, that although high temperatures were not a stress on aquatic life, high sediment levels accompanied increased discharge in 1993.

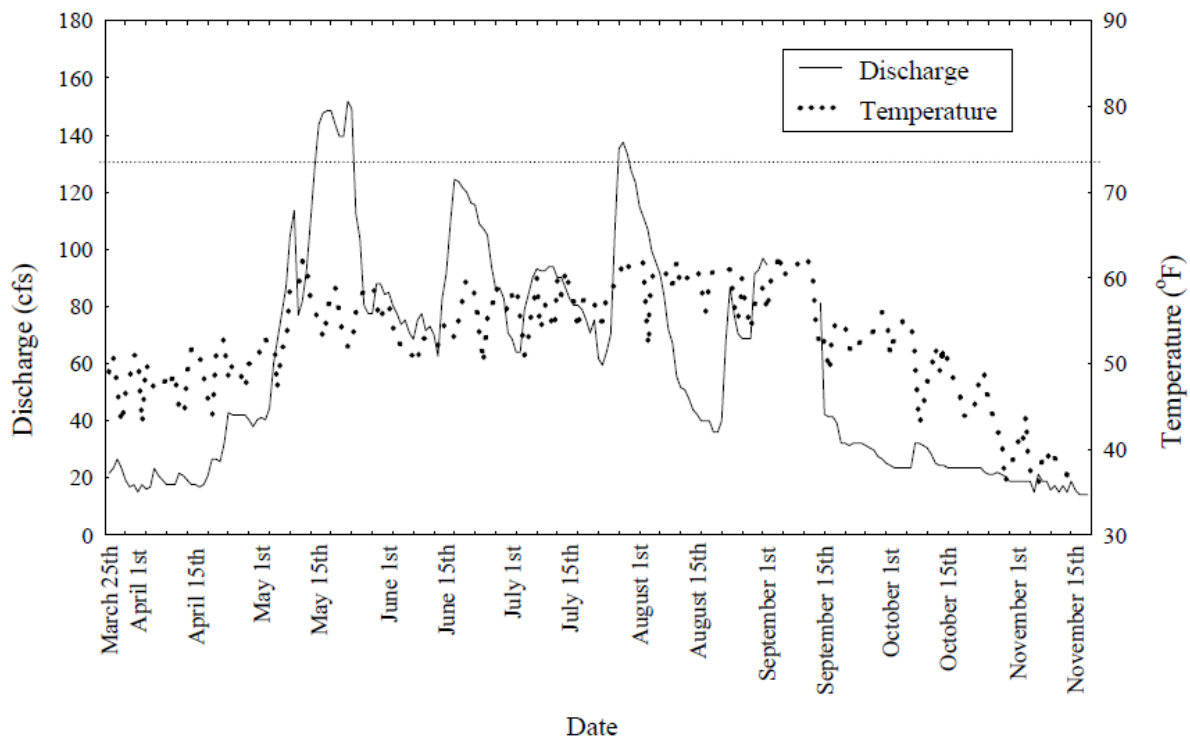
Figure 20. Discharge and water temperature measured at Montana Ditch gauging station and thermograph during 1993. Horizontal line represents thermal threshold for trout (Bell 1986).

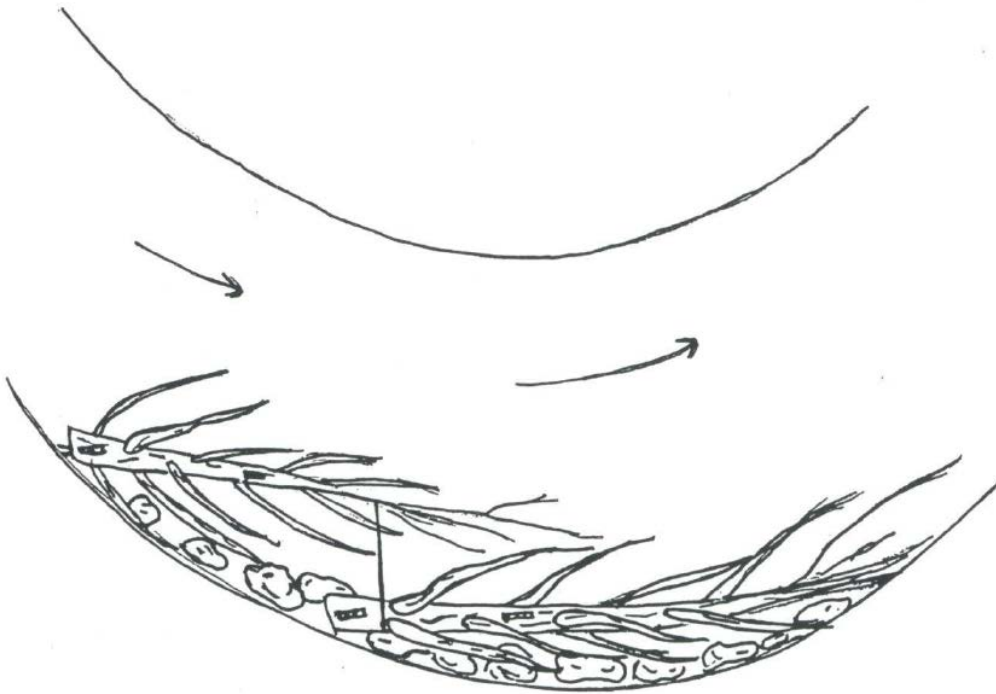
Figure 22. Diagram of juniper revetment for stabilizing outer meander bend

Tree revetments are recommended over riprap for bank stabilization on Deep Creek. In a comparison of riprap with tree revetments on Deep Creek, McClure (1991) concluded that tree revetments have several advantages. Tree revetments immediately increase instream cover for trout and decompose over time allowing restoration of more natural and functional streambanks. Revetments allow for the establishment of vegetation, particularly shrubs which promote long-term bank stability. In some locations, banks stabilized with tree revetments are virtually indistinguishable from natural, pristine streambanks within 5 years after installation (Endicott, personal observation). Another advantage of juniper revetments over riprap is cost as they do not require large machinery to install. Finally, a key feature of revetments is that they function to trap sediment which provides soil for re-establishment of riparian vegetation. Trapping of sediment is a desirable characteristic in a sediment rich stream like Deep Creek.

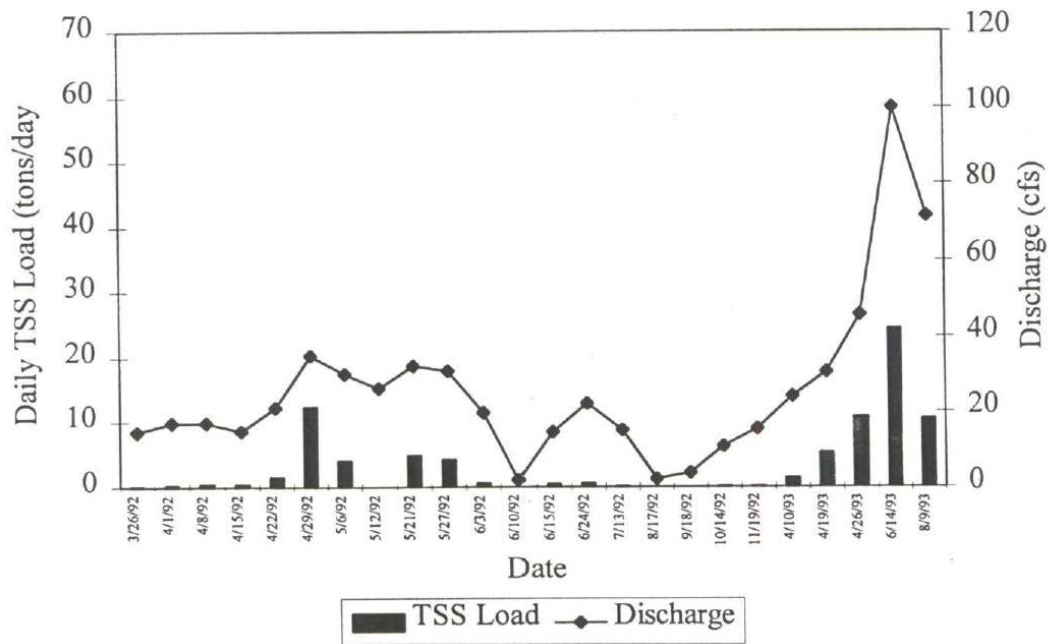
Figure 2b. Daily TSS load and discharge pre sampling date for above Broadwater-Missouri ditch water sampling site

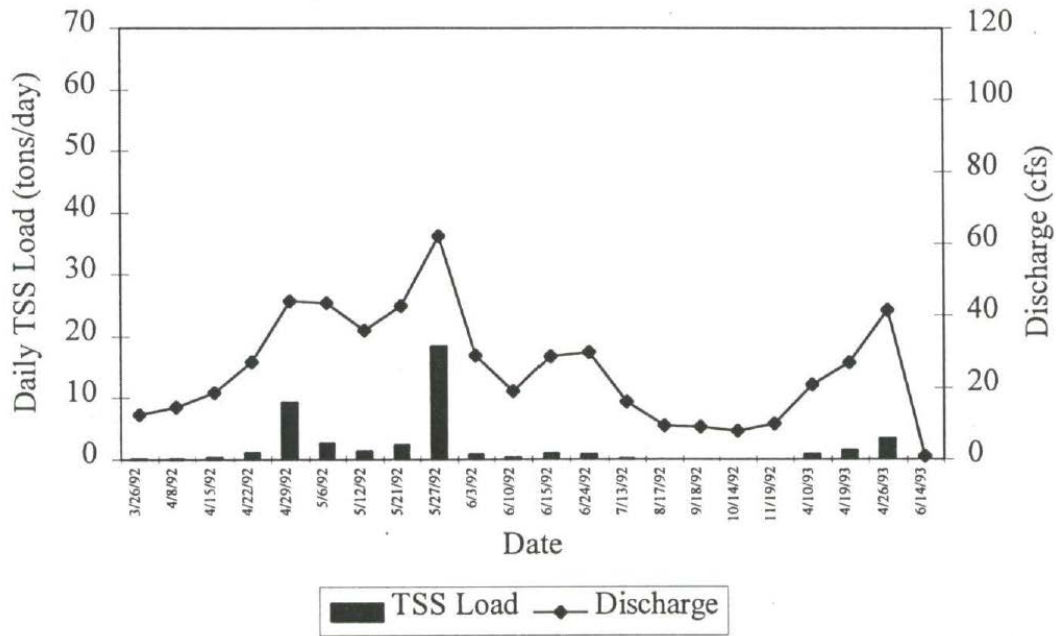
Figure 3b. Daily TSS load and discharge per sampling date at Lippert Gulch water sampling site

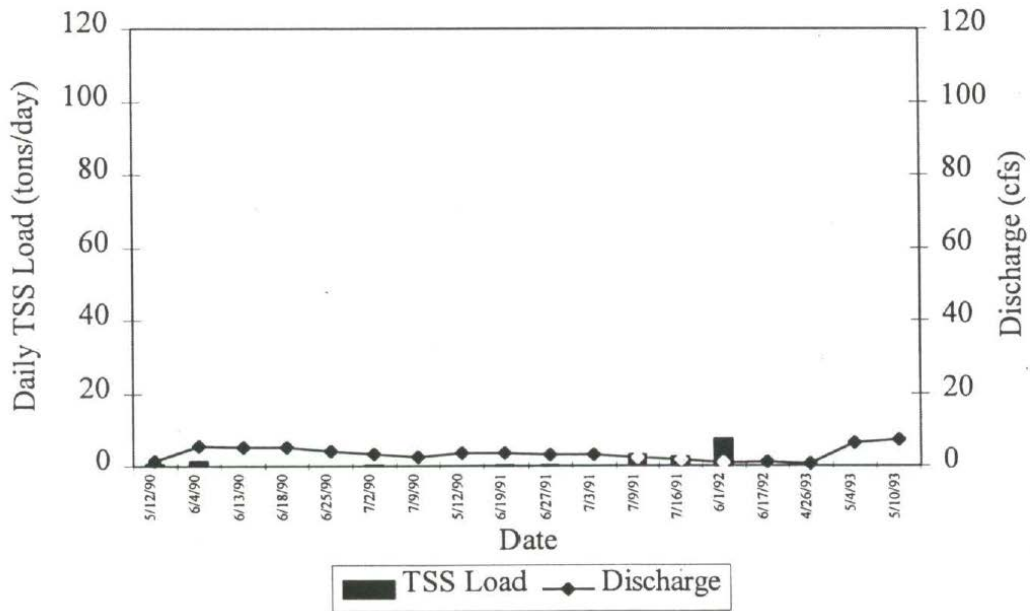
Figure 4b. Daily TSS load and discharge per sampling date at Cabin Gulch water sampling site

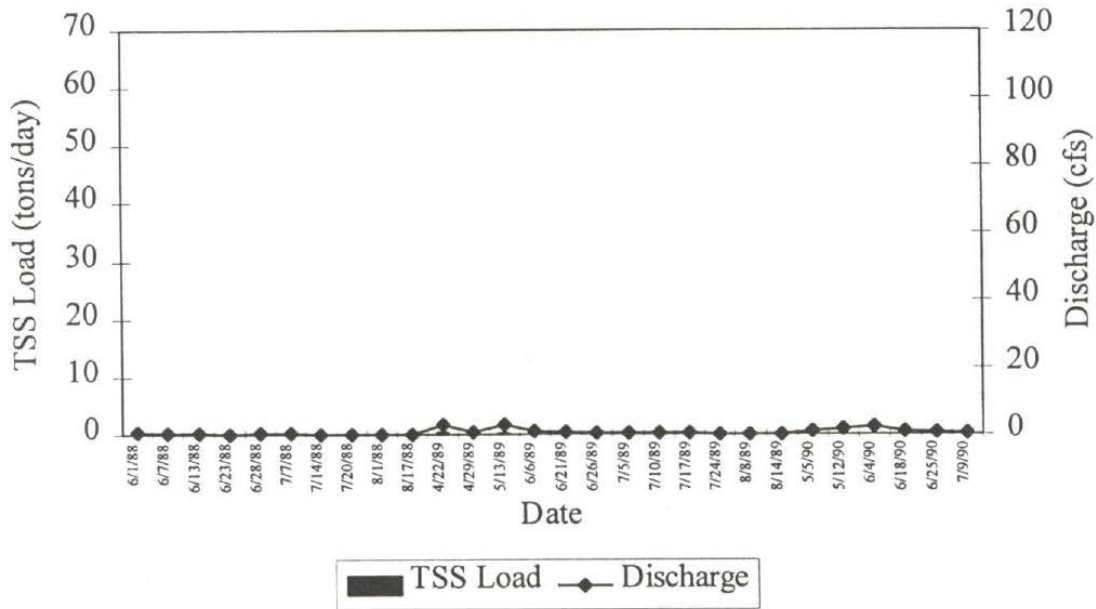
Figure 6b. Daily TSS load and discharge per sampling date at Carl Creek water sampling site

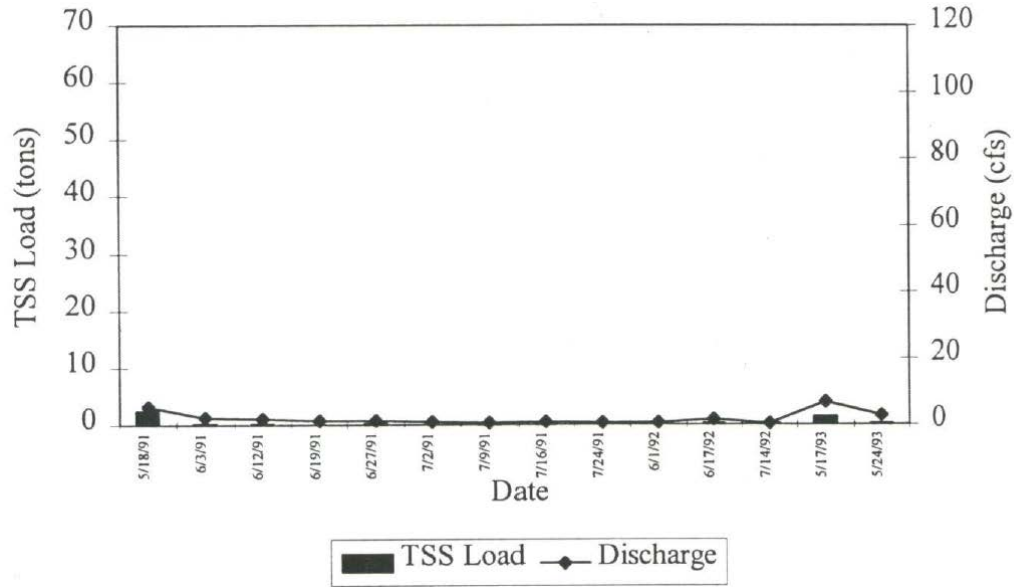
Figure 7b. Daily TSS load and discharge per water sampling date at Sulphur Bar water sampling site

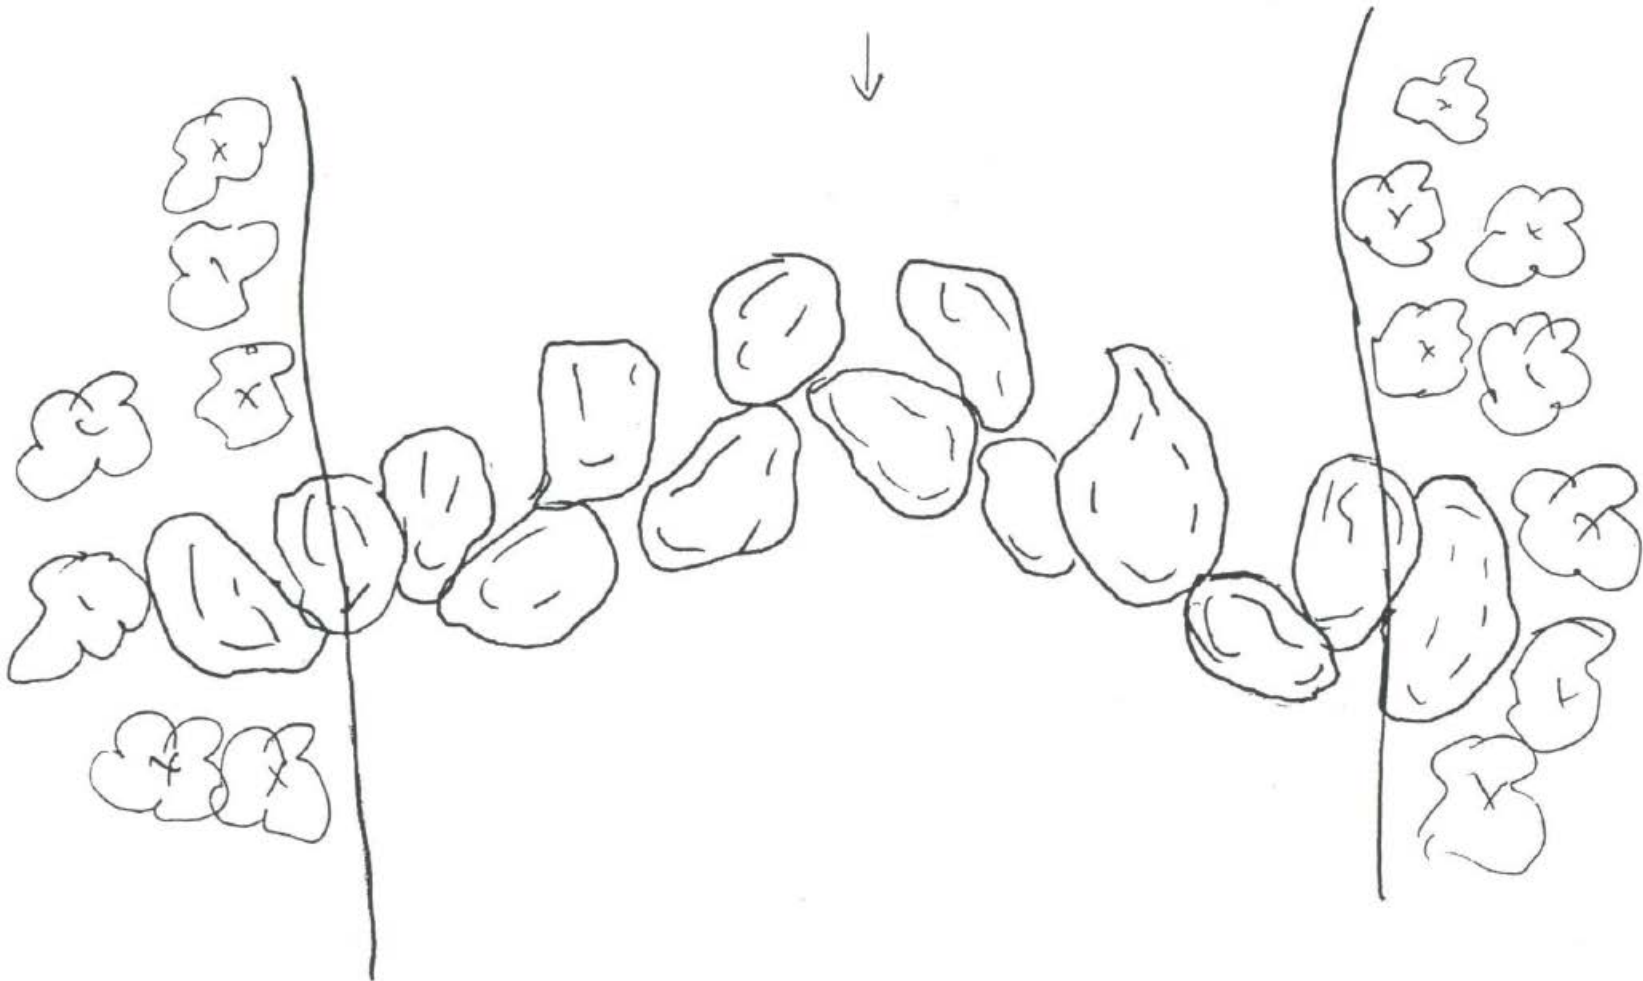
Figure 5e. Plan view of vortex rock weir to be used for grade control, reduction of bank erosion and improvement of fish habitat in alterations of F4 channel types to B4 channel types.
