Flathead-Stillwater TMDL Planning Area Sediment and Habitat Assessment Summary Report

Prepared by:
Watershed Consulting, LLC
P.O. Box 1701
Kalispell, MT 59903

Submitted to:
Montana DEQ
1520 E. Sixth Avenue
Helena, MT 59620

March 15, 2009

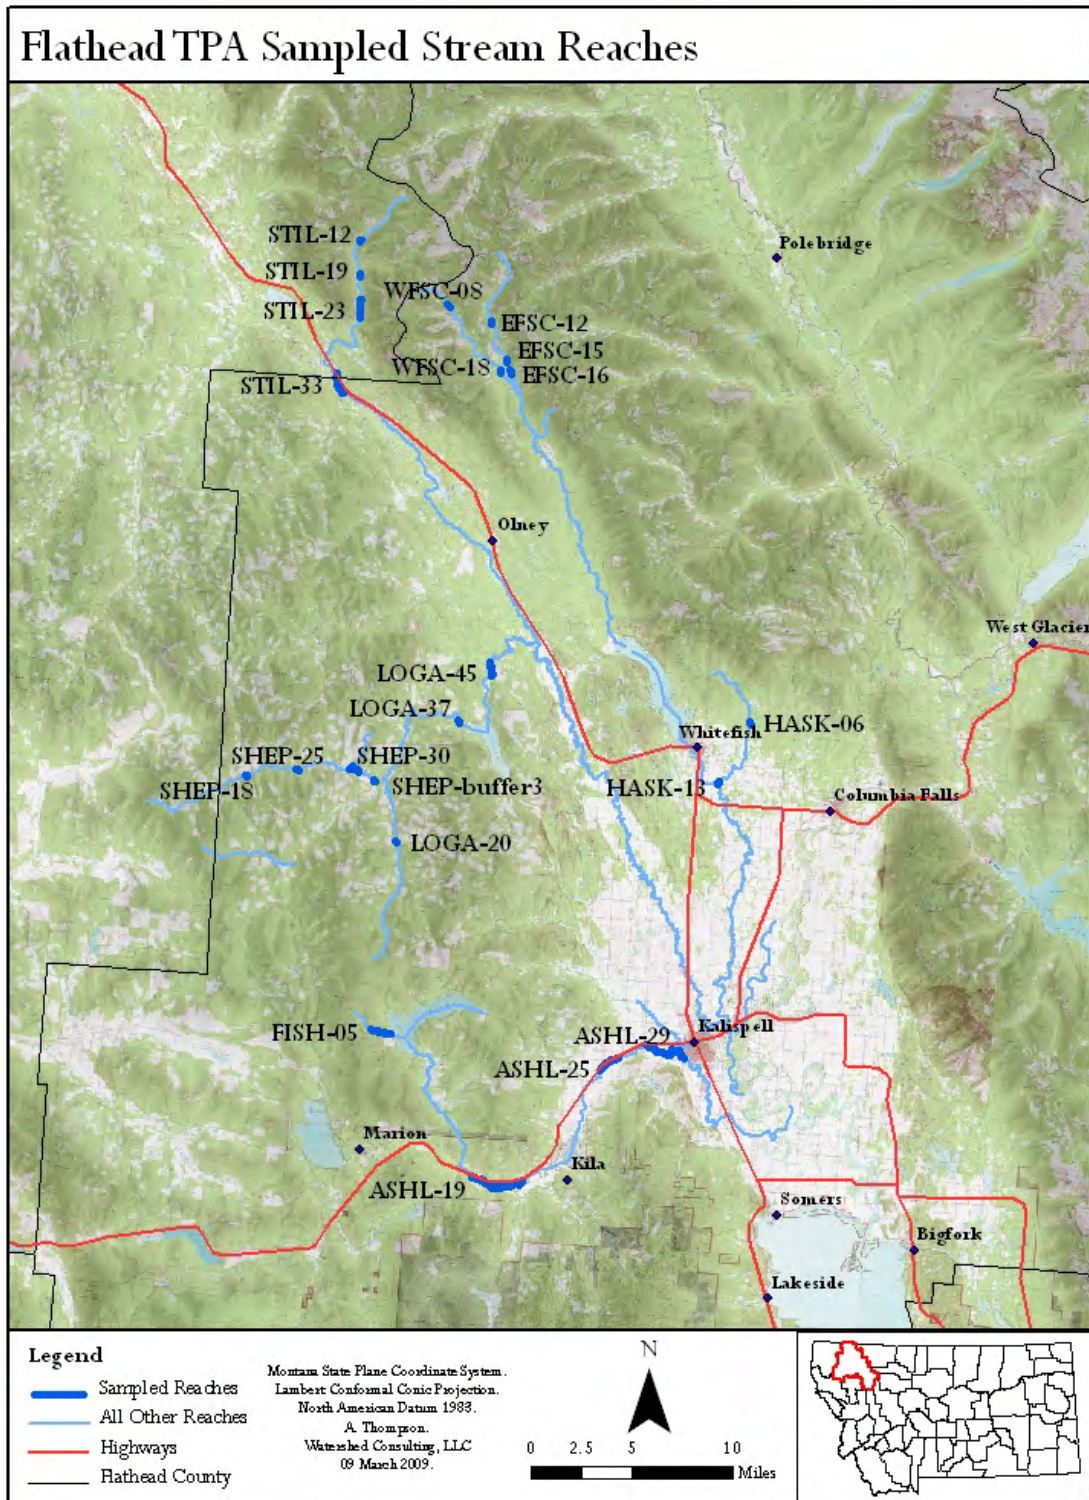
Figure 1-1. Reaches surveyed in the Flathead-Stillwater TPA during the 2008 assessment.

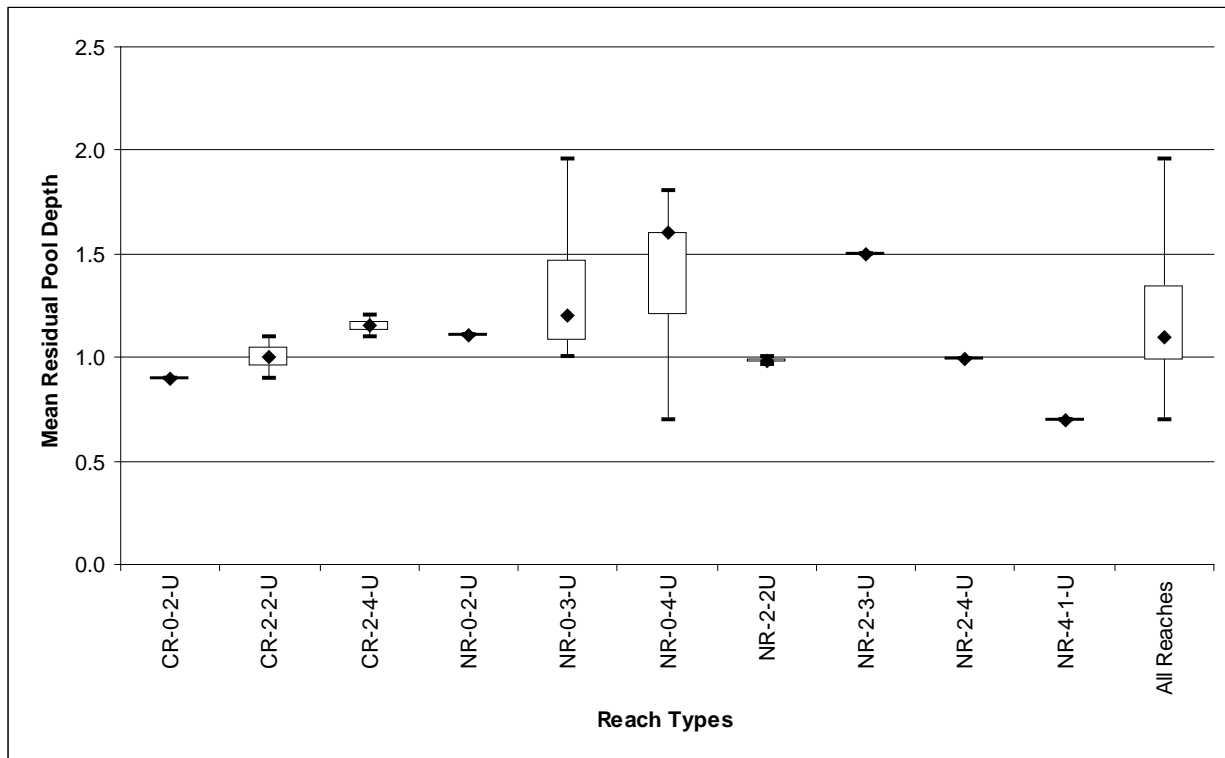
Reach mean residual pool depth measured in the study reaches is plotted by reach type in Figure 3-6. Summary statistics for residual pool depth results by reach type are included in Table 3-6 following the box plot.

Figure 3-6. Mean Residual Pool Depths Segregated by Reach Type

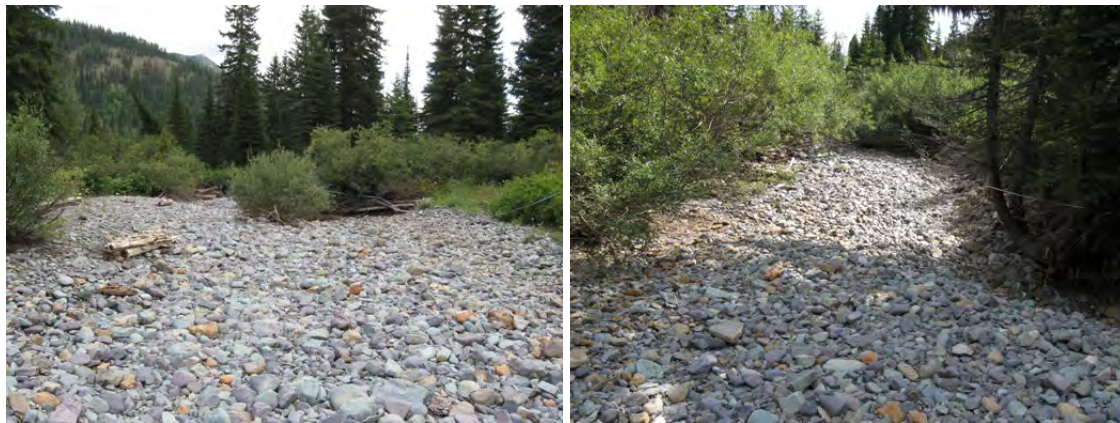
3.3.1.1 Reach EFSC-12

Figure 3-11. Typical stream conditions in EFSC-12 Reach.

Reach EFSC-12 is the only reach within the CR-0-2-U reach type. The reach, classified as a Rosgen C4b stream type (Rosgen 1996) is on the East Fork of Swift Creek above Upper Whitefish Lake. Vegetation outside the riparian area is dominated by mature conifer forest and grass. Past logging activity (50+ years prior) likely caused shifts in stream morphology and stability, particularly at the lower ends of the reach, though good shrub cover and some conifers along banks have stabilized the channel. There is a small amount of visible bank erosion attributed to de-stabilized banks of non-natural origin, mostly at the downstream ends of the reach. The streambed is dominated by coarse gravels and at the time of the survey was mostly dry. In high water, deep pools and wide riffle sections would be present.

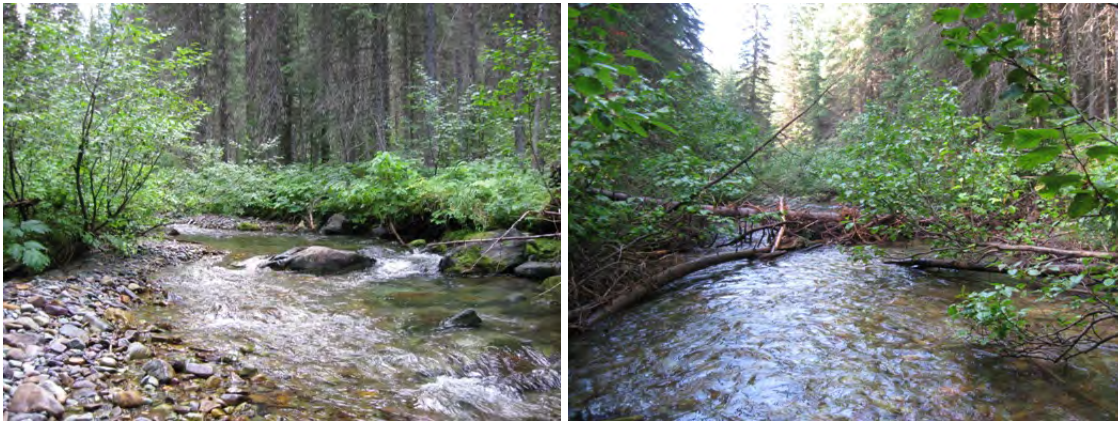
3.3.2.1 Reach STIL-12

Figure 3-12. Typical stream conditions in STIL-12 Reach.

Reach STIL-12 is on the Stillwater River in an area dominated by mature conifers (spruce, subalpine fir) on both banks. The riparian communities along the banks are diverse and vigorous, with dense root masses contributing to good bank stability. Bank erosion is minimal and primarily of natural cause. The stream is a C4b Rosgen stream type (Rosgen 1996) with a coarse gravel substrate. Spawning gravels are common, as is large woody debris. Pools are infrequent and shallow.

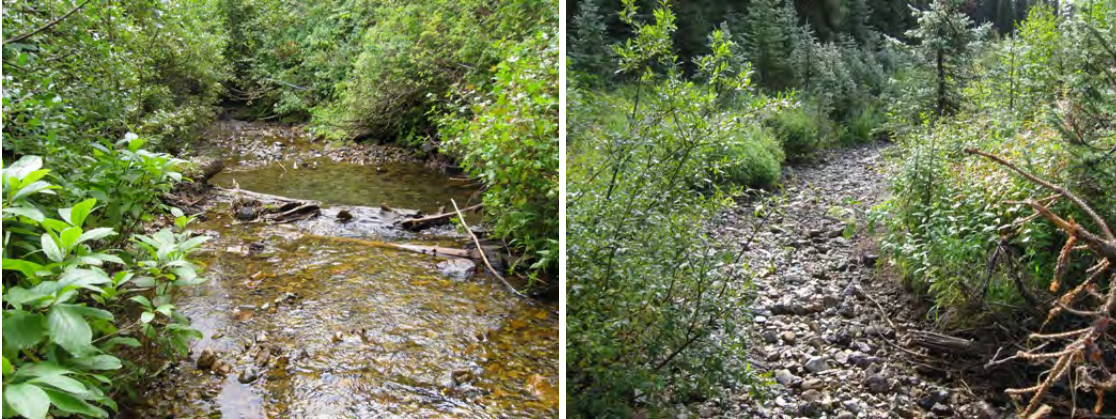
3.3.2.2 Reach WFSC-08

Figure 3-13. Typical stream conditions in WFSC-08 Reach.

Reach WFSC-08 of the West Fork of Swift Creek is classified as a B4 Rosgen stream type and is dominated by mature conifer forest. Historic logging activity in the drainage is not currently impacting the stream. Understory shrub growth is vigorous. The substrate is medium to coarse gravel, with larger gravels having potentially been deposited recently. Spawning gravels are present. Large woody debris is present, but not abundant.

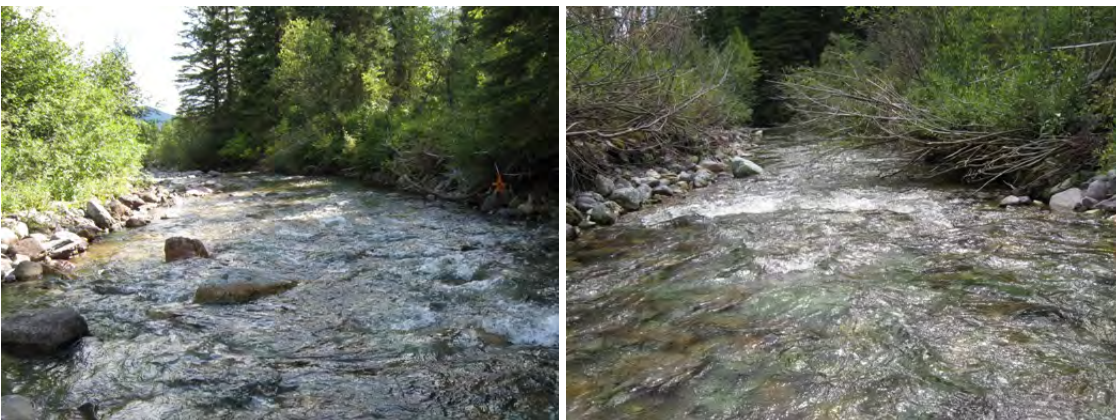
3.3.3.1 Reach STIL-19

Figure 3-14. Typical stream conditions in STIL-19 Reach.

Reach STIL-19 of the Stillwater River is surrounded by coniferous forest. The reach is a Rosgen C3b stream type within the Crestal Alpine-Subalpine fourth level Ecoregion. Due to past logging around and upstream of the reach, the channel shows signs of adjustment, with some

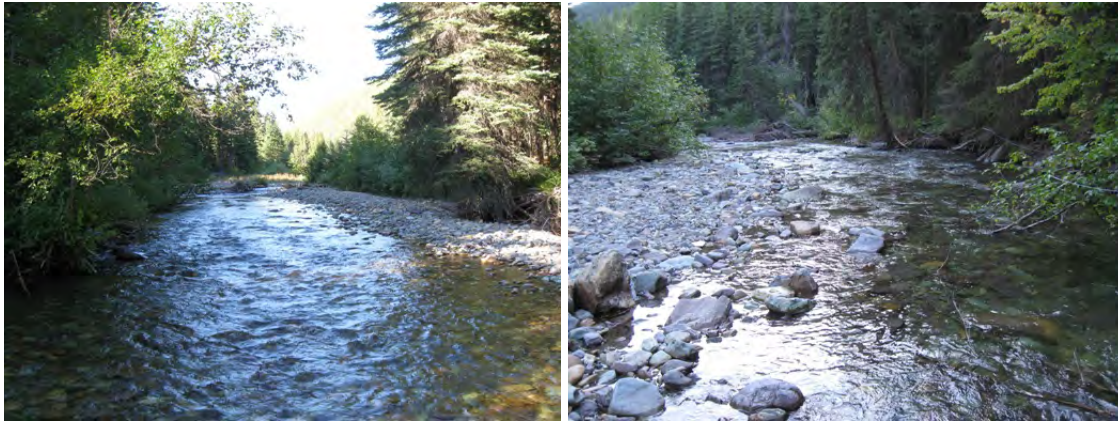
Reach STIL-23 is surrounded by mature mid-seral forest and shrub land. The reach is classified as a B4 stream type in the Western Canadian Rockies fourth level Ecoregion. The reach shows some signs of active adjustment to historic logging activity. Most bank erosion is occurring slowly and influence by natural cycles and high-flow events. Large gravels are the dominant substrate and spawning gravels are present in most cells. Pools and large woody debris are not abundant.

Figure 3-15. Typical stream conditions in STIL-23 Reach.

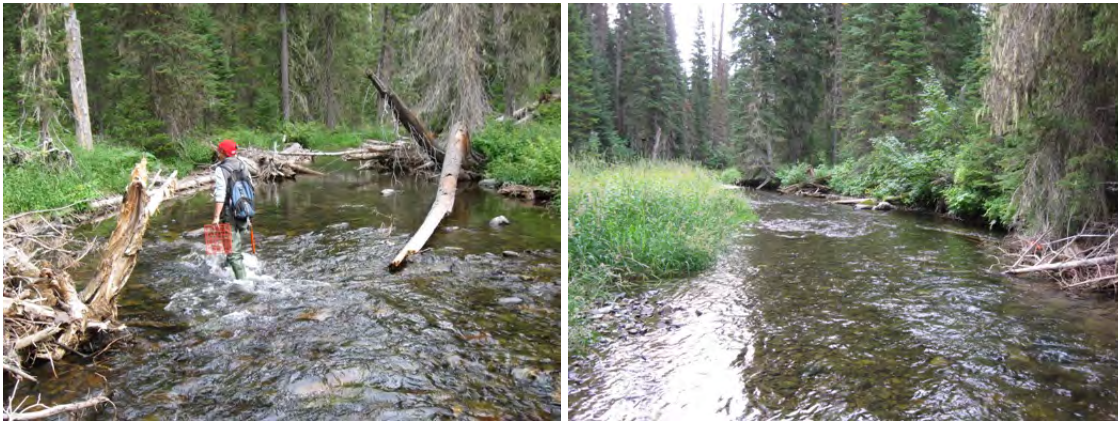
3.3.4.1 Reach EFSC-15

Figure 3-16. Typical stream conditions in EFSC-15 Reach.

Reach EFSC-15 is on the East Fork of Swift Creek in the Stillwater-Swan Wooded Valley fourth-level Ecoregion. It is a B4 Rosgen stream type and is surrounded by mature conifers. Land use impacts to the stream are negligible. Erosion is minimal and the channel is mostly stable, with large amounts of woody debris in the stream. The substrate is predominantly large gravels, of which some are suitable for spawning.

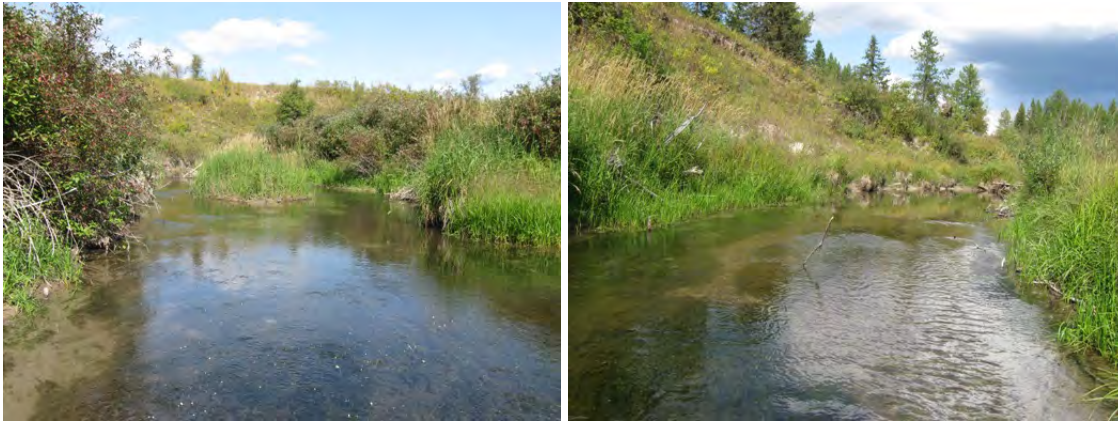
3.3.5.1 Reach HASK-13

Figure 3-17. Typical stream conditions in HASK-13 Reach.

The HASK-13 stream reach on Haskill Creek is within the Flathead Valley fourth level Ecoregion. It is a Rosgen C5 stream type with low sinuosity. The riparian vegetation is dominated by invasive grass species and provides a very limited supply of large woody debris. Beaver activity has influenced the stream historically but less so in the last few years. The substrate type is predominantly sand with naturally silted conditions due to beaver. Upstream agricultural activity does not appear to affect habitat conditions in this reach noticeably.

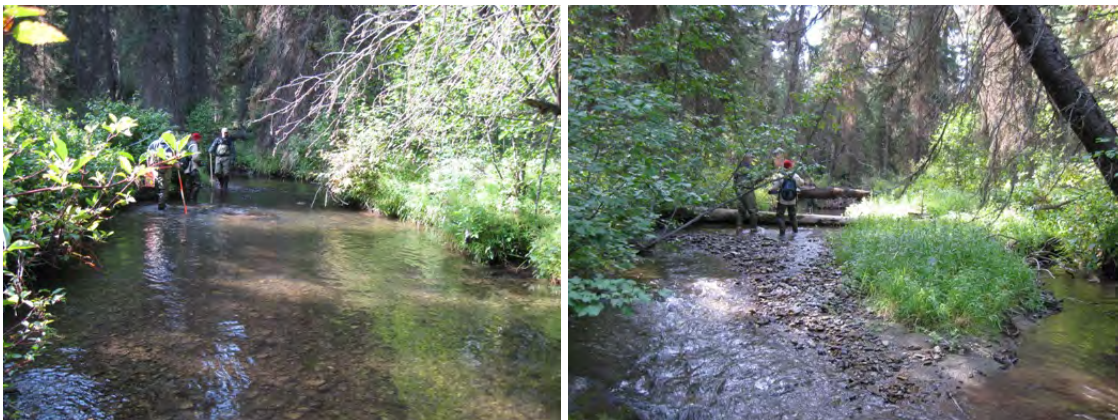
3.3.5.2 Reach LOGA-20

Figure 3-18. Typical stream conditions in LOGA-20 Reach.

The LOGA-20 reach is on Logan Creek in the Salish Mountain fourth level Ecoregion. It is a C4 Rosgen stream type characterized by a low sinuosity and dominated by mature spruce forest. Signs of light recreational use were observed. Large woody debris is present in the stream, although the riparian area is dominated by shrubs. This reach displays a diversity of aquatic habitat. The substrate type is small to medium gravels with some siltation. There is limited spawning habitat.

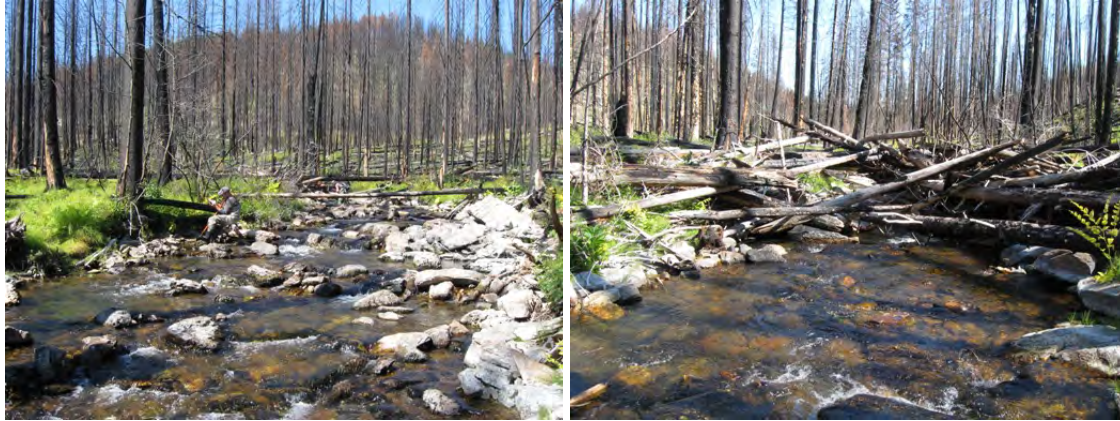
3.3.5.3 Reach SHEP-25

Figure 3-19. Typical stream conditions in SHEP-25 Reach.

The SHEP-25 reach is on Sheppard Creek within a mature conifer forest in the Salish Mountain level four Ecoregion (USEPA 2002). The reach is classified as a C3 Rosgen Stream type. Cobble substrates are dominant with few gravels suitable for spawning. The stream is well-armored and streambank erosion is infrequent. Large woody debris is present throughout the stream. Fire consumed this area in 2007, and forbs and shrub regrowth currently dominate the riparian area and adjacent uplands.

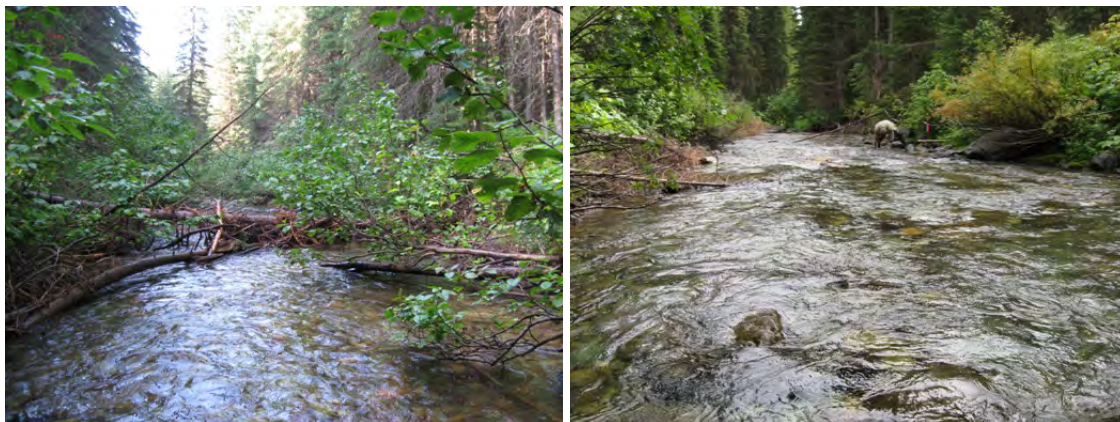
3.3.5.4 Reach WFSC-18

Figure 3-20. Typical stream conditions in WFSC-18 Reach.

Reach WFSC-18 is within the Stillwater-Swan Wooded Valley level four Ecoregion. It is classified as a C4b Rosgen stream type. No past human impacts are apparent, and this stream reach possesses some of the best available conditions within the study reaches. The riparian shrub community has good vigor and condition, and the channel is stable throughout this reach.

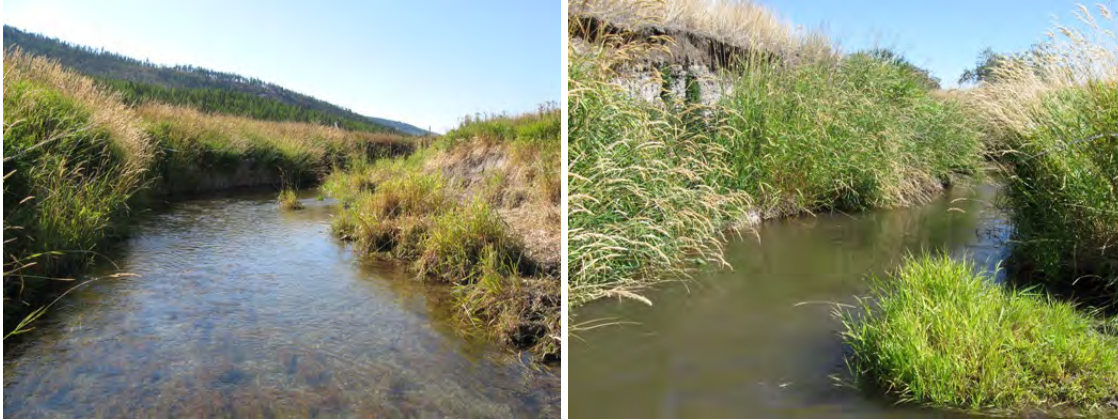
3.3.6.1 Reach ASHL-19

Figure 3-21. Typical stream conditions in ASHL-19 Reach.

This reach is in the Salish Mountains level four Ecoregion. Agricultural crops and grazing are the dominant land uses along this reach. It is a B4 Rosgen stream type with a low slope. The stream is incised and has unstable banks trampled by cattle in some areas. Small gravels are dominant and provide ample spawning substrate. Woody debris is very limited, as the riparian area is predominantly introduced grasses and forbs with minimal overstory canopy and understory shrub cover. Sediment loading from actively eroding banks is notable.

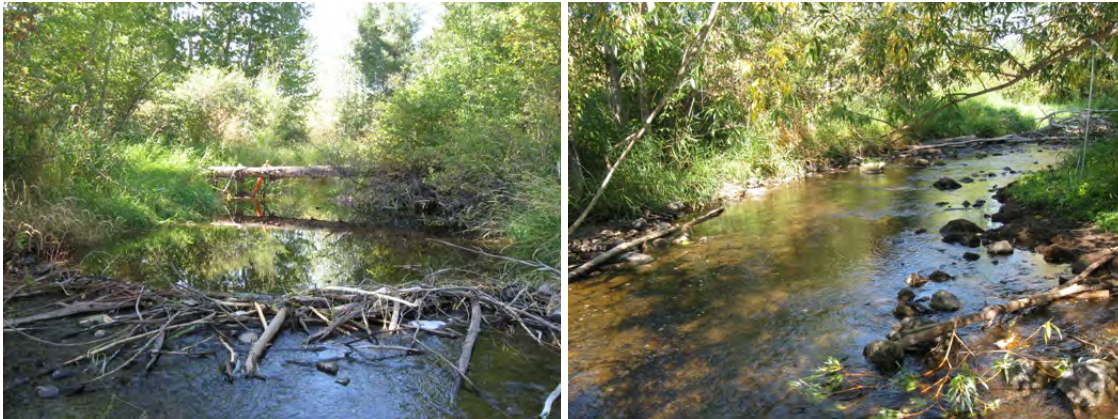
3.3.6.2 Reach ASHL-25

Figure 3-22. Typical stream conditions in ASHL-25 Reach.

The ASHL-25 reach is on Ashley Creek in the Flathead Valley fourth level Ecoregion. It is classified a C4 Rosgen stream type. Shrubs are the dominant vegetation and medium-sized gravels the dominant substrate. The stream has been channelized due to its urban setting, confined between housing developments and a highway. The substrate is small to medium gravels. Recent beaver activity is evident in the reach. Introduced riparian species and garbage are common in this reach.

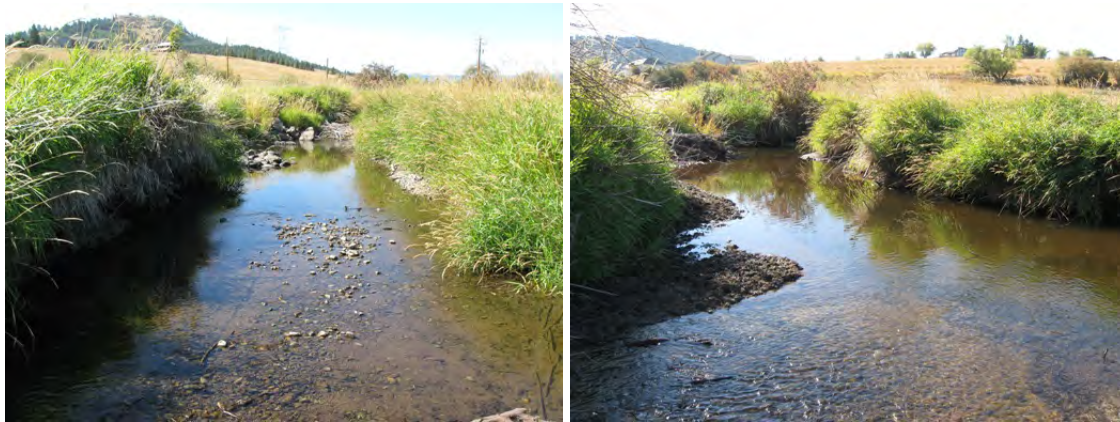
3.3.6.3 Reach ASHL-29

Figure 3-23. Typical stream conditions in ASHL-29 Reach.

This reach, ASHL-29, is in the Flathead Valley fourth level Ecoregion. This reach of Ashley Creek is classified as a B4c Rosgen stream type. The stream energy has been altered from both natural and historic land use causes. Rip-rap in the channel indicates historic manipulation of the channel. Grasses and shrubs are the dominant vegetation. The substrate is small gravels. Erosion is not severe but is widespread.

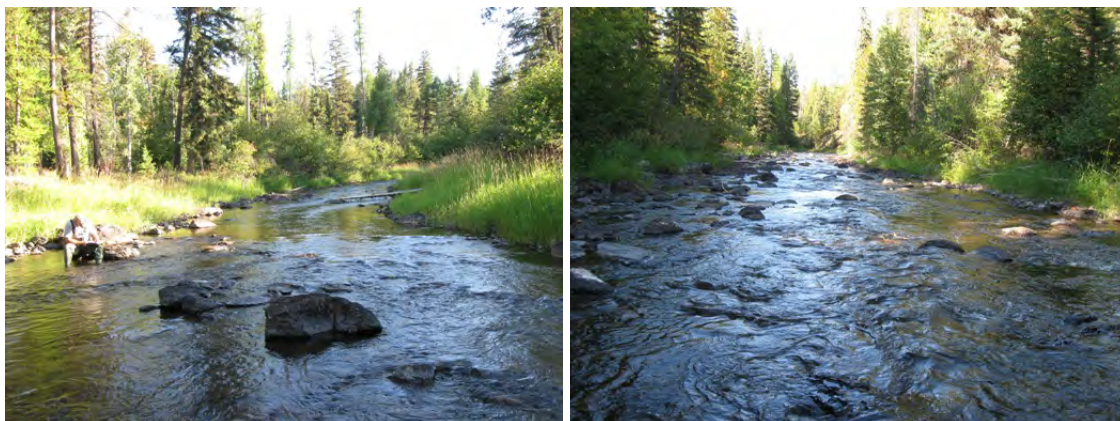
3.3.6.4 Reach LOGA-45

Figure 3-24. Typical stream conditions in LOGA-45 Reach.

This reach of Logan Creek is in the Stillwater-Swan Wooded Valley fourth level Ecoregion and is a B3 Rosgen stream type. Mature conifers line the riparian areas of this reach. There has been

recent and historic logging in the watershed. Riparian shrub cover is good and the channel is stable and well-armored. The cobble substrate has few pools or large woody debris.

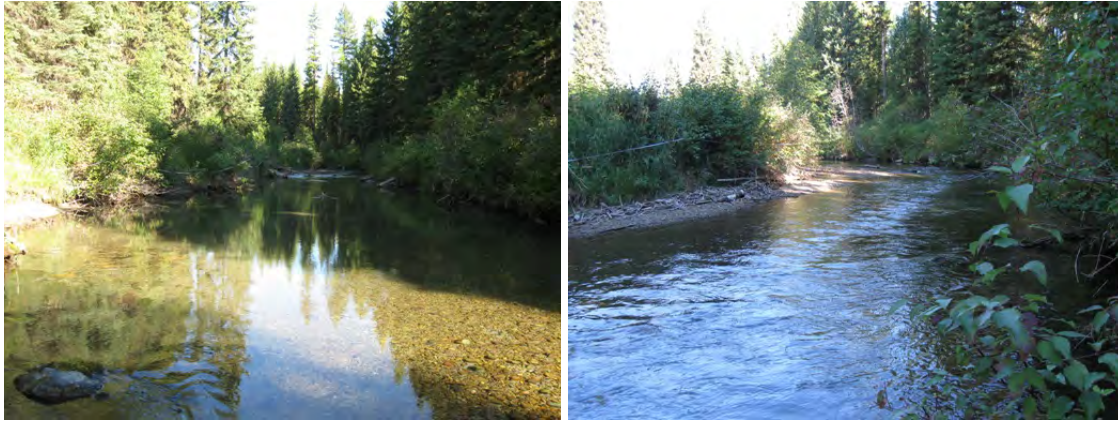
3.3.6.5 Reach STIL-33

Figure 3-25. Typical stream conditions in STIL-33 Reach.

This reach of the Stillwater River is in the Stillwater-Swan Wooded Valley fourth level Ecoregion. It is classified as B4c Rosgen stream type and is dominated by mature conifers. Large stumps in the floodplain indicate historic logging. The stream is highly embedded and fine sediment is common throughout the small gravel- dominated substrate. Vigorous riparian shrubs and some exotic grasses on banks are present.

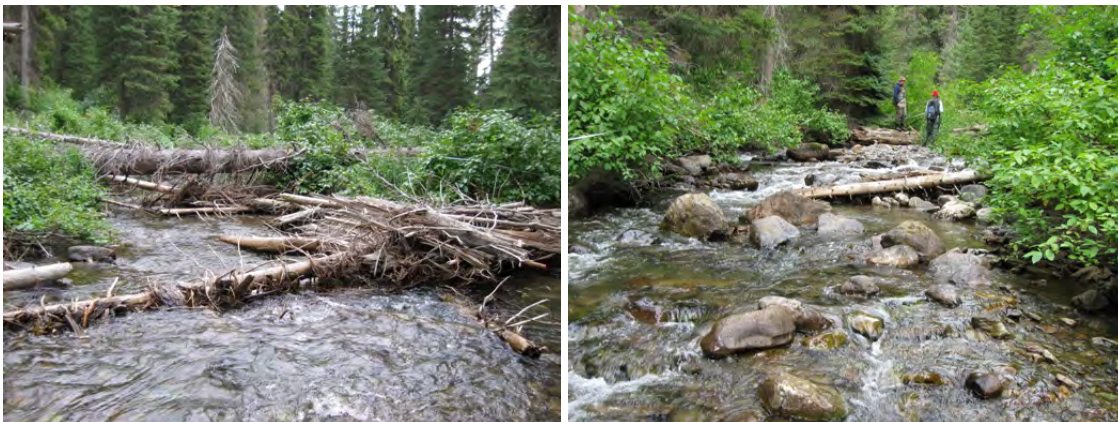
3.3.7.1 Reach EFSC-16

Figure 3-26. Typical stream conditions in EFSC-16 Reach.

This reach is in the Stillwater-Swan Wooded Valley fourth level Ecoregion. It is a C4 Rosgen stream type with well-defined pools and excellent riparian vegetation. The substrate is medium

to large gravels. This stream reach is an example of best available conditions among the assessed reaches.

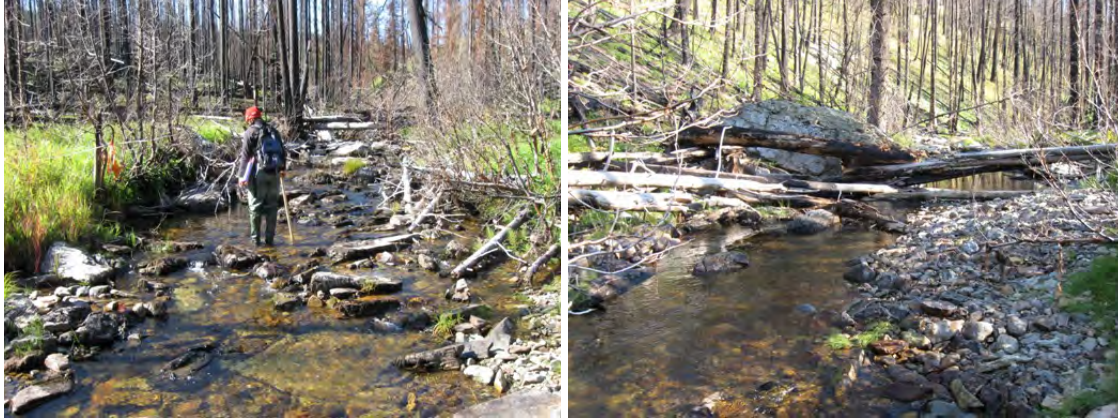
3.3.7.2 Reach SHEP-18

Figure 3-27. Typical stream conditions in SHEP-18 Reach.

Reach SHEP-18 is within the Salish Mountains fourth level Ecoregion. Described as a C4b Rosgen stream type, it runs through an area that was completely burned in 2007. Forbs are dominant and woody debris is common in the stream. Substrate is predominantly gravel, and larger substrate creates deep but infrequent pools.

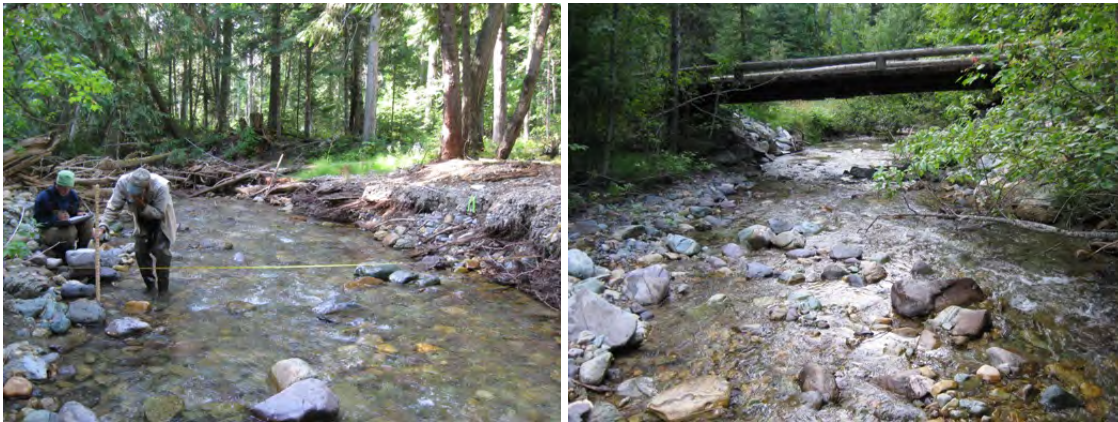
3.3.8.1 Reach HASK-06

Figure 3-28. Typical stream conditions in HASK-06 Reach.

This reach is on Haskill Creek within the Stillwater-Swan Wooded Valley fourth level Ecoregion. The reach is characterized as a B4 Rosgen stream type with low sinuosity. The

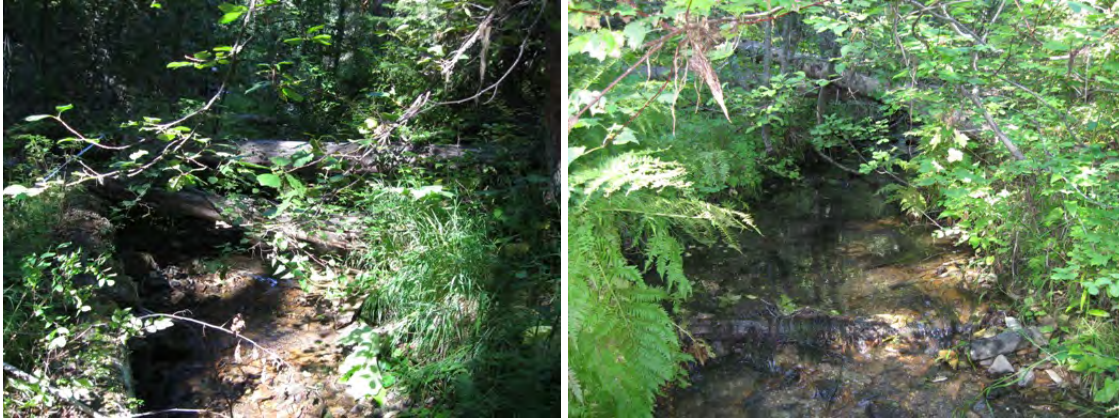
This reach of Fish Creek is within the Salish Mountains fourth level Ecoregion and is classified as an A4 Rosgen stream type. The reach is generally characteristic of Rosgen A-type streams but is not as entrenched. There is infrequent spawning habitat in the gravel substrate, and a light surface of silt is common. There is minimal land use impact on the stream, potentially some from roads upstream of the reach and slight reduction in canopy cover due to timber harvest outside the riparian corridor.

Figure 3-30. Typical stream conditions in FISH-05 Reach.

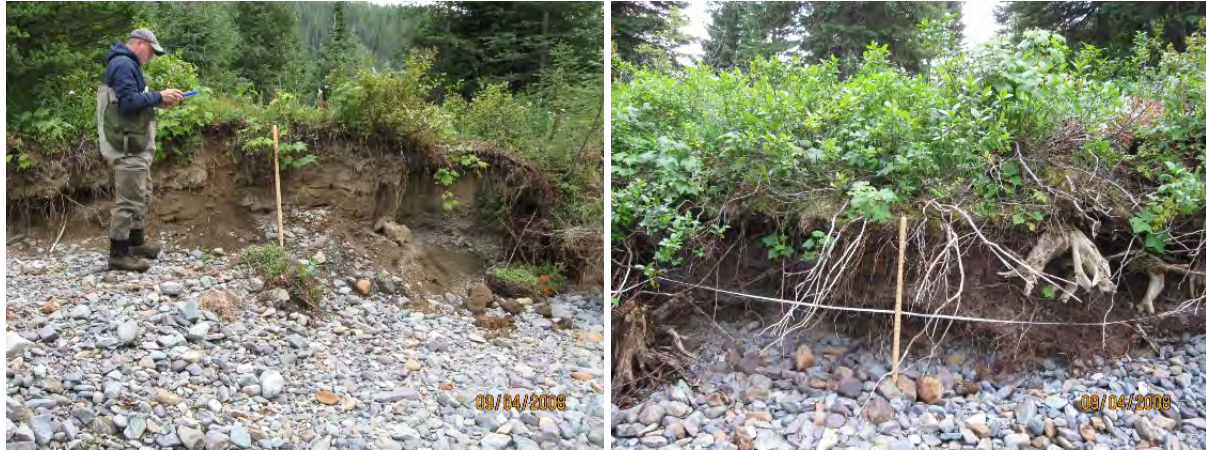
The EFSC-12 stream reach is within a valley that has experienced historic logging. Due to some resulting stream instability from historic activities, 16.1% are unstable and actively eroding. Overall stream conditions, however, are natural and the channel is stable. The riparian community is diverse and recruitment is good, limiting the amount of erosion. Typical reach photographs are included in Figure 4-1. BEHI results for Reach EFSC-12 are included in Table 4-4 and Table 4-5.

Figure 4-1. Typical streambank conditions in EFSC-12 Reach

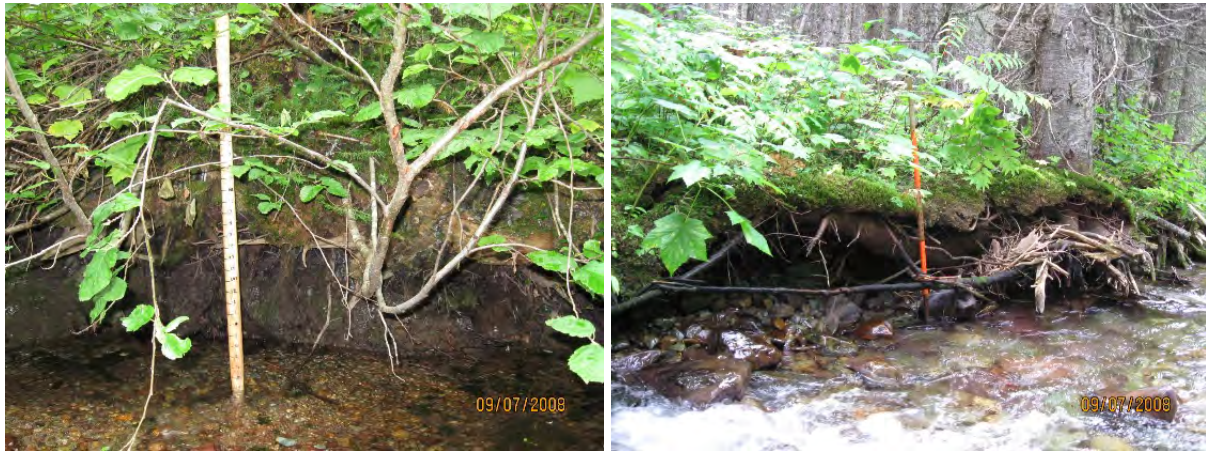
Reach STIL-12 is in a forested setting with dense riparian vegetation providing bank stabilizing rootmass. Streambanks are generally stable with some slowly-eroding undercut banks located along meander outcurves and constrictions. Typical reach photographs are included in Figure 4-2. BEHI results for Reach STIL-12 are included in Table 4-6 and Table 4-7.

Figure 4-2. Typical streambank conditions in STIL-12 Reach

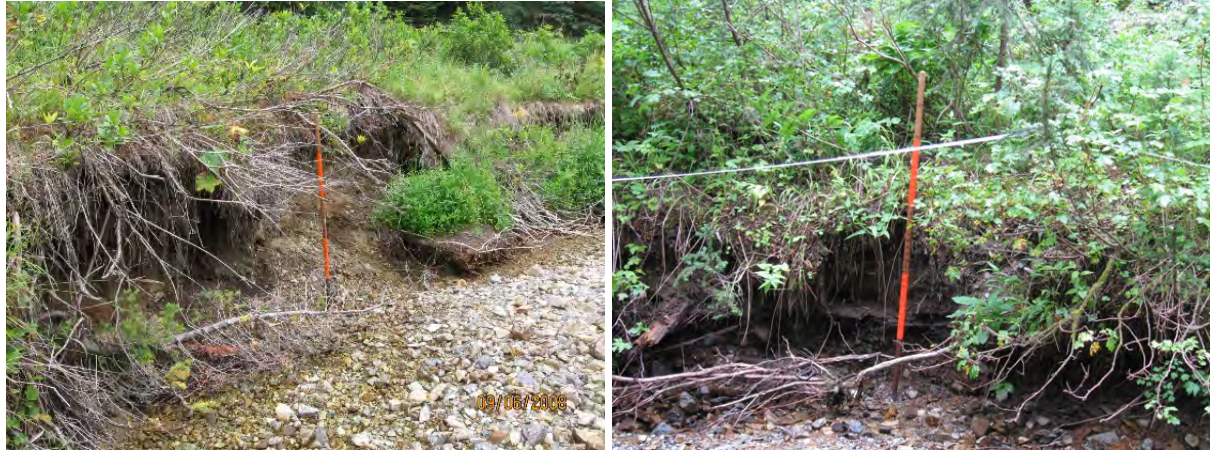
Erosion in this stream reach is natural in cause and infrequent, occurring along 106' of the total reach length, or 5.6%. The limited extent of bank erosion does include some actively eroding banks. Some historic logging and road beds present may have caused some bank instability and subsequent erosion, but the riparian community is vigorous and regenerating well. Typical reach photographs are included in Figure 4-3. BEHI results for Reach WFSC-08 are included in Table 4-8 and Table 4-9.

Figure 4-3. Typical streambank conditions in WFSC-08 Reach

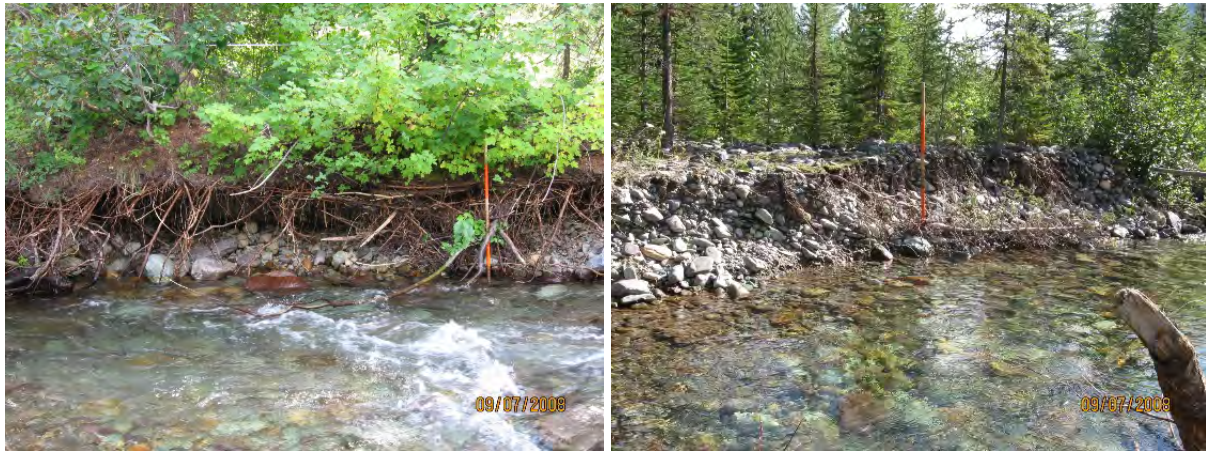
Reach STIL-19 showed erosion along 16.6% of the total bank length. Field notes indicate frequent bank scour and signs of channel adjustment from past upstream logging, albeit occurring within a natural stream channel with good shrub diversity and cover. The floodplain forest is considered to be young and emerging. Typical reach photographs are included in Figure 4-4. BEHI results for Reach STIL-19 are included in Table 4-10 and Table 4-11.

Figure 4-4. Typical streambank conditions in STIL-19 Reach

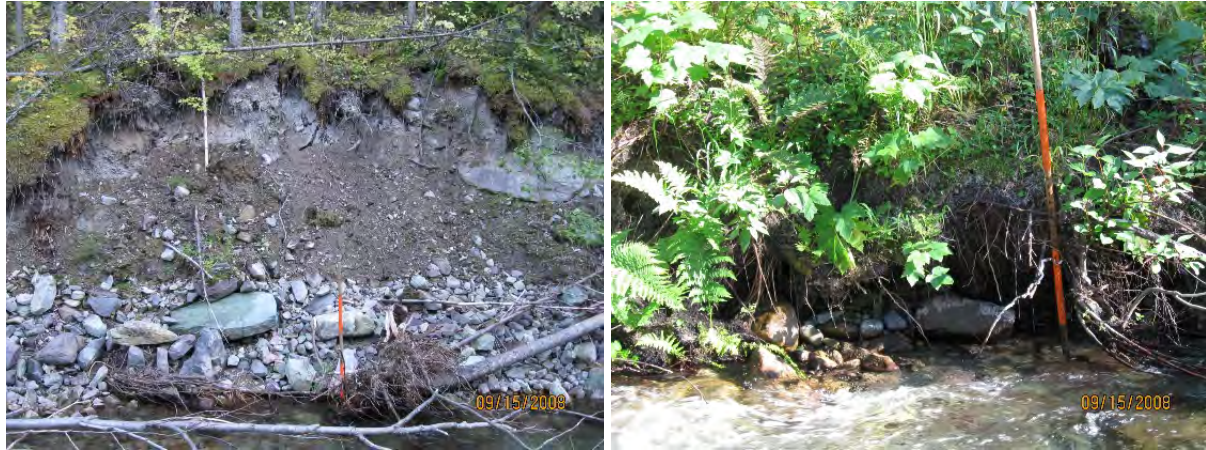
The STIL-23 reach is within a valley that has experienced historic logging. These past silvicultural activities have destabilized some banks and account for an estimated 10% of the active erosion along the channel. Total sediment contribution to the stream is 24.5 tons/year, attributed primarily to natural causes. The upstream end of this reach shows some signs of adjustment. Typical reach photographs are included in Figure 4-5. BEHI results for Reach STIL-23 are included in Table 4-12 and Table 4-13.

Figure 4-5. Typical streambank conditions in STIL-23 Reach

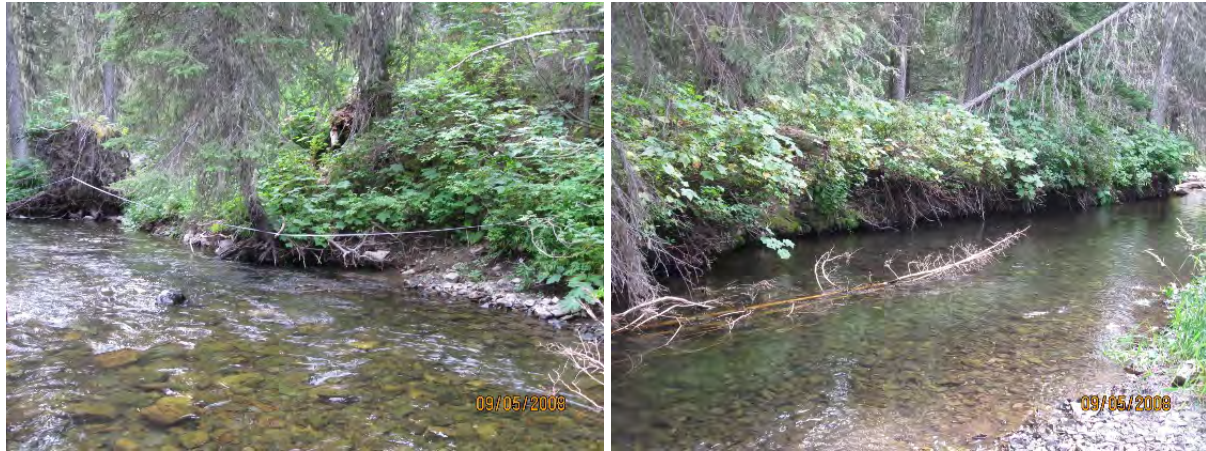
Reach EFSC-15 is within a valley where human impacts are negligible. No active bank erosion was noted and slow streambank erosion is occurring on 9.4% of the reach, totaling 4 tons of sediment/year per 1000 ft. Typical reach photographs are included in Figure 4-6. BEHI results for Reach EFSC-15 are included in Table 4-14 and Table 4-15.

Figure 4-6. Typical streambank conditions in EFSC-15 Reach

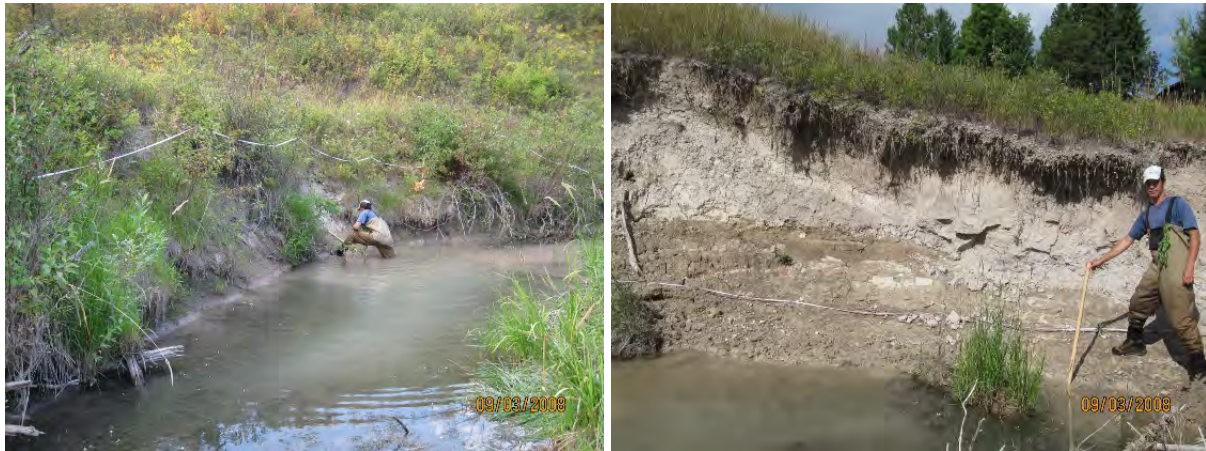
Reach HASK-13 is downstream of agricultural land, but shows minimal impacts from immediate land uses. A total of 26.9 tons of sediment/year are deposited to the stream, primarily from a few areas, totaling 120 feet of streambank, where active erosion is visible (see Figure 4-7, right). Some beaver activity contributes sediment to the stream. Typical reach photographs are included in Figure 4-7. BEHI results for Reach HASK-13 are included in Table 4-16 and Table 4-17.

Figure 4-7. Typical streambank conditions in HASK-13 Reach

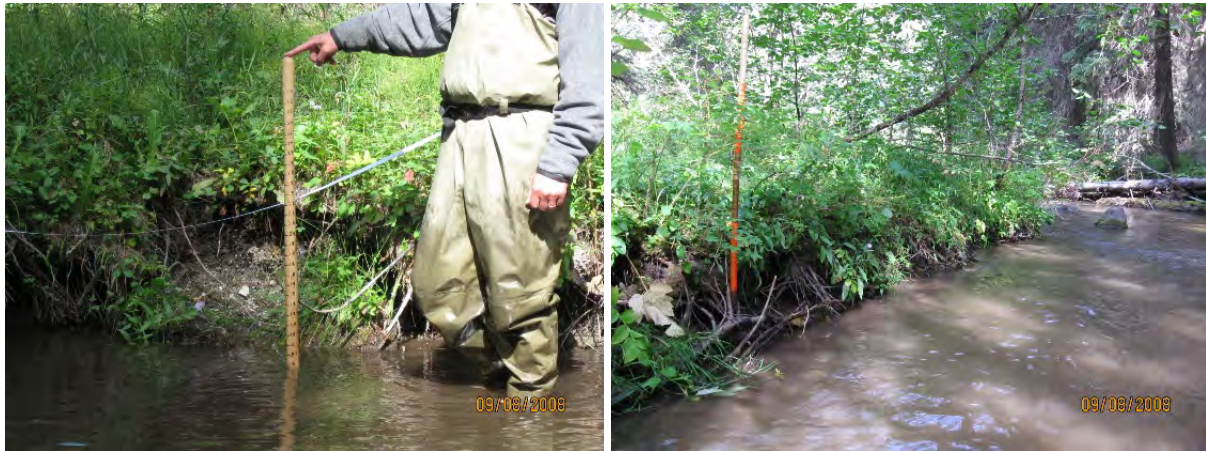
The LOGA-20 reach is within a spruce forest valley with minimal human impacts. A total of 218 feet of the reach is eroding, two-thirds of which is naturally occurring slow erosion (see Figure 4-8, left). The riparian community is diverse and well established. Typical reach photographs are included in Figure 4-8. BEHI results for Reach LOGA-20 are included in Table 4-18 and Table 4-19.

Figure 4-8. Typical streambank conditions in LOGA-20 Reach

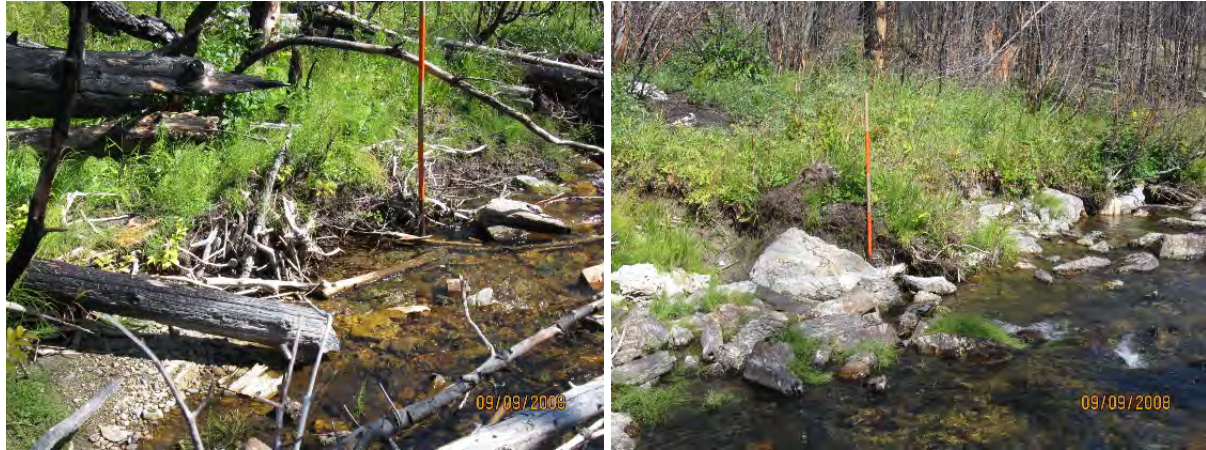
The SHEP-25 reach is within a burned area which has seen past and present upstream logging. Mature riparian tree species are all burned and banks are dominated by fast-growing forbs and shrubs. The well-armored banks allow for some slow, naturally caused erosion, totaling 6.2 tons/year per 1000 ft. The riparian community is diverse and well established. Typical reach photographs are included in Figure 4-9. BEHI results for Reach SHEP-25 are included in Table 4-20 and Table 4-21.

Figure 4-9. Typical streambank conditions in SHEP-25 Reach

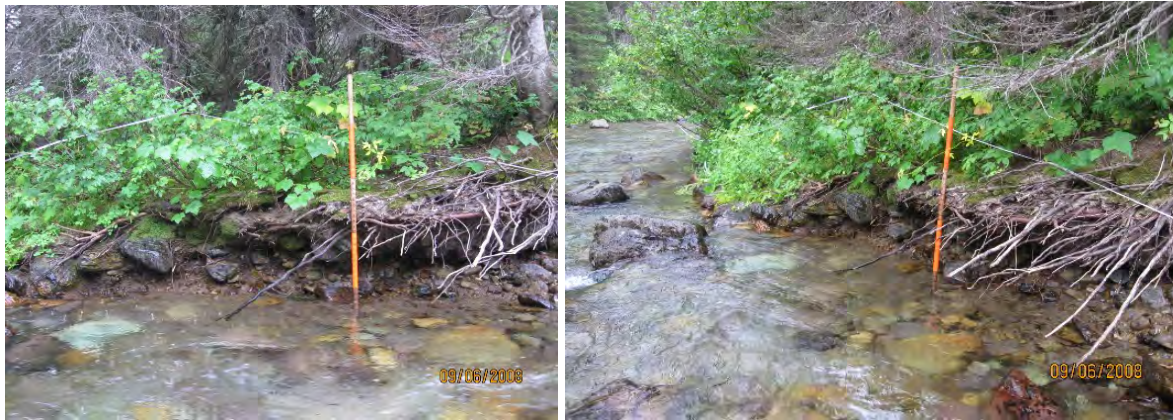
The WFSC-18 reach is an example of best available conditions among the sample size of this project. Less than 2% of the streambanks show active or slow erosion, totaling 1.7 tons/year. The riparian is dominated by well-established shrubs and surrounded by a mature conifer forest. Typical reach photographs are included in Figure 4-10. BEHI results for Reach WFSC-18 are included in Table 4-22 and Table 4-23.

Figure 4-10. Typical streambank conditions in WFSC-18 Reach

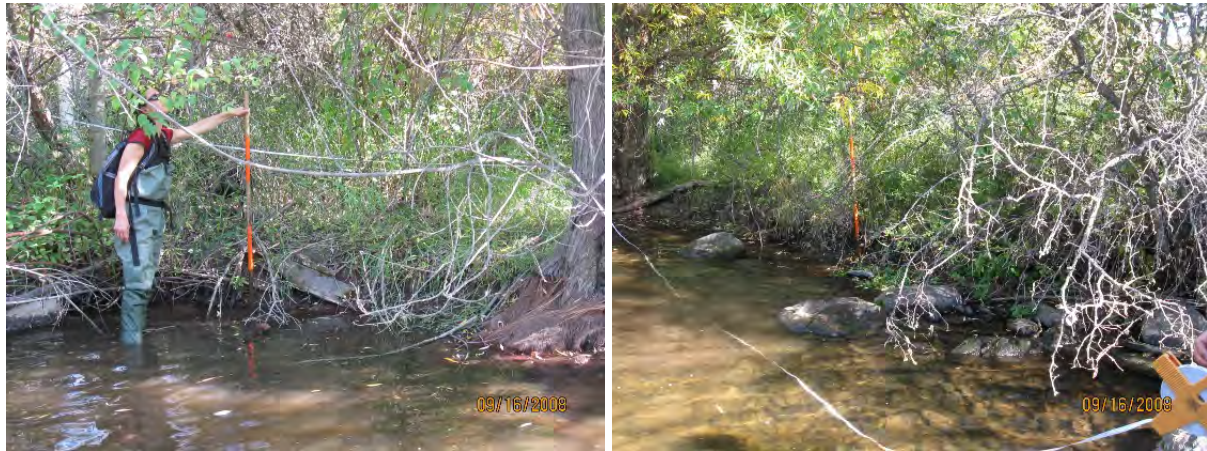
The ASHL-25 stream reach is within an urban setting. There is a bridge crossing at the upstream end and the reach has been channelized and confined. Streambank erosion is limited to some slowly eroding banks along 14.5% of the reach. Some beaver activity influences sediment loading but the predominant causes of sediment loading are natural. Typical reach photographs are included in Figure 4-12. BEHI results for Reach ASHL-25 are included in Table 4-26 and Table 4-27.

Figure 4-12. Typical streambank conditions in ASHL-25 Reach

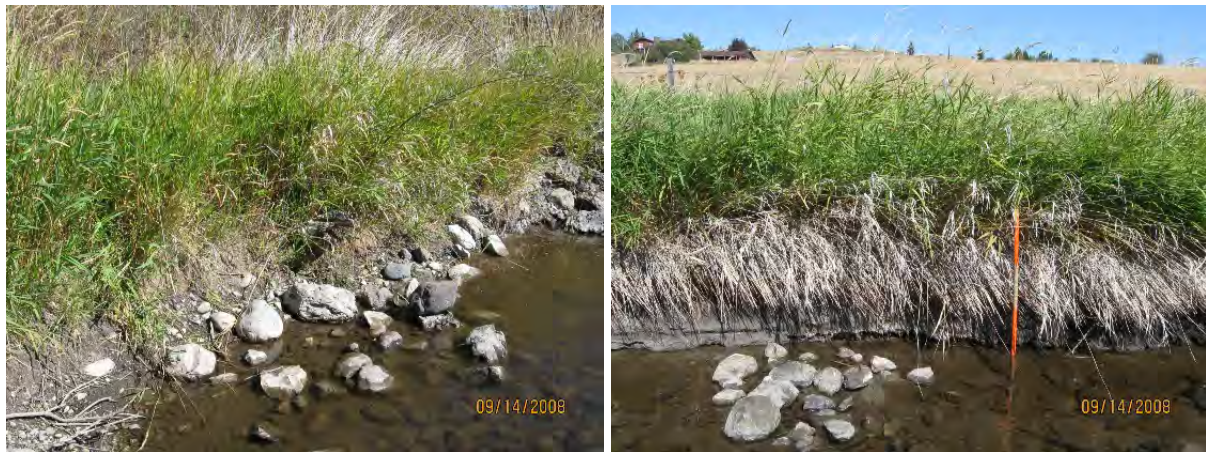
Streambank erosion in this stream reach is low but widespread, covering 29.4% of the streams total bank length. Riparian grazing and cropland are the surrounding land uses, causing over 50% of the total sediment contribution to the stream, which approaches 35 tons/year. Typical reach photographs are included in Figure 4-13. BEHI results for Reach ASHL-29 are included in Table 4-28 and Table 4-29.

Figure 4-13. Typical streambank conditions in ASHL-29 Reach
