Flathead-Stillwater TMDL Planning Area Sediment and Habitat Assessment Summary Report

Prepared by:
Watershed Consulting, LLC
P.O. Box 1701
Kalispell, MT 59903

Submitted to:
Montana DEQ
1520 E. Sixth Avenue
Helena, MT 59620

March 15, 2009

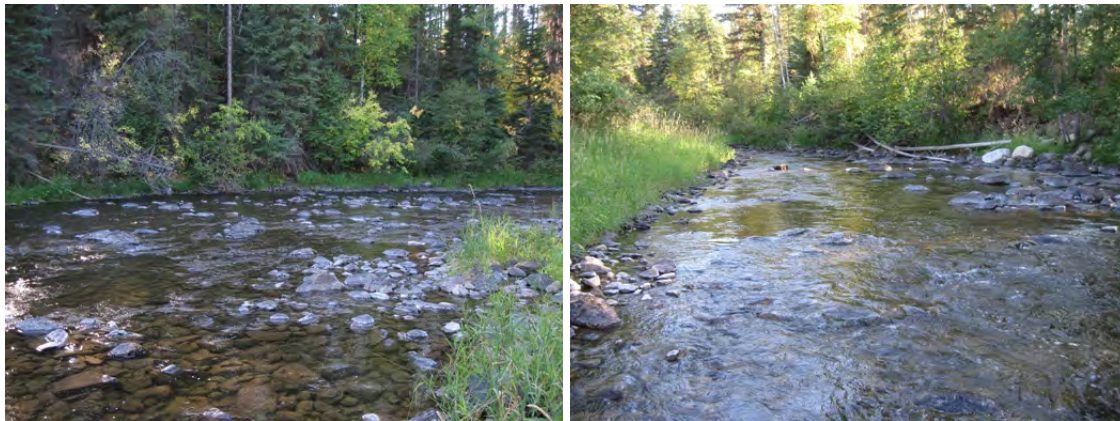
The LOGA-45 stream reach is within a stable and well-armored stream channel. There was no observed erosion in this stream reach. Typical reach photographs are included in Figure 4-14. BEHI results for Reach LOGA-45 are included in Table 4-30.

Figure 4-14. Typical streambank conditions in LOGA-45 Reach

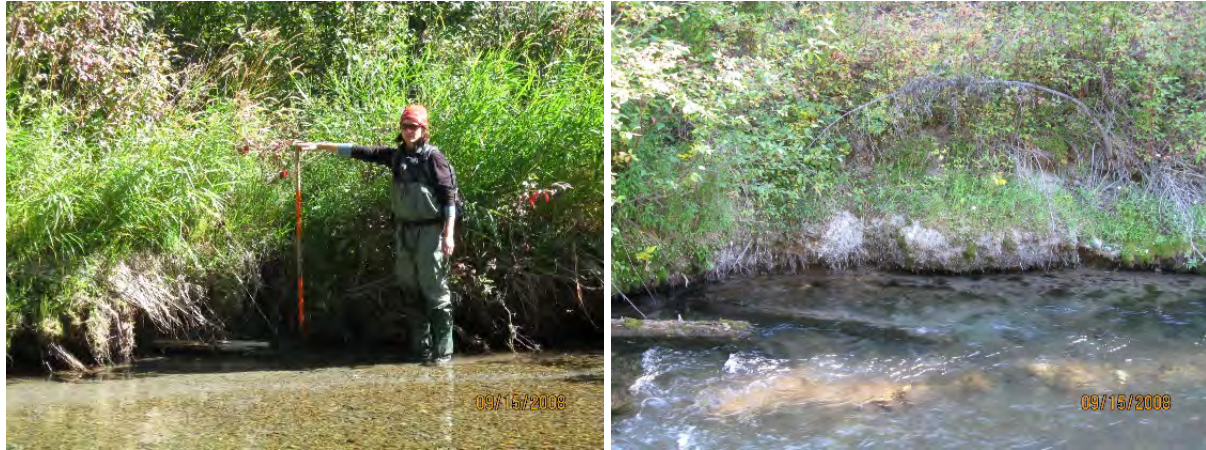
The STIL-33 reach is within a highly embedded channel in an area that was previously logged. Riparian shrubs and some exotic grasses dominate the streambank vegetation, providing some streambank stability. Over half of the streambank length within the reach shows signs of slow erosion. Most erosion is from low undercut banks, which in total contribute 78.2 tons of sediment/year to the channel. Typical reach photographs are included in Figure 4-15. BEHI results for Reach STIL-33 are included in Table 4-31 and Table 4-32.

Figure 4-15. Typical streambank conditions in STIL-33 Reach

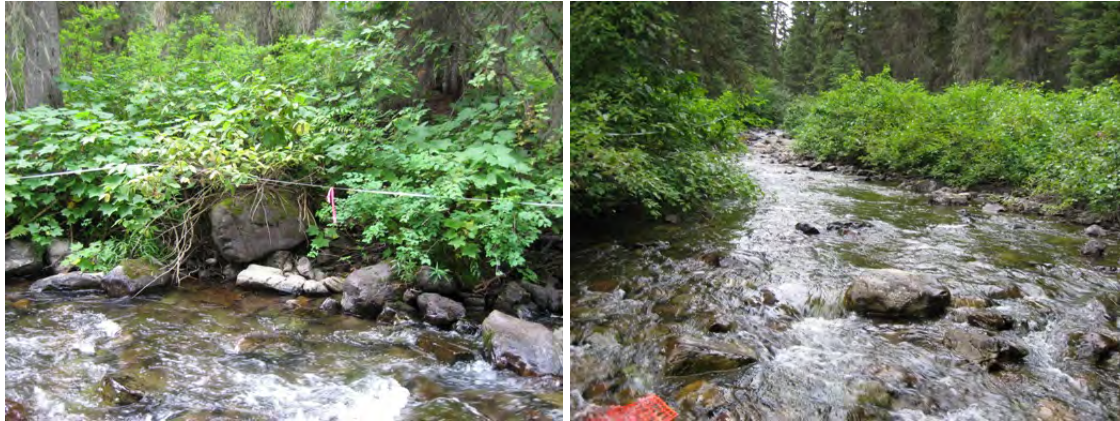
The EFSC-16 reach is an example of the best available conditions among the streams sampled. No visible erosion was noted in this reach. Typical reach photographs are included in Figure 4-16. BEHI results for Reach EFSC-16 are included in Table 4-33.

Figure 4-16. Typical streambank conditions in EFSC-16 Reach

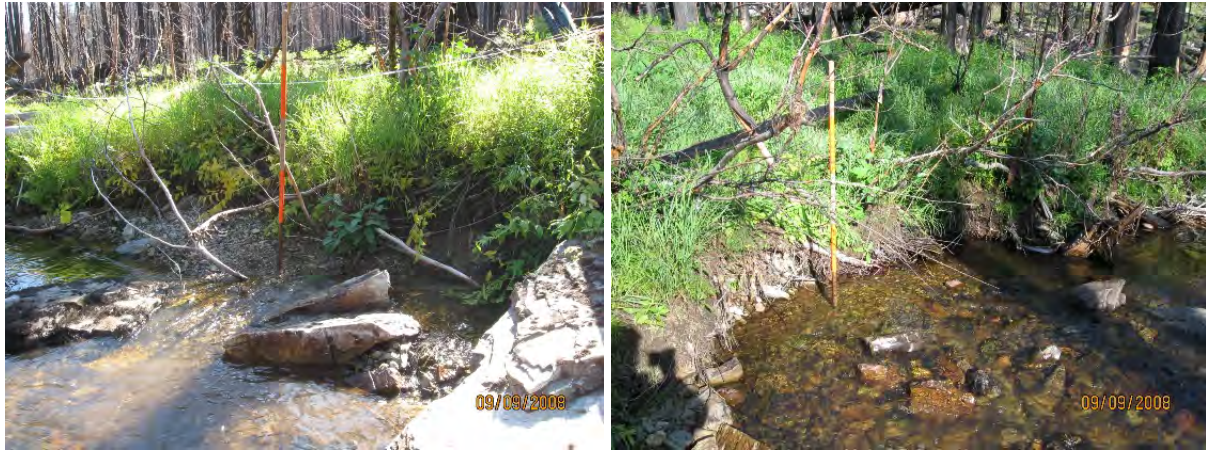
This stream reach is within a burned valley, whose riparian vegetation has been reduced due to fire. Shrub roots are still intact and shrubs are resprouting. Well-armored banks provide for a stable channel, which shows mostly low and slowly eroding banks. All erosion, totaling 10 tons/year, is natural in cause in this reach. Typical reach photographs are included in Figure 4-17. BEHI results for Reach SHEP-18 are included in Table 4-34 and Table 4-35.

Figure 4-17. Typical streambank conditions in SHEP-18 Reach

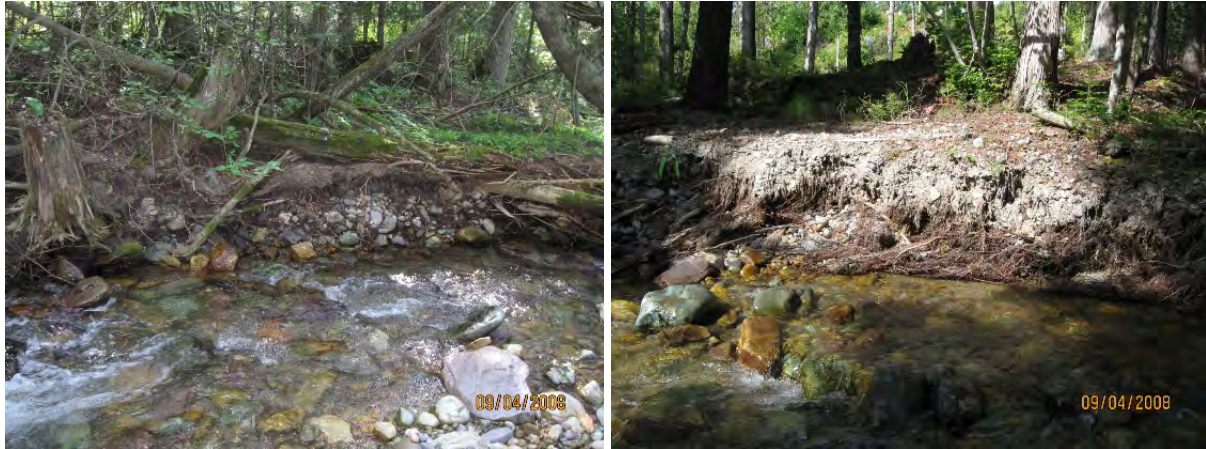
photographs are included in Figure 4-18. BEHI results for Reach HASK-06 are included in Table 4-36 and Table 4-37.

Figure 4-18. Typical streambank conditions in HASK-06 Reach

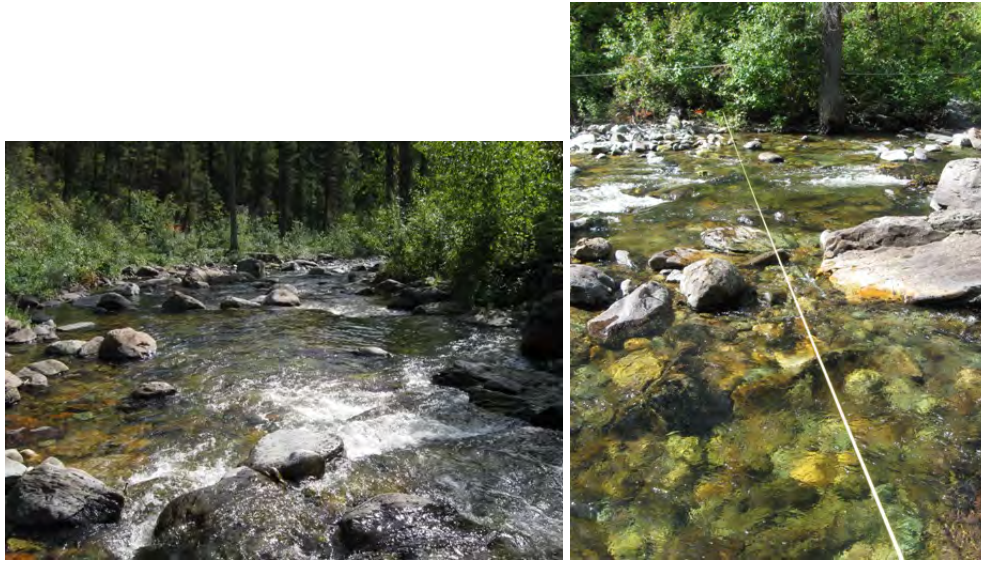
The LOGA-37 reach shows no visible erosion. Banks are naturally well-armored with large rock. Healthy riparian communities are present throughout the reach and there are no notable anthropogenic influences on the channel. Typical reach photographs are included in Figure 4-19. BEHI results for Reach LOGA-37 are included in Table 4-38.

Figure 4-19. Typical streambank conditions in LOGA-37 Reach

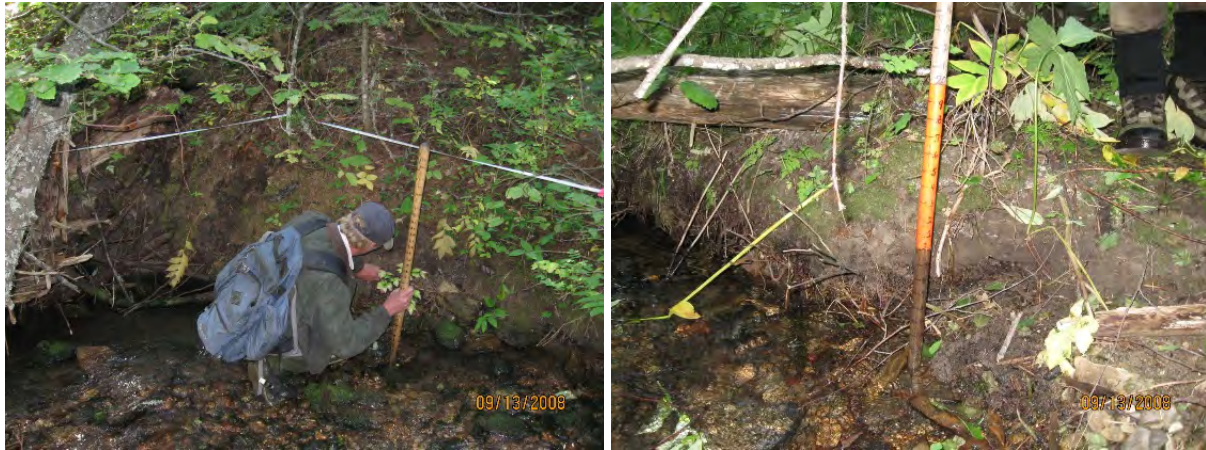
Stream reach FISH-05 shows a total sediment load of 2.6 tons/year per 1000 ft, a low level when seen in comparison to the best available reaches (although Rosgen stream types and other factors differ). Examples of some of the slowly eroding banks present in the stream are shown in Figure 4-20. Typical reach photographs are included in Figure 4-20. BEHI results for Reach FISH-05 are included in Table 4-39 and Table 4-340.

Figure 4-20. Typical streambank conditions in FISH-05 Reach.
