# Flint Creek Planning Area Sediment and Metals TMDLs and Framework Water Quality Improvement Plan

**October 2012**

Water Quality Planning Bureau  
Watershed Management Section

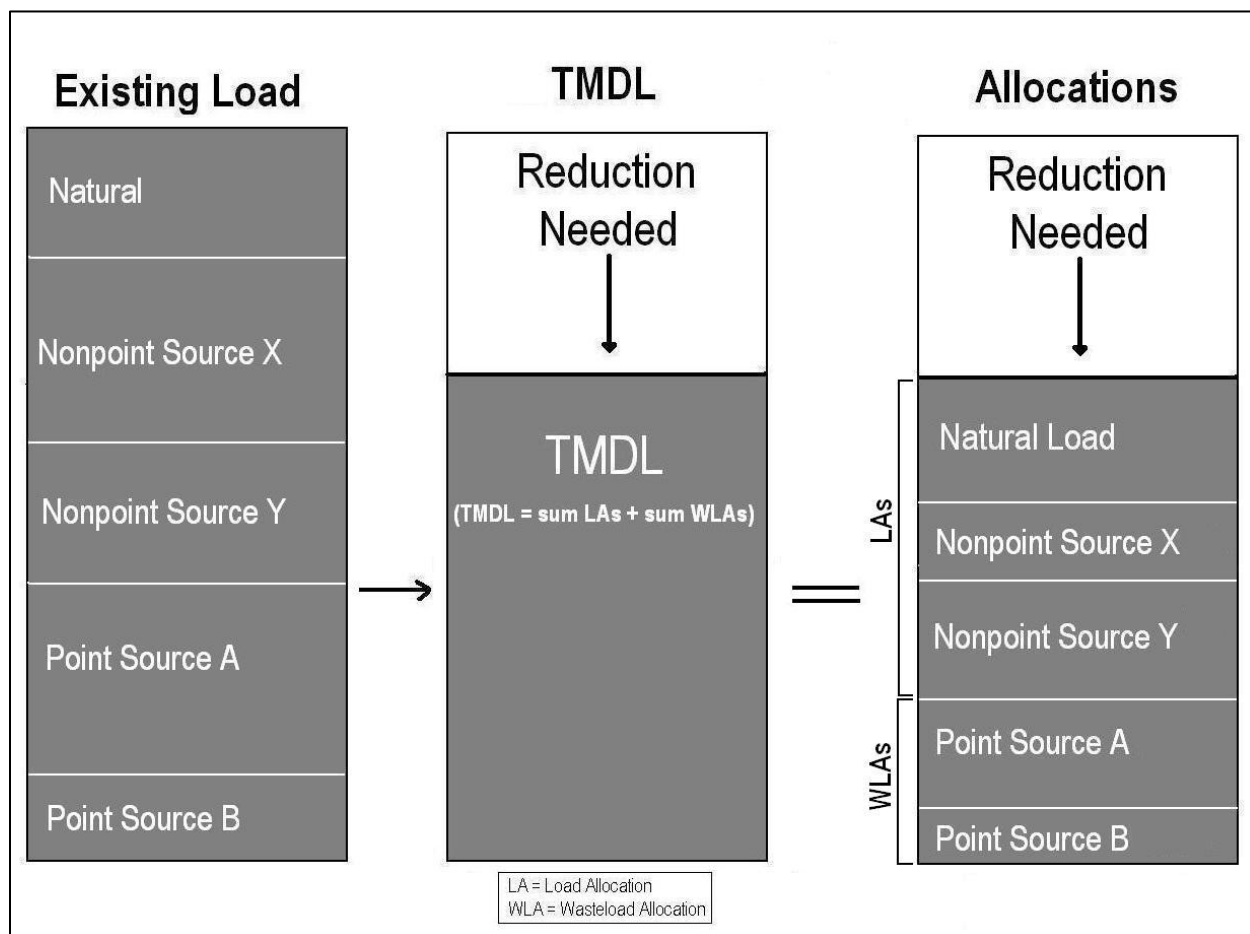
**Figure 4-2** illustrates how TMDLs are allocated to different sources using WLAs for point sources and LAs for natural and nonpoint sources. Although some flexibility in allocations is possible, the sum of all allocations must meet the water quality standards in all segments of the waterbody.

**Figure 4-2. Schematic Diagram of a TMDL and its Allocations**

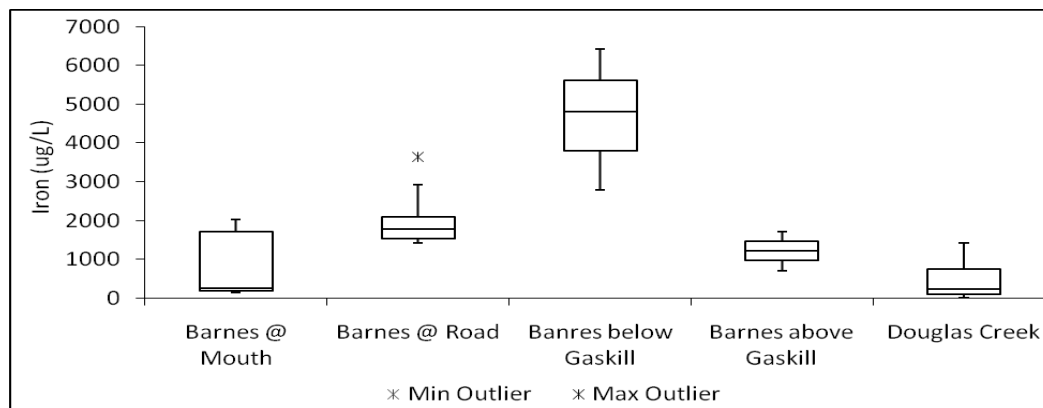
**Figure 6-2. Iron concentrations at Barnes Creek sites and in Douglas Creek.**
