**ANALYTICAL RESULTS REPORT  
for a  
CERCLA SITE INSPECTION**

**PHILIPSBURG MINING AREA (Douglas Creek)  
Near Philipsburg, Granite County, Montana**

**TDD No. 1103-02**

**June 21, 2012**

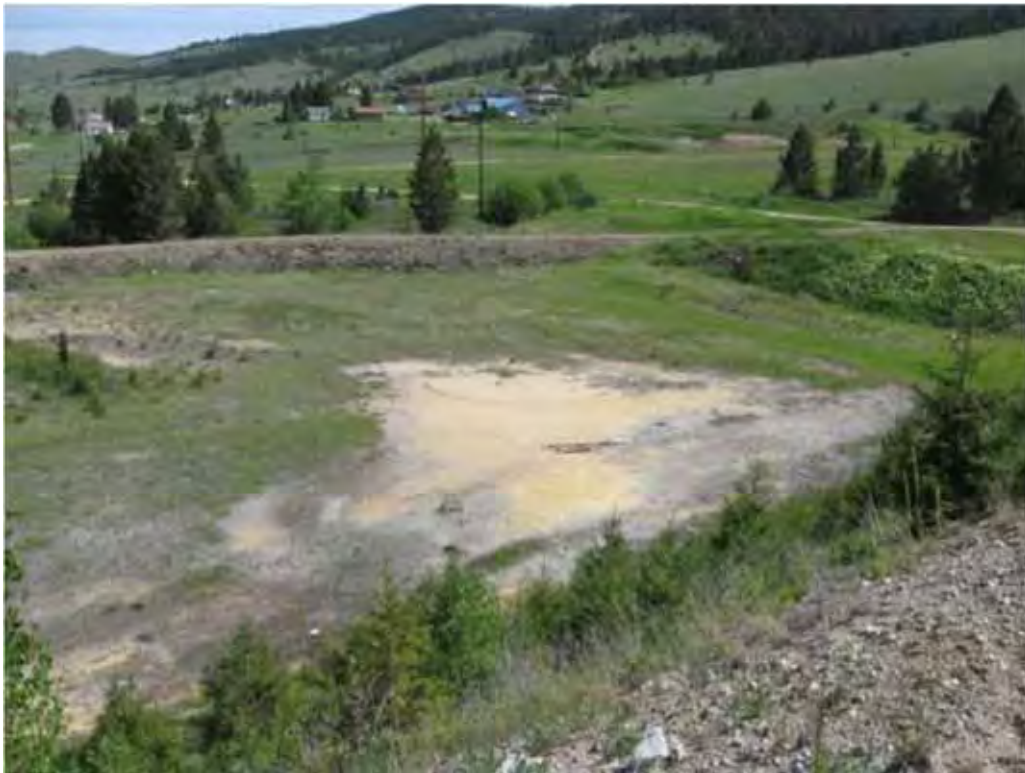
**PHOTO 1**

Area of historical Bi-Metallic Mill tailings pile with no vegetation, looking northwest. Note dirt bike track.

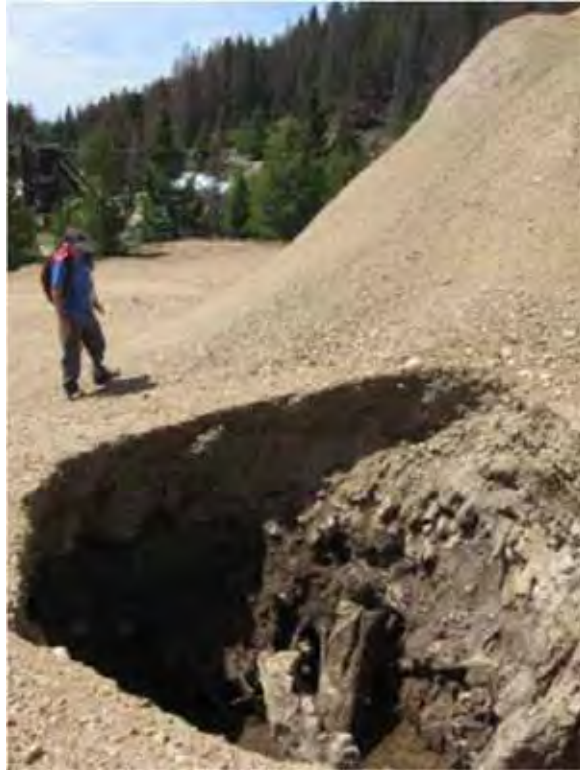
**PHOTO 12**

Jeff Miller (START) at sinkhole at base of Granite Mountain waste rock pile. Looking west.

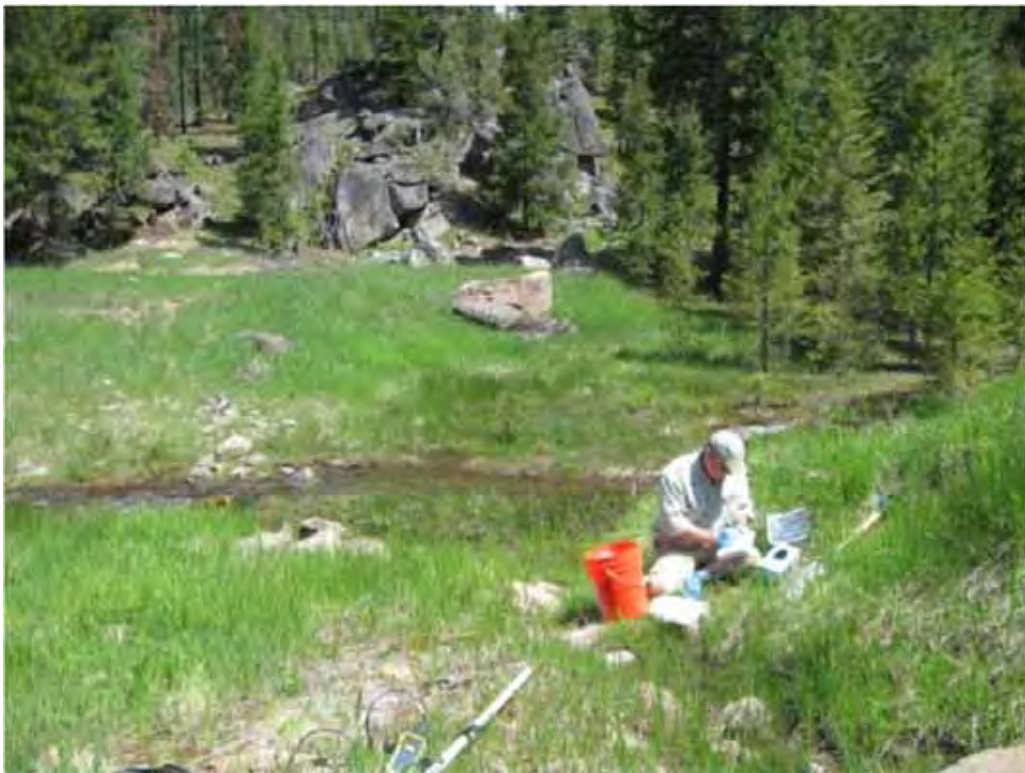
**PHOTO 18**

Chuck Baker (START) collecting source sample PMA\_DC\_SW\_15\_0611 from seep near east end of Douglas Creek West tailings pile. Looking north.

Five aqueous source samples (includes one duplicate sample collected for mercury only) were collected from two flowing adits (Photos 26, 36, 45) and two seeps (Photos 17, 18) (Tables 4, 6; Figure 2). The third seep historically identified on the east side of the Douglas Creek east tailings pile could not be found.

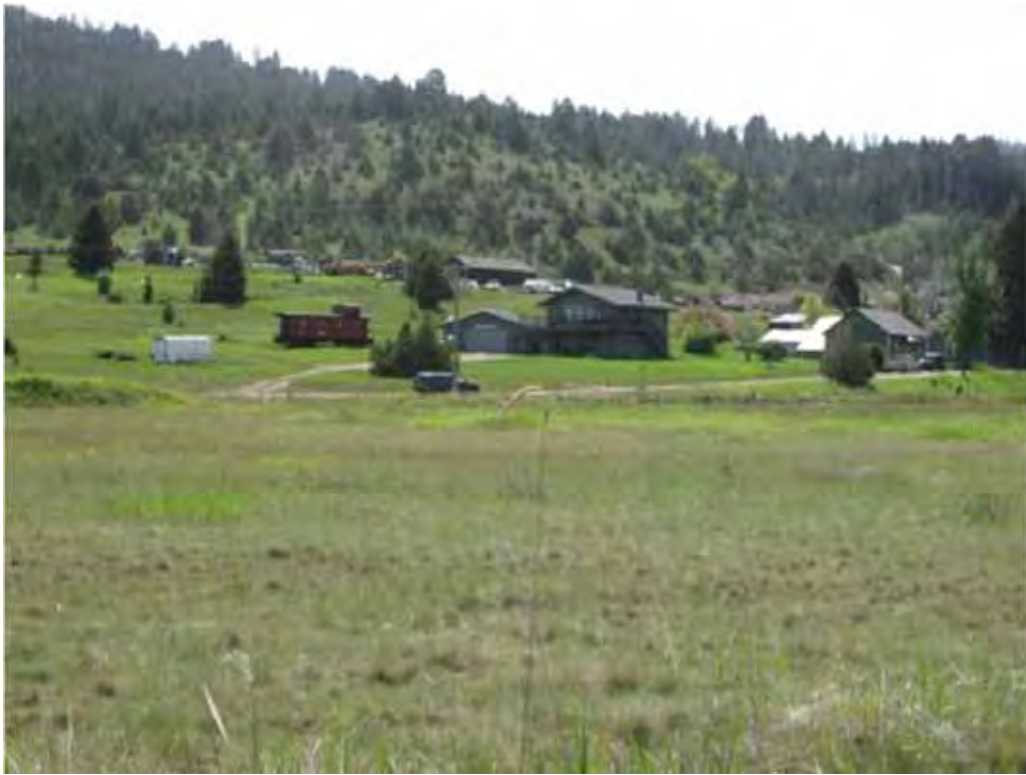
**PHOTO 21**

Houses located adjacent to historical Bi-Metallic tailings pile (in fore- and mid-ground). Looking southeast.

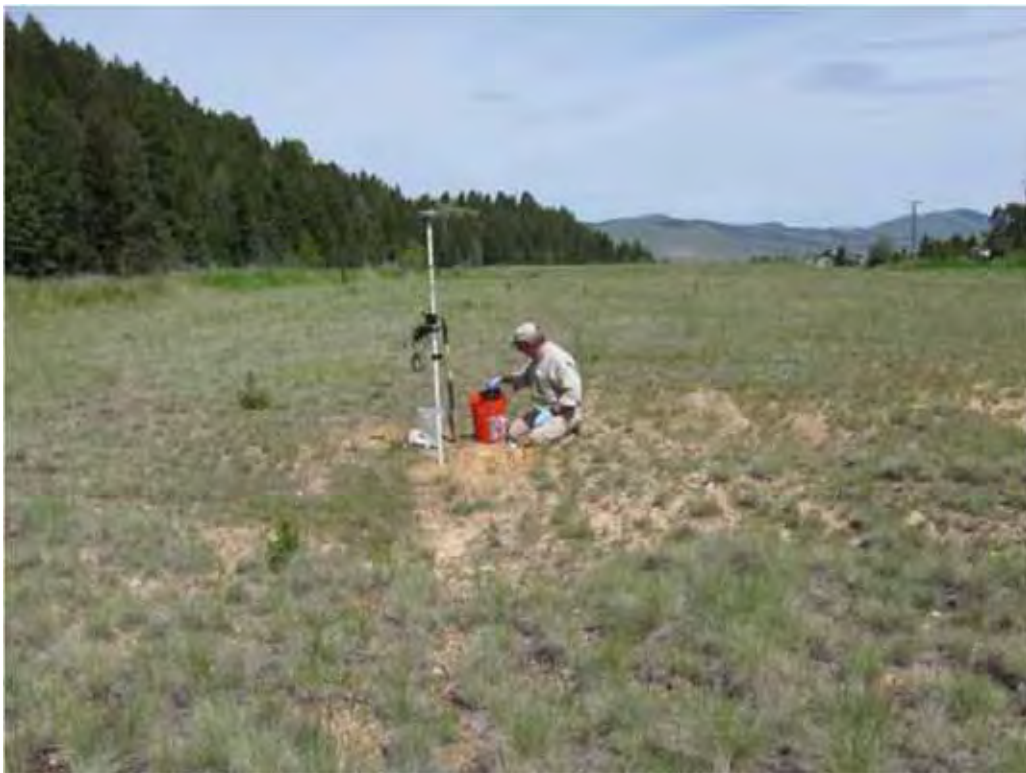
**PHOTO 22**

Chuck Baker (START) collecting source sample PMA\_DC\_SO\_17\_0611 from the historical Bi-Metallic Mill tailings. Looking northwest.

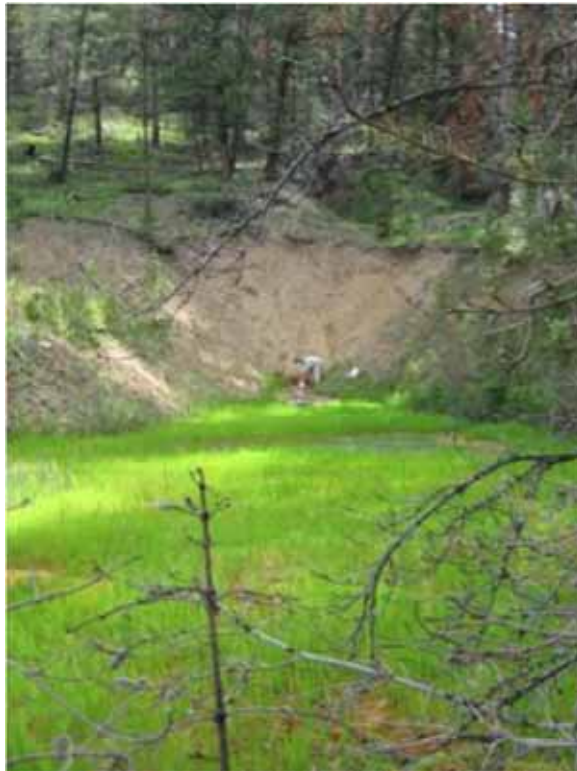
**PHOTO 26**

Chuck Baker (START) collecting aqueous source sample PMA\_DC\_SW\_13\_0611 from the Granite Mountain/Bi-Metallic adit (Granite Drain). Facing northeast.

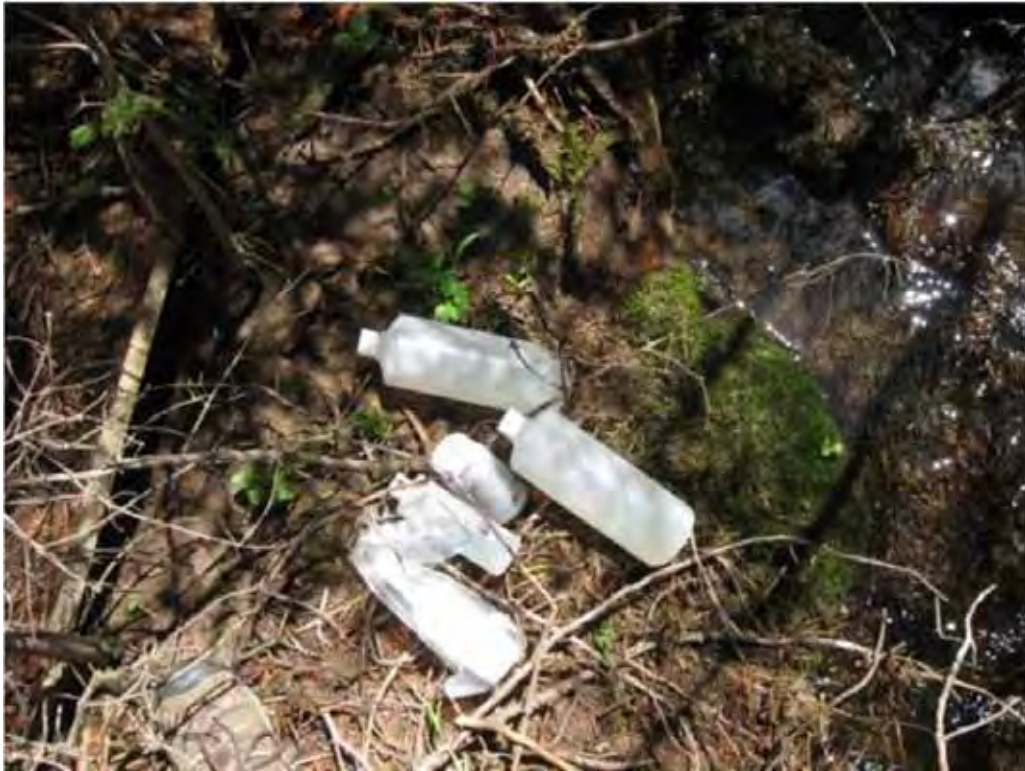
**PHOTO 53**

Photo of surface water and sediment sample location PMA\_DC\_SW/SE\_21\_0611, below the PPE for the Bi-Metallic/Old Red waste piles. Douglas Creek on the right and the wooden tailings flume is on the left.
