**Water Quality Restoration Plan and Total Maximum Daily Loads
(TMDLs) for the Lake Helena Watershed Planning Area:**

**Volume I – Watershed Characterization and Water Quality Status
Review**

December 30, 2004

Prepared for the Montana Department of Environmental Quality

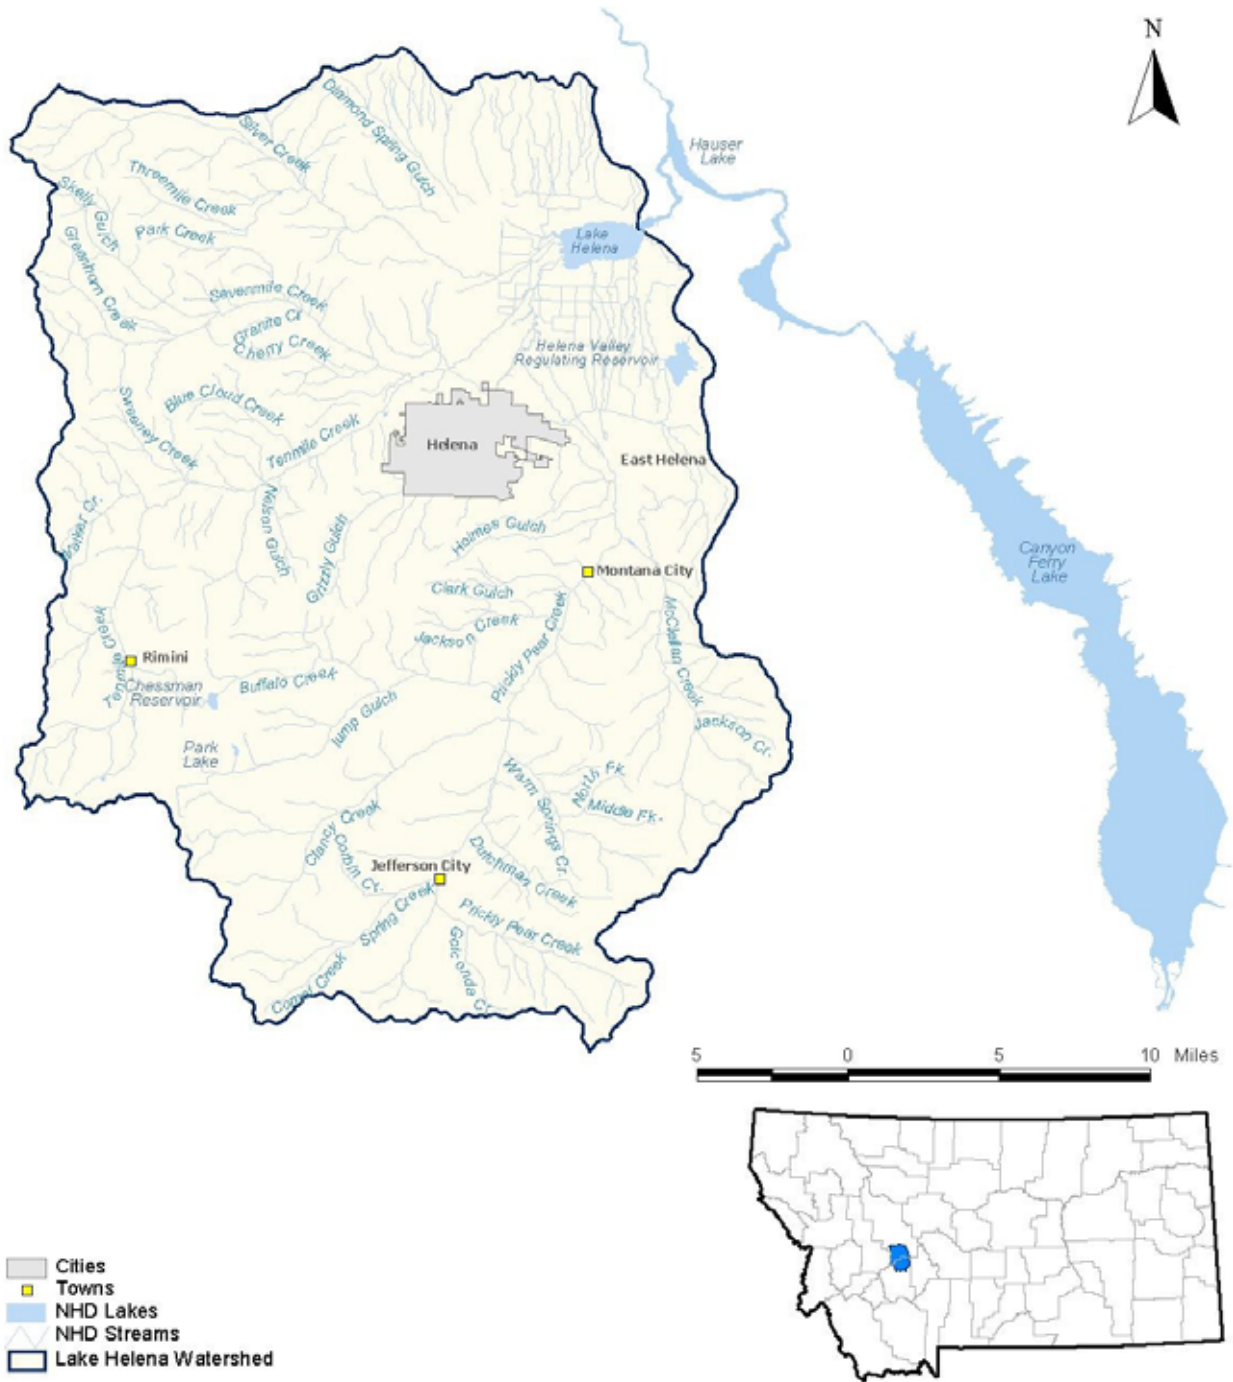
Figure 2-1. Streams in the Lake Helena watershed.

The Lake Helena watershed is in west-central Montana and encompasses an area of nearly 620 square miles (Figure 2-1). There are three major streams in the watershed—Silver, Tenmile, and Prickly Pear Creeks. All three flow into Lake Helena, which is a regulated reservoir formed in the old creek valleys just north of the city of Helena, Montana. Lake Helena eventually flows into Hauser Reservoir on the Missouri River. Other impoundments in the watershed are the Chessman Reservoir, Scott Reservoir, and the Helena Valley Regulating Reservoir, all of which are part of the City of Helena’s water supply storage and delivery system.

This section presents summaries and evaluations of all available water quality data for Lake Helena proper. The location of Lake Helena is shown in relation to its watershed in Figure 2-1.

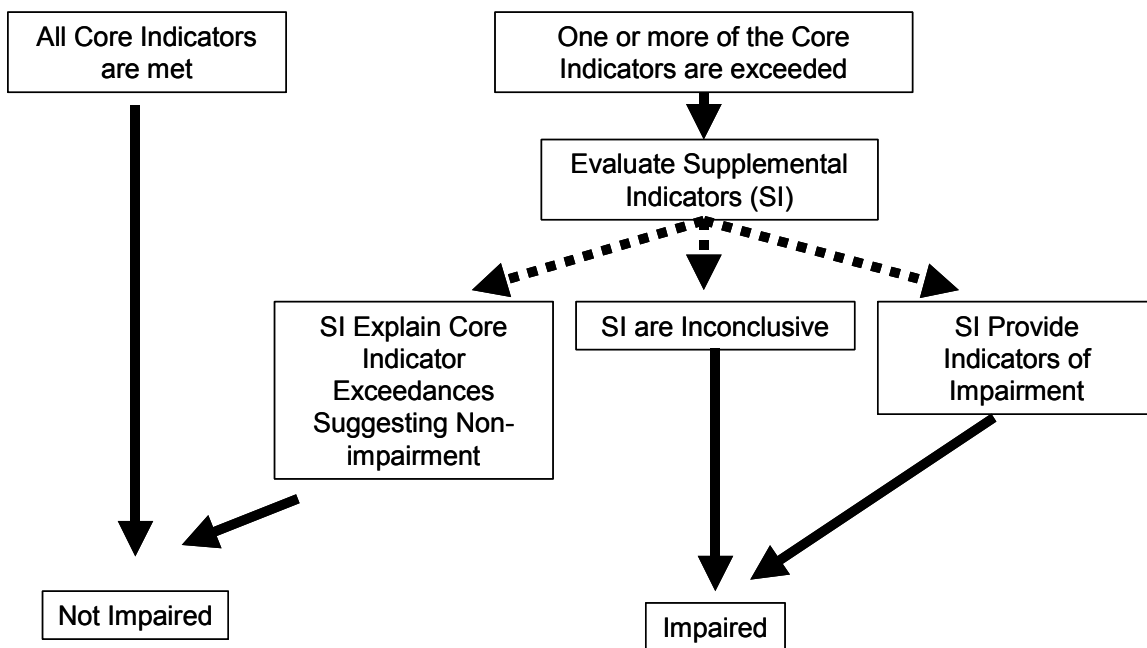
Figure 3-2. Weight-of-evidence approach for determining beneficial use impairments.

The beneficial use impairment determinations presented in Section 3.4 are based on a weight-of-evidence approach in combination with the application of best professional judgment. The weight-of-evidence approach is outlined in Figure 3-2 and is applied as follows. If none of the target values are exceeded, the water is considered to be fully supporting its uses and no TMDL is necessary. This is true even if one or more of the supplemental indicator values are exceeded. On the other hand, if one or more of the target values are exceeded, the circumstances around the exceedance are investigated and the supplemental indicators are used to provide additional information to support a determination of impairment/non-impairment. The circumstances around the exceedance of a target value are investigated before it is automatically assumed that the exceedance represents human-caused impairment (for example: Are the data reliable and representative of the entire reach? Might the exceedance be a result of natural causes such as floods, drought, fire, or the physical character of the watershed?). In addition, the supplemental indicators assist by providing collaborative and supplemental information, and the weight of evidence of the complete suite of targets and supplemental indicators is used to make the impairment determination.

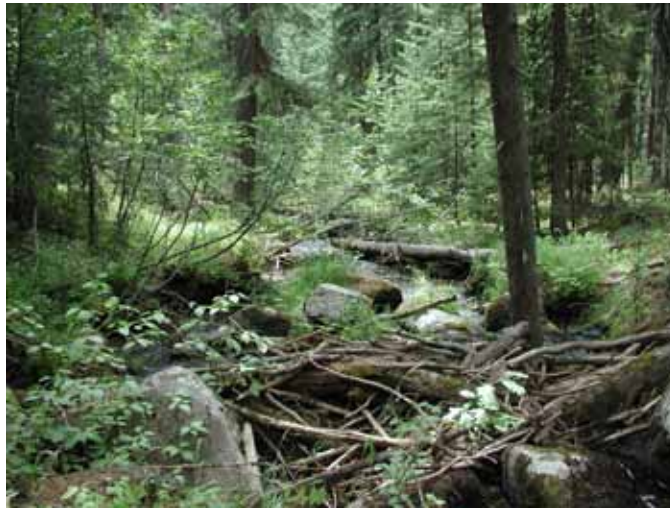
Prickly Pear Creek from headwaters to Spring Creek

In 1996, the cold-water fishery uses in this 8.7-mile headwater segment of Prickly Pear Creek were listed as threatened due to suspended solids and metals. The basis for the suspended solids listing is a 1981 report that describes undesirable channel and riparian conditions resulting from historical placer mining. The worst of these conditions begins at the confluence with Golconda Creek. In subsequent years the segment has not been listed for suspended solids. However, fish habitat and habitat alterations have been added to the list as sources of pollution. The rationale for the metals listing is unknown. In 2000, the impaired water uses were changed to include aquatic life and drinking water (non-supporting), and agriculture (partial support). Fisheries uses were upgraded from threatened to fully supporting. A typical view of this segment is shown in the photo below.

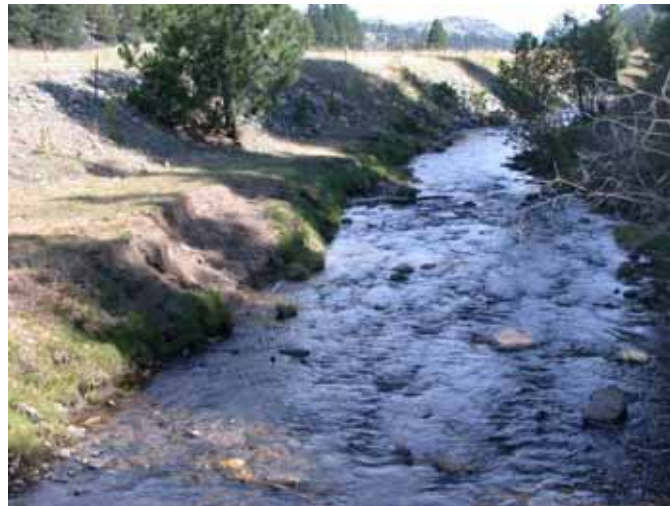
Prickly Pear Creek from Spring Creek to Lump Gulch

In 1996, this 7-mile segment of Prickly Pear Creek was listed as not supporting aquatic life, cold-water fisheries, swimming, and agricultural uses due to suspended solids and siltation. The basis for the listings are five reports dating back to the 1980s that summarize undesirable channel conditions, such as stream channelization, lack of riparian vegetation, and bank erosion. In subsequent years, the segment has been listed as not supporting aquatic life, cold-water fisheries, and drinking water uses, and partially supporting agricultural uses, because of siltation, fish habitat degradation, habitat alterations, bank erosion, and metals. A typical view of this segment is shown in the photo below.

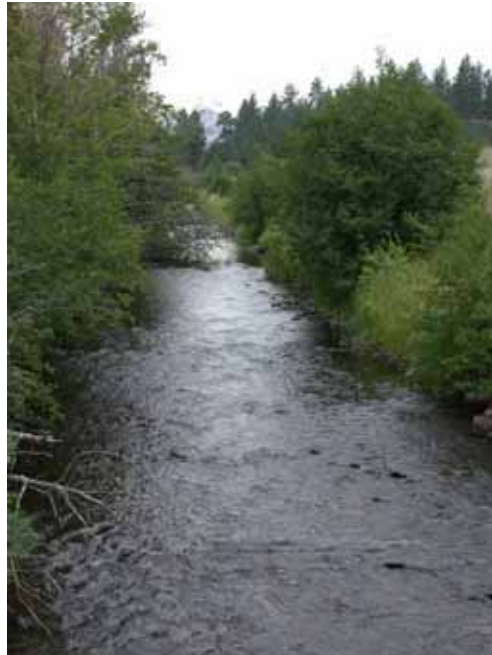
Prickly Pear Creek from Lump Gulch to Wylie Drive

In 1996, the aquatic life, cold-water fishery, and agricultural water uses in this 11-mile segment of Prickly Pear Creek were listed as partially supported because of habitat alterations, flow alterations, and metals. The basis for the listings was four reports dating back to the 1980s that summarized undesirable channel conditions, such as stream channelization and substrate embeddedness, and a total of 11 in-stream water chemistry samples taken between June 1999 and August 2003. In subsequent years, the segment has been listed as not supporting aquatic life, cold-water fishery, and drinking water uses, and partially supporting agricultural uses, because of siltation, habitat alterations, fish habitat degradation, and metals. Although this segment of Prickly Pear Creek is not listed for thermal modifications, data collected from a continuous recording thermograph in 2003 indicate the probability of thermal modifications. A typical view of this segment is shown in the photo below.

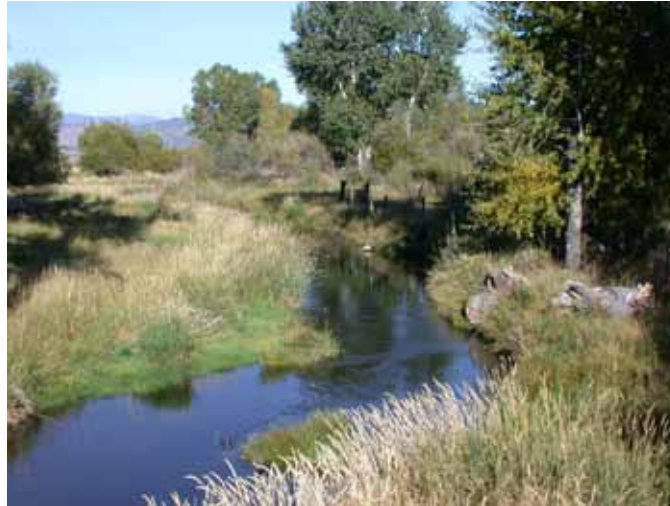
Prickly Pear Creek from Wylie Drive to Helena Wastewater Treatment Plant Discharge

Stream segment MT41I006_030 was listed on Montana’s 1996 303(d) list as not supporting aquatic life, cold-water fisheries, drinking water, swimming, and agricultural water uses because of siltation, suspended solids, habitat alterations, flow alterations, and metals. This segment is approximately 5 miles in length. In subsequent years, aquatic life, cold-water fisheries, and drinking water have been listed as not supported, while swimming and agricultural water uses have been listed as partially supported, because of thermal modifications, fish habitat degradation, riparian degradation, and nutrients, in addition to the causes of impairment listed in 1996. A typical view of this segment is shown in the photo below.

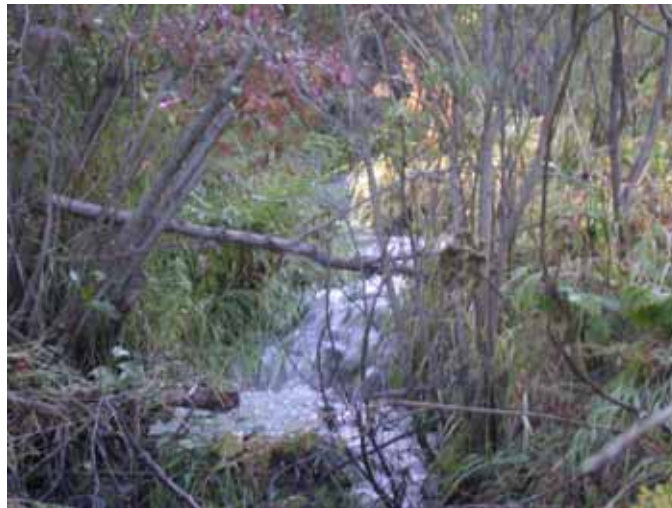
In 1996, the cold-water fishery, aquatic life, drinking water, and body contact recreational uses in the 3.7 miles of Golconda Creek were listed as not supported because of suspended solids, turbidity, metals, and unknown toxicity. One basis for the listing was a citizen complaint in 1989 that the creek would turn milky white during high flows. The source of the turbidity was found to be tailings piles at the headwaters of a tributary stream to Golconda Creek. In subsequent years, the segment has been listed for siltation, channel incisement, other habitat alterations, and metals (including specific reference to arsenic, lead, and mercury). The unknown toxicity listing was removed from the 303(d) lists once the sources of milky turbidity were discovered (the tailings piles). A typical view of Golconda Creek is shown in the photo below.

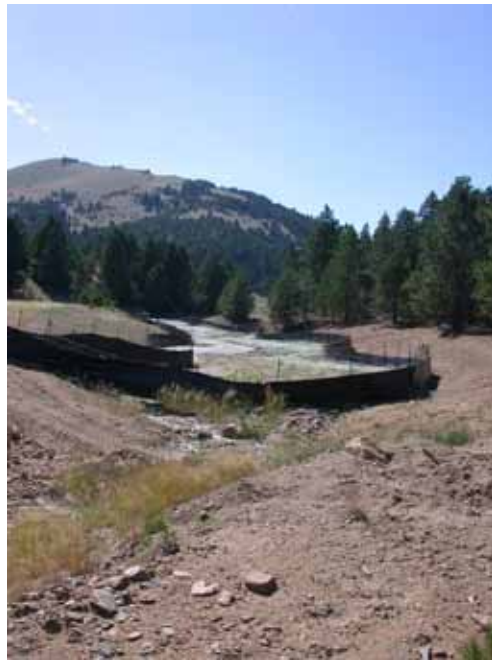
In 1996, the aquatic life, cold-water fishery, drinking water, recreational, and agricultural uses in the 2.5 miles of Corbin Creek were listed as non-supported because of suspended solids, metals, pH, salinity/total dissolved solids/chlorides, and other inorganics. The basis for the 1996 listing was a series of reports dating from the 1980s to 1990s that described severe impairments of the stream from abandoned mines and riparian grazing. In subsequent years, agricultural water uses were upgraded from non-supporting to partially supporting, and thermal modifications and habitat alterations were added to the list of impairment causes for Corbin Creek. Salinity, total dissolved solids, and chlorides did not appear as impairment causes on either the 2002 or 2004 303(d) lists. A typical view of Corbin Creek is shown in the photo below.

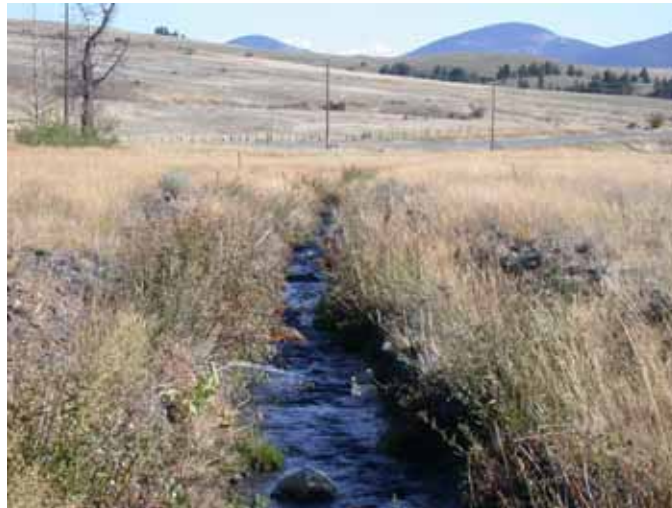
In 1996, this 1.7-mile segment of Spring Creek was listed as not supporting its designated aquatic life, cold-water fishery, drinking water, recreation, and agricultural water uses because of suspended solids, habitat alterations, nutrients, metals, and pH. The basis for the listing was elevated concentrations of metals, total suspended solids, and turbidity in grab samples collected from 1974 to 1981, and a report that described turbid water conditions in the stream during storm events only below the confluence with Corbin Creek. In subsequent years, recreational water uses were upgraded from non-supporting to partially supporting, and dewatering, fish habitat degradation, and riparian degradation were added to the list of impairment causes. A typical view of Spring Creek from Corbin Creek to the mouth is shown in the photo below.

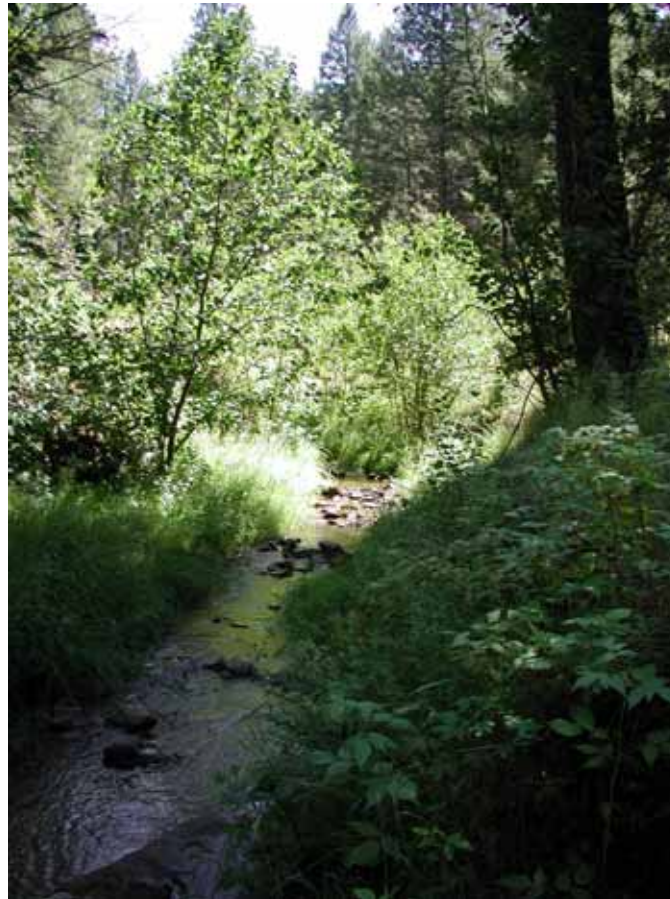
Middle Fork Warm Springs Creek is a tributary of Warm Springs Creek, which is a tributary of Prickly Pear Creek. The listed segment (MT41I006_100) of the Middle Fork extends for 2.7 miles from the headwaters to the mouth. In 1996, the cold-water fishery and aquatic life uses in the Middle Fork Warm Springs Creek were listed as partially supported because of siltation, habitat alterations, and metals. The basis for the listing is unknown. However, a habitat survey performed in 2001 reported substrate embeddedness, erosion-prone banks, and excessive road sediment inputs. In 2000, the stream was listed only for metals, while in 2002 siltation and other habitat alterations were again added as contributing causes of impairment. The 2000 and 2002 303(d) lists showed aquatic life, cold-water fishery, and drinking water uses as non-supported, and included arsenic, copper, and zinc as specific metals-related causes. A typical view of this segment is shown in the photo below.

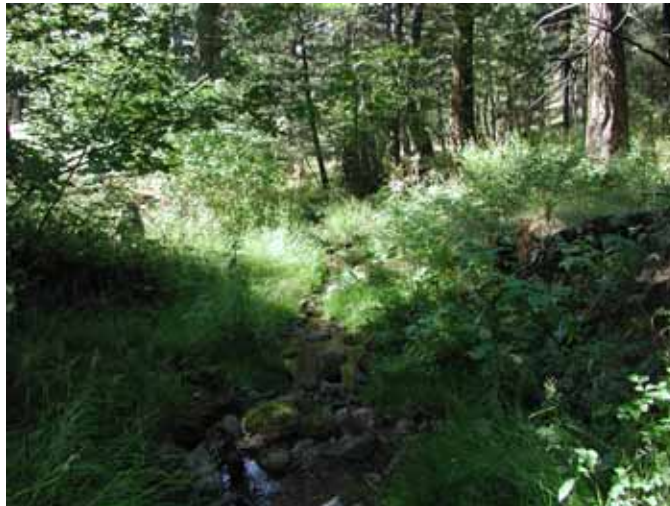
North Fork Warm Springs Creek

The North Fork of Warm Springs Creek was added to the 303(d) list in 1998. The segment, which extends for 3.5 miles from its headwaters to the mouth, was originally listed as partially supporting its designated aquatic life and cold-water fishery uses because of siltation. However, its status changed in 2002 when it was listed as partially supporting cold-water fishery use and not supporting drinking water use because of metals, arsenic, bank erosion, fish habitat degradation, other habitat alterations, and organic enrichment/low dissolved oxygen. A typical view of the North Fork of Warm Springs Creek is shown in the photo below.

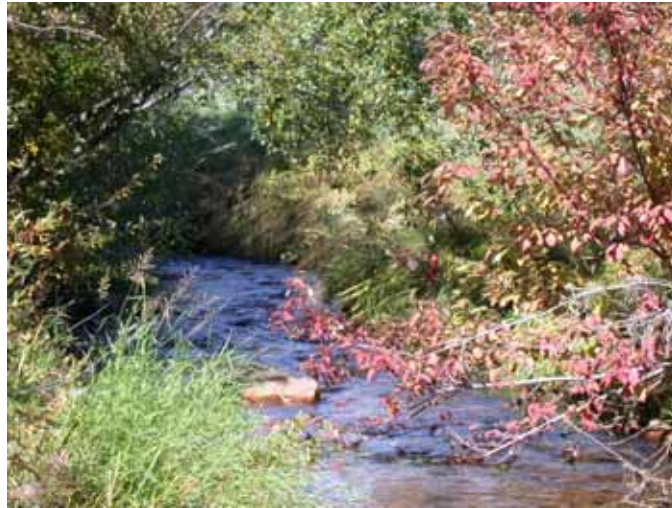
In 1996, this 3-mile segment of Warm Springs Creek was listed as partially supporting aquatic life and cold-water fishery uses because of suspended solids and metals. The basis for the original listing is unknown. However, MDEQ habitat assessments conducted in 1999 and 2001 indicated that pool infilling and embeddedness are common. In subsequent years, the segment was listed as not supporting drinking water use and partially supporting aquatic life and cold-water fishery uses. Impairment causes included metals (arsenic, lead, and cadmium) and siltation. A typical view of this segment is shown in the photo below.

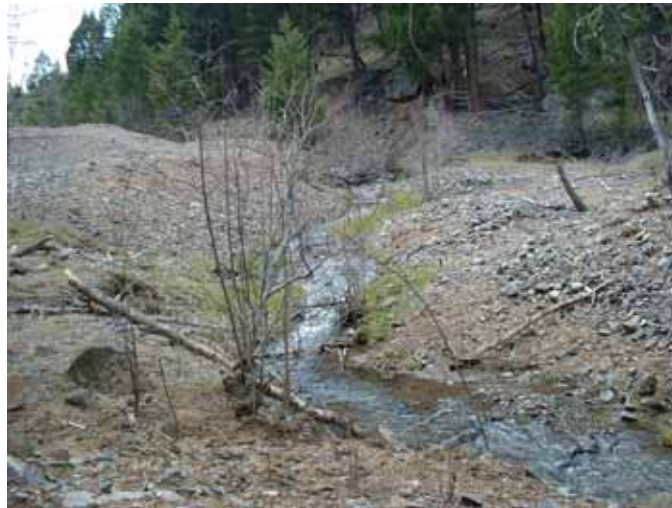
Stream segment MT41I006_100, approximately 11.6 miles in length, was listed as partially supporting aquatic life, cold-water fishery, drinking water, and recreational uses on Montana's 1996 303(d) list. In subsequent years, the list was modified to show aquatic life, cold-water fishery, and drinking water uses as non-supporting. Impairment causes in 1996 included siltation, suspended solids, habitat alterations, nutrients, and metals. Channel incisement and lead, arsenic, and mercury were added to the list of impairment causes in later 303(d) lists. A typical view of Clancy Creek is shown in the photo below.

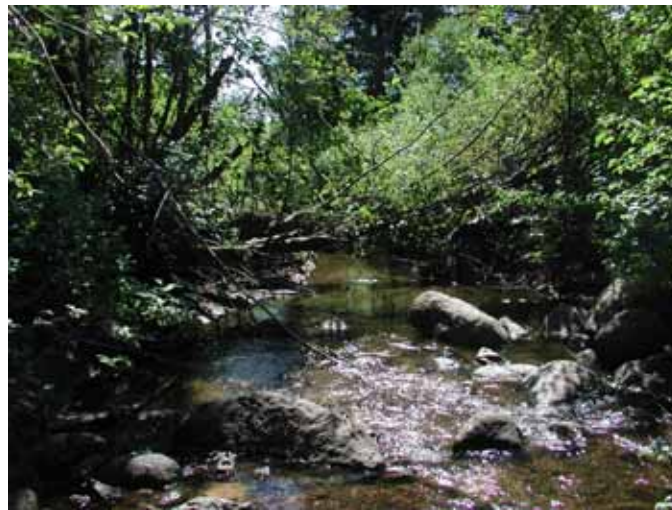
In 1996, the cold-water fishery, aquatic life, and drinking water uses in the 14.5 miles of Lump Gulch were listed as partially supported because of suspended solids and metals. In subsequent years, Lump Gulch was listed as not supporting cold-water fishery, aquatic life, and drinking water uses, and cadmium, mercury, copper, lead, and zinc were added to the list of metals. Suspended solids were removed as a suspected cause of impairment. The basis for the listing is from inventories performed in 1980 and 1994 that describe eroding stream banks and anthropogenic sediment inputs to the stream. An Environmental Impact Statement released in 2000 by the Helena National Forest described a thousand-fold increase in sediment inputs over natural conditions because of human-caused disturbance (based on models). Water chemistry data supported the metals listings. A typical view of Lump Gulch is shown in the photo below.

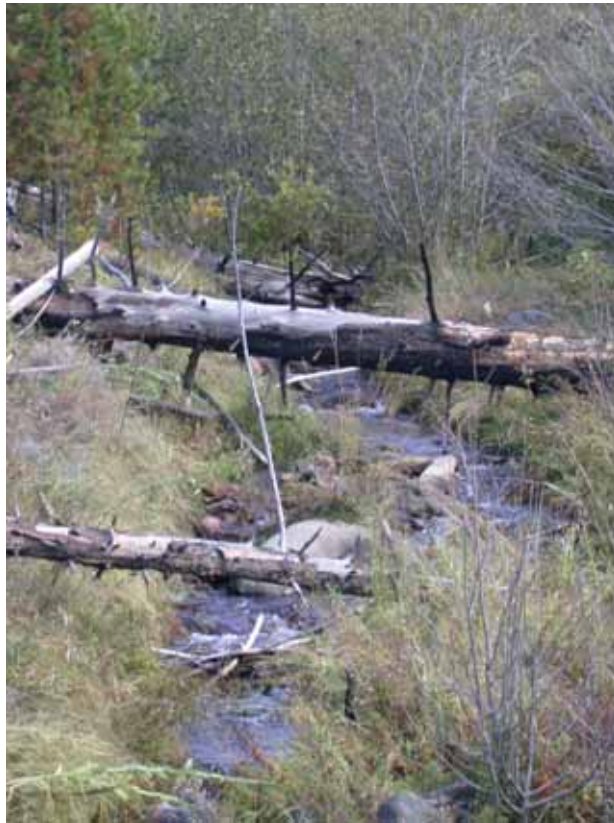
In 1998, the cold-water fishery and aquatic life uses in the 2.5 miles of Jackson Creek were listed as partially supported because of siltation. The basis for the listing is unknown, and in 1998 and subsequent years the stream was removed from the 303(d) list because of insufficient credible data. A typical view of Jackson Creek is shown in the photo below.

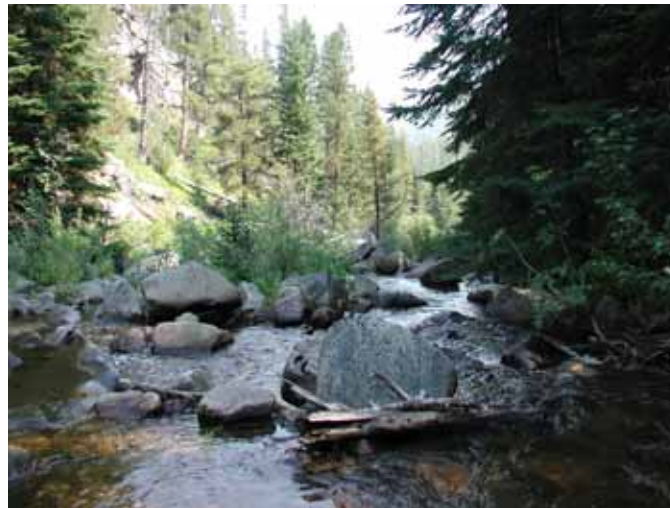
Tenmile Creek from headwaters to Helena public water supply intake above Rimini

In 1996, the aquatic life, cold-water fishery, drinking water, and recreational uses of this 6-mile segment of Tenmile Creek were listed as only partially supported because of siltation, habitat alterations, flow alterations, metals, and pH. In subsequent 303(d) lists, the segment was listed as not supporting its designated aquatic life, cold-water fishery, and drinking water uses, while recreational uses were reassessed at a level of full support. The list of impairment causes was expanded to include turbidity, and the specific metals cadmium, arsenic, lead, zinc, and copper. A typical view of this segment is shown in the photo below.

The channel survey included a Proper Functioning Condition assessment. The Helena National Forest rated the headwaters reach as “Proper Functioning Condition” (PFC), noting that the site could be used as a reference reach. The riparian land type aggregate assigned to this survey site is 24, defined as Granitic Glacial Till Moraines. According to Helena National Forest data collected for streams occurring in this riparian aggregate, surface fines and subsurface fines are common but usually not excessive.

The channel survey included a Proper Functioning Condition assessment. The field crew rated the reach above Banner Creek as “Functional – at risk” (FAR). The stream was noted as being incised, with a fair amount of sediment deposition. The riparian land type aggregate assigned to the survey site is 22, Granitic Rock – Glaciated Mountain Slopes. According to Helena National Forest data collected for streams occurring in this riparian aggregate, surface and subsurface fines are common and can be excessive.

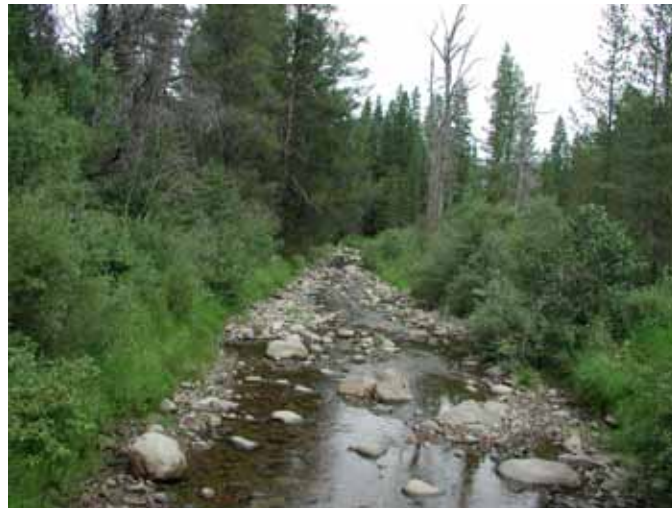
Tenmile Creek from Helena PWS intake above Rimini to Helena WTP

Segment MT41I006_142 of Tenmile Creek extends 7.7 miles from the Helena public water supply intake above Rimini to the Helena Water Treatment Plant. In 1996, the aquatic life, cold-water fishery, drinking water, and recreational uses of this 7.7-mile segment of Tenmile Creek were listed as only partially supported because of siltation, habitat alterations, flow alterations, metals, and pH. In subsequent 303(d) lists, the former uses plus agricultural and industrial uses were rated as not supported because of siltation (2002 list), and because of flow alterations and metals, specifically arsenic, cadmium, copper, lead, and zinc (2000 and 2002 lists). A typical view of this segment is shown in the photo below.

The channel survey included a Proper Functioning Condition assessment. Tetra Tech and Land & Water Consulting rated this site as "Functional – at risk" (FAR), noting that the stream was under-sized for the available channel. Sediment deposition was observed as was a limited riparian zone. The riparian land type aggregate assigned to this site is 29, Alluvial (Borolls) Floodplains and Terraces. According to Helena National Forest data collected for streams occurring in this riparian aggregate, surface and subsurface fines are common but generally not excessive.

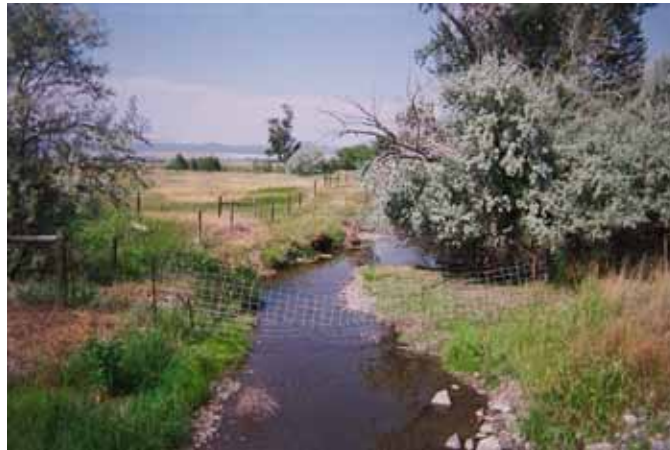
Tenmile Creek from Helena WTP to mouth

Segment MT41I006_143 of Tenmile Creek extends 15.9 miles from the Helena water treatment plant to the mouth where it meets Prickly Pear Creek. In 1996, aquatic life, cold-water fishery, drinking water, and recreational uses were listed as partially supported because of siltation, habitat alterations, flow alterations, metals, and pH. In 2000, the segment was listed as not supporting aquatic life, cold-water fishery, and drinking water uses and as partially supporting recreation. In 2002, the segment was listed as partially supporting aquatic life and cold-water fishery uses and as not supporting drinking water uses. Suspected causes of impairment in 2000 and 2002 included flow alterations, habitat alterations, metals (specifically arsenic, cadmium, lead, copper, mercury, and zinc). Siltation was also a suspected cause of impairment in 2000 but not 2002. Nutrients were added to the causes of impairment in 2002. A typical view of this segment is shown in the photo below.

Part of the channel survey included a Proper Functioning Condition assessment. The field crew rated the reach above Sevenmile as "Functional – at risk" (FAR), noting that the stream has healthy and diverse riparian vegetation. However, the field crew also noted that the stream was ripped and that pool

The channel survey included a Proper Functioning Condition assessment. The field crew rated the reach below above Green Meadow Drive as “Functional – at risk” (FAR) verging on “Non-functional” (NF). The field crew noted that the stream had eroding banks, excess sediment deposition, and a limited riparian area. The riparian land type aggregate assigned to the survey sites is also 29, Alluvial (Borolls) Floodplains and Terraces.

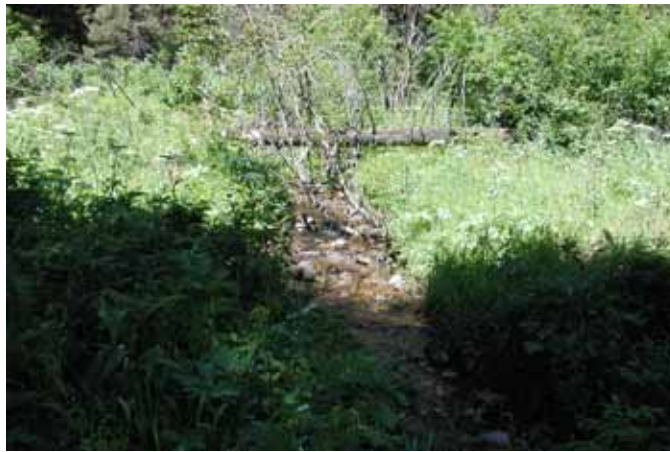
Skelly Gulch is a tributary of Greenhorn Creek, which drains to Sevenmile Creek. In 1996, the 7.7-mile segment from the headwaters to the confluence with Greenhorn Creek was listed as partially supporting aquatic life and cold-water fishery uses because of siltation. In 2002, metals were added to the suspected causes of impairment. A typical view of Skelly Gulch is shown in the photo below.

In summary, roads and localized sources are probably the biggest contributors of sediment to Skelly Gulch. Near the mouth of the stream, a culvert was observed to be plugged by beaver dams, thereby creating an area of excessive sedimentation.

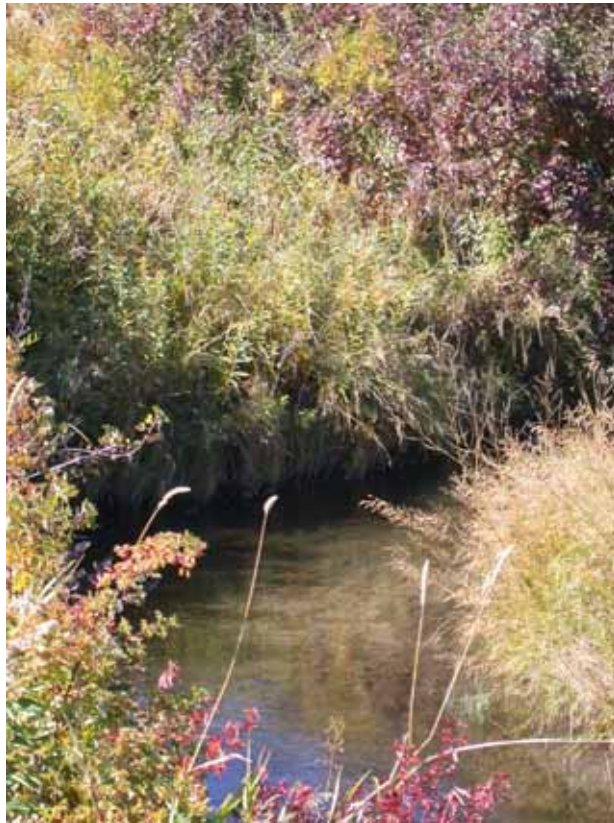
Sevenmile Creek is a tributary of Tenmile Creek. It extends for 7.8 miles from its headwaters to the mouth (MT41I006_160). Montana's 1996 303(d) list rated this stream segment as threatened relative to cold-water fishery use because of siltation and habitat alterations. In 2002, the stream was listed as partially supporting aquatic life and cold-water fishery uses because of siltation, other habitat alterations, riparian degradation, flow alterations, nutrients, and metals. A typical view of Sevenmile Creek is shown in the photo below.

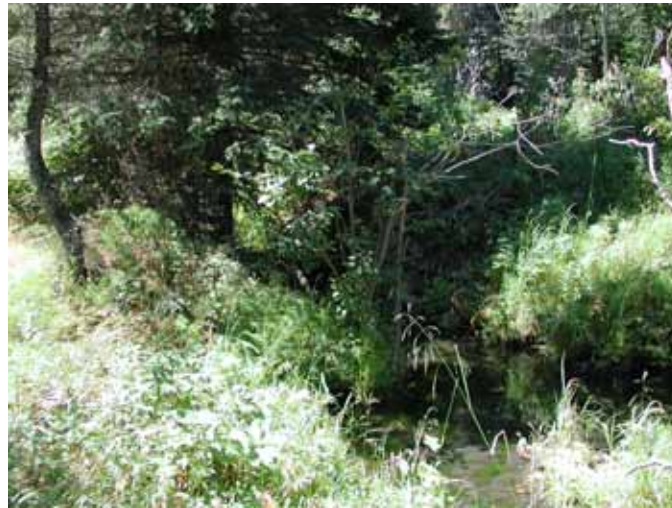
Granite Creek (MT41I006_179)

Granite Creek is a tributary to Austin Creek. It extends for 1.6 miles from its headwaters to the mouth (MT41I006_179). This Granite Creek shares its name with a separate 303(d)-listed segment located further downstream within the same Sevenmile Creek sub-basin (segment MT41I006_230). Figure 3-11 shows the location of both water bodies. Montana's 1996 303(d) list rated the Granite Creek tributary to Austin Creek (segment 179) as threatened relative to cold-water fishery use because of habitat alterations. Additional monitoring of the stream was performed in 2002 and 2003. Based on a detailed review of these data, Granite Creek was listed as fully supporting all of its designated uses on the 2004 303(d) list. A typical view of Granite Creek is shown in the photo below.

During field monitoring activities in 2003, the lower portion of the stream was noted as having rigorous riparian vegetation.

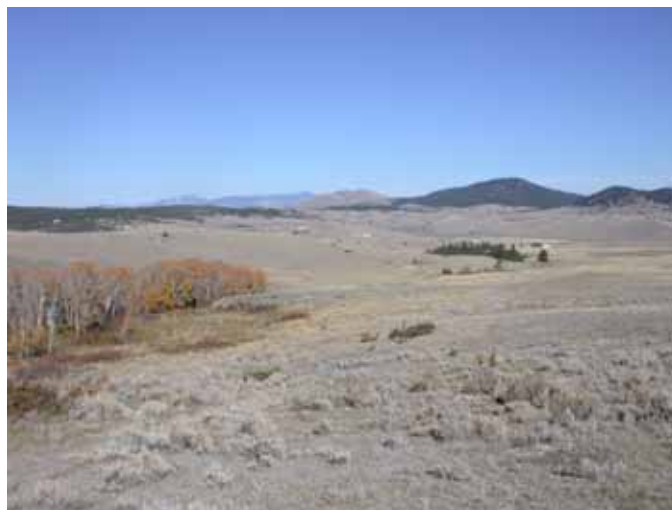
Granite Creek (MT41I006_230)

Available water quality assessment information for Granite Creek segment 41I006_230 is very limited. It consists of a single set of water analysis results from 1983, information from the MBMG Abandoned and Inactive Mines database, correspondence from the BLM, and observations made during an October 2004 field survey. These data are described in the following paragraphs. A typical view of Granite Creek is shown in the photo below.

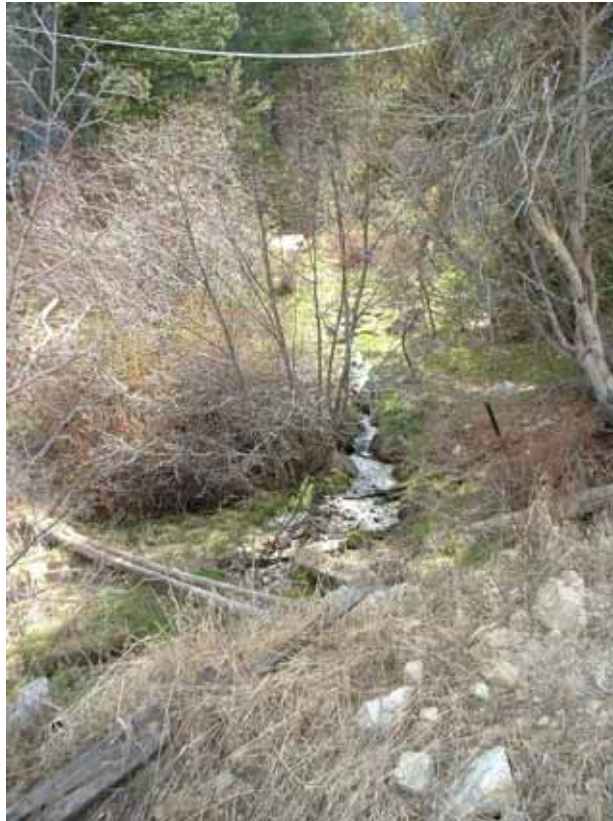
Jennie's Fork is a tributary of Silver Creek. It extends for 1.2 miles from its headwaters to the mouth. In 1996, Jennie's Fork was listed as not supporting its designated aquatic life, cold-water fishery, drinking water, and recreational uses. In subsequent years, it was rated as fully supporting its designated uses, except aquatic life and cold-water fishery uses, which could not be assessed adequate data were lacking. Suspected causes of impairment in Jennie's Fork have included siltation and metals (1996 303(d) list). A typical view of Jennie's Fork is shown in the photo below.

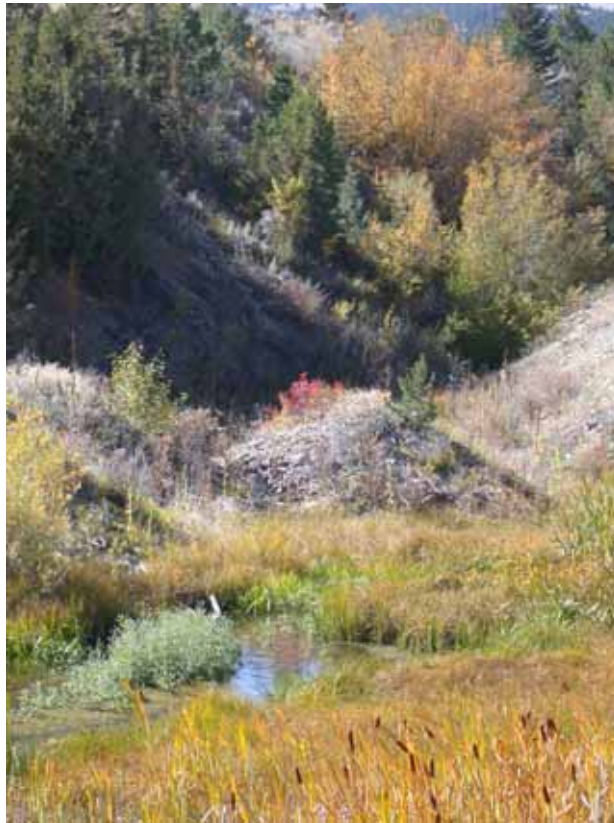
Silver Creek is a 21.6-mile-long stream that drains directly to Lake Helena (MT41I006_150). Montana's 1996 303(d) list indicated that Silver Creek did not support aquatic life, cold-water fishery, and recreational uses because of metals, flow alterations, habitat alterations, and priority organics. In 2000 and 2002, drinking water and industrial water uses were added to the list of non-supported or partially supported uses, while the causes of impairment remained essentially the same. A typical view of Silver Creek is shown in the photo below.
