LOWER BLACKFOOT TOTAL MAXIMUM DAILY LOADS AND WATER QUALITY IMPROVEMENT PLAN

Sediment, Trace Metal and Temperature TMDLs December 2009

Montana Department of Environmental Quality
P.O. Box 200901
Helena, MT 59620-0901

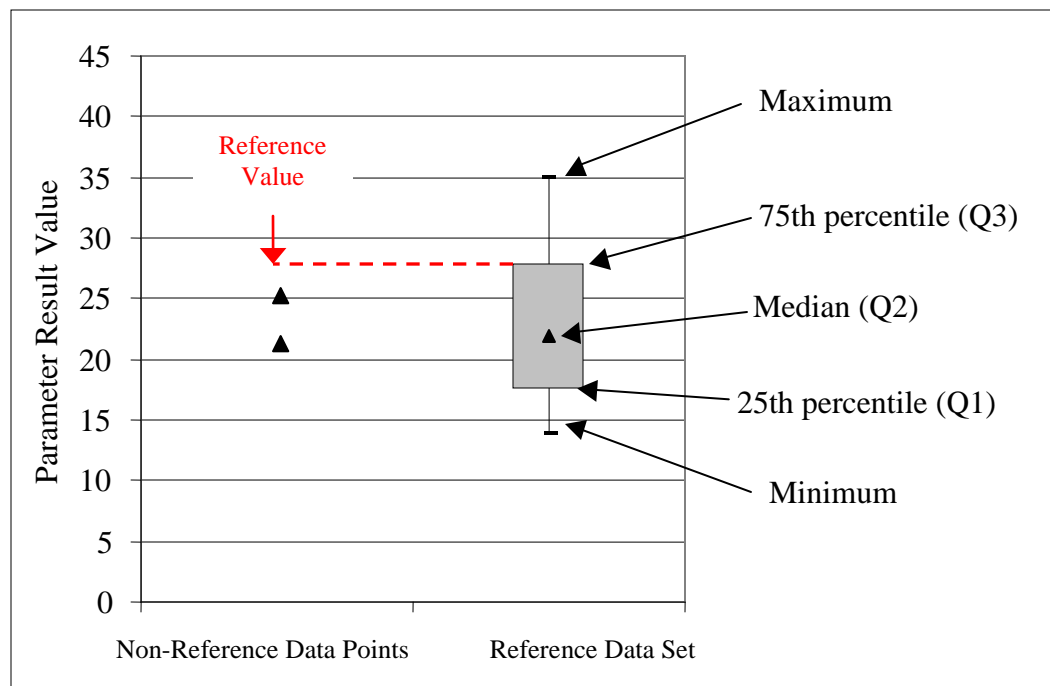
Normally distributed data are evaluated according to their degree of variance from a central mean, non-normally distributed data are most often evaluated based upon how they are ranked from lowest to highest. Ranked data are summarized according to their position among four quartiles of the data set. Quartiles are used to split the data distribution into four groups, each containing 25 percent of the measurements. A “box and whisker” diagram with labeled quartiles of a hypothetical reference data distribution is illustrated on the right in **Figure 2-1** with two comparison data points on the left.

Figure 2-1. Box and Whisker Diagram of Ranked Data Distributed in Quartiles

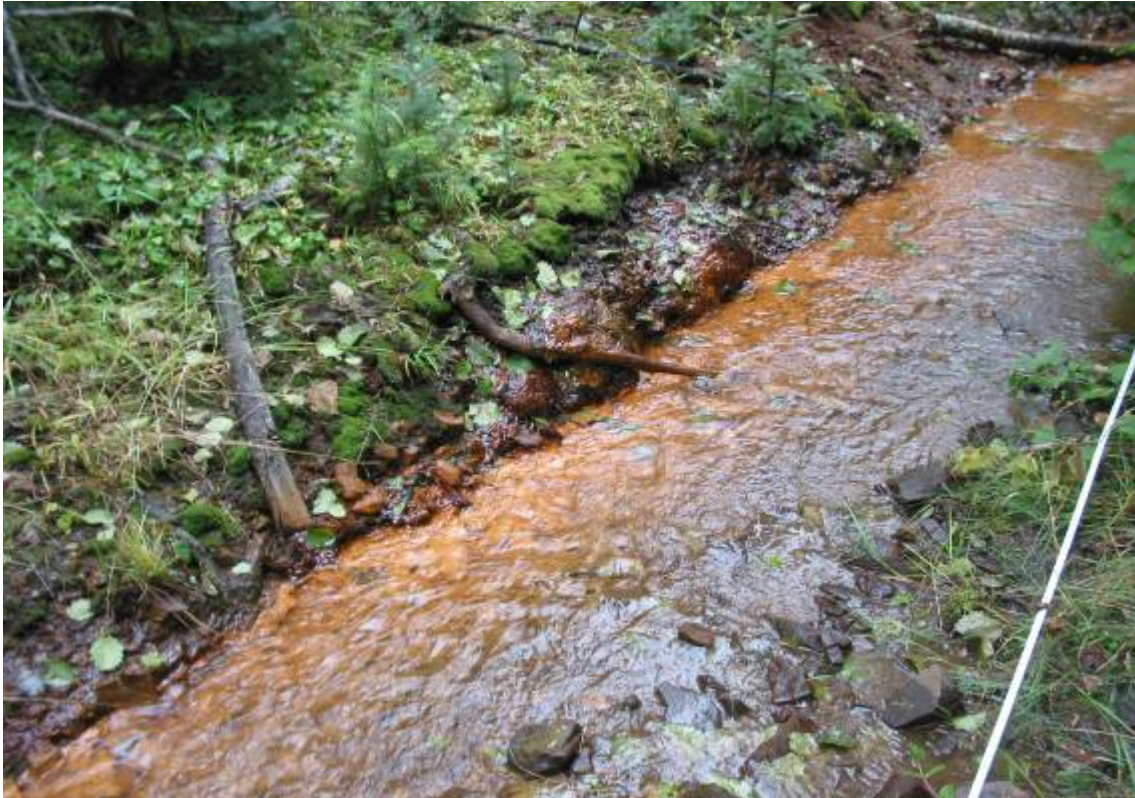
The discharge from the bank line seep zone, pictured in **Figure 6-2**, is a source of dissolved iron to Union Creek.

Figure 6-2. Left bank seep in reach Union 1 in the vicinity of Frog’s Diner Mine.

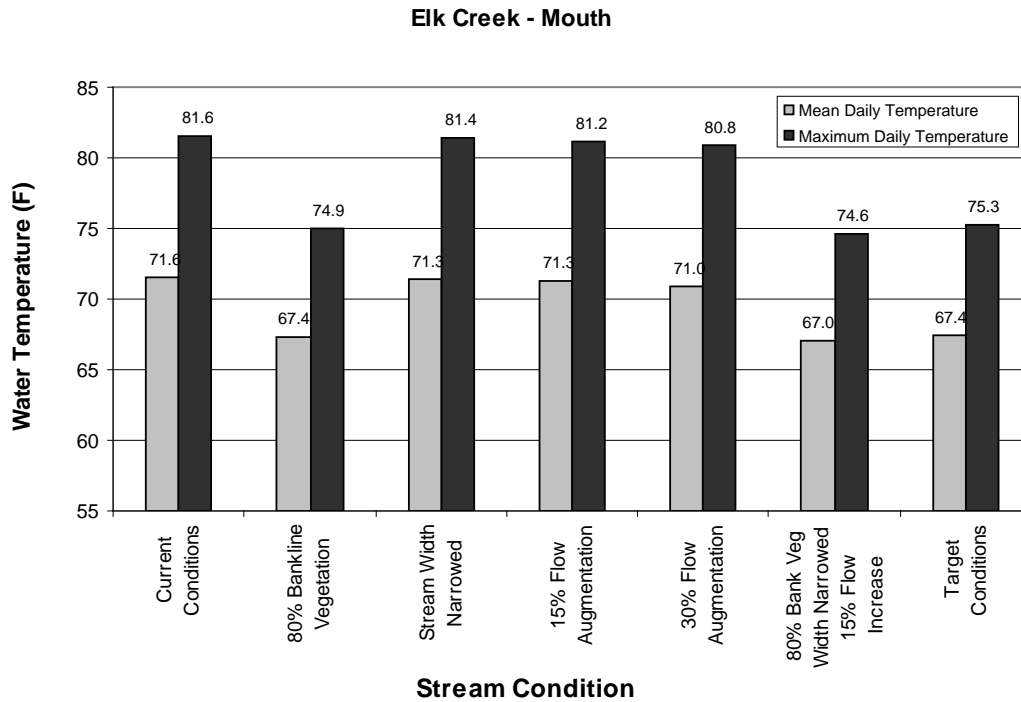
Figure 7-1. Simulated Mean and Maximum Temperature with Change in Bank line Vegetation, Flow and Stream Width for Elk Creek.

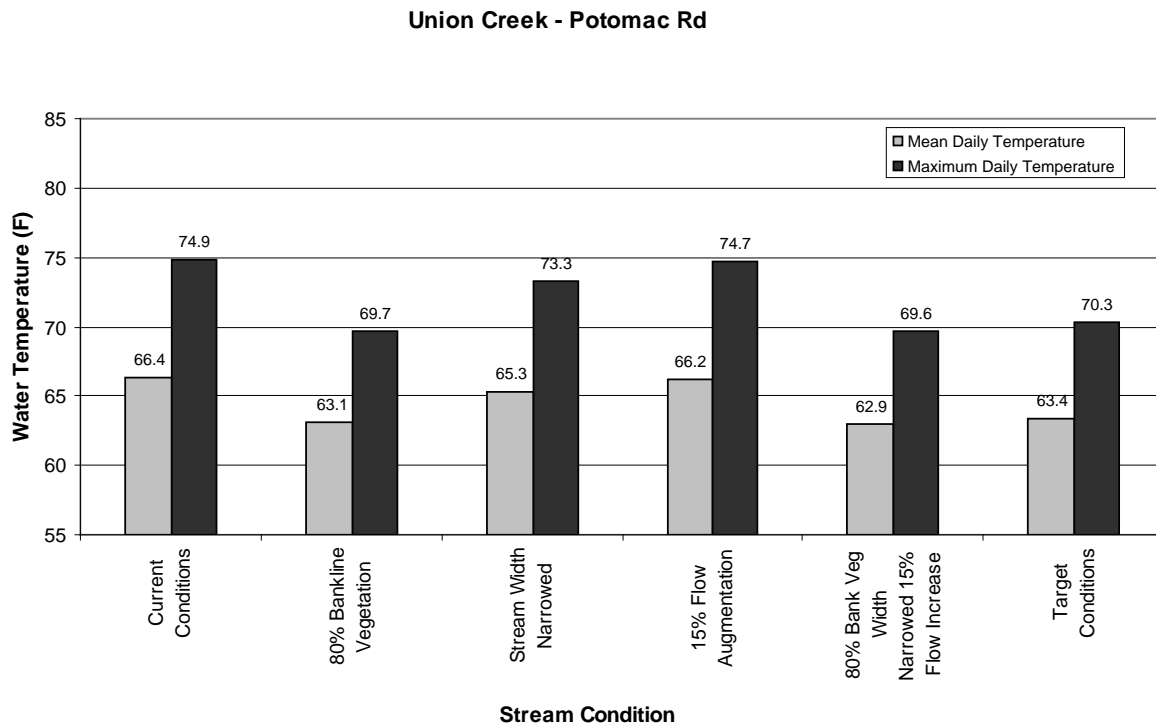
Figure 7-3. Simulated Mean and Maximum Temperature with Change in Bank line Vegetation, Flow, and Stream Width for Union Creek, Washoe Creek to Potomac Road

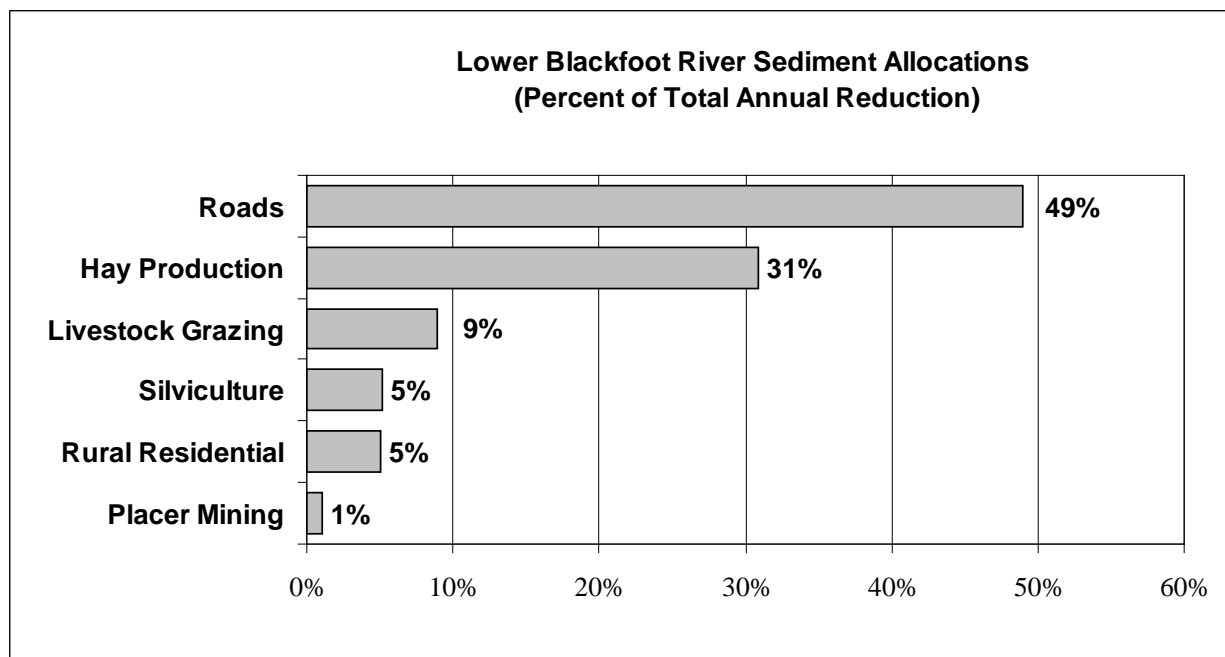
Similar to the hillslope allocations, those for stream bank erosion were allocated according to the percentage of the total stream bank length exhibiting a specific land use as identified during the 2006 field assessment. These percentages are given in **Appendix F, Table F-7**. The reduction allocations for roads are the sum of those for road surface erosion and culvert failure possible with BMP implementation. **Figure 8-3** summarizes the total sediment load reduction allocations by contributing land use category for the Lower Blackfoot planning area.

Figure 8-3. Sediment Load Allocations as a Percent of the Total Reduction by Contributing Land Use Category for the Lower Blackfoot Planning Area

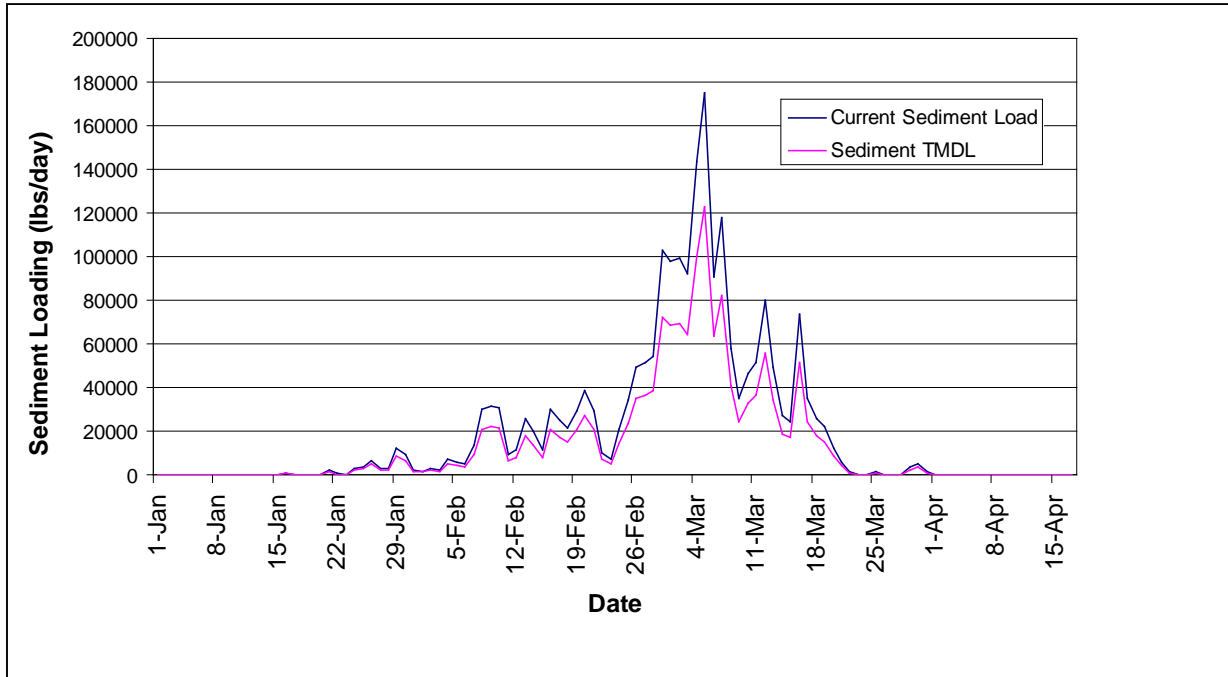
allowable daily sediment loading remaining after a 30 percent reduction in Belmont Creek. The time period in the graph is centered on the runoff period to better illustrate the difference between current sediment loading and the TMDL.

Figure 8-4. Current and Maximum Daily Sediment Loading for Belmont Creek

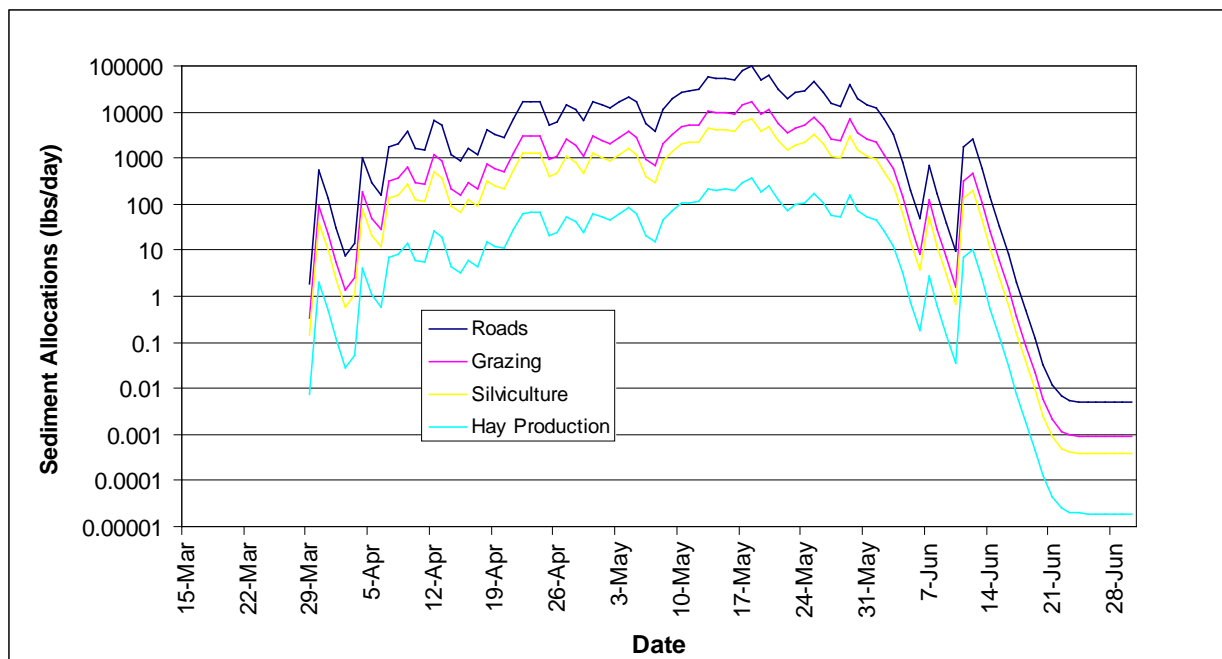
The daily load reductions calculated for Belmont Creek are allocated to the corresponding land use categories identified for this segment in **Table 8-6**. The daily loads allocated to these land uses are presented in **Table K-1** of **Appendix K** and illustrated in **Figure 8-5**.

Figure 8-5. Daily Sediment Load Allocations for Belmont Creek

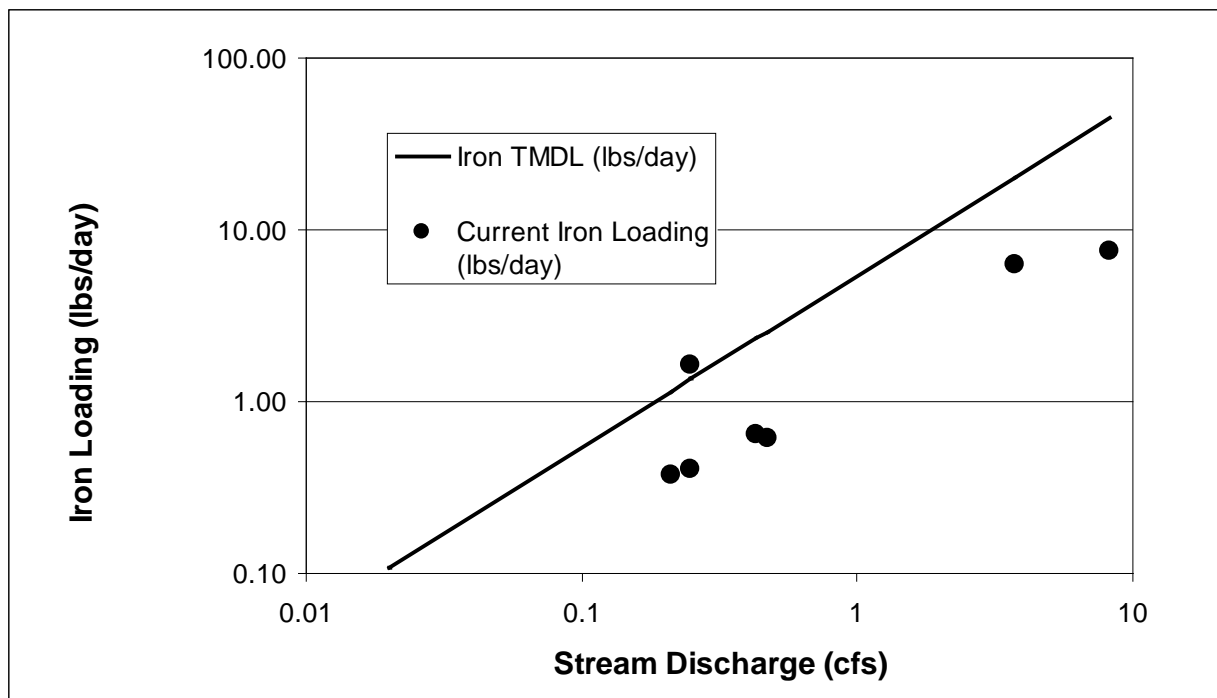
Figure 8-6. The Graph of the Union Creek Iron TMDL with Current Loads Calculated from 2006 Analysis Results

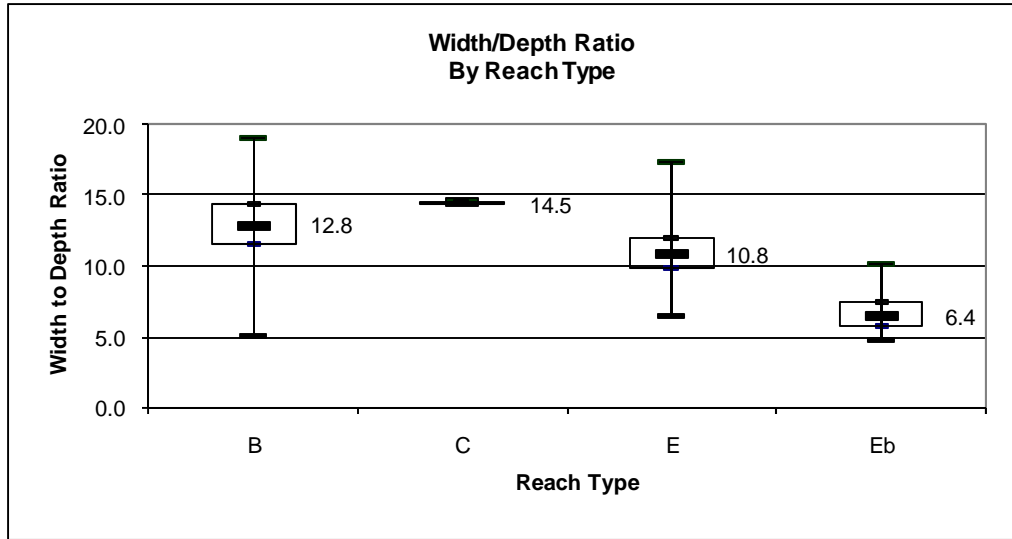
Figure C-1. Width to depth ratio summarized by channel type, Lower Blackfoot Planning Area; median values are labeled.

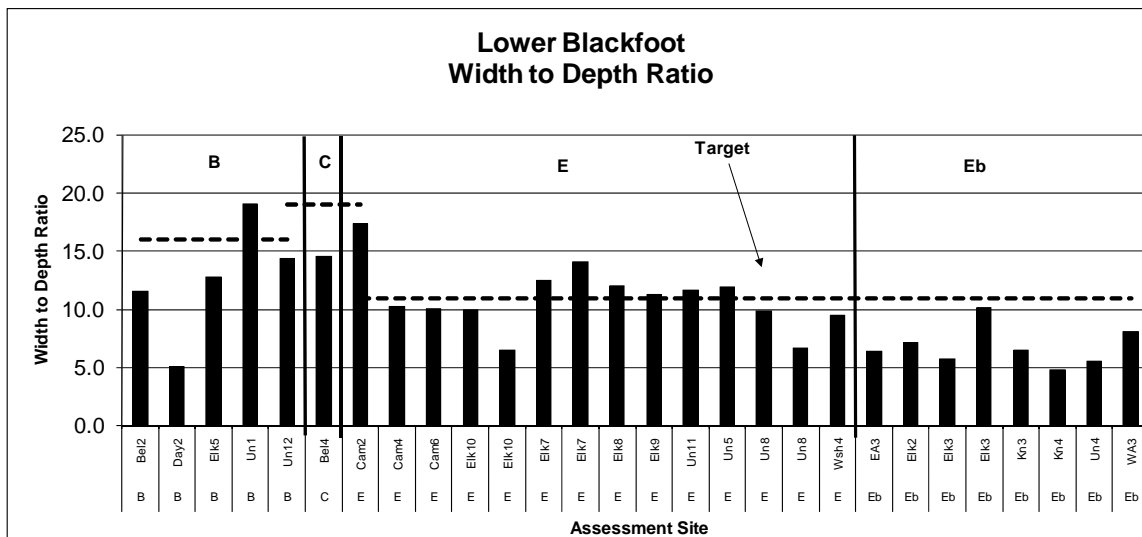
Figure C-2. Width to depth ratio values for assessment reaches and target values.

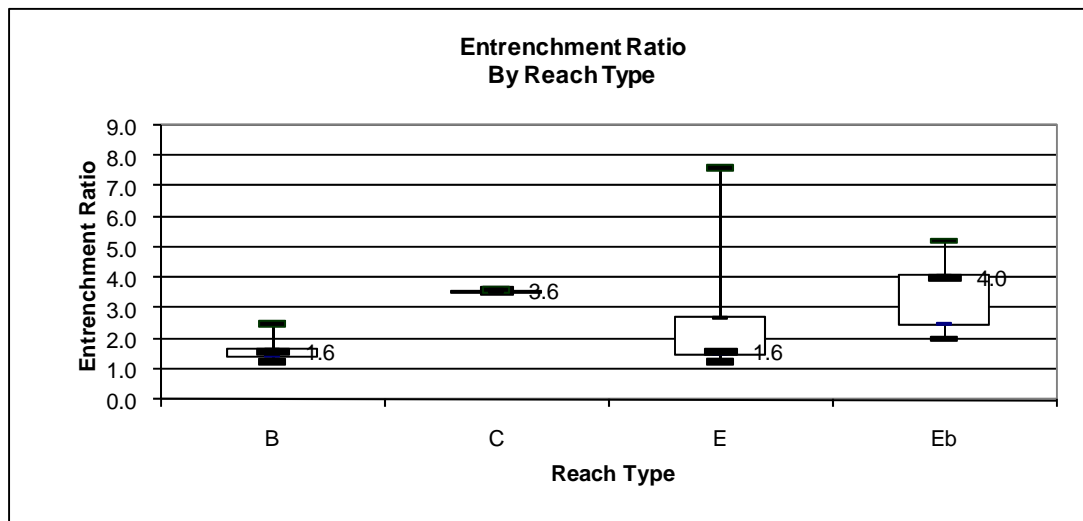
Figure C-3. Entrenchment ratio summarized by channel type, Lower Blackfoot Planning Area

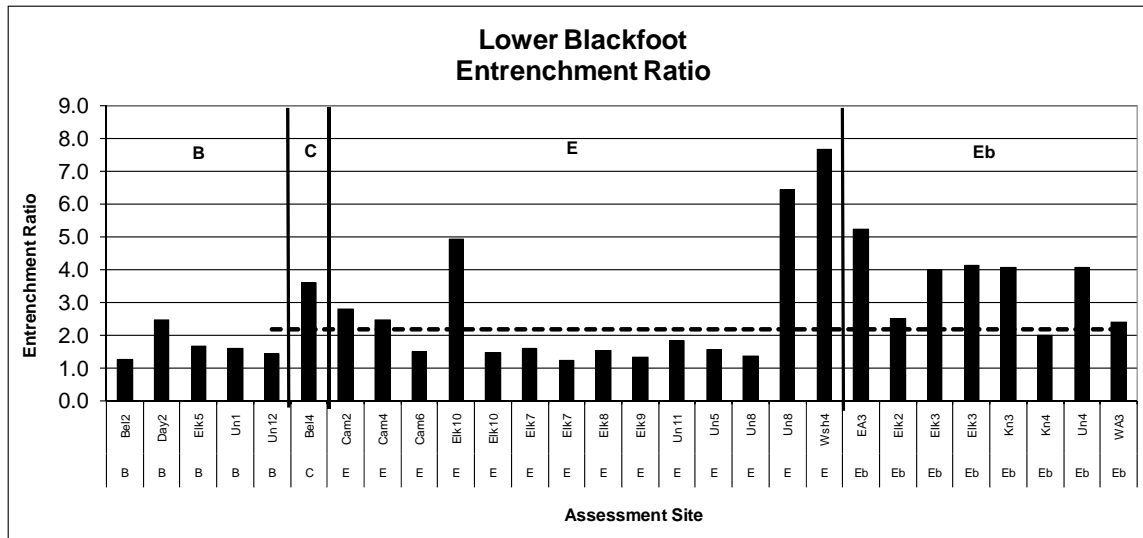
Figure C-4. Entrenchment ratio values for assessment reaches and target values.

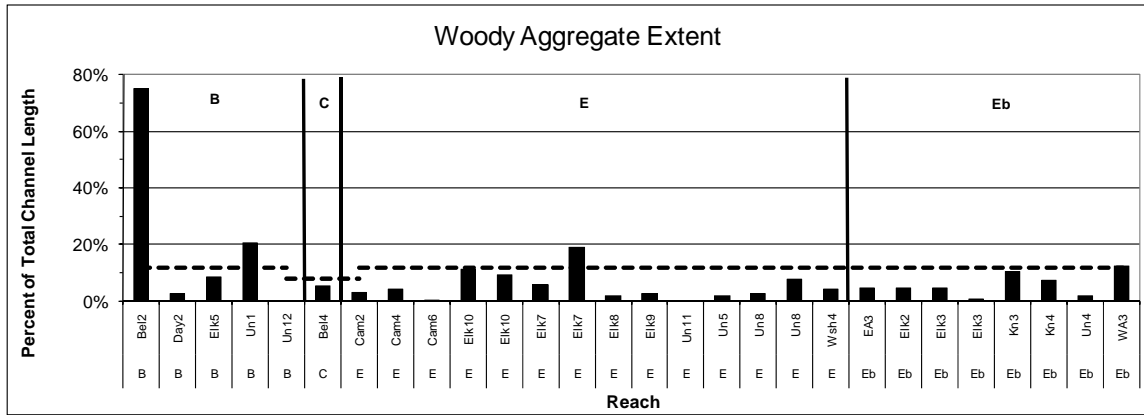
Figure C-12. Woody debris aggregate extent values for assessment reaches and proposed target values.

Table C-13. Lower Blackfoot targets for woody debris aggregate extent.

Parameter	Target Level	Lower Blackfoot Statistics						Middle Blackfoot Targets		Nevada Creek Targets		Lower Blackfoot Target		
		Channel Type	Q1	Min	Median	Max	Q3	N	Target	Basis	Target	Basis	Target	Basis
Woody Debris Aggregate Extent	Supp. Indicator	B	3%	0%	9%	75%	21%	5	> 3 %	Nevada Creek Q3	> 3 %	Nevada Creek Q3	>12%	Lower Blackfoot Q3 (Bel4 excluded)
		B (no Bel4)	2%	0%	6%	21%	12%	4						
		C	6%	6%	6%	6%	6%	1	> 8%	Middle Blackfoot Q3	> 7%	Nevada Creek Q3	> 8%	Middle Blackfoot Q3
		E	2%	0%	4%	19%	7%	14	> 12%	Middle Blackfoot reference Q3	> 12%	Middle Blackfoot reference Q3	> 12%	Middle Blackfoot reference Q3
		Eb	4%	1%	5%	12%	8%	8
