**MIDDLE BLACKFOOT-NEVADA CREEK
TOTAL MAXIMUM DAILY LOADS AND WATER QUALITY
IMPROVEMENT PLAN**

Sediment, Nutrient, Trace Metal and Temperature TMDLs

September 22, 2008

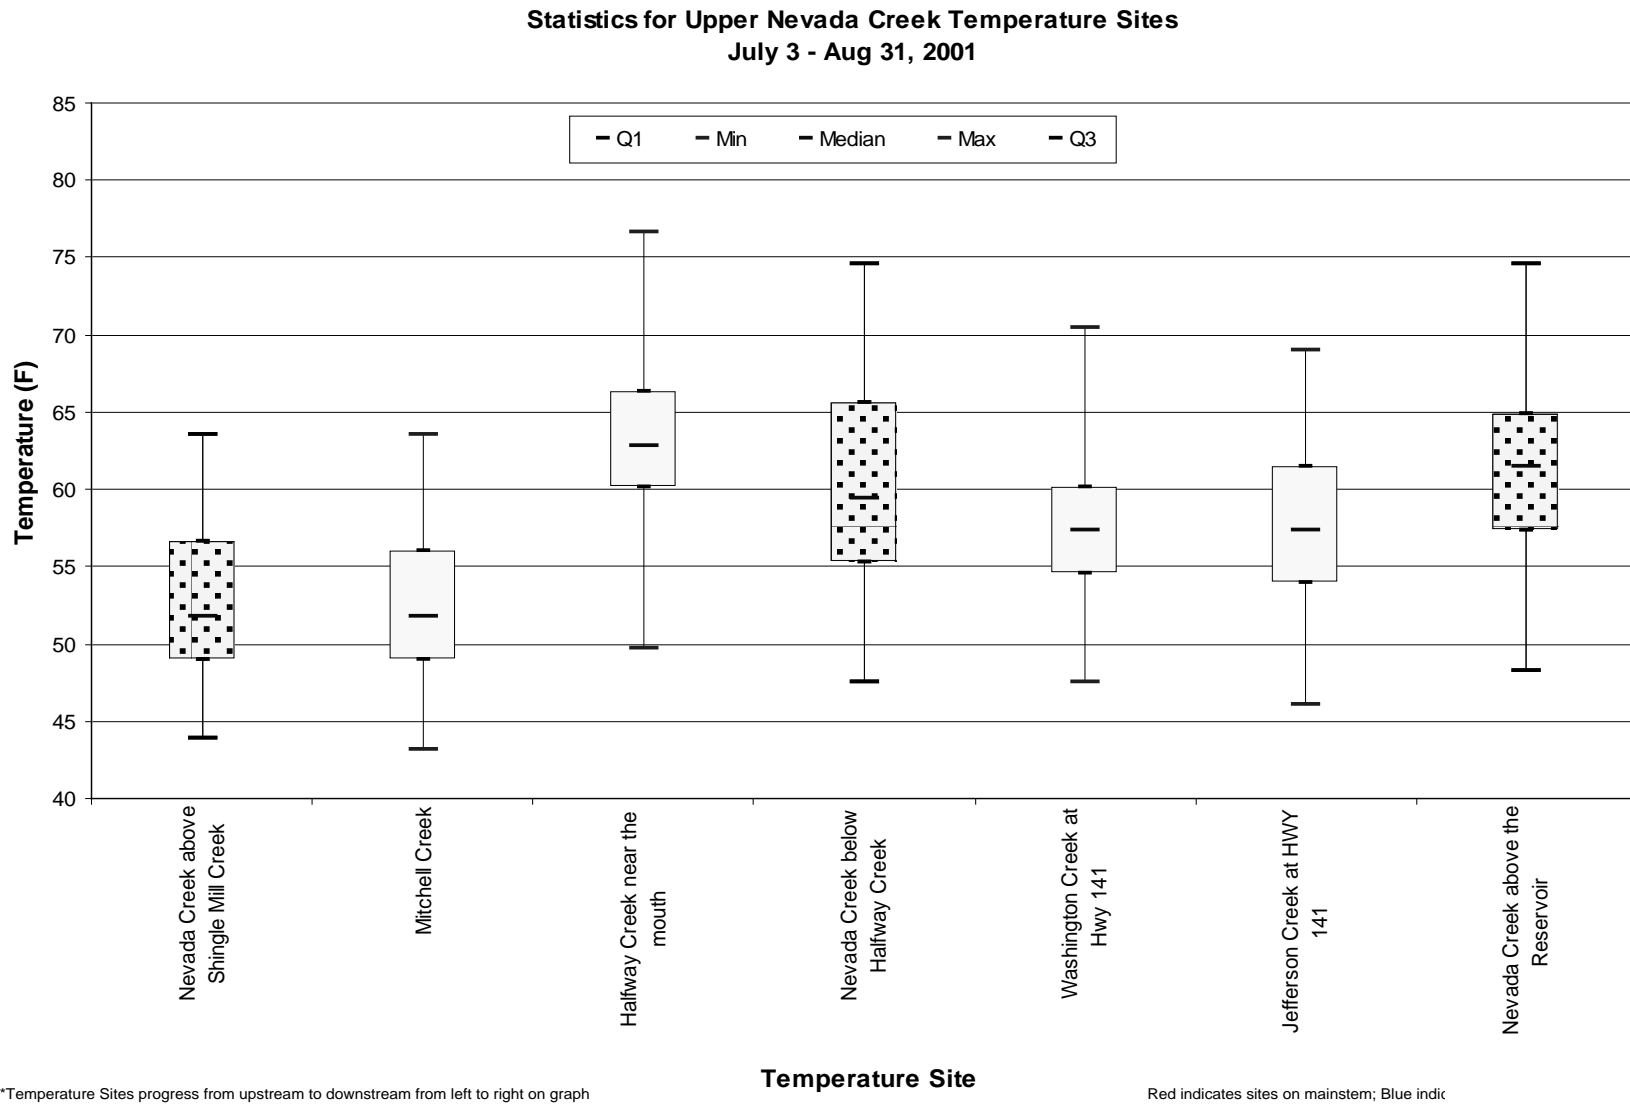
Figure 8-5. Upstream To Downstream Temperature Variation, Upper Nevada Creek, 2001

Figure 8-5 shows the distribution of summer temperatures during 2001 at the seven monitoring sites and allows comparison of temperatures between sites. The data shows significant warming from above Shingle Mill Creek to below Halfway Creek. Nevada Creek temperatures increase significantly between the site above Shingle Mill Creek and the site below Halfway Creek; with Halfway Creek having the highest temperatures of all the sites.
