**ST. REGIS WATERSHED
TOTAL MAXIMUM DAILY LOADS AND FRAMEWORK
WATER QUALITY RESTORATION ASSESSMENT**

Sediment and Temperature TMDLs

September 10, 2008

Montana Department of Environmental Quality

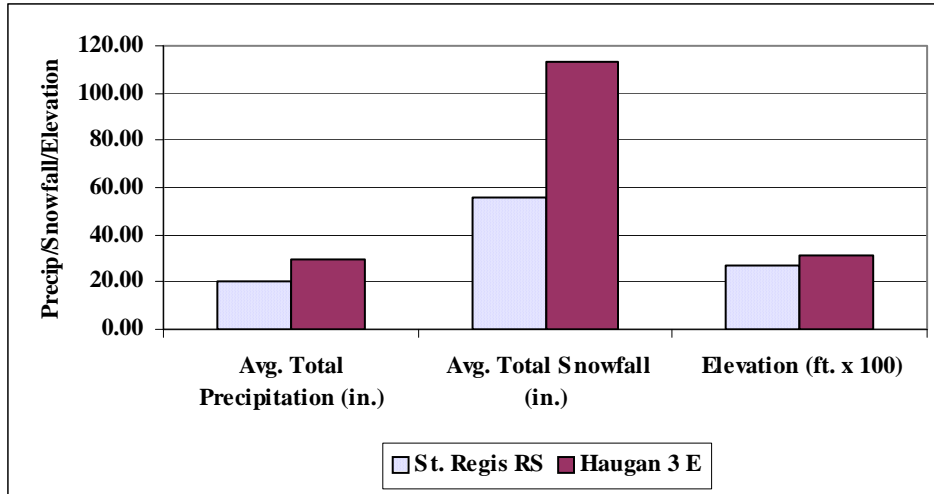
Figure 2-1. Average Annual Snowfall and Precipitation at the St. Regis Ranger Station and Haugan 3 E NOAA Climate Stations

Average annual precipitation and temperature patterns for the two stations are presented in **Figures 2-3 through 2-8**. Temperature patterns are similar for both stations, with July and August being the warmest months and December and January the coldest months. Summertime highs are typically in the mid-eighties Fahrenheit, and winter lows typically fall into the mid- to low-teens (**Table 2-1**). Precipitation records show that most precipitation at Haugan and St. Regis occurs in the form of snowfall during the months of November through March, followed by rain in May and June. Average annual precipitation at these two sites ranges from about 20 inches at St. Regis to nearly 30 inches at Haugan.

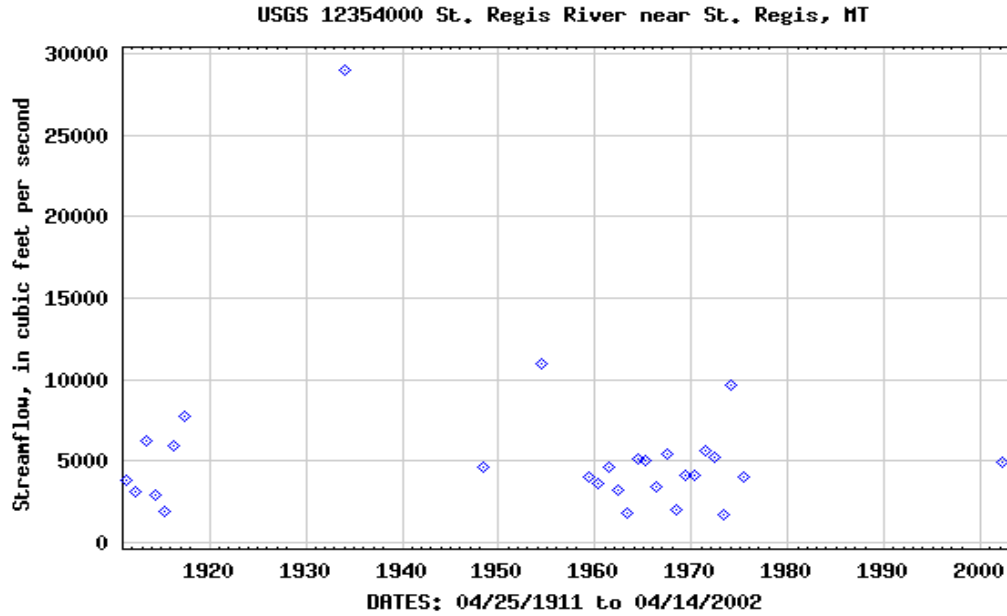
Figure 2-9. Peak Streamflows Measured in the St. Regis River near St. Regis, MT, 1910-2002 (USGS Gaging Station 12354000)

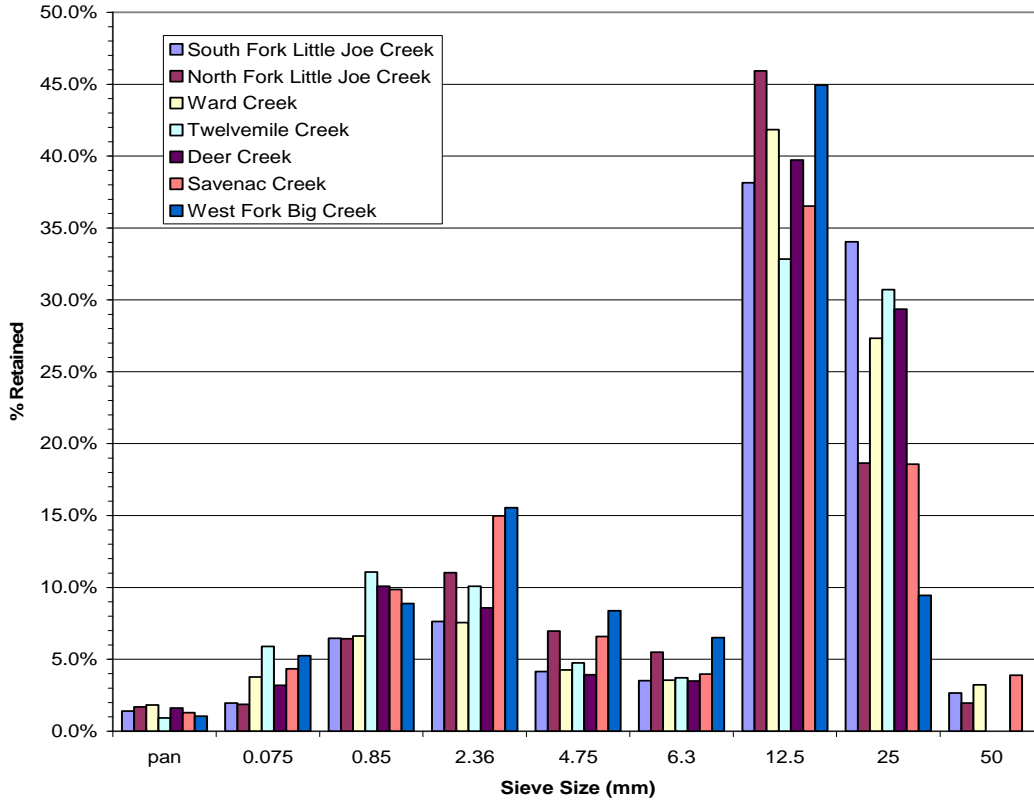
Figure A-2. Mean Percent Retained by Each Sieve Size for McNeil Core Samples Taken in Tributaries of the St. Regis River

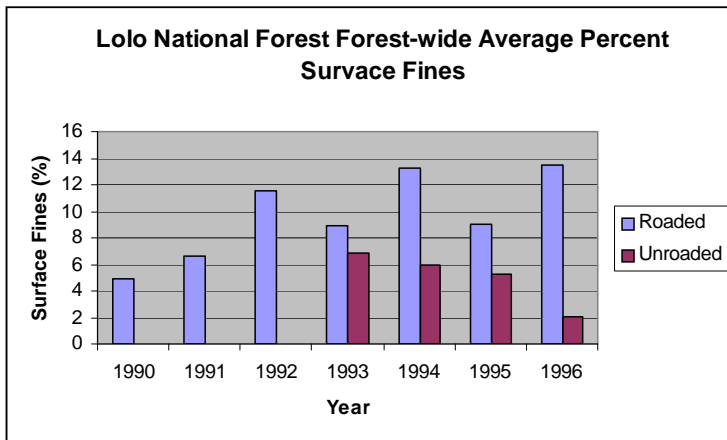
Figure B-1. Lolo National Forest Percent Surface Fines Data from 1994-1996 Monitoring Report

Riggers et al. (1998) described reference conditions for natural streams on the Lolo National Forest based on six years of data (1989-1995) collected on 69 streams (**Figure B-1**) using the 49-point grid-toss method. Percent surface fines <6.3 mm data collected in the St. Regis watershed included 17 lateral scour pools, 4 on B streams, and 13 on C streams, and 32 low gradient riffles, 8 on B streams and 24 on C streams. These data were compared to the reference conditions described by Riggers. Results and discussion follow.

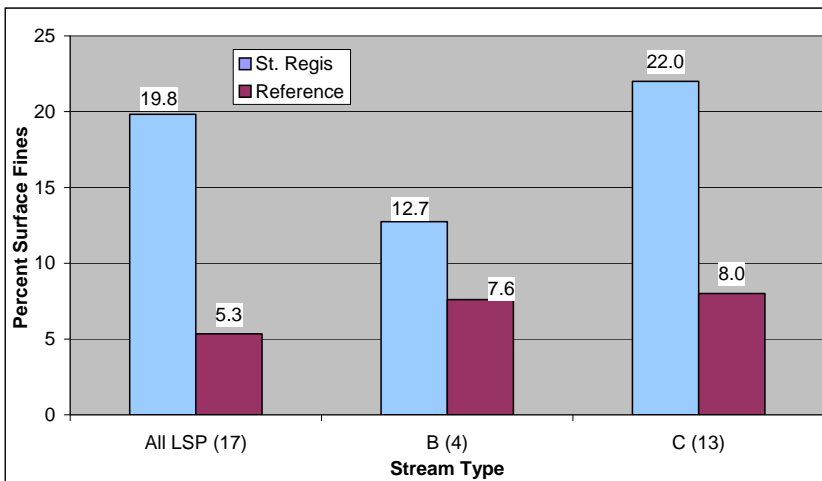
The combined PSF values by stream type for lateral scour pools exceed the proposed reference conditions for various habitat types (**Figure B-2**). C channels appear to have a greater departure from reference conditions than B channels. When specifically compared to the mean value of about 5.3% PSF for all lateral scour pools, the departures from reference are even greater.

Figure B-2. Mean Percent Surface Fines in Lateral Scour Pools (LSP) By Stream Type

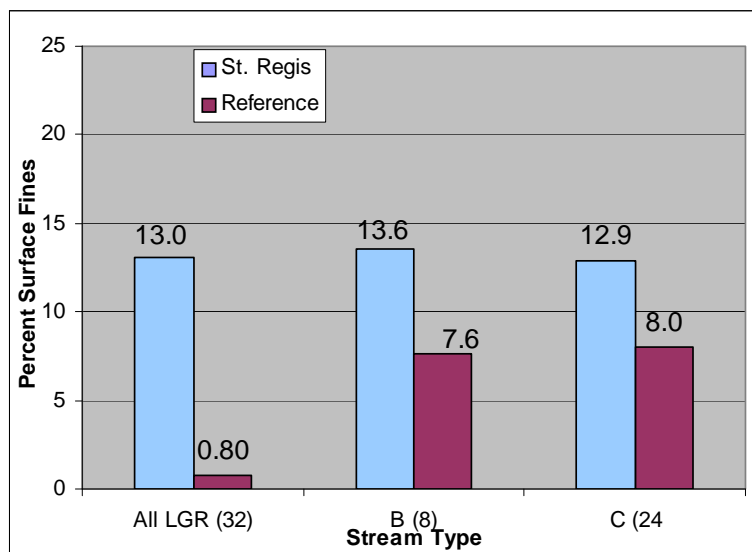
The combined PSF values by stream type for low gradient riffles exceed the proposed composite channel reference conditions. C and B channels appear to have approximately equal departures from reference conditions, B channels being slightly higher. When specifically compared to the mean value of about 0.8% PSF for all low gradient riffles, the departures from potential reference are even greater (**Figure B-3**).

Figure B-3. Mean percent surface fines in low gradient riffles (LGR) by stream type

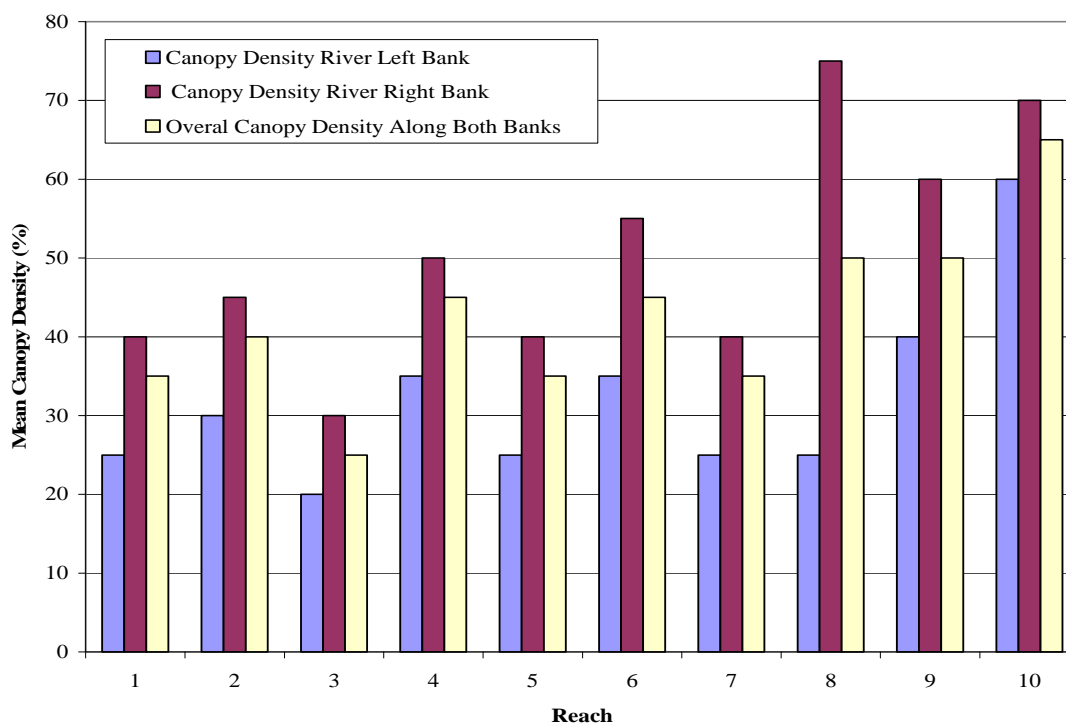
Figure F- 1. Mean Canopy Densities for the River Left Bank, River Right Bank, and Overall Density for Both Banks in Reaches 1-9 along the St. Regis River

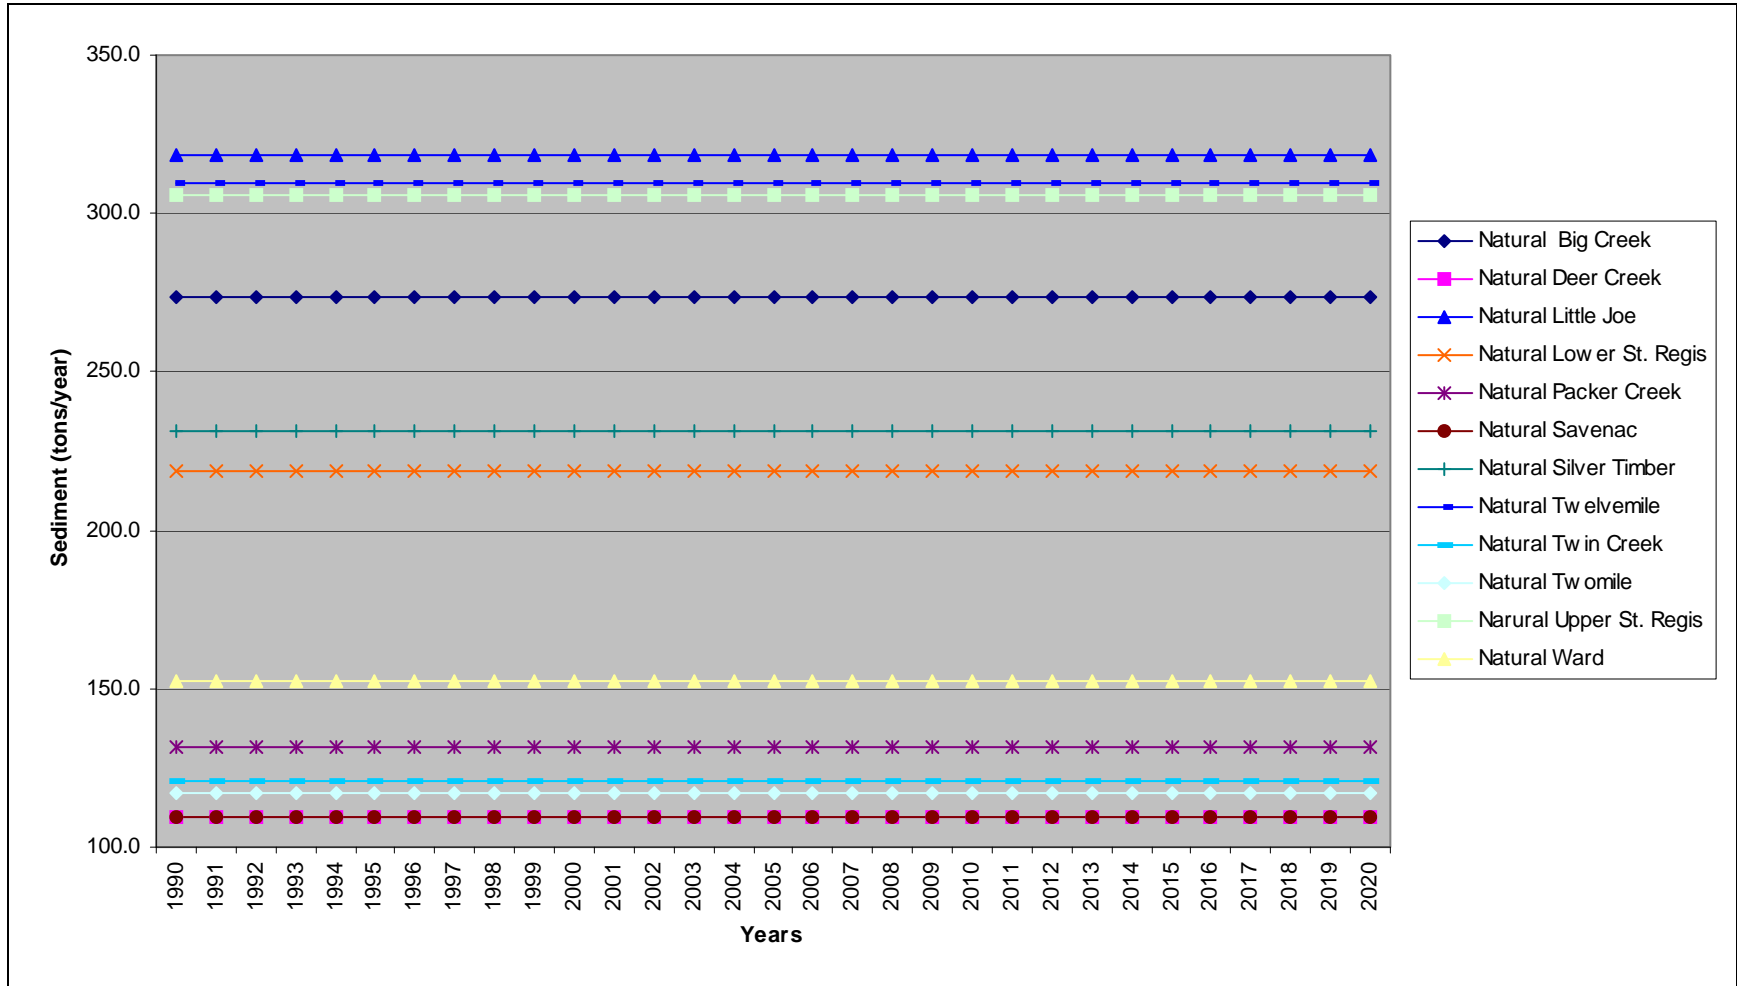
Figure H-2. LoloSED Modeled Natural Sediment Production for St. Regis River Tributary Watersheds

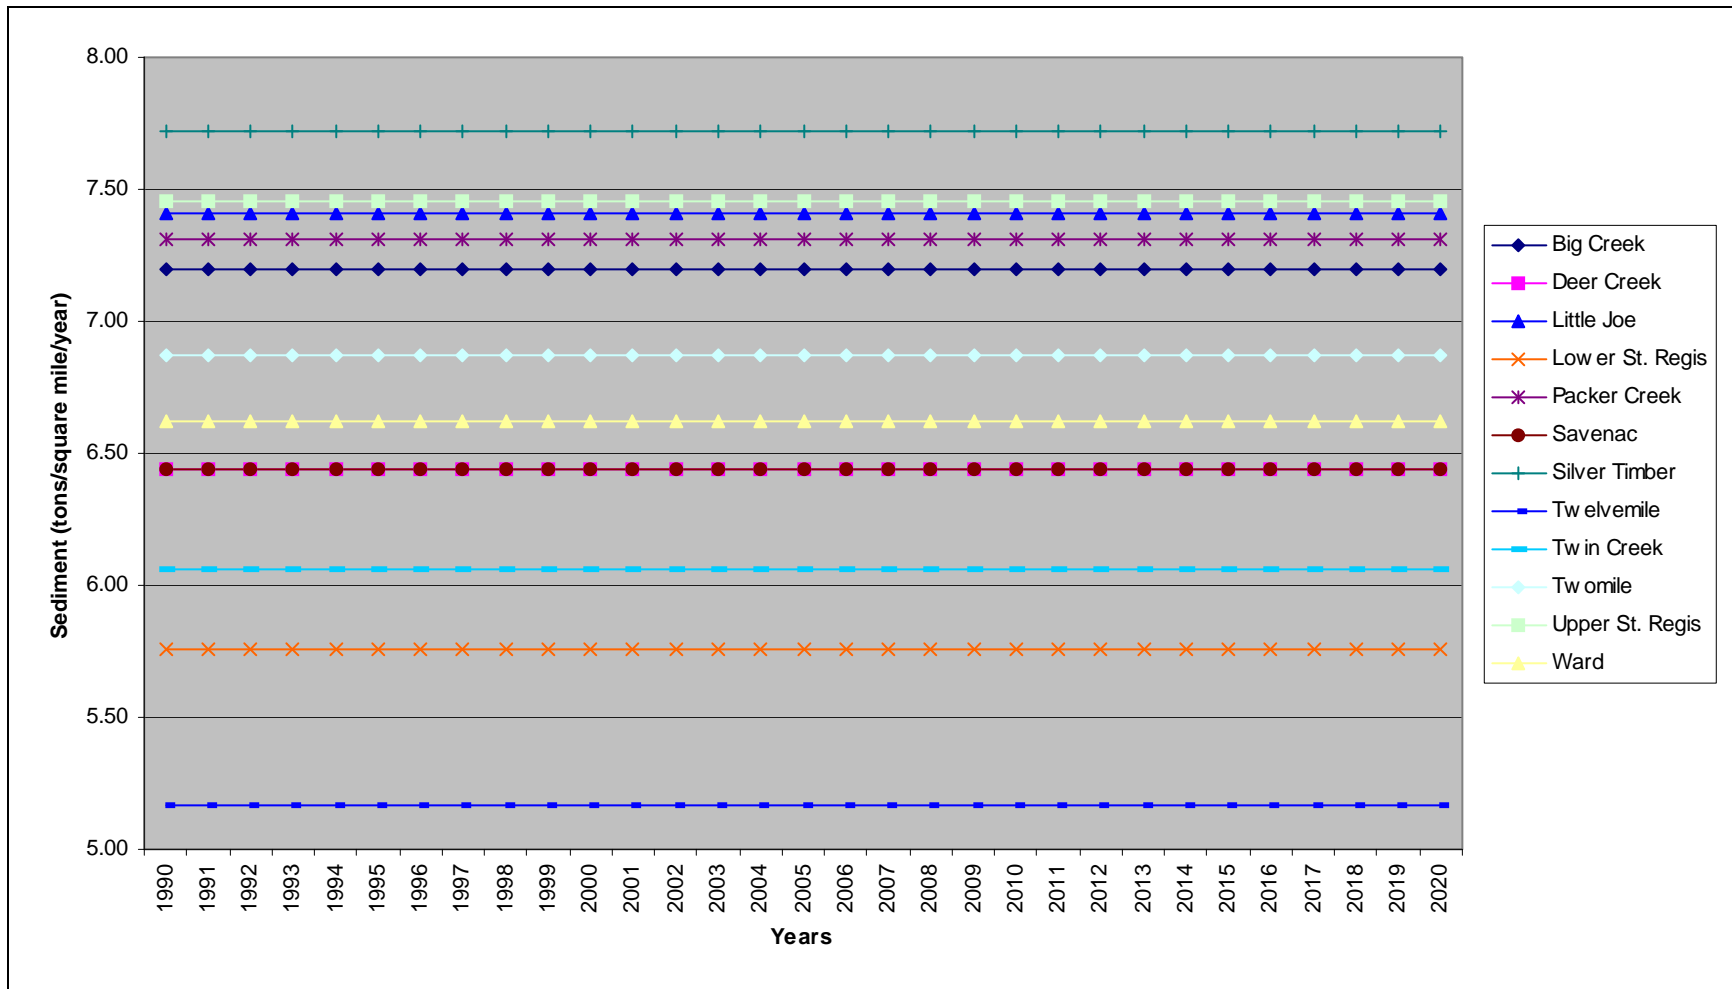
Figure H-3. LoloSED Modeled Natural Sediment Production for St. Regis River Tributary Watersheds, Normalized By Drainage Area

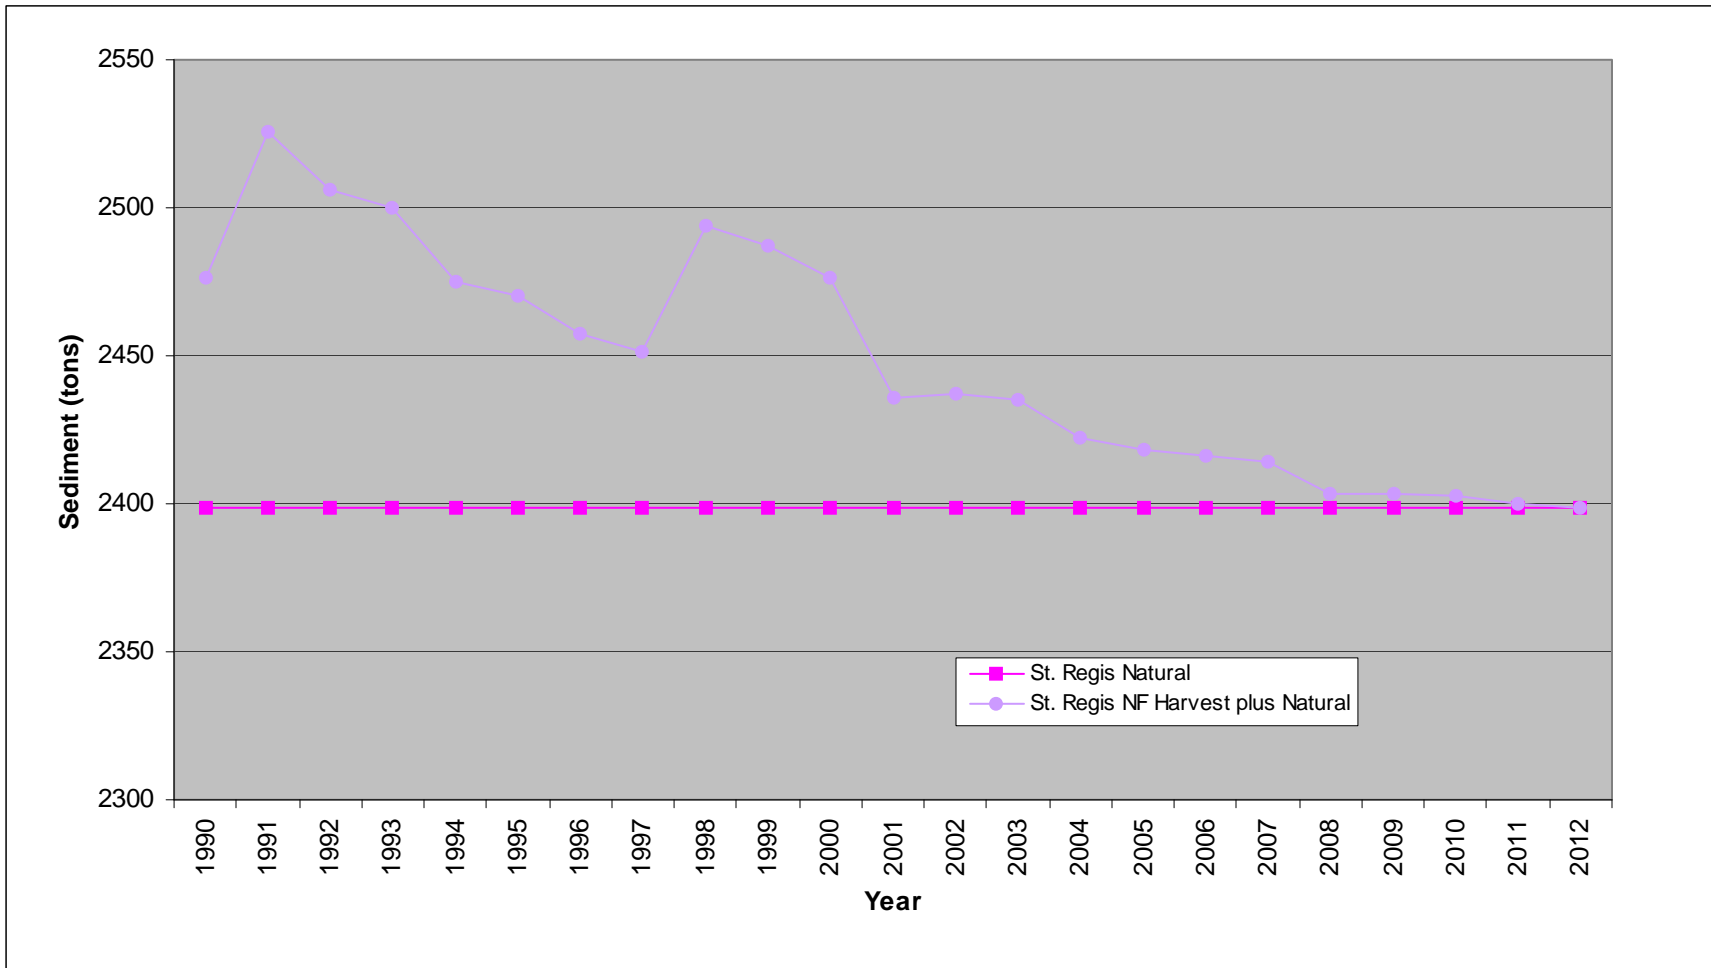
Based on model results for years 1990 - 2020, sediment production from timber harvest peaked in the early 1990's at approximately 250 tons above natural, and continued to decline until 1997 (**Figure H-4**). In 1998, additional timber harvest activity resulted in a less than 50-ton increase followed by another decline in harvest-related sediment production through the remainder of the analysis period. Note that sediment projected in future years reflects a static condition. Future harvest may increase sediment above the static condition. Also note that this modeling does not include road sediment contributions at stream crossings, does not include any mass wasting that may have occurred from harvest, and assumes overall BMP implementation compliance. The results of this modeling will be used to provide an estimate of natural background sediment loading due to hill slope erosion and bank erosion. Results will also be used for timber harvest upland sediment production source assessment and allocations.

Figure H-4. LoloSED Modeled Sediment from National Forest Harvest Activity Compared to Natural Modeled Sediment Production for the St. Regis Watershed

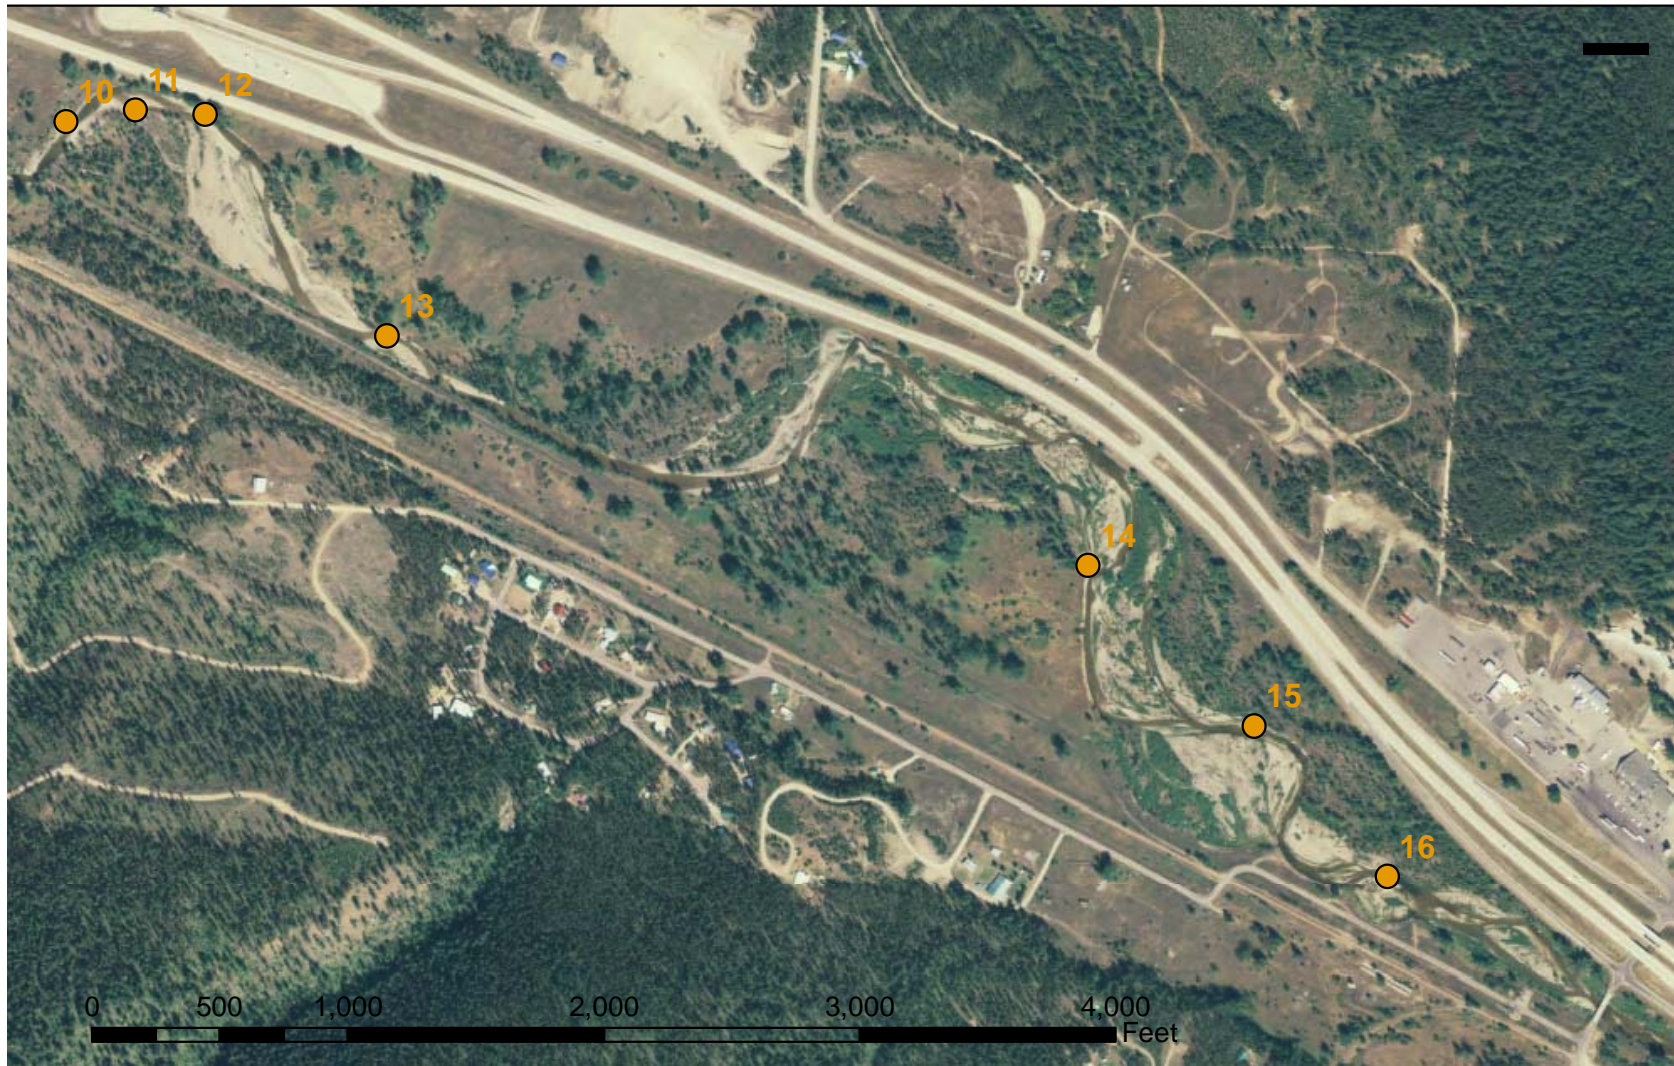
Much of the streambank erosion along the St. Regis River was observed in a wide and aggraded area near Haugen, where 7 eroding streambanks were assessed upstream of the Big Creek Road crossing (BEHI measurements 10-16) and 3 eroding streambanks were assessed downstream of the road crossing (BEHI measurements 17-19) (Figure I-2). A sediment load of 249.5 tons/year was estimated due to streambank erosion around the Haugen area. This accounts for 48% of the total sediment load due to streambank erosion along the St. Regis River. Sediment loading due to the shifting of sparsely vegetated gravel bars likely represents an additional source of sediment within this area, though this additional sediment load was not quantified in the streambank erosion assessment. This gravel bar complex is comprised of a sediment size class that would most likely affect overall channel form, including pool formation, rather than contributing to the concentration of fine sediment. A high capacity for sediment transport upstream of this reach due to extensive channelization is the likely reason for aggradation in this relatively wide and flat area. A second area of aggradation along the St. Regis River was observed downstream of the Little Joe Creek confluence, though no eroding banks were noted. Sediment loading due to shifting unvegetated gravel bars in this area may also be significant.

Figure I-2. Eroding Streambanks in the Haugan Vicinity

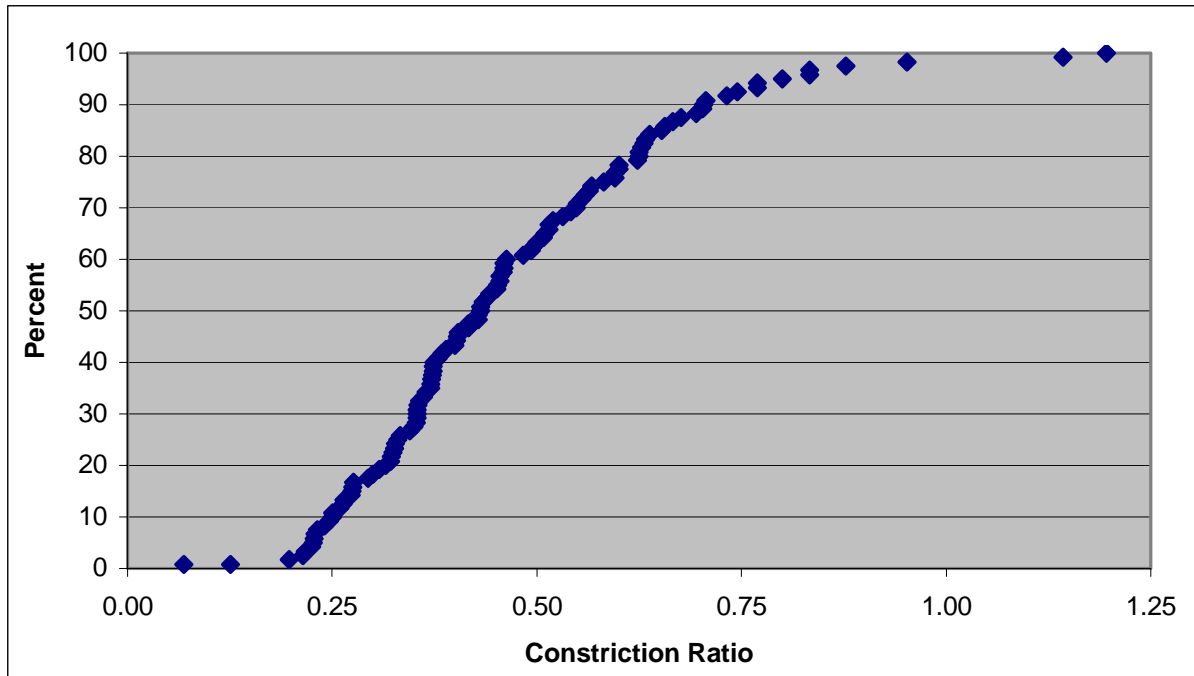
The culvert fish passage analysis revealed that almost all of the culverts surveyed span less than the bankfull width of the streams they cross. This relationship is expressed as a ratio of culvert width to bankfull width, also known as constriction ratio. Ninety-eight percent of culverts surveyed have a constriction ratio less than 1.0 (Figure J-2).

Figure J-2. Cumulative Percent Distribution of Constriction Ratio for Culverts on Fish-Bearing Streams in the St. Regis Watershed

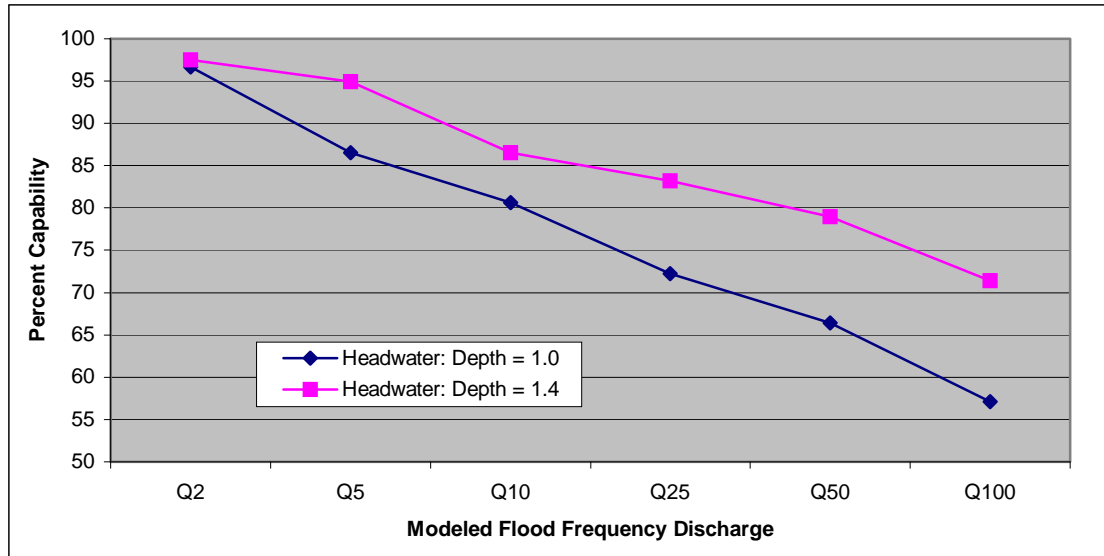
Figure J-4. Percent of Culverts Surveyed Capable of Passing Flows

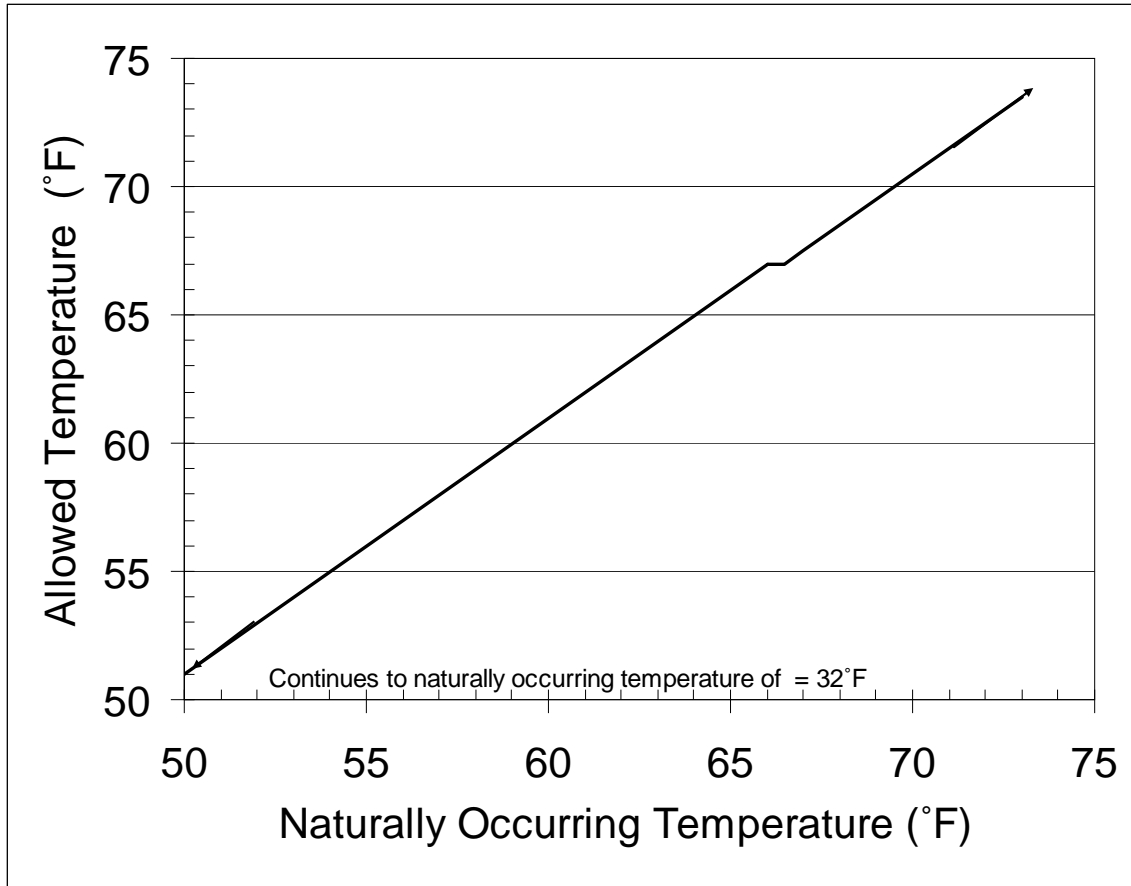
Figure O-1. In-stream Temperatures Allowed by Montana's B-1 Classification Temperature Standard
