**Final –
Addendum to Flint Creek Planning Area
Sediment and Metals TMDLs and Framework
Water Quality Improvement Plan**

May 2015

Prepared by:

Water Quality Planning Bureau
Watershed Management Section

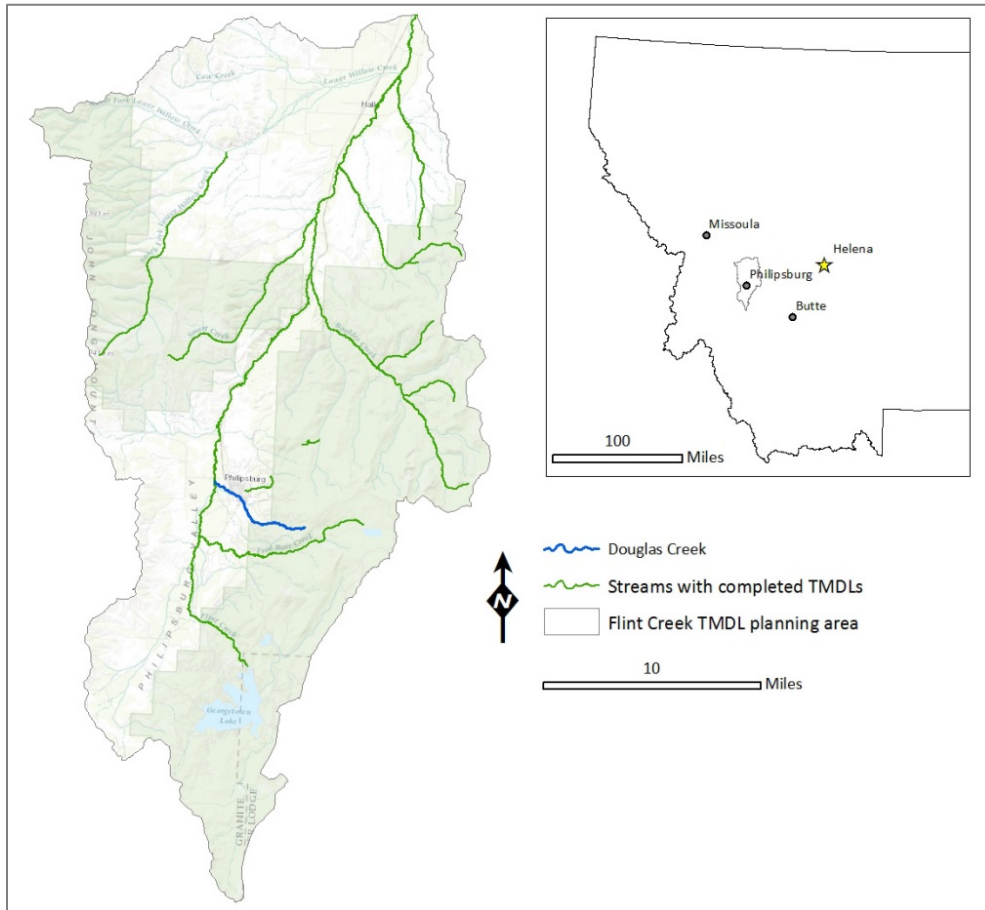
Figure 1-1. Douglas Creek and streams with approved TMDLs in the Flint Creek TPA

This document is an addendum to the 2012 TMDL document *Flint Creek Planning Area Sediment and Metals TMDLs and Framework Water Quality Improvement Plan* (Montana Department of Environmental Quality, 2012a). This addendum includes an analysis of water quality data and establishes a TMDL for antimony in Douglas Creek. The location of Douglas Creek relative to the Flint Creek TMDL Planning area is shown in **Figure 1-1**.

This document addresses one waterbody segment and metal-related impairment cause identified on the 2014 Montana 303(d) List: antimony in Douglas Creek (**Figure 1-1**). The assessment unit for Douglas Creek was based upon the National Hydrography Dataset (NHD), which depicts Douglas Creek expiring in the alluvial fan south of Philipsburg. However, Douglas Creek flows all the way to Flint Creek, via natural channel and ditch diversions. As of this writing, DEQ is pursuing corrections to both the NHD and DEQ's assessment unit description. In this document, Douglas Creek is shown flowing to Flint Creek in all figures. The flowline is based upon recent aerial photographs.

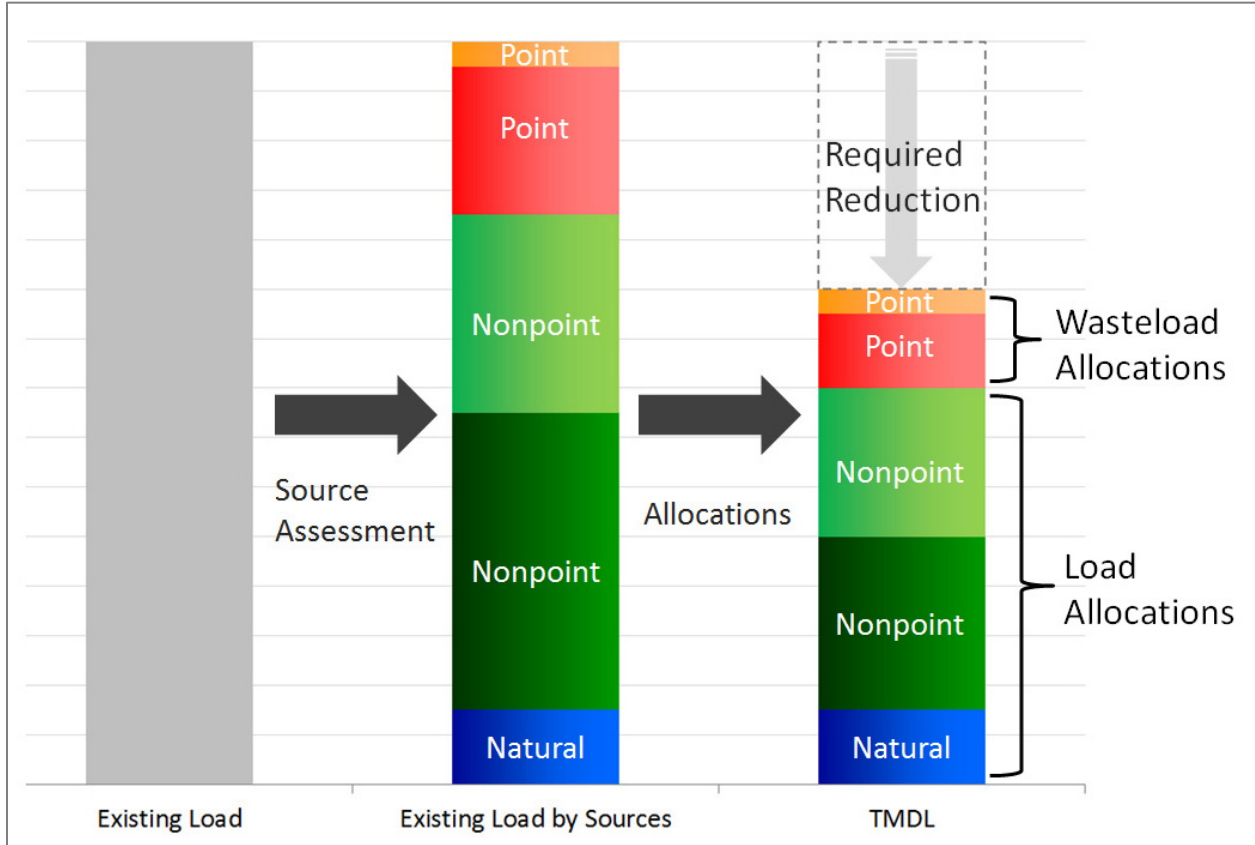
Figure 4-1. Illustration of TMDL components and the TMDL development process.

Section 4.0 in the parent document (Montana Department of Environmental Quality, 2012a) provides an introductory description of the TMDL components with more detailed description of the TMDL process and components in **Sections 4.1** through **4.4**. The reader should refer to those sections for more detail. **Figure 4-1** below provides a graphical summary of the TMDL process and components. **Figure 4-1** shows multiple point and nonpoint source allocations; however, composite allocations may be used in some cases where data is limited. Composite wasteload or load allocations provide stakeholders with flexibility in addressing sources, allowing them to choose where to focus remediation or restoration efforts.

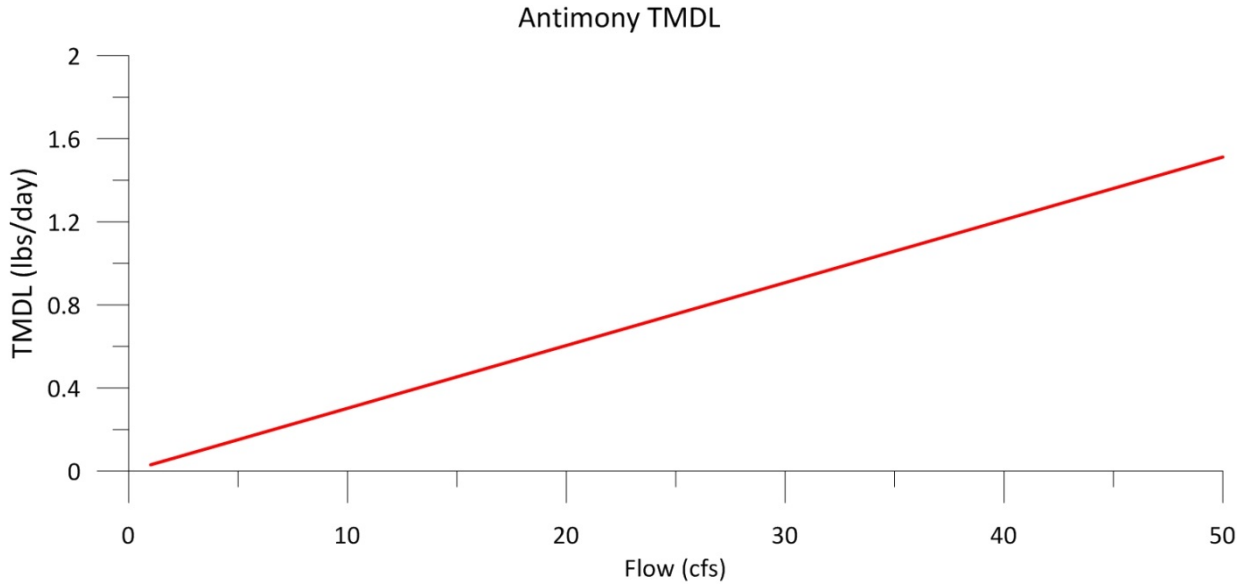
Figure 5-3. Plot of antimony TMDL versus streamflow

The TMDL has a linear relationship to streamflow, and this can be expressed graphically as shown below in **Figure 5-3**.

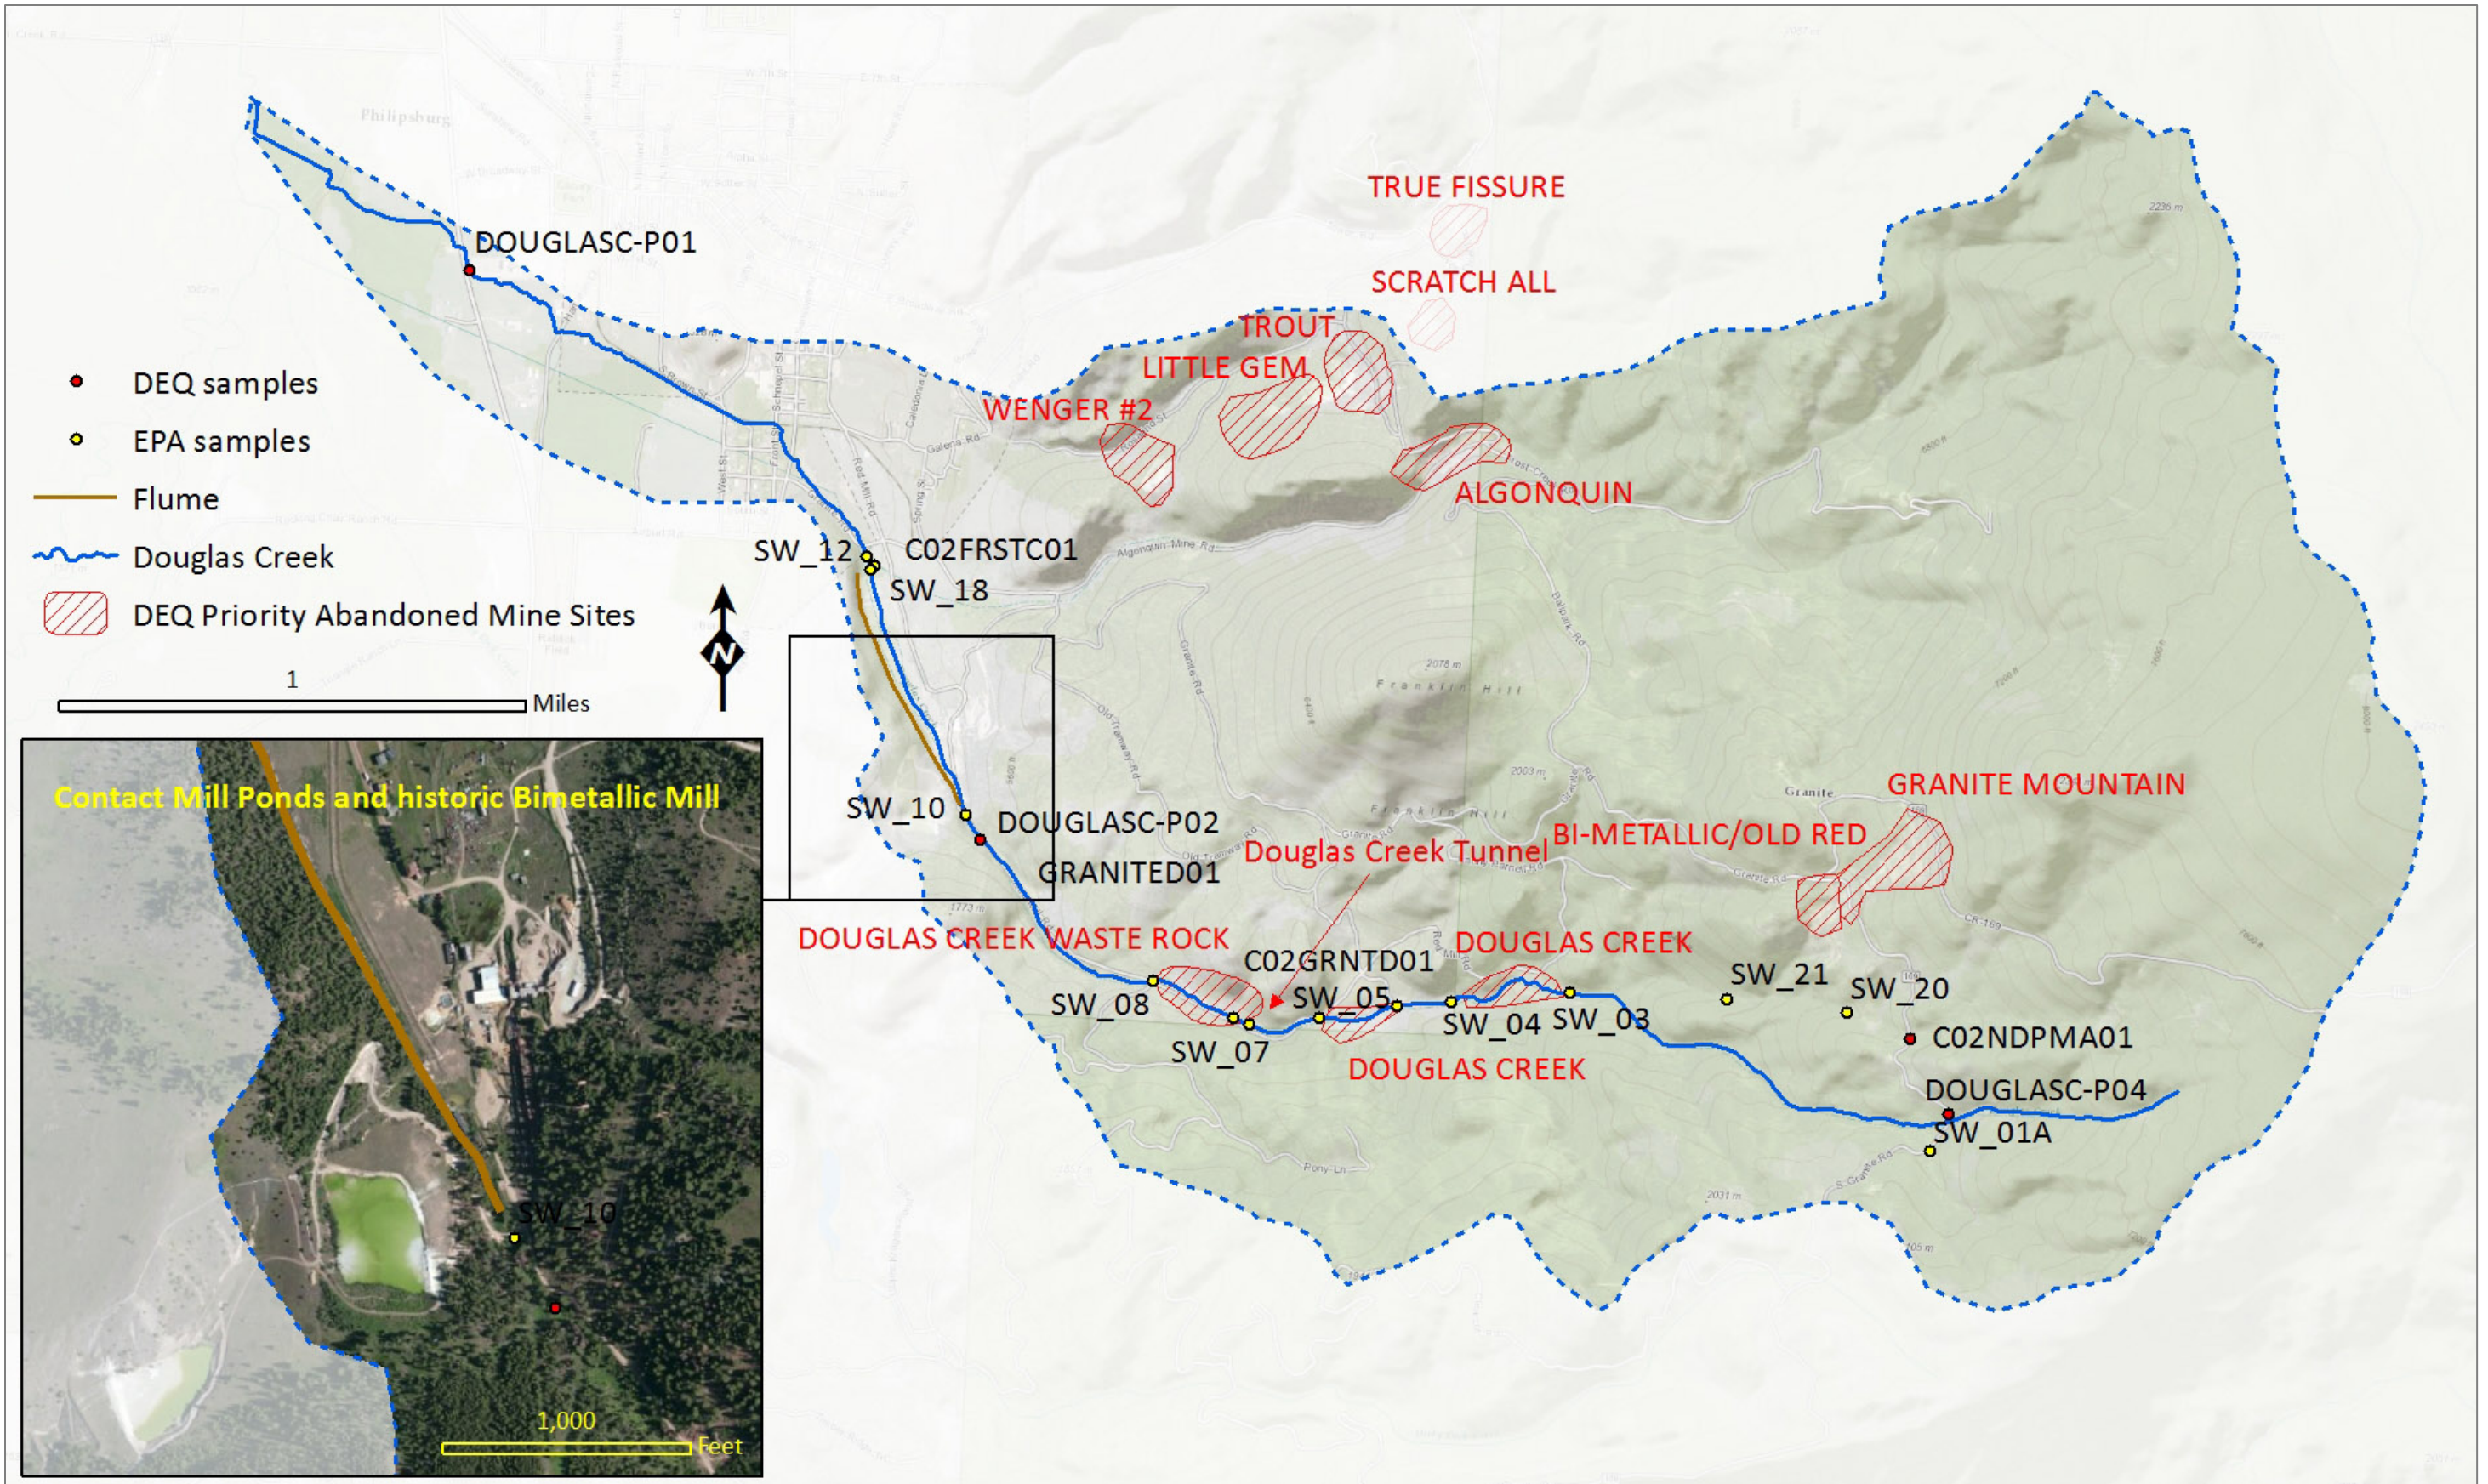
APPENDIX A - LOCATION OF MINING-RELATED FEATURES AND WATER QUALITY SAMPLE SITES

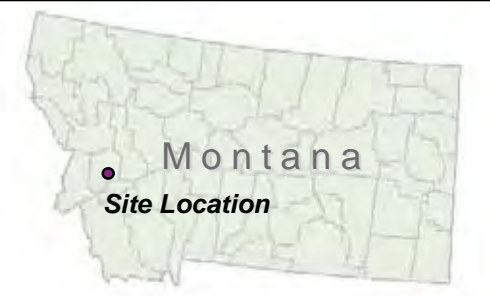
Philipsburg Mining Area (Douglas Creek)
 TDD Title: Site Location, Area of Influence, and 15 - Mile Downstream Target Distance Limit Map
 Figure Title:
 Figure No. 1
 TDD State: MT
 TDD County: Granite
 TDD: 1103-02
 Date: 06/2012

- Legend**
- Douglas Creek 15 - Mile Target Distance Limit
 - 4 - Mile Area of Influence
 - Phillipsburg Mining Area

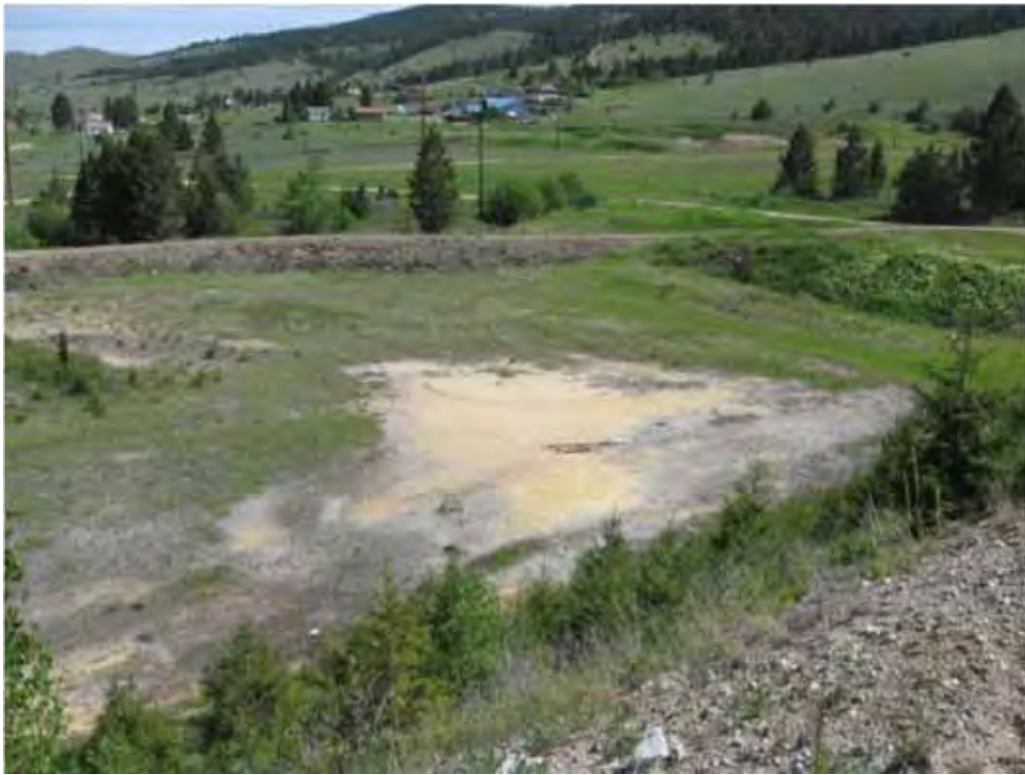
PHOTO 1

Area of historical Bi-Metallic Mill tailings pile with no vegetation, looking northwest. Note dirt bike track.

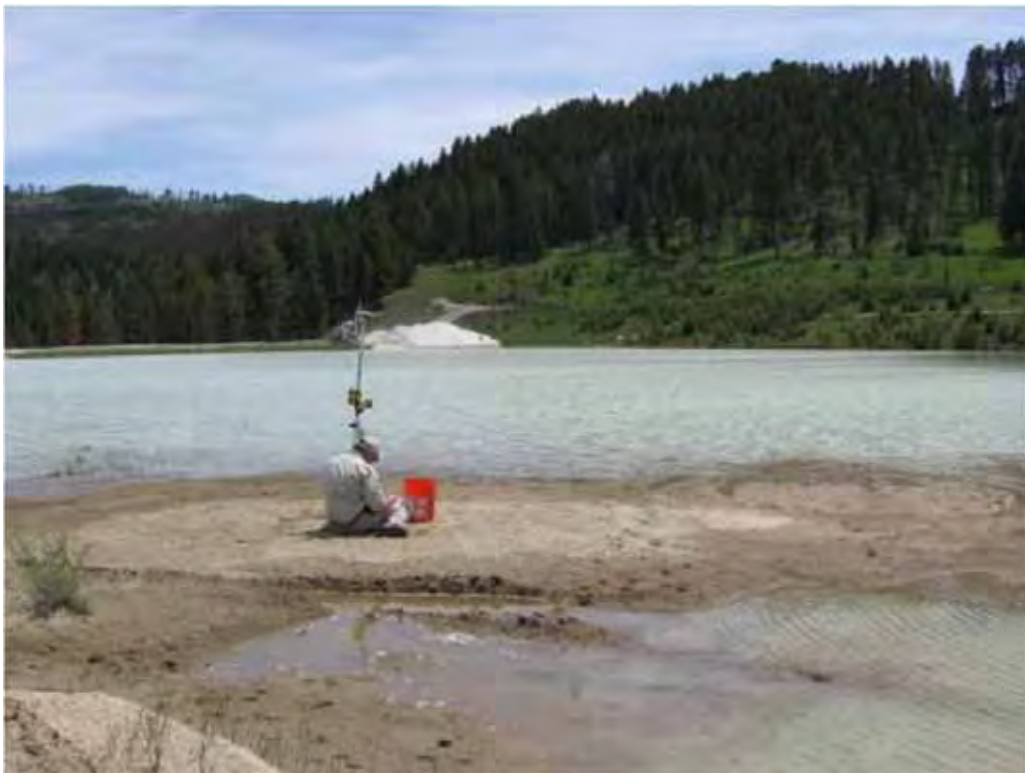
PHOTO 2

Chuck Baker (START) collecting source sample PMA_DC_SO_15_0611 from Contact Mill east tailings. Photo shows water on surface and active pumping of tailings onto crest of tailings dam in distance (white material). Looking southeast.

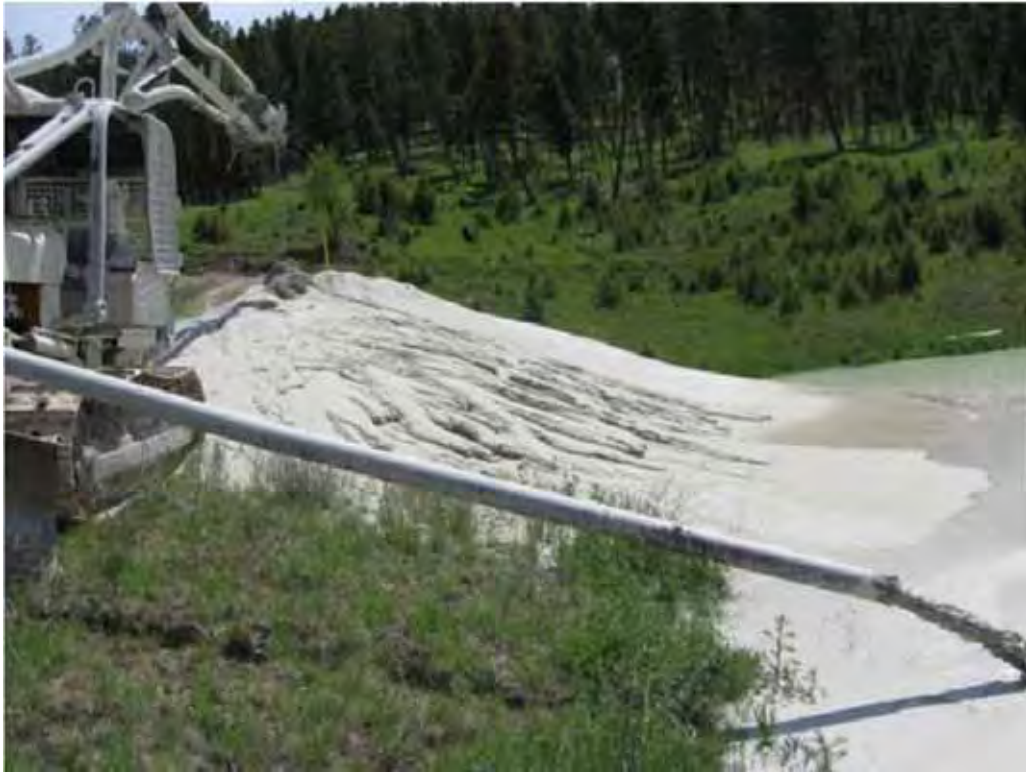
PHOTO 3

Pumping of tailings onto crest of Contact Mill east tailings dam. Looking south.

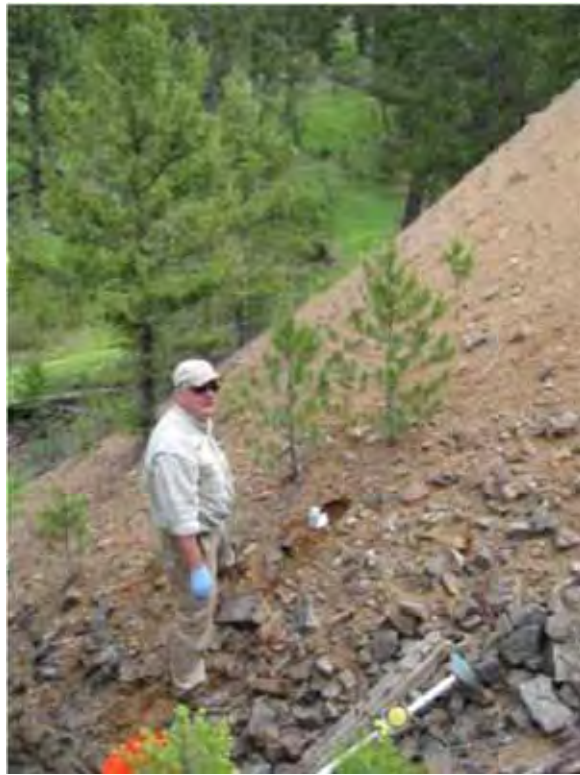
PHOTO 5

Chuck Baker (START) collecting source sample PMA_DC_SO_13_0611 at toe of Douglas Creek Waste Rock pile, showing lack of vegetative cover. Looking north.

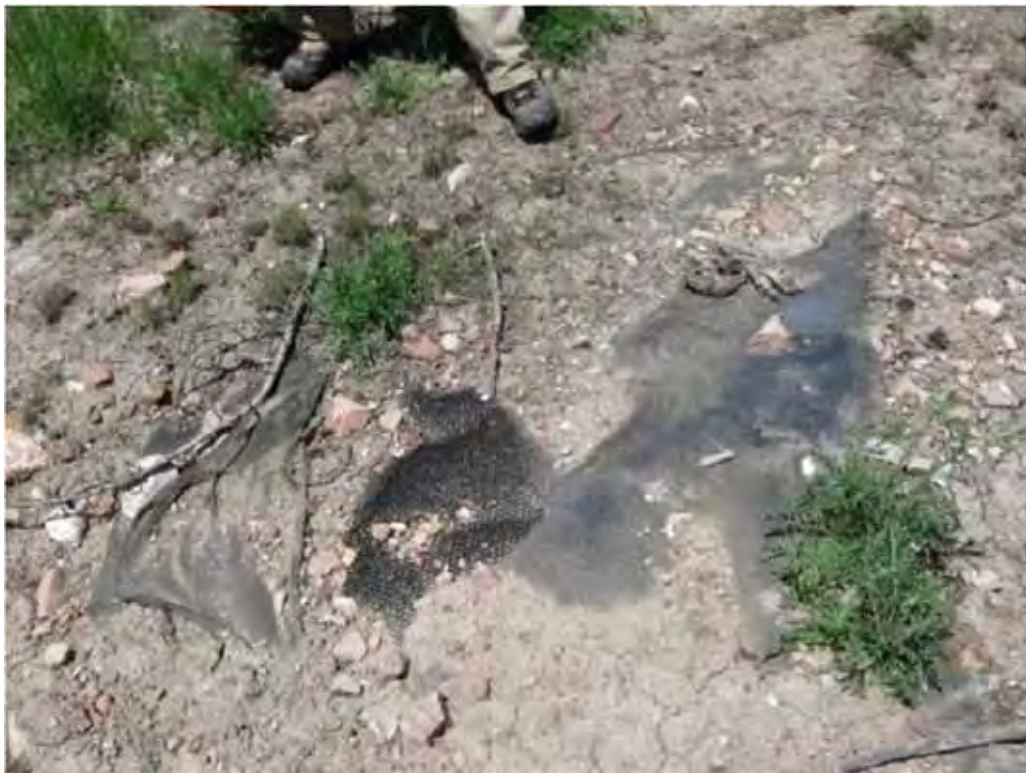
PHOTO 6

Erosion of cover material over Douglas Creek East tailings pile.

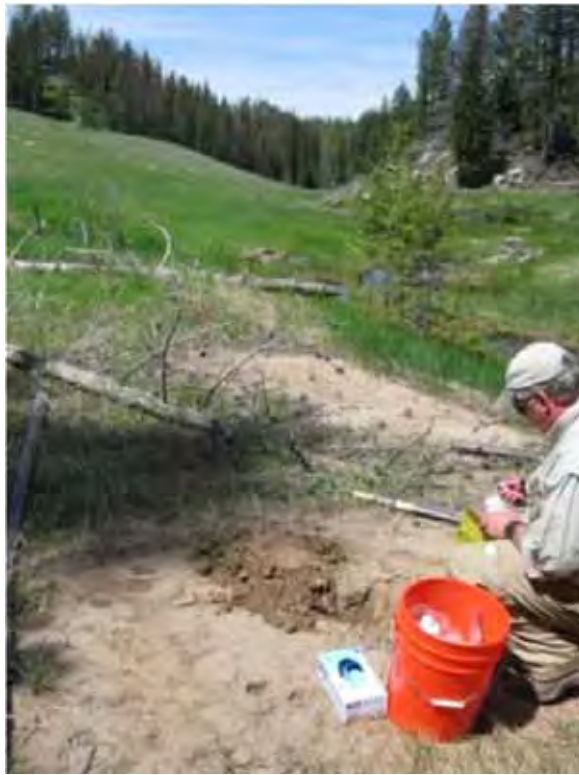
PHOTO 7

Chuck Baker (START) collecting source sample PMA_DC_SO_11_0611 from apparent exposed tailings at Douglas Creek West tailings pile. Looking west.

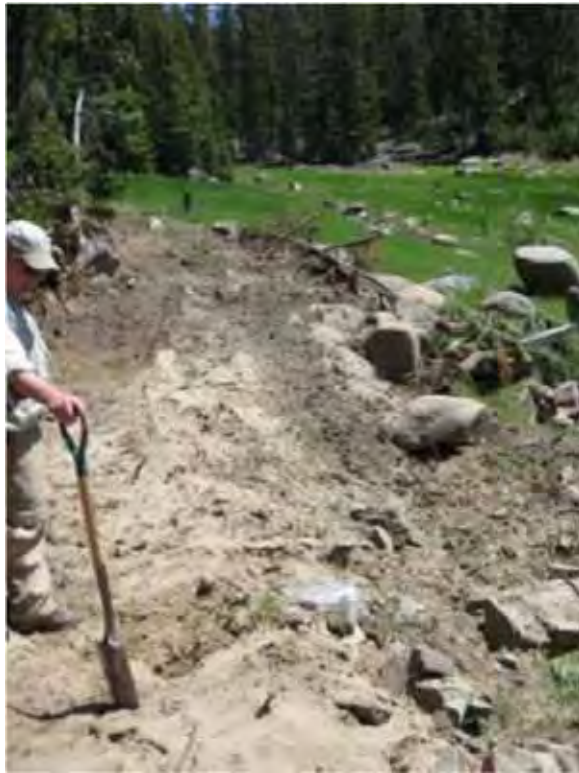
PHOTO 8

Chuck Baker (START) at apparent exposed tailings due to logging operations, Douglas Creek East tailings pile. Looking east.

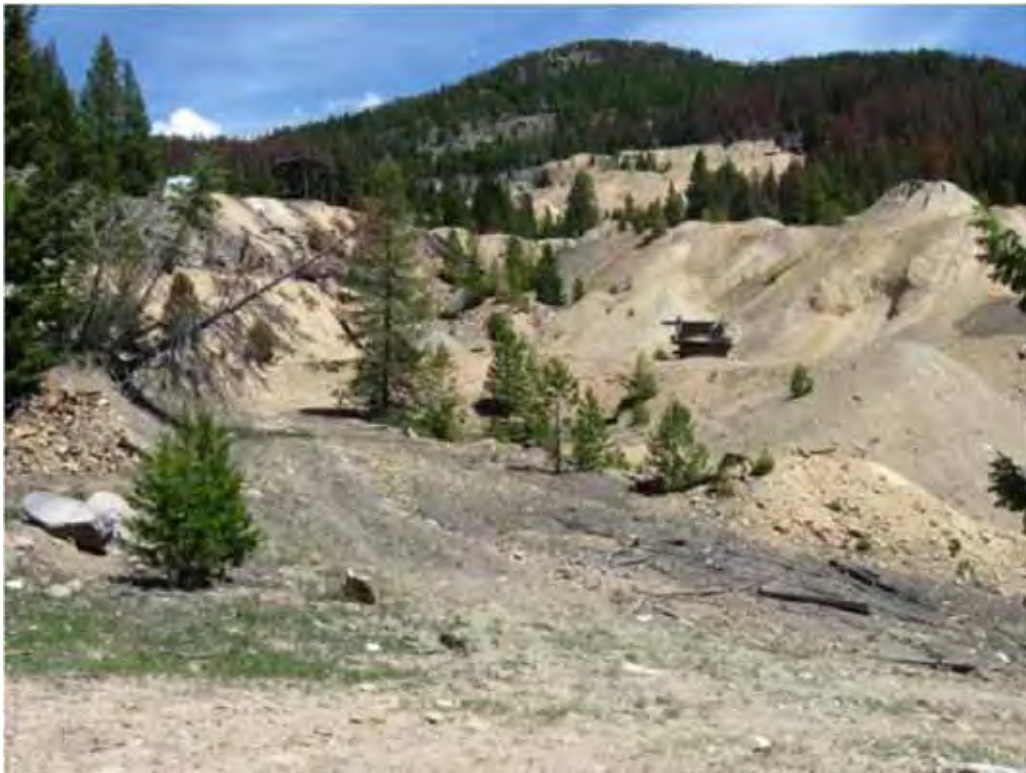
PHOTO 9

Granite Mountain (far background, upper right) and Bi-Metallic/Old Red (middle ground) mining waste rock piles. Looking north.

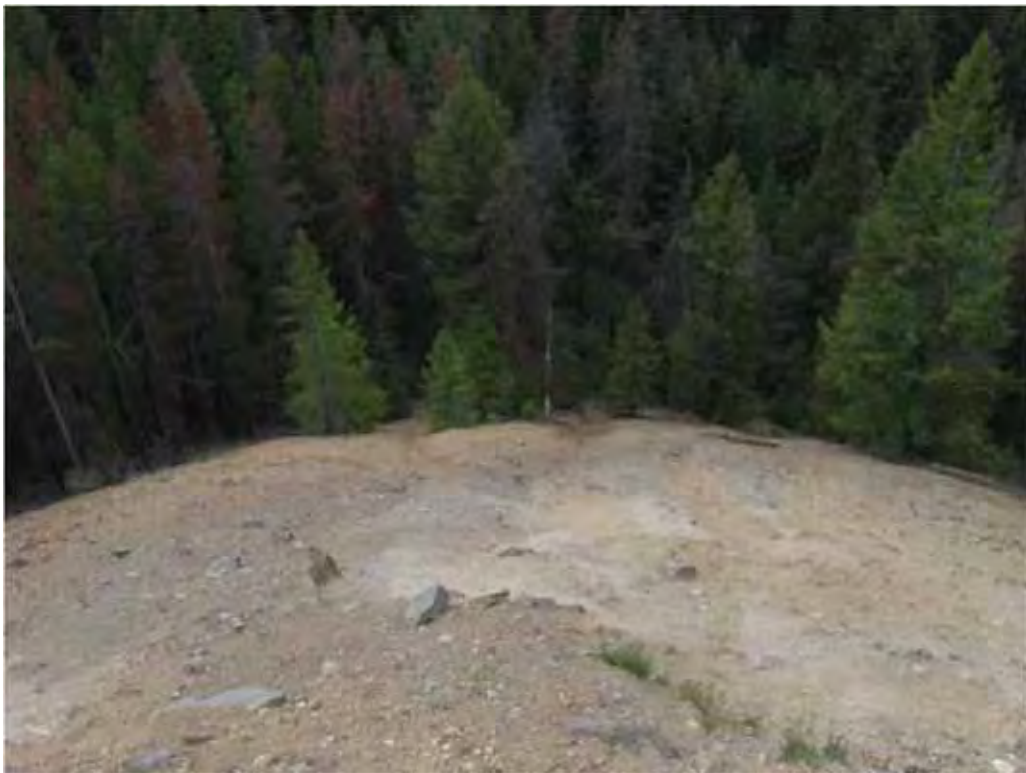
PHOTO 10

Erosion channels on surface of Bi-Metallic waste rock pile, looking south.

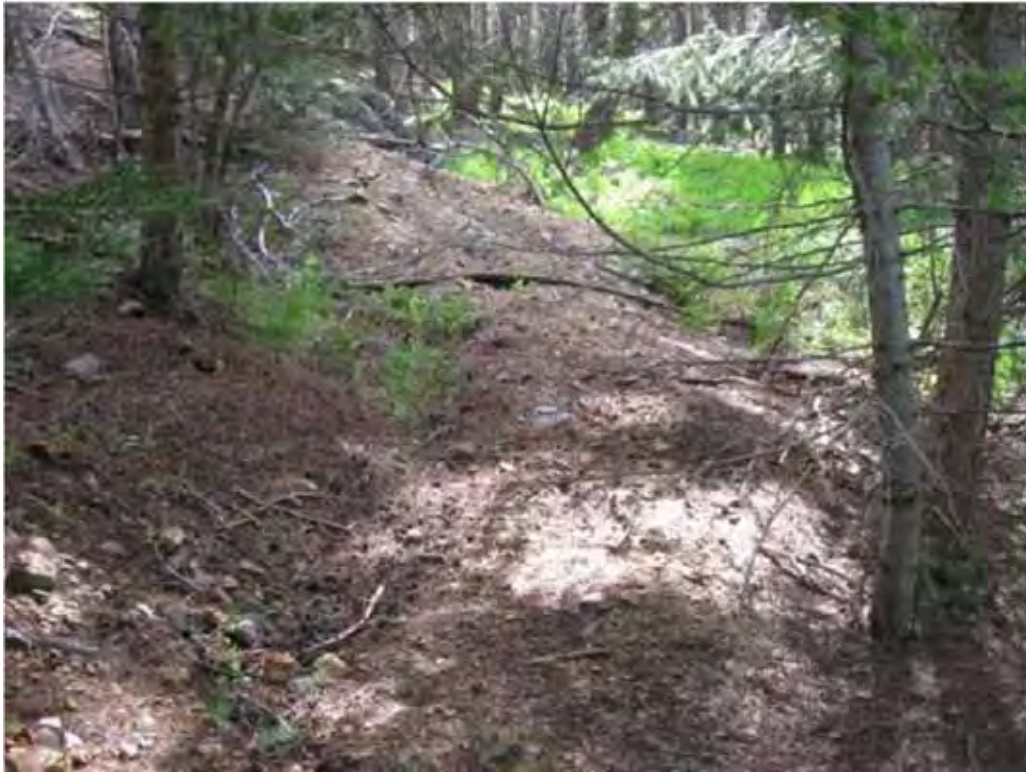
PHOTO 11

Lobe of eroded waste rock at toe of Bi-Metallic waste rock pile. Looking east.

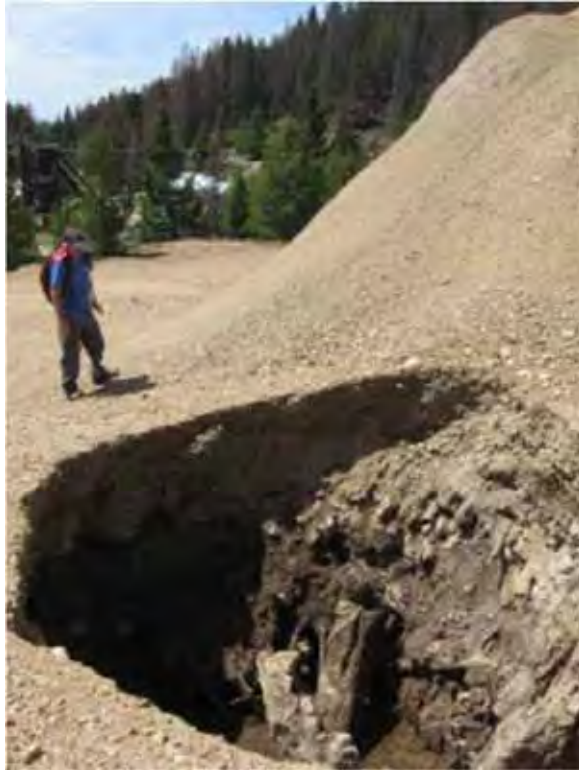
PHOTO 12

Jeff Miller (START) at sinkhole at base of Granite Mountain waste rock pile. Looking west.

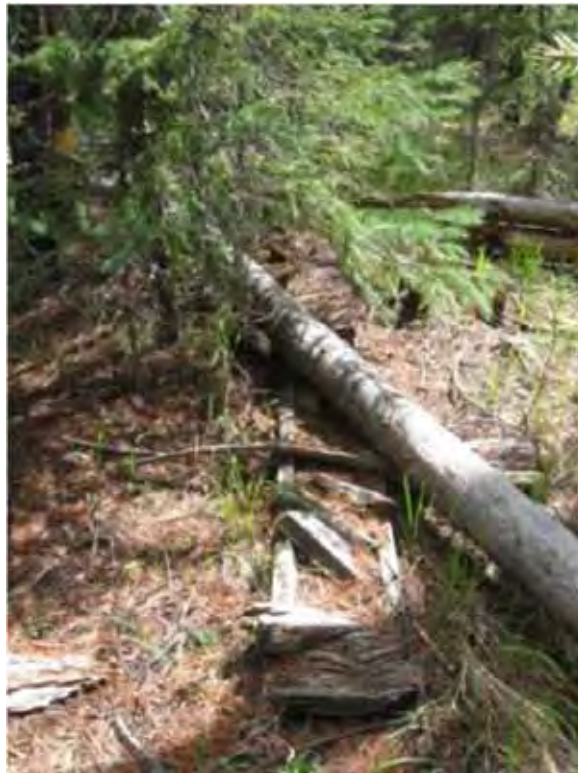
PHOTO 13

Decomposed flume near base of Bi-Metallic waste rock pile. Looking east.

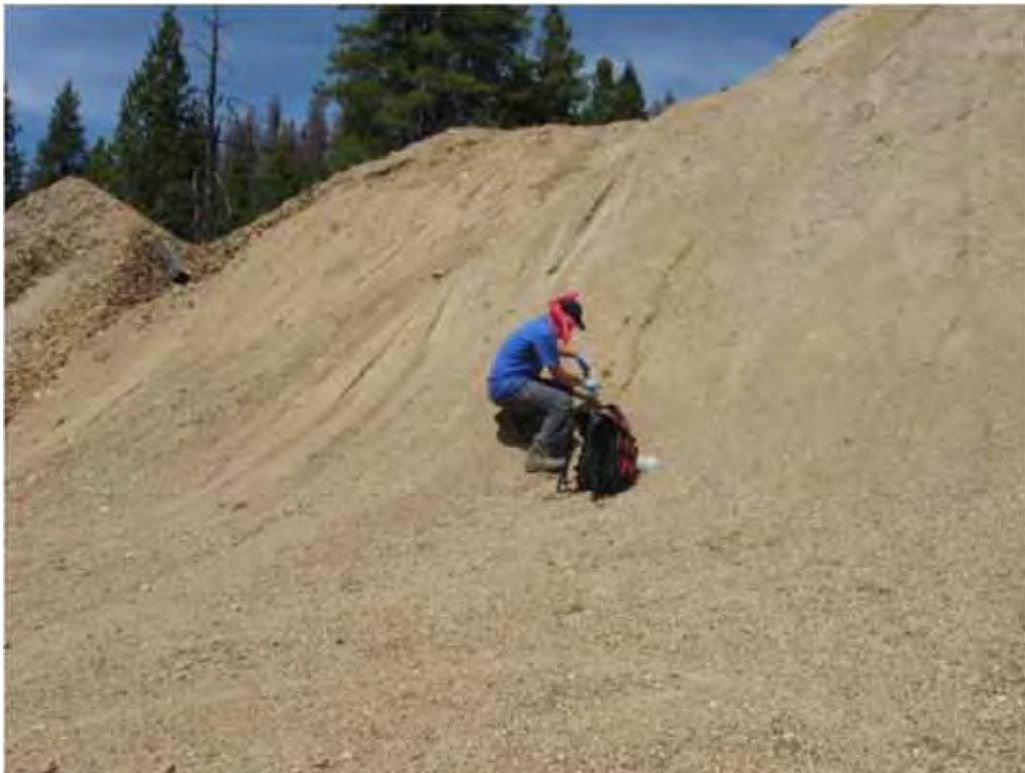
PHOTO 15

Jeff Miller (START) collecting source sample PMA_DC_SO_05_0611 from the Granite Mountain waste rock pile. Note dirt bike tracks through pile. Looking north.

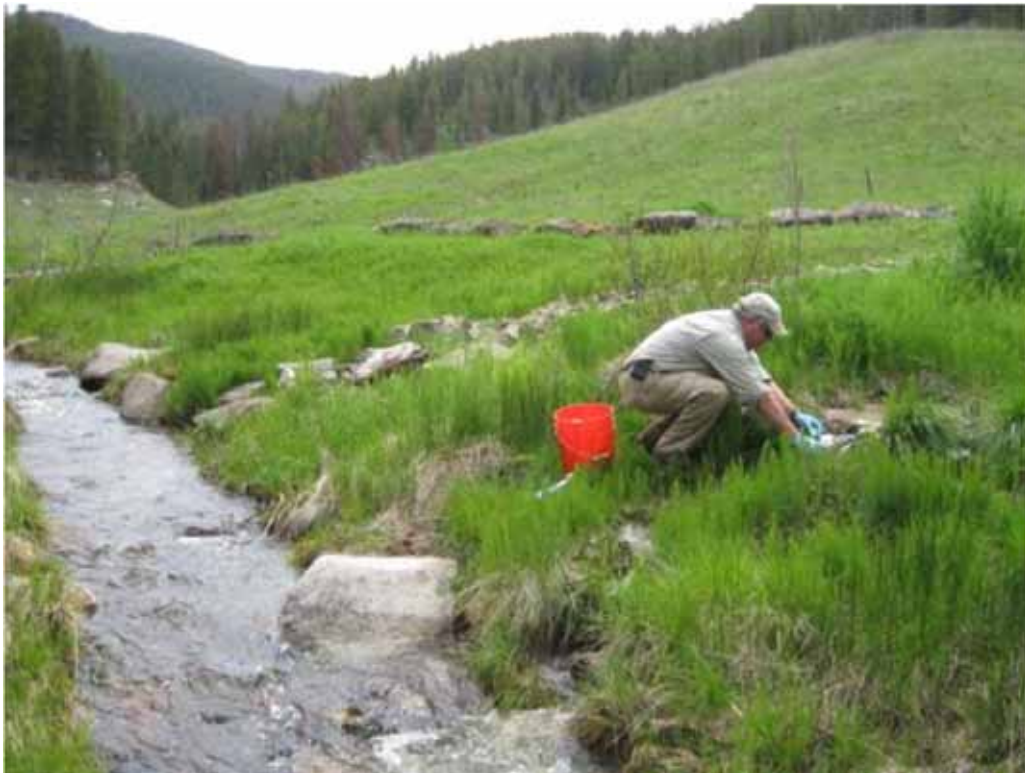
PHOTO 17

Chuck Baker (START) collecting source sample PMA_DC_SW_16_0611 from seep near west end of Douglas Creek West tailings pile. Looking east.

Five aqueous source samples (includes one duplicate sample collected for mercury only) were collected from two flowing adits (Photos 26, 36, 45) and two seeps (Photos 17, 18) (Tables 4, 6; Figure 2). The third seep historically identified on the east side of the Douglas Creek east tailings pile could not be found.

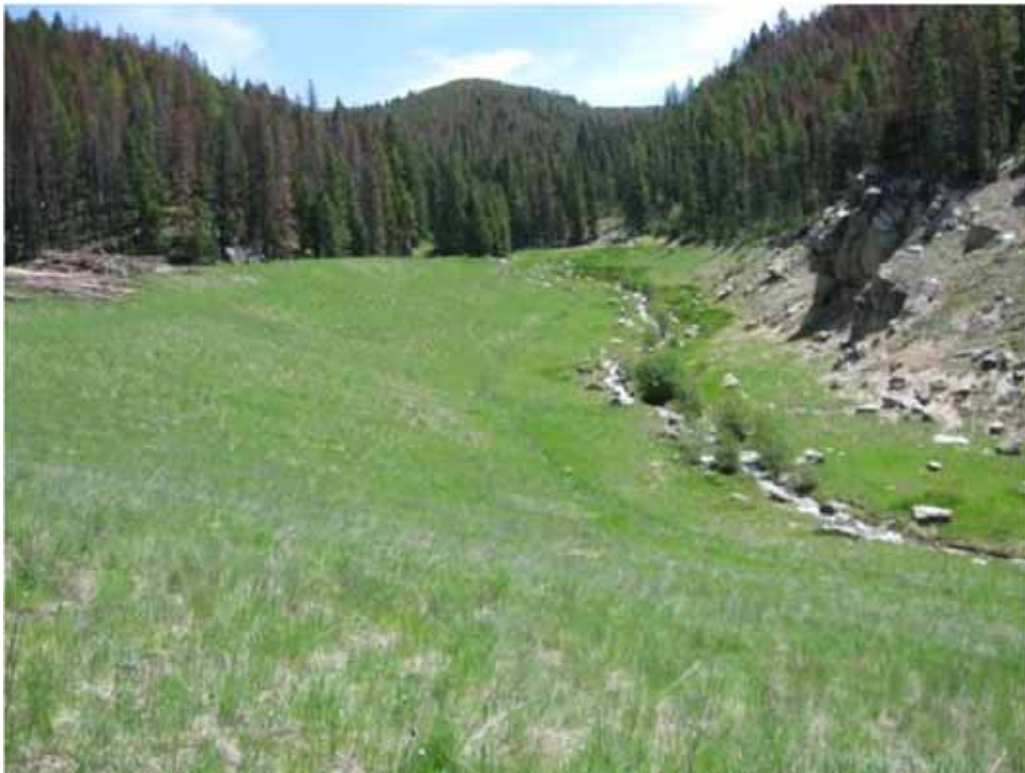
PHOTO 19

View of Douglas Creek East tailings pile, showing “wetlands.” Looking east.

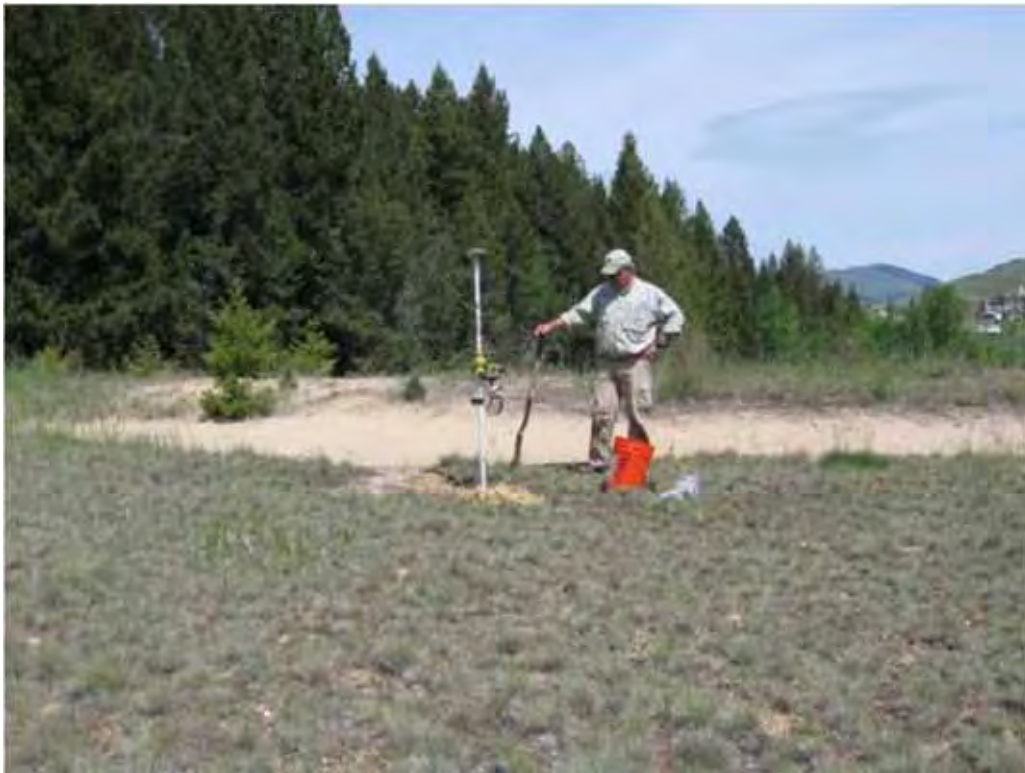
PHOTO 23

Chuck Baker (START) collecting GPS data at source sample location PMA_DC_SO_16_0611 on the historical Bi-Metallic tailings pile. Looking northwest.

At sediment sampling locations, co-located surface water samples were collected prior to the collection of sediment so as to minimize the entrainment of sediment into the water. Soil and sediment samples for total metals were placed in appropriate sample containers and were stored on ice to $< 4^{\circ}\text{C}$. All sampling locations were photographed and their locations recorded with the GPS (Photo 23).

The historical Bi-Metallic Mill tailings pile is the most downstream source investigated (Photos 1, 21, 22, 23). The pile is located approximately 1 mile south-southeast of the town of Philipsburg (Figure 2) and sits at an elevation of approximately 5,400 feet amsl. According the MDEQ, these tailings were reclaimed in the 1980s as a condition of the original Contact Mill discharge permit (MDEQ 2011b). While the volume of the tailings pile could not be determined in the field as representative depth measurements could not be gathered, from aerial photographs the surface area of the pile is estimated to be approximately 101,000 yd².

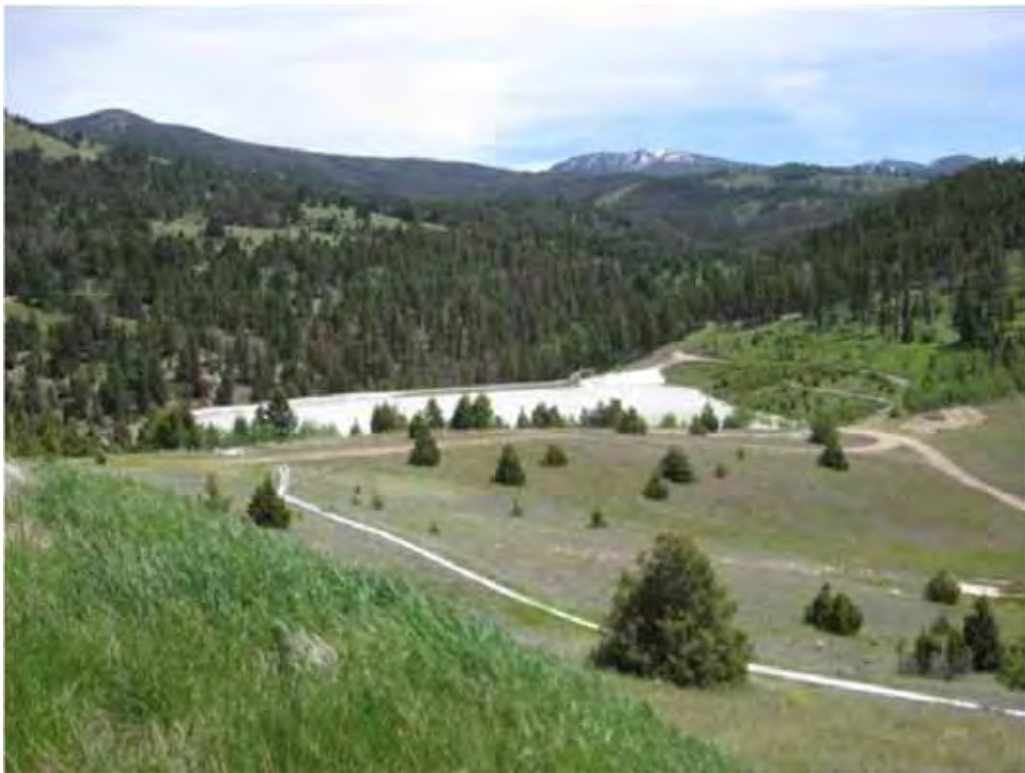
PHOTO 24

Contact Mill east tailings impoundment. Looking east-southeast.

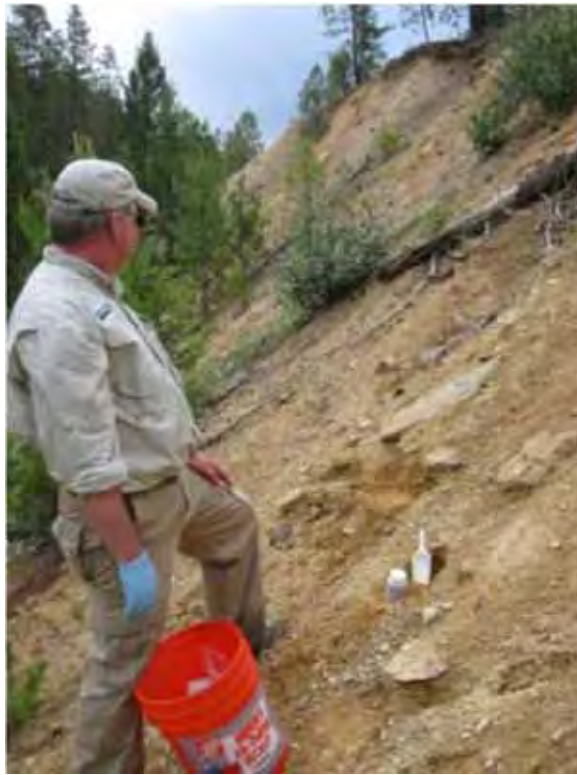
PHOTO 25

Chuck Baker (START) at PMA_DC_SO_12 source sample location at the Douglas Creek waste rock pile. Note sparse vegetation. Looking northeast.

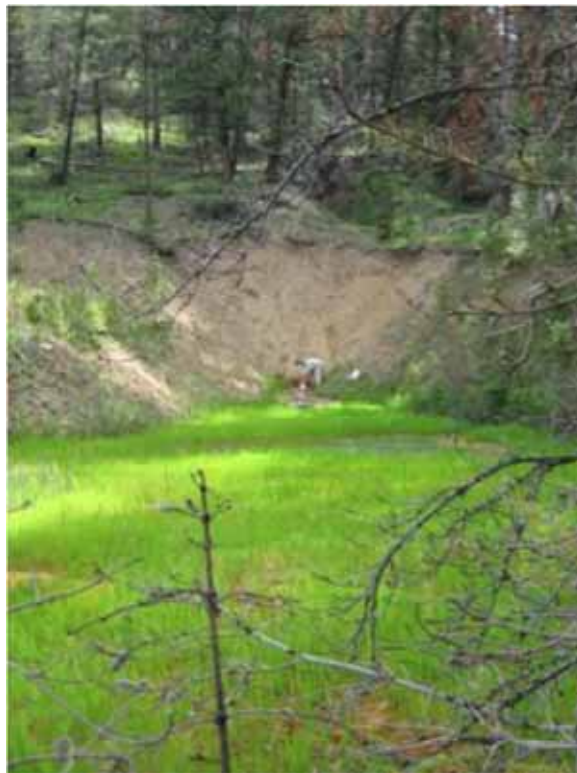
PHOTO 26

Chuck Baker (START) collecting aqueous source sample PMA_DC_SW_13_0611 from the Granite Mountain/Bi-Metallic adit (Granite Drain). Facing northeast.

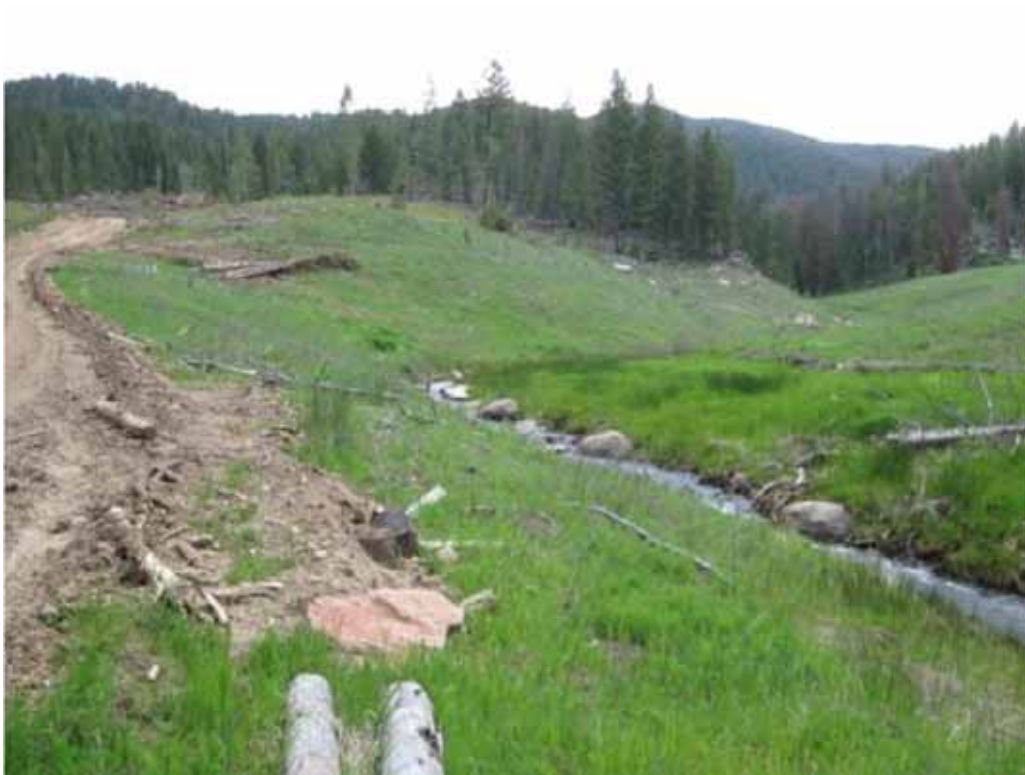
PHOTO 27

Logging road through reclaimed Douglas Creek west tailings. Looking northeast.

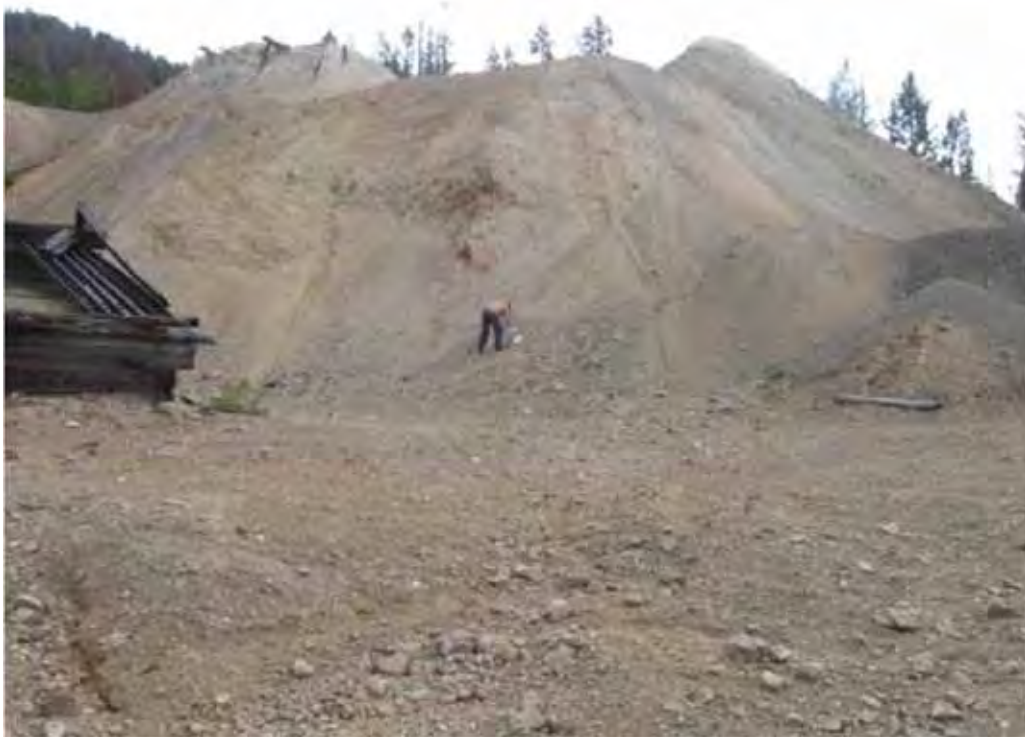
PHOTO 30

Jeff Miller (START) collecting source sample PMA_DC_SO_07_0611 from Bi-Metallic/Old Red waste rock pile. Looking southeast.

An unplanned additional soil/source sample (PMA_DC_SO_07A_0611, Photo 31) was collected from the Bi-Metallic/Old Red waste rock source from a lobe of material that appeared possibly to have a different origin from the other material due to its location. However, the analytical results show that a sample of this material has very similar metals concentrations to the other Bi-Metallic/Old Red waste rock sample (PMA_DC_SO_07_0611, Photo 30).
