**Final –
Addendum to Flint Creek Planning Area
Sediment and Metals TMDLs and Framework
Water Quality Improvement Plan**

May 2015

Prepared by:

Water Quality Planning Bureau
Watershed Management Section

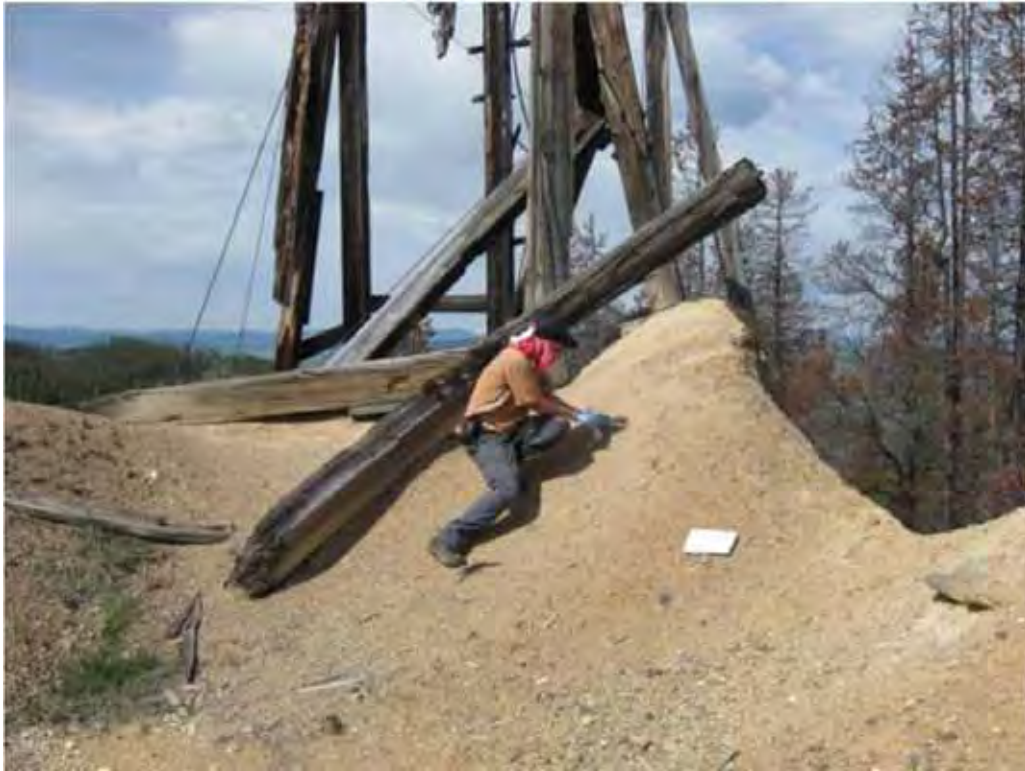
PHOTO 31

Jeff Miller (START) collecting source sample PMA_DC_SO_07A_0611 from Bi-Metallic/Old Red waste rock pile. Looking southwest.

An unplanned additional soil/source sample (PMA_DC_SO_07A_0611, Photo 31) was collected from the Bi-Metallic/Old Red waste rock source from a lobe of material that appeared possibly to have a different origin from the other material due to its location. However, the analytical results show that a sample of this material has very similar metals concentrations to the other Bi-Metallic/Old Red waste rock sample (PMA_DC_SO_07_0611, Photo 30).

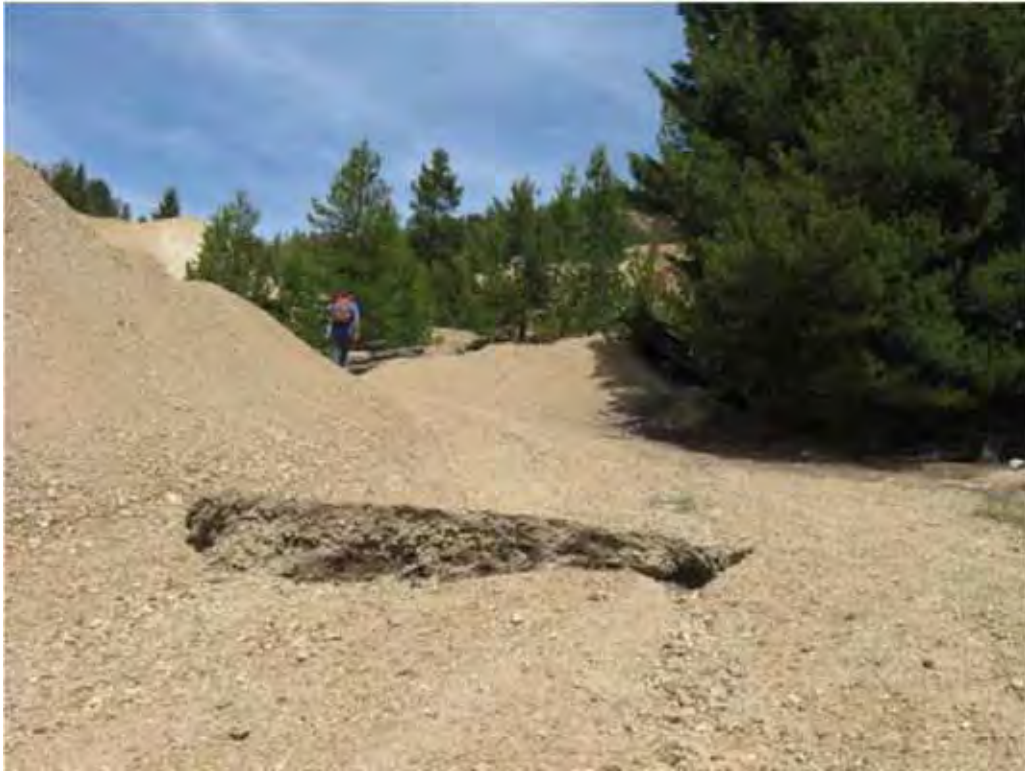
PHOTO 35

Jeff Miller (START) conducting reconnaissance at Granite Mountain tailings. Sinkhole in foreground. Looking northeast.

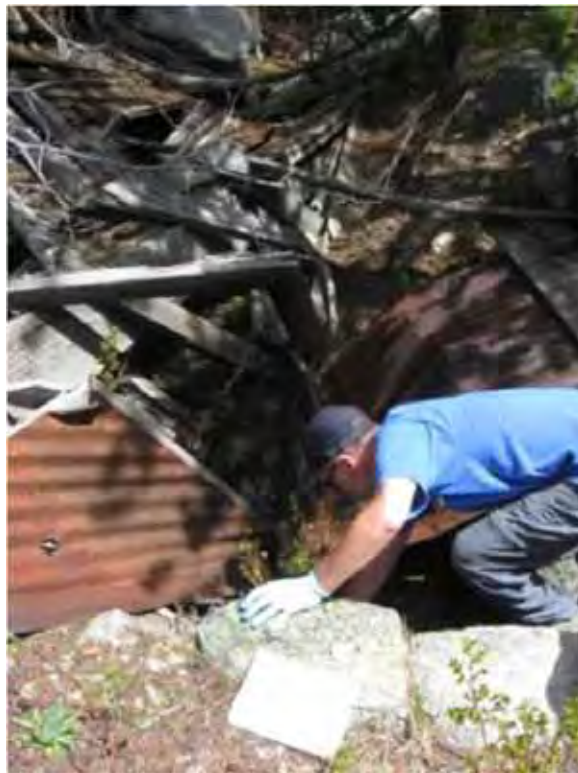
PHOTO 36

Jeff Miller (START) collecting aqueous source sample PMA_DC_SW_17_0611 from New Departure adit.

Five aqueous source samples (includes one duplicate sample collected for mercury only) were collected from two flowing adits (Photos 26, 36, 45) and two seeps (Photos 17, 18) (Tables 4, 6; Figure 2). The third seep historically identified on the east side of the Douglas Creek east tailings pile could not be found.

Two sediment source samples (includes one replicate) were collected from the New Departure adit (Photos 36, 37) (Tables 4, 7; Figure 2).

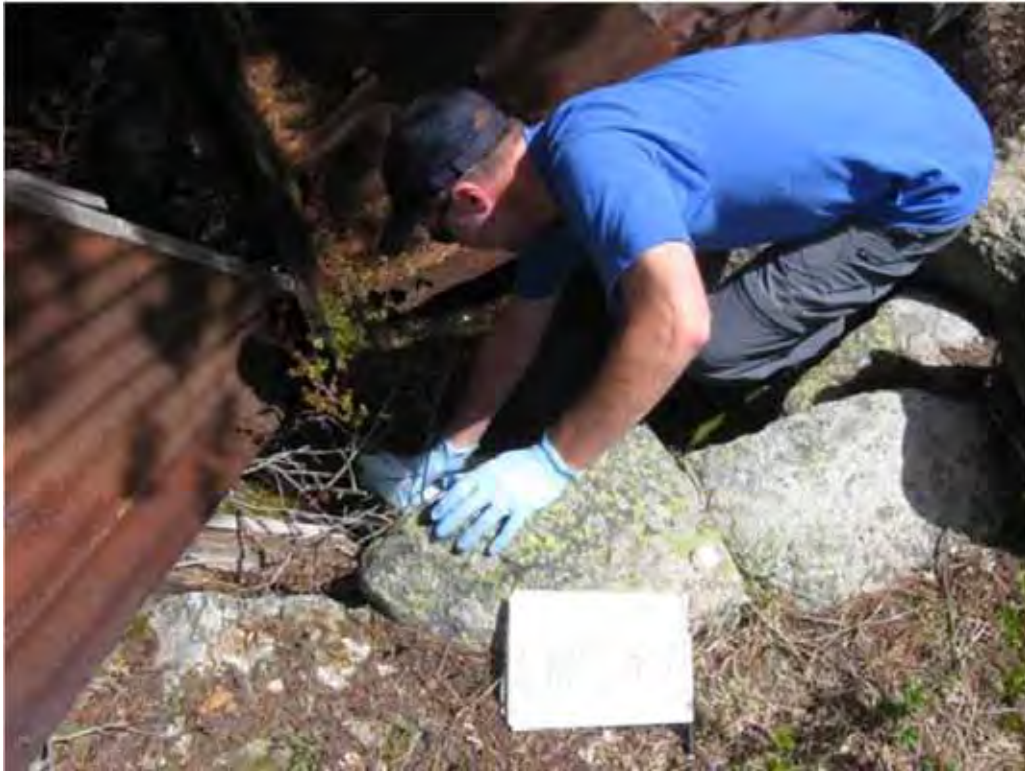
PHOTO 37

Jeff Miller (START) collecting aqueous source sample PMA_DC_SW_17_0611 from New Departure adit.

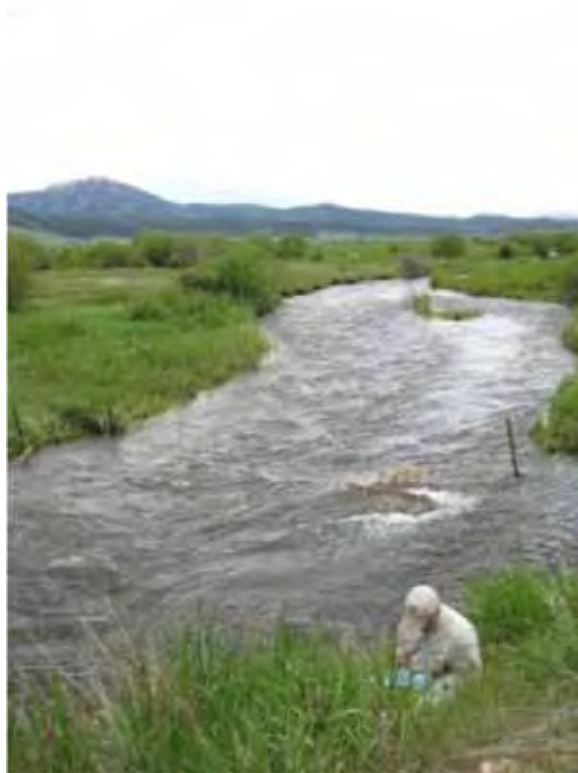
PHOTO 38

Chuck Baker (START) collecting surface water sample PMA_DC_SW_22_0611 from Flint Creek, approximately ½ mile downstream of confluence with Douglas Creek. Note high and fast water. Looking south.

Access to the land parcel where Douglas Creek enters Flint Creek was not granted by the land owners, so sampling locations on Flint Creek upstream and downstream from its confluence with Douglas Creek had to be collected from locations some distance away (i.e., downstream location was approximately 0.5 miles below the confluence, upstream location was approximately 5.5 miles above the confluence). No sediment sample could be collected from Flint Creek downstream of Douglas Creek due to safety concerns with high and fast water (Photos 38, 39).

The background sediment sampling locations (Photos 40 and 41) and a selection of photos of other sediment sampling locations (Photos 42, 43, 44, 45, 46) are shown in Appendix B. No sediment could be collected from the downstream Flint Creek location due to safety concerns related to high and fast flowing water (Photos 38, 39).

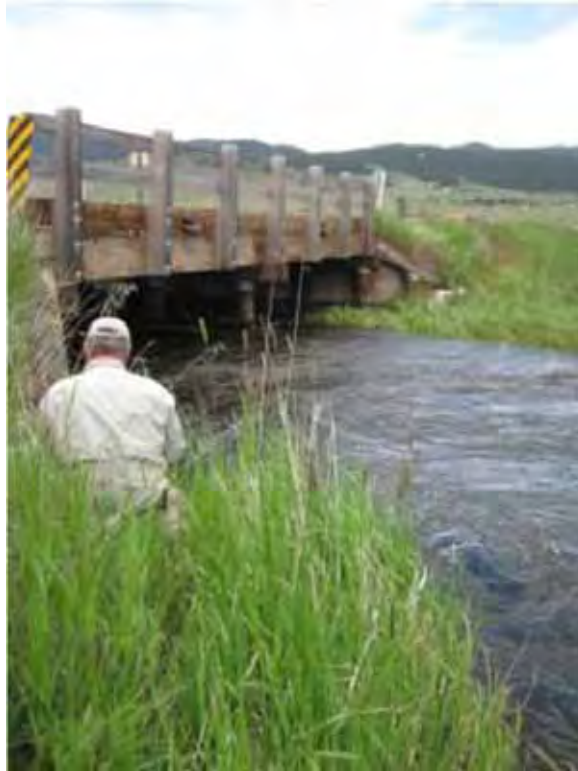
PHOTO 39

Chuck Baker (START) collecting surface water sample PMA_DC_SW_22_0611 from Flint Creek, approximately ½ mile downstream of confluence with Douglas Creek. Note high and fast water. Looking east.

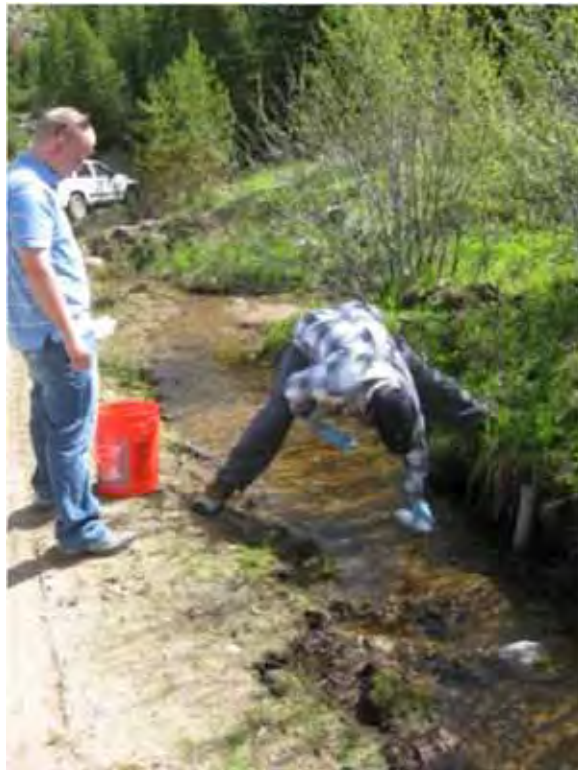
PHOTO 40

Jeff Miller (START) collecting “upper” background surface water sample PMA_DC_SW_01A_0611 from southern branch of Douglas Creek. Robert Parker (USEPA) on left. Looking northwest.

determined in the FSP with some exceptions, which are outlined in Section 3.0 of the SAR (UOS 2011b). The background surface water sampling locations (Photos 40 and 41) and a selection of photos of other surface water sampling locations (Photos 42, 43, 44, 45, and 46) are shown in Appendix B.

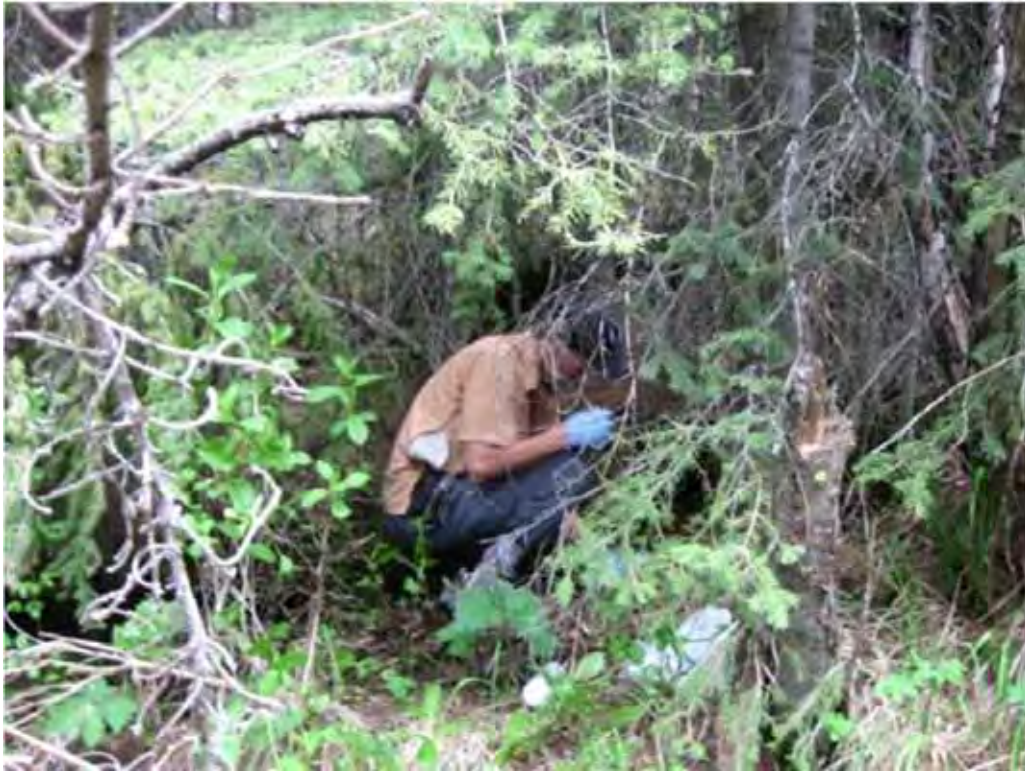
PHOTO 41

Jeff Miller (START) collecting “lower” background surface water sample PMA_DC_SW_01B_0611 from southern branch of Douglas Creek, just upstream of its confluence with the northern branch. Looking northeast.

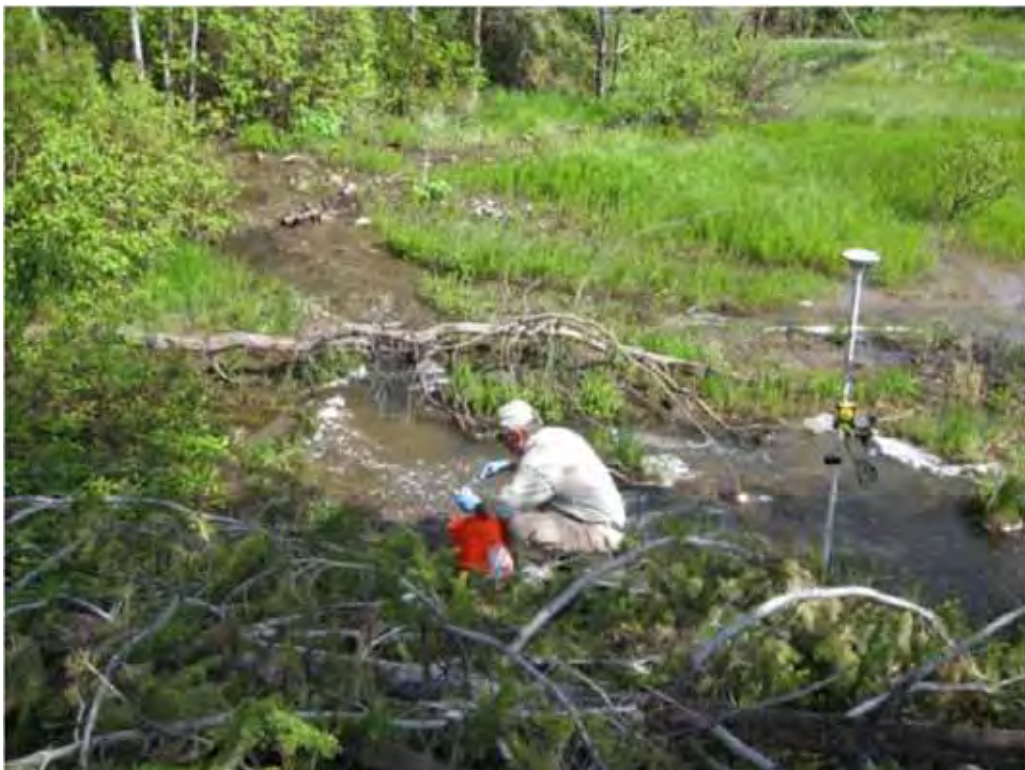
PHOTO 42

Chuck Baker (START) collecting sediment sample PMA_DC_SE_12_0611 from Douglas Creek tailings. Looking northeast.

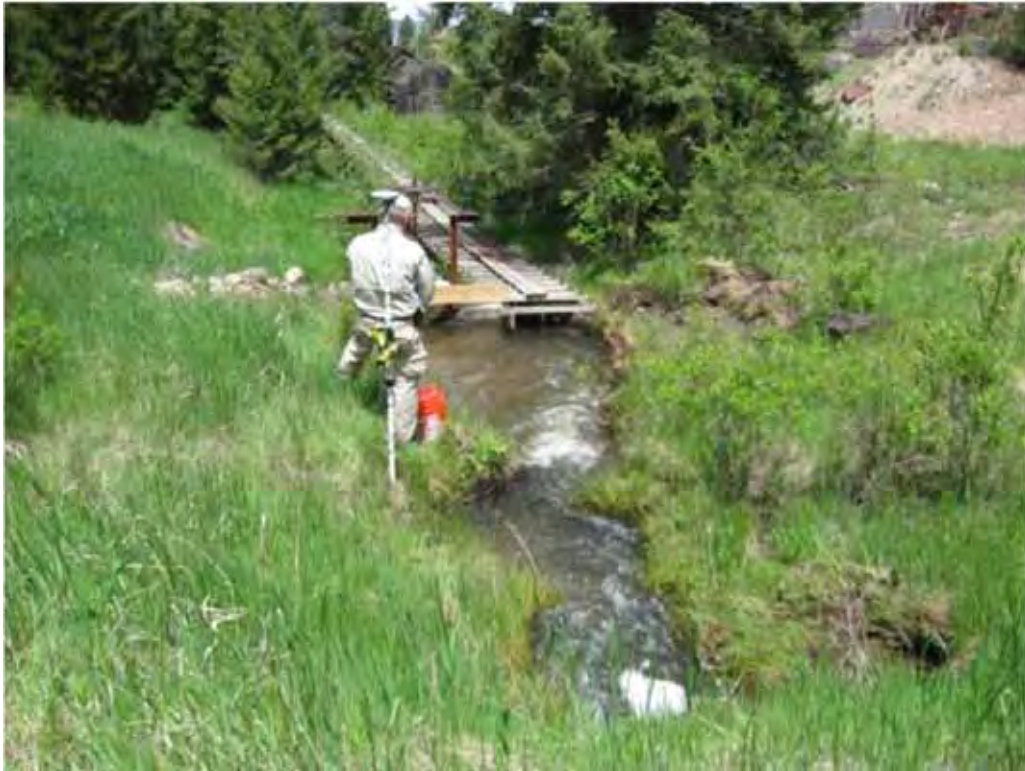
PHOTO 43

Chuck Baker (START) collecting surface water sample PMA_DC_SW_10_0611 from Douglas Creek, above the Contact Mill east tailings. Looking northeast.

Although there is a channel constructed through the middle of the pile for run-on control, Douglas Creek has been diverted around the pile through a flume (Photo 43). The channel through the pile was dry at the time of the site inspection. Water that falls on the tailings pile would most likely percolate downward through the pile.

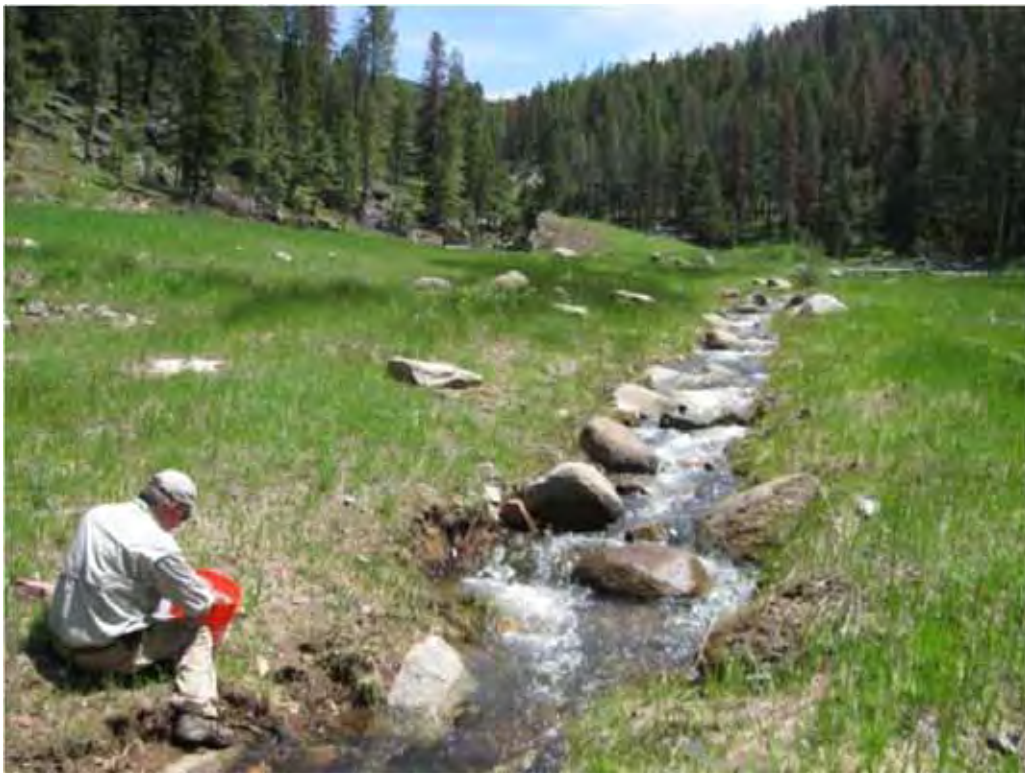
PHOTO 44

Chuck Baker (START) collecting surface water sample PMA_DC_SW_04_0611 from Douglas Creek, below the Douglas Creek east tailings pile. Looking east.

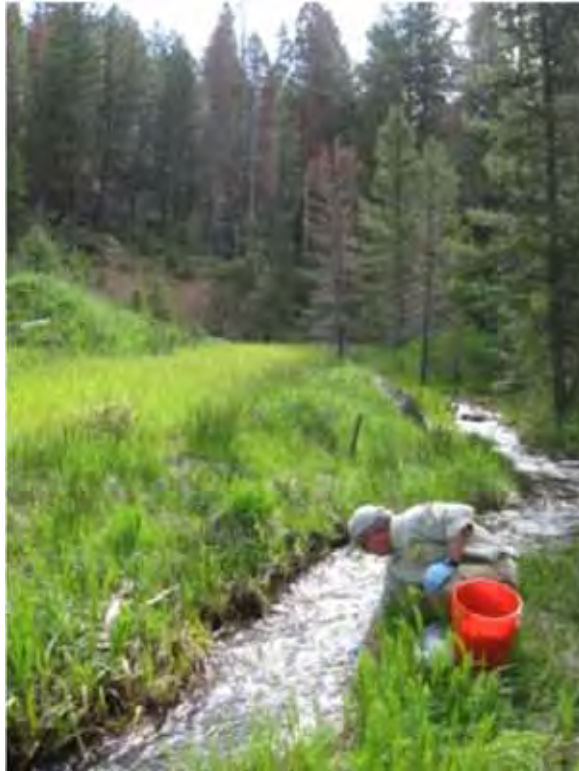
PHOTO 45

Chuck Baker (START) collecting surface water sample PMA_DC_SW_08_0611 from Douglas Creek, below the Granite Mountain/Bi-Metallic adit discharge. Looking east.

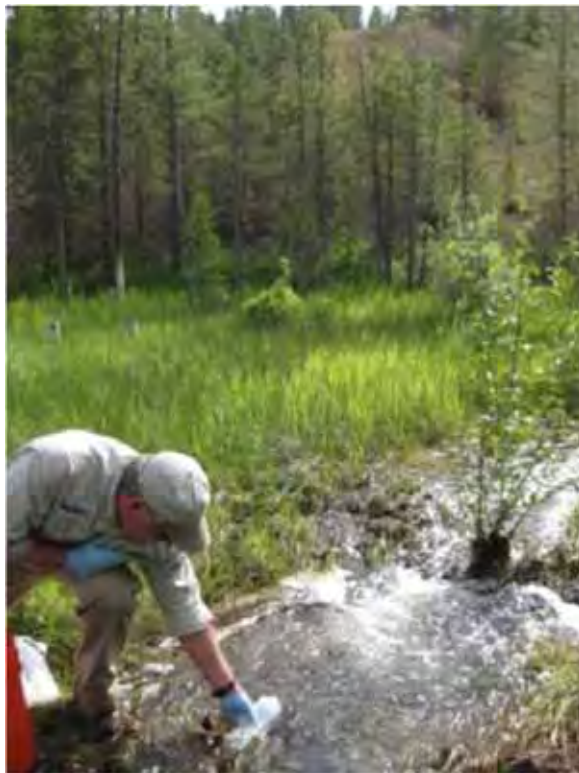
PHOTO 46

Chuck Baker (START) collecting surface water sample PMA_DC_SW_09_0611 from Douglas Creek, below the Douglas Creek waste rock pile. Note pile in background. Looking east.

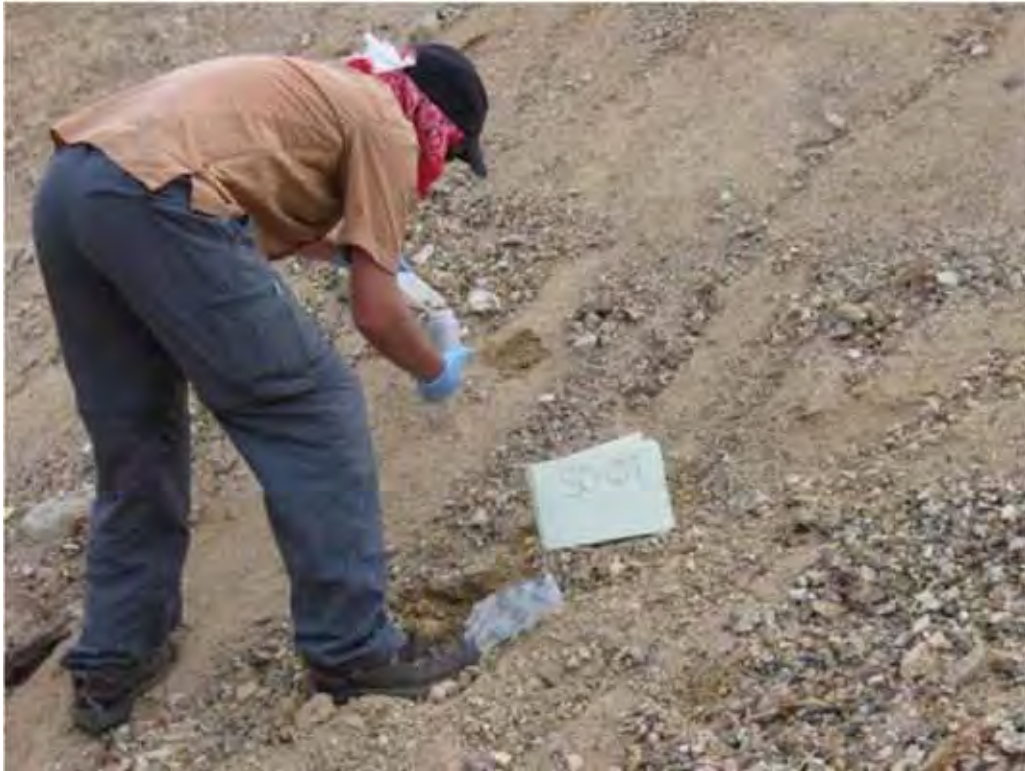
PHOTO 47

Jeff Miller (START) collecting source sample PMA_DC_SO_07_0611 from the Bi-Metallic/Old Red waste rock pile. Looking northeast.

Soil and sediment source samples were collected in accordance with procedures described in UOS TSOP 4.16, “Surface and Shallow Depth Soil Sampling” and UOS TSOP 4.17, “Sediment Sampling” (UOS 2005b), respectively. Disposable, dedicated plastic scoops were used for soil and sediment collection (Photo 47). All soil and sediment samples were collected as biased grab samples from the 0- to 2-foot depth interval. Discrete sample locations for soils were determined in the field based upon field screening with a field-portable Innov-X *Omega*TM XRF (Photo 28). Using the XRF, metals concentrations at a number of locations in an area of interest (e.g. the ‘east end’ of a tailings pile) were compared to known approximate background concentrations, and then a sample for laboratory analysis was collected from the location showing the highest average concentration of metals of interest (e.g. arsenic and lead).
