Bitterroot Temperature and Tributary Sediment Total Maximum Daily Loads and Framework Water Quality Improvement Plan

August 17, 2011

Water Quality Planning Bureau
Watershed Management Section

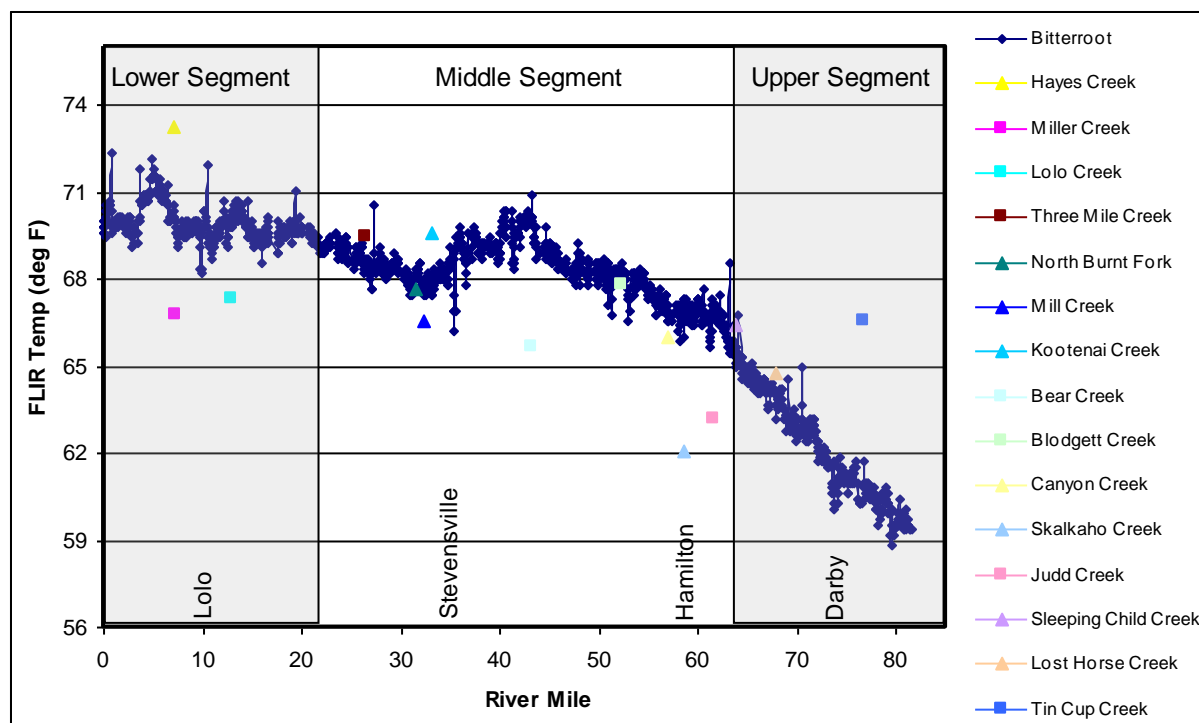
During the 2004 data logger deployment, a thermal infrared flight (TIR) was conducted along the Bitterroot River (**Attachment B**). The River heats significantly from the headwaters to near Victor. The TIR results include warm and cold water influences along with temperatures of the main channel (**Figure 6-2**). Identified warm water tributaries include Kootenai and Tin Cup creeks, while most other identified tributaries in this segment had temperatures similar to, or lower than, the Bitterroot River. Many tributaries were not identified in the TIR due to dry conditions or canopy overhang. The TIR report also provides a review of cold water springs entering the river, which cumulatively slightly reduce water temperatures near Stevensville.

Figure 6-2. Bitterroot River Thermal Infrared Assessment Results

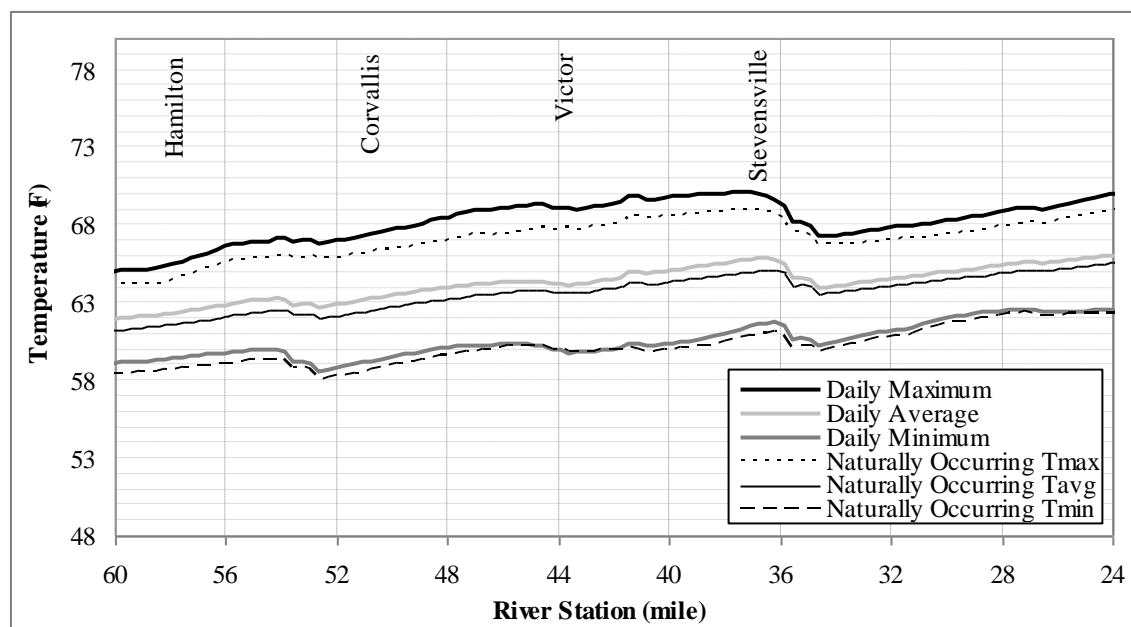
None of the shade, irrigation water use, irrigation water return flow, or tributary targets are fully met. Both the temperature modeling and target assessments indicate Montana's water temperature standards are not being met. Therefore, the segment is in need of a temperature TMDL.

Figure 6-4. Middle segment of the Bitterroot River simulated water temperatures for existing conditions and naturally occurring scenario

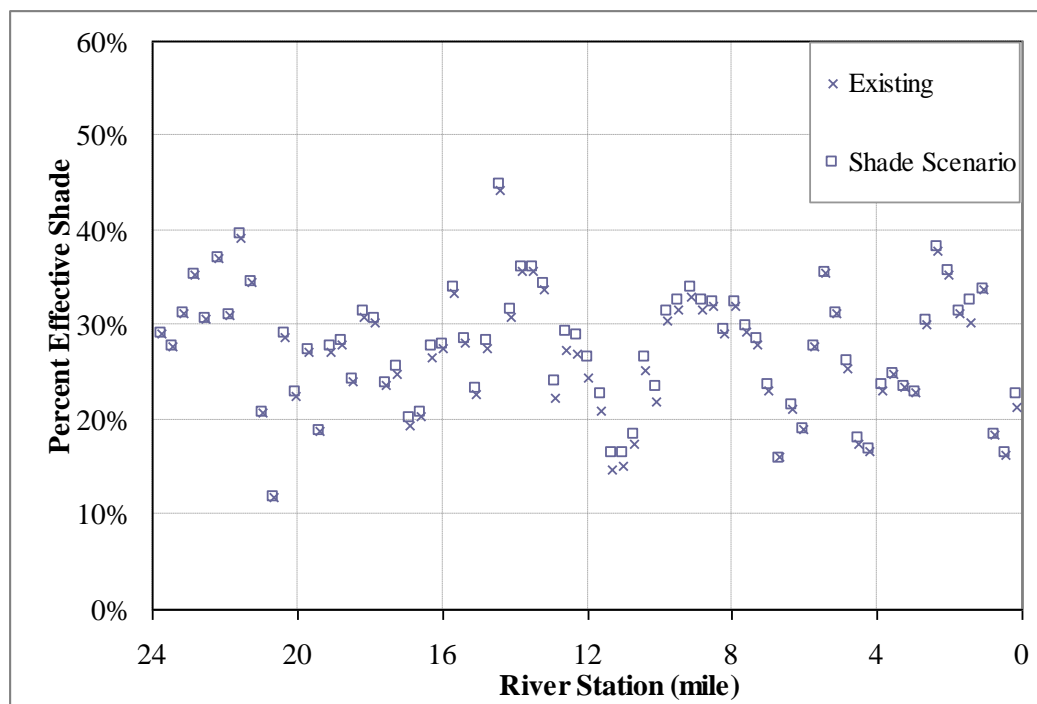
During 2007 DEQ conducted an assessment of riparian vegetation class, height, density, and offset using a stereoscope and aerial photos (**Attachment A**). Riparian effective shade was estimated along each 500-meter reach (**Figure 6-5**). Field verification was also conducted. The riparian canopy information was used to calibrate the shade components of the QUAL2K water quality temperature model.

Figure 6-5. Lower Bitterroot River Effective Shade Assessment Results

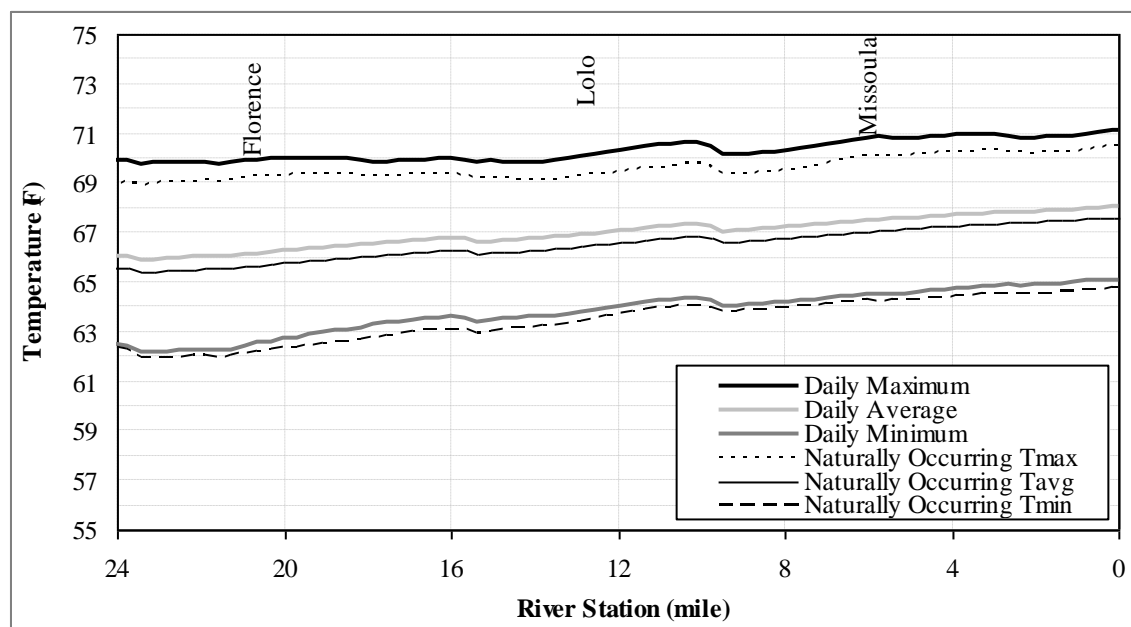
None of the shade, irrigation water use, irrigation water return flow, or tributary targets are fully met. Both the temperature modeling and target assessments indicate Montana's water temperature standards are not being met. Therefore, the segment is in need of a temperature TMDL.

Figure 6-6. Lower segment of Bitterroot River simulated water temperatures for existing conditions and naturally occurring scenario

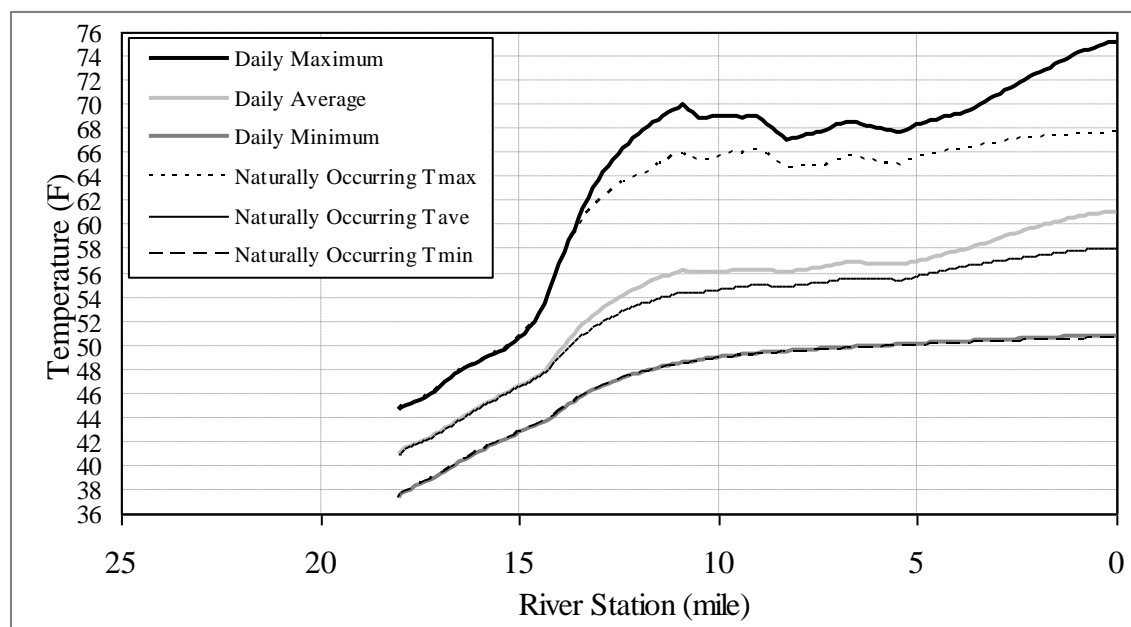
None of the targets have been attained. Both the modeling and temperature influencing target assessment approaches indicate Montana's water temperature standards are not being met. Therefore, Miller Creek is in need of a temperature TMDL.

Figure 6-8. Miller Creek simulated water temperatures for existing conditions and naturally occurring scenario.

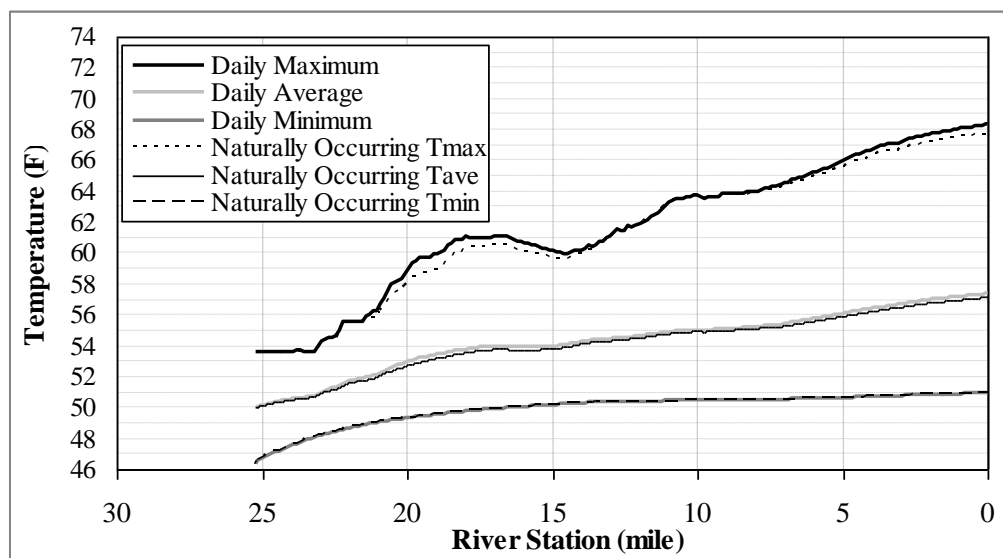
None of the targets have been attained. Both the modeling and temperature influencing target assessment approaches indicate Montana’s water temperature standards are not being met. Therefore, Sleeping Child Creek is in need of a temperature TMDL.

Figure 6-10. Sleeping Child Creek simulated water temperatures for existing conditions and naturally occurring scenario.

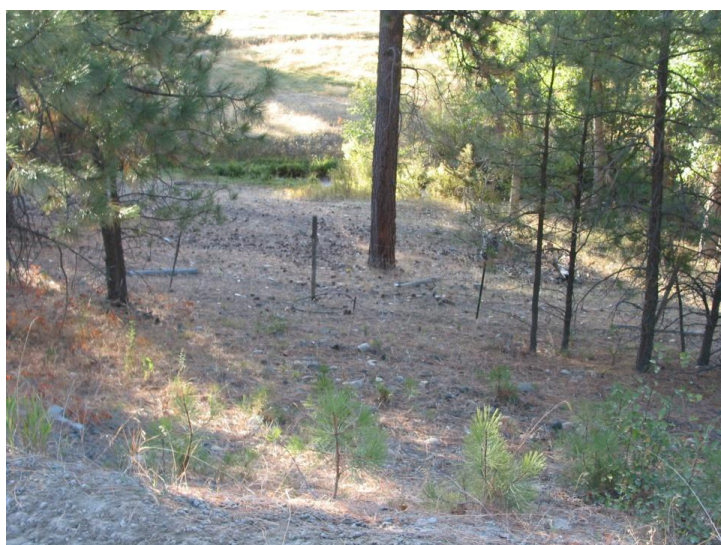
Figures G3-2 and G3-3 show the differences noted in the field between parallel sites with small and large buffer lengths. Parallel sites with buffer lengths greater than 20 feet have a greater filtering capacity and potential for sediment removal.

Figure G3-2. Parallel Segment BRLC-F161P – Average Buffer Distance 75 feet

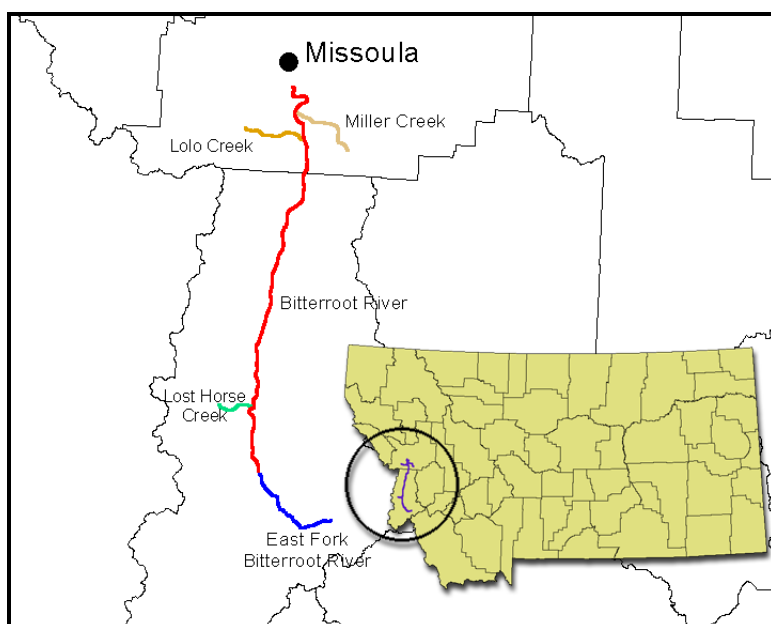
Figure 1. Project area overview.

During the summer of 2004, Infrared Image Solutions, Inc. of Hermiston, OR was contracted to collect multi-spectral imagery on the Bitterroot River and selected tributaries near Missoula, Montana (Figure 1).

The purpose of the project was to collect continuous temperature measurements along the entire project area and to identify areas of cool water inputs to the stream. A morning flight and an evening flight were conducted on each stream to document diurnal fluctuations. Project data consists of digital imagery in thermal infrared (FLIR), color-infrared (CIR) and normal color videography.

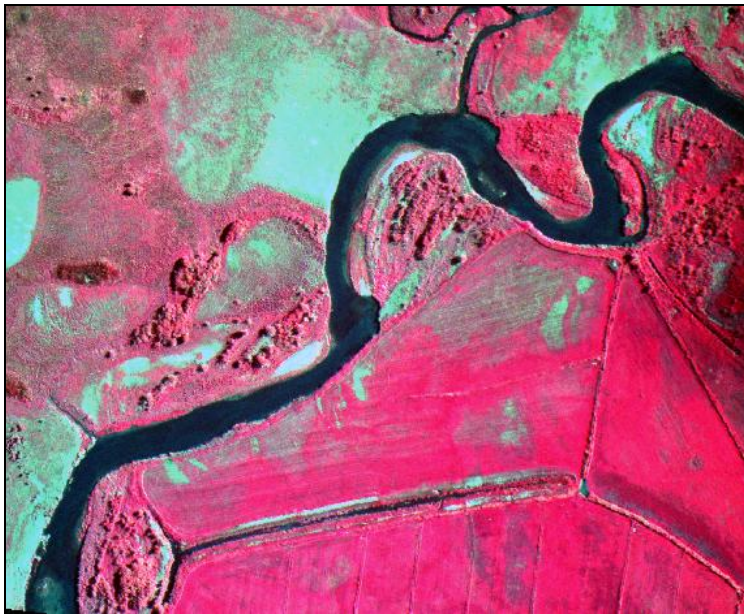
Figure 4. CIR Image on the Bitterroot.

Color-infrared images were collected from a fixed-wing airplane on August 2nd and 4th, 2004. The CIR camera has a much higher resolution than the FLIR camera and therefore can be flown from a higher altitude. The higher altitude affords a wider field of view while still maintaining pixel resolutions of less than a meter. The CIR images put the watershed into context by showing the adjacent terrain and associated land use practices (Figure 3 and 4).

CIR images were captured at a rate of 1 image every 5 seconds. This rate yielded an endlap of approximately 60%. A shapefile of the CIR image locations was created to facilitate comparison of FLIR and CIR images. Additionally, the CIRs were geo-referenced and put in mosaic at a 2 meter resolution to facilitate comparison of temperature trends and land use practices over a greater area.
