Grave Creek Watershed Water Quality and Habitat Restoration Plan and Sediment Total Maximum Daily Loads

March 2005

ERRATA SHEET FOR THE GRAVE CREEK WATERSHED WATER QUALITY AND HABITAT RESTORATION PLAN AND SEDIMENT TOTAL MAXIMUM DAILY LOADS

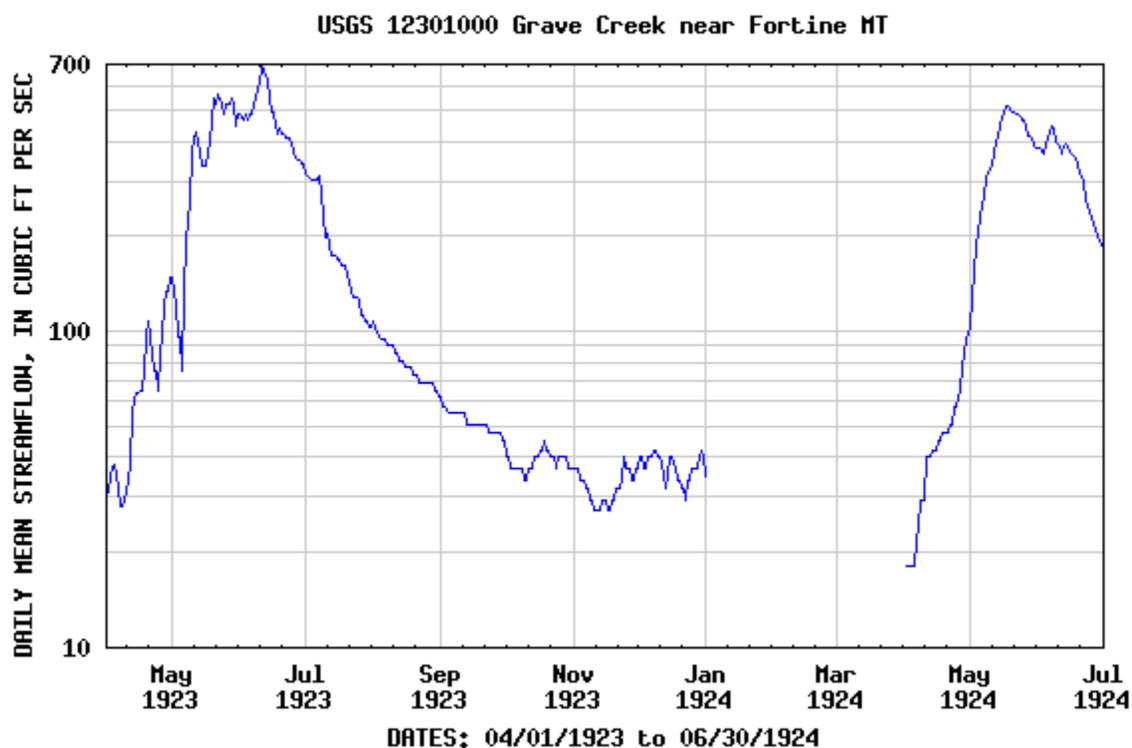
Figure 2-1: Grave Creek Hydrograph for April 1, 1923 through June 30, 1924 (Data Missing from January through April 1, 1924).

The United States Geological Survey (USGS) maintained a streamflow gaging station on Grave Creek from April 1, 1923 through June 30, 1924 (Figure 2-1). The limited period of records is not sufficient to conduct standard flood frequency analyses. The Montana Fish Wildlife and Parks (FWP) has also collected discrete flow data in lower Grave Creek, but this data is also insufficient for conducting a flood frequency analyses.

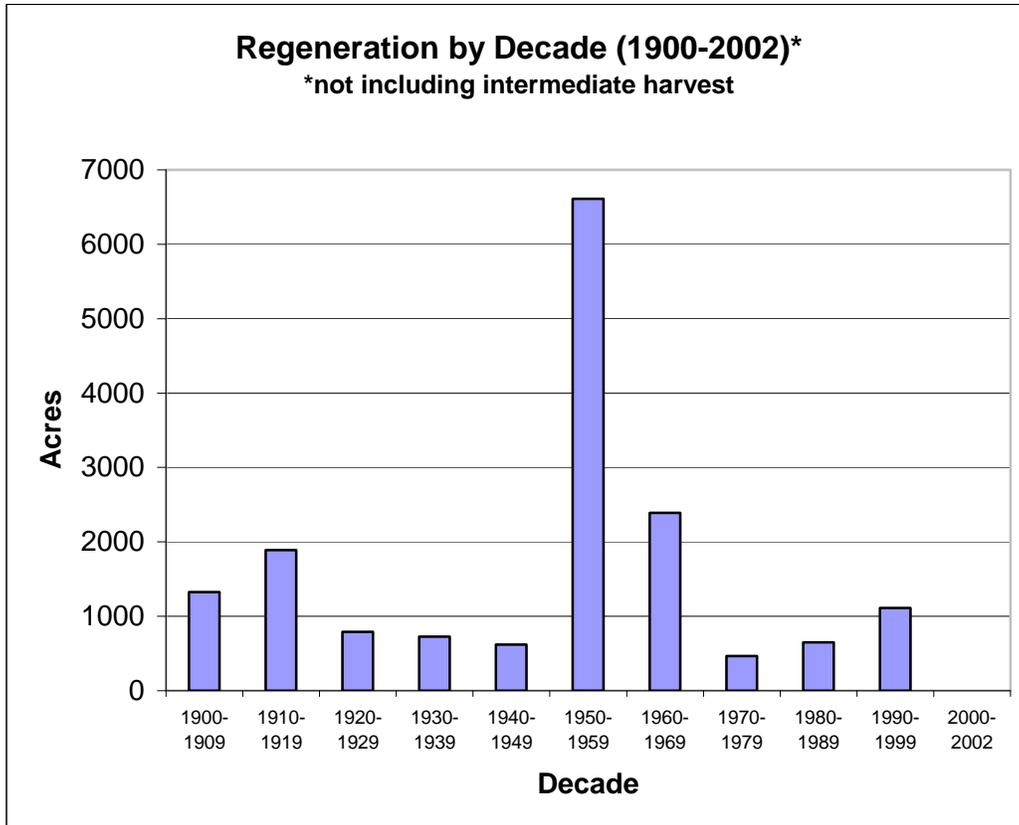
Figure 2-2: Acres of Regenerating Disturbance by Decade Over the 20th Century. The peak in the 1950s and 1960s is from spruce beetle logging; the higher figure from the 1990s is almost entirely attributable to the 1988 fire in Blue Sky drainage (1,040 acres burned). (Only US Forest Service ownership calculated, based on stand database query of year origin per decade) (USFS, 2002).

The management of the spruce bark beetle epidemic changed the character of the entire Grave Creek basin. In the 1950s and 1960s, large-scale logging was initiated in response to the spruce bark beetle infestation that affected northwestern Montana and Idaho. A timber salvage program was implemented to remove decaying trees and portions of the forest expected to succumb to the beetle infestation (USFS, 2002). Large (dominant trees 15 inch to 21 inch DBH) and very large (dominant trees >21 inch DBH) Engelmann spruce (*Picea engelmannii*) and alpine fir (*Abies lasiocarpa*) were removed from the headwaters of most of the primary tributaries in the watershed (Figure 2-2).

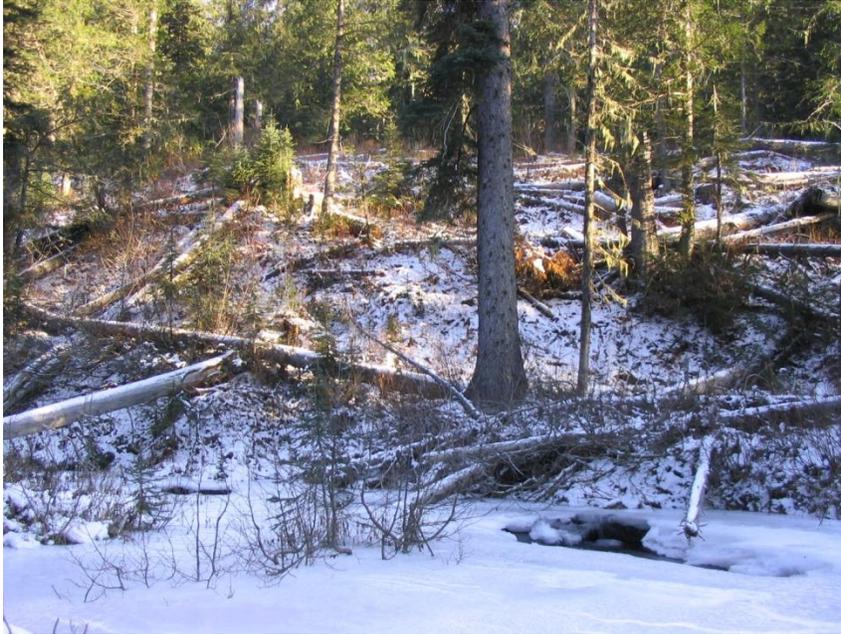
Photo 1: Clarence Creek – Riparian Harvest

may not have occurred in the portion of the stand that is within the riparian buffer as discussed in Appendix A. Nevertheless, harvest did occur in riparian areas as noted later in the assessment of mass wasting events in Section 6.0 and as shown by Photos 1 and 2.

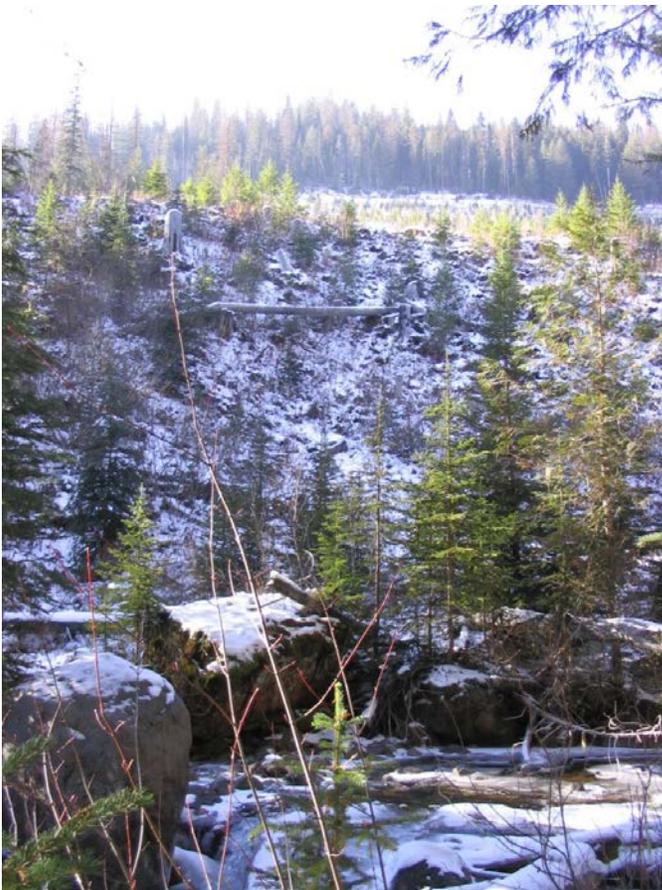
Photo 2: Stahl Creek - Riparian Harvest with No Buffer

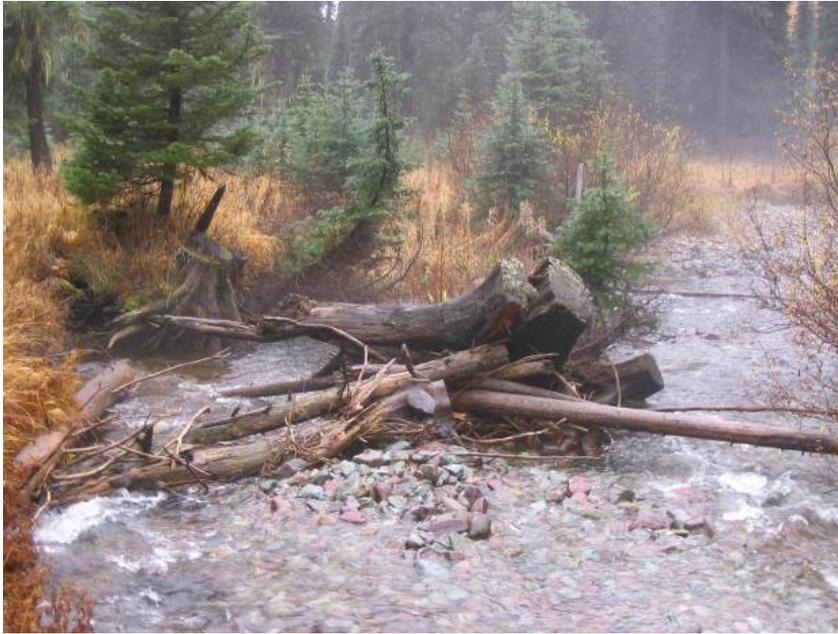
Photo 3: Main Stem Middle - Cut logs In-Stream - Marginal Habitat

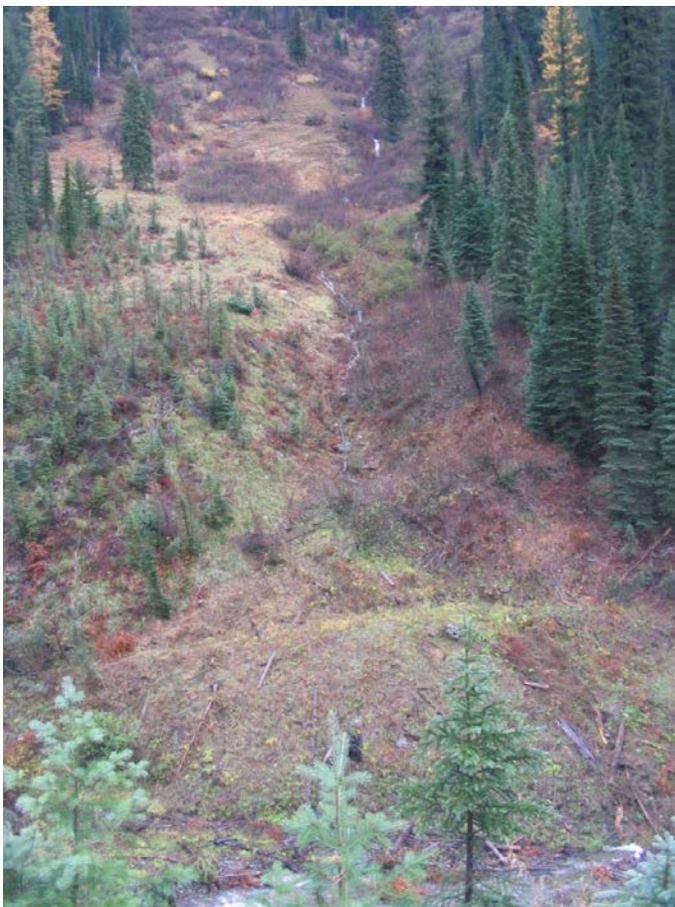
Photo 4: Main Stem Upper - Typical Avalanche Chute

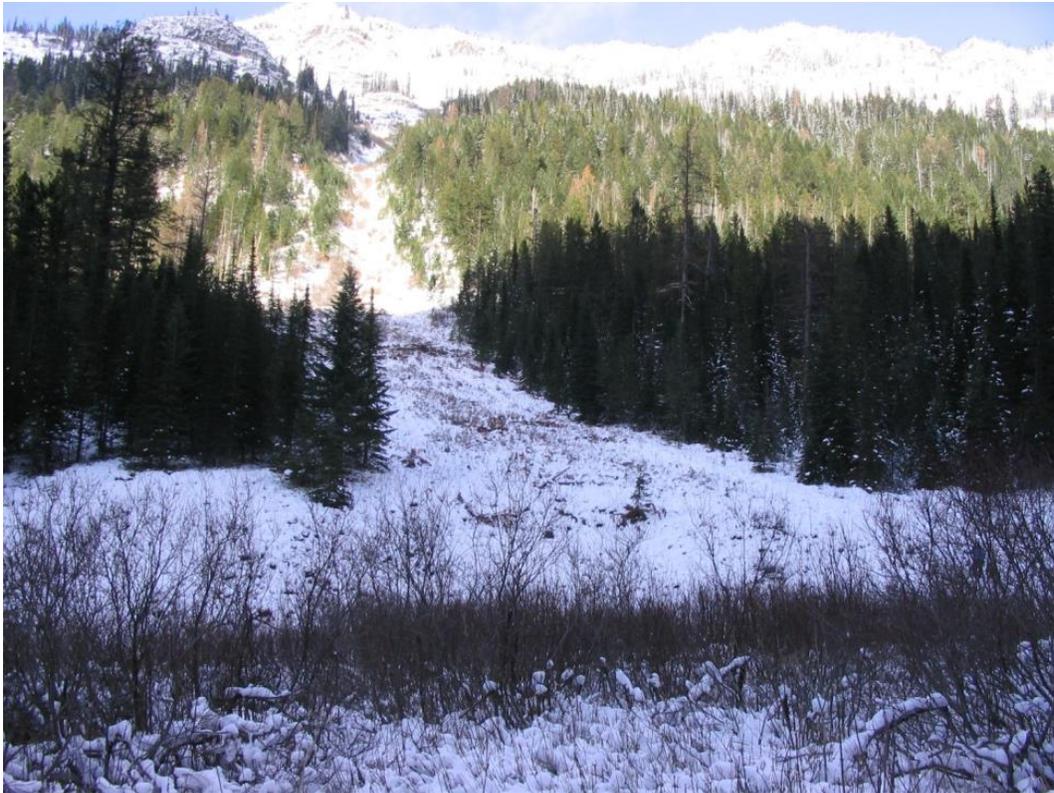
Photo 5: Lewis - Typical Natural Avalanche Chute

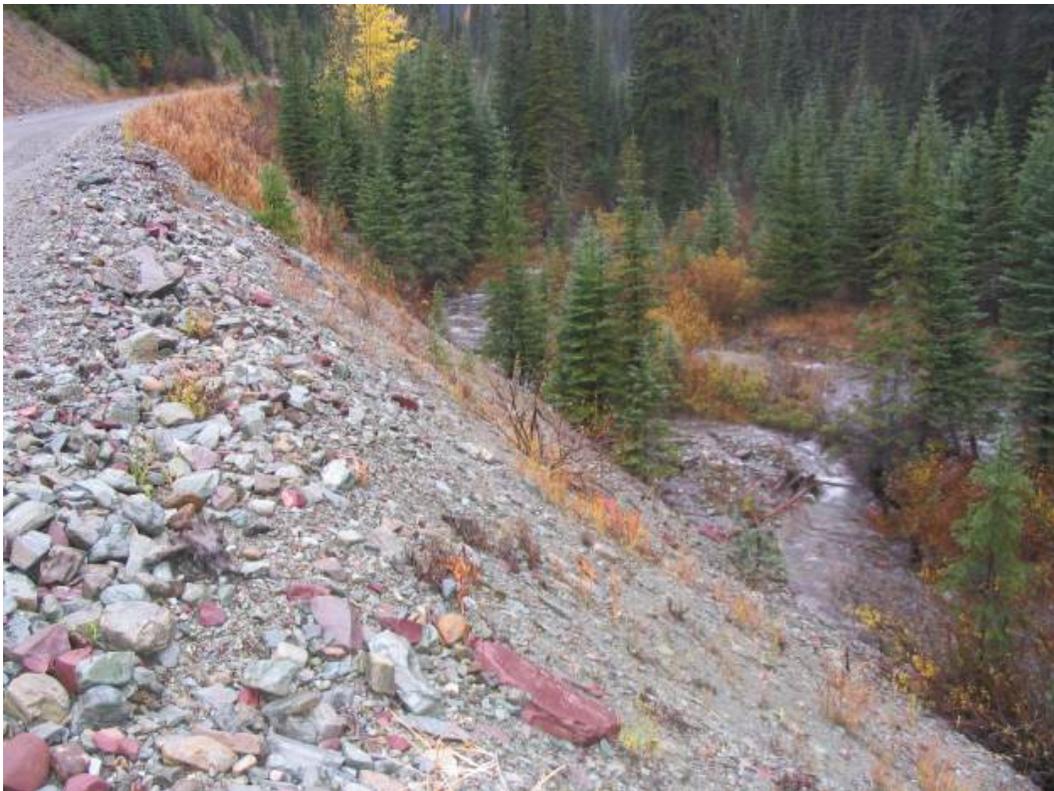
Photo 6: Main Stem Upper - Road Fill Road Encroachment

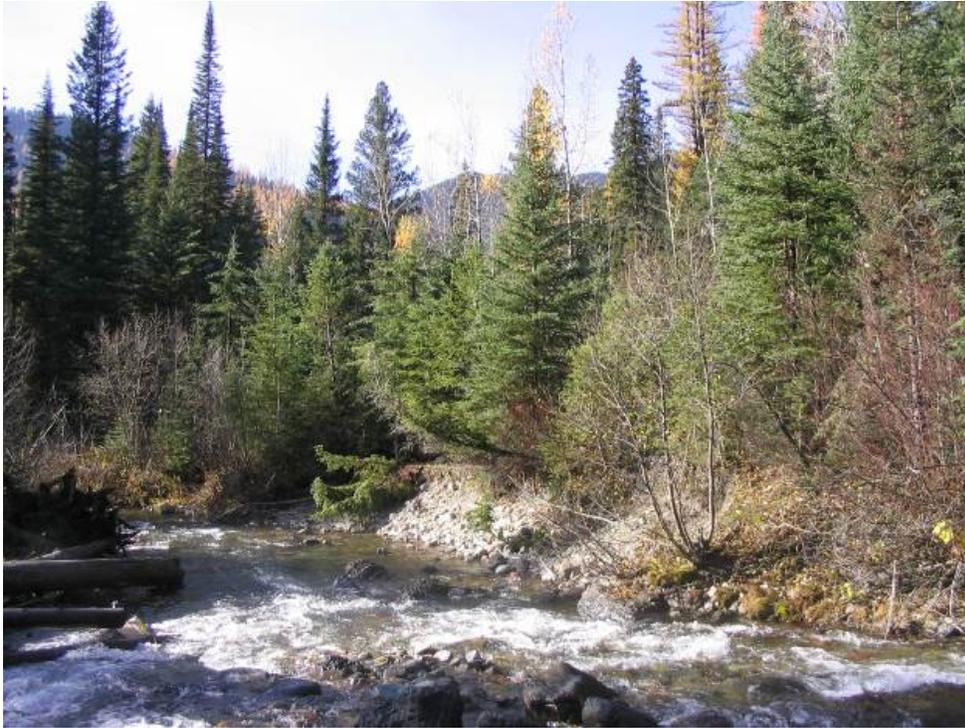
Photo 7: Main Stem Upper - Bank Erosion

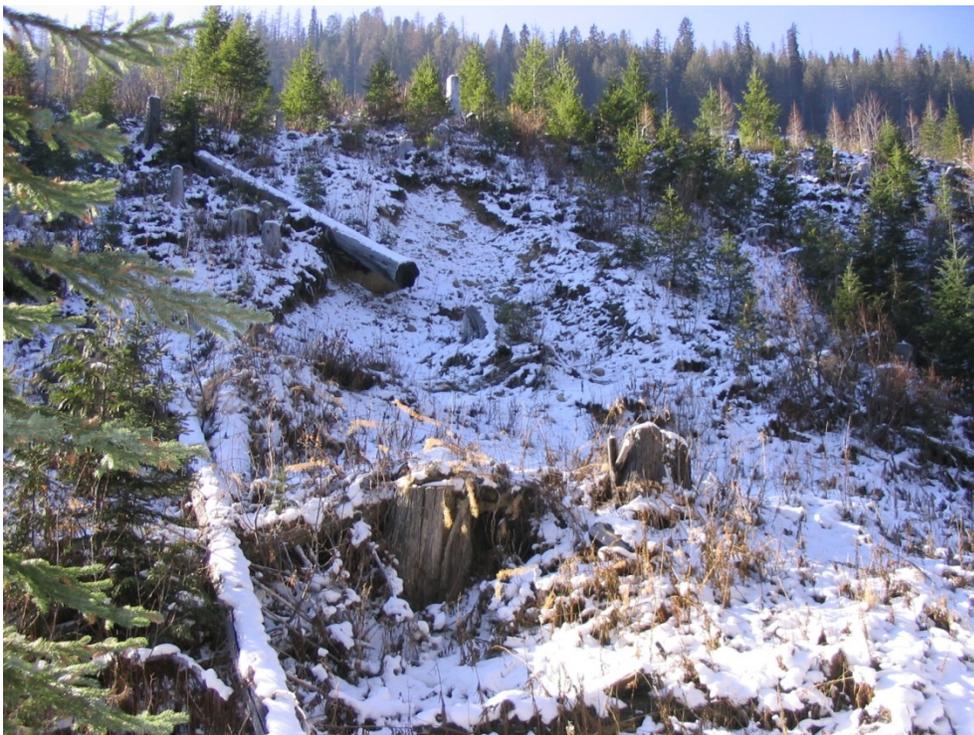
Photo 8: Stahl Creek - Riparian Harvest with No Buffer and with Mass Wasting

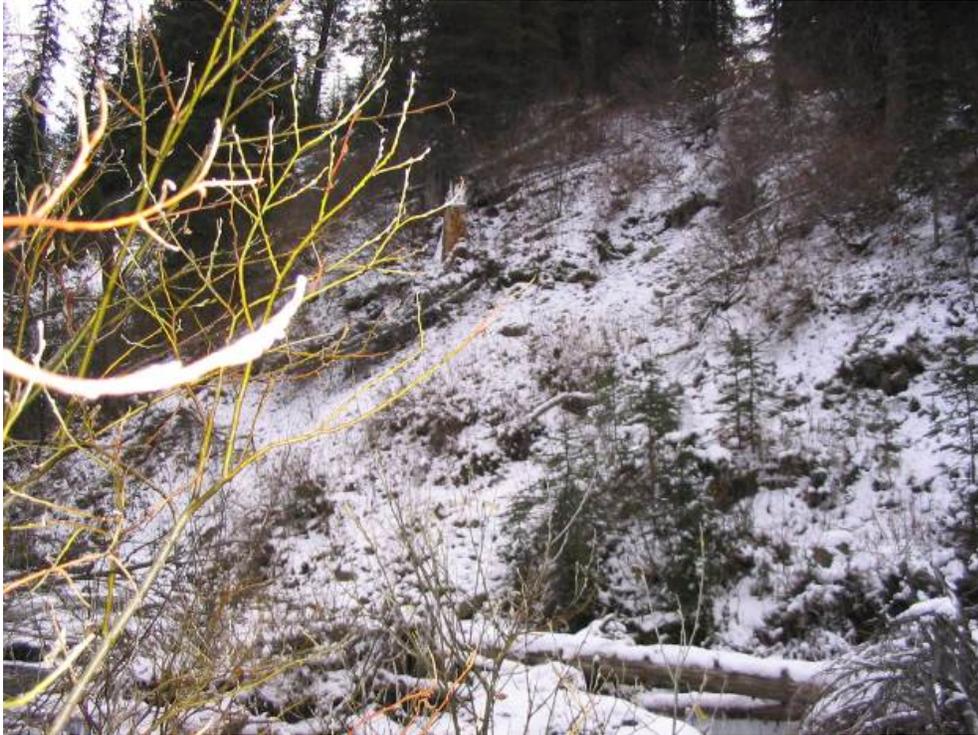
Photo 9: Blue Sky - Riparian Modification and Mass Wasting

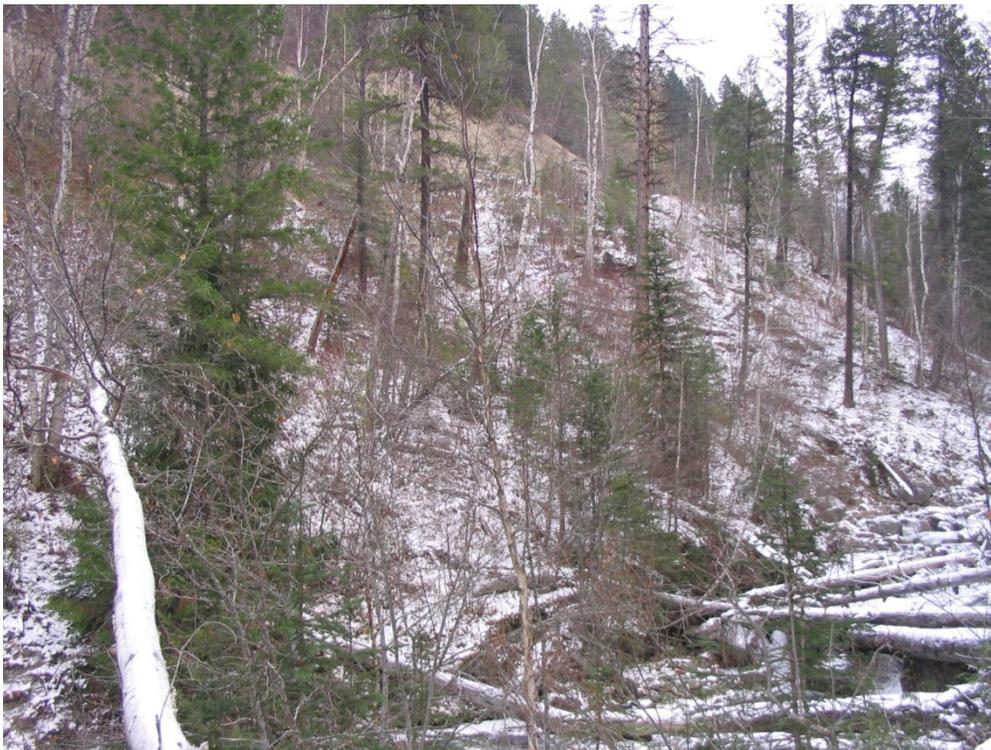
Photo 10: Williams - Road Encroachment and Riparian Harvest with Mass Wasting

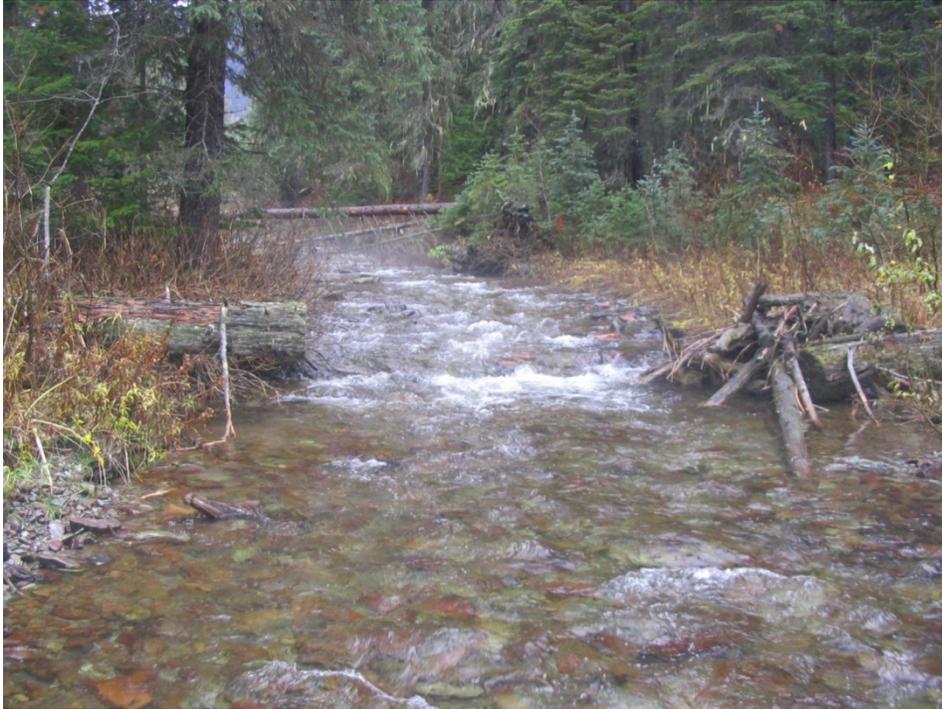
Photo 11: Main Stem Upper - Example of In-Stream LWD Removal

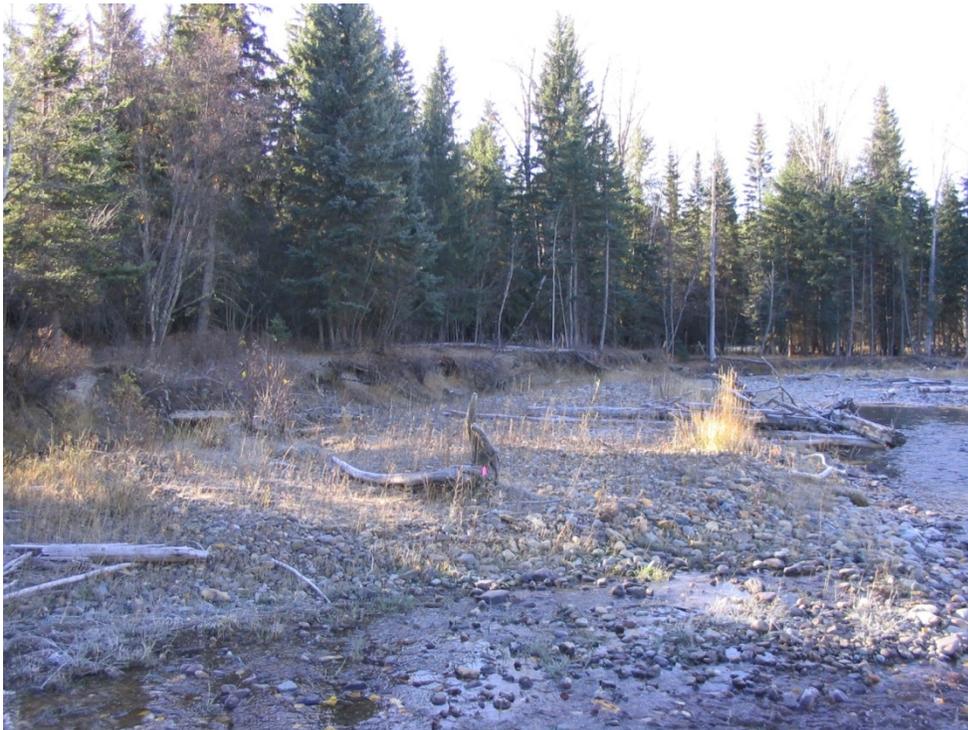
Photo 12: Main Stem Lower Below Canyon - Bank Erosion and Evidence of Aggradation

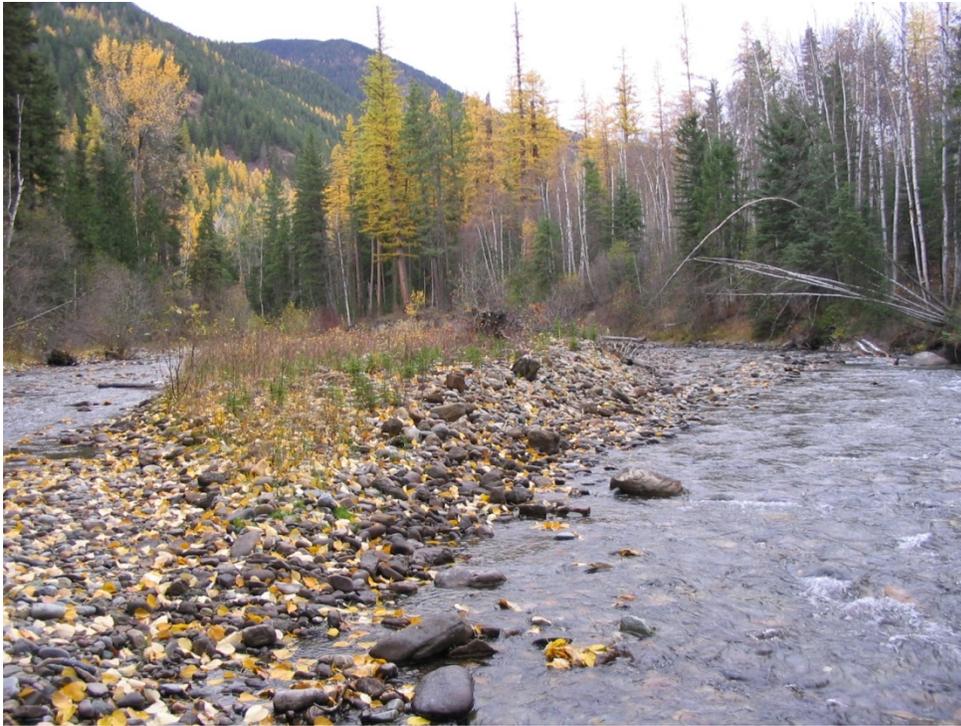
Photo 13: Main Stem Lower Above Canyon – Evidence of Aggradation

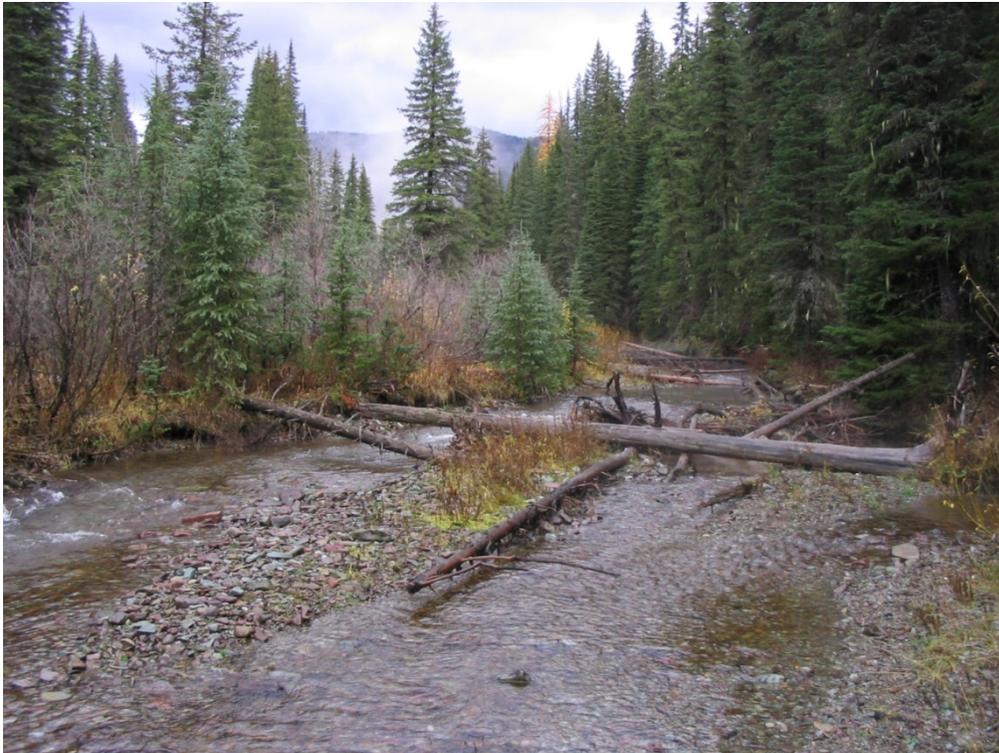
Photo 15: Main Stem Upper – Mid-Channel Bar, Evidence of Possible Aggradation

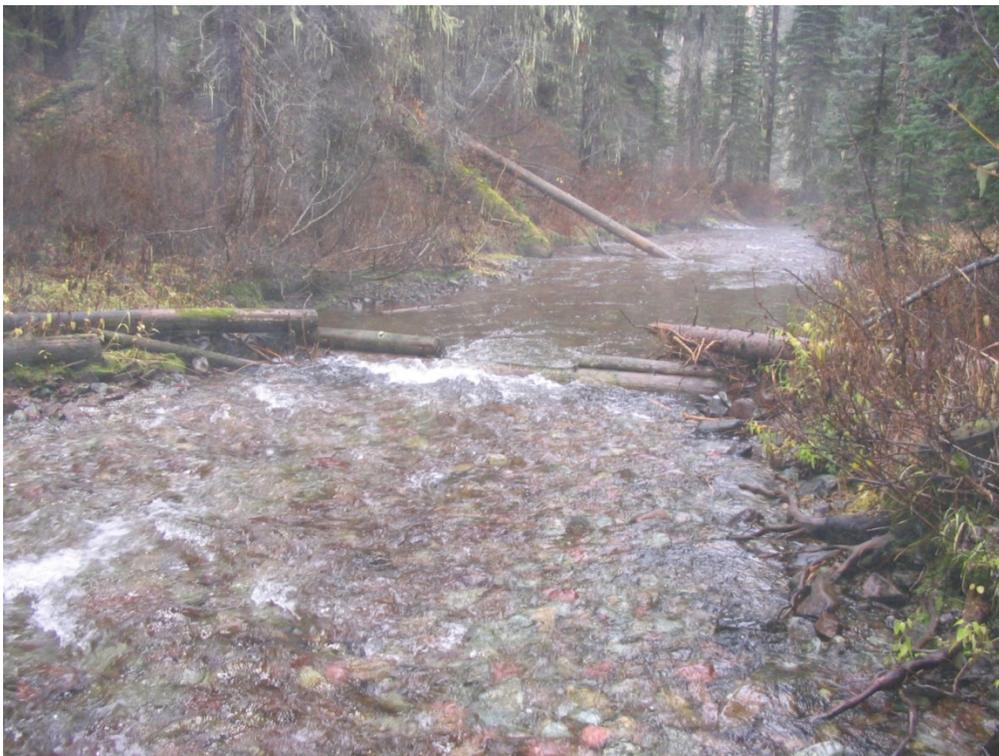
Photo 16: Main Stem Upper - Check Dam

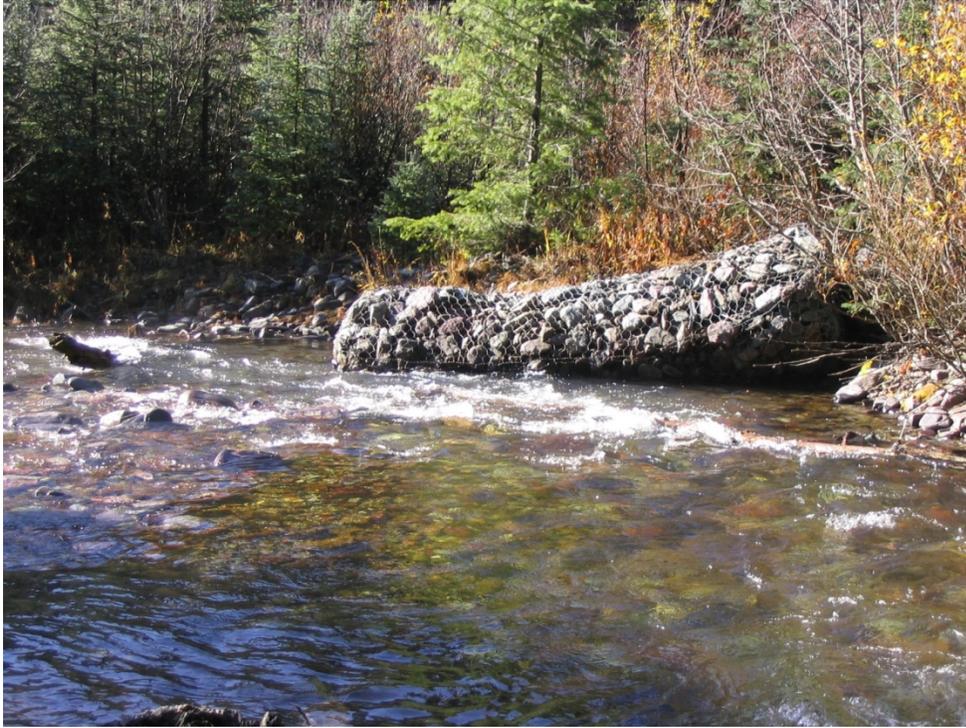
Photo 17: Main Stem Upper - Gabion for Fill Slope Protection

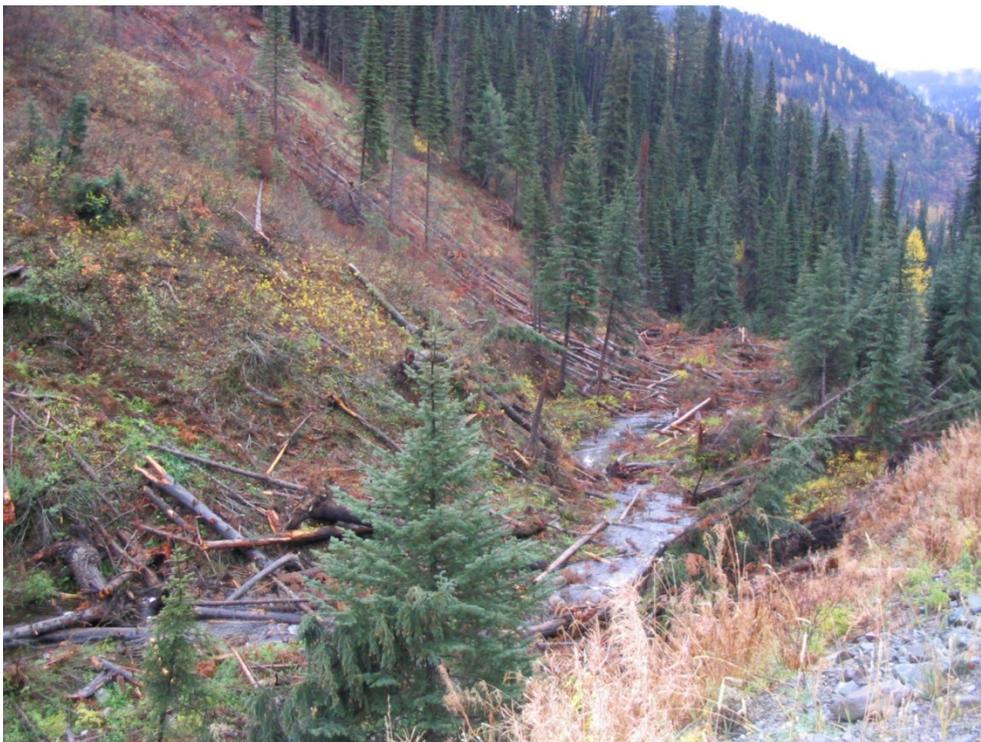
Photo 18: Main Stem Upper - Avalanche Slide - Woody Debris Contribution

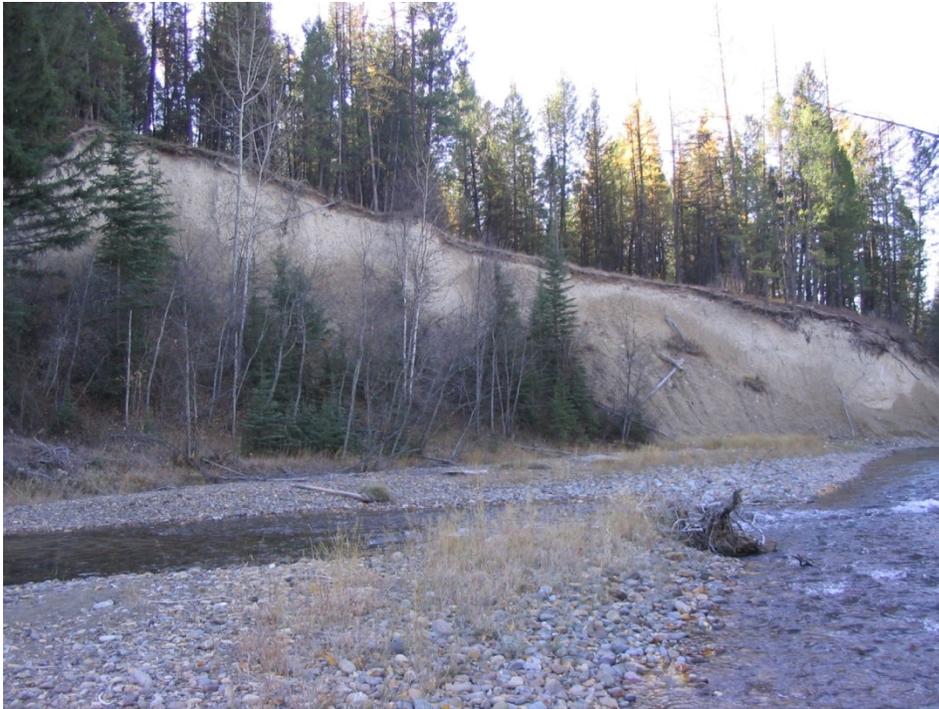
Photo 19: Main Stem Lower Below Canyon – Terrace Erosion

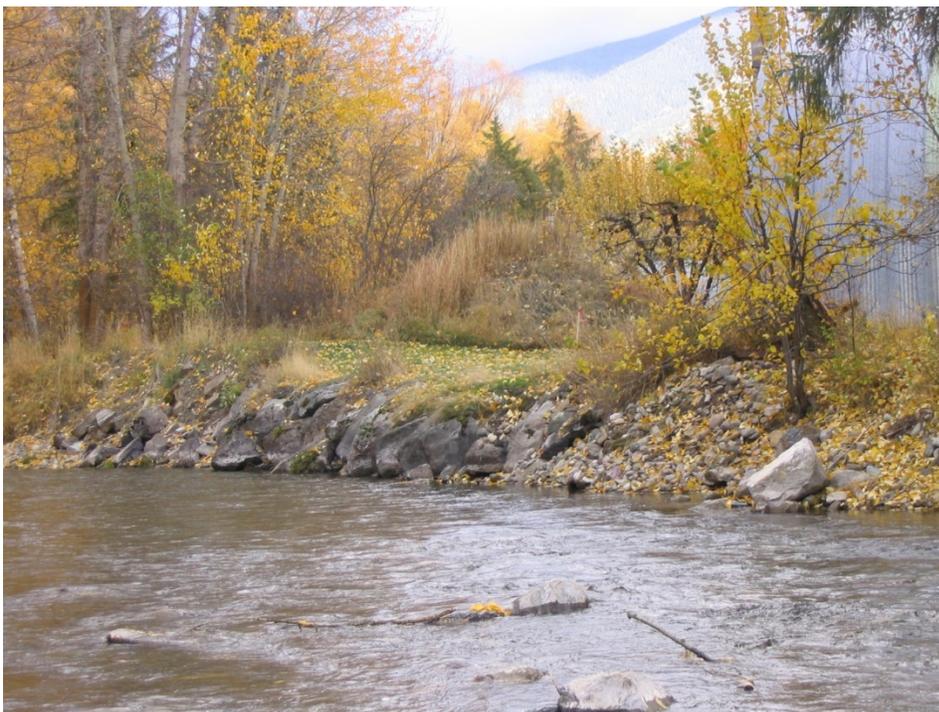
Photo 20: Main Stem Lower - Bank Armoring

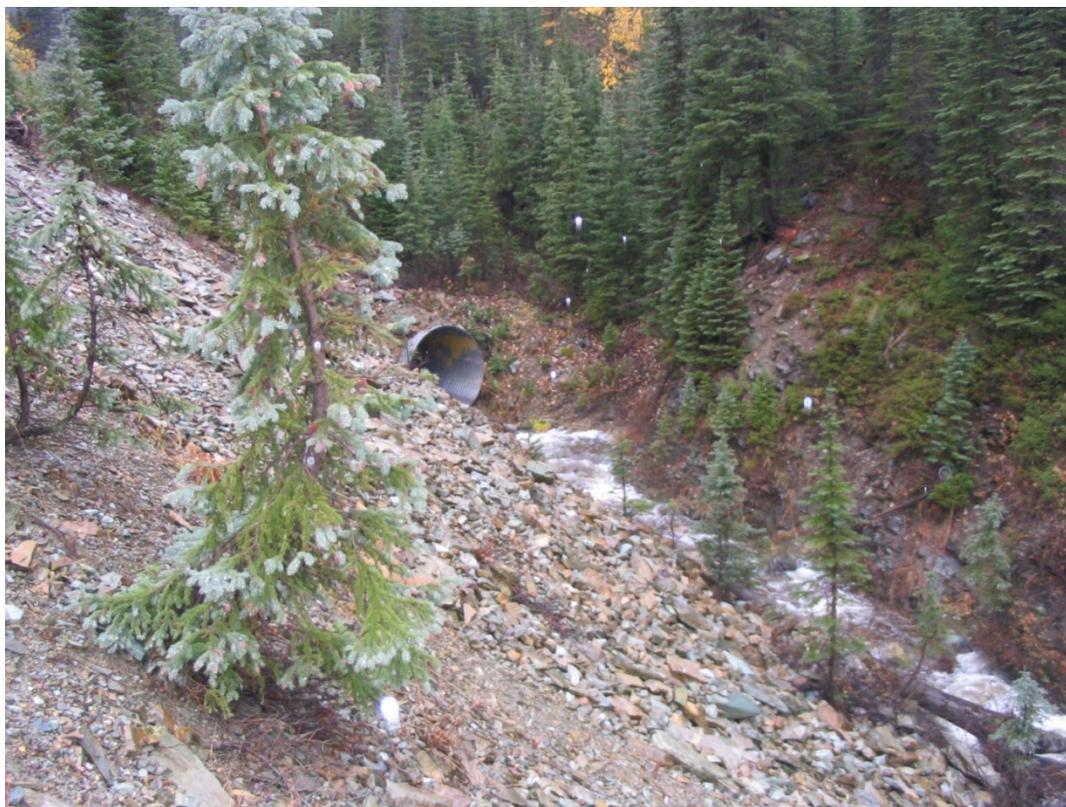
Photo 21: Fish Passage Barrier on Foundation Creek

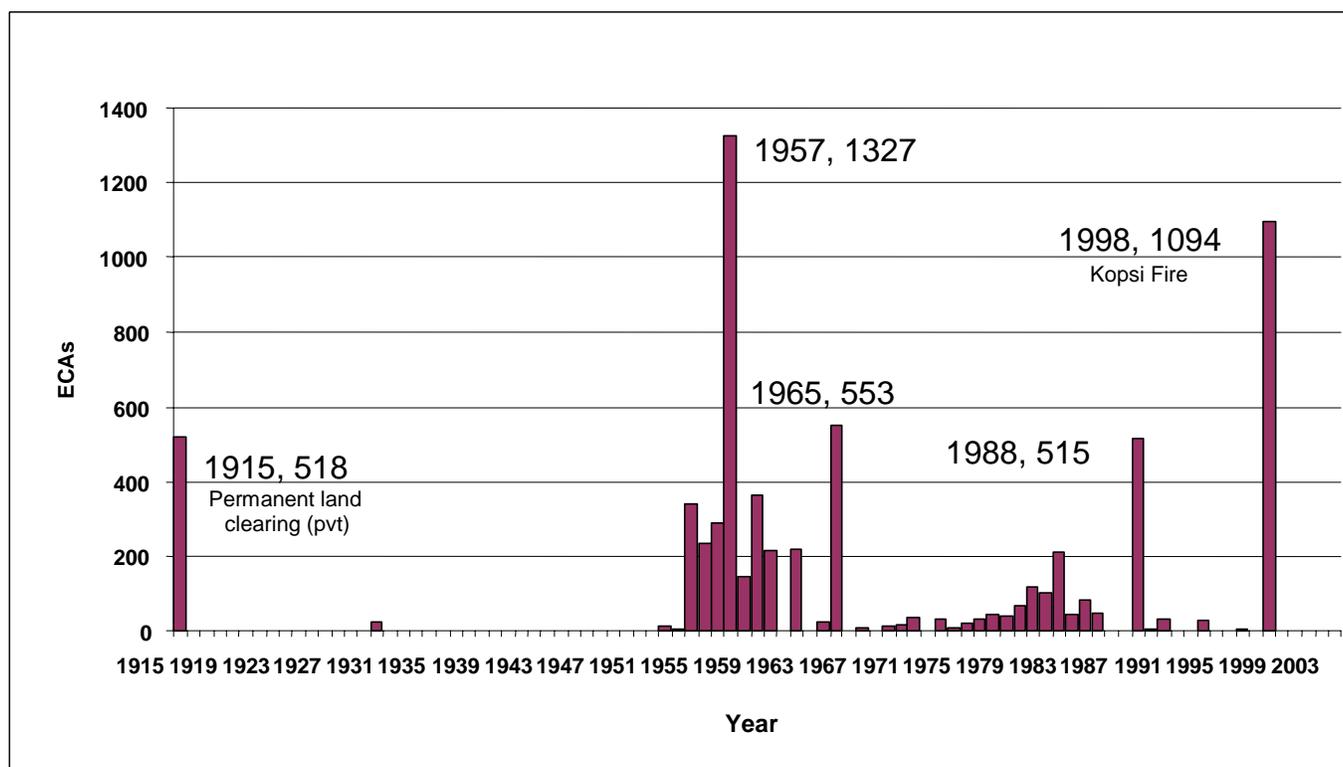
Figure C.3: Summary of ECA in Grave Creek Watershed. Does not include timber harvest on privately owned land or land clearing on privately owned land after early twentieth-century development.

Figure C-3 provides a historical context for the equivalent clearcut acreage. Table C-8 summarizes the results of the equivalent clearcut area (ECA) and peak flow increase (PFI) analyses for tributary watersheds and all of the Grave Creek Watershed. The road modeling portion of the ECA is based on 2003 conditions. Watershed ECA from road and vegetation changes, either from historic harvest or the more recent Kopsi Fire, was modeled at 5 percent, with vegetation change constituting 72 percent of the cumulative ECA. Total watershed PFI was 2.5 percent. These existing PFI values linked to timber harvest activities in all watersheds are not considered very high and are likely not of significant concern. When the Kopsi Fire ECA results are removed, the harvest related PFI in the Blue Sky drainage would be within the range of the other watersheds (personal communication with Julie Gott, February 2005).

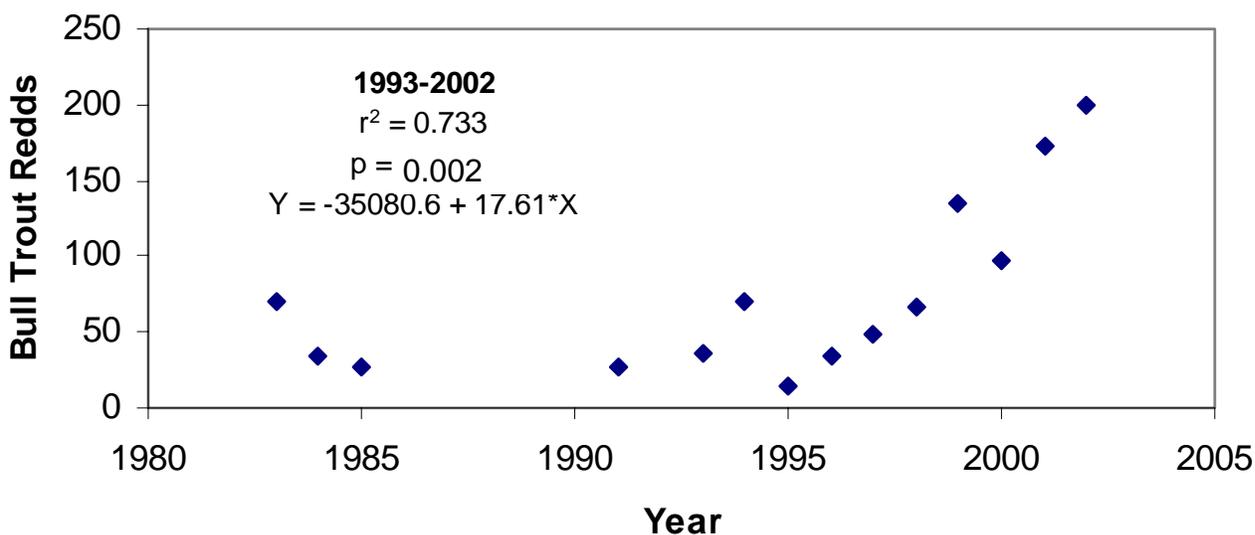
Figure D-1: Bull Trout Spawning Redd Counts in the Grave Creek Drainage Between 1983 and 2003.

Long-term monitoring of bull trout redd numbers can be an important and useful tool to assess bull trout population trends (Rieman and McIntyre, 1993). Based on annual redd counts in Grave Creek, and spring gill net catch rates in Koocanusa Reservoir, adult bull trout abundance within Koocanusa Reservoir has increased over the past 8 to 10 years. Based on spawning redd counts in Grave Creek and a ratio of 1.55 fish per redd (Baxter and Westover, 2000), approximately 380 spawning bull trout may have used Grave Creek in 2003. These data indicate that most of the criteria established by the USFWS

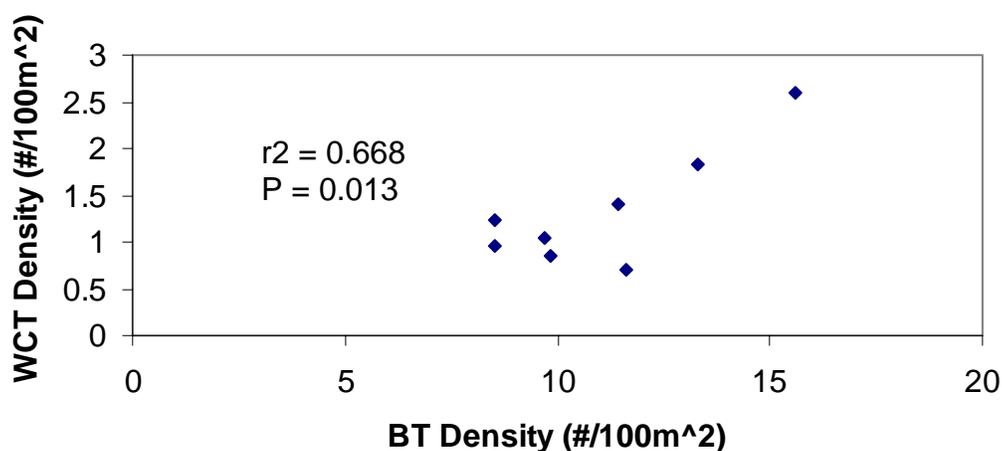
Figure D-2: Comparison of Juvenile Bull Trout and Westslope Cutthroat Trout Densities for the Main Stem Grave Creek Sampling Reach Near Blue Sky Creek.

The juvenile bull trout and juvenile WCT data suggest that juvenile bull trout abundance is positively and significantly correlated ($r^2 = 0.668$, $p\text{-value} = 0.013$) to juvenile WCT densities in the survey reach (Figure D-2) (MFWP, unpublished data).

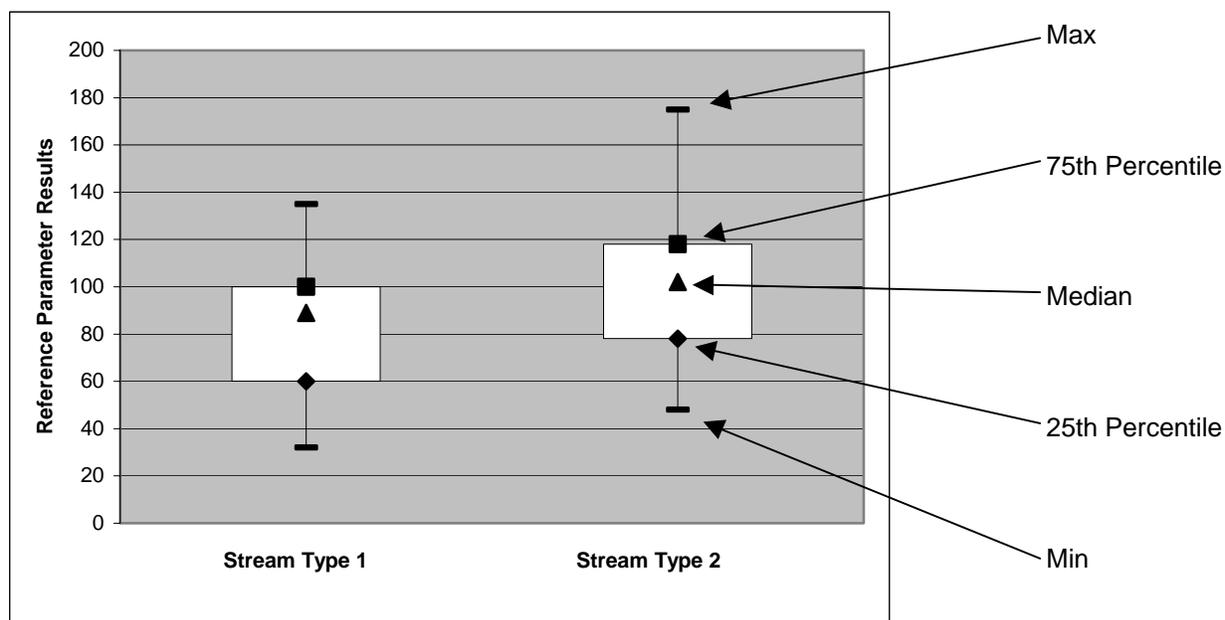
Figure E-1: Boxplot Example for Reference Data.

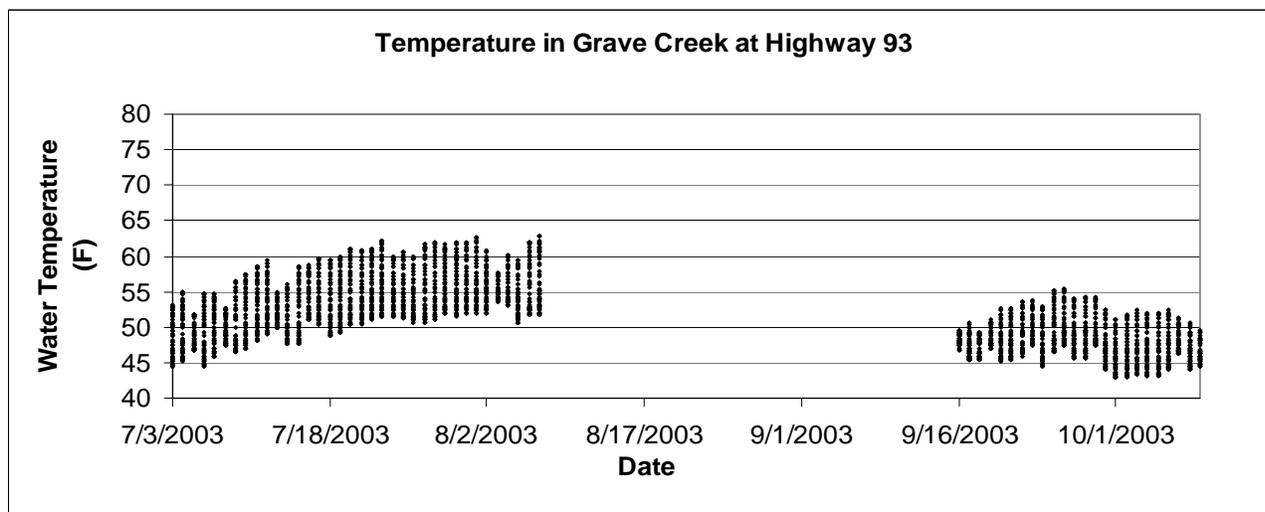
Figure G-1. Daily Temperature of Grave Creek at Highway 93. Temperature Recorded at 30-Minute Intervals. (MDEQ Unpublished Data).

The USFS installed a DEQ temperature logger in Grave Creek near Highway 93. Temperature was recorded daily at 30-minute intervals from the beginning of July 2003 through the beginning of October 2003. From August 8 to September 15, data more closely reflect air temperature and is therefore not included here. It is possible that the stream either went dry or some other problem occurred. Before and after this erroneous timeframe, temperatures in Figure G-1 are considered representative of actual stream temperatures at that location.

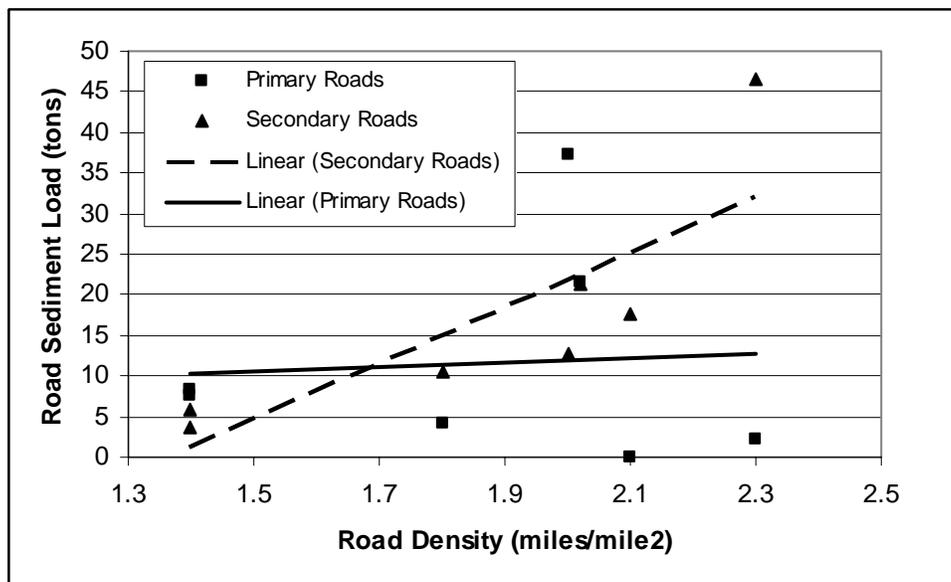
Figure I-1: Relationship between road density and sediment load from road surface erosion.

Road density provides an indication of sediment loading, with location or distance from a stream and road condition influencing the amount of sediment load likely to reach a stream network. Figure I-1 demonstrates that for secondary roads in the Grave Creek watershed (which generally lack BMPs) road surface sediment load increases more rapidly with increasing road density than for primary roads. Most of the sediment is contributed from secondary roads, which generally lack adequate BMPs such as cross drains and graveled, paved, or chip-sealed surface. BMP implementation, which is more common on primary roads, partially offsets sediment load increase from increasing road density.

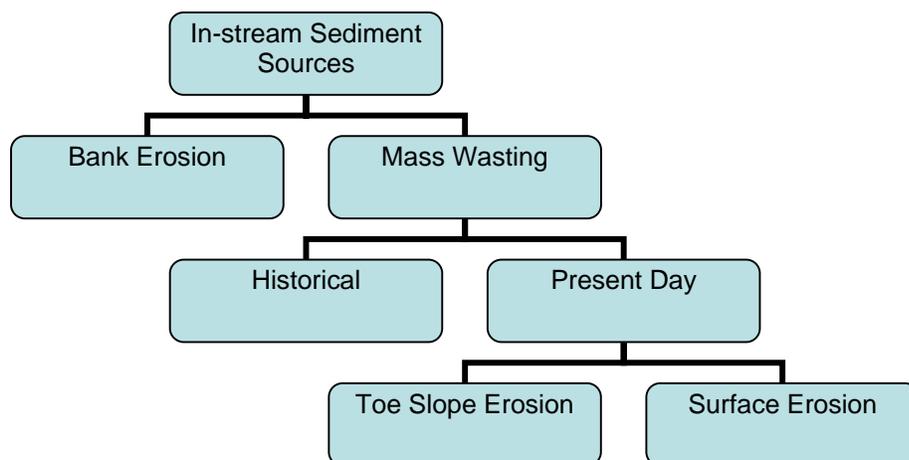
Figure J-1: Hierarchical Organization of In-Stream Sediment Sources.

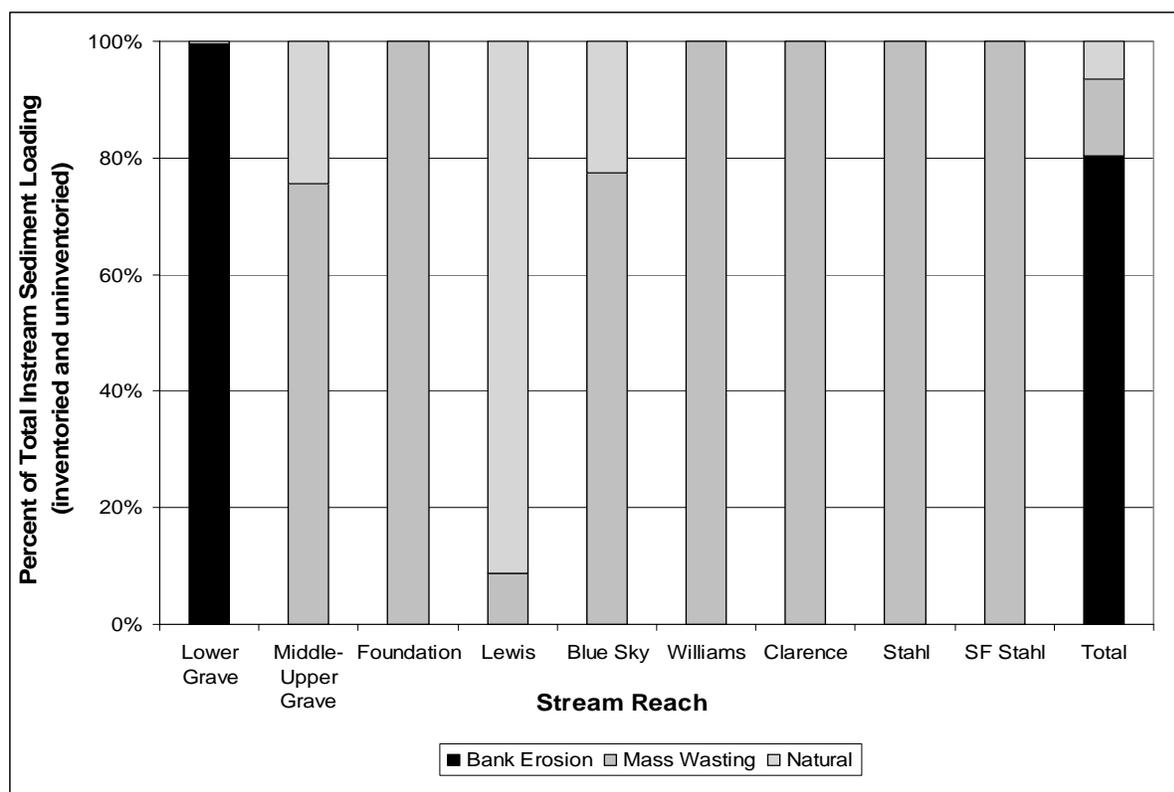
Figure J-4: Histogram of Total In-Stream Sediment Load (Mass Wasting and Bank Erosion) for Inventoried Segments and Extrapolated to Uninventoried Segments (Does Not Include Small Extrapolated Natural Background Loads of about 3 to 5% for Stahl, S. Fk. Stahl, Clarence and Foundation, and about 5 to 10% for Williams).
