Grave Creek Watershed Water Quality and Habitat Restoration Plan and Sediment Total Maximum Daily Loads

March 2005

ERRATA SHEET FOR THE GRAVE CREEK WATERSHED WATER QUALITY AND HABITAT RESTORATION PLAN AND SEDIMENT TOTAL MAXIMUM DAILY LOADS

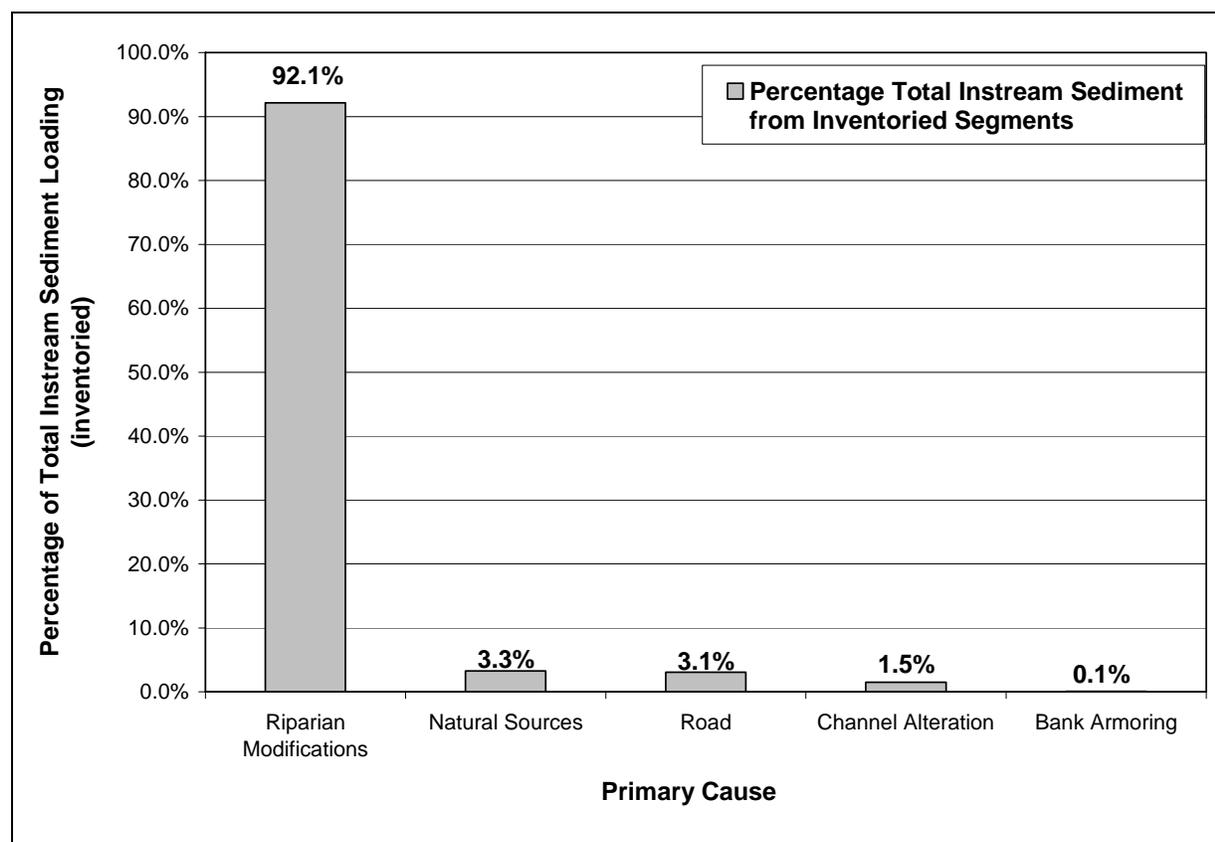
Figure J-5: Percentage of Sediment Loading Related to In-Stream Sediment Sources (Bank Erosion and Mass Wasting) by Sediment Source Cause for Inventoried Segments in the Grave Creek Drainage.

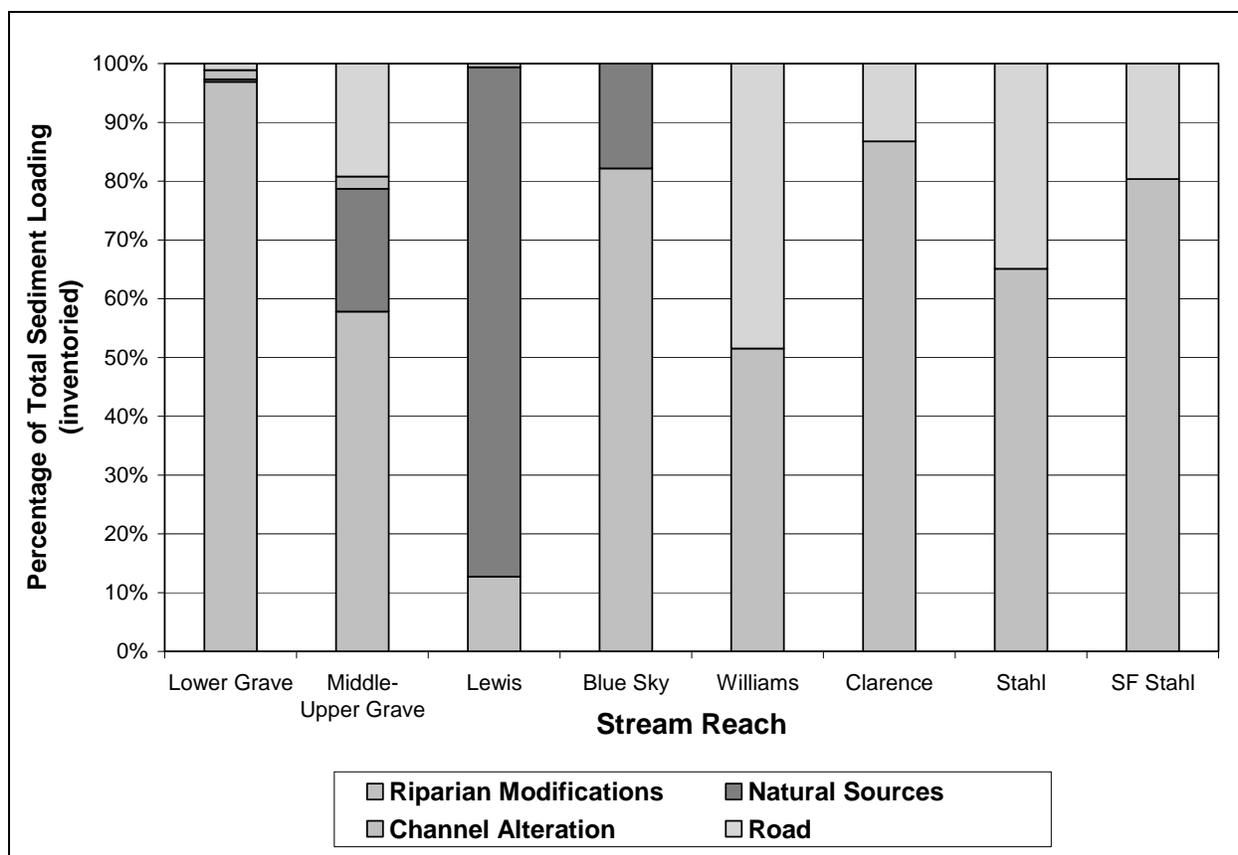
Figure J-6: Percentage of Total Sediment Loading Related to In-Stream Sediment Sources (Bank Erosion and Mass Wasting) by Stream/Reach and Cause of Sediment Source (Inventoried Segments Only).

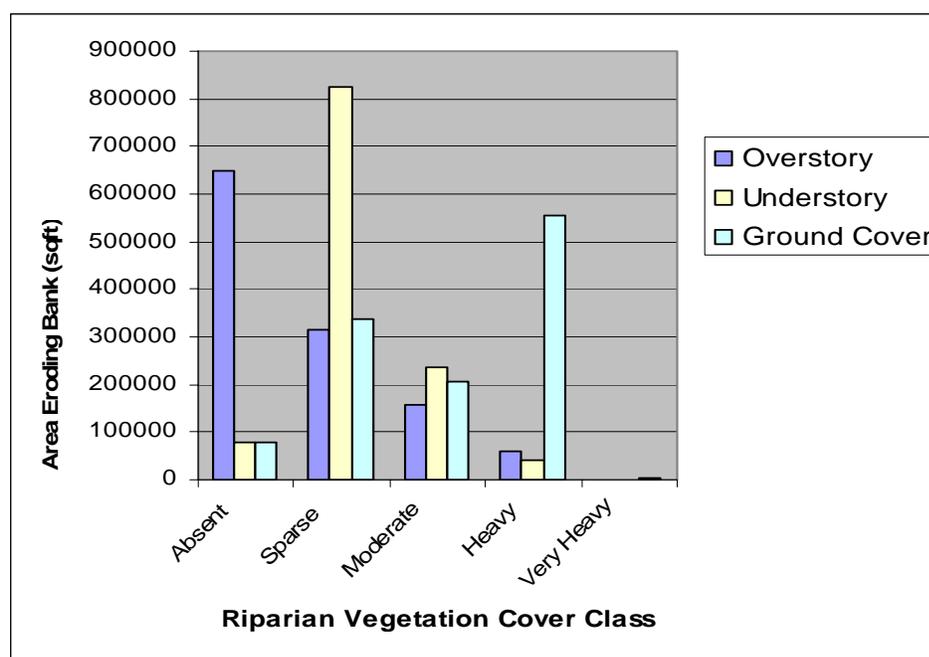
Figure J-7: Area of Eroding Banks by Vegetation Cover Class.

The relationship between cover type and density of vegetation cover is similar. The greatest lengths of eroding bank are associated with absent overstory, sparse understory and very heavy ground cover. Heavy ground cover, usually grasses and forbs do not have the rooting density or depth to stabilize banks. Where overstory and understory is very heavy, there is very small length of eroding bank. Cottonwoods, conifers, alder, willow and dogwood provide greater bank stability with deeper and denser root systems. These are significant findings given historical removals of larger trees in the watershed and ongoing riparian impacts that limit larger trees in places.

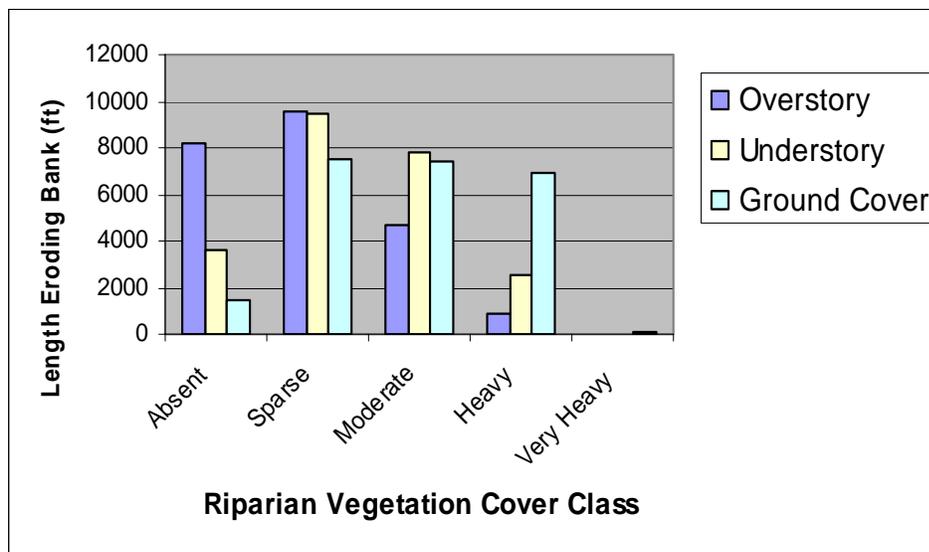
Figure J-8: Length of Eroding Bank by Percent Vegetation Cover Class.
