Sediment, Nutrients, and Temperature TMDLs and Water Quality Improvement Plans for the Boulder-Elkhorn Planning Area

September 2013

Water Quality Planning Bureau
Watershed Management Section

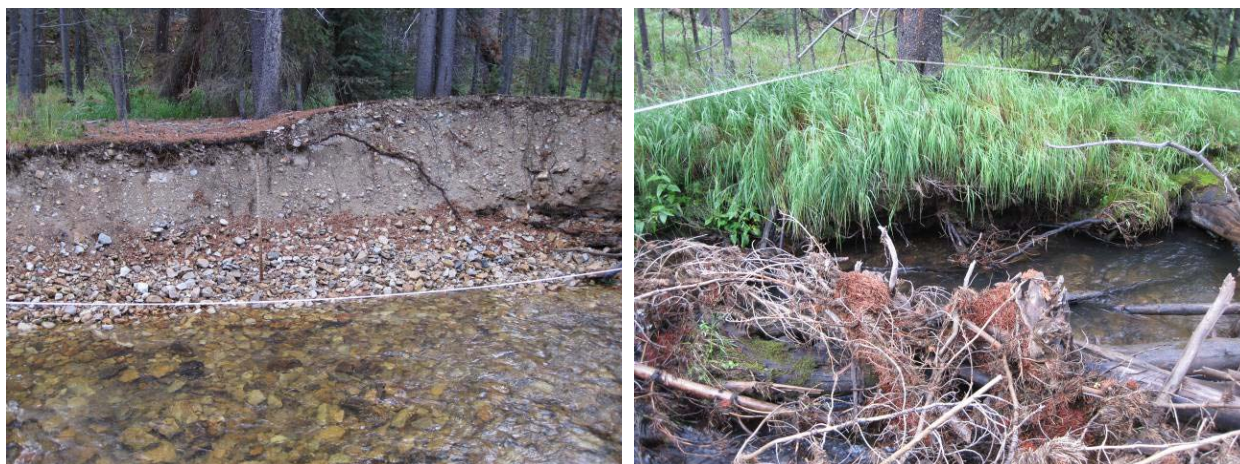
Only three eroding banks were identified in this reach, including two actively eroding banks and one slowly eroding bank. Banks are typically armored with cobbles and large gravel. The stream channel is overwidened through this reach. Typical eroding streambank conditions are depicted for this reach in **Figure 4-1** and sediment loading results are provided in **Table 4-5**.

Figure 4-1. Typical eroding streambank conditions in Basin Creek Reach 08-02.

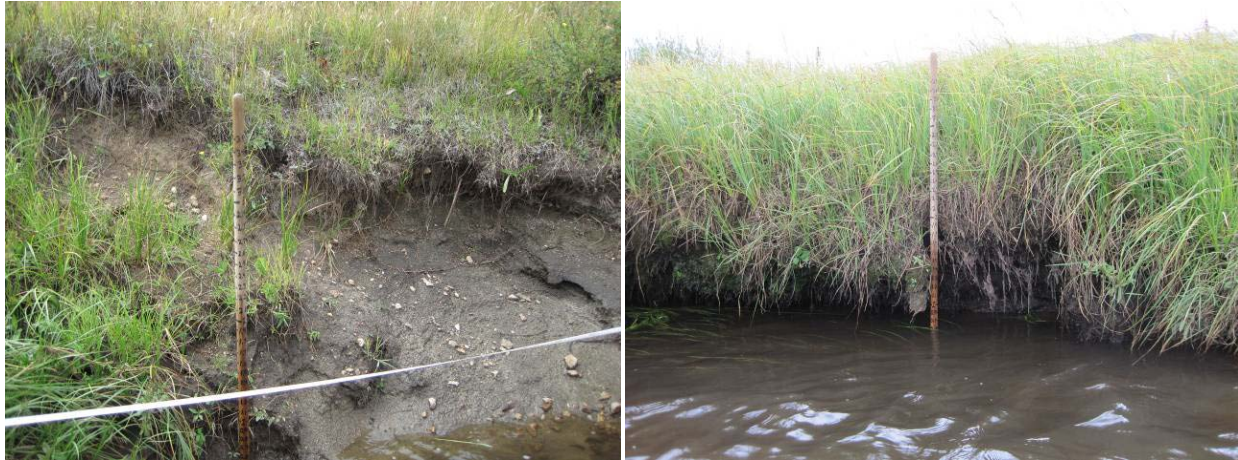
Figure 4-3. Typical eroding streambank conditions in Bison Creek Reach 04-02.

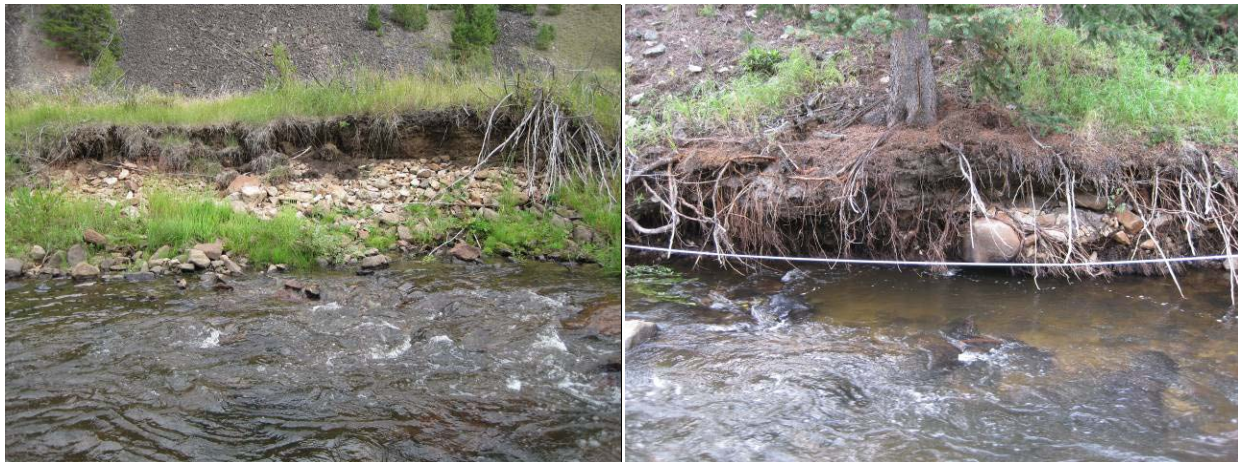
Figure 4-4. Typical eroding streambank conditions in Bison Creek Reach 11-01.

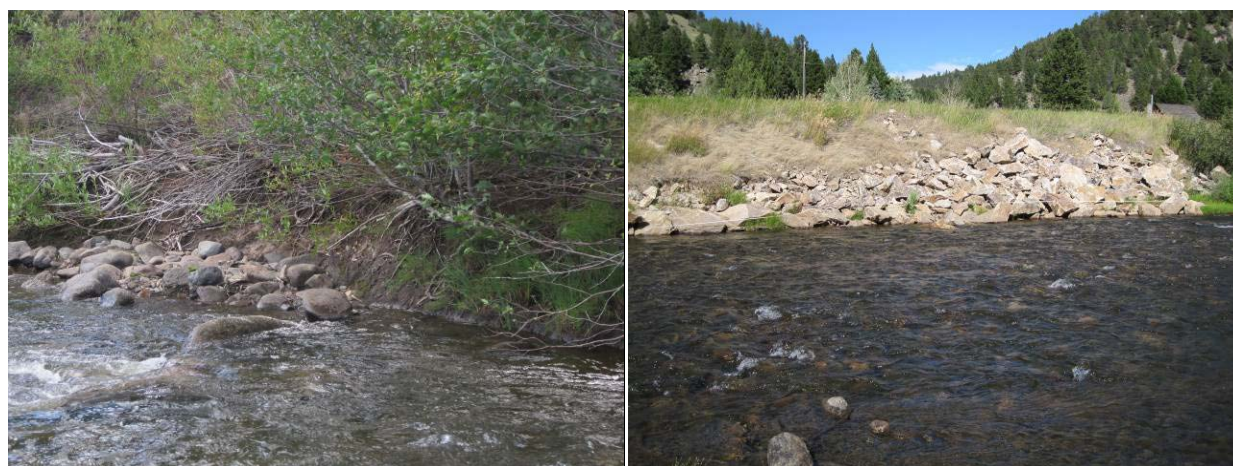
Figure 4-5. Typical eroding streambank conditions in Boulder River Reach 12-04.

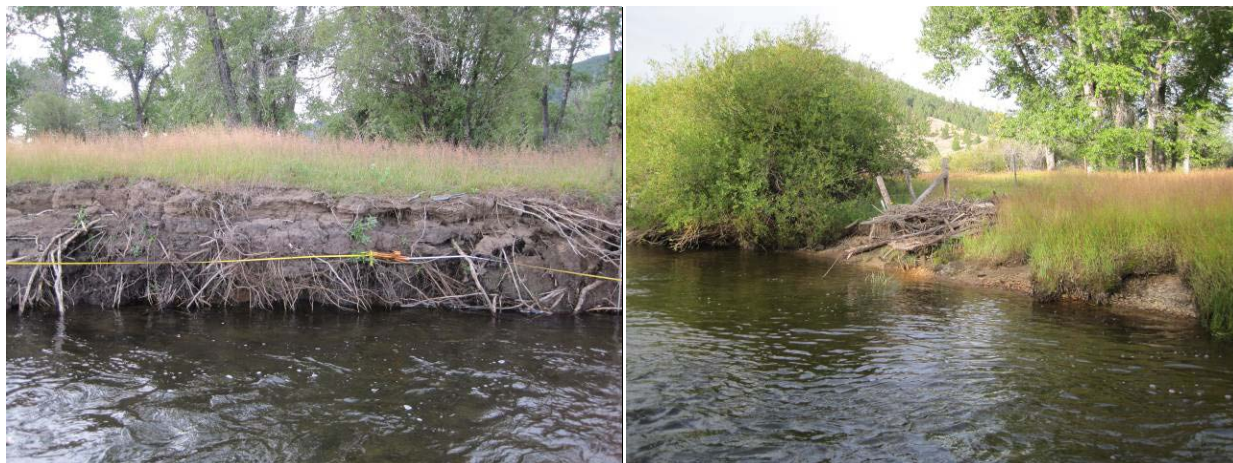
Figure 4-6. Typical eroding streambank conditions in Boulder River Reach 13-04.

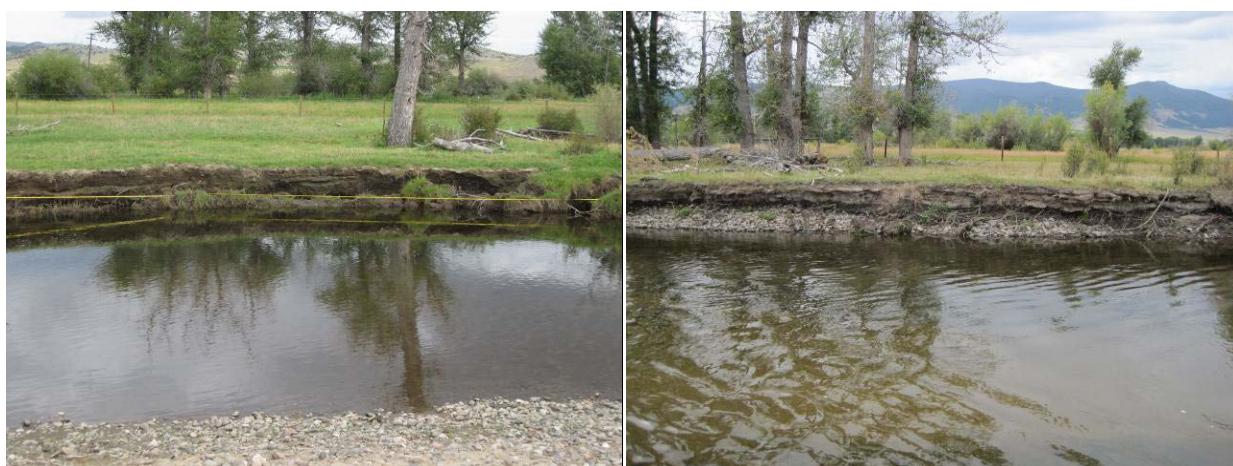
Figure 4-7. Typical eroding streambank conditions in Boulder River Reach 13-10.

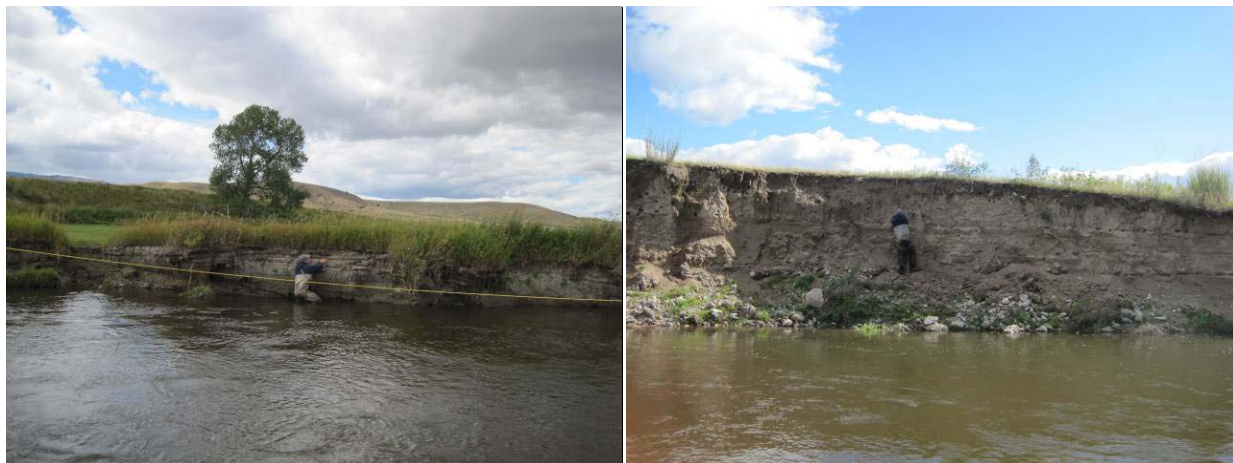
Figure 4-8. Typical eroding streambank conditions in Boulder River Reach 13-23.

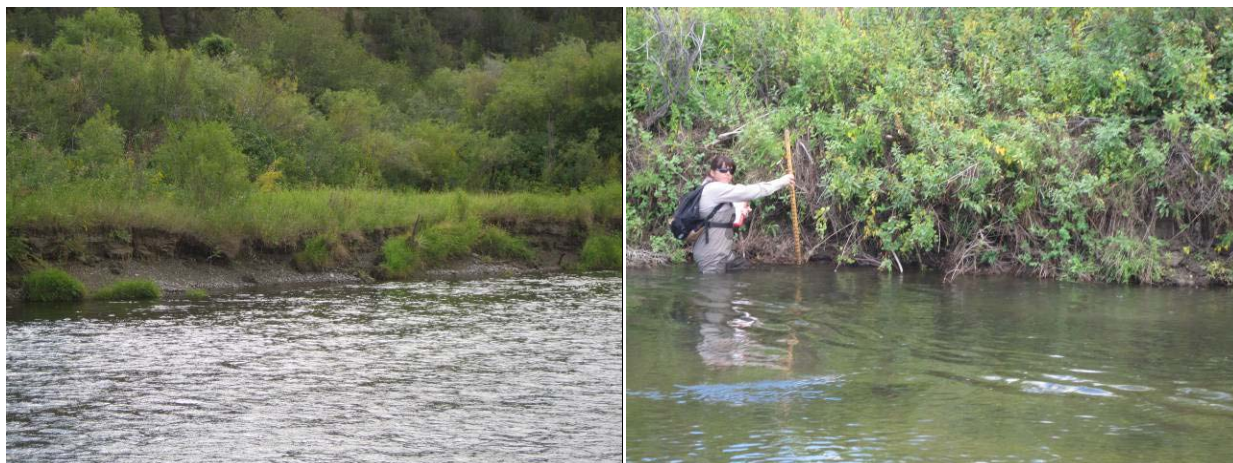
Figure 4-9. Typical eroding streambank conditions in Boulder River Reach 13-33.

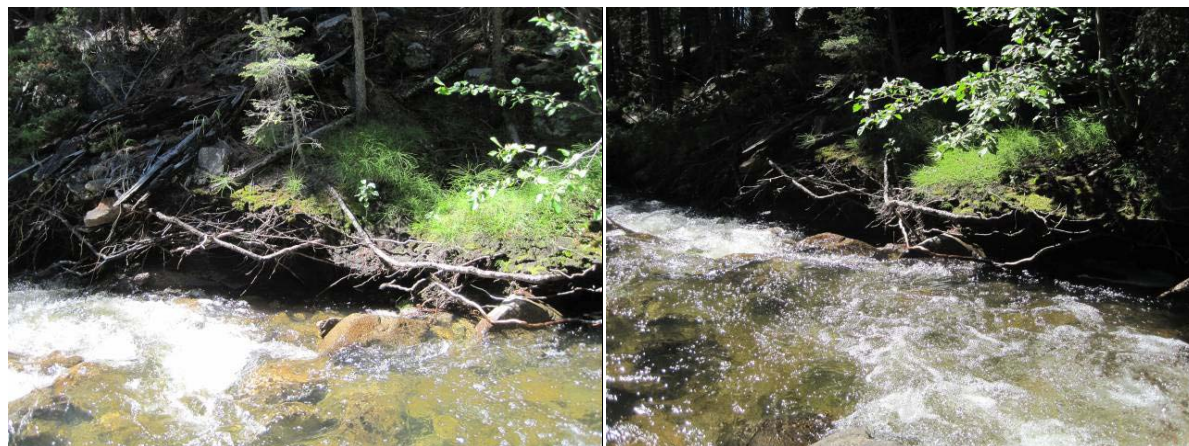
Figure 4-10. Typical eroding streambank conditions in Cataract Creek Reach 18-01.

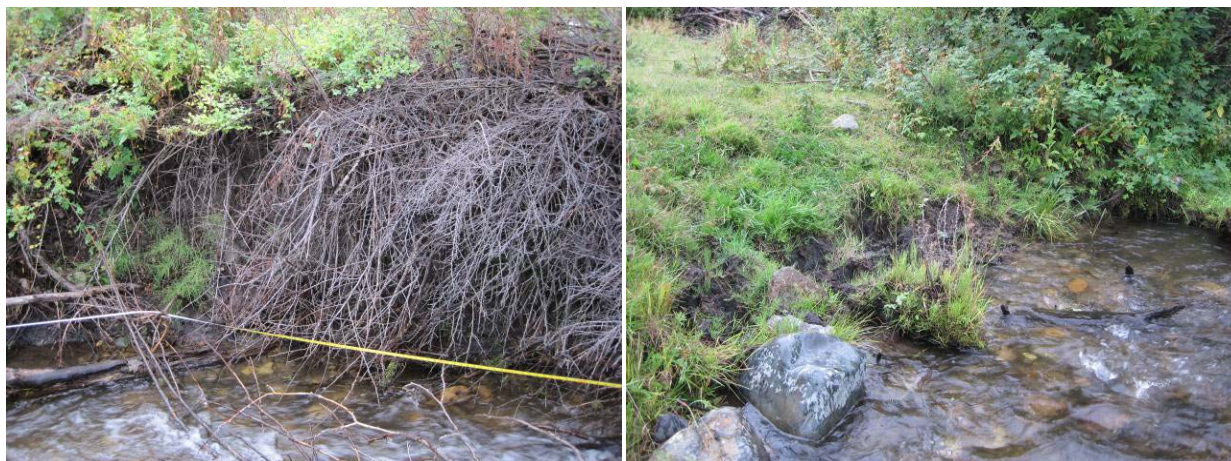
Figure 4-12. Typical eroding streambank conditions in Elkhorn Creek Reach 28-01.

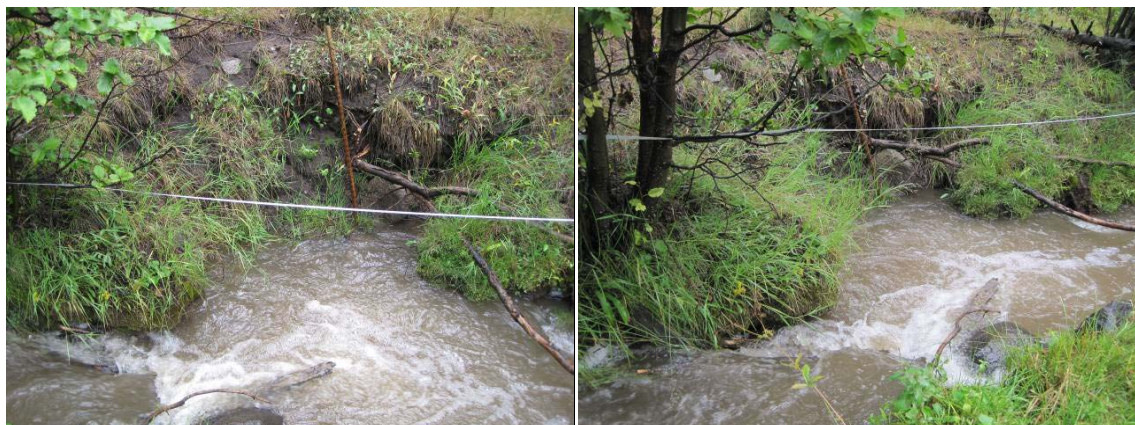
Figure 4-13. Typical eroding streambank conditions in High Ore Creek Reach 09-01.

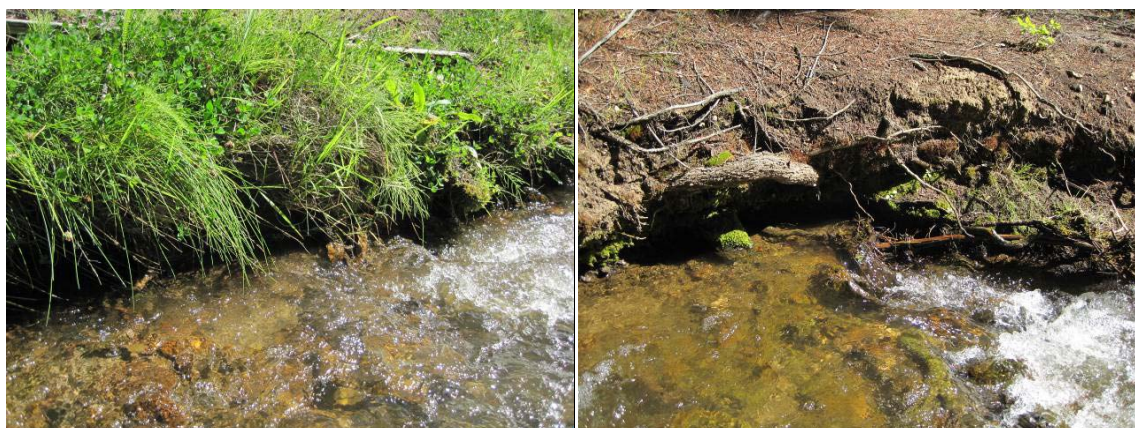
Figure 4-14. Typical eroding streambank conditions in High Ore Creek Reach 15-01.

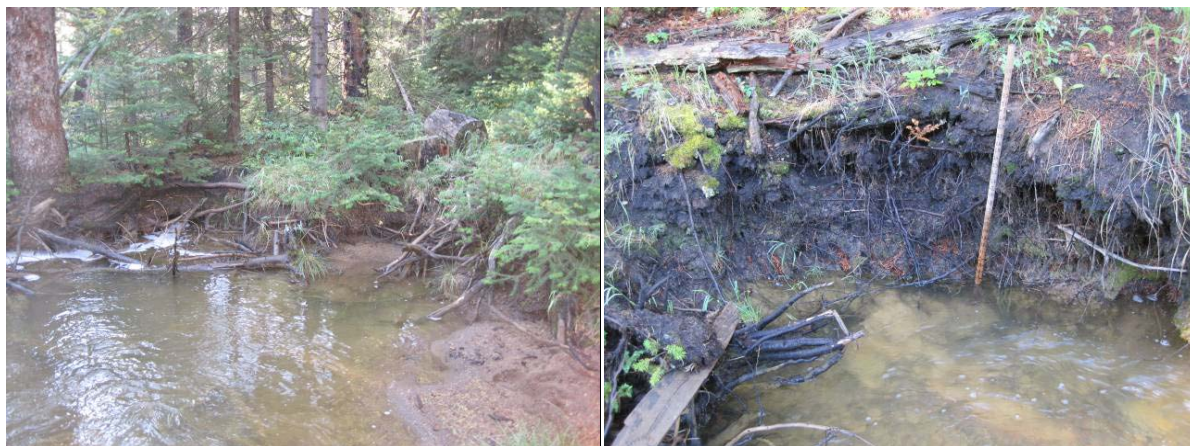
Figure 4-23. Typical eroding streambank conditions in Uncle Sam Gulch Reach 10-01.

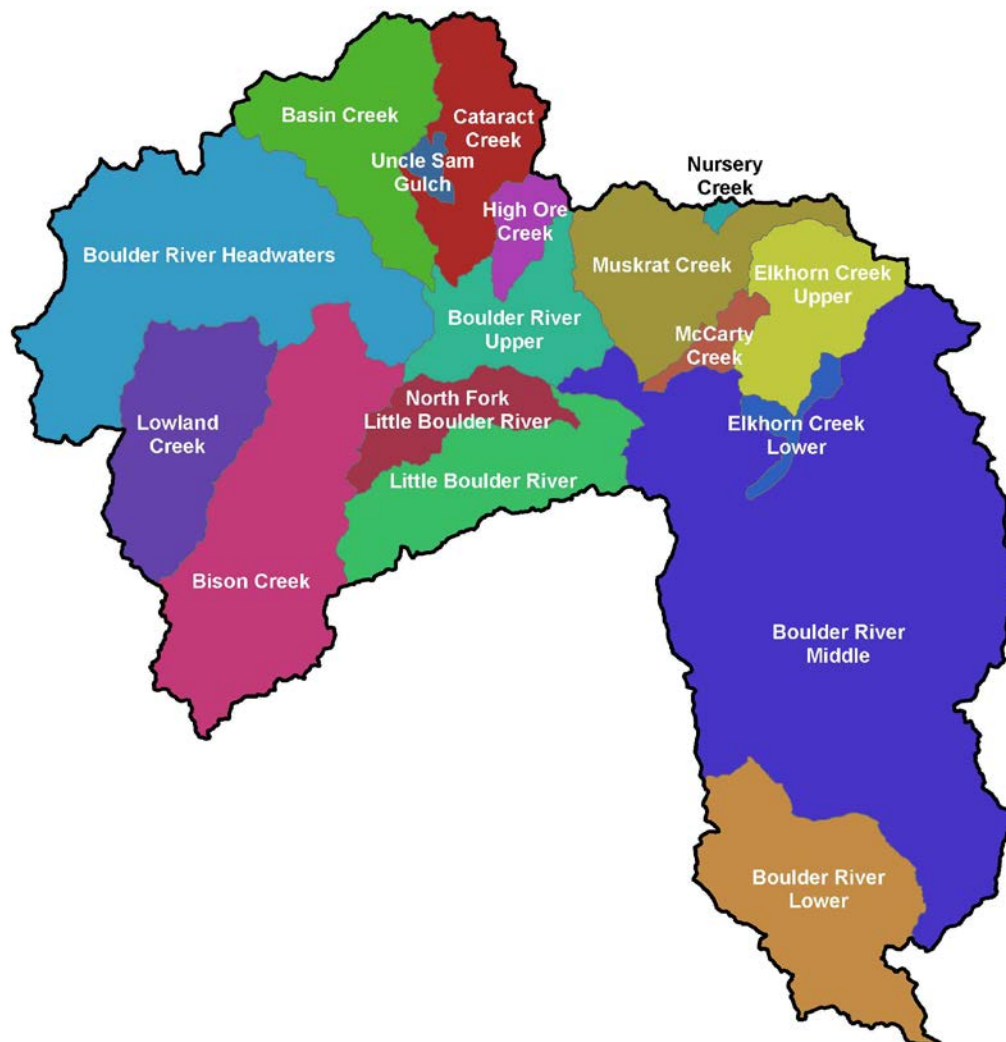
Figure 1-1. Sub-basin polygons for the Boulder Elkhorn Watershed.

The Boulder Elkhorn watershed boundary and the sub-basin boundaries were defined using the USGS 6th code Hydrologic Unit Codes (HUC). High Ore Creek, McCarty Creek, Nursery Creek, and Uncle Sam Gulch are 303(d) listed streams that were not represented in the 6th code HUCs. These sub-basins were cut from the larger HUC sub-basins using USGS topography as a guide to drainage divides. Additionally, the Elkhorn Creek sub-basin was divided into an upper and lower sub-basin, above and below Wood Gulch respectively.

Overall, the Boulder River watershed was divided into 4 sections: headwaters to Basin Creek (Headwaters), Basin Creek to the town of Boulder (Upper), the town of Boulder to Cottonwood Creek (Middle), and Cottonwood Creek to the mouth (Lower). The division between these sections coincided with HUC sub-basin boundaries except between the Upper and Middle sections. This division was made using the USGS topography as a guide.
