**SCAT Area Transition Report  
for A06**

Silvertip Pipeline Incident  
Laurel, Montana

October 27, 2011

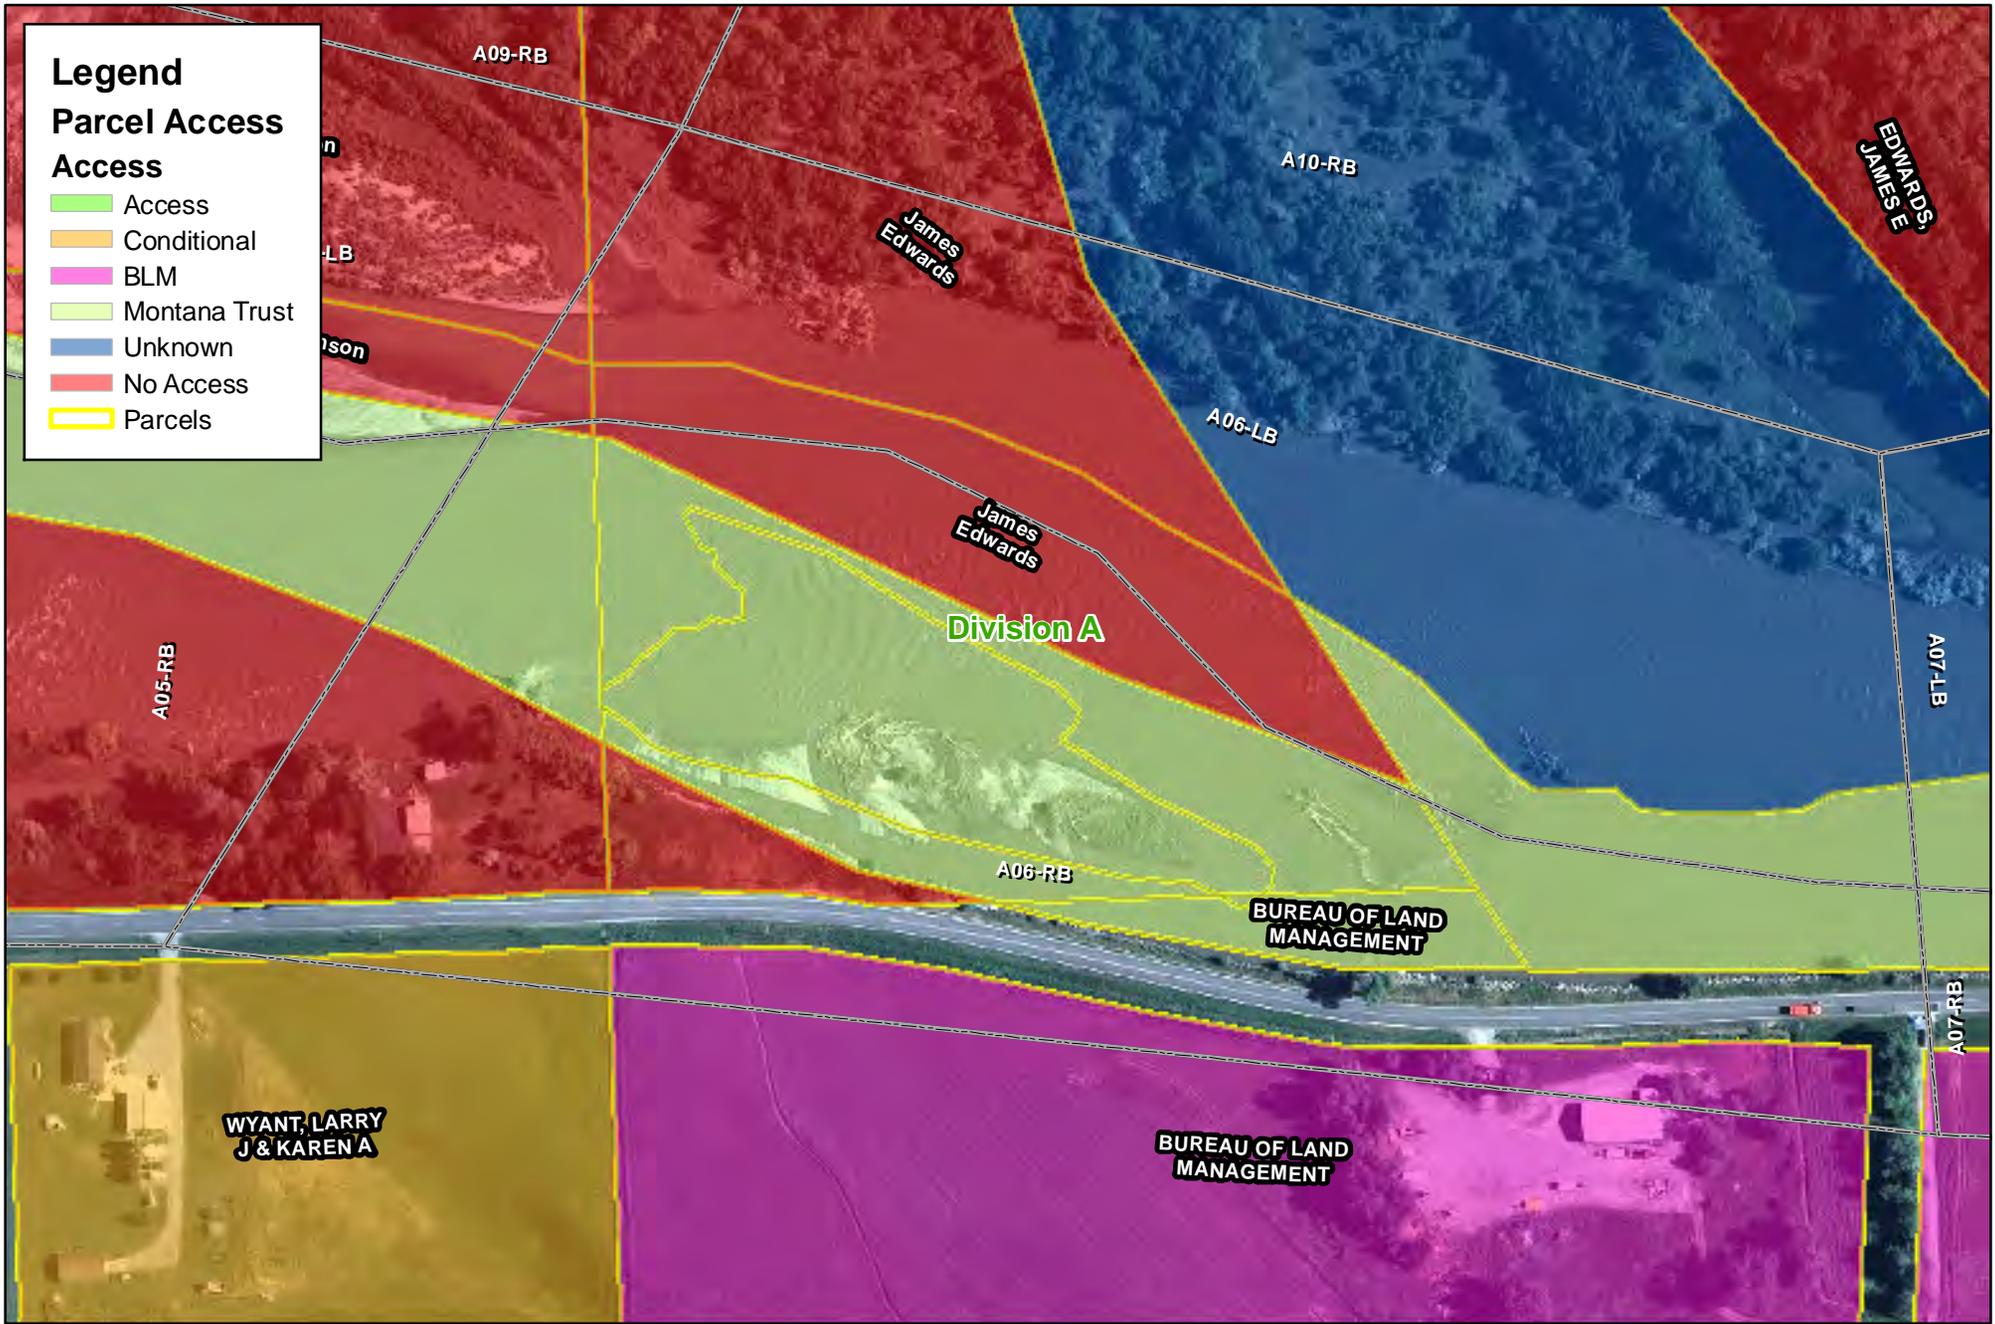
Figure 1 provides an aerial map of SCAT Area A06, along with the (a) SCAT Area boundary, (b) parcel boundaries and respective property owners, and (c) access constraints identified during the oil cleanup process. The acreage surveyed in Area A06 is 13.9. There were access issues for the right and left bank.

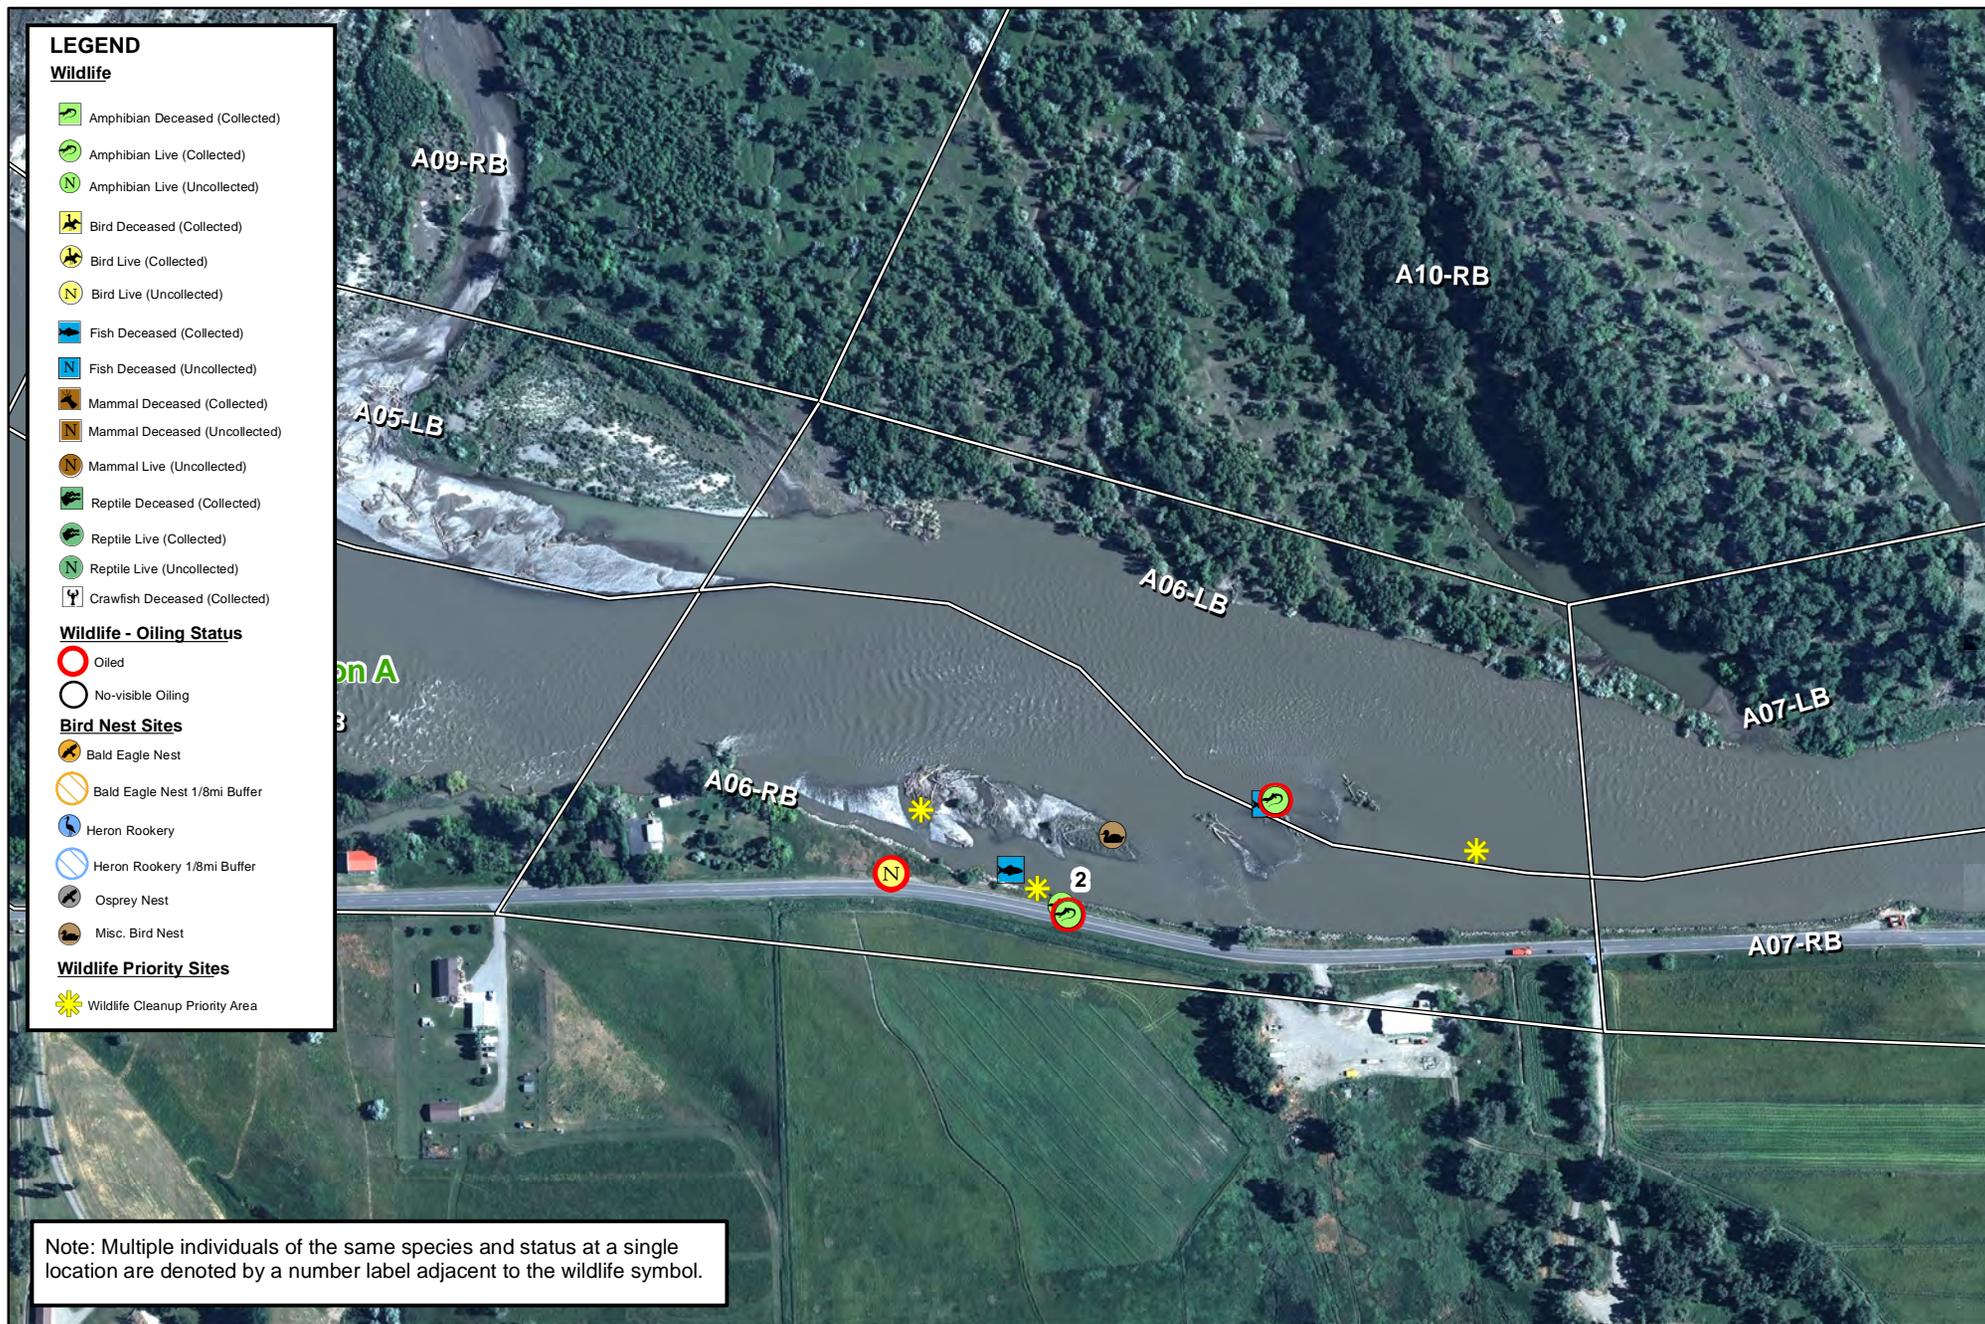
**Figure 2**  
**Wildlife Resources**

Figure 2 summarizes the natural resources identified in this segment. International Bird Rescue and Resource Advisors from U.S. Fish and Wildlife Service conducted regular inspections of Area A06. Two oiled Woodhouse's toads (*Bufo woodhousii*) were captured, cleaned, and released. In addition, two Woodhouse's toads were captured and taken to the Wildlife Recovery Center for an oiling evaluation, determined to be un-oiled, and released. Two deceased catfish (unknown species) with no visible oiling were also recovered. Three Wildlife Priority Cleanup Areas (WPCAs) were identified. One WPCA was a heavily oiled debris pile near the western end of a small island adjacent to the south bank. The second WPCA consisted of two small pools with persistent sheen located on a gravel bar in the eastern portion of the previously noted small island. The third WPCA was oiled debris and vegetation around a spring located above rip-rap on the right bank; Unified Command generated a General Message for oil associated with the rip-rap. These WPCAs have been addressed and no longer pose a risk to wildlife. One spotted sandpiper (*Actitis macularius*) nest was identified on the eastern portion of the same small island.

As described in Section 1.2, the Wildlife Branch identified transferrable oil posing a risk to wildlife in three areas of Area A06. One of the three areas was addressed and signed off in the normal SCAT process (Appendix F) prior to the Wildlife Branch's first use of Exception Memos. An Exception Memo was generated for the two remaining locations: a debris pile on a small island, and oiled debris and vegetation around a spring. Both areas were addressed and the Exception Memo was signed off as complete (Appendix G).

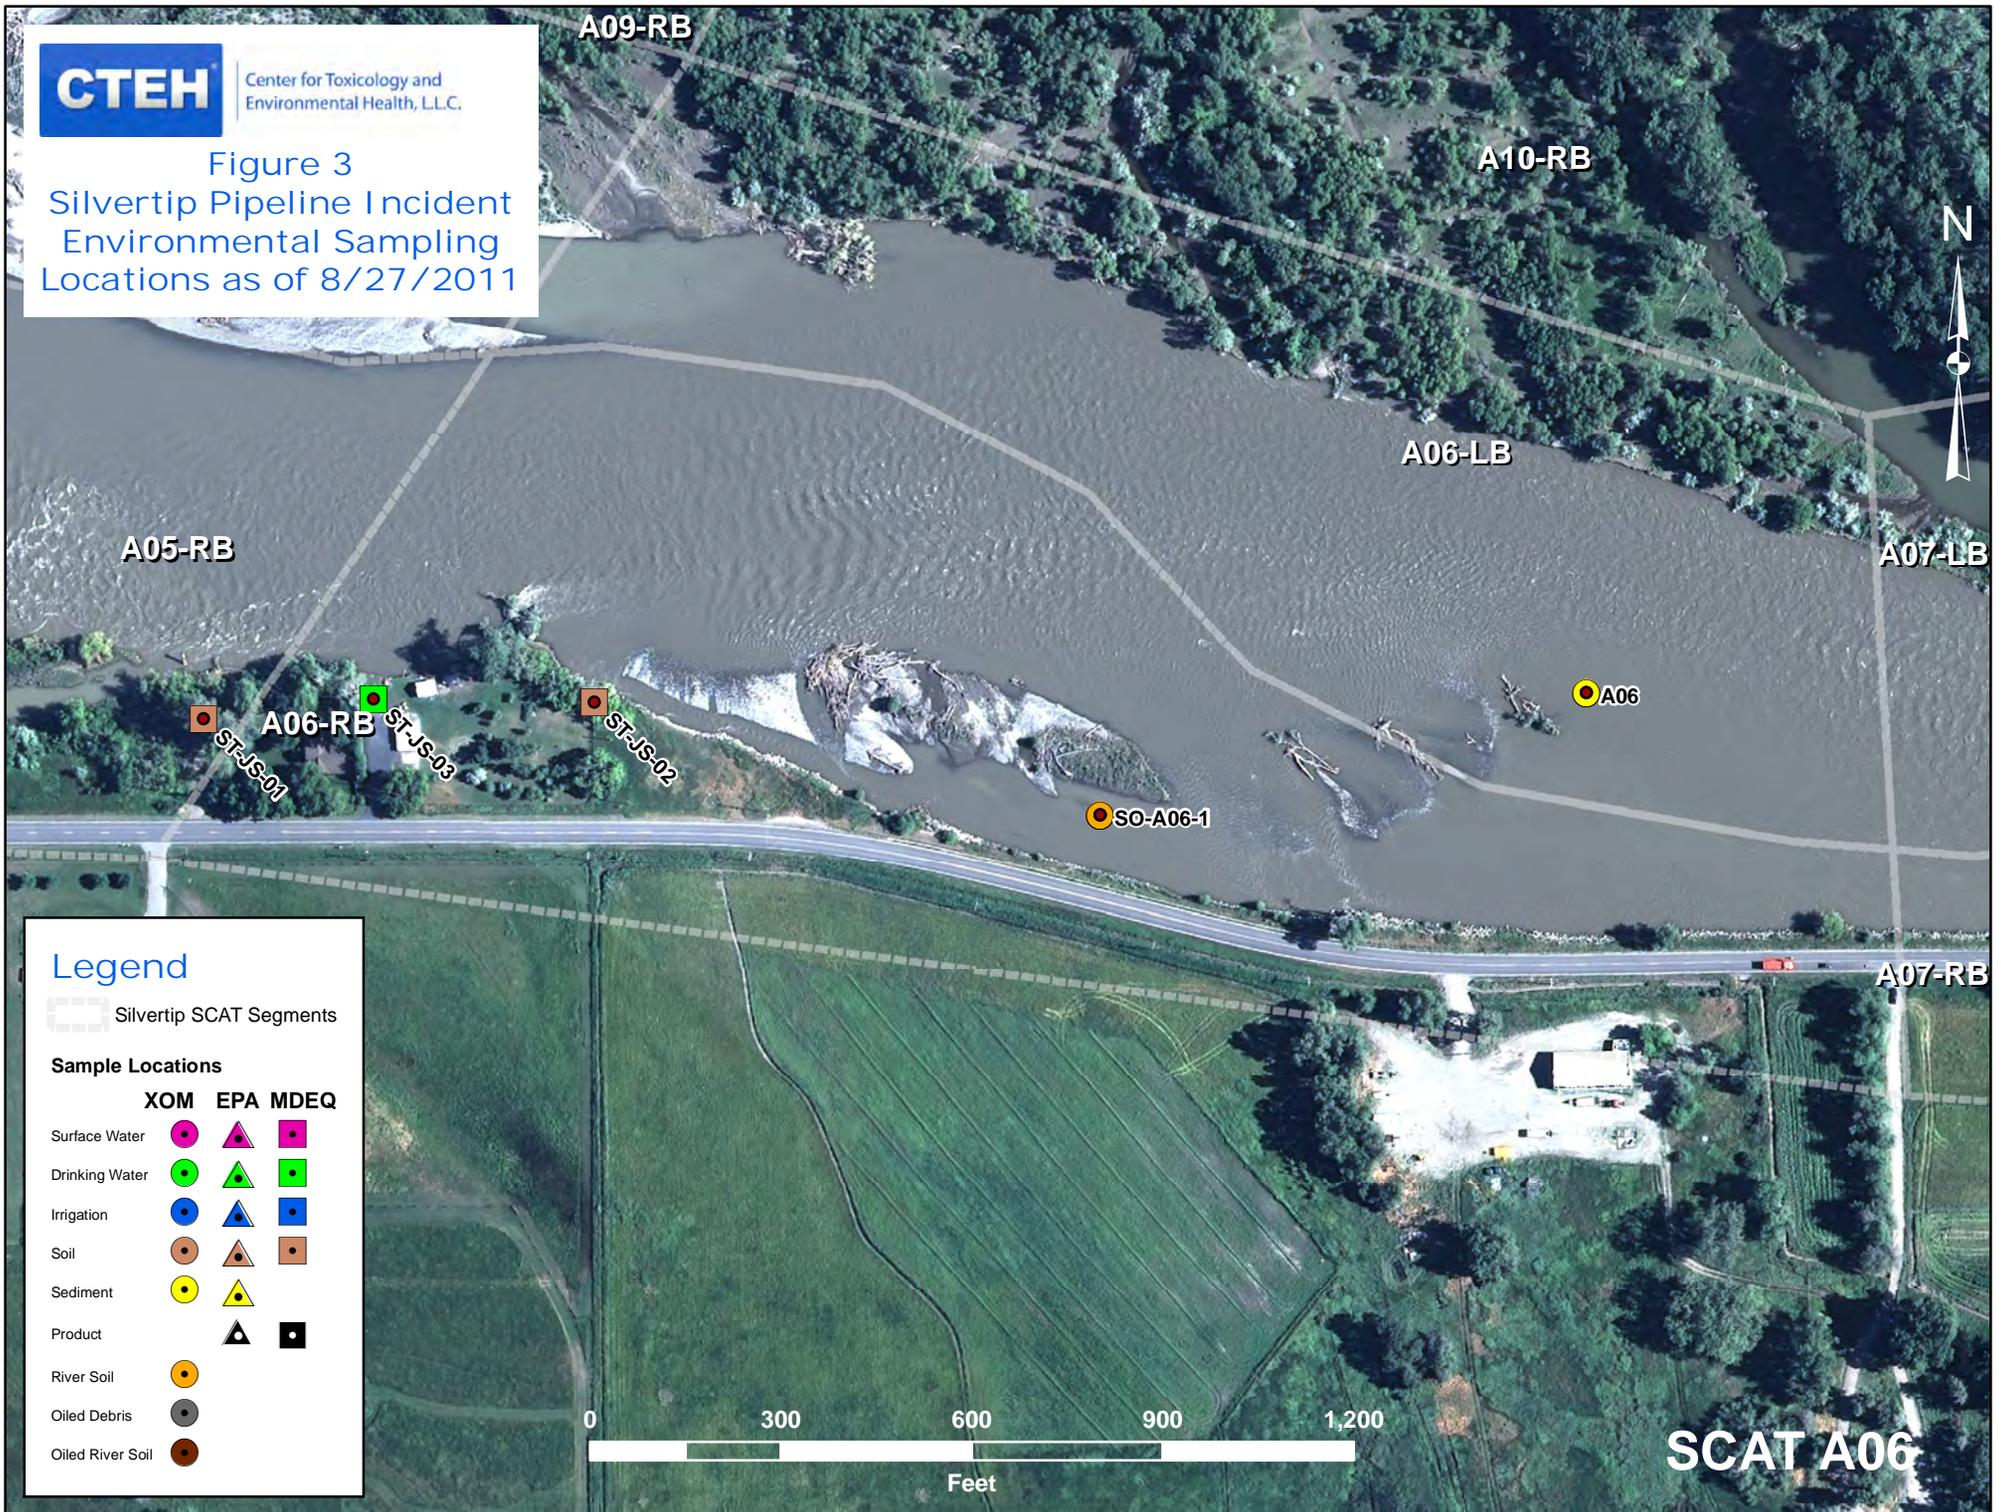
Figure 3  
Silvertip Pipeline Incident  
Environmental Sampling  
Locations as of 8/27/2011

Table 1 (below) summarizes samples collected within Area A06. The analytical results for the samples collected can be accessed through a publicly accessible database on the United States Environmental Protection Agency's (USEPA's) website. The approximate locations of samples collected within Area A06 are provided on Figure 3.

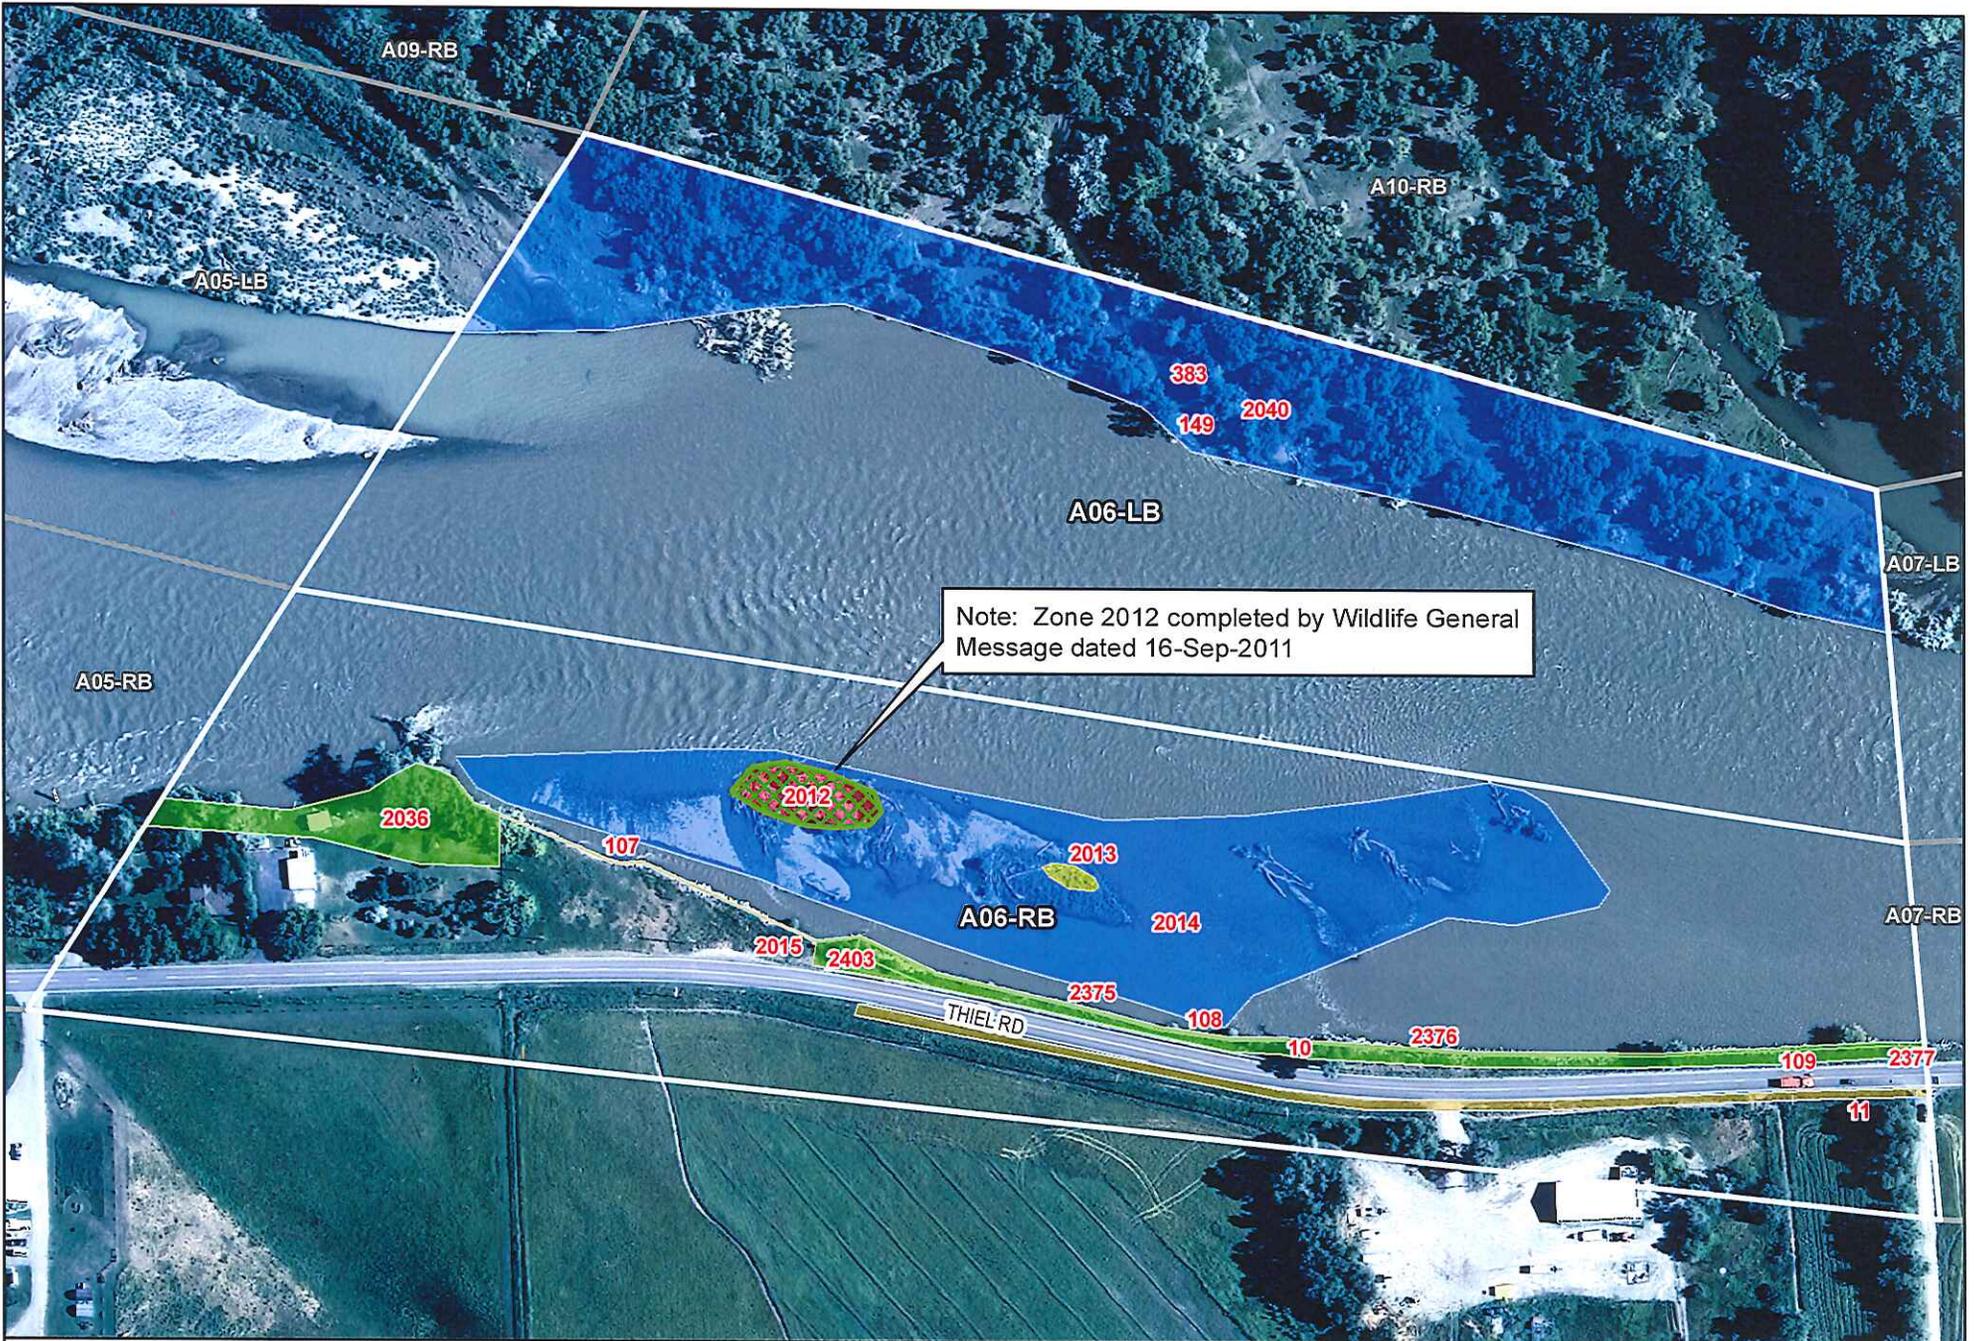
**Figure 5 - Final SCAT Observations**  
**For SCAT Area: A06**

Figure 5 shows the oiling conditions within Area A06 following completion of oil removal activities. The SCAT team performed final surveys of the right bank(s) within SCAT Area A06 to confirm the agreed-upon cleanup endpoints identified in the applicable CTRs had been achieved. The final SCAT survey documentation is presented in Appendix E.

Note: Zone 2012 completed by Wildlife General Message dated 16-Sep-2011

Based on the initial SCAT surveys performed within Area A06, no oil was observed or no further treatment was recommended for the left bank. Based on the final SCAT surveys performed on the right bank(s) within Area A06, no further treatment is

recommended for these segments. SCAT Segment Sign-Off Forms are included as Appendix F.

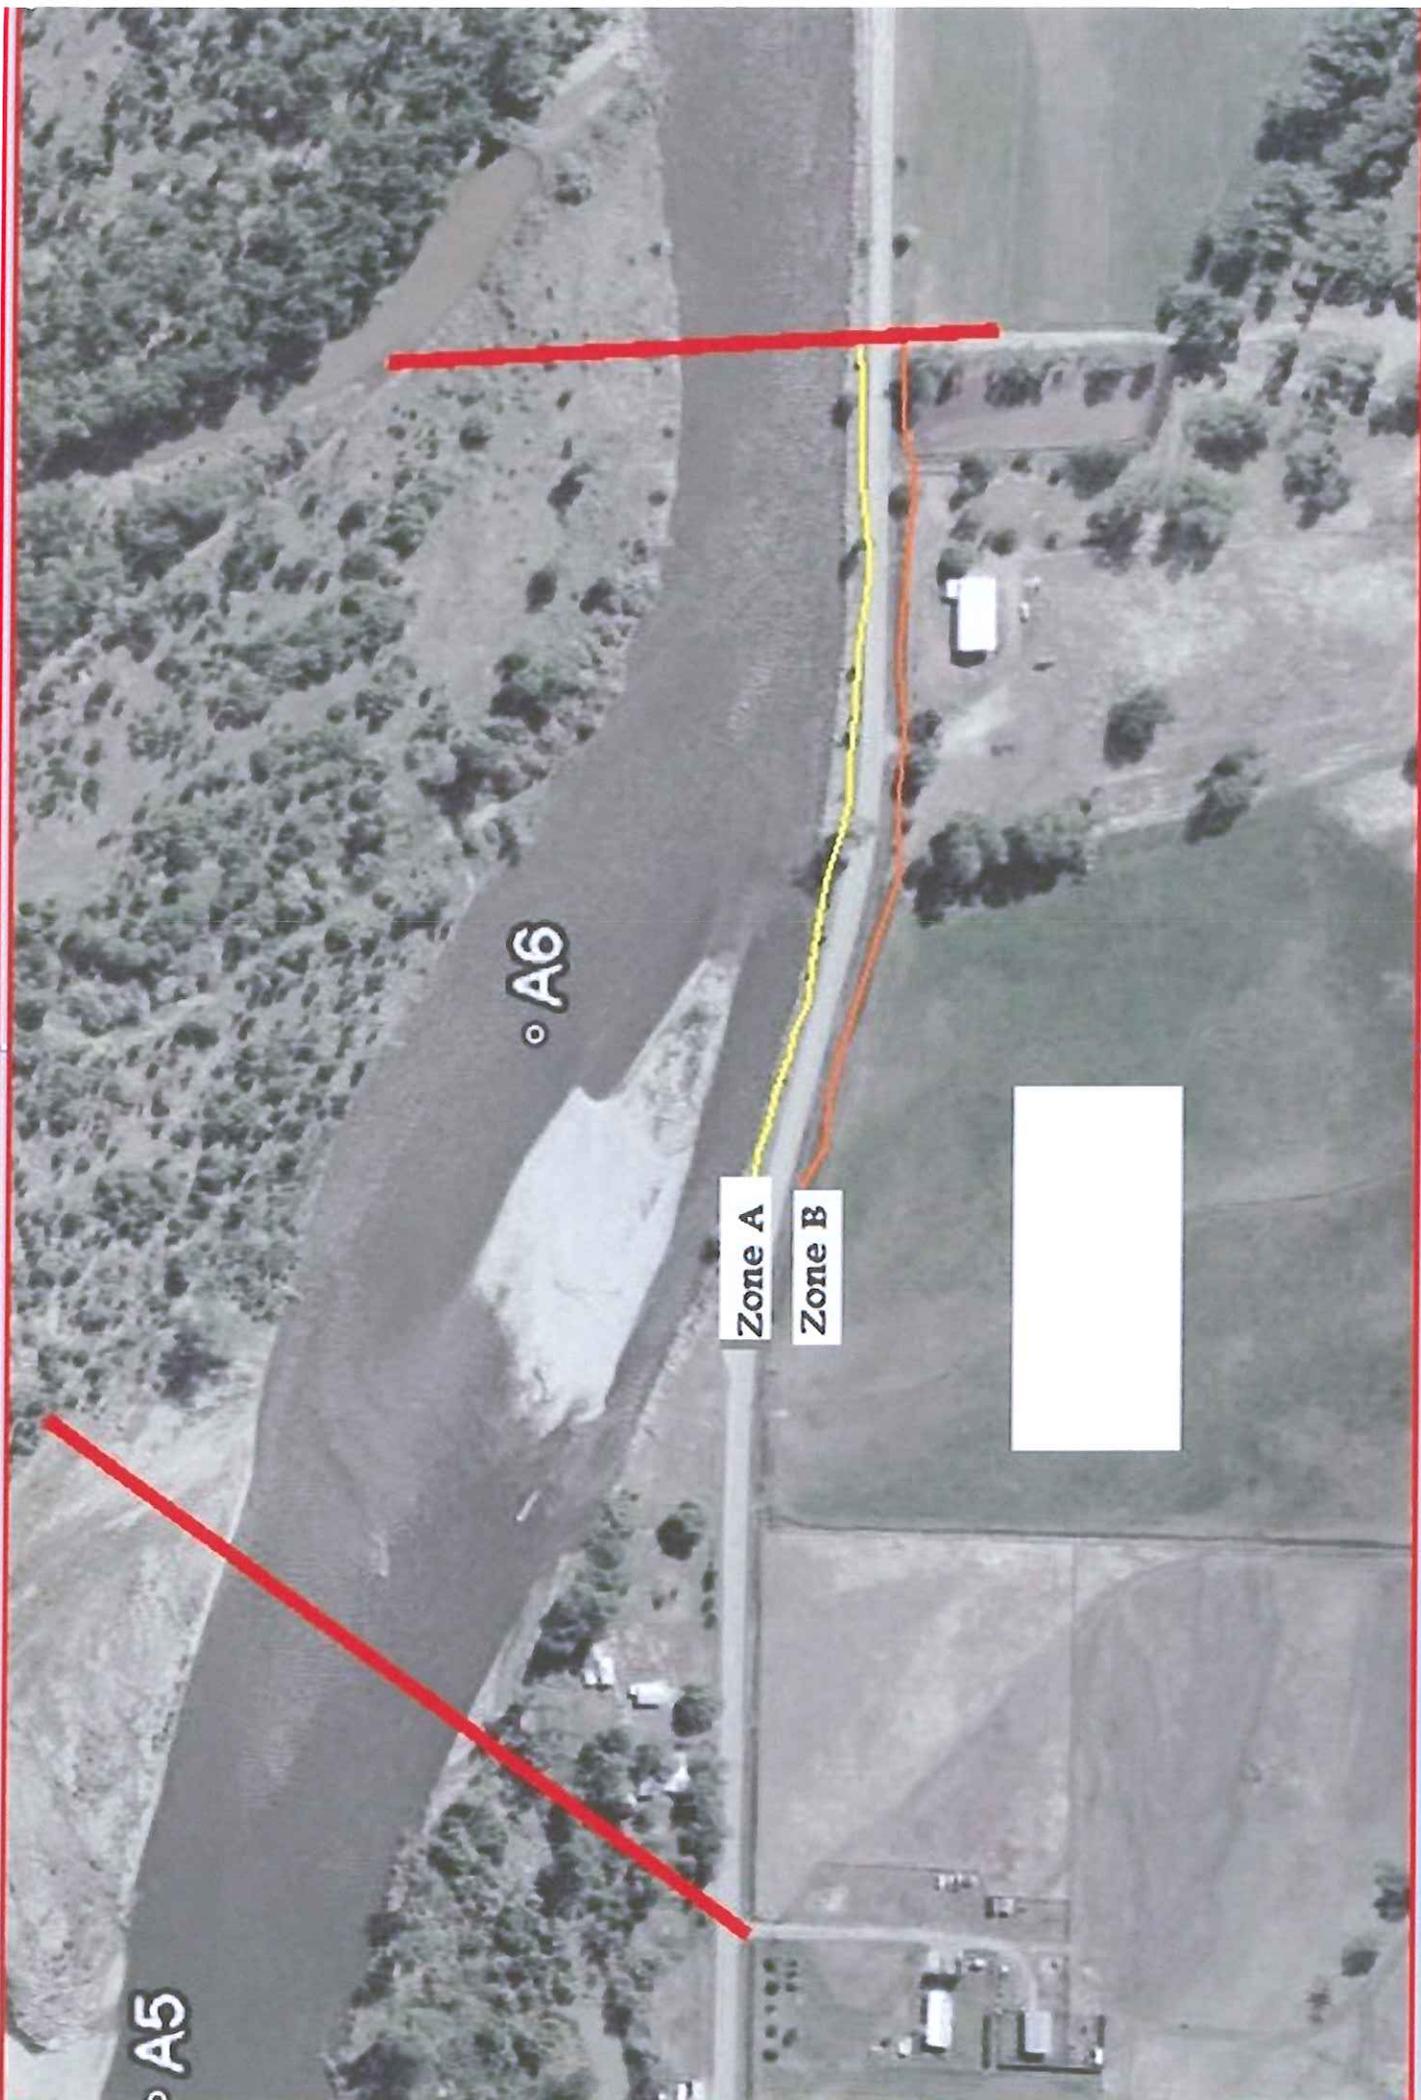
Oil band also observed on side of barn.

Cleanup Recommendations: Trim oiled vegetation; wipe large oiled debris; remove small oiled debris; wipe oiled trees; wipe rocks (if can be performed safely).

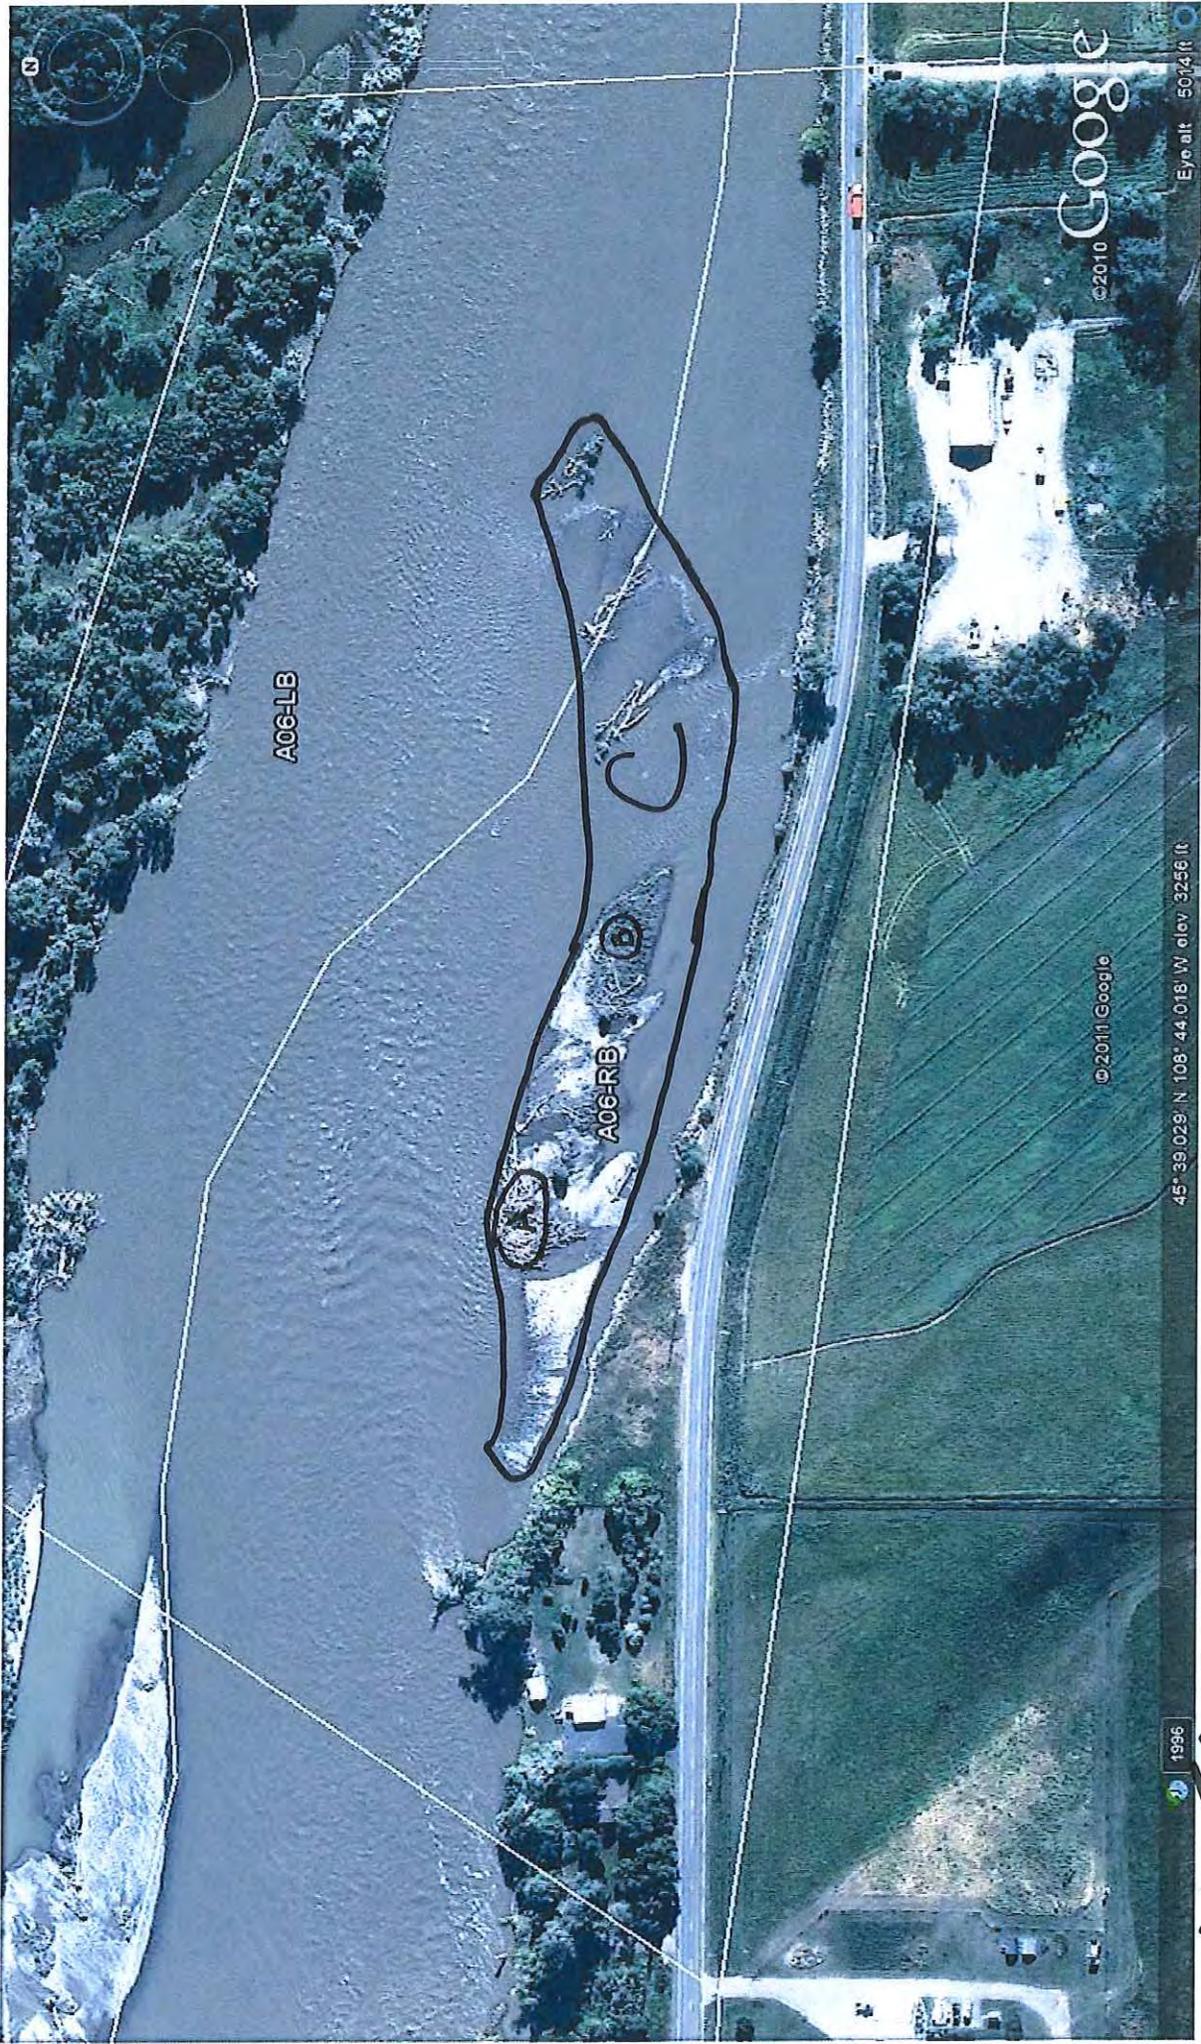
**A6-IS**  
**SCAT 5**  
**19 Aug 2011**

Zone A: large oiled debris pile. Recommend ATM 10

Zone B: Oiled bank on veg. Access difficult over riprap. Recommend ATM 1+2

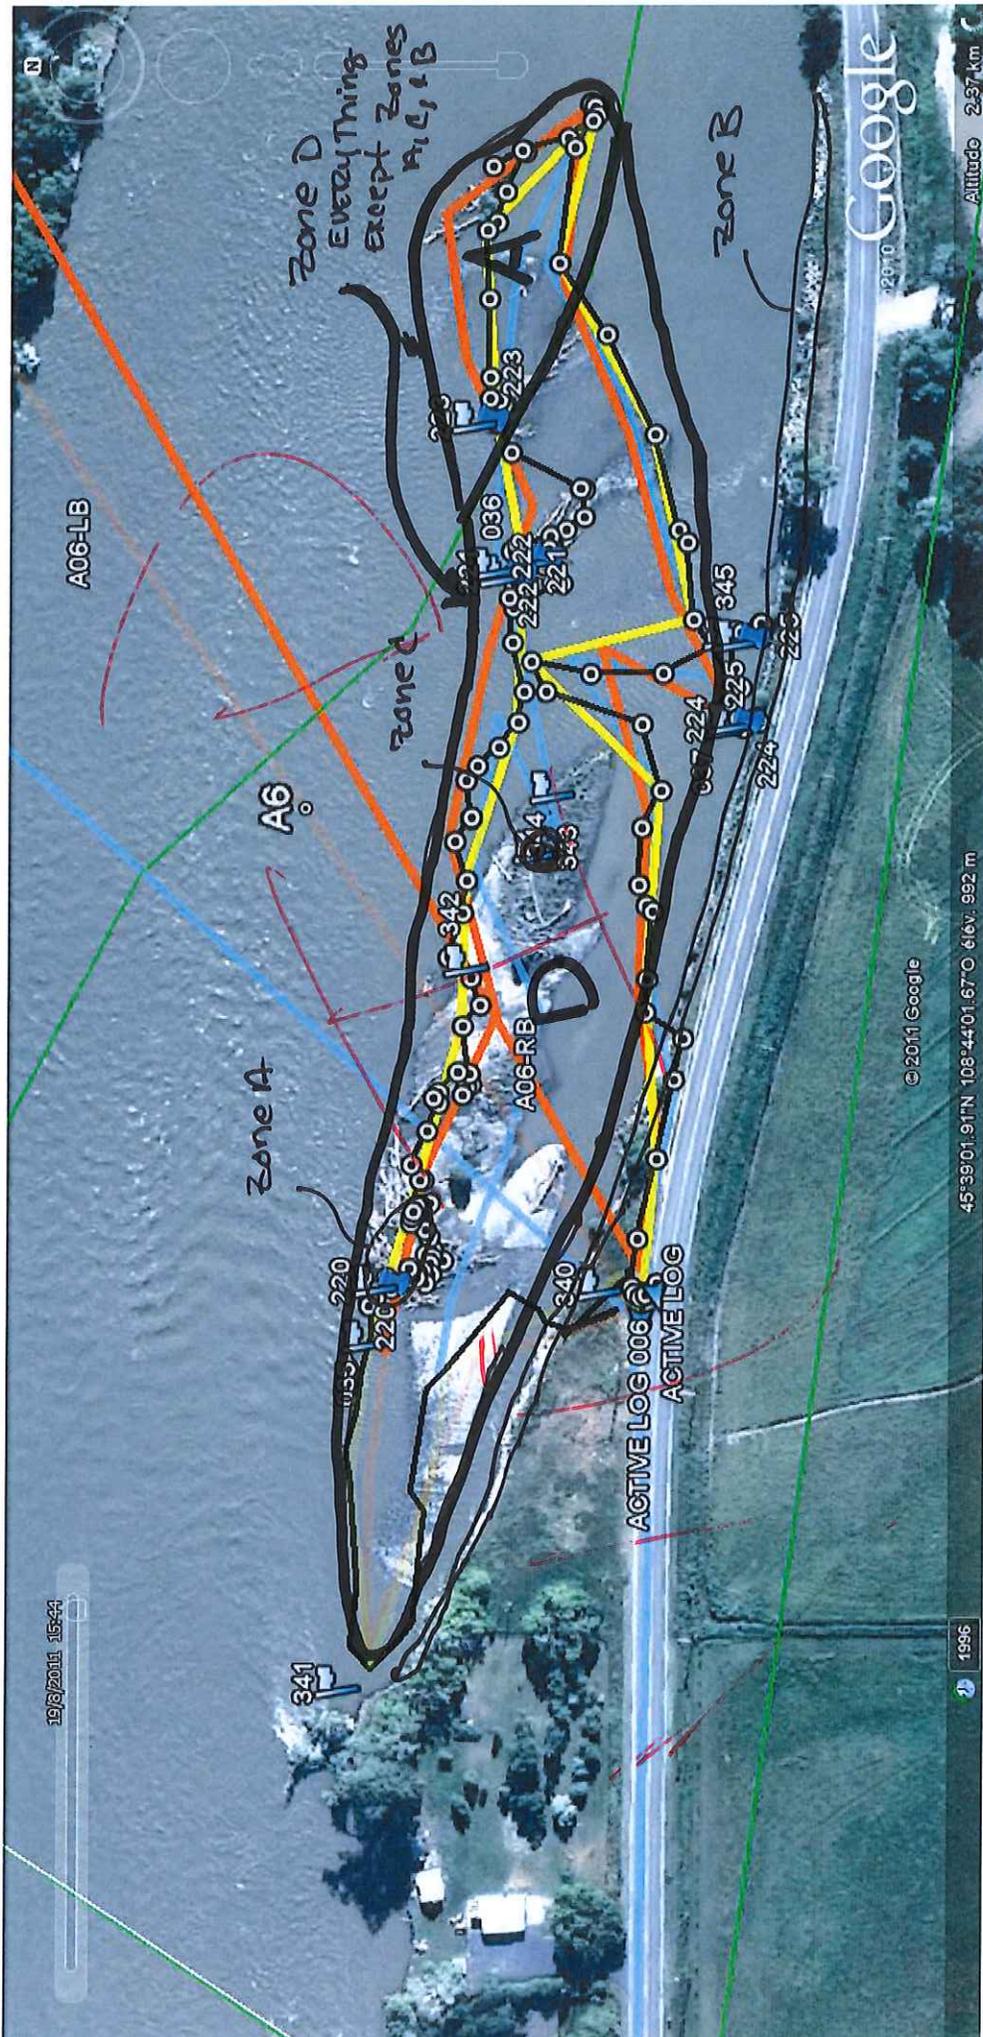
A6-RB  
 SCAT 5  
 19 Aug 2011

Zone A: Oiled band on veg. Access difficult over riprap. Recommended ATM 1&2.

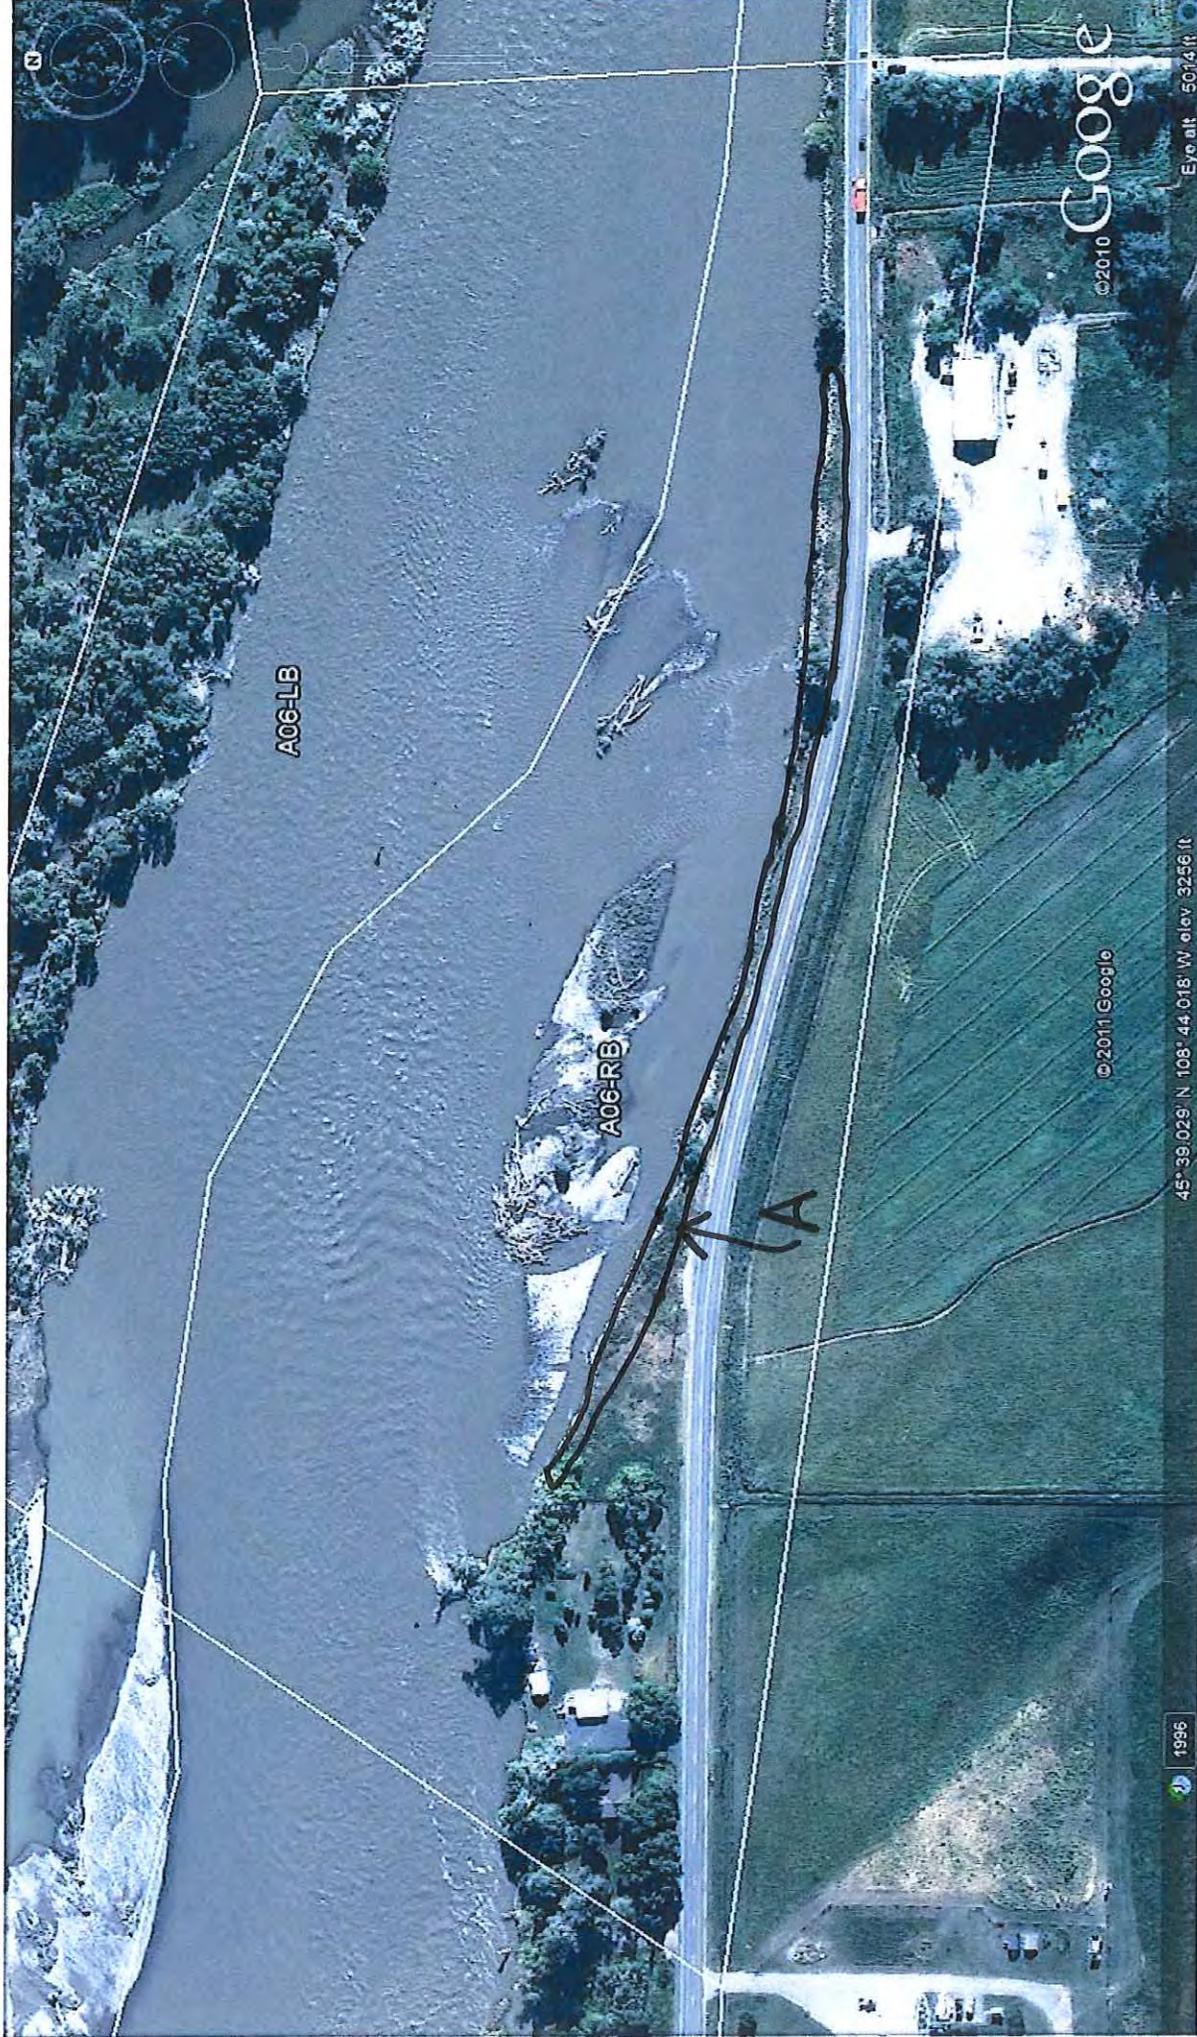
A6-RB  
SCAT 5  
19 Aug 2011

Revised by Connor Kobeski  
9/2/11 to reflect  
segment boundaries
