**SCAT Area Transition Report  
for A06**

Silvertip Pipeline Incident  
Laurel, Montana

October 27, 2011

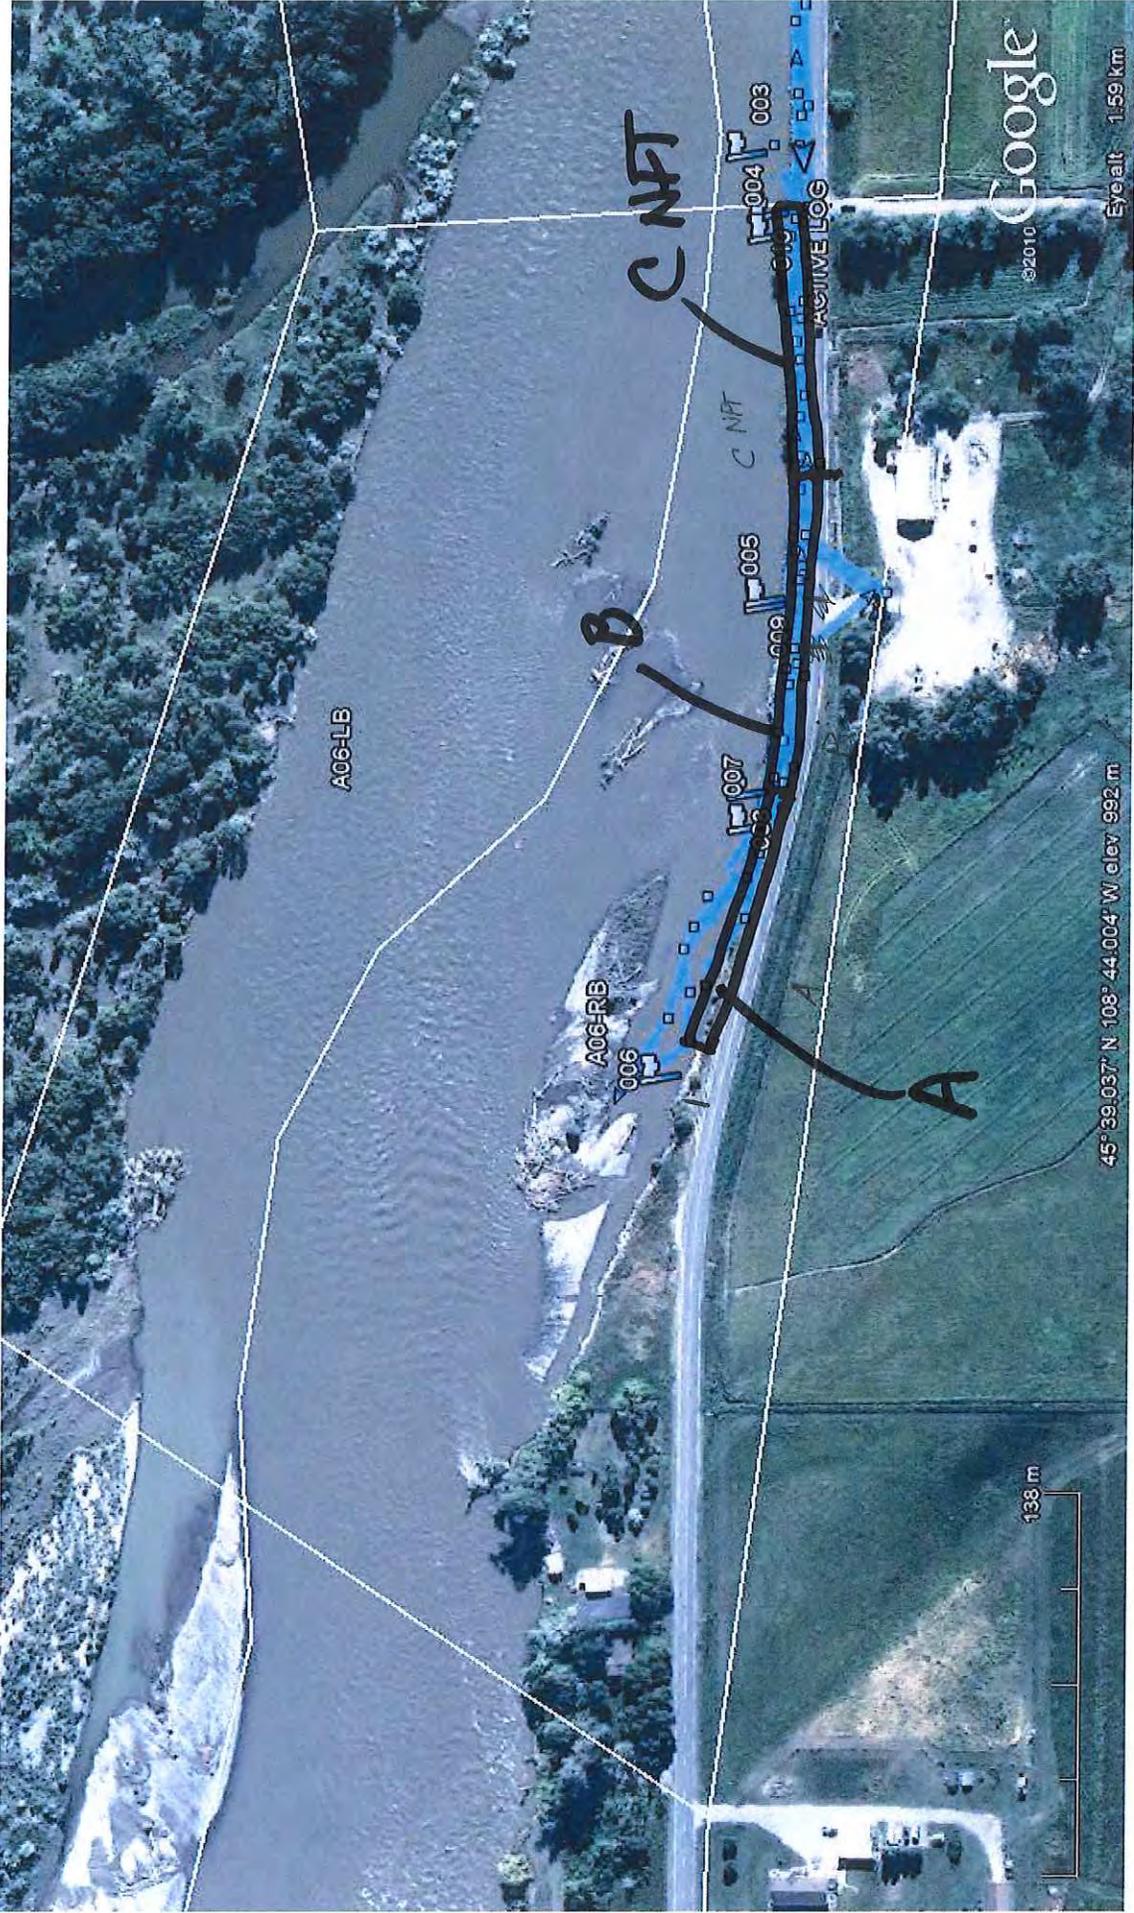
T3 9/21/11

Zones A and B have transmittable oil-coated vegetation and debris that can be cut/removed. Bank is rip-rap. Ops safety conditions for steep slopes apply.

Treatment recommendations:  
 Zone A : Treated by Ops as per POST and HotShot crew;  
 Zone : No further Treatment (NFT)

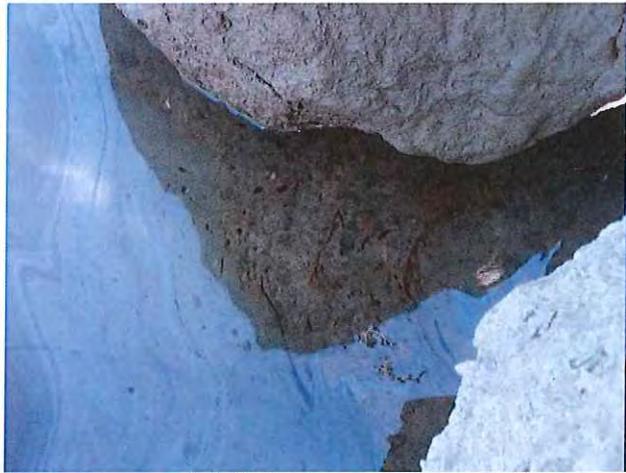
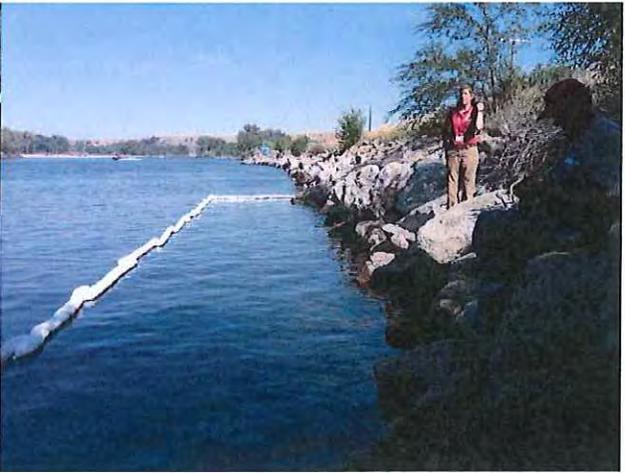
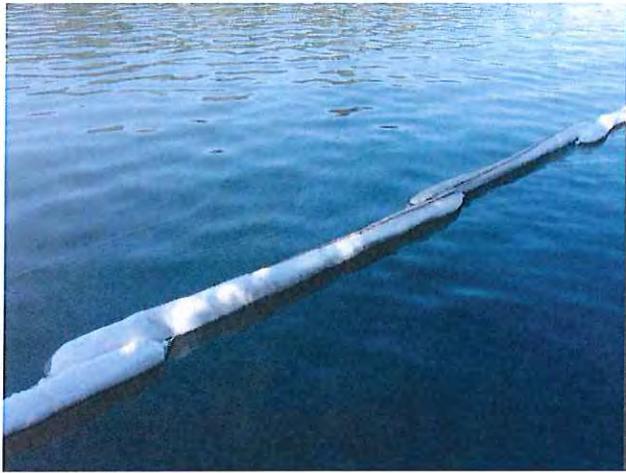
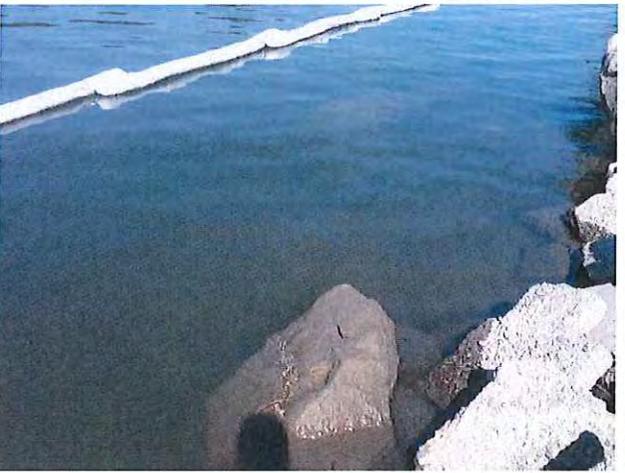
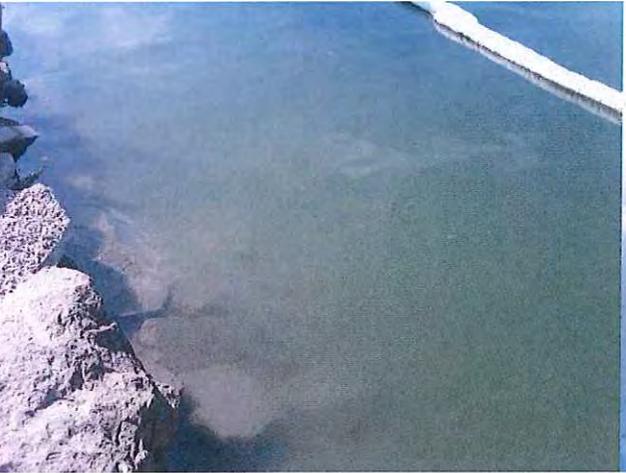
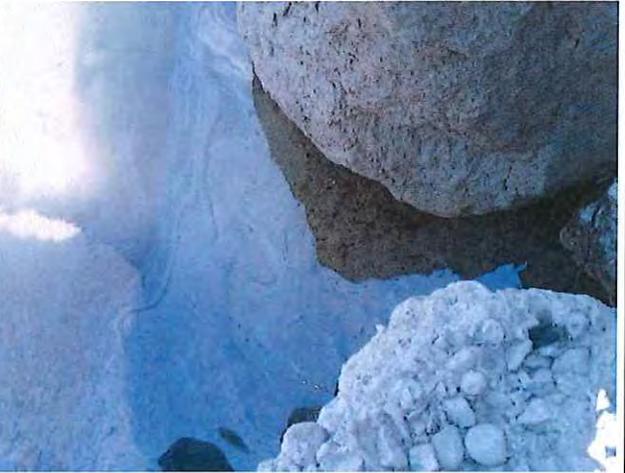
We visited the area of riprap at A-6 RB where visible sheen has been noted emanating from the shore over past several weeks, especially when wakes from passing boats are breaking on the shoreline. The site presently has sorbent boom anchored offshore to contain and recover oil that leaches out of the riprap. The A-6 RB segment is not accessible at this time due to the owner denying his permission to either SCAT or conduct cleanup operations on his property. Therefore, at this time operations have been limited to booming from the river side by boat.

We have been told that agency representatives have recommended that the riprap be flushed with water to ensure that all oil is released, contained and recovered prior to closure of the site. The only flushing that could safely be conducted from the water side would be high pressure flushing using a portable pump. Our recommendation to flush the riprap would be limited to a high volume/low pressure flushing operation. Our preference for this operation would be to use a blanked off plastic or aluminum pipe with 1" holes drilled into the casing every four or five inches. A high volume of water would then be pumped into the pipe at low pressure and the water directed through pipes as described to flush the riprap area to release any oil held in the void spaces and collect it within sorbent boom in the river. Length of pipe would be defined by the pumps GPM capacity. However, this would require access to the shore to install the pipe and pump equipment as well as personnel for operation.

Until access to the shore is approved or negotiated with the landowner(s), we recommend no further action beyond maintenance of the present sorbent boom, which can be continued from the river.

Flushing was performed until no sheen was found. Booms remained in place + did not catch sheen for a period of time. Flushing was again performed. No sheen developed. No additional work required.
