**SCAT Area Transition Report for
A07**

Silvertip Pipeline Incident
Laurel, Montana

October 27, 2011

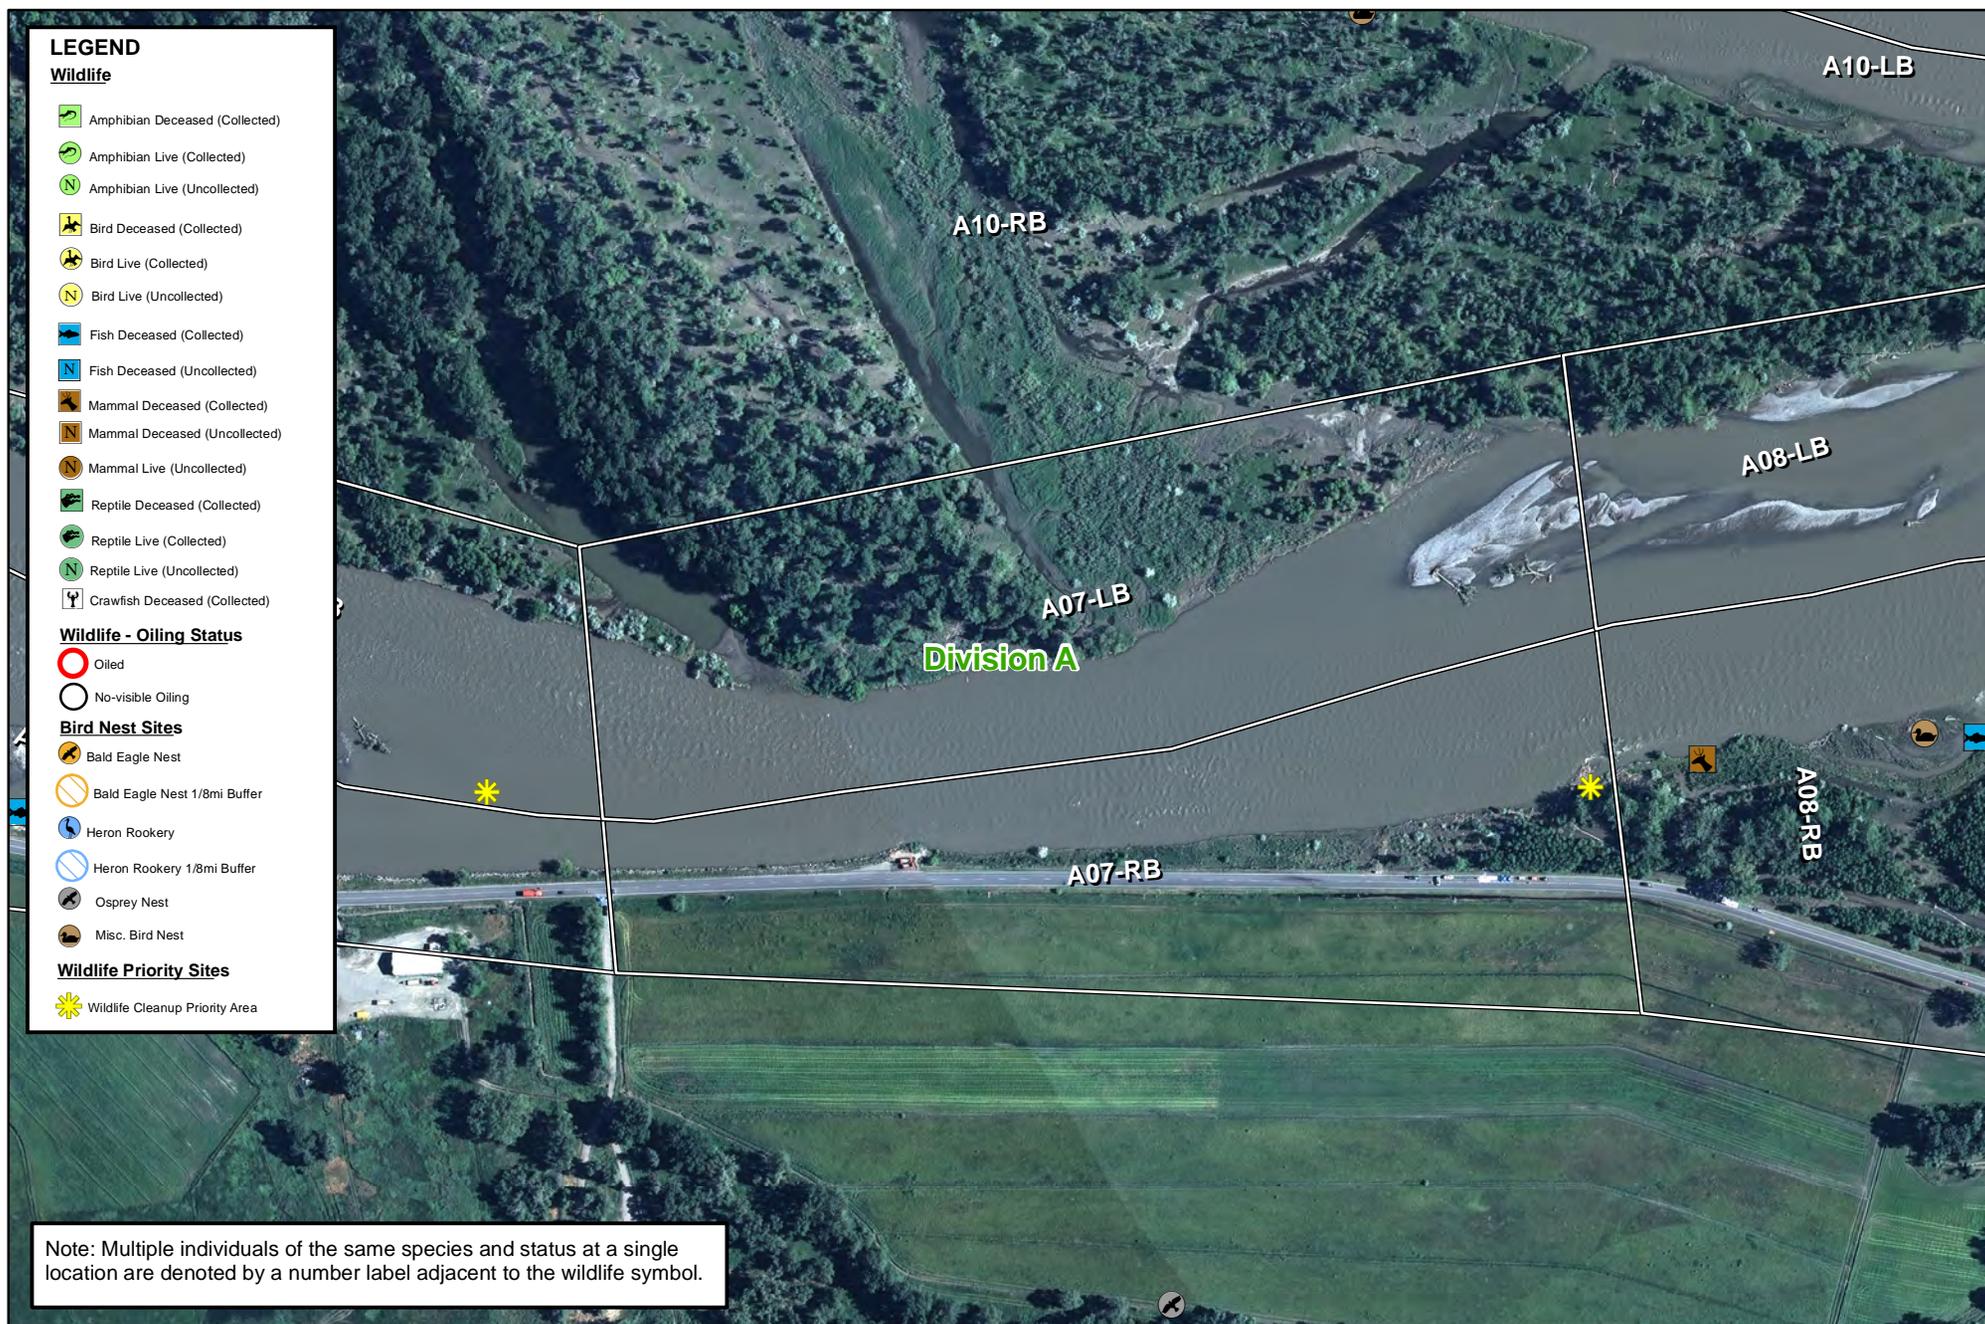
Figure 2
Wildlife Resources

Figure 2 summarizes the natural resources identified in this segment. International Bird Rescue and Resource Advisors from U.S. Fish and Wildlife Service conducted regular inspections of Area A07. No oiled wildlife was observed or recovered. One Wildlife Priority Cleanup Area (WPCA) was identified. The WPCA consists of a log depression area on the edge of the river bank; treatment efforts are ongoing at the site as discussed in Section 1.10. No active migratory bird nests were identified in Area A07.

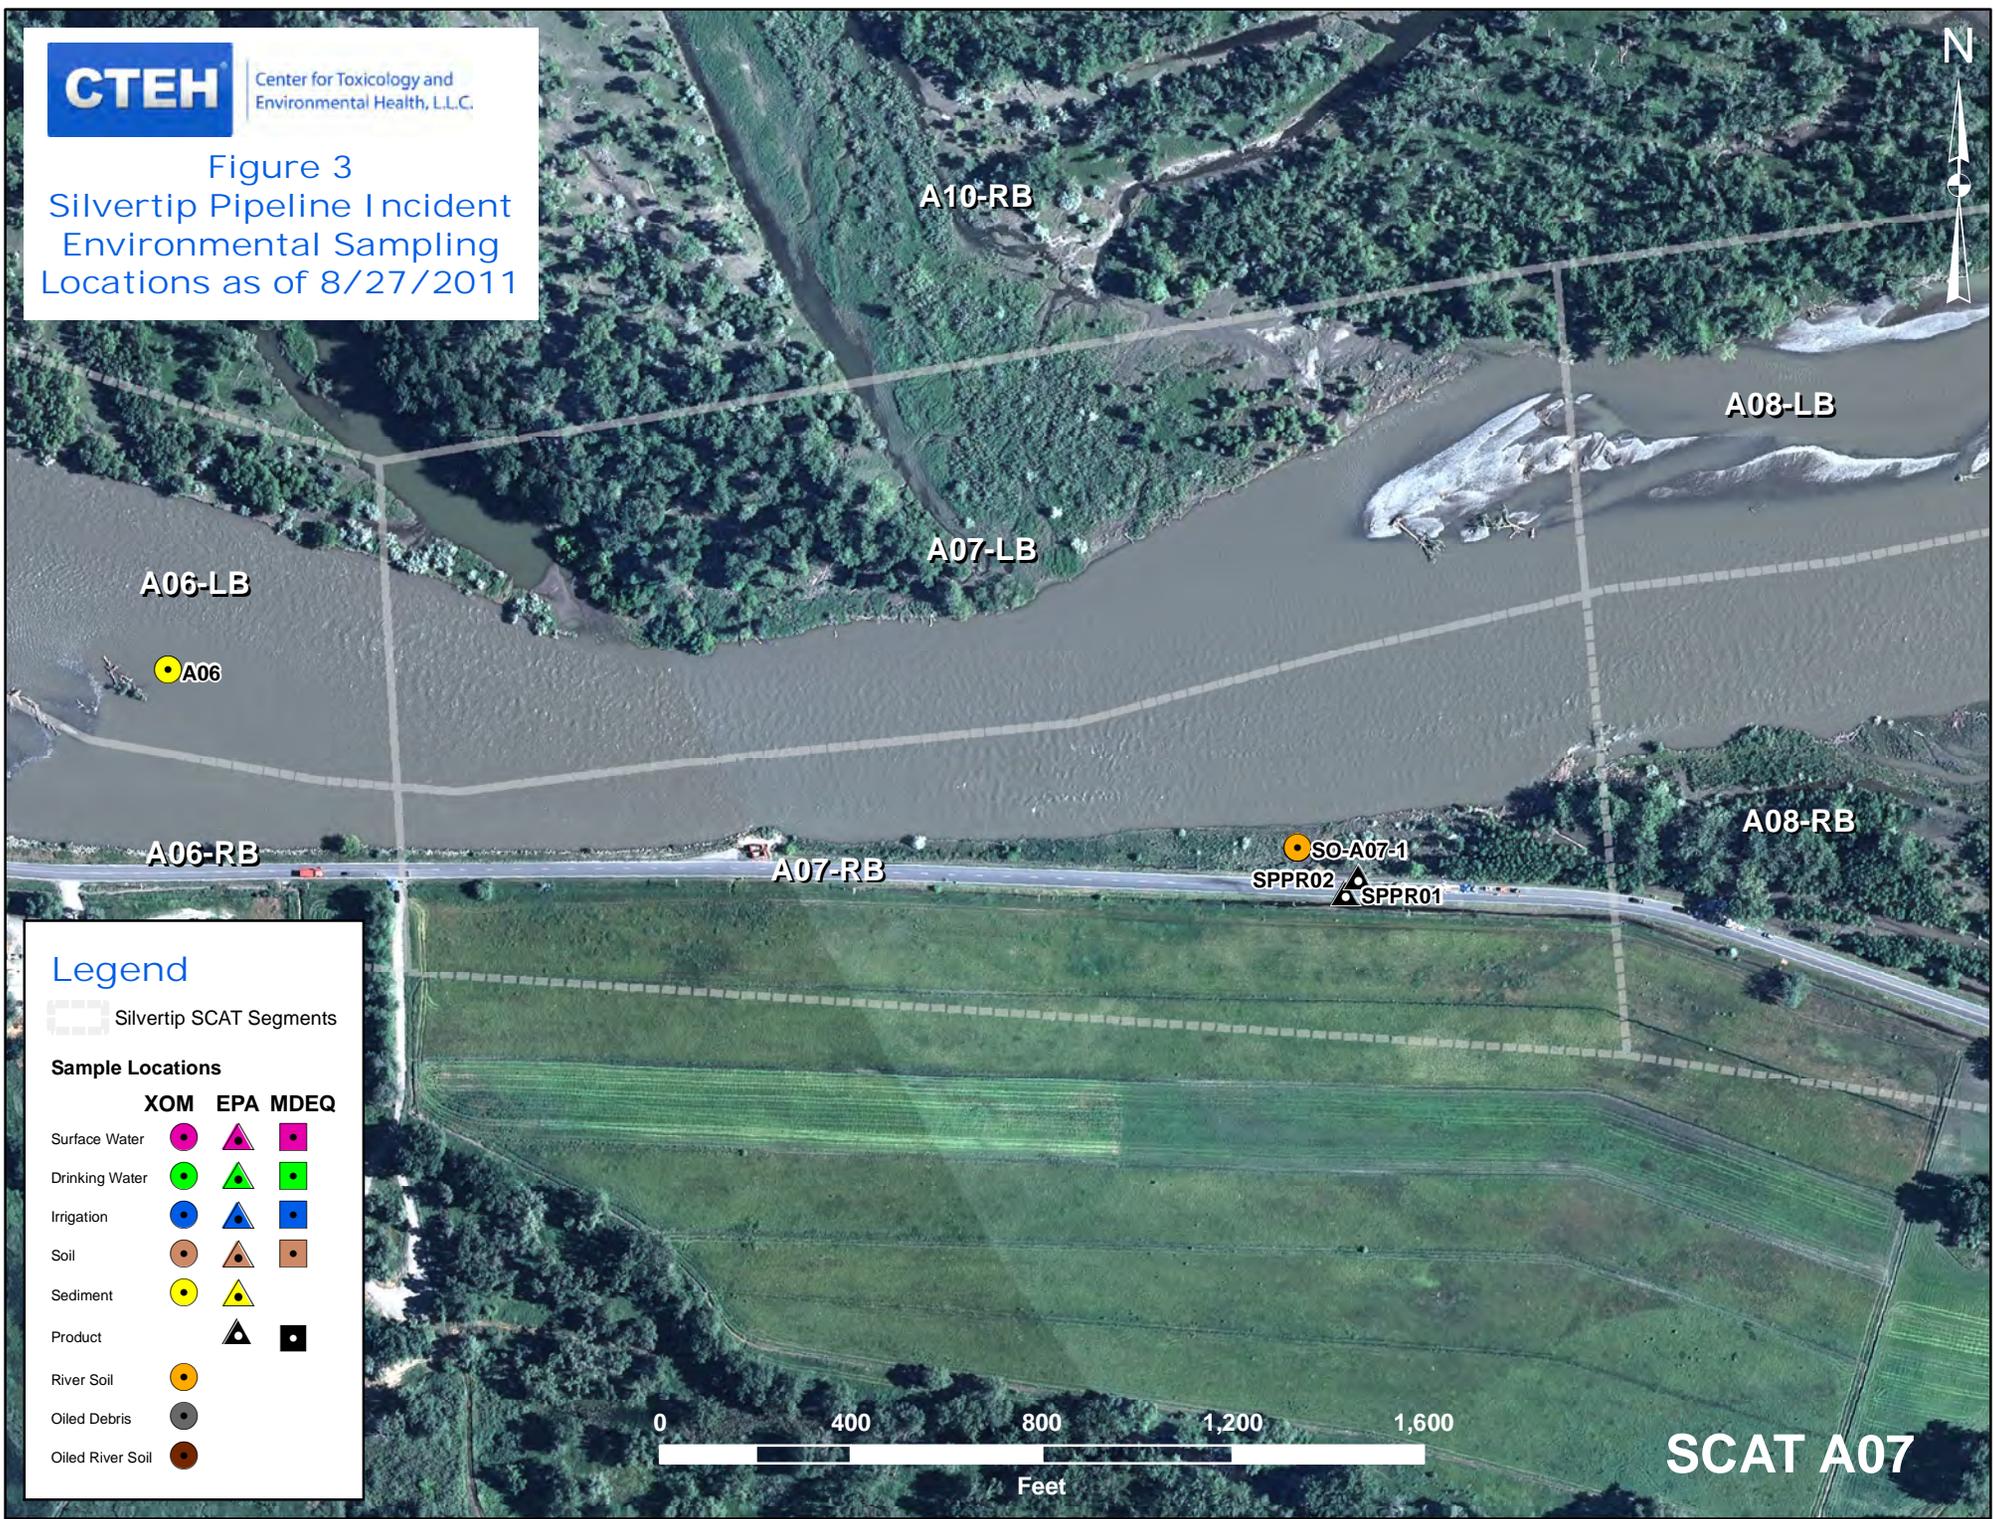
Figure 3
 Silvertip Pipeline Incident
 Environmental Sampling
 Locations as of 8/27/2011

Table 1 (below) summarizes samples collected within Area A07. The analytical results for the samples collected can be accessed through a publicly accessible database on the United States Environmental Protection Agency's (USEPA's) website. The approximate locations of samples collected within Area A07 are provided on Figure 3.

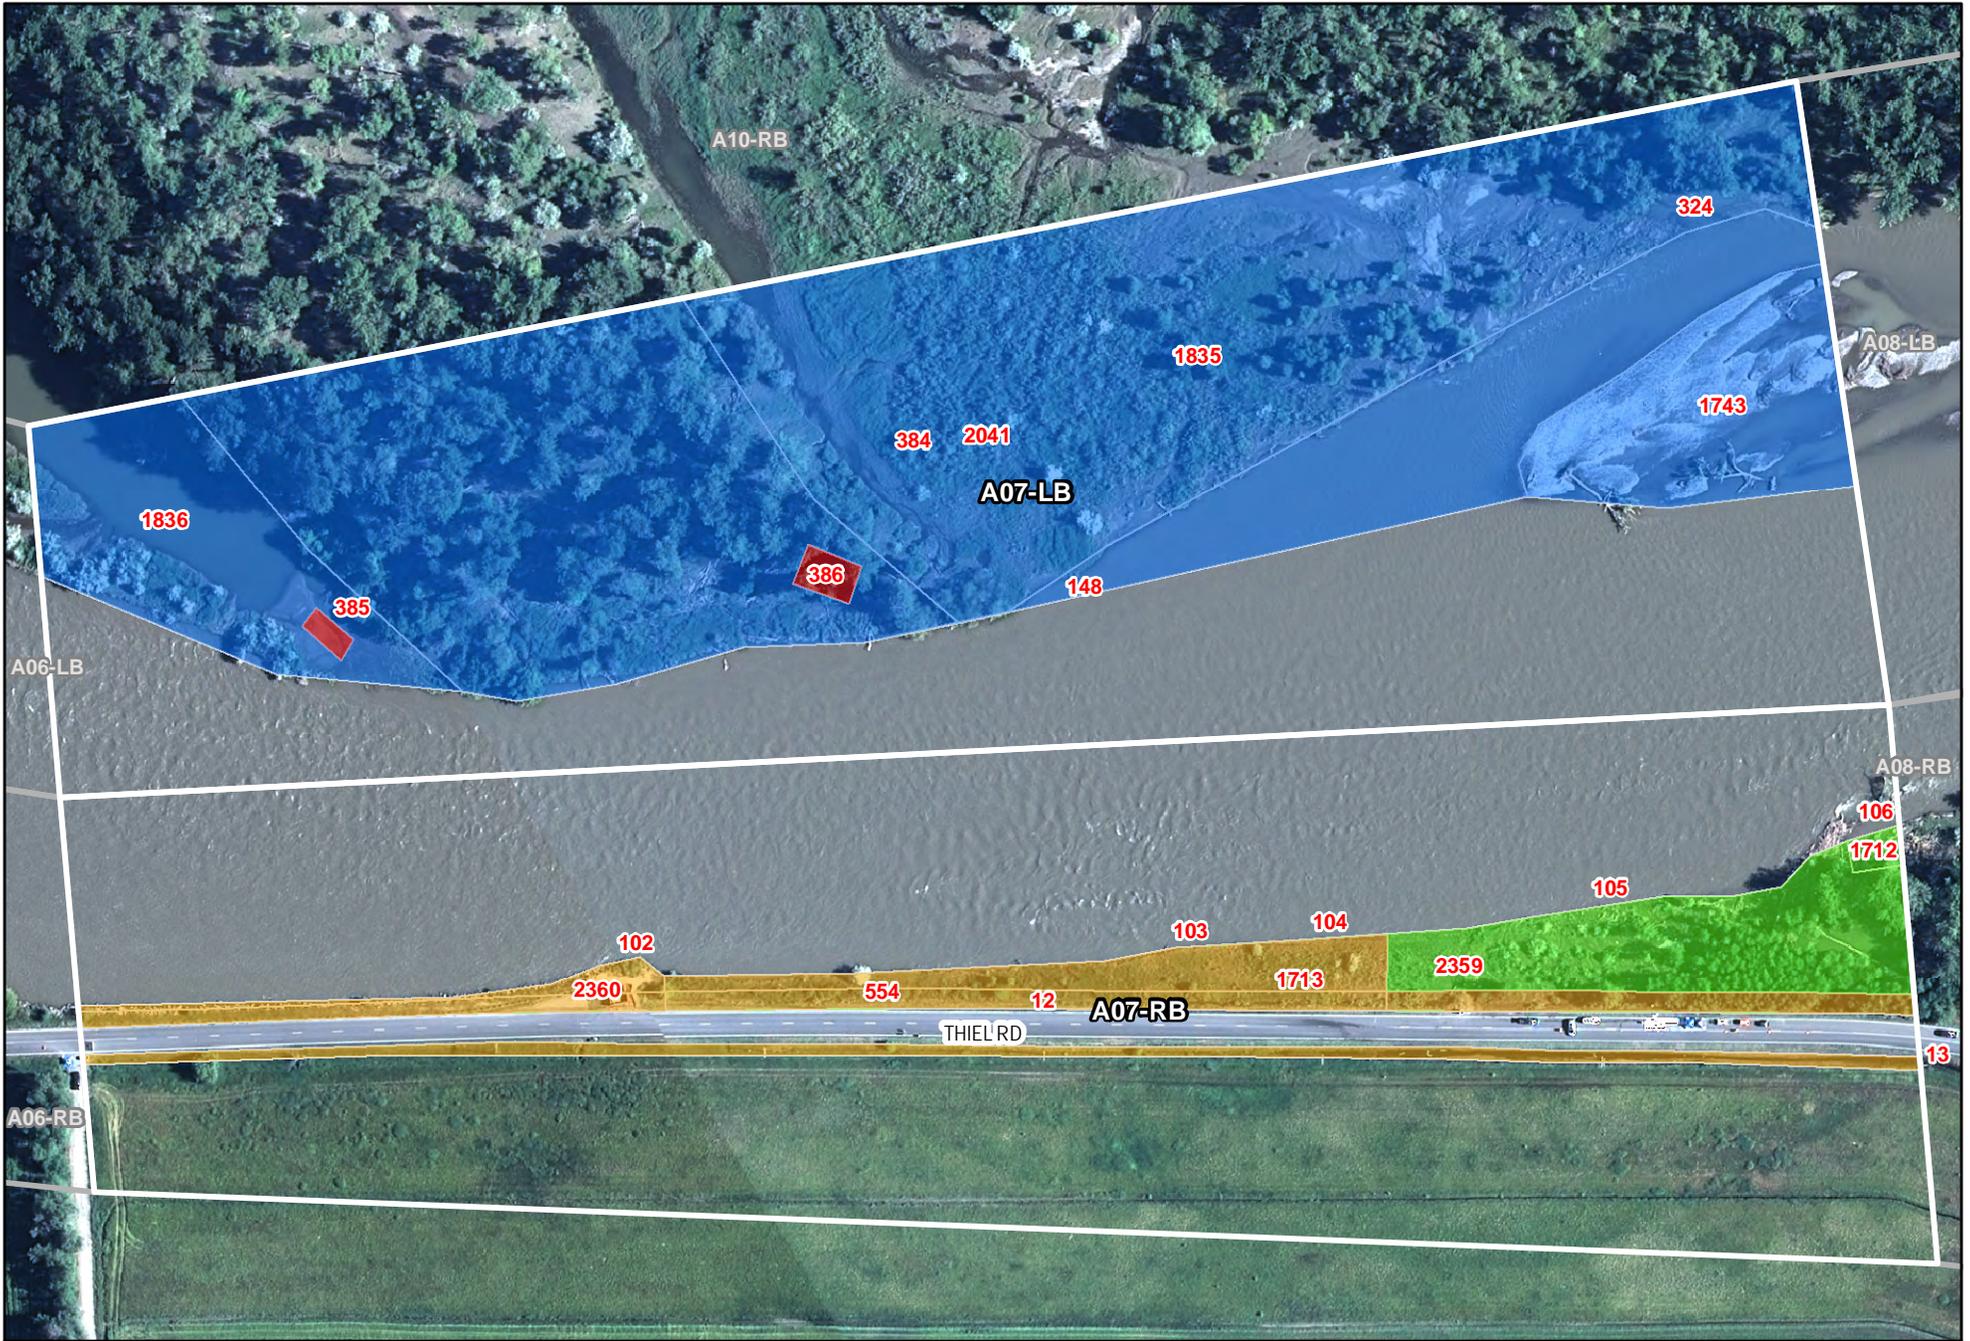
**Figure 4 - Maximum SCAT Observations
For SCAT Area: A07**

The SCAT teams used systematic evaluation criteria and treatment method tables approved by the National Oceanic and Atmospheric Administration to provide a standard approach for data collection and conducting field surveys. The forms and sketches from the initial SCAT surveys performed along the river bank (water edge) and floodplain within Area A07 are included in Appendix B. Figure 4 provides the maximum oiling zones observed by the SCAT team during the initial surveys of Area A07.

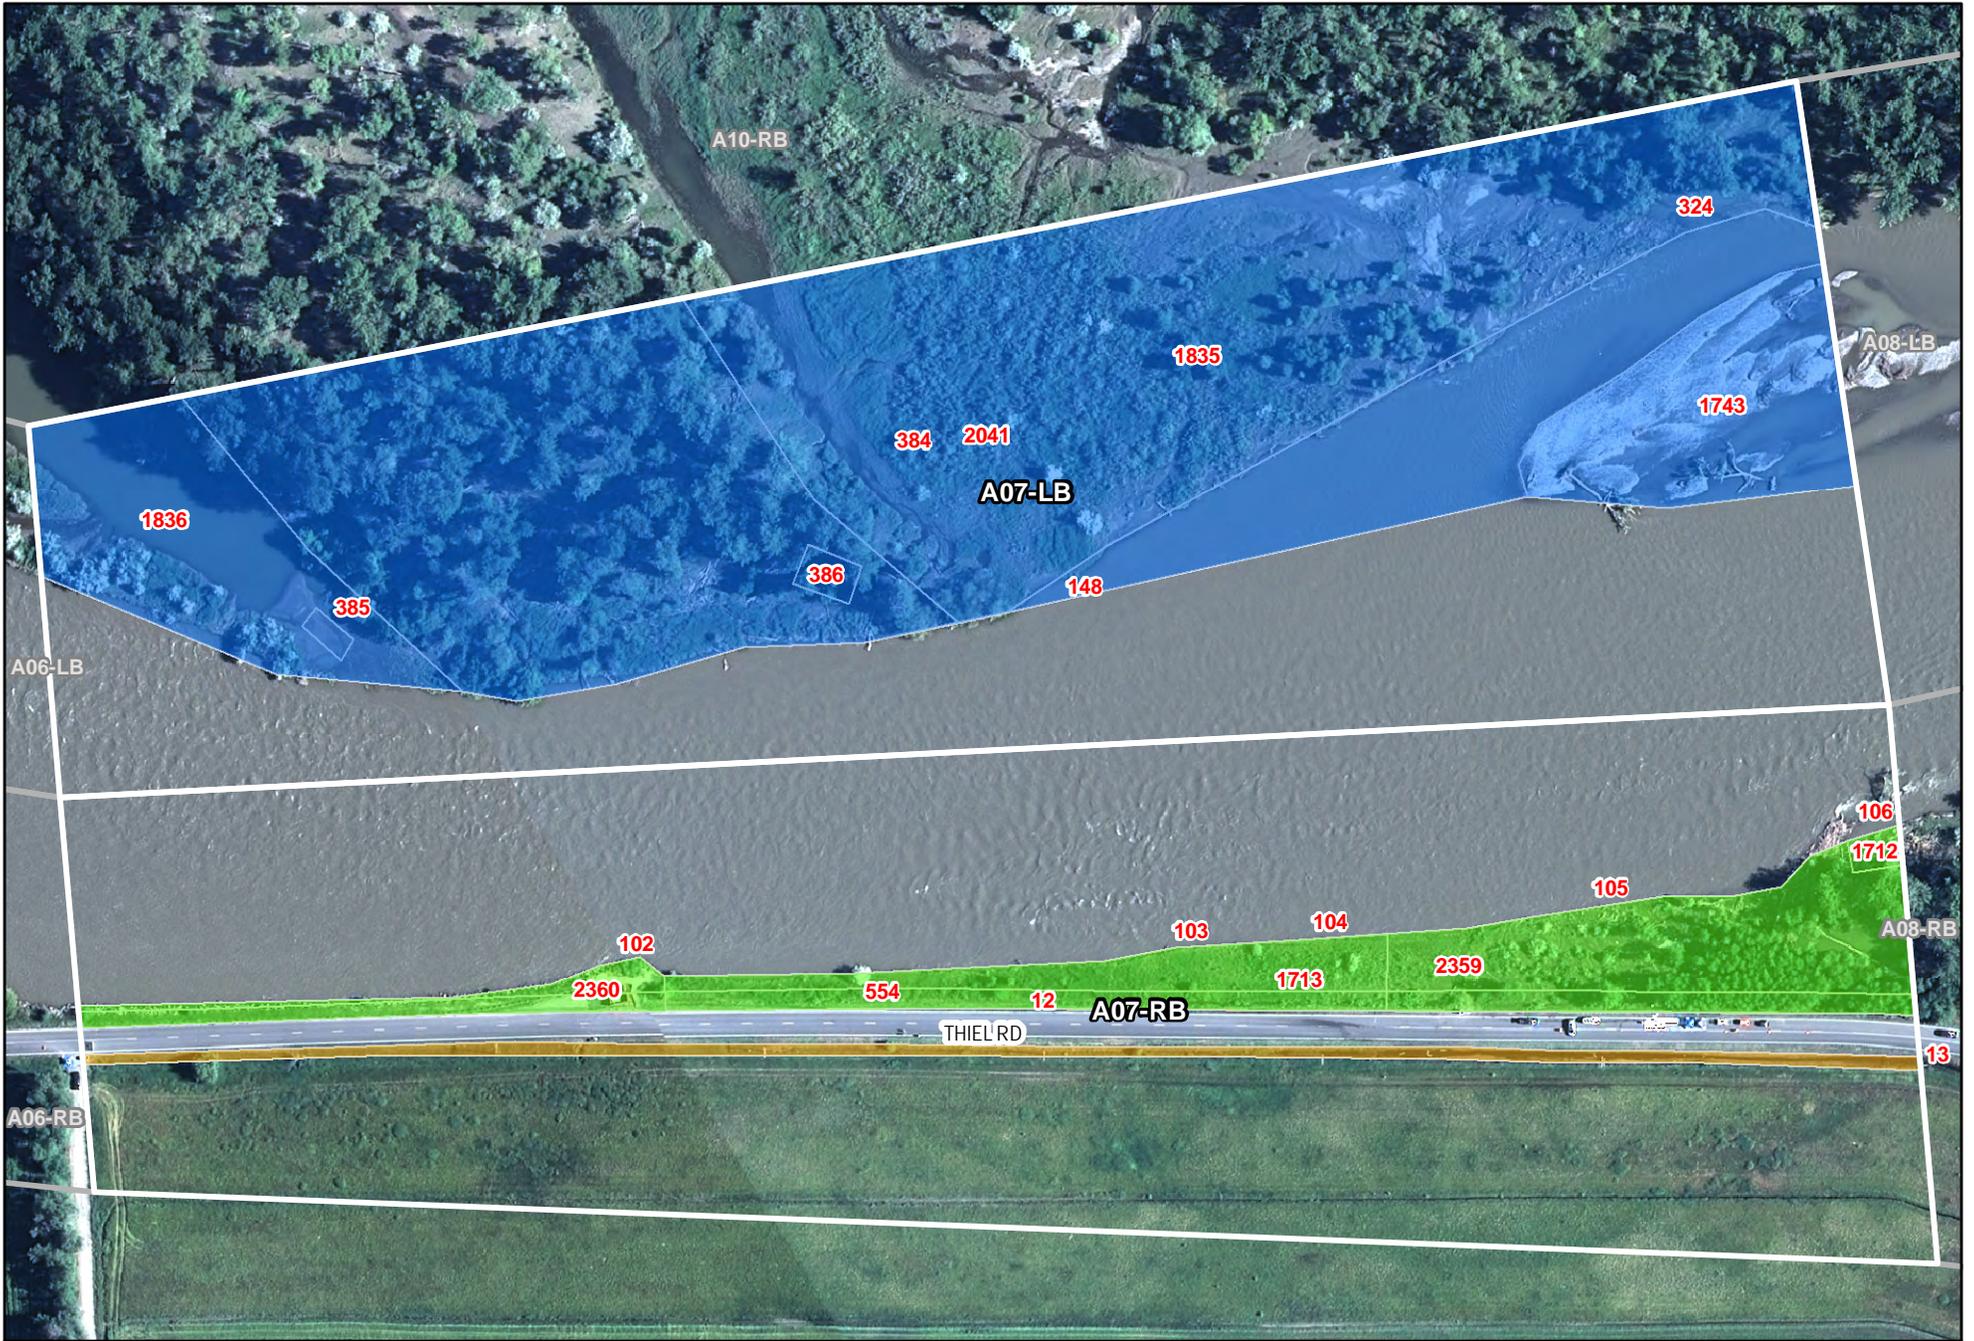
<p>9999 Oiling Zone ID</p> <p>Heavy Oiling</p> <p>Moderate Oiling</p>	<p>Light Oiling</p> <p>Very Light Oiling</p> <p>No Oil Observed</p>	<p>Figure 5 - Final SCAT Observations</p> <p>For SCAT Area: A07</p>	
---	---	---	--

Figure 5 shows the oiling conditions within Area A07 following completion of oil removal activities. The SCAT team performed final surveys of the right and left banks within SCAT Area A07 to confirm the agreed-upon cleanup endpoints identified in the applicable CTRs had been achieved. The final SCAT survey documentation is presented in Appendix E.

Based on the final SCAT surveys performed on the right and left banks within Area A07, no further treatment is recommended and no oil is observed for the right and left banks. SCAT Segment Sign-Off Forms are included as Appendix F.

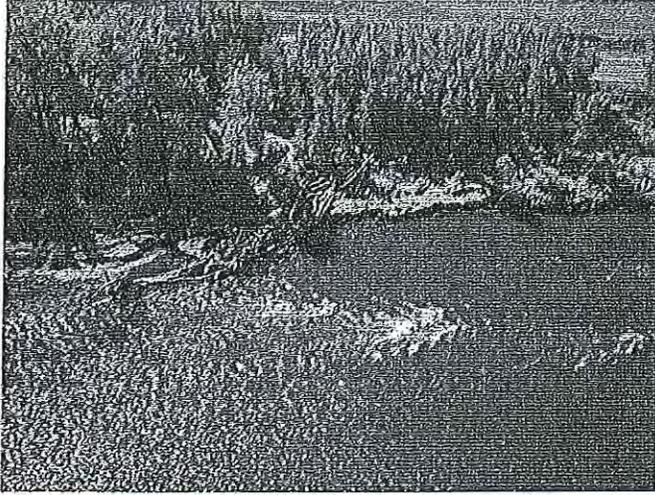
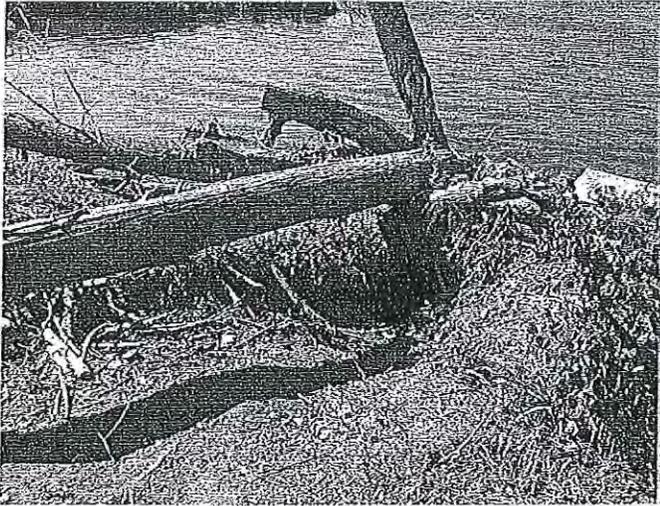
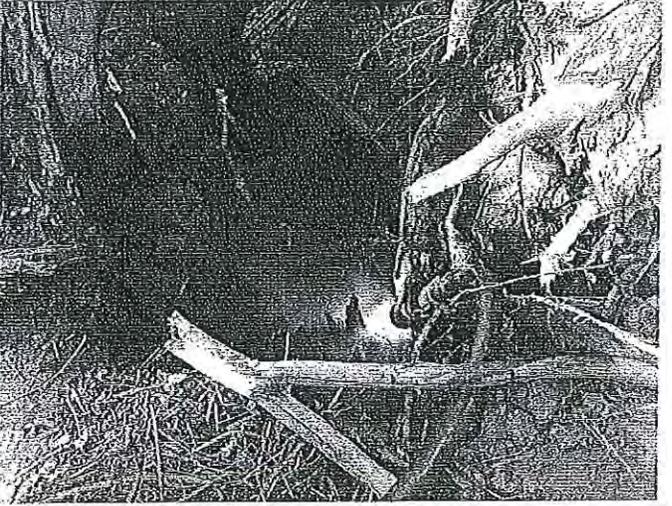
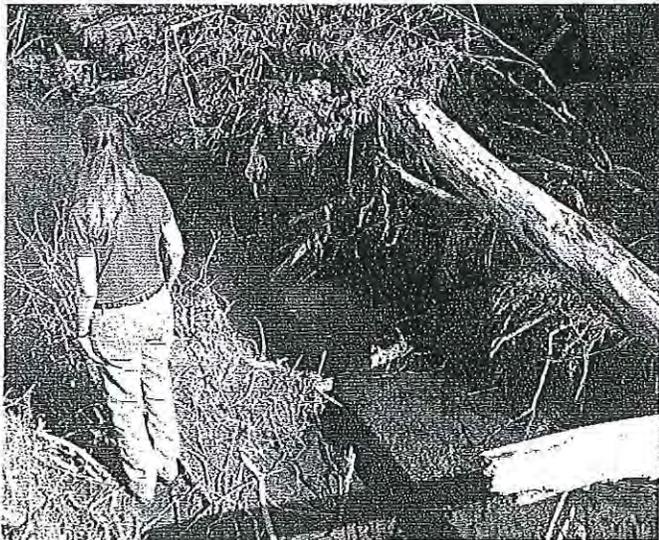
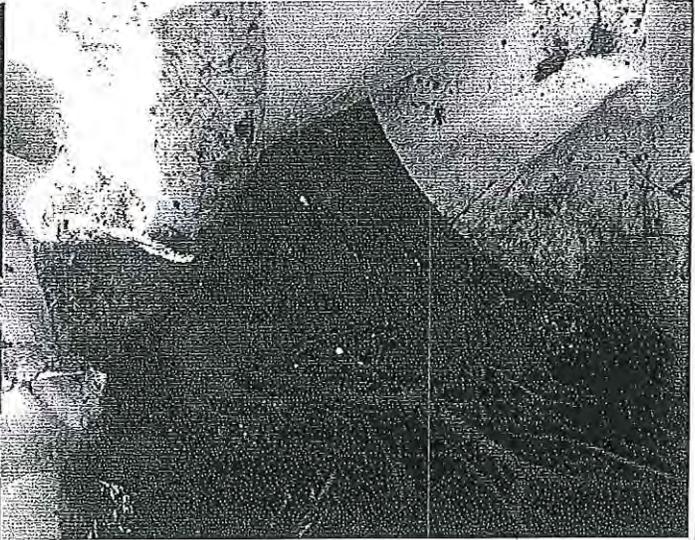
We recommend that at A-7 the flushing operations be stopped and it be allowed to sheen naturally if it does so. The boom should be maintained, but at a distance away from the depression to allow any sheen that may emanate from the depression to disperse and degrade from sun exposure. Once flushing is stopped, locally obtained dirt should be used to immediately dust the depression area and exposed roots while still damp to minimize possibility of oil being transferred to any wildlife that may enter the depressions.

As recommended for A-7, we also recommend that the sorbents at both A-8 depressions be removed to facilitate natural evaporation and drying of sediment and wood in the depression. If possible, oiled roots that can be safely reached should be trimmed to extent possible. The sorbent boom should be maintained at a distance from the depressions to allow sheen to disperse and degrade from sun exposure, but to also ensure sheen does not escape from site and into the river.

these log depressions will now transition into long term monitoring + maintenance. Site will be inspected when water level rises to ensure "no sheen" continues. If sheen is found, booms + pads will be placed as appropriate.

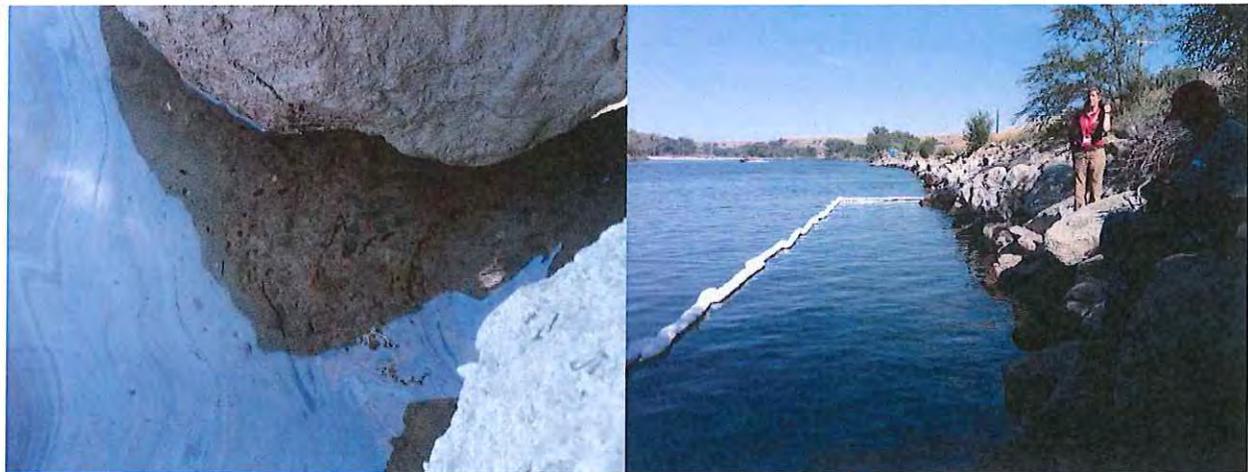
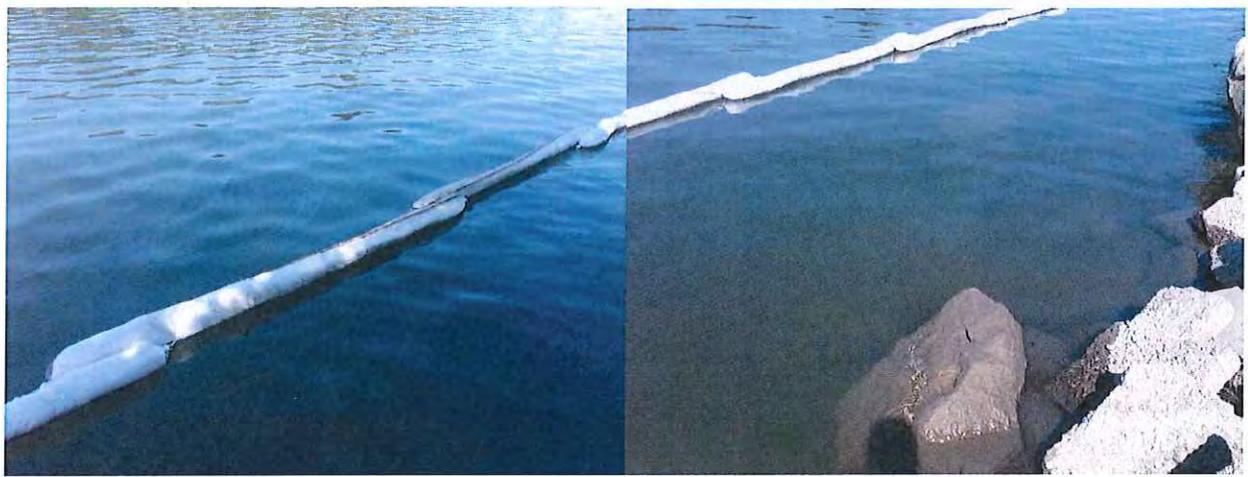
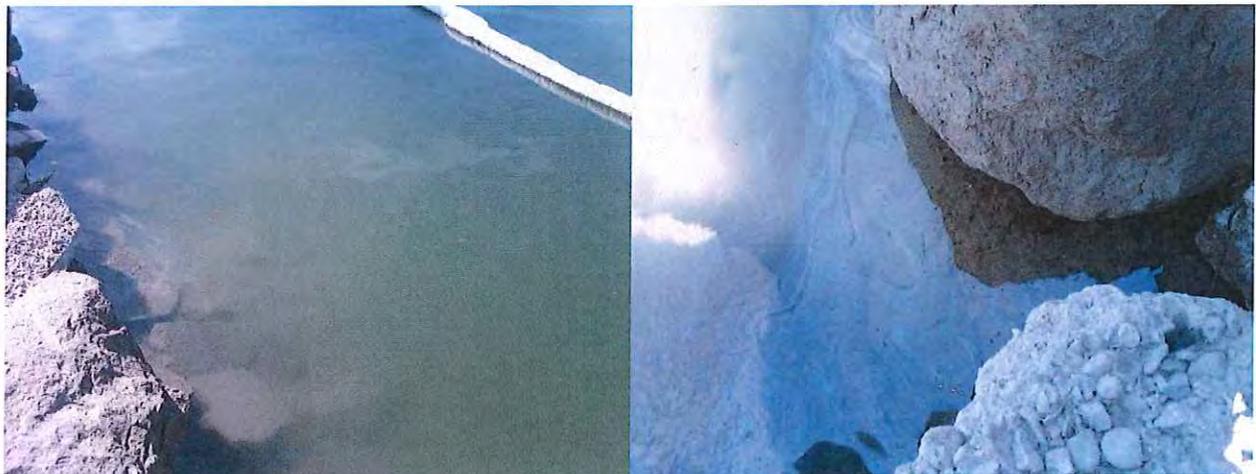
We visited the area of riprap at A-6 RB where visible sheen has been noted emanating from the shore over past several weeks, especially when wakes from passing boats are breaking on the shoreline. The site presently has sorbent boom anchored offshore to contain and recover oil that leaches out of the riprap. The A-6 RB segment is not accessible at this time due to the owner denying his permission to either SCAT or conduct cleanup operations on his property. Therefore, at this time operations have been limited to booming from the river side by boat.

We have been told that agency representatives have recommended that the riprap be flushed with water to ensure that all oil is released, contained and recovered prior to closure of the site. The only flushing that could safely be conducted from the water side would be high pressure flushing using a portable pump. Our recommendation to flush the riprap would be limited to a high volume/low pressure flushing operation. Our preference for this operation would be to use a blanked off plastic or aluminum pipe with 1" holes drilled into the casing every four or five inches. A high volume of water would then be pumped into the pipe at low pressure and the water directed through pipes as described to flush the riprap area to release any oil held in the void spaces and collect it within sorbent boom in the river. Length of pipe would be defined by the pumps GPM capacity. However, this would require access to the shore to install the pipe and pump equipment as well as personnel for operation.

Photos from a site visit conducted on 8/24/2011 are enclosed within the following page.

Until access to the shore is approved or negotiated with the landowner(s), we recommend no further action beyond maintenance of the present sorbent boom, which can be continued from the river.
