**SCAT Area Transition Report  
for A09**

Silvertip Pipeline Incident  
Laurel, Montana

Prepared for:  
ExxonMobil Pipeline Company

Prepared by:  
ARCADIS G&M of North Carolina, Inc.  
11000 Regency Parkway  
West Tower, Suite 205  
Cary, North Carolina 27518-8518  
Tel 919.469.1952  
Fax 919.469.5676

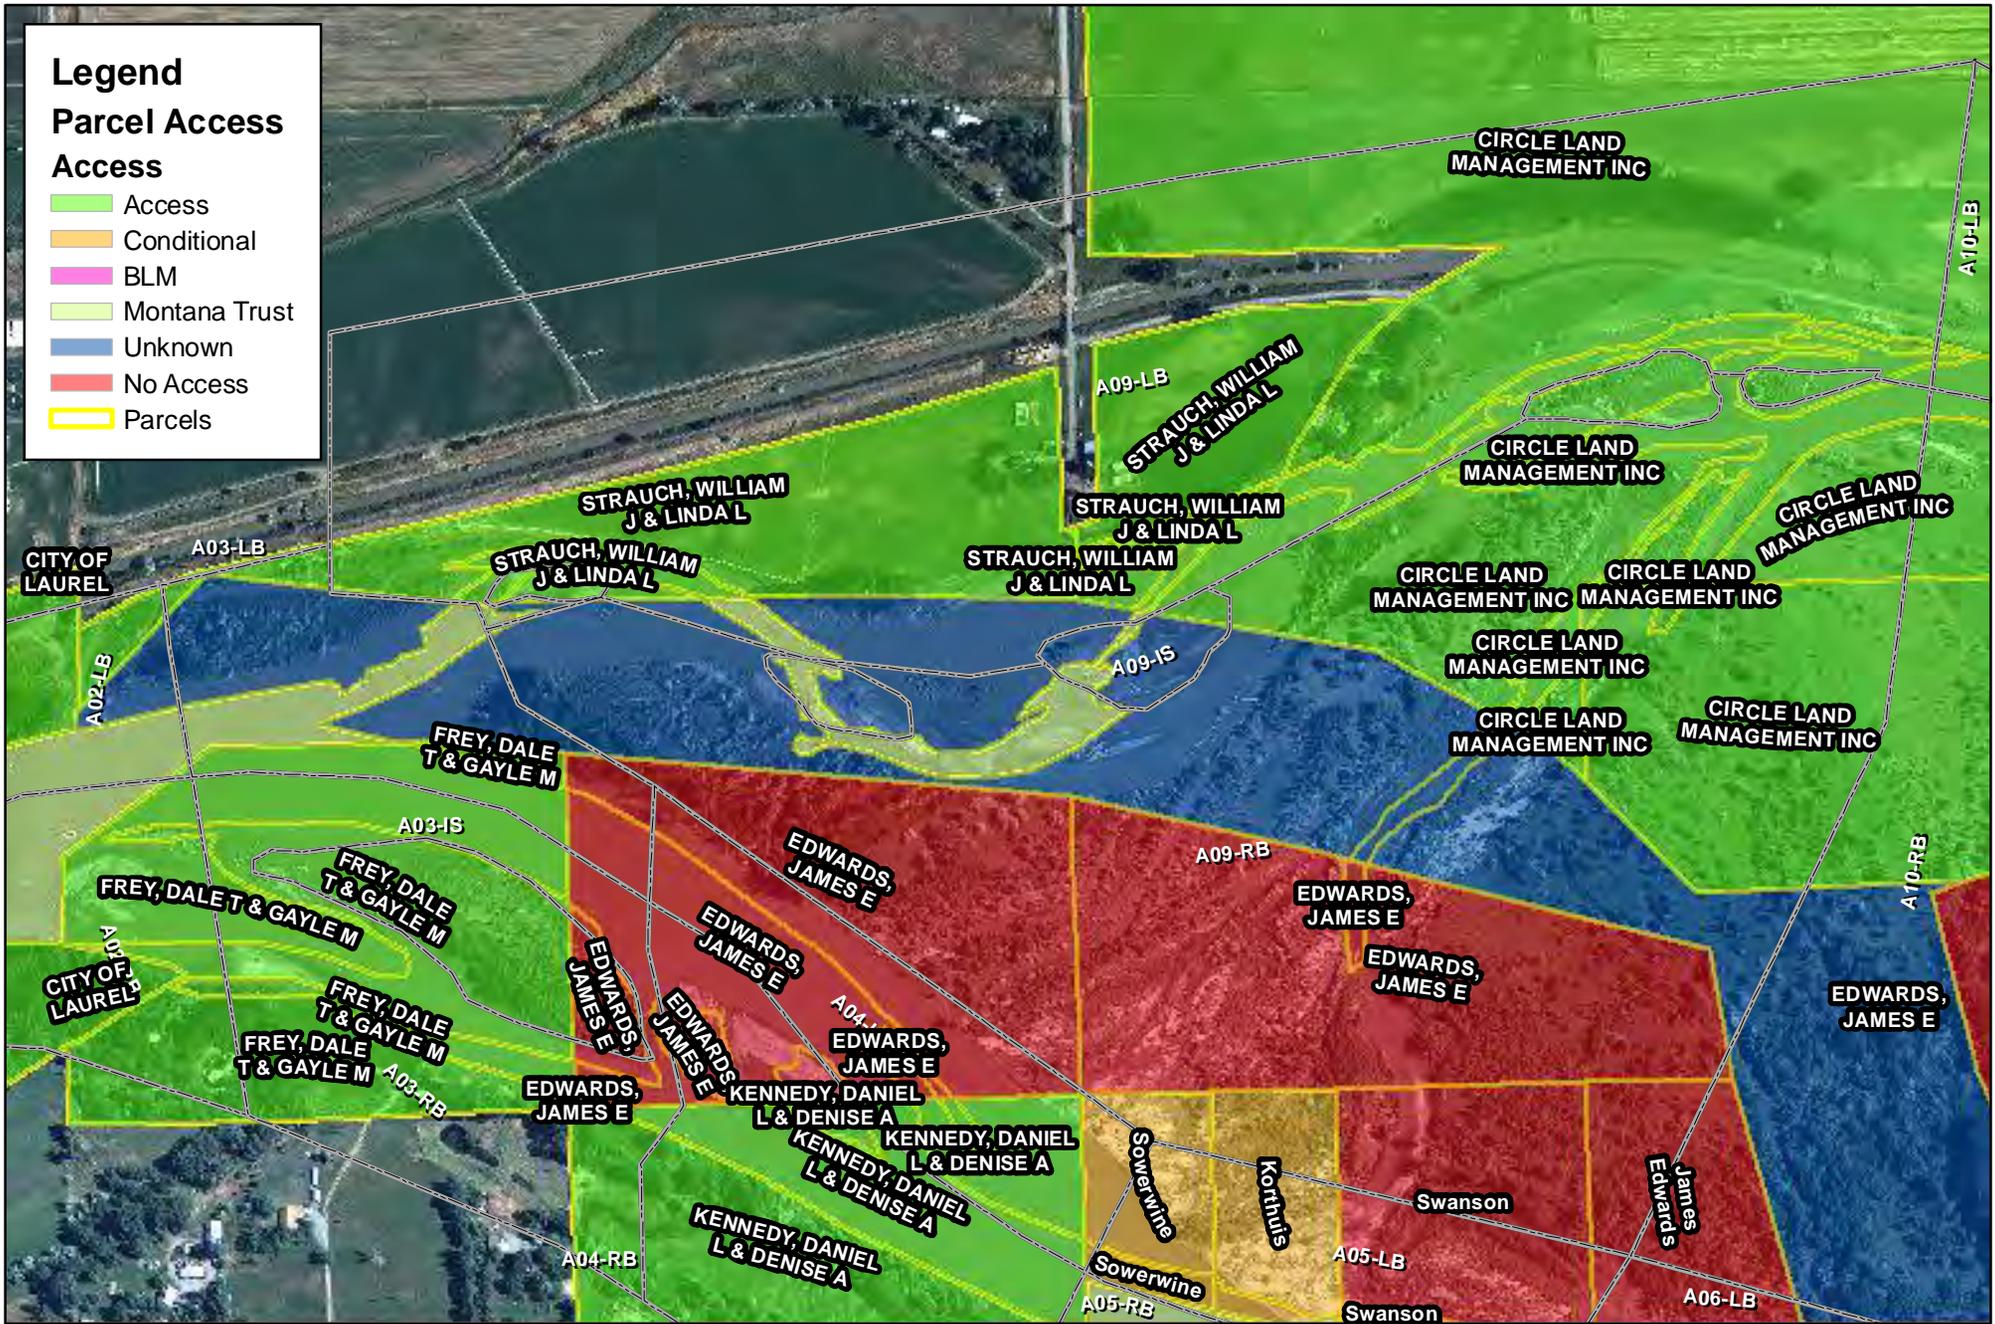
Figure 1 provides an aerial map of SCAT Area A09, along with the (a) SCAT Area boundary, (b) parcel boundaries and respective property owners, and (c) access constraints identified during the oil cleanup process. The acreage surveyed in Area A09 is 101.9. There were access issues for a partial piece of the right bank.

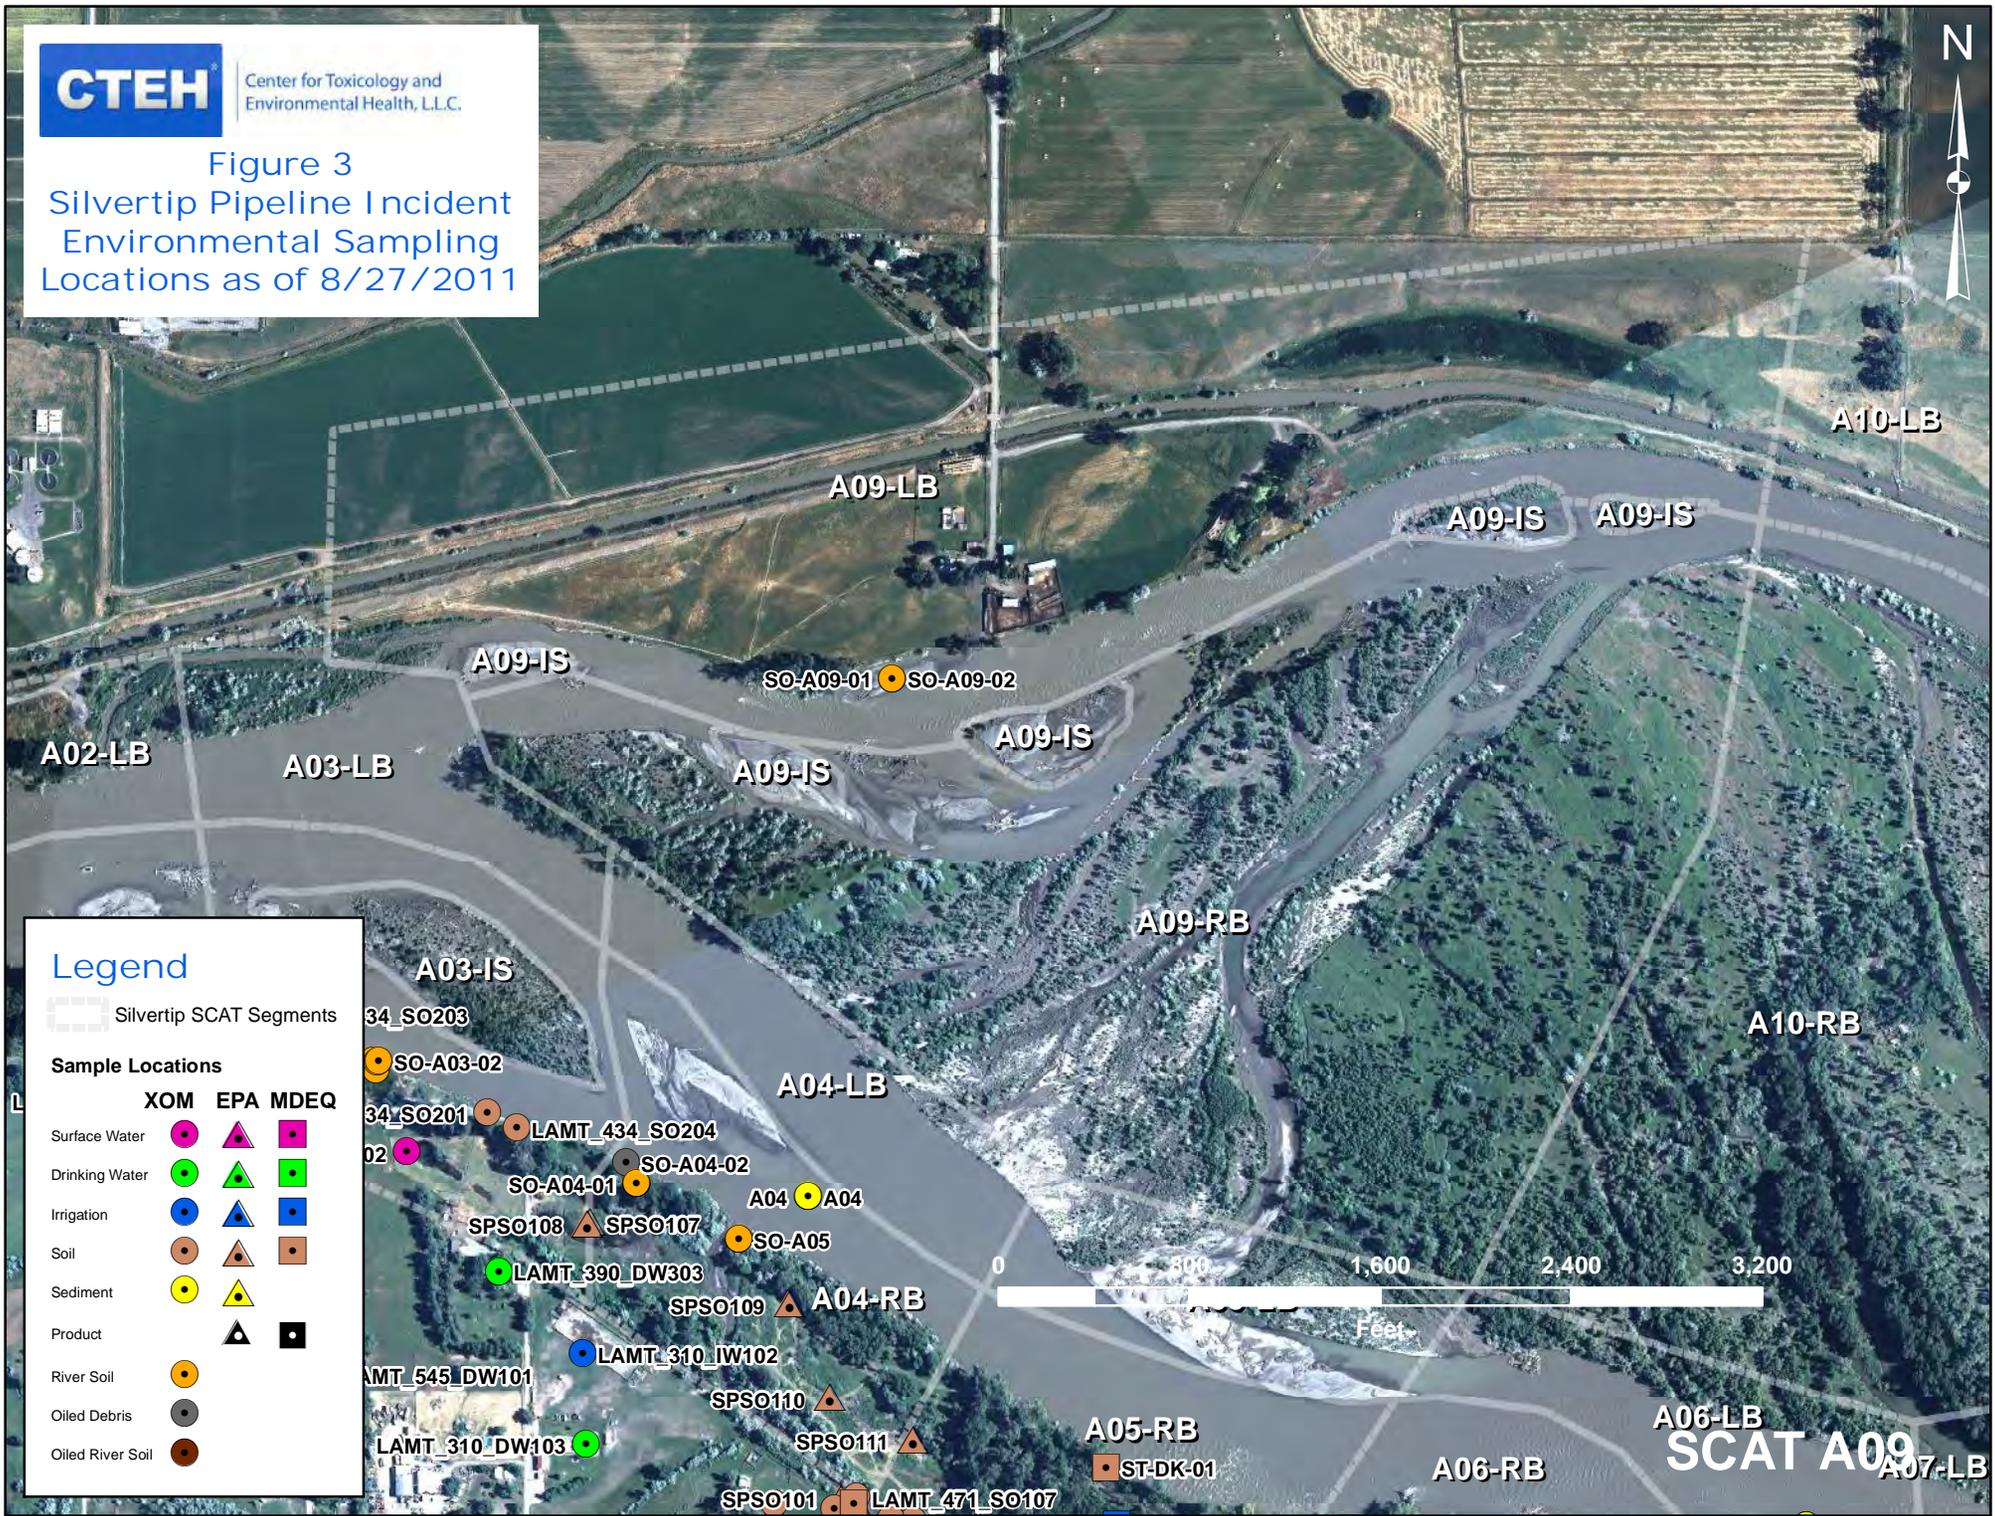
**Figure 3**  
 Silvertip Pipeline Incident  
 Environmental Sampling  
 Locations as of 8/27/2011

Table 1 (below) summarizes samples collected within Area A09. The analytical results for the samples collected can be accessed through a publicly accessible database on the United States Environmental Protection Agency's (USEPA's) website. The approximate locations of samples collected within Area A09 are provided on Figure 3.

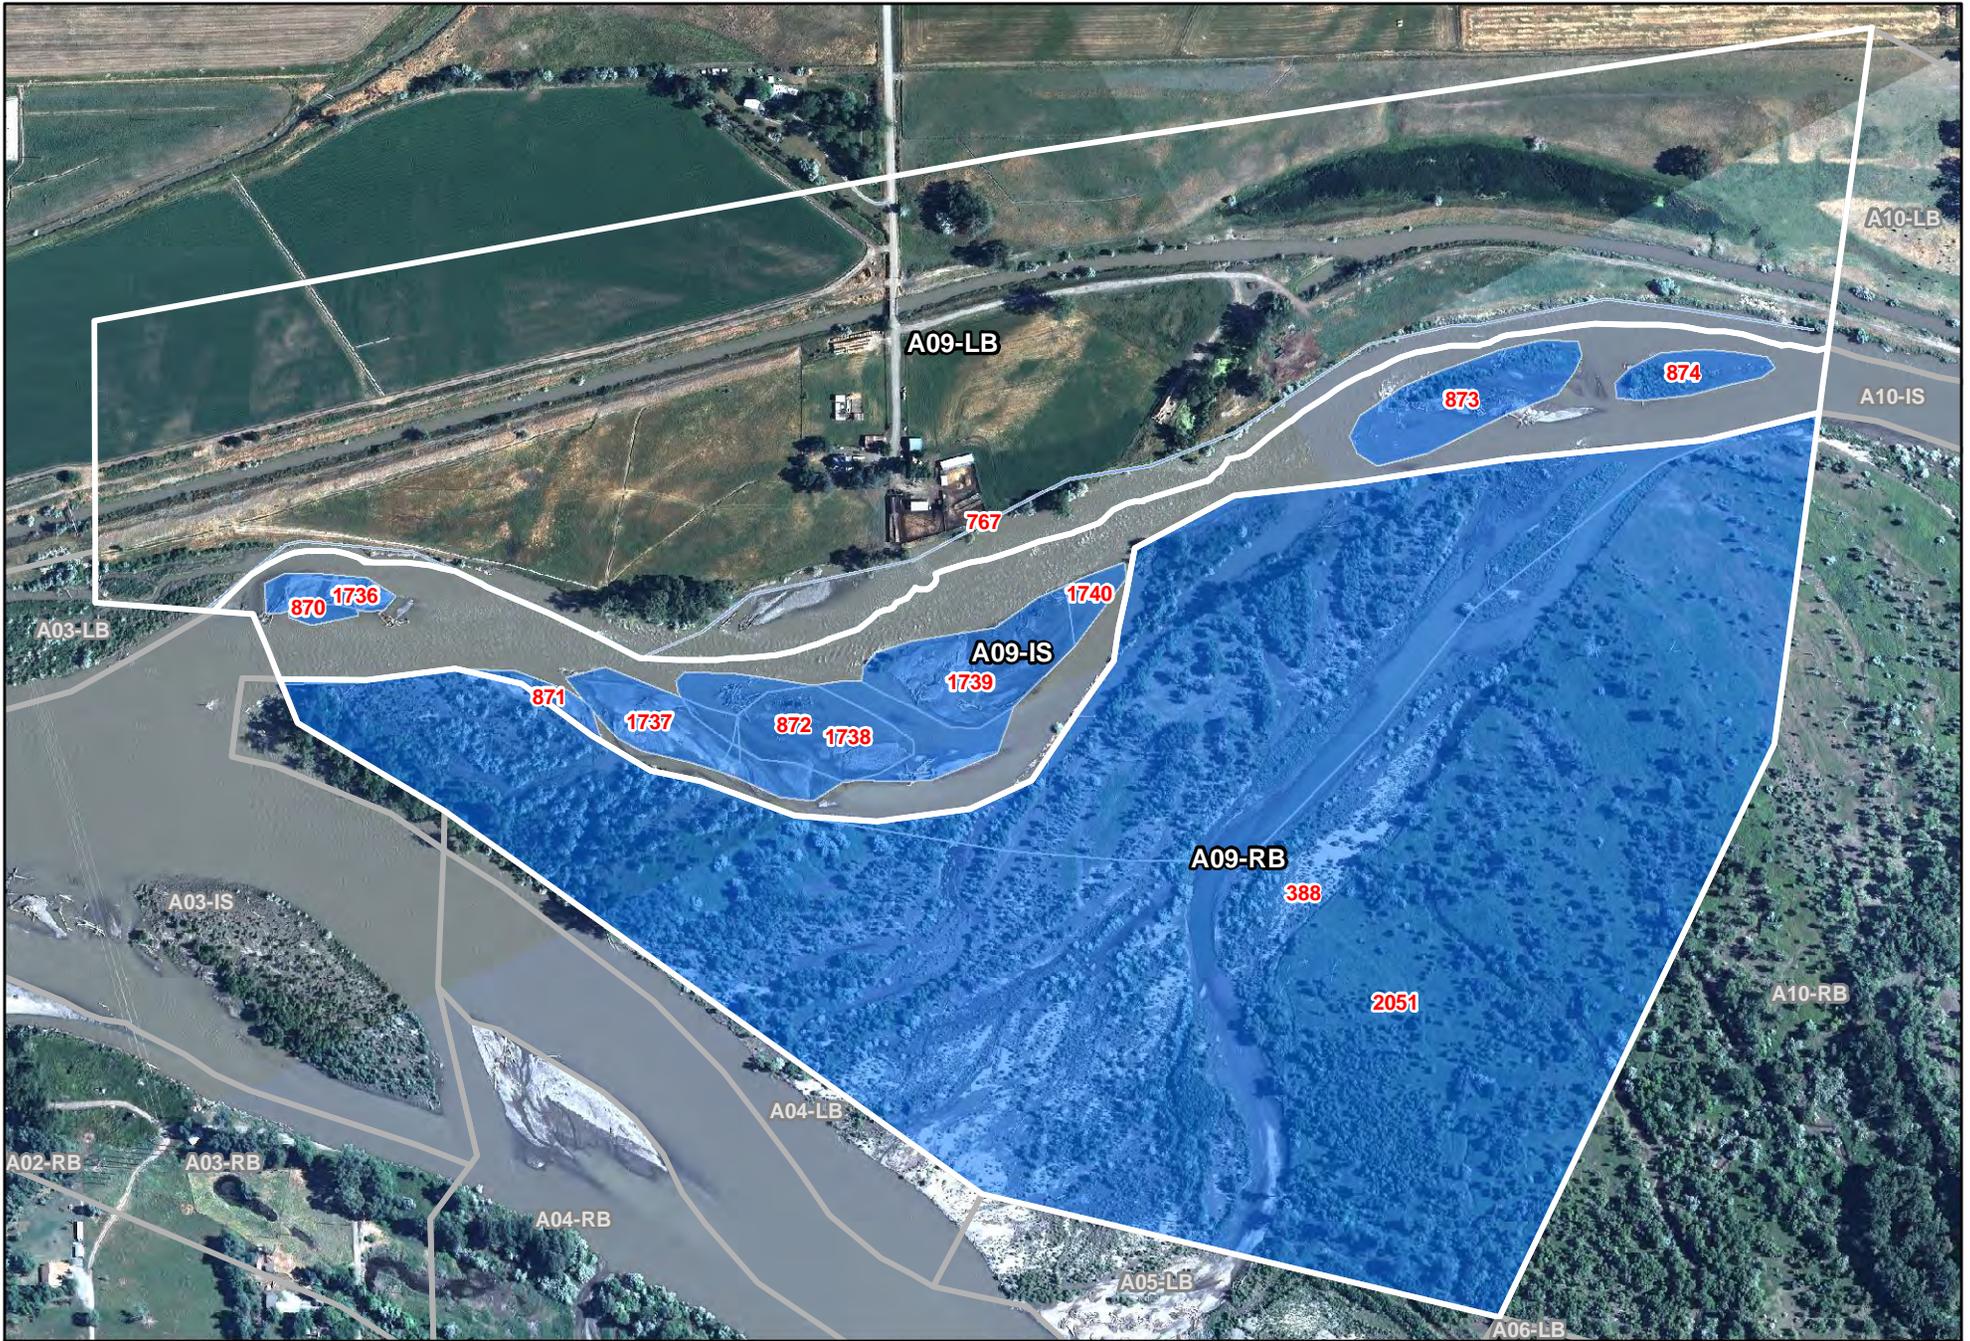
**Figure 4 - Maximum SCAT Observations  
For SCAT Area: A09**

Based on the initial SCAT survey performed within Area A09, no oiling was observed on the right bank, left bank, or islands. Therefore, a PIST, POST, and final SCAT survey were not performed and a SCAT Segment Sign-Off Sheet is not necessary.

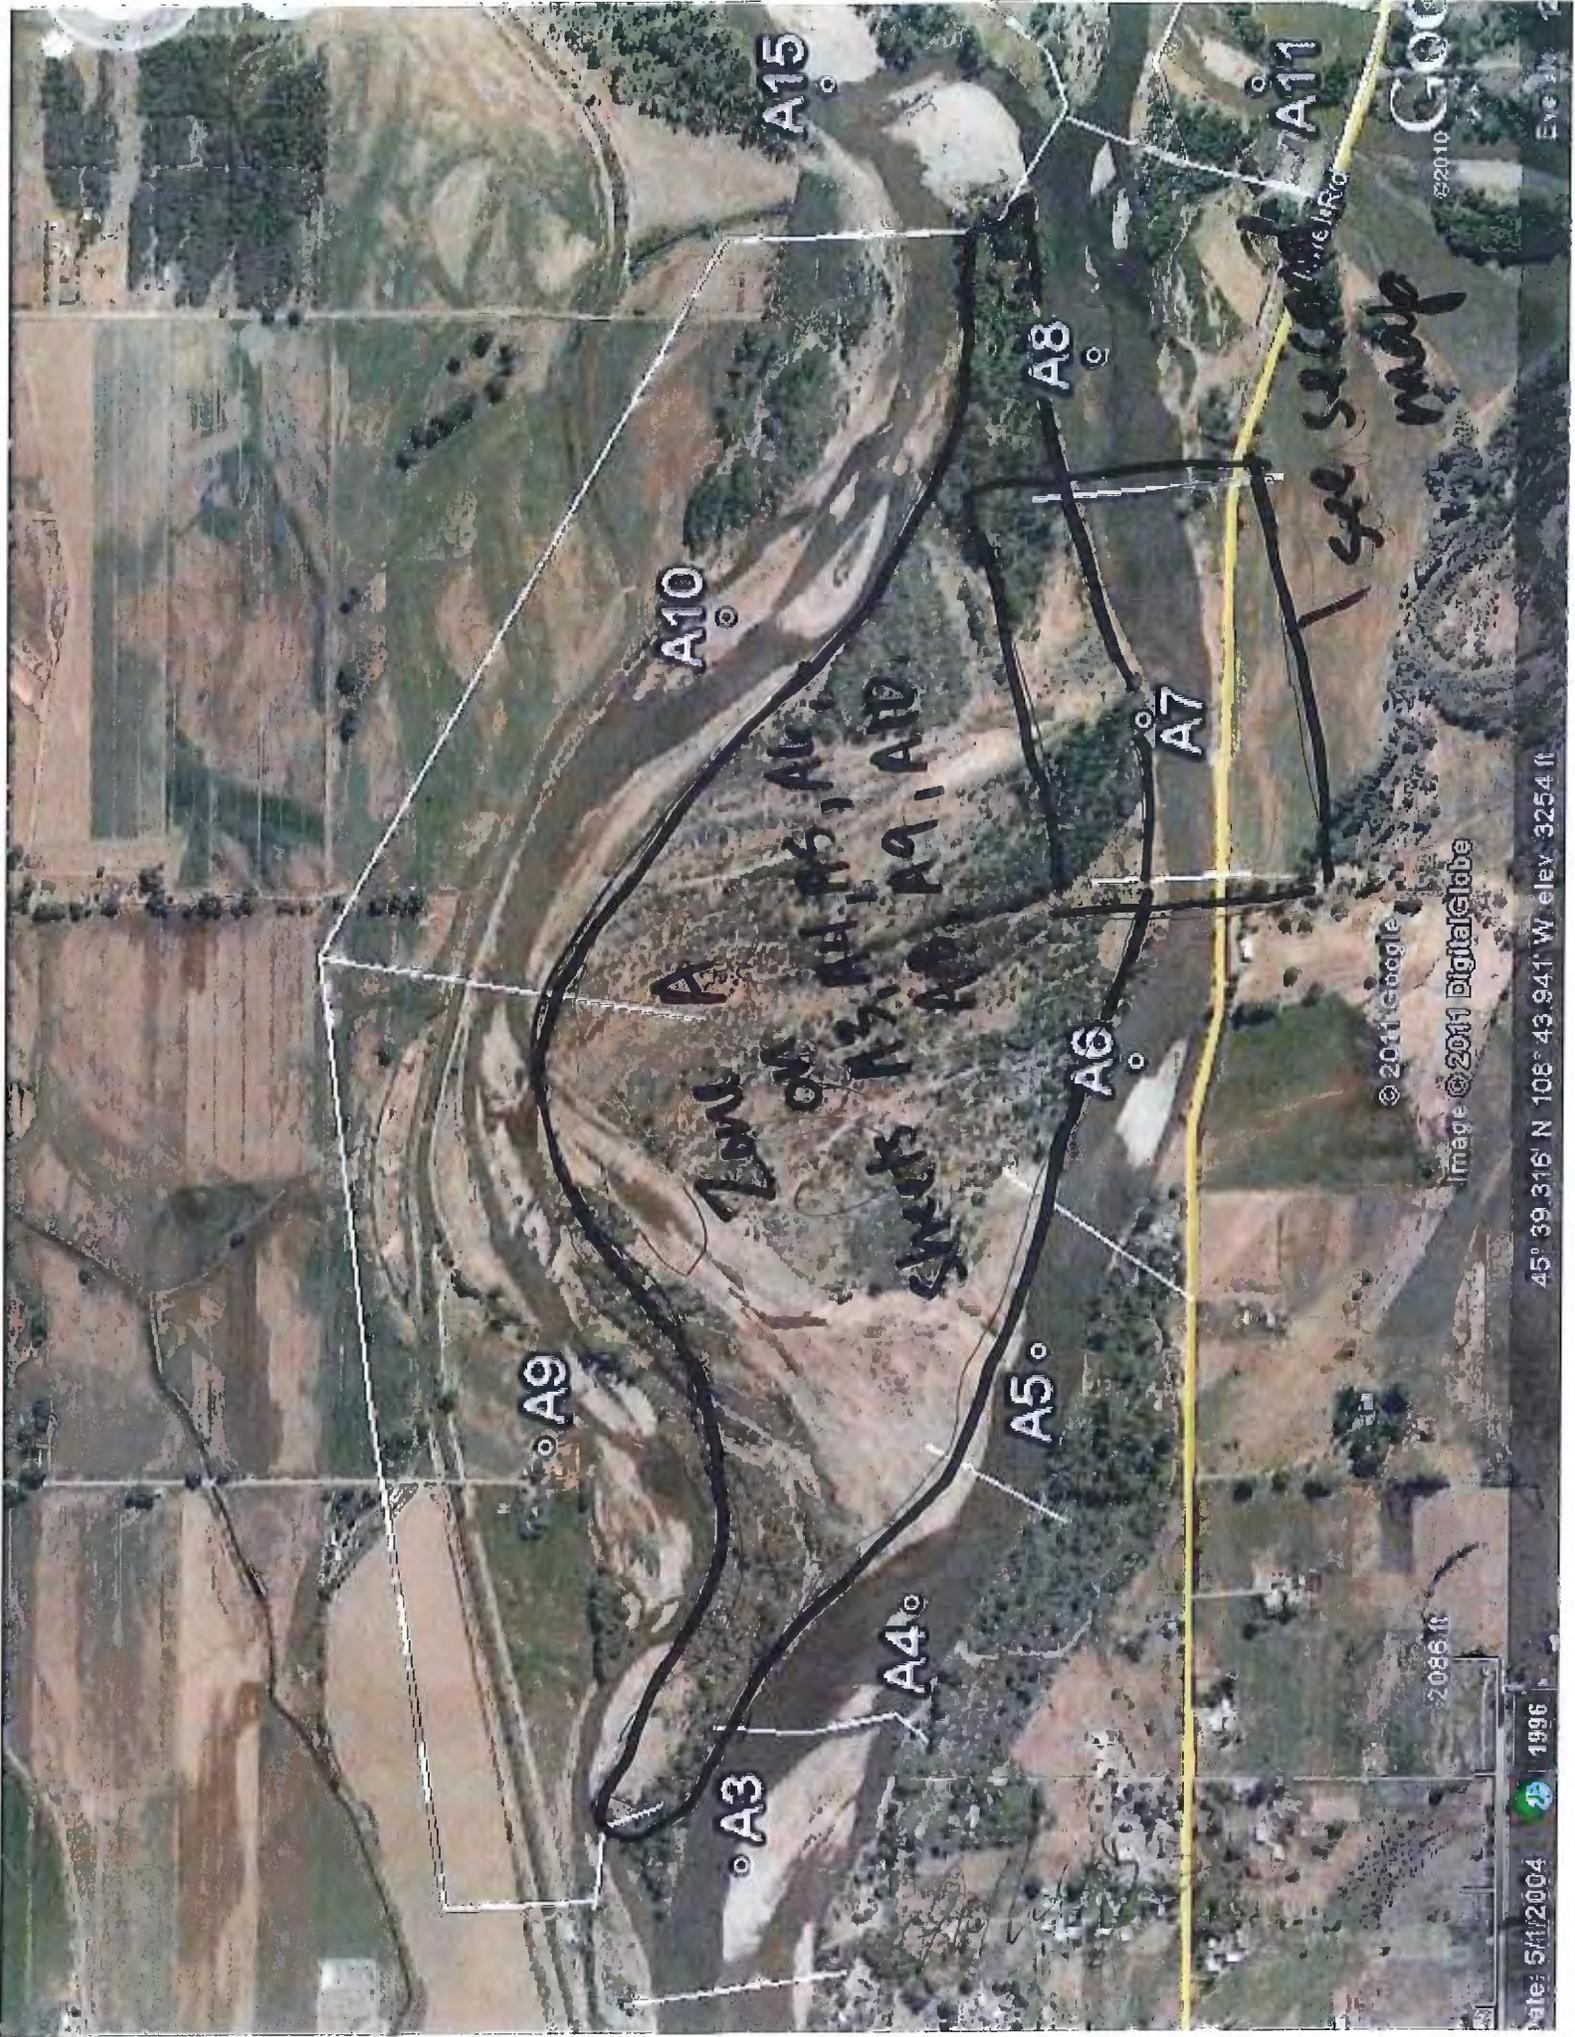
Zone A recommendations: NFT

*Zone of A3, A5, A6, A7, A8, A9, A10, A11*

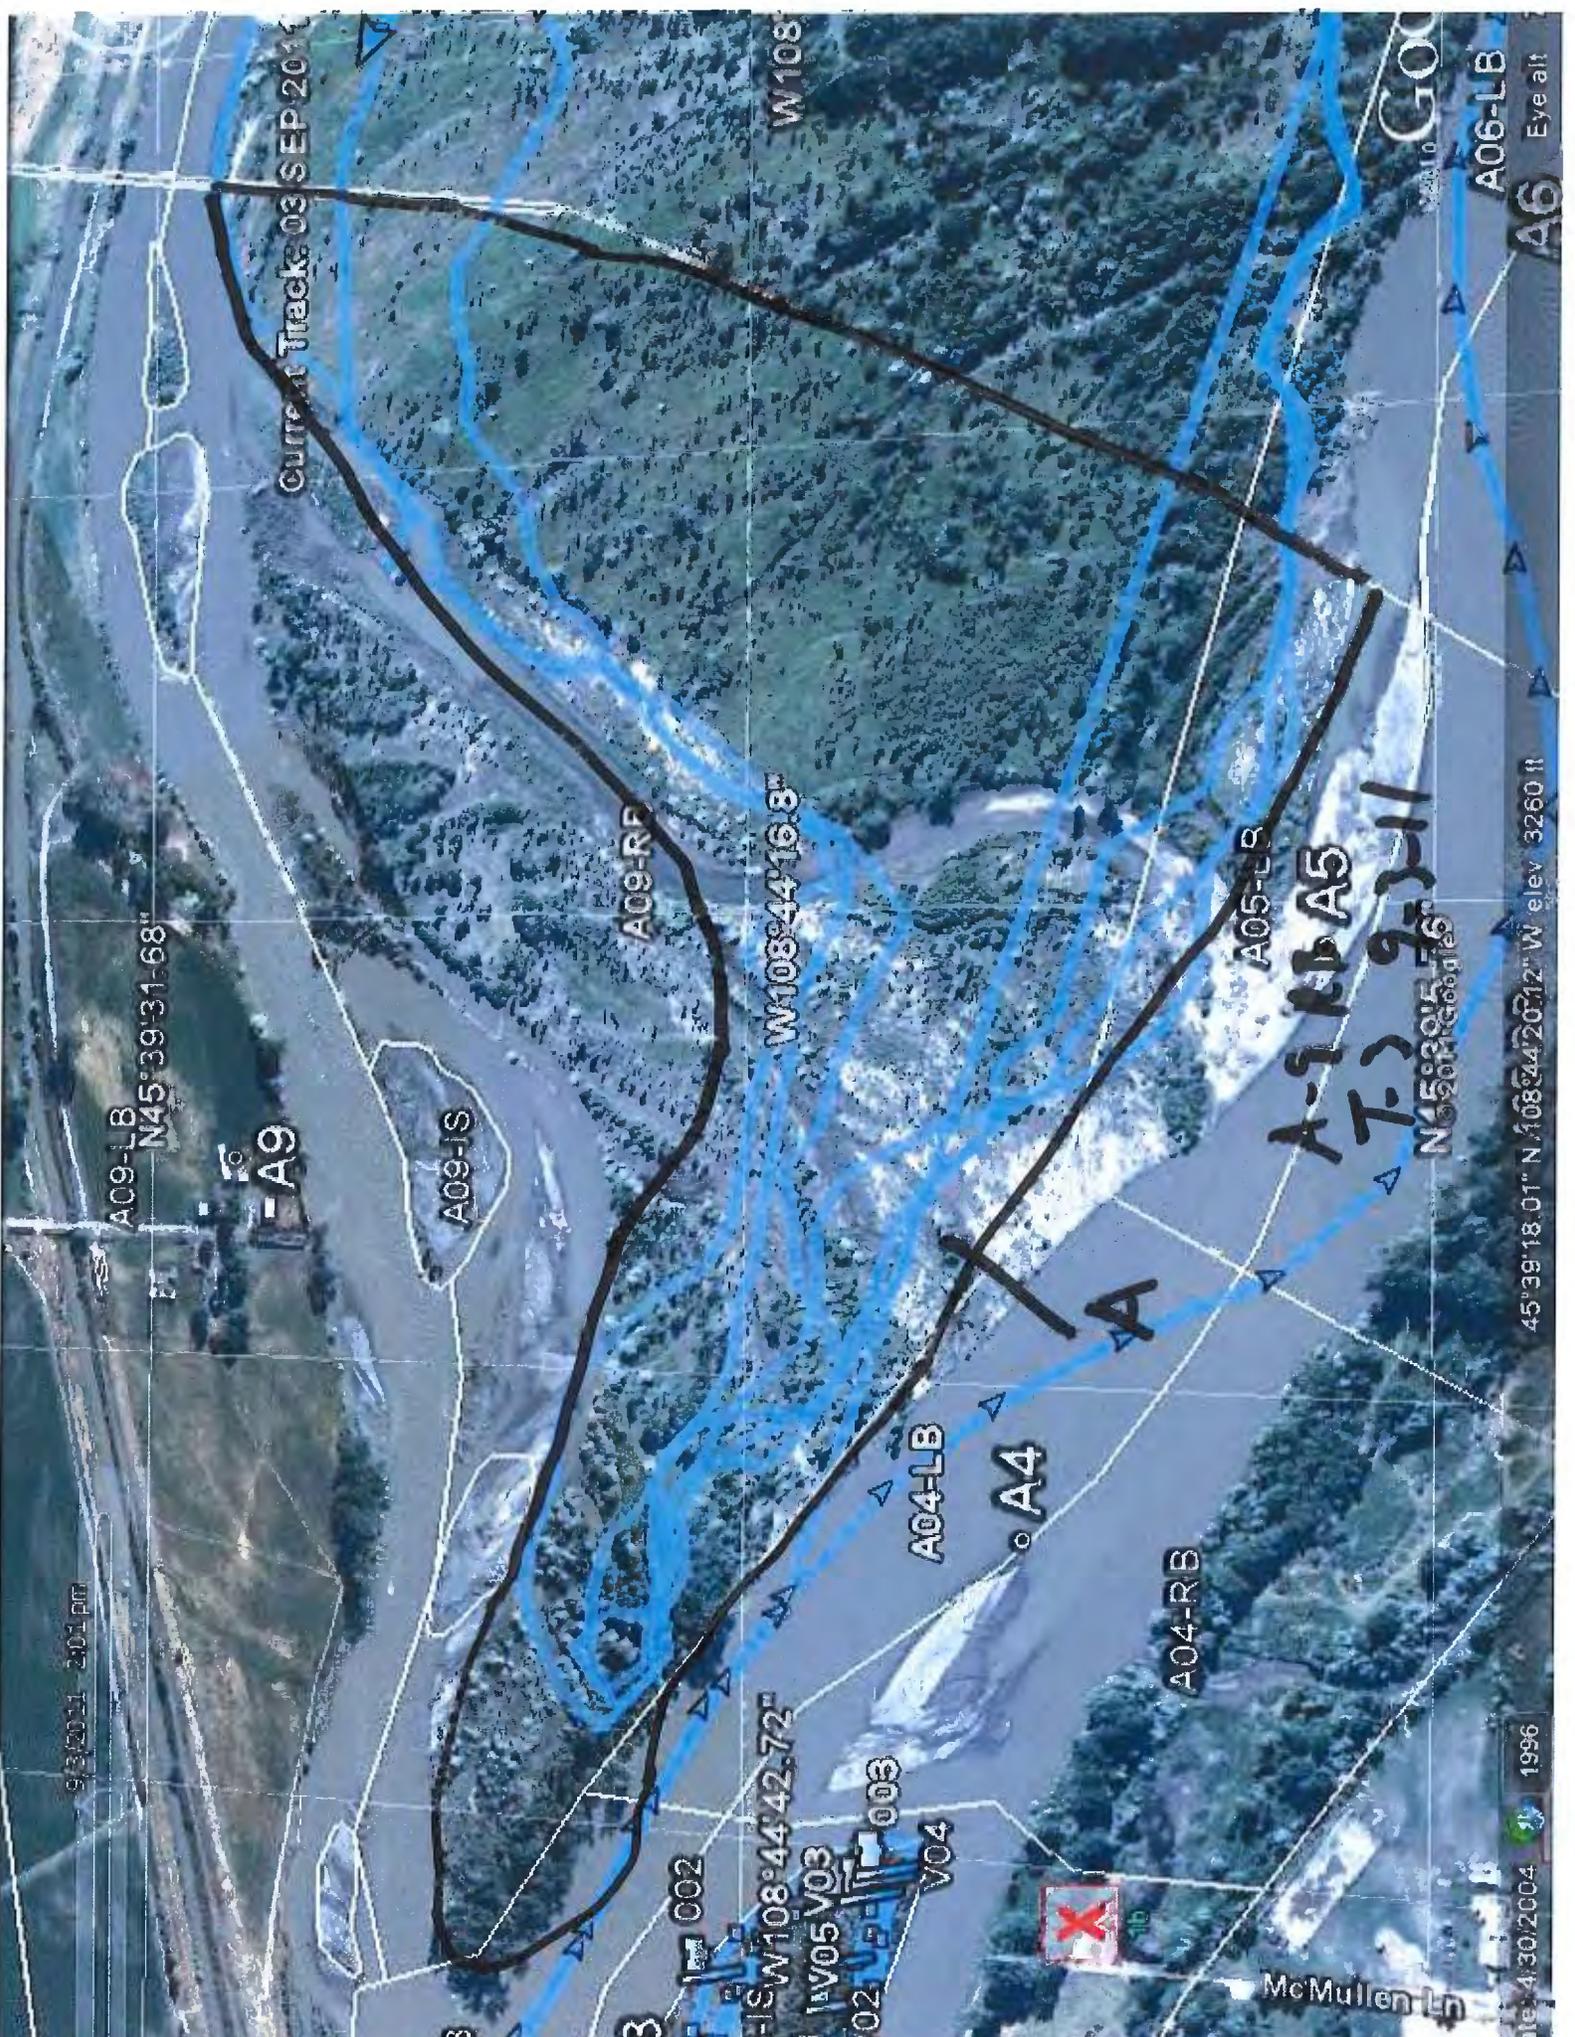
Zone A - No OIL observed

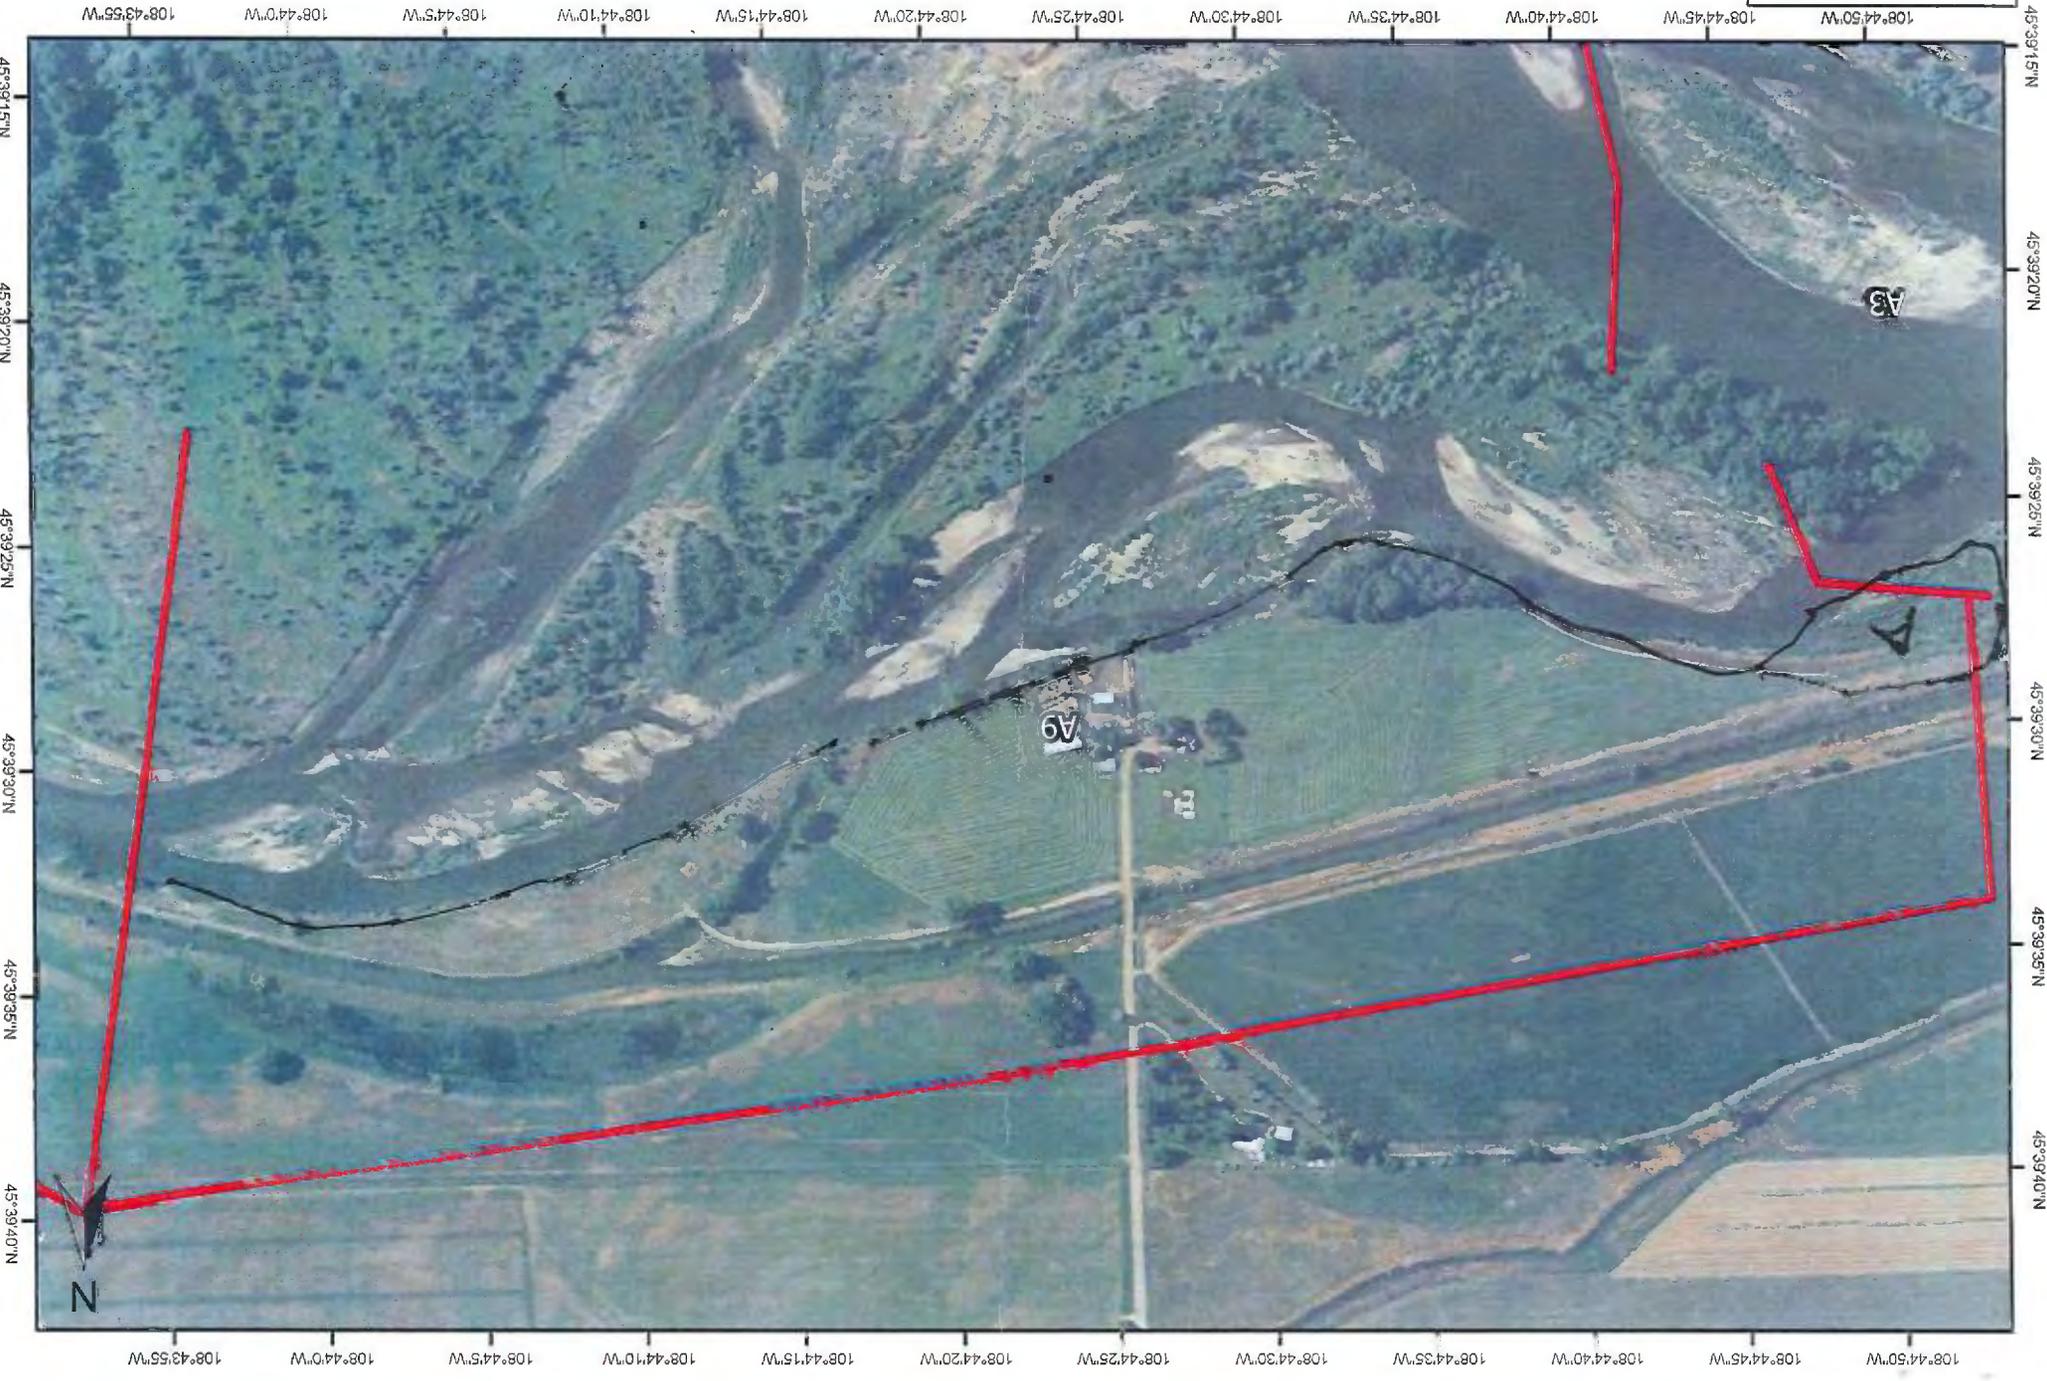
**A09 -**  
(L/R/I)??

Zone A - No oil observed

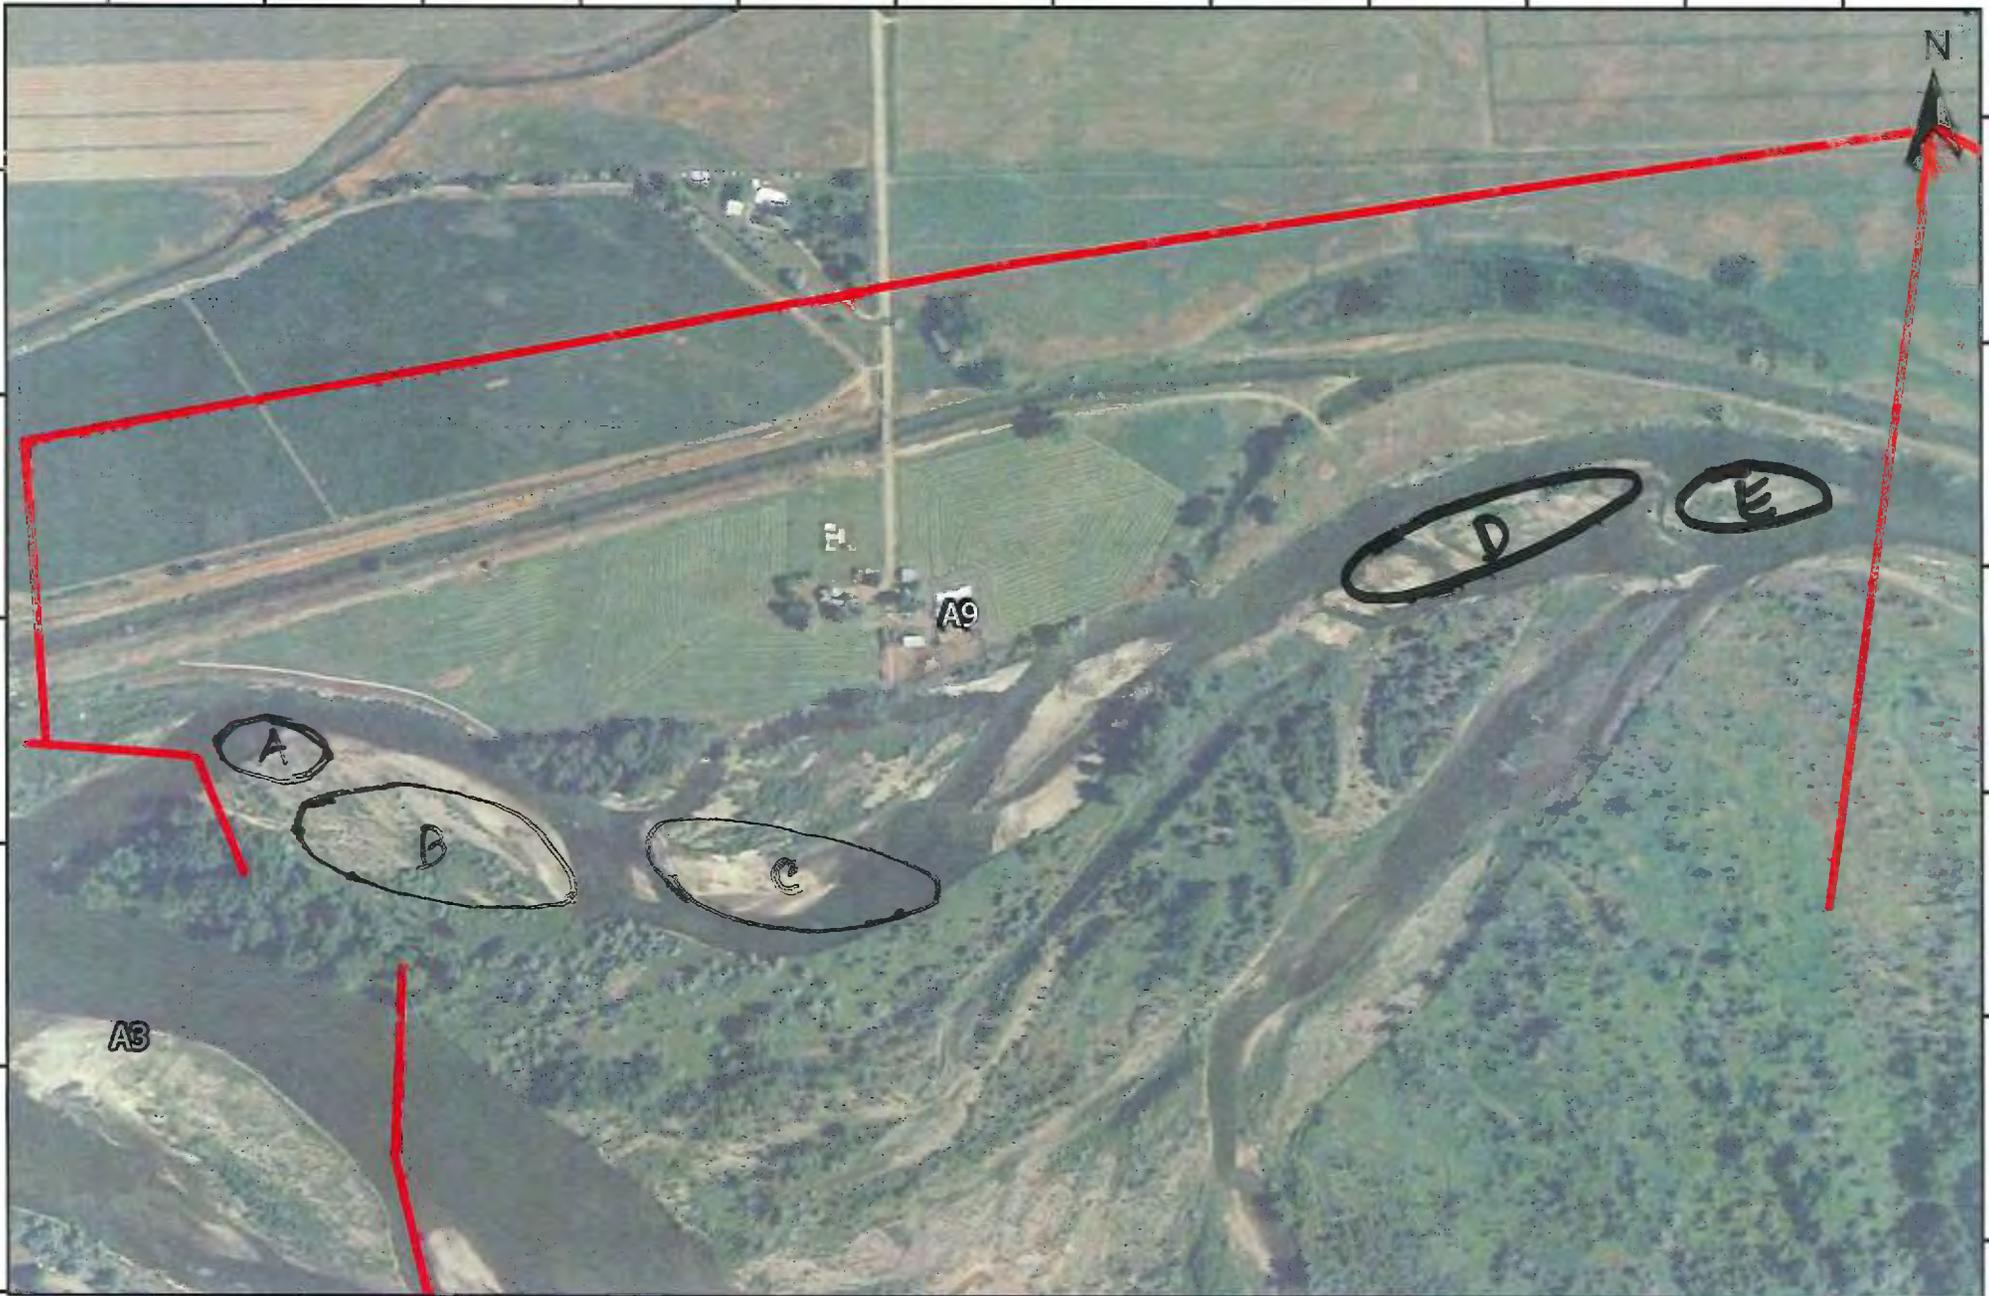
**A09 -**  
(L/R/I)??

Treatment recommendations:  
Zone A, B, C, <sup>D/E</sup> : No oil observed; no treatment required.

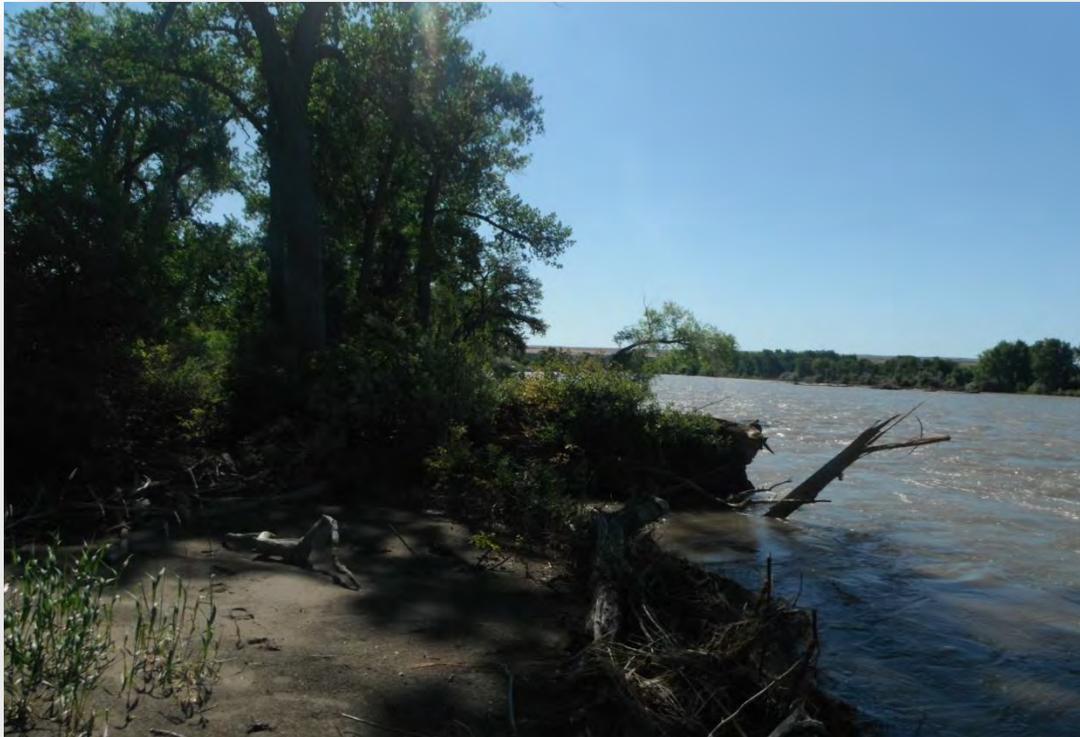
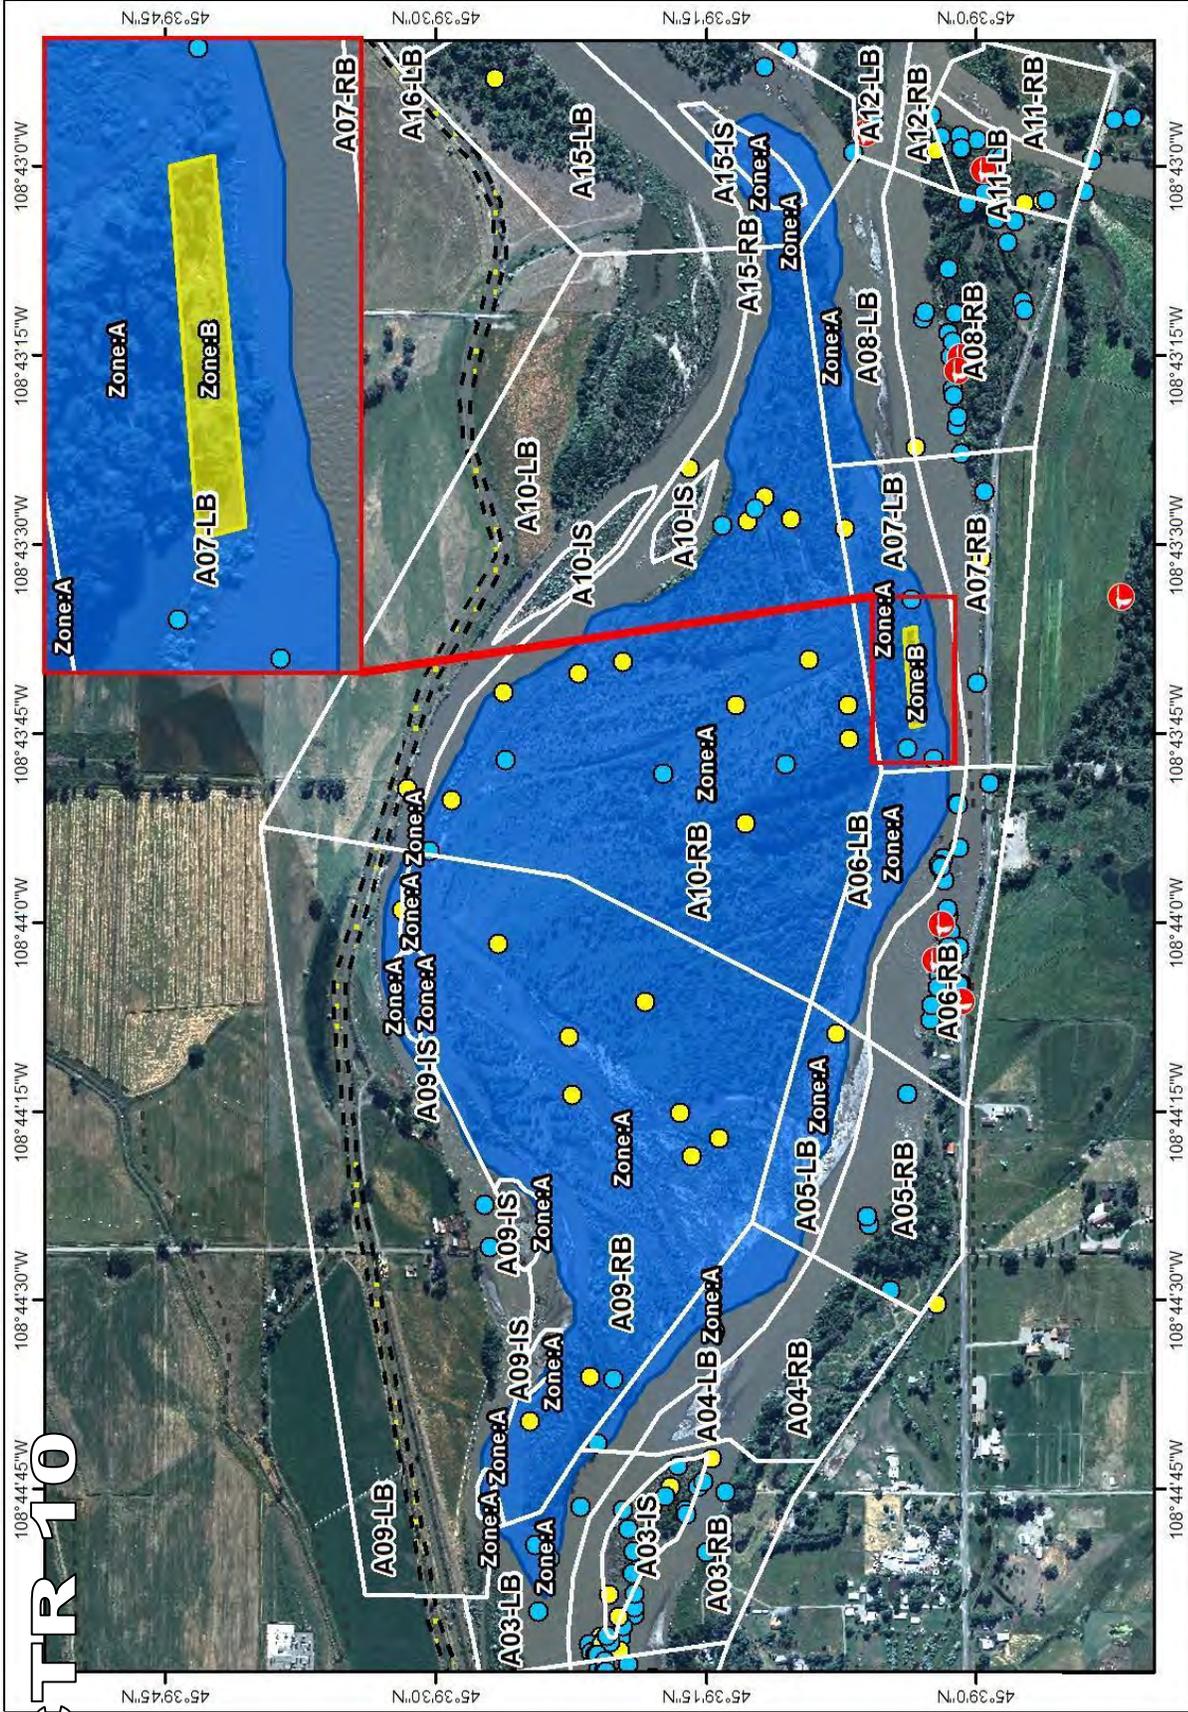
**CTR 10**

**Primary Oiling Conditions:** No Oil Observed

**Cleanup Recommendations:** No Further Treatment
