**SCAT Area Transition Report  
for A09**

Silvertip Pipeline Incident  
Laurel, Montana

Prepared for:  
ExxonMobil Pipeline Company

Prepared by:  
ARCADIS G&M of North Carolina, Inc.  
11000 Regency Parkway  
West Tower, Suite 205  
Cary, North Carolina 27518-8518  
Tel 919.469.1952  
Fax 919.469.5676

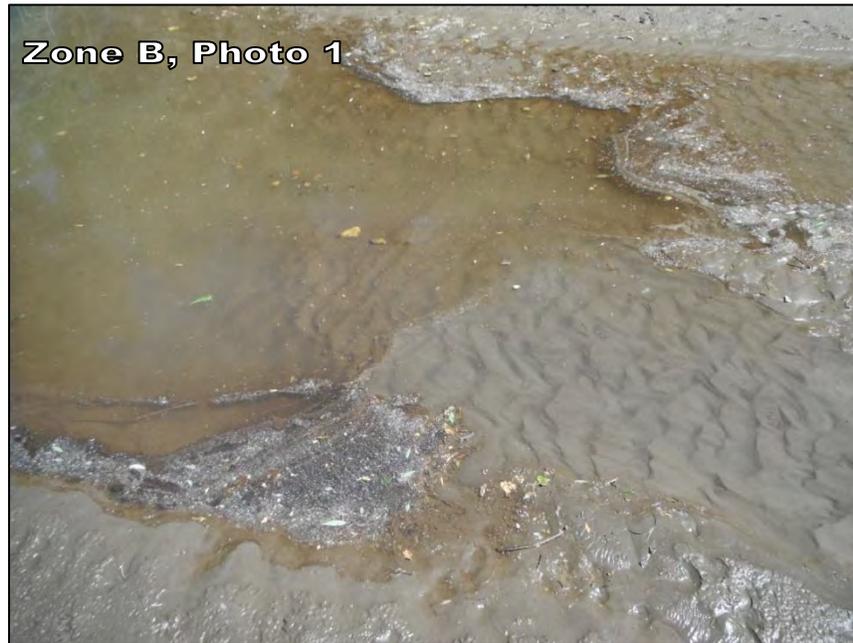
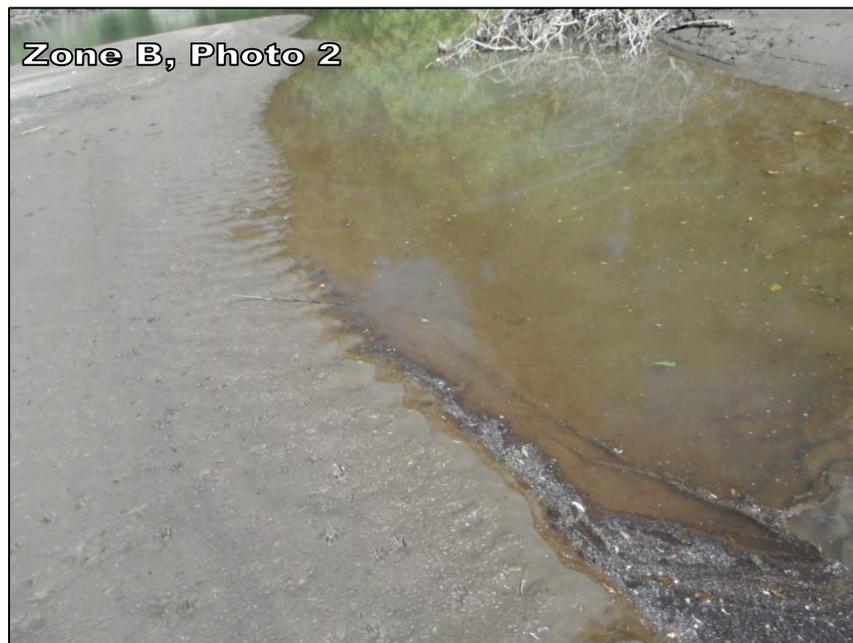
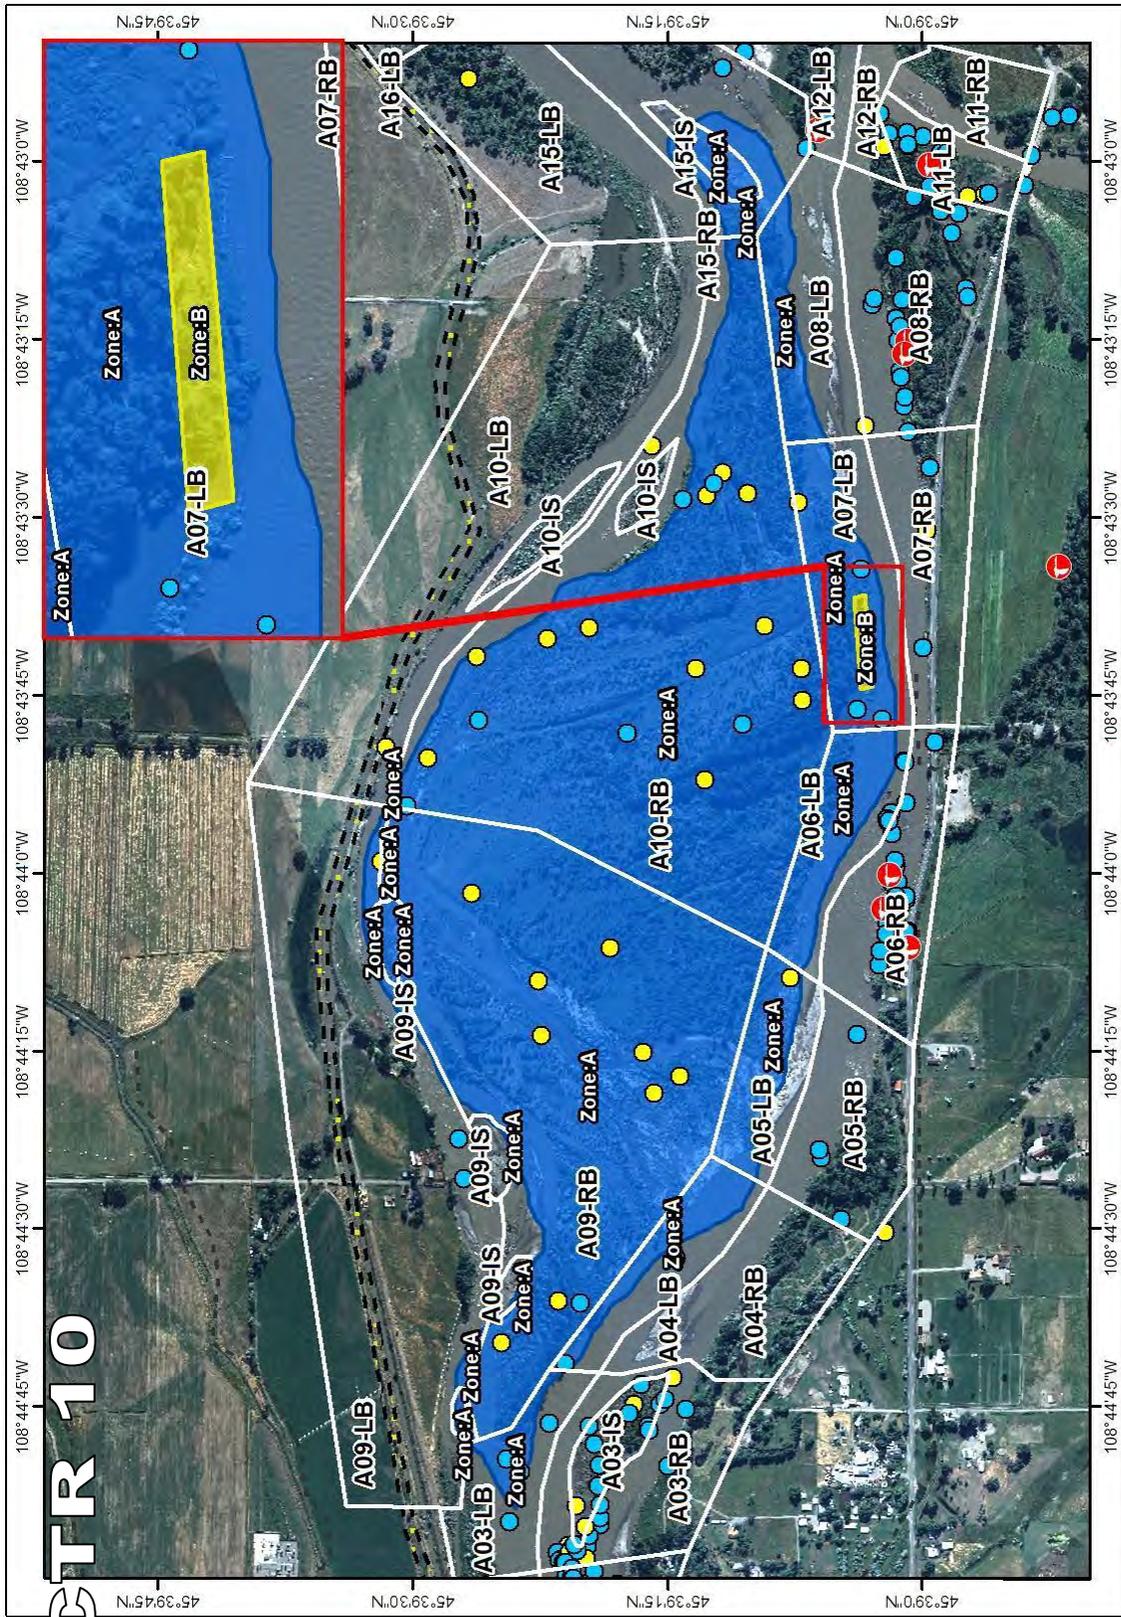
**CTR 10**

**Primary Oiling Conditions:** ~15% distribution of fresh oil debris (coat) on water surface.

**Cleanup Recommendations:** Deploy sorbents on water surface.

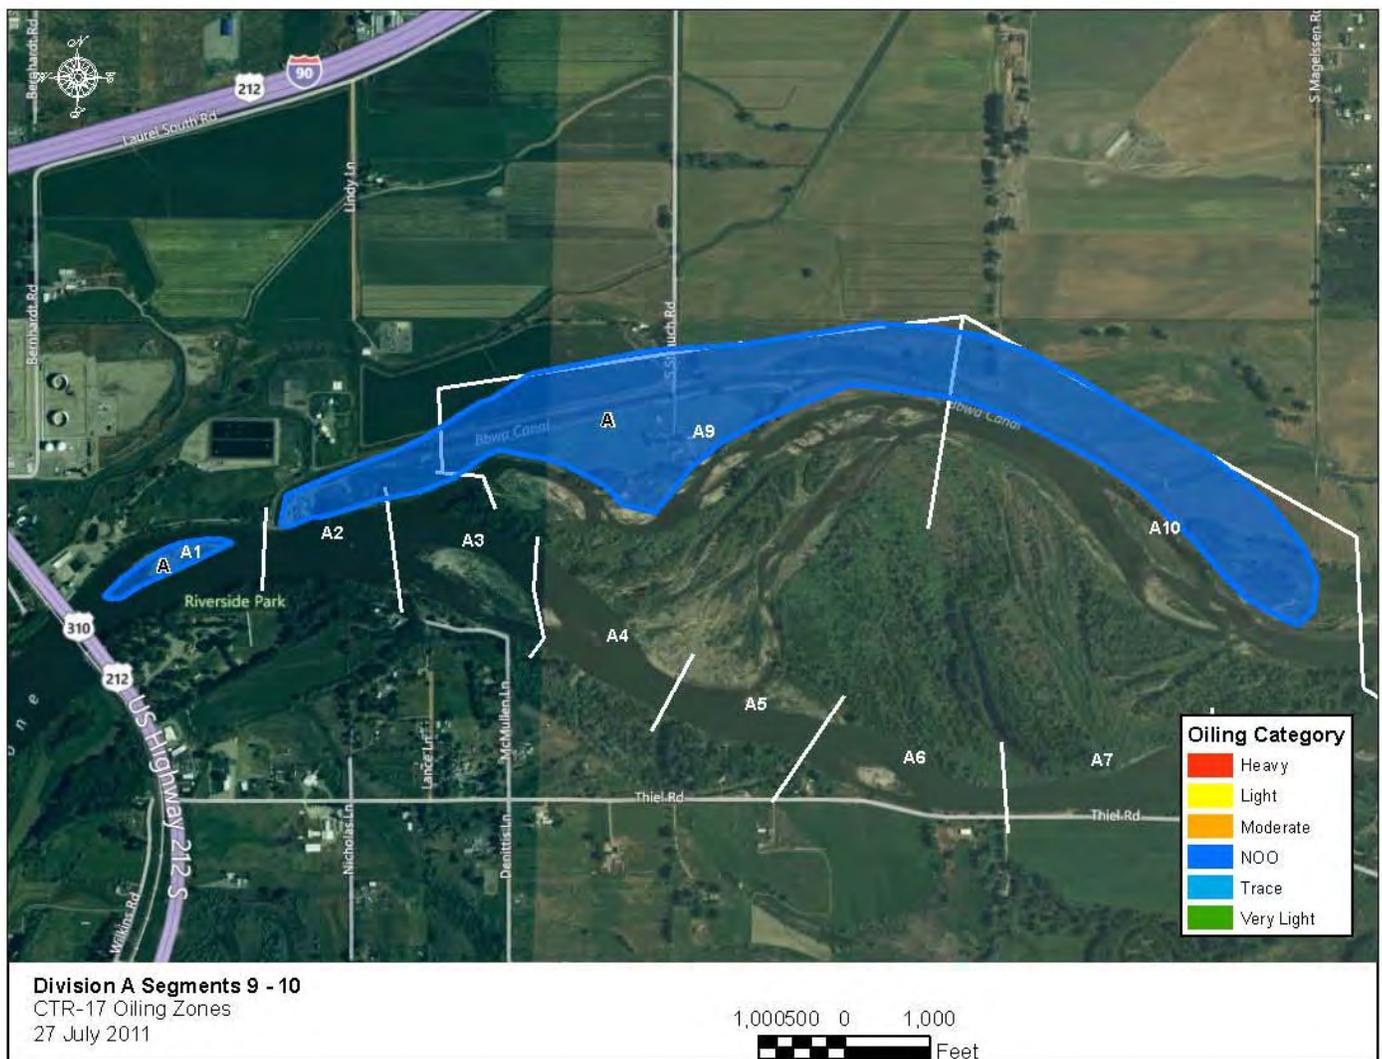
**Primary Oiling Conditions:** ~No oil was observed in this section including along the bank and in adjacent floodplains.

**Cleanup Recommendations:** None.
