**SCAT Area Transition Report
for A10**

Silvertip Pipeline Incident
Laurel, Montana

October 18, 2011

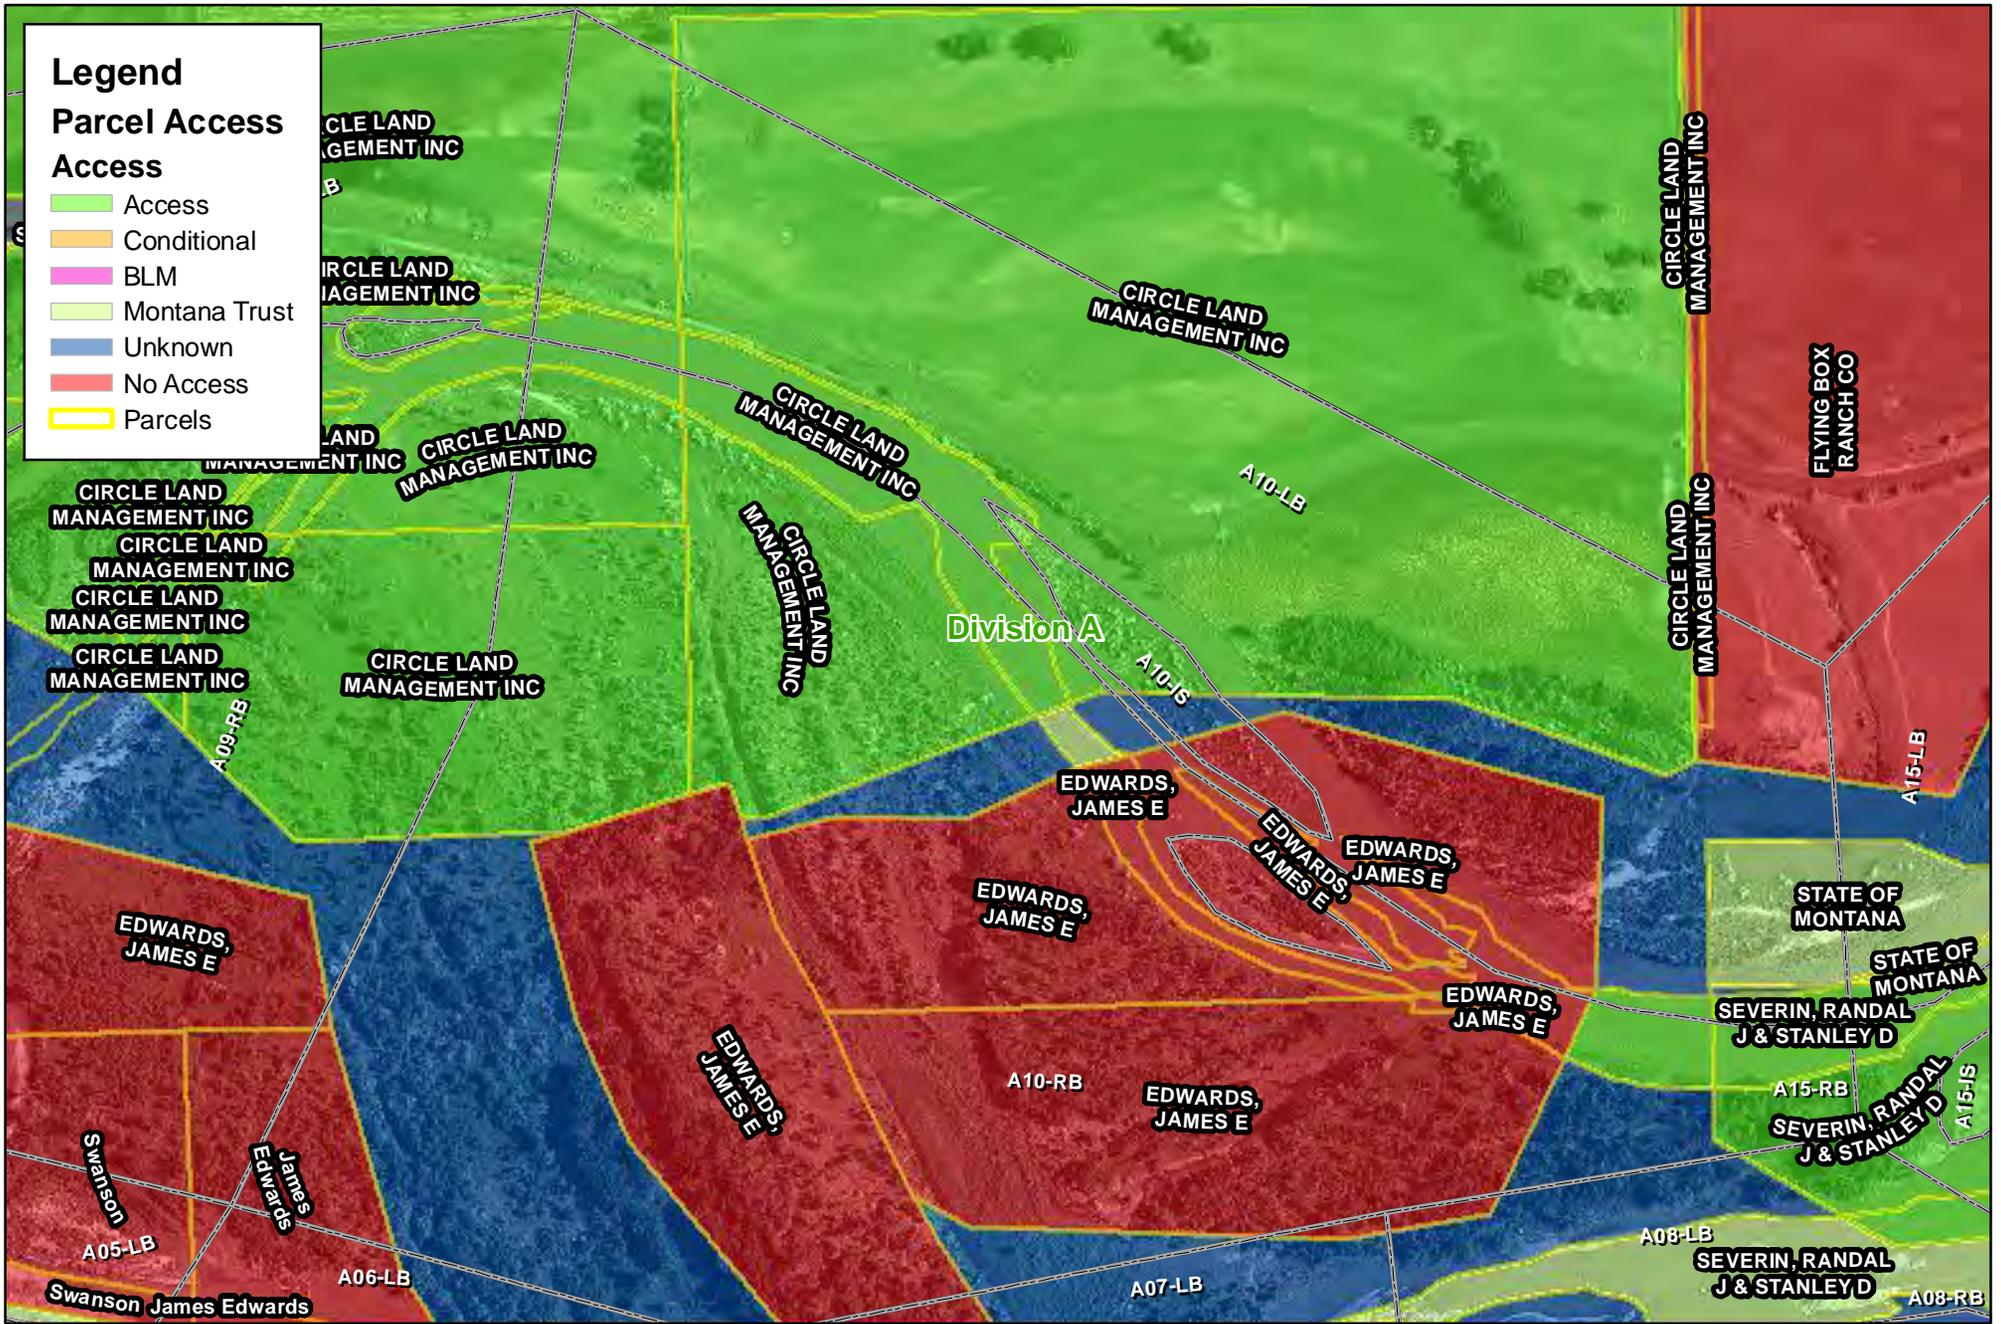
Figure 1 provides an aerial map of SCAT Area A10, along with the (a) SCAT Area boundary, (b) parcel boundaries and respective property owners, and (c) access constraints identified during the oil cleanup process. The acreage surveyed in Area A10 is 137.6. There were partial access issues for this area including the left and right banks and islands.

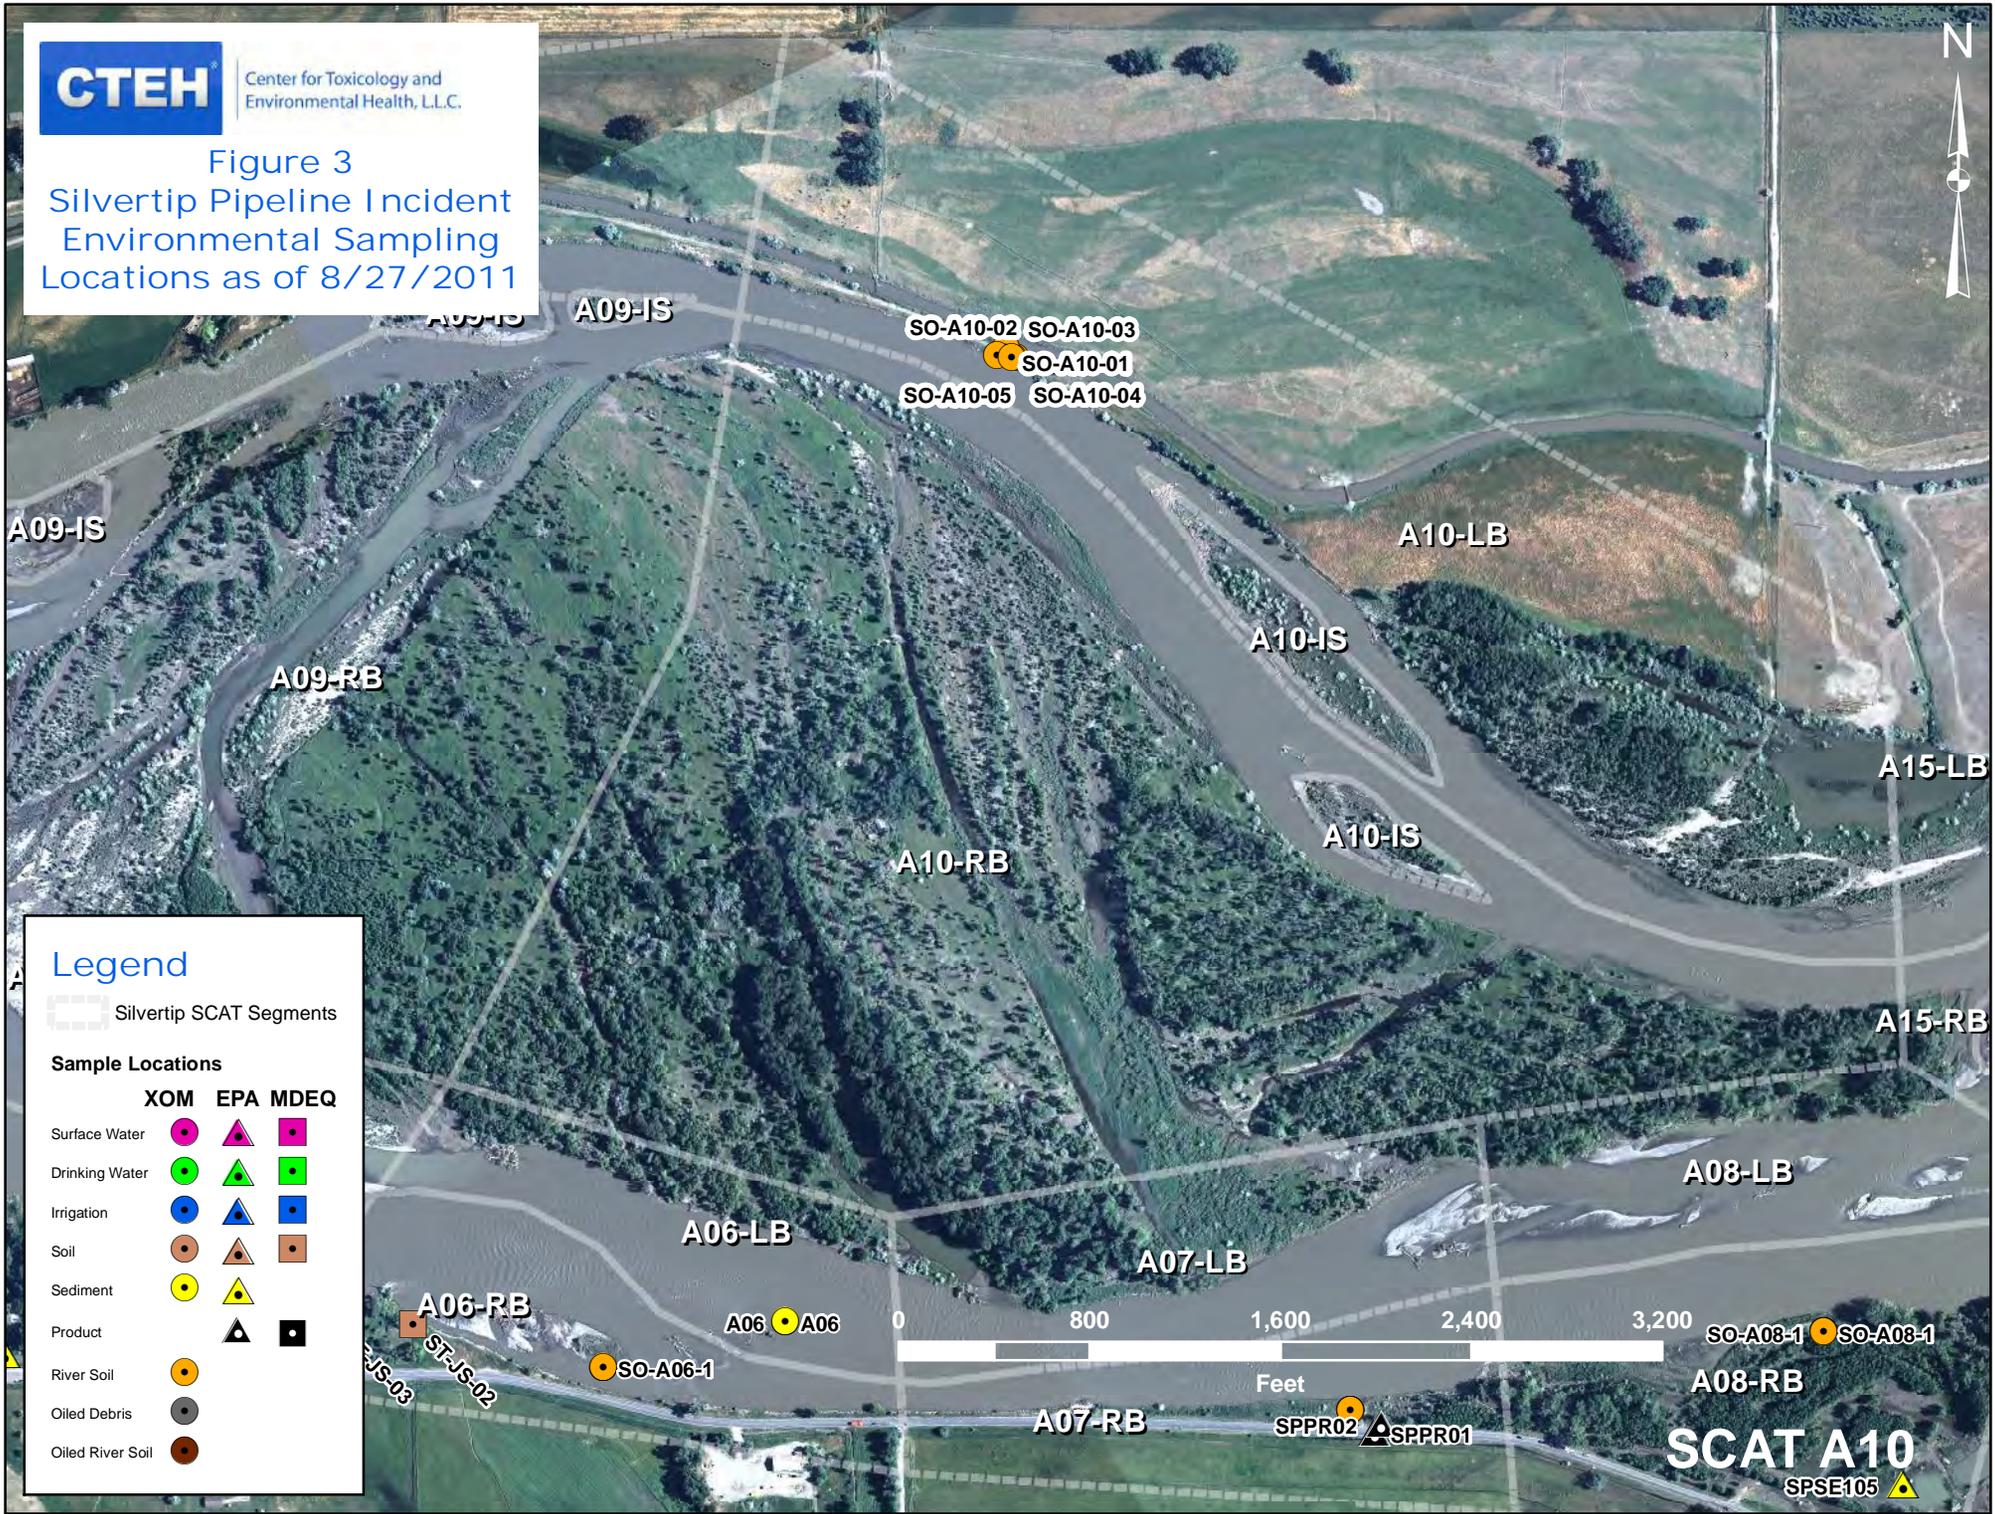
Figure 3
Silvertip Pipeline Incident
Environmental Sampling
Locations as of 8/27/2011

Table 1 (below) summarizes samples collected within Area A10. The analytical results for the samples collected can be accessed through a publicly accessible database on the United States Environmental Protection Agency's (USEPA's) website. The approximate locations of samples collected within Area A10 are provided on Figure 3.

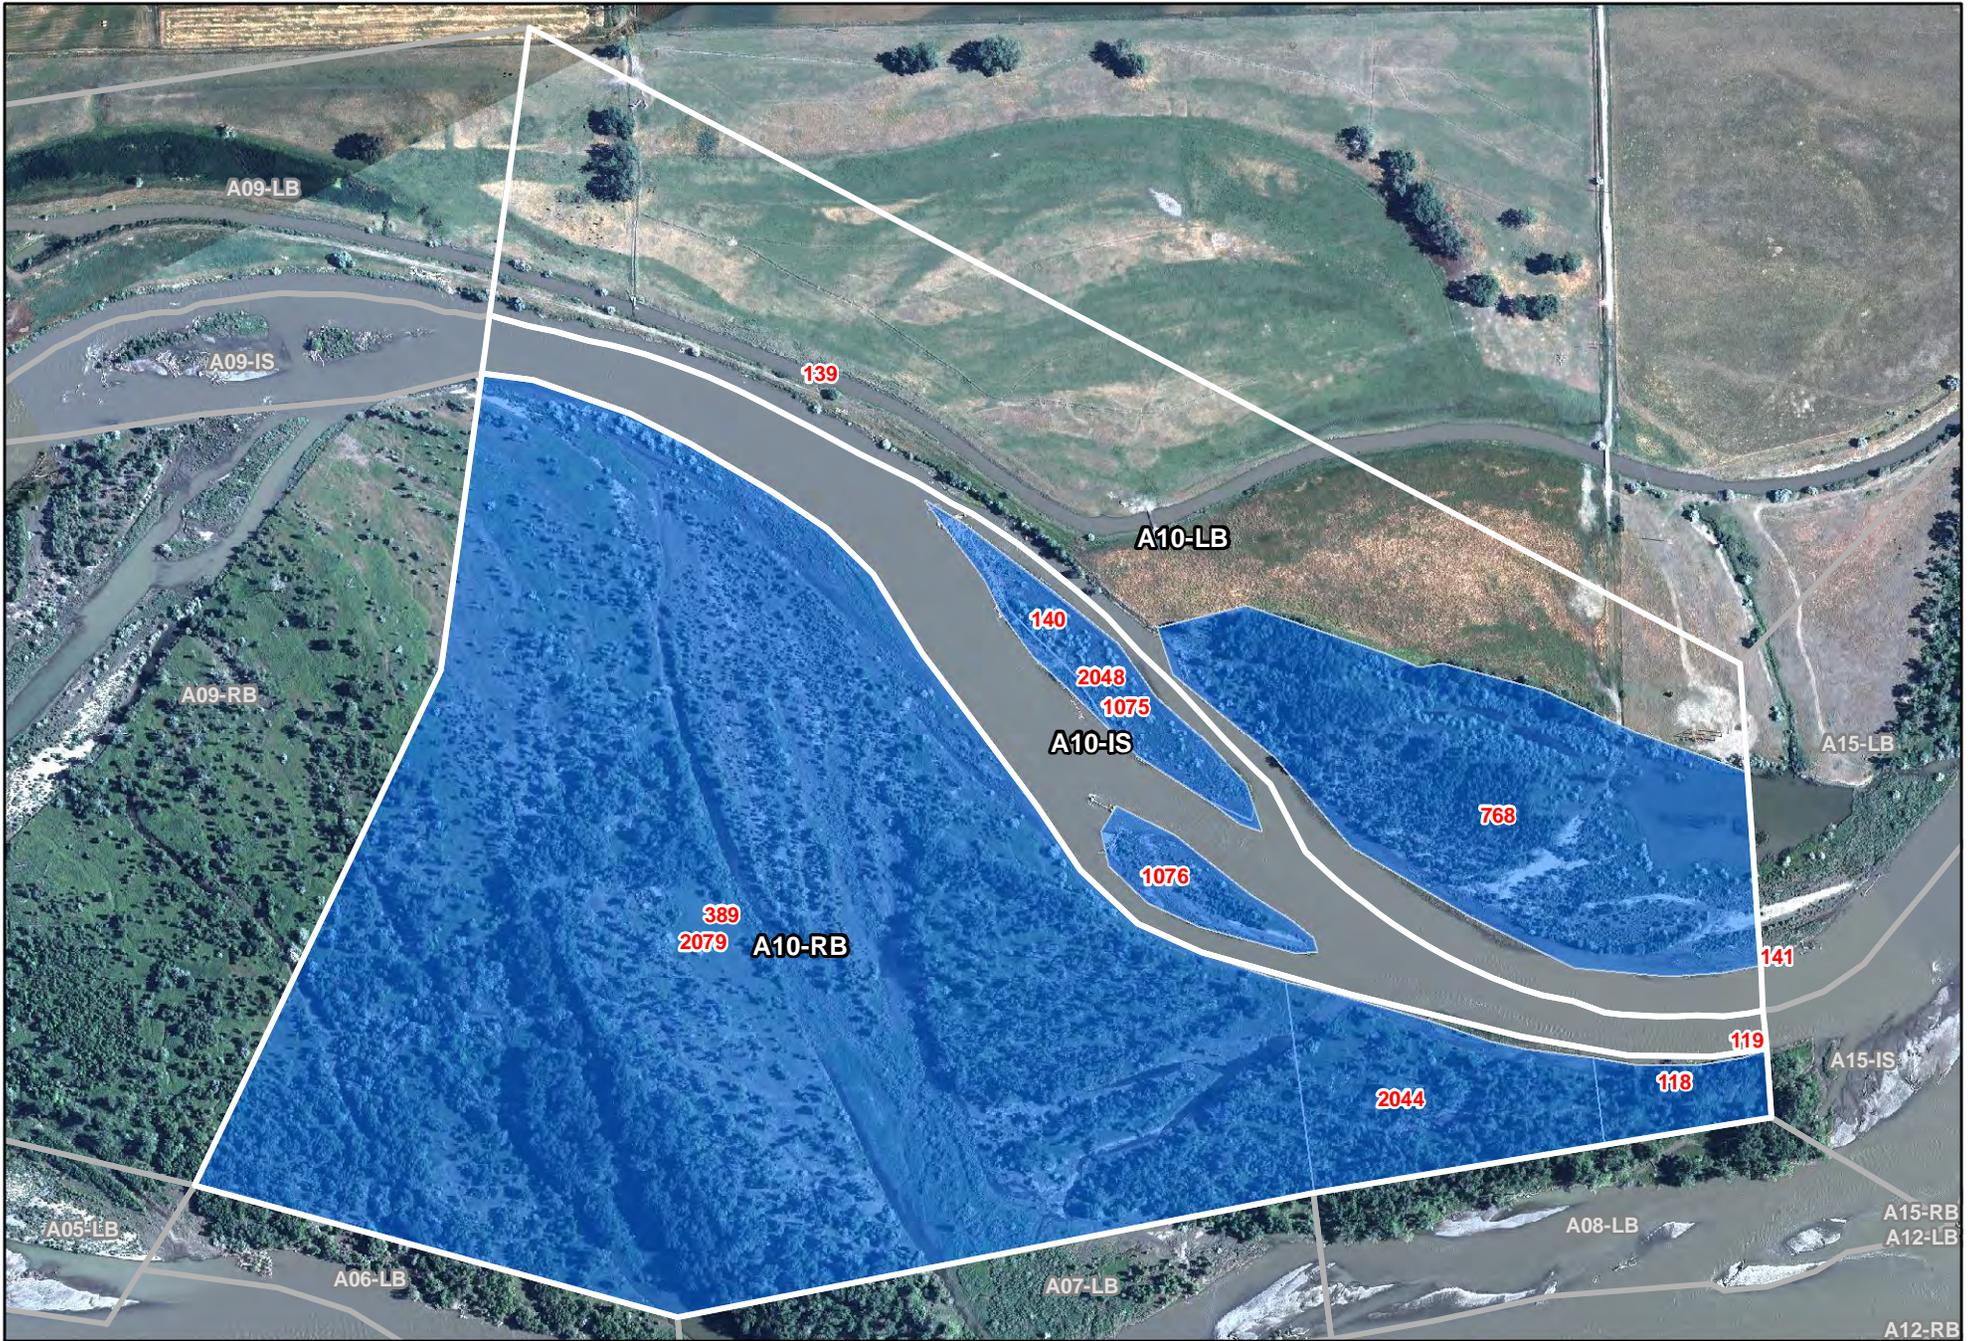
Figure 4 - Maximum SCAT Observations
For SCAT Area: A10

The SCAT teams used systematic evaluation criteria and treatment method tables approved by the National Oceanic and Atmospheric Administration to provide a standard approach for data collection and conducting field surveys. The forms and sketches from the initial SCAT surveys performed along the river bank (water edge) and floodplain within Area A10 are included in Appendix B. Figure 4 provides the maximum oiling zones observed by the SCAT team during the initial surveys of Area A10.

Based on the initial SCAT surveys performed within Area A10, no oiling was observed on the left or right banks or islands. Therefore, a PIST, POST, and final SCAT survey were not performed and a SCAT Segment Sign-Off Form was not necessary.

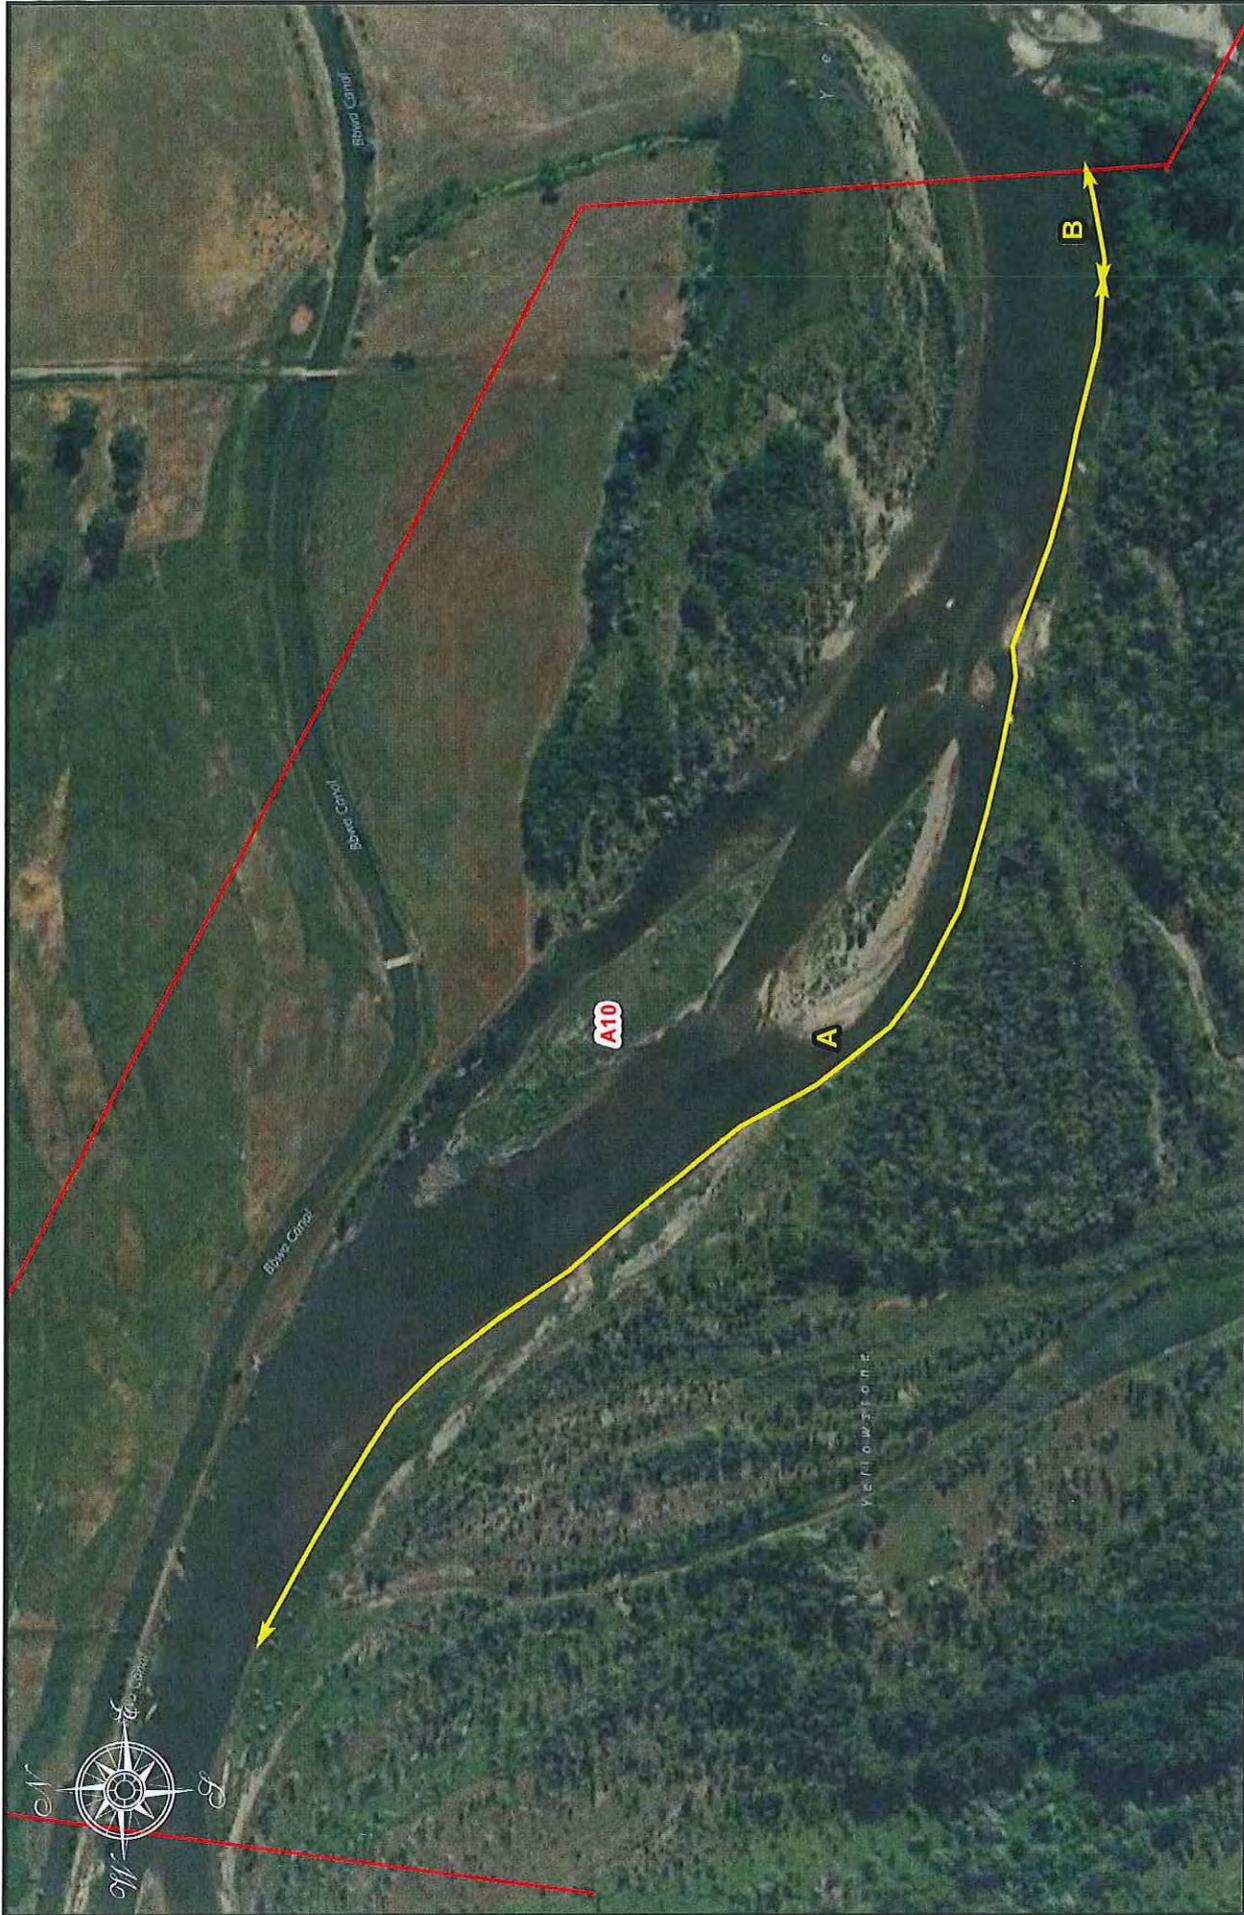
SCAT Teams 2 & 4 Survey
 Segment A10 Right Bank
 11-Jul-2011

OIL ZONE ID	RIVER BANK ZONE				OIL COVER			OIL THICKNESS					OIL CHARACTER							SUBST. TYPE(S)		
	MS	LB	UB	OB	Length m	Width m	Distrib. %	TO	CV	CT	ST	FL	FR	MS	TB	PT	TC	SR	AP		NO	
A			X		1069	1															X	Grass, trees, debris
B			X		72	1	65			X	X		X									Grass, trees, debris

Oiled Band Heights: Zone A - 20cm

Due to survey platform (jet-drive boat) oil band width and heights are estimates. Unable to verify by foot.

Cleanup Recommendations: Trim oiled vegetation; wipe large oiled debris; remove small oiled debris; wipe oiled trees;

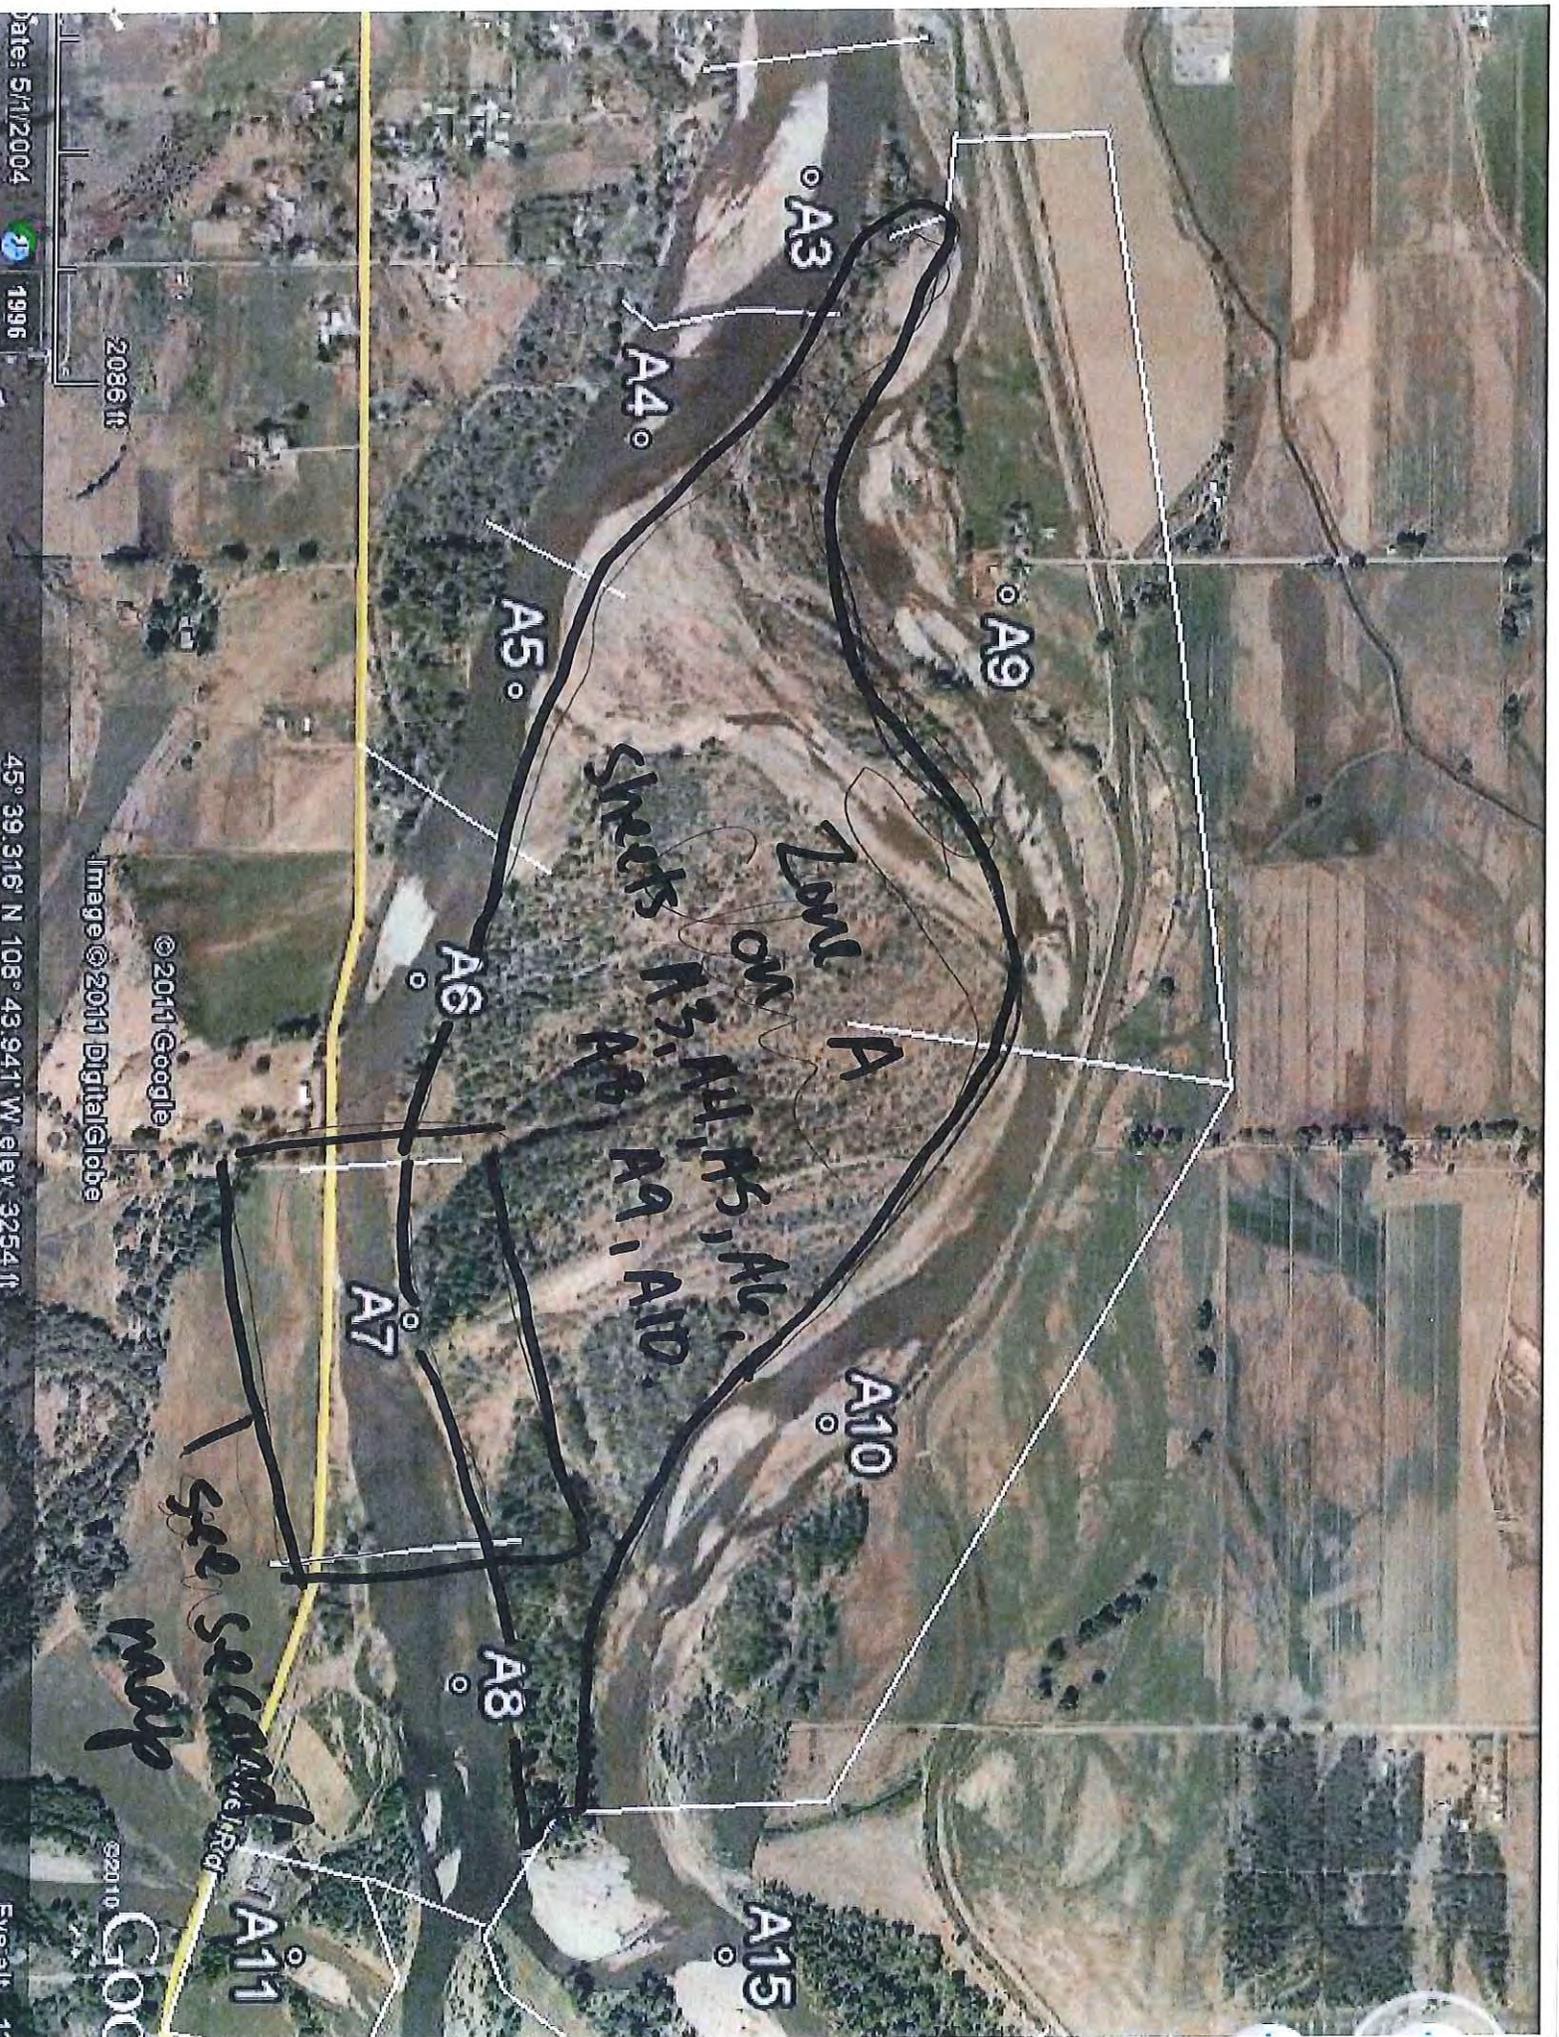
OIL ZONE ID	RIVER BANK ZONE				OIL COVER			OIL THICKNESS					OIL CHARACTER							SUBST. TYPE(S)		
	MS	LB	UB	OB	Length m	Width m	Distrib. %	TO	CV	CT	ST	FL	FR	MS	TB	PT	TC	SR	AP		NO	
A	S	S		P	1200	300	0														P	veg

No recommendations for Oil zone A in A10.

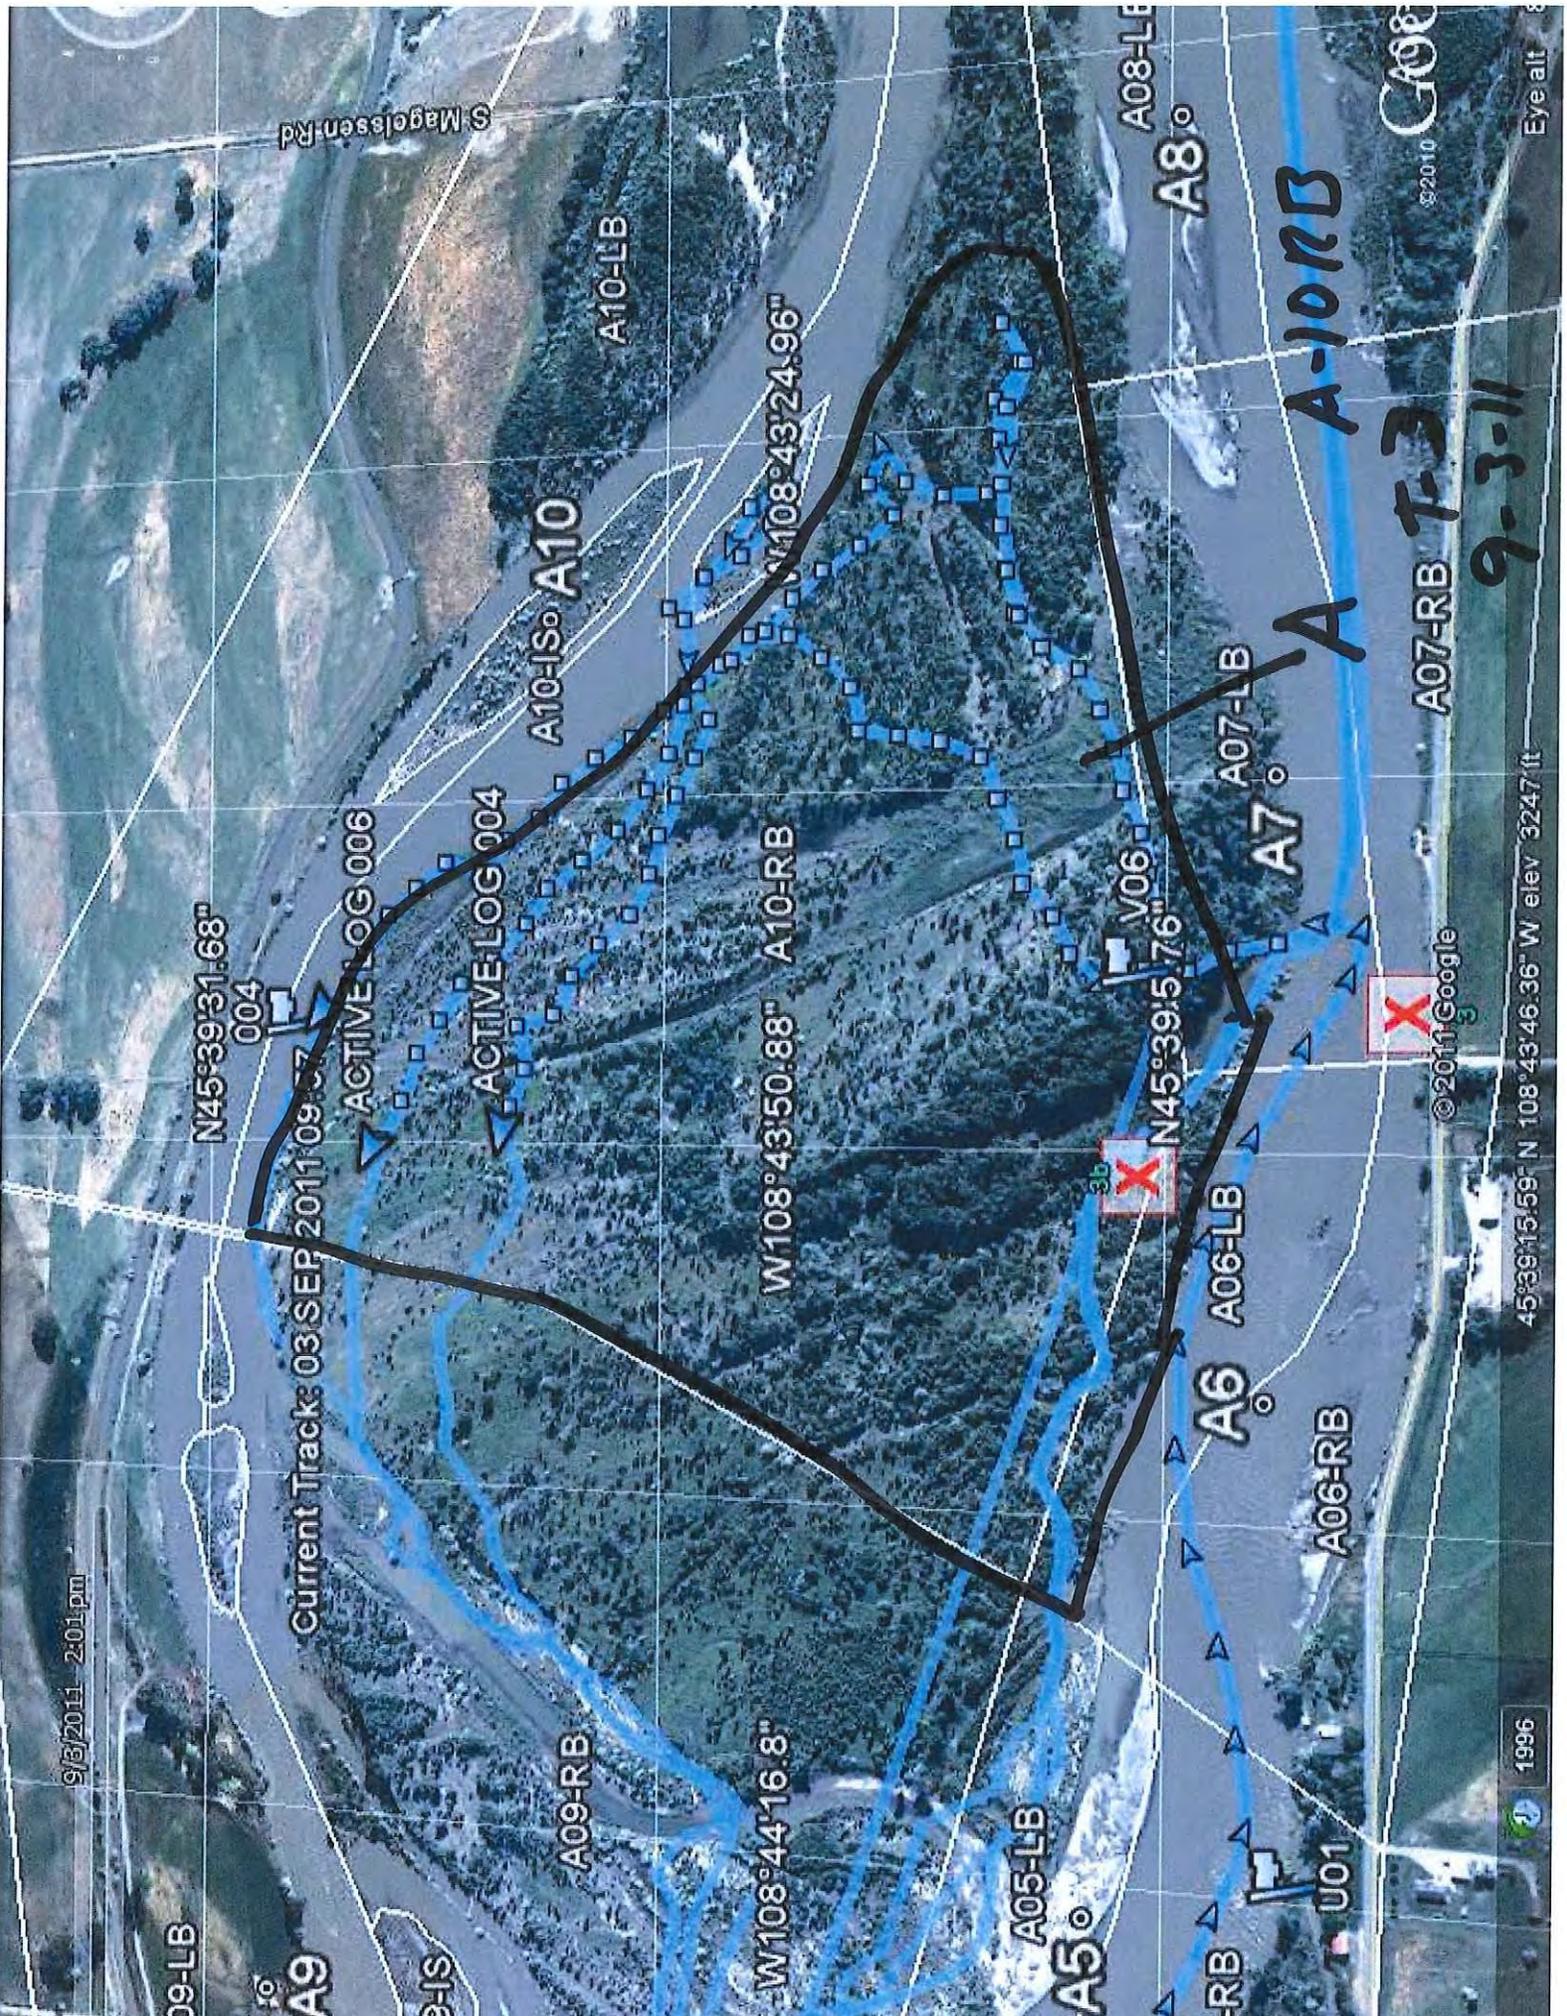
OIL ZONE ID	RIVER BANK ZONE				OIL COVER			OIL THICKNESS					OIL CHARACTER							SUBST. TYPE(S)		
	MS	LB	UB	OB	Length m	Width m	Distrib. %	TO	CV	CT	ST	FL	FR	MS	TB	PT	TC	SR	AP		NO	
<u>2079</u> A				<u>X</u>	<u>1270</u>	<u>690</u>	<u>0</u>														<u>X</u>	<u>S</u>

Zone A - No oil observed

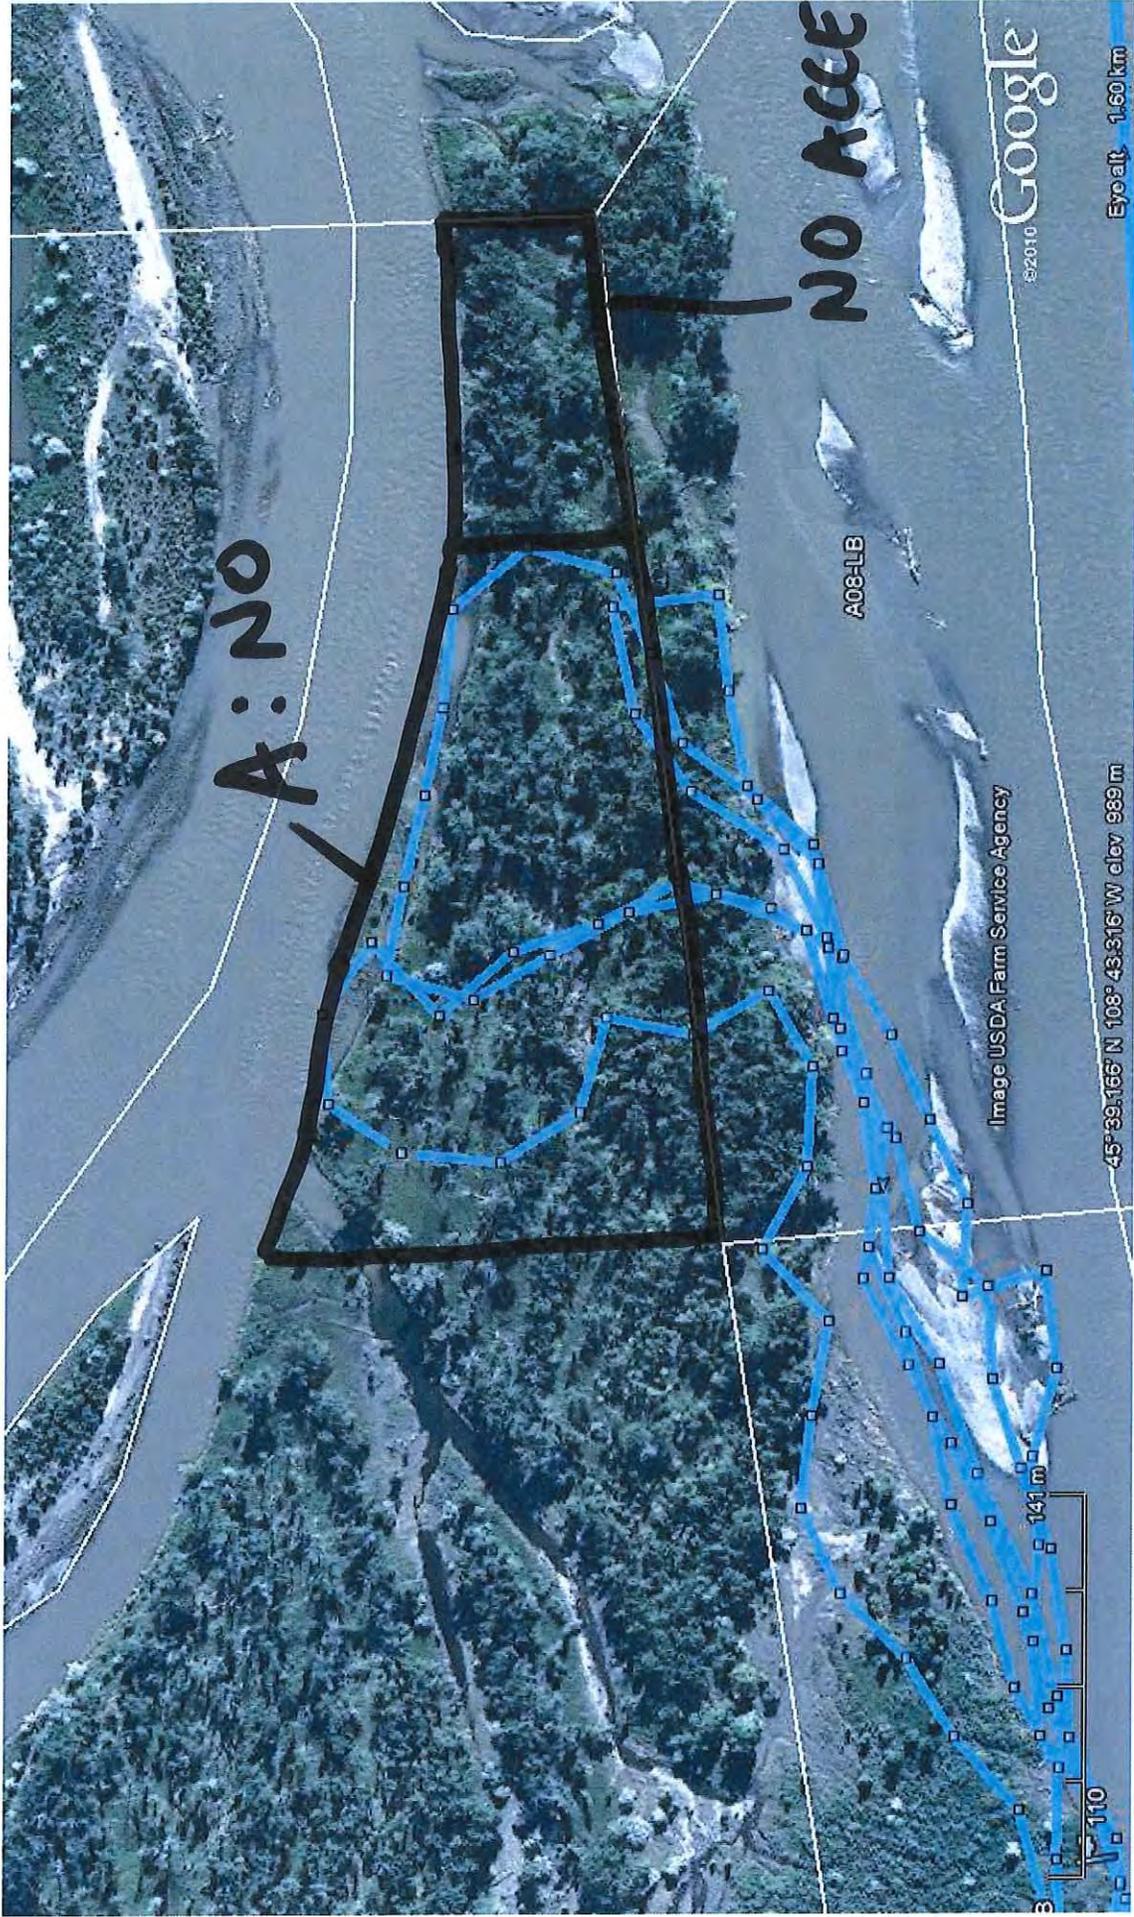
Surveyed portion of A10RB with Team 3
Private land surveyed ; eastern portion no access

A: NO

NO ACCESS

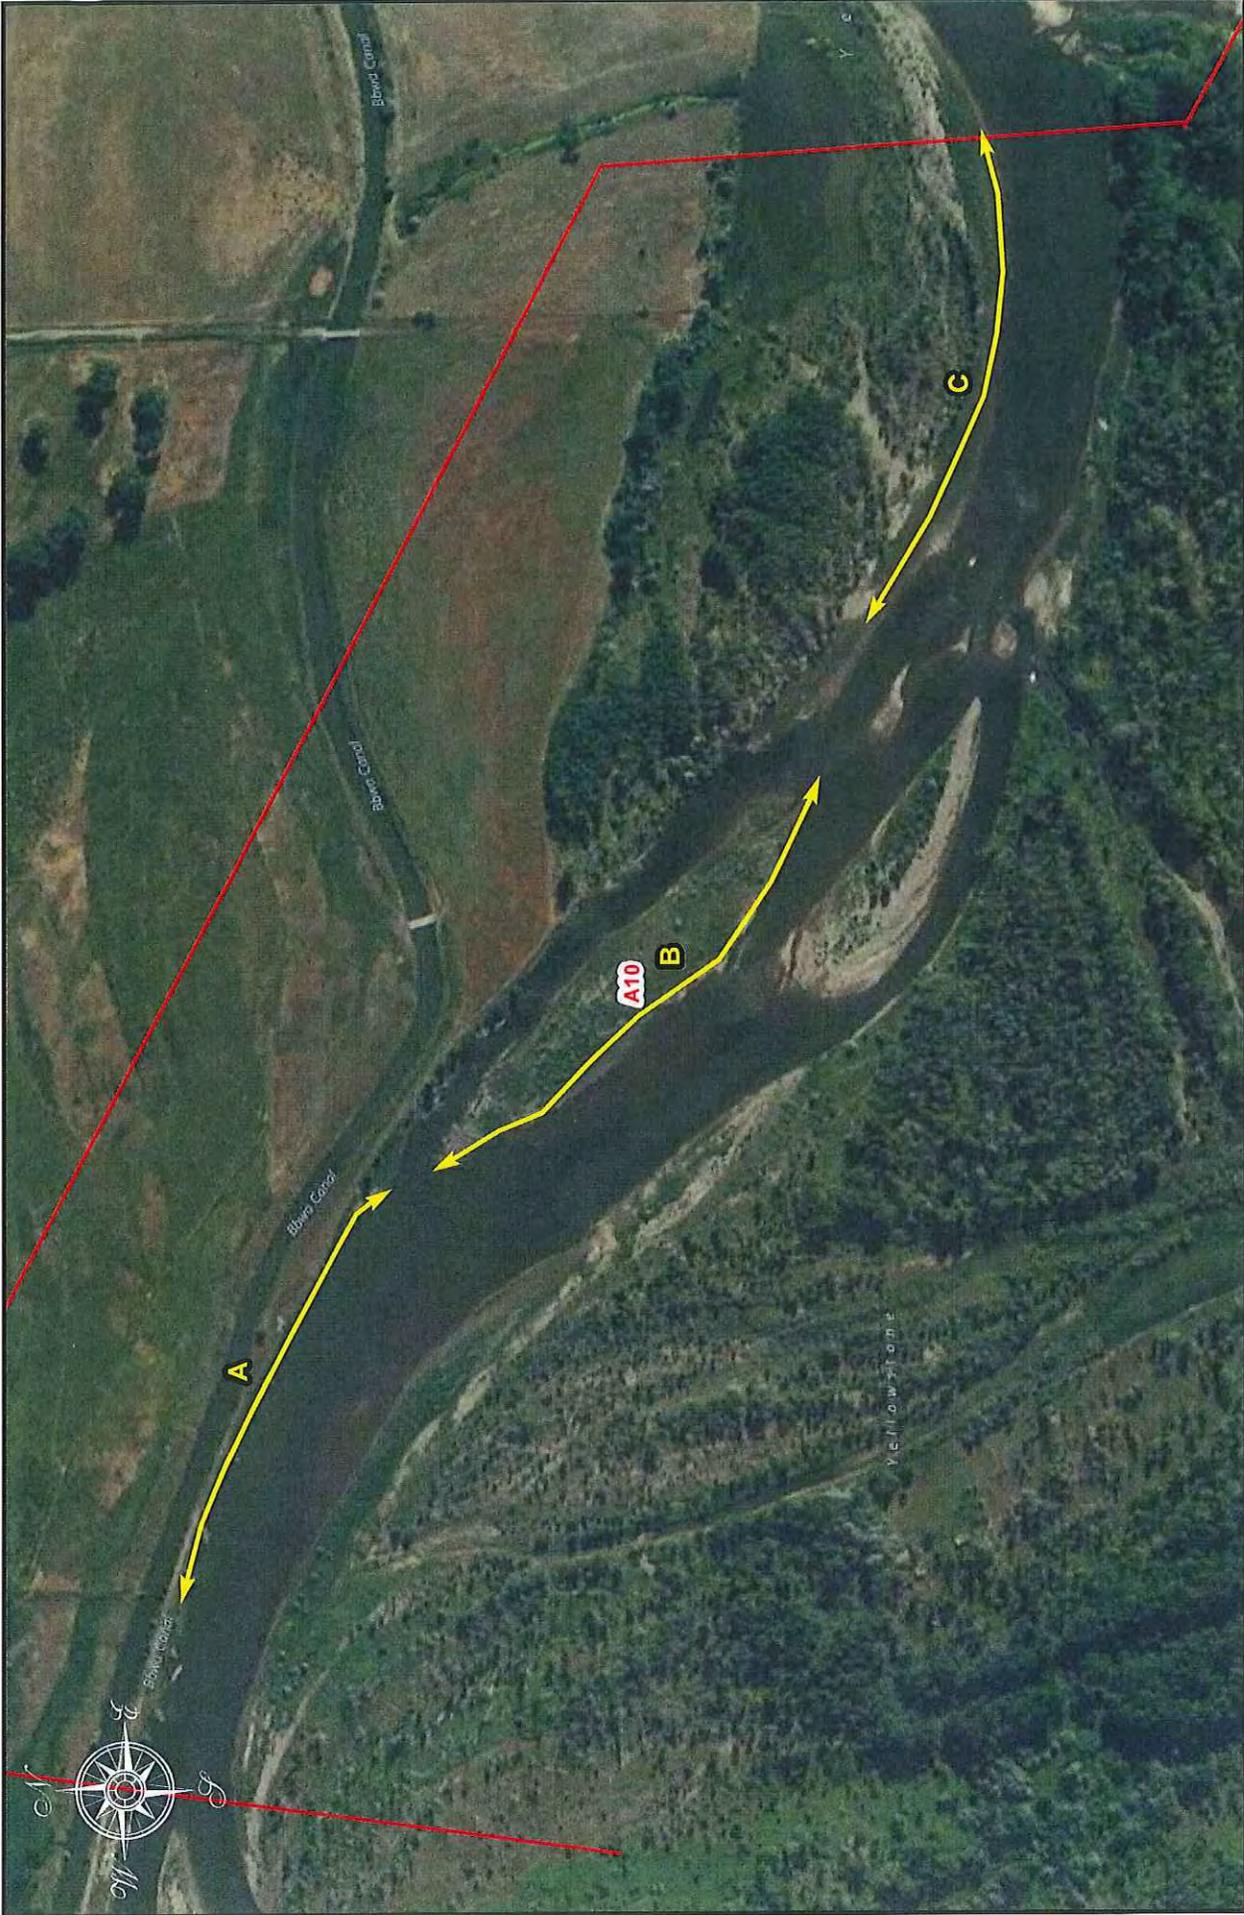
Cleanup Recommendations: No oil observed along river channel margin
