**SCAT Area Transition Report
for A10**

Silvertip Pipeline Incident
Laurel, Montana

October 18, 2011

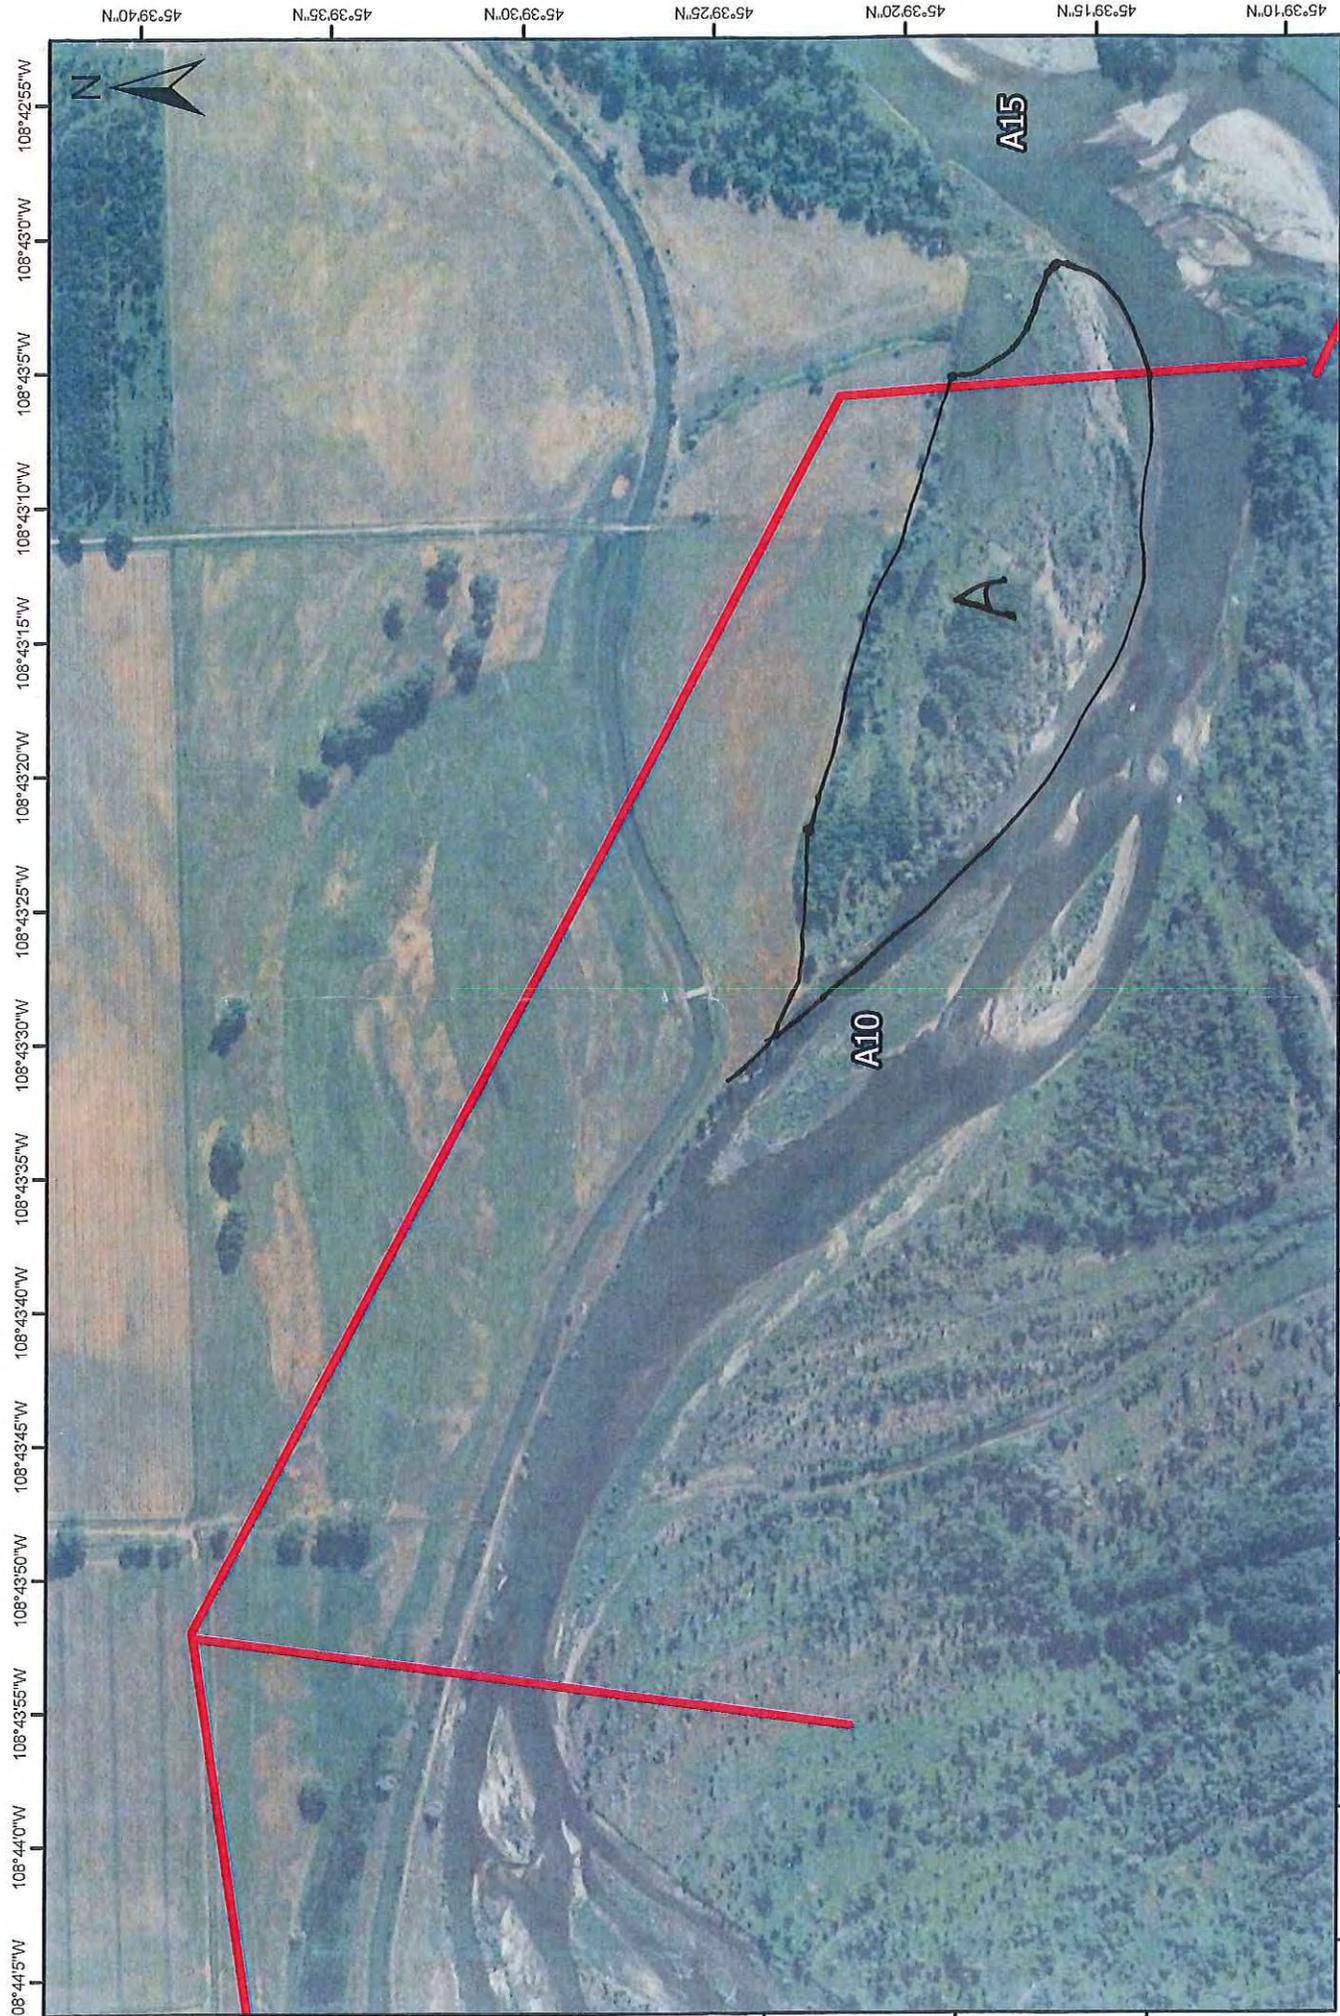
Zone A - No oil observed.

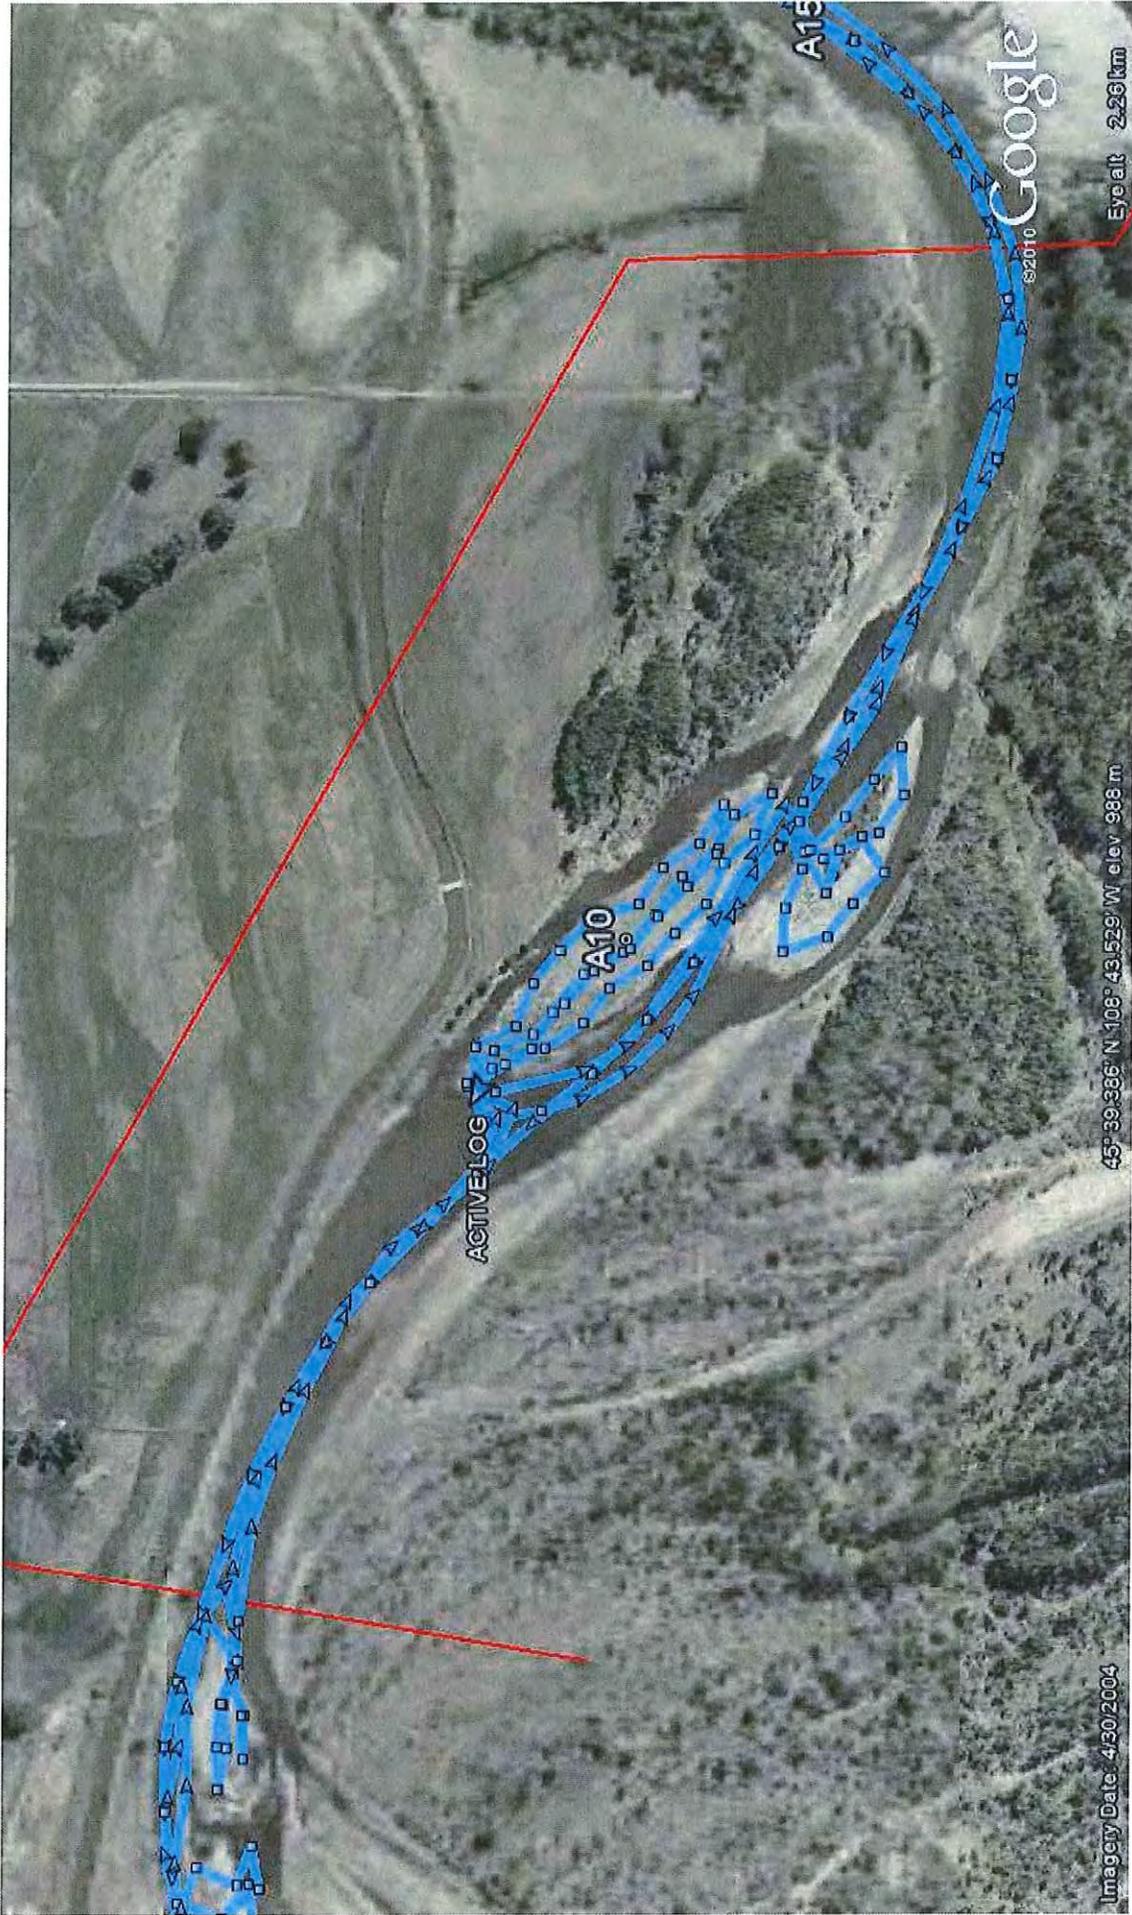
Zone A, B : No oil observed; no treatment required.

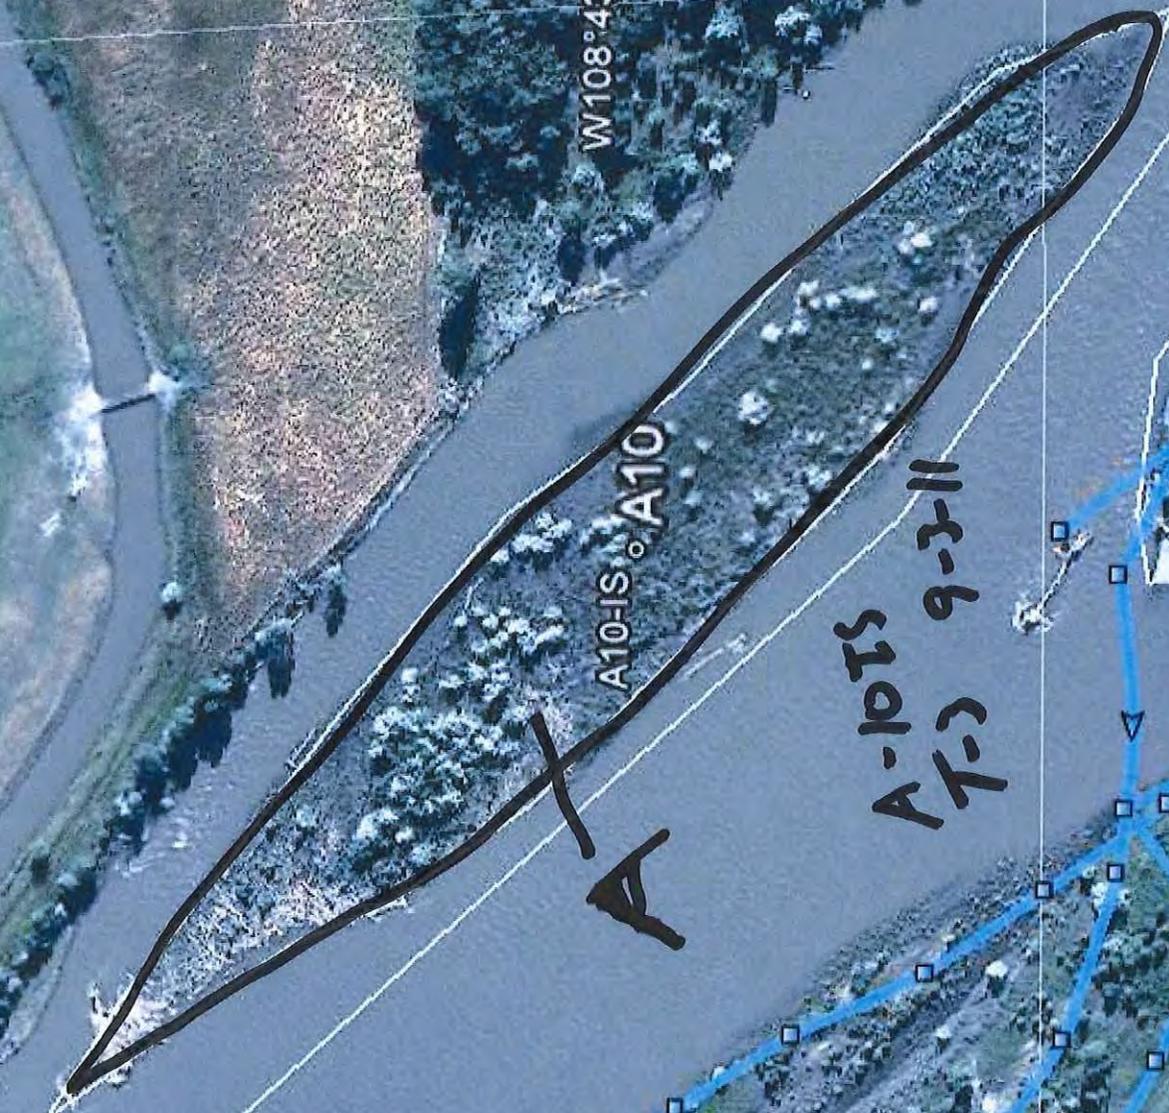
Zone A - No oil observed
