**SCAT Area Transition Report
for A11**

Silvertip Pipeline Incident
Laurel, Montana

October 18, 2011

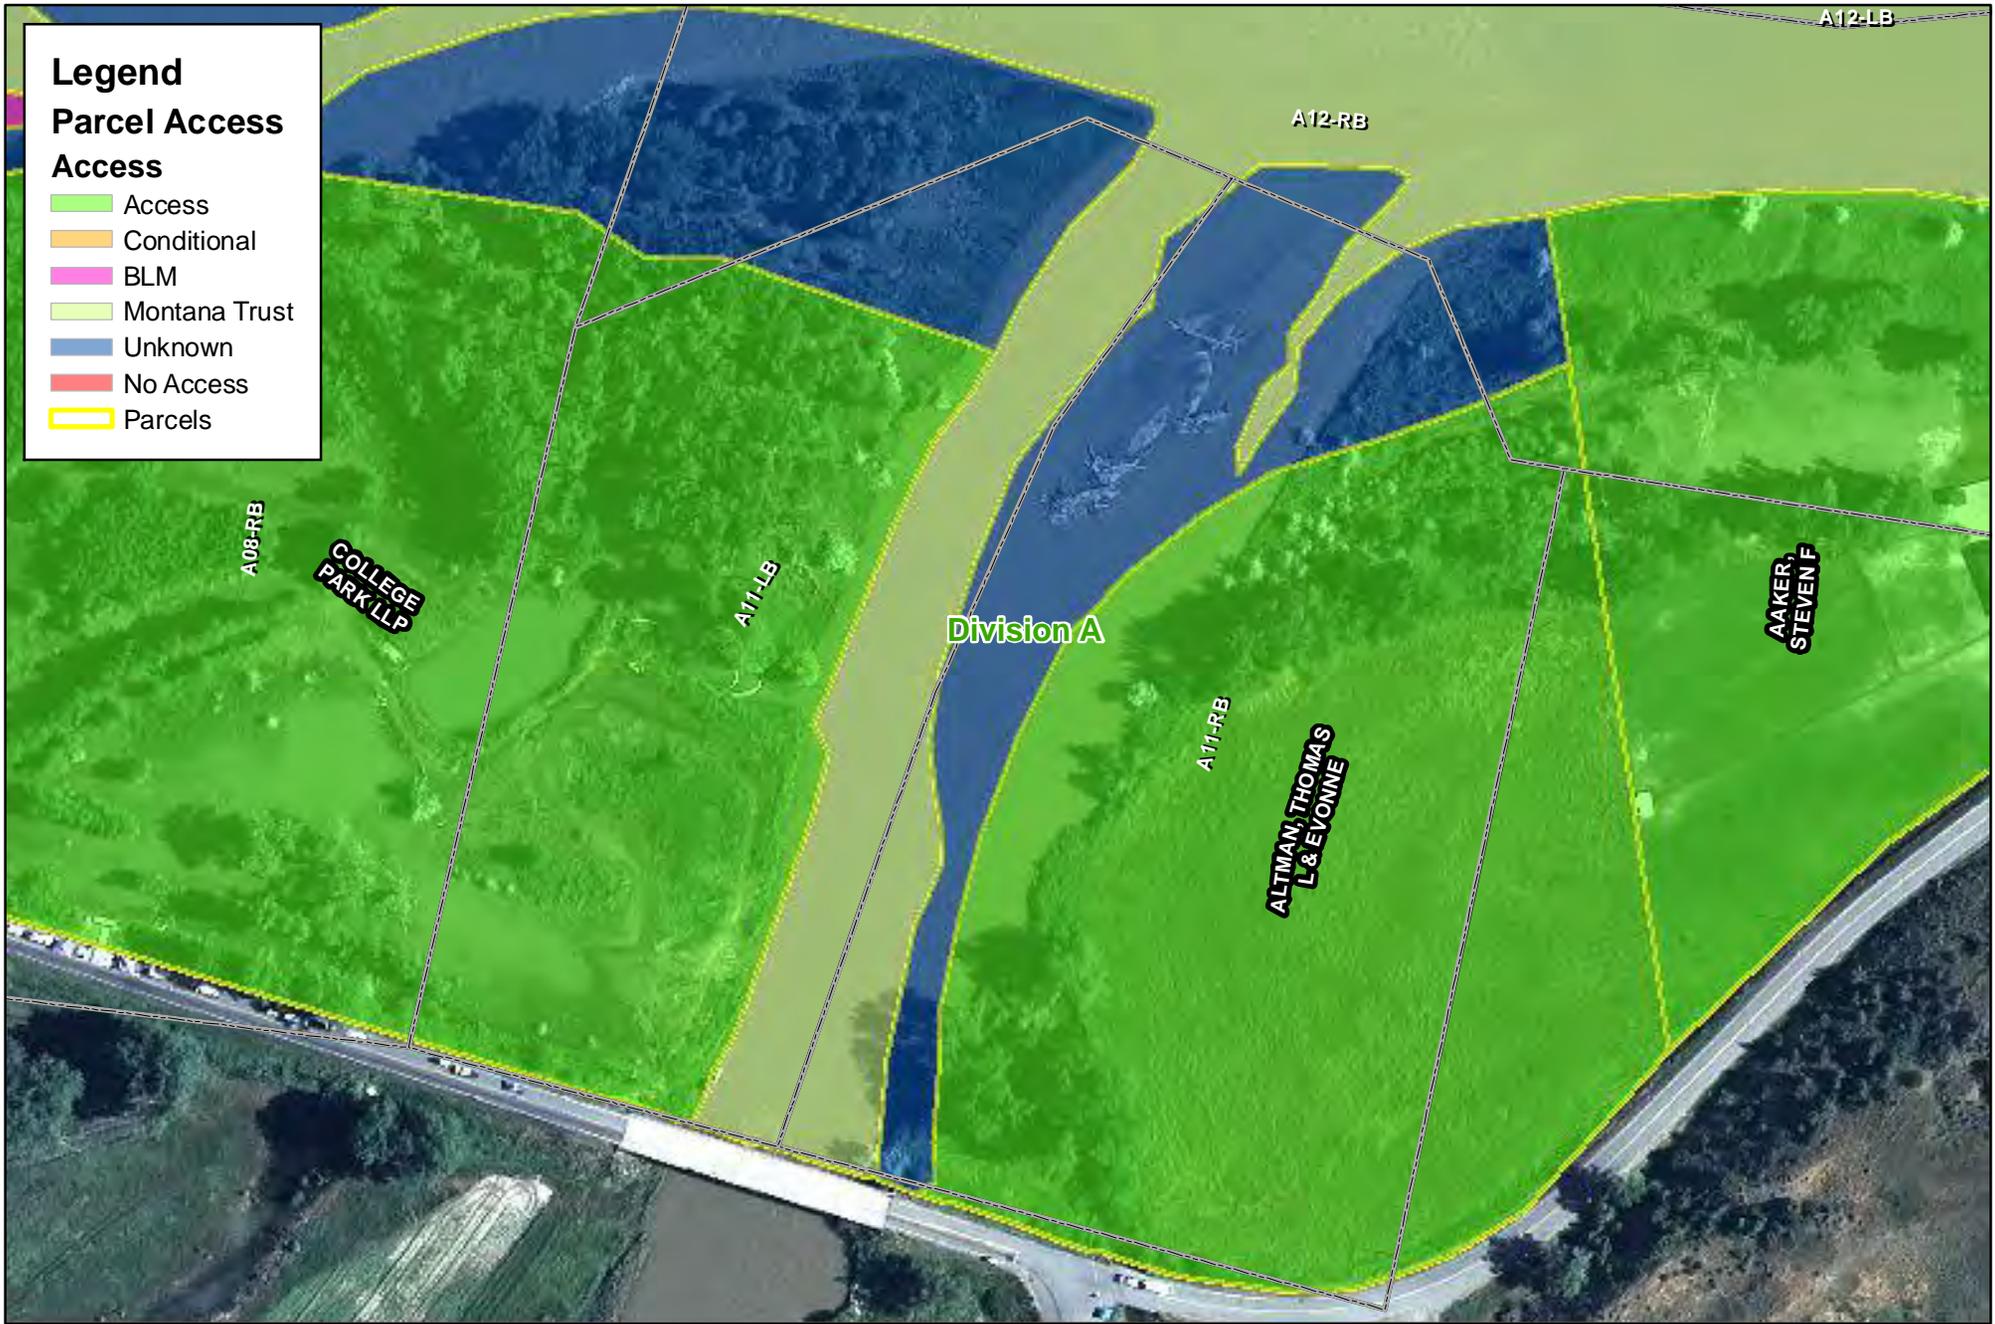
Figure 1 provides an aerial map of SCAT Area A11, along with the (a) SCAT Area boundary, (b) parcel boundaries and respective property owners, and (c) access constraints identified during the oil cleanup process. The acreage surveyed in Area A11 is 17.5. There were no access issues for this area.

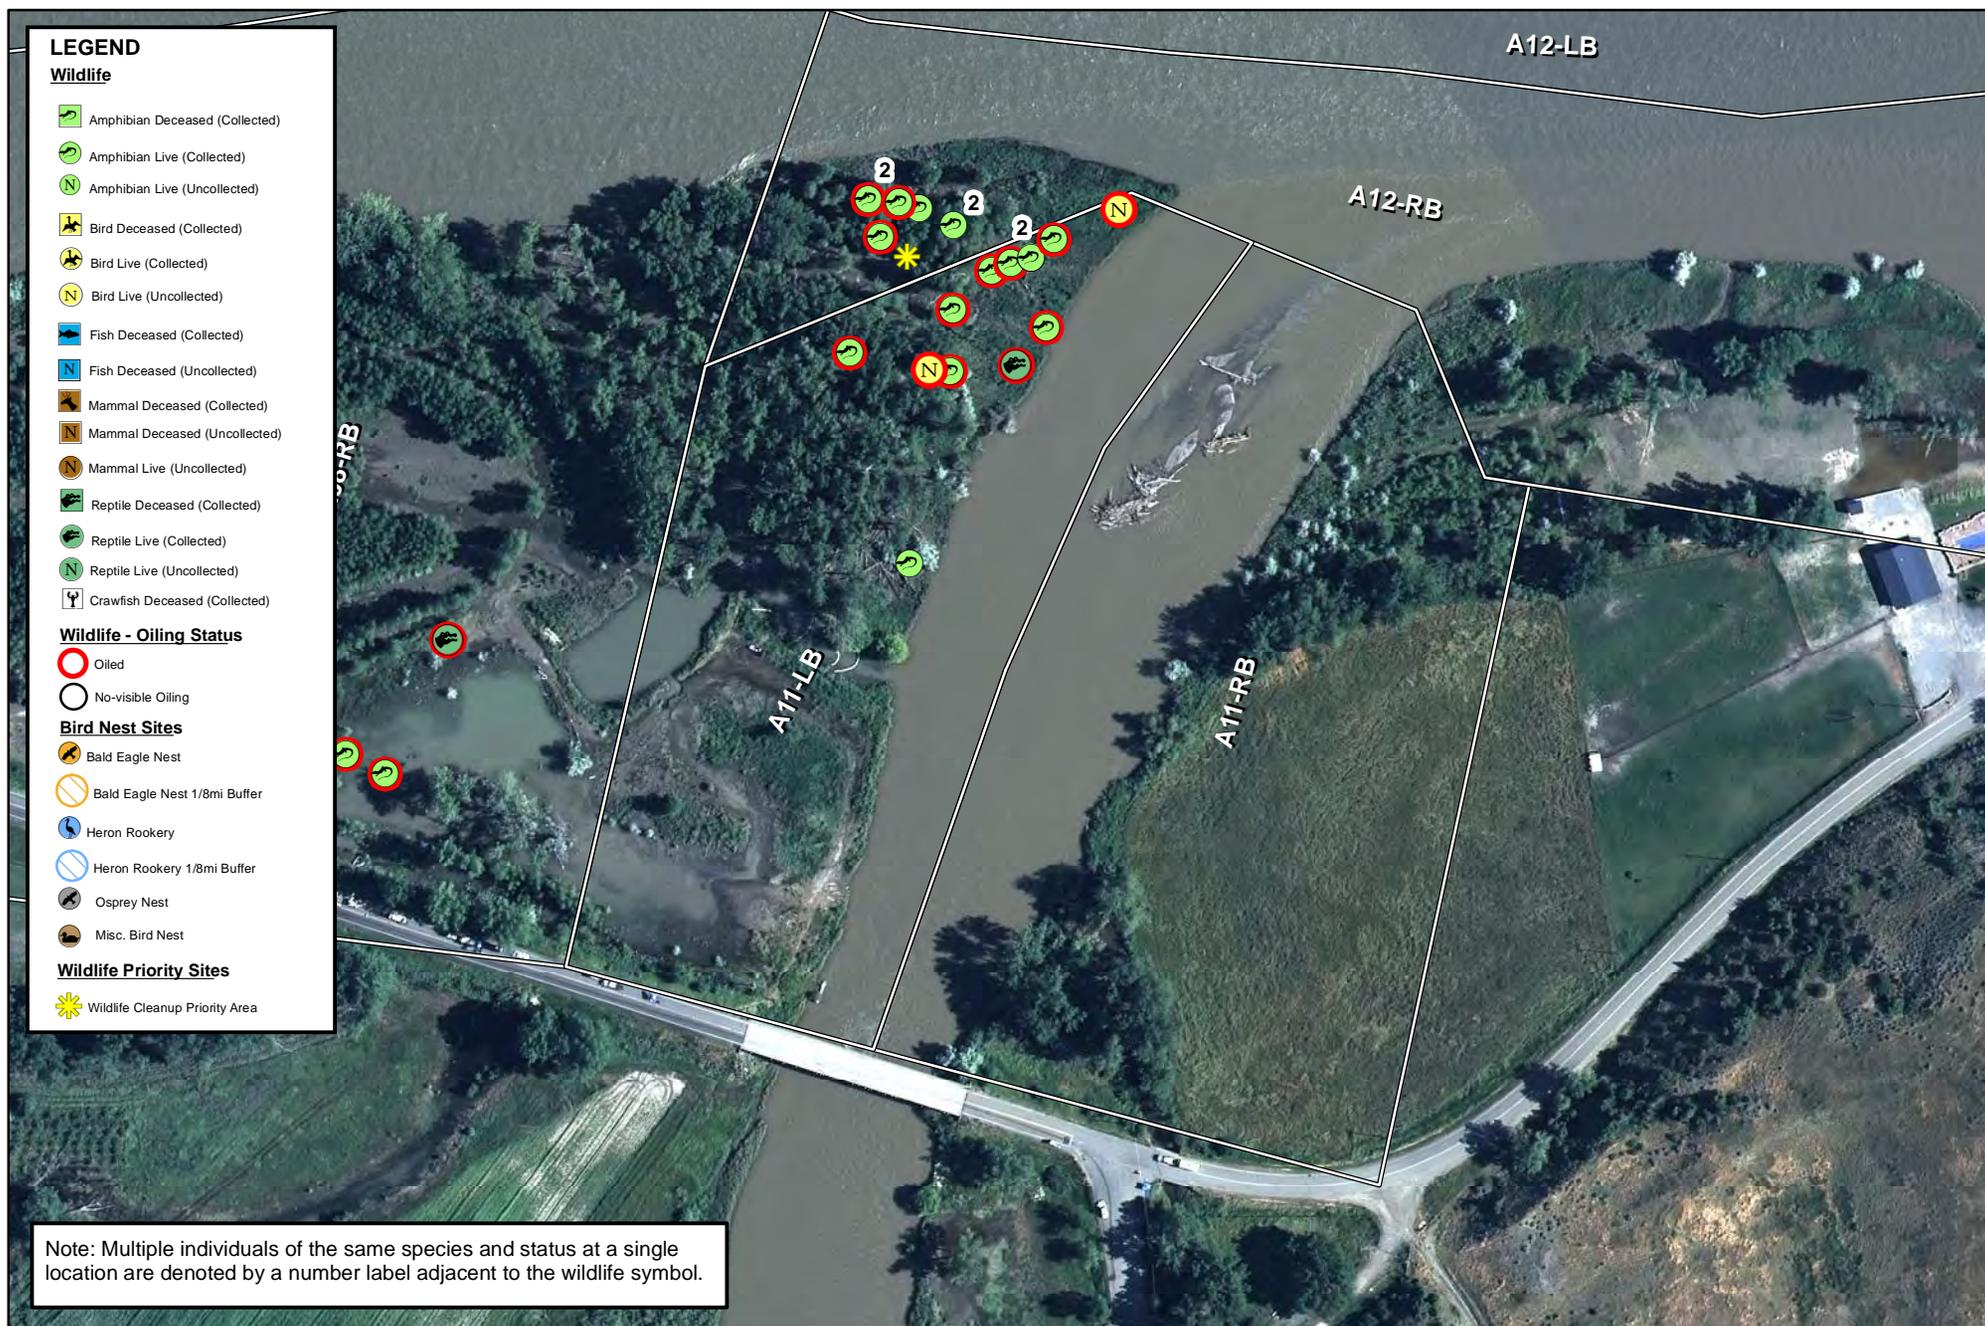
Figure 2
Wildlife Resources

Figure 2 summarizes the natural resources identified in this segment. International Bird Rescue and Resource Advisors from U.S. Fish and Wildlife Service conducted regular inspections of Area A11. Seven oiled Woodhouse's toads (*Bufo woodhousii*) and one western terrestrial garter snake (*Thamnophis elegans*) were captured, cleaned, and released. In addition, three Woodhouse's toads were captured and taken to the Wildlife Recovery Center for an oiling evaluation, determined to be un-oiled, and subsequently released. One America white pelican (*Pelecanus erythrorhynchos*) with heavy oiling was observed but could not be captured. One song sparrow (*Melospiza melodia*) with light oiling was identified and monitored; capture was not deemed necessary. No Wildlife Priority Cleanup Areas were identified. No active migratory bird nests were identified in Area A11.

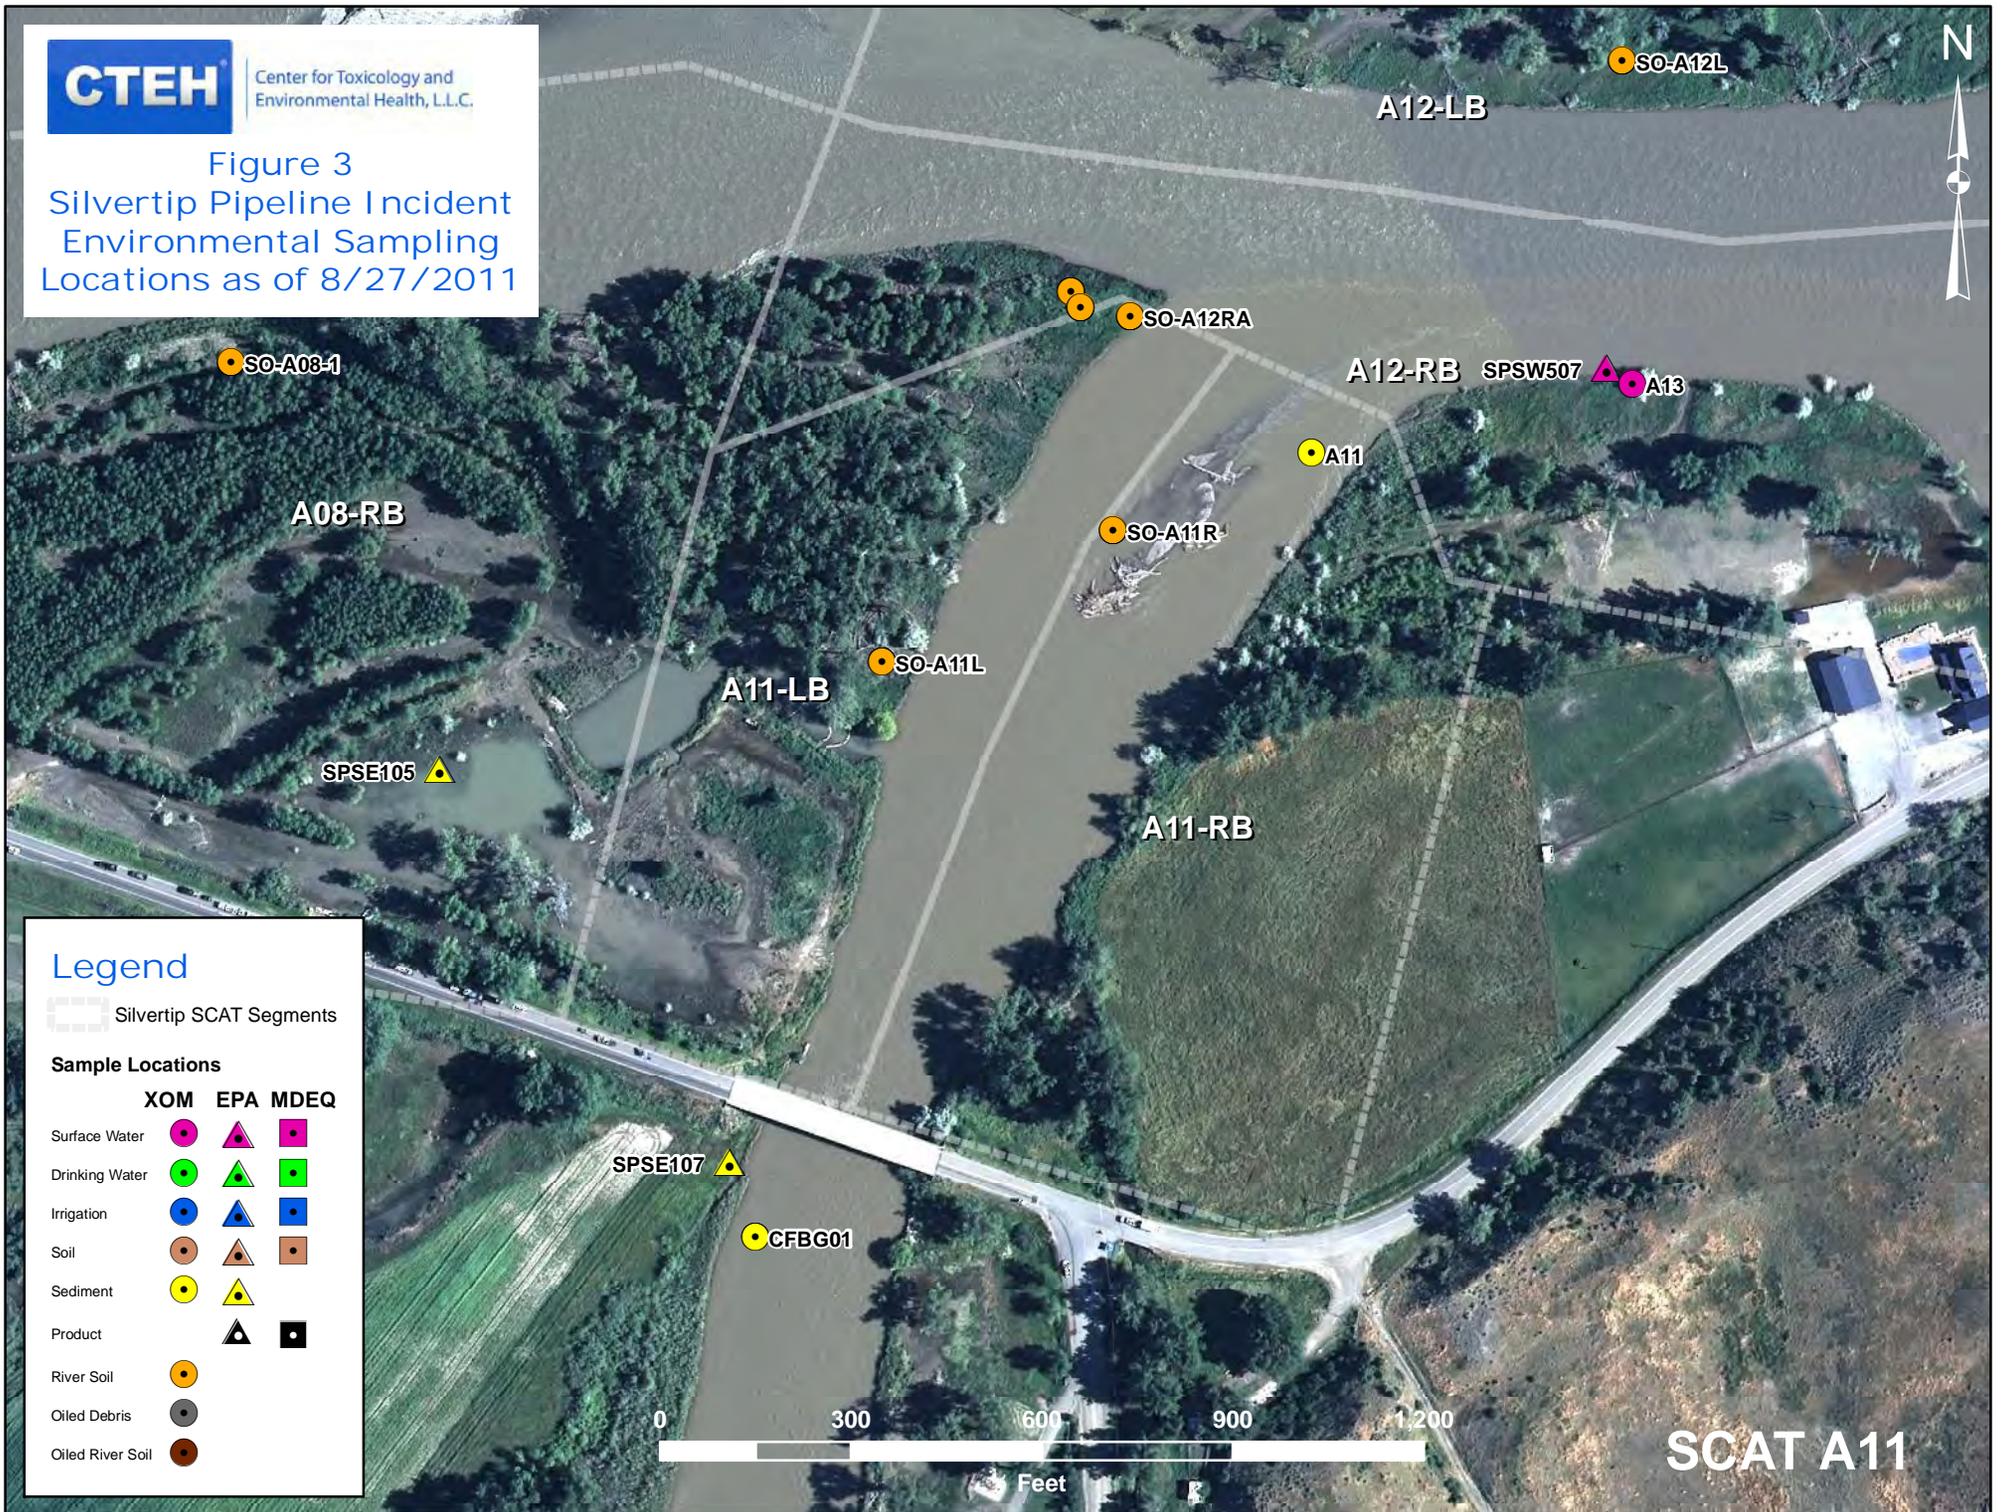
Figure 3
Silvertip Pipeline Incident
Environmental Sampling
Locations as of 8/27/2011

Table 1 (below) summarizes samples collected within Area A11. The analytical results for the samples collected can be accessed through a publicly accessible database on the United States Environmental Protection Agency's (USEPA's) website. The approximate locations of samples collected within Area A11 are provided on Figure 3.

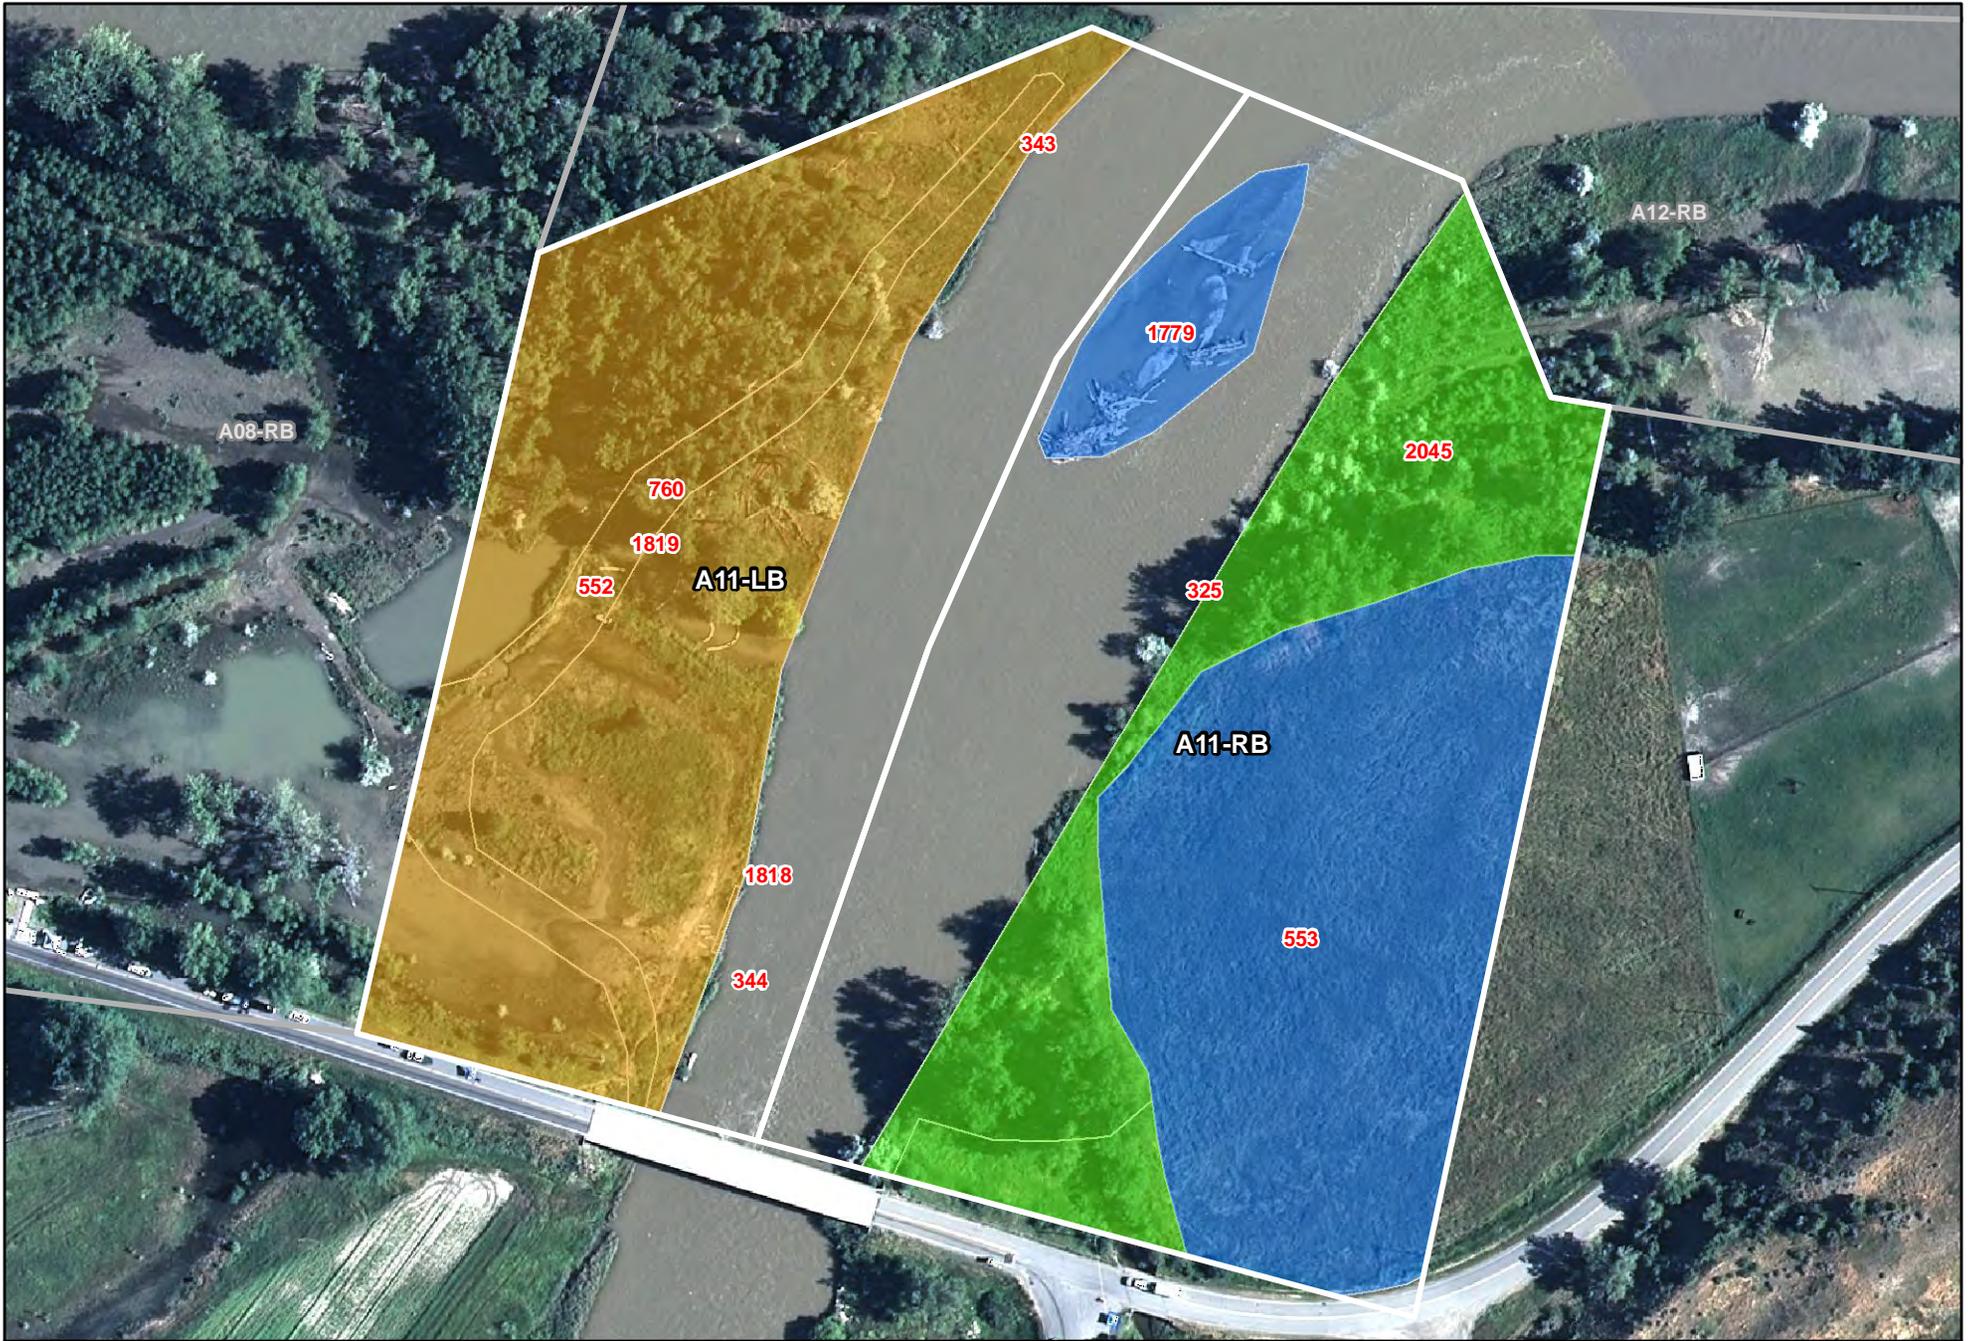
Figure 4 - Maximum SCAT Observations
For SCAT Area: A11

The SCAT teams used systematic evaluation criteria and treatment method tables approved by the National Oceanic and Atmospheric Administration to provide a standard approach for data collection and conducting field surveys. The forms and sketches from the initial SCAT surveys performed along the river bank (water edge) and floodplain within Area A11 are included in Appendix B. Figure 4 provides the maximum oiling zones observed by the SCAT team during the initial surveys of Area A11.

The SCAT team developed compiled treatment recommendations (CTRs) providing approved treatment methods (ATMs) for each oiling zone identified during the initial SCAT surveys ([CTR No. 4](#) and [CTR No. 6](#)).

Oil removal activities were conducted within Area A11 in accordance with the ATMs identified in the CTRs. [Appendix I](#) of the Summary of Assessment and Oil Removal Activities report presents this data including: date range/days worked, average number of people working per day, equipment used, and various types of bags removed: oily debris, personal protective equipment (PPE), plastic, trash, super sacks, wood chips, and contaminated wood.

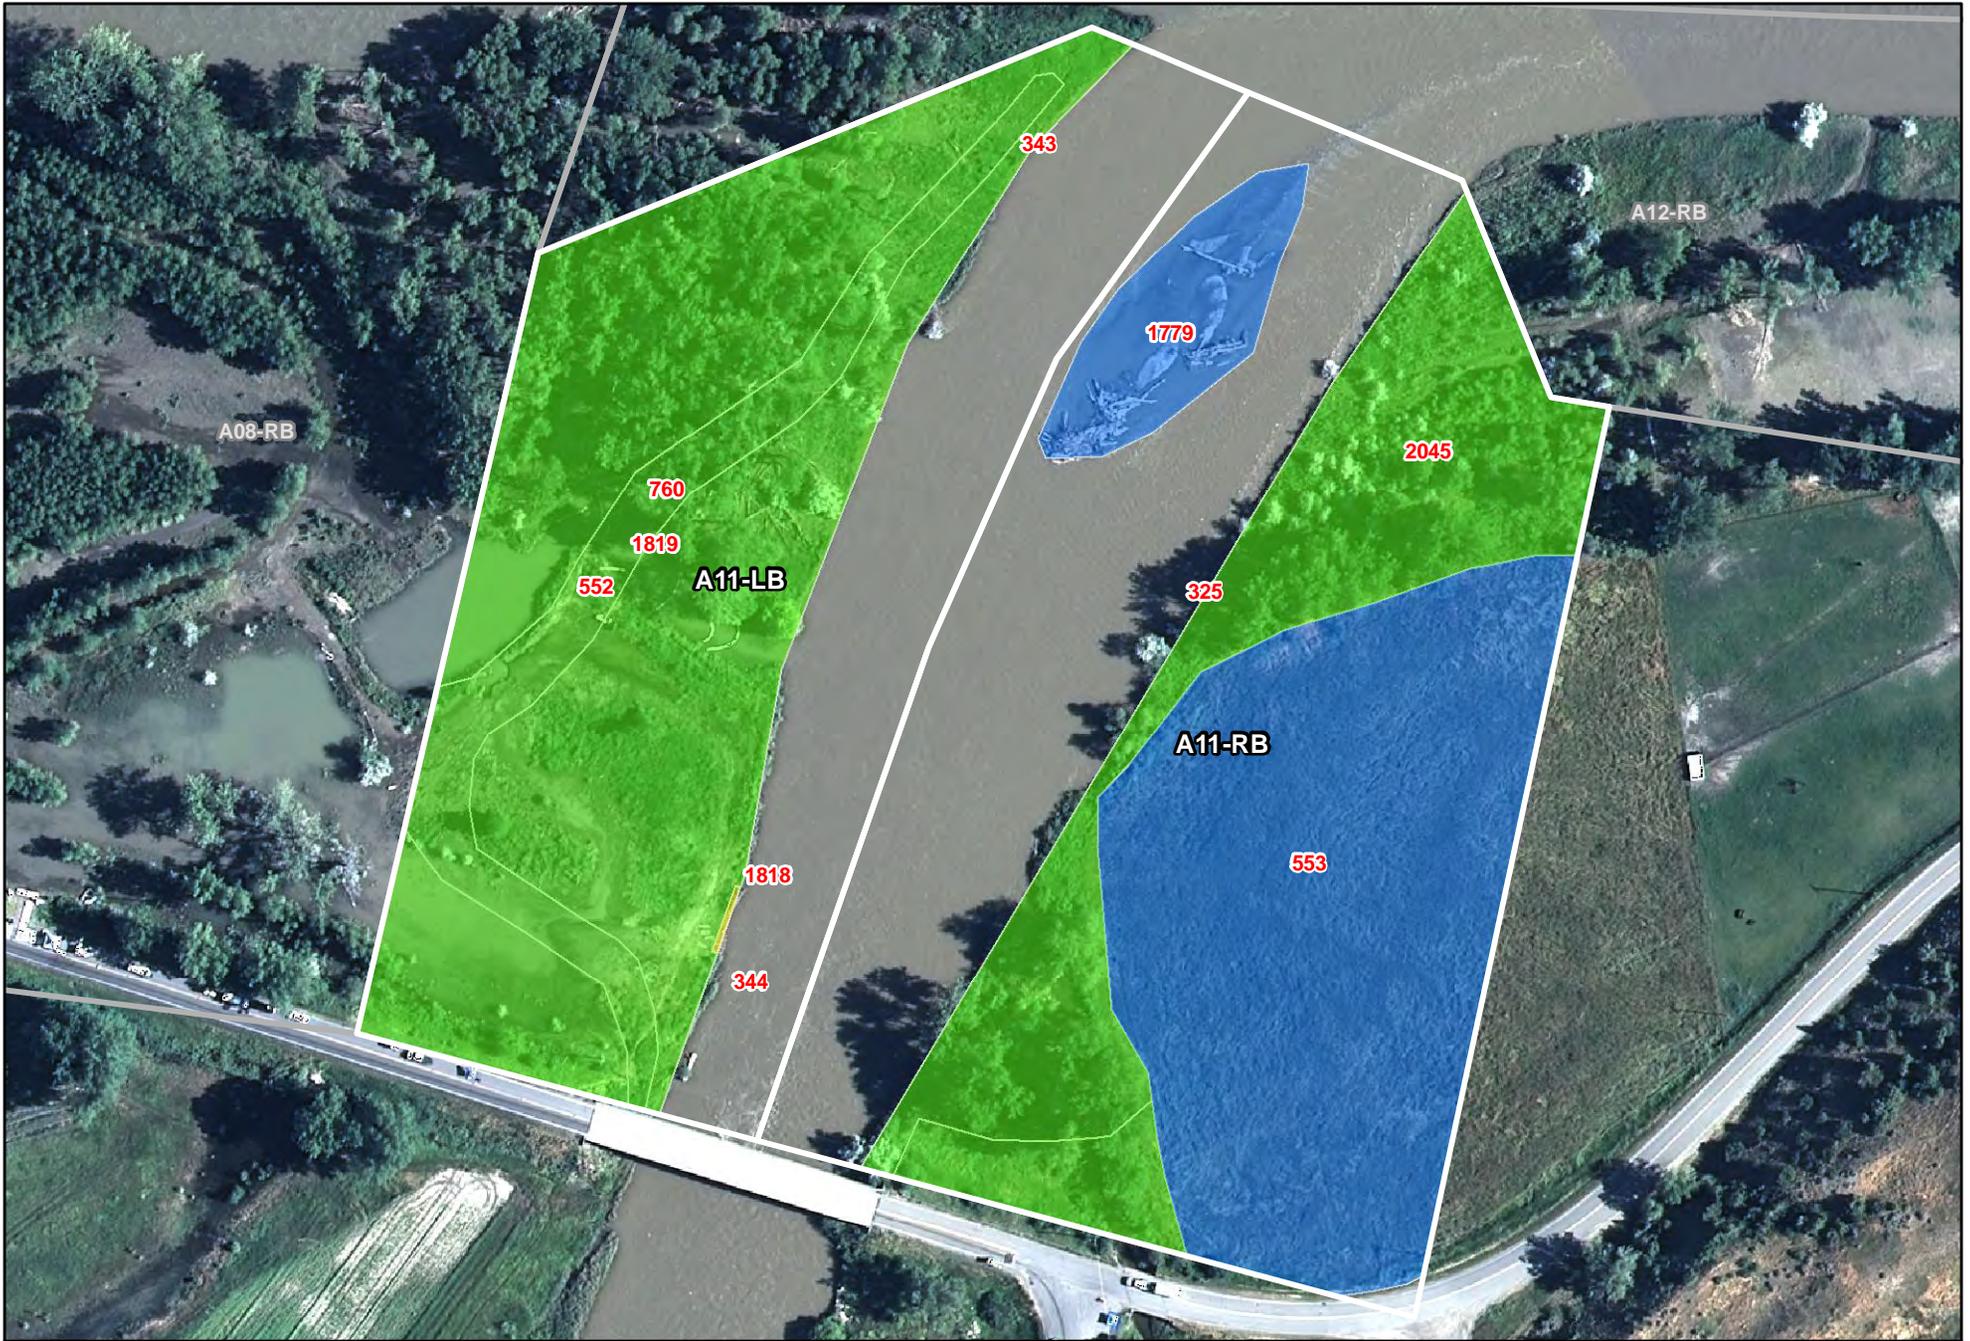
Figure 5 - Final SCAT Observations
For SCAT Area: A11

Figure 5 shows the oiling conditions within Area A11 following completion of oil removal activities. The SCAT team performed final surveys of the left and right banks within SCAT Area A11 to confirm the agreed-upon cleanup endpoints identified in the applicable CTRs had been achieved. The final SCAT survey documentation is presented in Appendix E.

Based on the final SCAT surveys performed on the left and right banks within Area A11, no further treatment is recommended for these areas. Based on the initial SCAT surveys, no oiling was observed on the island of Area A11. A SCAT Segment Sign-Off Form for the right bank is included as Appendix F.

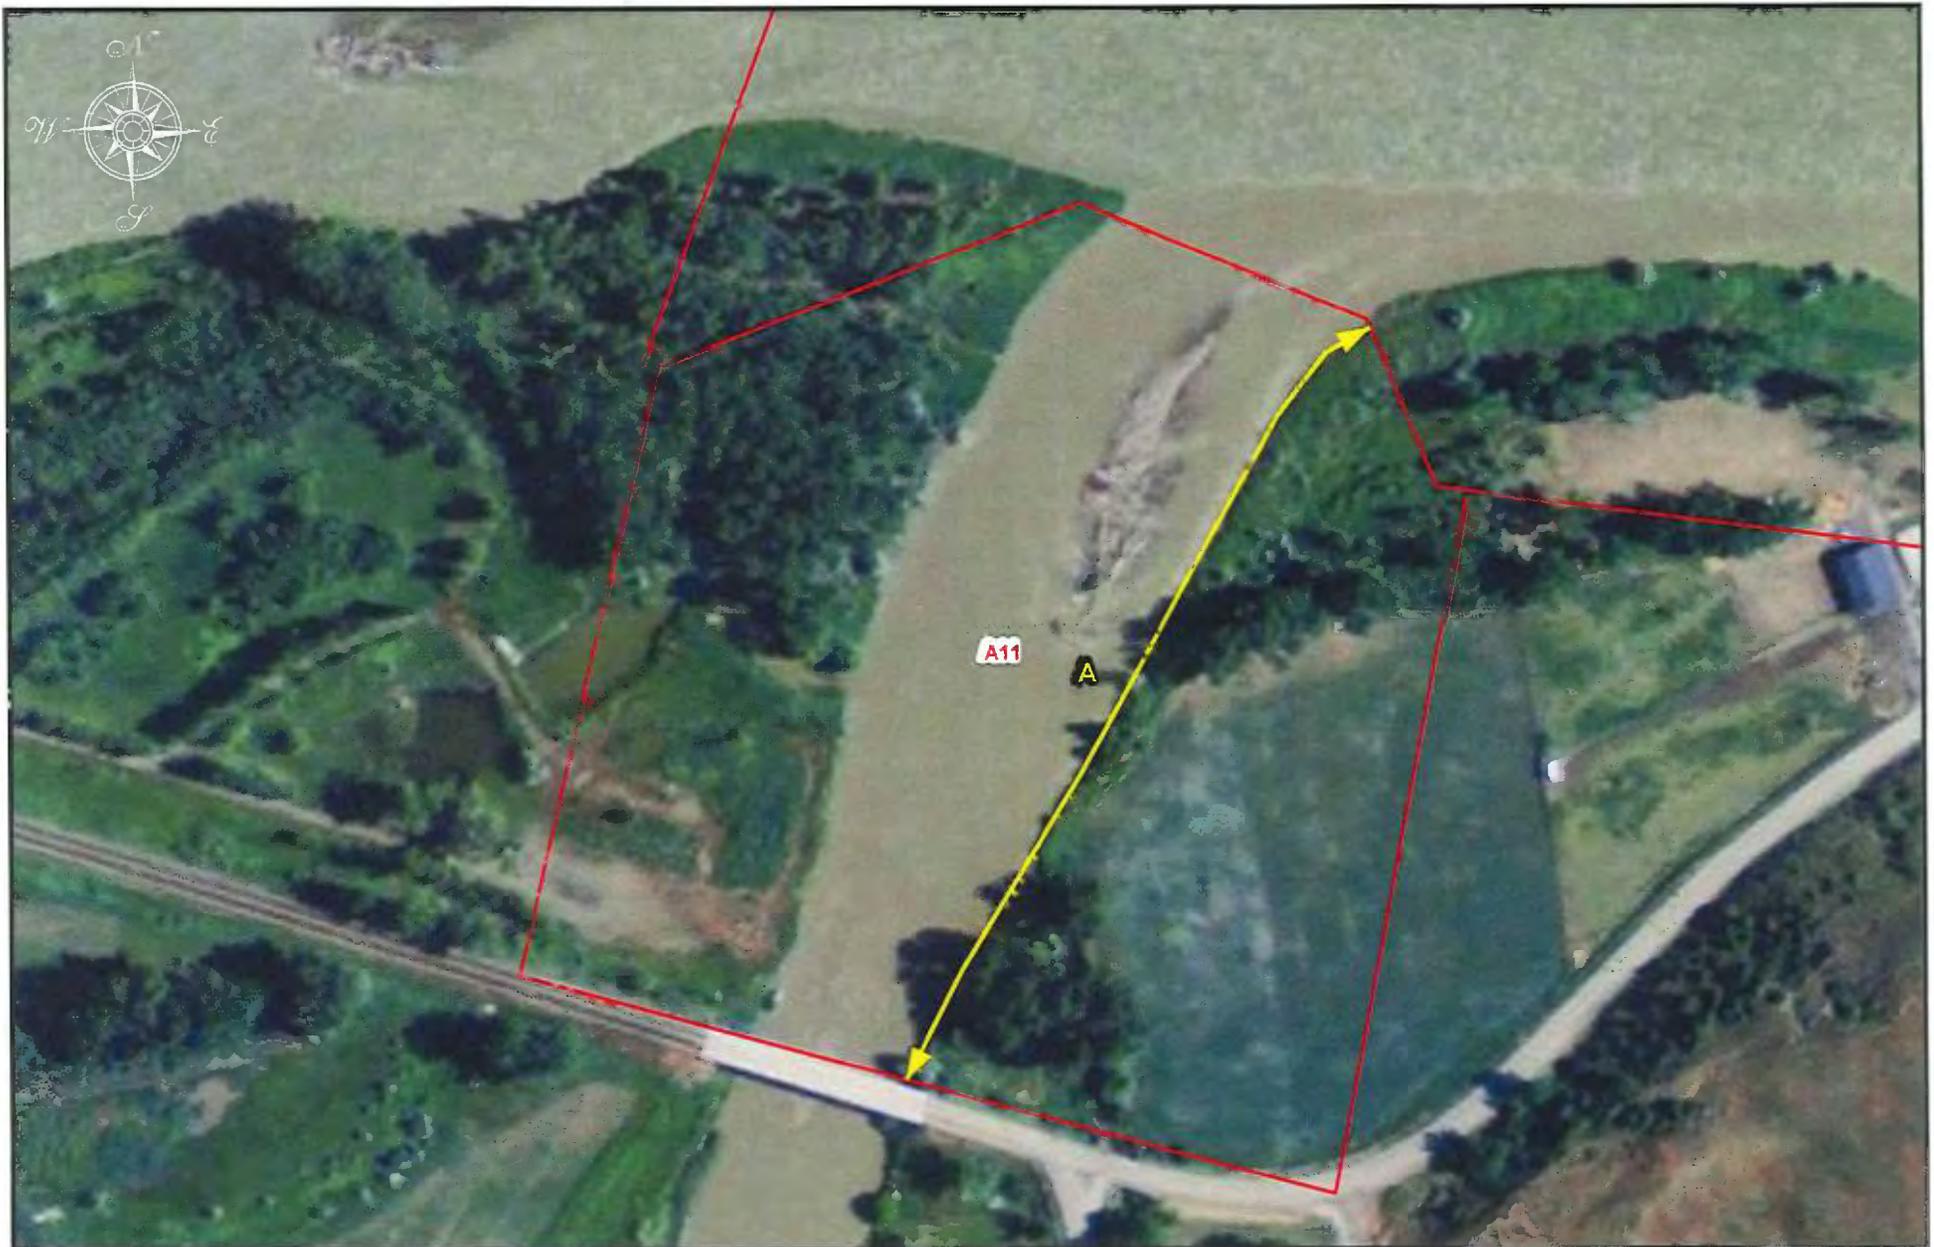
Segment A11 - Right Bank

Treatment Recommendations:
 Zone A: No oil observed along the shoreline. No treatment required along shoreline.

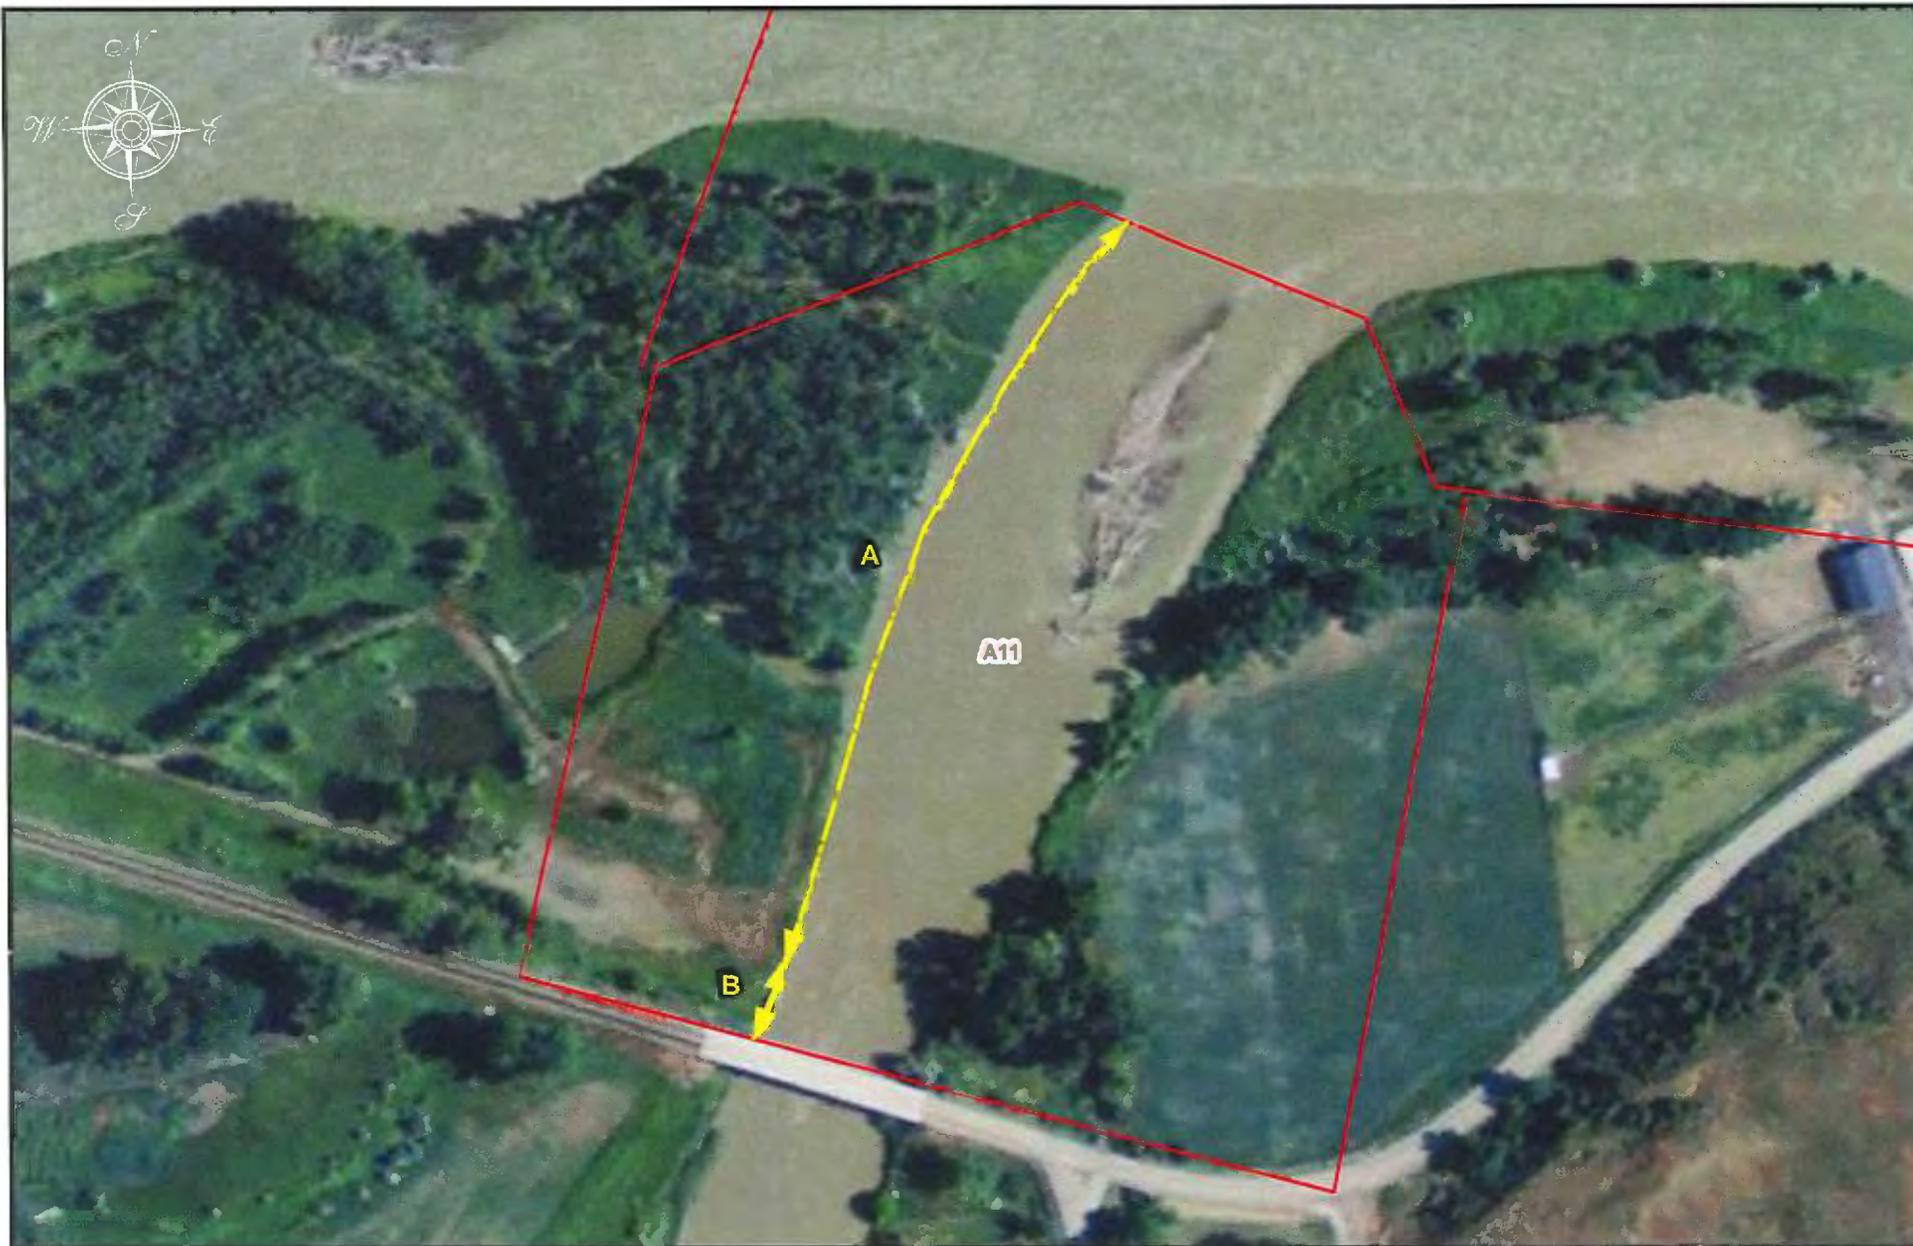
Segment A11 - Left Bank

Treatment Recommendations:
 Zone A: Cut & remove oil coated vegetation smaller than 1" diameter. Wipe larger oil coated vegetation.
 Zones B: No Oil Observed. No Treatment Required.

*Refer to current approved treatment methods #1 (Cutting of Vegetation)

Zone A Recommendation - Continue cleanup efforts. Recommend another survey when crews make more progress.
