**SCAT Area Transition Report
for A12**

Silvertip Pipeline Incident
Laurel, Montana

October 18, 2011

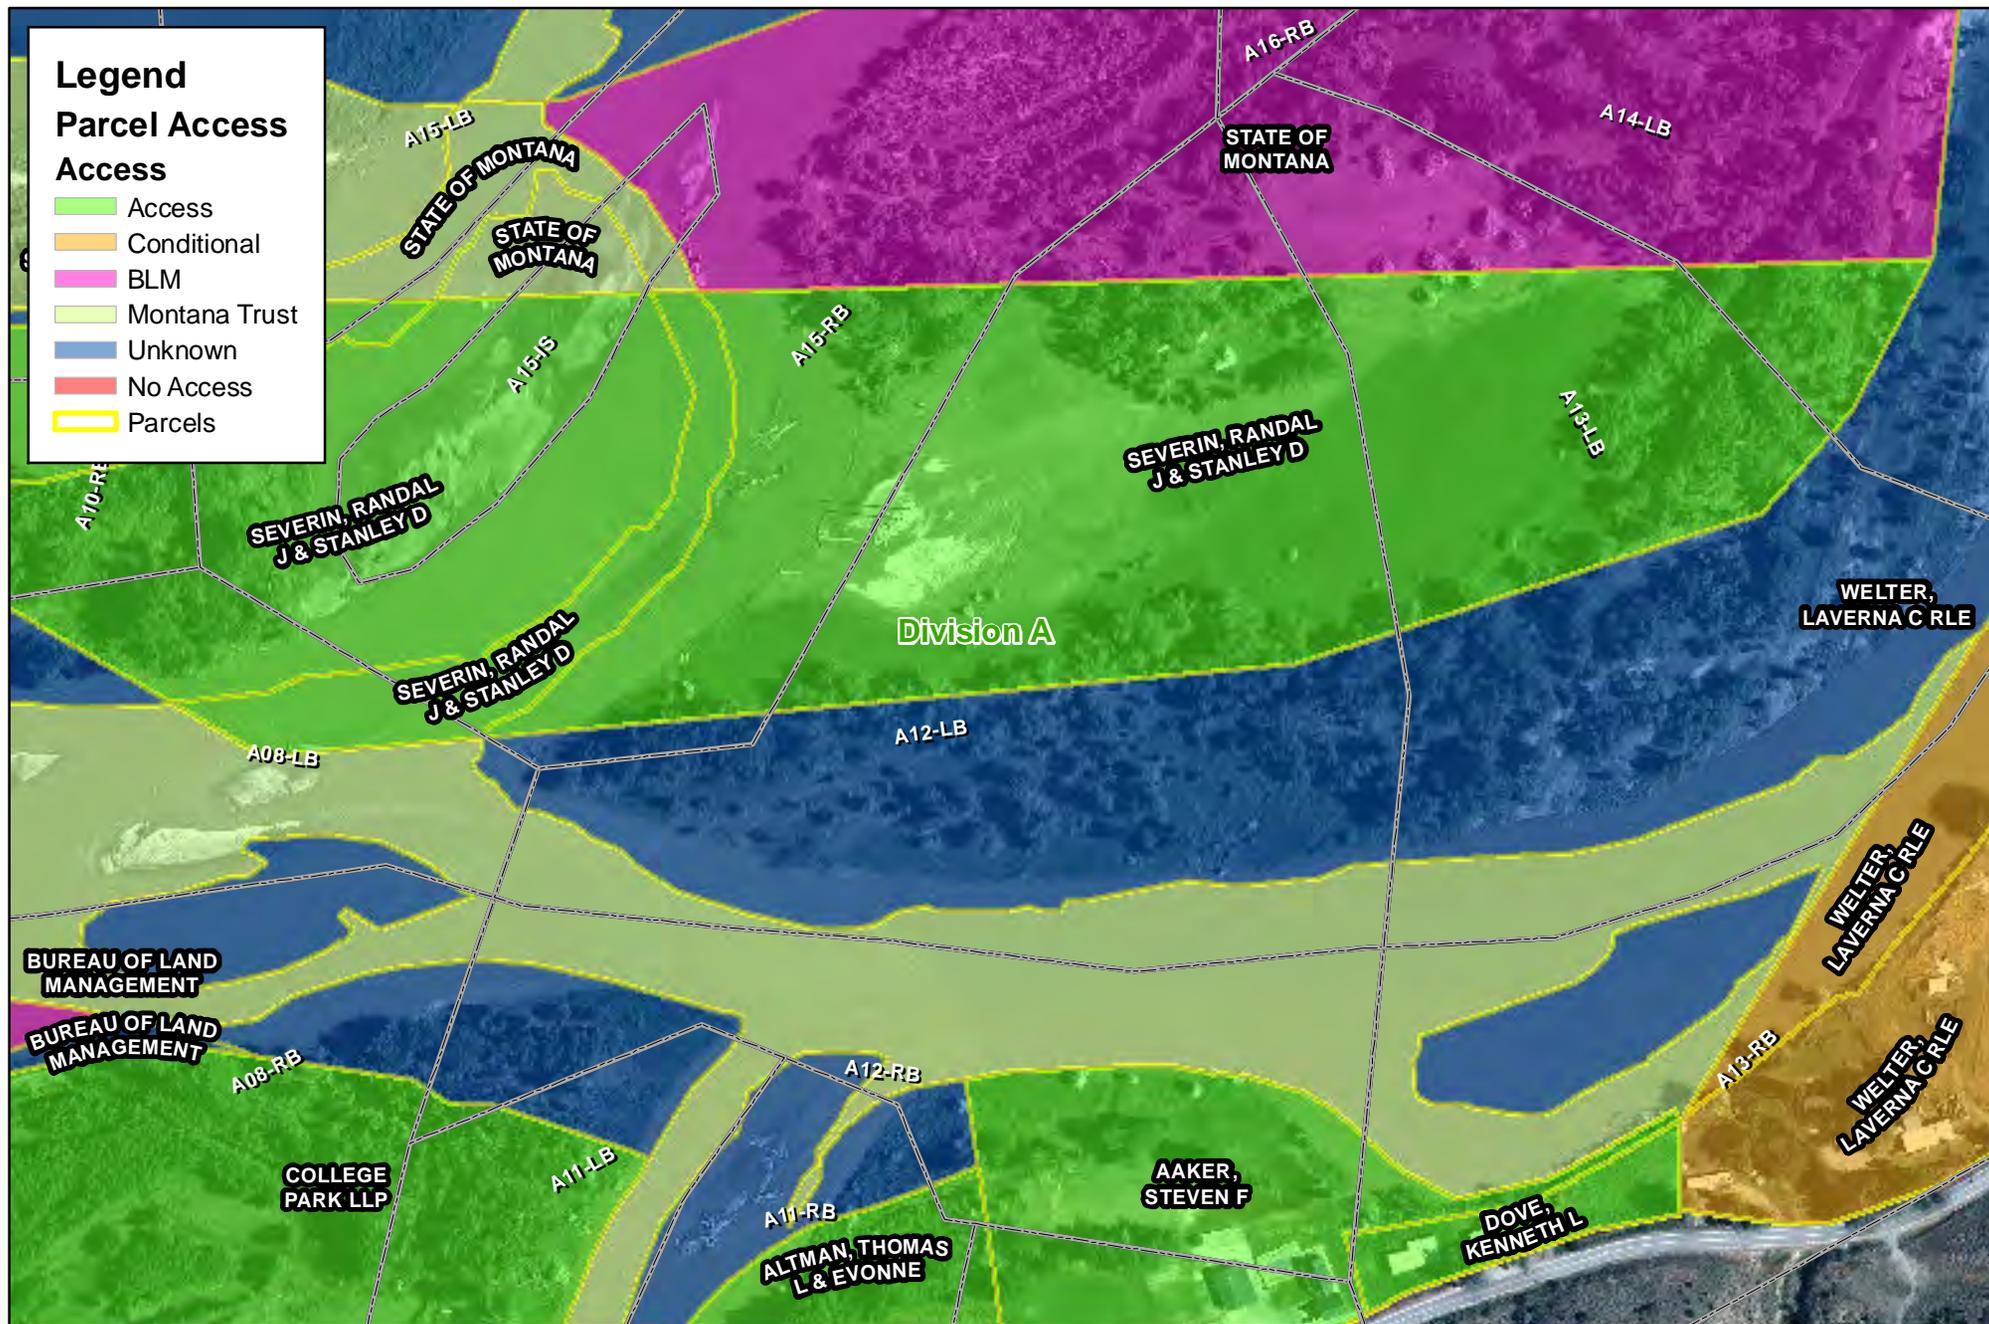
Figure 1 provides an aerial map of SCAT Area A12, along with the (a) SCAT Area boundary, (b) parcel boundaries and respective property owners, and (c) access constraints identified during the oil cleanup process. The acreage surveyed in Area A12 is 29.4. There were no access issues for this area.

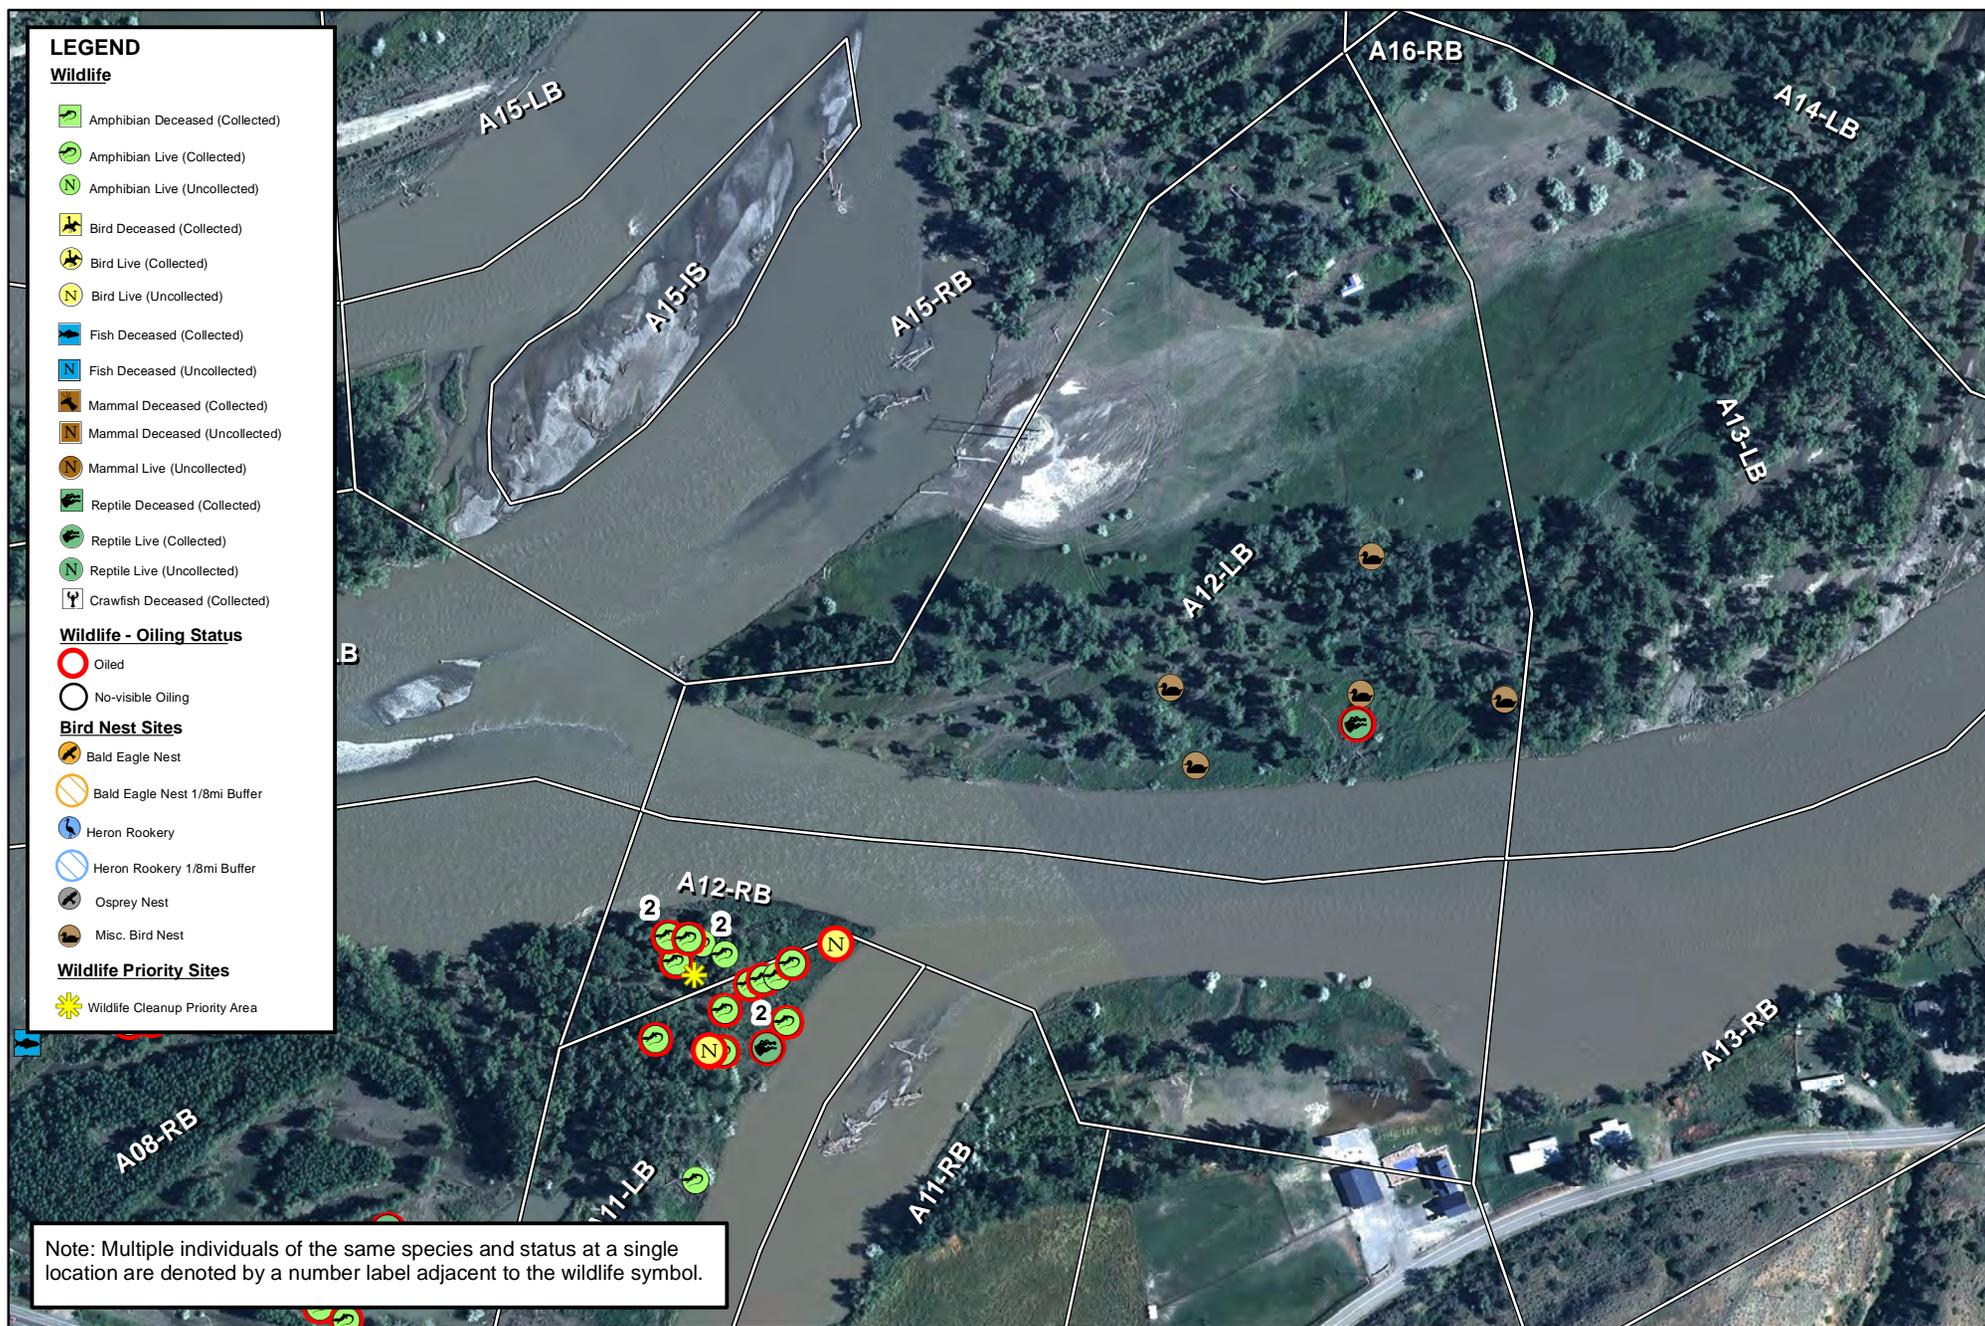
Figure 2
Wildlife Resources

Figure 2 summarizes the natural resources identified in this segment. International Bird Rescue and Resource Advisors from U.S. Fish and Wildlife Service conducted regular inspections of Area A12. Four oiled Woodhouse's toads (*Bufo woodhousii*) and one western terrestrial garter snake (*Thamnophis elegans*) were captured, cleaned, and released. In addition, three Woodhouse's toads were captured and taken to the Wildlife Recovery Center for an oiling evaluation and release. One Wildlife Priority Cleanup Area (WPCA) was identified. The WPCA consisted of several debris piles that contained oily debris as well as transferable oil on the ground. The WPCA was treated to reduce the potential for wildlife oiling and it is no longer considered a hazard.

Five active migratory bird nests were identified in Area A12: three unknown species nests, one mourning dove (*Zenaida macroura*) nest, and one cedar waxwing (*Bombycilla cedrorum*) nest.

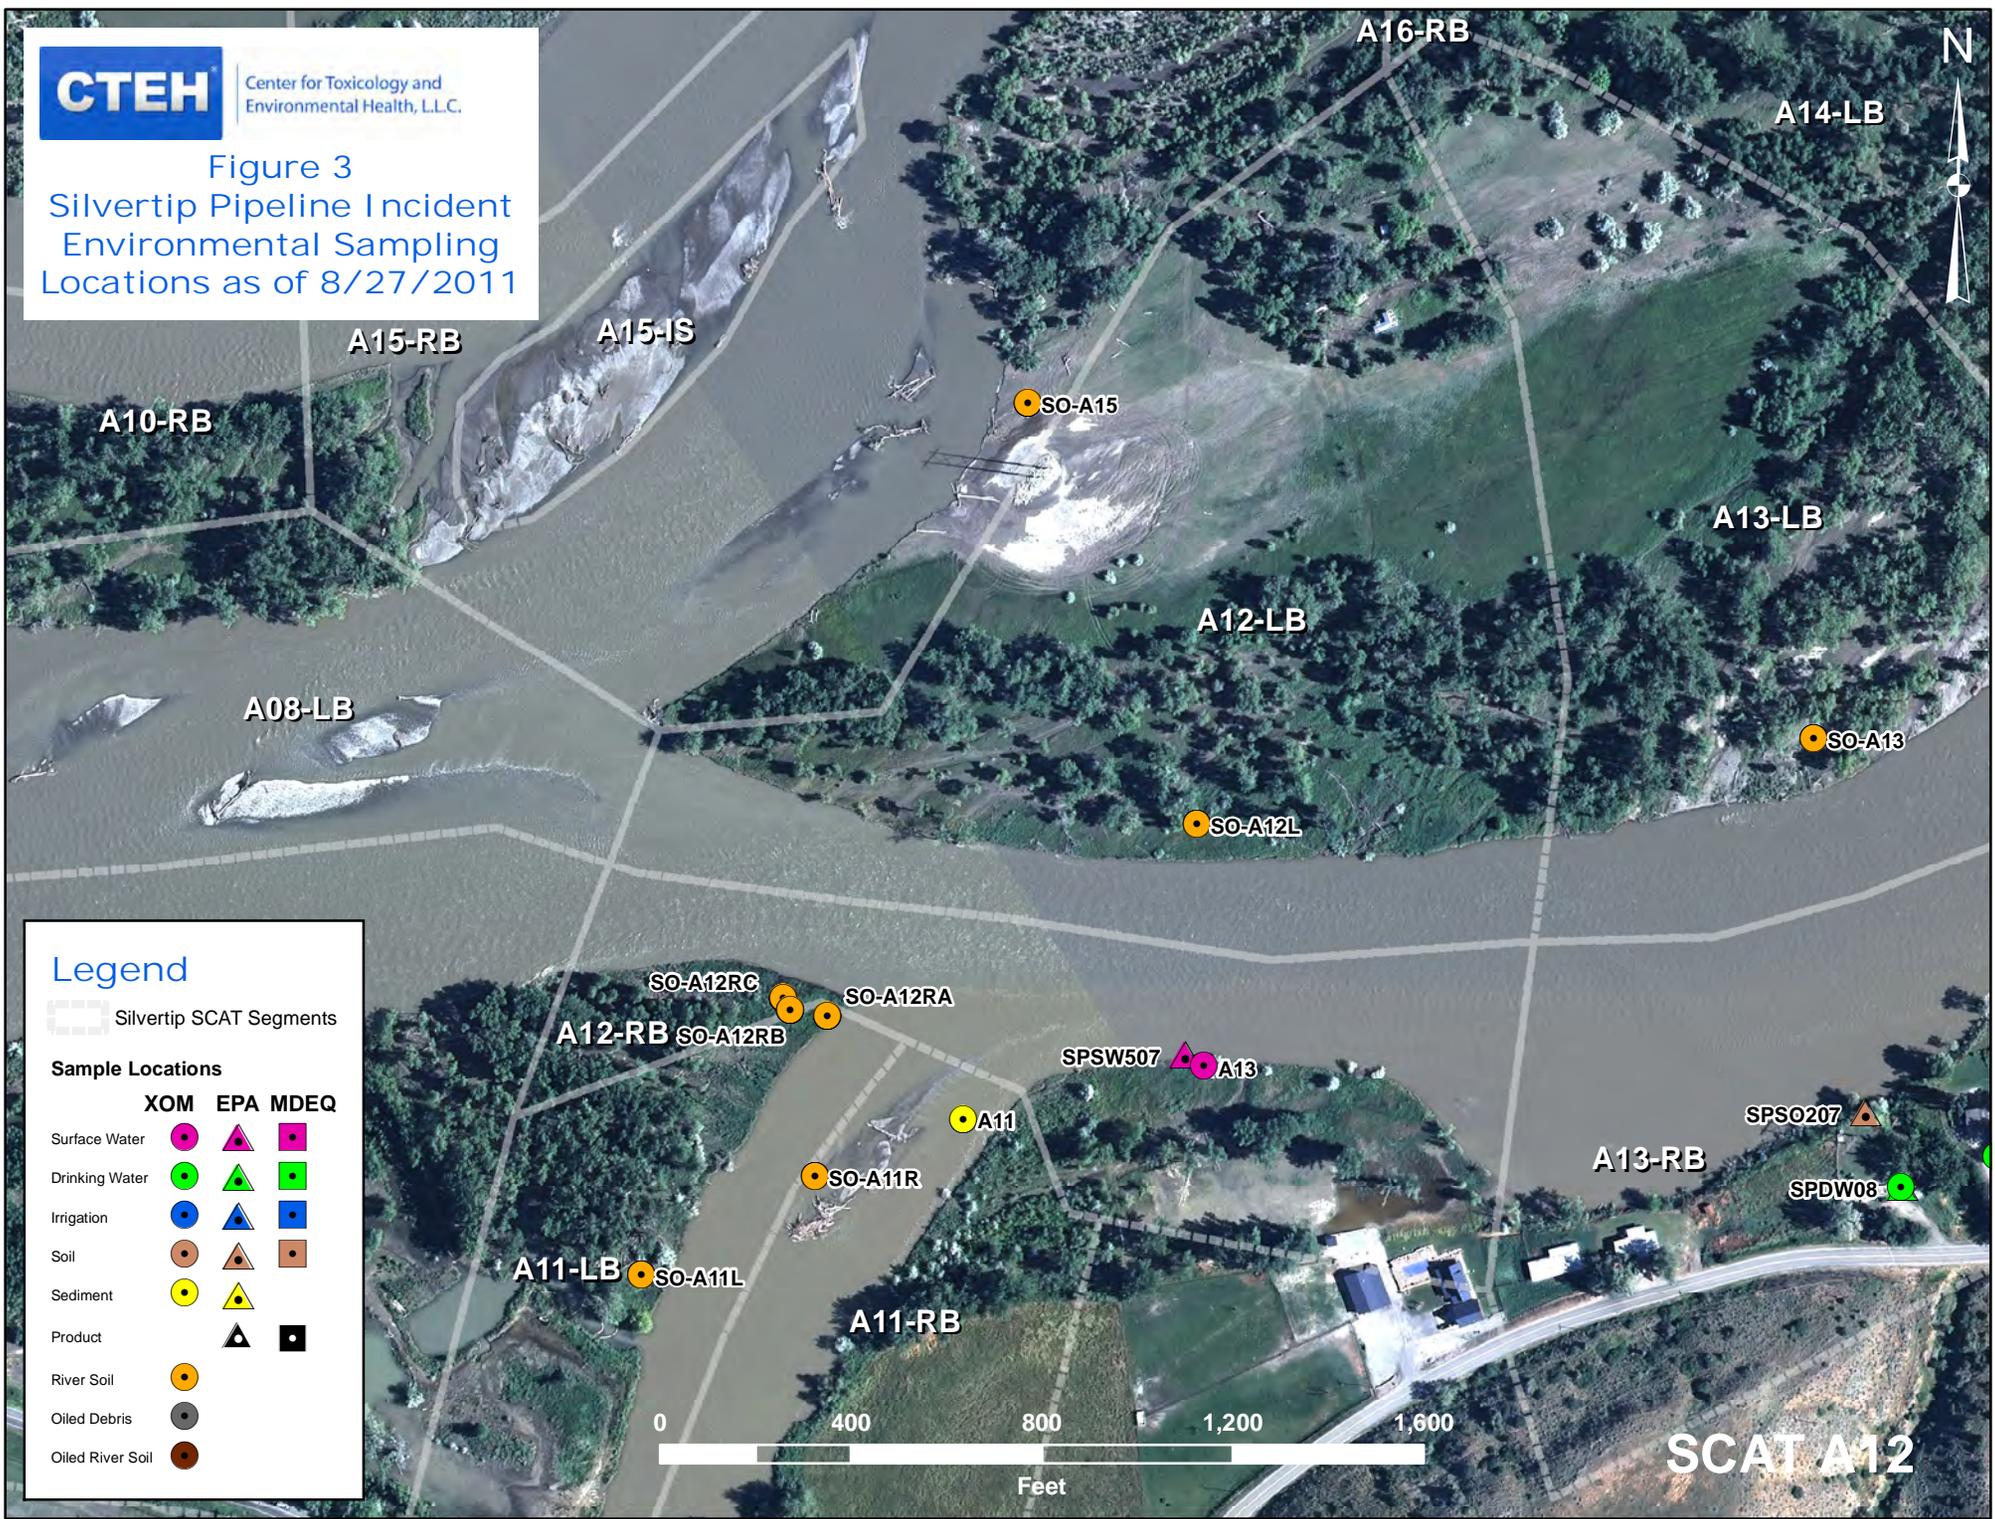
Figure 3
Silvertip Pipeline Incident
Environmental Sampling
Locations as of 8/27/2011

Table 1 (below) summarizes samples collected within Area A12. The analytical results for the samples collected can be accessed through a publicly accessible database on the USEPA’s website. The approximate locations of samples collected within Area A12 are provided on Figure 3.

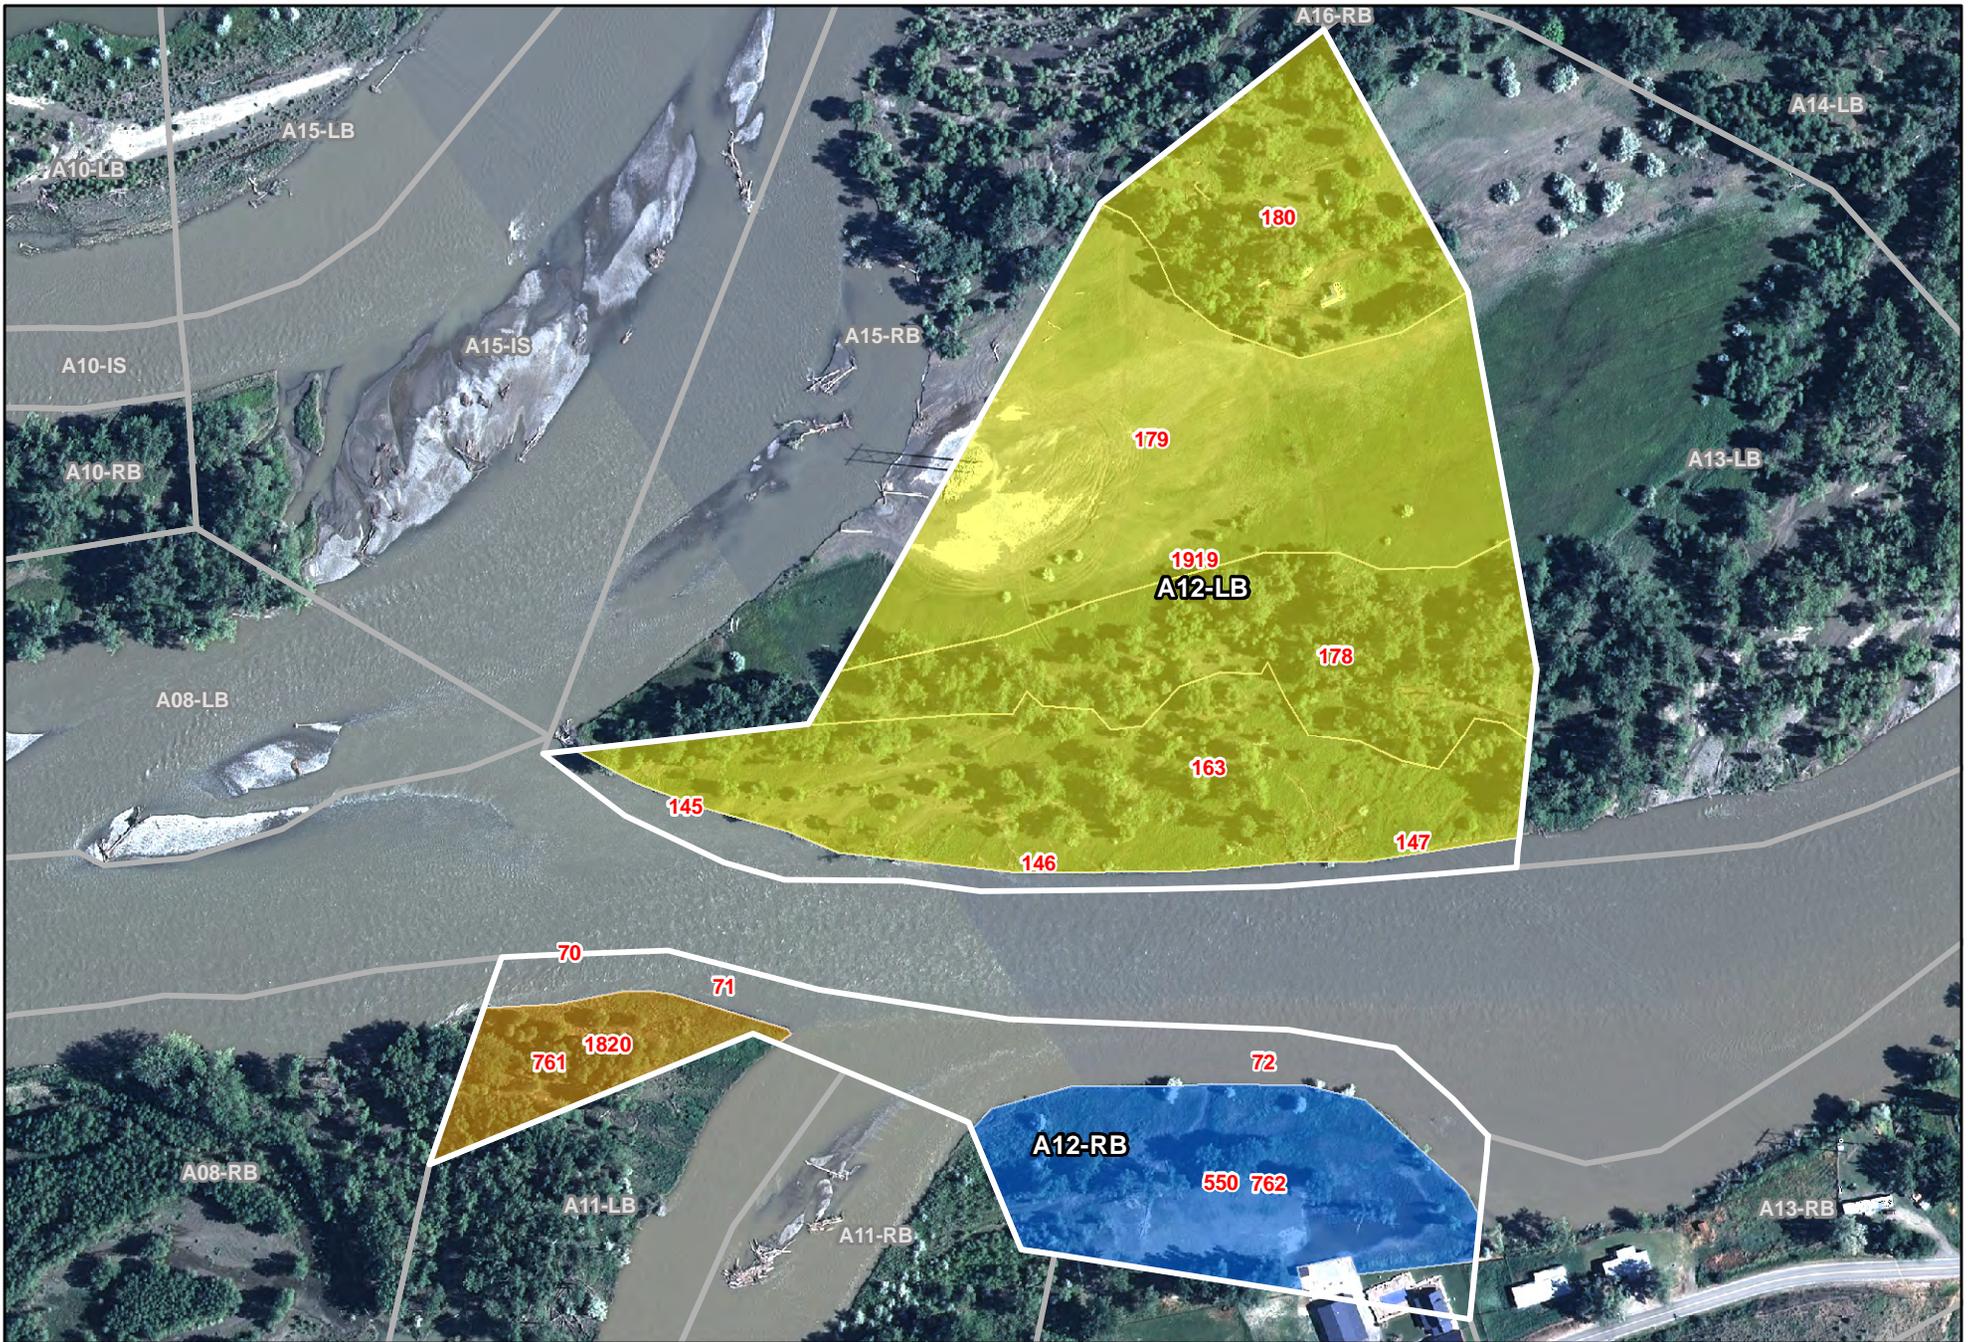
Figure 4 - Maximum SCAT Observations
For SCAT Area: A12

The SCAT teams used systematic evaluation criteria and treatment method tables approved by the National Oceanic and Atmospheric Administration to provide a standard approach for data collection and conducting field surveys. The forms and sketches from the initial SCAT surveys performed along the river bank (water edge) and floodplain within Area A12 are included in Appendix B. Figure 4 provides the maximum oiling zones observed by the SCAT team during the initial surveys of Area A12.

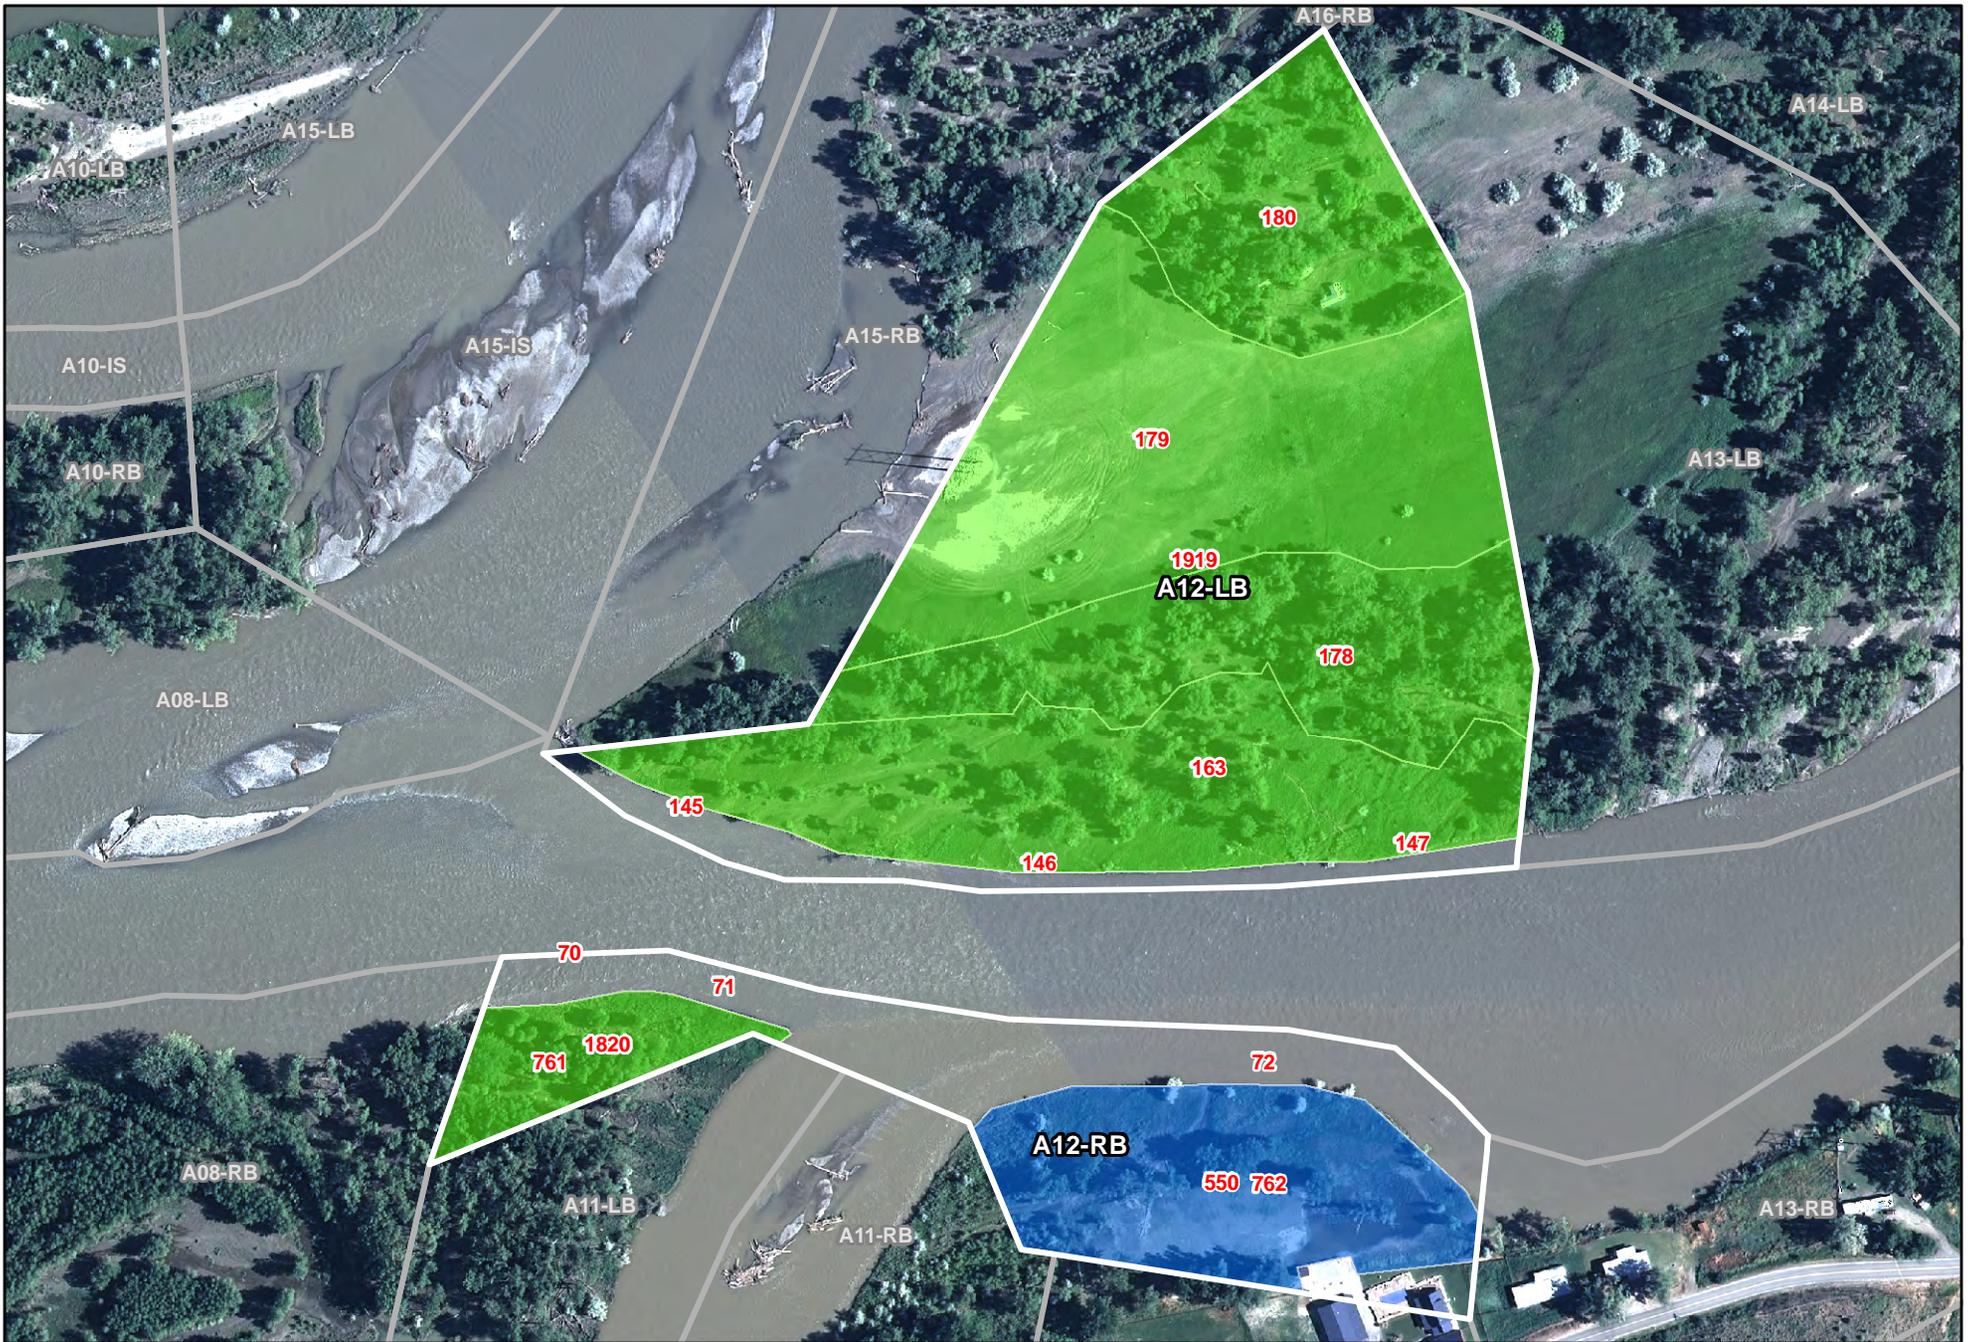
Figure 5 - Final SCAT Observations
For SCAT Area: A12

Figure 5 shows the oiling conditions within Area A12 following completion of oil removal activities. The SCAT team performed final surveys of the right and left banks within SCAT Area A12 to confirm the agreed-upon cleanup endpoints identified in the applicable CTRs had been achieved. The final SCAT survey documentation is presented in Appendix E.

Based on the final SCAT surveys performed on the right and left banks within Area A12, no further treatment is recommended for this area. SCAT Segment Sign-Off Forms are included as Appendix F.

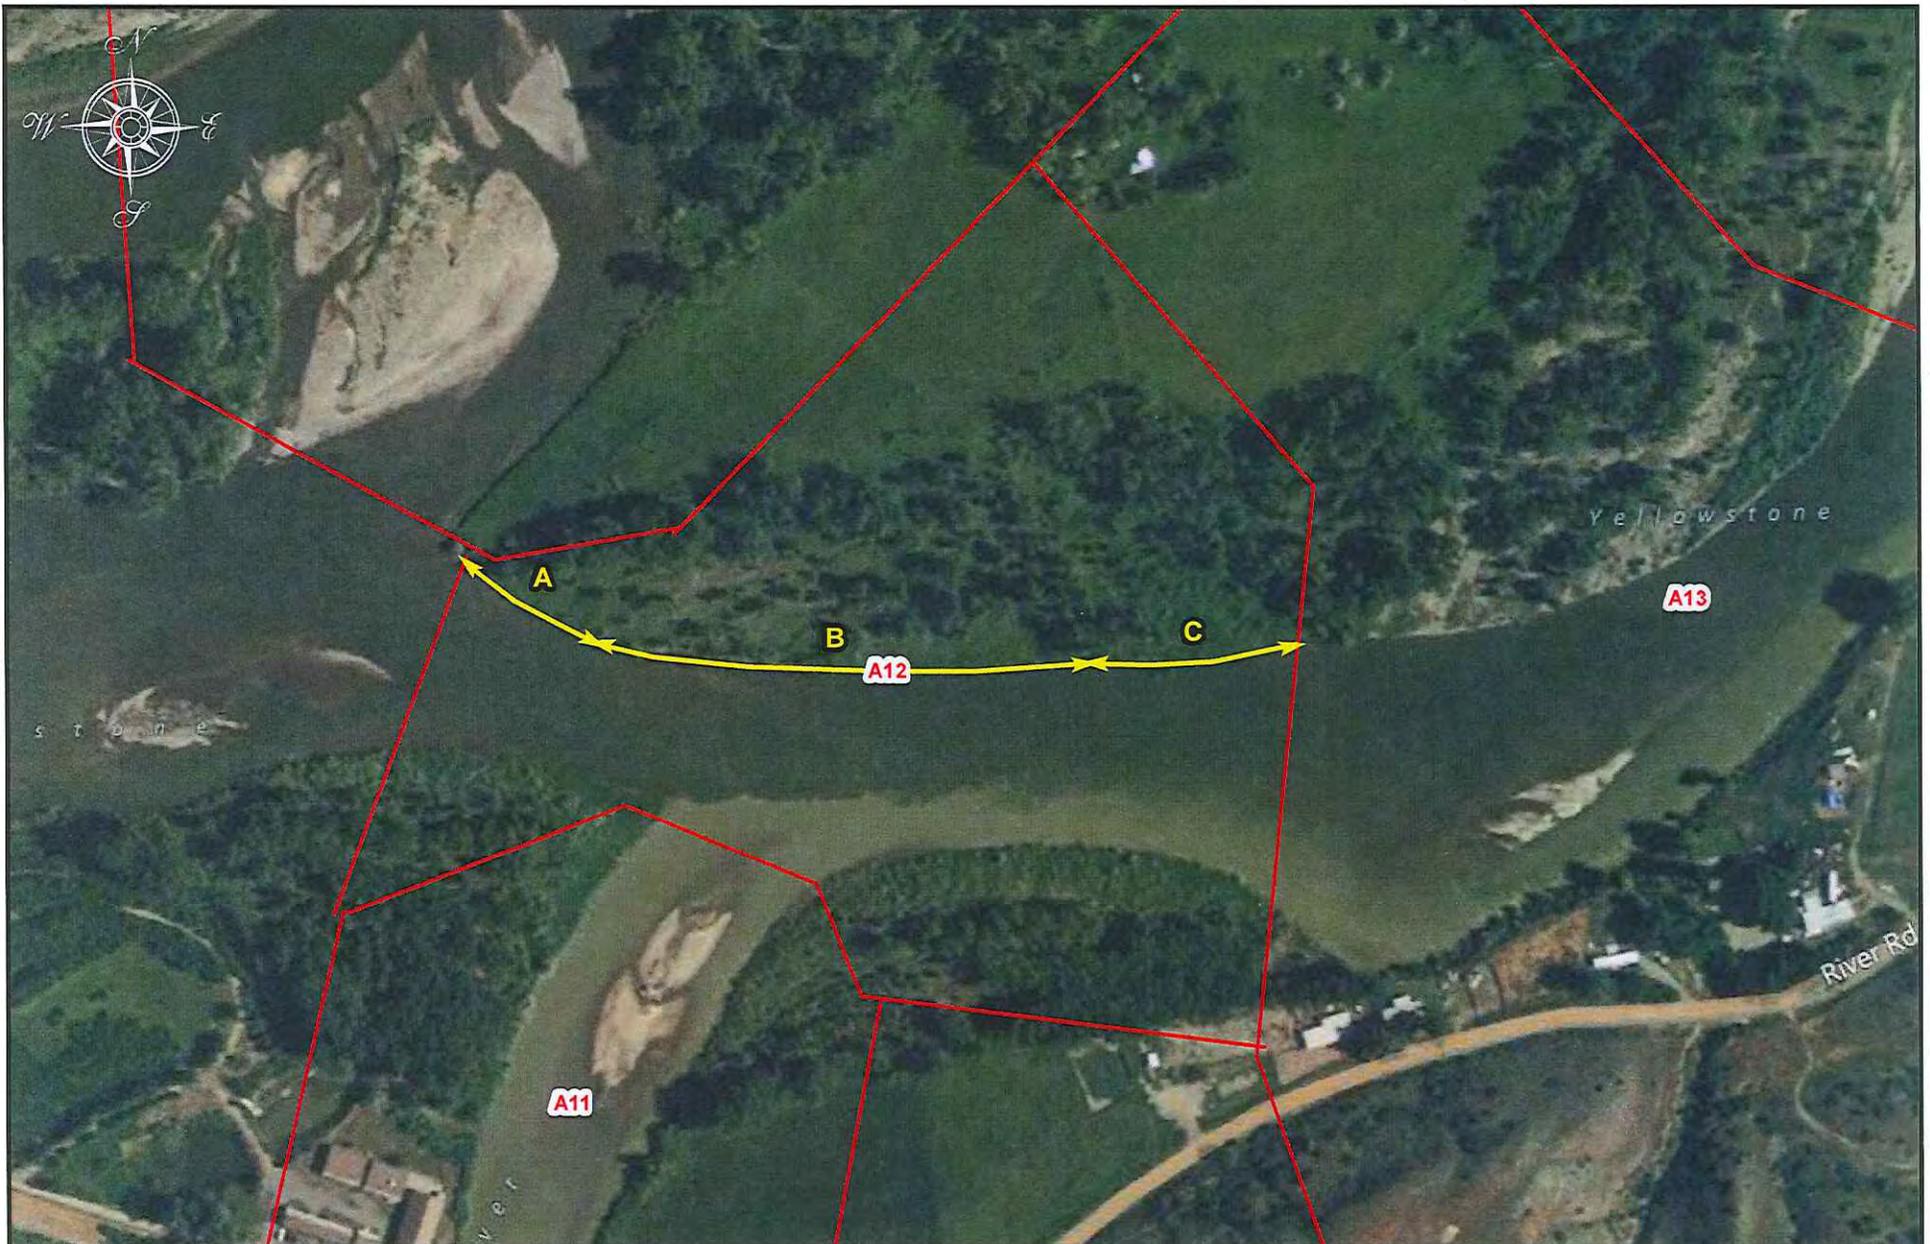
Segment A12 Left Bank

Oiled Band Heights: Zone A - 40cm; Zone B - 1m; Zone C 50cm

Due to survey platform (jet-drive boat) oil band width and heights are estimates. Unable to verify by foot.

Cleanup Recommendations: Trim oiled vegetation; wipe large oiled debris; remove small oiled debris; wipe oiled trees;

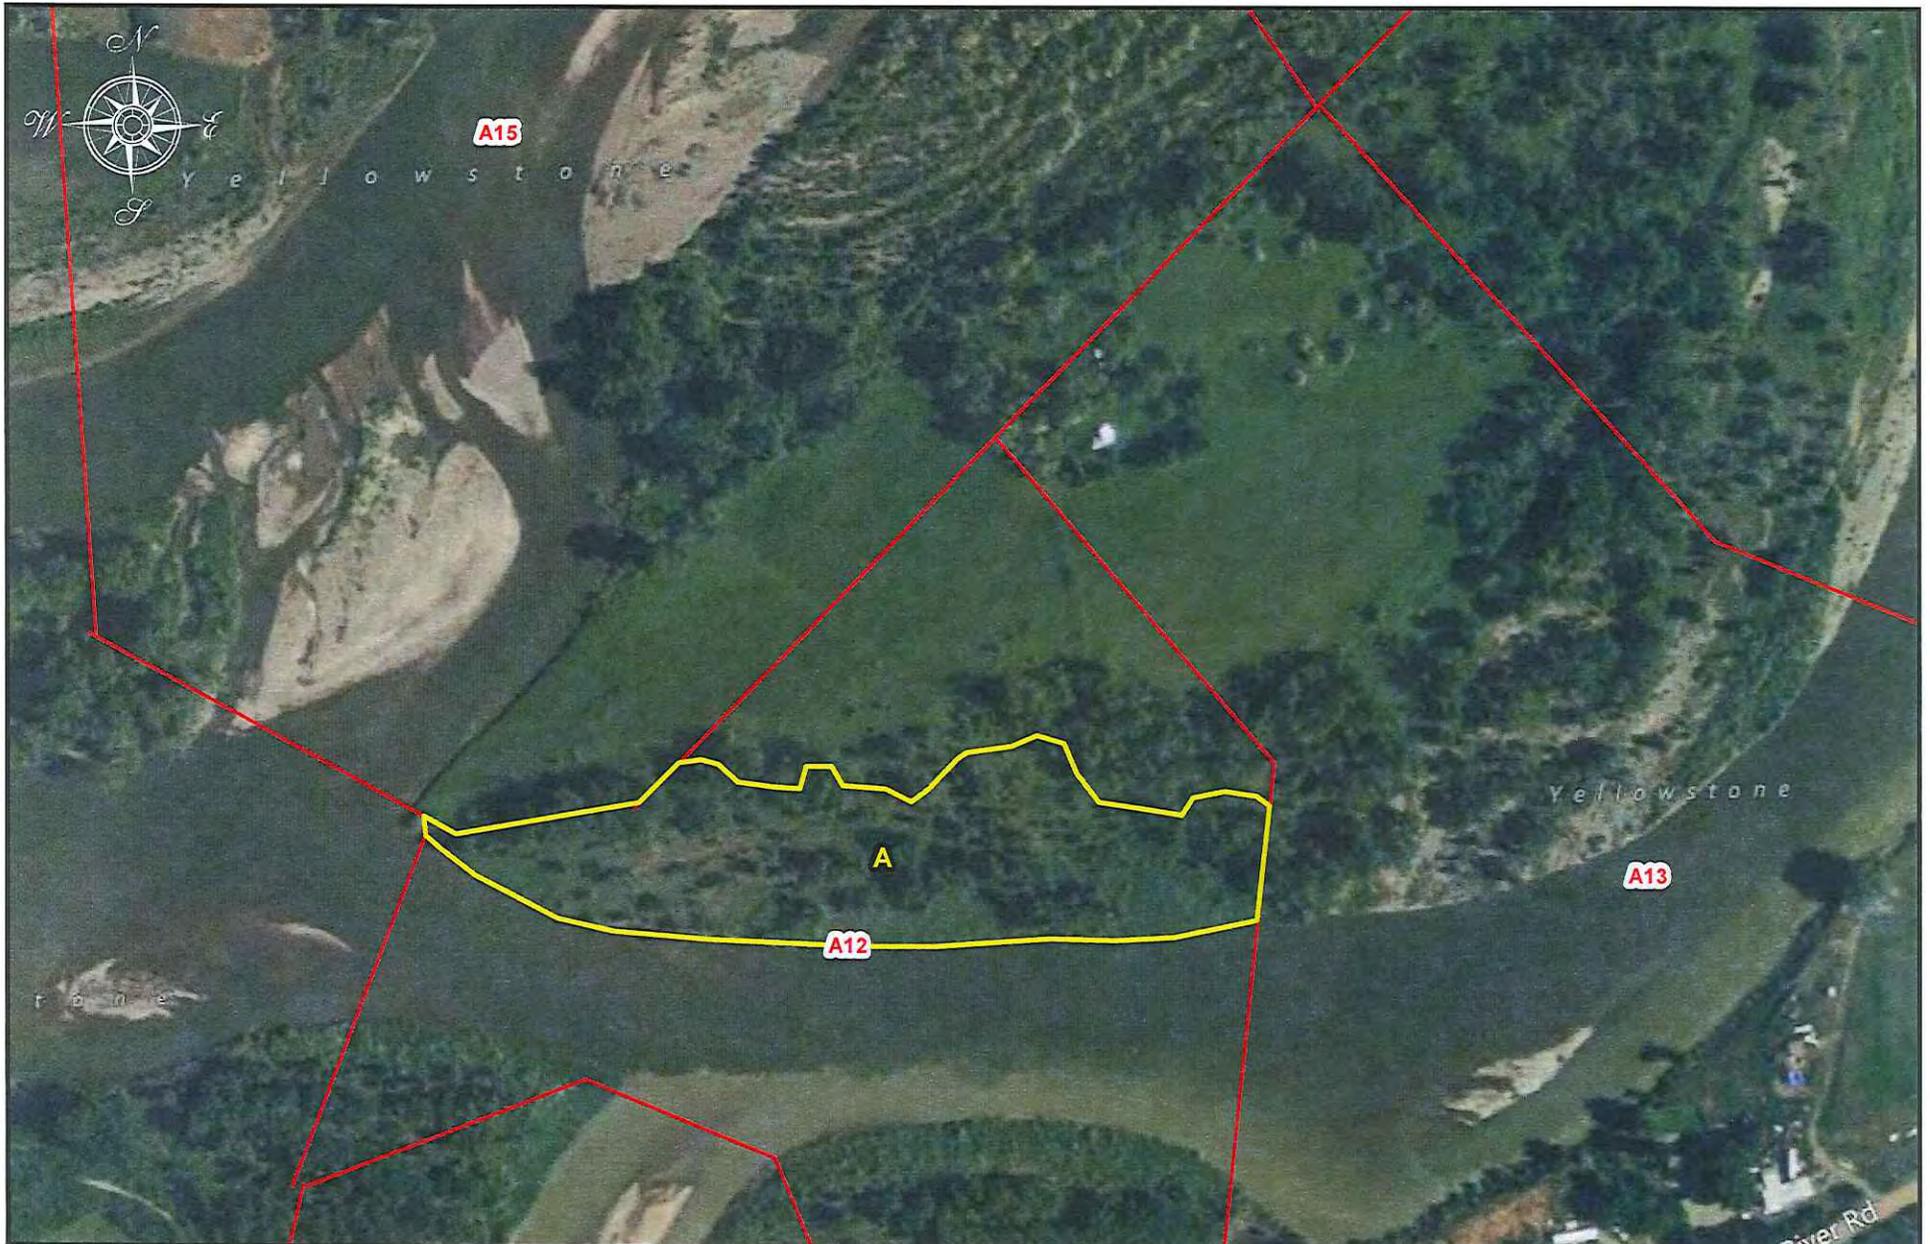
Segment A12 - Left Bank

Oiled Band Heights: Zone A - 10cm

Cleanup Recommendations: For substrates with oiling greater than stain, trim oiled vegetation; wipe large oiled debris; remove small oiled debris; wipe oiled trees. No treatment for stained substrates is recommended.

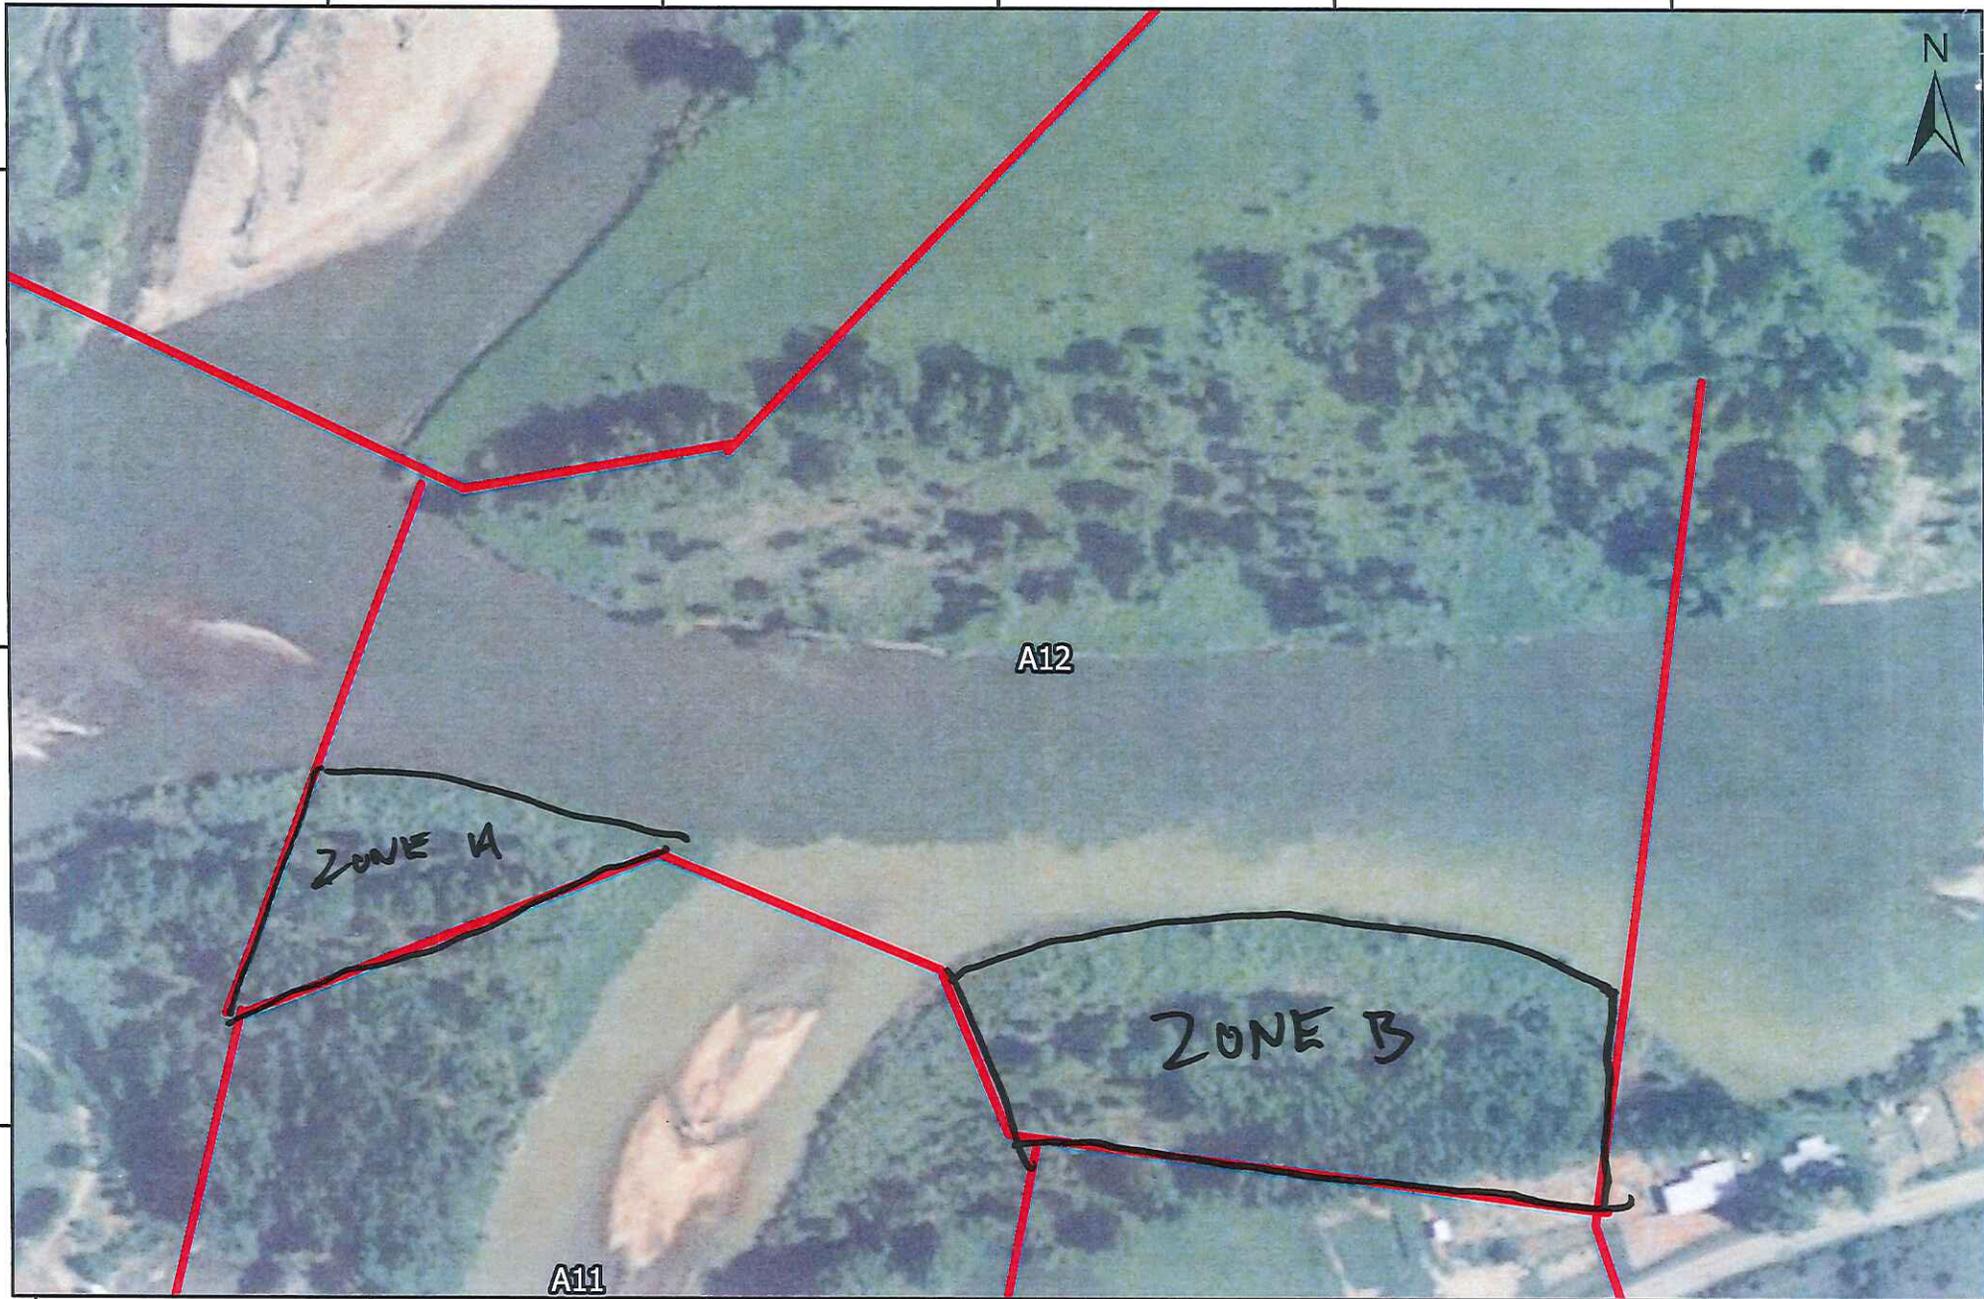
A12

ZONE A: high distribution of oil coated veg with isolated areas of oil coated debris
 recommendations: cut / trim oil coated veg, hand removal of oiled debris

ZONE B: No oil observed
 recommendations: scarf lower bank by boat
