**SCAT Area Transition Report
for A12**

Silvertip Pipeline Incident
Laurel, Montana

October 18, 2011

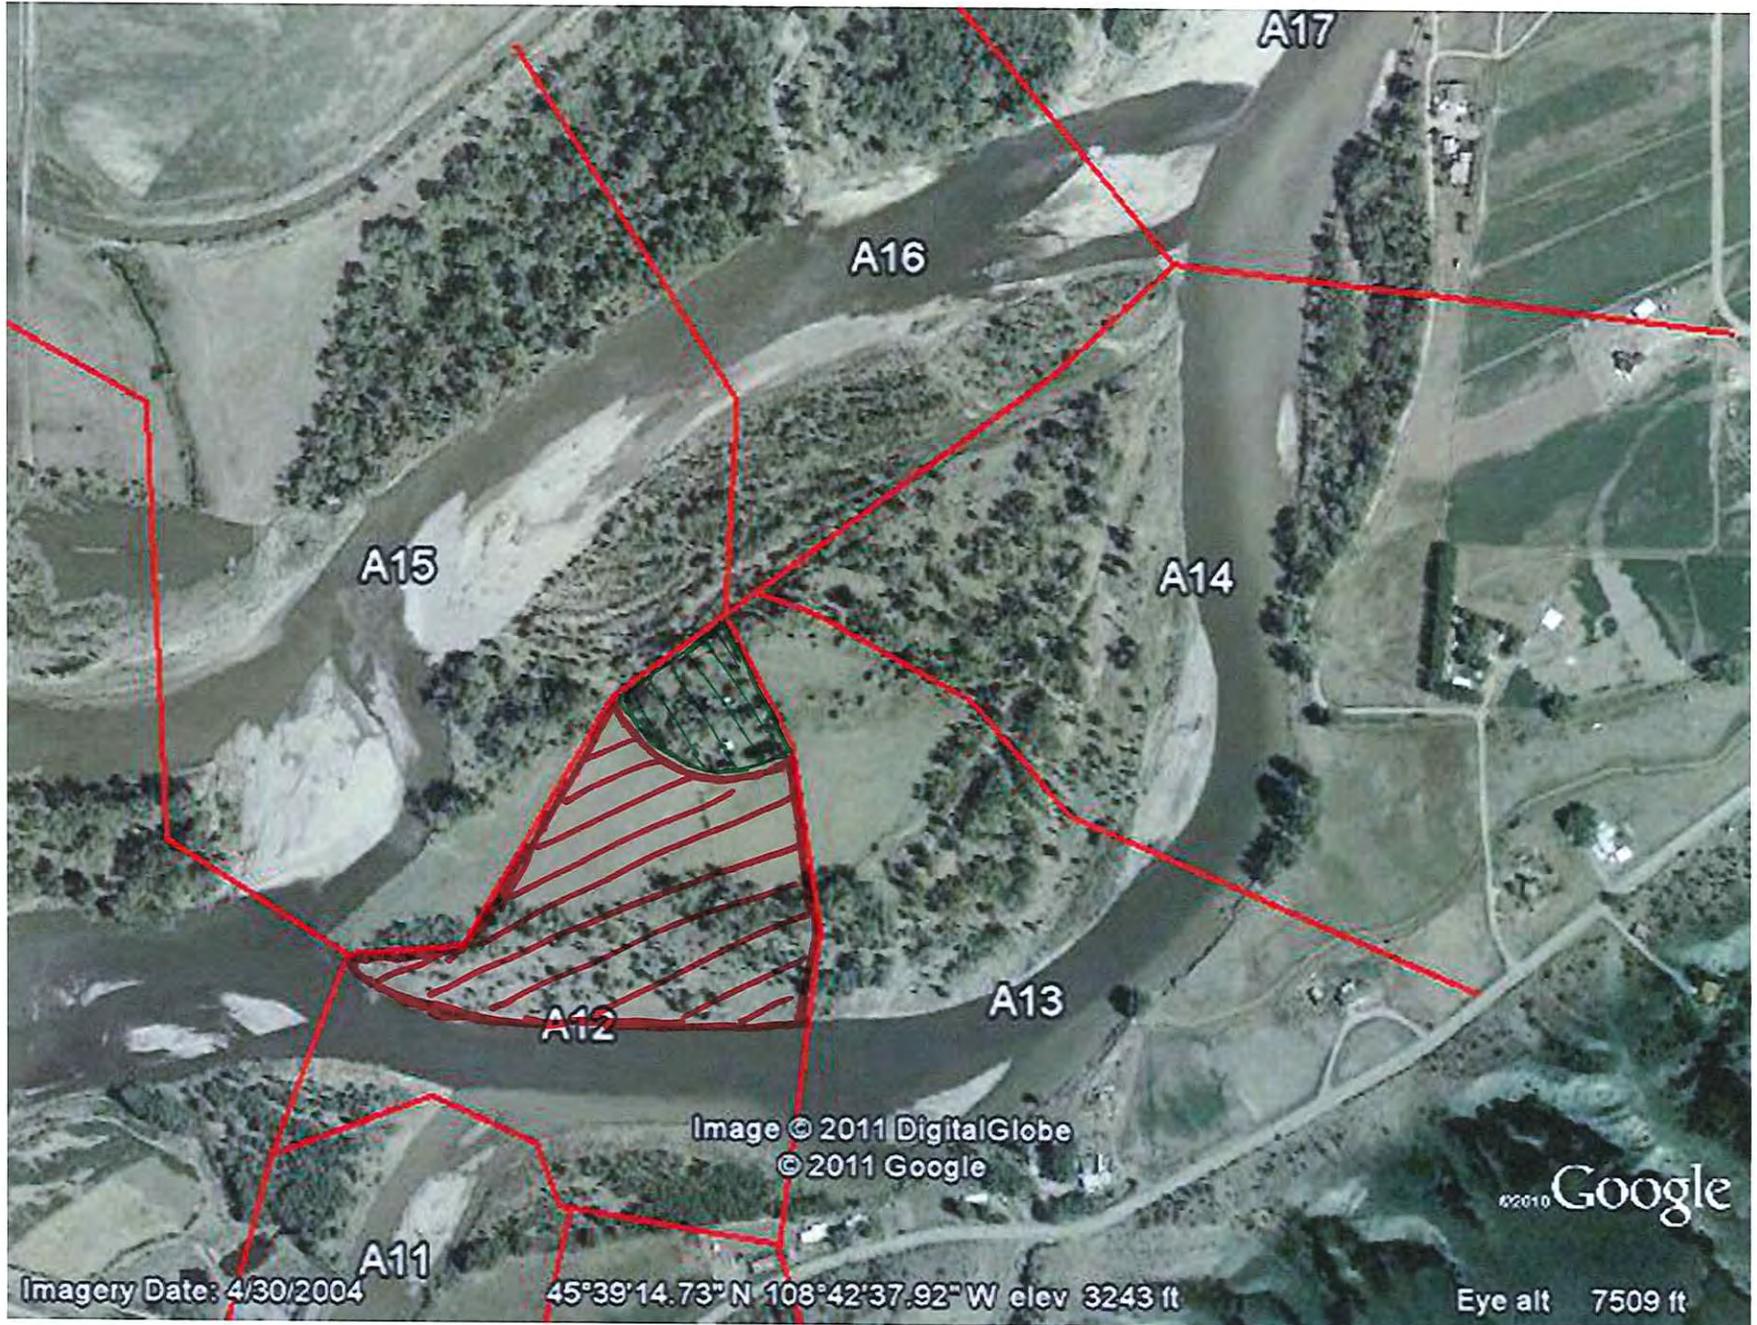
SCAT – Pre Inspection Survey Transmittal (PIST) Memo

There is an area designated under cultural heritage on the island. A portion of that site is located within segment A12. This area was not included in this PIST. Site-specific treatment recommendations were developed for that area and a cultural representative was on site during work.

RED = PIST AREA

GREEN = CULTURAL HERITAGE SITE

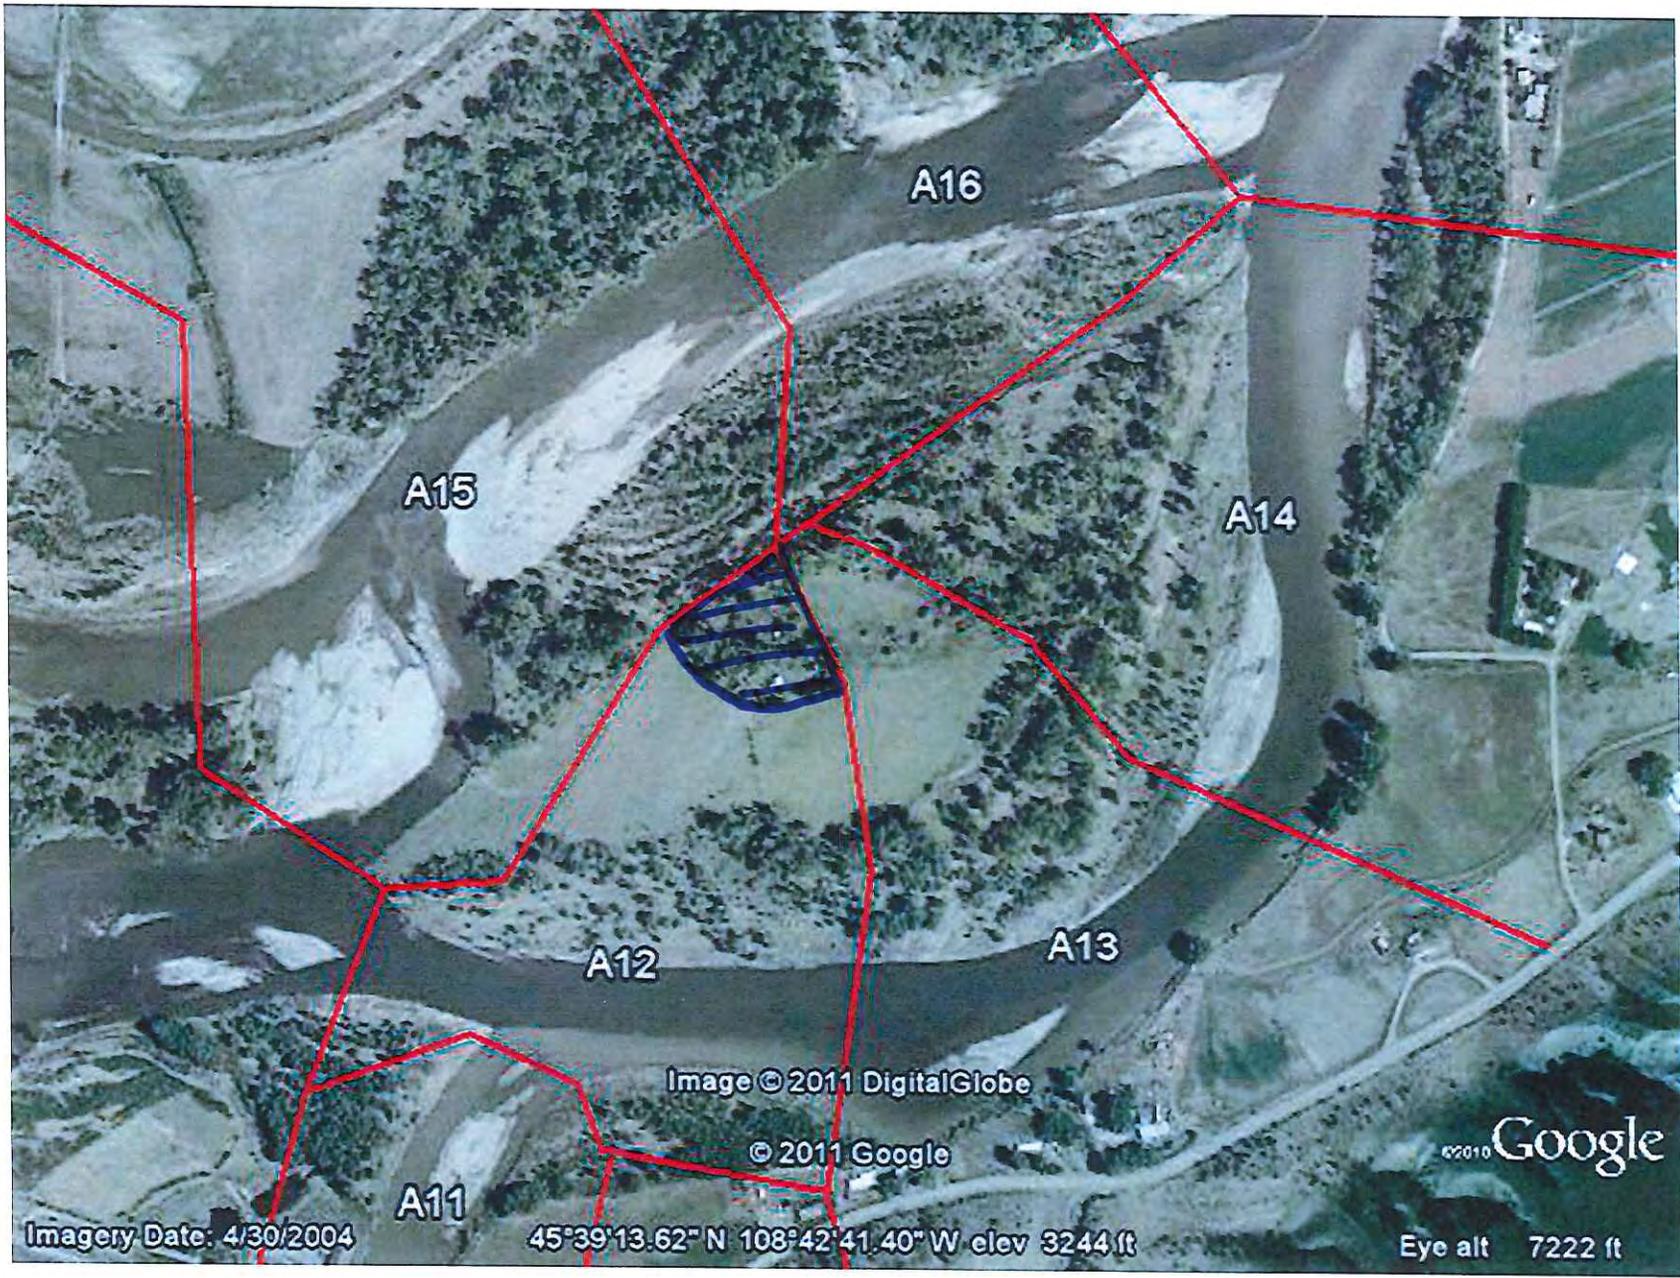
This PIST covers the Cultural Heritage site in segment A12LB.
Cultural Heritage representatives accompanied SCAT Ops Liaison for the PIST
and verified the site meets their completion criteria.
