**SCAT Area Transition Report for
A15**

Silvertip Pipeline Incident
Laurel, Montana

October 18, 2011

Our Ref.:
B0085883.1103

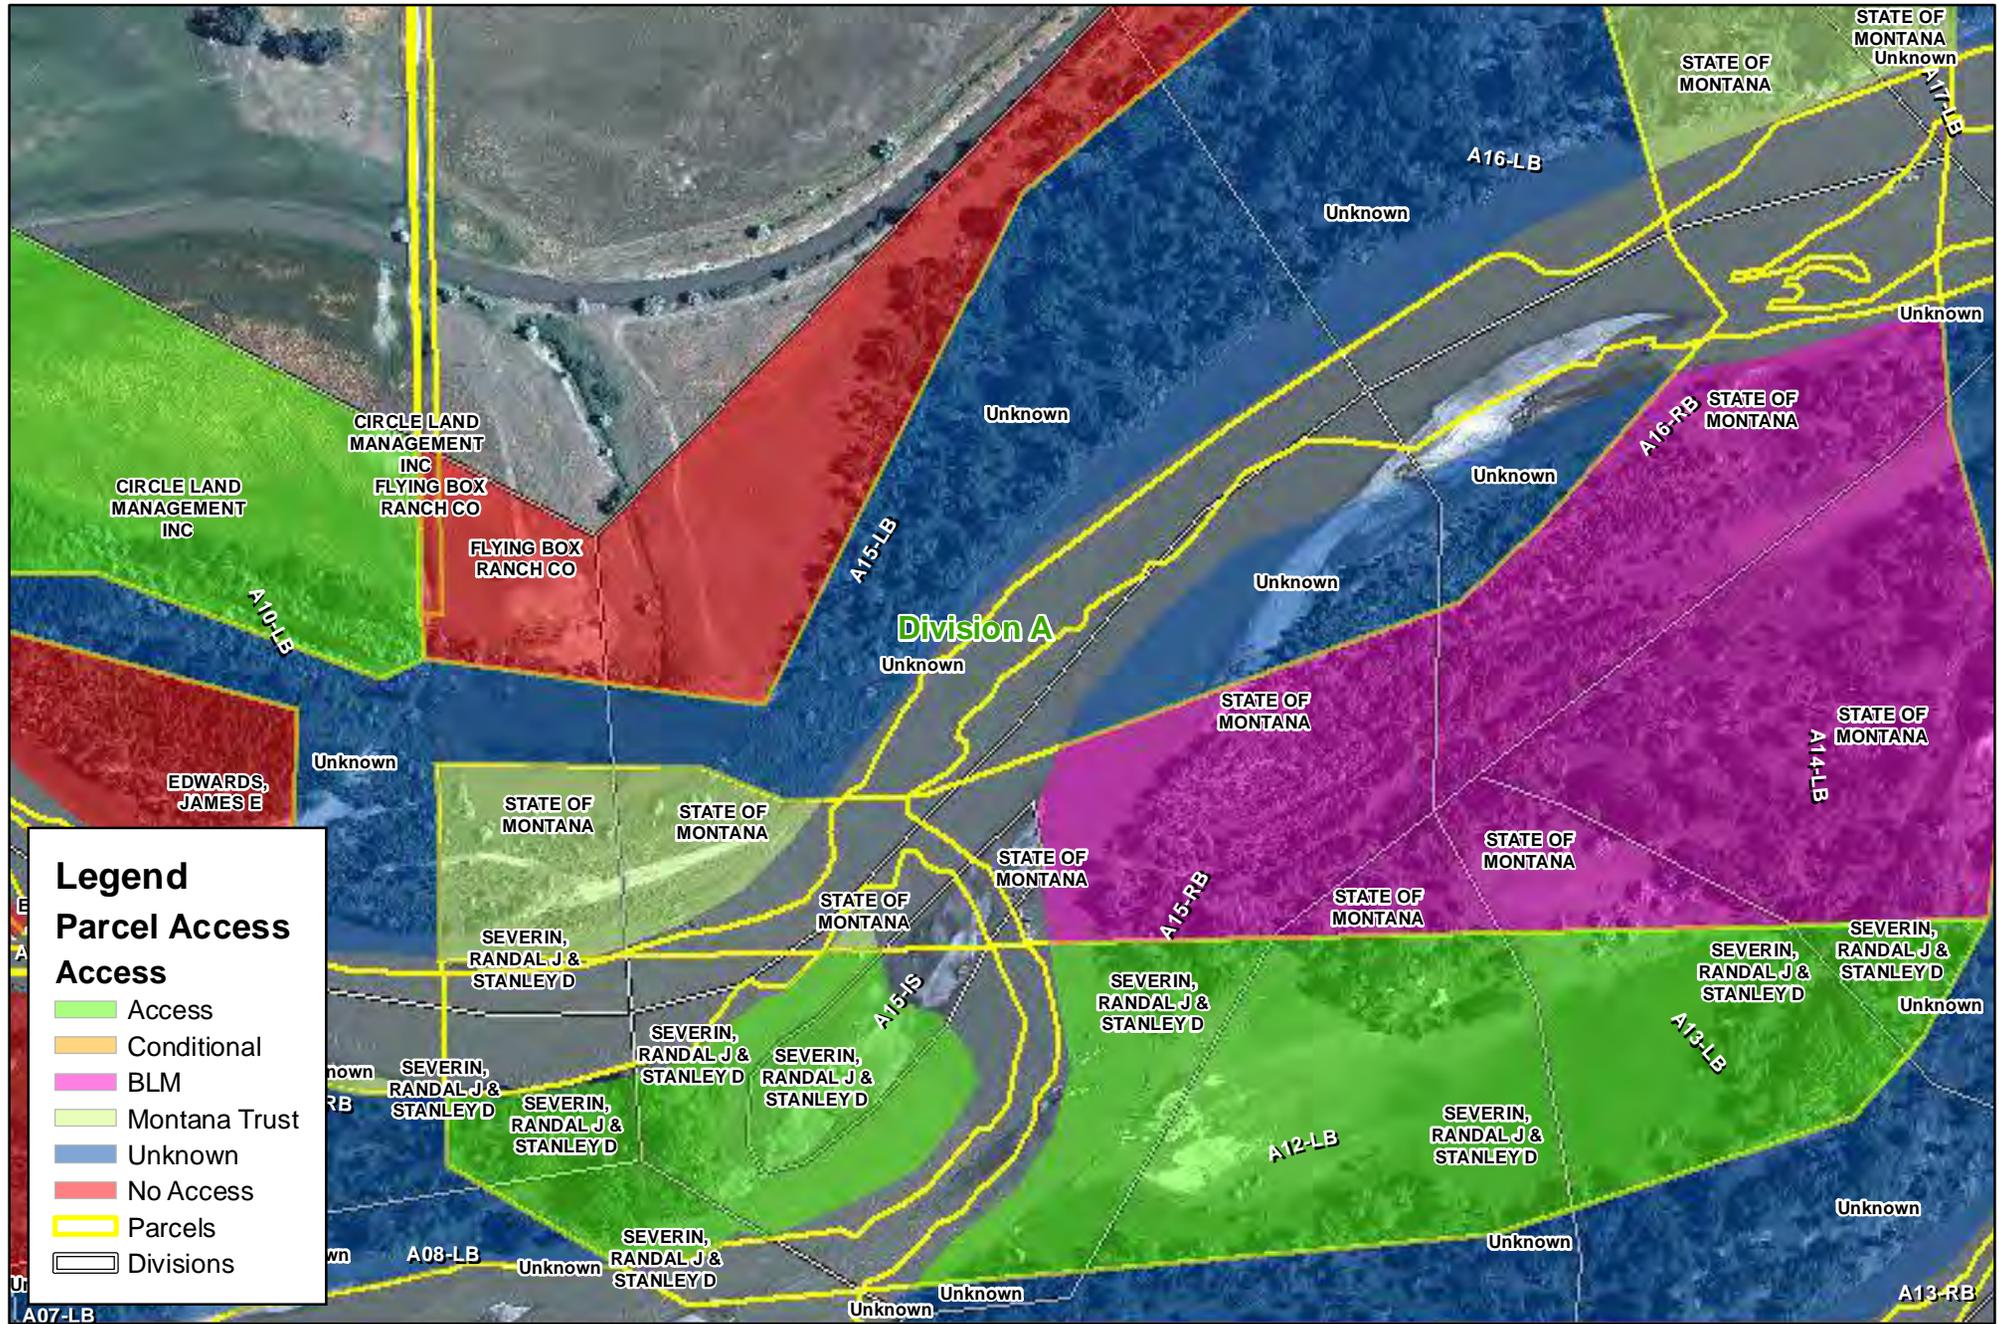
Figure 1 provides an aerial map of SCAT Area A15, along with the (a) SCAT Area boundary, (b) parcel boundaries and respective property owners, and (c) access constraints identified during the oil cleanup process. The acreage surveyed in Area A15 is 32.3. There were access issues for a partial section of the left bank of A15.

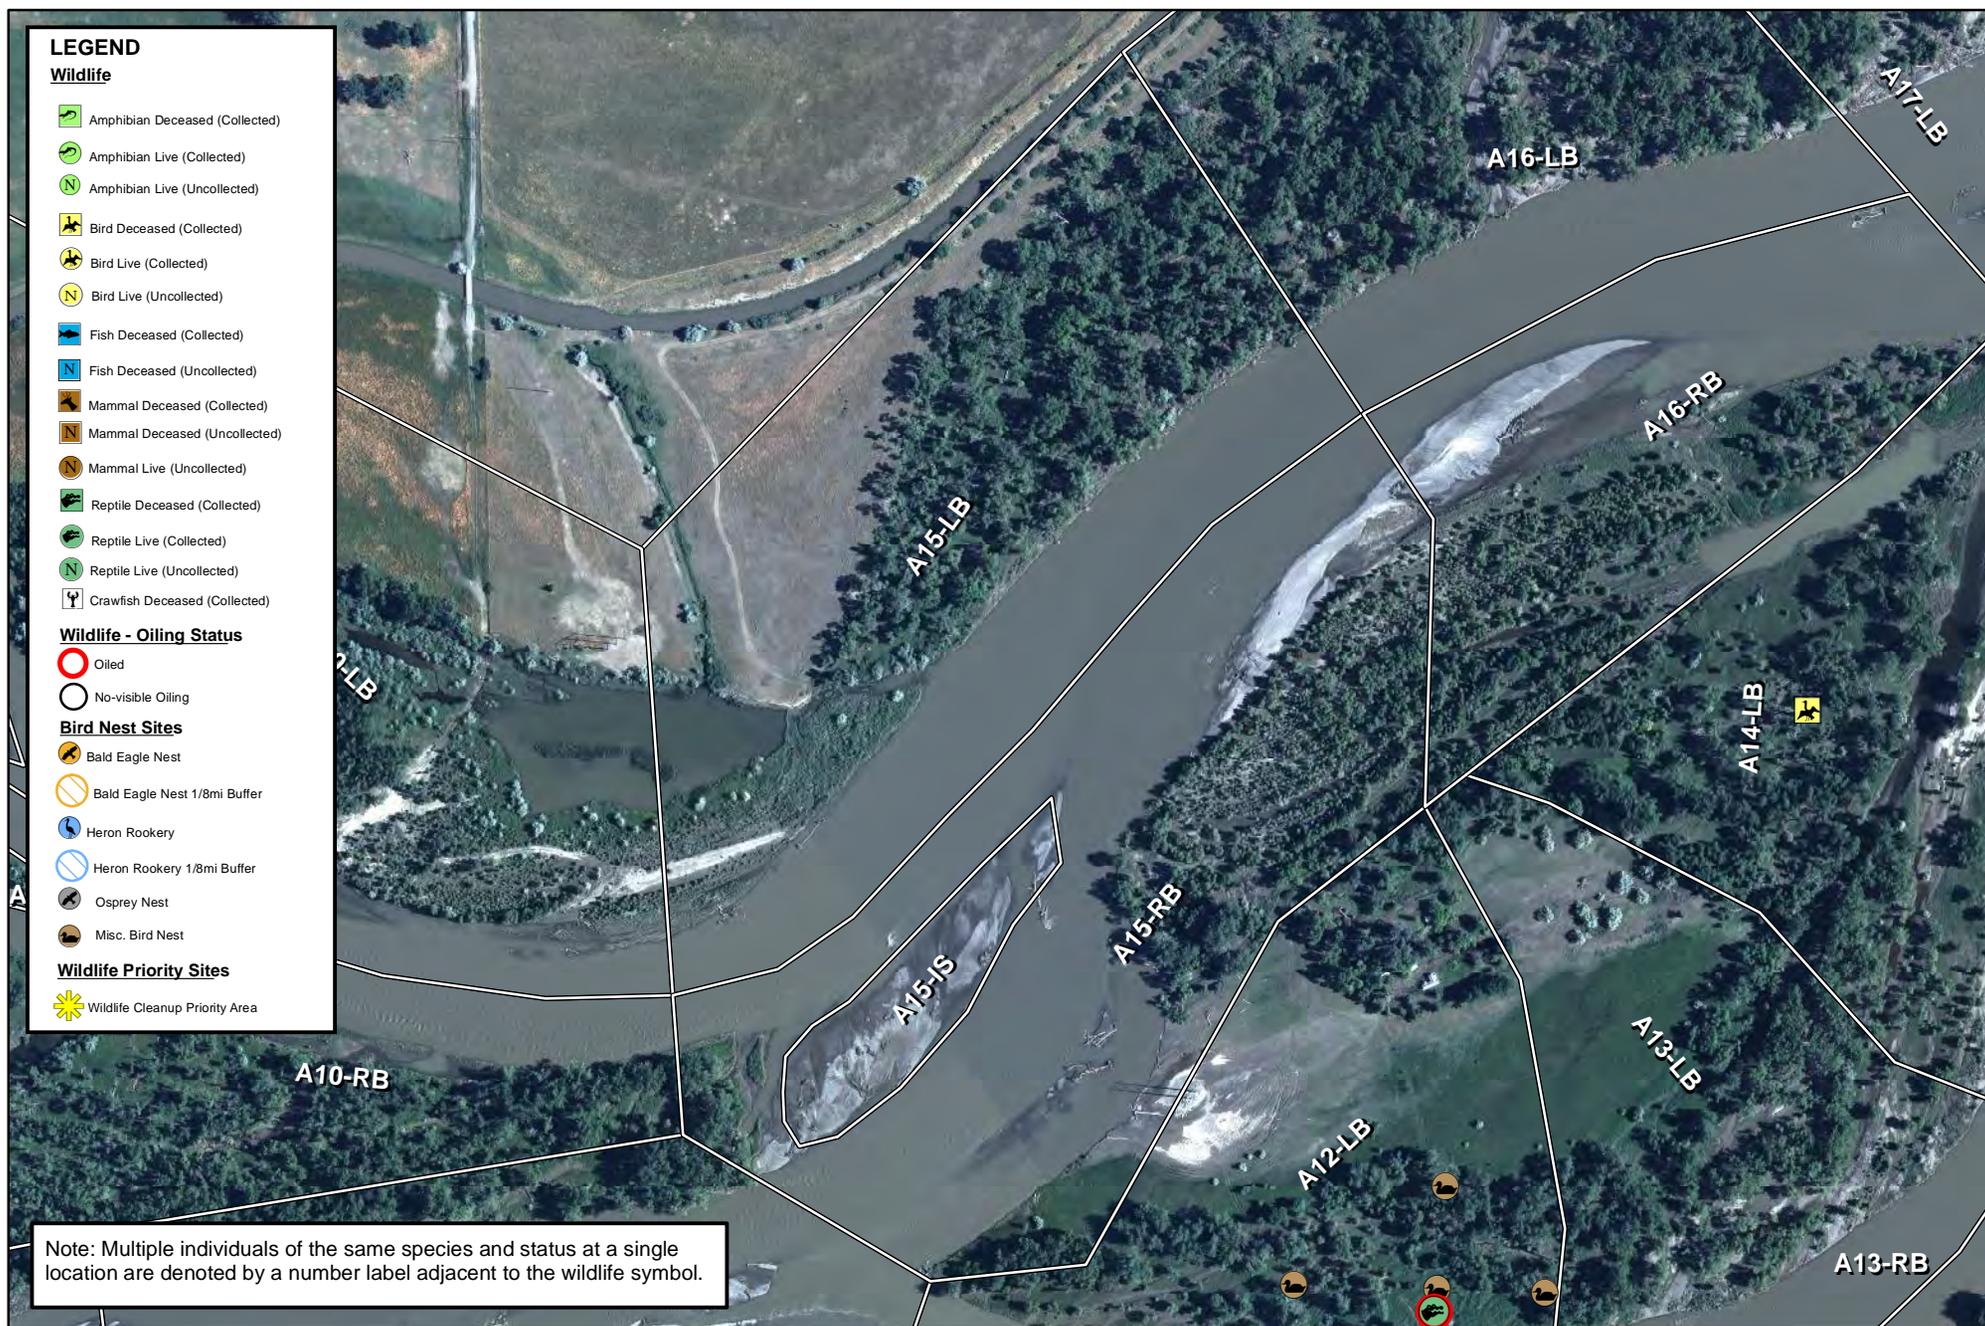
Figure 2
Wildlife Resources

Figure 2 summarizes the natural resources identified in this segment. International Bird Rescue and Resource Advisors from U.S. Fish and Wildlife Service conducted regular inspections of areas in A15 that did not have access issues. No oiled wildlife was observed or recovered. No Wildlife Priority Cleanup Areas were identified. No active migratory bird nests were identified in Area A15.

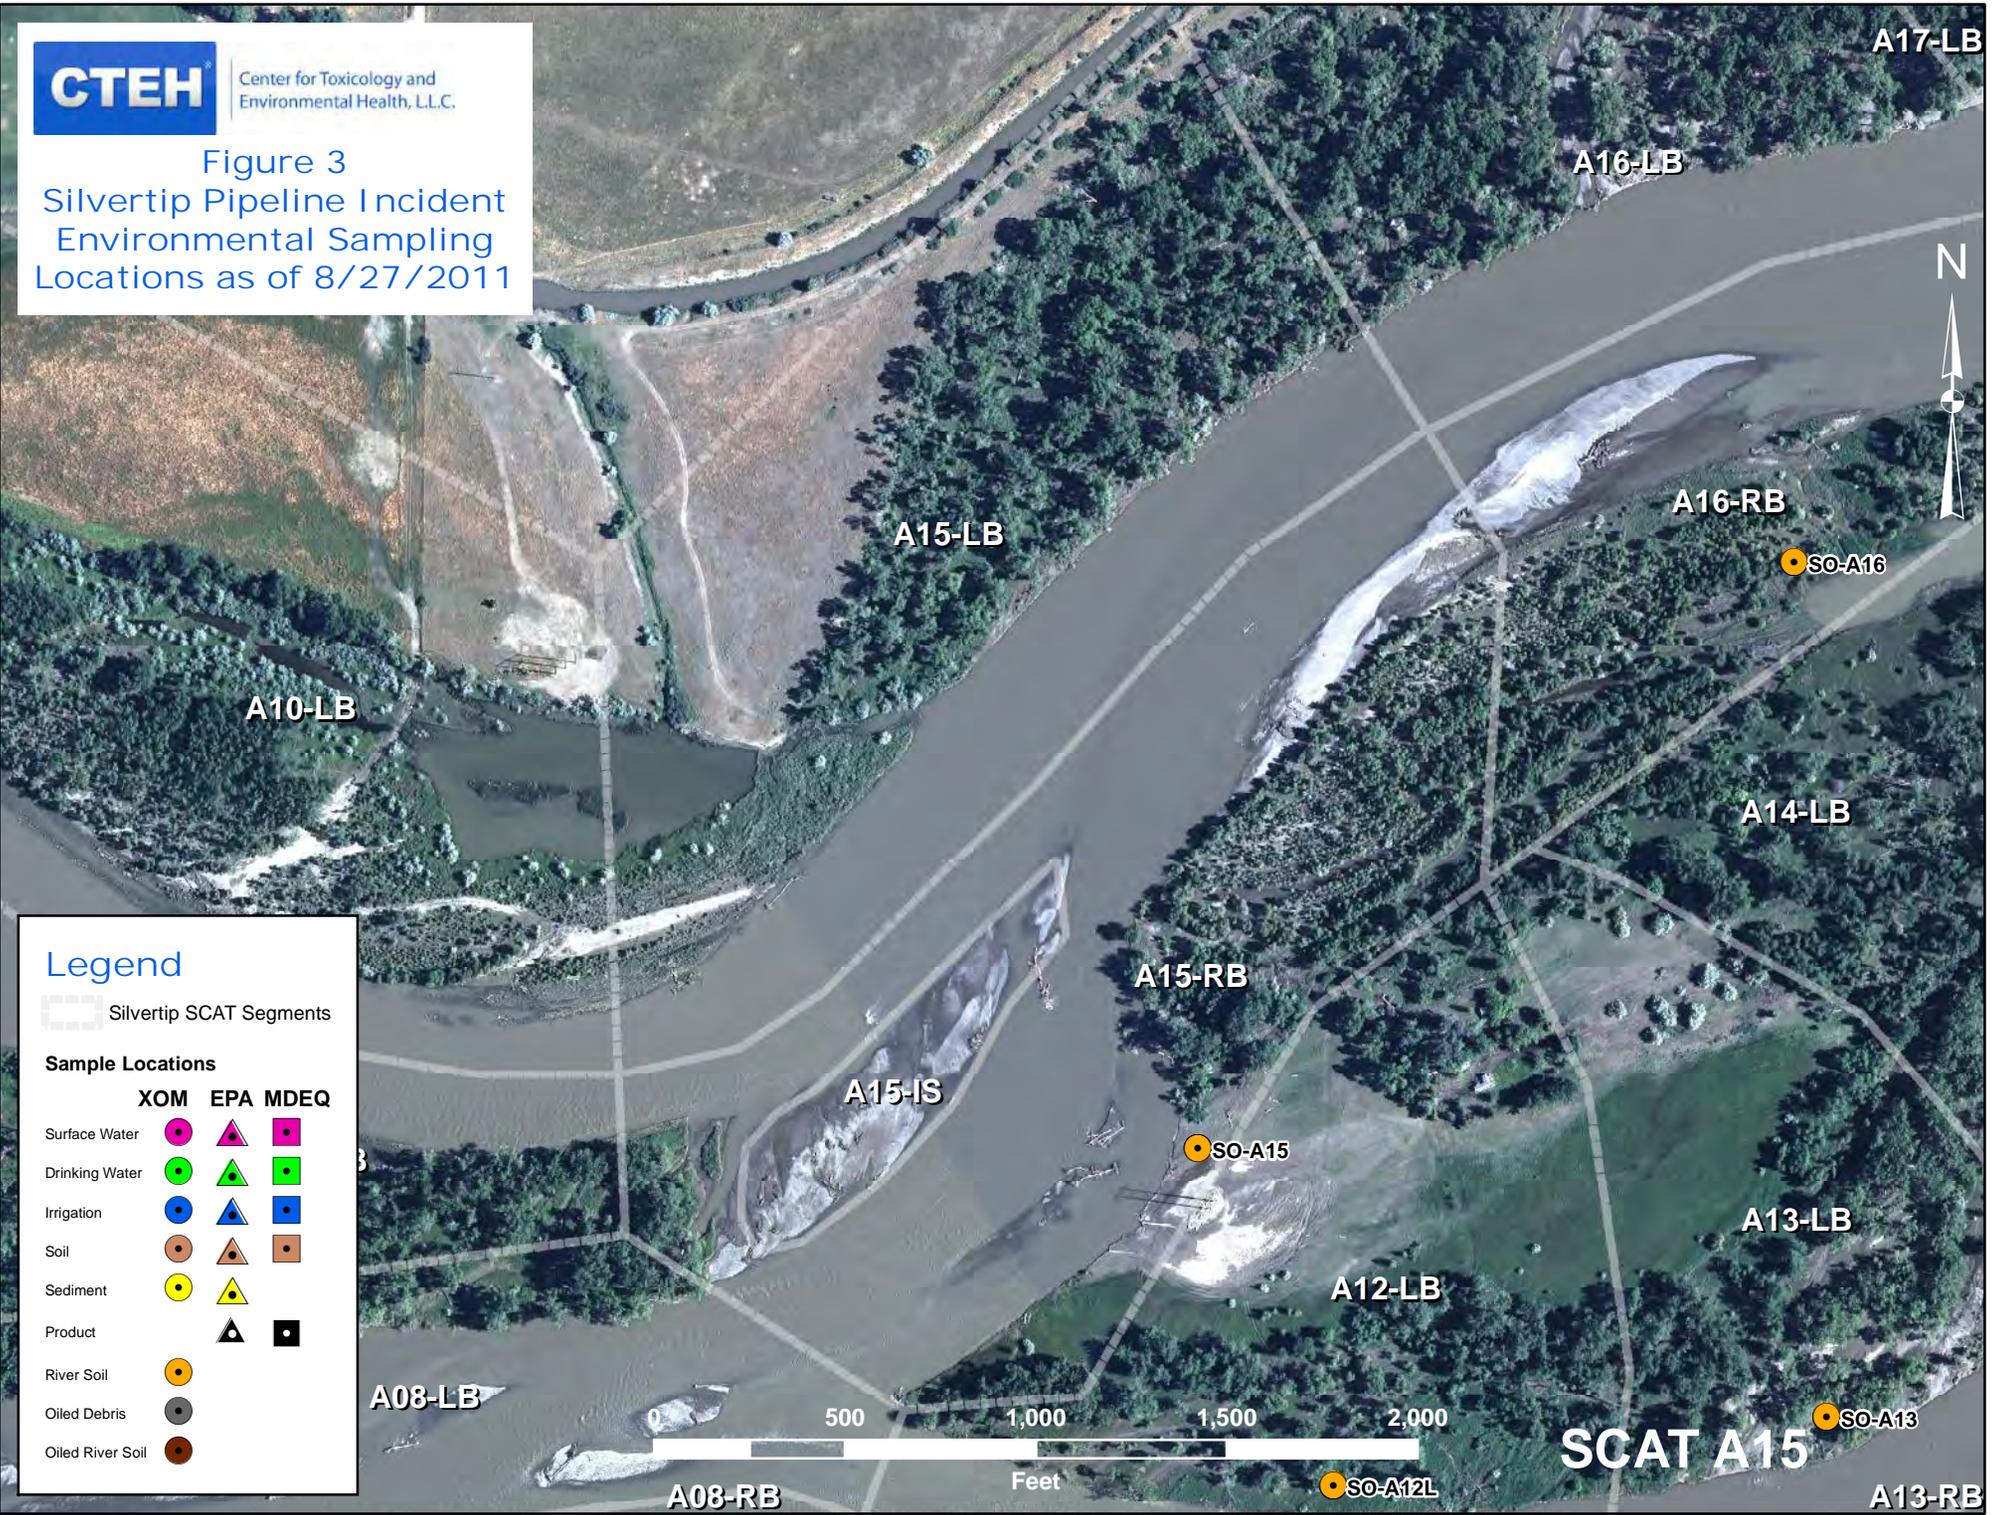
Figure 3
 Silvertip Pipeline Incident
 Environmental Sampling
 Locations as of 8/27/2011

Table 1 (below) summarizes samples collected within Area A15. The analytical results for the samples collected can be accessed through a publicly accessible database on the United States Environmental Protection Agency's (USEPA's) website. The approximate locations of samples collected within Area A15 are provided on Figure 3.

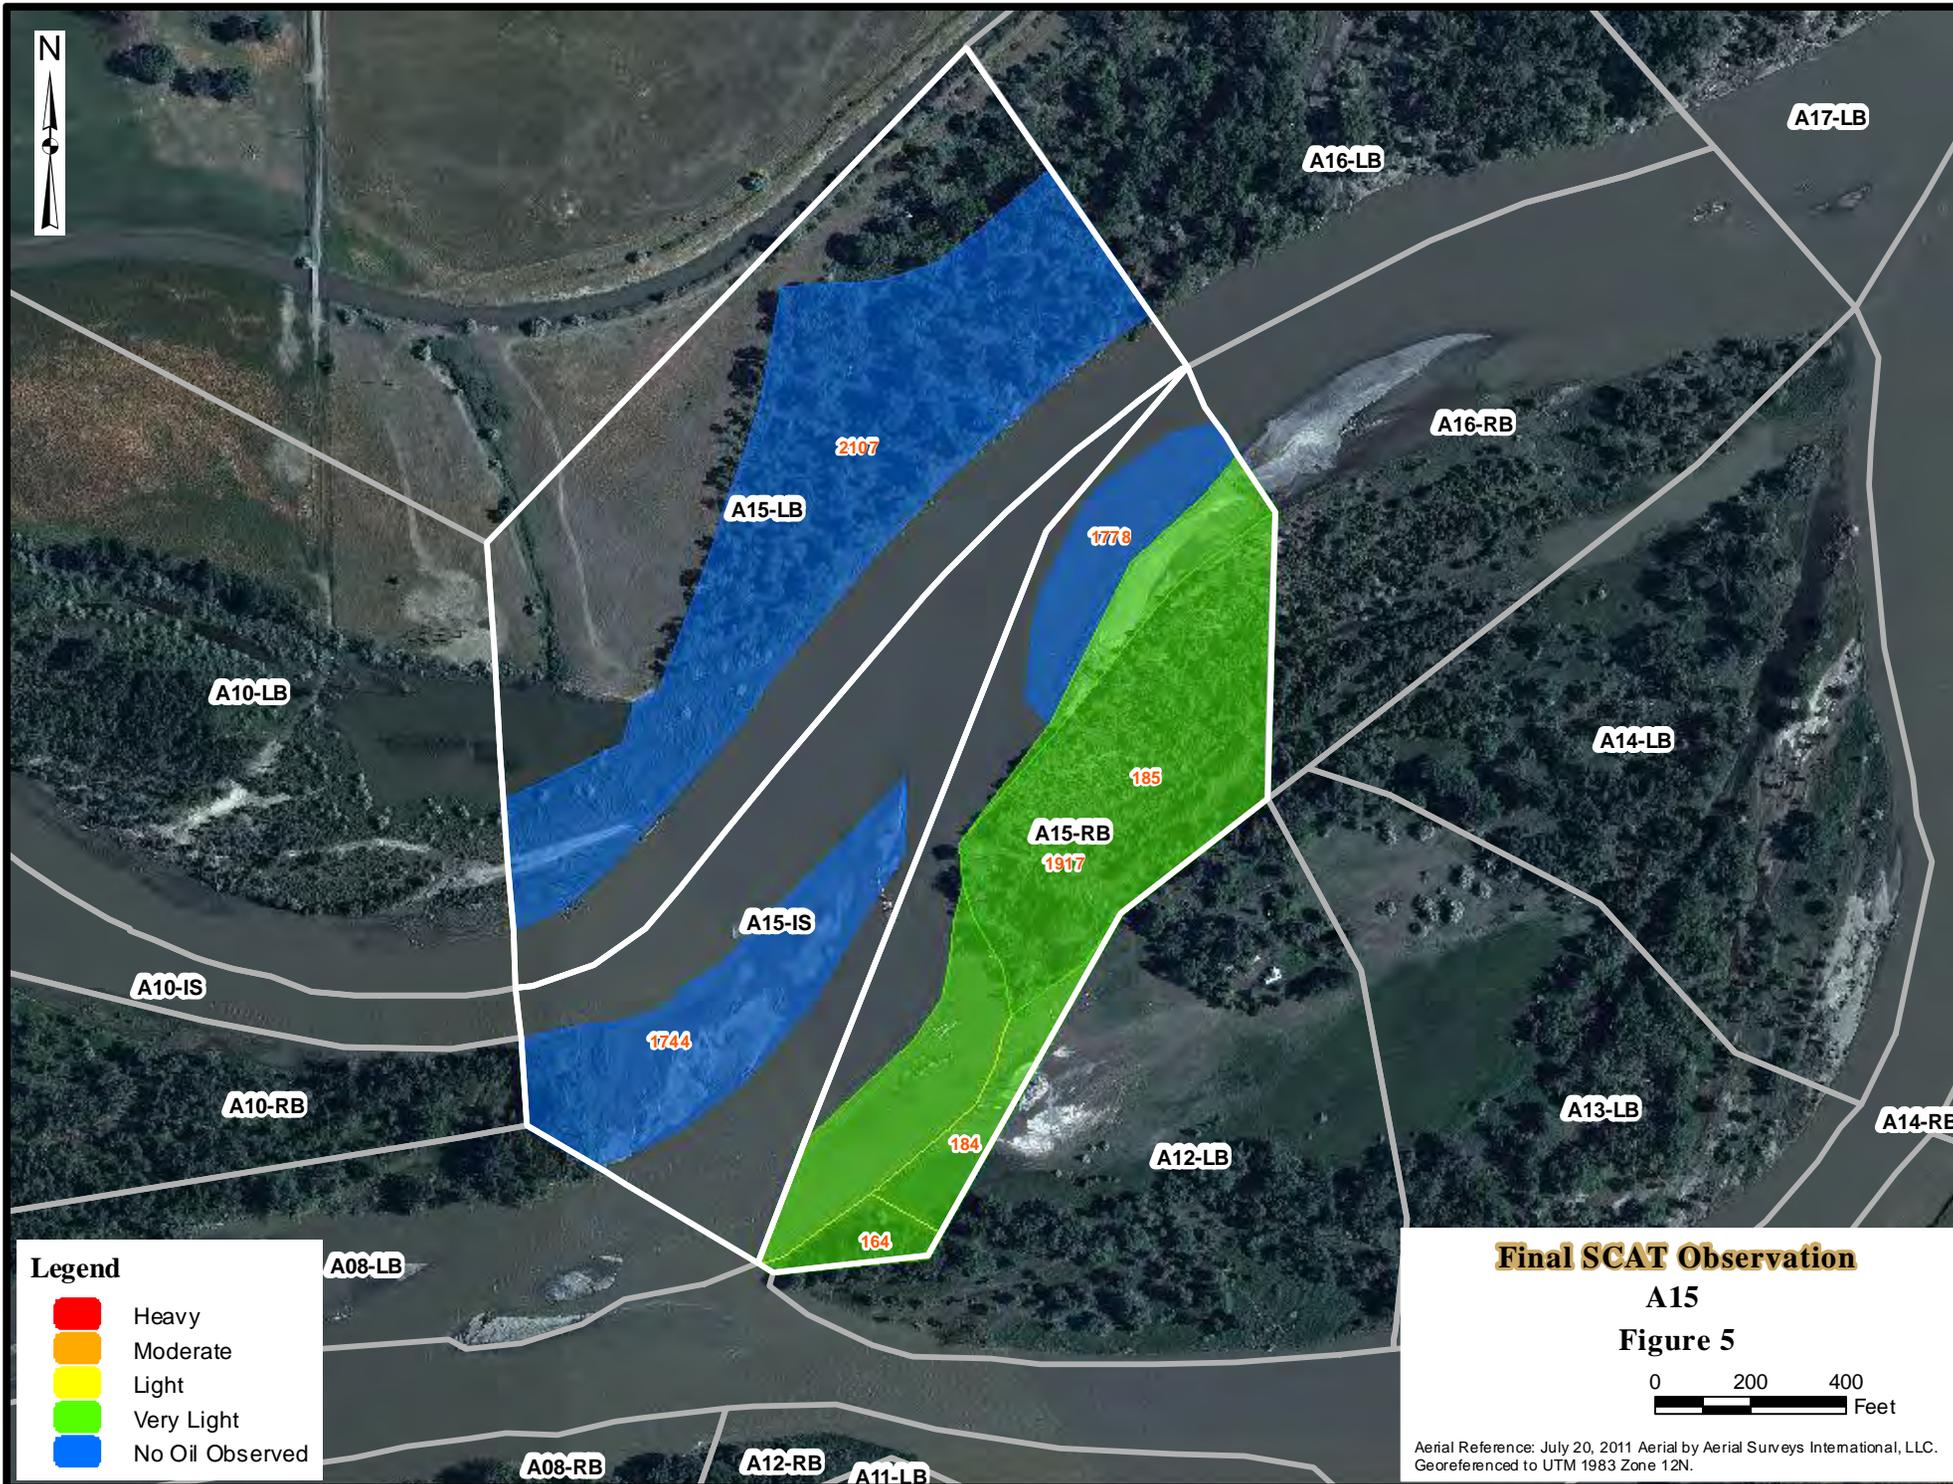
Figure 5 shows the oiling conditions within Area A15 following completion of oil removal activities. The SCAT team performed final surveys of the right bank within SCAT Area A15 to confirm the agreed-upon cleanup endpoints identified in the applicable CTRs had been achieved. The final SCAT survey documentation is presented in Appendix F.

Based on the final SCAT survey performed on the right bank within Area A15, no further treatment is recommended for this area. Based on the initial SCAT survey, no oiling was observed on the left bank or the island of Area A15. A SCAT Segment Sign-Off Sheet is included as Appendix G.

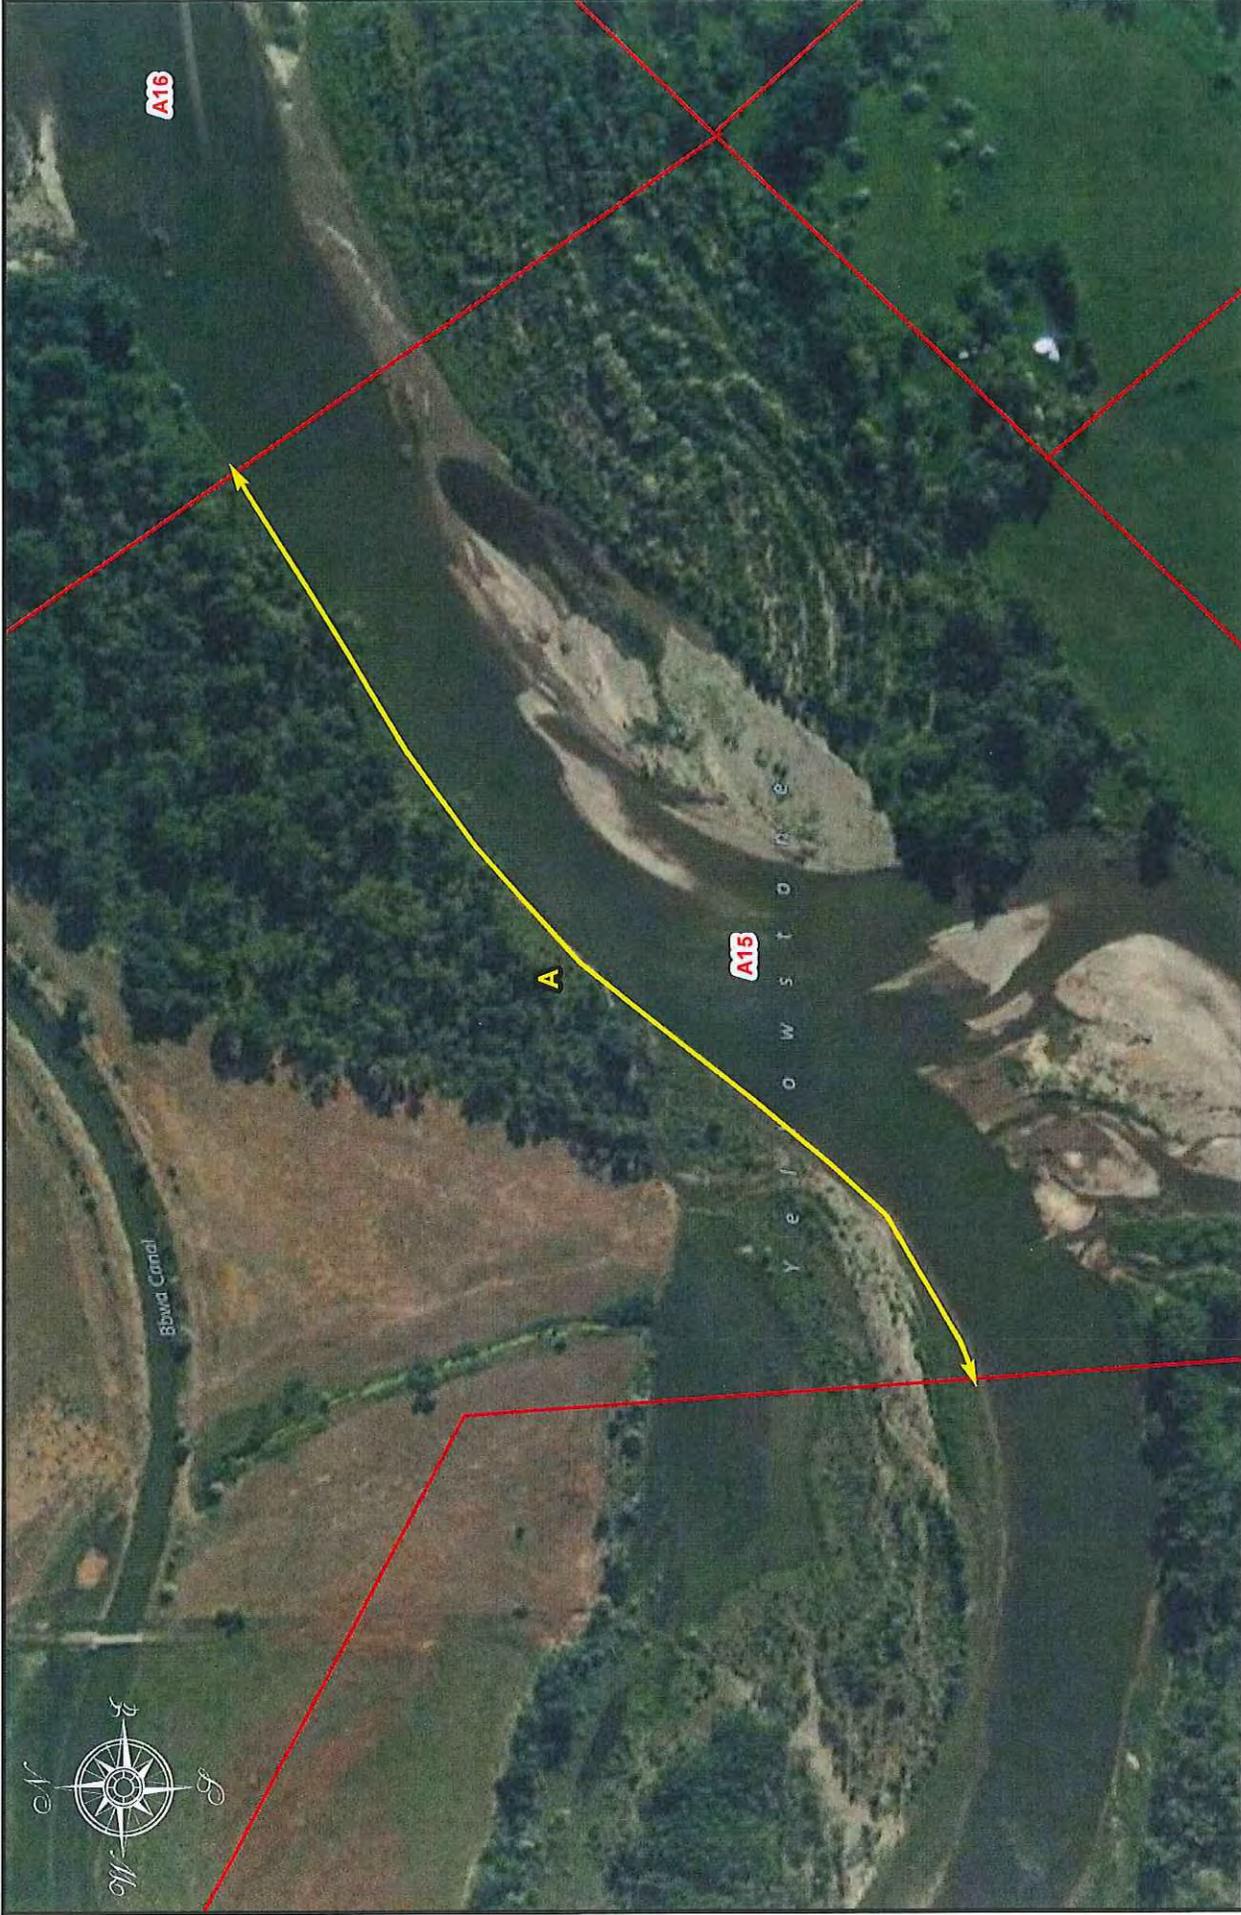
Segment A15 Left Bank

OIL ZONE	RIVER BANK ZONE				OIL COVER			OIL THICKNESS					OIL CHARACTER							SUBST. TYPE(S)			
	ID	MS	LB	UB	OB	Length m	Width m	Distrib. %	TO	CV	CT	ST	FL	FR	MS	TB	PT	TC	SR		AP	NO	
A					<u>X</u>	<u>550</u>	<u>120</u>															<u>X</u>	Grass, trees, debris

Zone A : No oil ; no treatment required

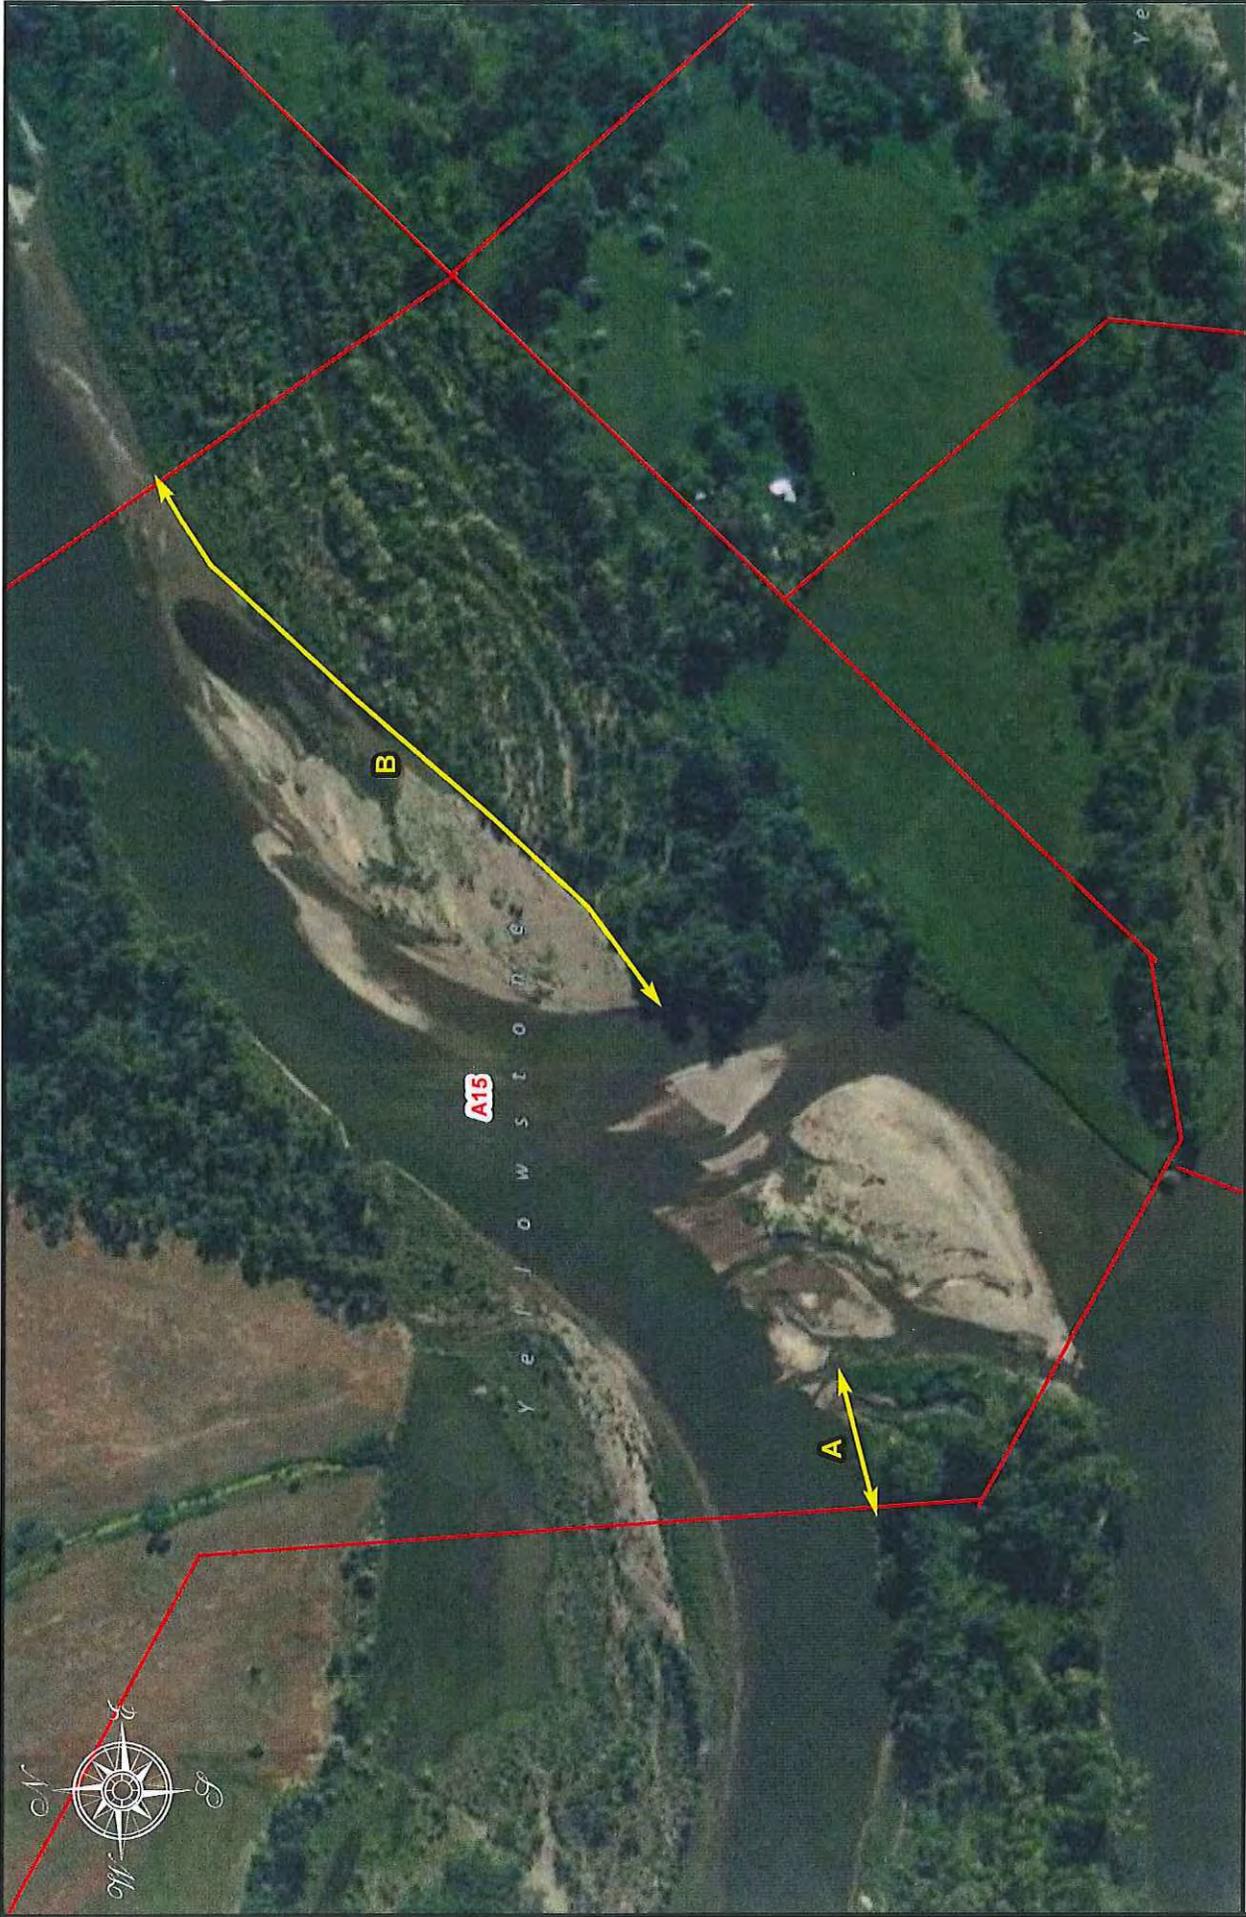
6 SURFACE OILING CONDITIONS																						begin with "A" in the lowest tidal zone - circle the zone/s that correspond to primary shoreline type	
OIL ZONE ID	RIVER BANK ZONE				OIL COVER			OIL THICKNESS					OIL CHARACTER							SUBST. TYPE(S)			
	MS	LB	UB	OB	Length m	Width m	Distrib. %	TO	CV	CT	ST	FL	FR	MS	TB	PT	TC	SR	AP		NO		
A				X	75	35	60			X	X		X								Grass, trees, debris

Cleanup Recommendations: For substrates with oiling greater than stain, trim oiled vegetation; wipe large oiled debris; remove small oiled debris; wipe oiled trees. No treatment for stained substrates is recommended.

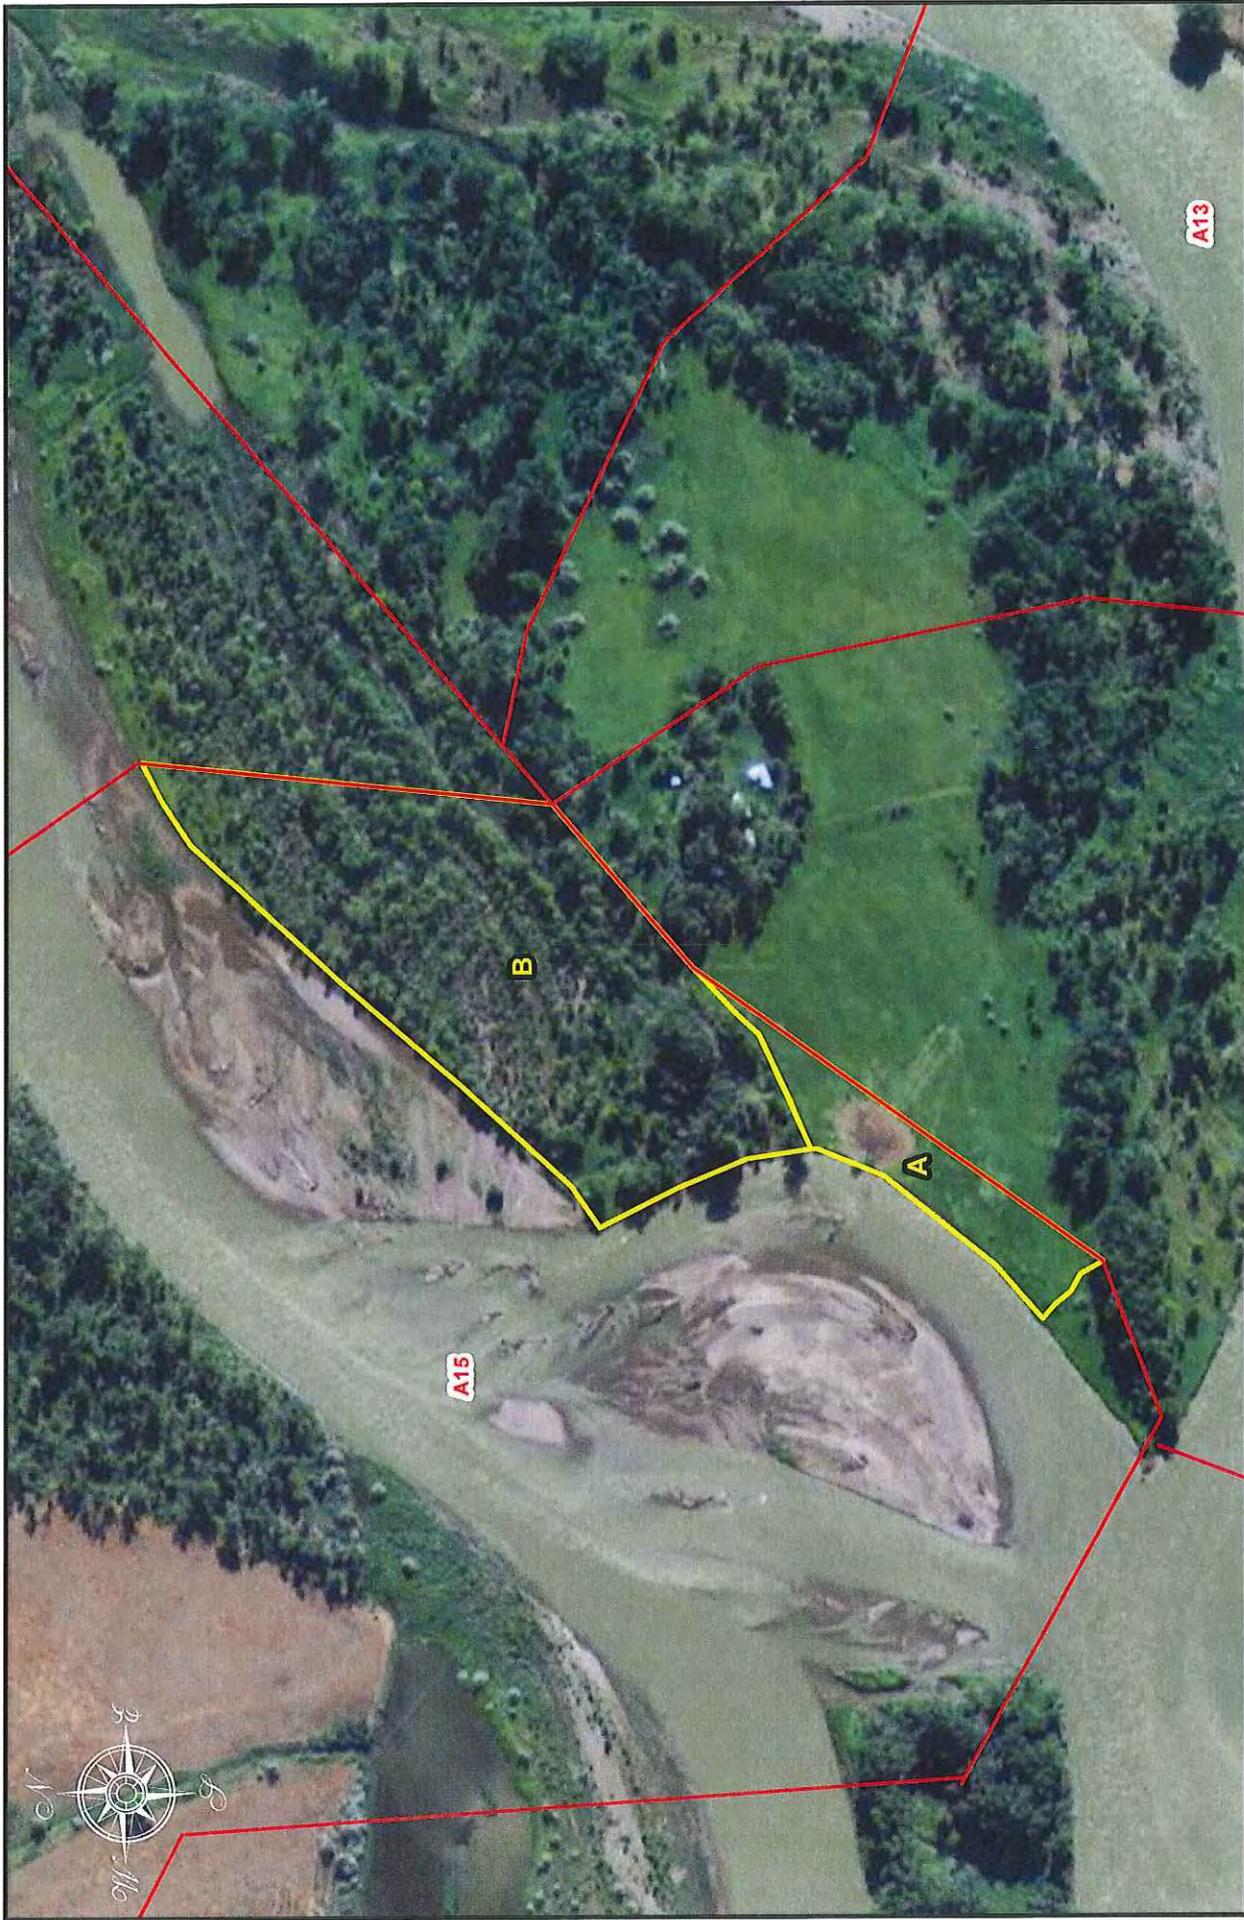
Zone A - Part of New Emerging Island - No oil observed
No further Treatment Required

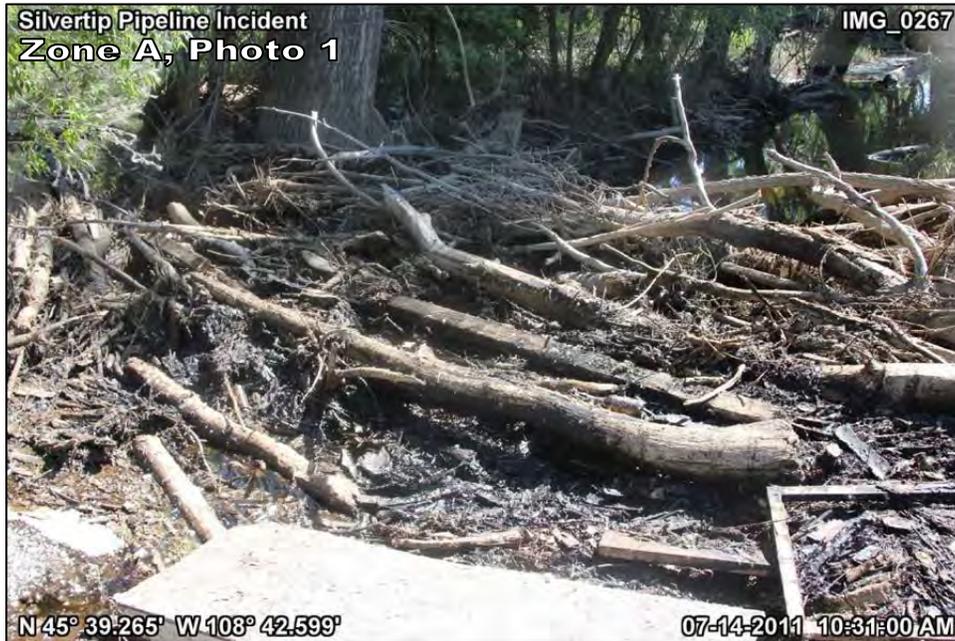
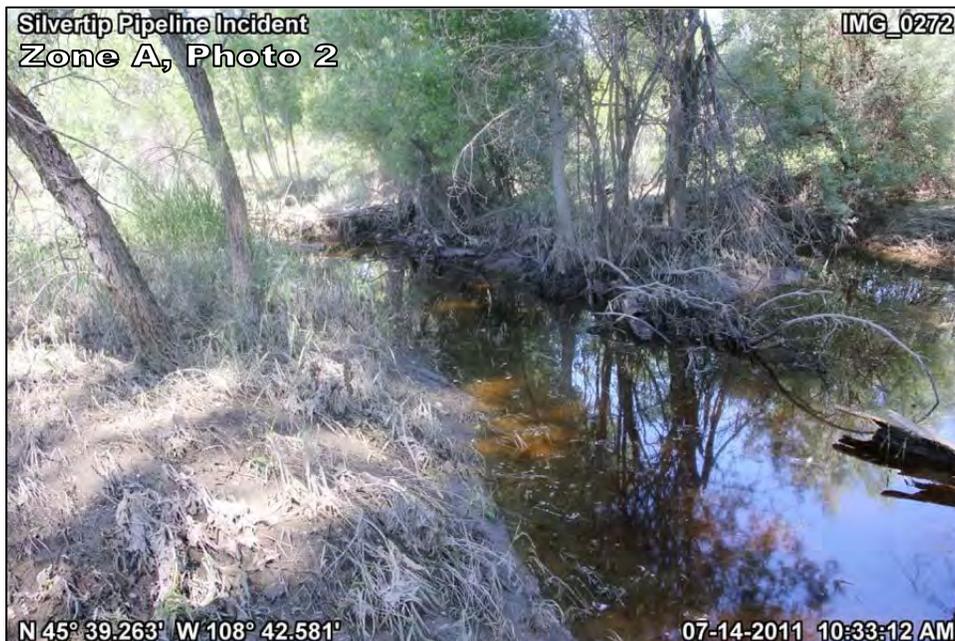
Primary Oiling Conditions: ~45% distribution of oiled debris (coat/cover), pooled oil on water, oil coat/stain on vegetation. Note: Quantity of oil-coated debris exceeds 10 roll-offs.

Cleanup Recommendations: Remove pooled oil with sorbents. Cut and remove oil-coated vegetation smaller than 1" diameter. Do not cut grass shorter than 1". Remove oil-coated debris smaller than 4" diameter. Wipe larger oil coated vegetation and debris. The size and quantity of oil coated debris in this zone may warrant the use of fixatives. Consult SCAT Ops Liaison for use and applicability.

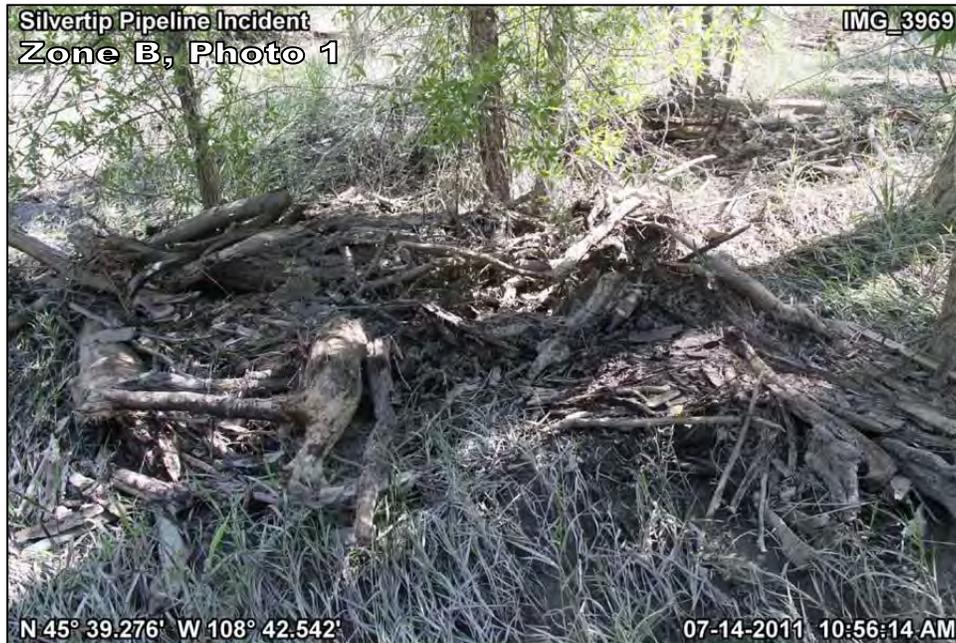
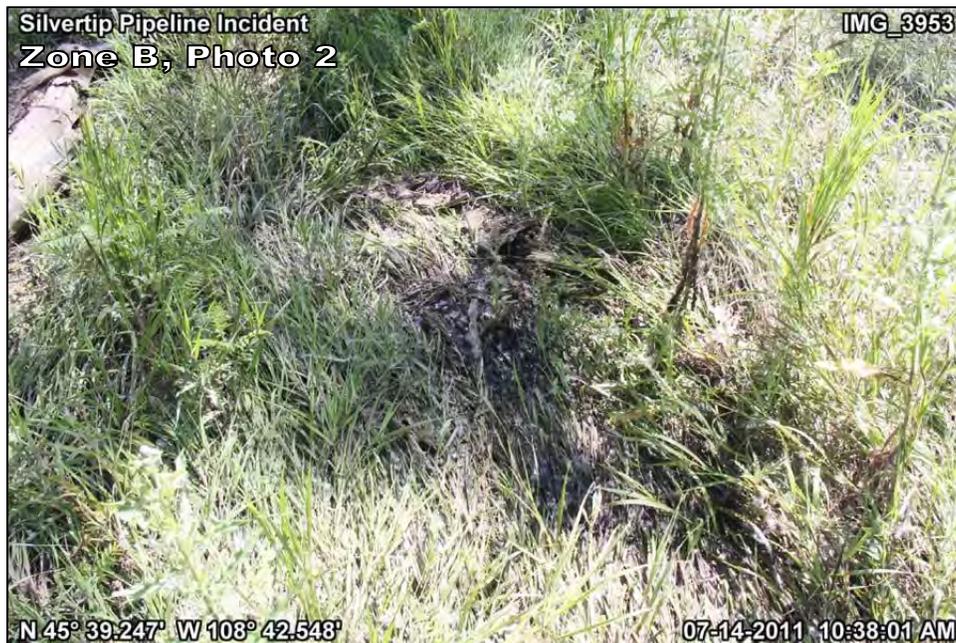
Primary Oiling Conditions: ~15% distribution of oiled debris (coat) and oil coat/stain on vegetation.

Cleanup Recommendations: Cut and remove oil coated vegetation smaller than 1" diameter. Wipe oil coated vegetation larger than 1" diameter. Only remove oil coated debris smaller than 4" diameter. Wipe oil coated debris larger than 4" diameter.

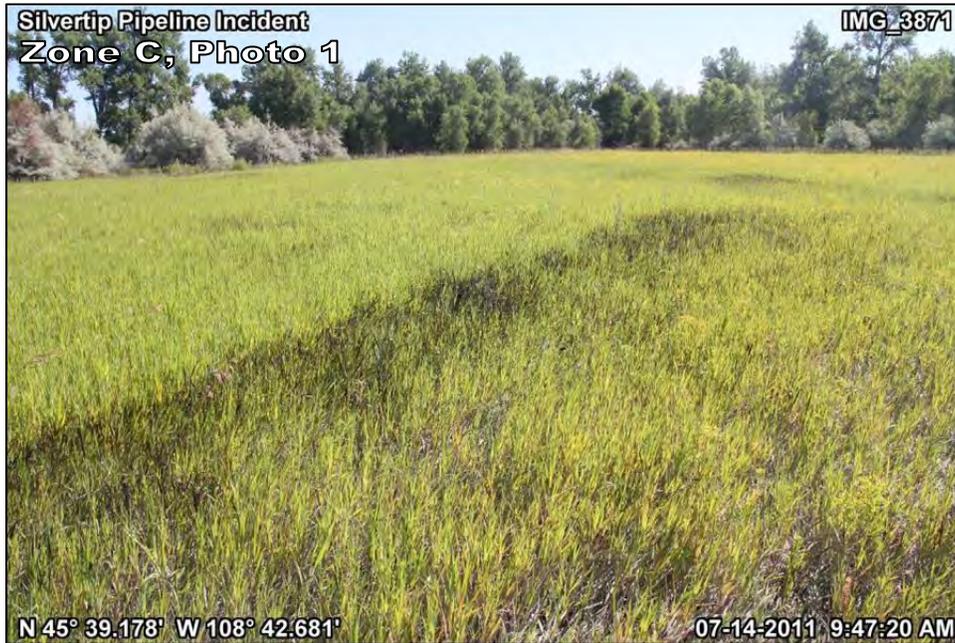
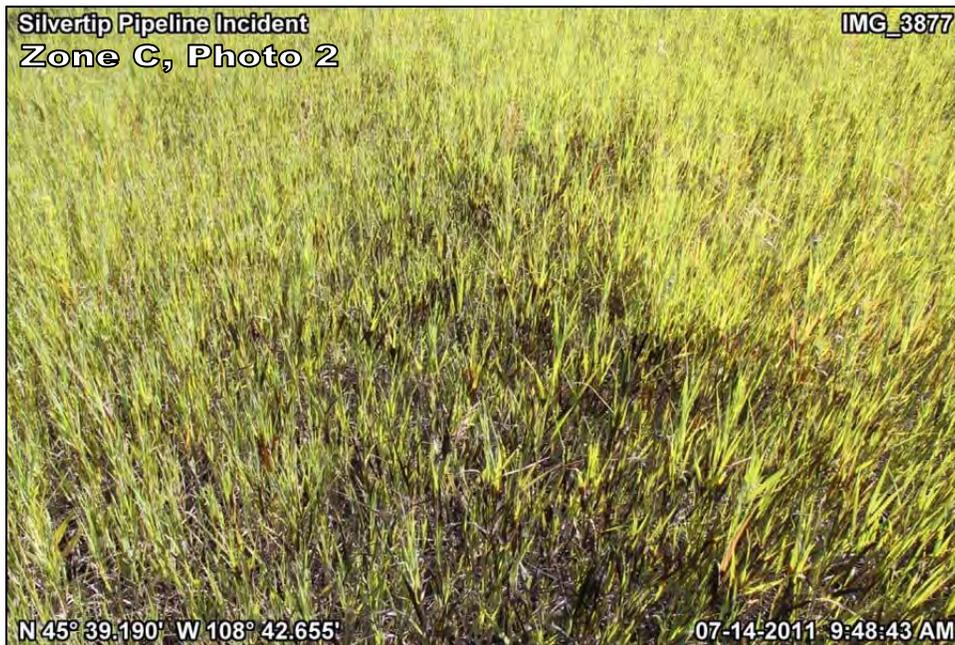
Primary Oiling Conditions: ~25% distribution of oil coat/stain on vegetation in field.

Cleanup Recommendations: Cut and remove oil coated vegetation smaller than 1" diameter. Portions of this zone contain cultural resources requiring recordation and assessment. Refer to the Cultural Heritage field teams for guidance.
