**SCAT Area Transition Report for
A15**

Silvertip Pipeline Incident
Laurel, Montana

October 18, 2011

Our Ref.:
B0085883.1103

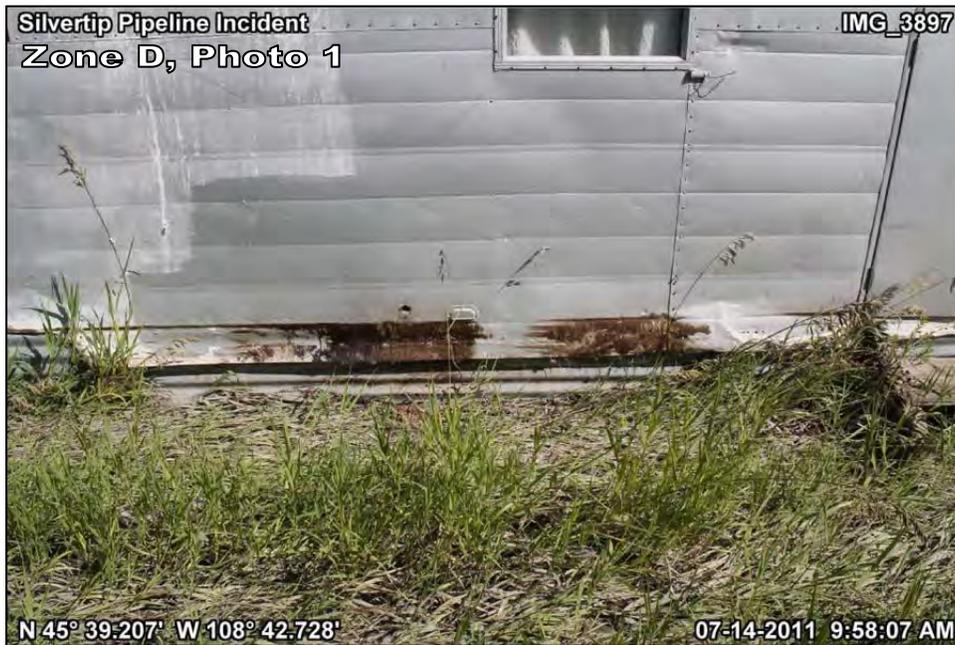
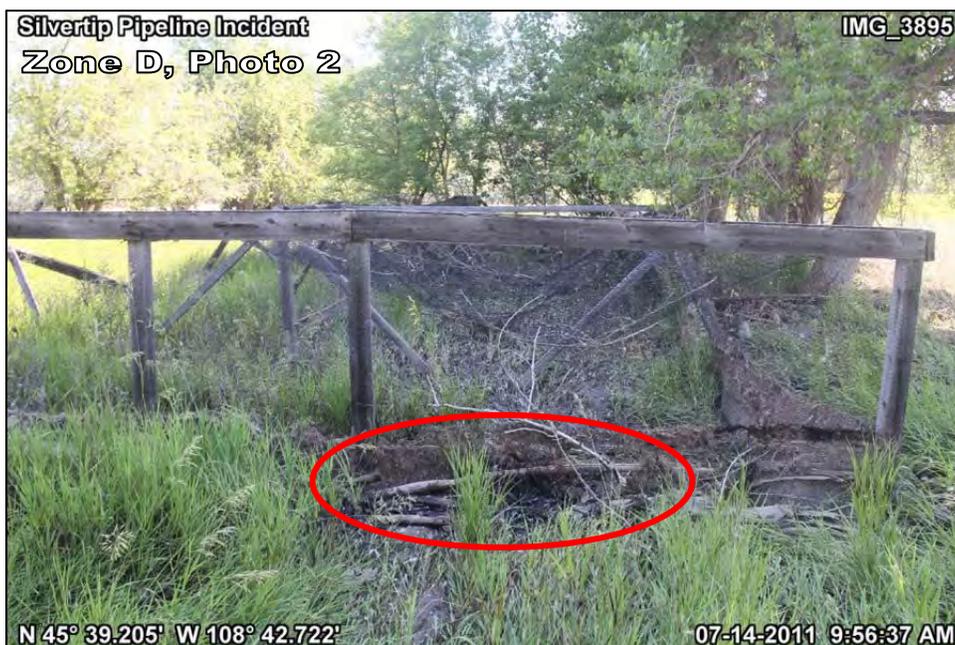
Primary Oiling Conditions: Private homestead consisting of living quarters, barns, and other farm structures. ~5% distribution of oil cover/coat/stain on vegetation, trees, debris, and structures.

Cleanup Recommendations: Cut and remove oil coated vegetation smaller than 1" diameter. Remove oil coated debris smaller than 4" diameter. Wipe larger oil coated vegetation and debris. Wipe oil-coated structures. In consideration of private property, this zone may require treatment of oil stained vegetation, debris, and structures in coordination with the land owner. Portions of this zone contain cultural resources requiring recordation and assessment. Refer to the Cultural Heritage field teams for guidance.

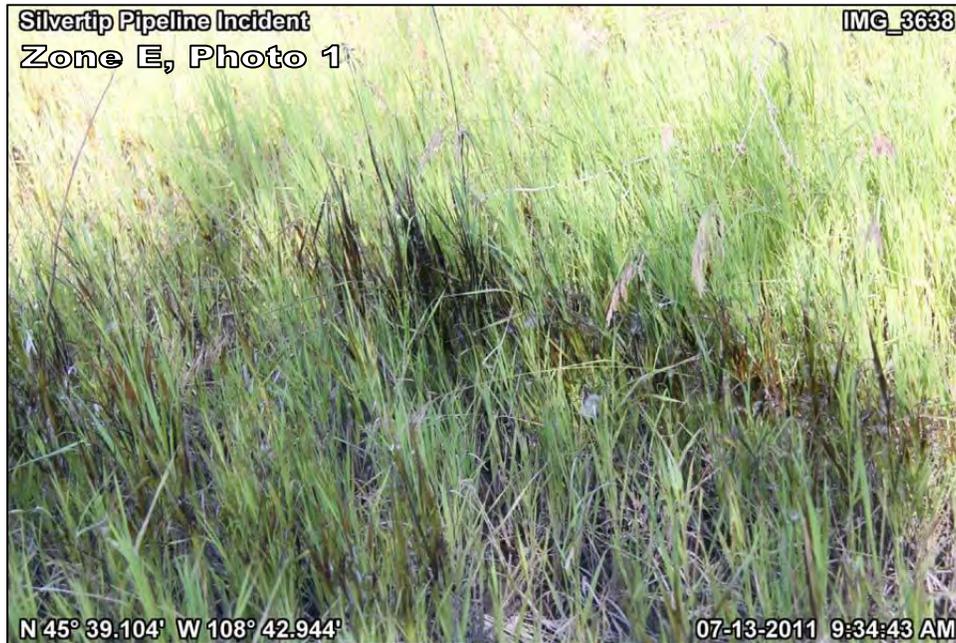
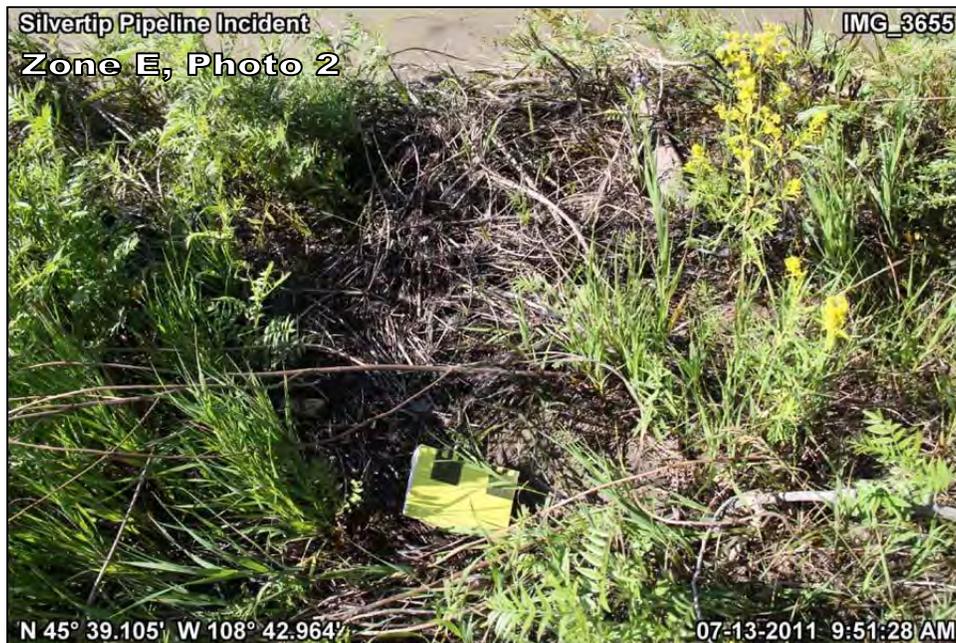
Primary Oiling Conditions: ~20% distribution of oil stained (primary) / coated vegetation and debris.

Cleanup Recommendations: Cut and remove oil coated vegetation smaller than 1" diameter. Remove oil coated debris smaller than 4" diameter. Wipe larger oil coated vegetation and debris.

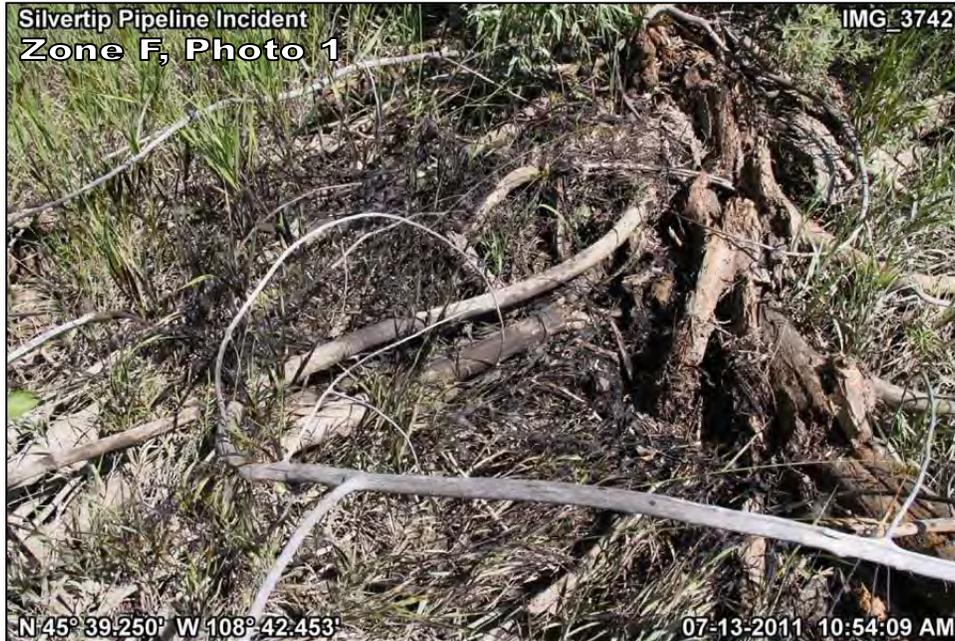
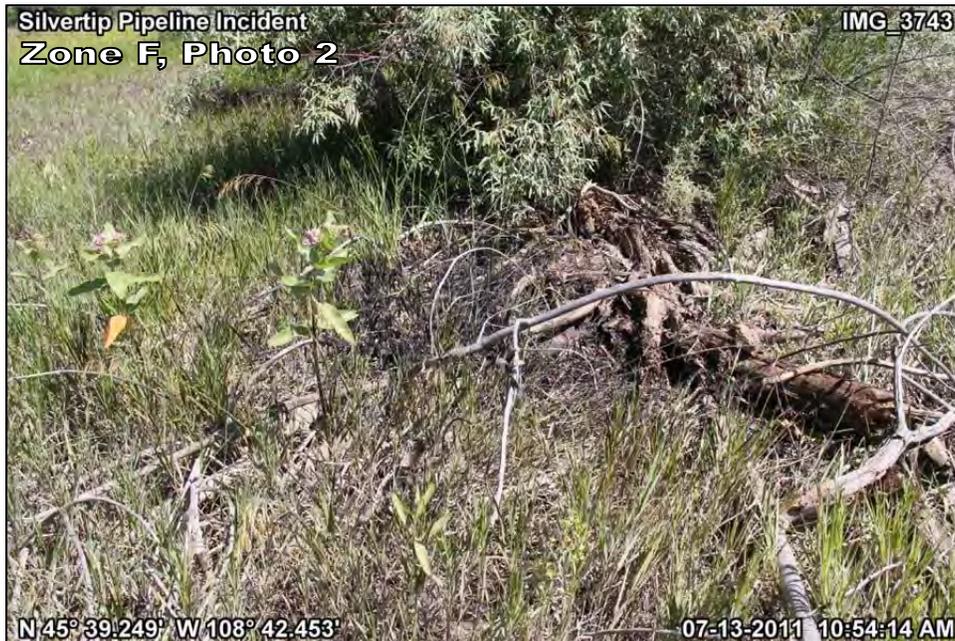
Primary Oiling Conditions: Discrete areas of oiled debris (coat/cover), pooled oil on water, oil coat/stain on vegetation.

Cleanup Recommendations: Remove pooled oil with sorbents. Cut and remove oil coated vegetation smaller than 1" diameter. Remove oil coated debris smaller than 4" diameter. Wipe larger oil coated vegetation and debris.

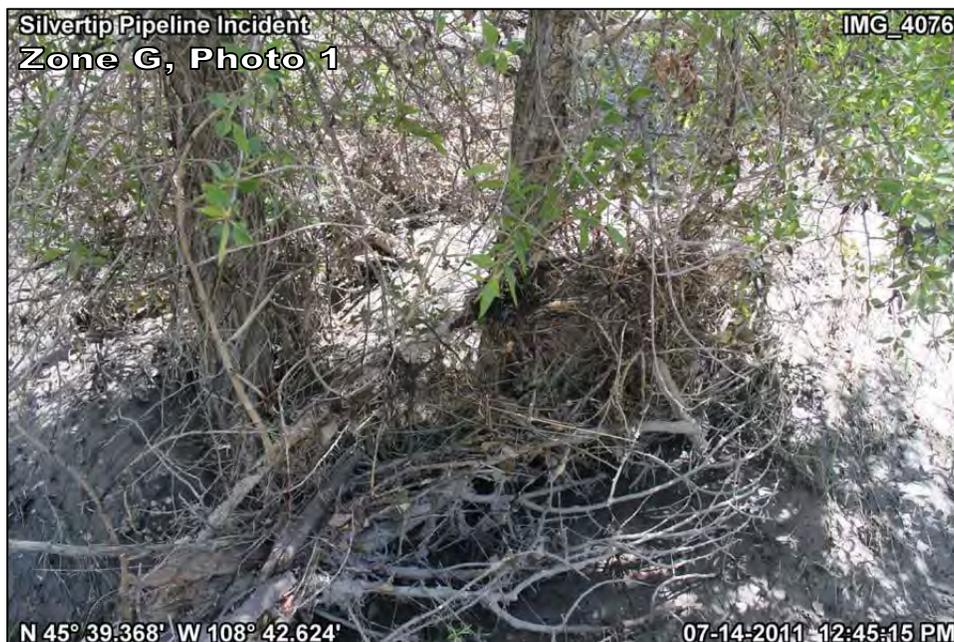
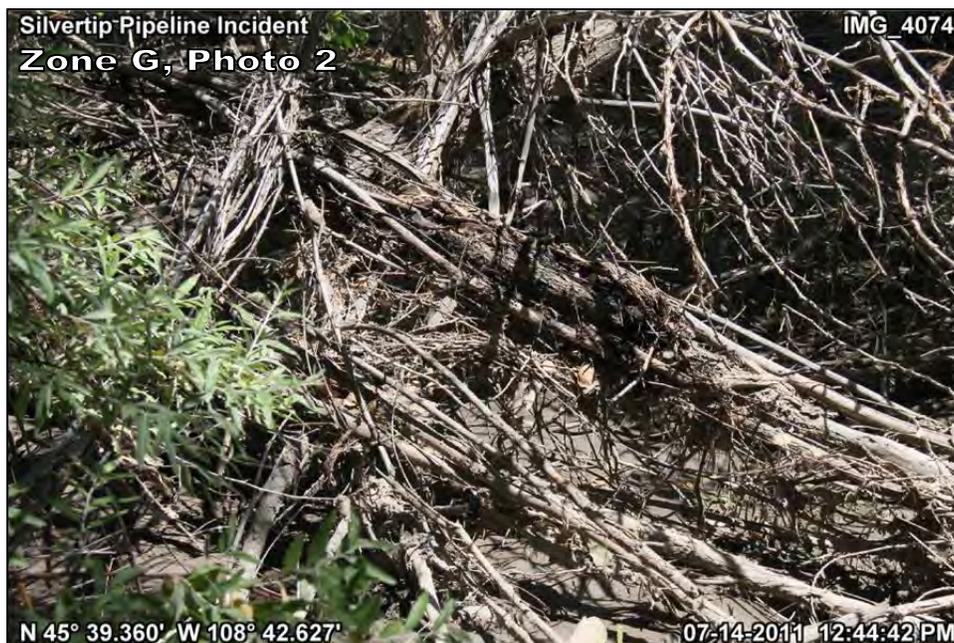
Primary Oiling Conditions: Discrete areas of oiled debris (coat/cover), pooled oil on water, oil coat/stain on vegetation.

Cleanup Recommendations: Remove pooled oil with sorbents. Cut and remove oil coated vegetation smaller than 1" diameter. Remove oil coated debris smaller than 4" diameter. Wipe larger oil coated vegetation and debris.

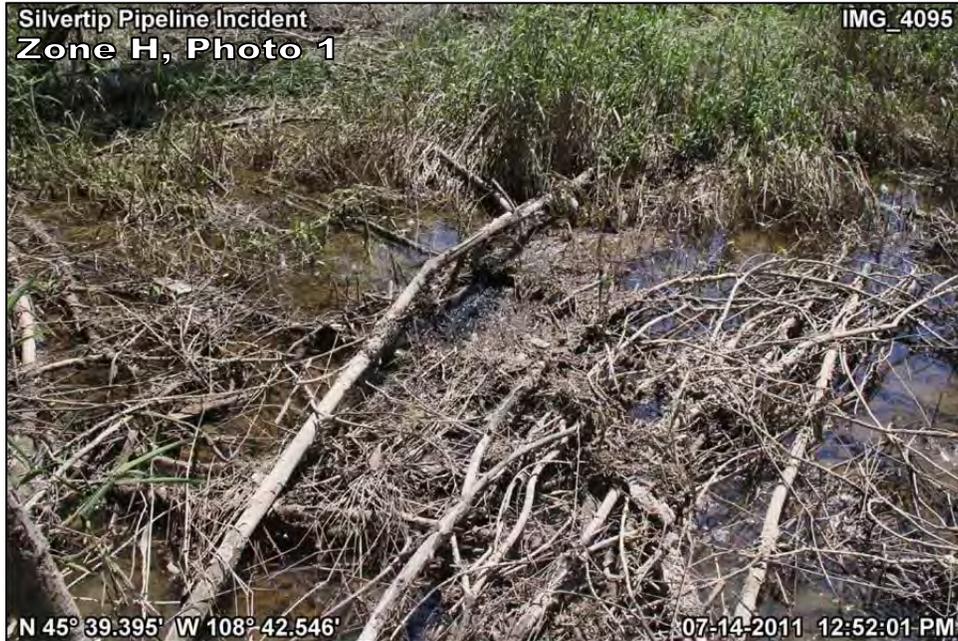
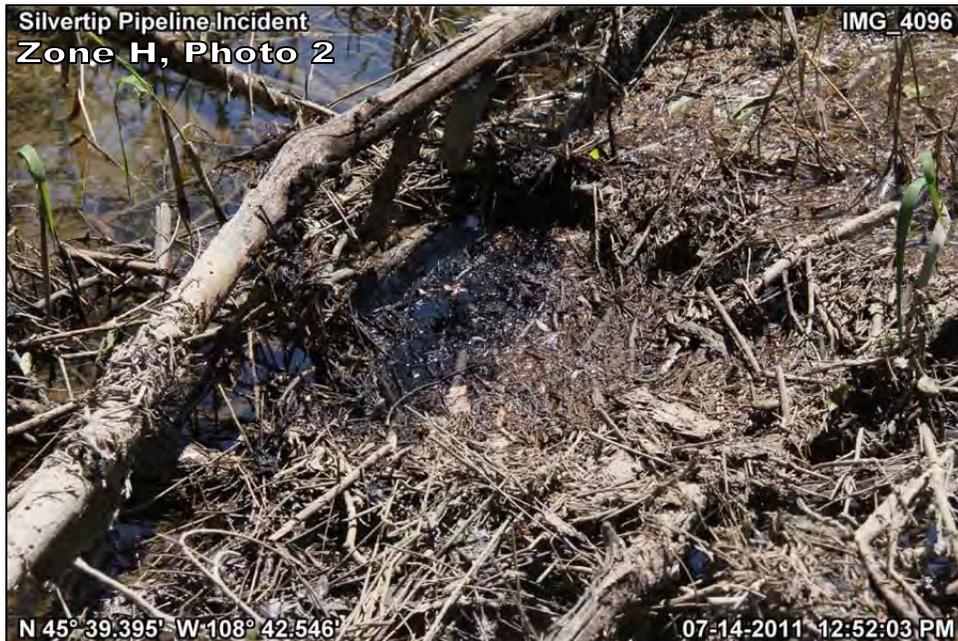
Primary Oiling Conditions: Discrete areas of oiled debris (coat/cover), pooled oil on water, oil coat/stain on vegetation.

Cleanup Recommendations: Remove pooled oil with sorbents. Cut and remove oil coated vegetation smaller than 1" diameter. Remove oil coated debris smaller than 4" diameter. Wipe larger oil coated vegetation and debris.

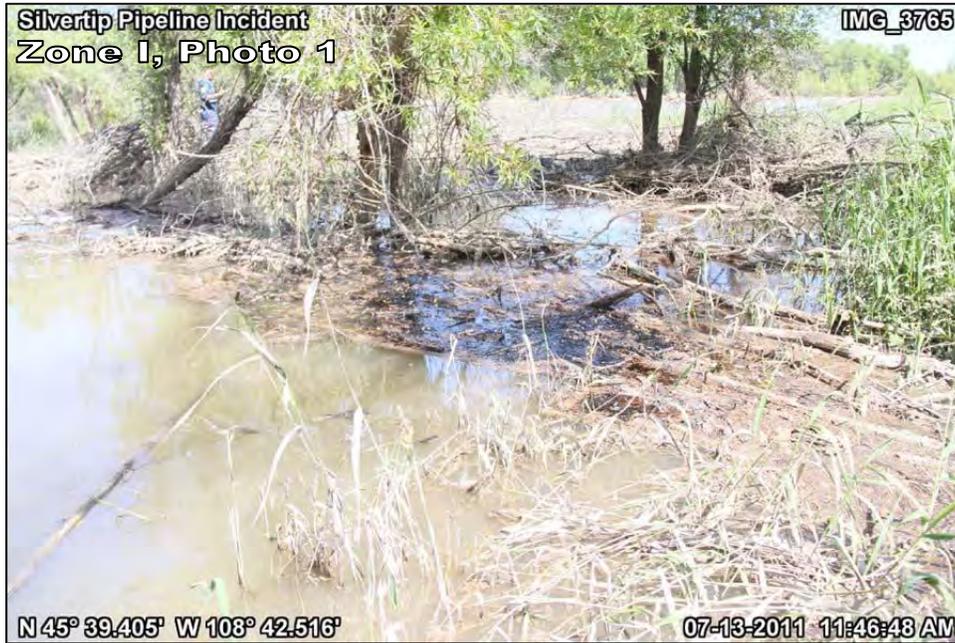
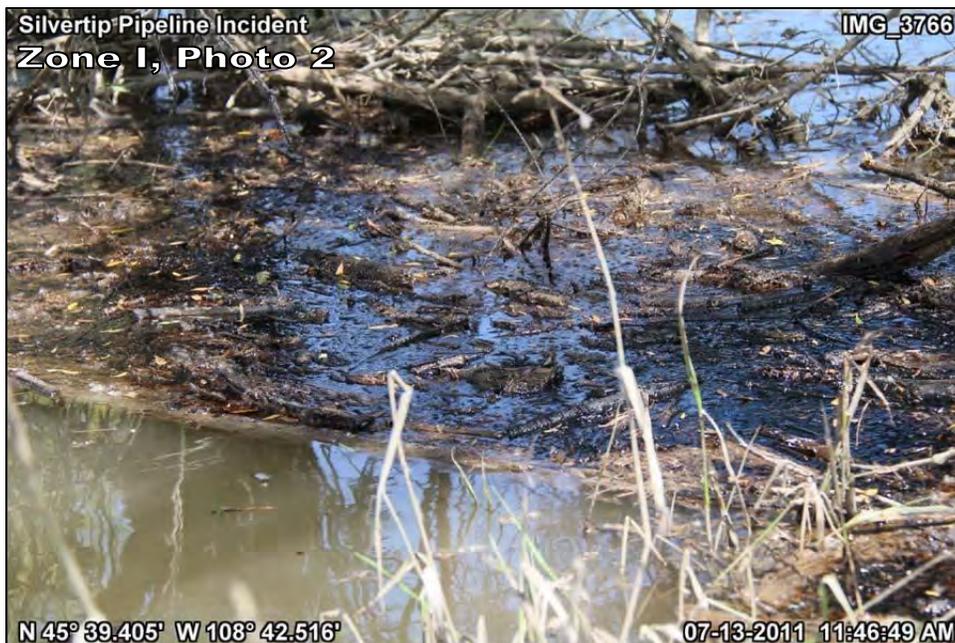
Primary Oiling Conditions: Discrete areas of oiled debris (coat/cover), pooled oil on water, oil coat/stain on vegetation.

Cleanup Recommendations: Remove pooled oil with sorbents. Cut and remove oil coated vegetation smaller than 1" diameter. Remove oil coated debris smaller than 4" diameter. Wipe larger oil coated vegetation and debris.

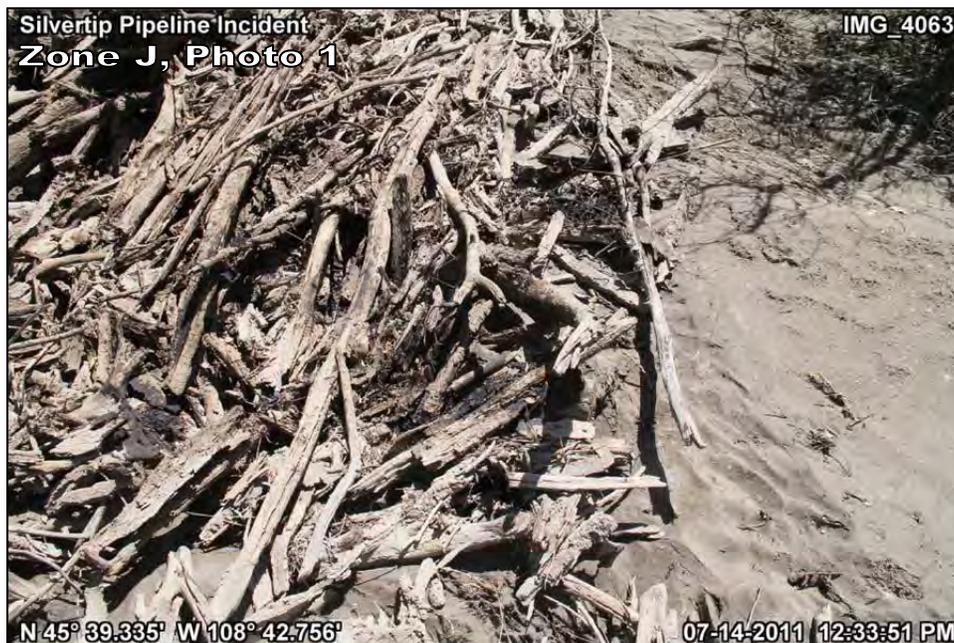
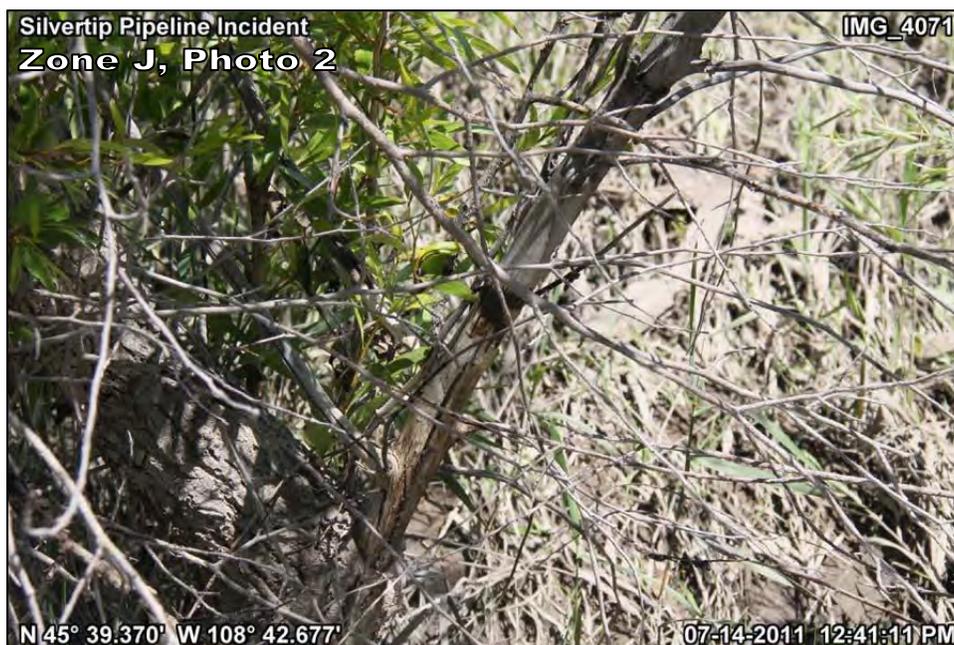
Primary Oiling Conditions: <1% distribution of narrow (~5cm) band of oil coat/stain on vegetation and trees. <1% distribution of oil coated debris.

Cleanup Recommendations: Cut and remove oil coated vegetation smaller than 1" diameter. Remove oil coated debris smaller than 4" diameter. Wipe larger oil coated vegetation and debris.

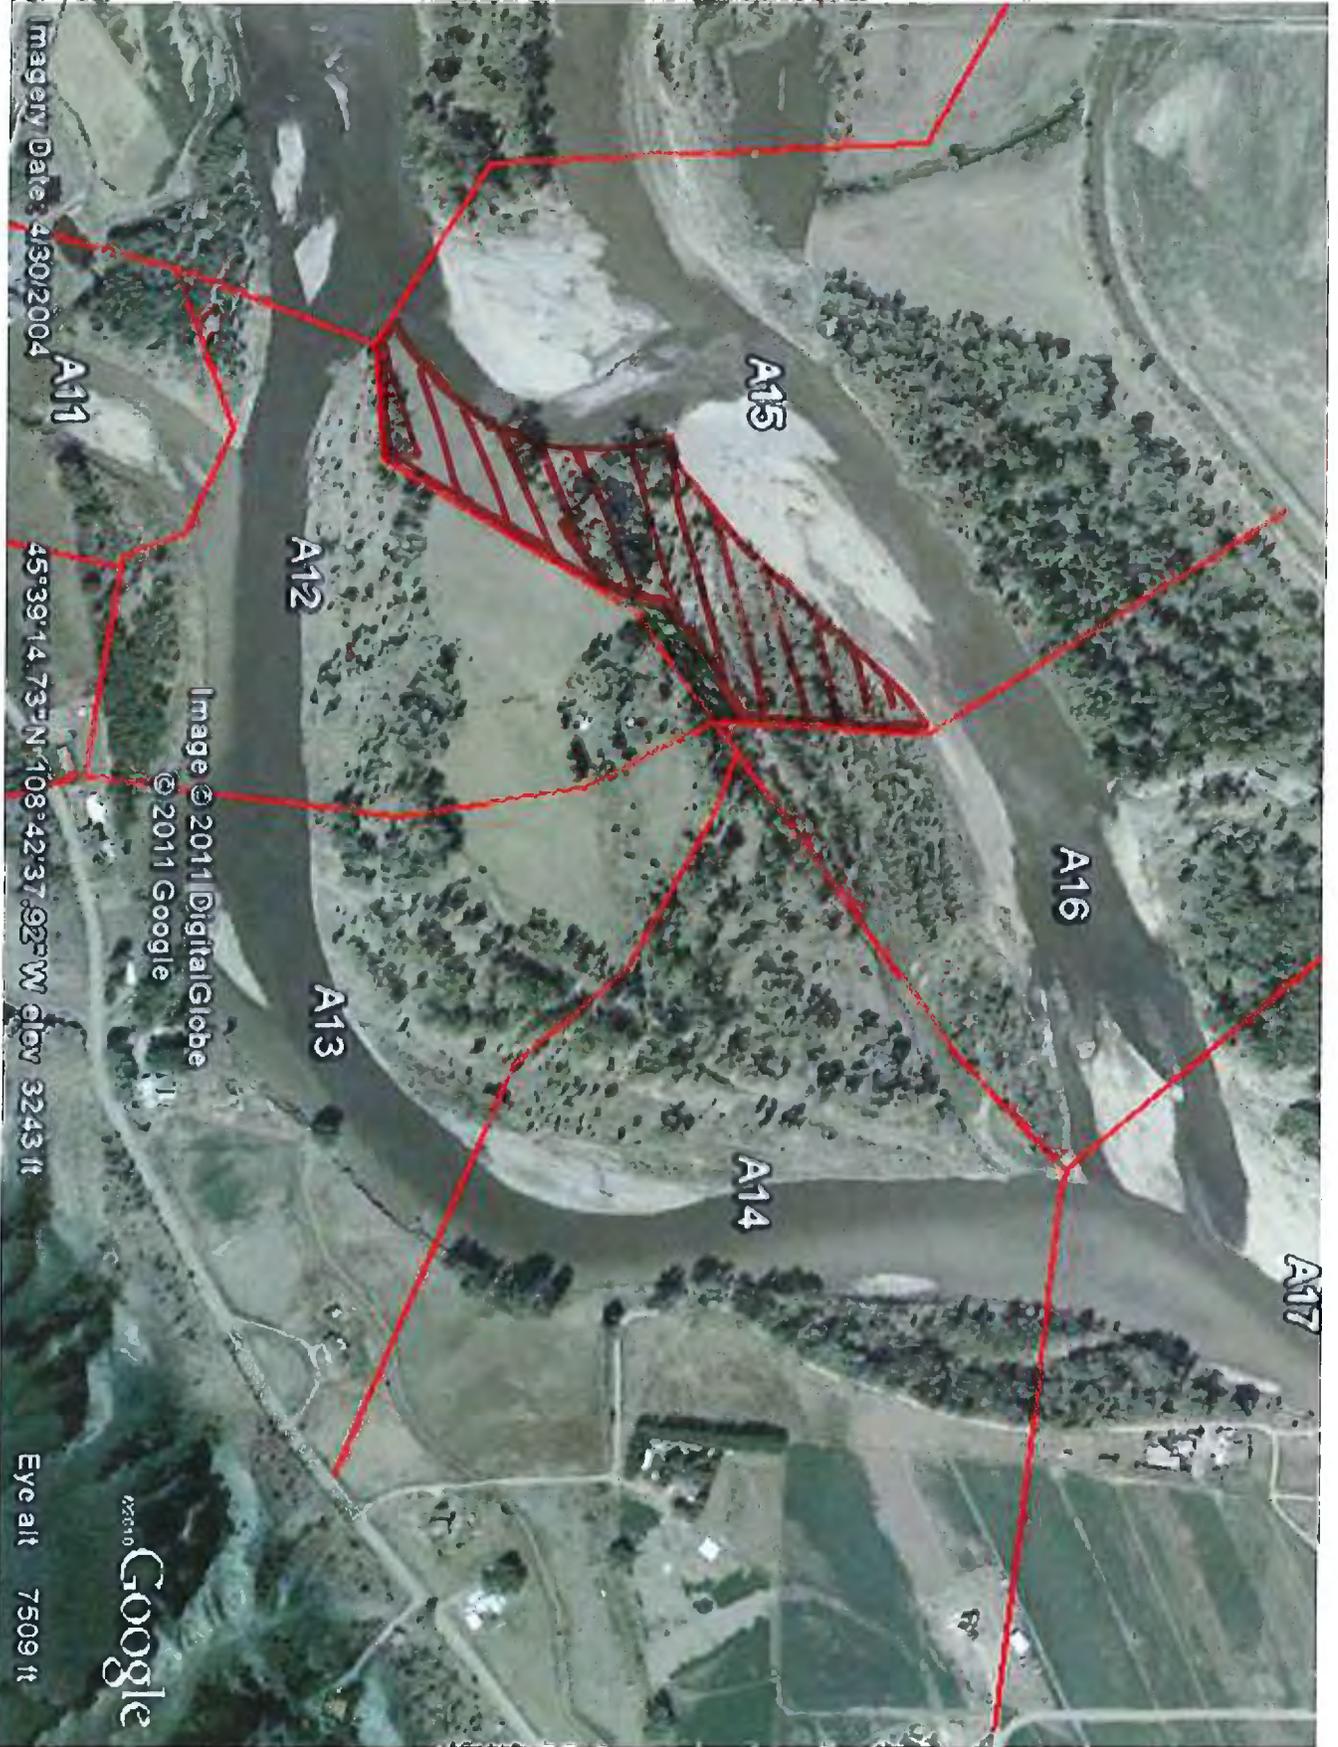
This PIST covers the Cultural Heritage site in segment A15RB Tower Island. Cultural Heritage representatives accompanied SCAT Ops Liaison for the PIST and verified the site meets their completion criteria.
