**SCAT Area Transition Report for  
A17**

Silvertip Pipeline Incident  
Laurel, Montana

Prepared for:  
ExxonMobil Pipeline Company

Prepared by:  
ARCADIS G&M of North Carolina, Inc.  
11000 Regency Parkway  
West Tower, Suite 205  
Cary, North Carolina 27518-8518  
Tel 919.469.1952  
Fax 919.469.5676

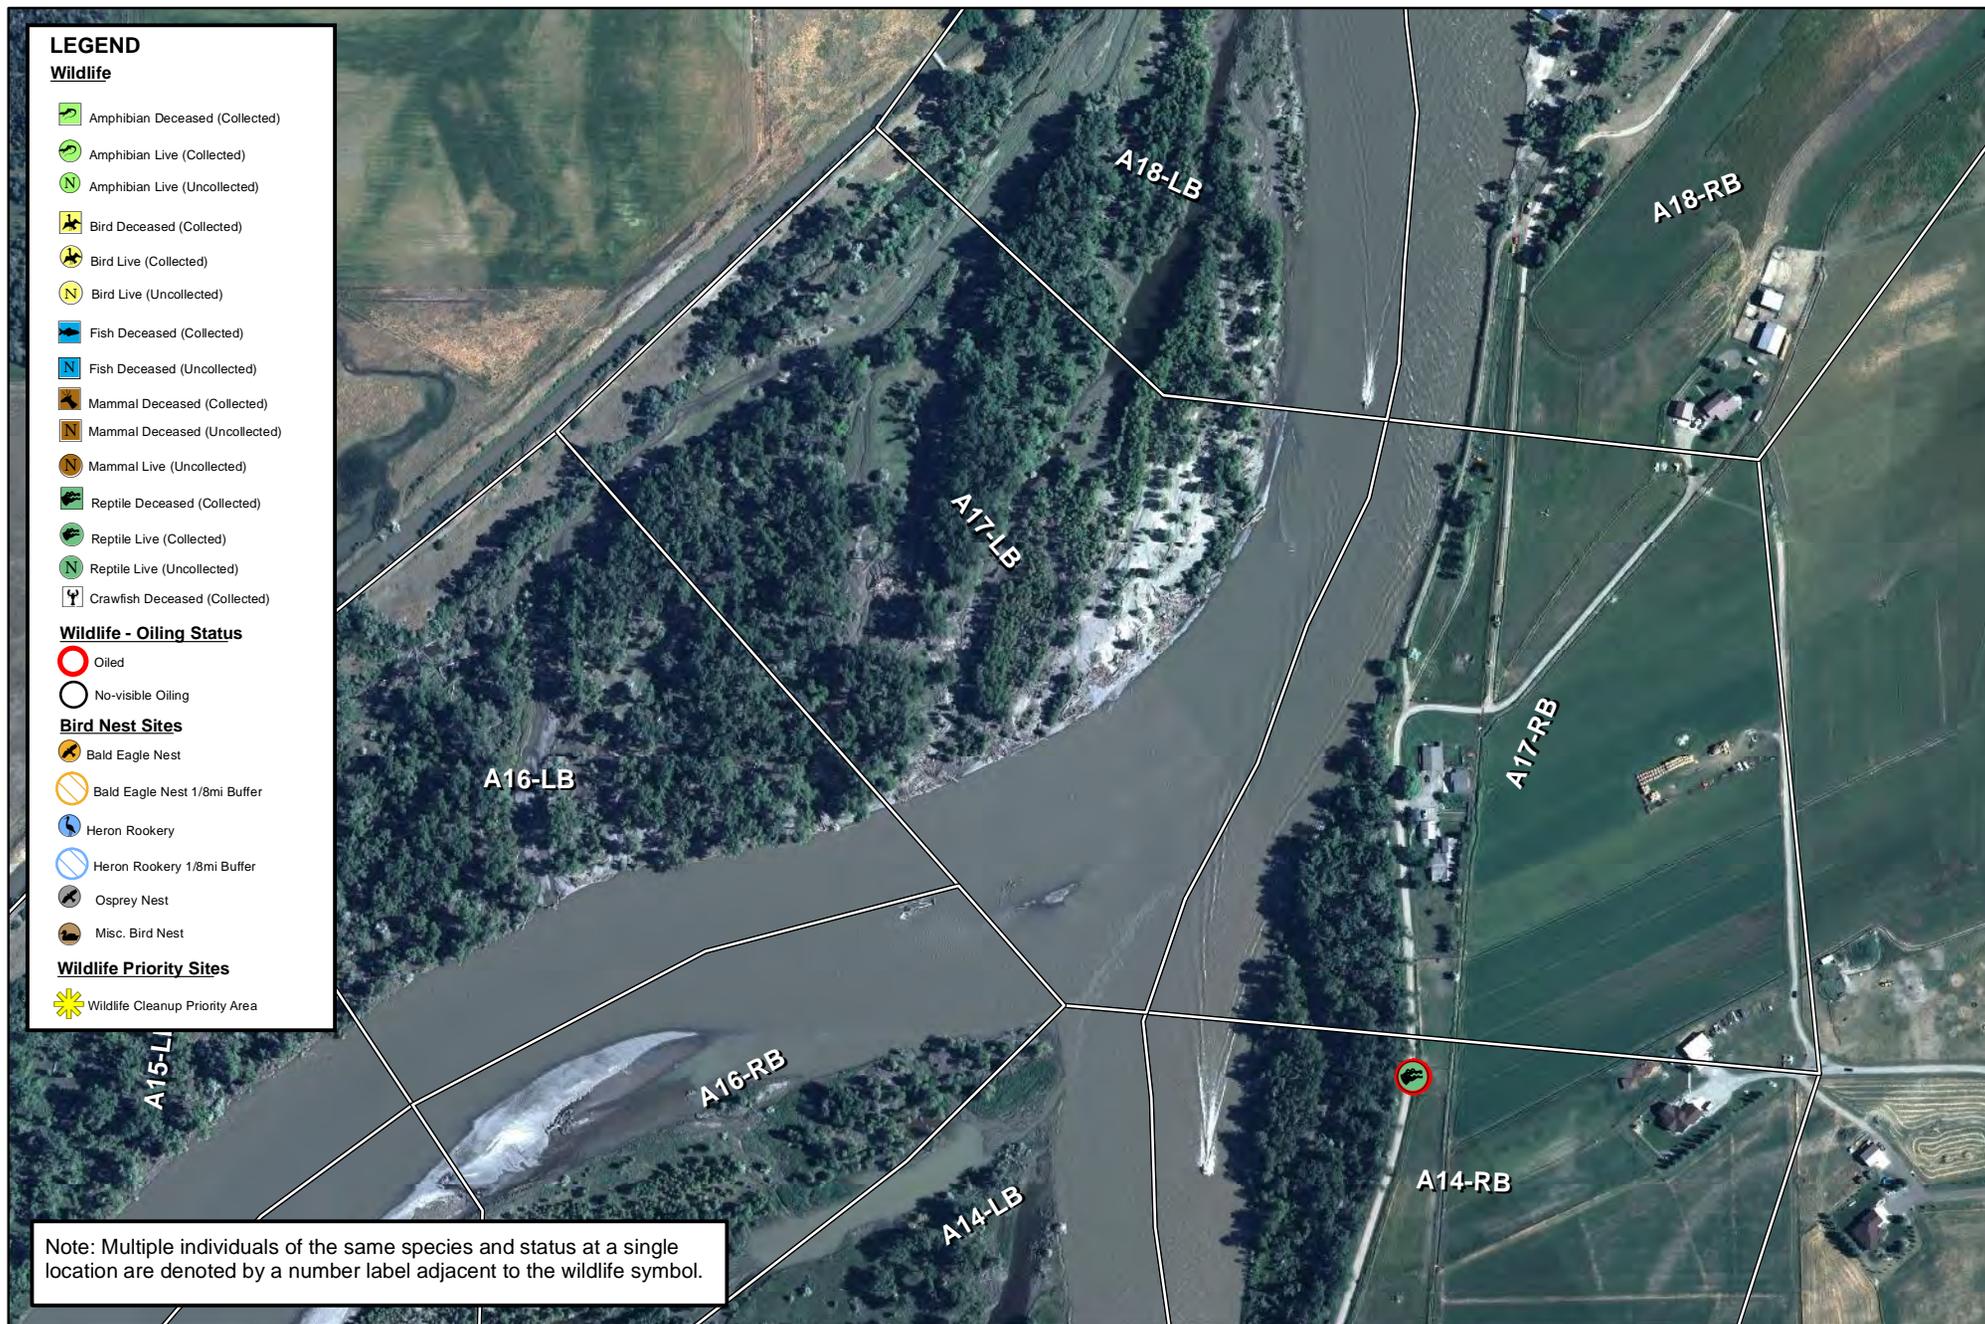
**Figure 2**  
**Wildlife Resources**

Figure 2 summarizes the natural resources identified in this segment. International Bird Rescue and Resource Advisors from U.S. Fish and Wildlife Service conducted regular inspections of the areas in A17 that did not have access issues. No oiled wildlife was observed or recovered. No Wildlife Priority Cleanup Areas were identified. No active migratory bird nests were identified in Area A17.

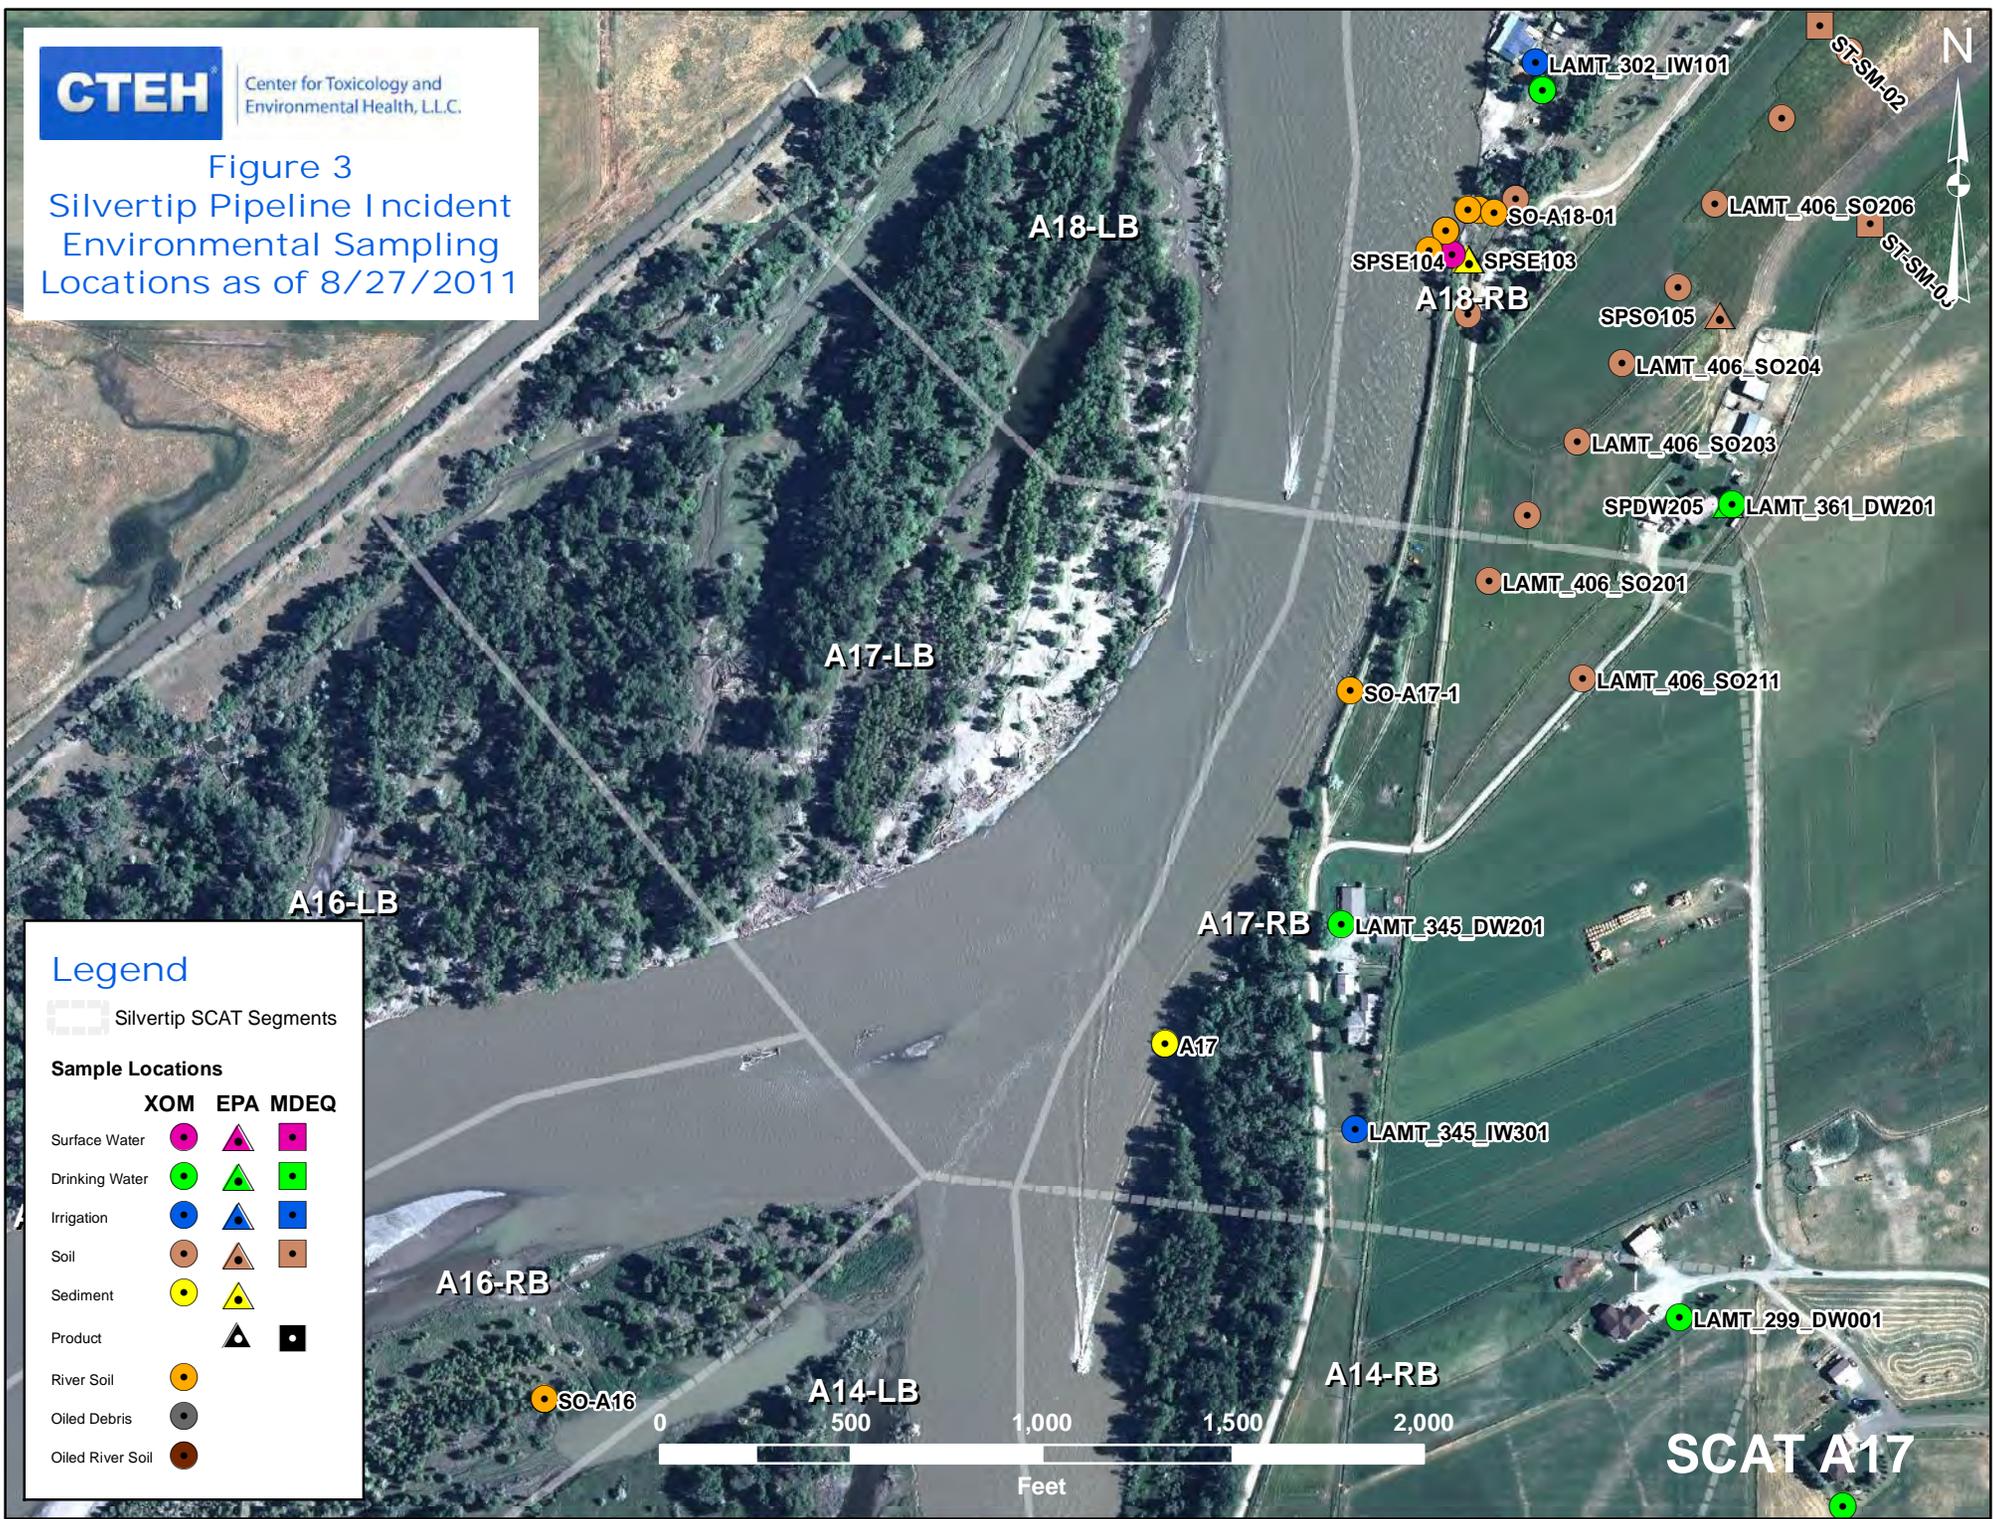
Table 1 (below) summarizes samples collected within Area A17. The analytical results for the samples collected can be accessed through a publicly accessible database on the United States Environmental Protection Agency's (USEPA's) website. The approximate locations of samples collected within Area A17 are provided on Figure 3.

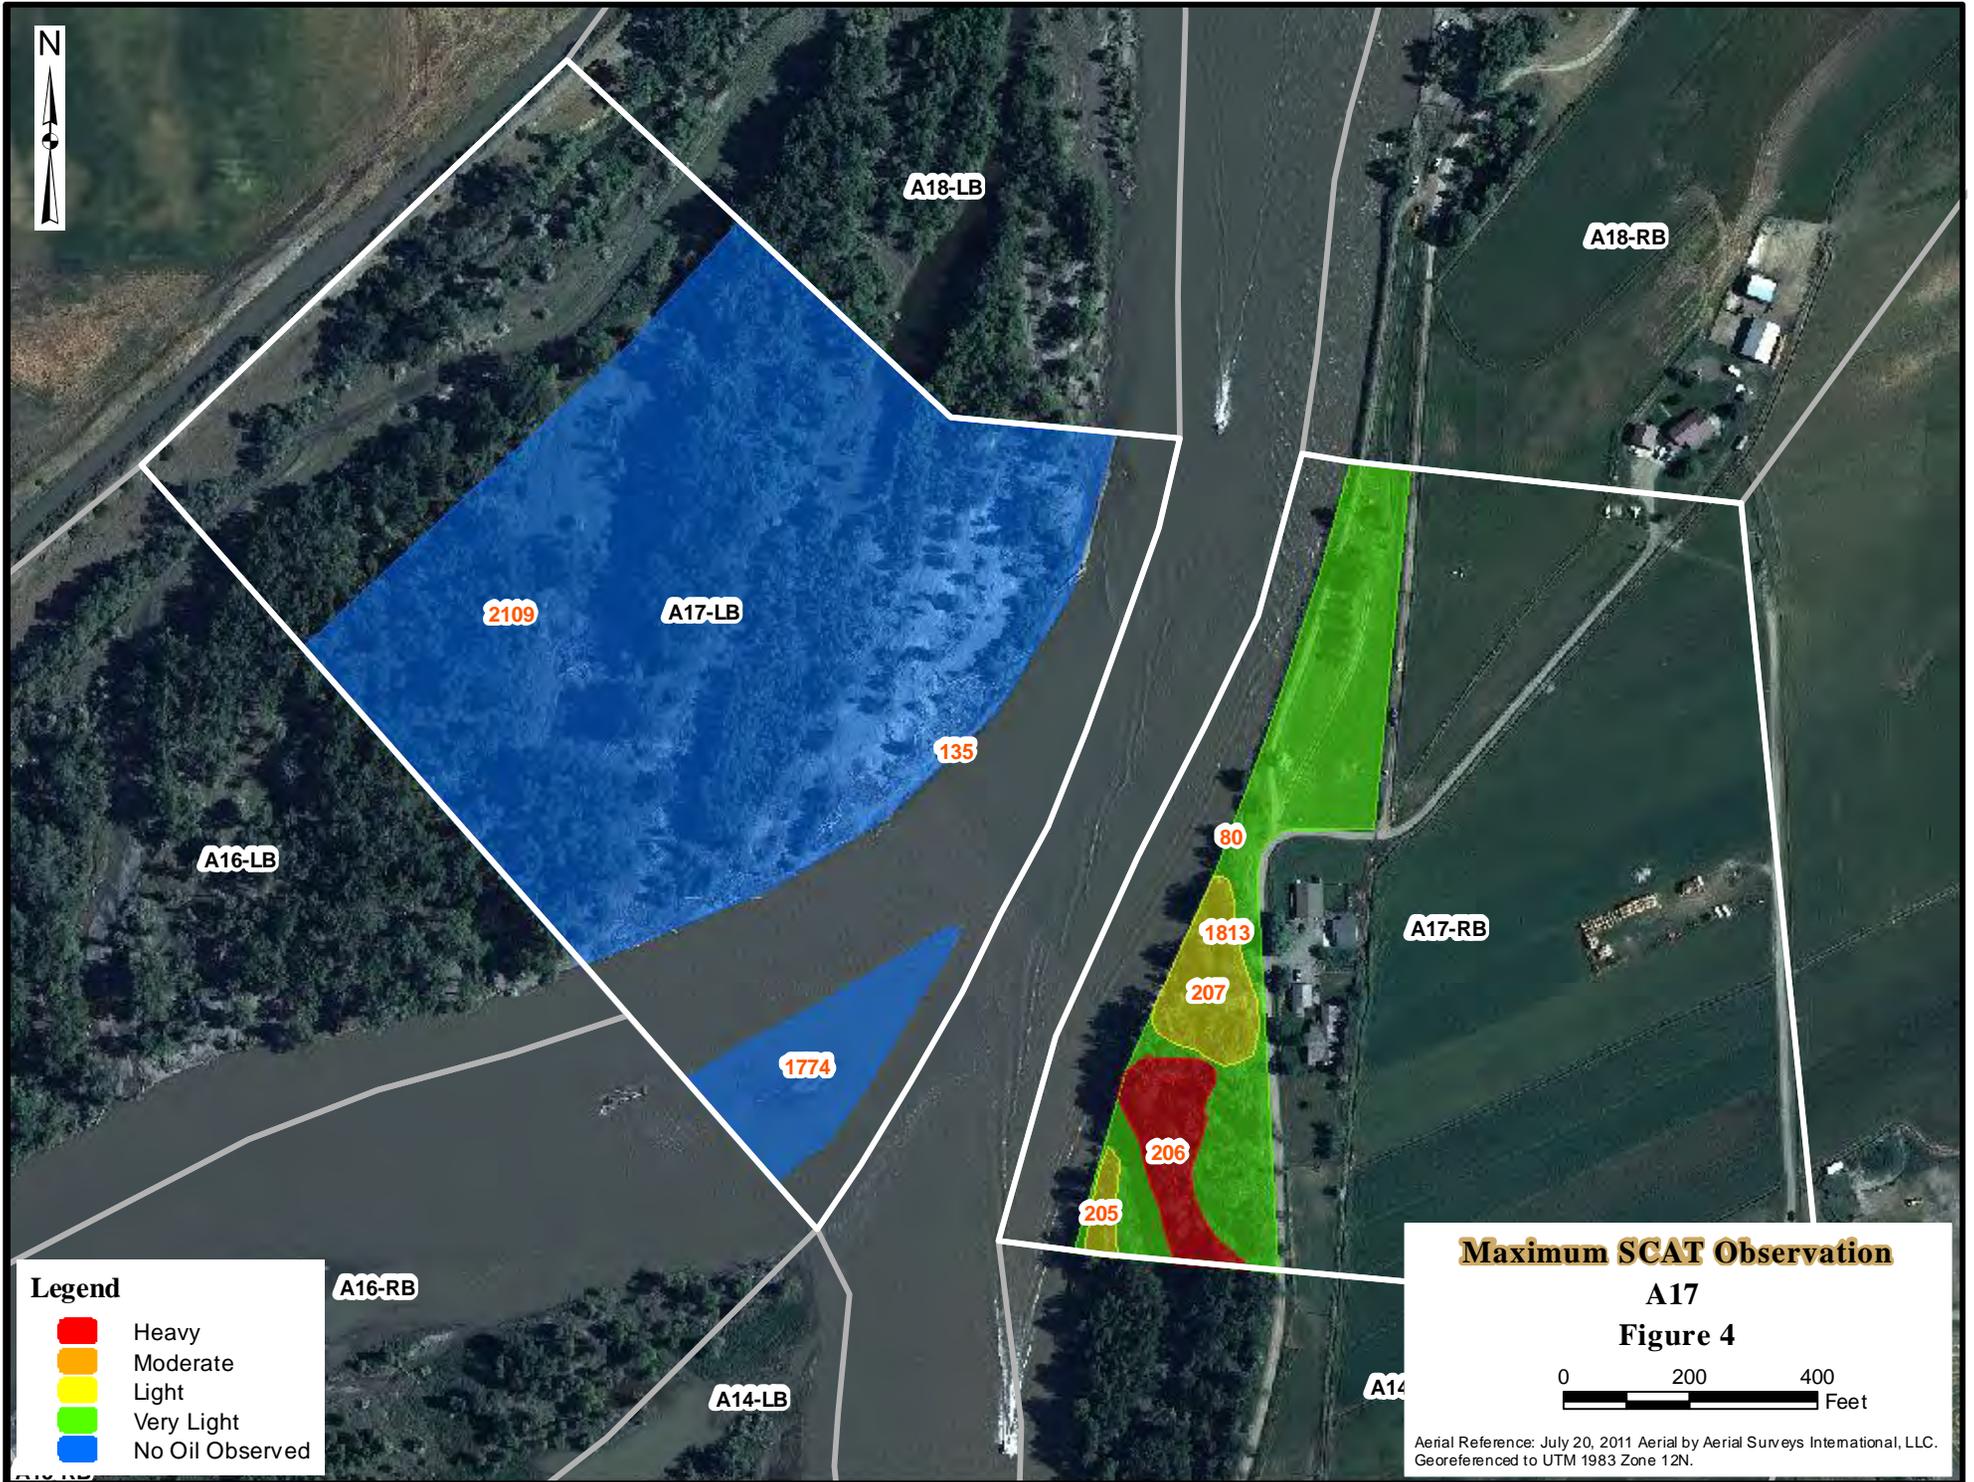
A17  
Figure 4

The SCAT teams used systematic evaluation criteria and treatment method tables approved by the National Oceanic and Atmospheric Administration to provide a standard approach for data collection and conducting field surveys. The forms and sketches from the initial SCAT surveys performed along the river bank (water edge) and floodplain within Area A17 are included in Appendix B. Figure 4 provides the maximum oiling zones observed by the SCAT team during the initial surveys of Area A17.

- Heavy
- Moderate
- Light
- Very Light
- No Oil Observed

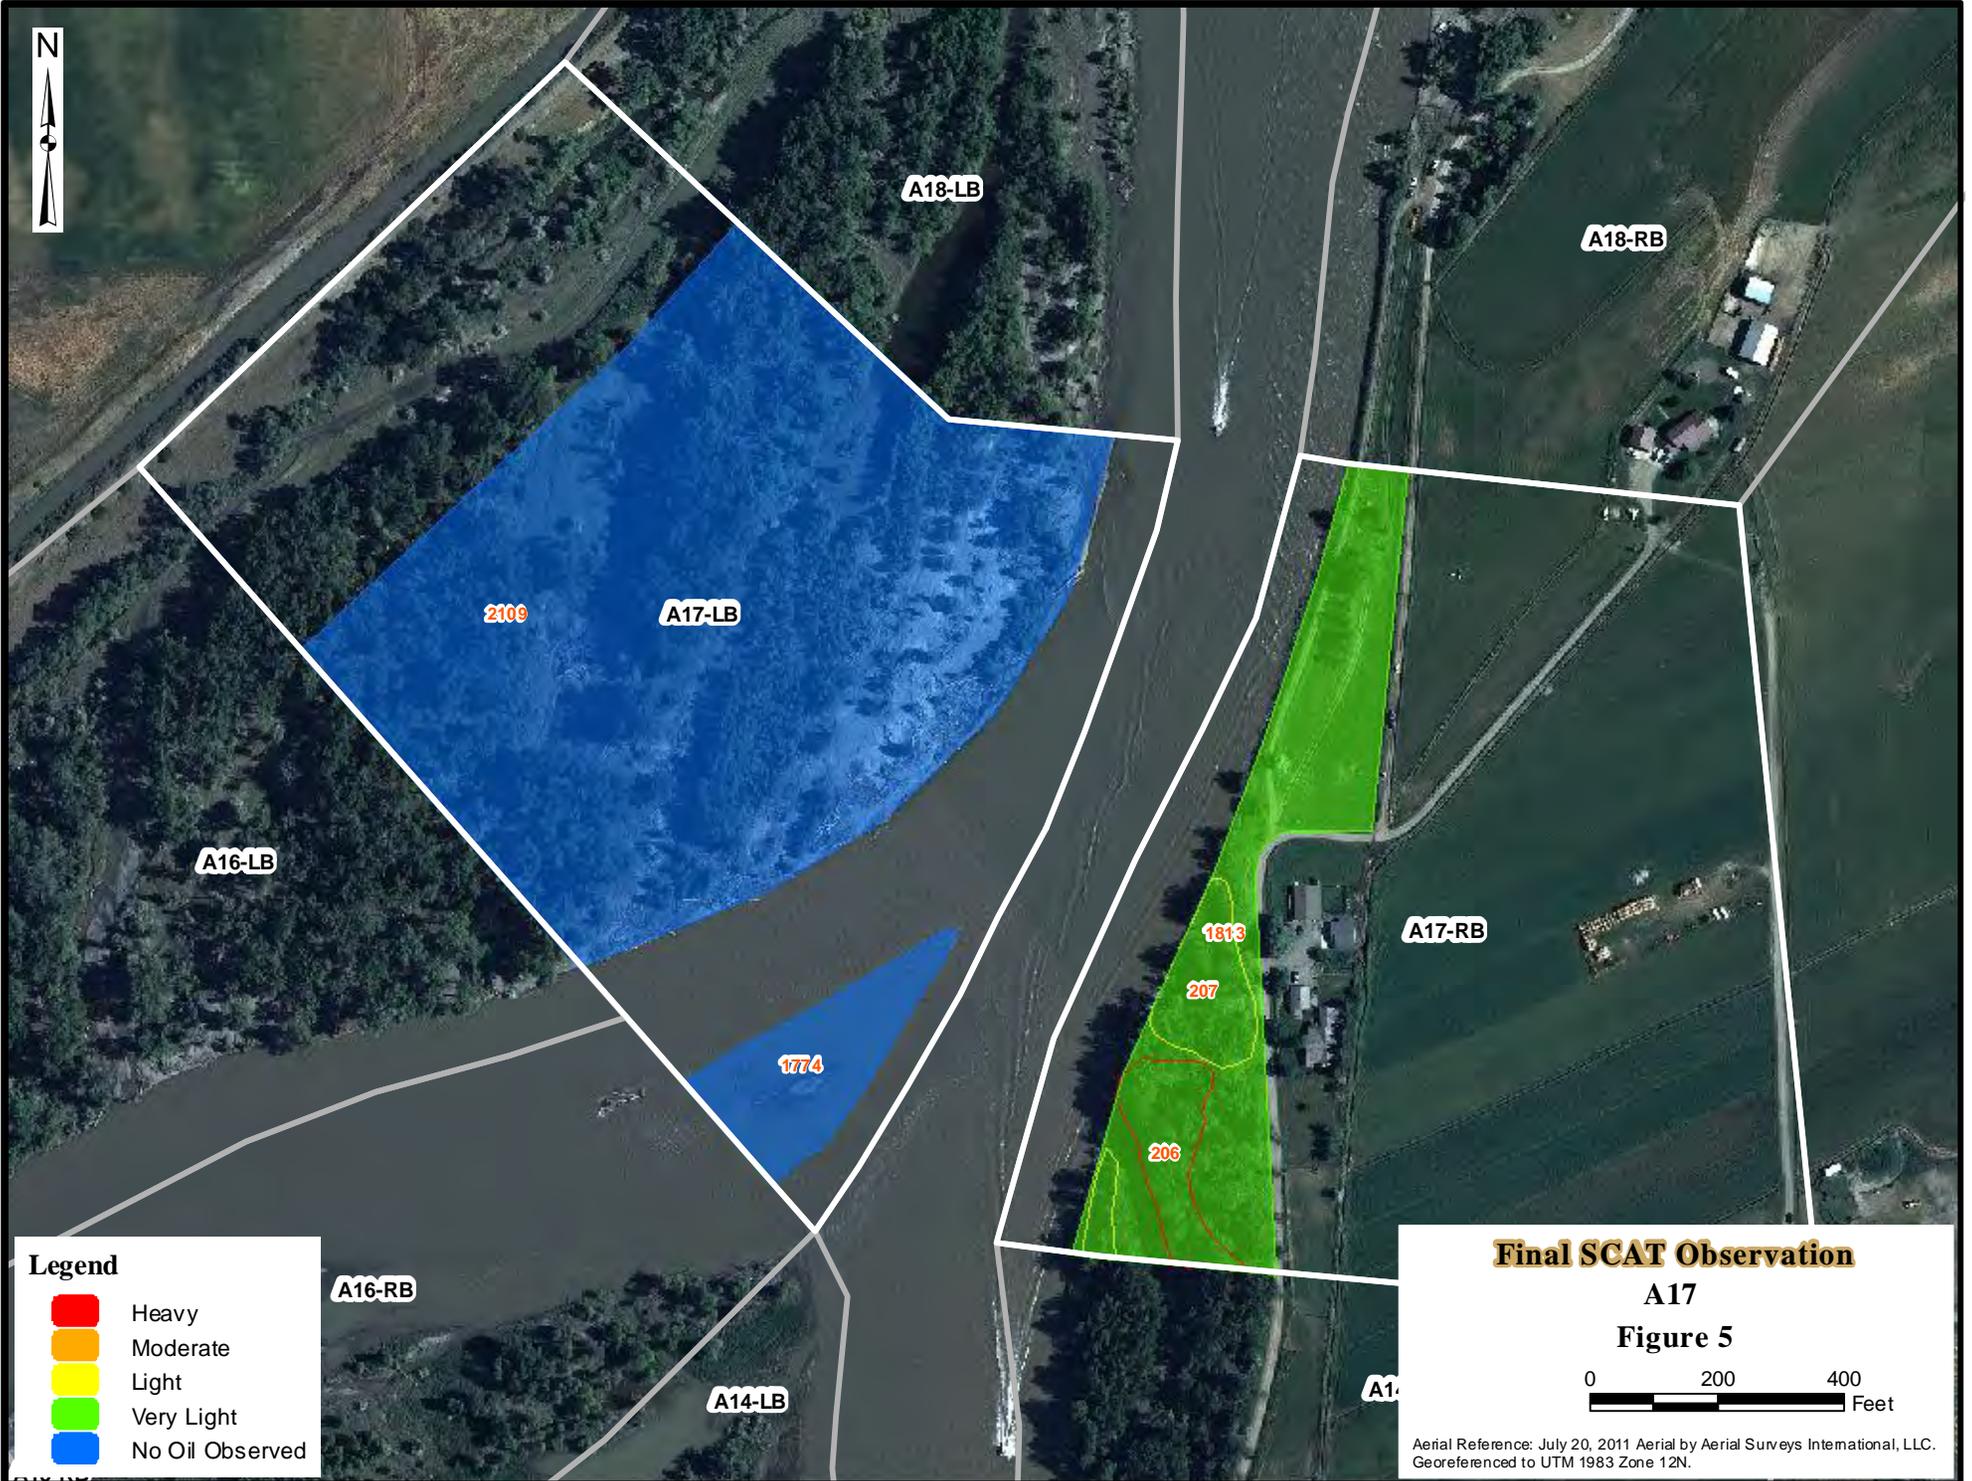
Figure 5 shows the oiling conditions within Area A17 following completion of oil removal activities. The SCAT team performed final surveys of the right bank within SCAT Area A17 to confirm the agreed-upon cleanup endpoints identified in the applicable CTRs had been achieved. The final SCAT survey documentation is presented in Appendix F.

Based on the final SCAT survey performed on the right bank within Area A17, no further treatment is recommended for this area. Based on the initial SCAT survey, no oiling was observed on the left bank or the island of Area A17. A SCAT Segment Sign-Off Sheet is included as Appendix G.

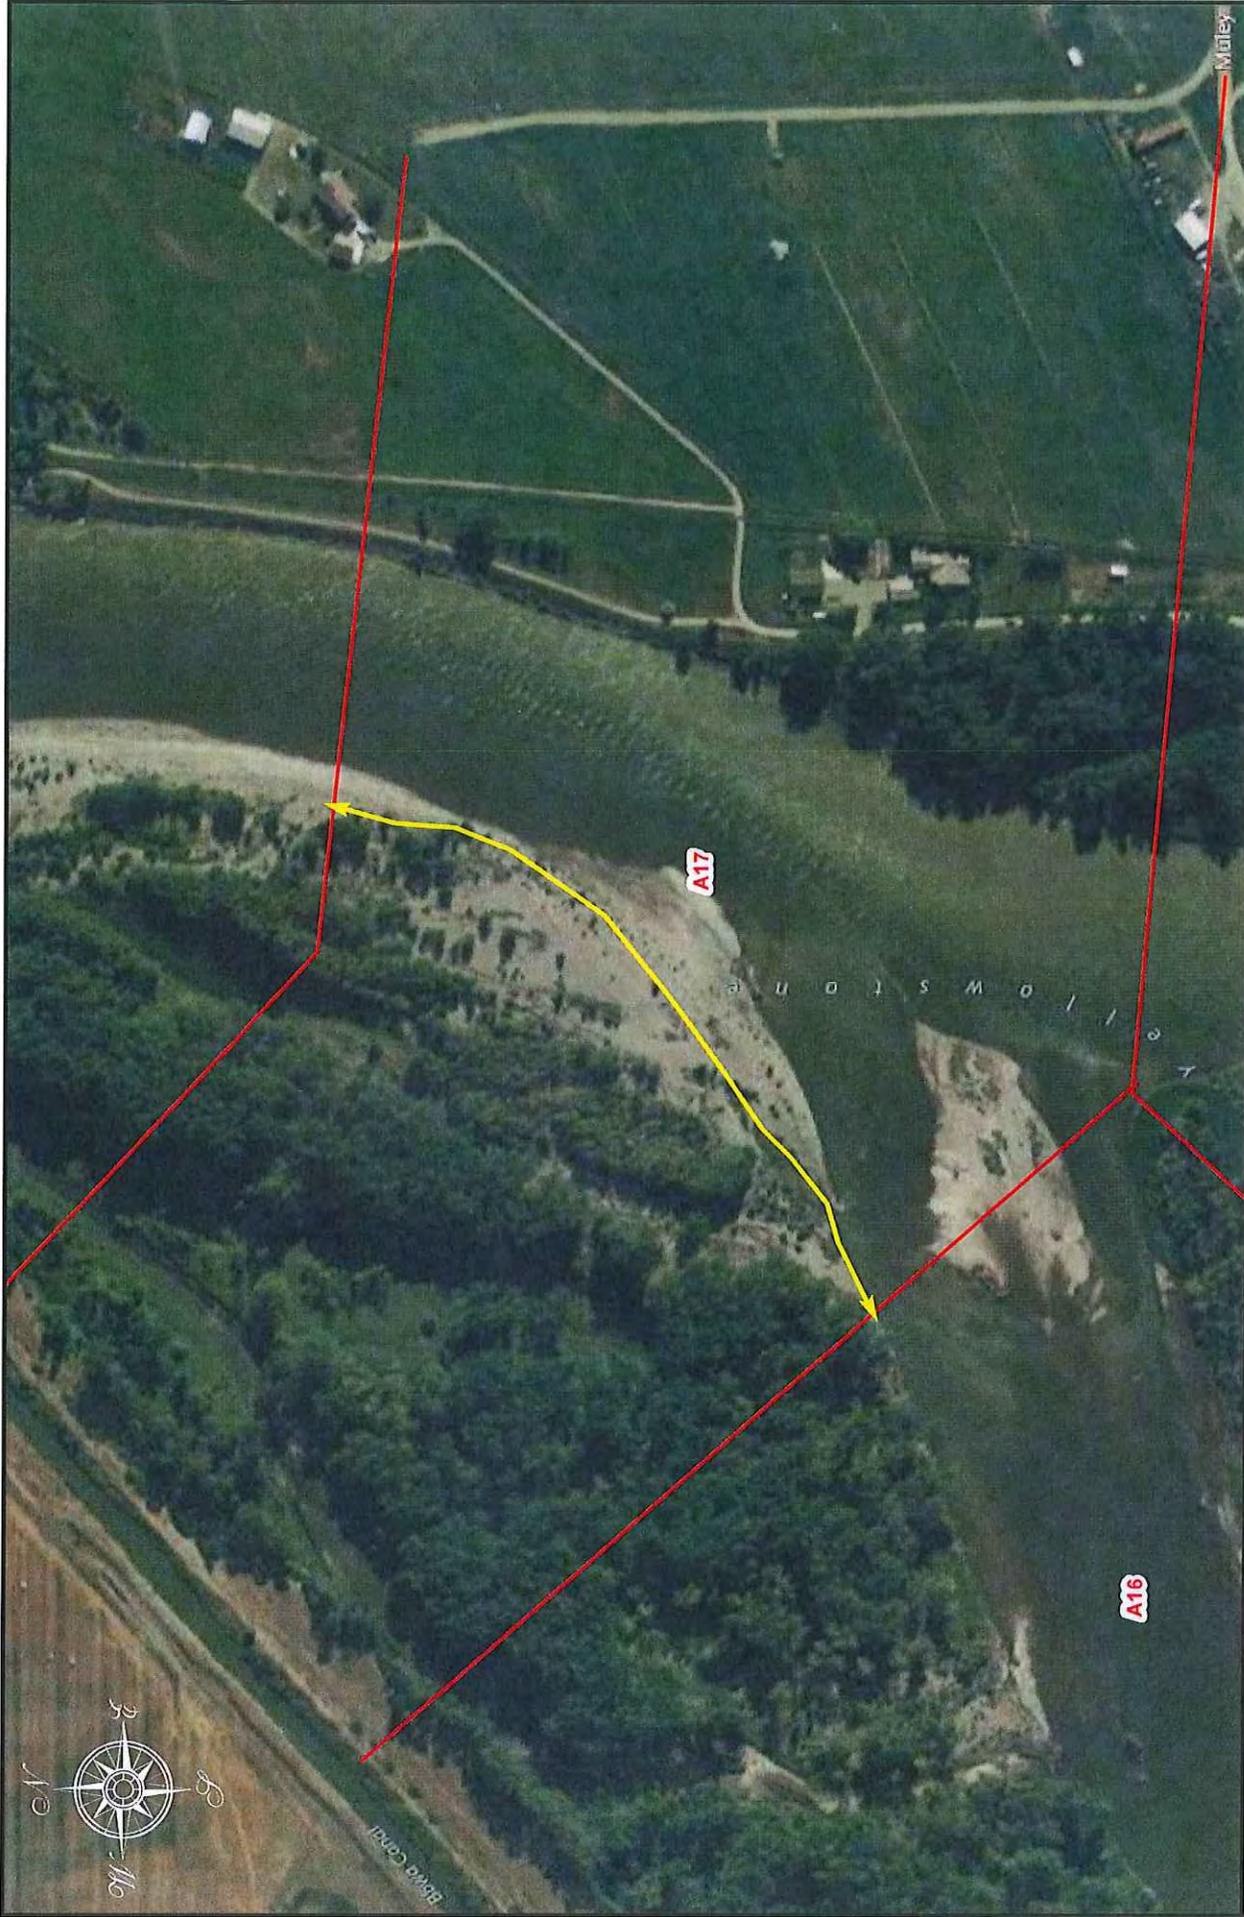
Segment A17 Left Bank

Cleanup Recommendations: No oil observed along river channel margin

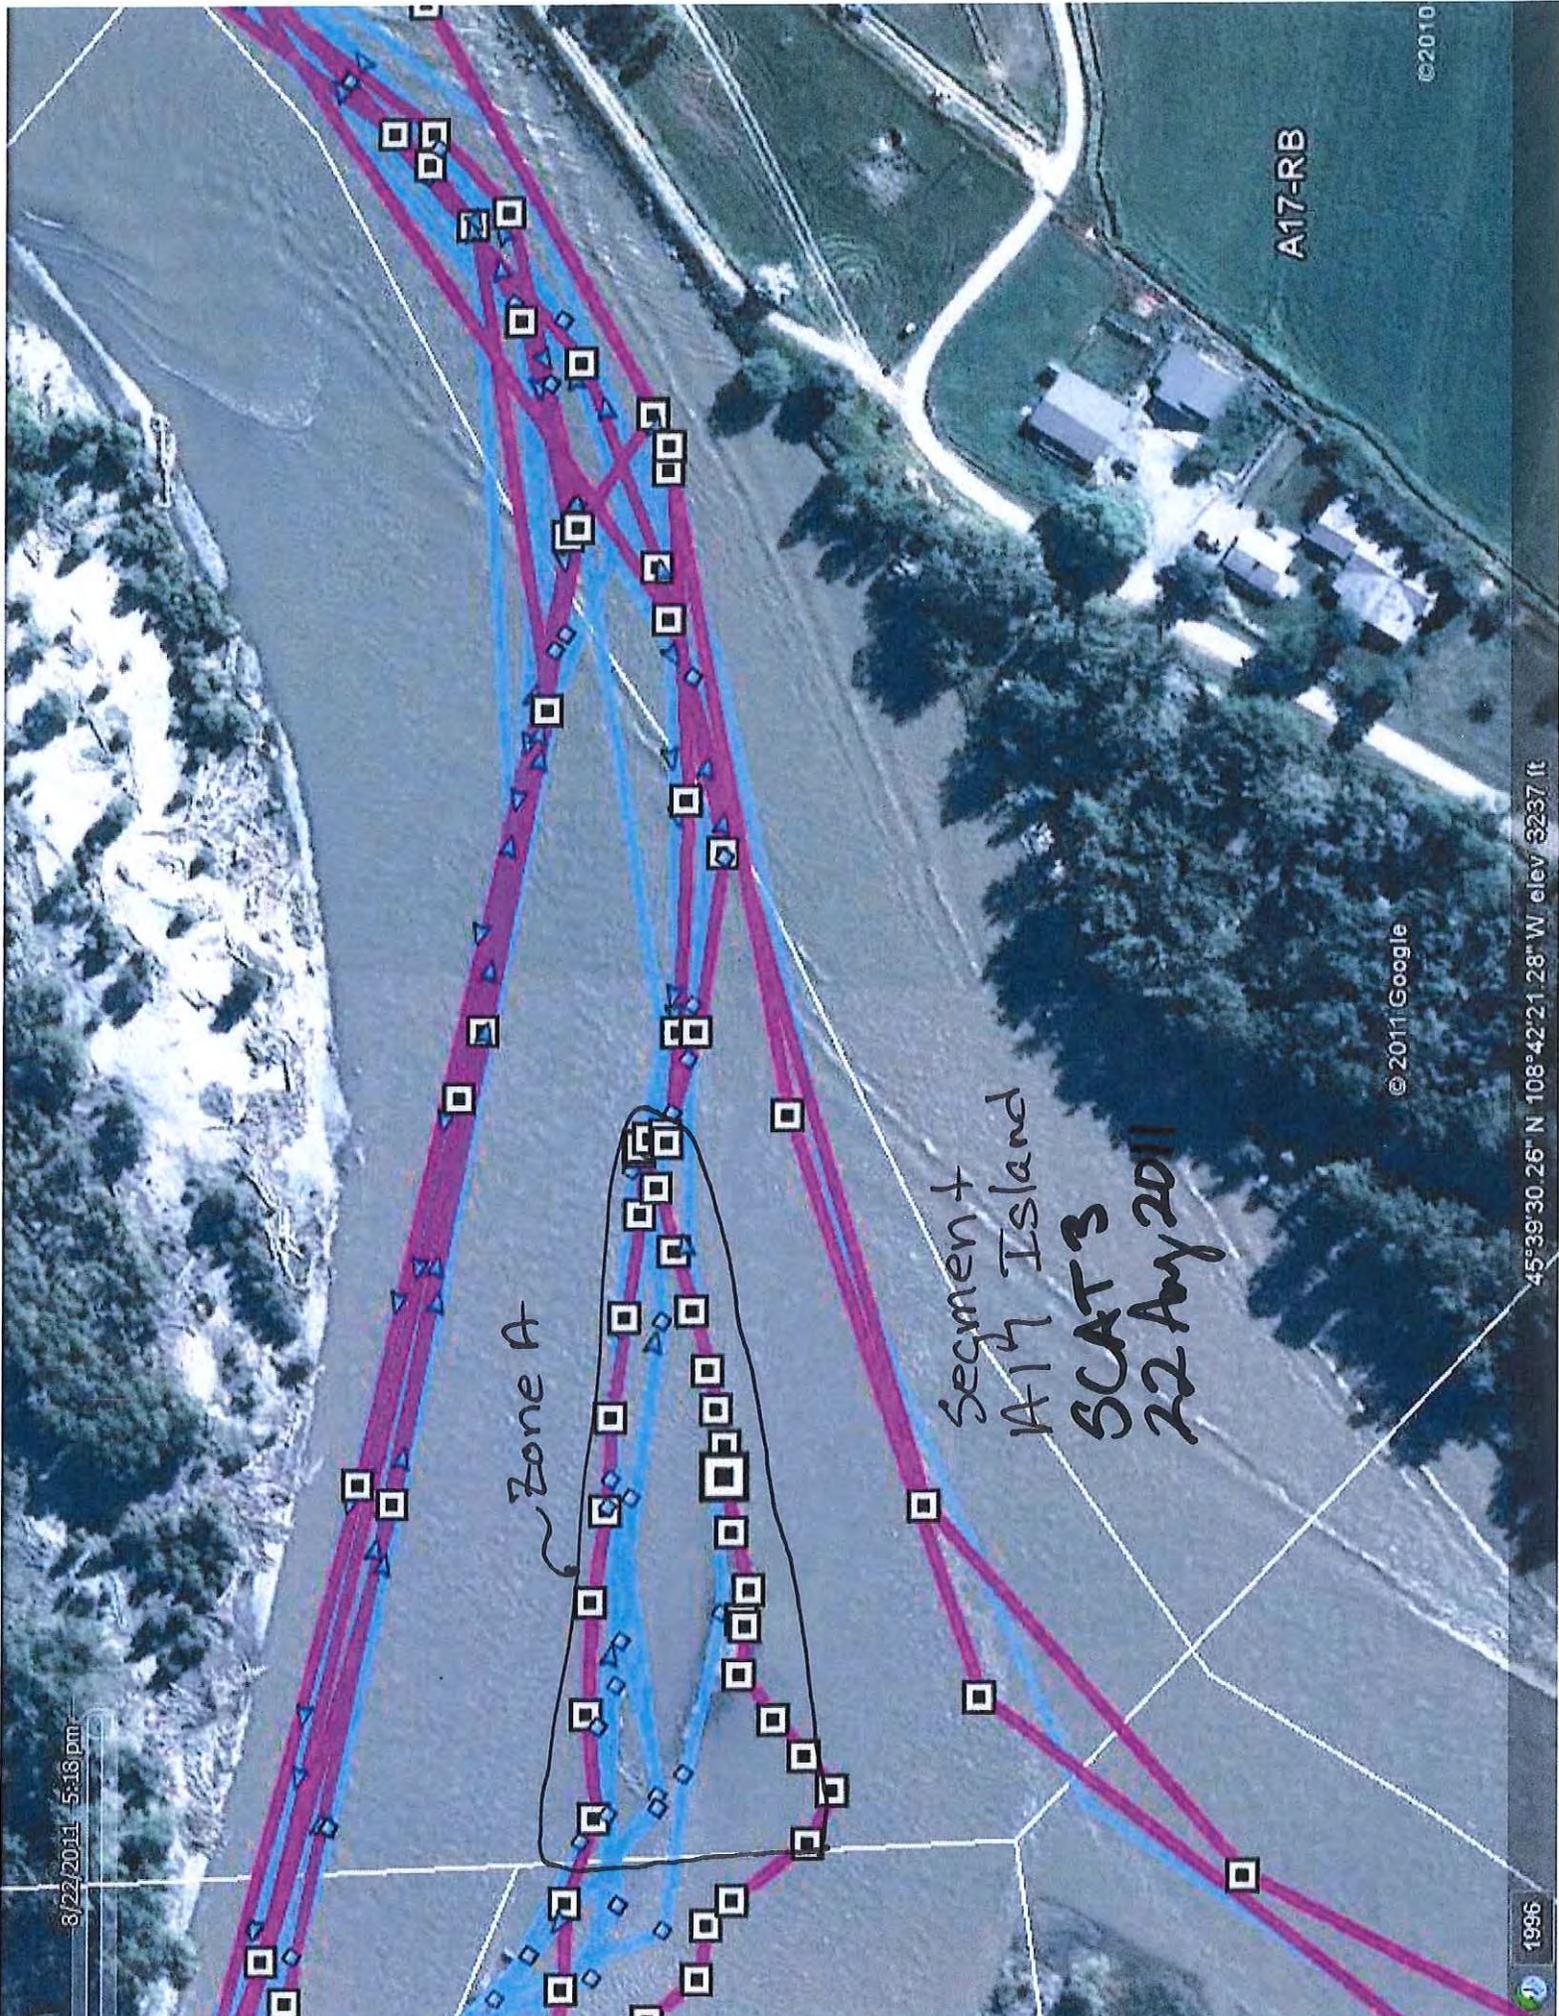
Segment +  
A17 Island  
SCAT 3  
22 Aug 2011

New Emerging Island - No Oiling Observed

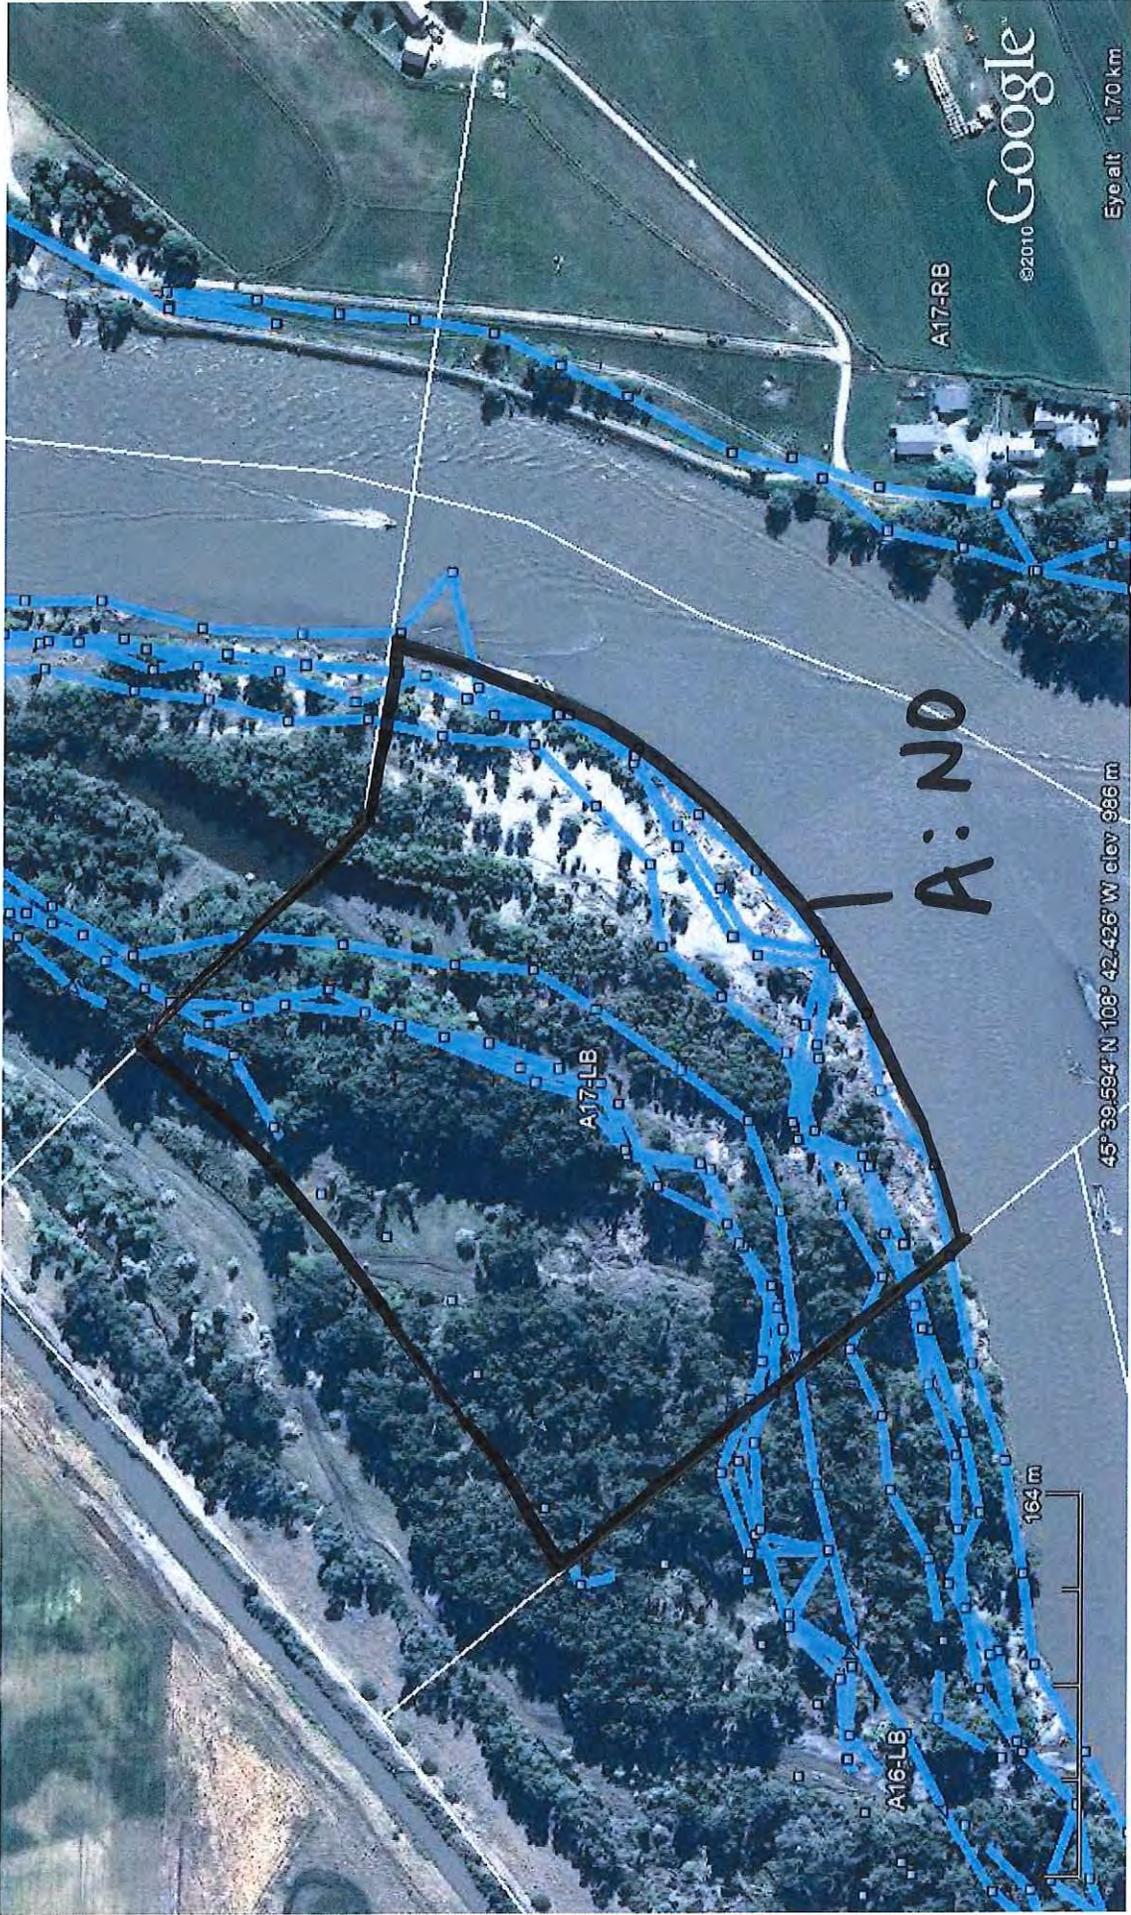
A17 LB  
T2 9/5/11

Zone A : No oil ; no treatment required

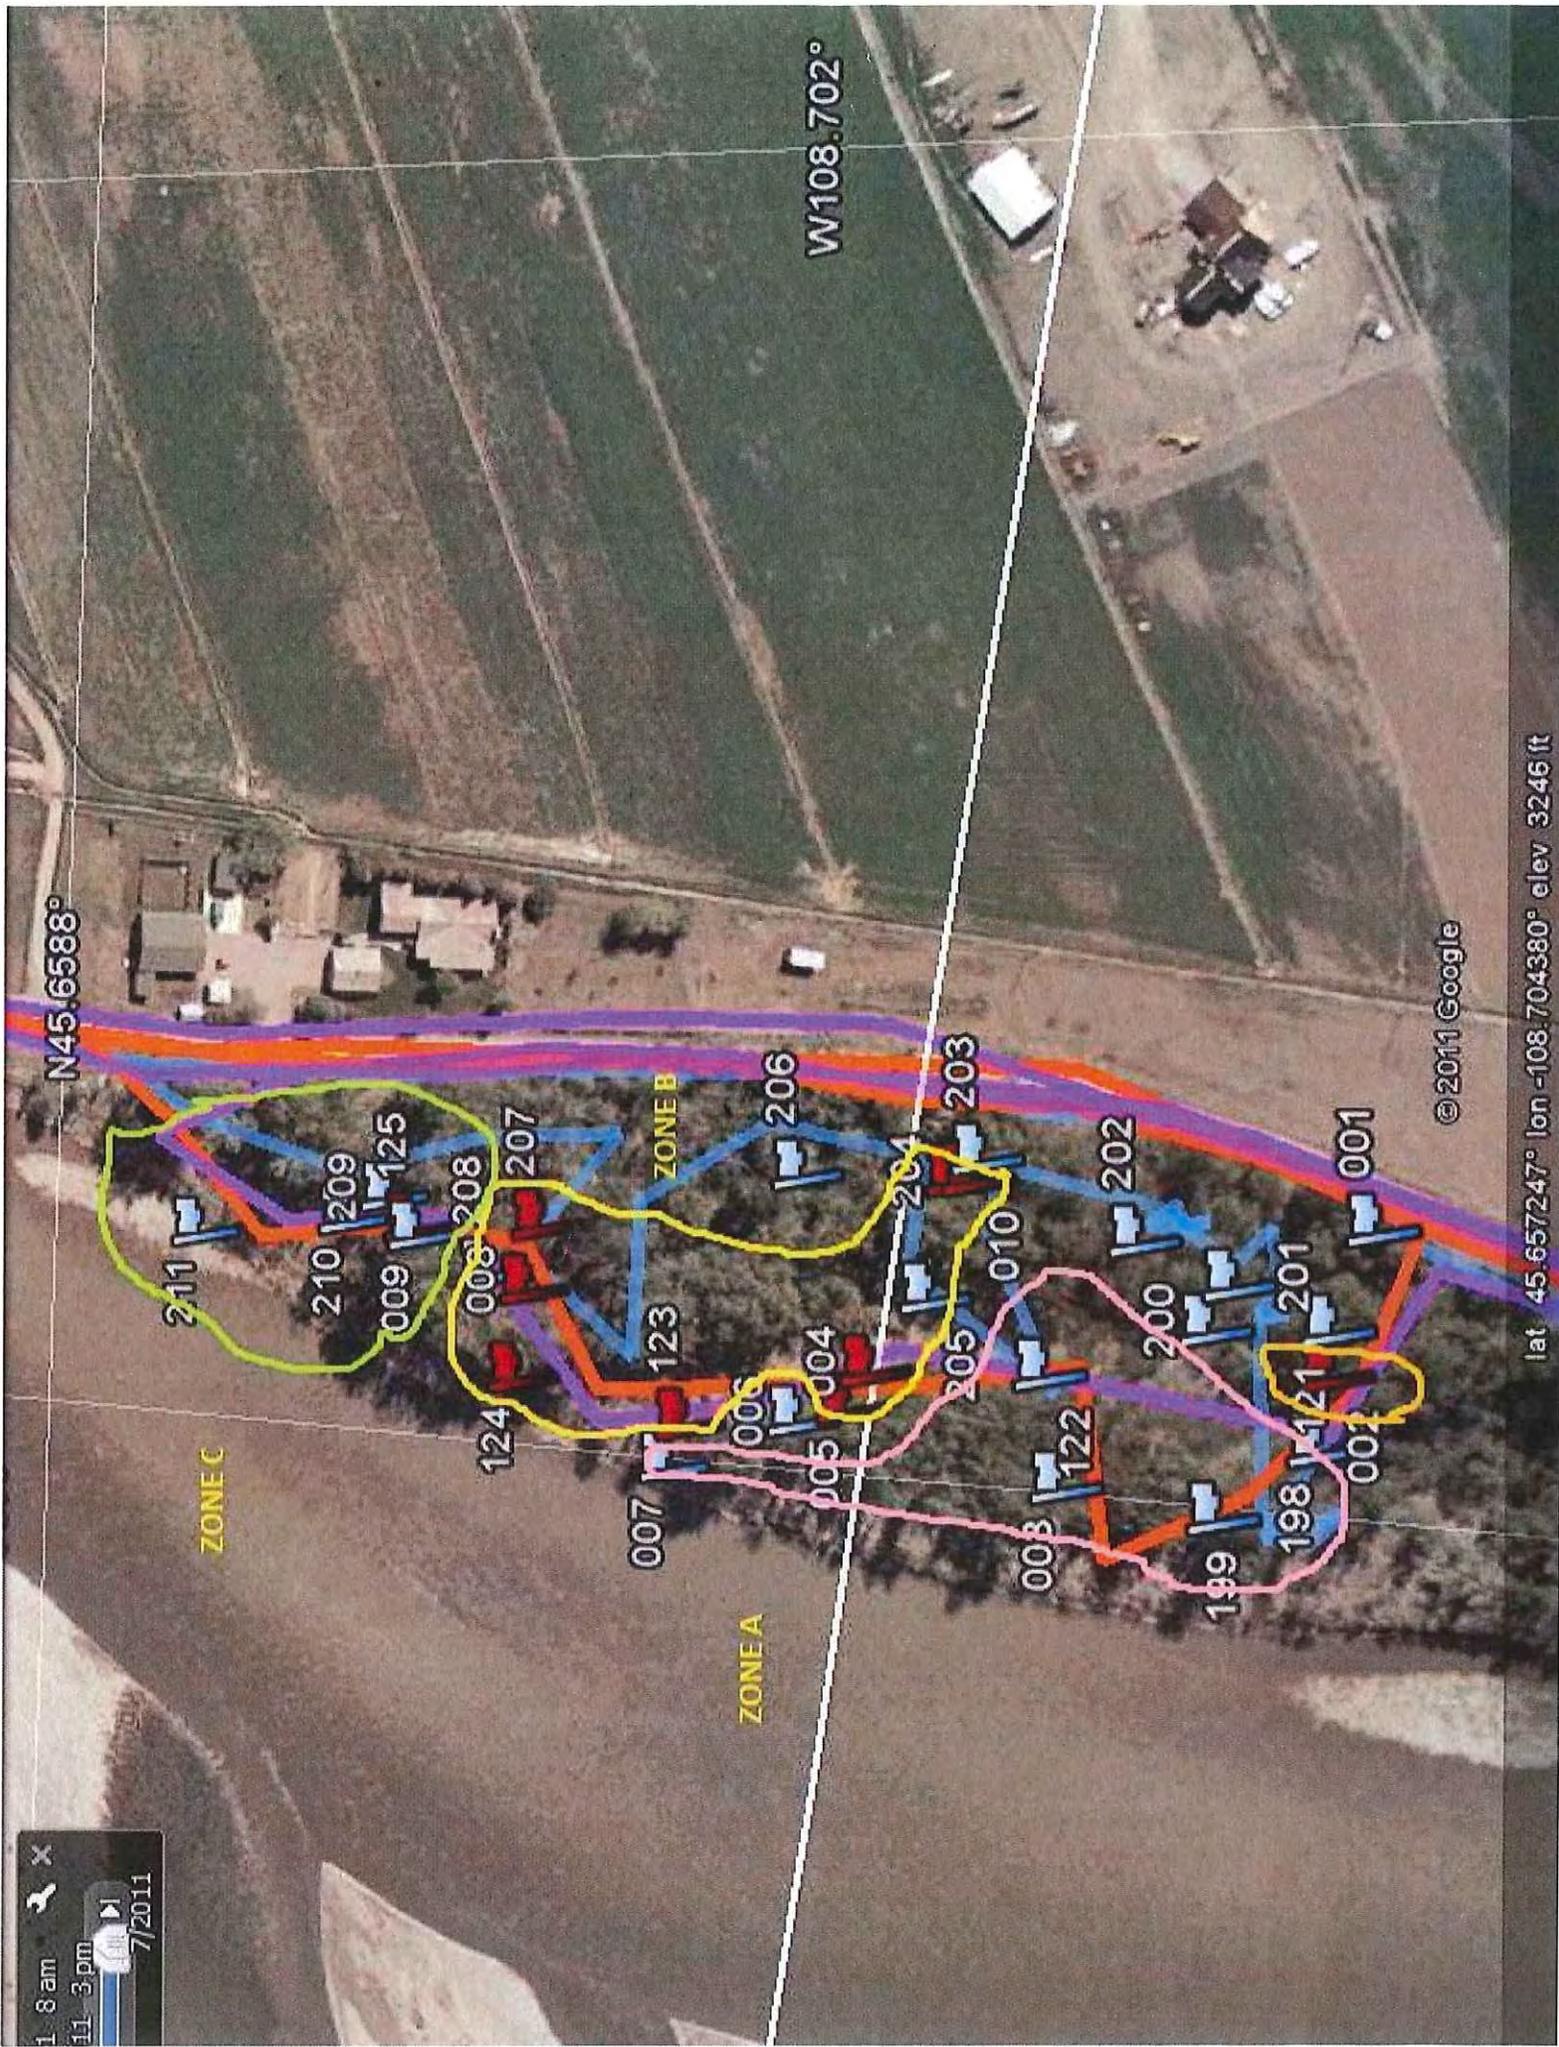
Cleanups are required in zones A, B, and C but the areas are muddy and contain standing water. The thick oil and oiled vegetation GPS Point 204 was flagged with Red Flagging for immediate attention with sorbent flags.
