**SCAT Area Transition Report for  
A17**

Silvertip Pipeline Incident  
Laurel, Montana

Prepared for:  
ExxonMobil Pipeline Company

Prepared by:  
ARCADIS G&M of North Carolina, Inc.  
11000 Regency Parkway  
West Tower, Suite 205  
Cary, North Carolina 27518-8518  
Tel 919.469.1952  
Fax 919.469.5676

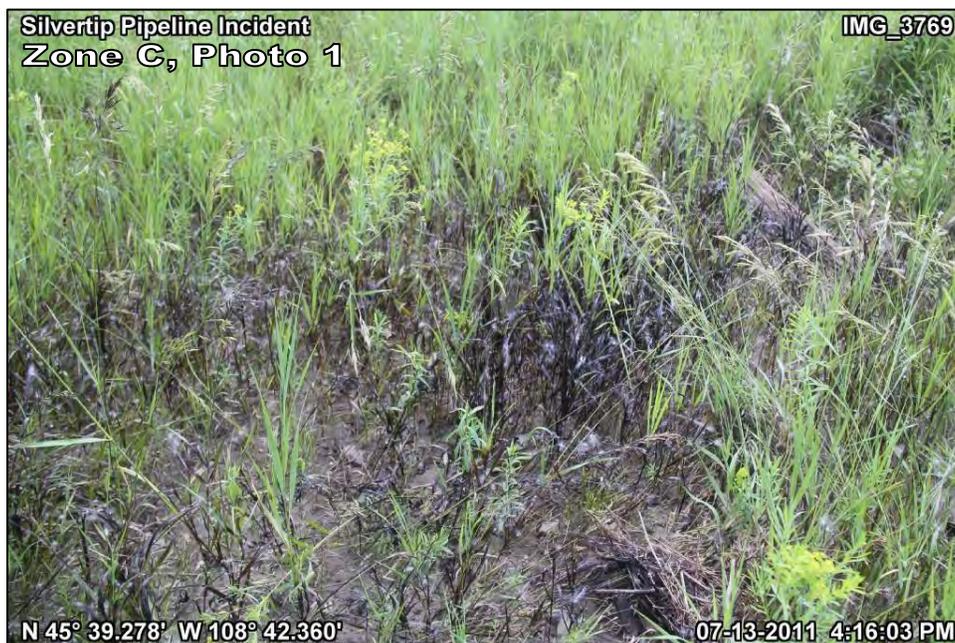
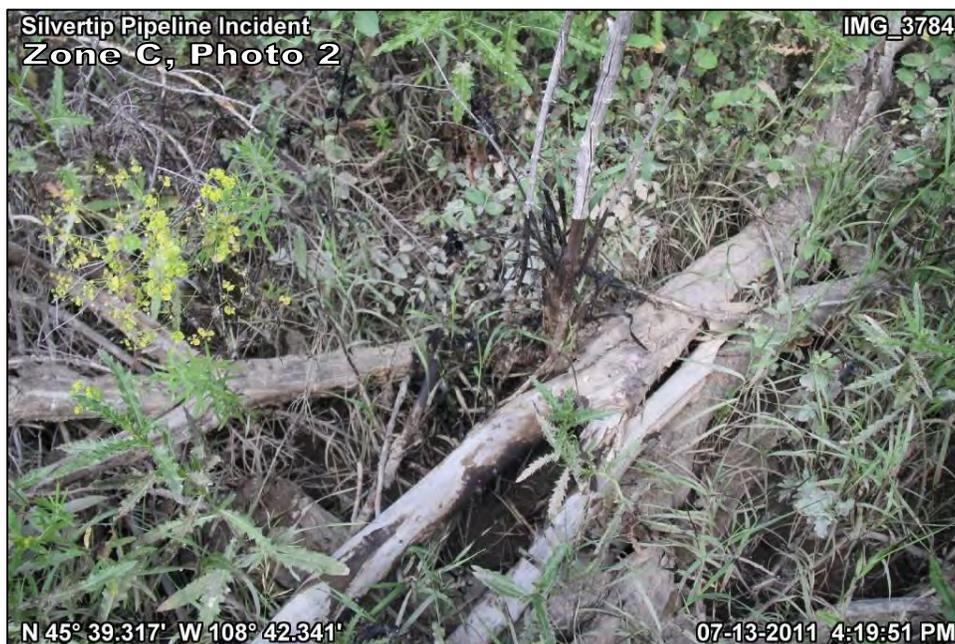
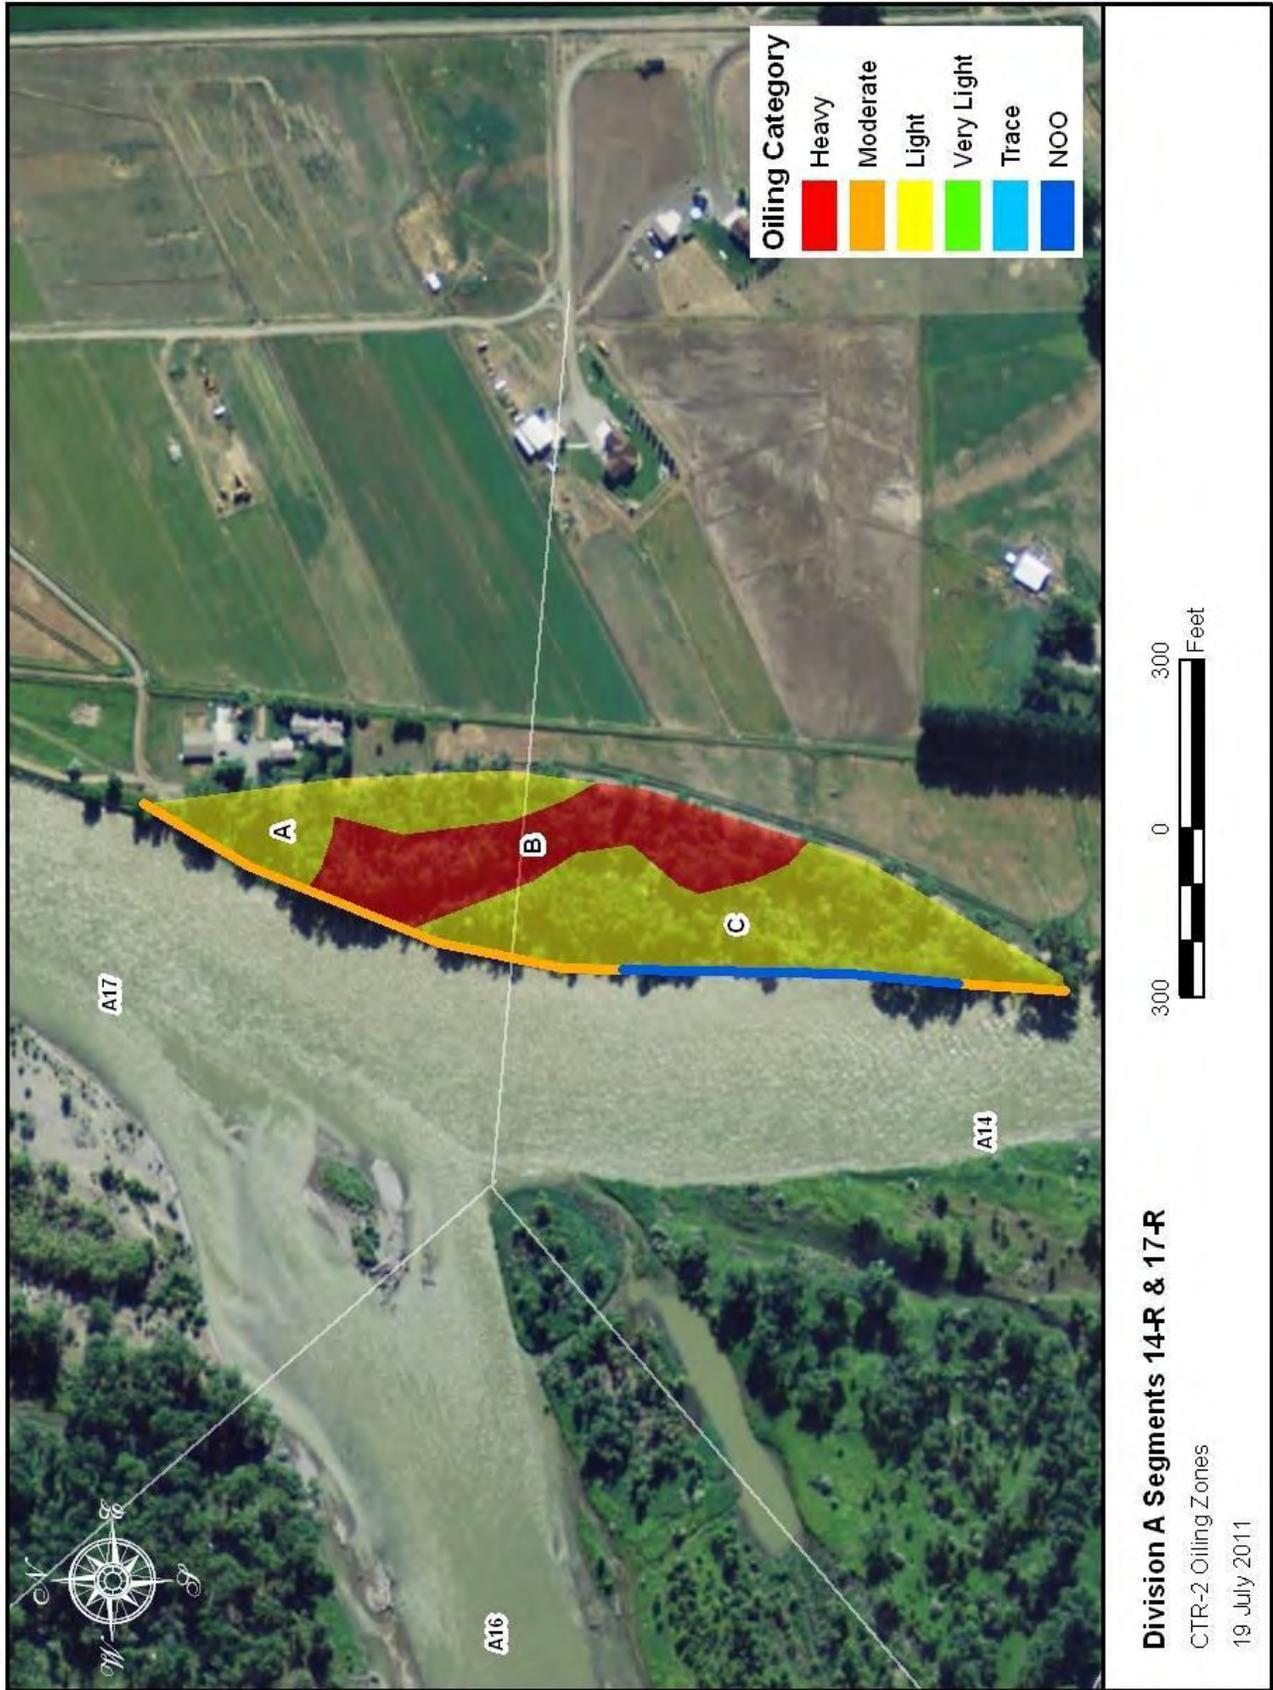
**Zones A & C:**

**Primary Oiling Conditions:** ~30% distribution of oiled debris (coat) and oil coat/stain on vegetation.

**Cleanup Recommendations:** Cut and remove oil coated vegetation smaller than 1" diameter. Do not cut grasses shorter than 2" from the ground. Wipe oil-coated vegetation larger than 1" diameter. Only remove oil coated debris smaller than 4" diameter. Wipe oil-coated debris larger than 4" diameter.

Do not cut grasses shorter than 2" from the ground.

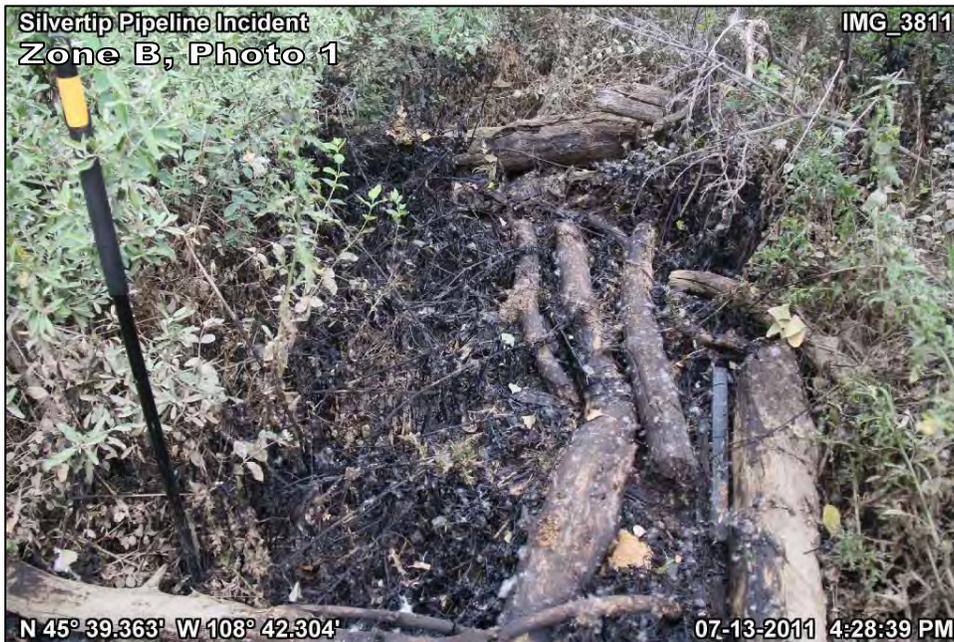
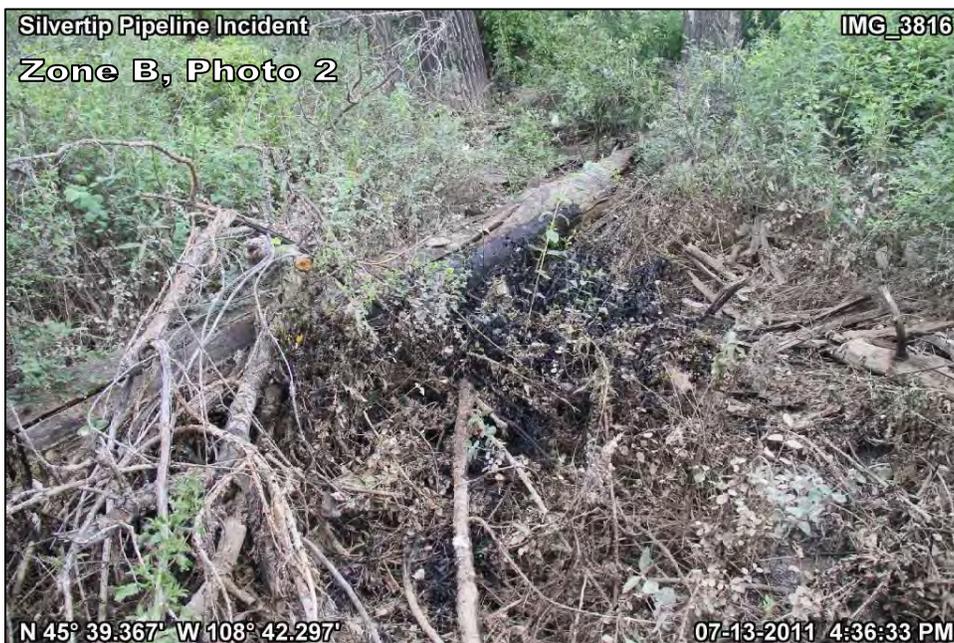
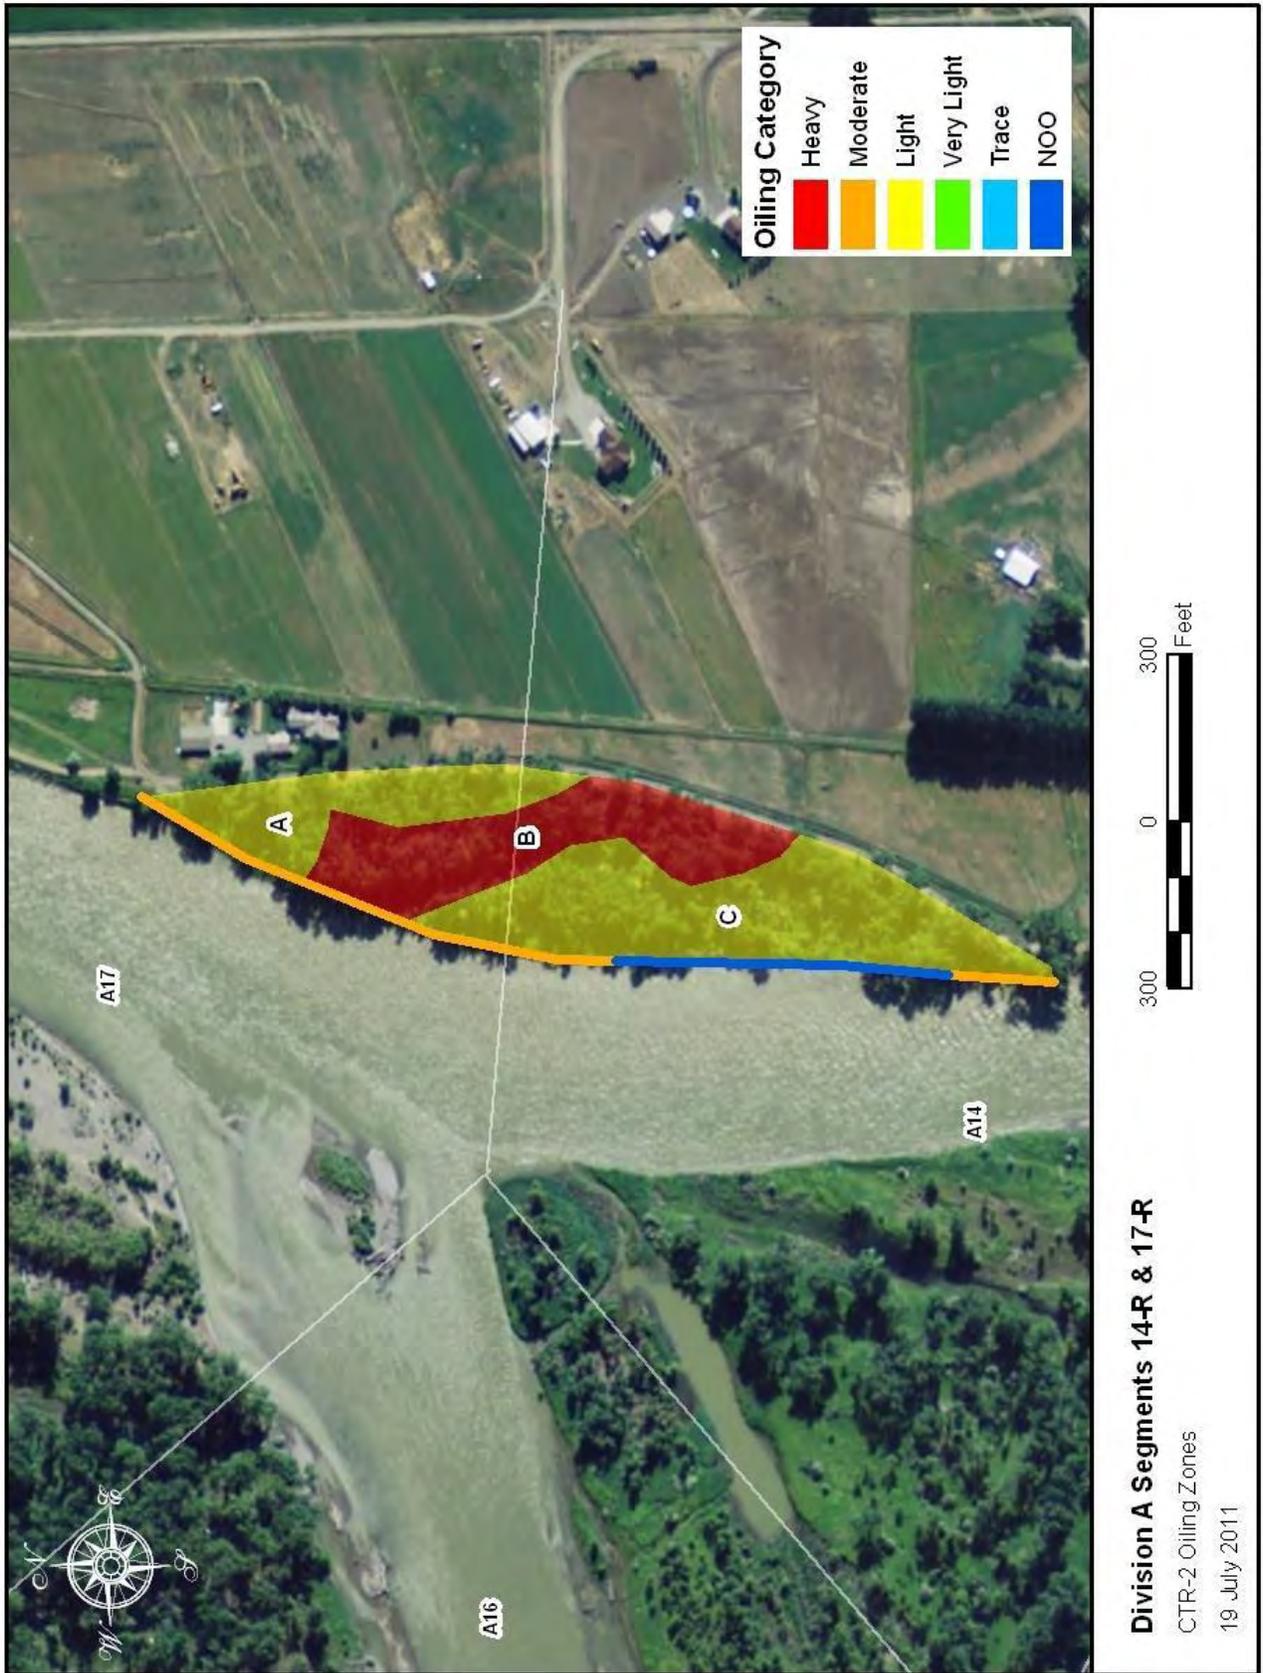
**Zone B:**

**Primary Oiling Conditions:** ~30% distribution of oiled debris (coat/cover), pooled oil on water in ditches, oil coat/stain on vegetation. Note: Quantity of oil-coated debris exceeds 10 roll-offs.

**Cleanup Recommendations:** Remove pooled oil with sorbents. Cut and remove oil-coated vegetation smaller than 1" diameter. Do not cut grass shorter than 2" from the ground. Remove oil-coated debris smaller than 4" diameter. Wipe larger oil-coated vegetation and debris. **Pending further authorization, the size and quantity of oil-coated debris in this zone may warrant alternative cleanup methods such as burning or removal.**

Do not cut grasses shorter than 2" from the ground.

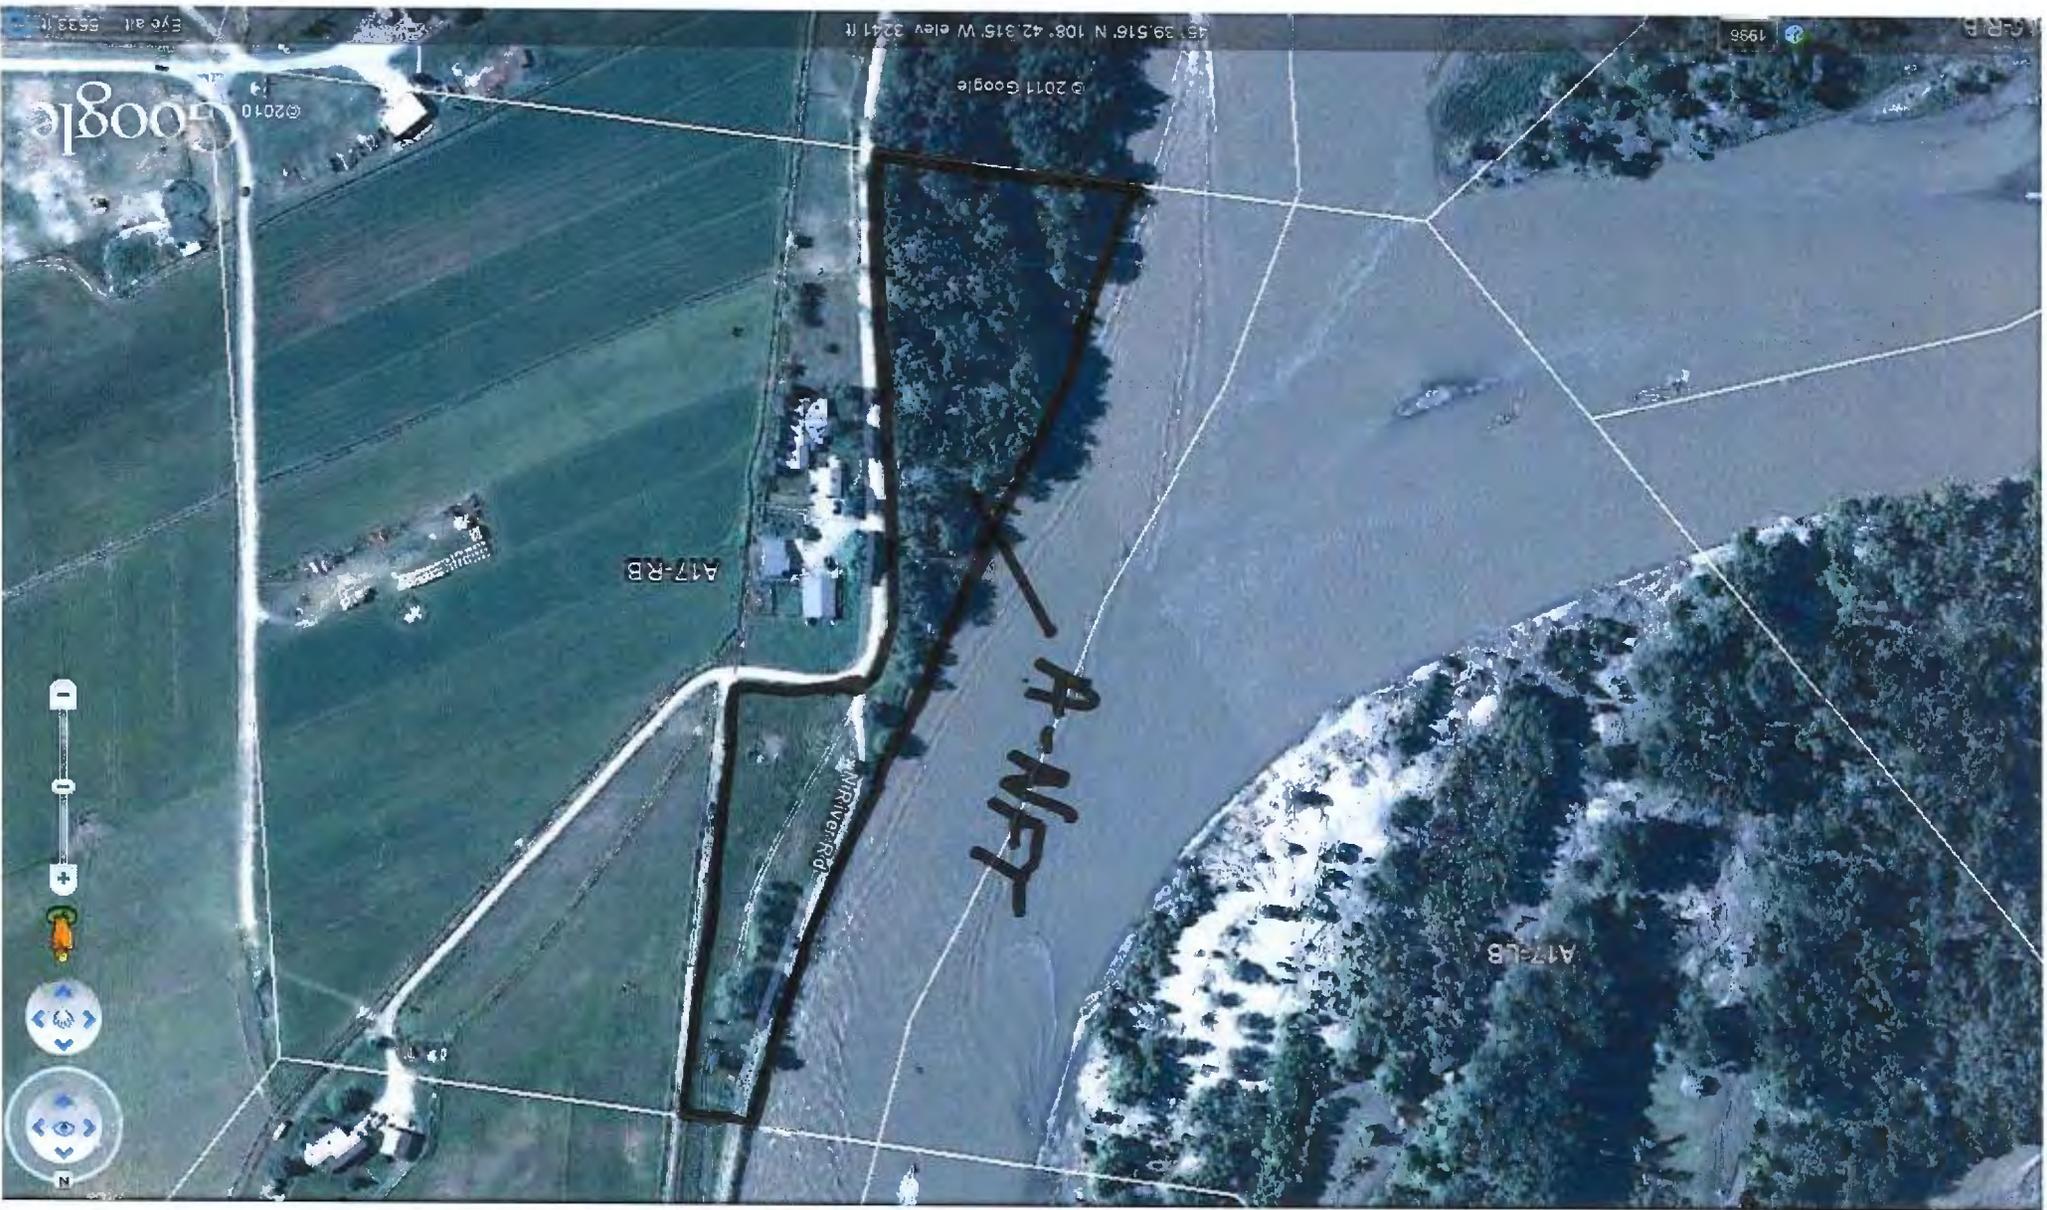
A17-RB  
SCAT 4  
24 Aug 2011

Previous Cleanup operations (CTR2)
