**SCAT Area Transition Report
for A23**

Silvertip Pipeline Incident
Laurel, Montana

October 18, 2011

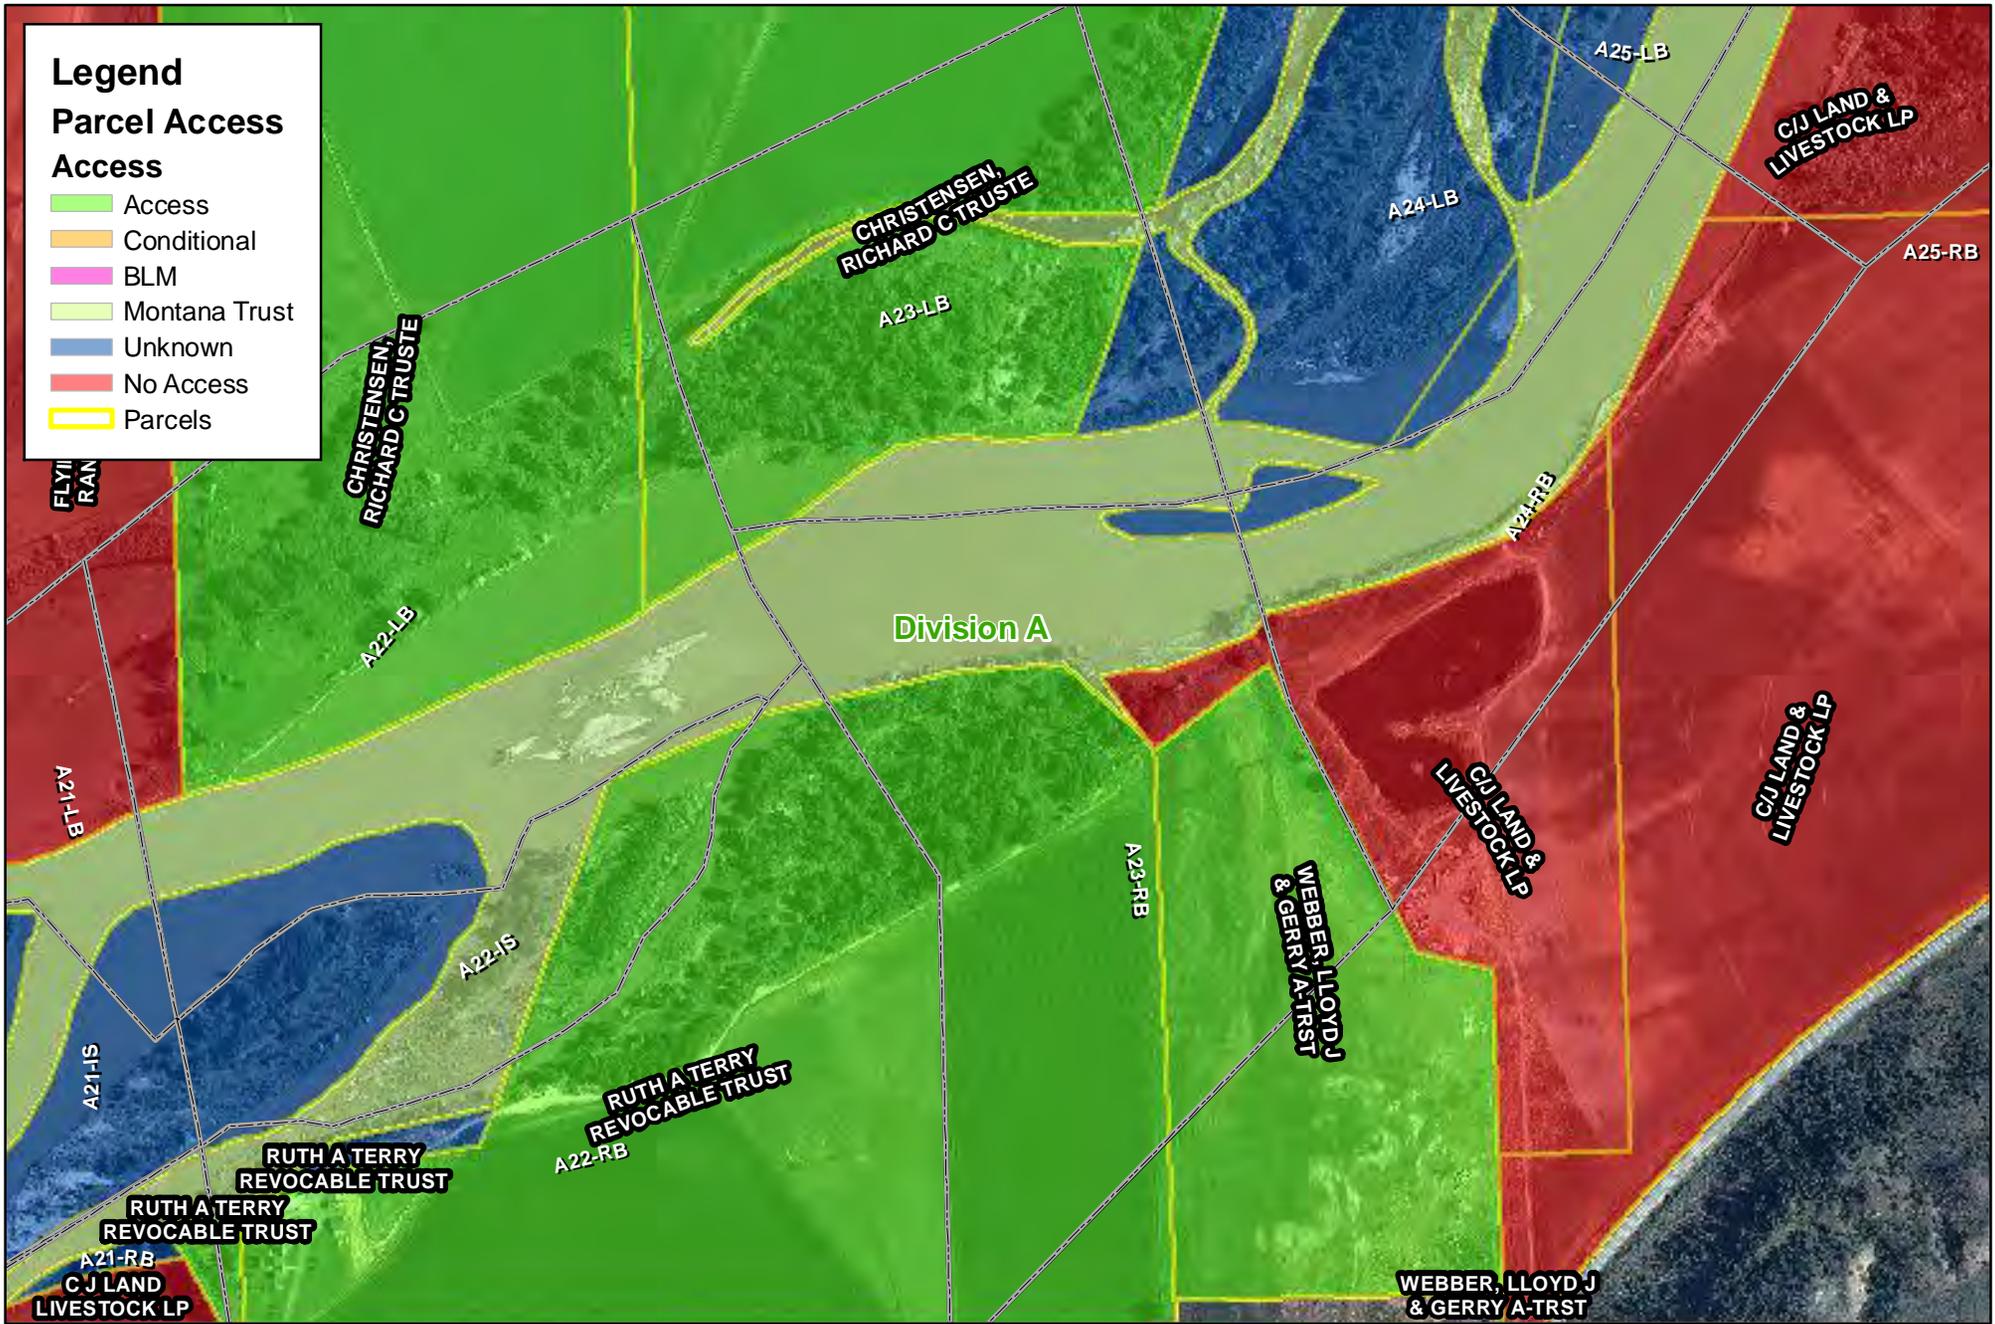
Figure 1 provides an aerial map of SCAT Area A23, along with the (a) SCAT Area boundary, (b) parcel boundaries and respective property owners, and (c) access constraints identified during the oil cleanup process. The acreage surveyed in Area A23 is 30.5. There were access issues for part of the right bank.

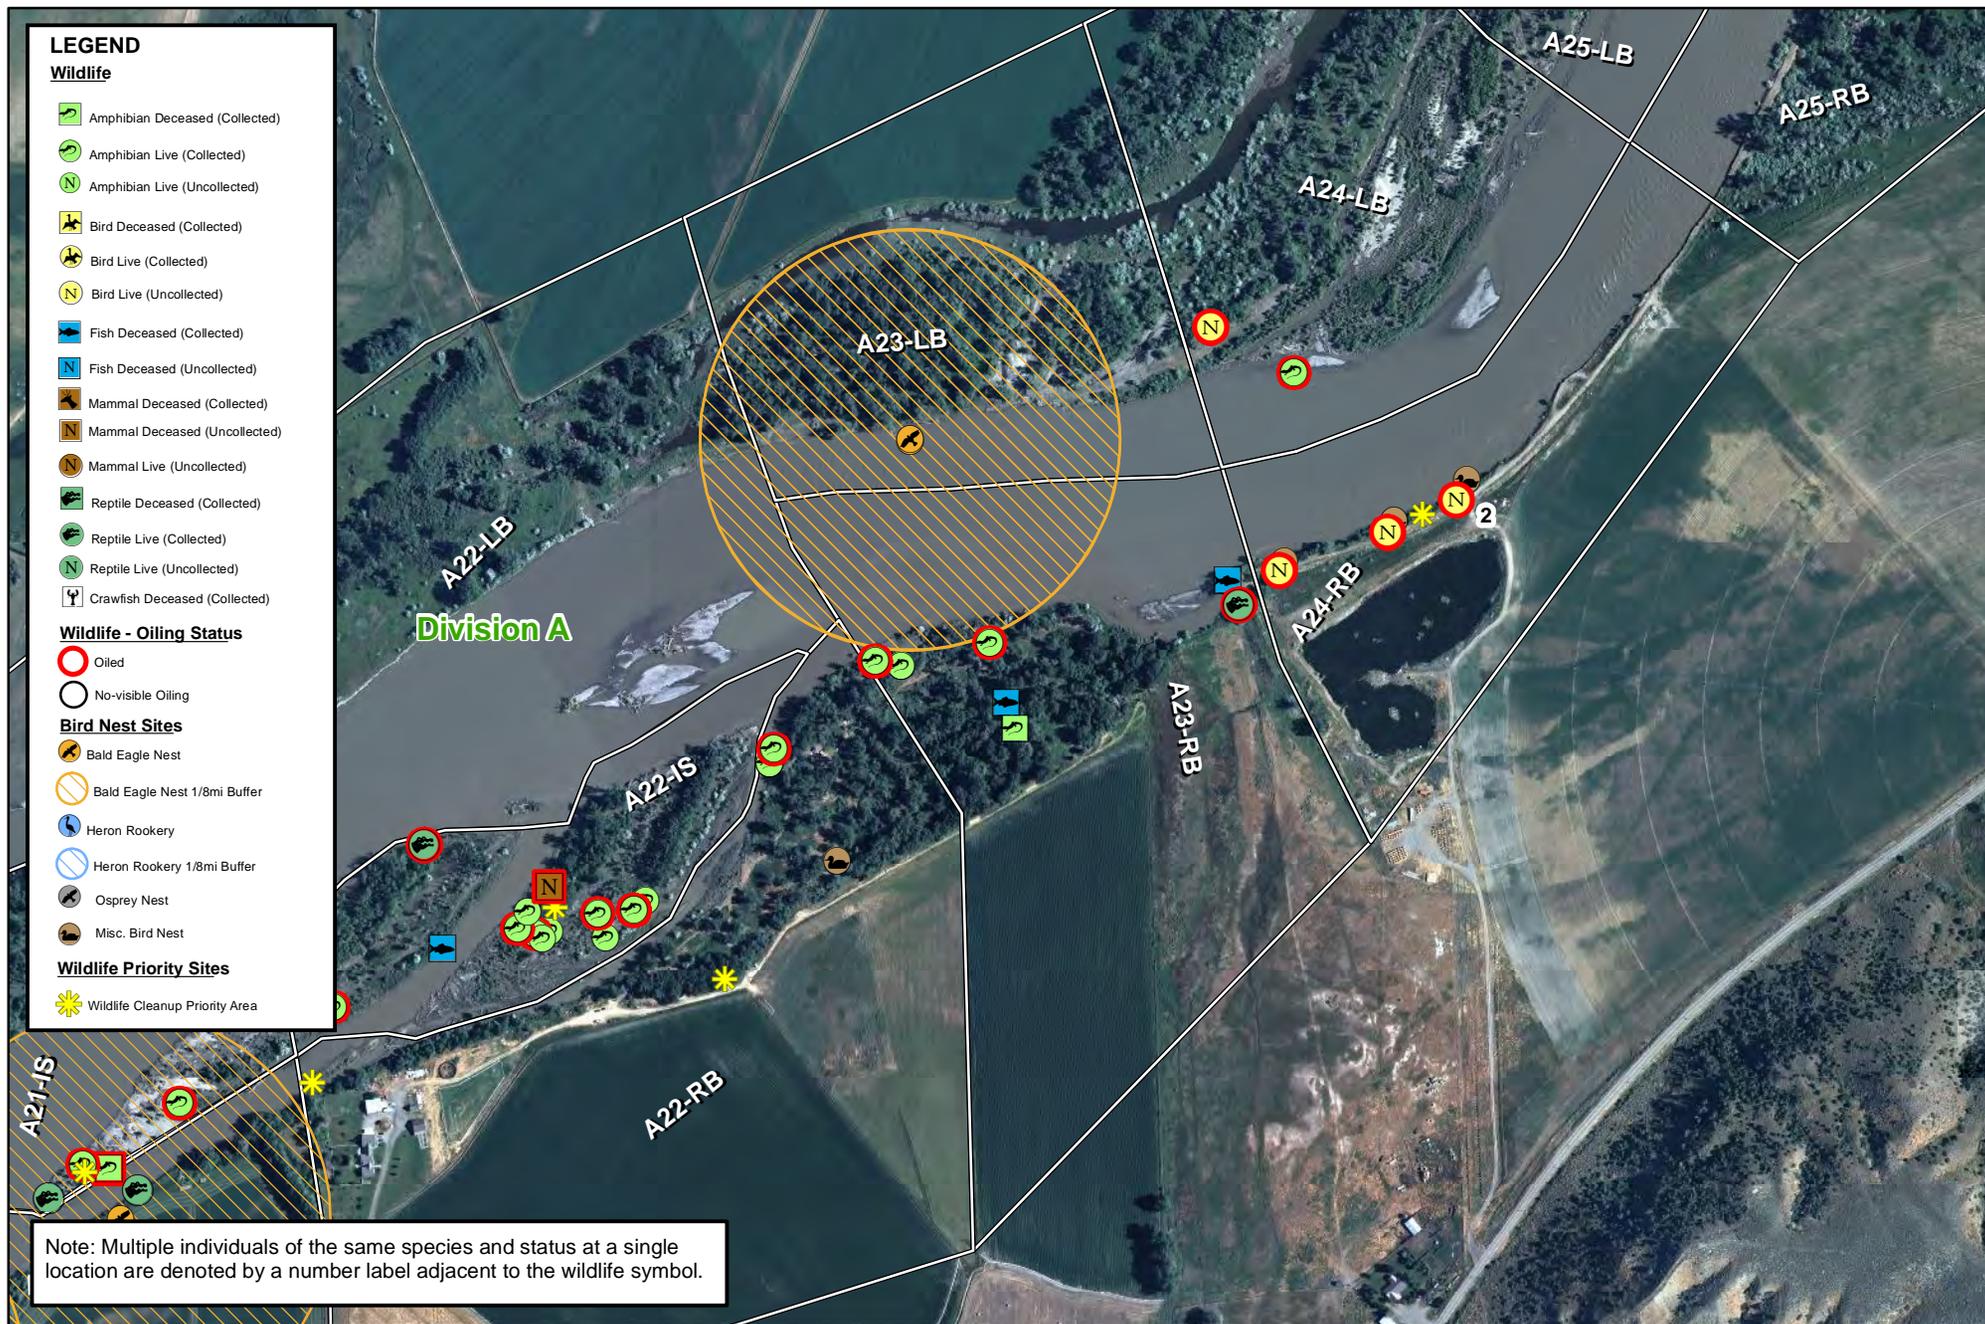
Figure 2
Wildlife Resources

Figure 2 summarizes the natural resources identified in this segment. International Bird Rescue and Resource Advisors from U.S. Fish and Wildlife Service conducted regular inspections of Area A23. Six oiled Woodhouse's toads (*Bufo woodhousii*) and one western terrestrial garter snake (*Thamnophis elegans*) were captured, cleaned, and released. In addition, three Woodhouse's toads were captured and taken to the Wildlife Recovery Center for an oiling evaluation, determined to be un-oiled, and released. One deceased catfish (unknown species) and fifty-four small fish (unknown species) with no visible oiling were collected and retained. No Wildlife Priority Cleanup Areas were identified. A bald eagle (*Haliaeetus leucocephalus*) nest was identified in Area A23 and the appropriate buffer zone was provided to Operations.

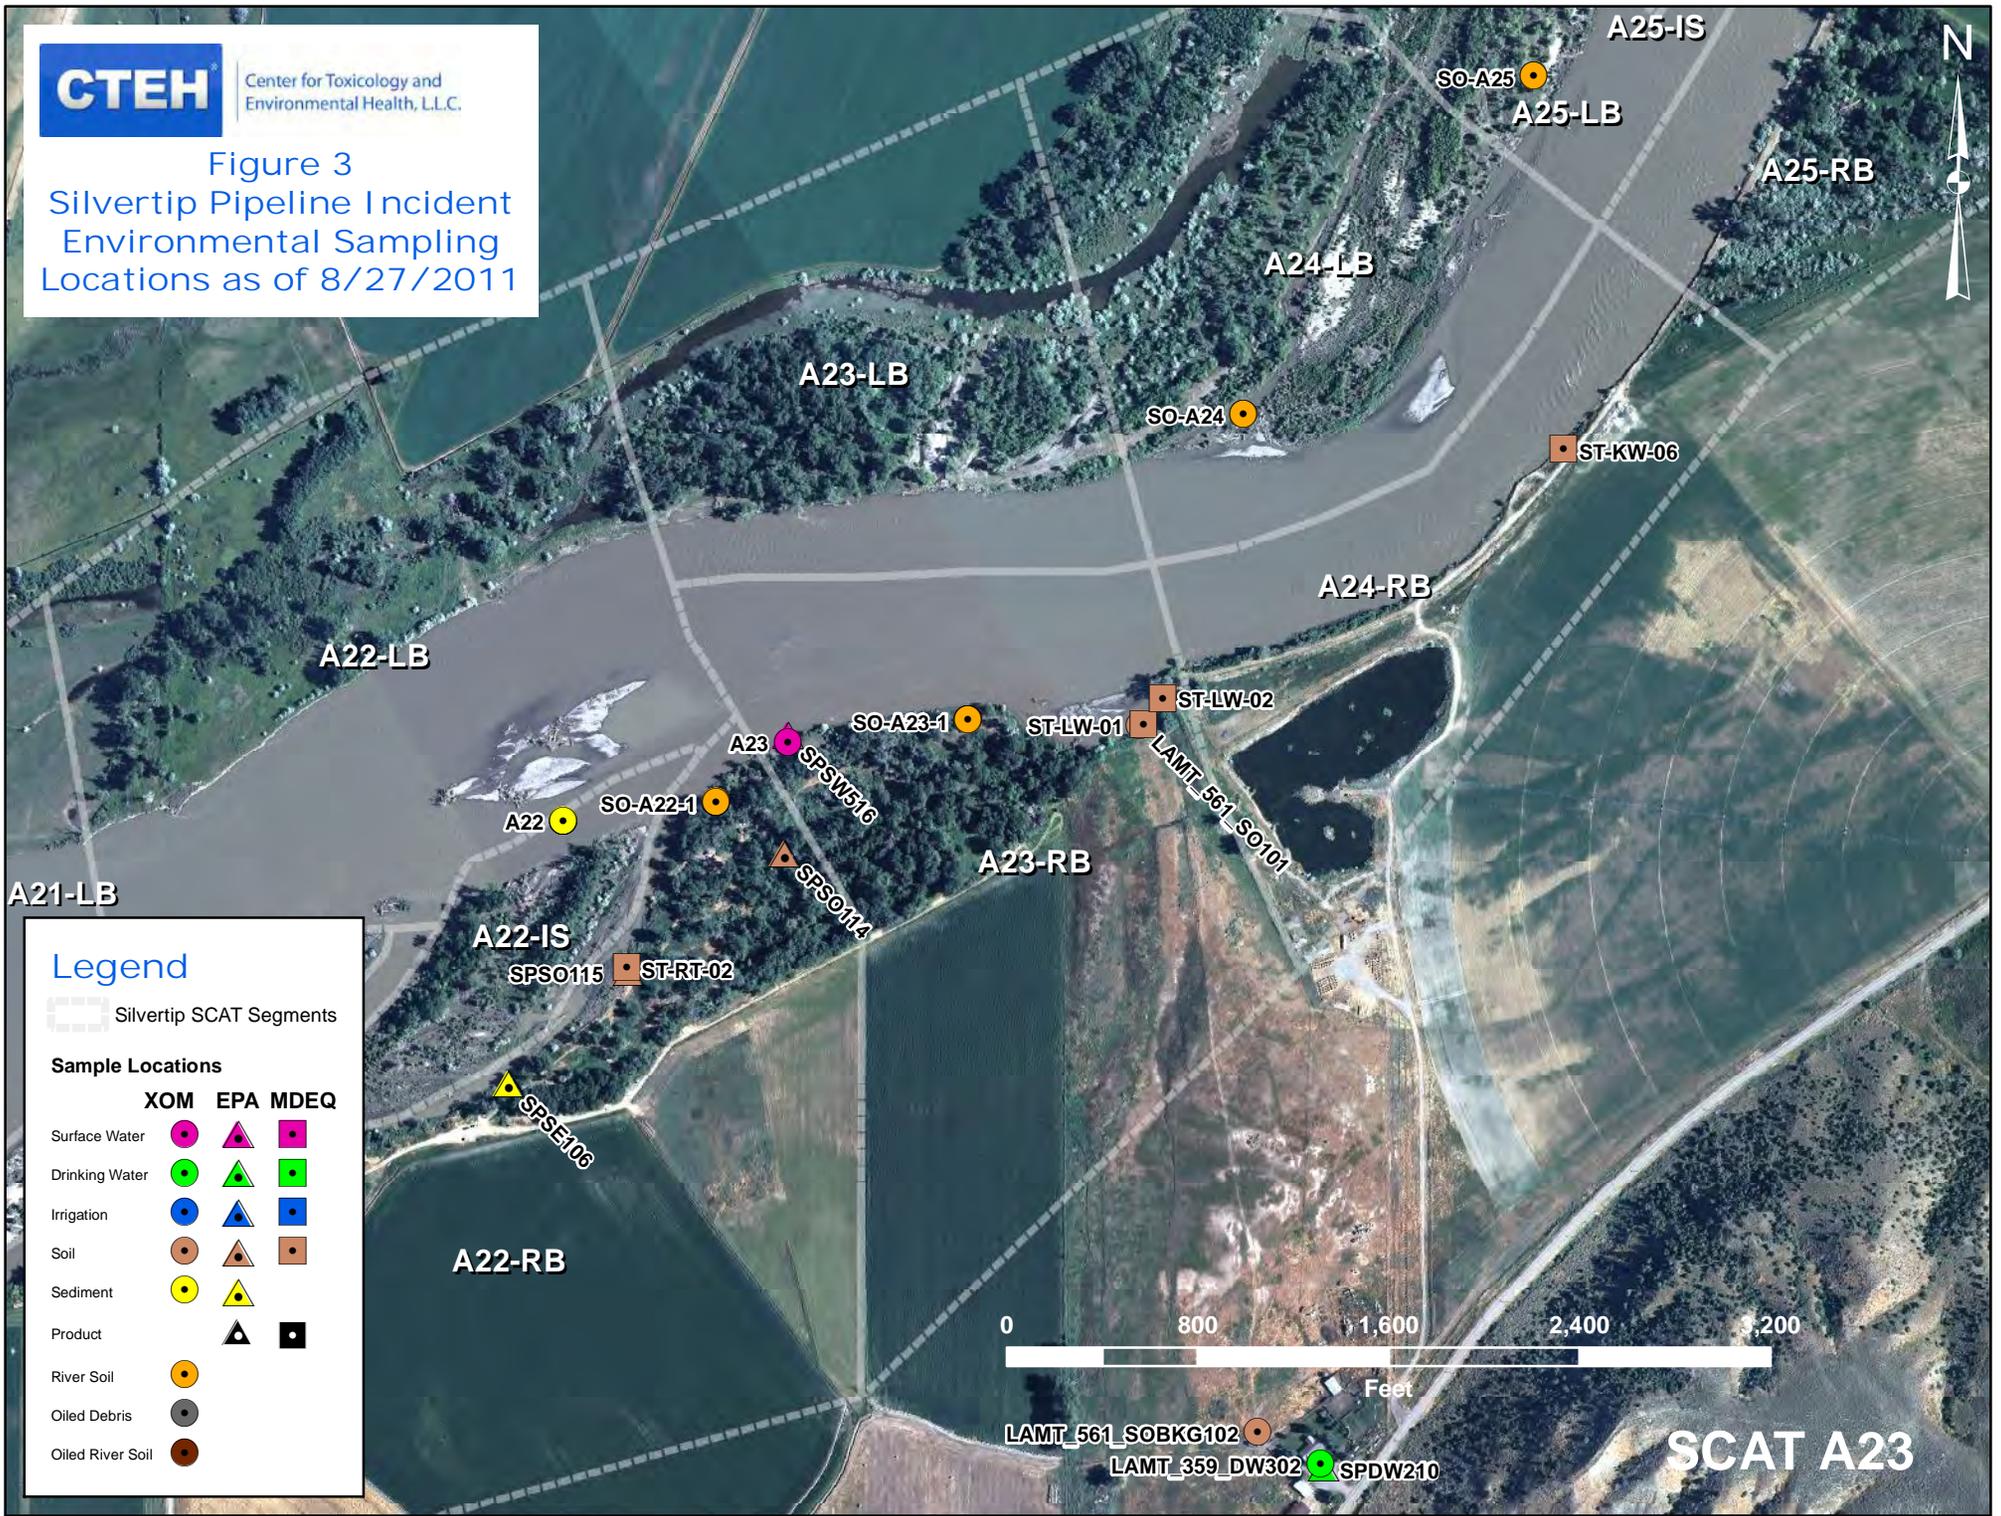
Figure 3
Silvertip Pipeline Incident
Environmental Sampling
Locations as of 8/27/2011

Table 1 (below) summarizes samples collected within Area A23. The analytical results for the samples collected can be accessed through a publicly accessible database on the United States Environmental Protection Agency's (USEPA's) website. The approximate locations of samples collected within Area A23 are provided on Figure 3.

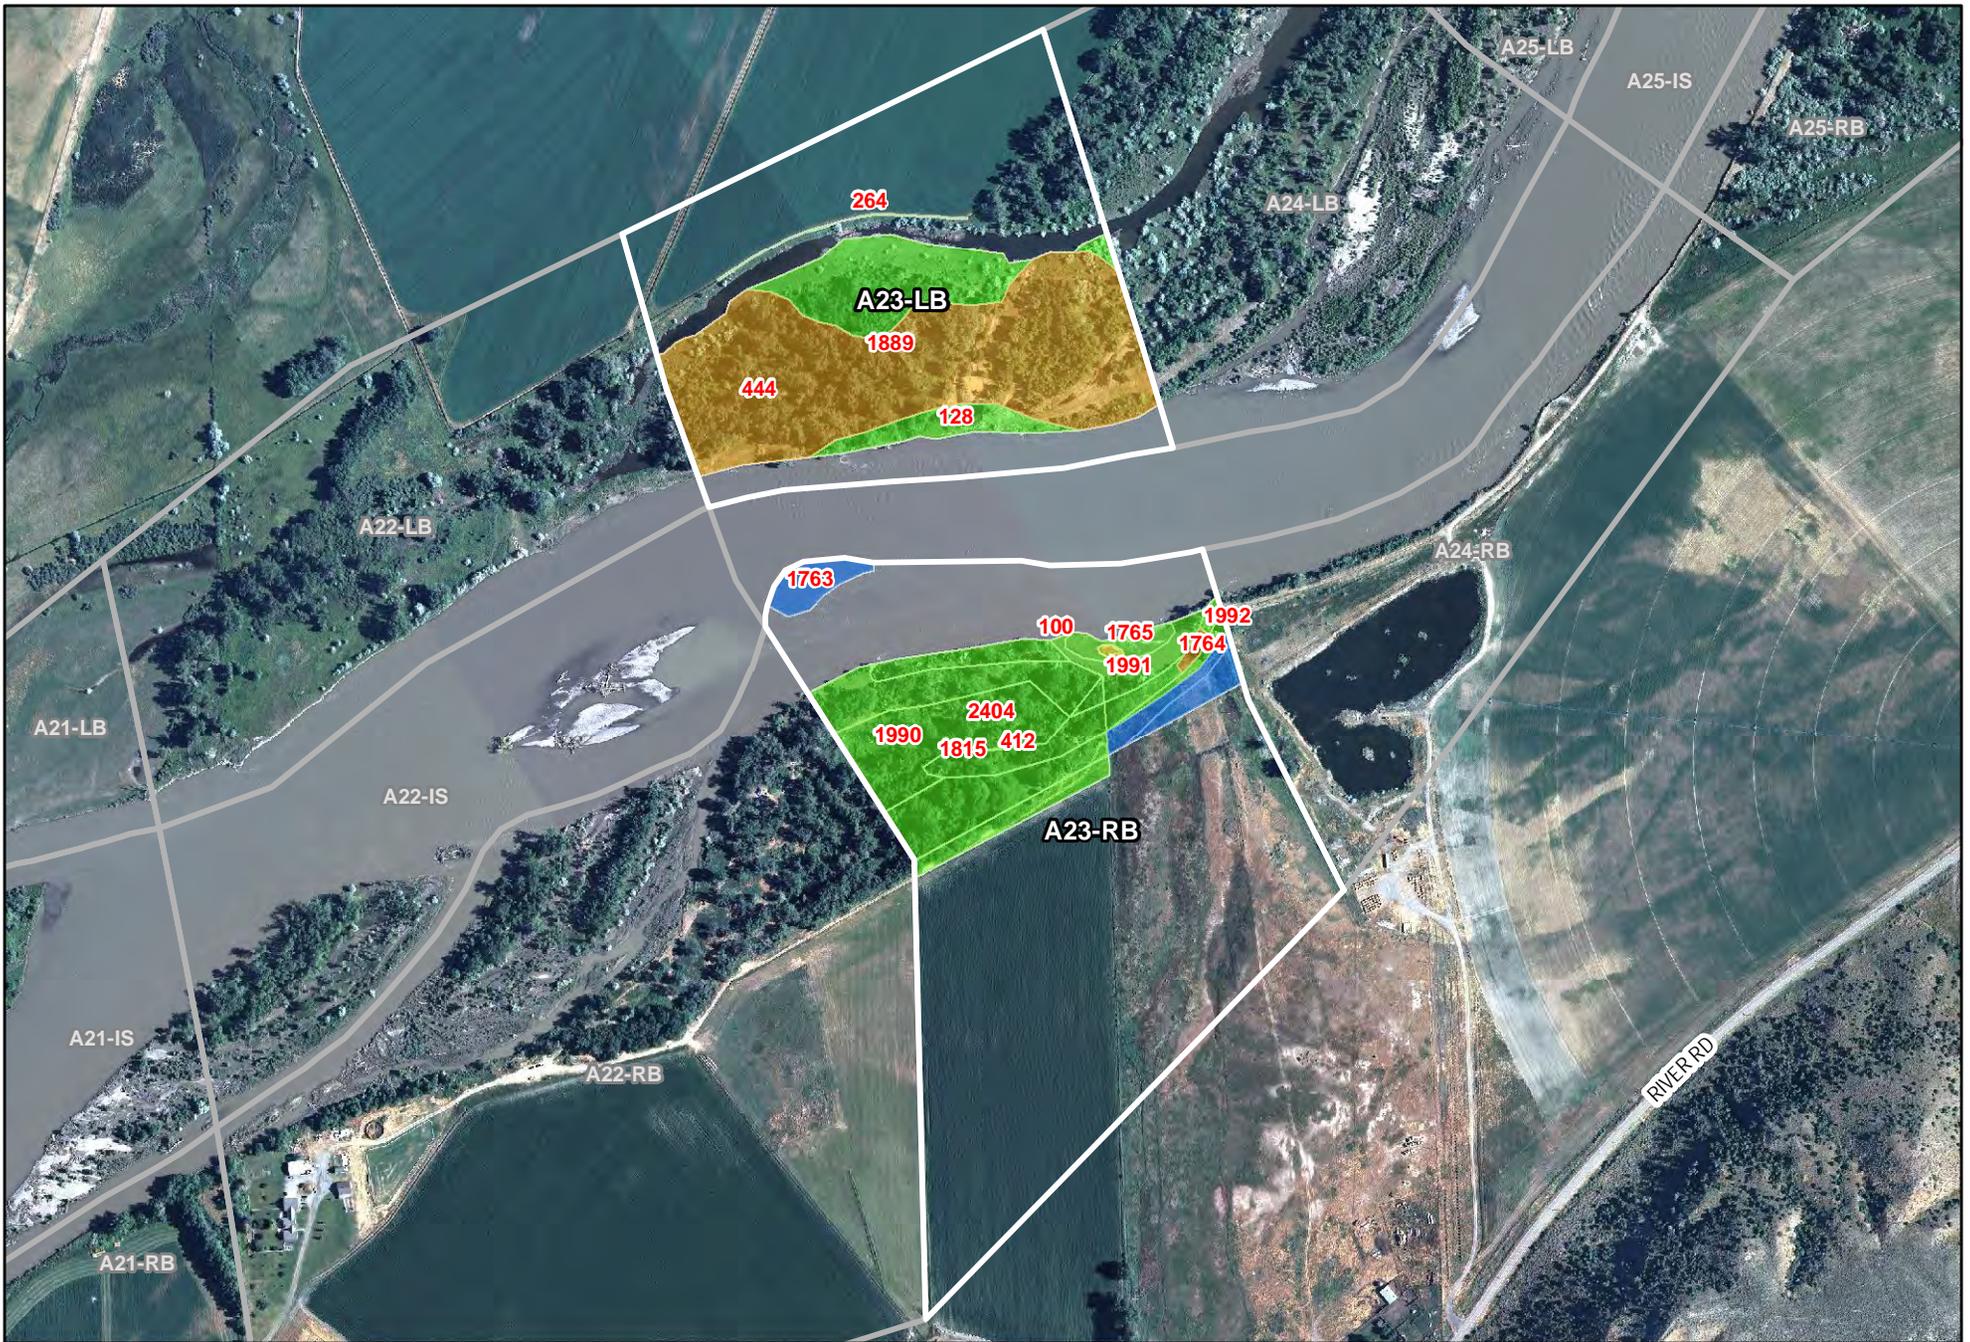
Figure 4 - Maximum SCAT Observations For SCAT Area:

The SCAT teams used systematic evaluation criteria and treatment method tables approved by the National Oceanic and Atmospheric Administration to provide a standard approach for data collection and conducting field surveys. The forms and sketches from the initial SCAT surveys performed along the river bank (water edge) and floodplain within Area A23 are included in Appendix B. Figure 4 provides the maximum oiling zones observed by the SCAT team during the initial surveys of Area A23.

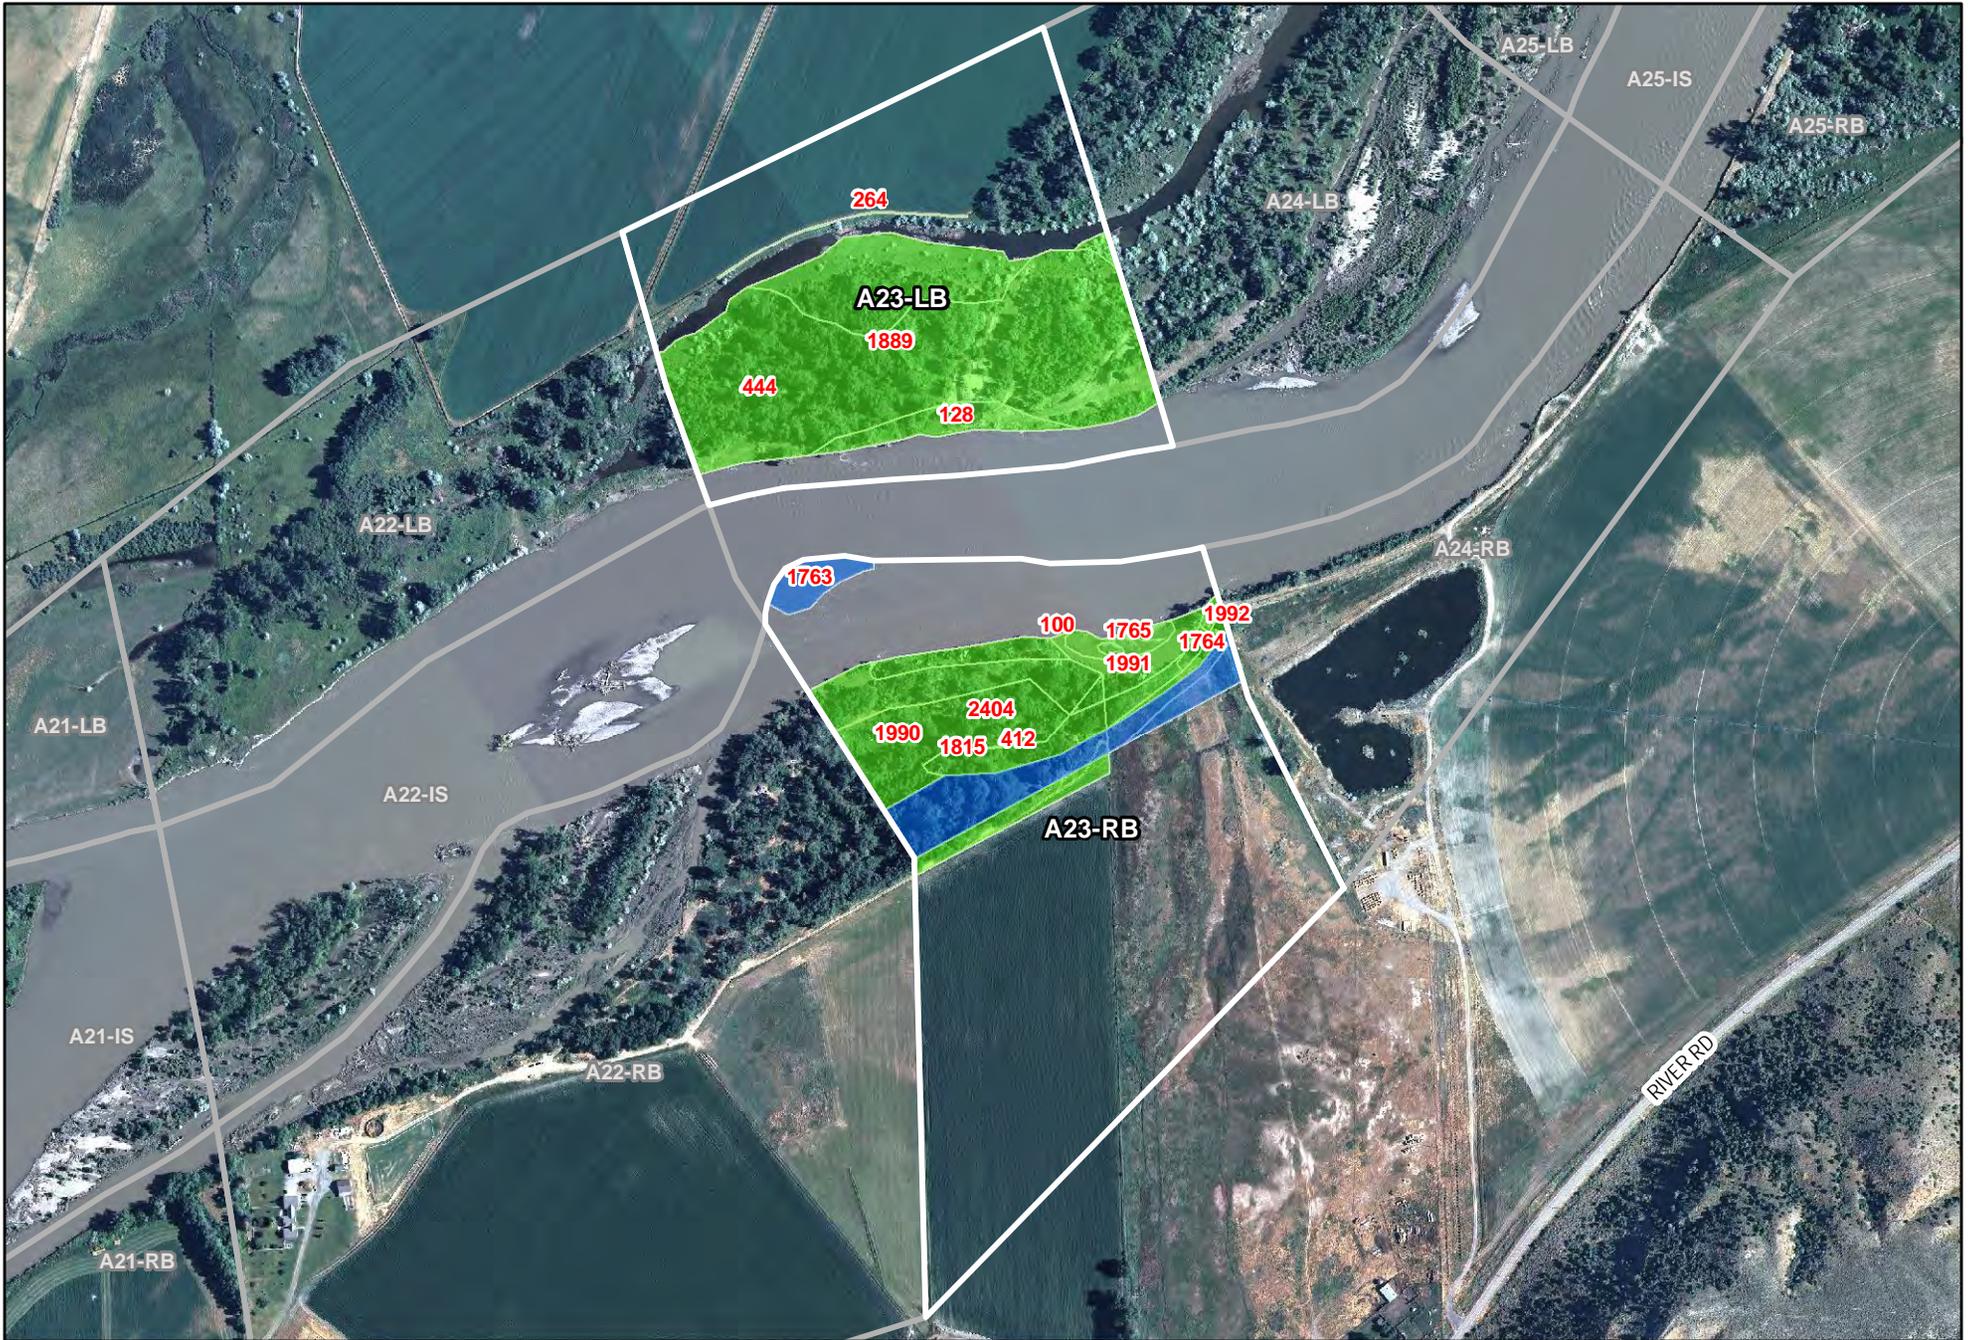
Figure 5 shows the oiling conditions within Area A23 following completion of oil removal activities. The SCAT team performed final surveys of the left and right banks within SCAT Area A23 to confirm the agreed-upon cleanup endpoints identified in the applicable CTRs had been achieved. The final SCAT survey documentation is presented in Appendix E.

No Oil Observed</p>	<p>Figure 5 - Final SCAT Observations</p> <p>For SCAT Area: A23</p> <p>0 450 900 Feet</p>

Based on the final SCAT surveys performed on the left and right banks within Area A23, no further treatment is recommended for these segments. SCAT Segment Sign-Off Forms are included as Appendix F.

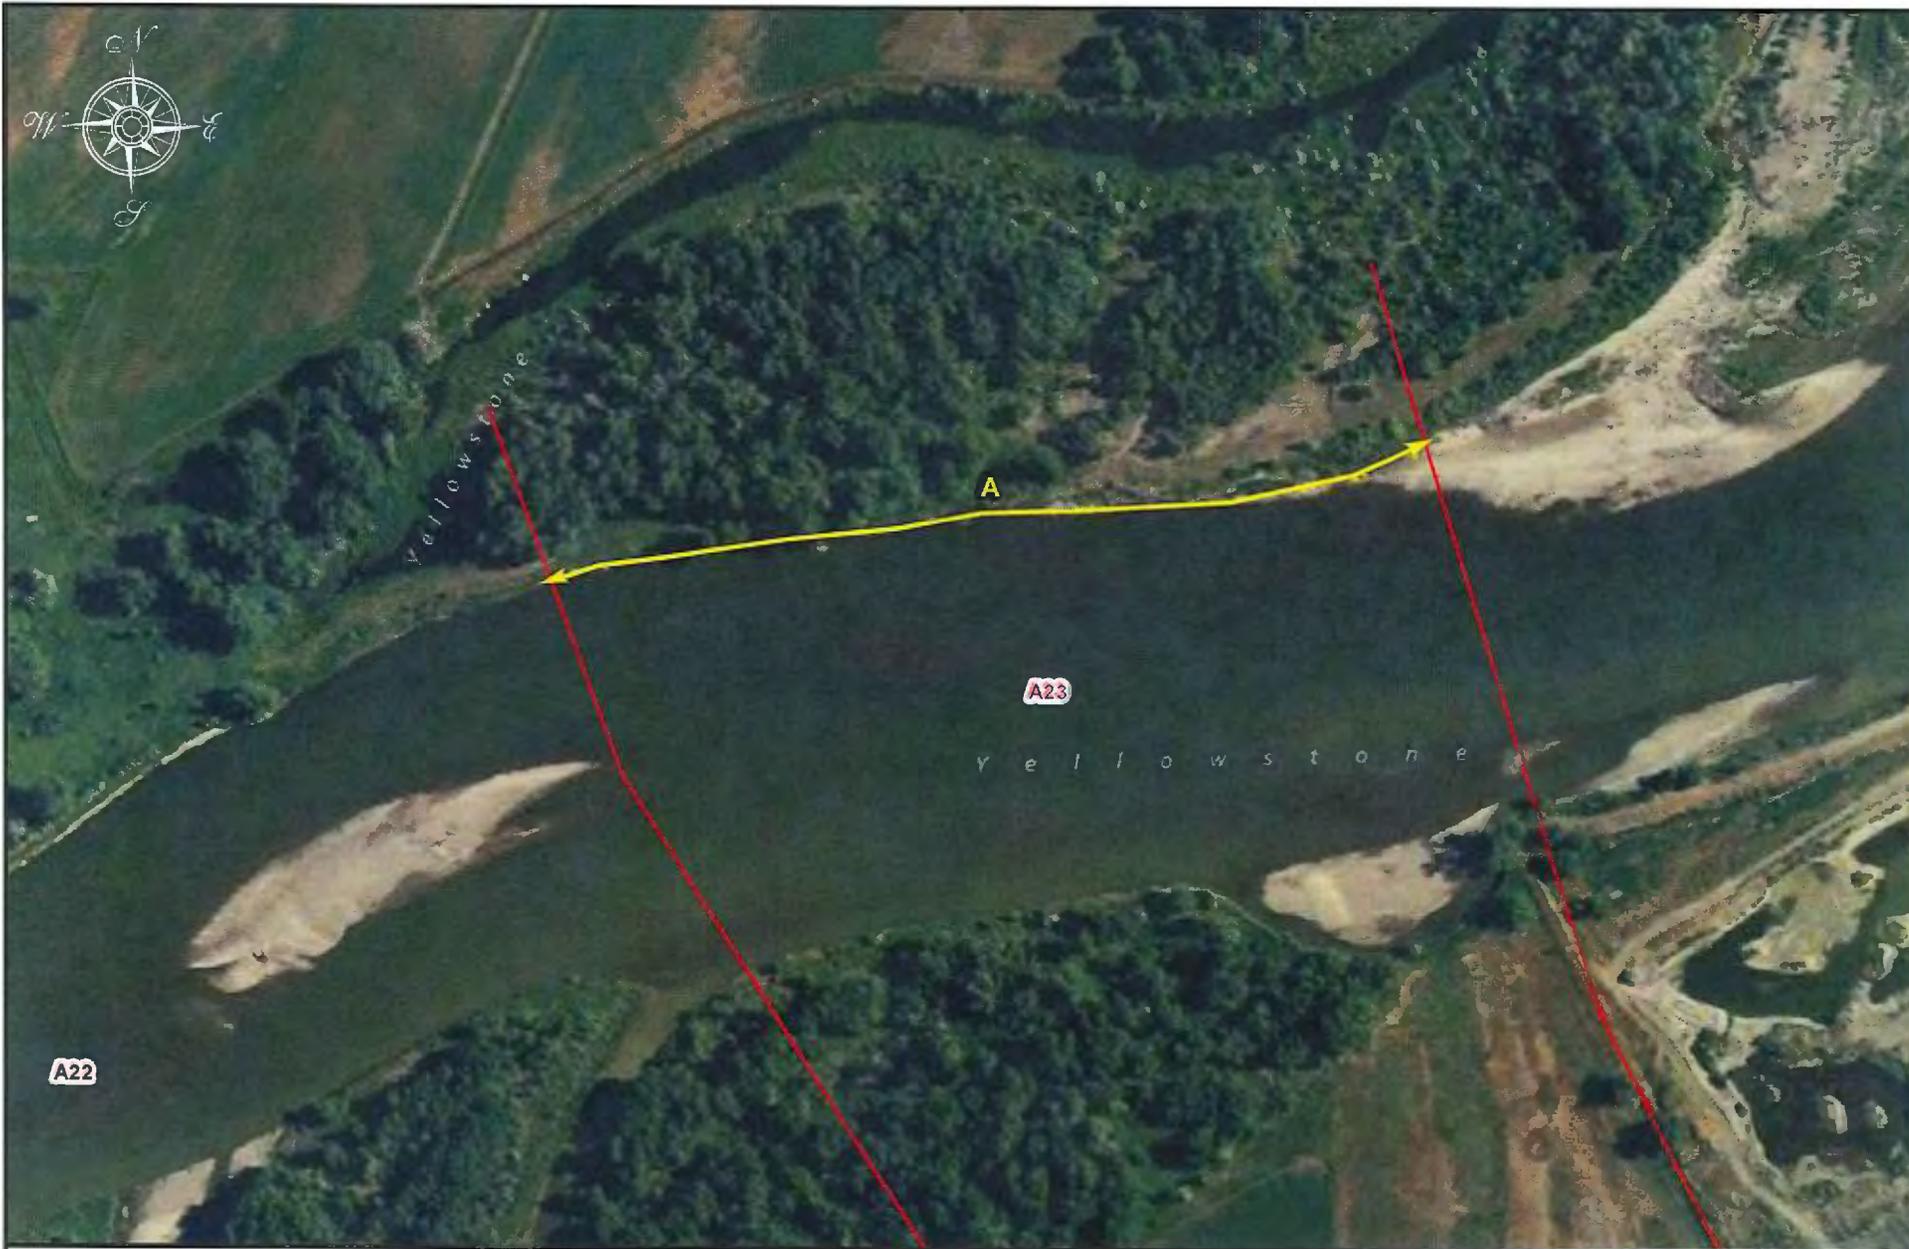
Segment A23 Left Bank

Oiled Band Heights: Zone A - 40cm

Due to survey platform (jet-drive boat) oil band width and heights are estimates. Unable to verify by foot.

Cleanup Recommendations: Trim oiled vegetation; wipe large oiled debris; remove small oiled debris; wipe oiled trees;

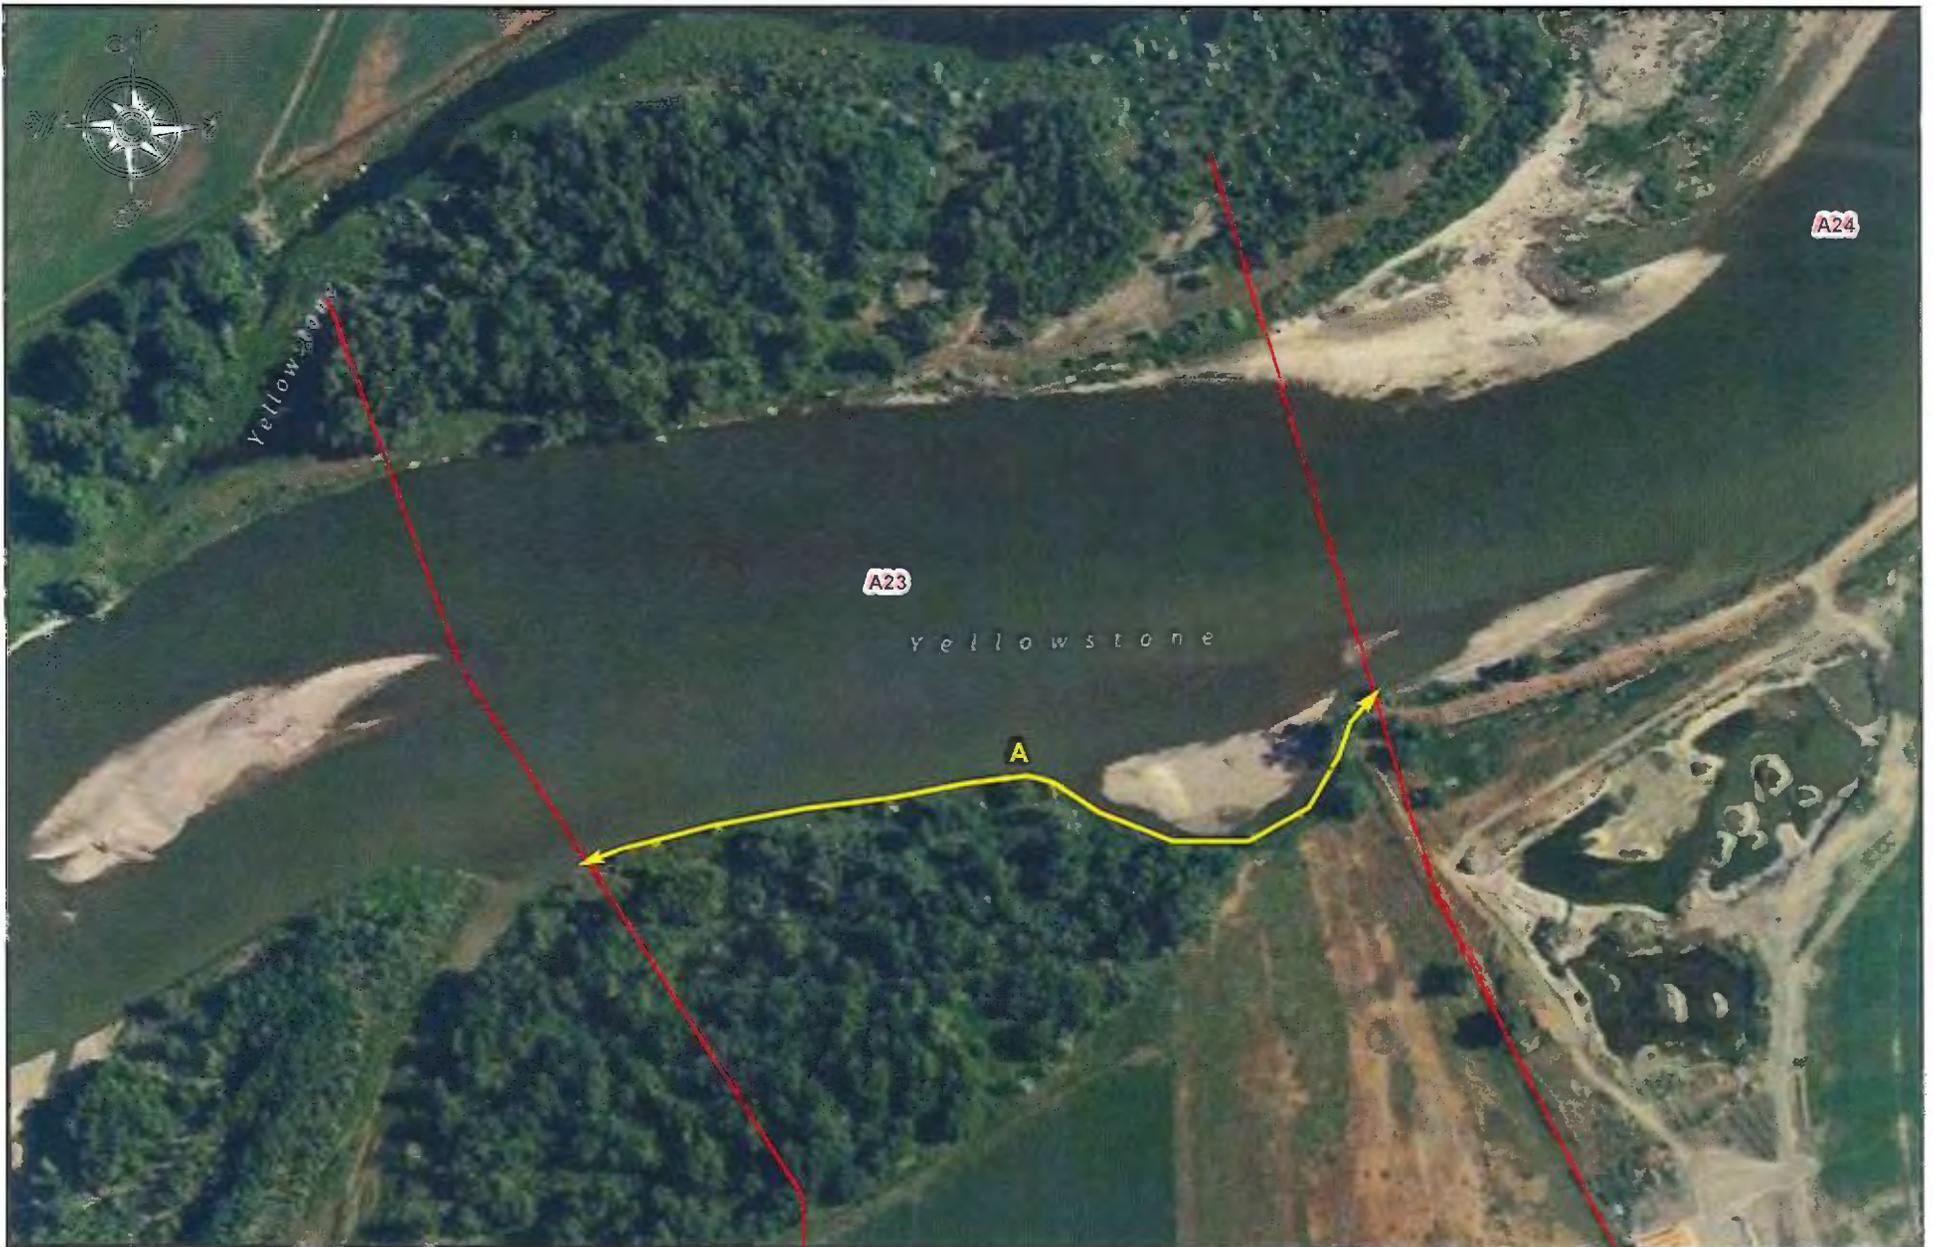
Segment A23 Right Bank

Zone A recommendations: NFT - NOD

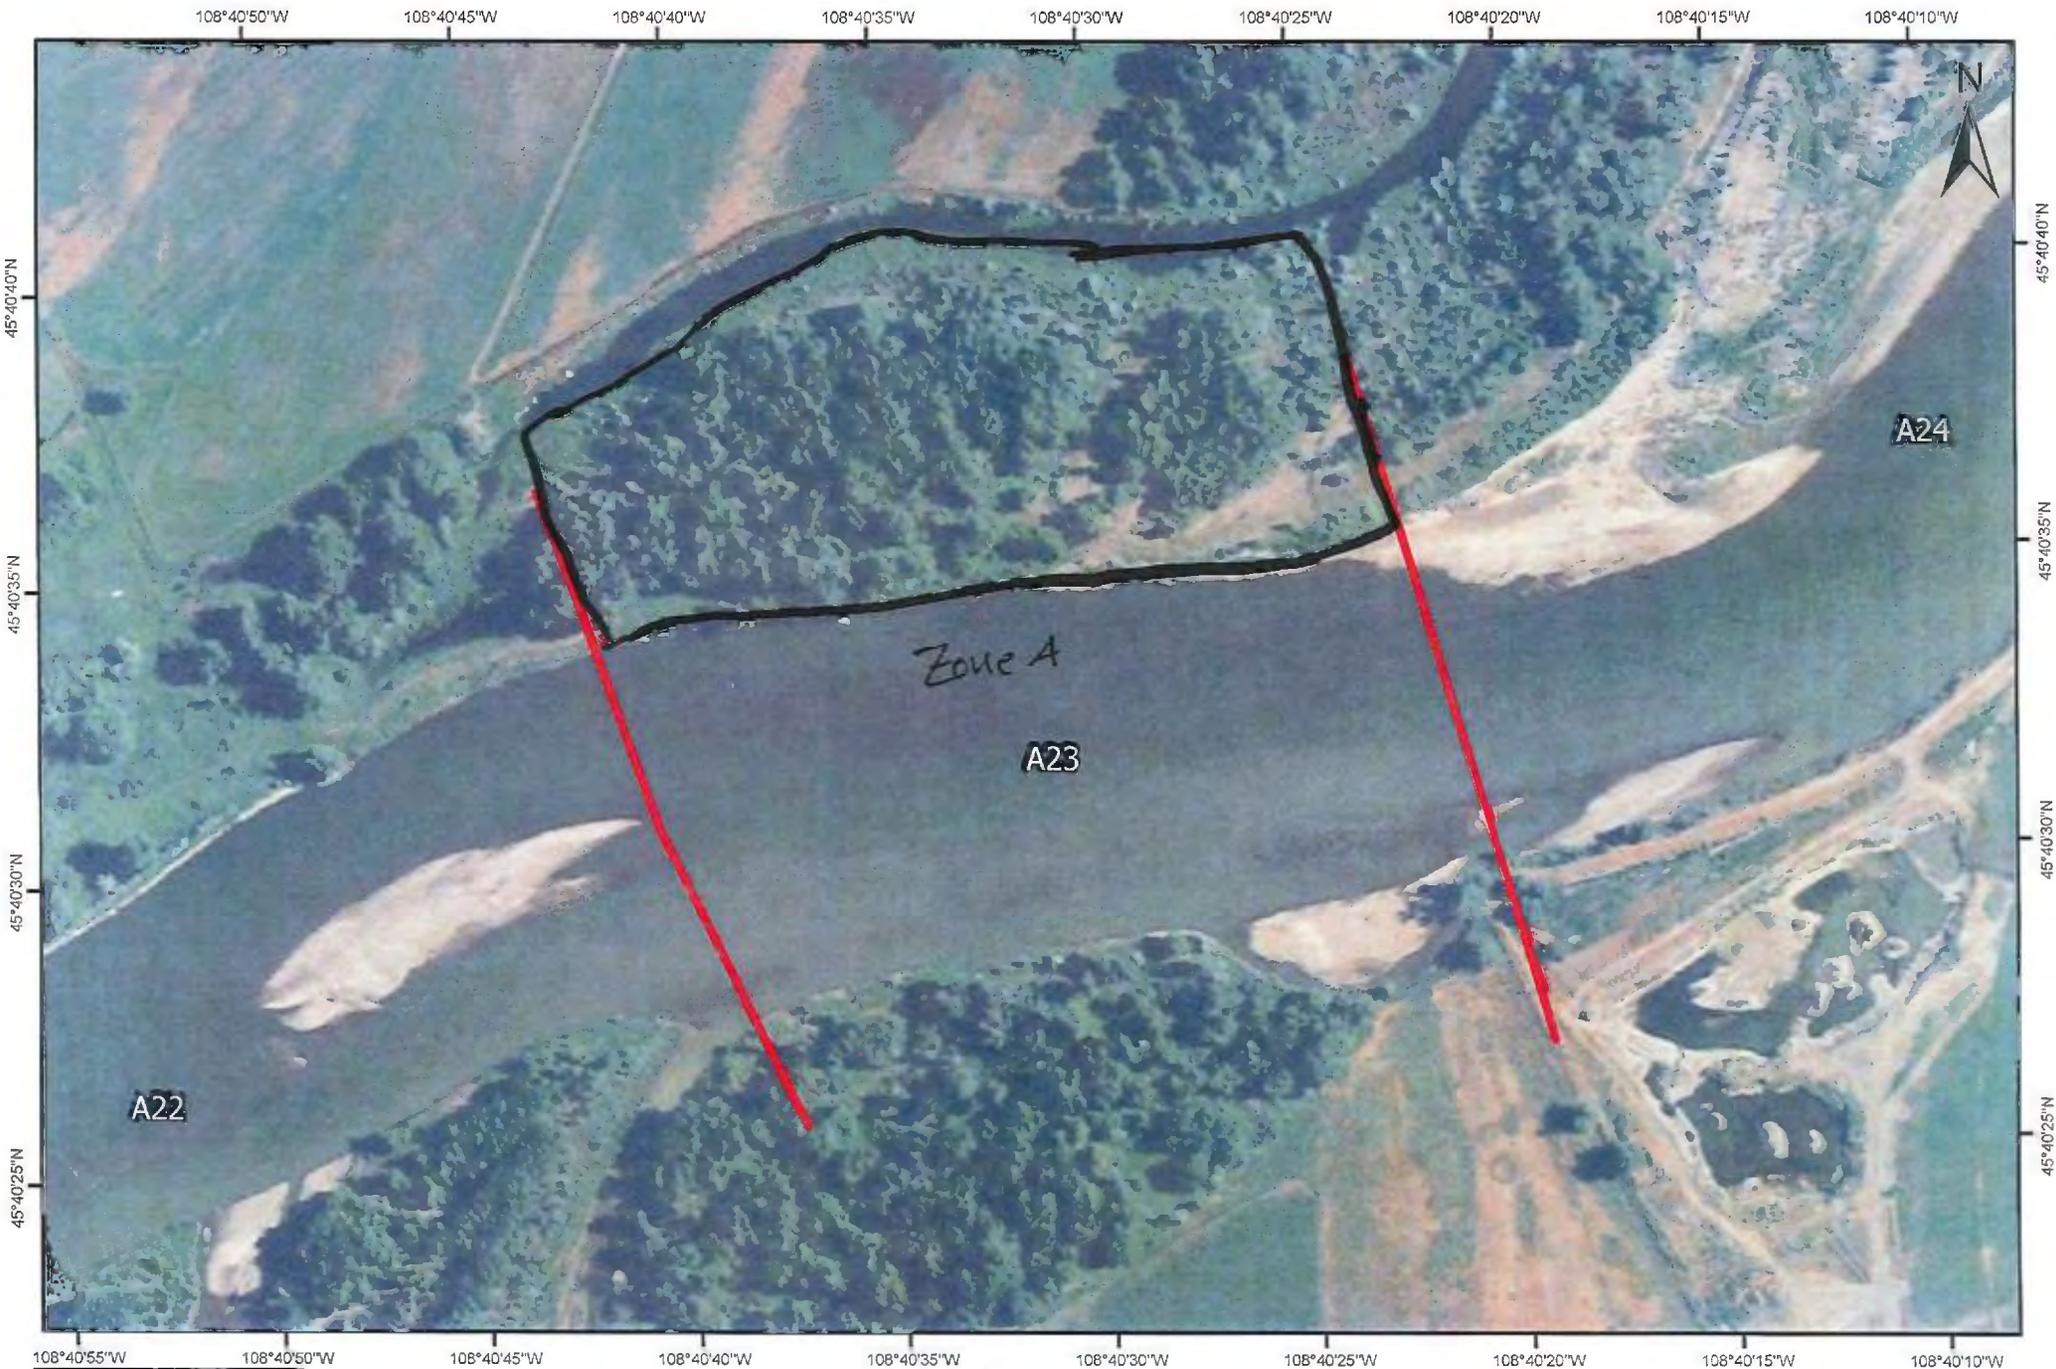
A23 - LB
(L/R/I)??

Zone A- Unit checked with hotshot team. Treated 10 minor spots (<1m square) with transferable stains and coatings- tar consistency. Treatments included cut and remove oiled vegetation <1 inch, remove oil coated material <4 inches, and dusted oil stained and coated material. No further treatment required.
