**SCAT Area Transition Report
for A23**

Silvertip Pipeline Incident
Laurel, Montana

October 18, 2011

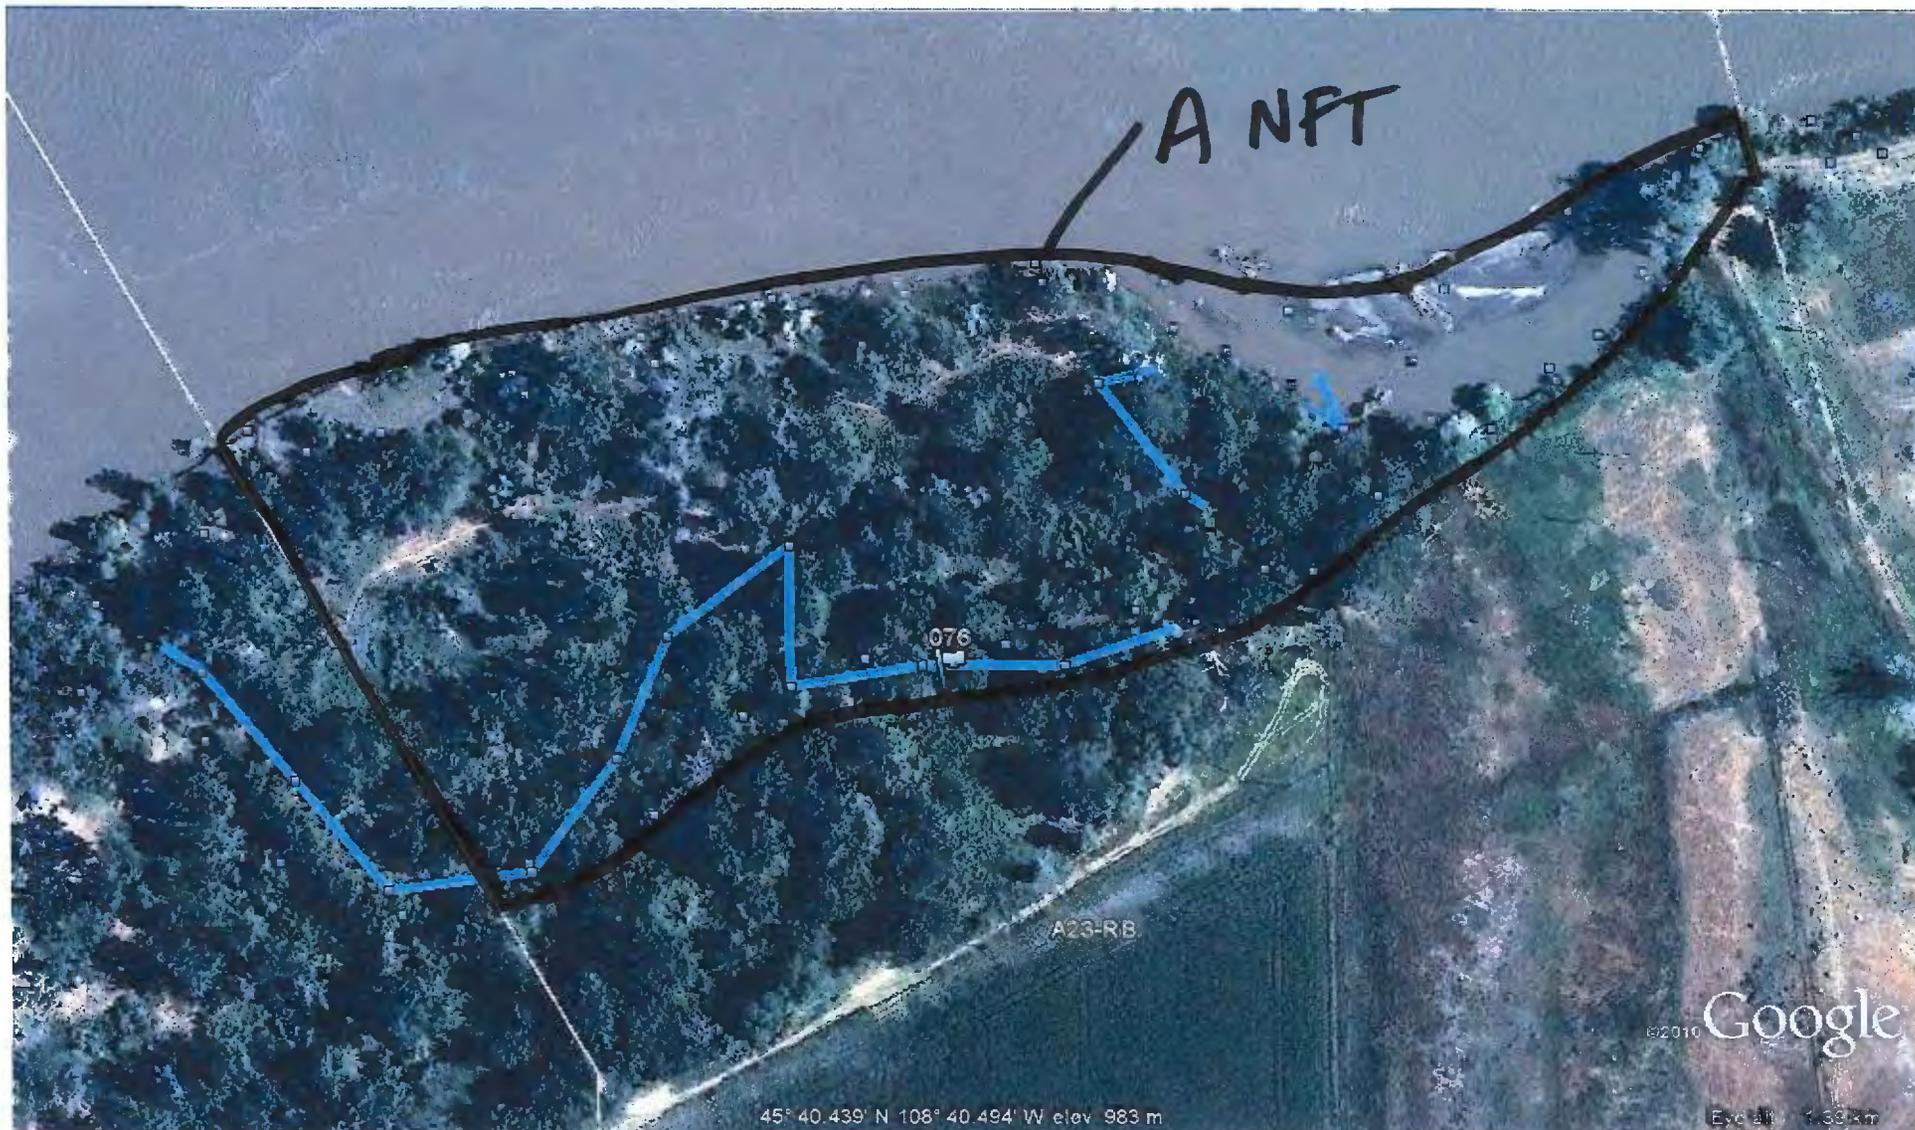
A23 RB
T3 9/27/11

Ops Hot Shot Team (Alex Barboza)
Removed 1 bag of VG/DB
Note: Stopped short of east segment boundary due to no access landowner
Previous cleanup operations (CTR 14)
